1. Survey number: CO-AS-008-001		2. Survey Name: West Main Street Survey	
3. County: Cole		4. Address (Street No.): 100	Street (name): East Circle Drive
5. City: Jefferson City	Vicinity <input type="checkbox"/>	6. Lat / Long:	7. Township/Range/Section: T: R: S:
8. Historic name (if known):		9. Present/other name (if known):	
10. Ownership: <input checked="" type="checkbox"/> Private <input type="checkbox"/> Public		11a. Historic use (if known): Domestic-Single Dwelling	11b. Current use: Domestic-Single Dwelling

MISSOURI DEPARTMENT OF NATURAL RESOURCES
STATE HISTORIC PRESERVATION OFFICE, P.O. Box 178, Jefferson City, MO 65102
ARCHITECTURAL/HISTORIC INVENTORY FORM

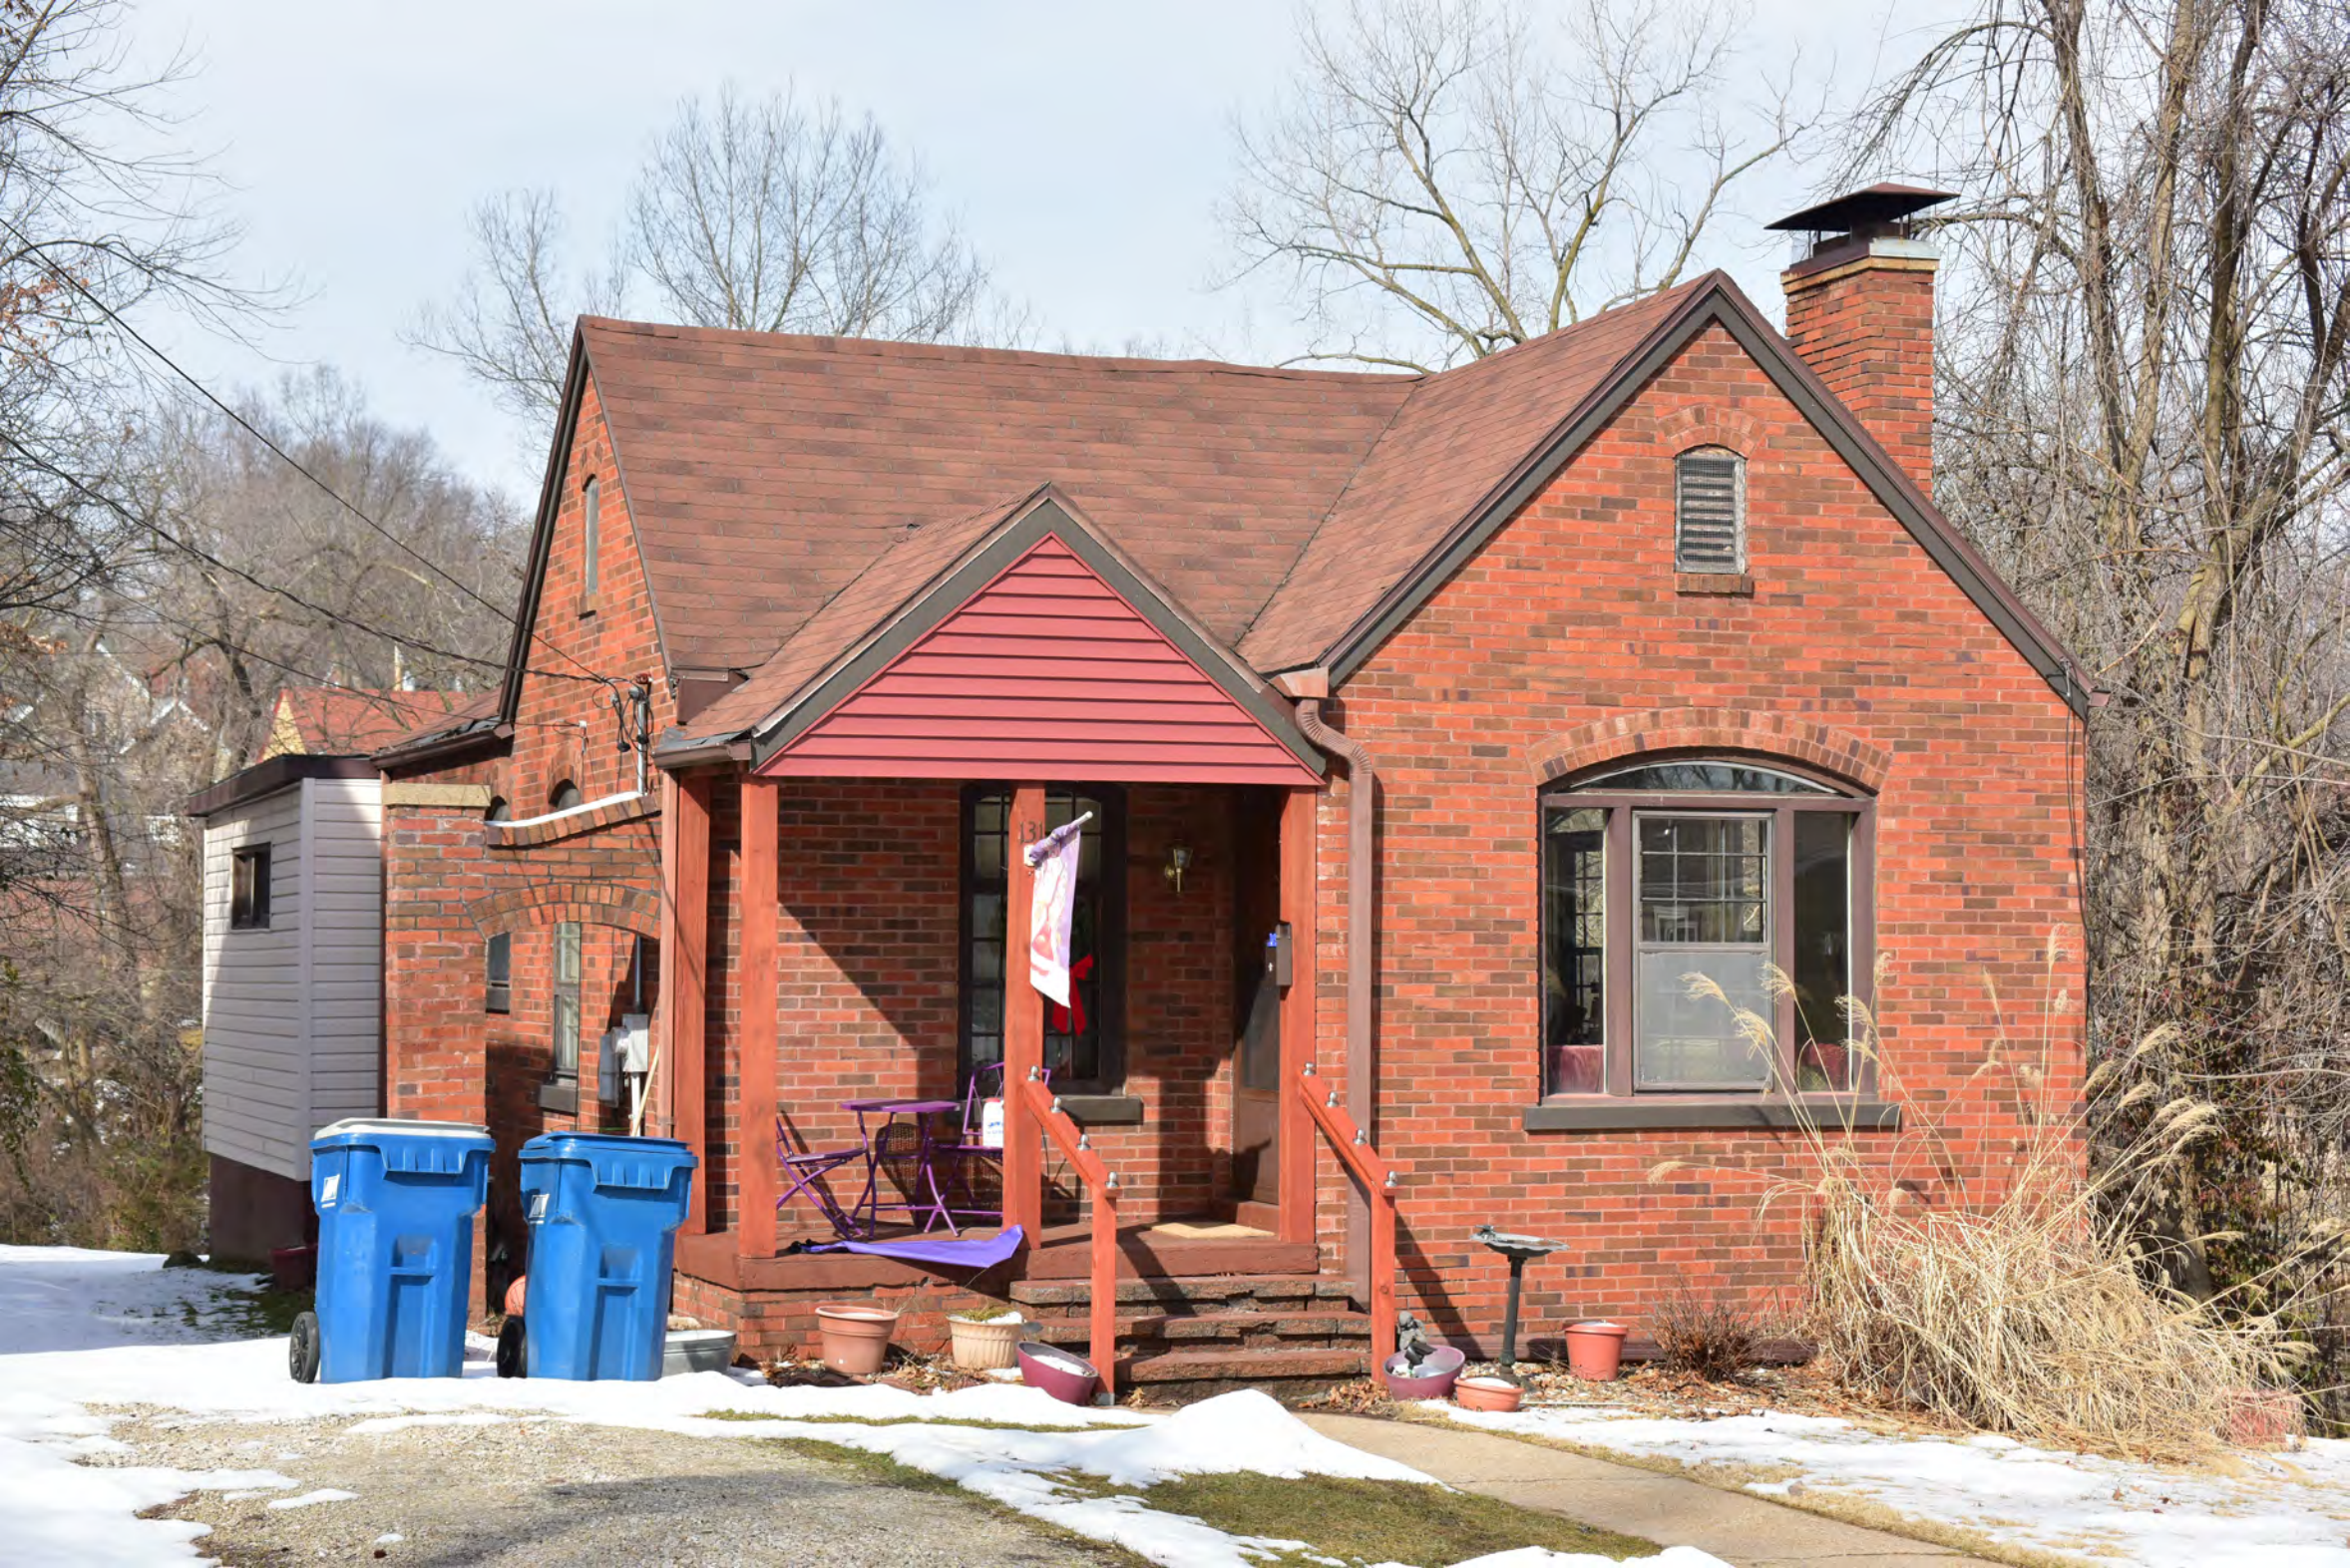
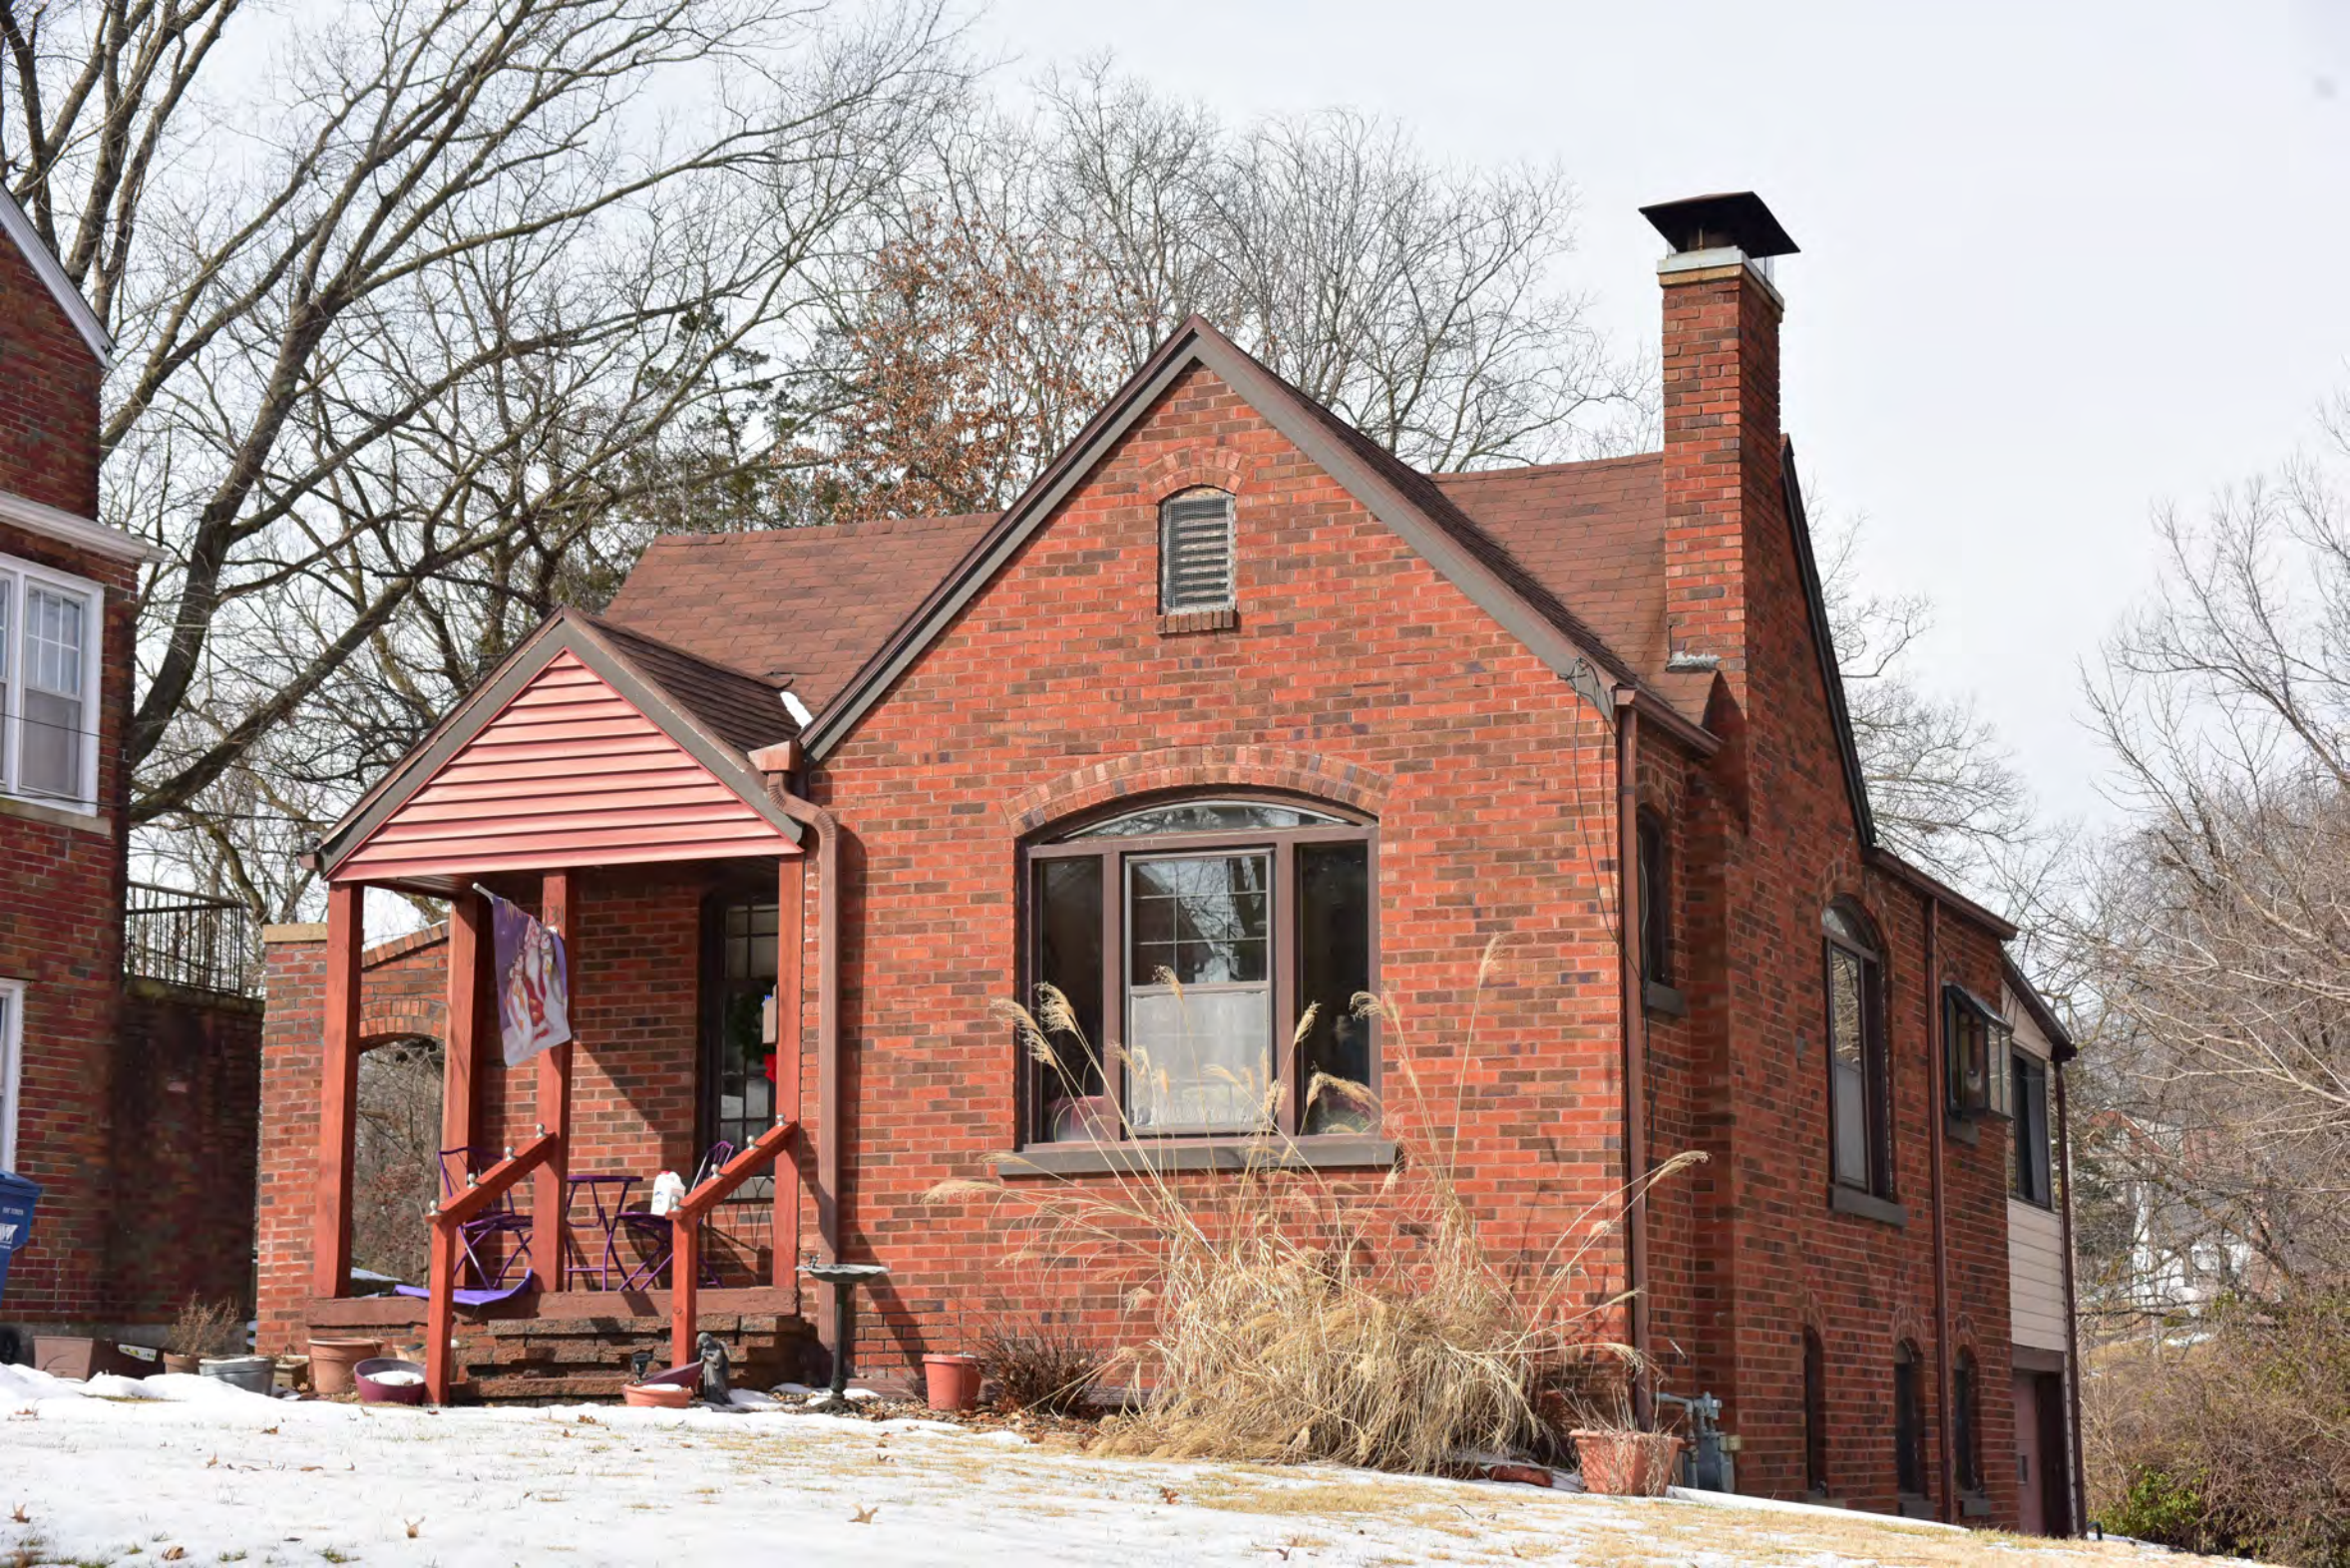
131 East Circle Drive is a one-story Minimal Traditional dwelling with a raised basement. The brick-clad dwelling has a concrete foundation and an asphalt intersecting gable roof. The primary roof mass is a gabled-ell while a perpendicular gable extends from the rear. A brick wingwall with arched opening extends from the southeast corner of the dwelling. A brick exterior chimney pierces the gable eave and the north elevation. The dwelling is two bays wide. A historic multi-light wood window defines the first bay. The second bay is in the gabled-ell. A tripartite metal window defines the bay. Fixed one-light windows flank the central 9/9 window. A thin, arched single-pane tops the window. The primary entrance is in the north wall of the ell. It contains a historic wood door with multi-light glazing. A partial-width open porch projects from the entrance. It has a concrete floor, brick foundation, and a gable roof. Non-historic squared wood posts support the roof and hardboard cladding fills the gable end. A vinyl-clad enclosed porch and addition project from the rear elevation. A historic integrated garage is located beneath the porch at the north elevation. A historic overhead door with glazing fills the vehicular bay.

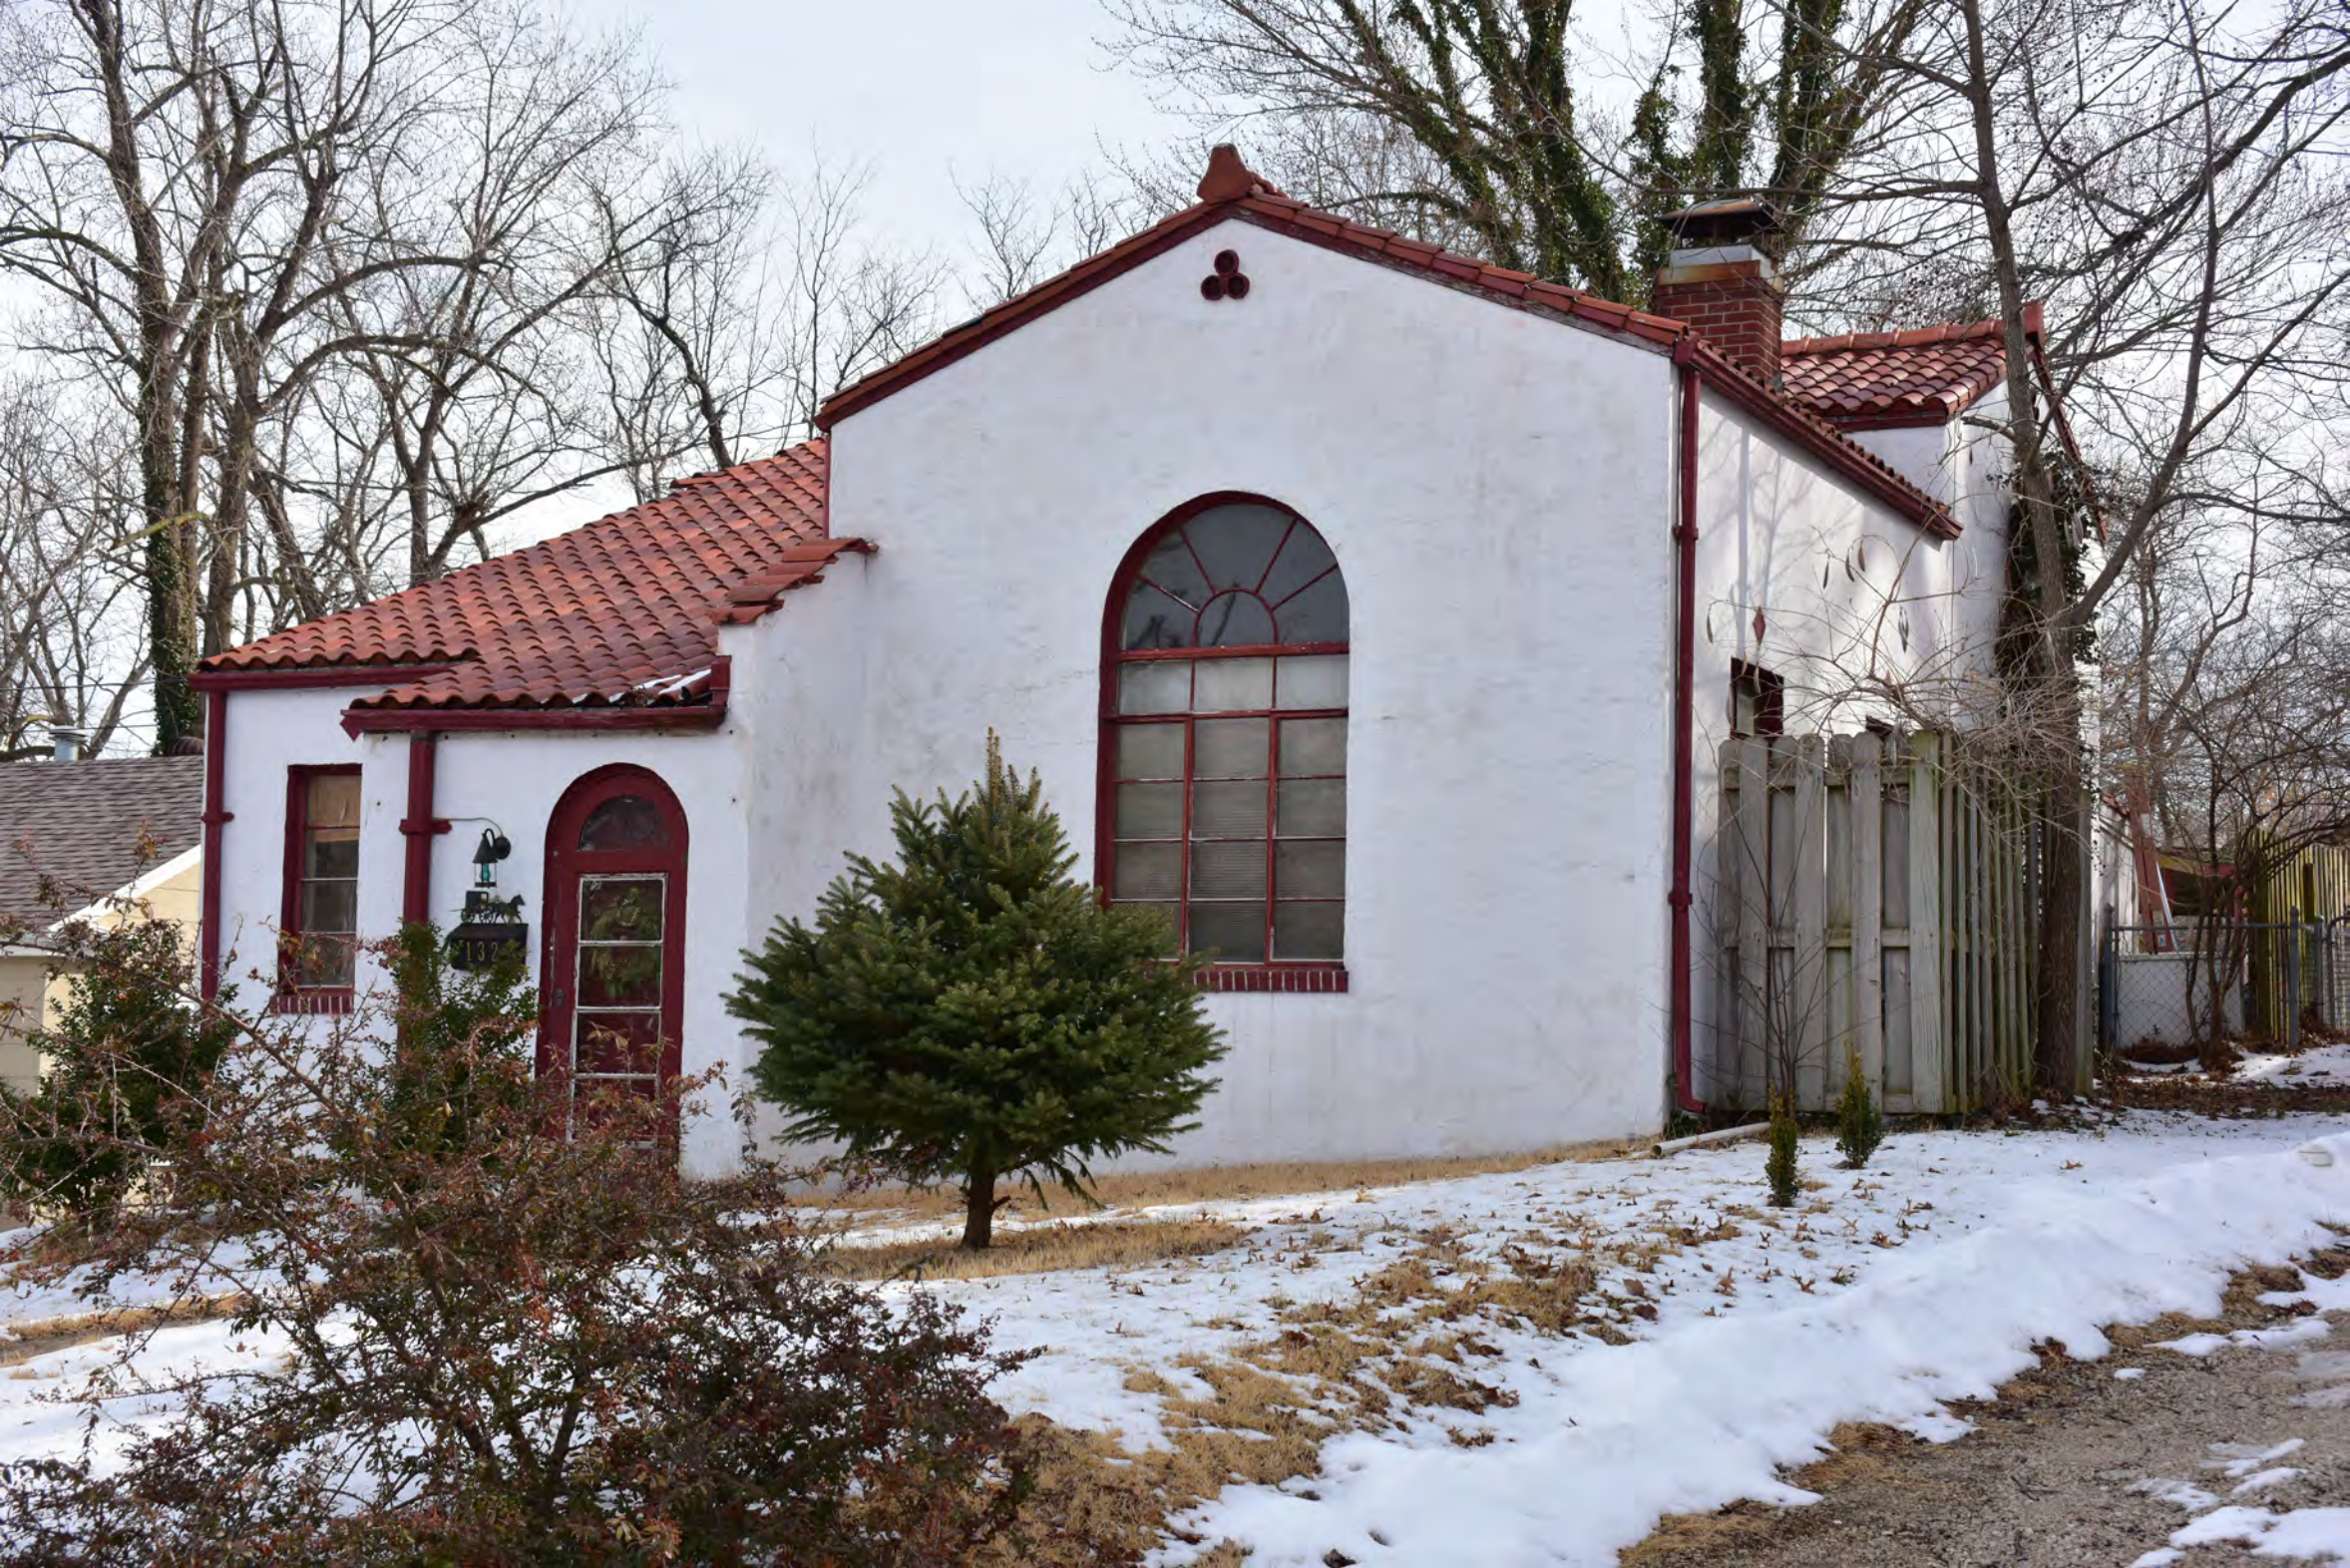
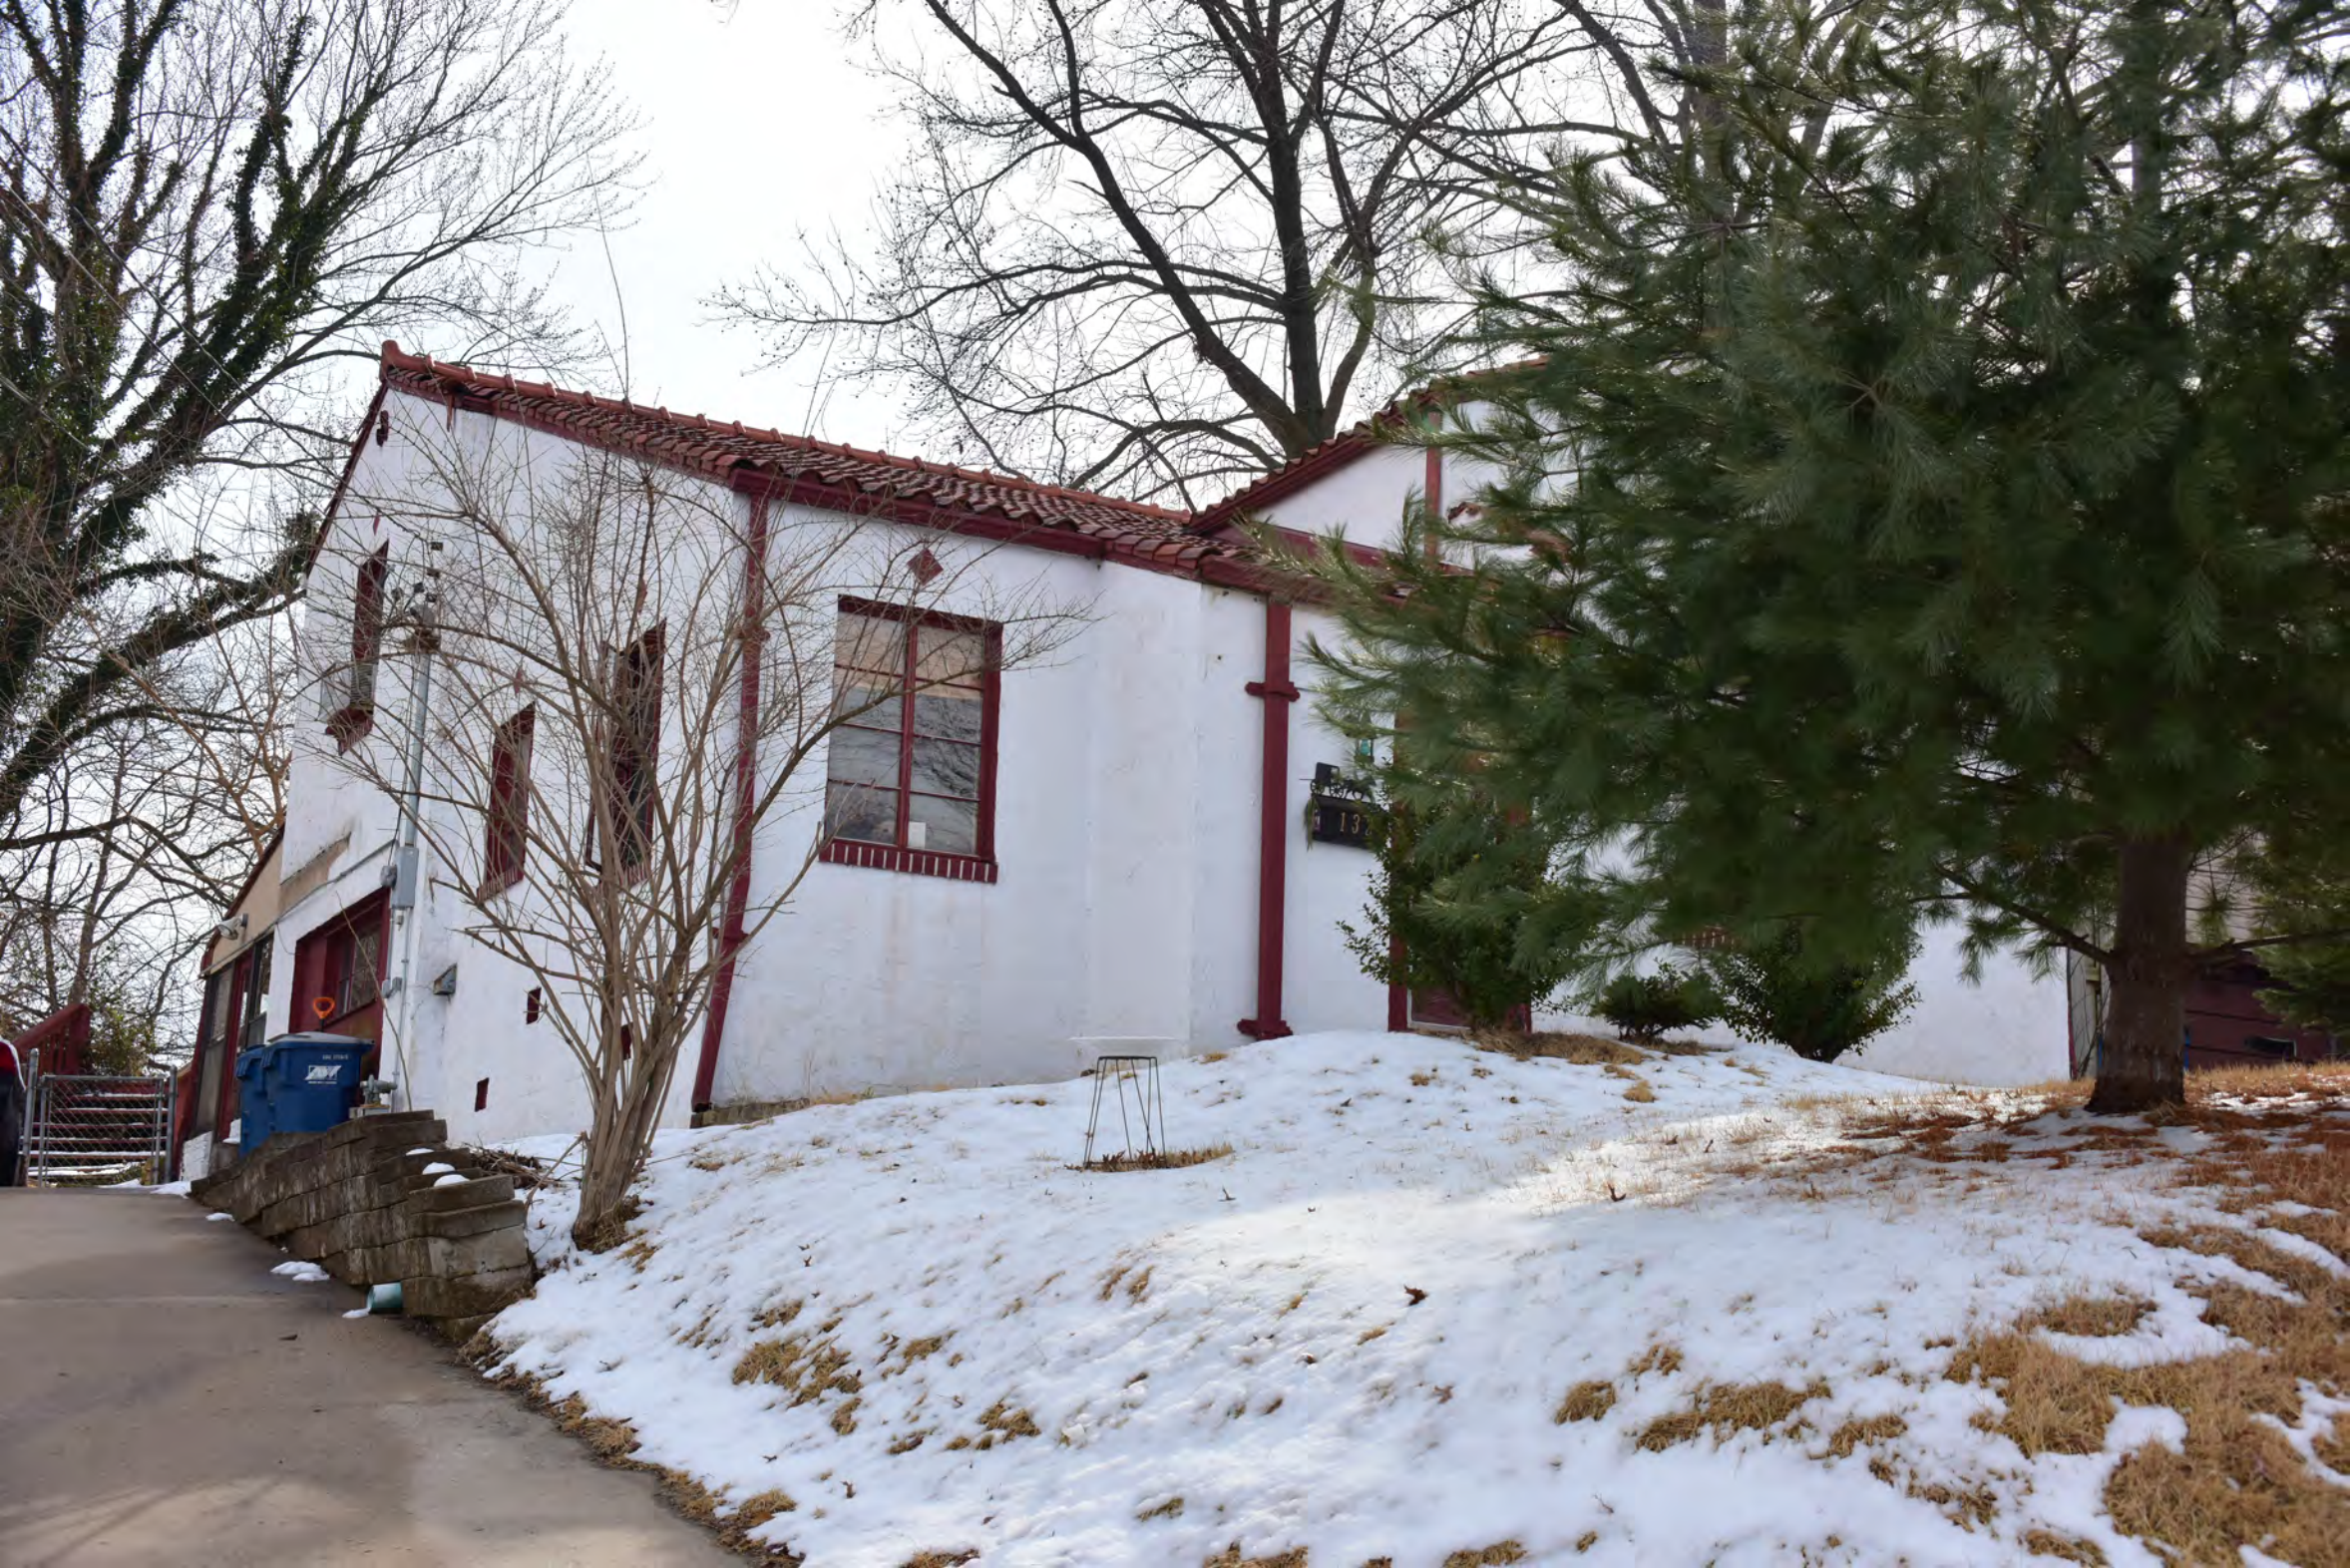
132 East Circle Drive is a one-and-one-half-story Minimal Traditional dwelling with Spanish/Mission influences. It has a concrete foundation, stucco cladding, and a tile roof form is complex. A gabled-ell fronts the street while a side-gable spans the rear. A shed roof fills the juncture. A brick chimney pierces the south slope of the gabled- ell. The dwelling is three bays wide. Bays 1 and 2 are in the shed-roof portion. A historic four-by-four casement window defines the first bay. A shed-roof vestibule defines the center bay and contains the entrance which includes a historic arched wood door and historic arched wood storm door with five-light glazing and transom. A historic twelve-light wood window with fanlight defines the third bay. Historic wood windows with a variety of pane arrangements are present at the north and south elevations. All windows have header-brick sills. Clay tile accents top each secondary elevation window bay. An integrated historic garage is located at basement level at the rear of the north elevation. A vertical wood infill six-light wood sash glazing occupies the vehicular bay. The windows appear historic. A shed-roof sunporch addition is located at the northeast corner of the dwelling. A non-historic deck is located adjacent to the sunporch.

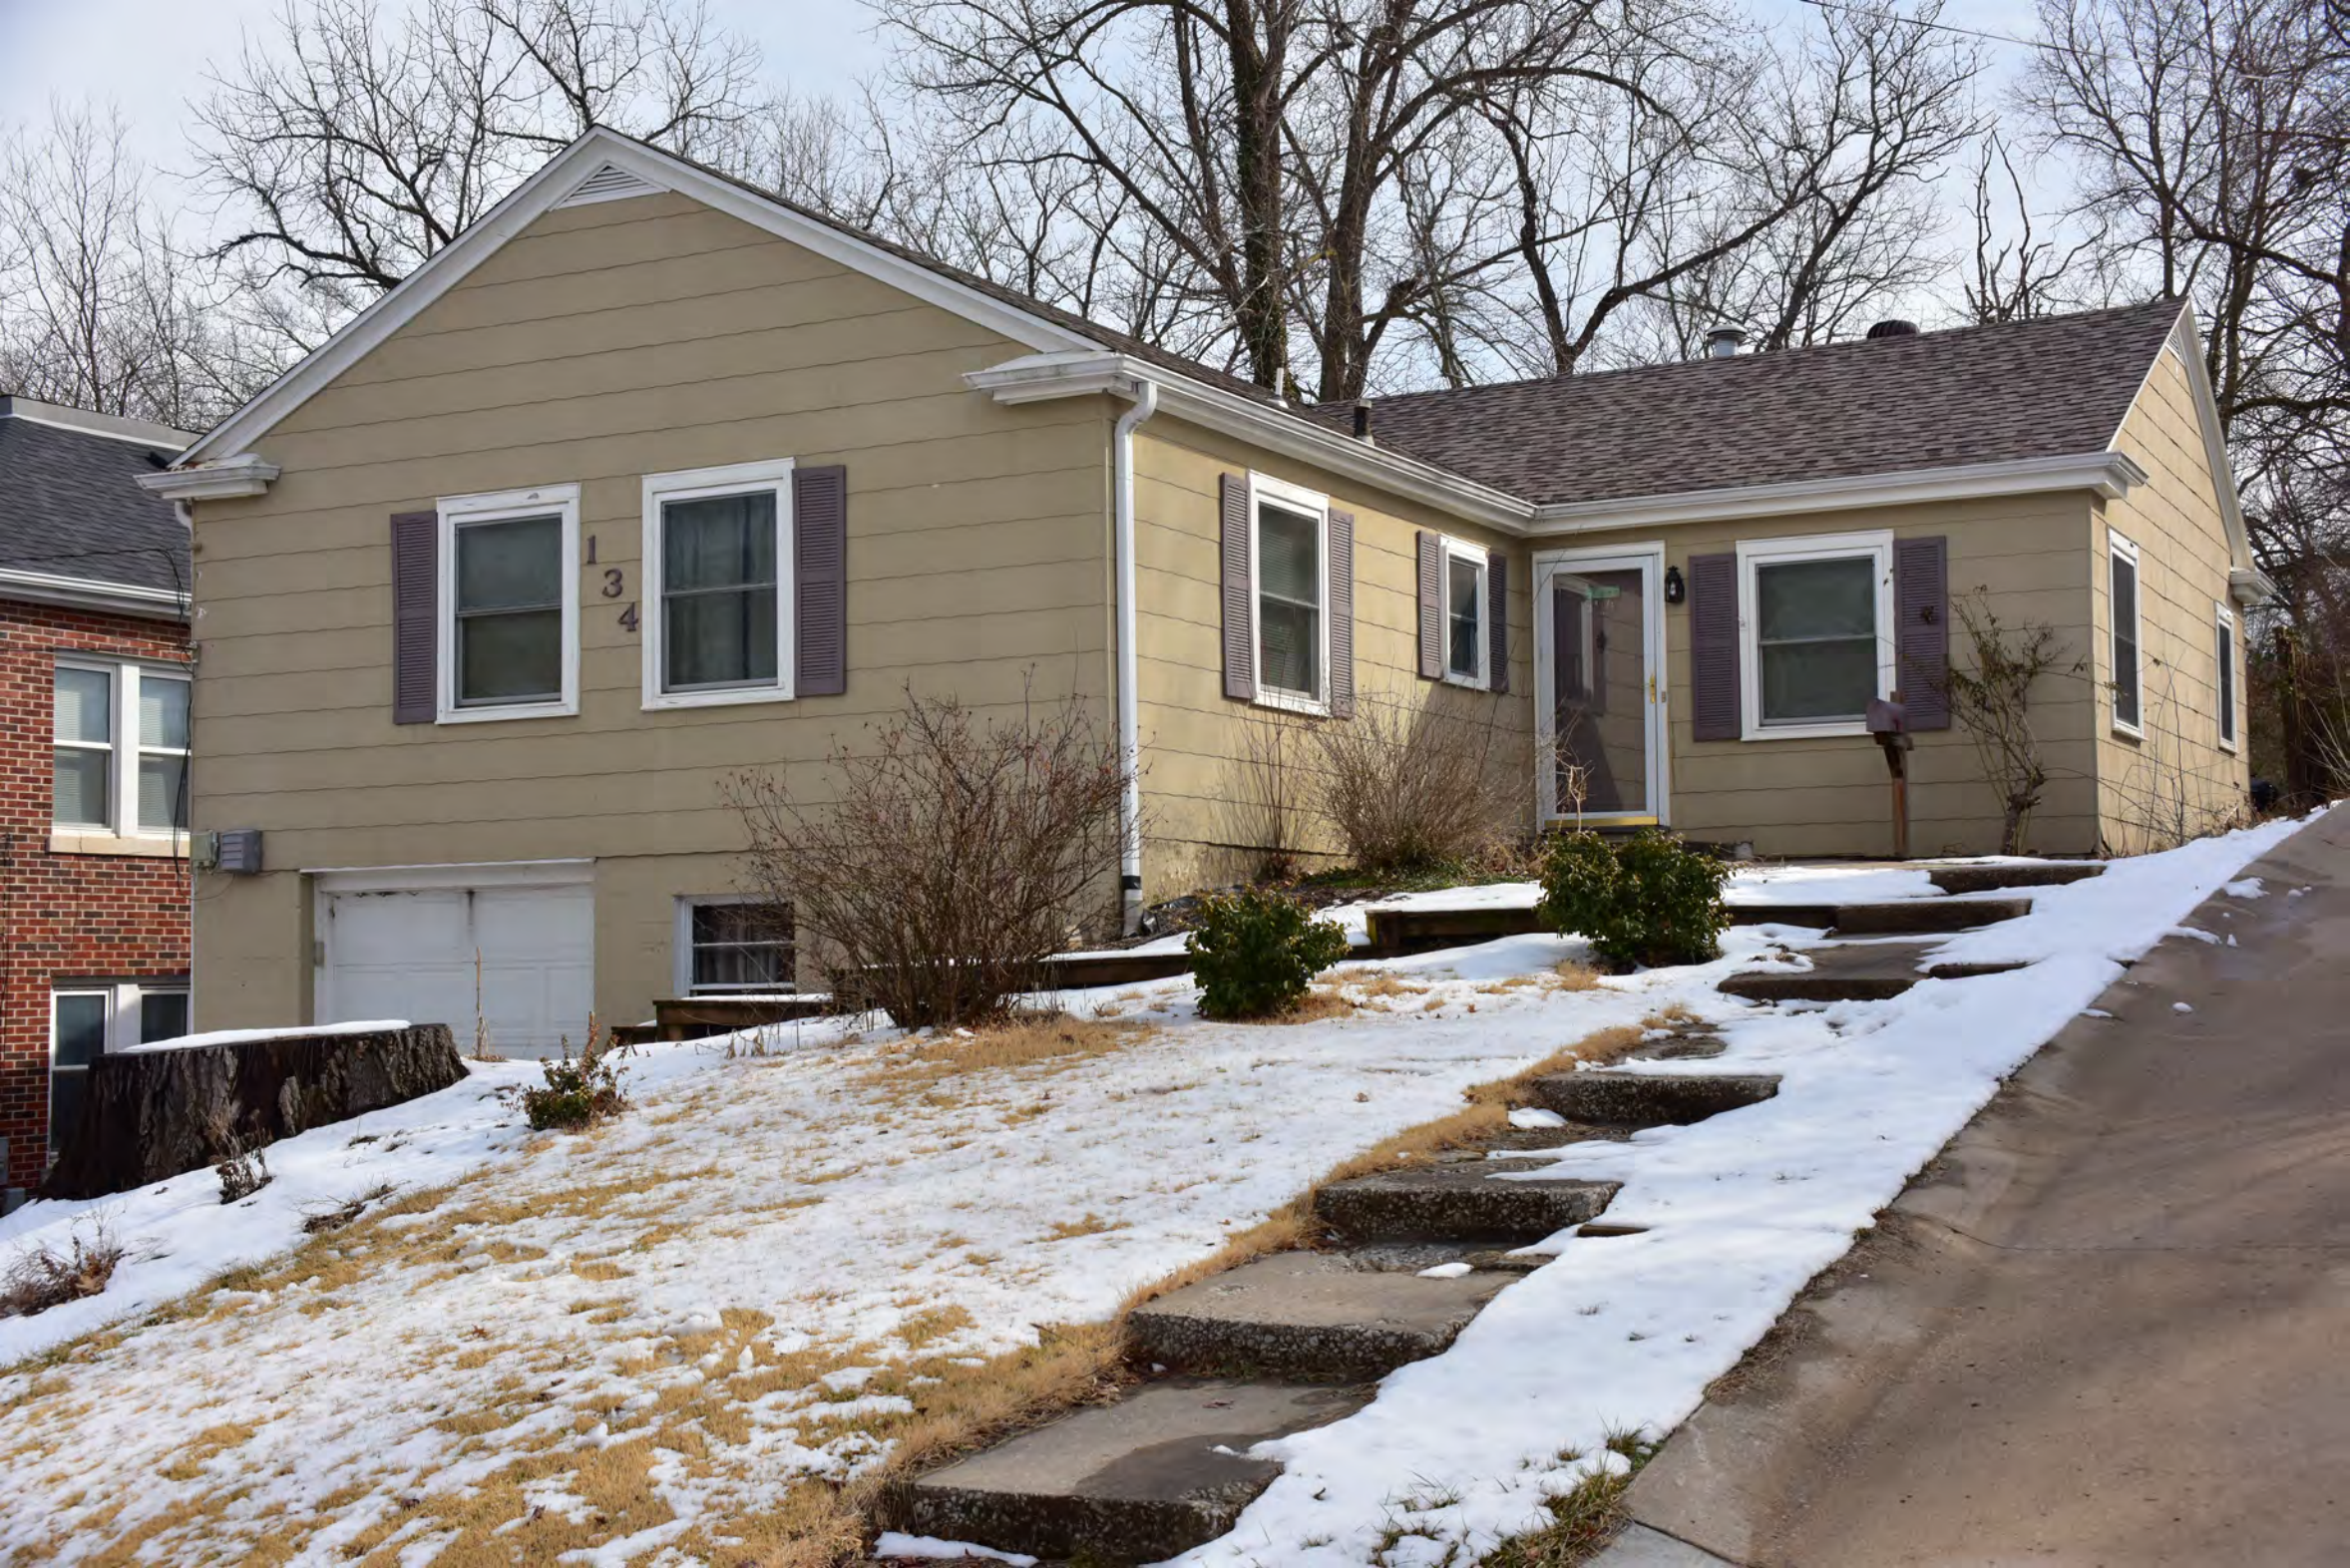
134 East Circle Drive is a one-story dwelling with a raised basement. The asbestos-clad dwelling has a concrete foundation and an asphalt intersecting gable roof. A gabled-ell fronts the street while a perpendicular gable extends south at the rear. The dwelling is four bays wide. Wood 1/1 windows fill Bays 1 and 2, which are centered in the gabled-ell. Bays 3 and 4 are positioned in the perpendicular gable. The primary entrance defines Bay 3 while a 1/1 wood window fills Bay 4. Wood 1/1 windows are visible in the south wall of the gabled-ell and at the north and south elevations. A historic integrated garage is present at basement level at the primary elevation. A non-historic overhead door fills the vehicular bay. A historic 2/2 wood window with horizontal muntins is positioned immediately south of the vehicular bay. Matching windows are located on the north elevation at basement level. Aerial imagery indicates a small porch is located at the southeast corner of the dwelling. It is not visible from the right of way.
