1. Survey number: CO-AS-008-001		2. Survey Name: West Main Street Survey	
3. County: Cole		4. Address (Street No.): 100	Street (name): East Circle Drive
5. City: Jefferson City	Vicinity <input type="checkbox"/>	6. Lat / Long:	7. Township/Range/Section: T: R: S:
8. Historic name (if known):		9. Present/other name (if known):	
10. Ownership: <input checked="" type="checkbox"/> Private <input type="checkbox"/> Public		11a. Historic use (if known): Domestic-Single Dwelling	11b. Current use: Domestic-Single Dwelling

MISSOURI DEPARTMENT OF NATURAL RESOURCES
STATE HISTORIC PRESERVATION OFFICE, P.O. Box 178, Jefferson City, MO 65102
ARCHITECTURAL/HISTORIC INVENTORY FORM

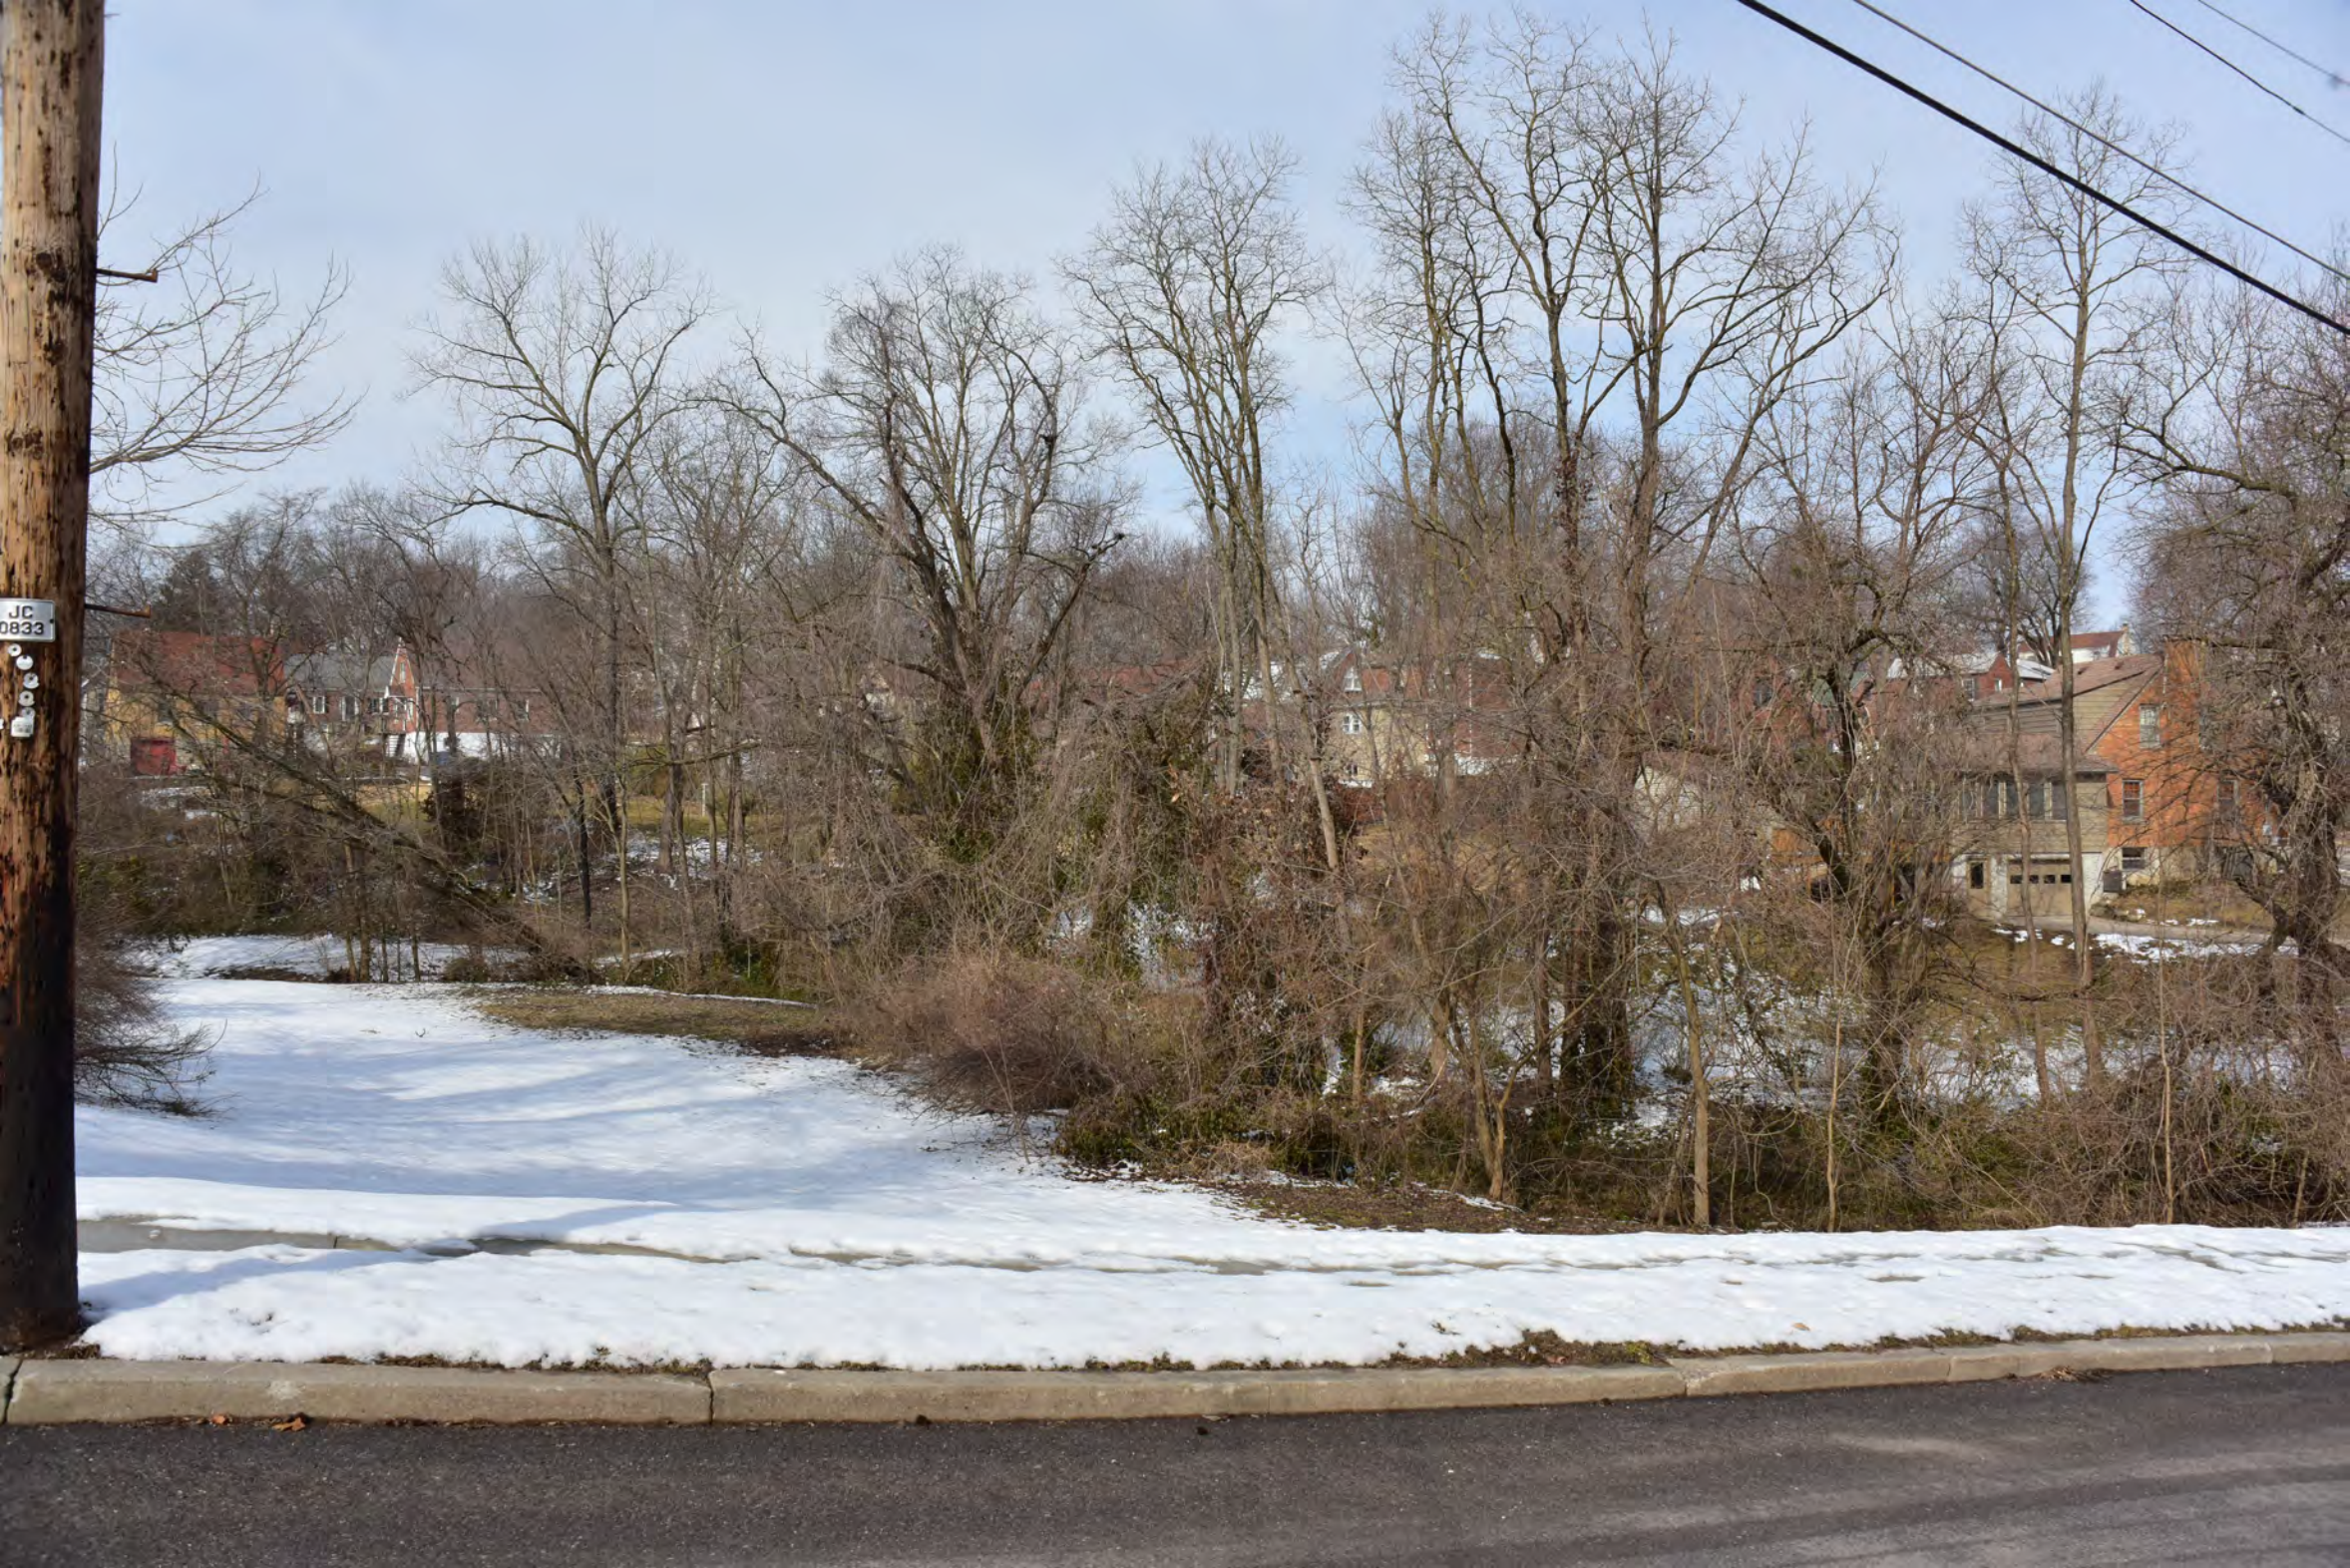
135 East Circle Drive is Lavinia Park. The park is located in a shallow valley at the approximate center of the Walinko Place subdivision and its plan is irregular. It is roughly bound by East Circle Drive to the east, residences on the south side of North Circle Drive to the north, Lavinia Street to the west, and South Circle Drive to the south. Deciduous tree and shrub growth characterize the vegetation and a small stream that is oriented northeast-southwest roughly bisects the park. Concrete culverts are present at the northeast and southwest ends of the stream.

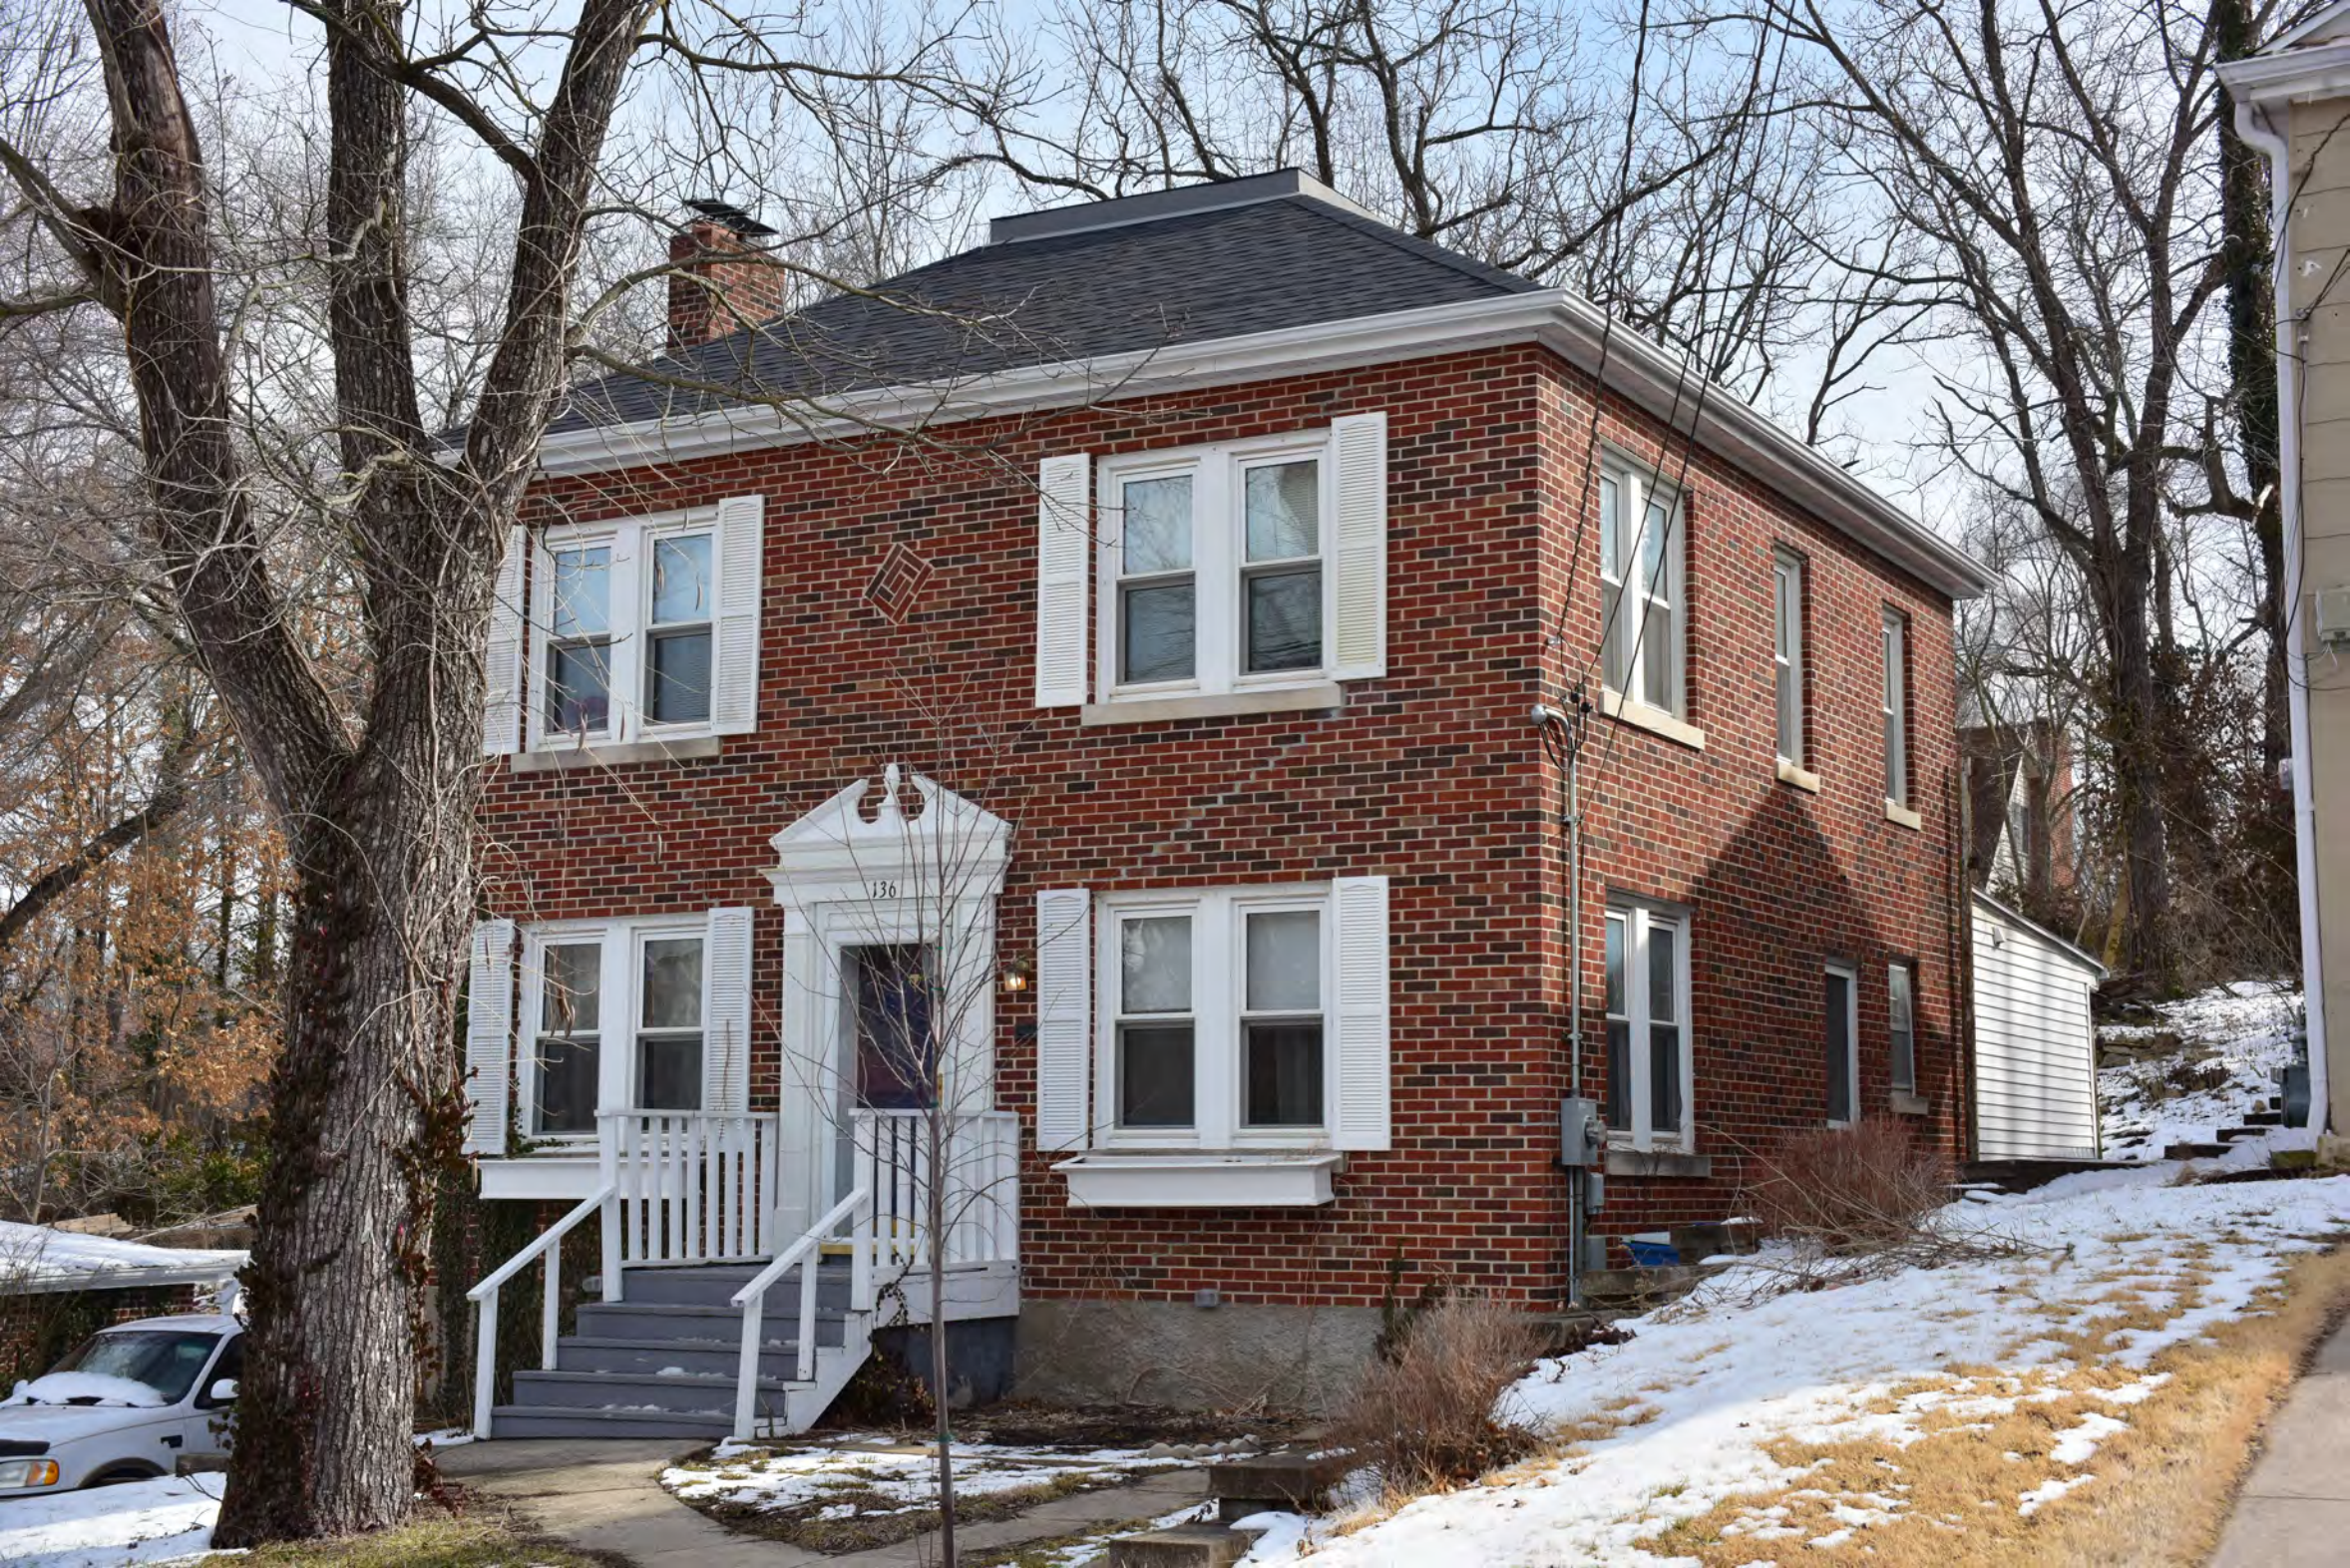
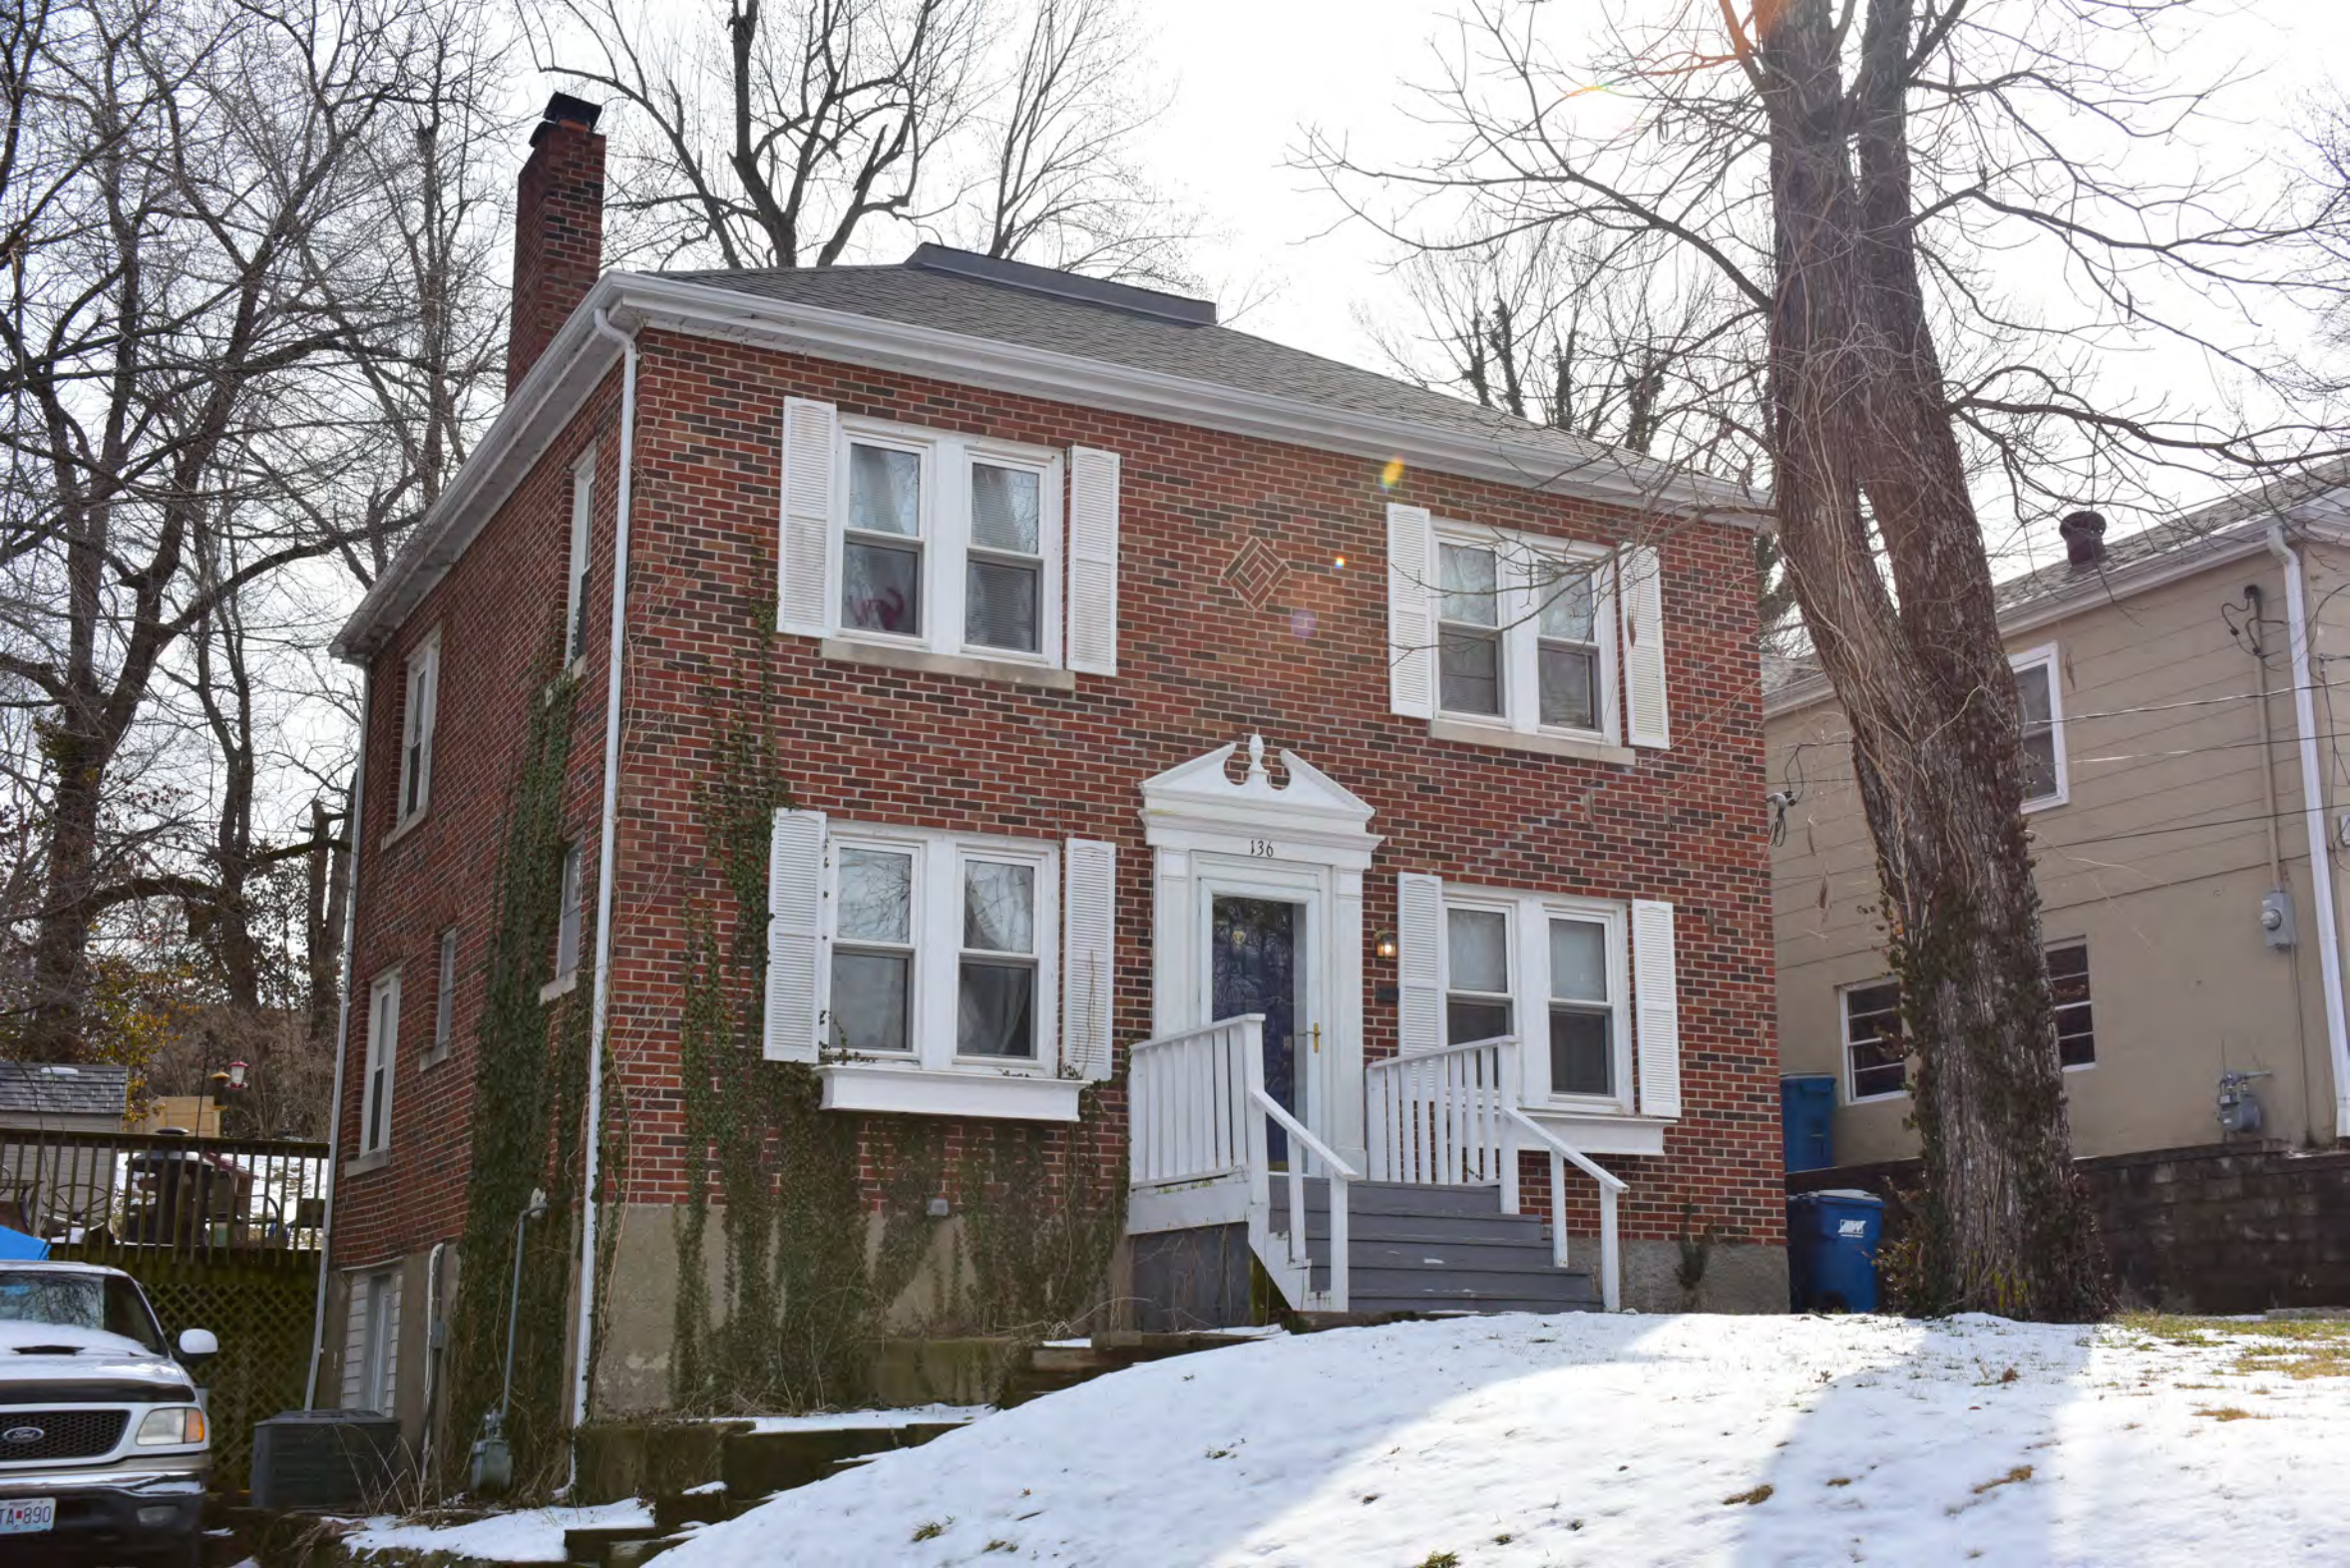
136 East Circle Drive is a two-story foursquare dwelling with restrained Colonial Revival influences. The brick-clad dwelling has a parged foundation and a hipped asphalt roof. A one-story vinyl-clad shed-roof addition and non-historic wood deck project from the rear elevation. A brick side-slope chimney pierces the roof at the north elevation. The dwelling is three bays wide. Paired 1/1 vinyl windows with concrete sills and false shutters flank the central entrance. Matching windows are located directly above at the second-story. A square of decorative brick work is centered between the second-story windows. The primary entrance features a Colonial Revival surround with pilasters and a broken pediment. A concrete stoop projects below the entrance. A simple wood balustrade lines the perimeter. Wood stairs access the stoop. A historic integrated garage is present at basement level at the north elevation. A pedestrian entrance and vinyl infill fill the garage bay.

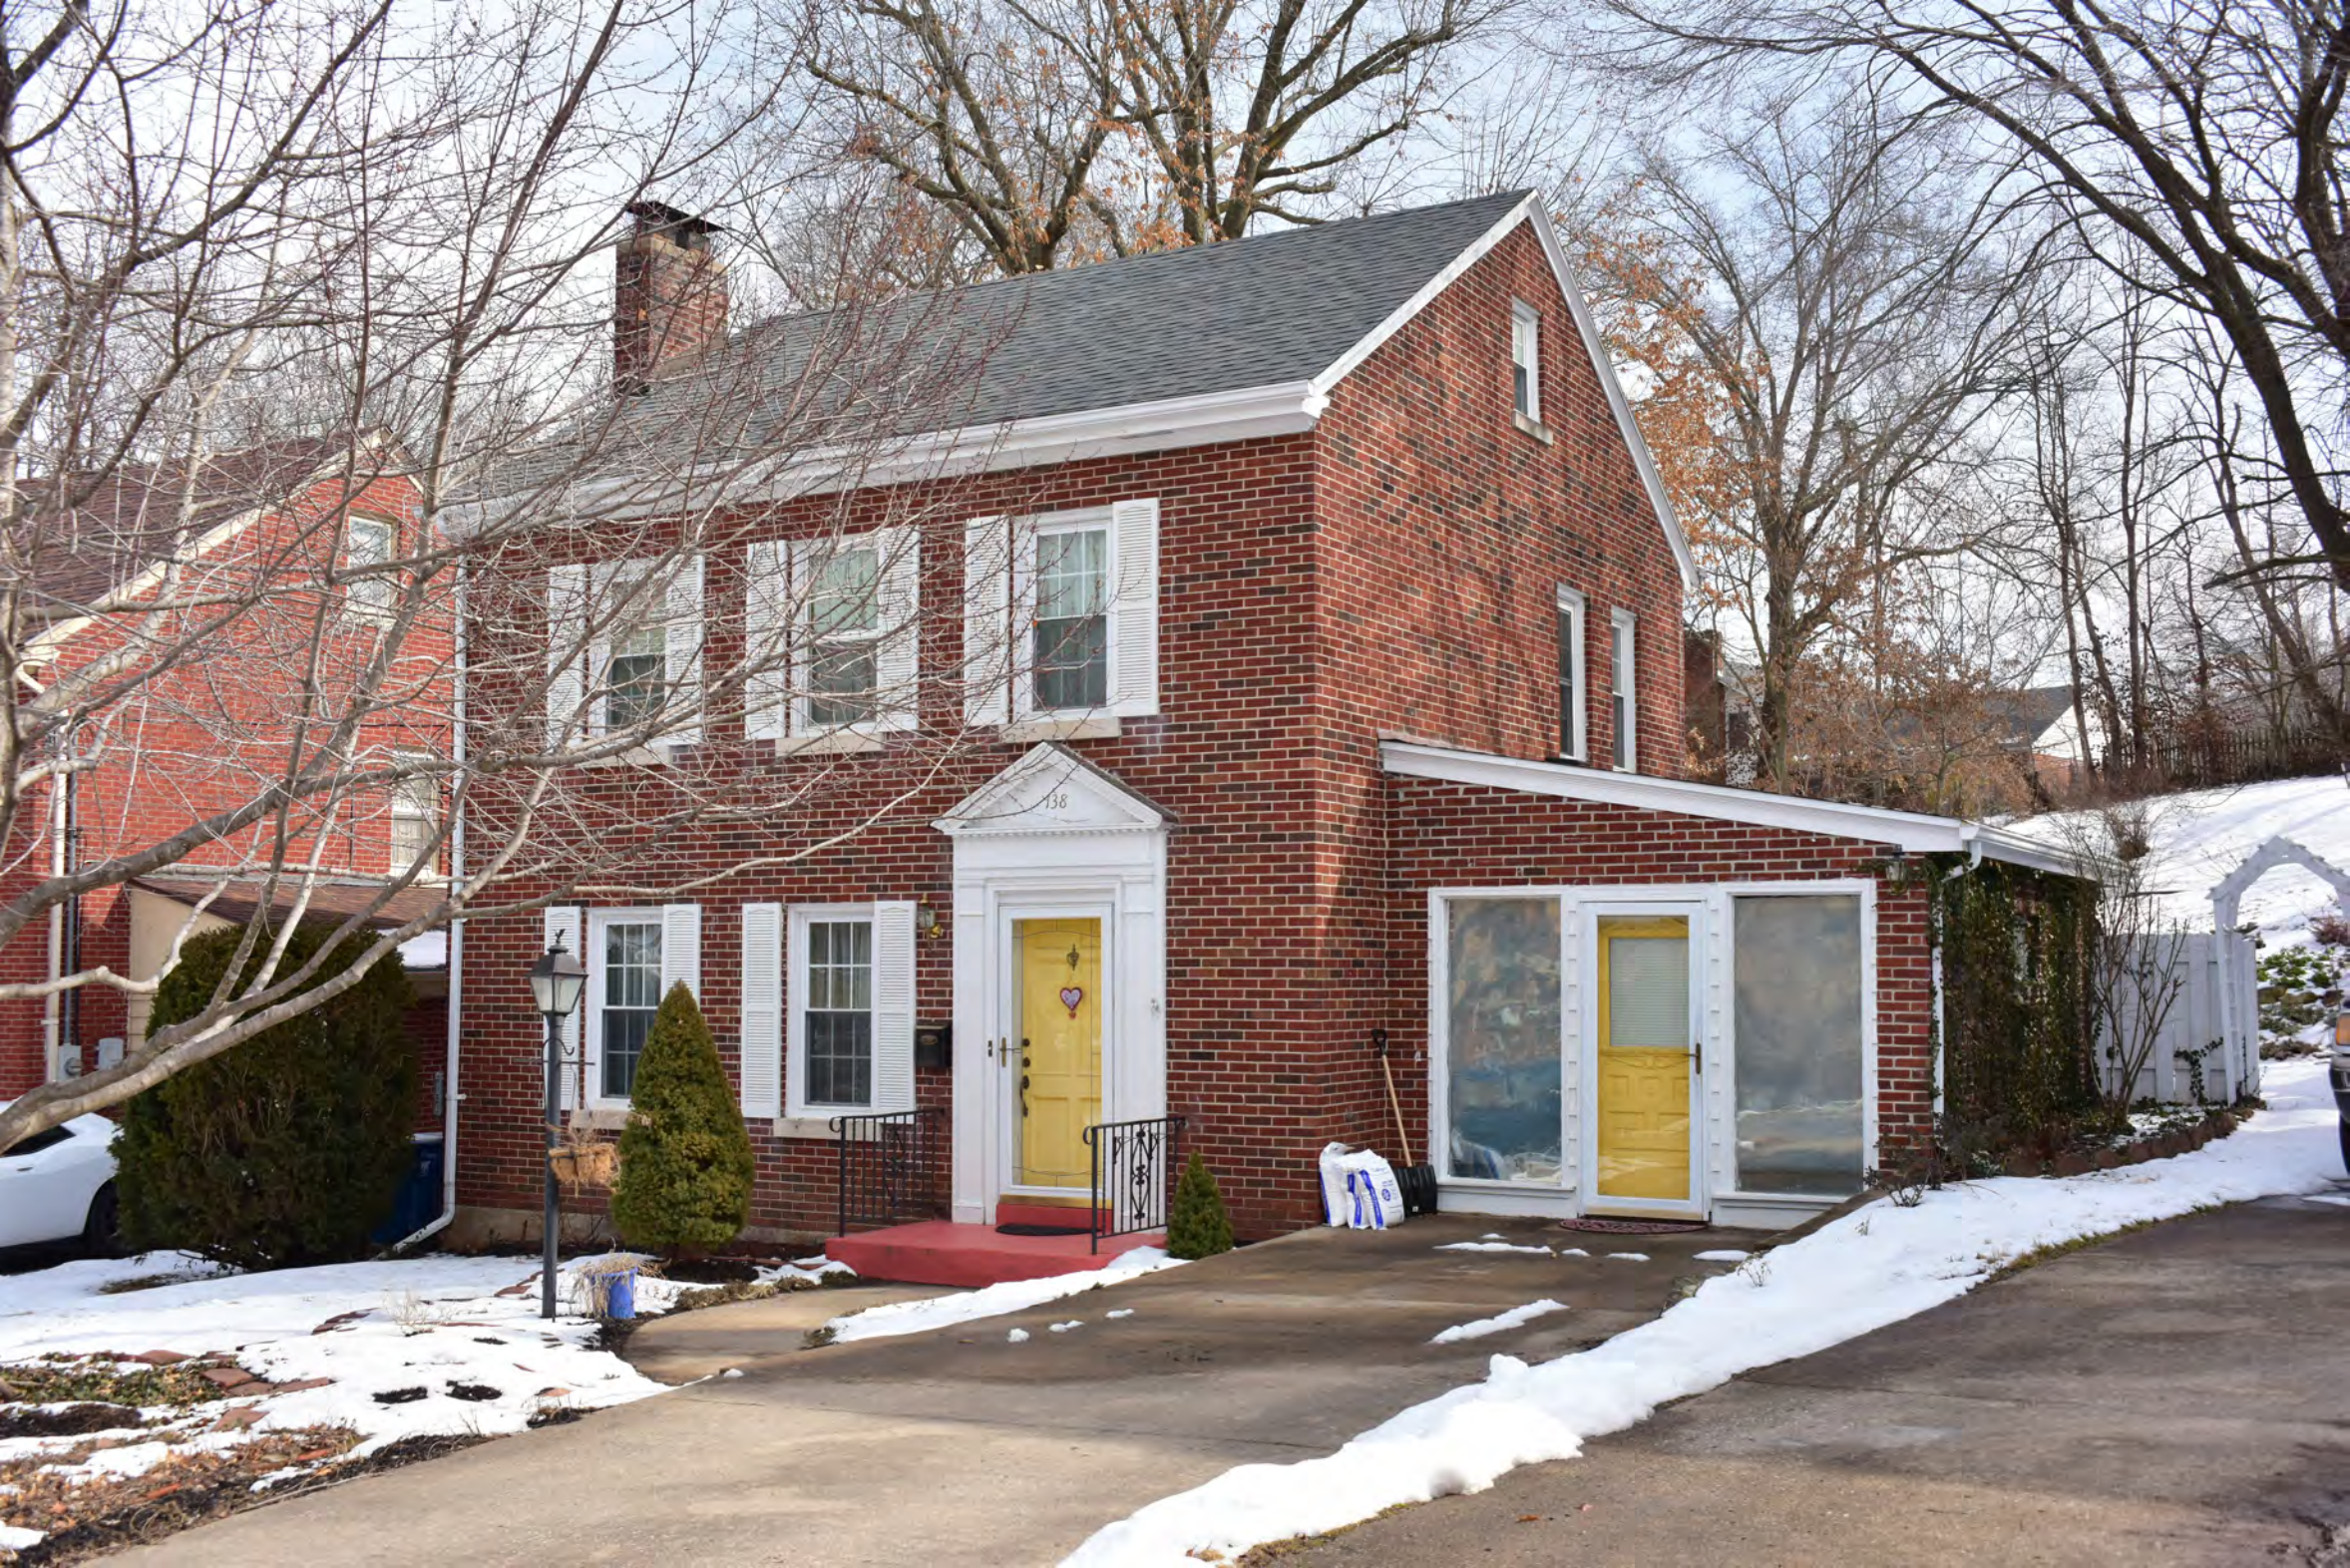
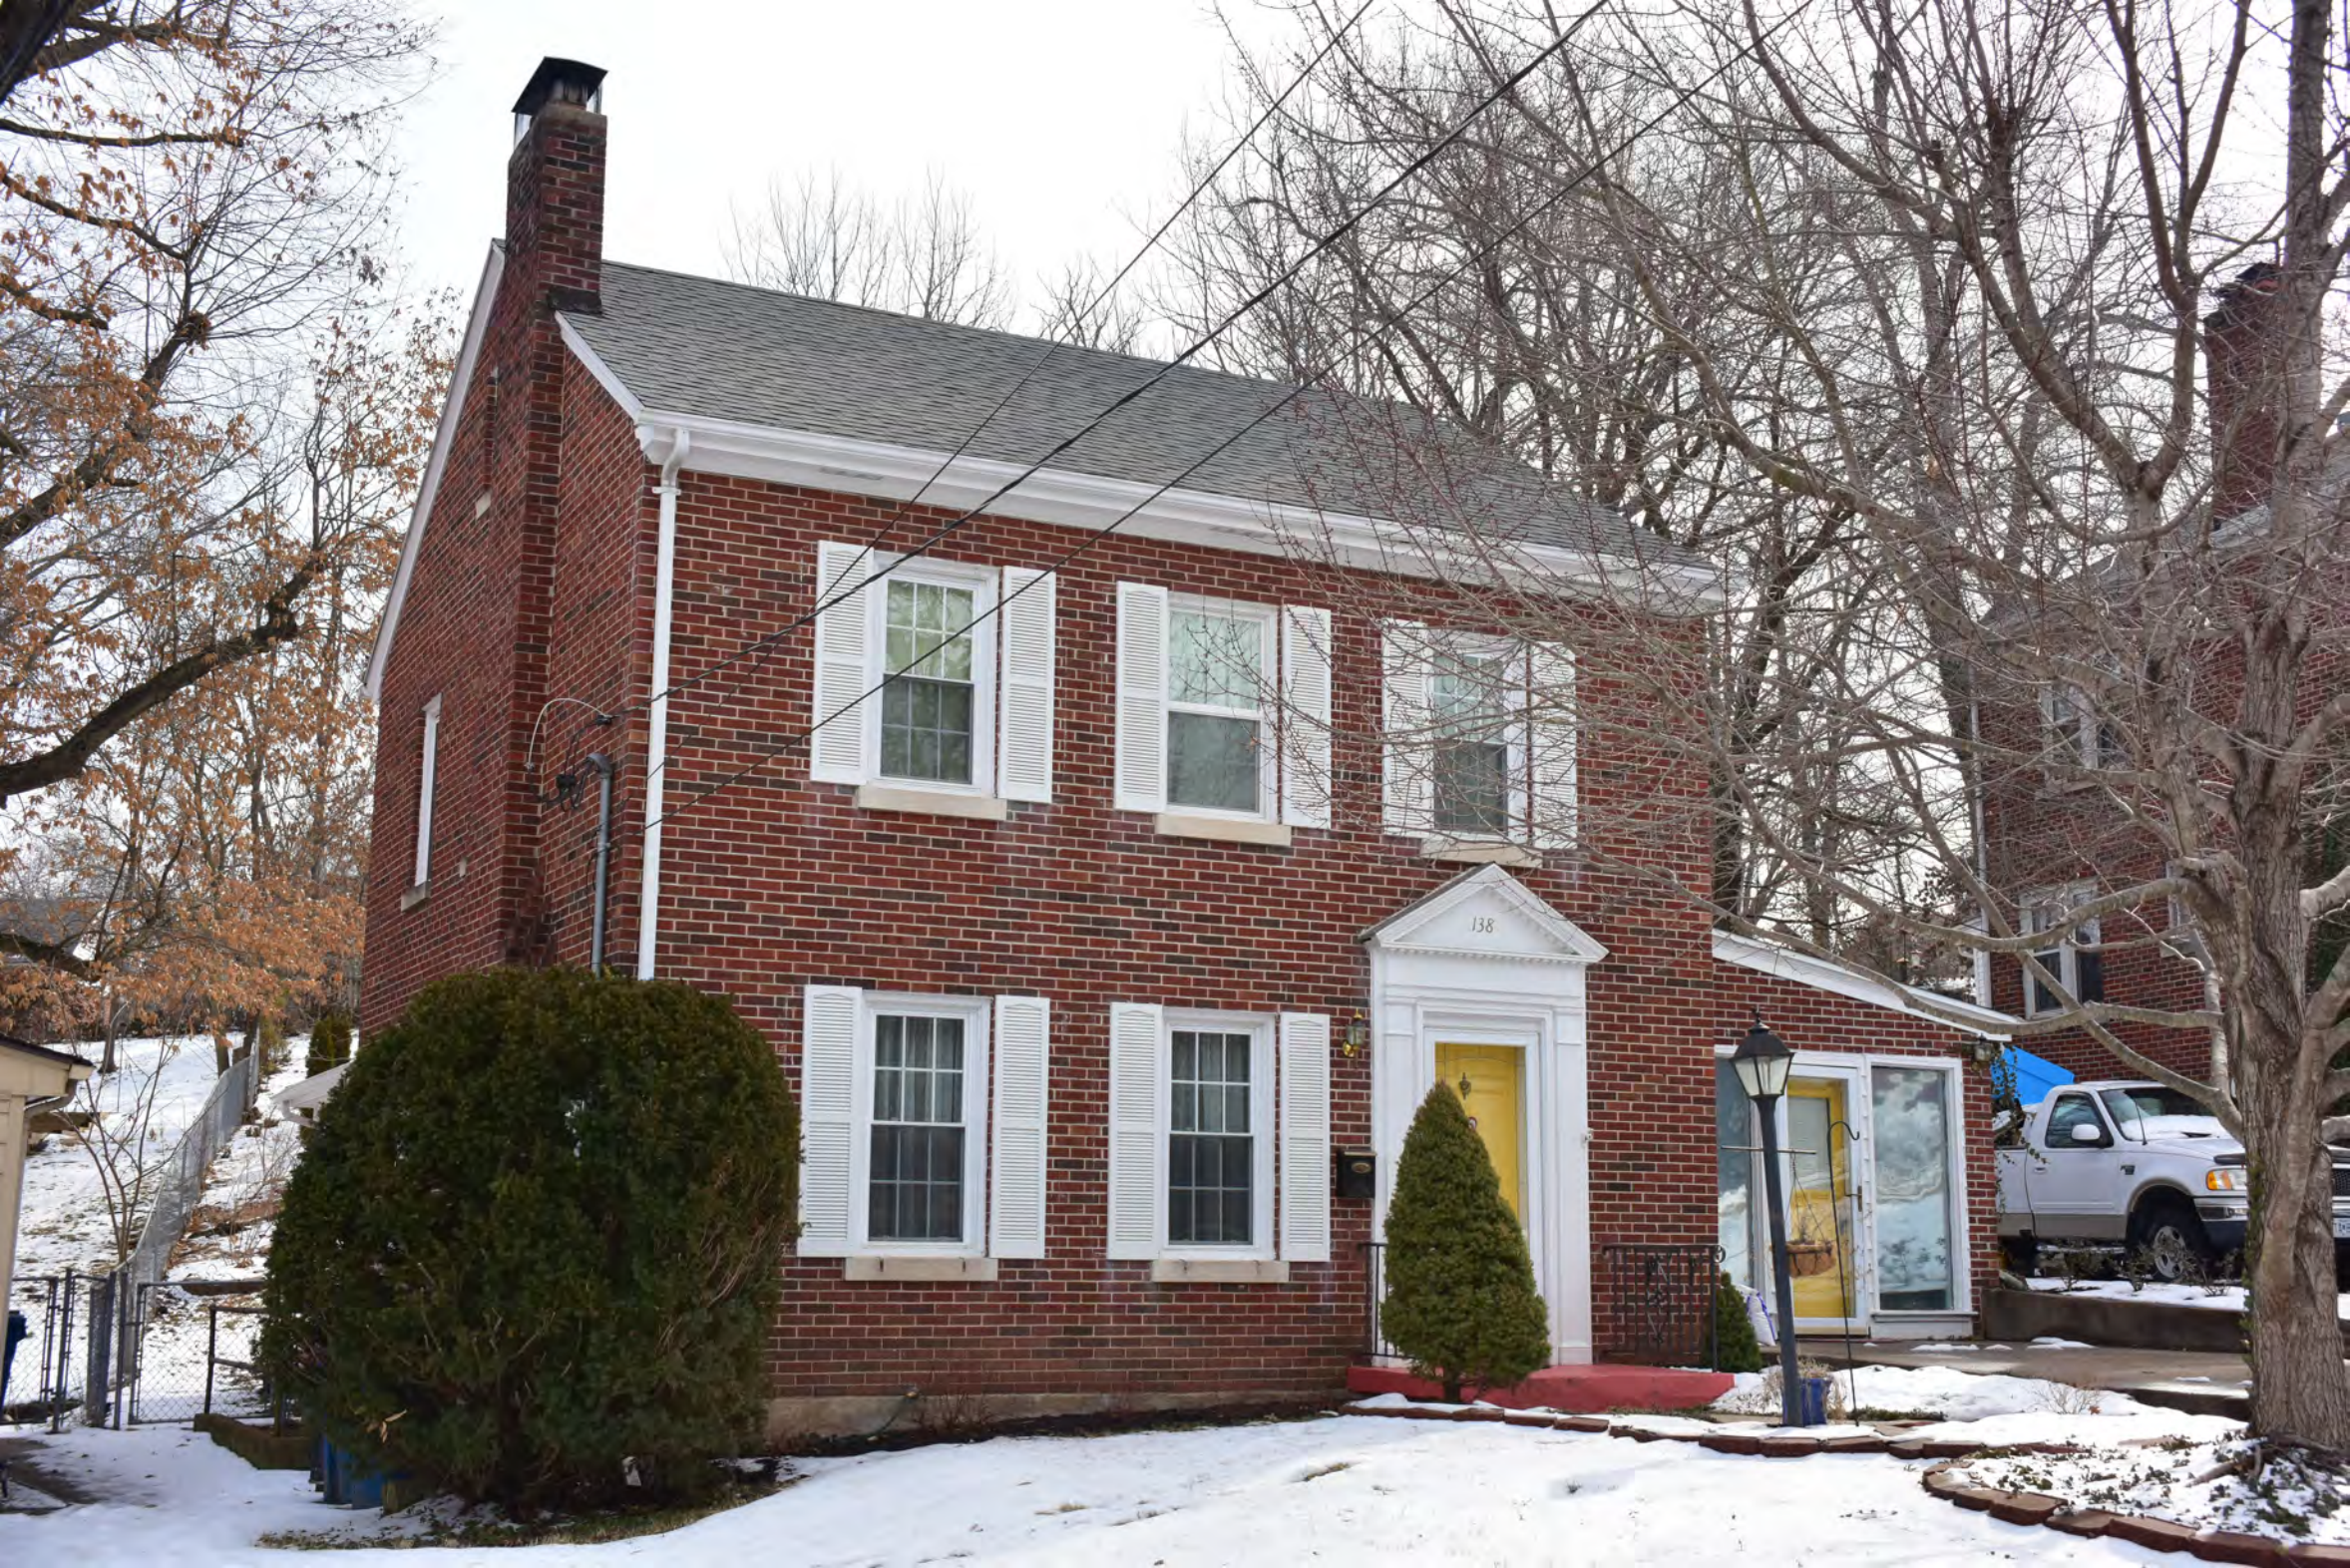
138 East Circle Drive is a two-story Minimal Traditional dwelling with restrained Colonial Revival influences. The brick-clad dwelling has a concrete foundation and a side-gable asphalt roof. A historic one-story shed-roof attached garage projects from the south elevation. A one-story vinyl-clad addition projects from the northeast corner of the dwelling. A brick exterior chimney pierces the narrow eave at the north elevation. The dwelling is three bays wide. Non-historic 6/6 vinyl windows with concrete sills and false shutters fill the north-two bays. The primary entrance defines the south bay. It includes features a Colonial Revival surround with pilasters and a pediment. A concrete stoop projects below the entrance. Decorative metal railings with scroll patterns line the north and south edges of the stoop. The garage bay has been altered to include a pedestrian entrance and two single-pane fixed windows which flank the entrance. Vinyl infills narrow gaps between the door, windows, and margins of the bay. 138 East Circle Drive is near identical to its neighbor, 140 East Circle Drive.
