1. Survey number: CO-AS-008-001		2. Survey Name: West Main Street Survey	
3. County: Cole		4. Address (Street No.): 100	Street (name): East Circle Drive
5. City: Jefferson City	Vicinity <input type="checkbox"/>	6. Lat / Long:	7. Township/Range/Section: T: R: S:
8. Historic name (if known):		9. Present/other name (if known):	
10. Ownership: <input checked="" type="checkbox"/> Private <input type="checkbox"/> Public		11a. Historic use (if known): Domestic-Single Dwelling	11b. Current use: Domestic-Single Dwelling

MISSOURI DEPARTMENT OF NATURAL RESOURCES
STATE HISTORIC PRESERVATION OFFICE, P.O. Box 178, Jefferson City, MO 65102
ARCHITECTURAL/HISTORIC INVENTORY FORM

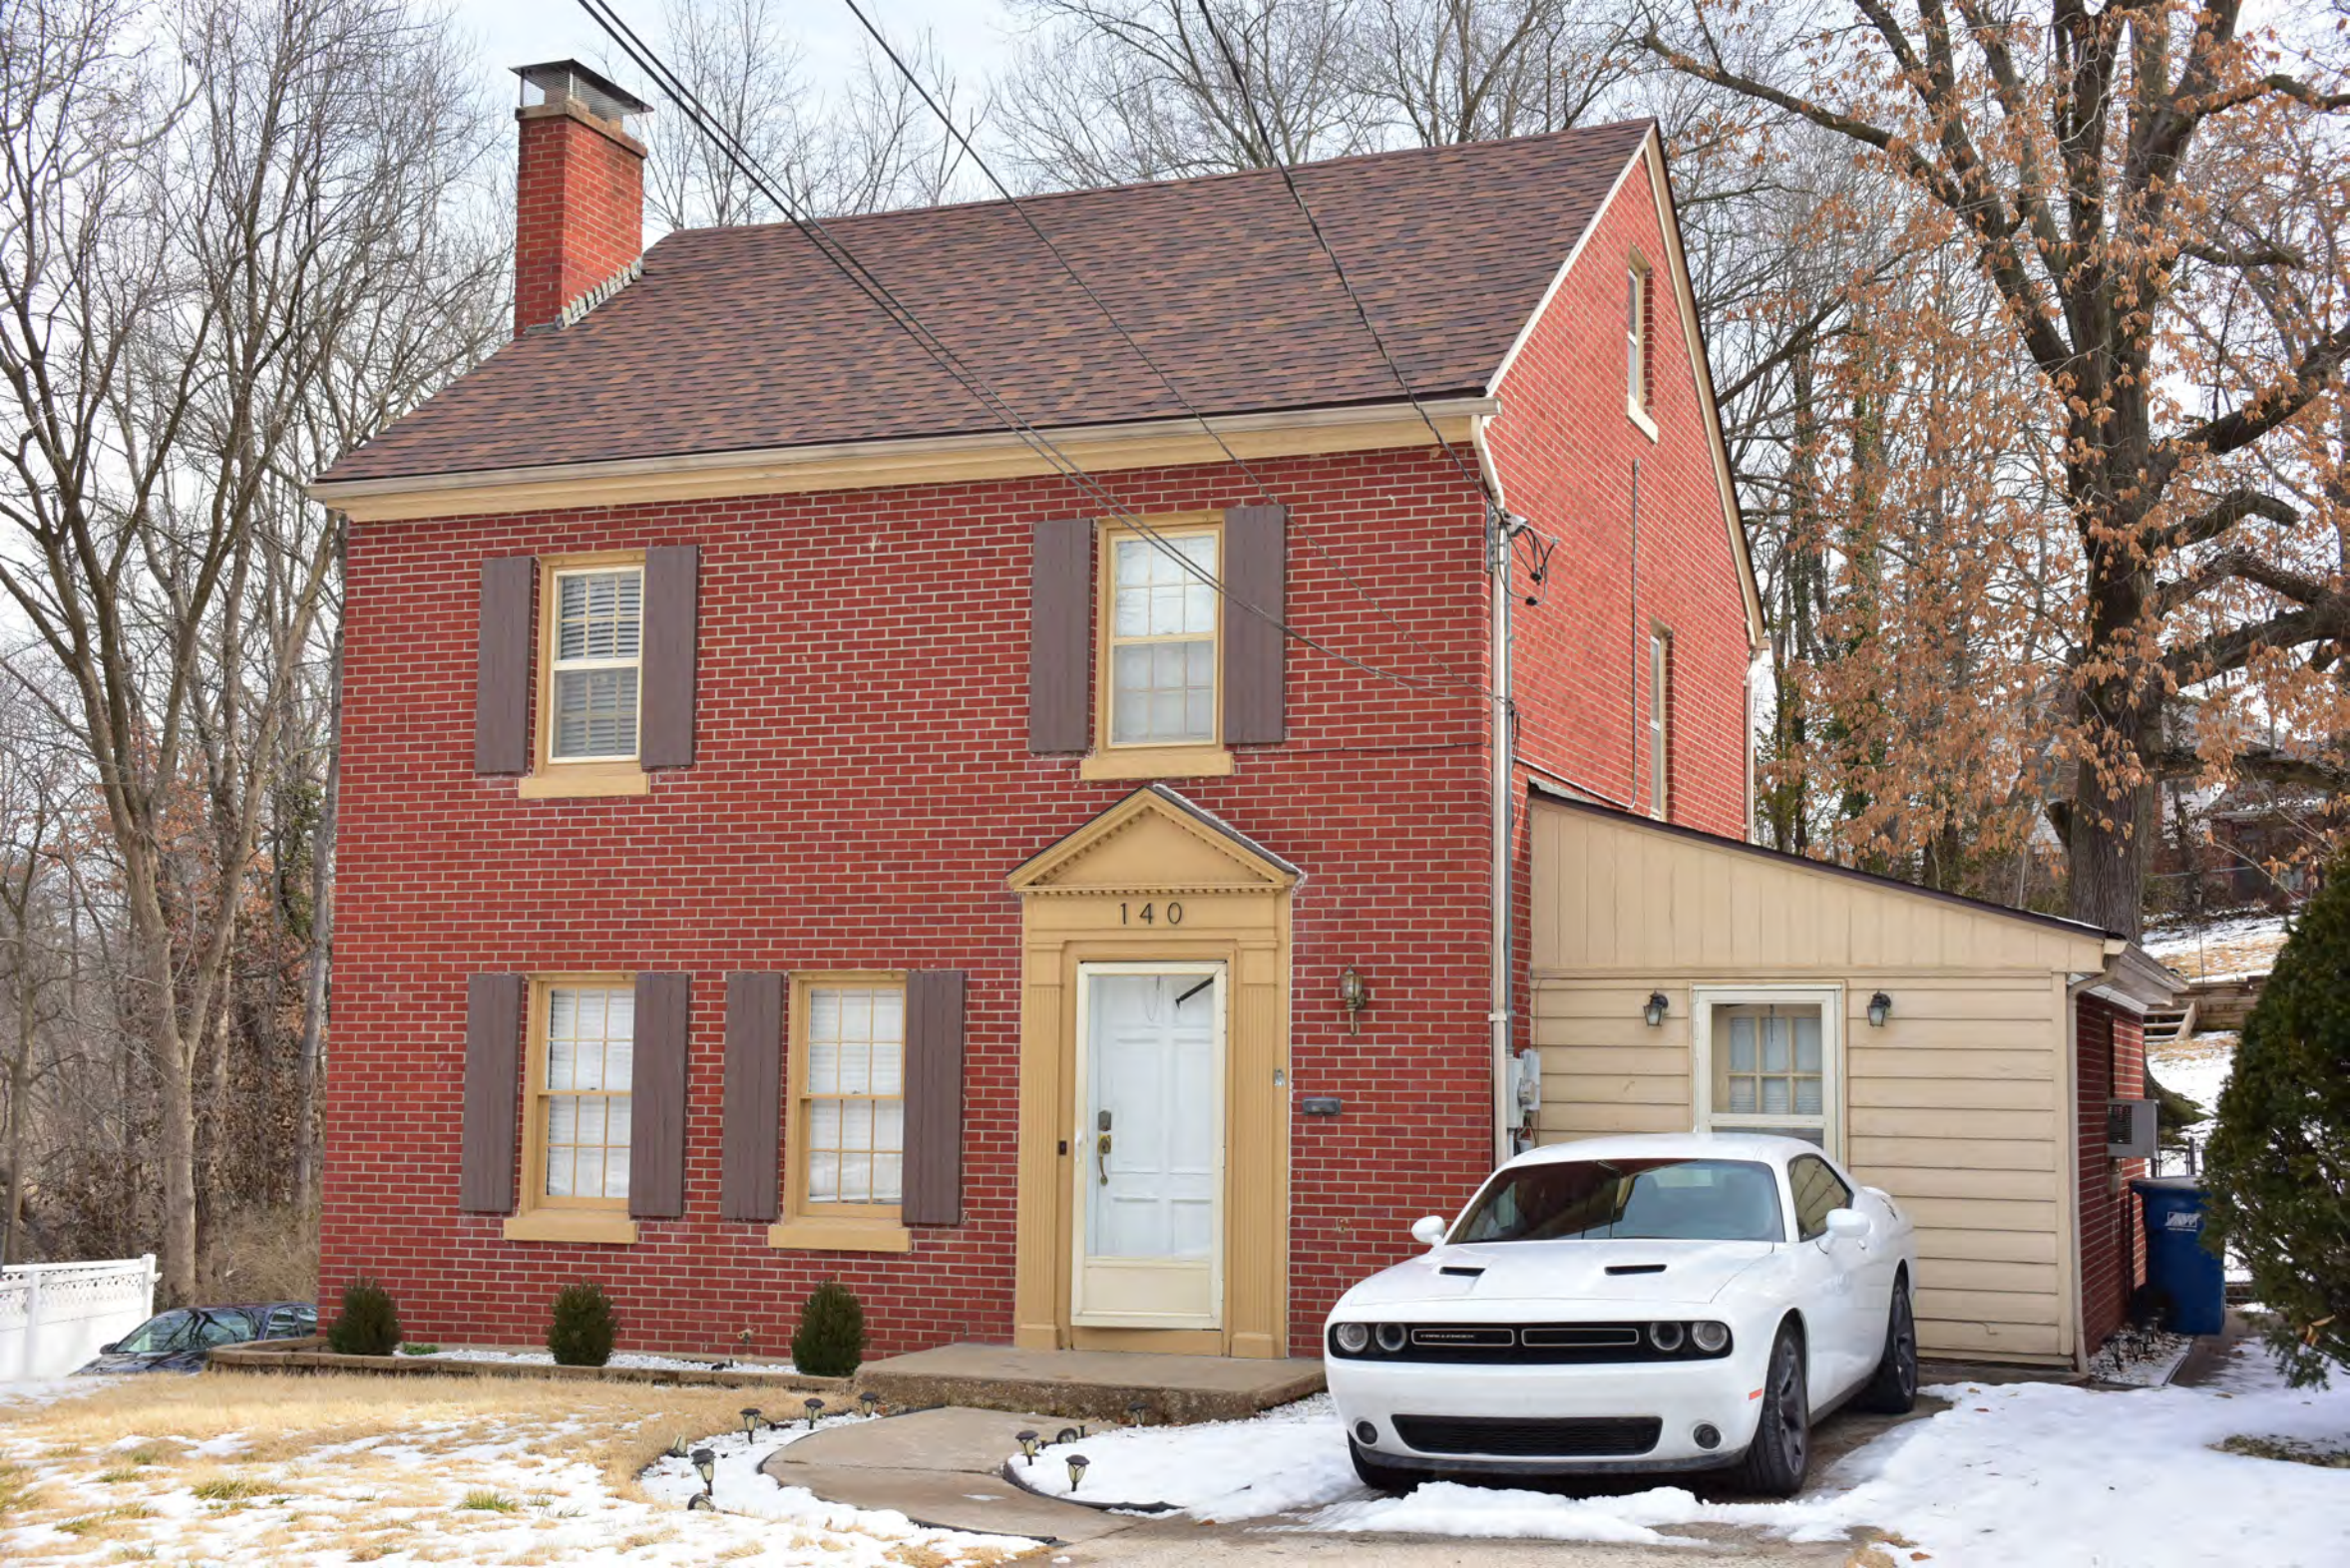
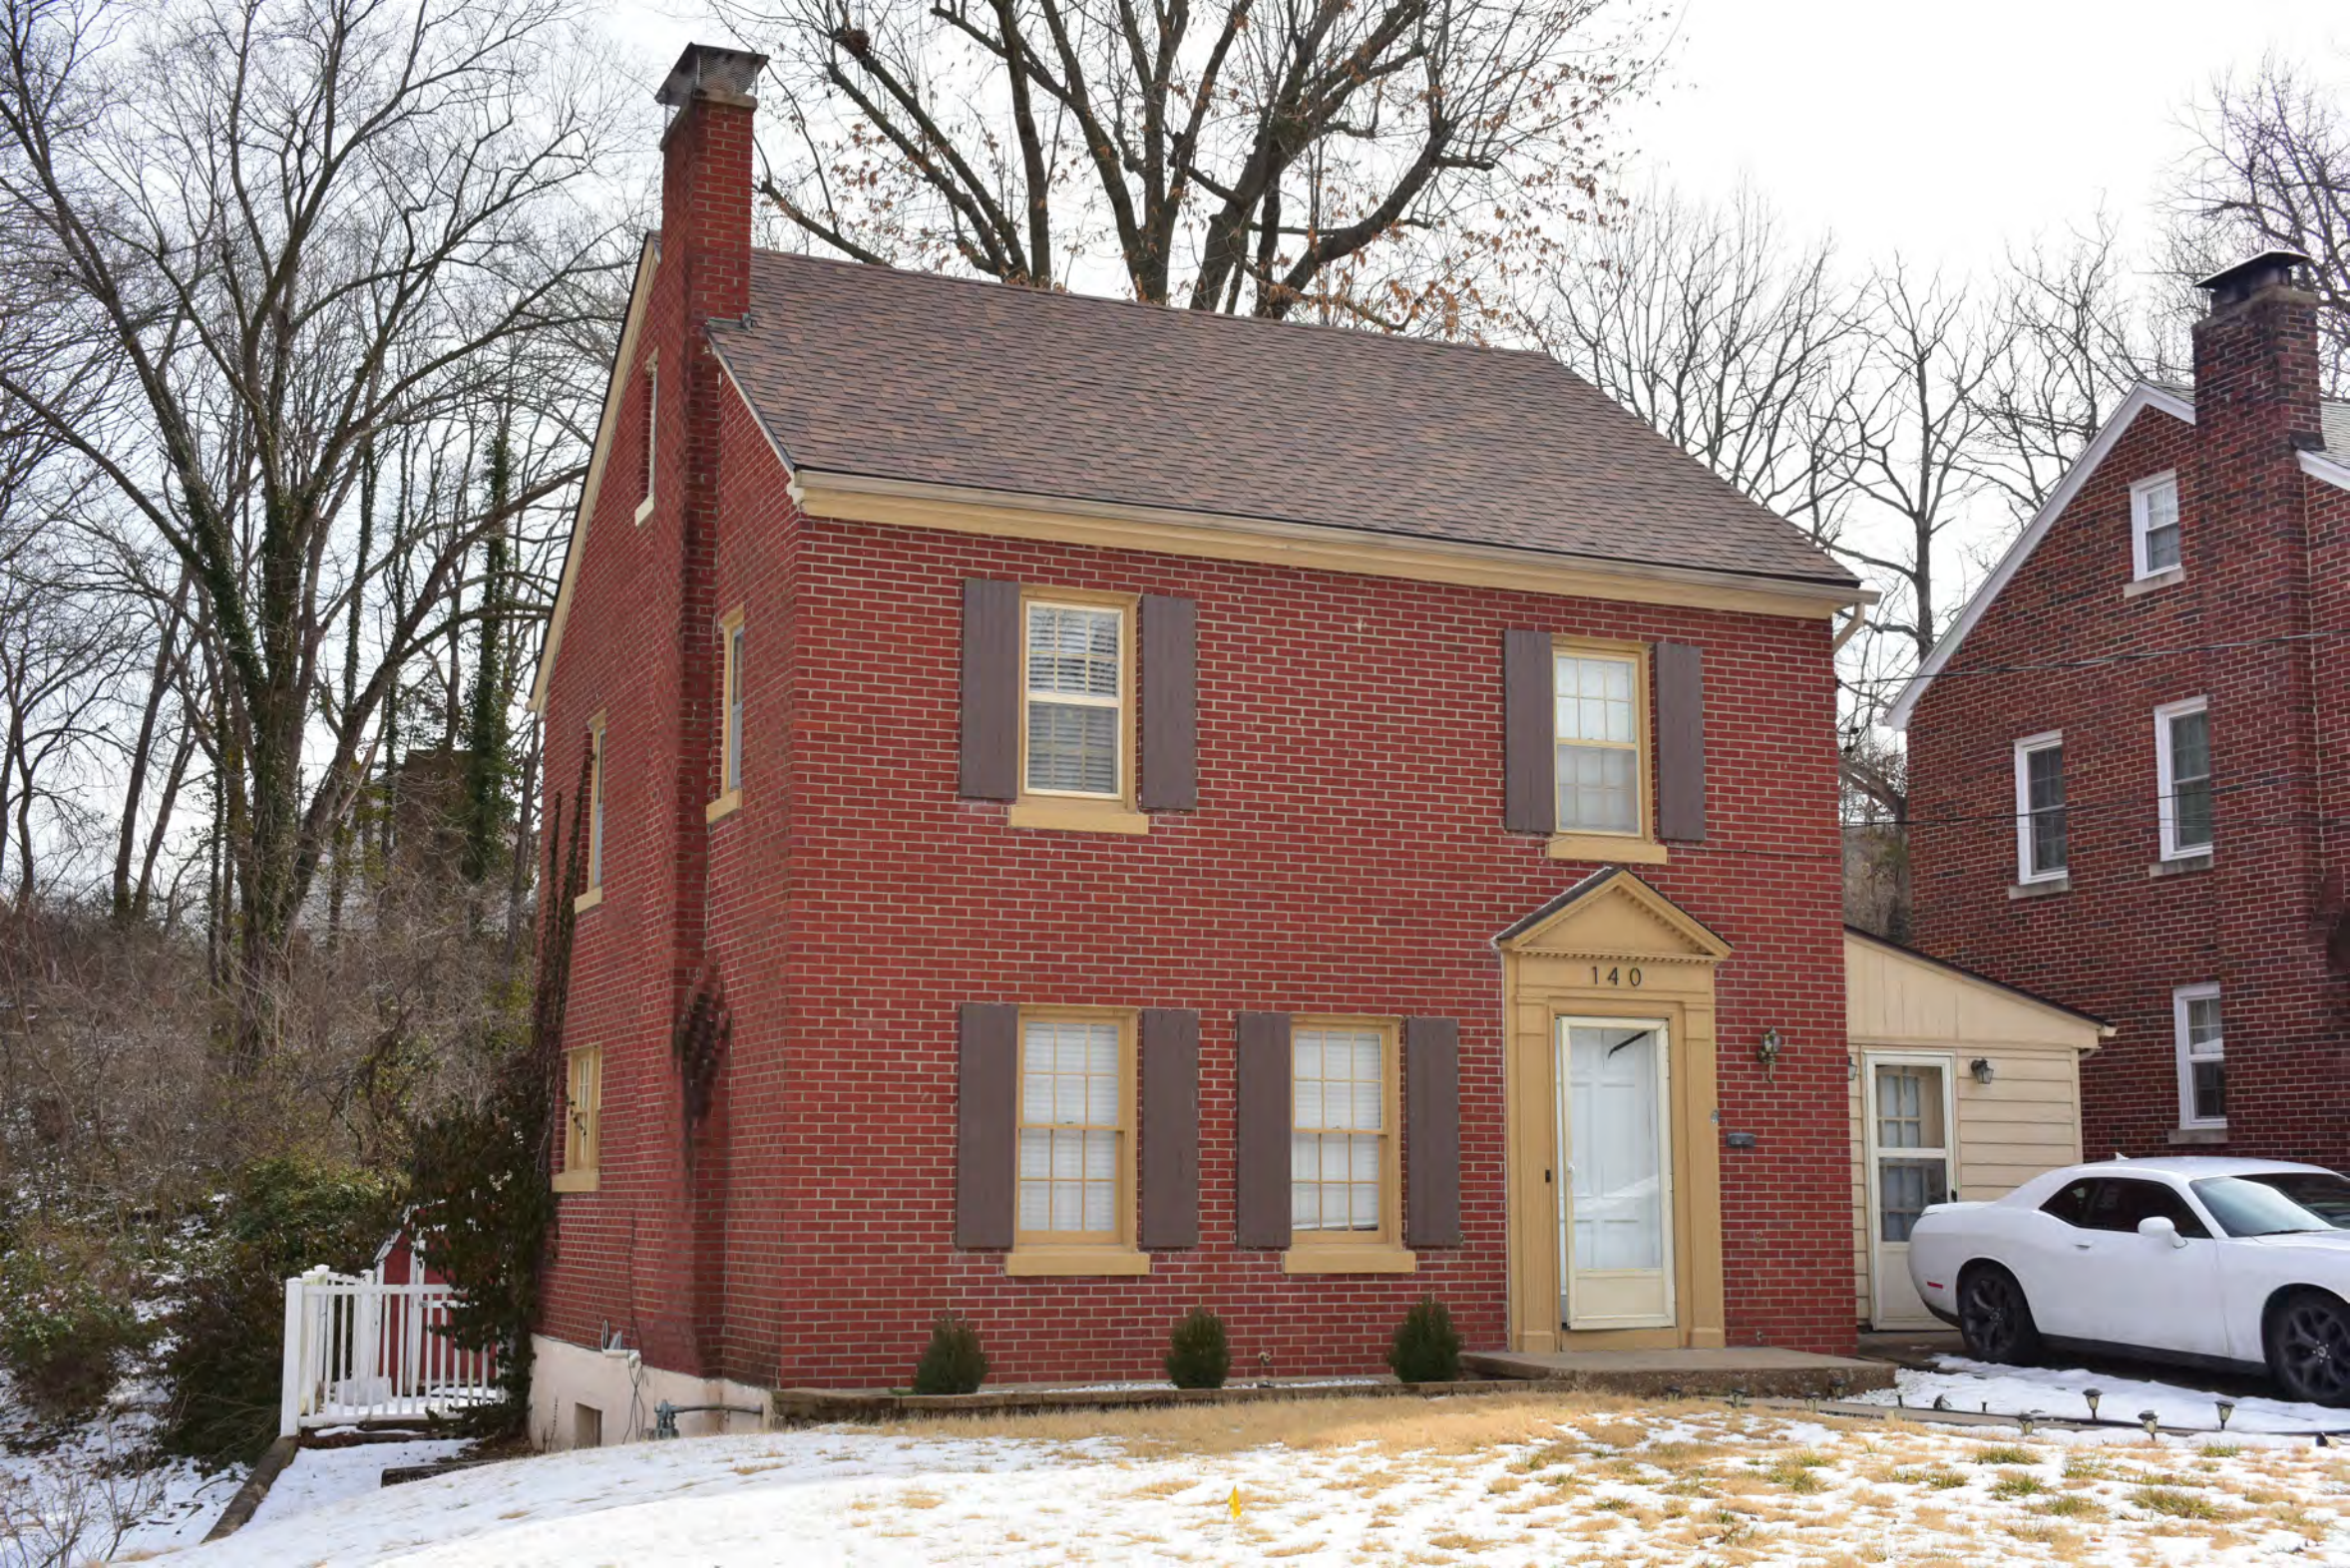
140 East Circle Drive is a two-story Minimal Traditional dwelling with restrained Colonial Revival influences. The brick-clad dwelling has a concrete foundation and a side-gable asphalt roof. A historic one-story shed-roof attached garage projects from the south elevation. A one-story vinyl-clad addition projects from the northeast corner of the dwelling. A brick exterior chimney pierces the narrow eave at the north elevation. The dwelling is three bays wide. Historic 6/6 wood windows with concrete sills and false shutters fill the north-two bays. The primary entrance defines the south bay. It includes features a Colonial Revival surround with pilasters and a pediment. A concrete stoop projects below the entrance. The garage bay has been altered to include a pedestrian entrance. Hardboard clads the primary elevation of the garage. 140 East Circle Drive is near identical to its neighbor, 138 East Circle Drive.

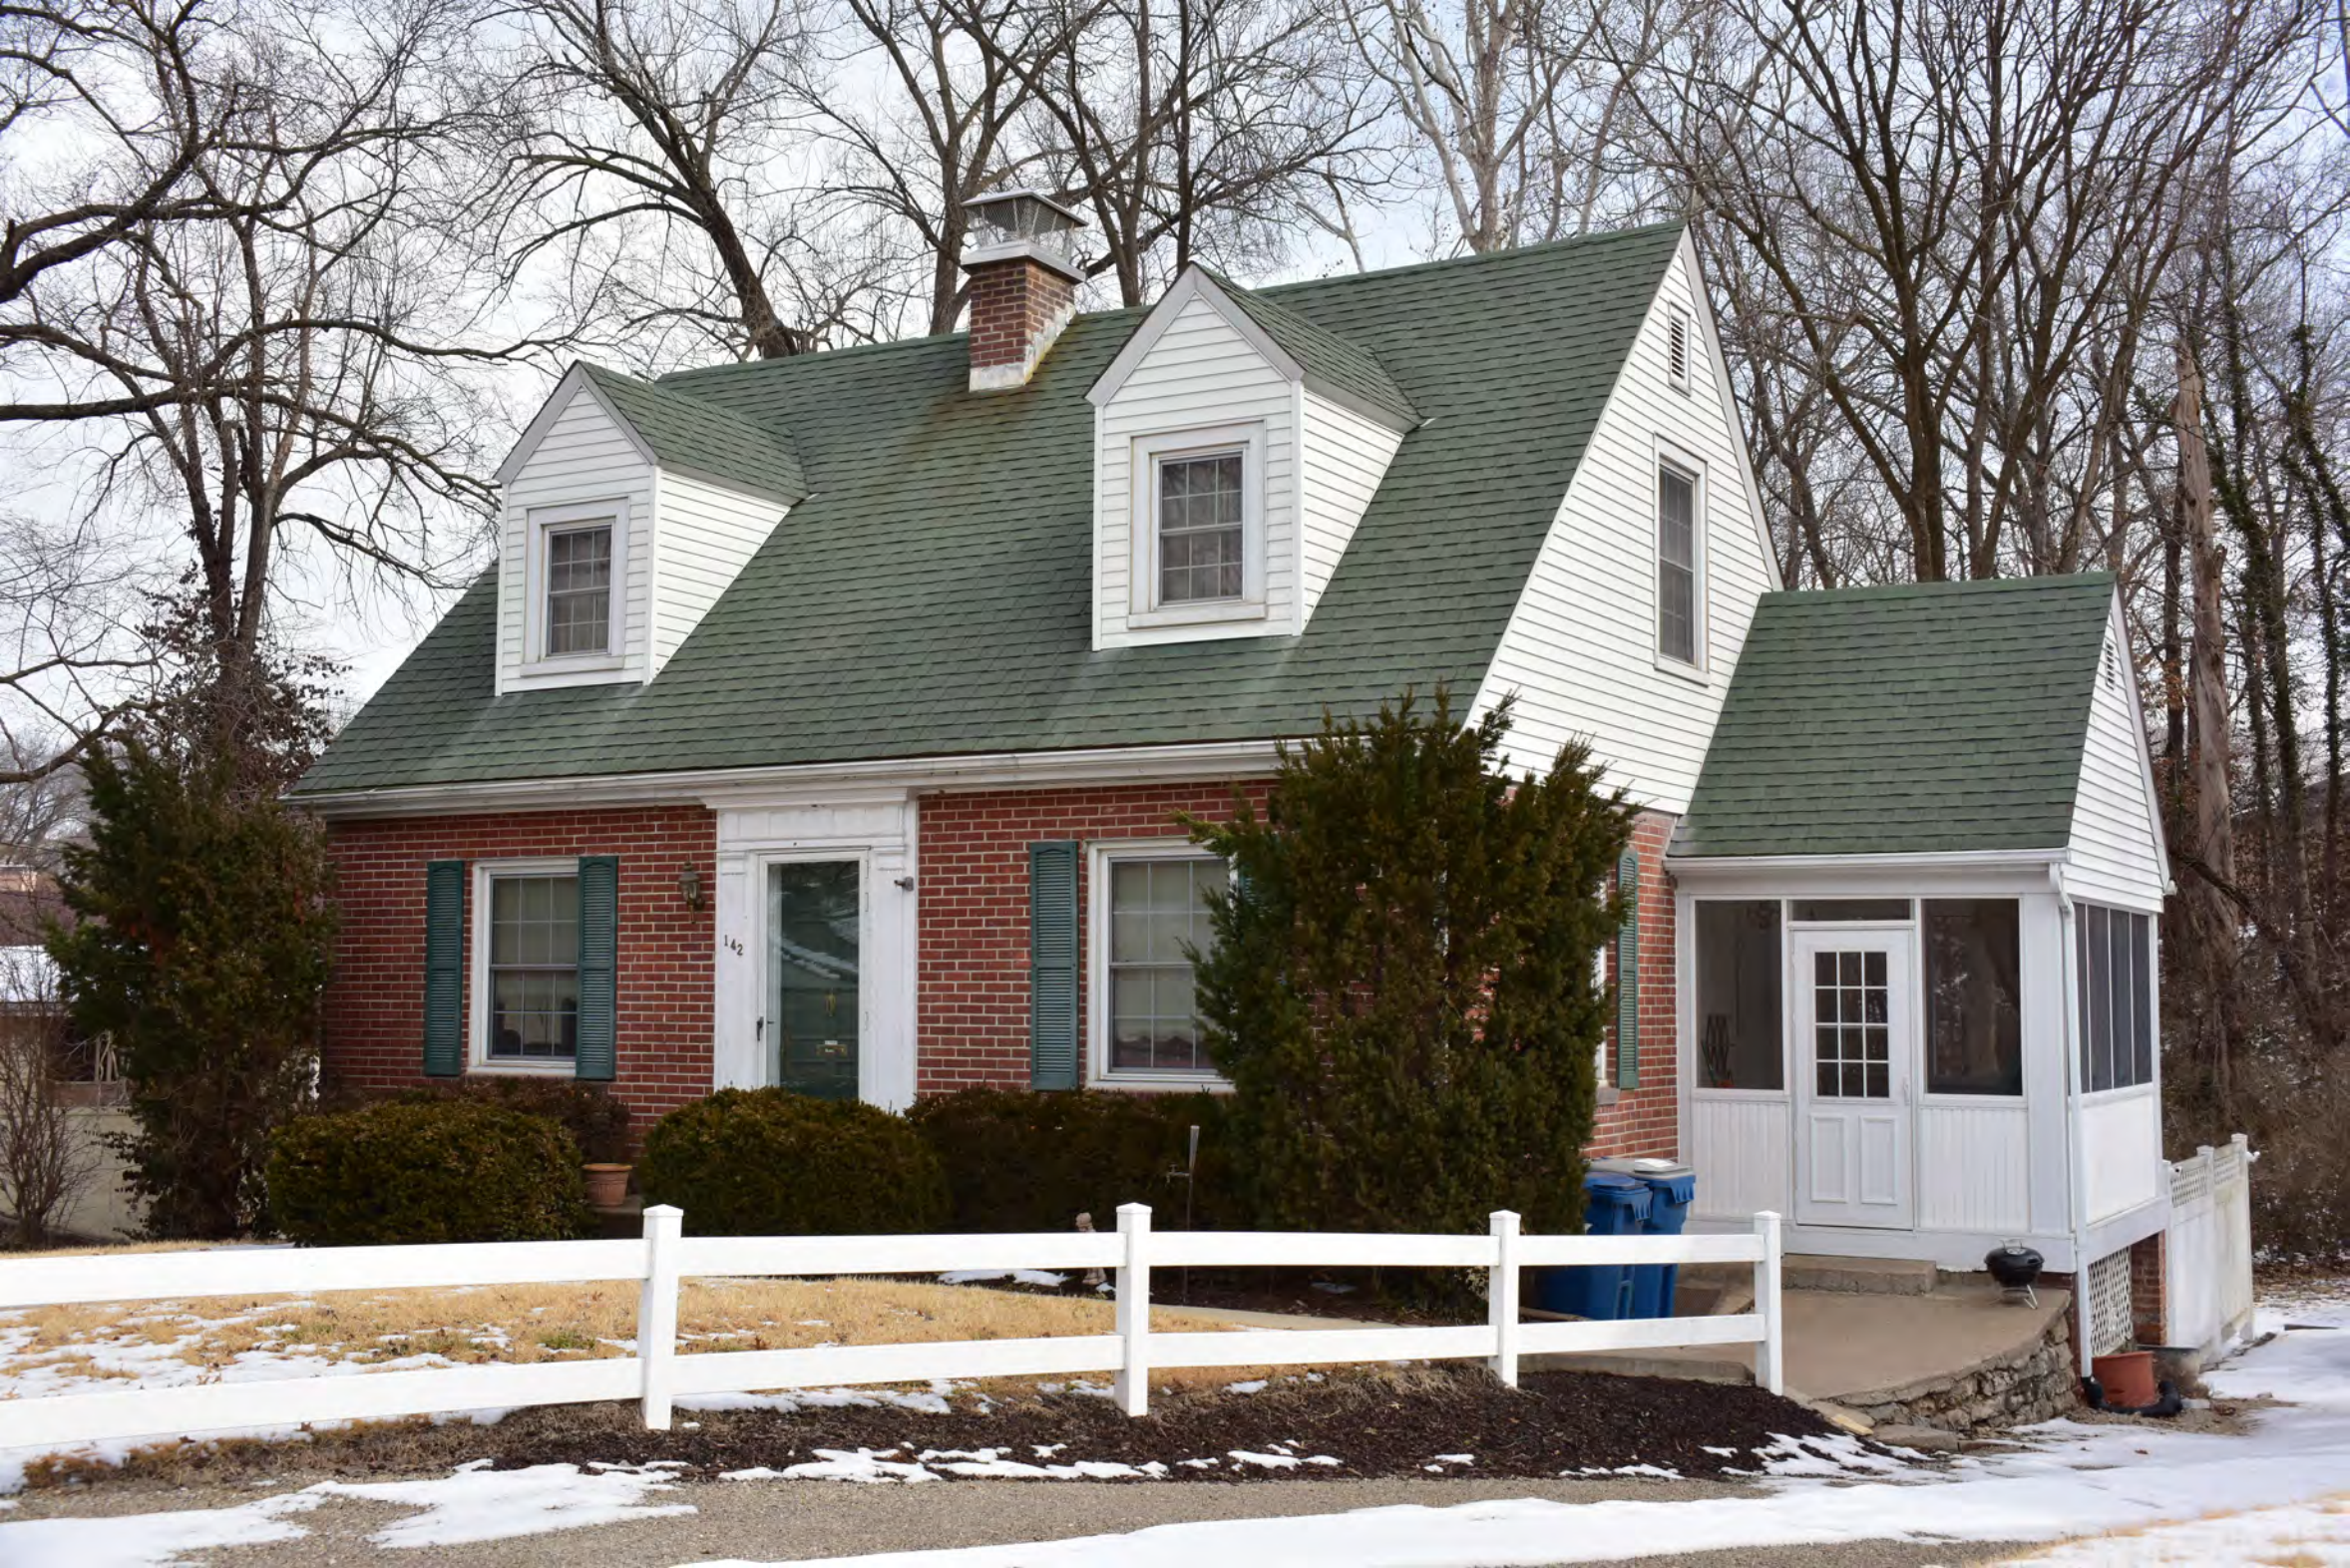
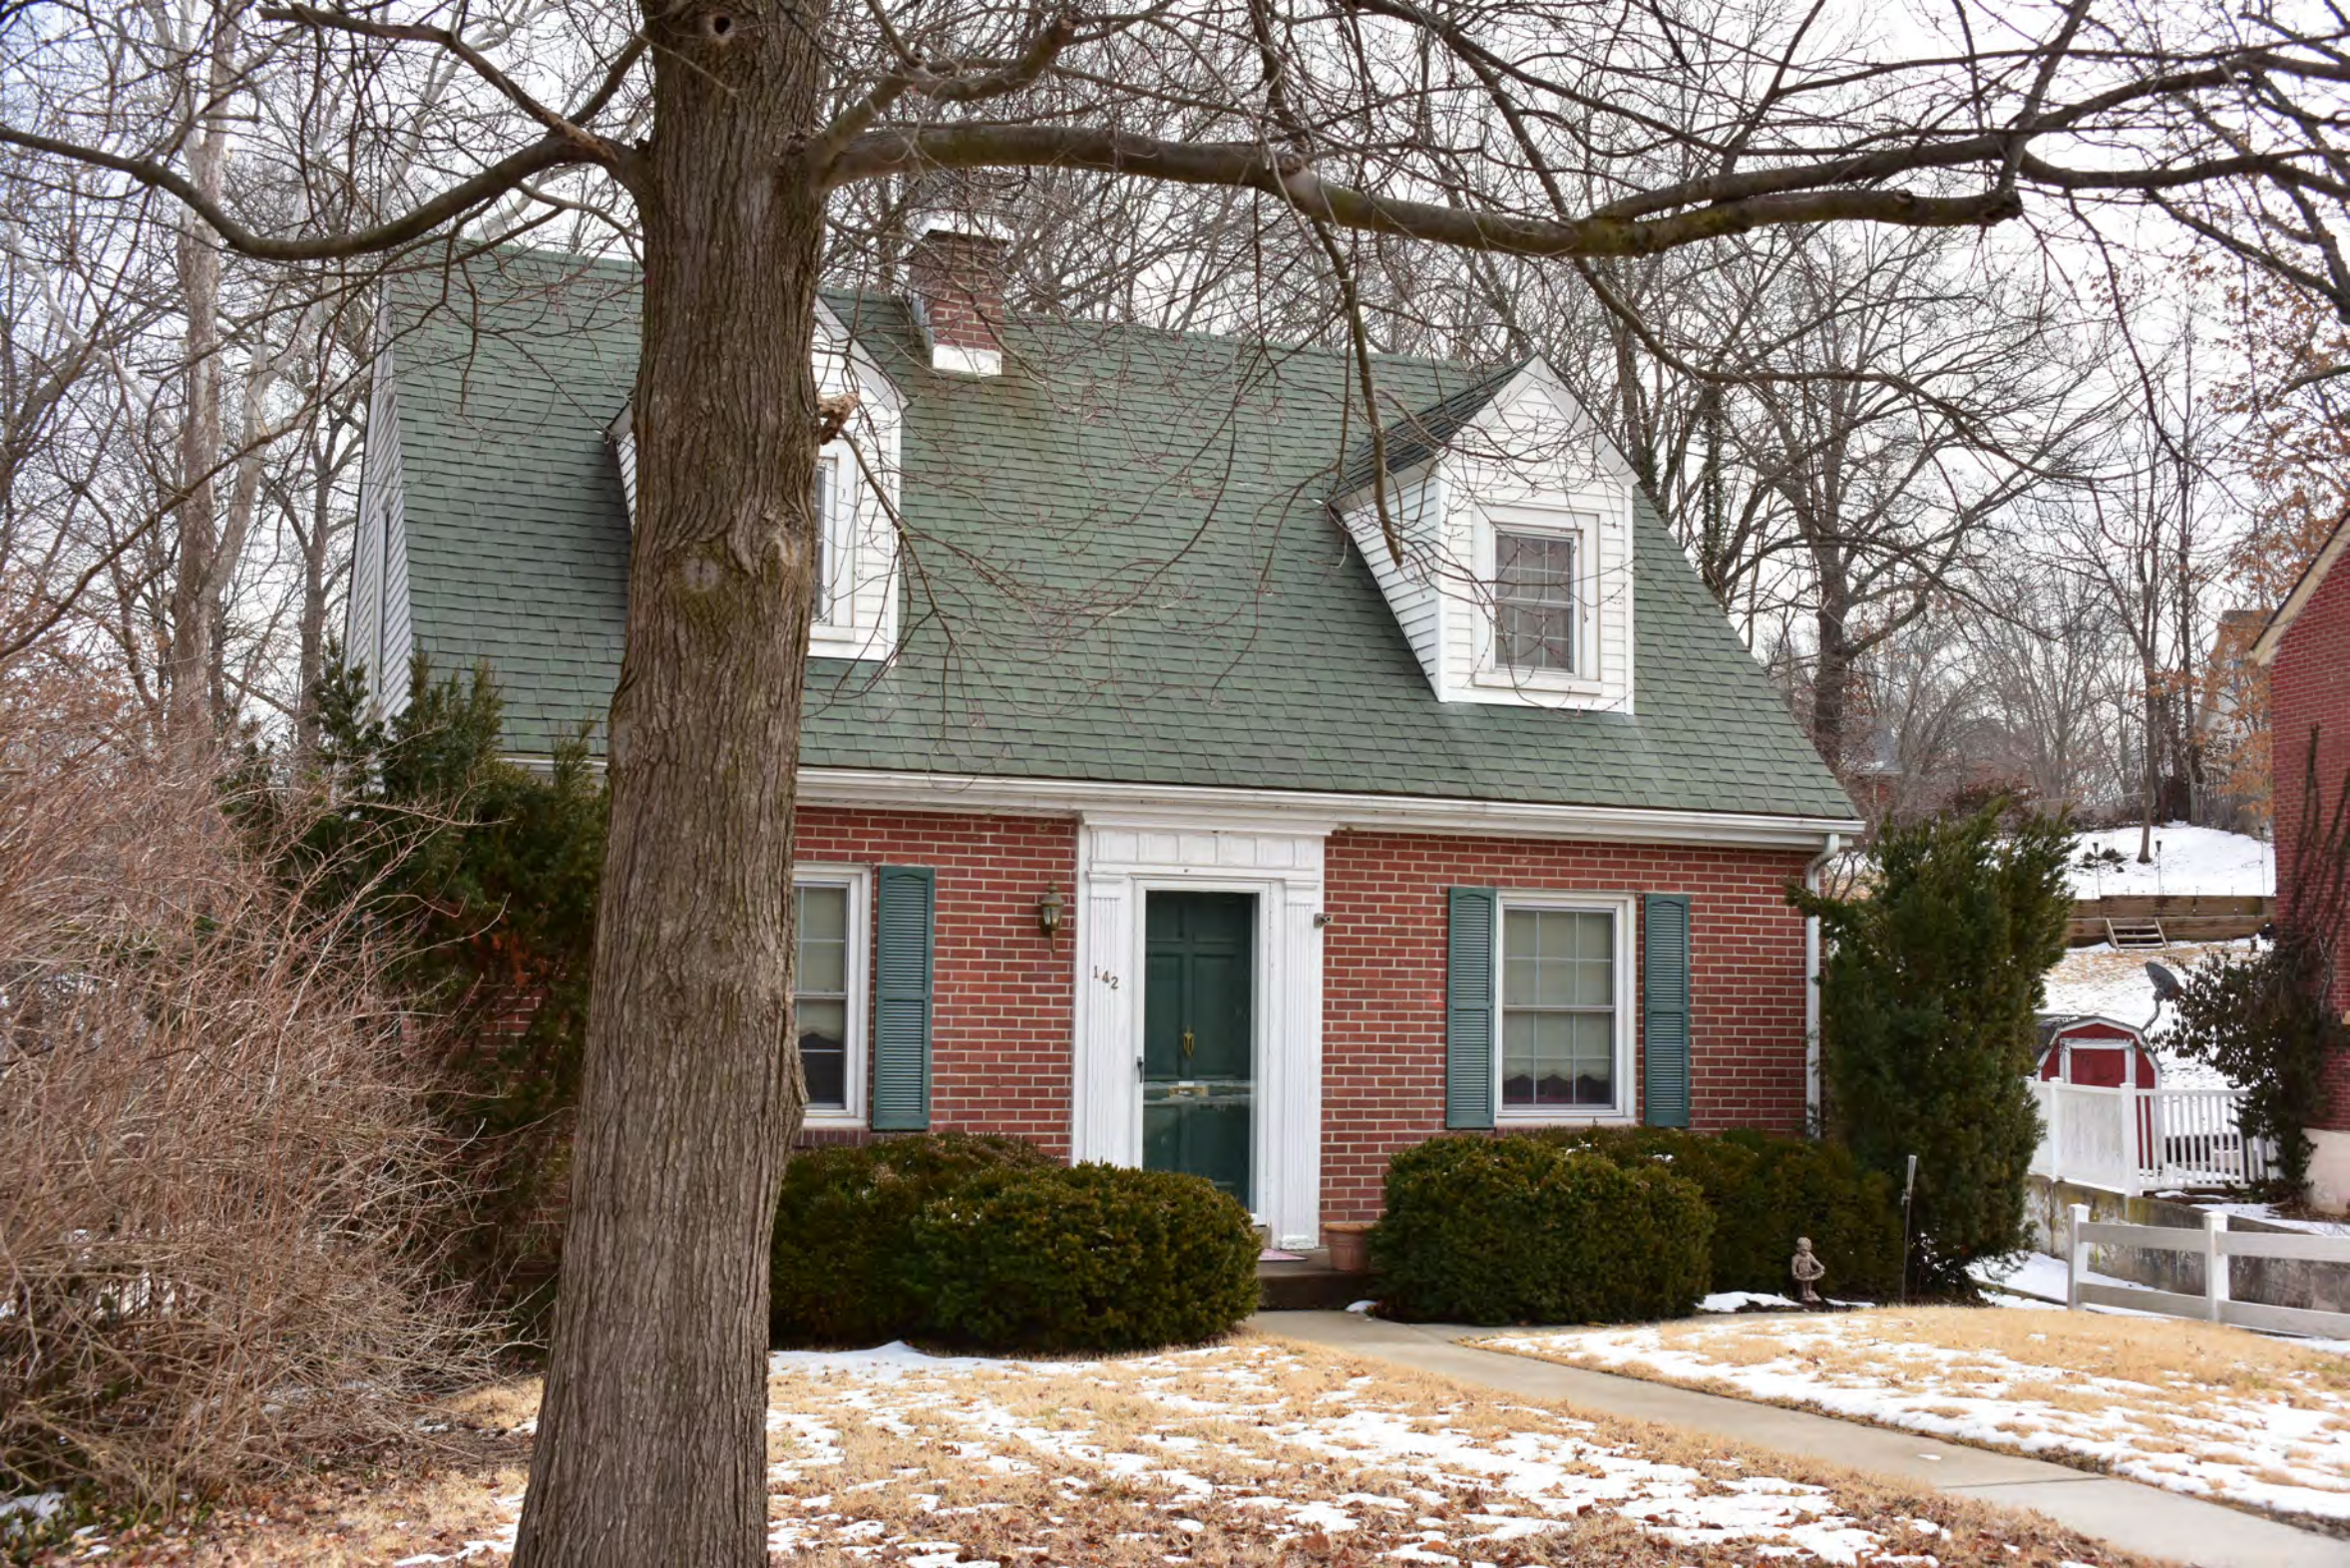
142 East Circle Drive is a one-and-one-half story Minimal Traditional dwelling with restrained Colonial Revival influences. The brick-clad dwelling has a concrete foundation and a side-gable asphalt roof. Two vinyl-clad gabled dormers are located on the front slope. A brick chimney is centered between the dormers near the ridgeline. Vinyl clads the gable ends. A historic one-story screened sunporch with a gable roof projects from the south elevation. Vinyl fills the sunporch roof gable end. Non-historic 6/6 windows with header brick sills and false shutters flank the primary entrance bay. The primary entrance includes features a Colonial Revival surround with pilasters and entablature. A concrete stoop projects below the entrance.

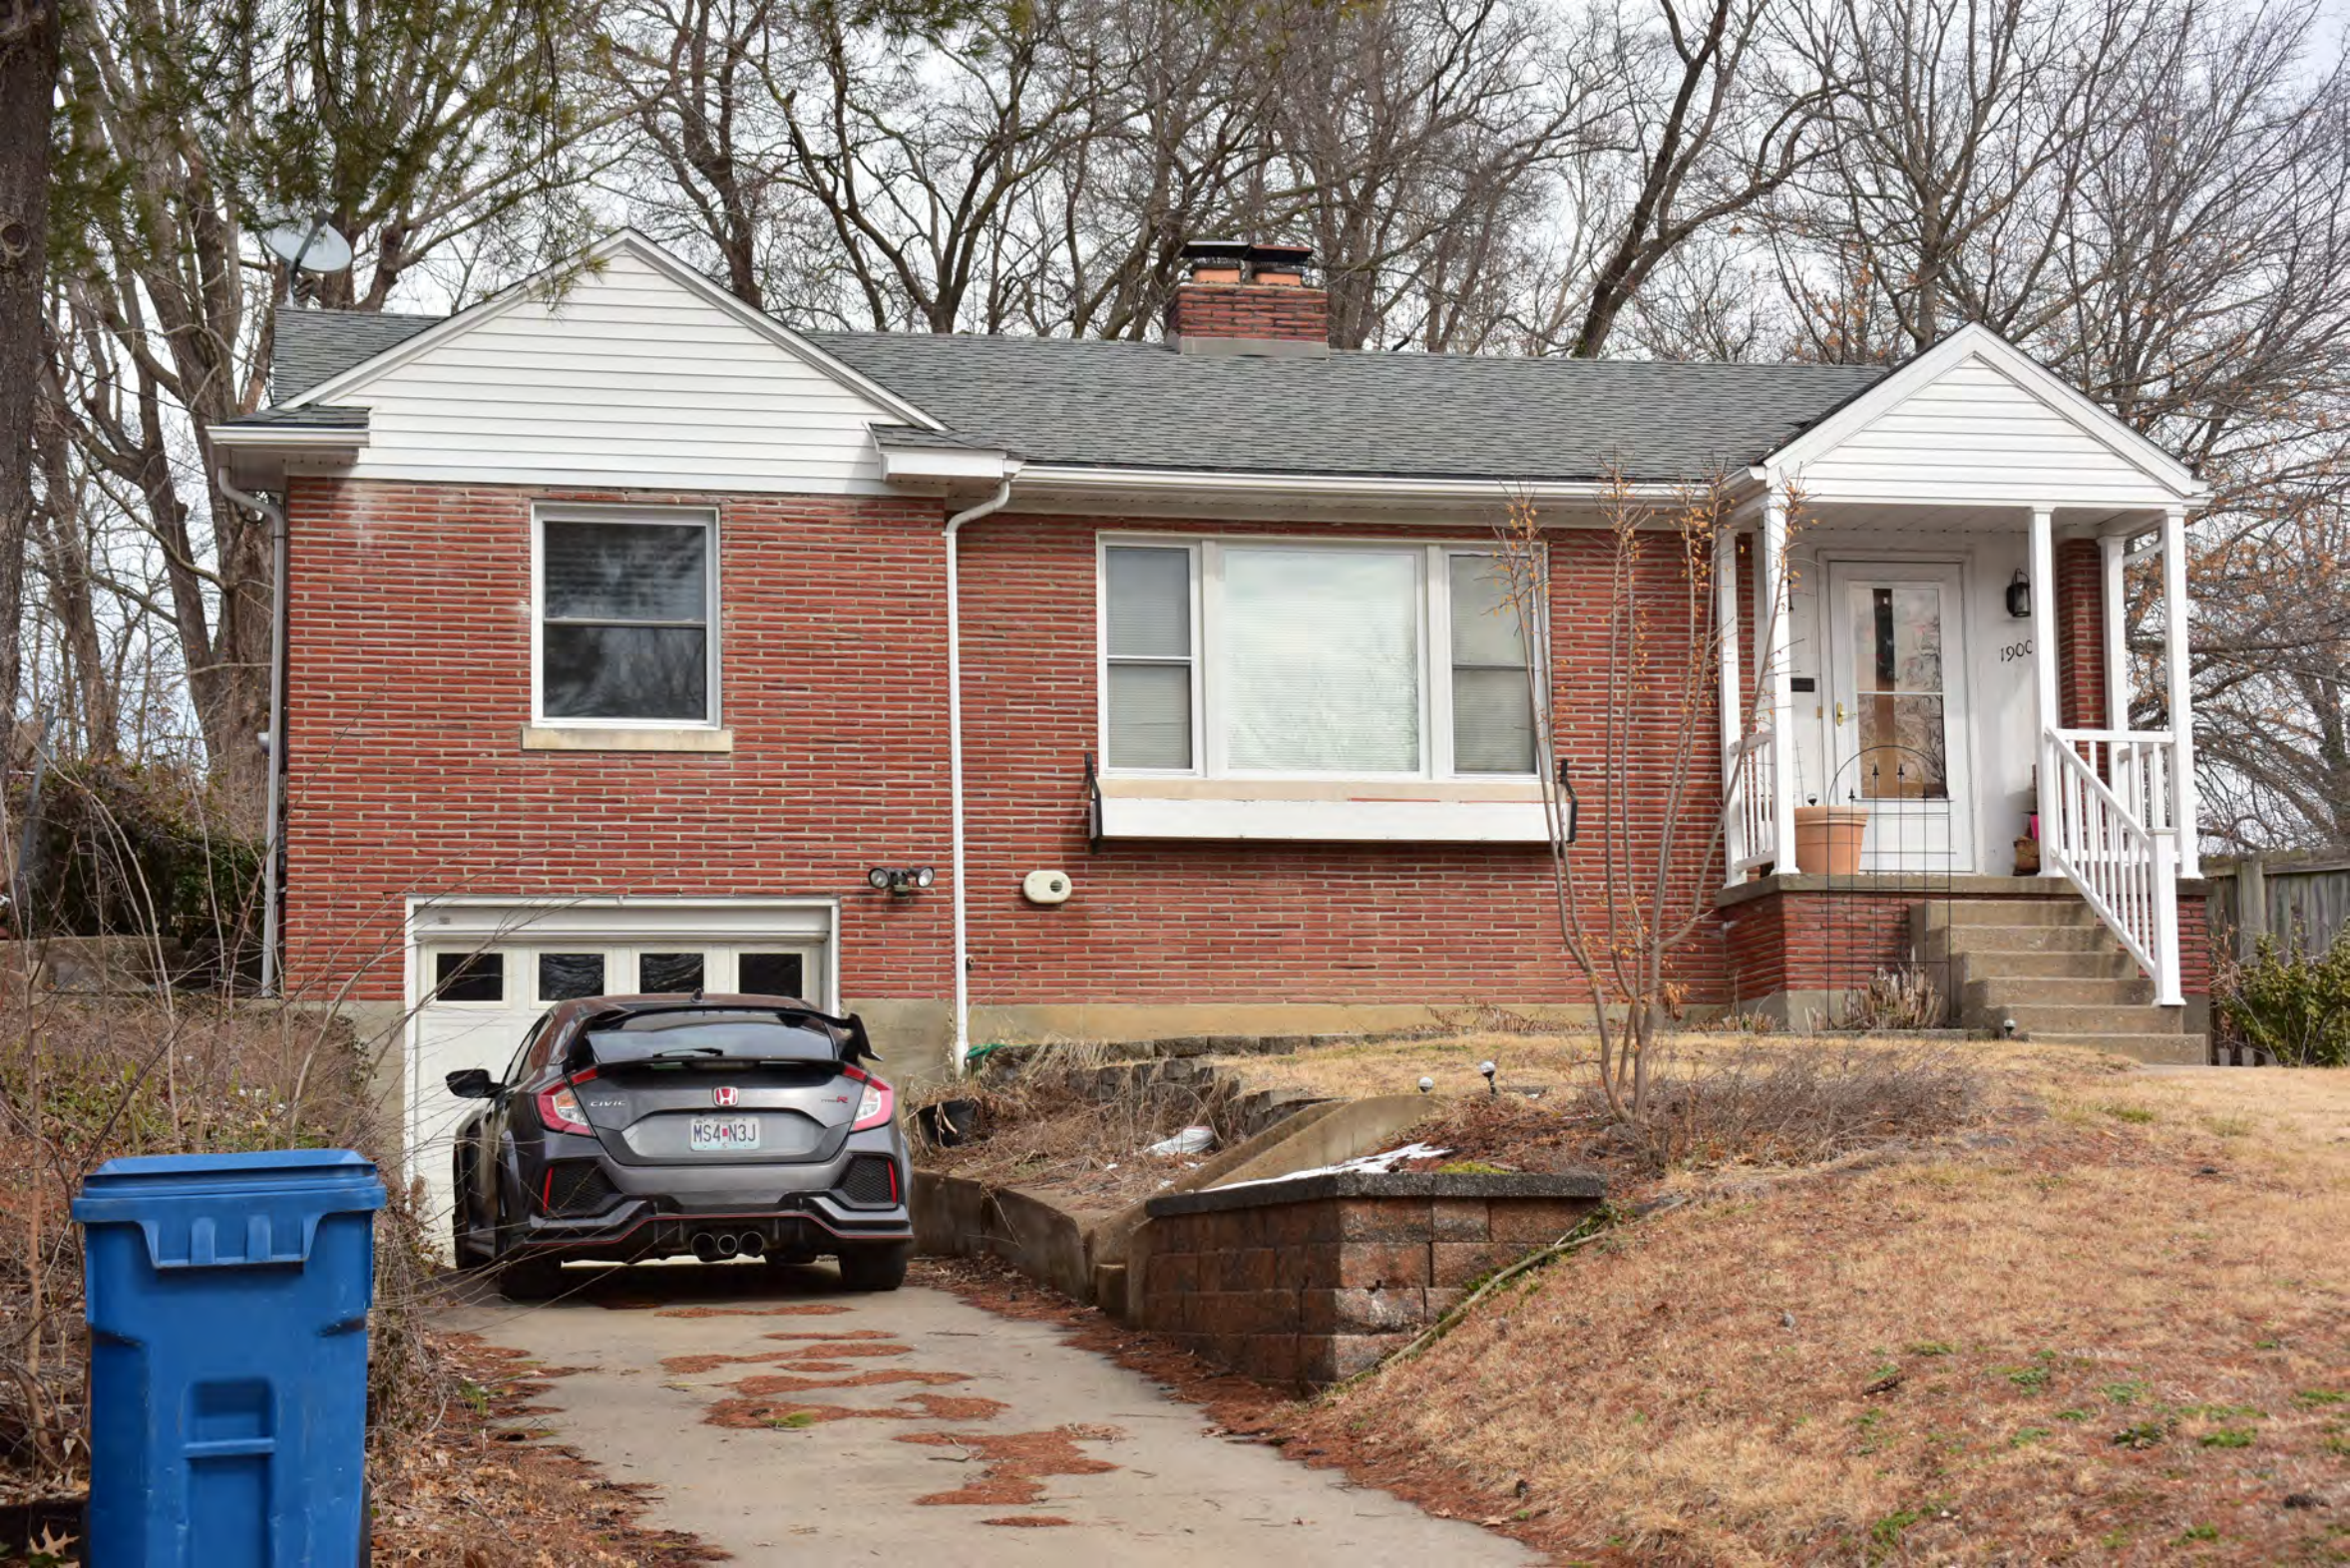
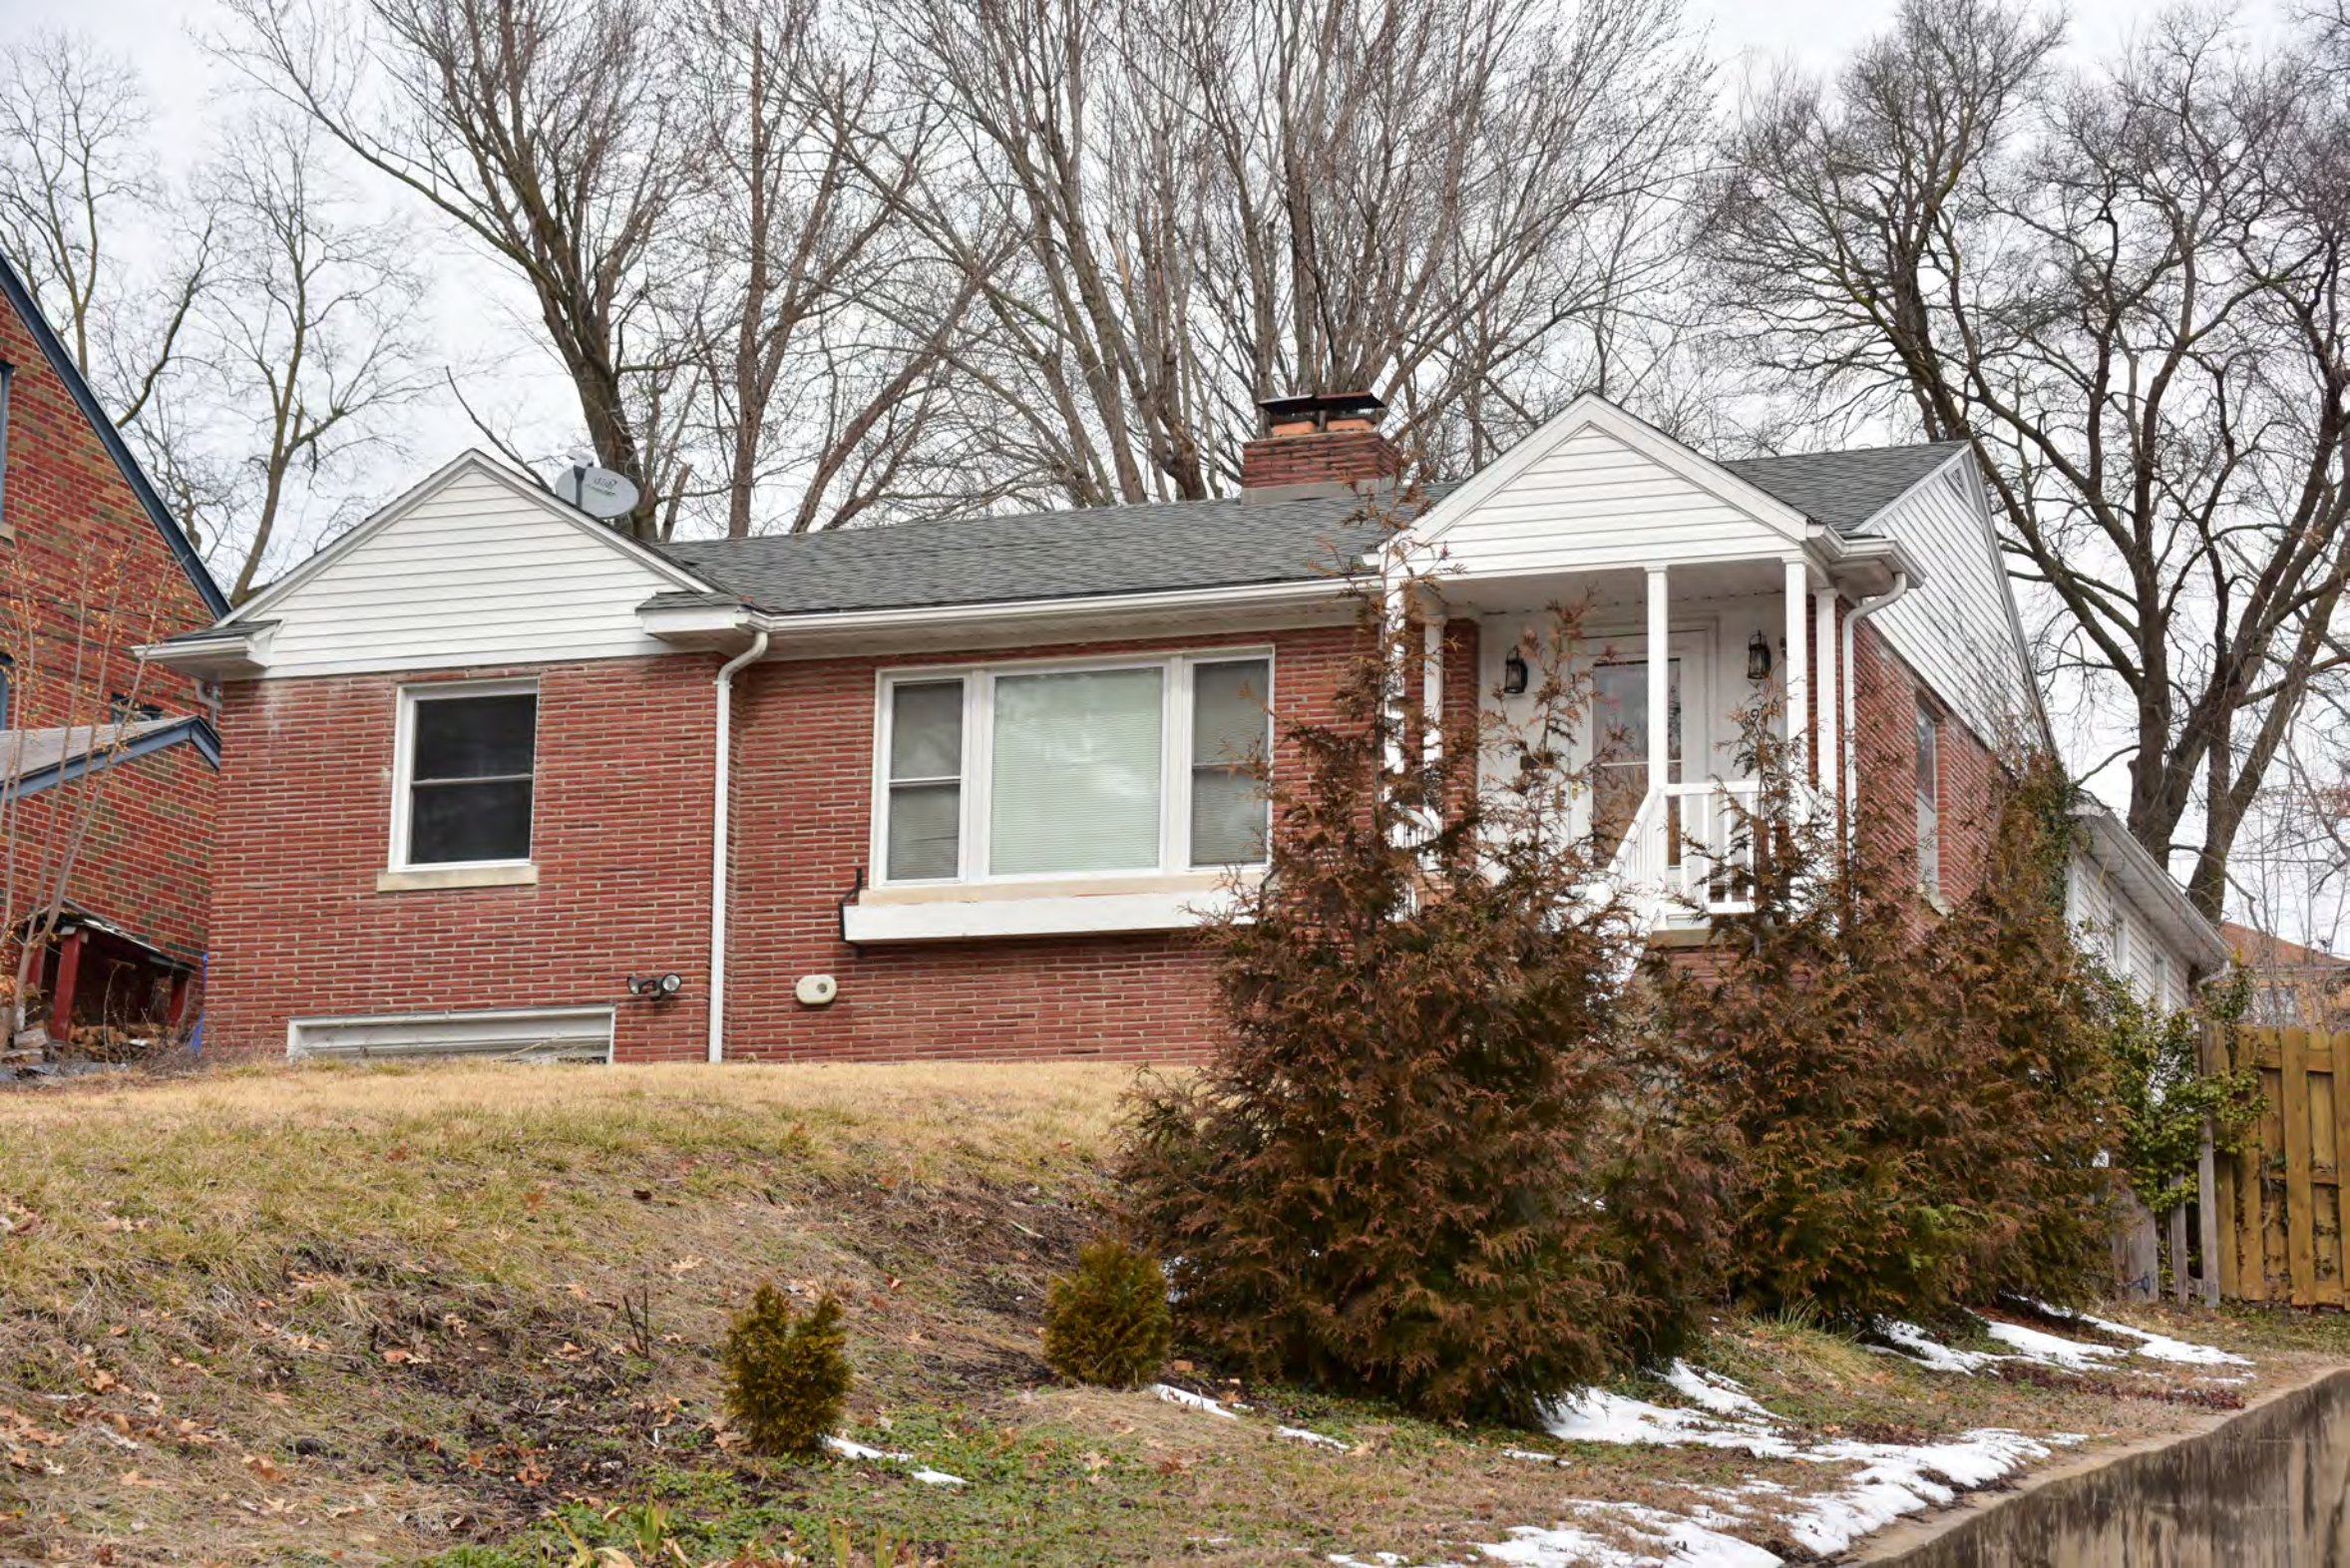
1900 North Circle Drive is a one-story Transitional Ranch dwelling with concrete foundation, narrow brick cladding, and a gabled-ell asphalt roof. A side-gable roof fronts North Circle Drive while a perpendicular gable extends to the rear from the east end. Low cross gables are located at the east and west ends of the primary (south) elevation. Vinyl clads the side-gable and cross-gable ends. The dwelling is three bays wide. A vinyl 1/1 window defines the first bay while a picture window fills the second bay. Non-historic 1/1 windows flank the fixed central pane. Both windows have concrete sills. The primary entrance defines the east bay and contains a non-historic door an aluminum storm door. The east cross-gable projects to shelter the entrance. Non-historic synthetic columns support the gable. A brick stoop with concrete floor and foundation projects from the entrance. Concrete steps with a synthetic railing access the stoop. A matching balustrade lines the stoop perimeter. An integrated one-car garage is positioned below the first bay. A non-historic paneled overhead door with glazing fills the vehicular bay. A c. 1967-1991 vinyl-clad addition extends to the rear.
