1. Survey number: CO-AS-008-001		2. Survey Name: West Main Street Survey	
3. County: Cole		4. Address (Street No.): 100	Street (name): East Circle Drive
5. City: Jefferson City	Vicinity <input type="checkbox"/>	6. Lat / Long:	7. Township/Range/Section: T: R: S:
8. Historic name (if known):		9. Present/other name (if known):	
10. Ownership: <input checked="" type="checkbox"/> Private <input type="checkbox"/> Public		11a. Historic use (if known): Domestic-Single Dwelling	11b. Current use: Domestic-Single Dwelling

MISSOURI DEPARTMENT OF NATURAL RESOURCES
STATE HISTORIC PRESERVATION OFFICE, P.O. Box 178, Jefferson City, MO 65102
ARCHITECTURAL/HISTORIC INVENTORY FORM

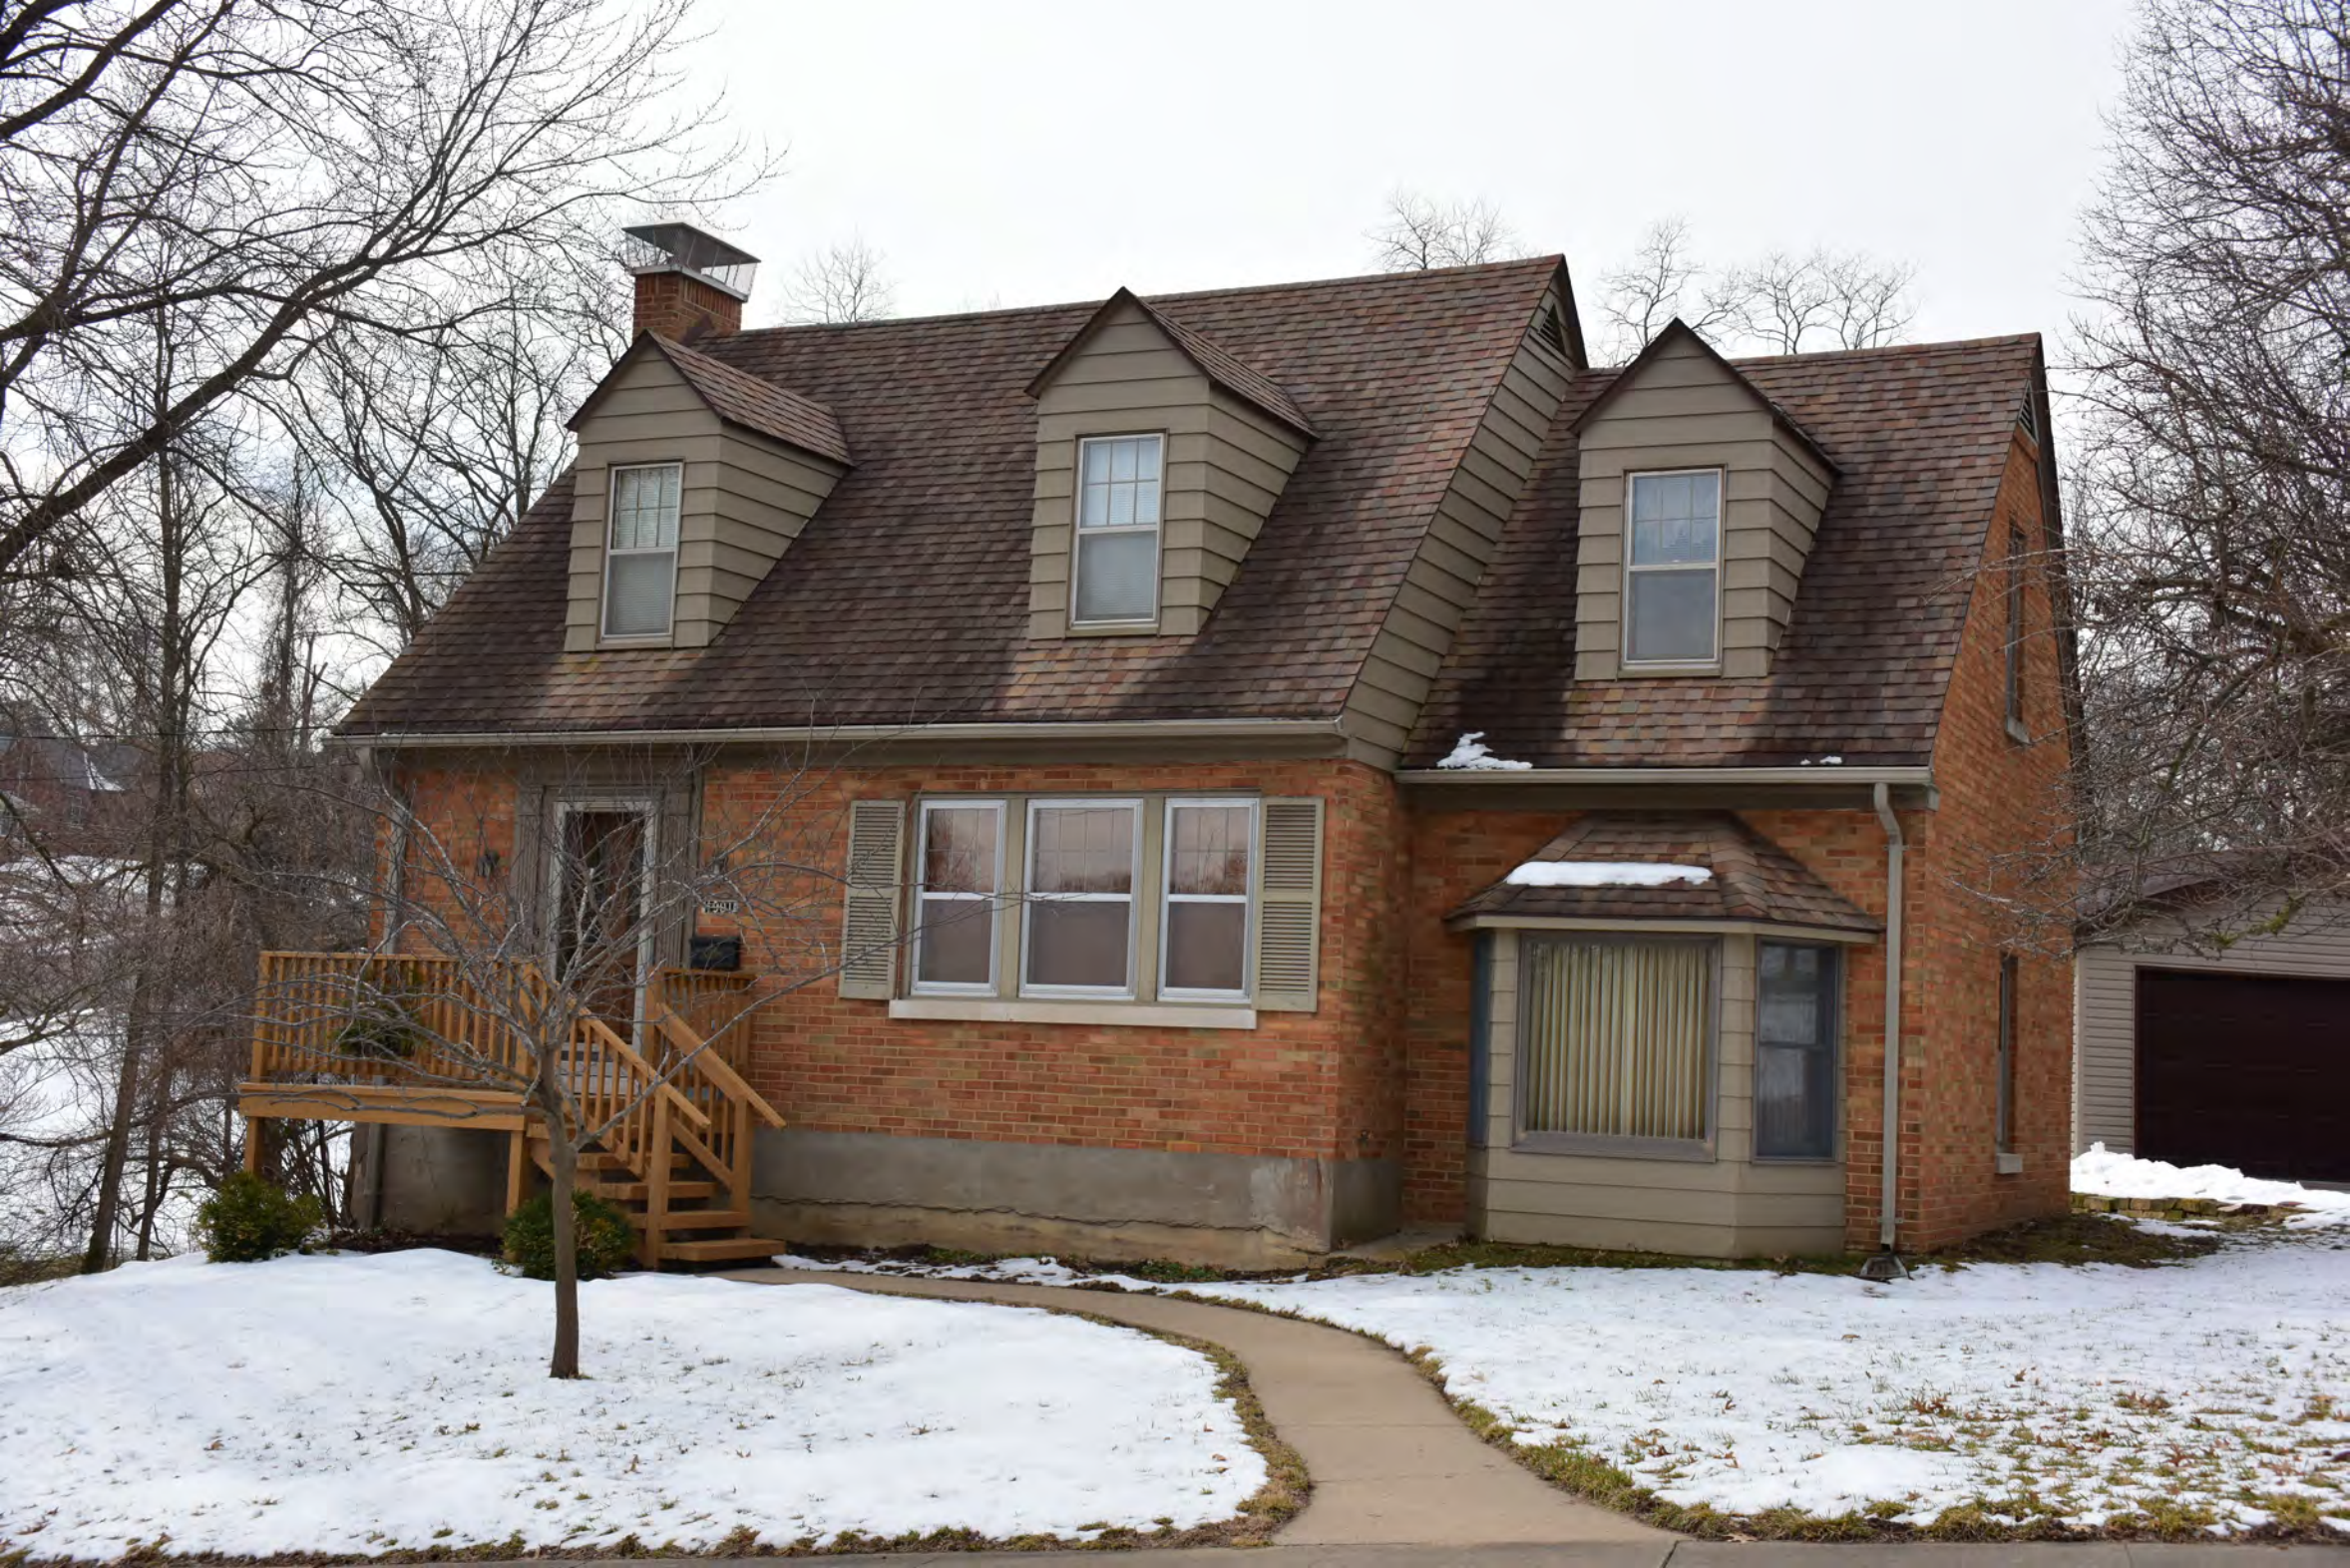
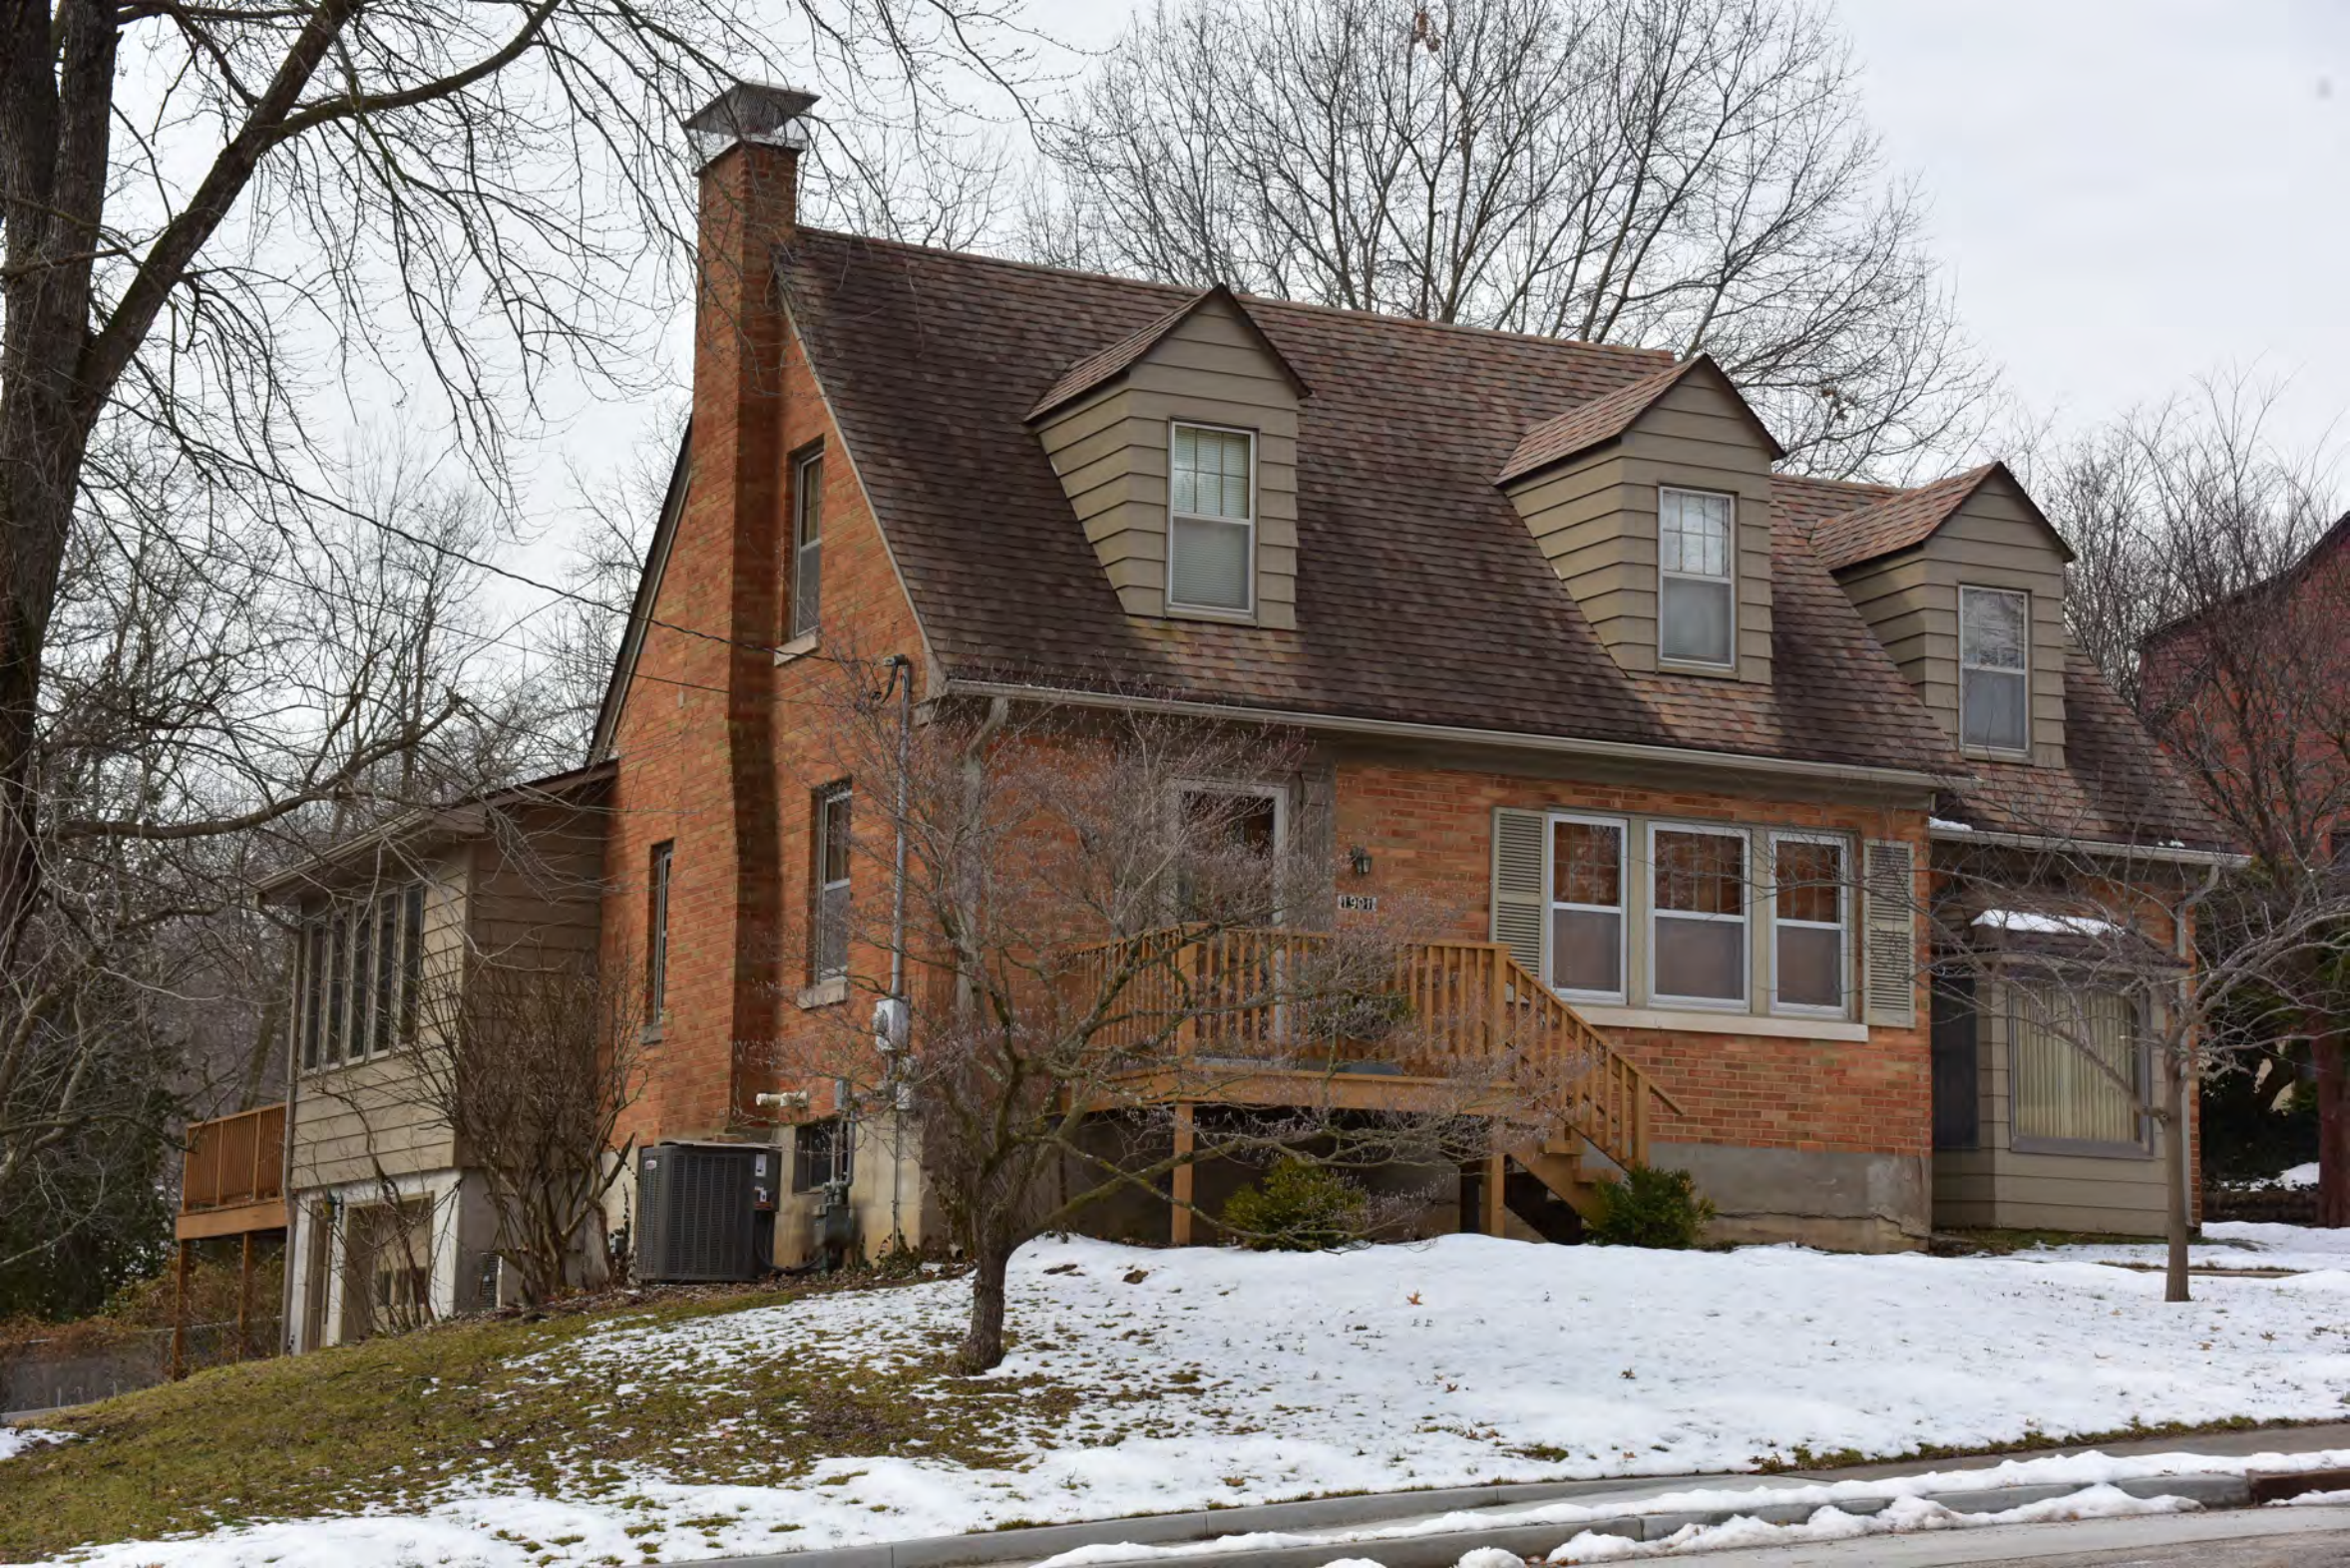
1901 North Circle Drive is a two-story Minimal Traditional dwelling. The brick-clad dwelling has a parged concrete foundation and asphalt side-gable roof. A brick exterior chimney pierces the east gable apex. The dwelling is three bays wide. Hardboard-clad gabled dormers with historic 6/1 wood windows pierce the front slope above each bay. The west bay recedes and formerly contained a single-car garage. A bay window now fills the bay. Non-historic 1/1 vinyl windows flank the center fixed pane window. Three-ganged historic 6/1 wood windows with a continuous concrete sill fill the center bay while the primary entrance defines the east bay. The entrance includes a wood door with glazing and neo-classical surround with pilasters and entablature. A non-historic wood deck projects below the entrance. Fenestration at the east and west elevations is symmetrical and includes historic 6/1 wood windows with concrete sills. A garage addition extends from the rear and slightly projects east. The garage is located at basement level and is accessed at the east elevation. A hardboard-clad enclosed porch tops the garage. A non-historic wood deck extends from the porch.

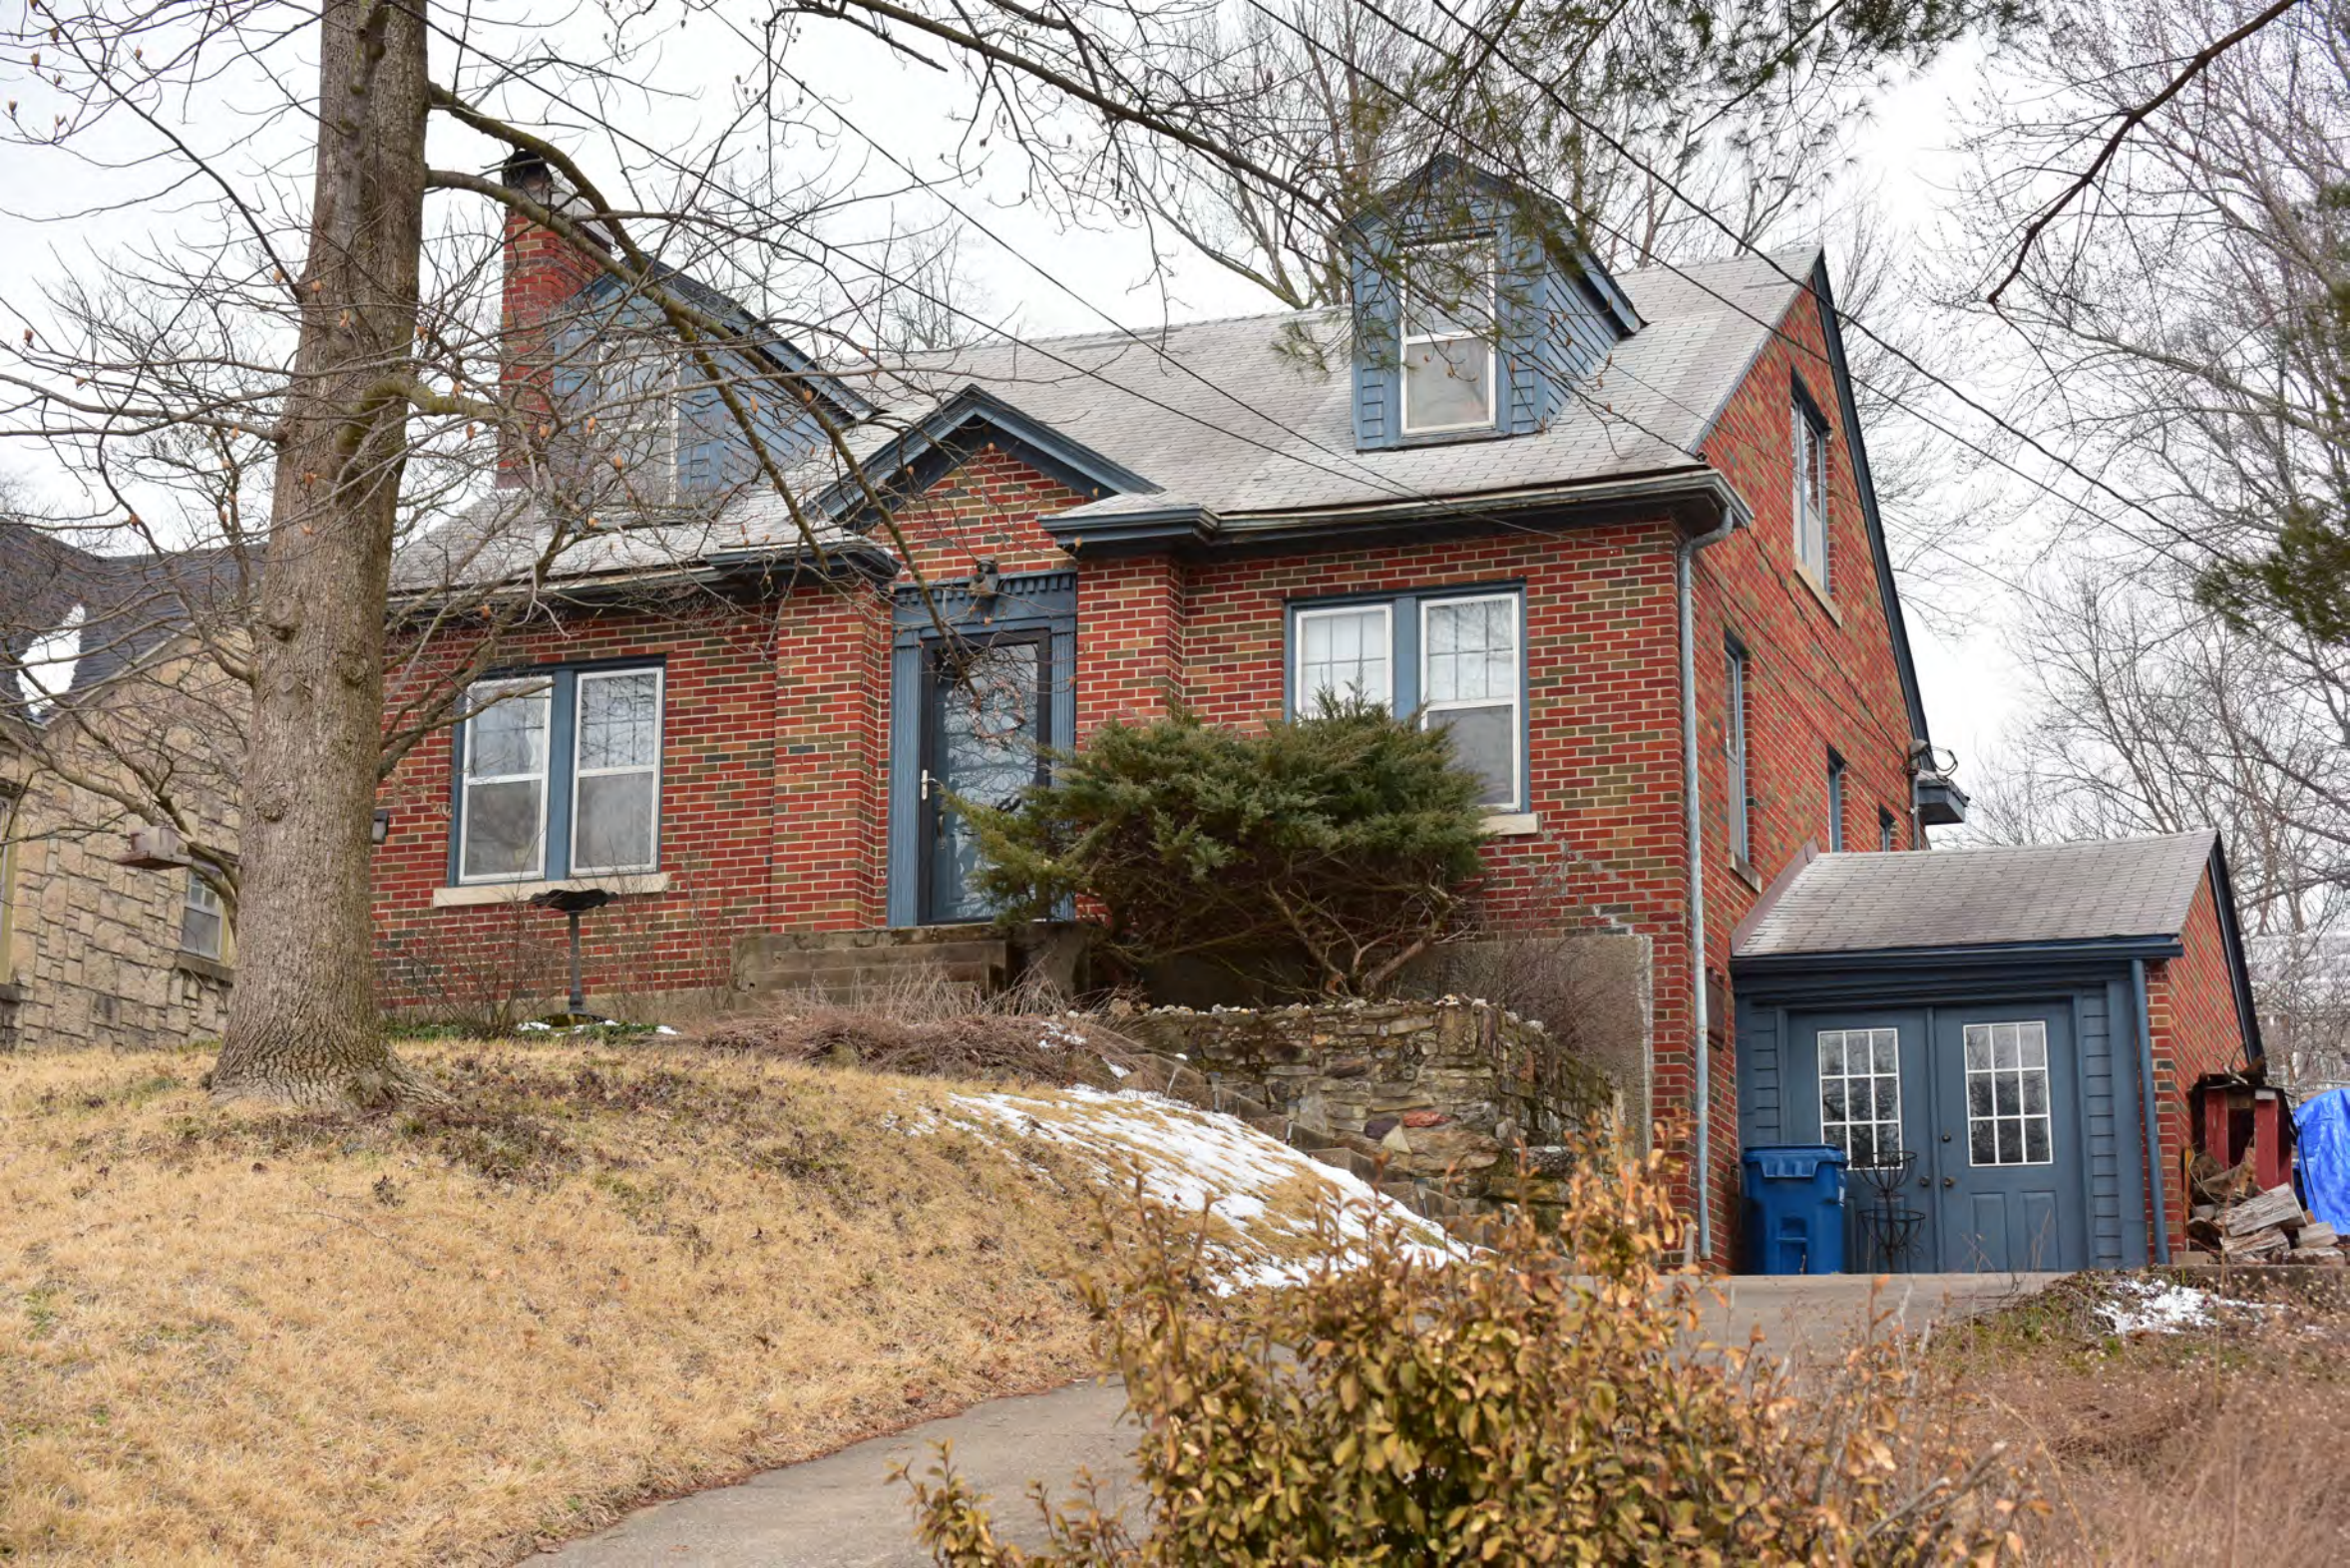
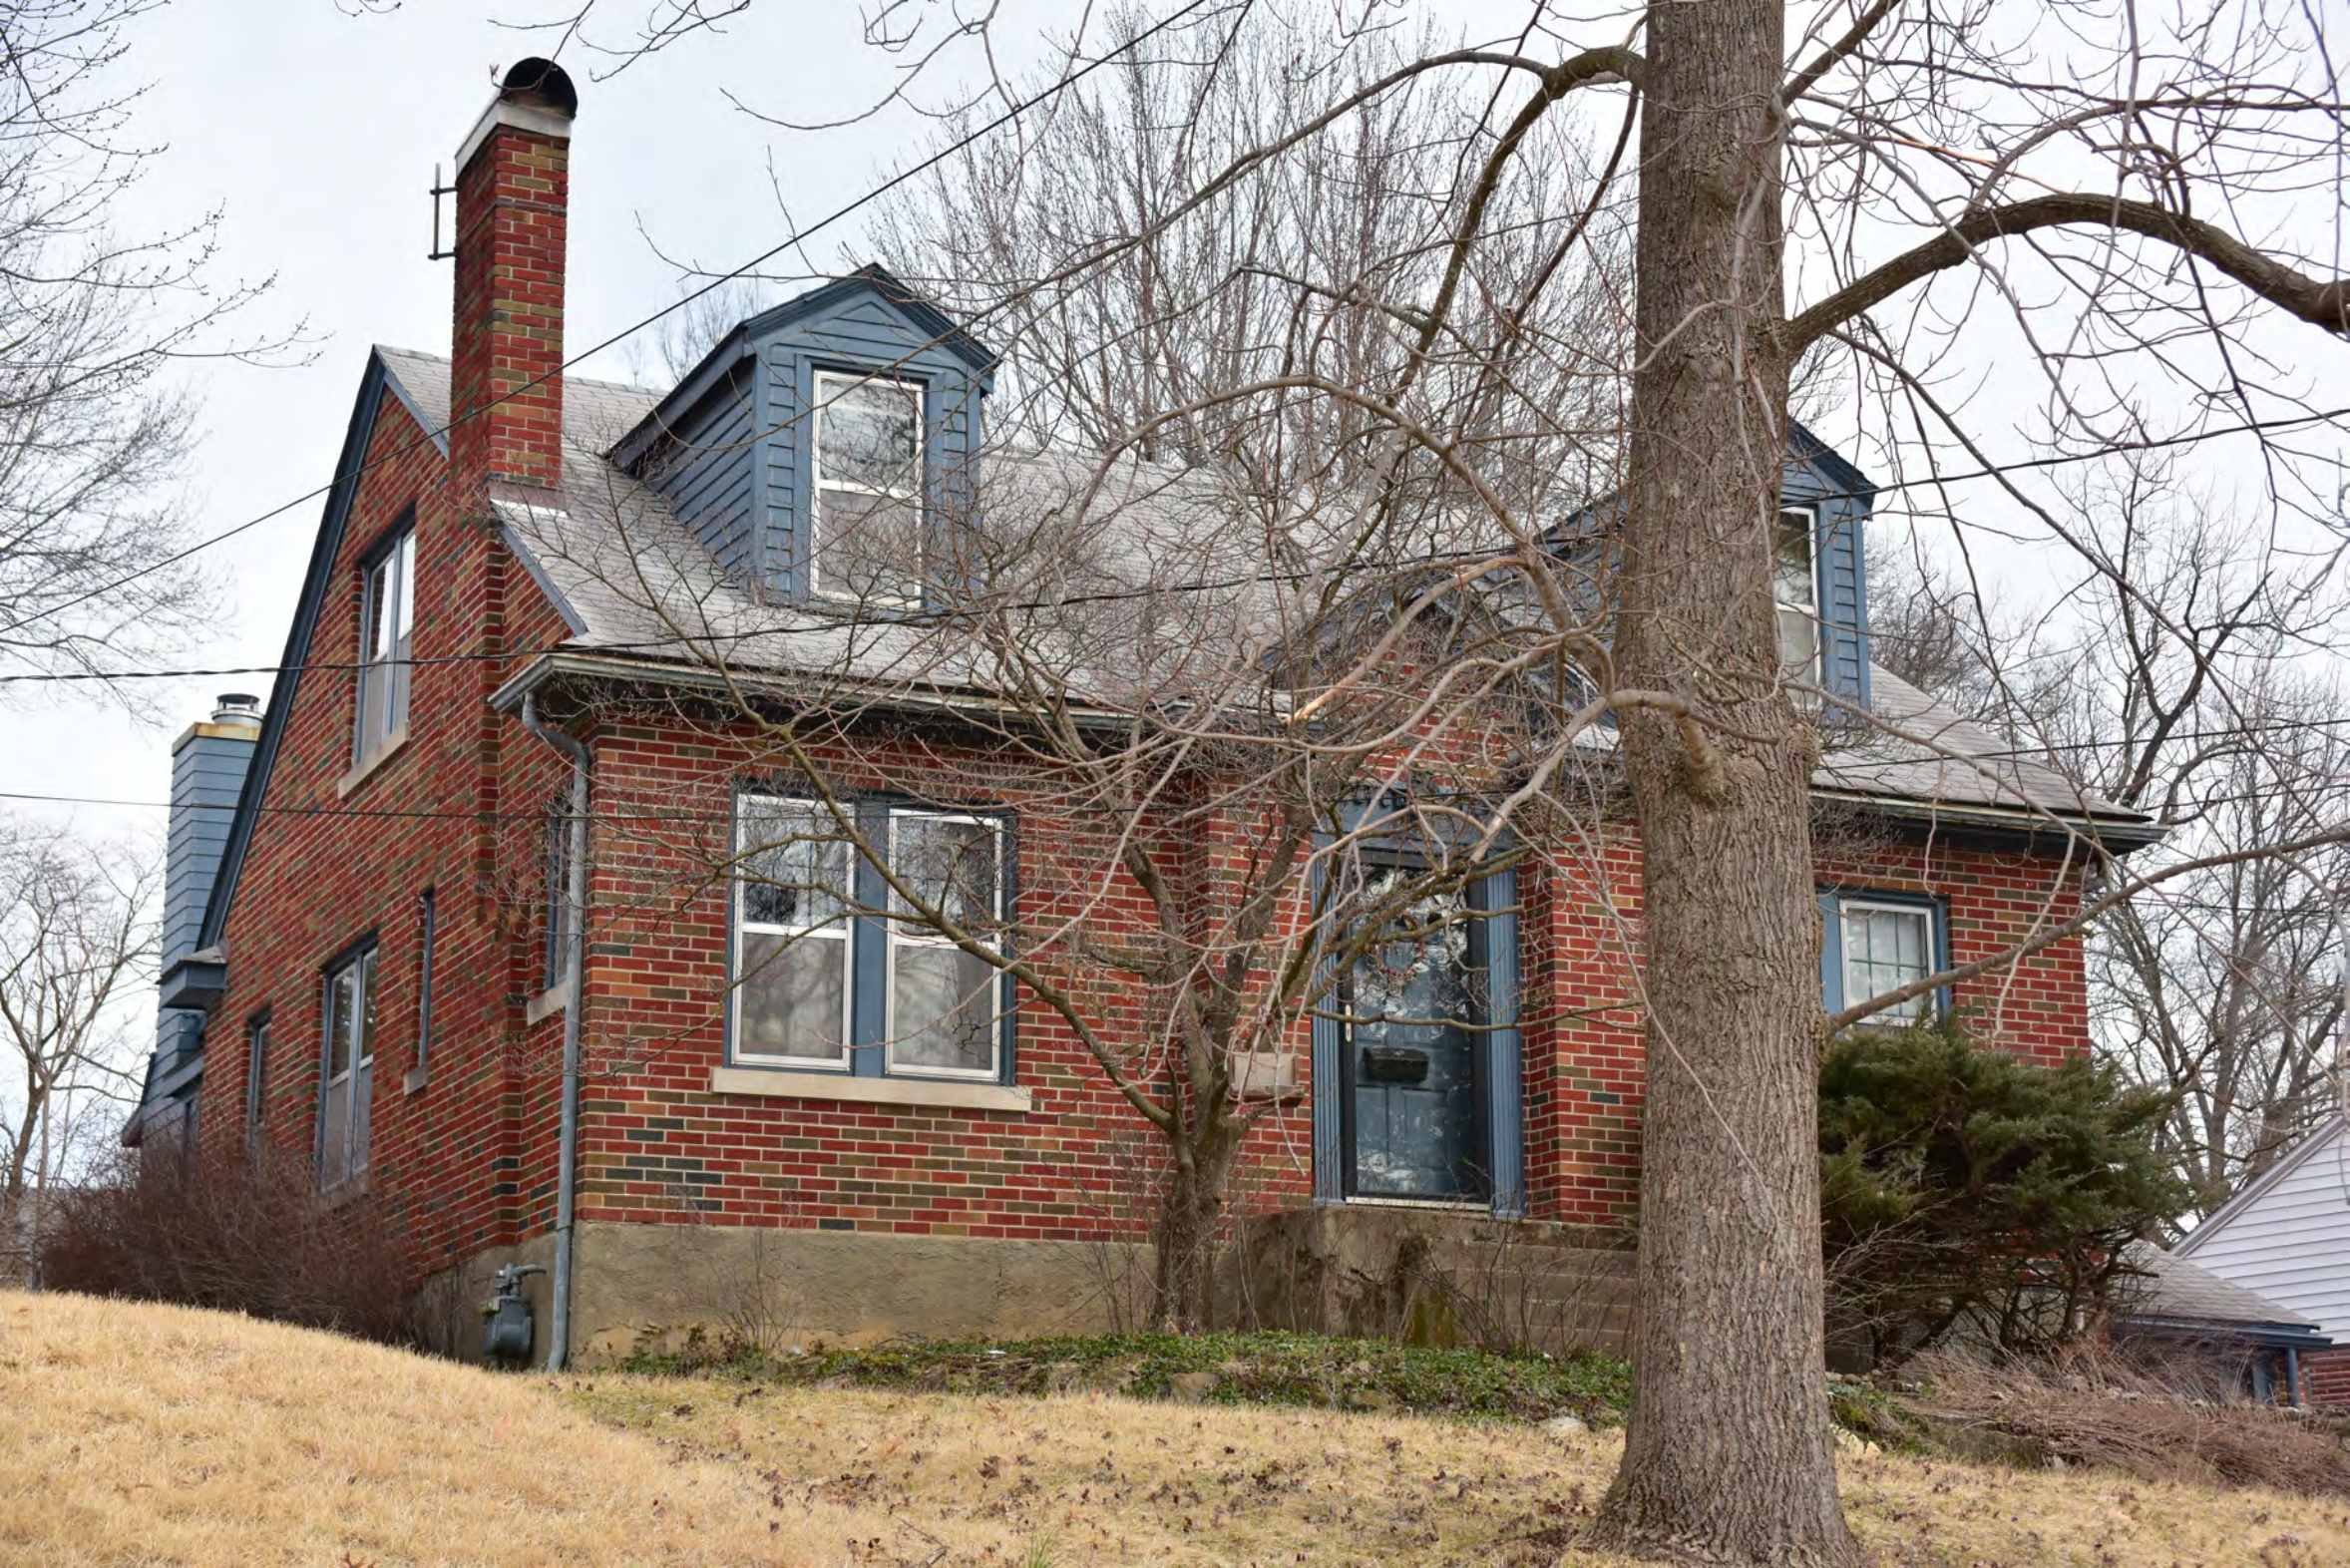
1902 North Circle Drive is a one-and-one-half-story Minimal Traditional dwelling. The brick-clad dwelling has a parged concrete foundation and asphalt side-gable roof. A brick exterior chimney pierces the west eave. The dwelling is three bays wide. Clapboard-clad gabled dormers with historic 6/1 wood windows pierce the front slope above the east and west bays. Paired historic 6/1 wood windows with continuous concrete sills fill the bays. A central wall dormer with broken pediment tops the center bay, which includes the primary entrance. The entrance features a historic wood door with glazing and neo-classical surround with pilasters and entablature. Brick pilasters flank the door surround. A concrete stoop projects below the entrance. Fenestration at the east and west elevations is symmetrical and includes historic 6/1 wood windows with concrete sills. A historic brick-clad single-car garage projects from the east elevation and is located at basement level. The garage has an asphalt side-gable roof. Paired non-historic doors with nine-light glazing and hardboard cladding infill the vehicular bay. A one-story hardboard-clad shed-roof addition spans the rear elevation. A hardboard-clad chimney pierces the west eave.
