1. Survey number: CO-AS-008-001		2. Survey Name: West Main Street Survey	
3. County: Cole		4. Address (Street No.): 100	Street (name): East Circle Drive
5. City: Jefferson City	Vicinity <input type="checkbox"/>	6. Lat / Long:	7. Township/Range/Section: T: R: S:
8. Historic name (if known):		9. Present/other name (if known):	
10. Ownership: <input checked="" type="checkbox"/> Private <input type="checkbox"/> Public		11a. Historic use (if known): Domestic-Single Dwelling	11b. Current use: Domestic-Single Dwelling

MISSOURI DEPARTMENT OF NATURAL RESOURCES
STATE HISTORIC PRESERVATION OFFICE, P.O. Box 178, Jefferson City, MO 65102
ARCHITECTURAL/HISTORIC INVENTORY FORM

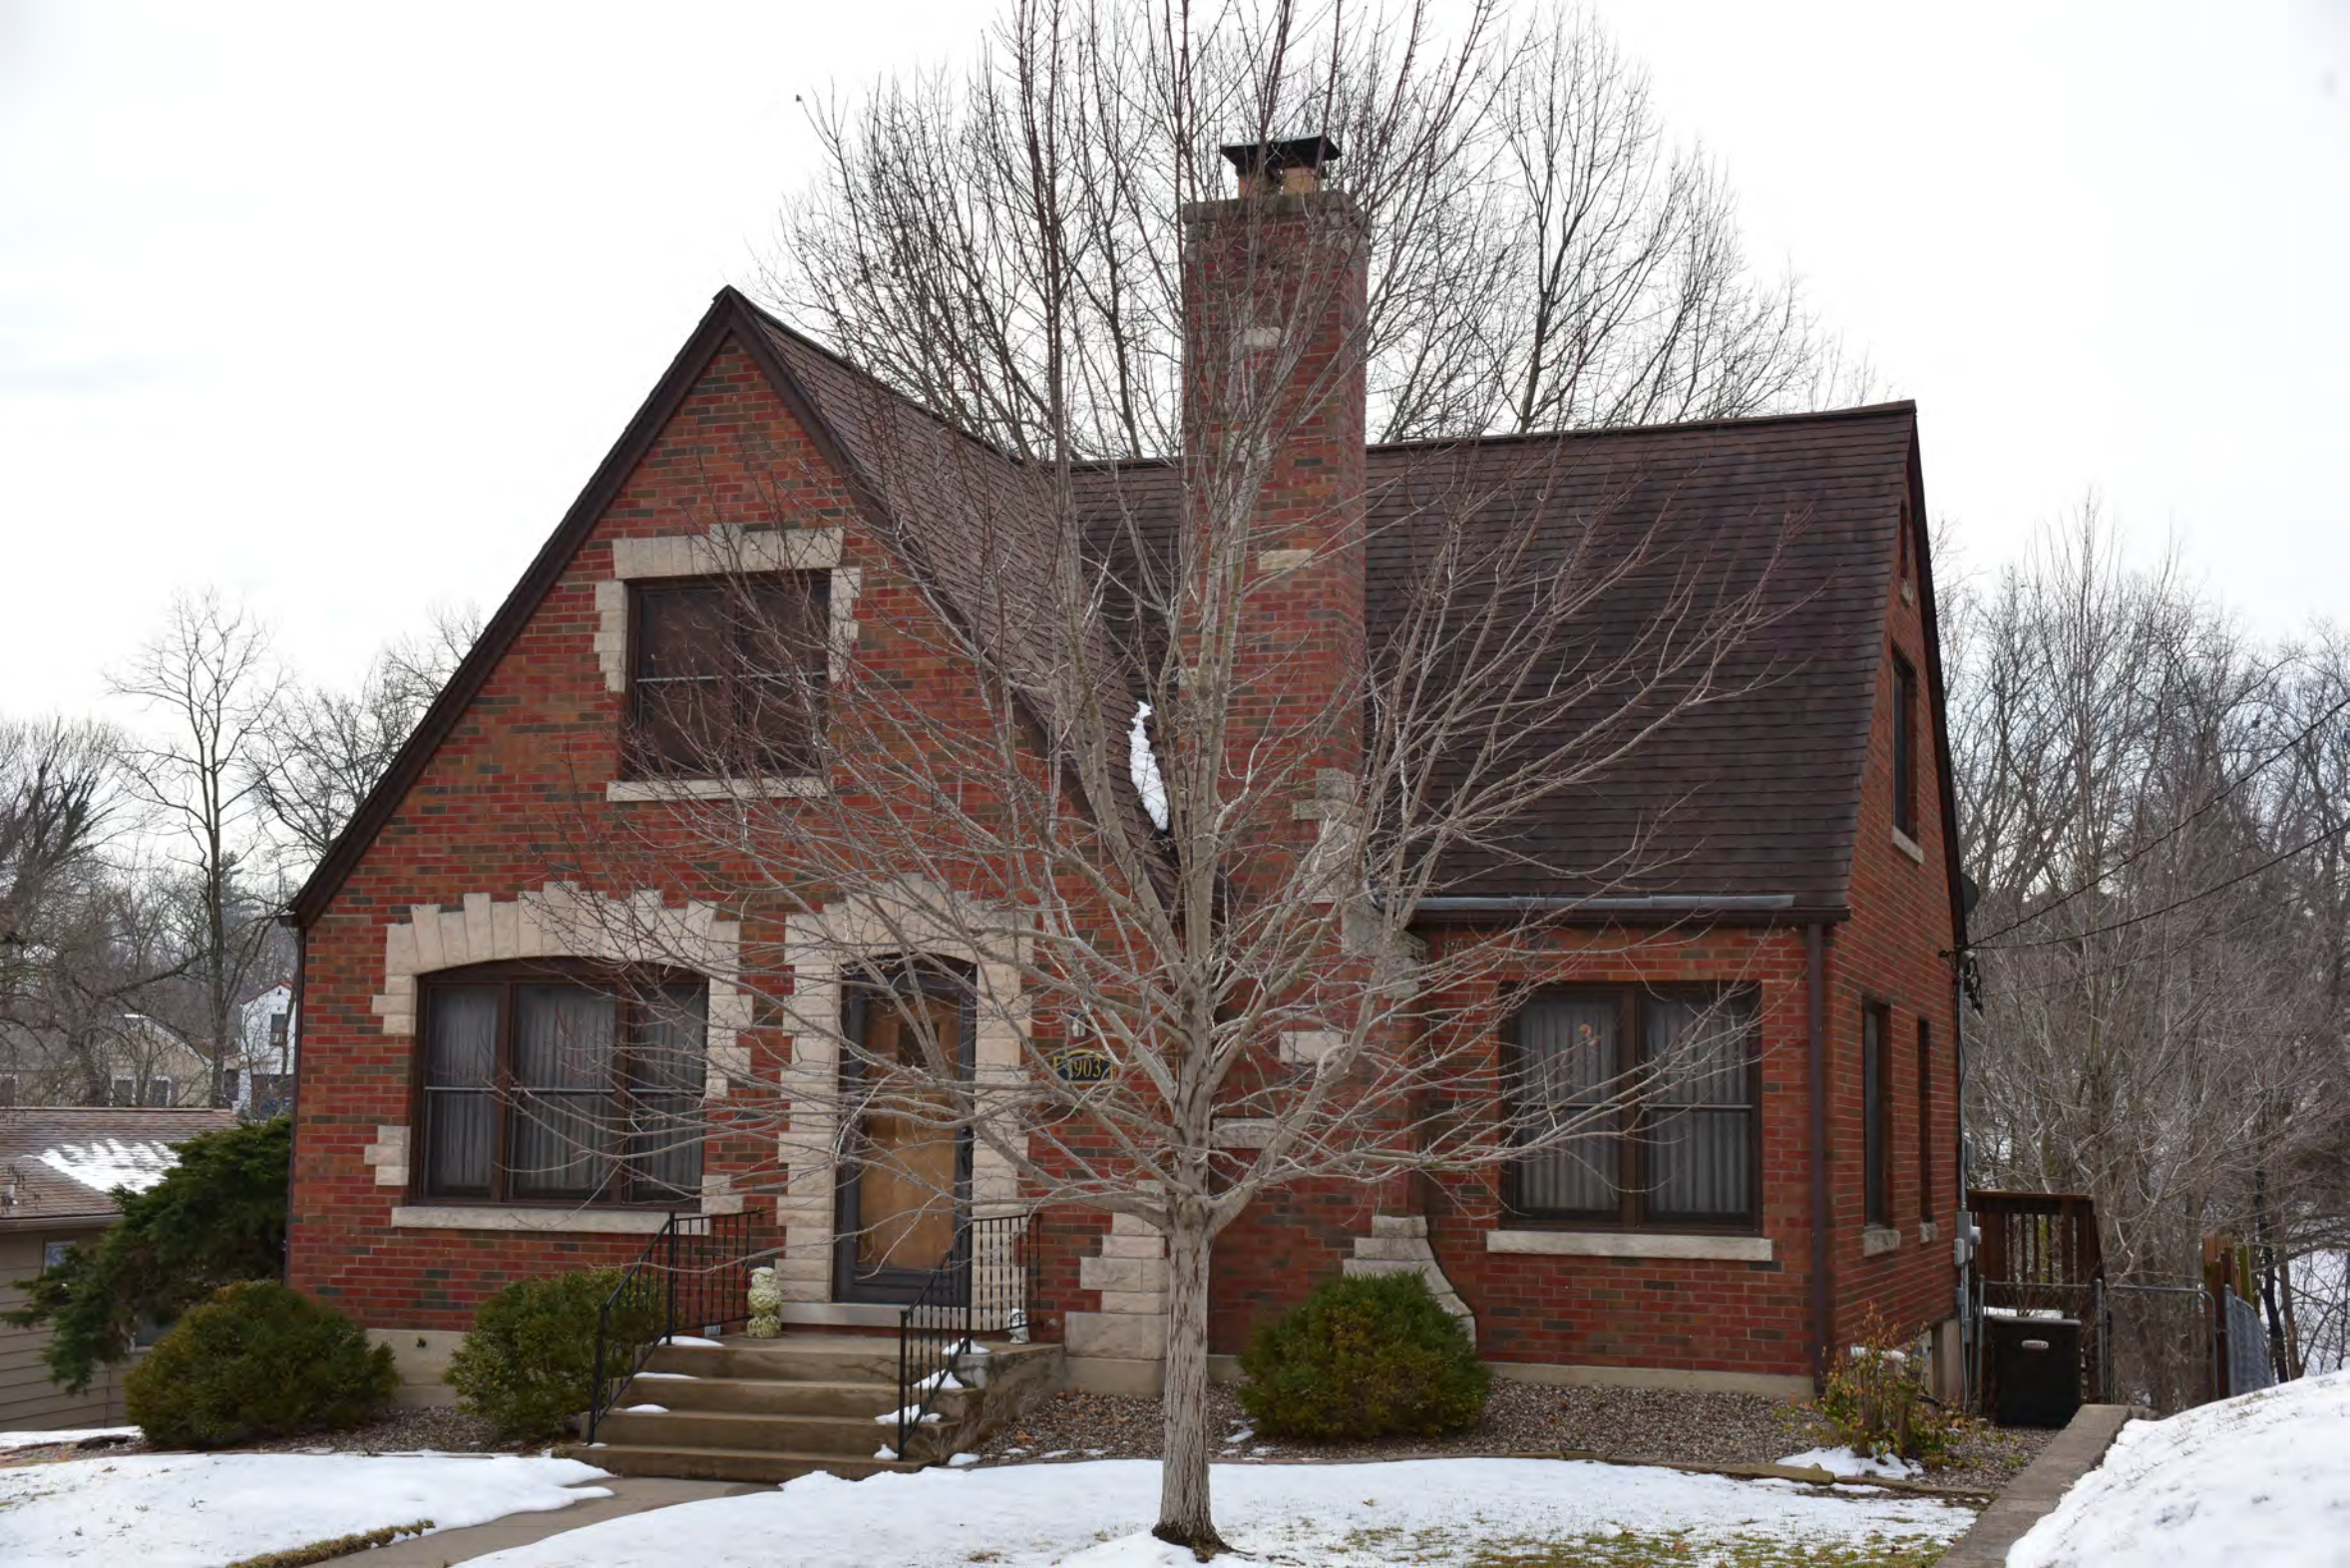
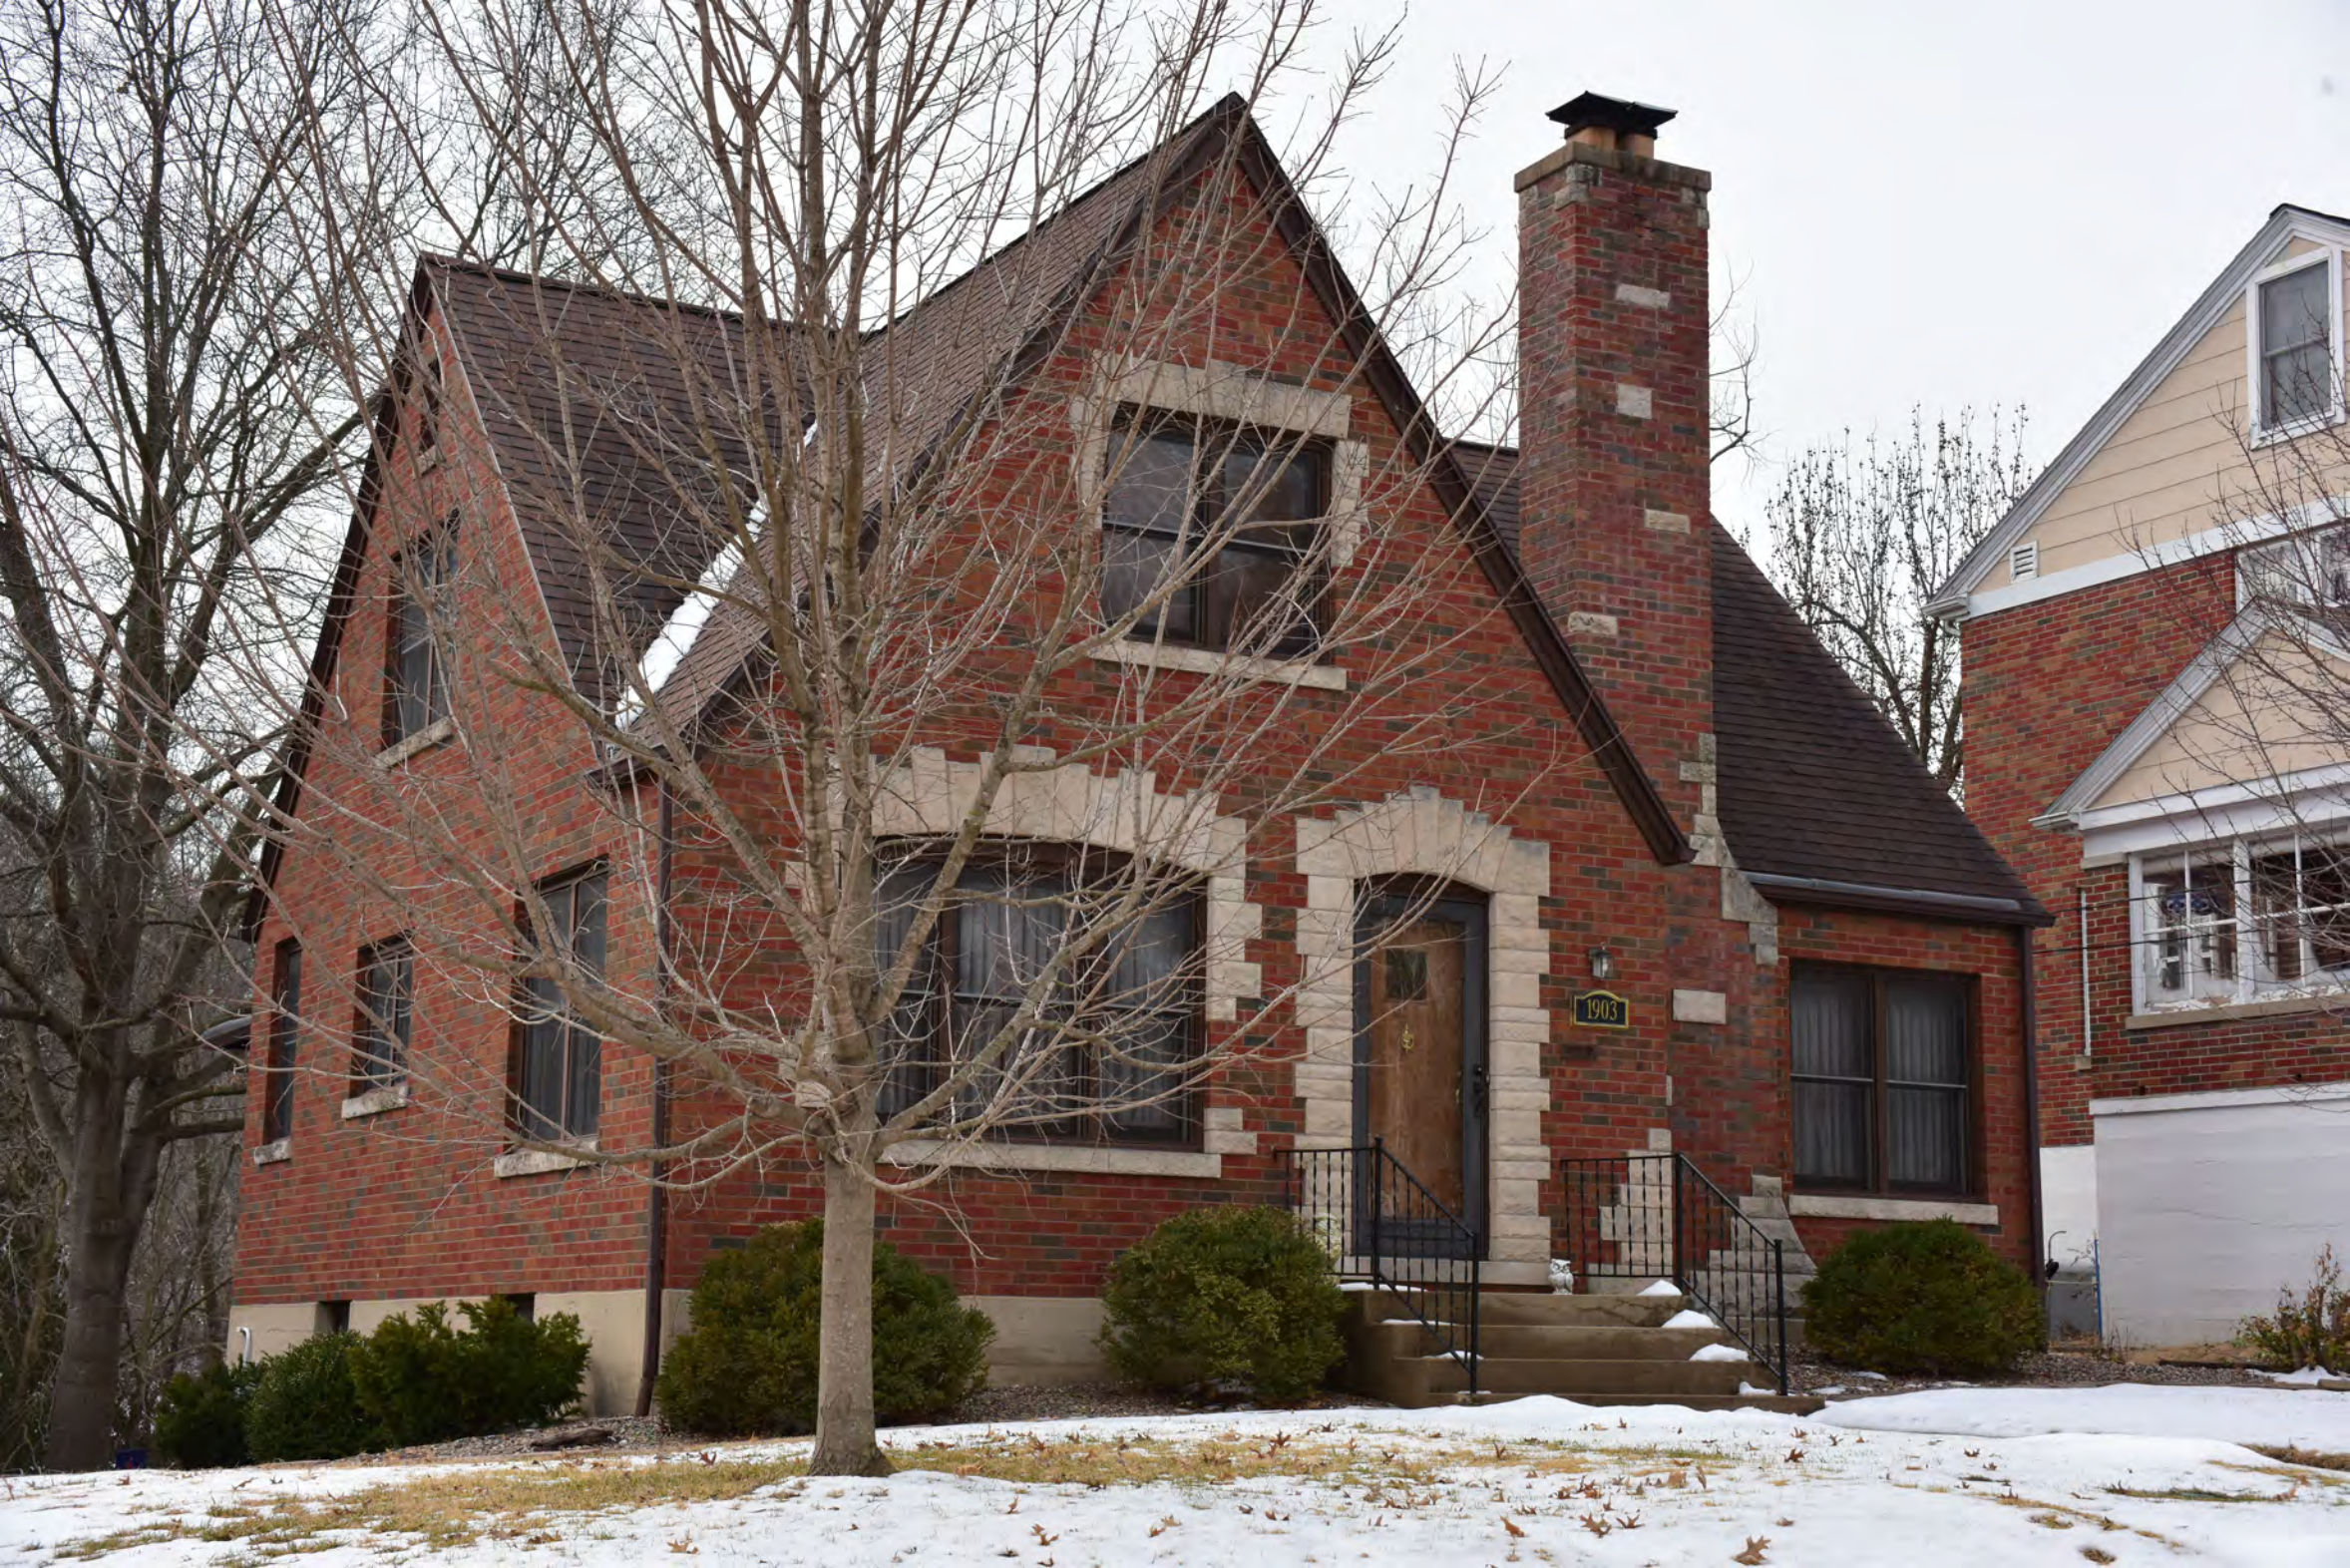
1903 North Circle Drive is a one-and-one-half-story Minimal Traditional dwelling with restrained Tudor Revival influences. The brick-clad dwelling has a concrete foundation and asphalt intersecting gable roof. A brick exterior chimney with limestone accents is located at the gable juncture on the primary (north) elevation. The dwelling is three bays wide. Bays 1 and 2 are located in the front-gable. A historic segmental-arch tripartite wood window fills the first bay. Narrow 1/1 windows flank a central 1/1 window. A limestone motif with exaggerated voussoirs tops the window. Matching stonework surrounds the entrance bay. The entrance features a historic wood door with door with glazing. A concrete stop with historic metal railings projects from the entrance. Historic two-ganged 1/1 wood windows with decorative limestone is centered above the east and center bays. Matching windows define the west bay. Single and paired historic 1/1 wood windows are present at the east and west elevations. All windows have stone stills and metal storm windows. A historic single-car garage projects from the rear elevation at the basement level. A non-historic wood deck projects from the southwest corner of the dwelling.

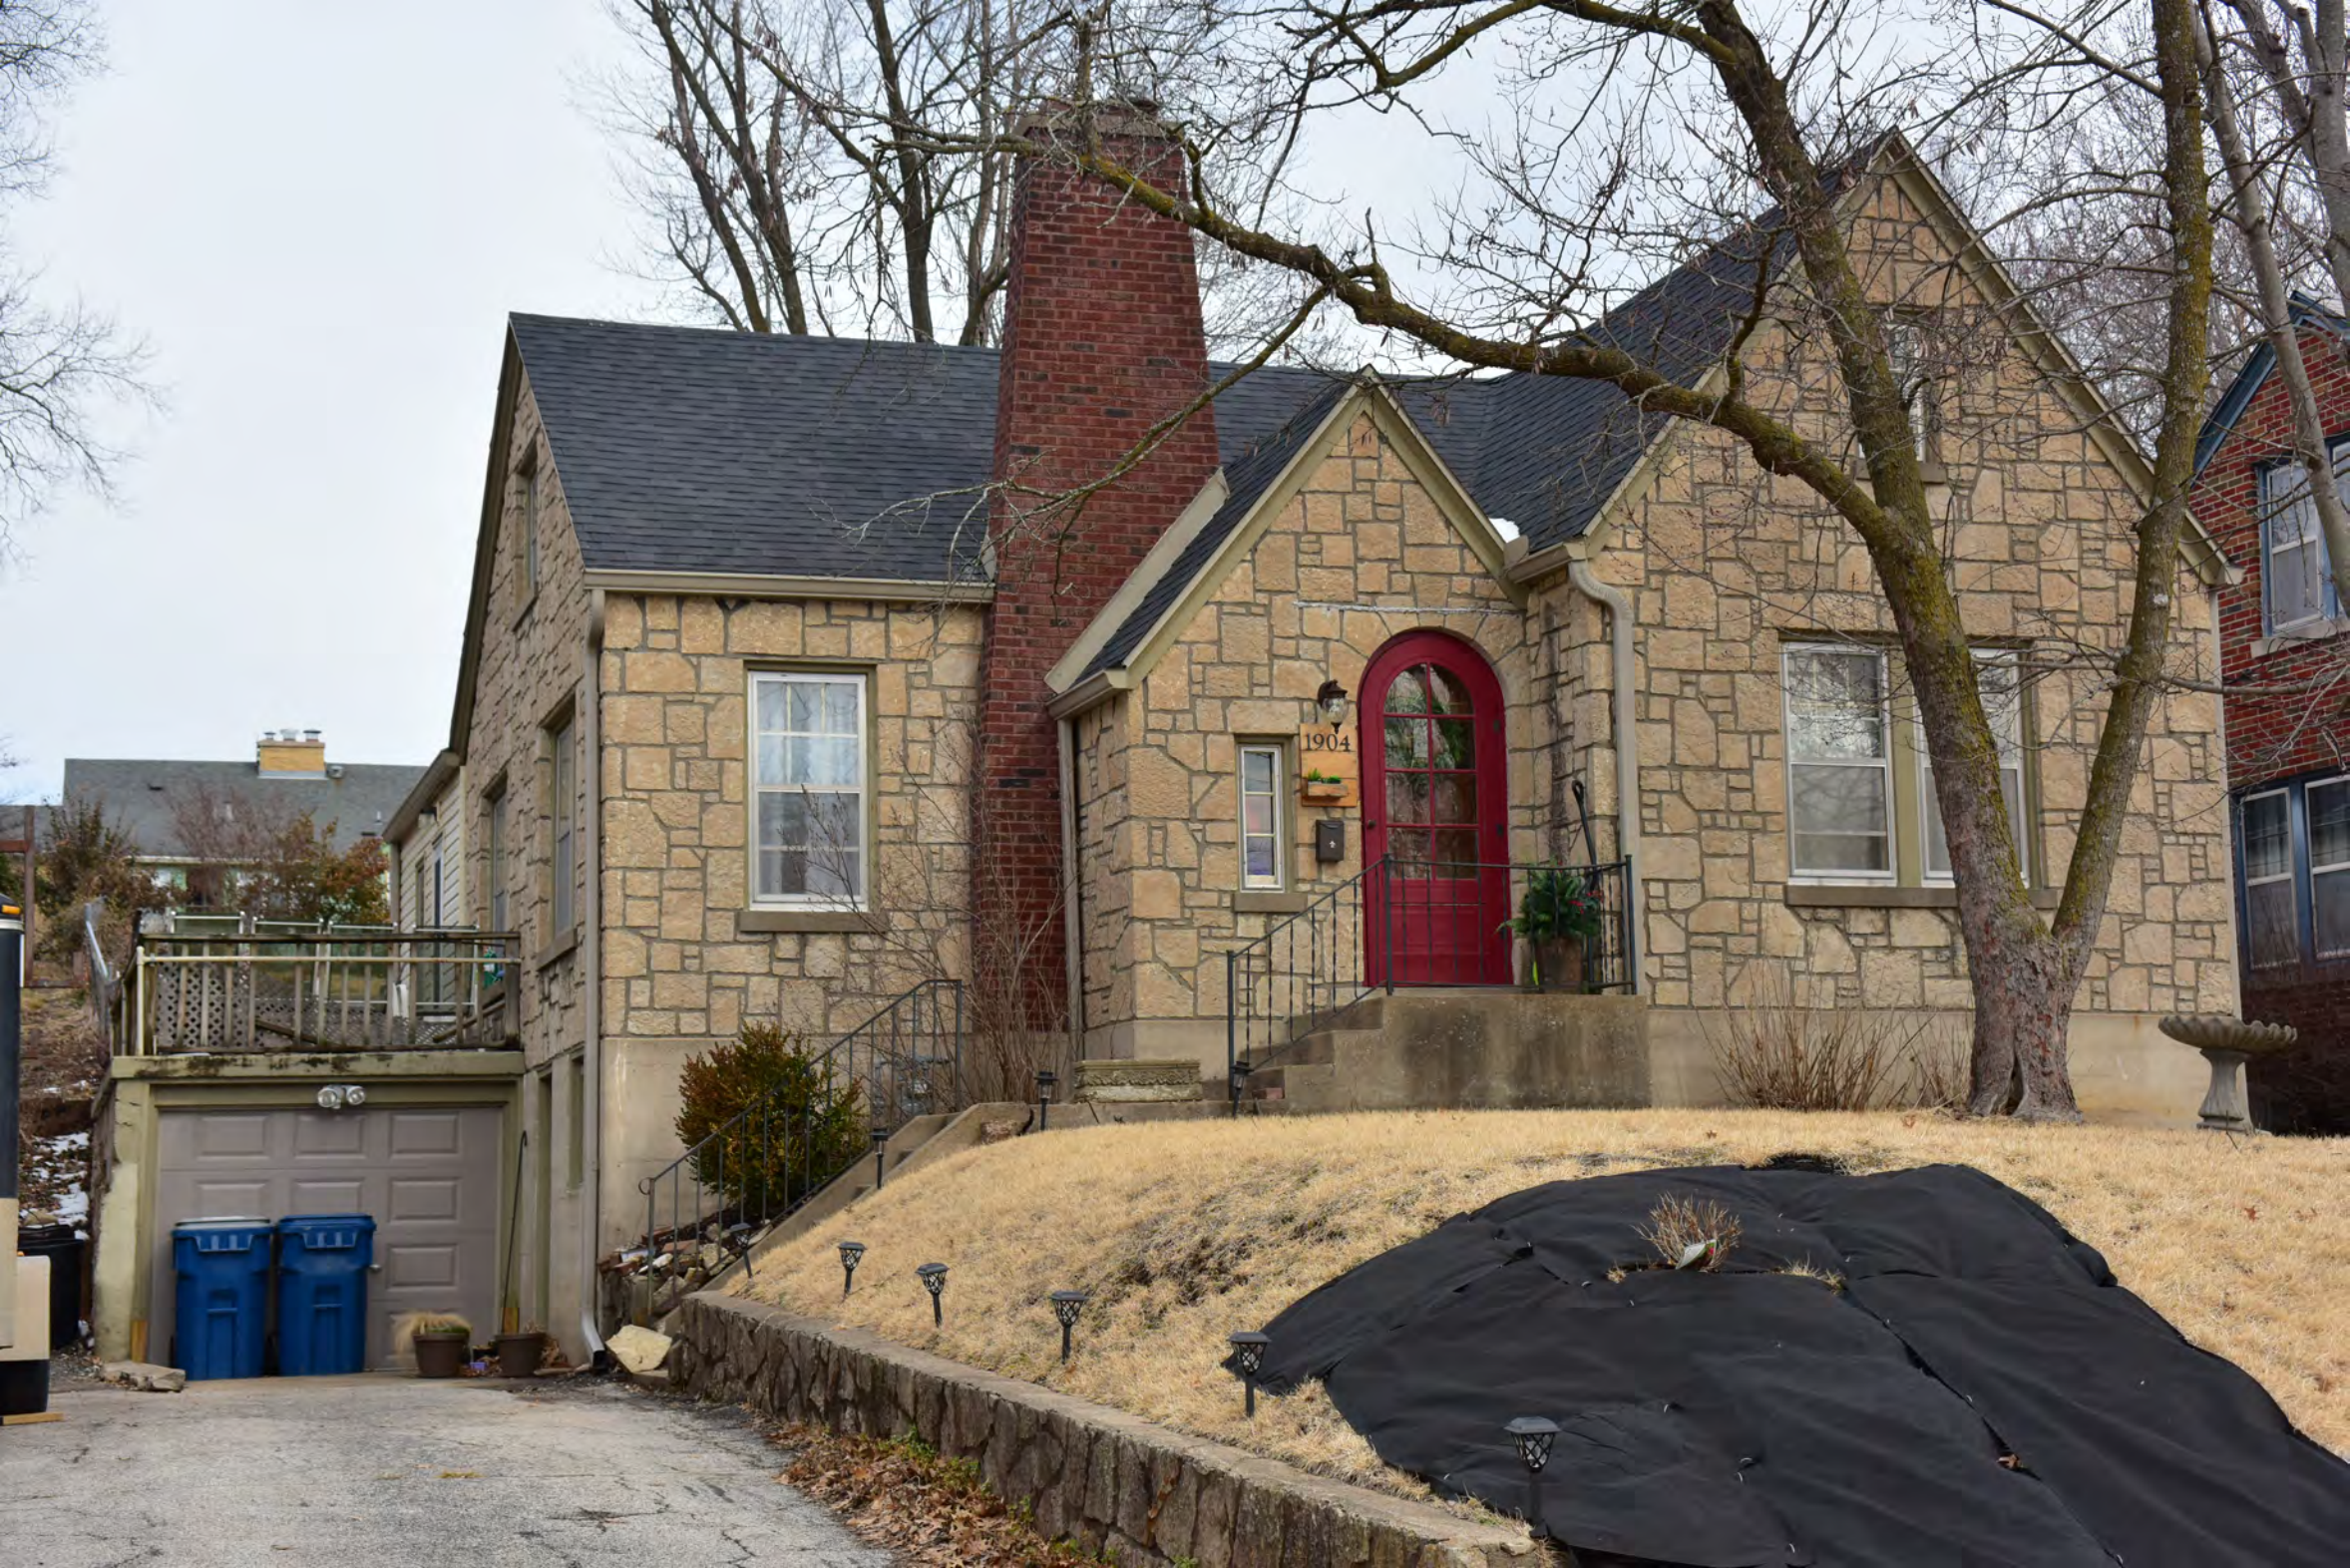
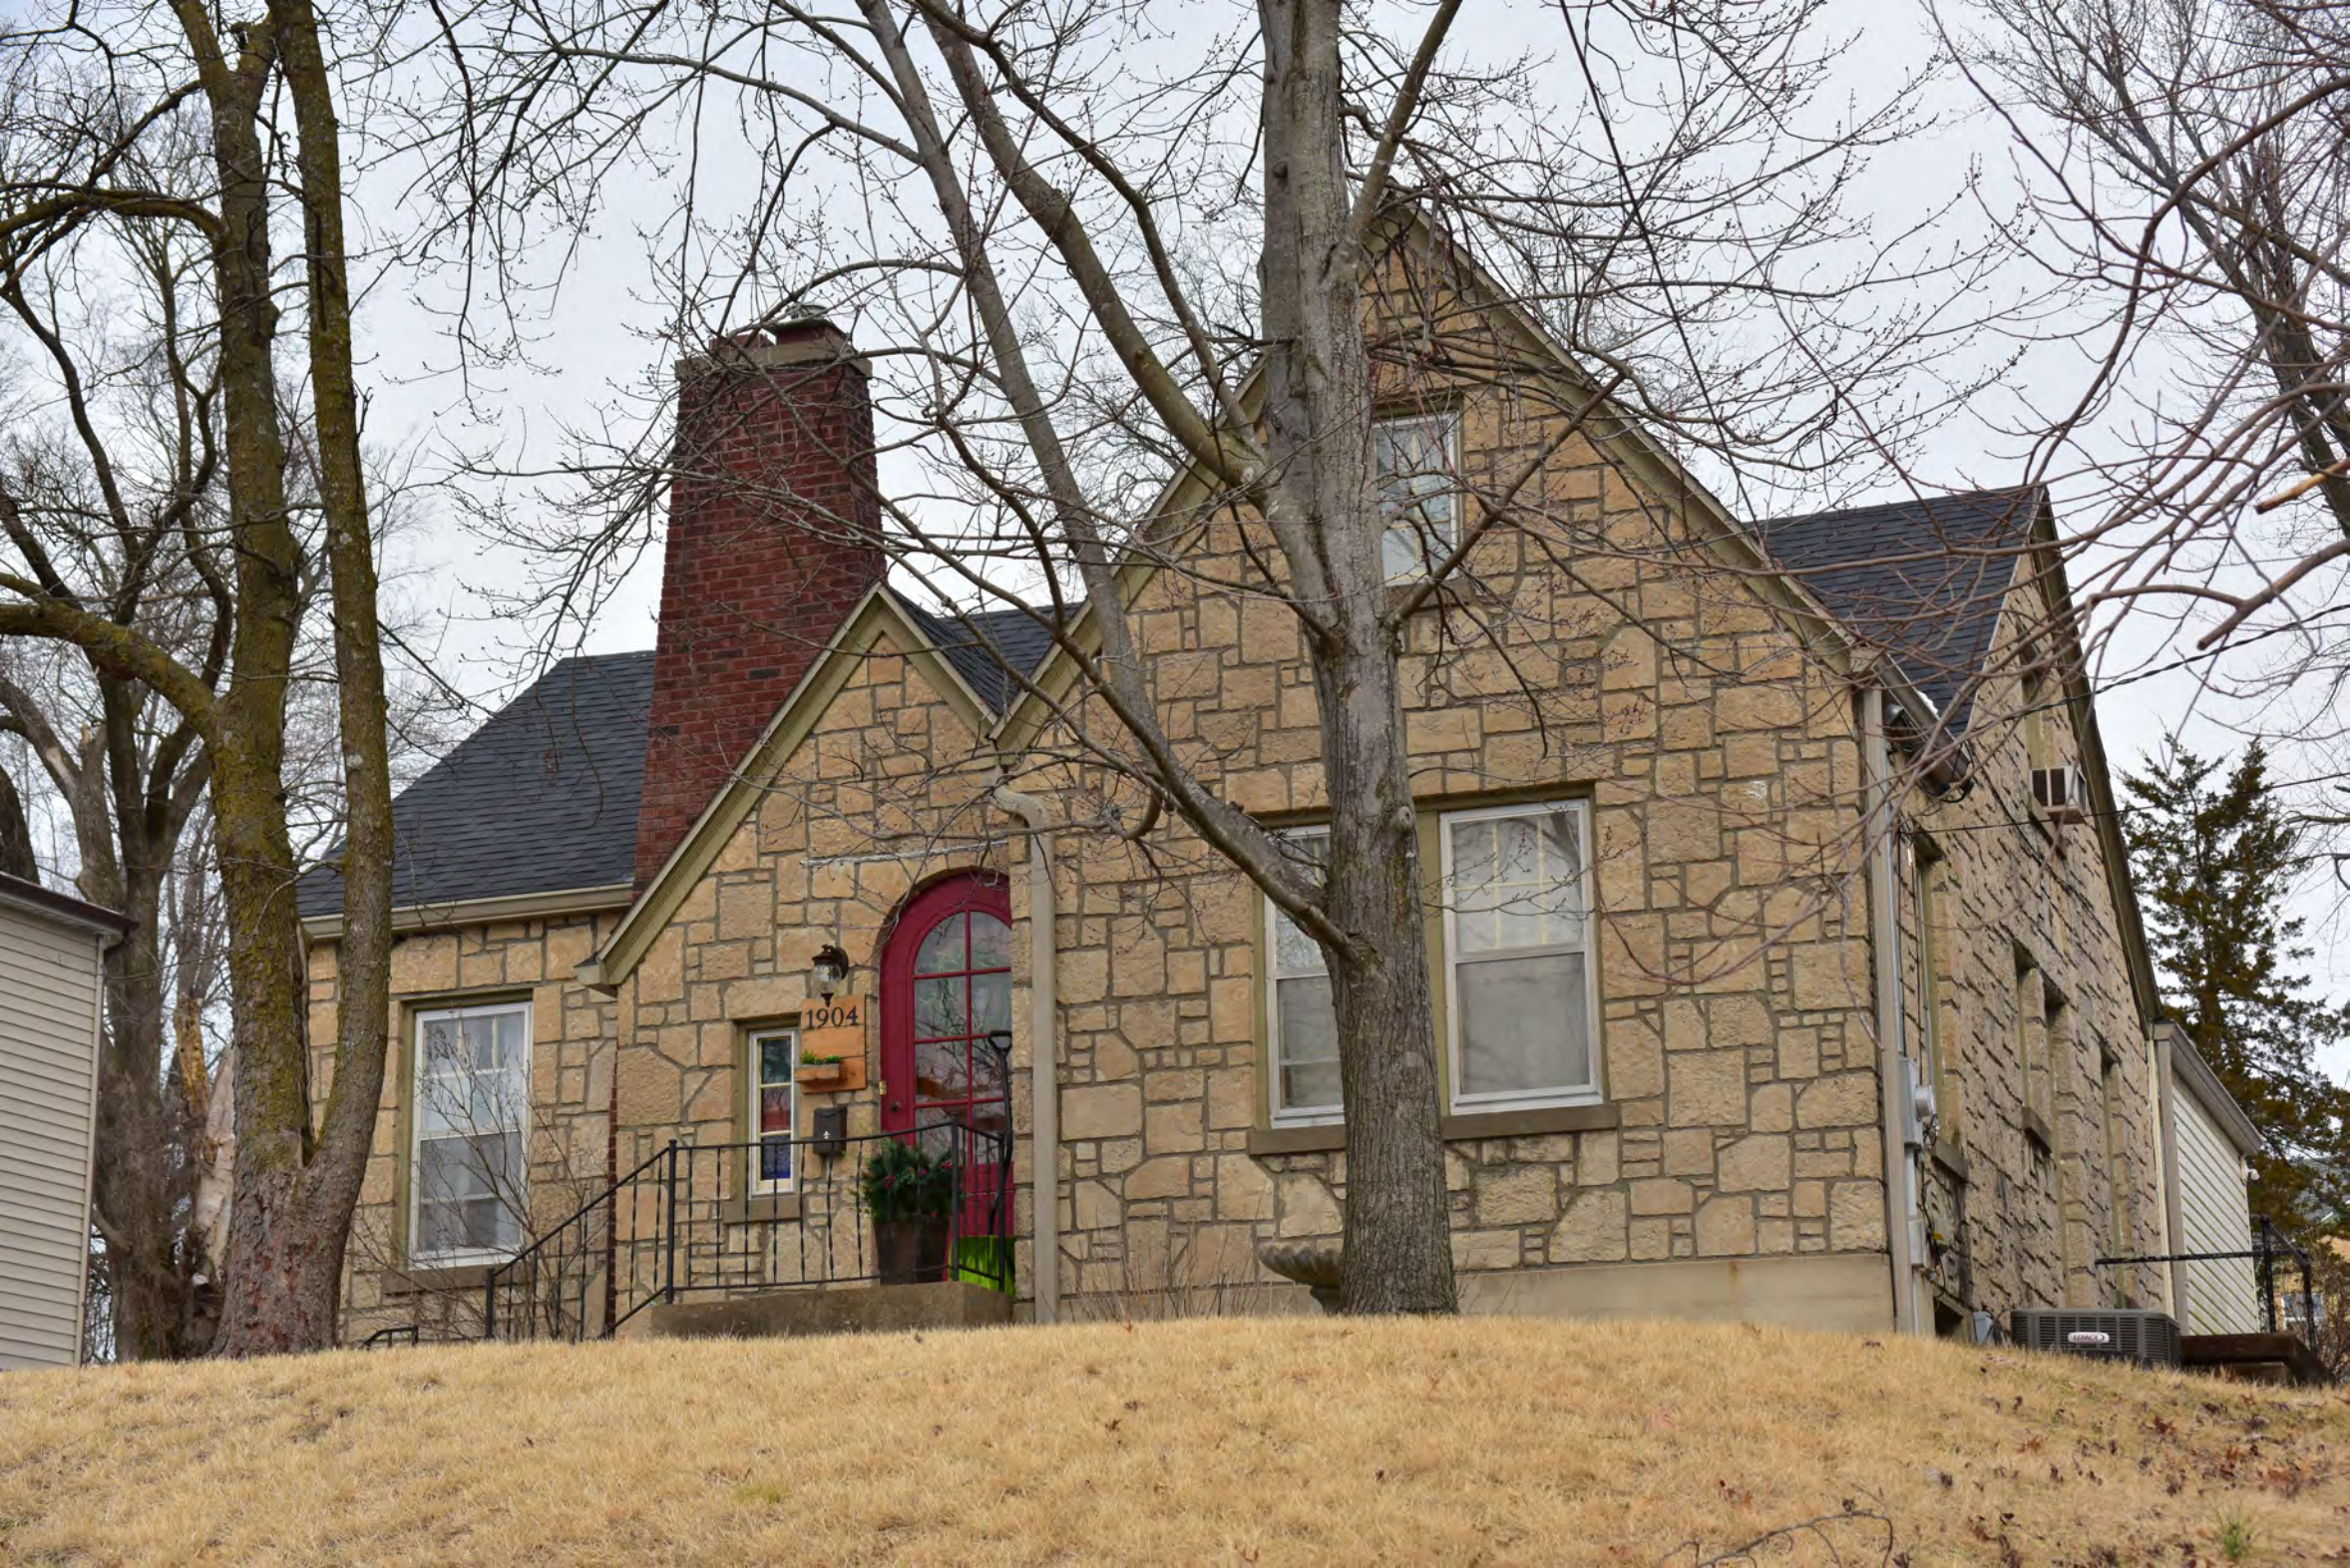
1904 North Circle Drive is a one-story Minimal Traditional dwelling. It has a concrete foundation, asphalt gabled-ell roof, and faced stone cladding. A gable-front vestibule projects from juncture of the gabled ells. A tapered exterior brick chimney abuts the vestibule to the west. The dwelling is three bays wide. A historic 6/1 wood window fills the first bay while two-ganged matching windows fill the third bay. A historic six-light fixed wood window is centered in the gable apex above the third bay. The vestibule contains the center bay. A historic wood door with glazing and historic wood storm door with eight-light glazing fill the rounded arch opening. A truncated historic three-light wood sidelight is located west of the entrance. A concrete stoop projects from the entrance. Terraced concrete steps with metal railings access the stoop from the west side. A historic single-car garage projects from the west elevation at the basement level and is set back several feet. A non-historic overhead door fills the vehicular bay. An open porch with historic metal bar railing tops the garage. A concrete stoop with metal railing projects from the secondary entrance at the east elevation. A c. 1967 vinyl-clad gabled addition spans the rear elevation.

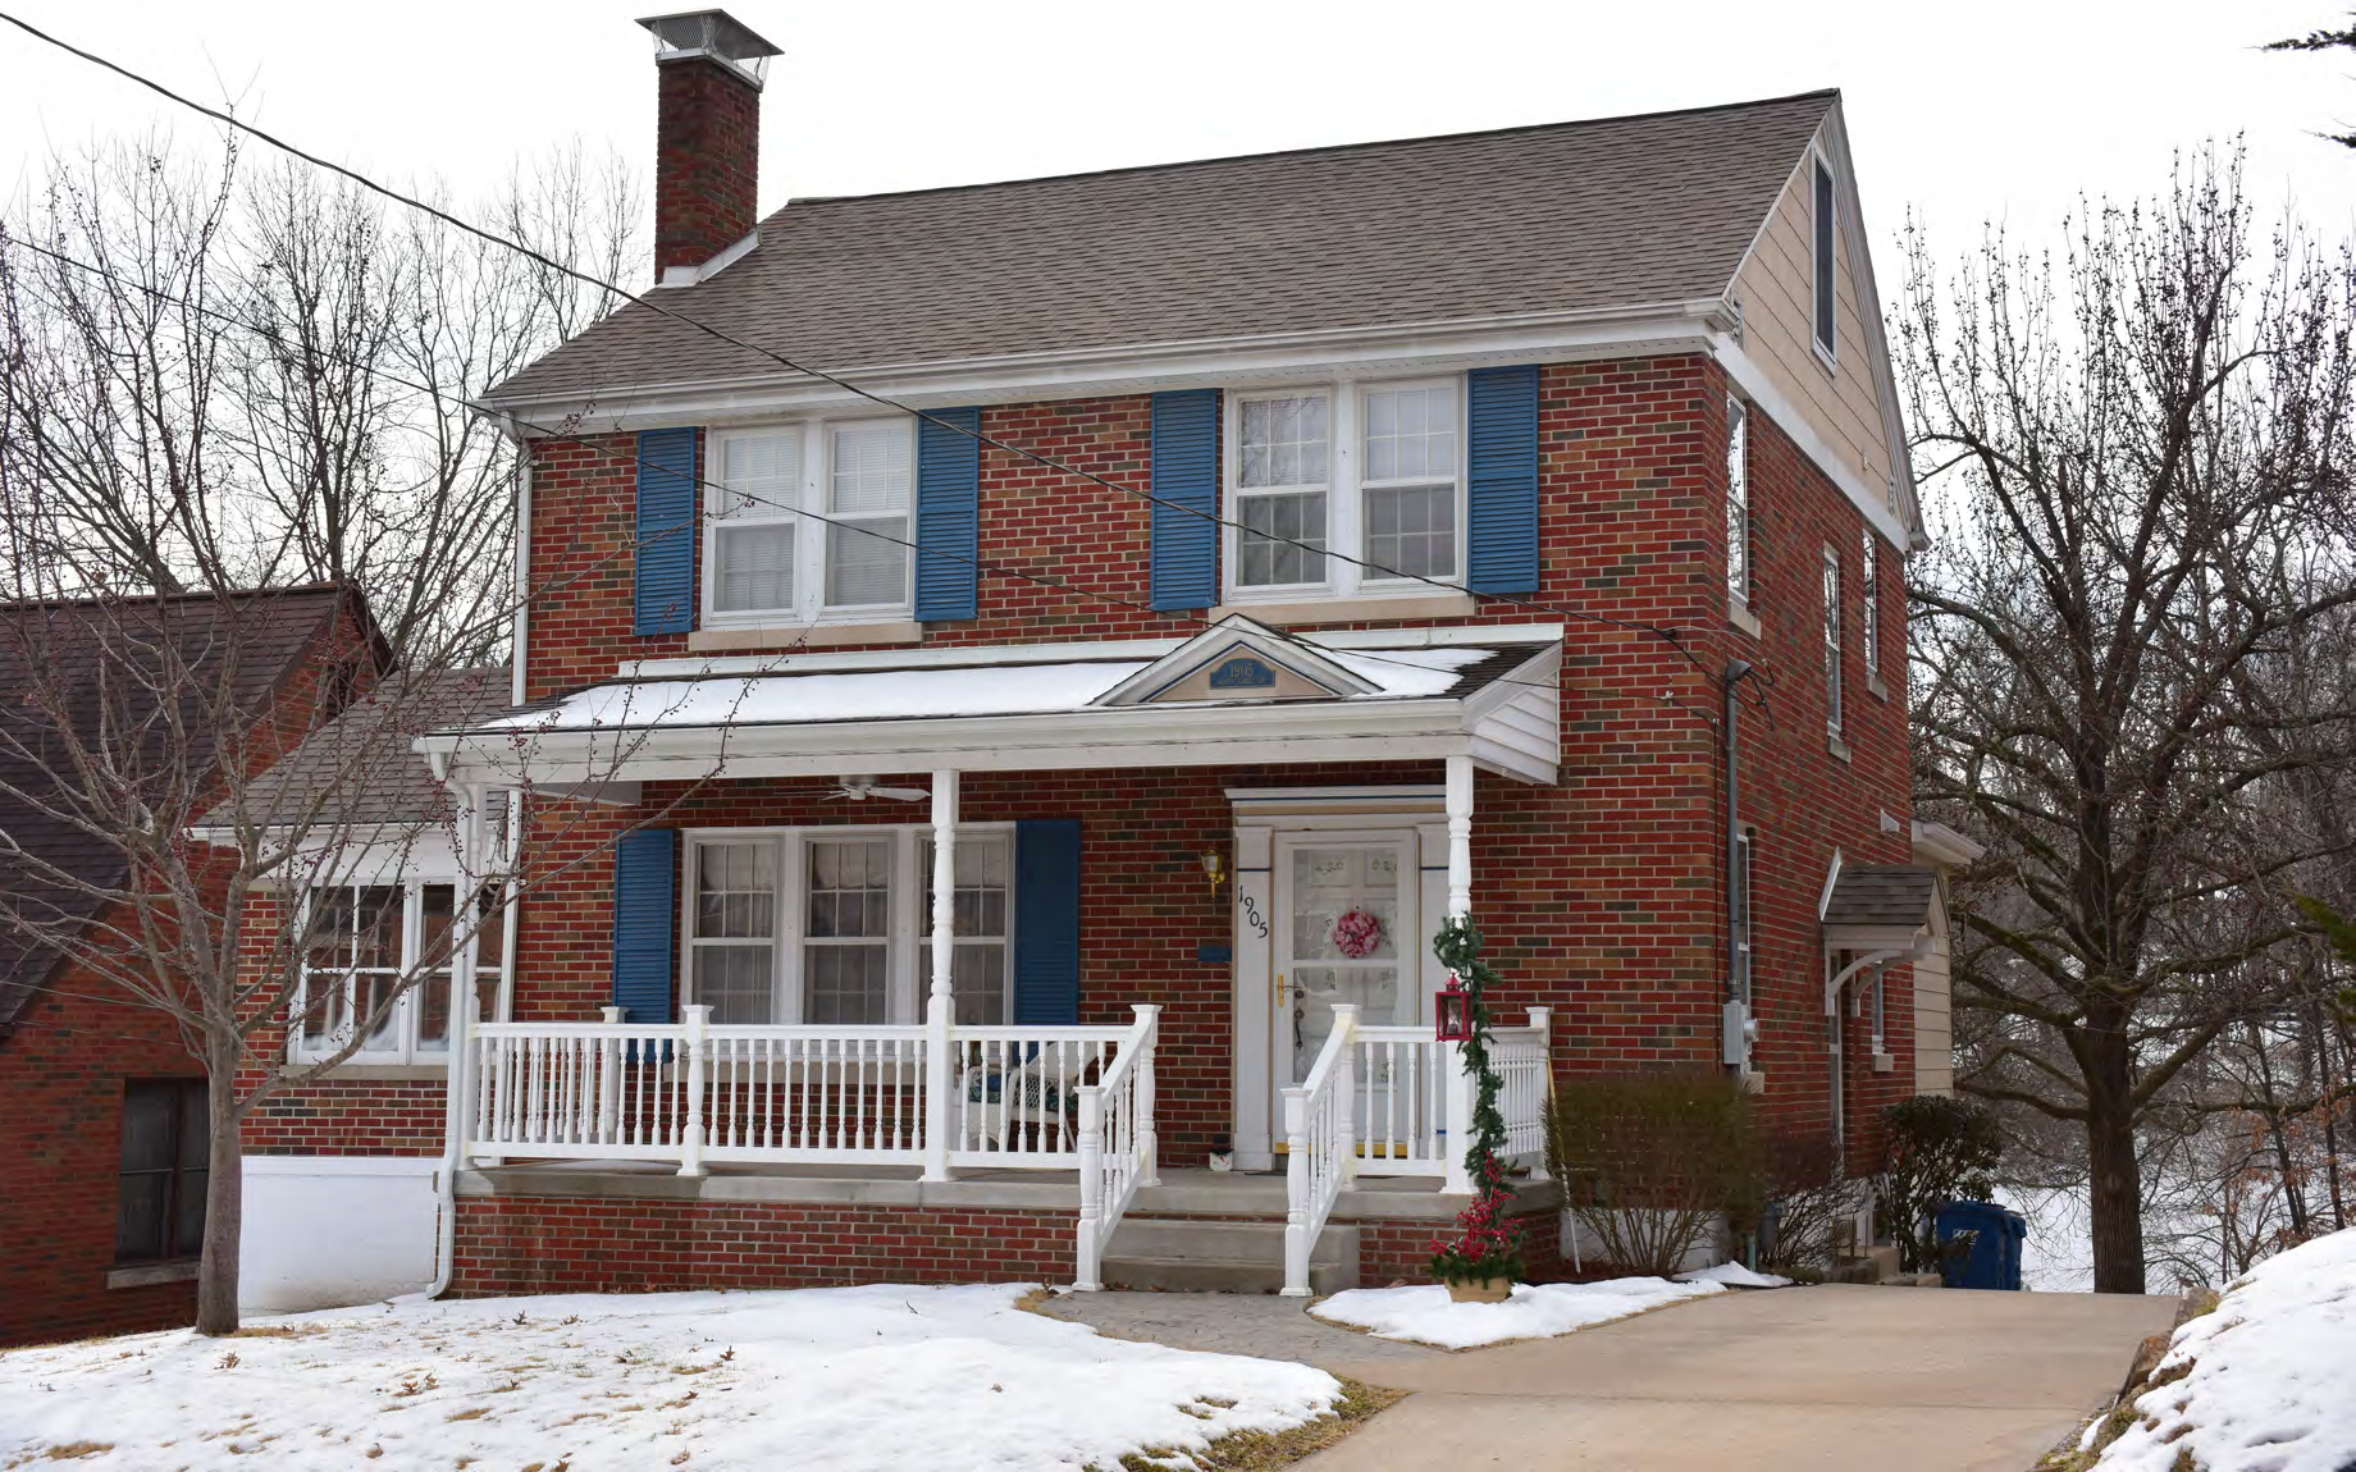
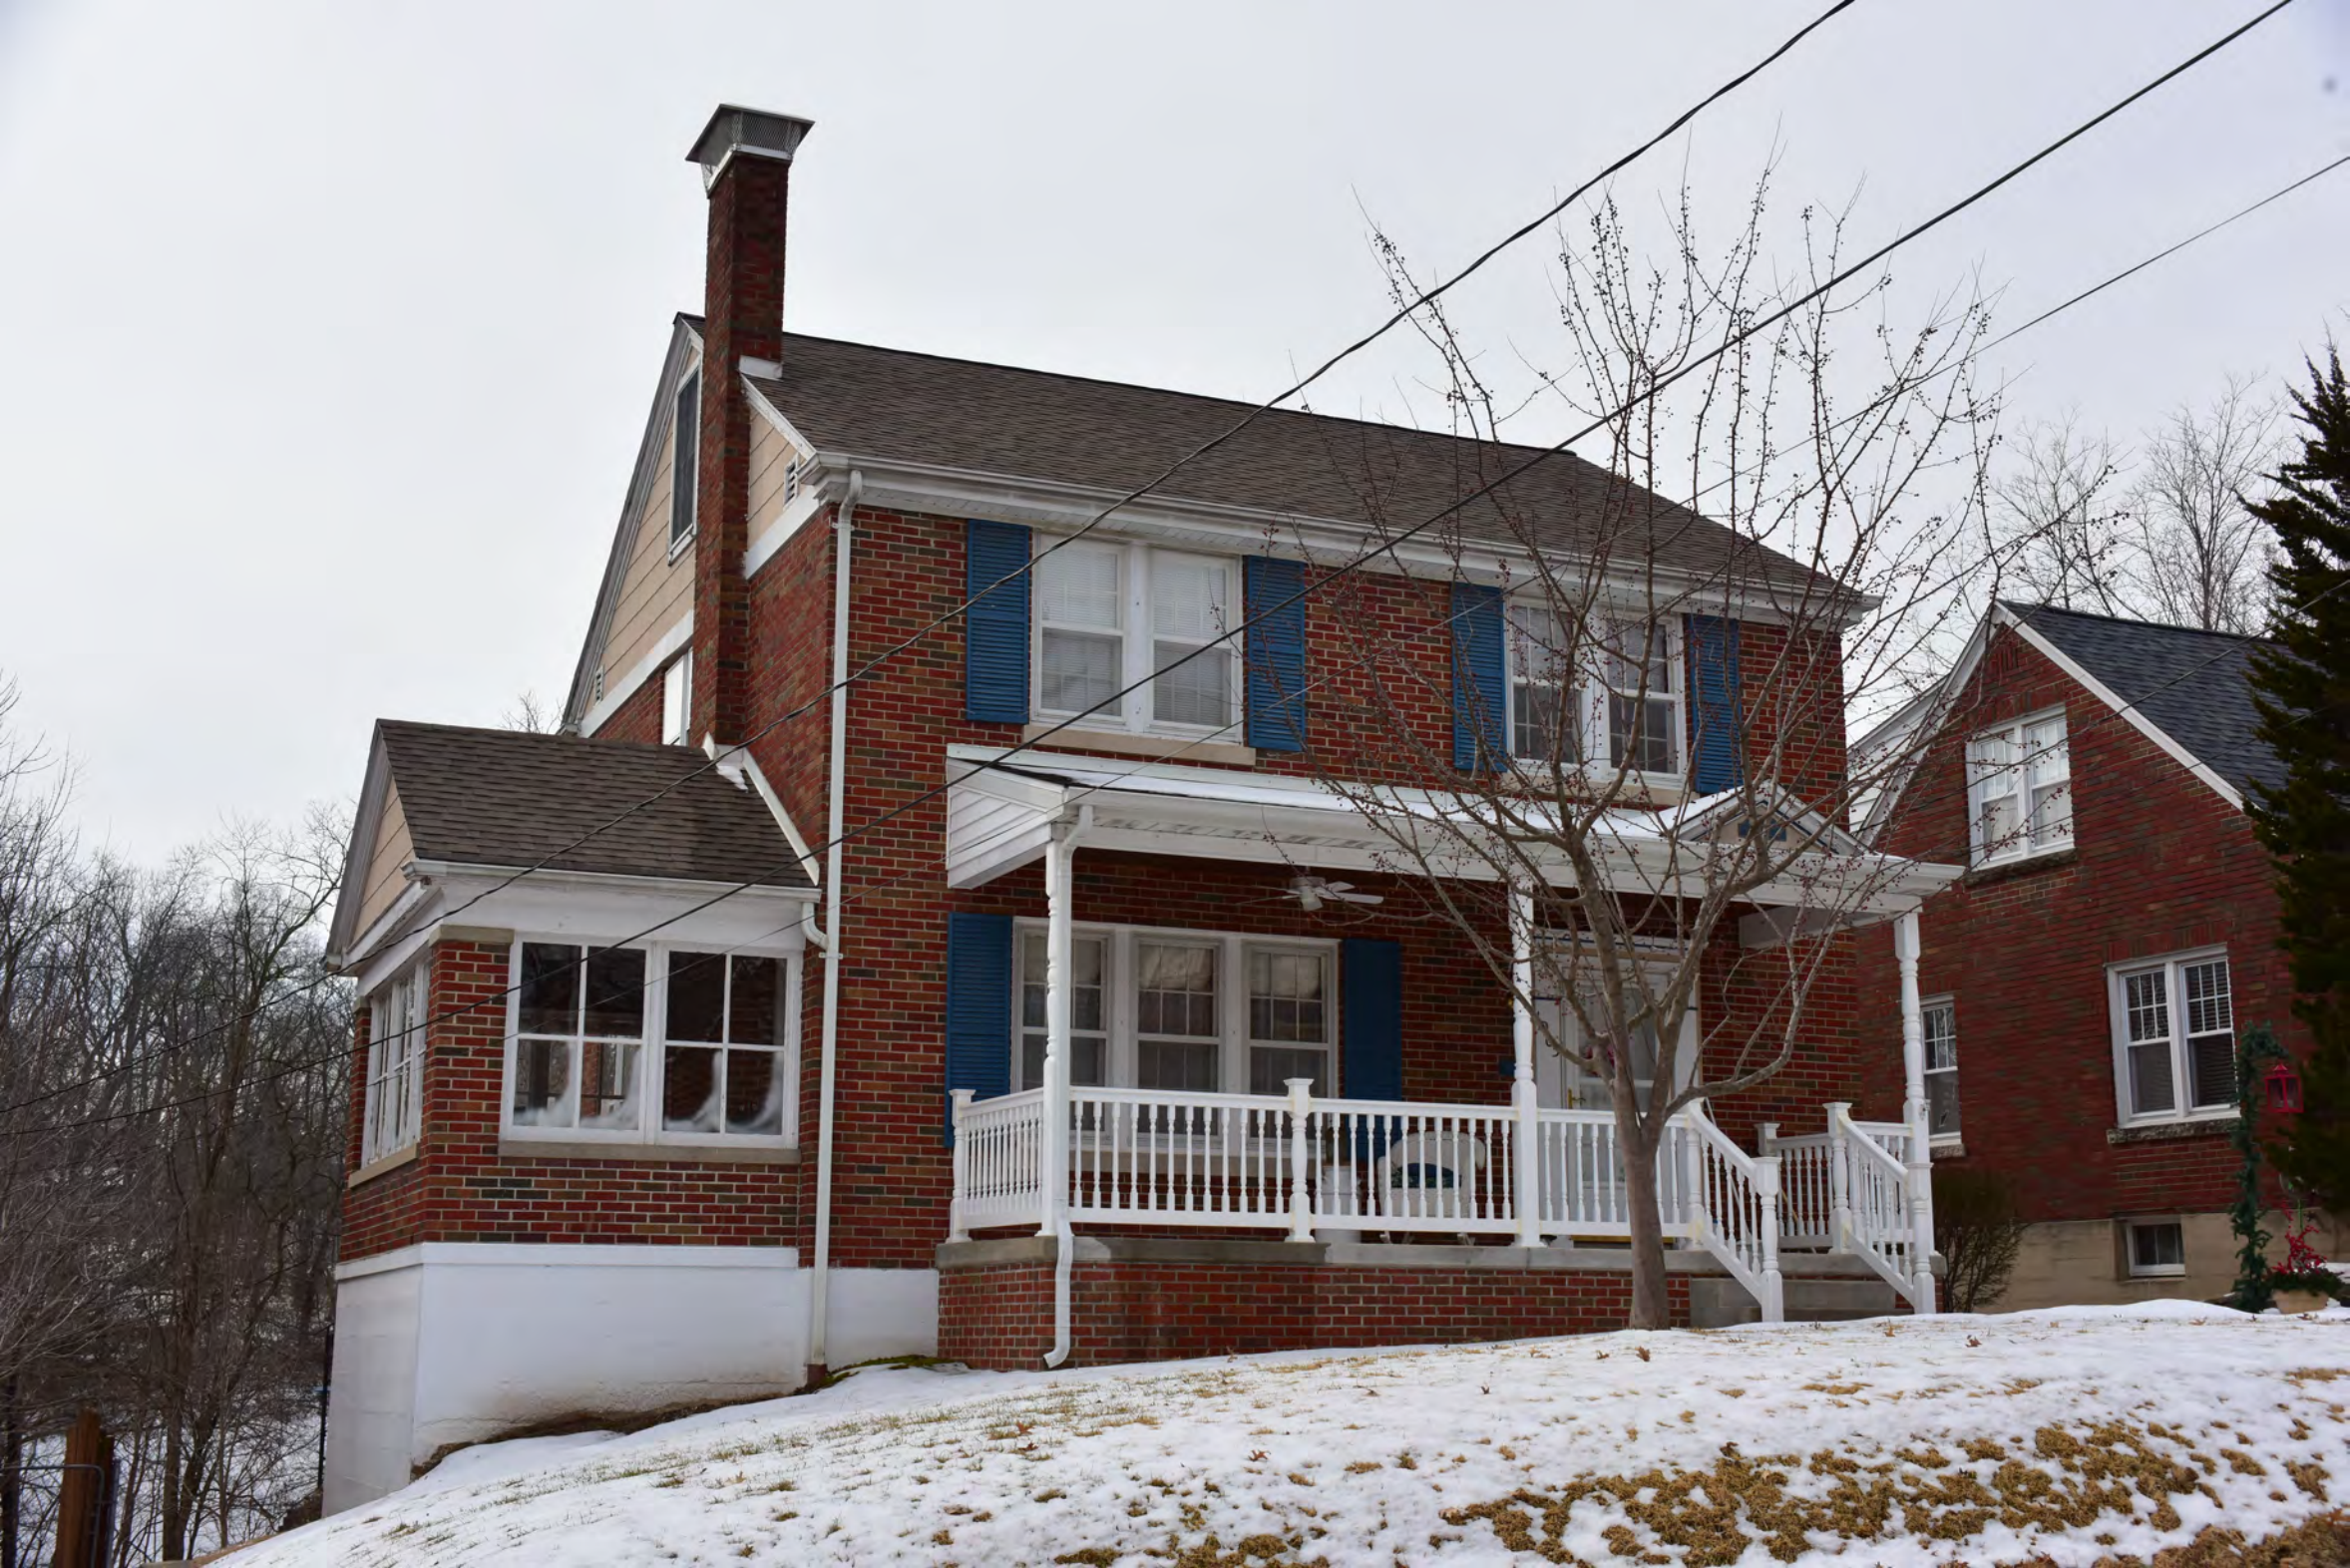
1905 North Circle Drive is a two-story Colonial Revival dwelling. The brick-clad dwelling has a concrete foundation and asphalt side-gable roof. Asbestos shingle clads the gable ends. A historic one-story brick enclosed sunporch projects from the east elevation. Banks of historic 2/2 fixed wood windows fill the sunporch elevations. A brick exterior chimney located between the sunporch and dwelling pierces the front slope eave. The dwelling is two bays wide. Three-ganged historic 6/6 wood windows with a continuous concrete sill fill the east bay while the primary entrance defines the west bay. Two-ganged historic 6/6 wood windows fill the second-story bays. Pilasters and a simple entablature surround the bay. A full-width open porch with a shed roof shelters the first-story bays. Non-historic turned columns support the porch roof while a matching non-historic balustrade lines the porch perimeter. Concrete stairs access the porch. A small gablet punctures the roof above the stairs. A secondary entrance is centered on the west elevation. A gable with curved brackets shelters the concrete access stairs. A c. 2015 one-story hipped roof addition spans the west half of the rear elevation. The hardboard-clad addition is minimally visible. Sanborn maps indicate the presence of an integrated garage at basement level accessed at the rear.
