1. Survey number: CO-AS-008-001		2. Survey Name: West Main Street Survey	
3. County: Cole		4. Address (Street No.): 100	Street (name): East Circle Drive
5. City: Jefferson City	Vicinity <input type="checkbox"/>	6. Lat / Long:	7. Township/Range/Section: T: R: S:
8. Historic name (if known):		9. Present/other name (if known):	
10. Ownership: <input checked="" type="checkbox"/> Private <input type="checkbox"/> Public		11a. Historic use (if known): Domestic-Single Dwelling	11b. Current use: Domestic-Single Dwelling

MISSOURI DEPARTMENT OF NATURAL RESOURCES
STATE HISTORIC PRESERVATION OFFICE, P.O. Box 178, Jefferson City, MO 65102
ARCHITECTURAL/HISTORIC INVENTORY FORM

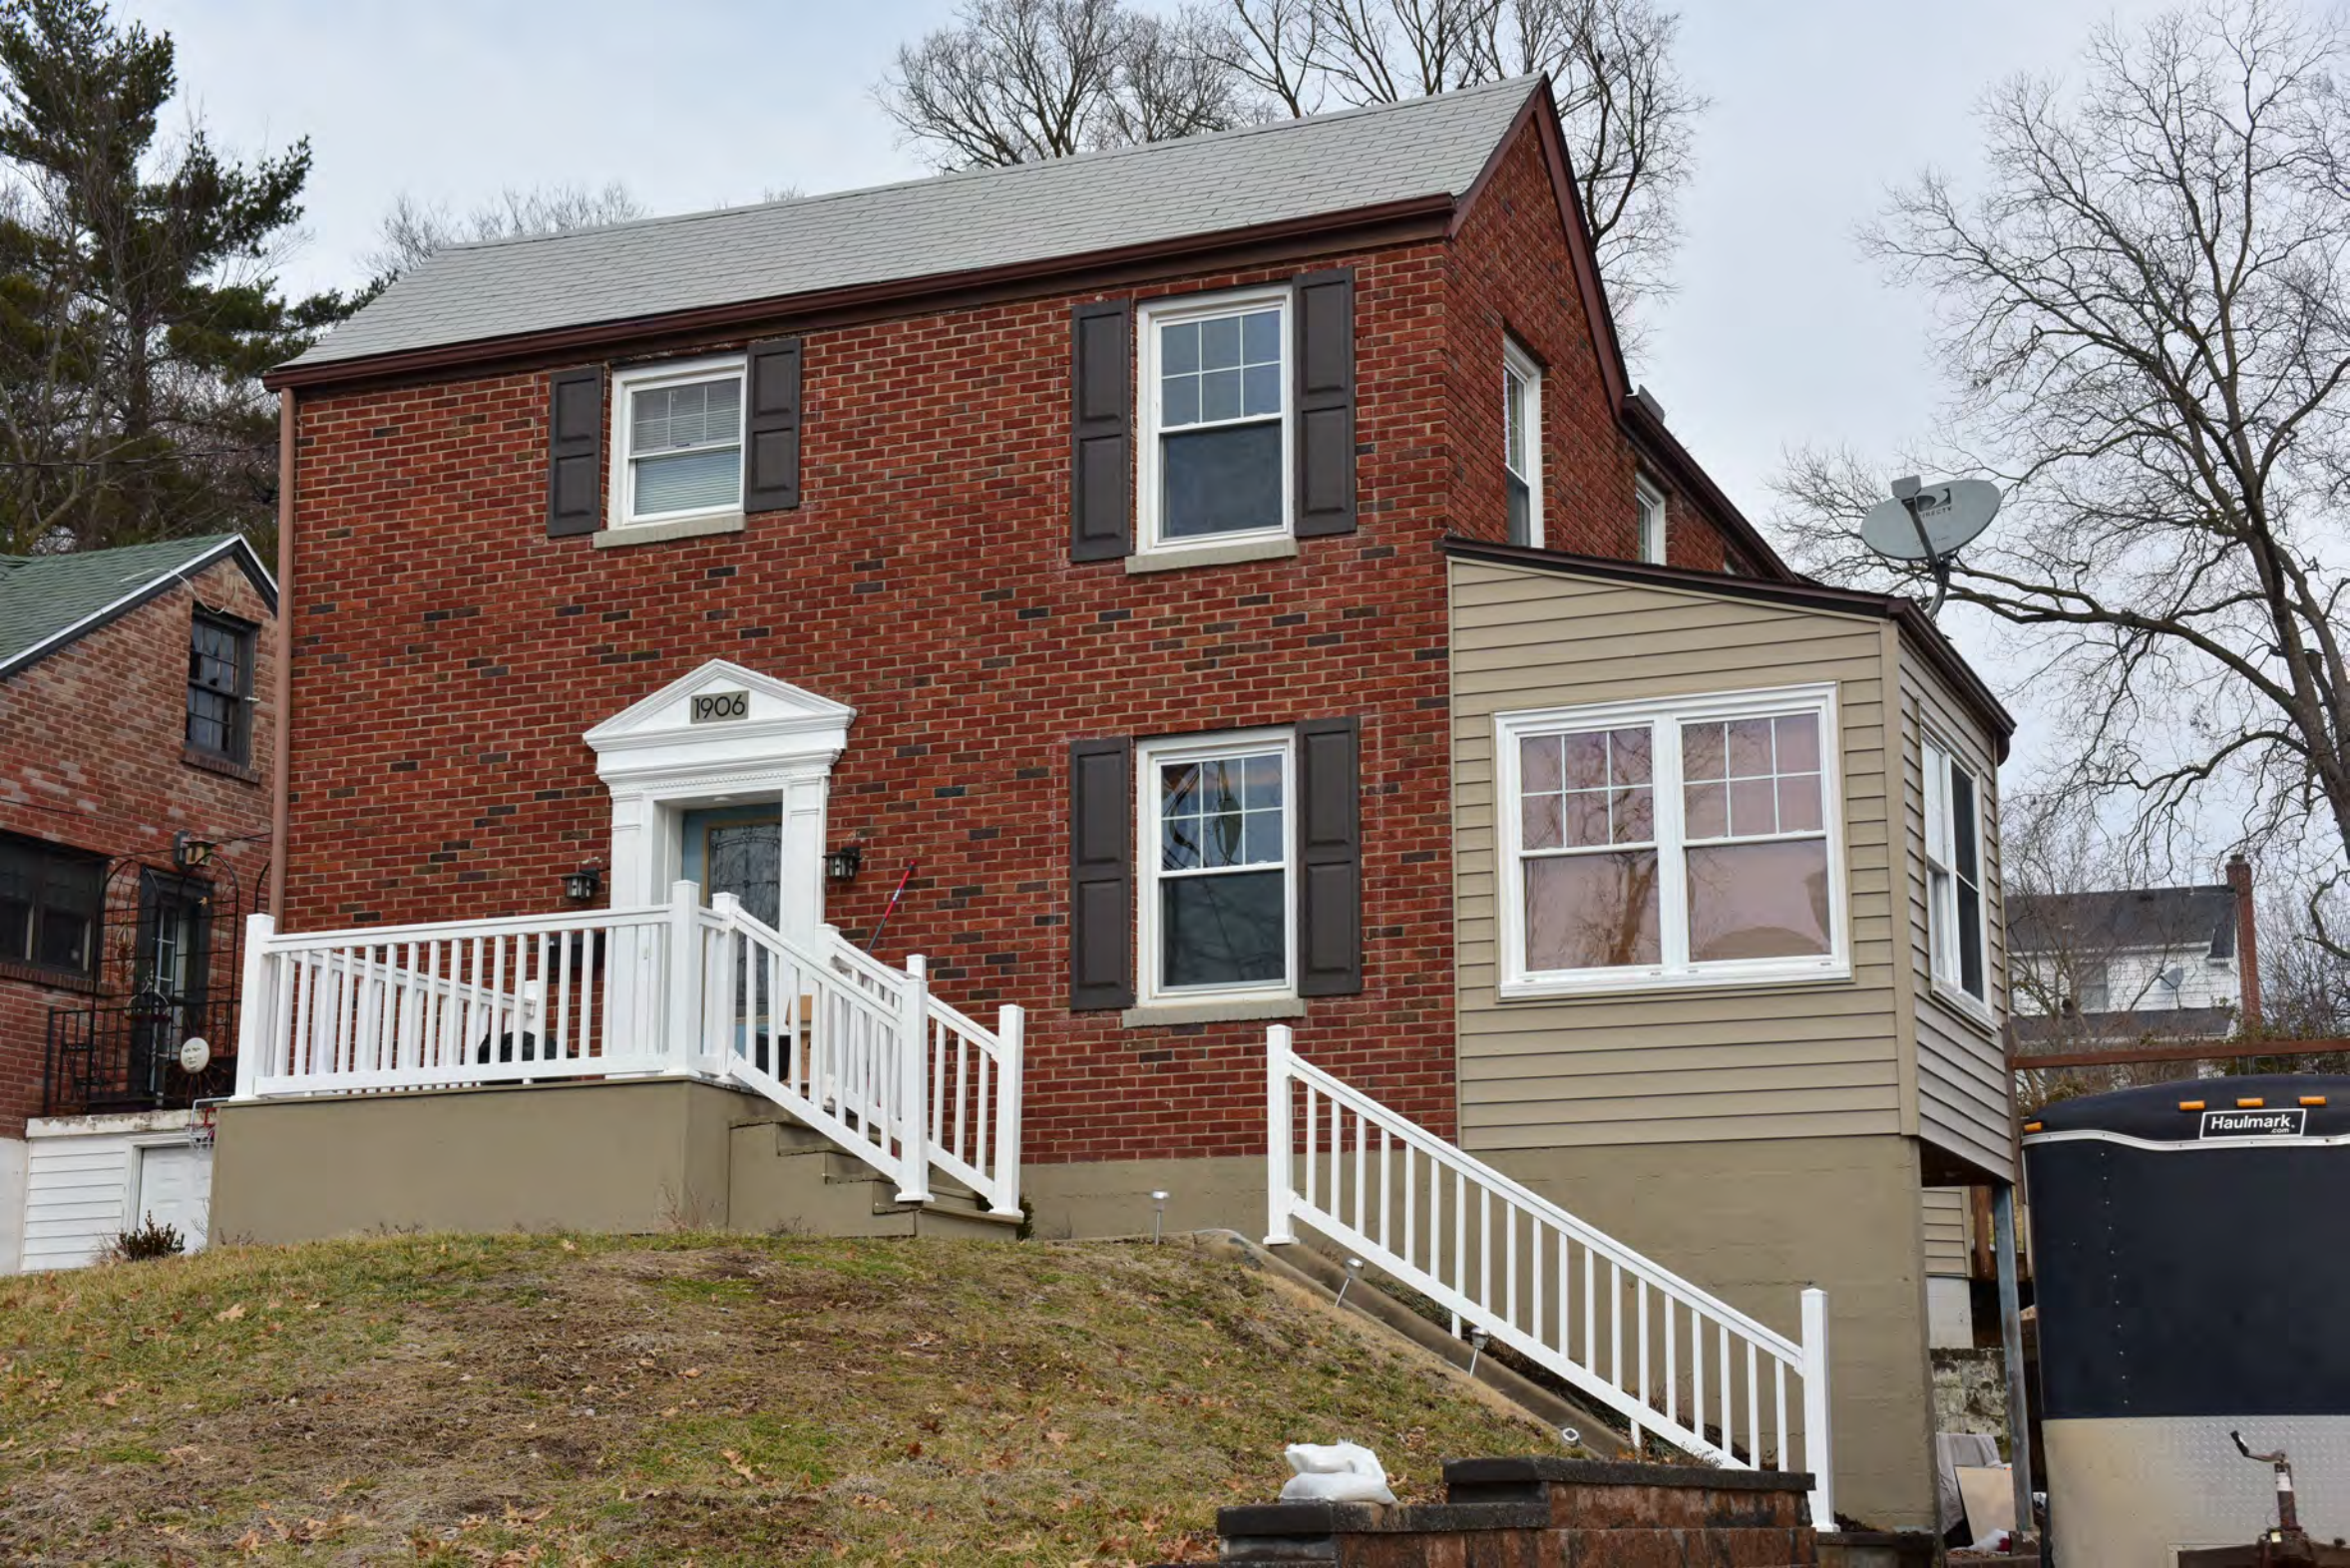
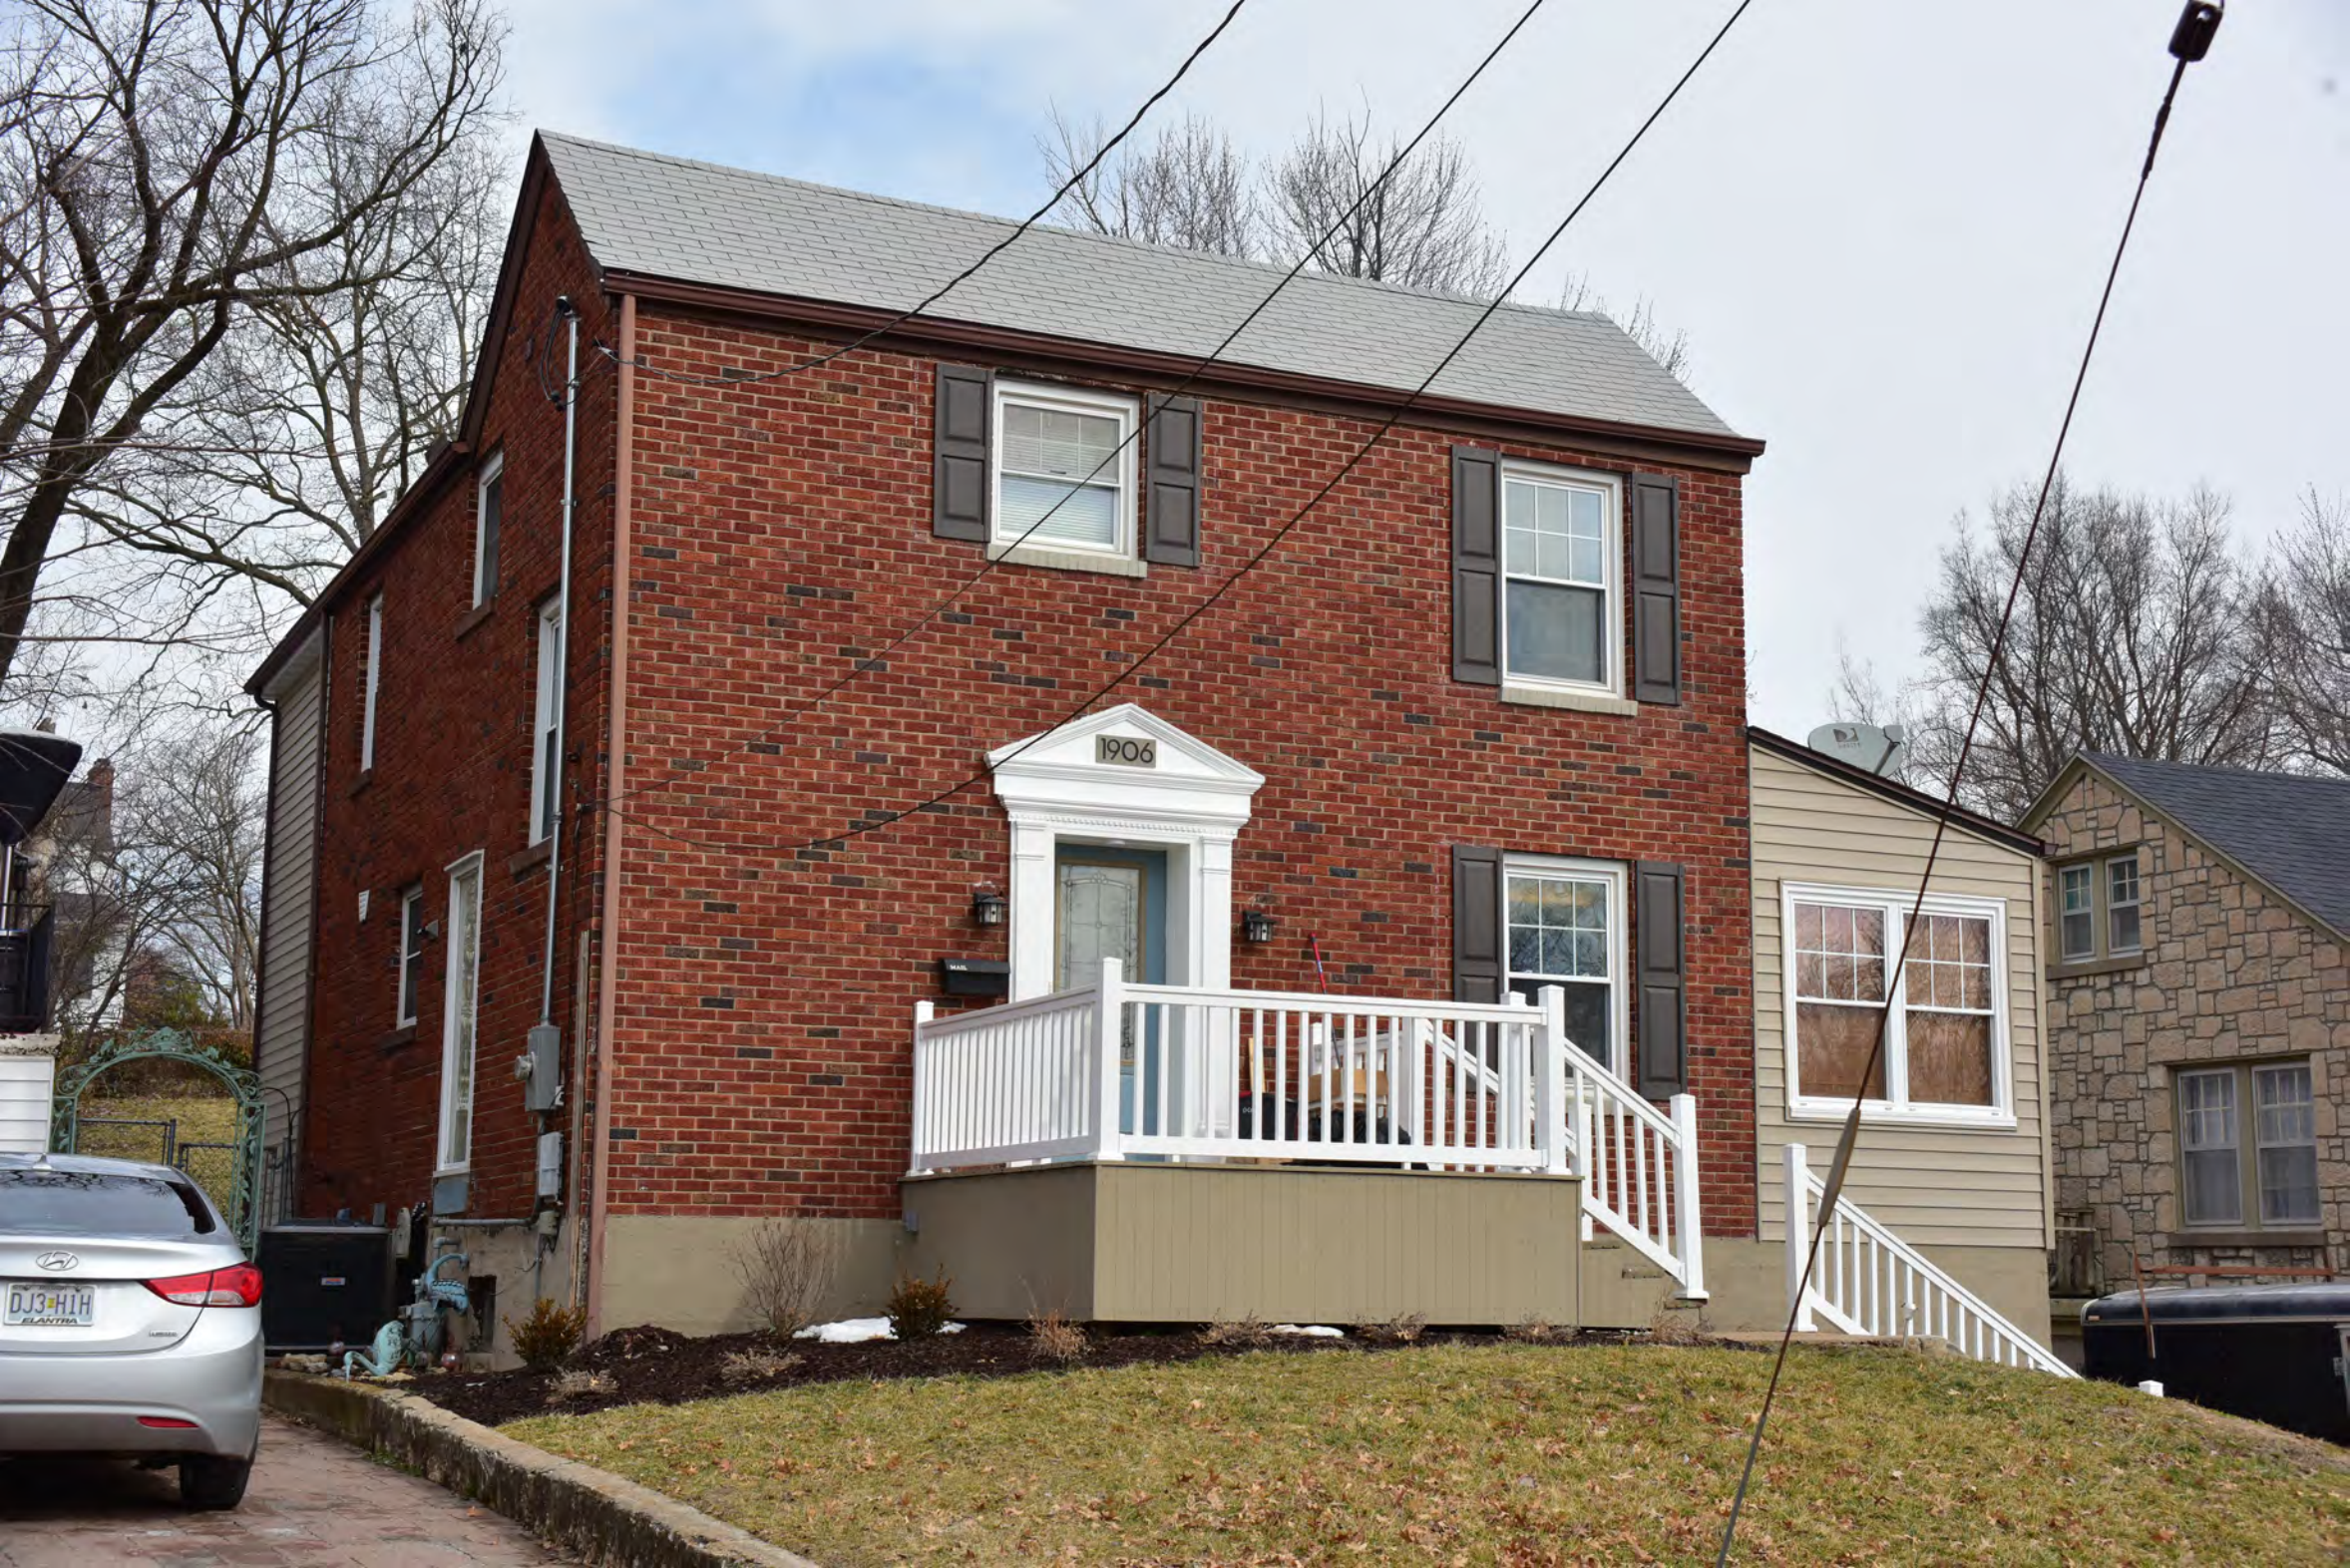
1906 North Circle Drive is a two-story Colonial Revival dwelling. The brick-clad dwelling has a concrete foundation and asphalt intersecting-gable roof. A side-gable fronts North Circle drive while a perpendicular gable extends from the rear. The dwelling is two bays wide. The primary entrance defines the west bay. The entrance features a non-historic wood door and neo-classical surround with pilasters and pediment Two. A non-historic 6/1 vinyl window with snap-in muntins and soldier brick sill fills the east bay. A pressboard-clad platform porch extends from the entrance. A non-historic vinyl balustrade lines the perimeter. Non-historic wood stairs access the porch at the east end. A historic concrete terrace and stairs access the wood stairs. Non-historic railings line both sets of stairs. A one-story shed-roof enclosed porch projects from the east elevation. A concrete wingwall and wood post support the porch. It is vinyl clad. Two-ganged 6/1 vinyl windows with snap-in muntin are centered on the south and east elevations. A c. 1990 two-story vinyl-clad gable-front addition spans the rear elevation.

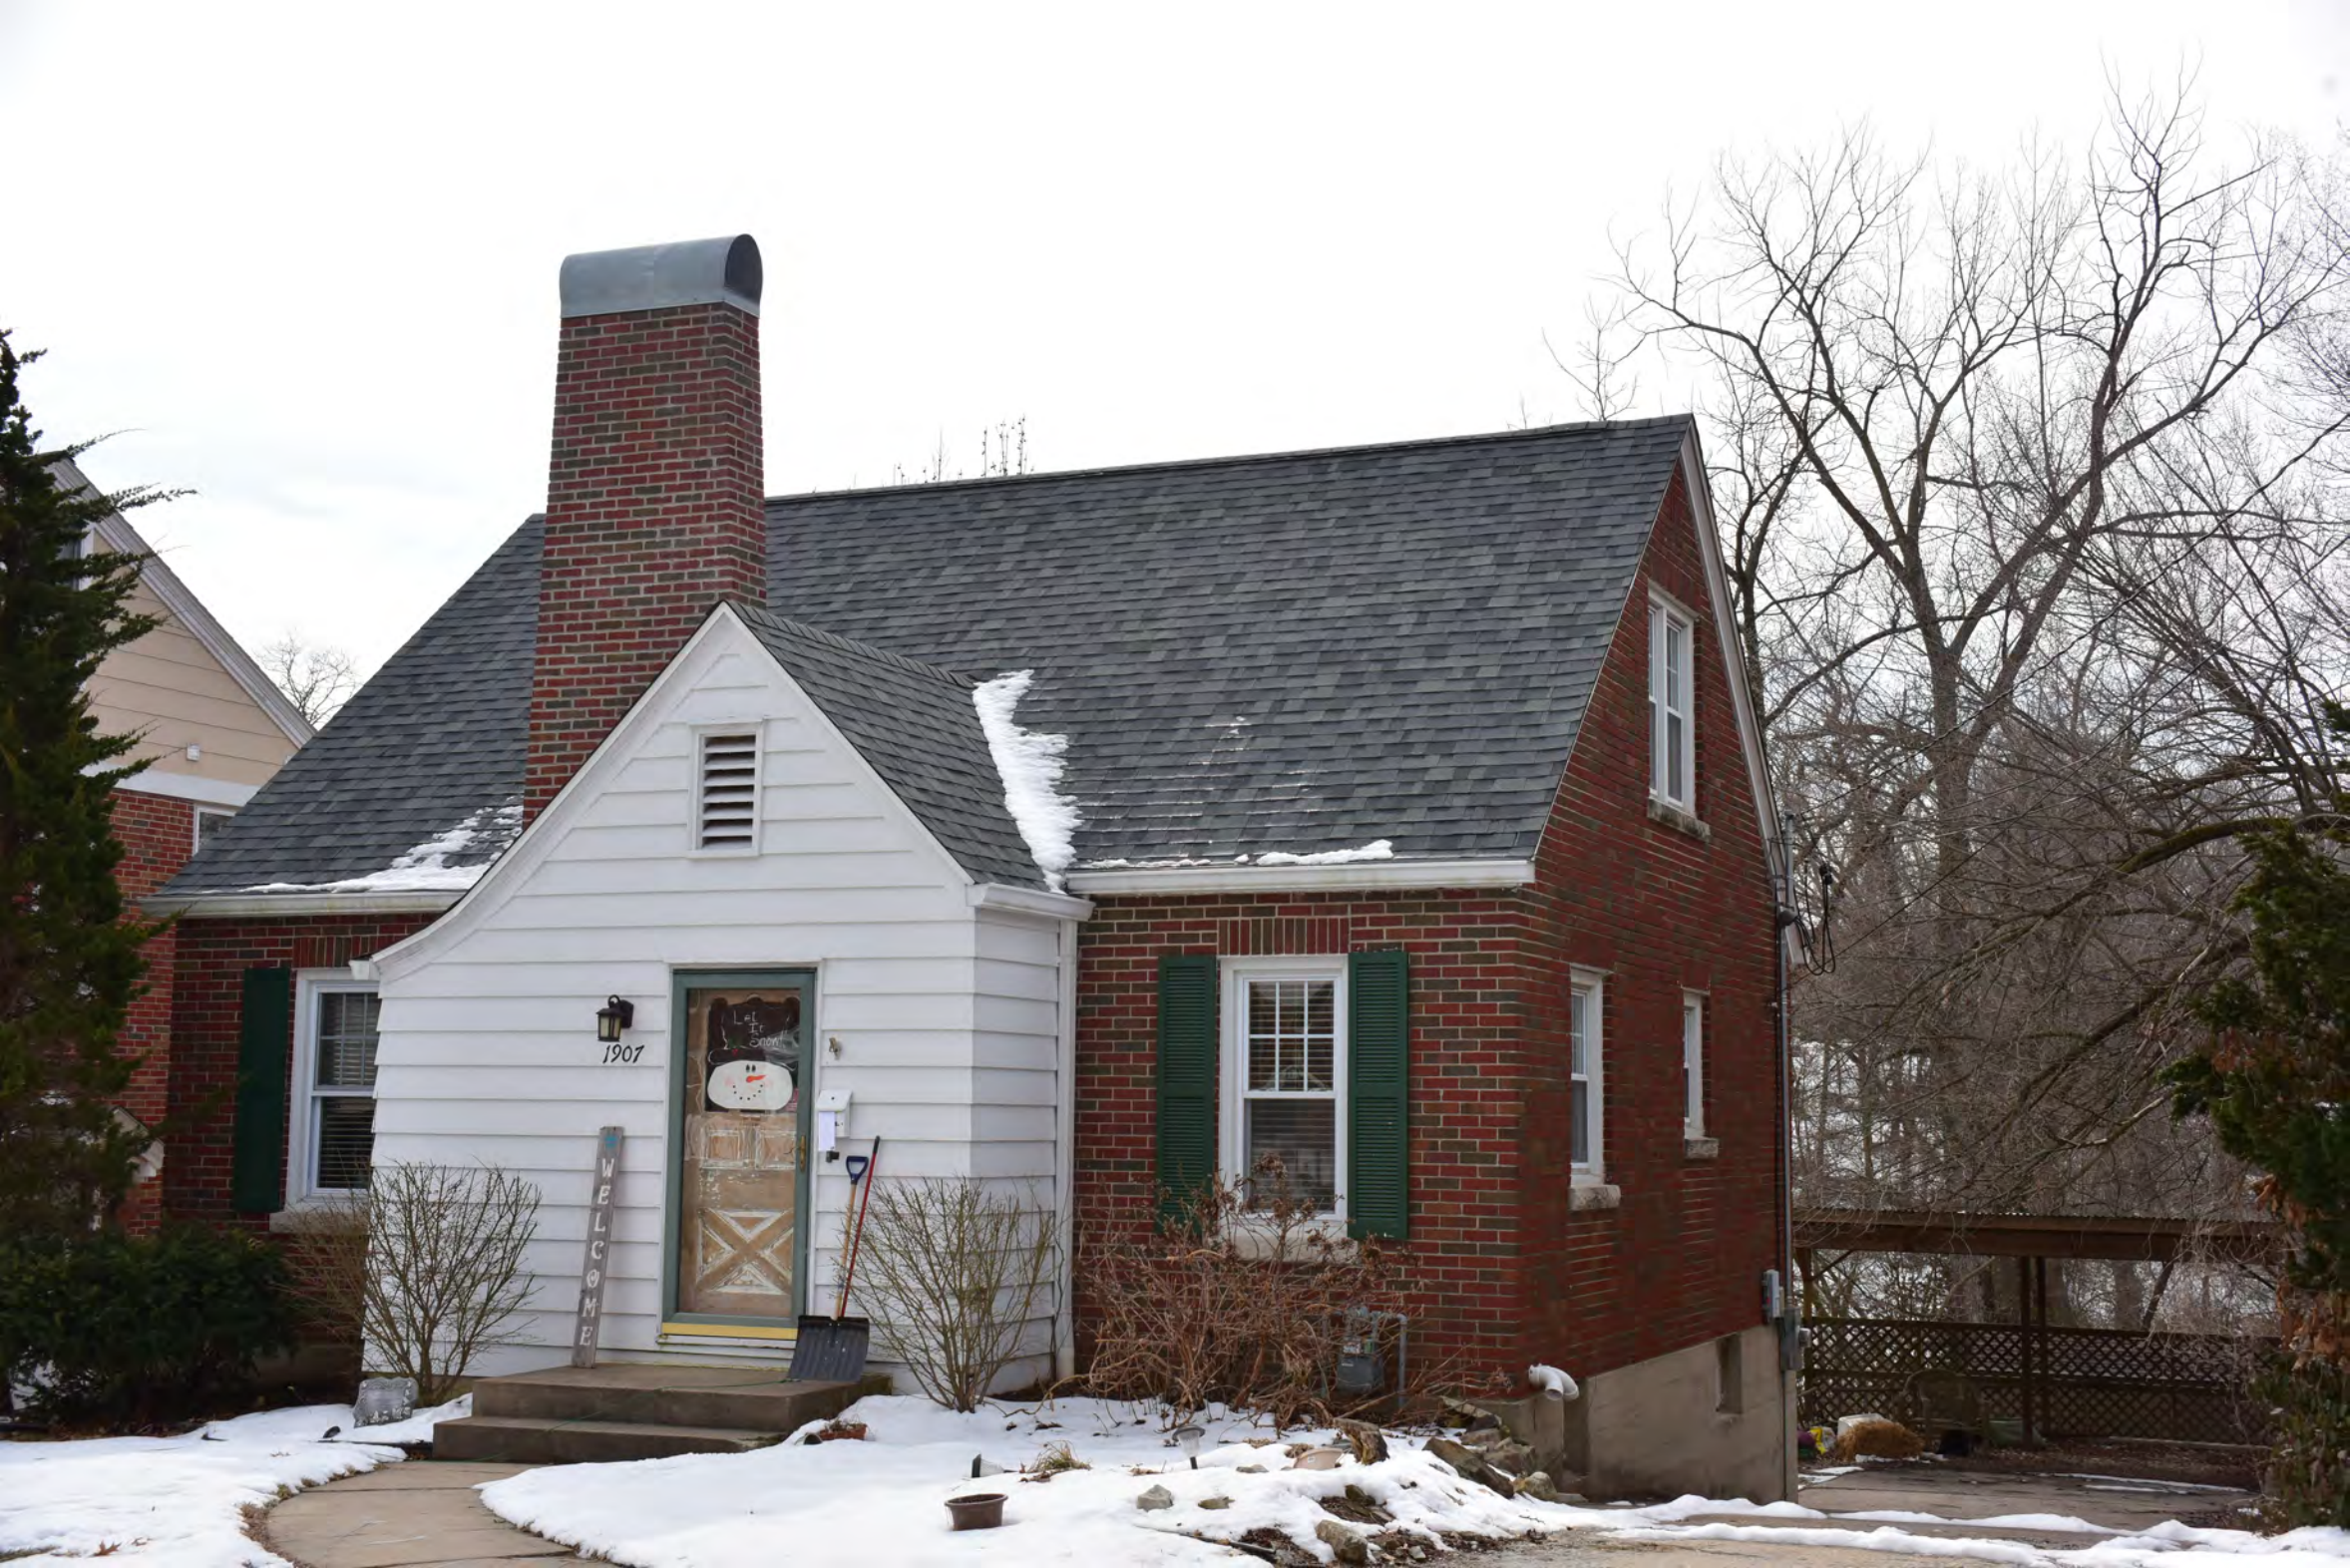
1907 North Circle Drive is a one-story Minimal Traditional dwelling with brick cladding, a concrete foundation, and an asphalt side-gable roof. A gable-front hardboard-clad enclosed vestibule projects from the center of the primary elevation. The east slope flares downward. A tapered brick chimney pierces the vestibule and roof. The dwelling is three bays wide. Non-historic 6/1 vinyl windows fill the east and west bays. Both windows have cast stone sills and vertically oriented brick lintels. Non-historic false shutters flank the window bays. The vestibule contains the primary entrance. A wood door with glazing fills the bay. A rectangular vent with wood slats is centered over the entrance in the gable apex. A concrete stoop extends from the entrance. An integrated garage is located at the rear at basement level. A non-historic wood deck extends from the rear elevation.

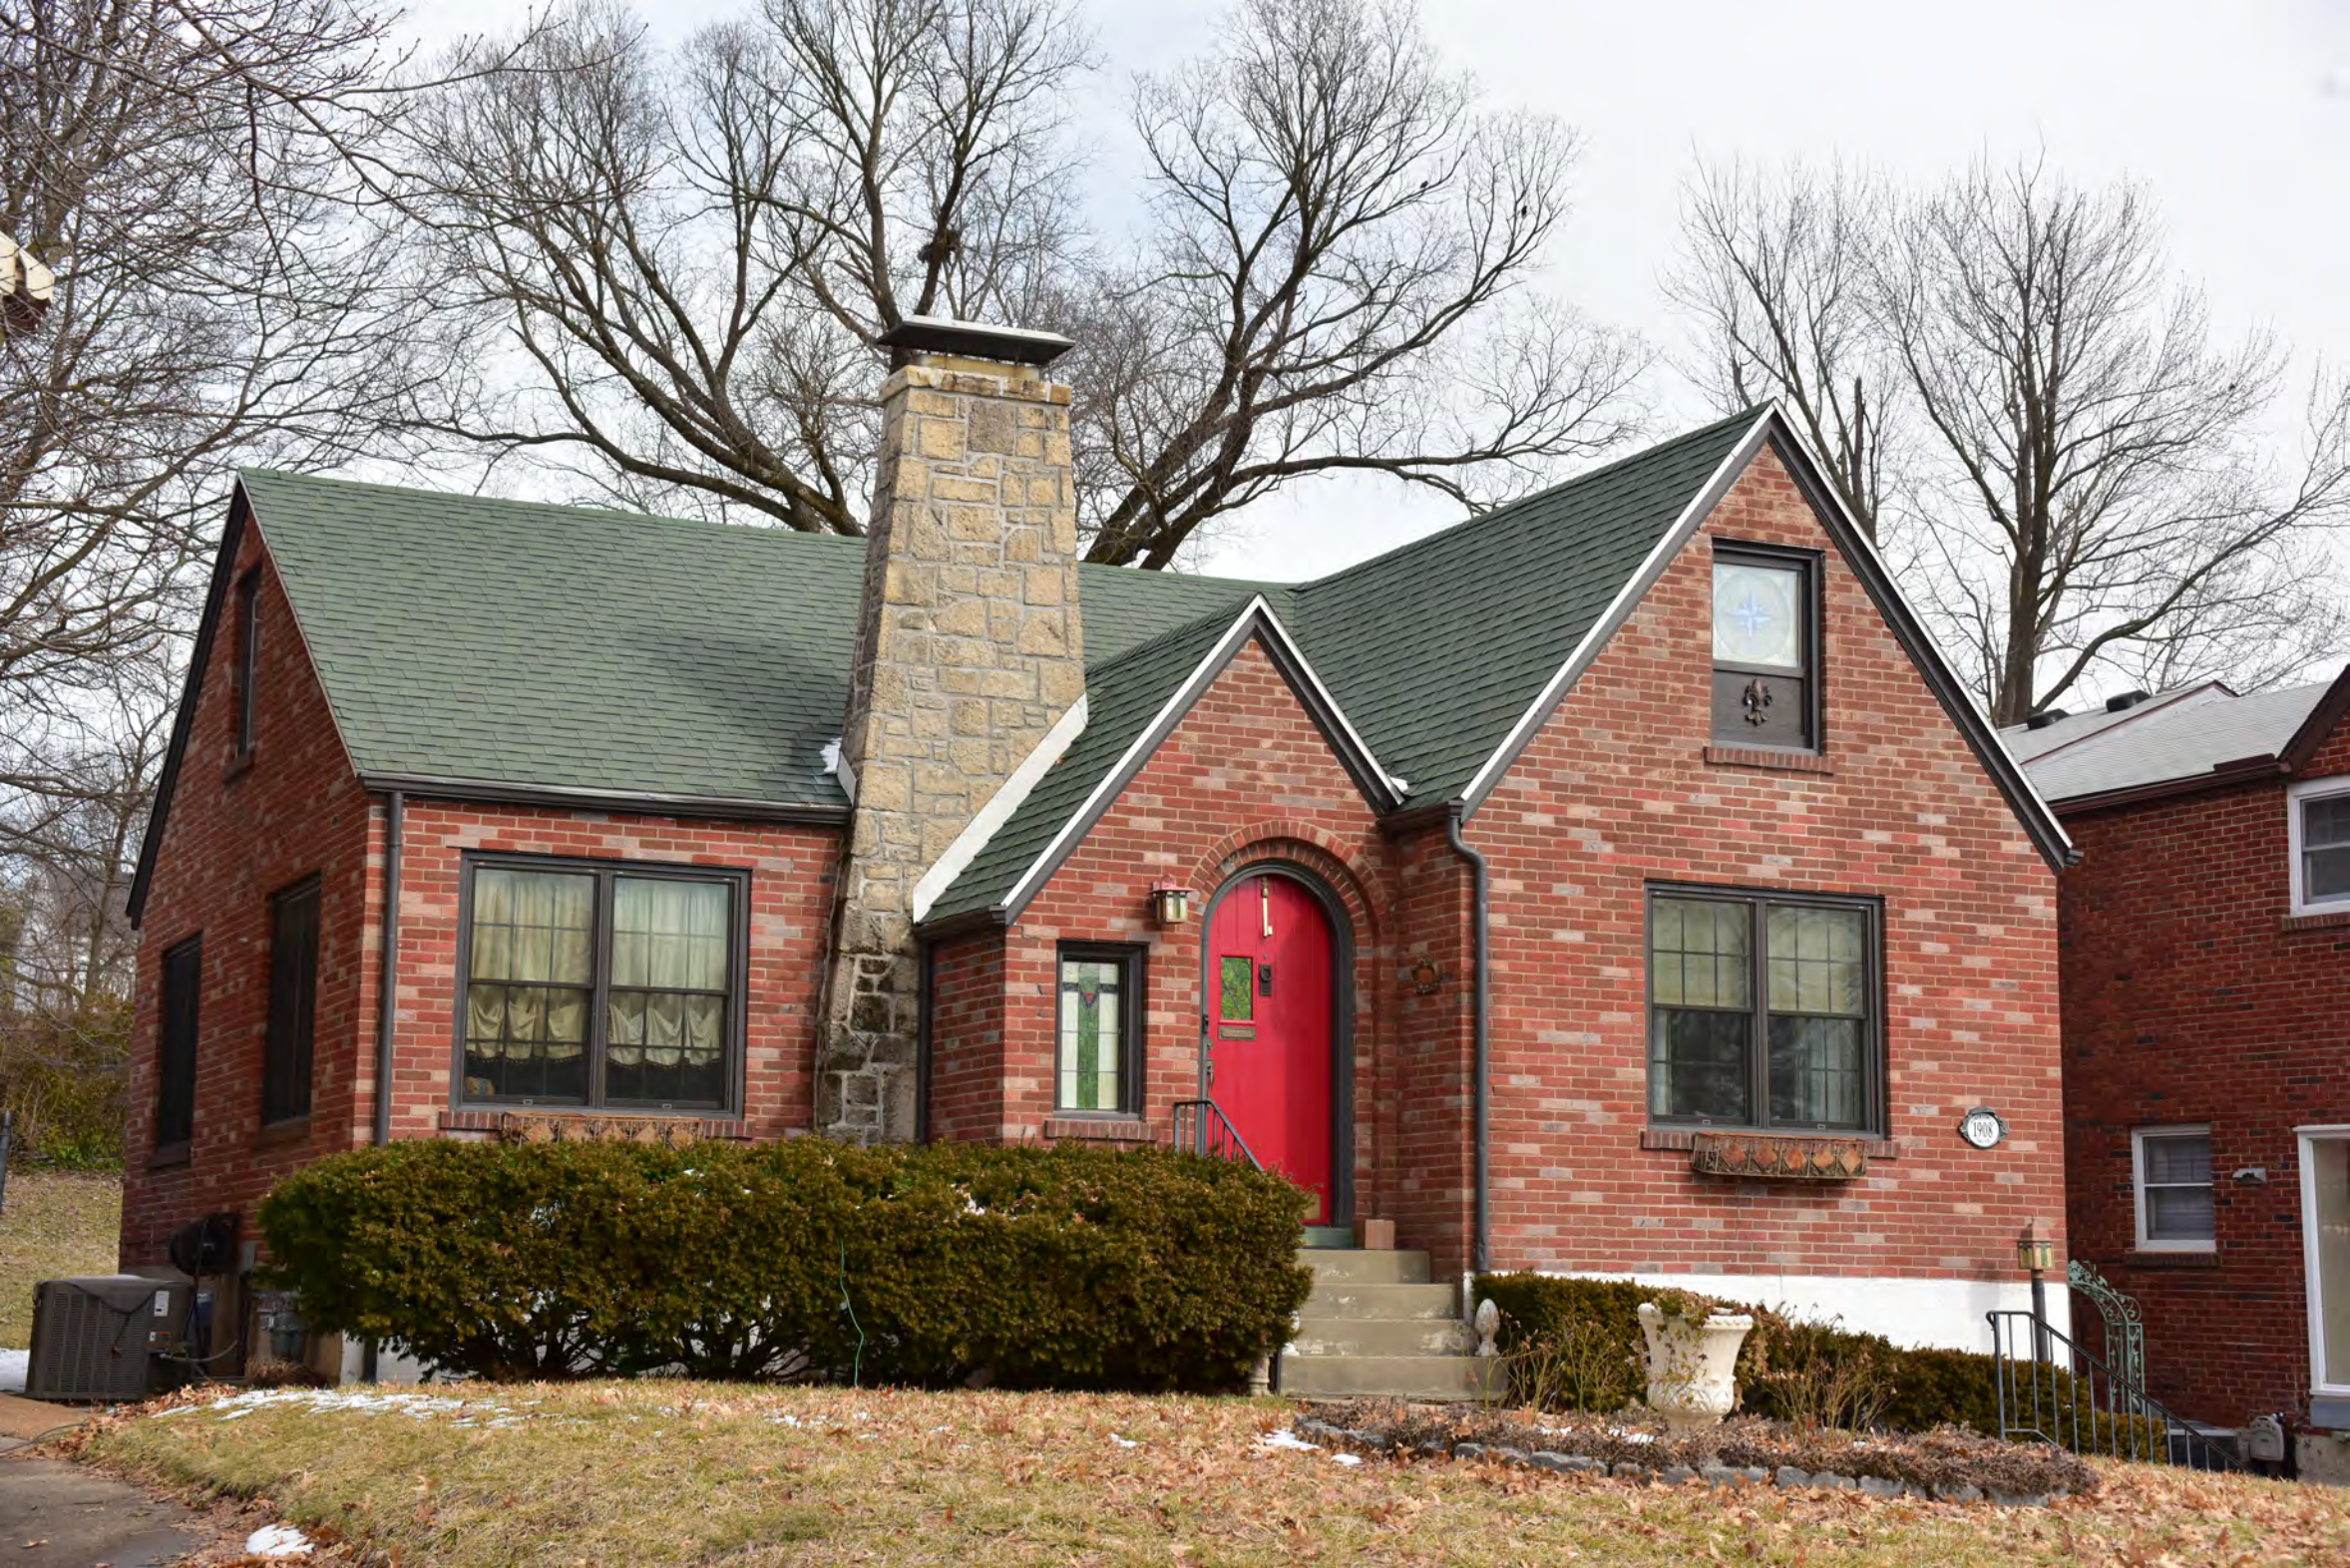
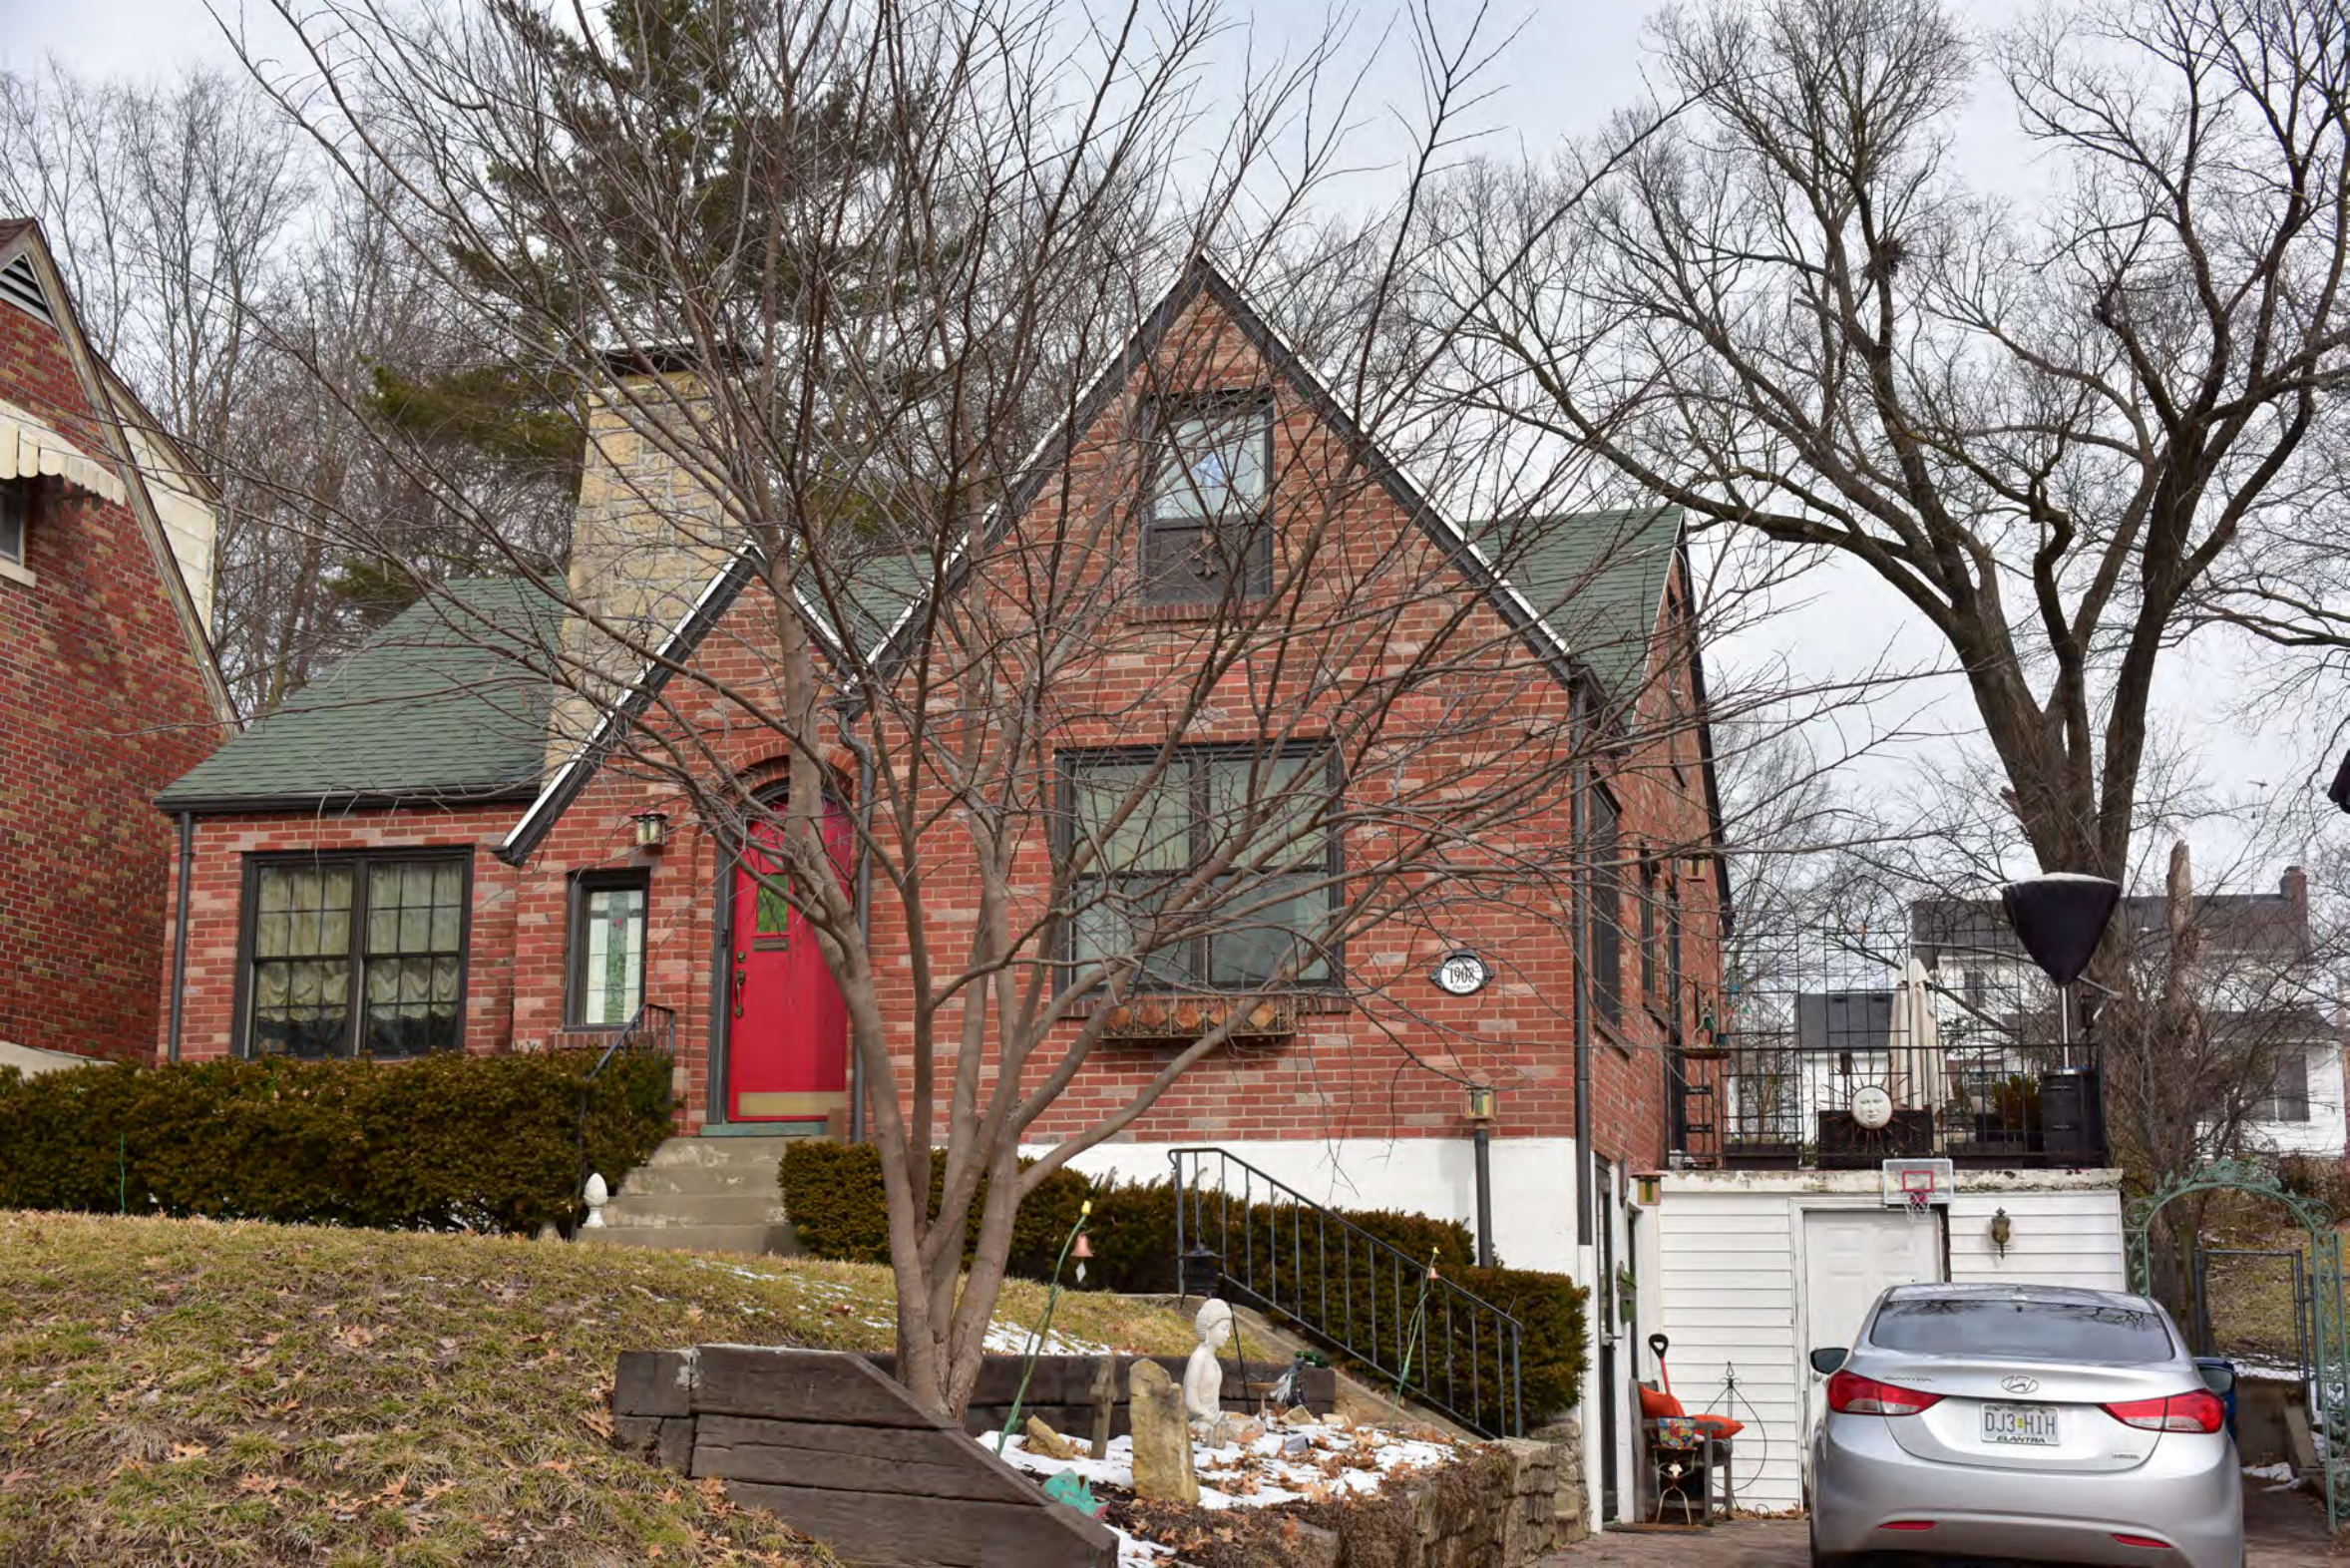
1908 North Circle Drive is a one-story Minimal Traditional dwelling with restrained Tudor Revival influences. The brick dwelling has gabled-ell asphalt roof and concrete foundation. A gable-front brick vestibule is located at the juncture between the ells. A tapered stone exterior chimney pierces the vestibule and roof. The dwelling is three bays wide. Two-ganged historic 6/6 wood windows fill the east and west bays. A non-historic art glass window with a nautical compass and fleur de lis motif is centered in the gable apex above the third bay. The bottom sash is infilled embellished with a fleur de lis. The vestibule contains the center bay. A historic wood door with diamond pane glazing fills the rounded arch opening. A truncated sidelight with a geometric stained-glass motif is located west of the entrance. A concrete stoop projects from the entrance. Terraced concrete steps with metal railings access the stoop from the west side. A historic single-car garage projects from the west elevation at the basement level and is set back several feet. The garage is hardboard-clad. The vehicular opening has been reduced to accommodate non-historic pedestrian door. A historic open porch with a concrete floor and a historic metal bar railing tops the garage. Aerial imagery indicates a shed-roof projection extends from the northwest corner of the dwelling; however, it is not visible from the right of way.
