1. Survey number: CO-AS-008-001		2. Survey Name: West Main Street Survey	
3. County: Cole		4. Address (Street No.): 100	Street (name): East Circle Drive
5. City: Jefferson City	Vicinity <input type="checkbox"/>	6. Lat / Long:	7. Township/Range/Section: T: R: S:
8. Historic name (if known):		9. Present/other name (if known):	
10. Ownership: <input checked="" type="checkbox"/> Private <input type="checkbox"/> Public		11a. Historic use (if known): Domestic-Single Dwelling	11b. Current use: Domestic-Single Dwelling

MISSOURI DEPARTMENT OF NATURAL RESOURCES
STATE HISTORIC PRESERVATION OFFICE, P.O. Box 178, Jefferson City, MO 65102
ARCHITECTURAL/HISTORIC INVENTORY FORM

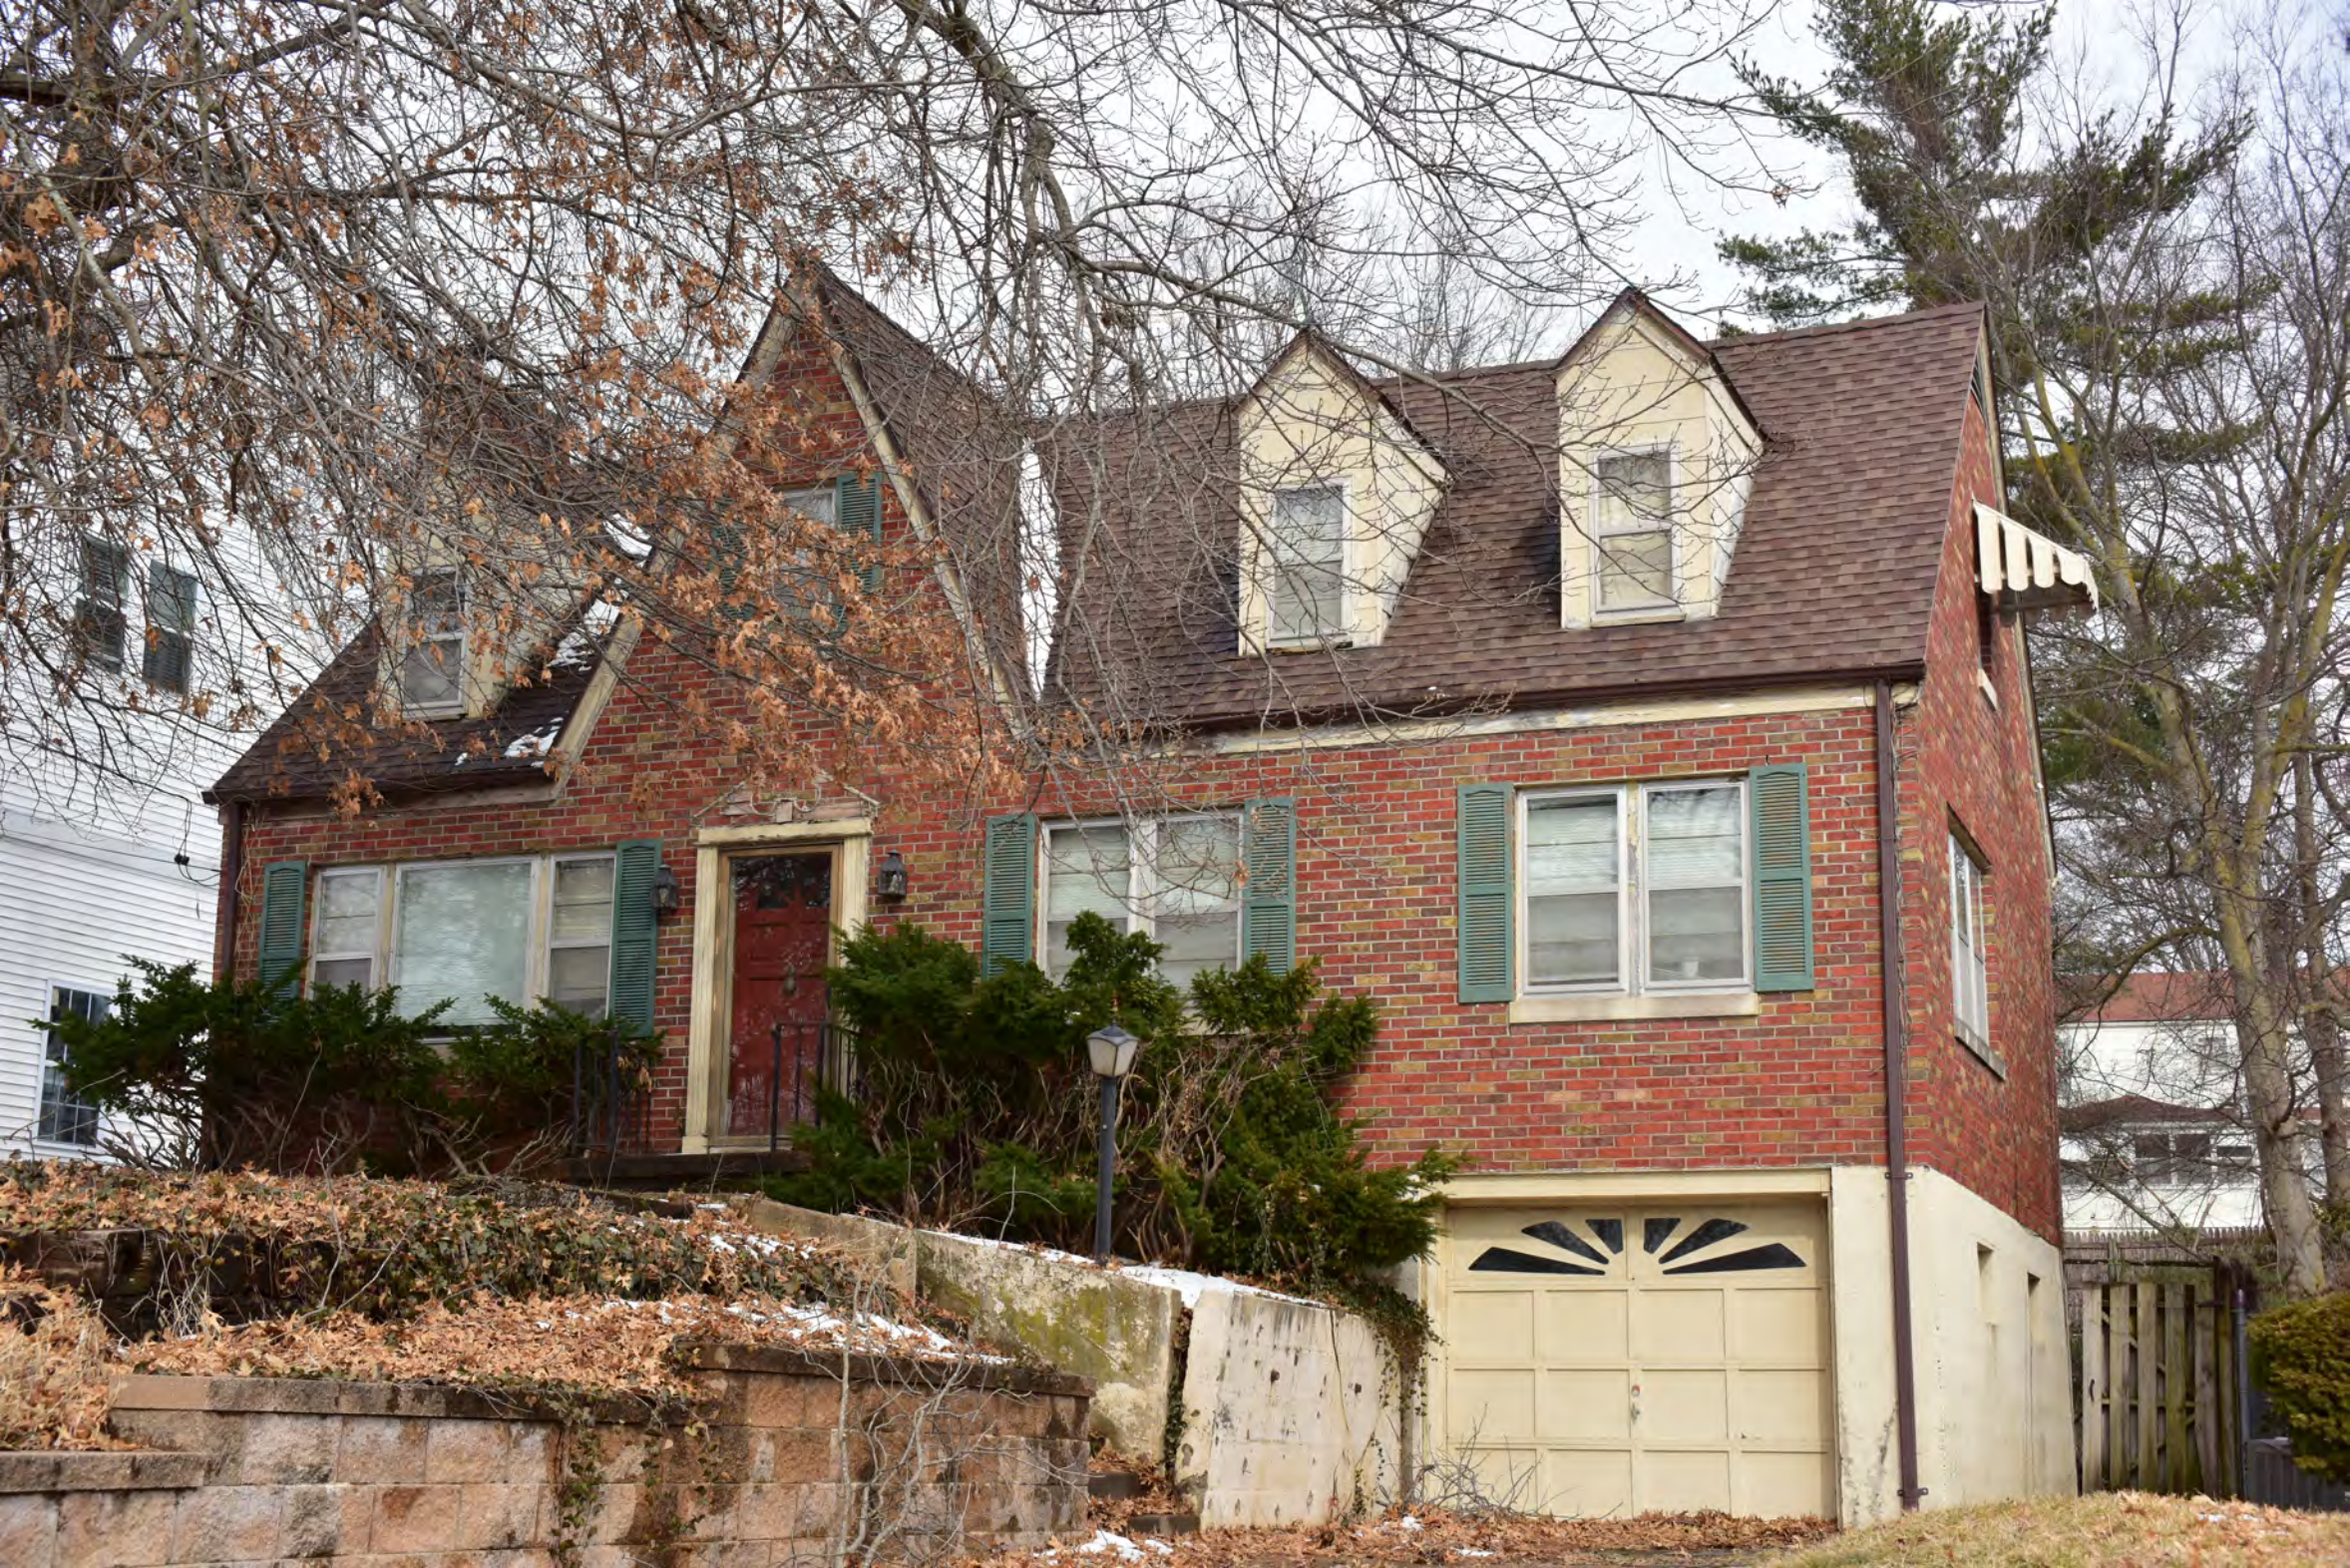
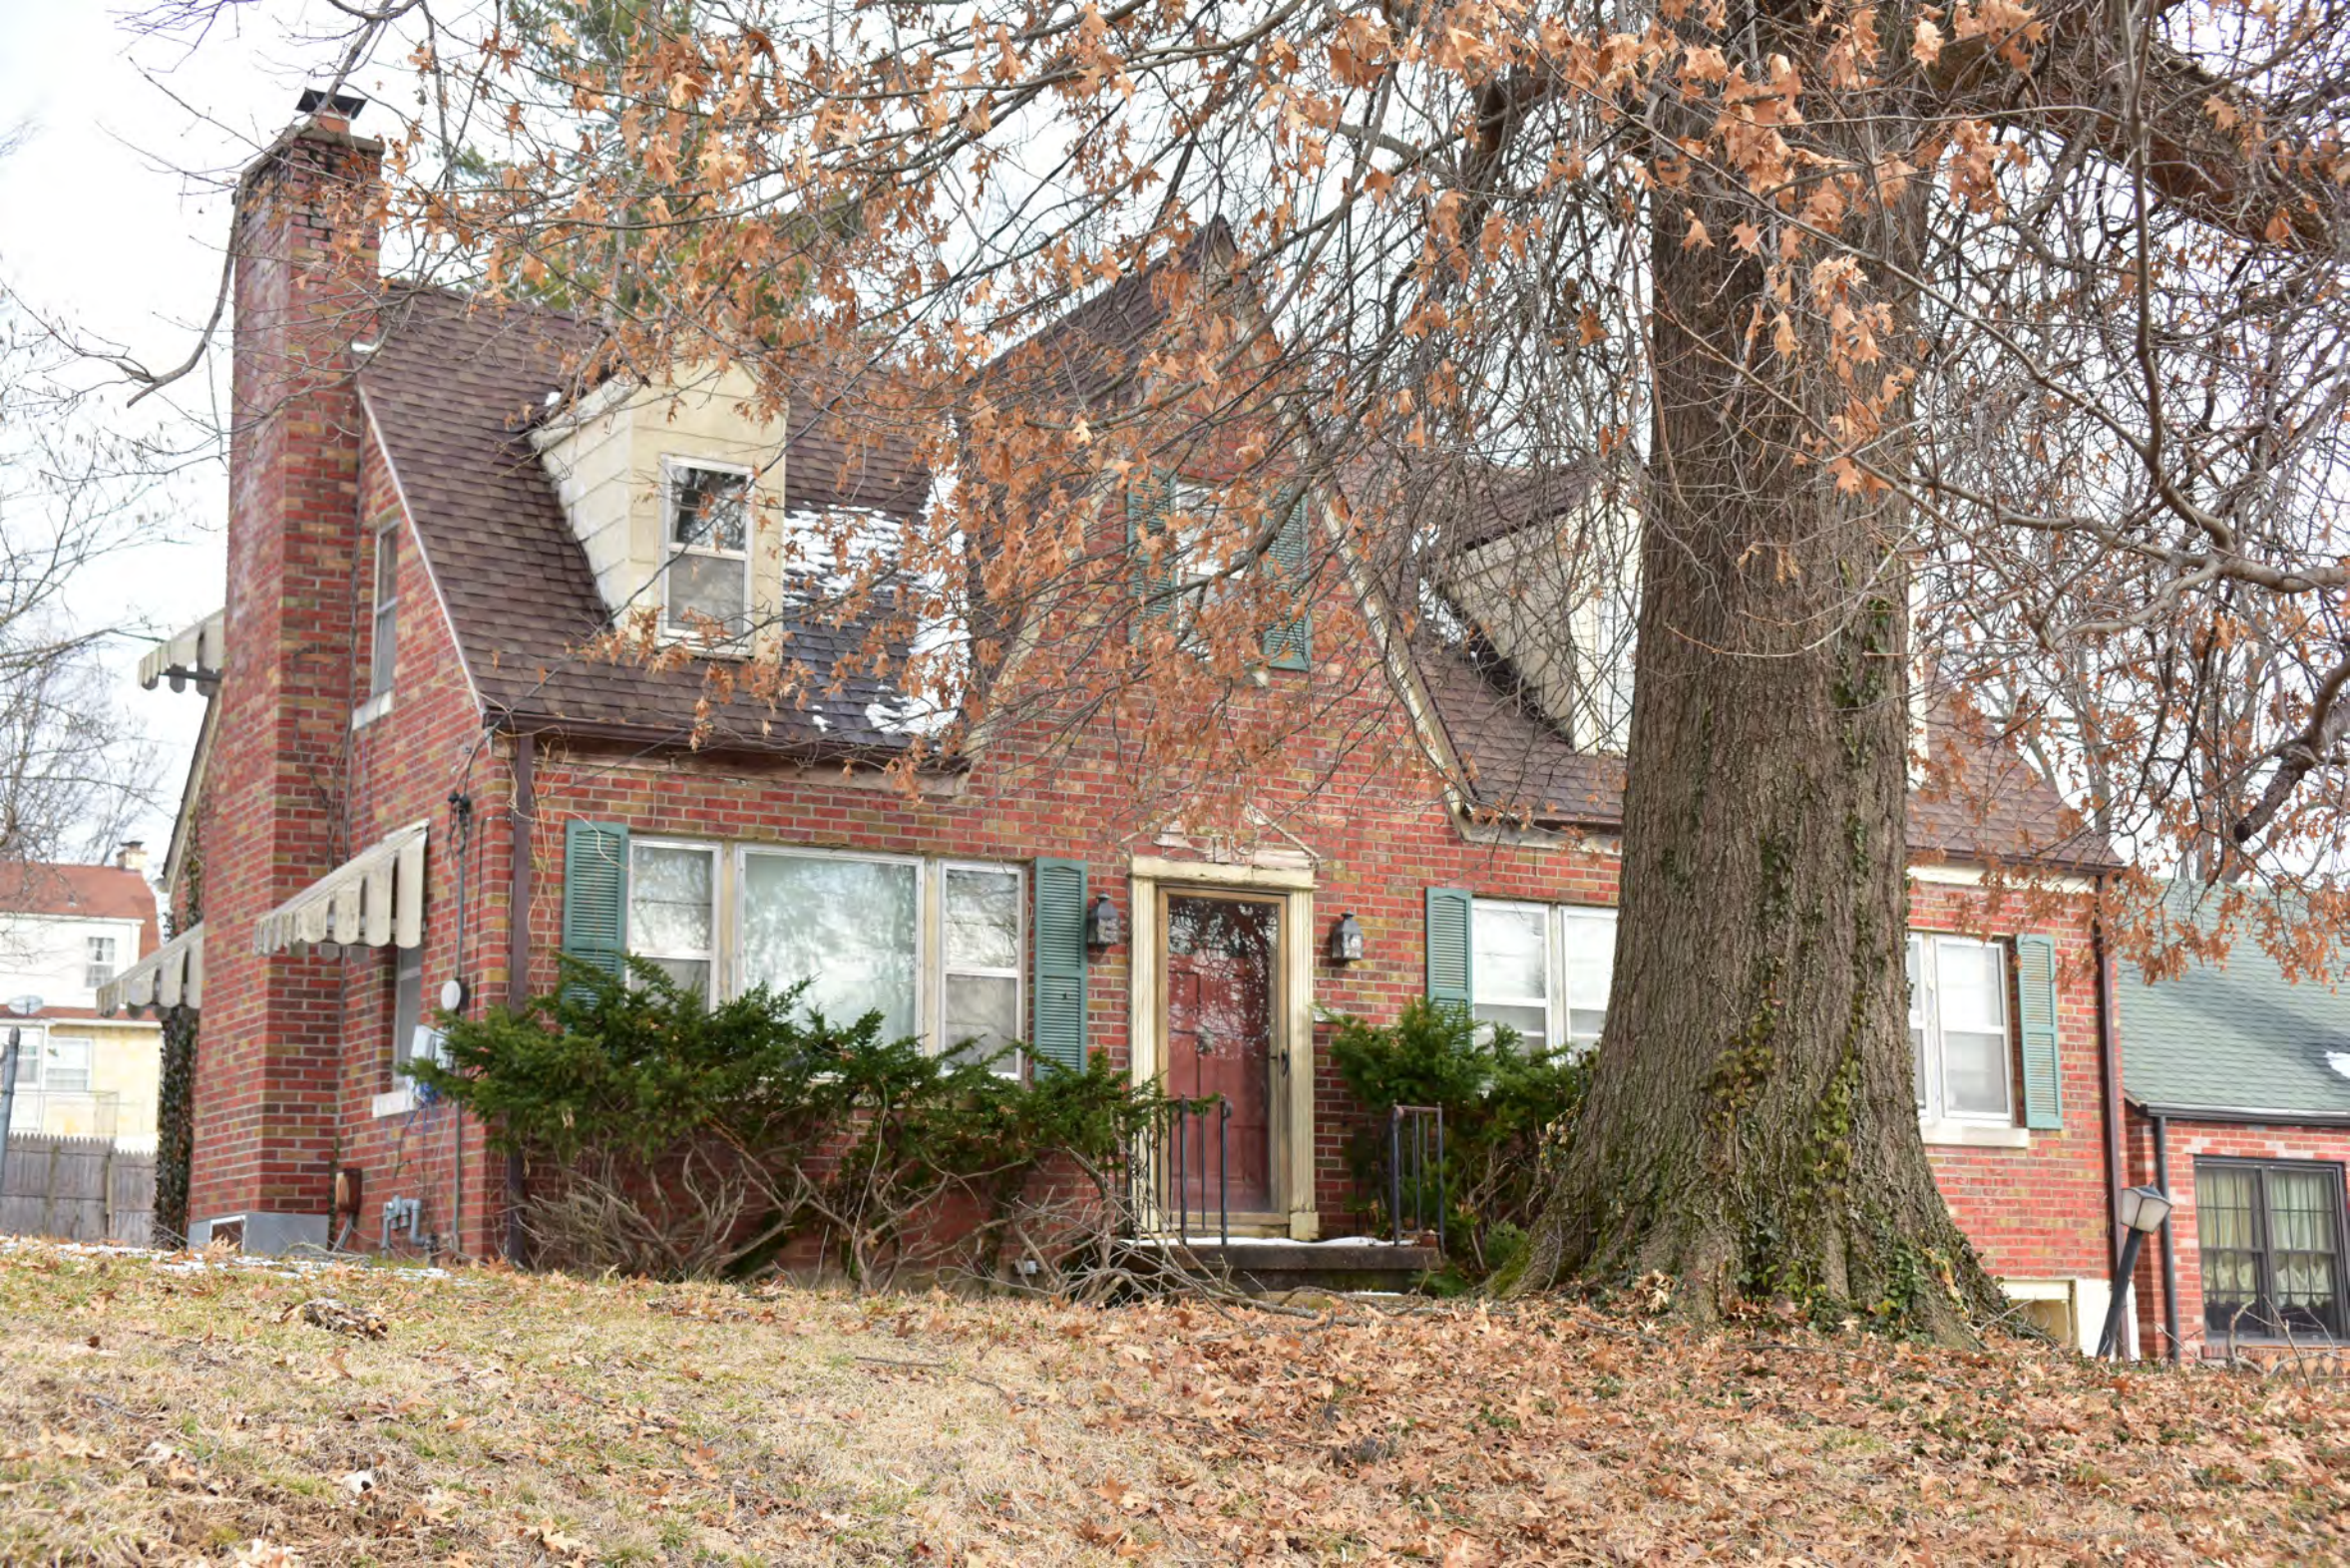
1910 North Circle Drive is a one-story Minimal Traditional Dwelling with restrained Colonial Revival influences. The brick-clad dwelling has a concrete foundation and asphalt side-gable roof. A brick exterior chimney pierces the gable apex at the west elevation. The dwelling is four bays wide. Asbestos-clad gabled dormers are positioned above Bays 1, 3, and 4 while a brick-clad gabled wall dormer extends above Bay 2. All dormers have steep pitch. A historic tripartite picture window fills Bay 1. Wood 2/2 windows with horizontal muntins flank a fixed single-pane window. The primary entrance defines Bay 2. Wood pilasters flank the opening while the remnants of a broken pediment top the doorway. A concrete stoop with historic metal railings extends from the entrance. Two-ganged historic 2/2 wood windows with horizontal muntins define the remaining two bays. An integrated one-car garage is positioned below the east bay at basement level. A historic paneled wood overhead door with fan-light glazing fills the bay. Historic 2/2 wood windows with horizontal muntins are present at the east and west elevations. Historic metal awnings shelter most secondary elevation windows.

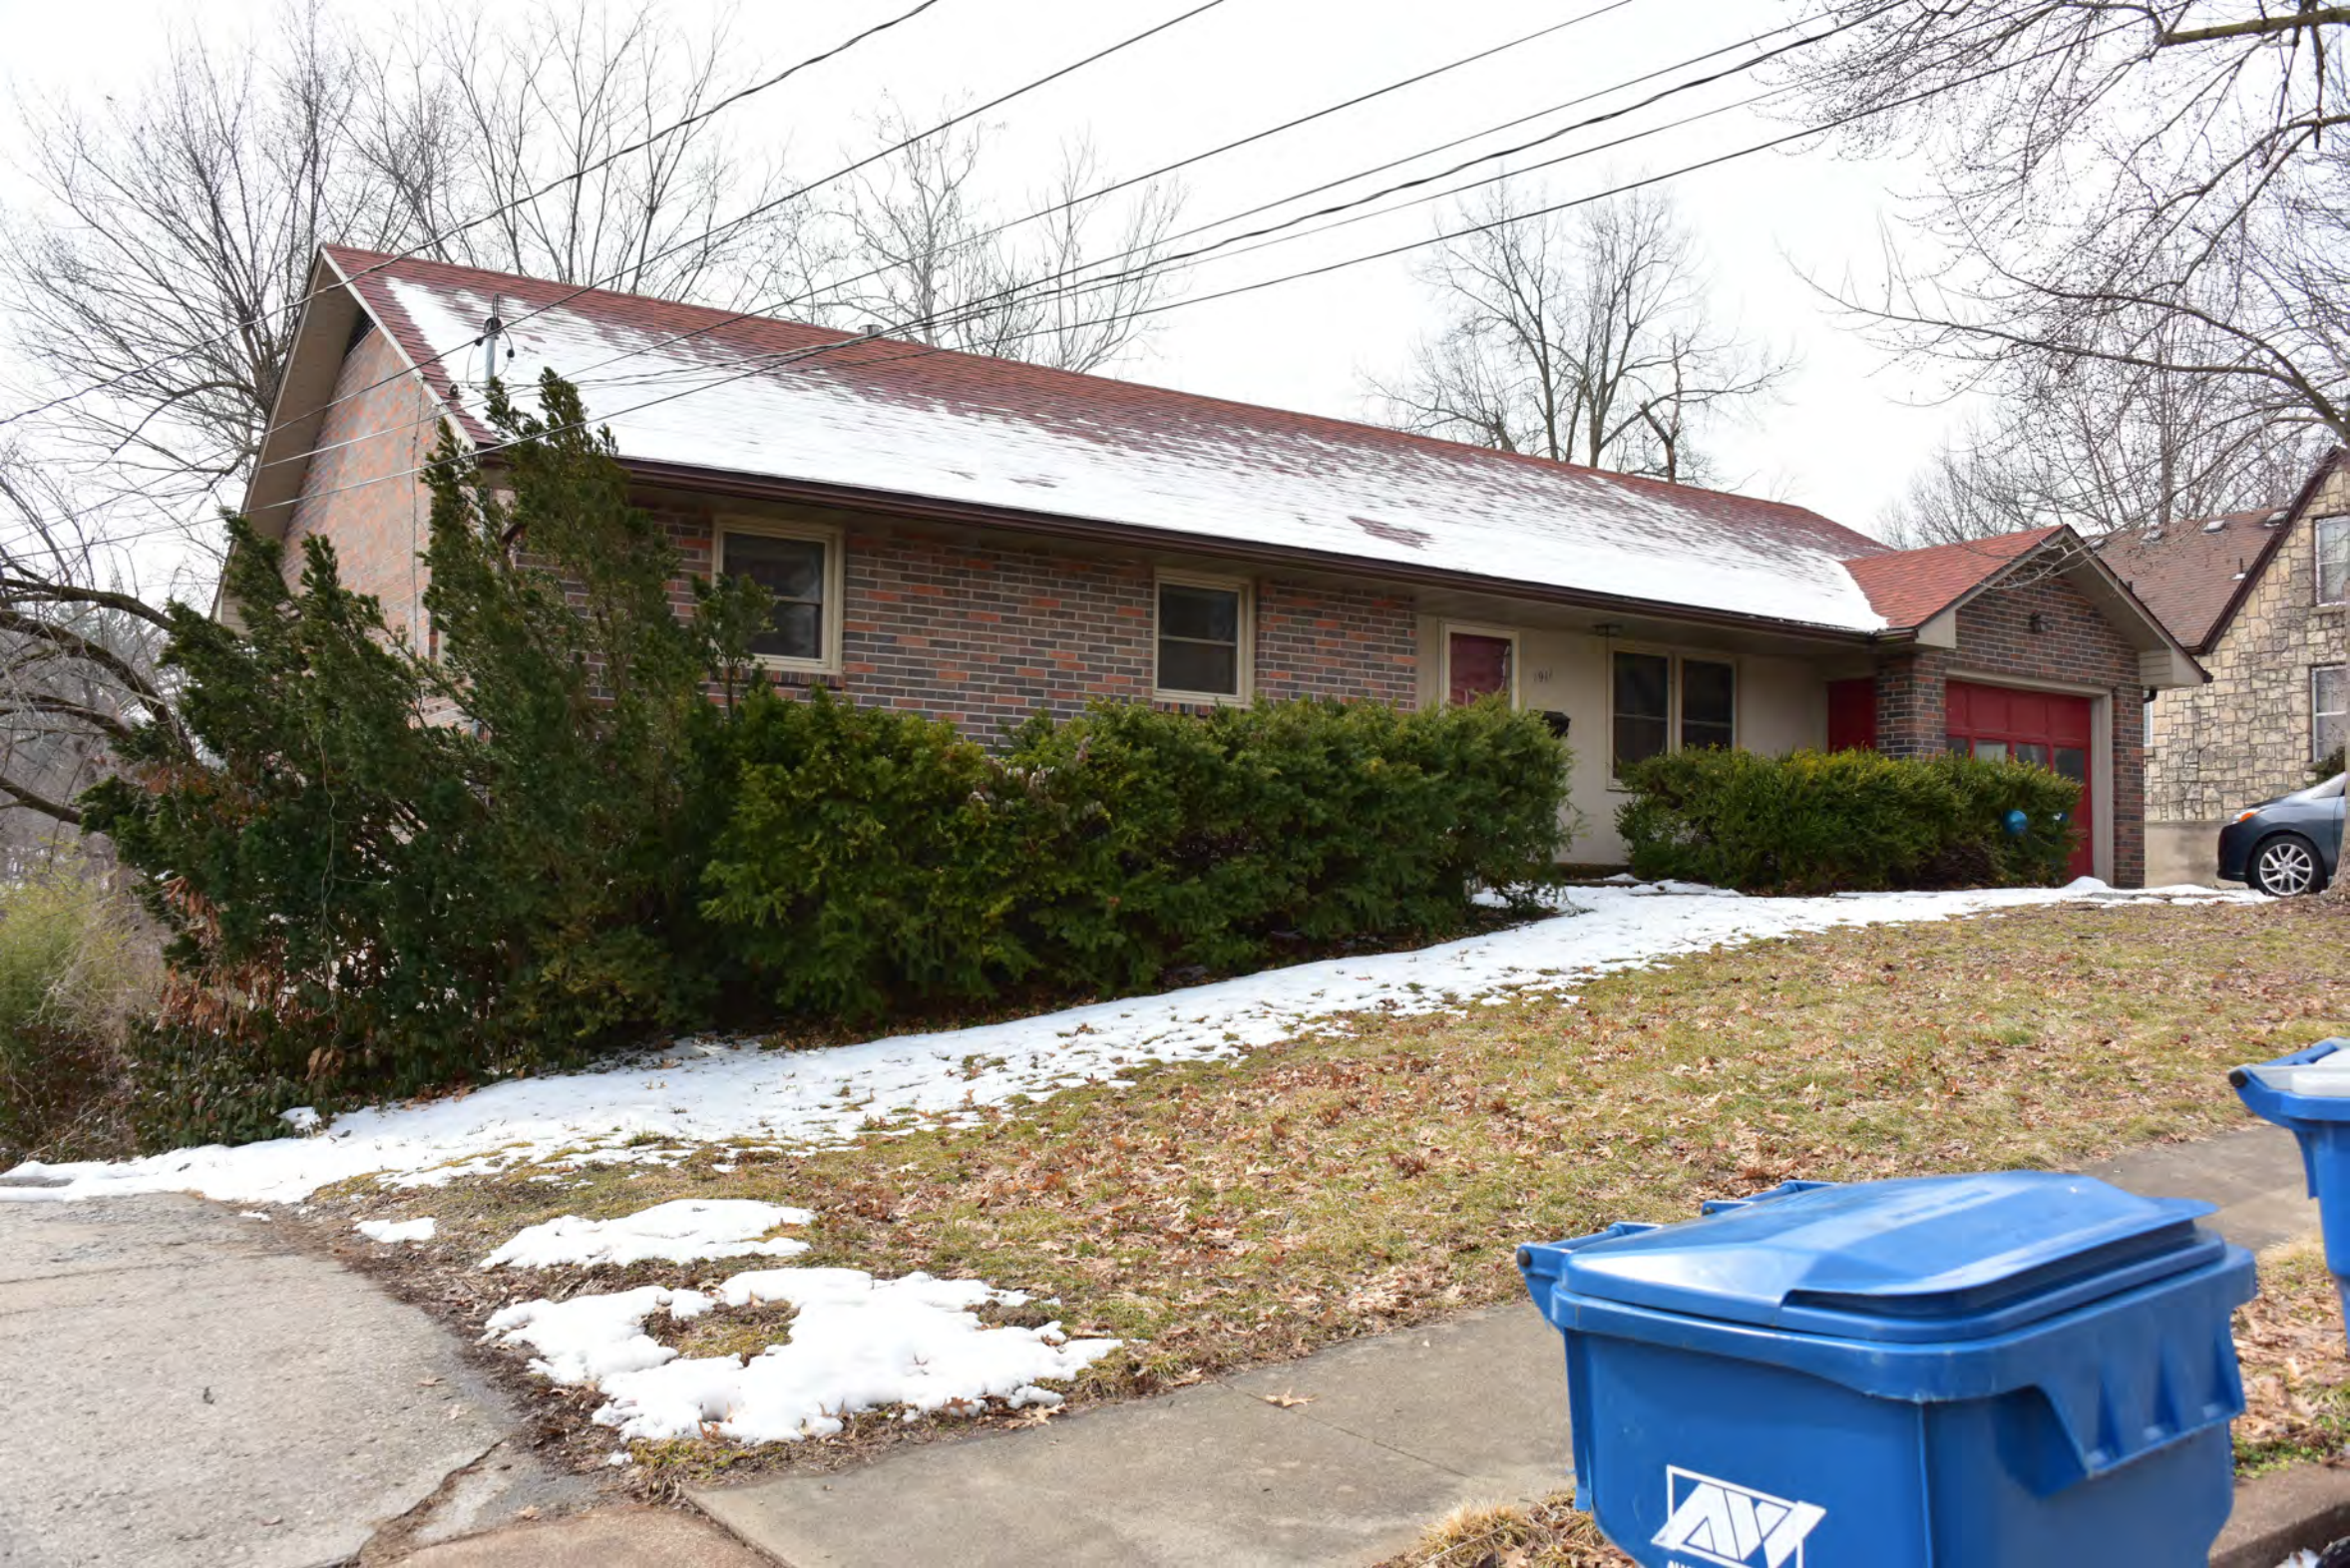
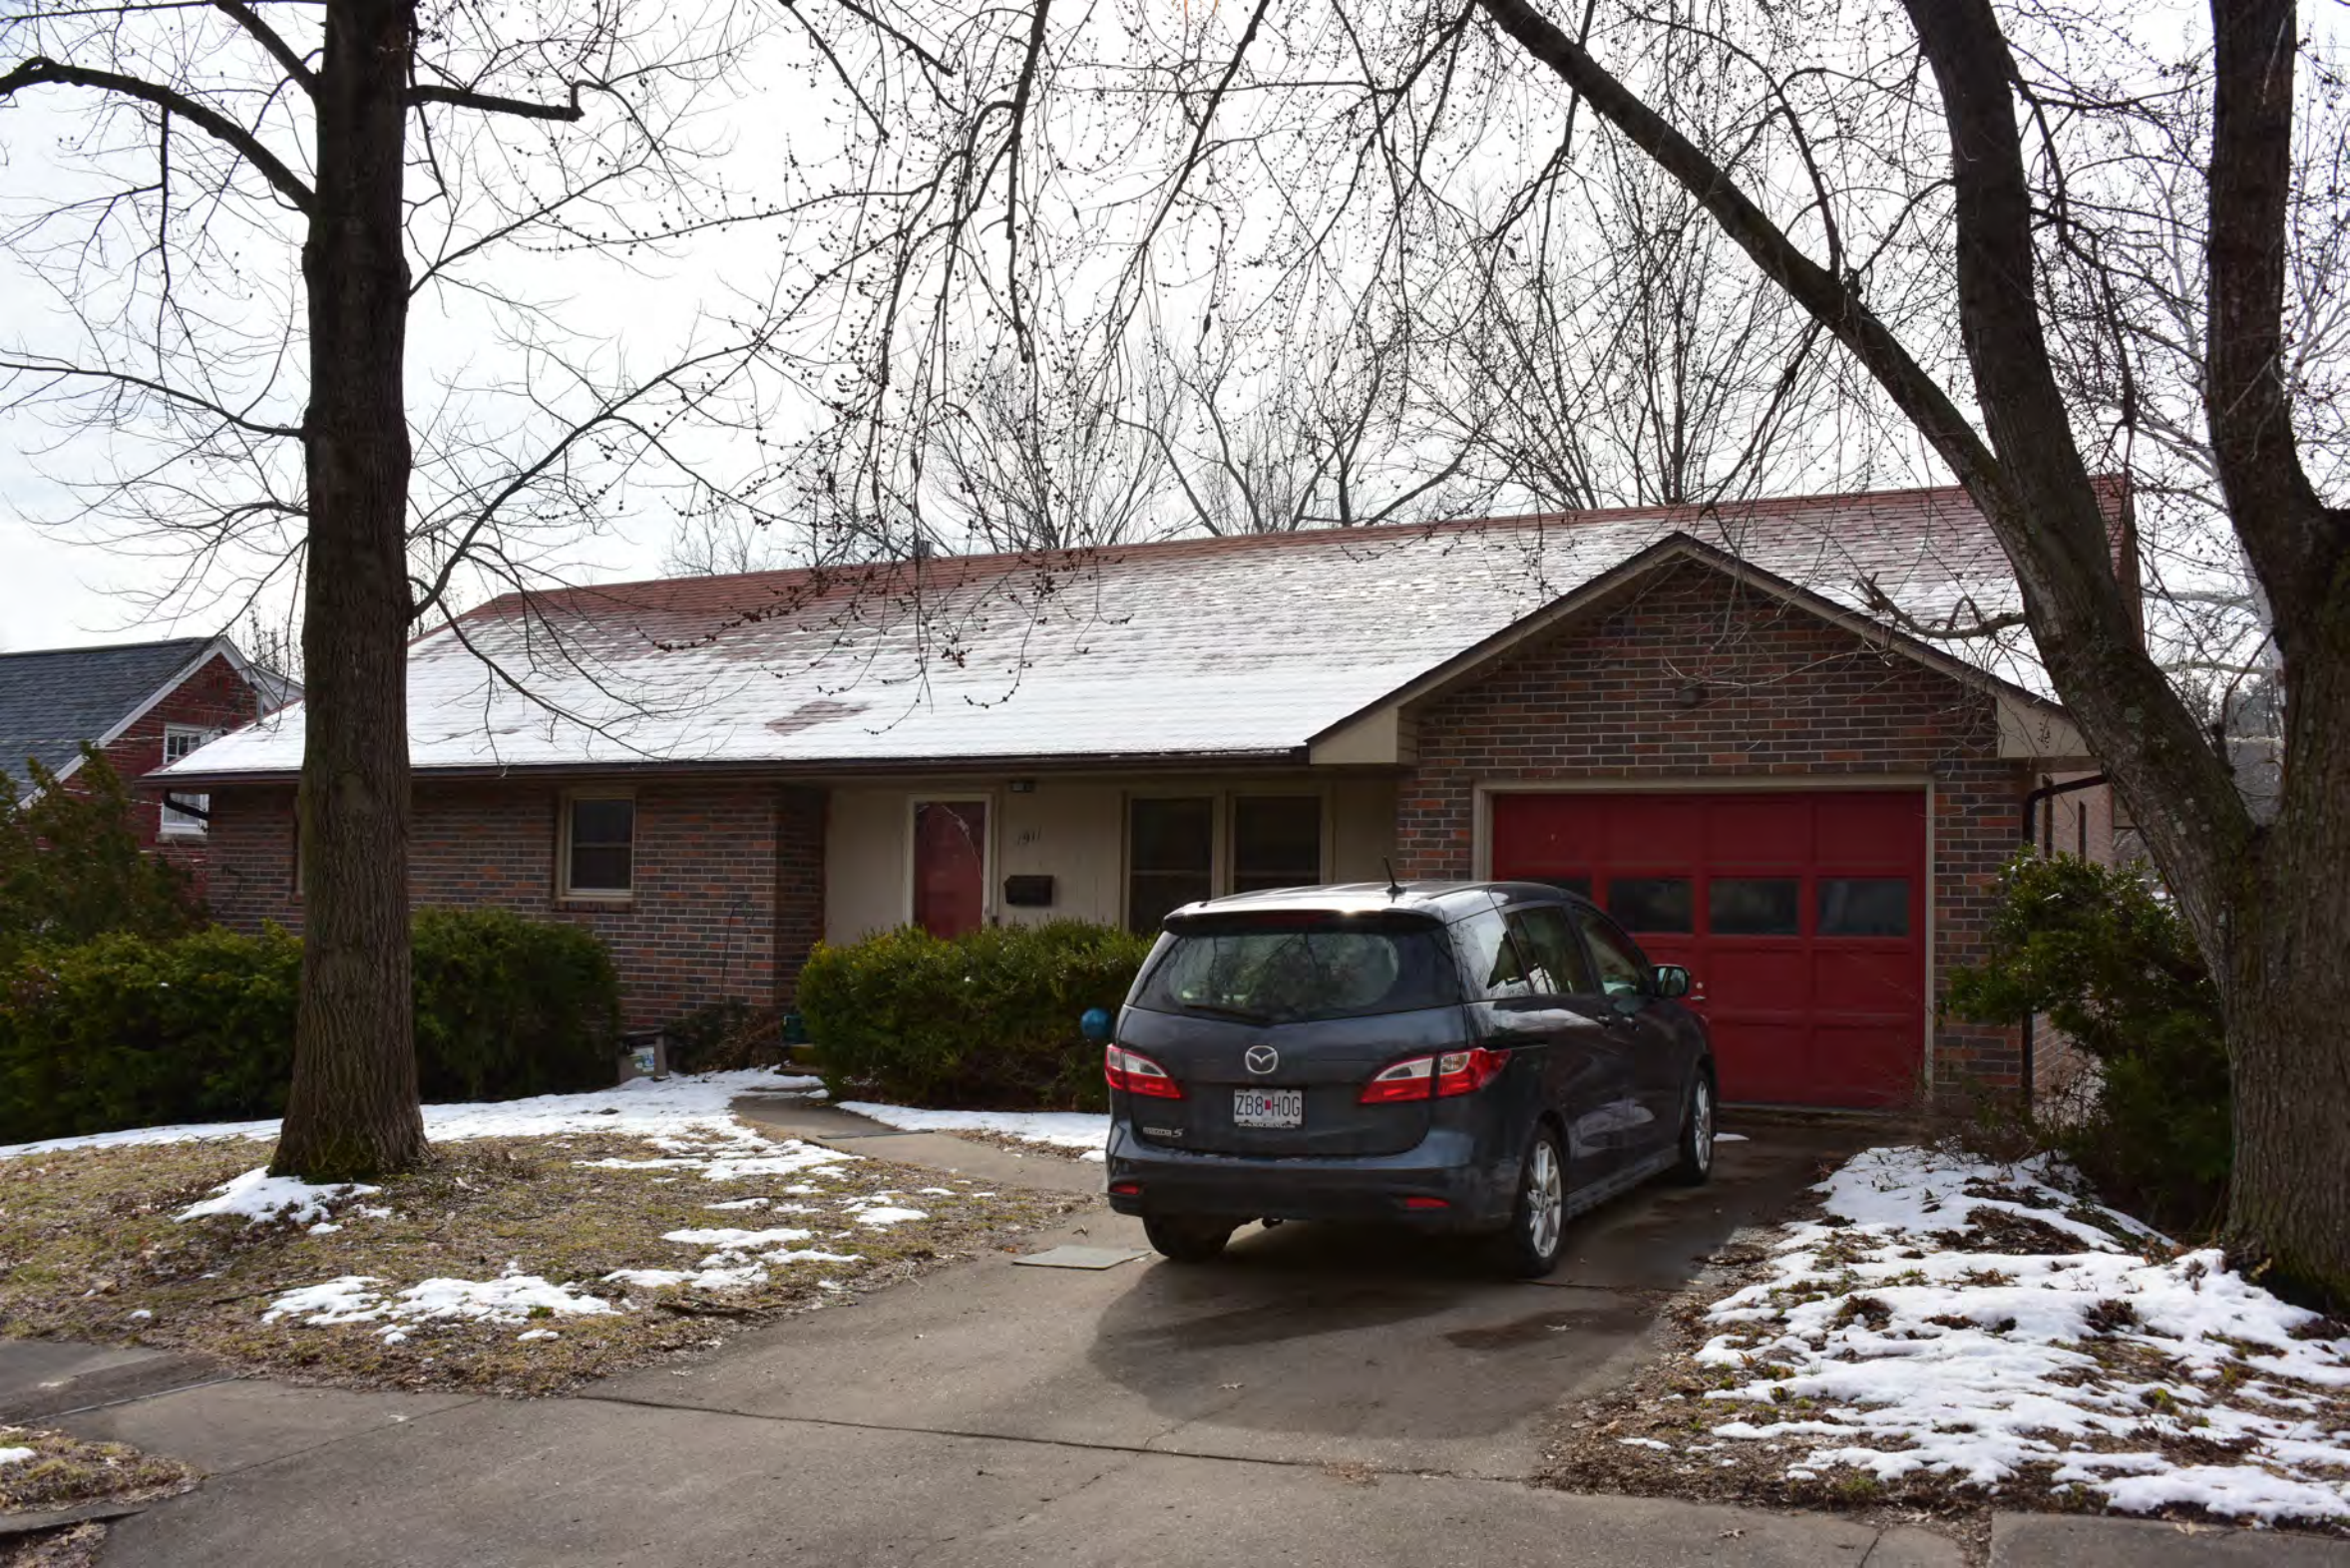
1911 North Circle Drive is a one-story ranch dwelling. The dwelling has brick cladding, a concrete foundation, and side-gable roof with shallow pitch. The dwelling is five bays wide. Small 1/1 historic windows fill the east two bays. The third and fourth bays recede, forming a partial-width open porch. The primary entrance fills the third bay while two-ganged 1/1 historic windows fill the fourth bay. Vertical wood cladding surrounds both bays. The fifth bay projects slightly and contains a one-car attached garage. A front-gable tops the bay. A historic overhead paneled door with glazing fills the vehicular bay. A pedestrian entrance is located in the east wall of the garage.

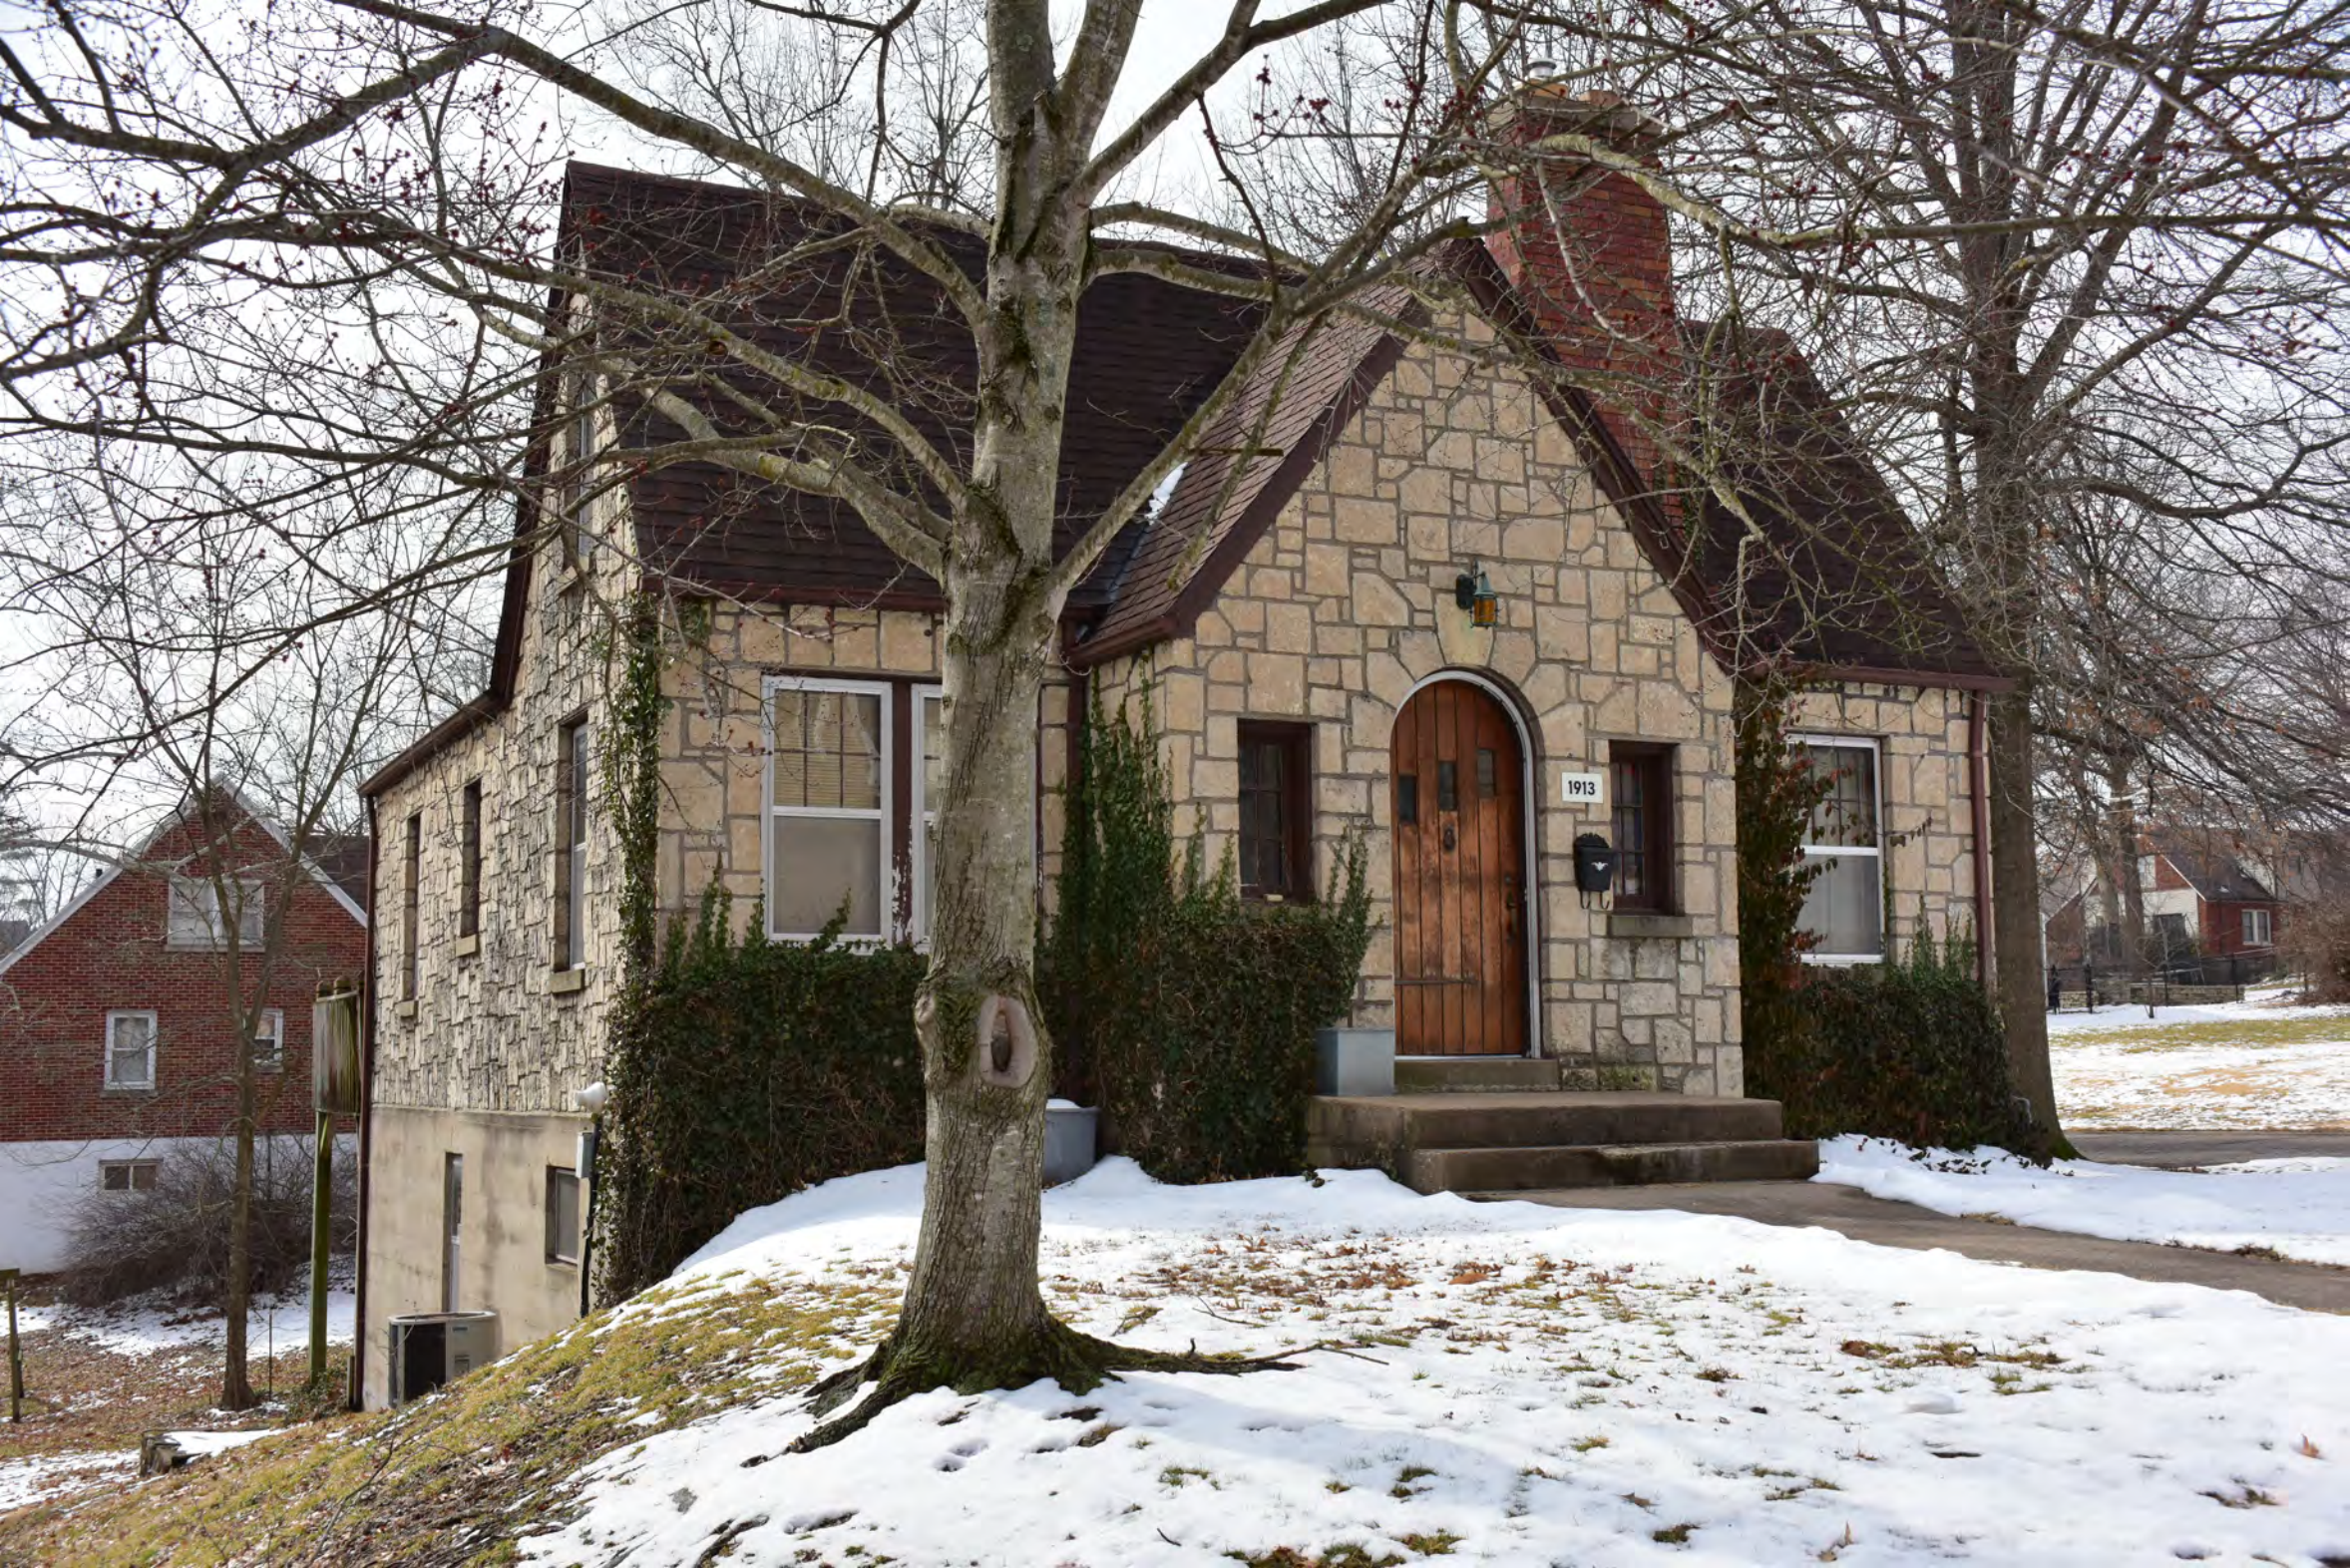
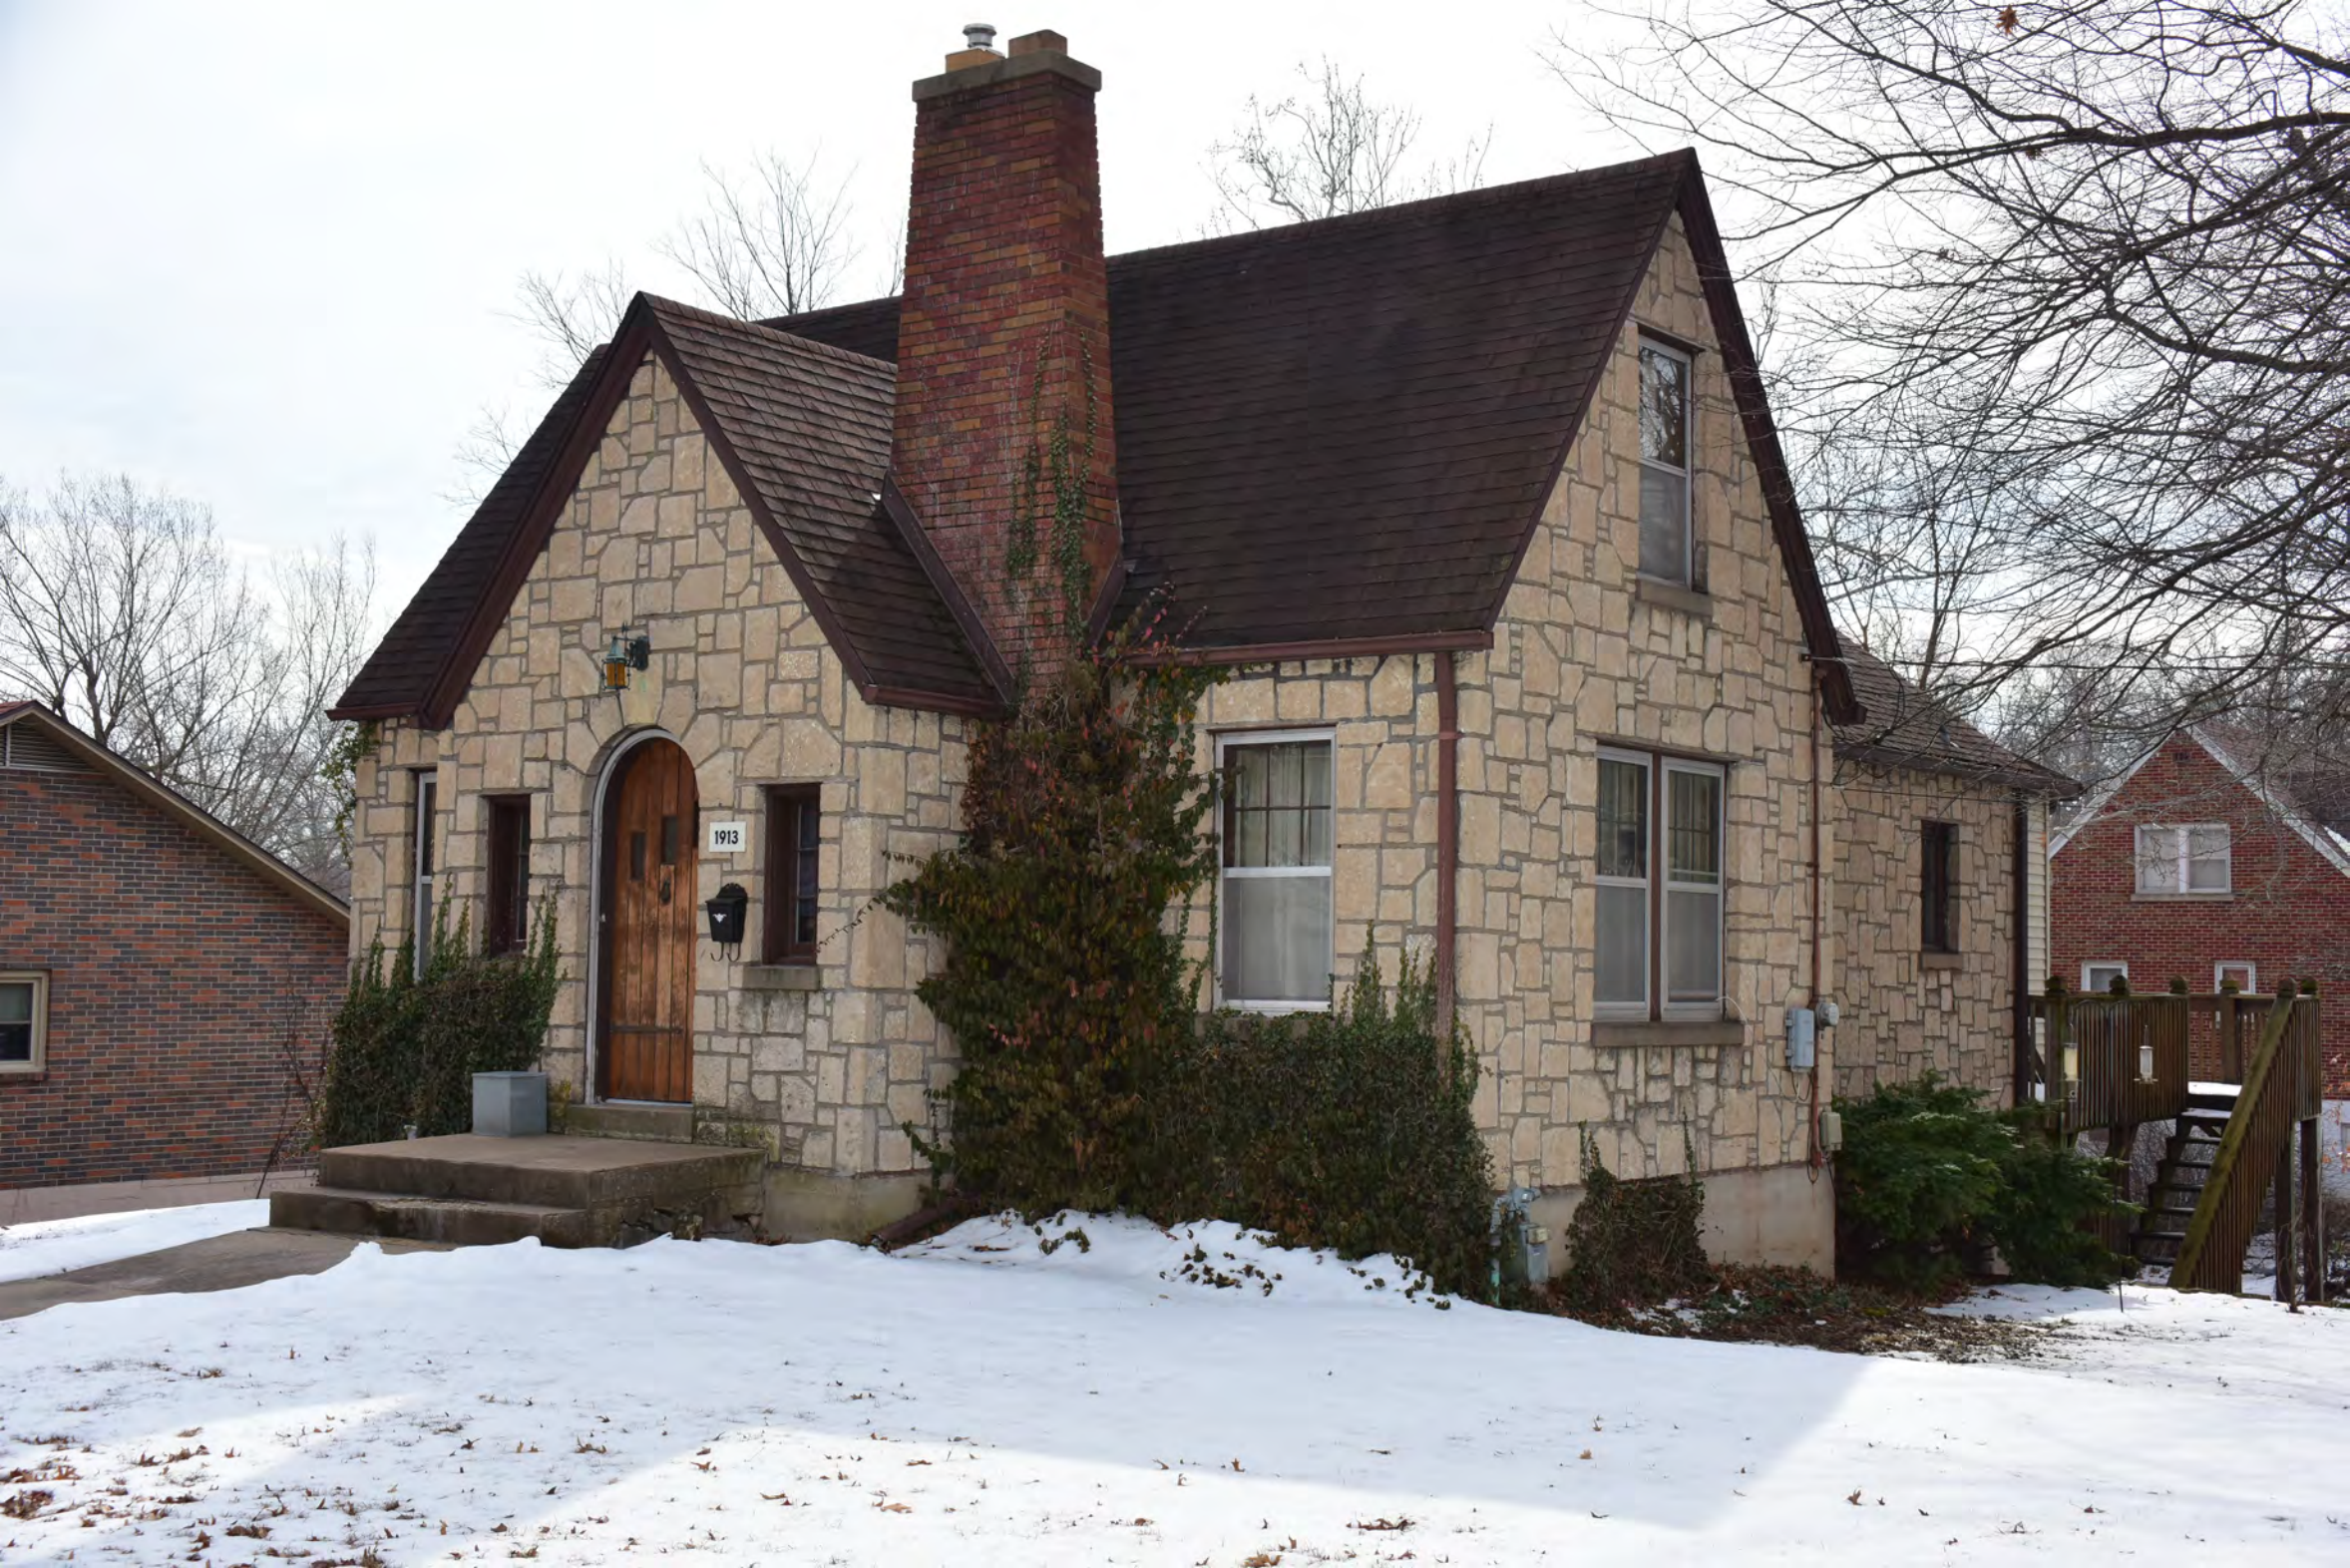
1913 North Circle Drive is a one-story Minimal Traditional dwelling with stone cladding, a concrete foundation, and an asphalt intersecting-gable roof. A gable-front enclosed vestibule projects from the center of the primary elevation. A tapered brick chimney pierces the vestibule and roof. The dwelling is three bays wide. Two-ganged historic 6/1 wood windows with a continuous cast stone sill fills the east bay while a single historic 6/1 wood window with cast stone sill fills the west bay. The vestibule defines the center bay and contains the primary entrance. A historic arched wood door with three-light glazing fills the entrance. Historic narrow six-light wood windows flank the entrance. A concrete stoop extends from the entrance. Historic windows remain at the east and west elevations. A secondary entrance is located on the east elevation at basement level. An integrated one-car garage is located at the west elevation at basement level. A vinyl-clad addition with a flat roof and wood deck extends from the rear.
