1. Survey number: CO-AS-008-001		2. Survey Name: West Main Street Survey	
3. County: Cole		4. Address (Street No.): 100	Street (name): East Circle Drive
5. City: Jefferson City	Vicinity <input type="checkbox"/>	6. Lat / Long:	7. Township/Range/Section: T: R: S:
8. Historic name (if known):		9. Present/other name (if known):	
10. Ownership: <input checked="" type="checkbox"/> Private <input type="checkbox"/> Public		11a. Historic use (if known): Domestic-Single Dwelling	11b. Current use: Domestic-Single Dwelling

MISSOURI DEPARTMENT OF NATURAL RESOURCES
STATE HISTORIC PRESERVATION OFFICE, P.O. Box 178, Jefferson City, MO 65102
ARCHITECTURAL/HISTORIC INVENTORY FORM

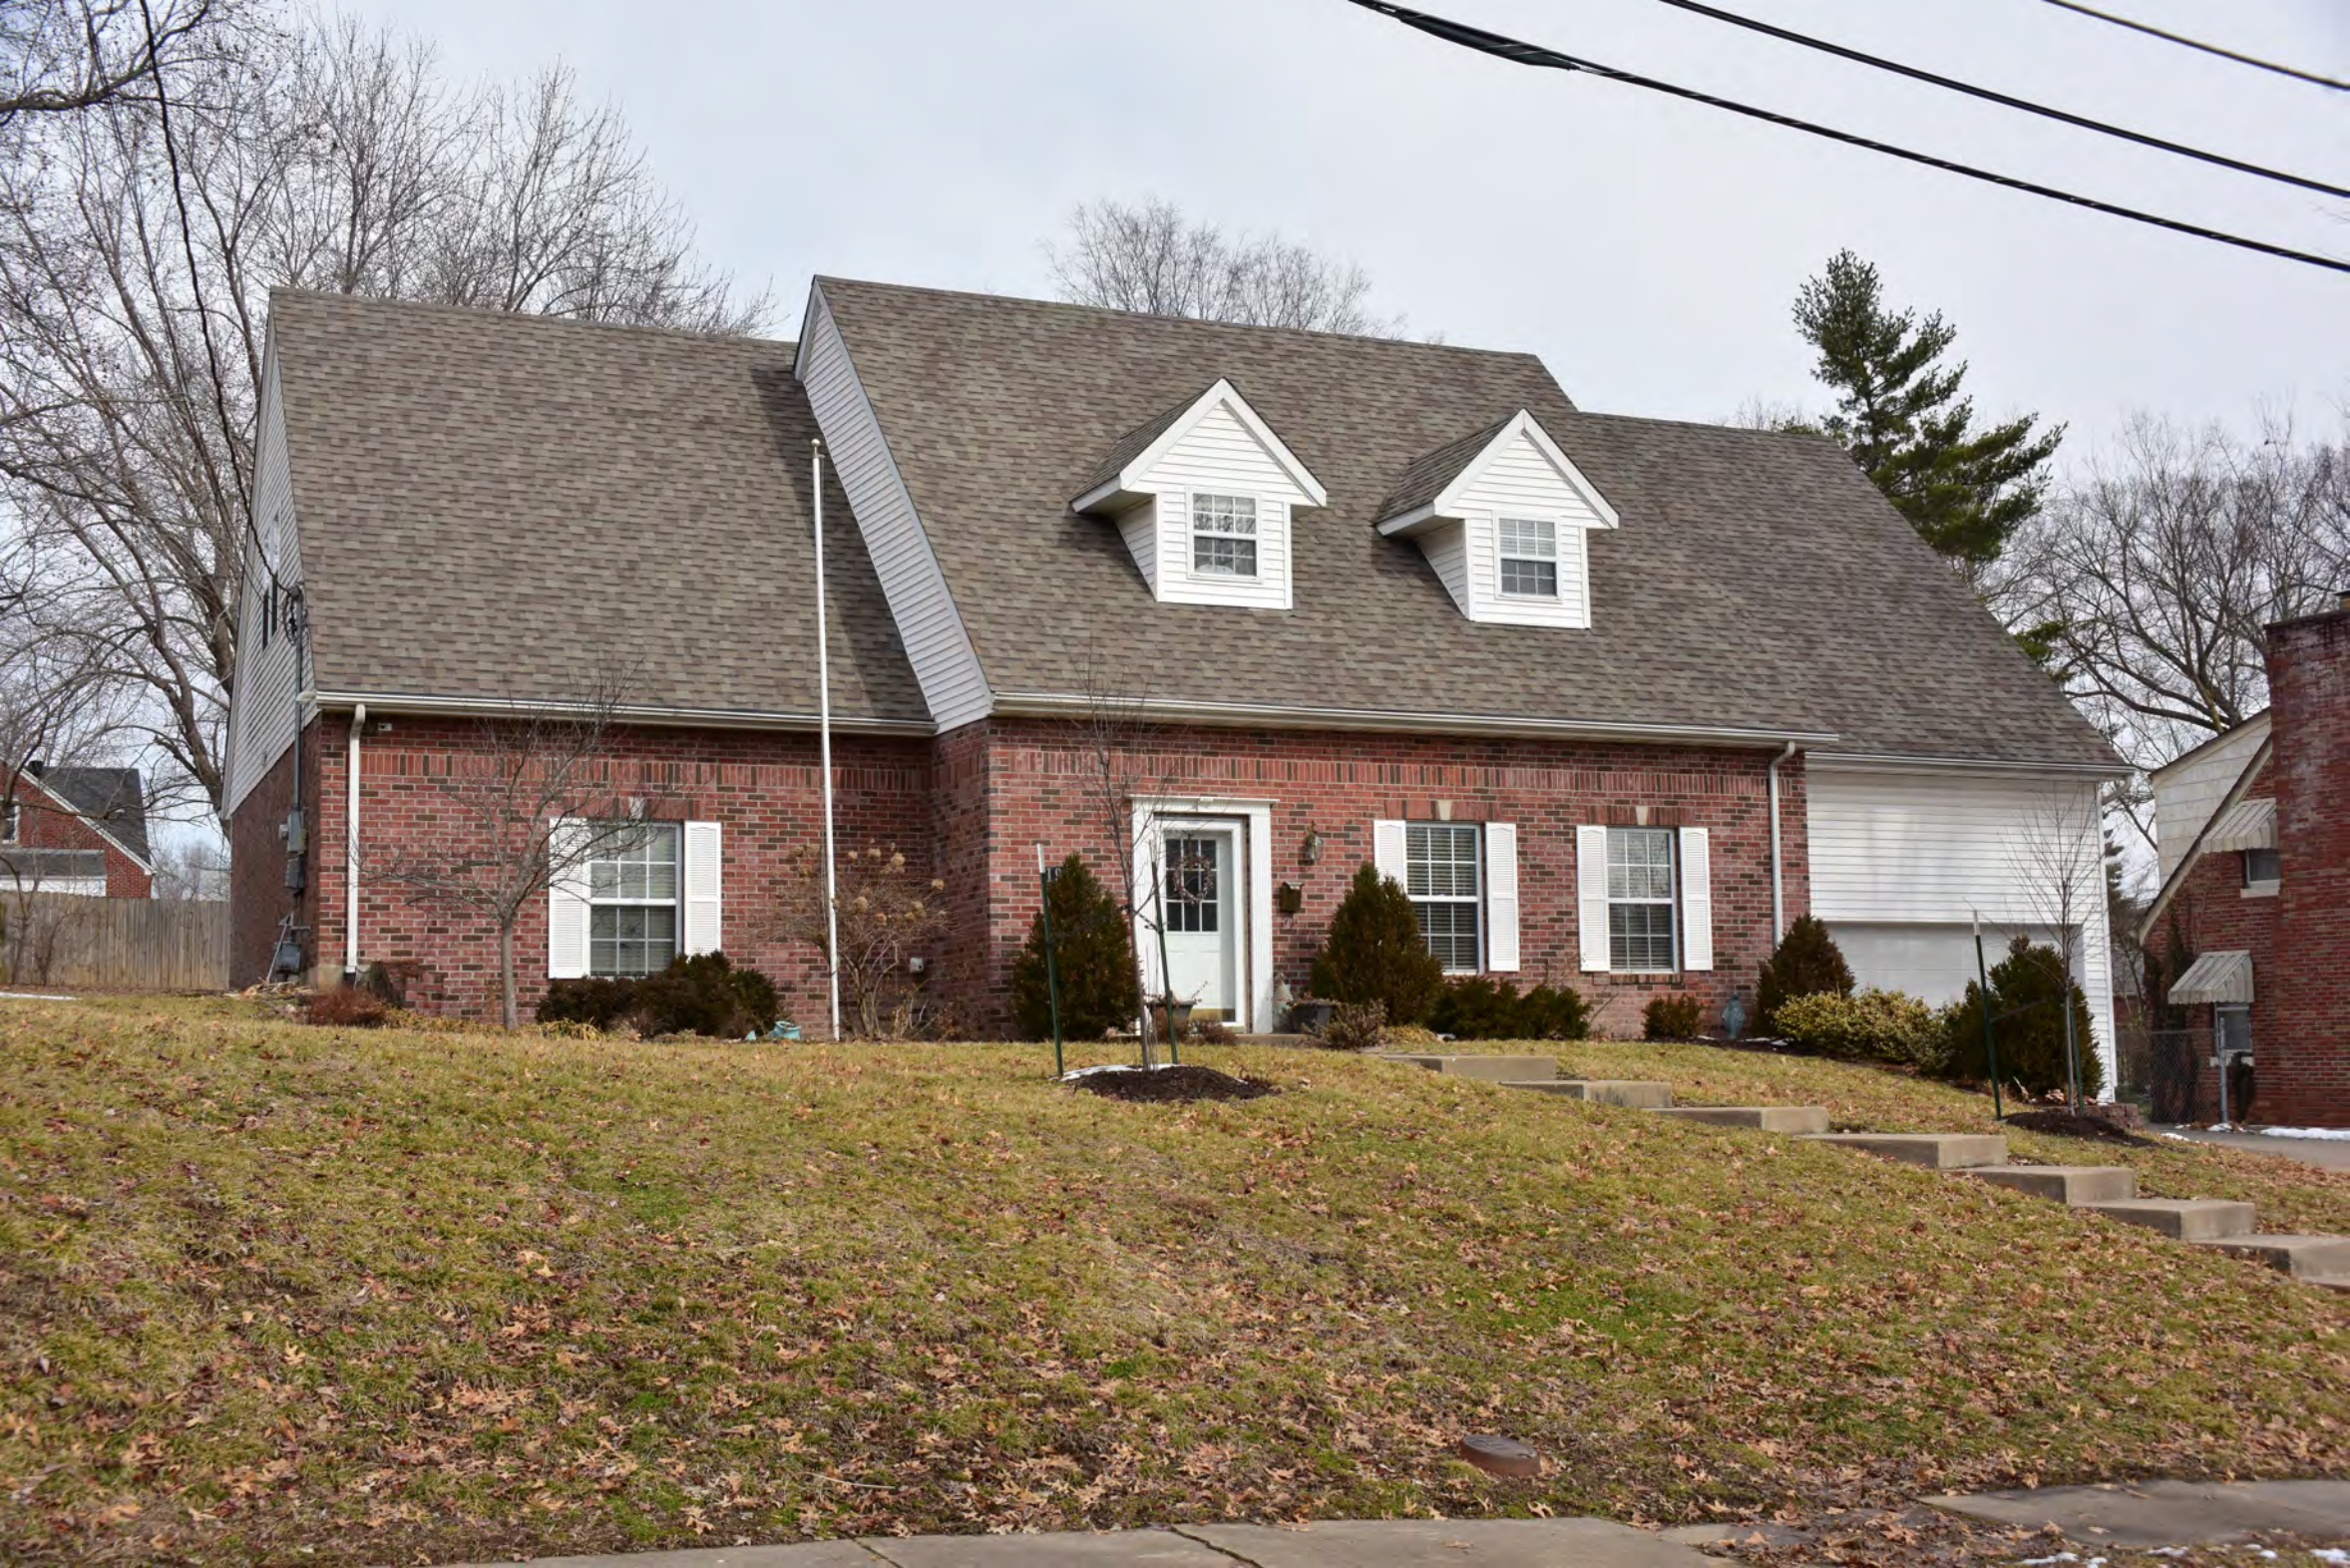
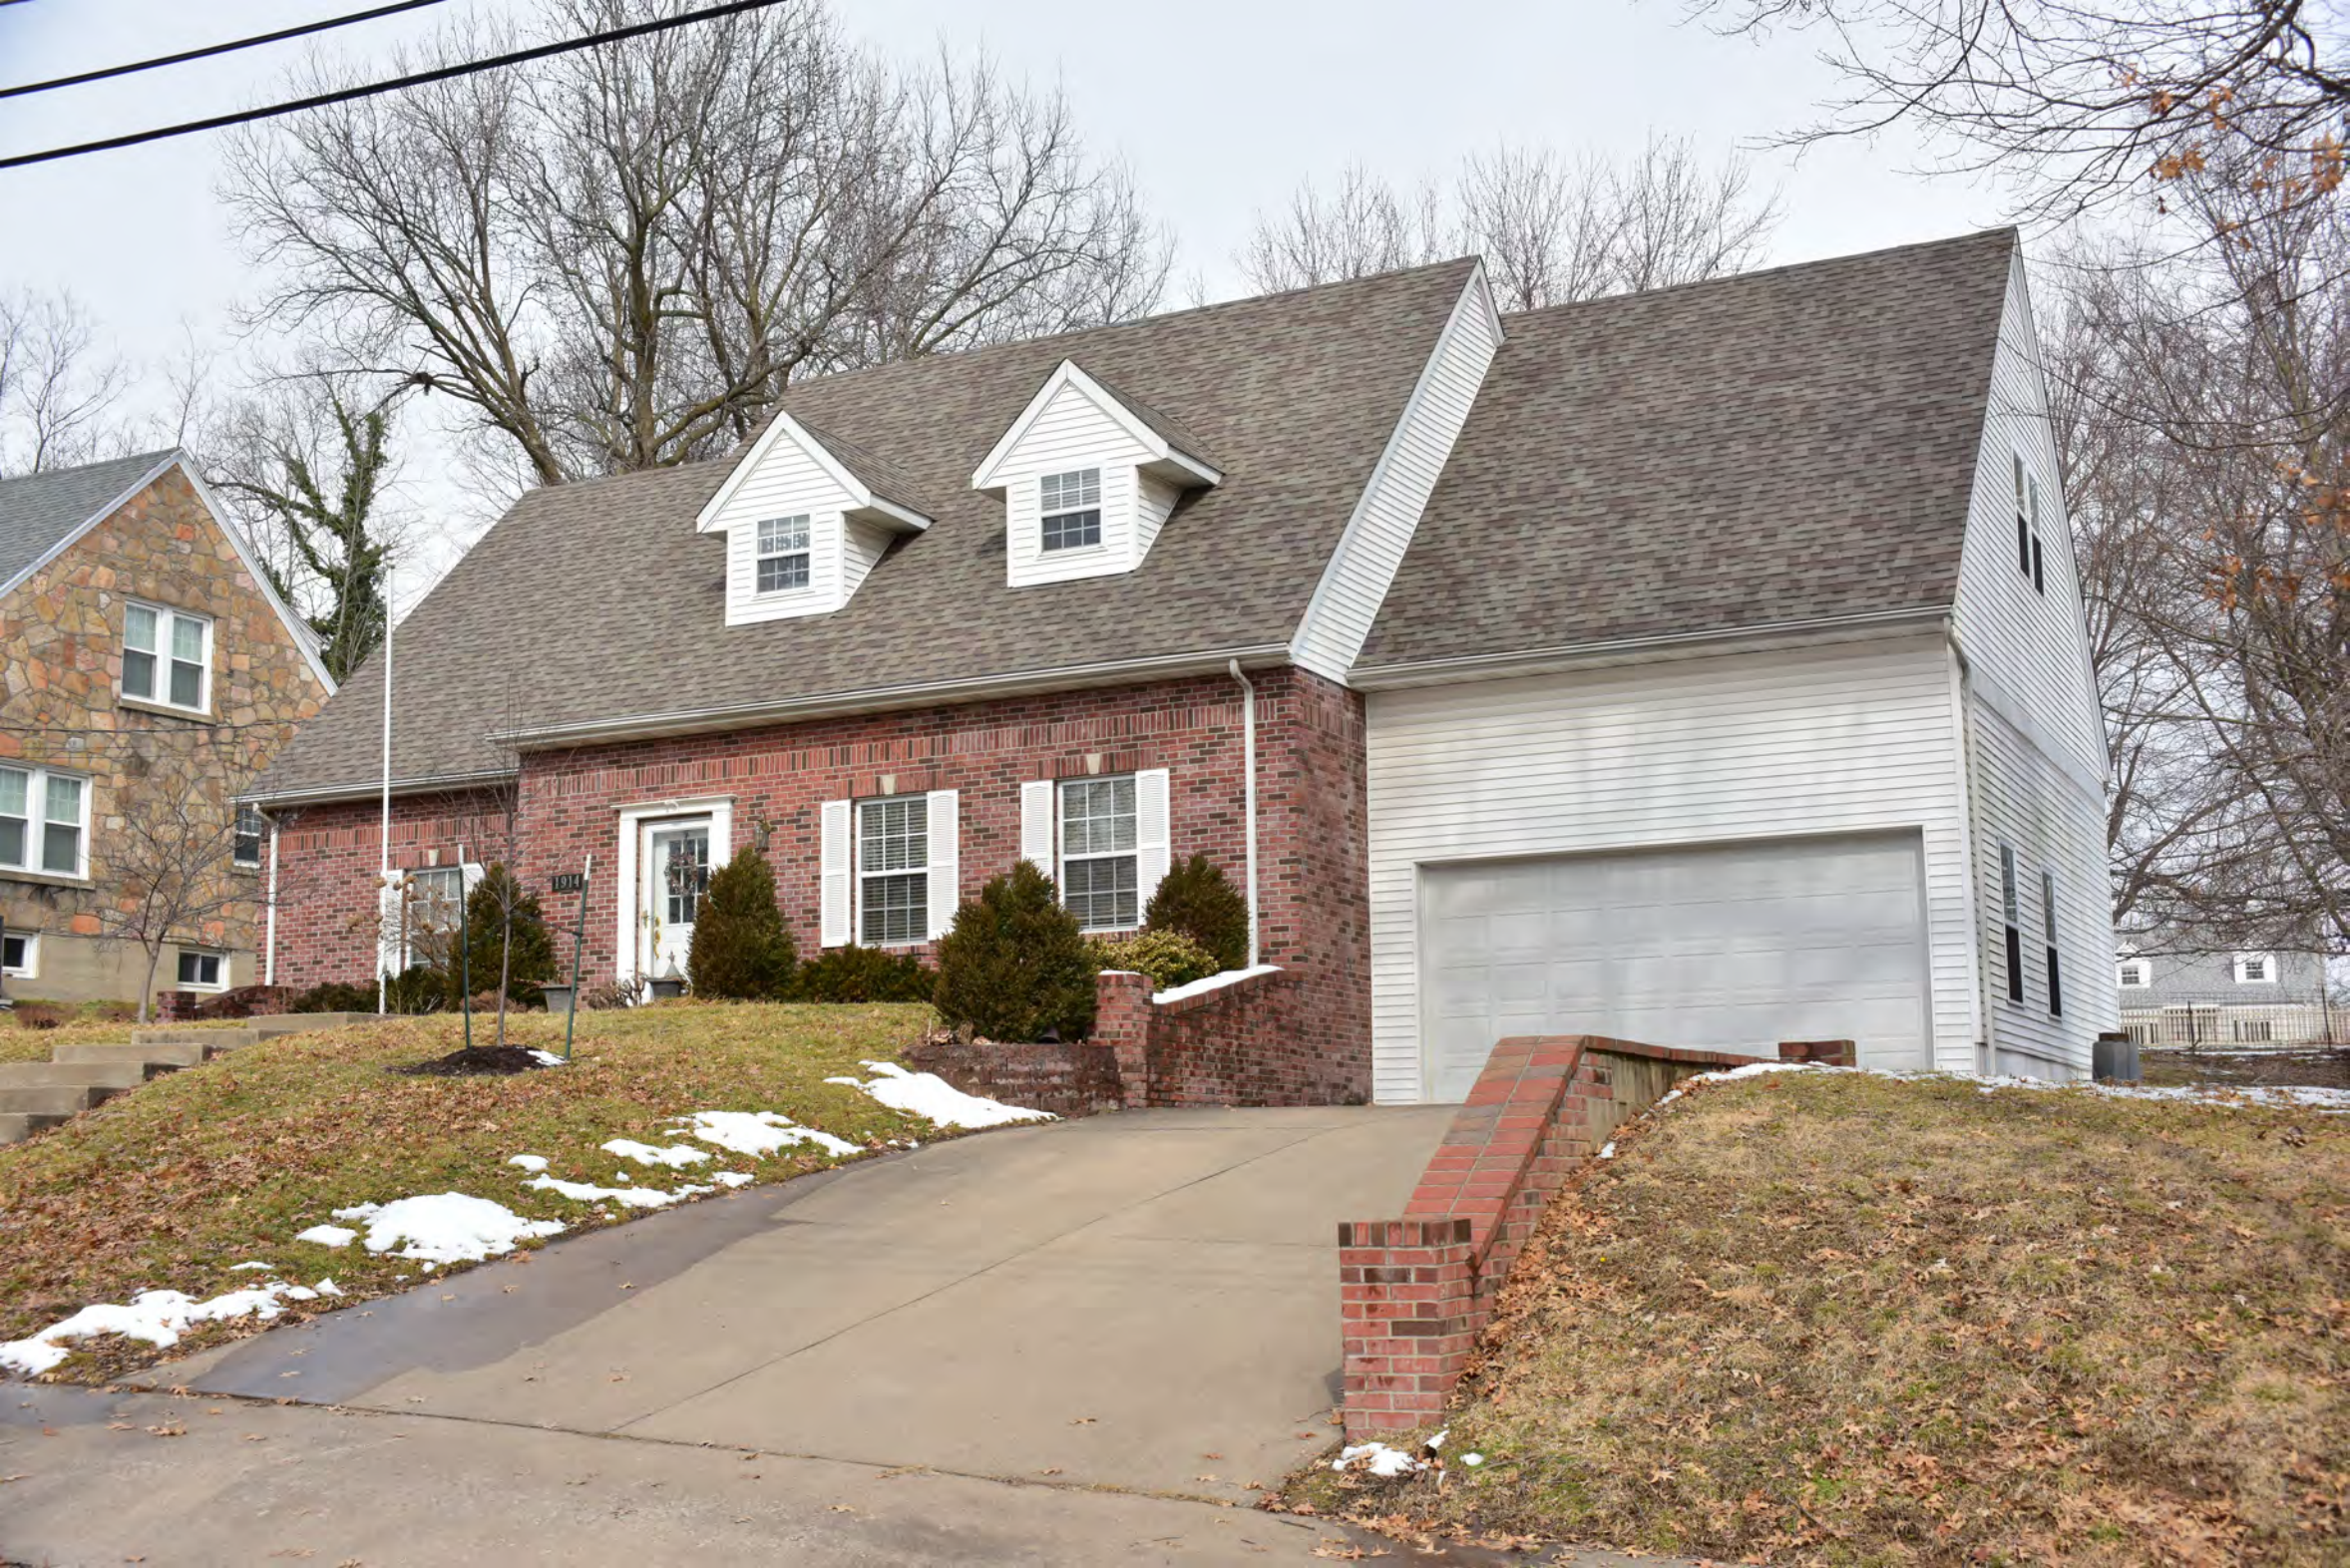
1914 North Circle Drive is a non-historic dwelling with restrained Colonial Revival influences. The brick-clad dwelling has an asphalt side-gable roof and concrete foundation. Vinyl clads the gable ends. The center of the roof projects and contains two vinyl-clad gabled dormers. The dwelling is five bays wide. Bays 2-4 project from the primary elevation. Bays 1, 3, and 4 contain 6/6 vinyl windows. Brick lintels with concrete keystones top the windows. Bay 5 contains a two-car garage. Vinyl clads the bay. The primary entrance defines Bay 2. A simplified entablature and pilasters surround the door. A concrete stoop projects from the entrance.

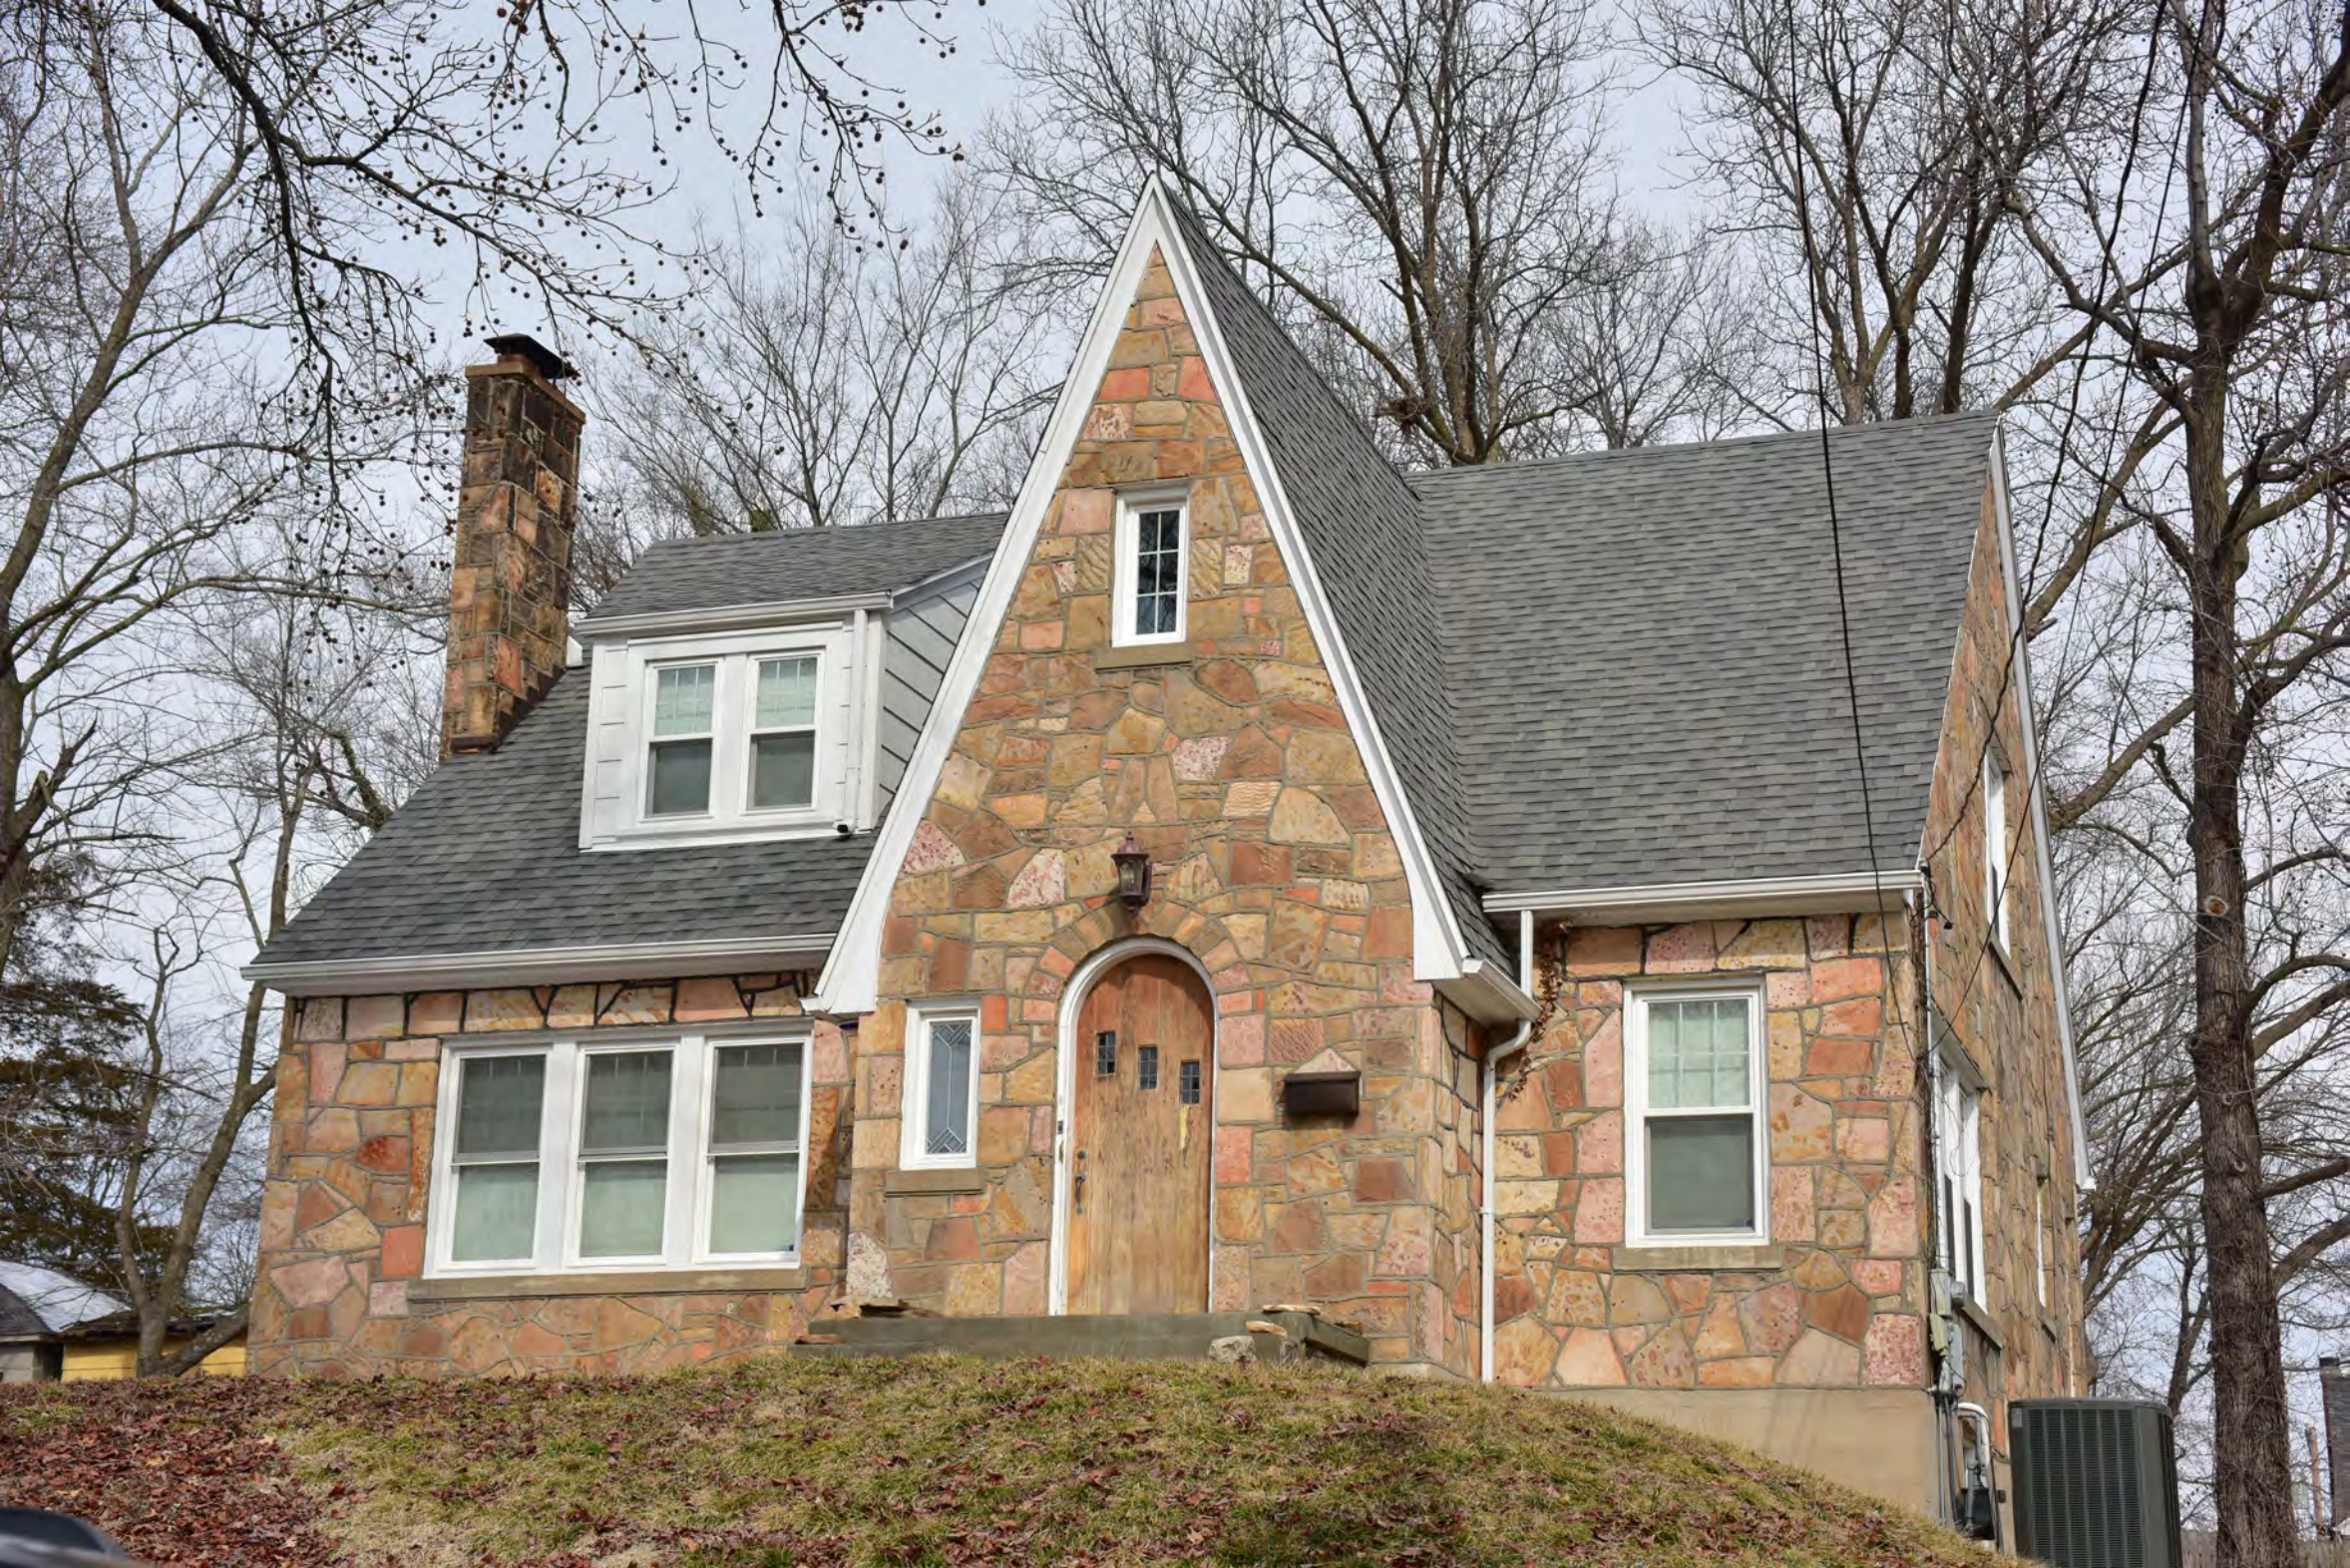
1920 North Circle Drive is a one-and-one-half story dwelling with split-stone cladding, a concrete foundation, and intersecting-gable asphalt roof. A stone exterior chimney pierces the west elevation eave. The dwelling is three bays wide. Three-ganged non-historic 6/1 vinyl windows with a continuous cast stone sill fill the west bay while a single non-historic 6/1 vinyl window fills the east bay. A shallow gabled-ell with steep pitch projects from the primary elevation slightly offset to the east. The ell contains a stone-clad vestibule and defines the center bay. The primary entrance is centered in the vestibule and contains a historic rounded arch wood door with glazing. A concrete stoop extends from the entrance. A narrow, truncated historic wood window with geometric glazing is positioned west of the entrance. A narrow historic six-light wood window is centered in the gable apex. A hardboard-clad shed-roof dormer punctures the roof immediately west of the intersecting gable. The dormer contains two non-historic 6/1 vinyl windows. A one-car integrated garage is located at the west elevation at basement level. A non-historic paneled overhead door fills the vehicular bay.

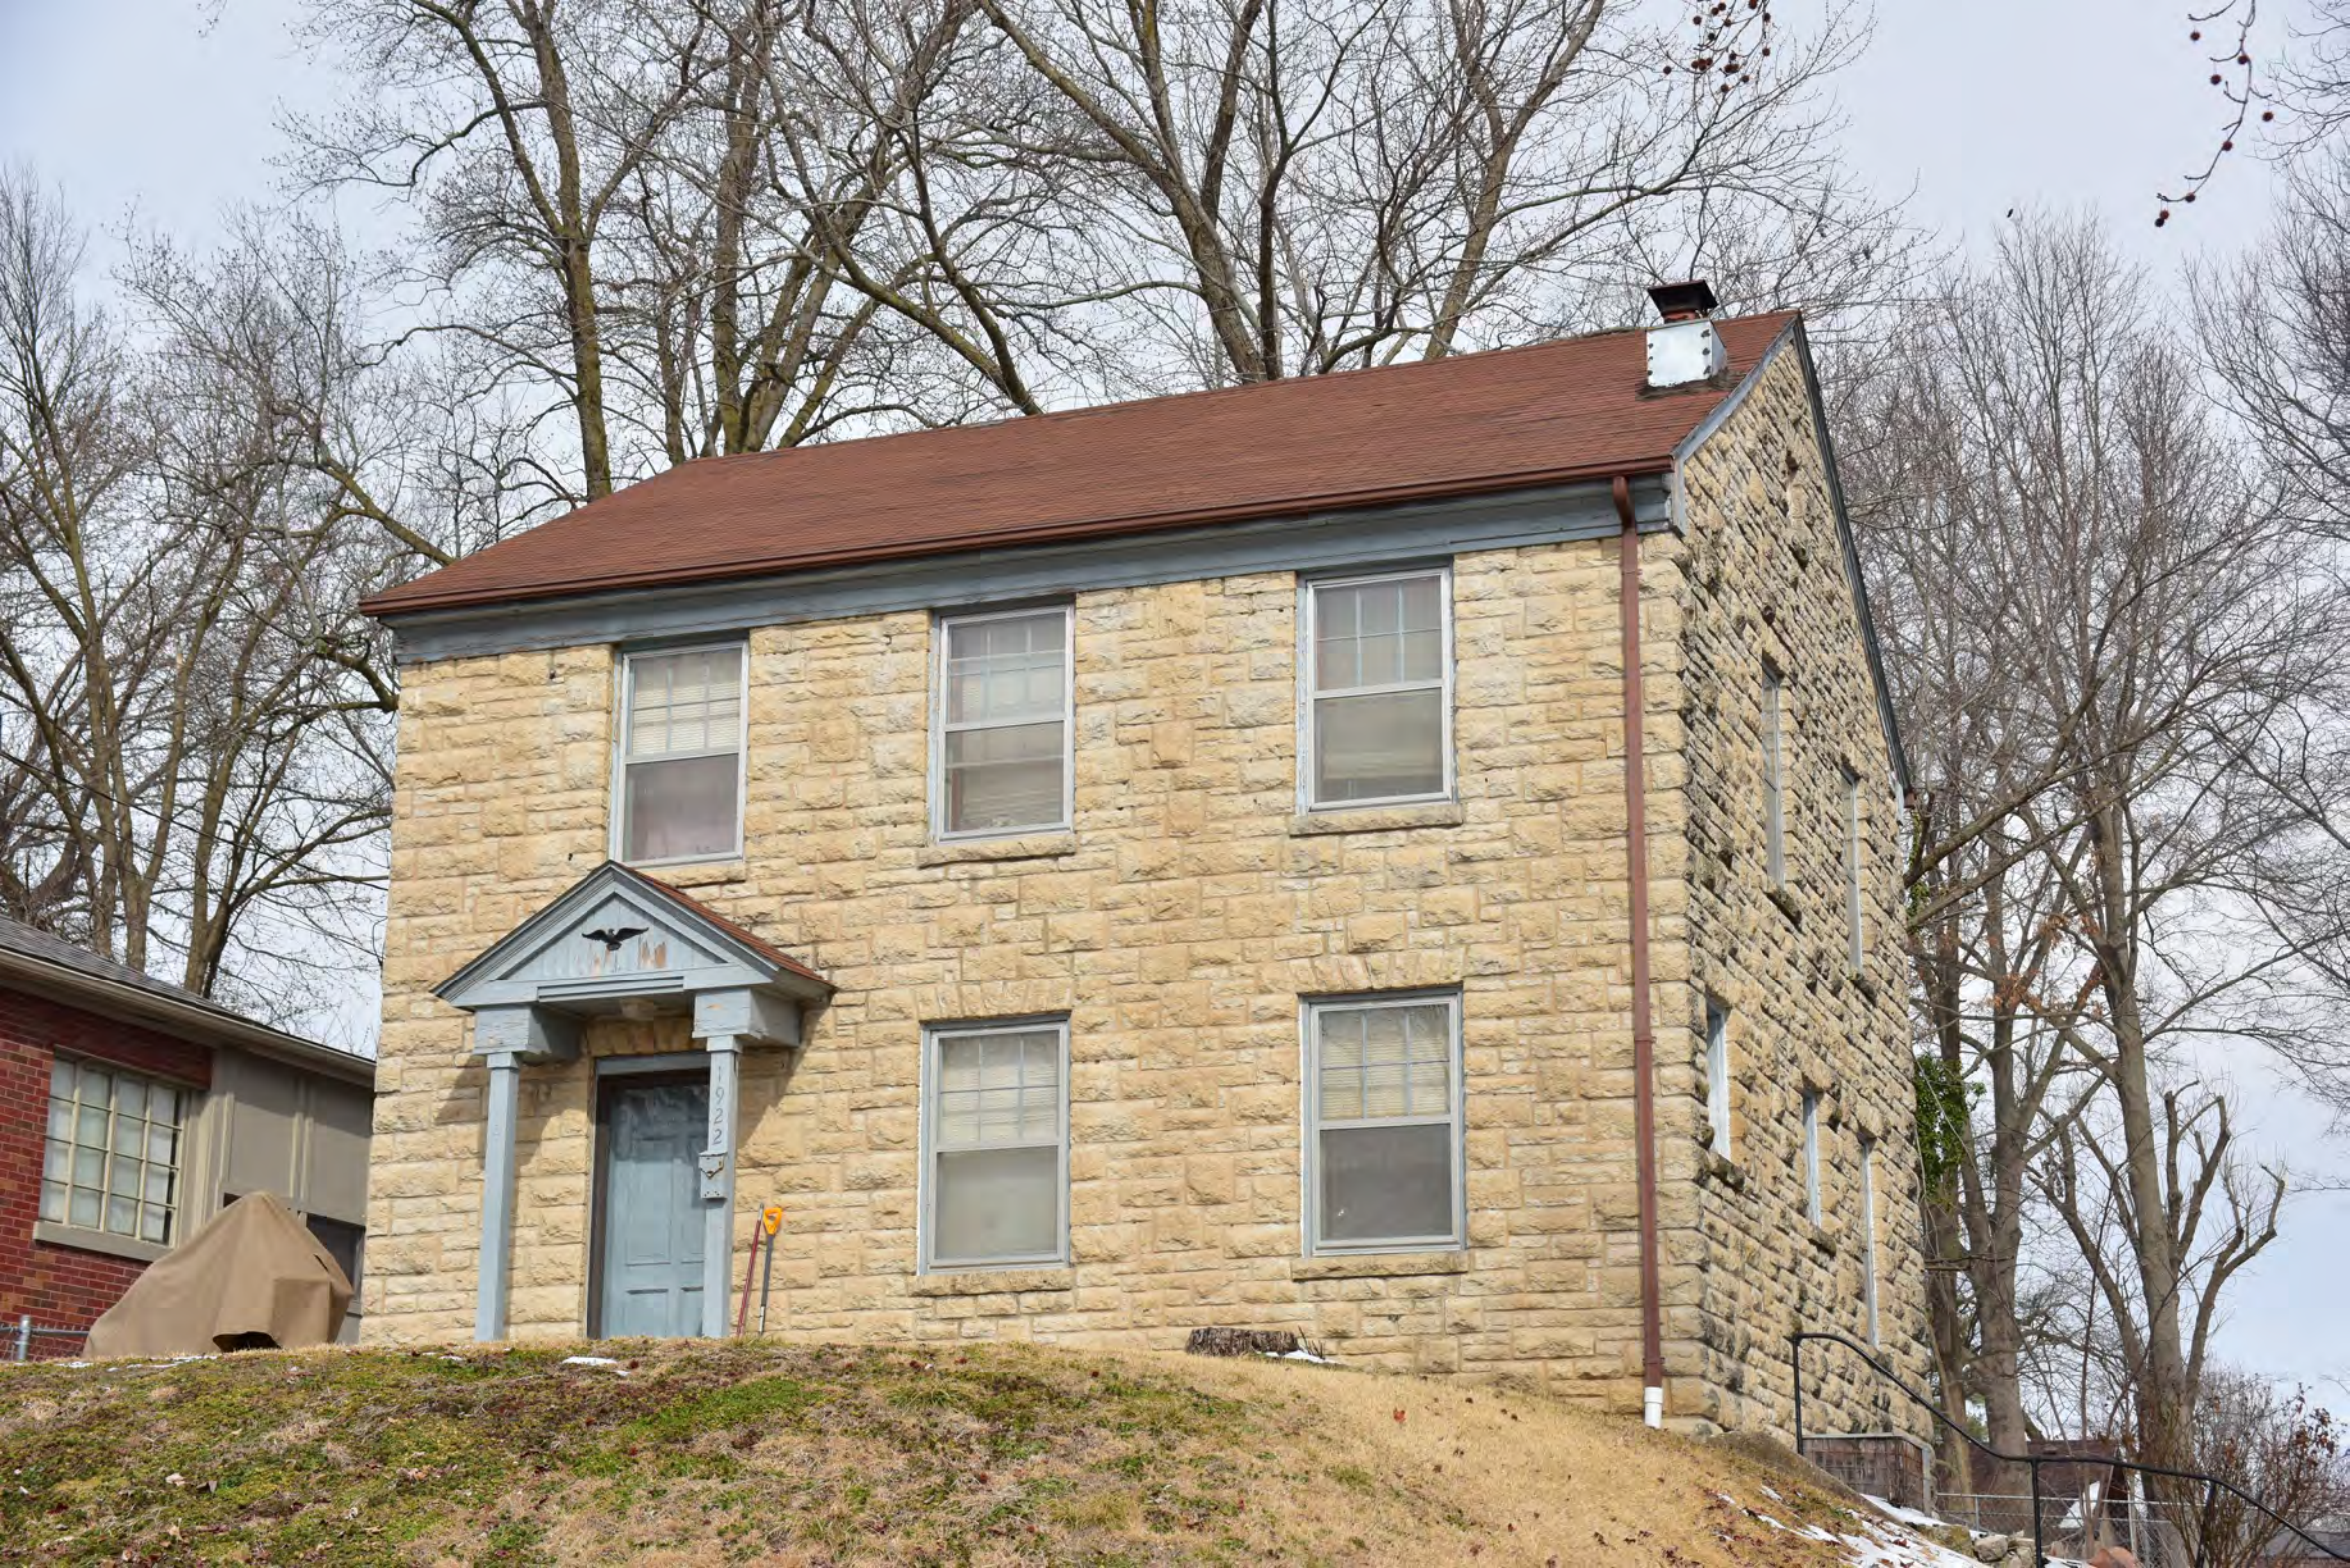
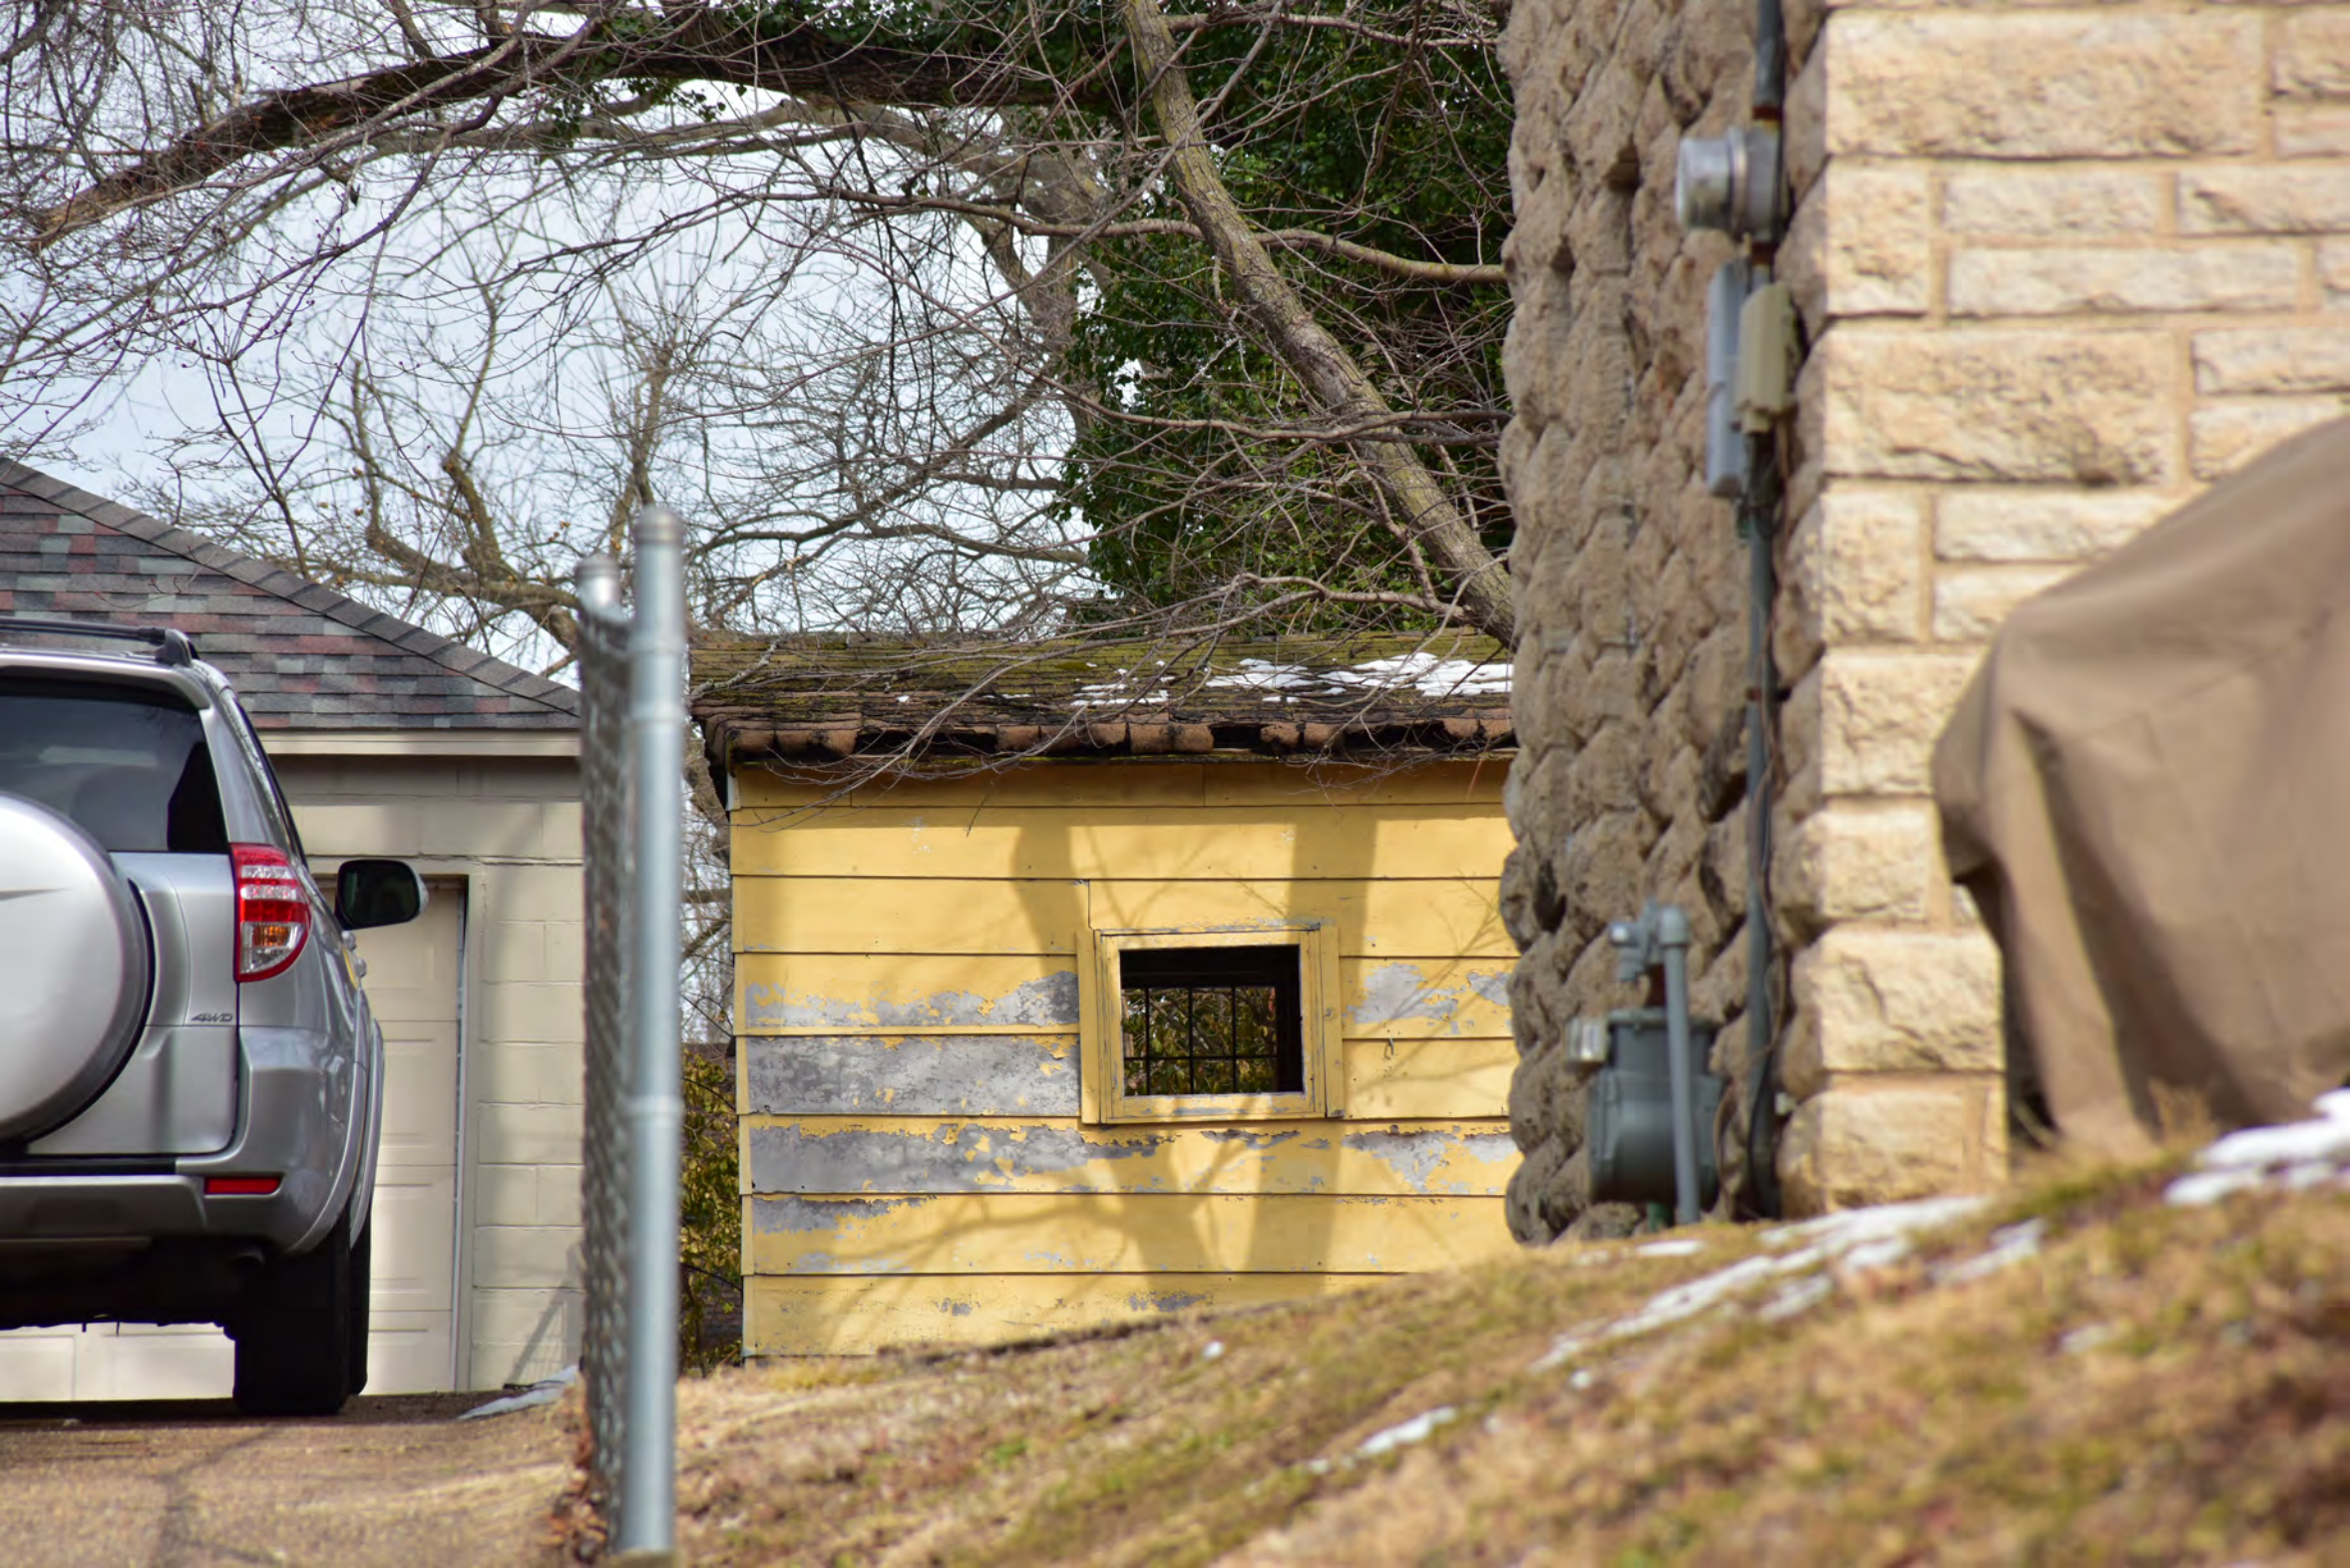
A side-gable shed is located in the northwest corner of the lot. It has an asphalt roof and cementitious cladding. Windows are centered on the north and south elevations. The glazing is missing from the south opening while a historic eight-light wood window remains in the north opening. The door is not visible. The date of construction is unknown; however, it post-dates construction of the dwelling.

1922 North Circle Drive is a two-story Minimal Traditional dwelling with restrained Colonial Revival influences. The limestone-clad dwelling has a concrete foundation and a side-gable asphalt roof. The dwelling is three bays wide. Historic 6/1 wood windows with stone sills fill the east-two bays. The primary entrance defines the west bay. A historic gable with pediment shelters the primary entrance. Historic squared wood posts support the gable. A low concrete stoop projects below the entrance. Historic terraced concrete steps with a historic metal pipe railing access the stoop from the east. Historic 6/1 wood windows with stone sills remain at the east and west elevations. An integrated one-car garage is accessed at basement level on the east elevation.
