1. Survey number: CO-AS-008-001		2. Survey Name: West Main Street Survey	
3. County: Cole		4. Address (Street No.): 100	Street (name): East Circle Drive
5. City: Jefferson City	Vicinity <input type="checkbox"/>	6. Lat / Long:	7. Township/Range/Section: T: R: S:
8. Historic name (if known):		9. Present/other name (if known):	
10. Ownership: <input checked="" type="checkbox"/> Private <input type="checkbox"/> Public		11a. Historic use (if known): Domestic-Single Dwelling	11b. Current use: Domestic-Single Dwelling

MISSOURI DEPARTMENT OF NATURAL RESOURCES
STATE HISTORIC PRESERVATION OFFICE, P.O. Box 178, Jefferson City, MO 65102
ARCHITECTURAL/HISTORIC INVENTORY FORM

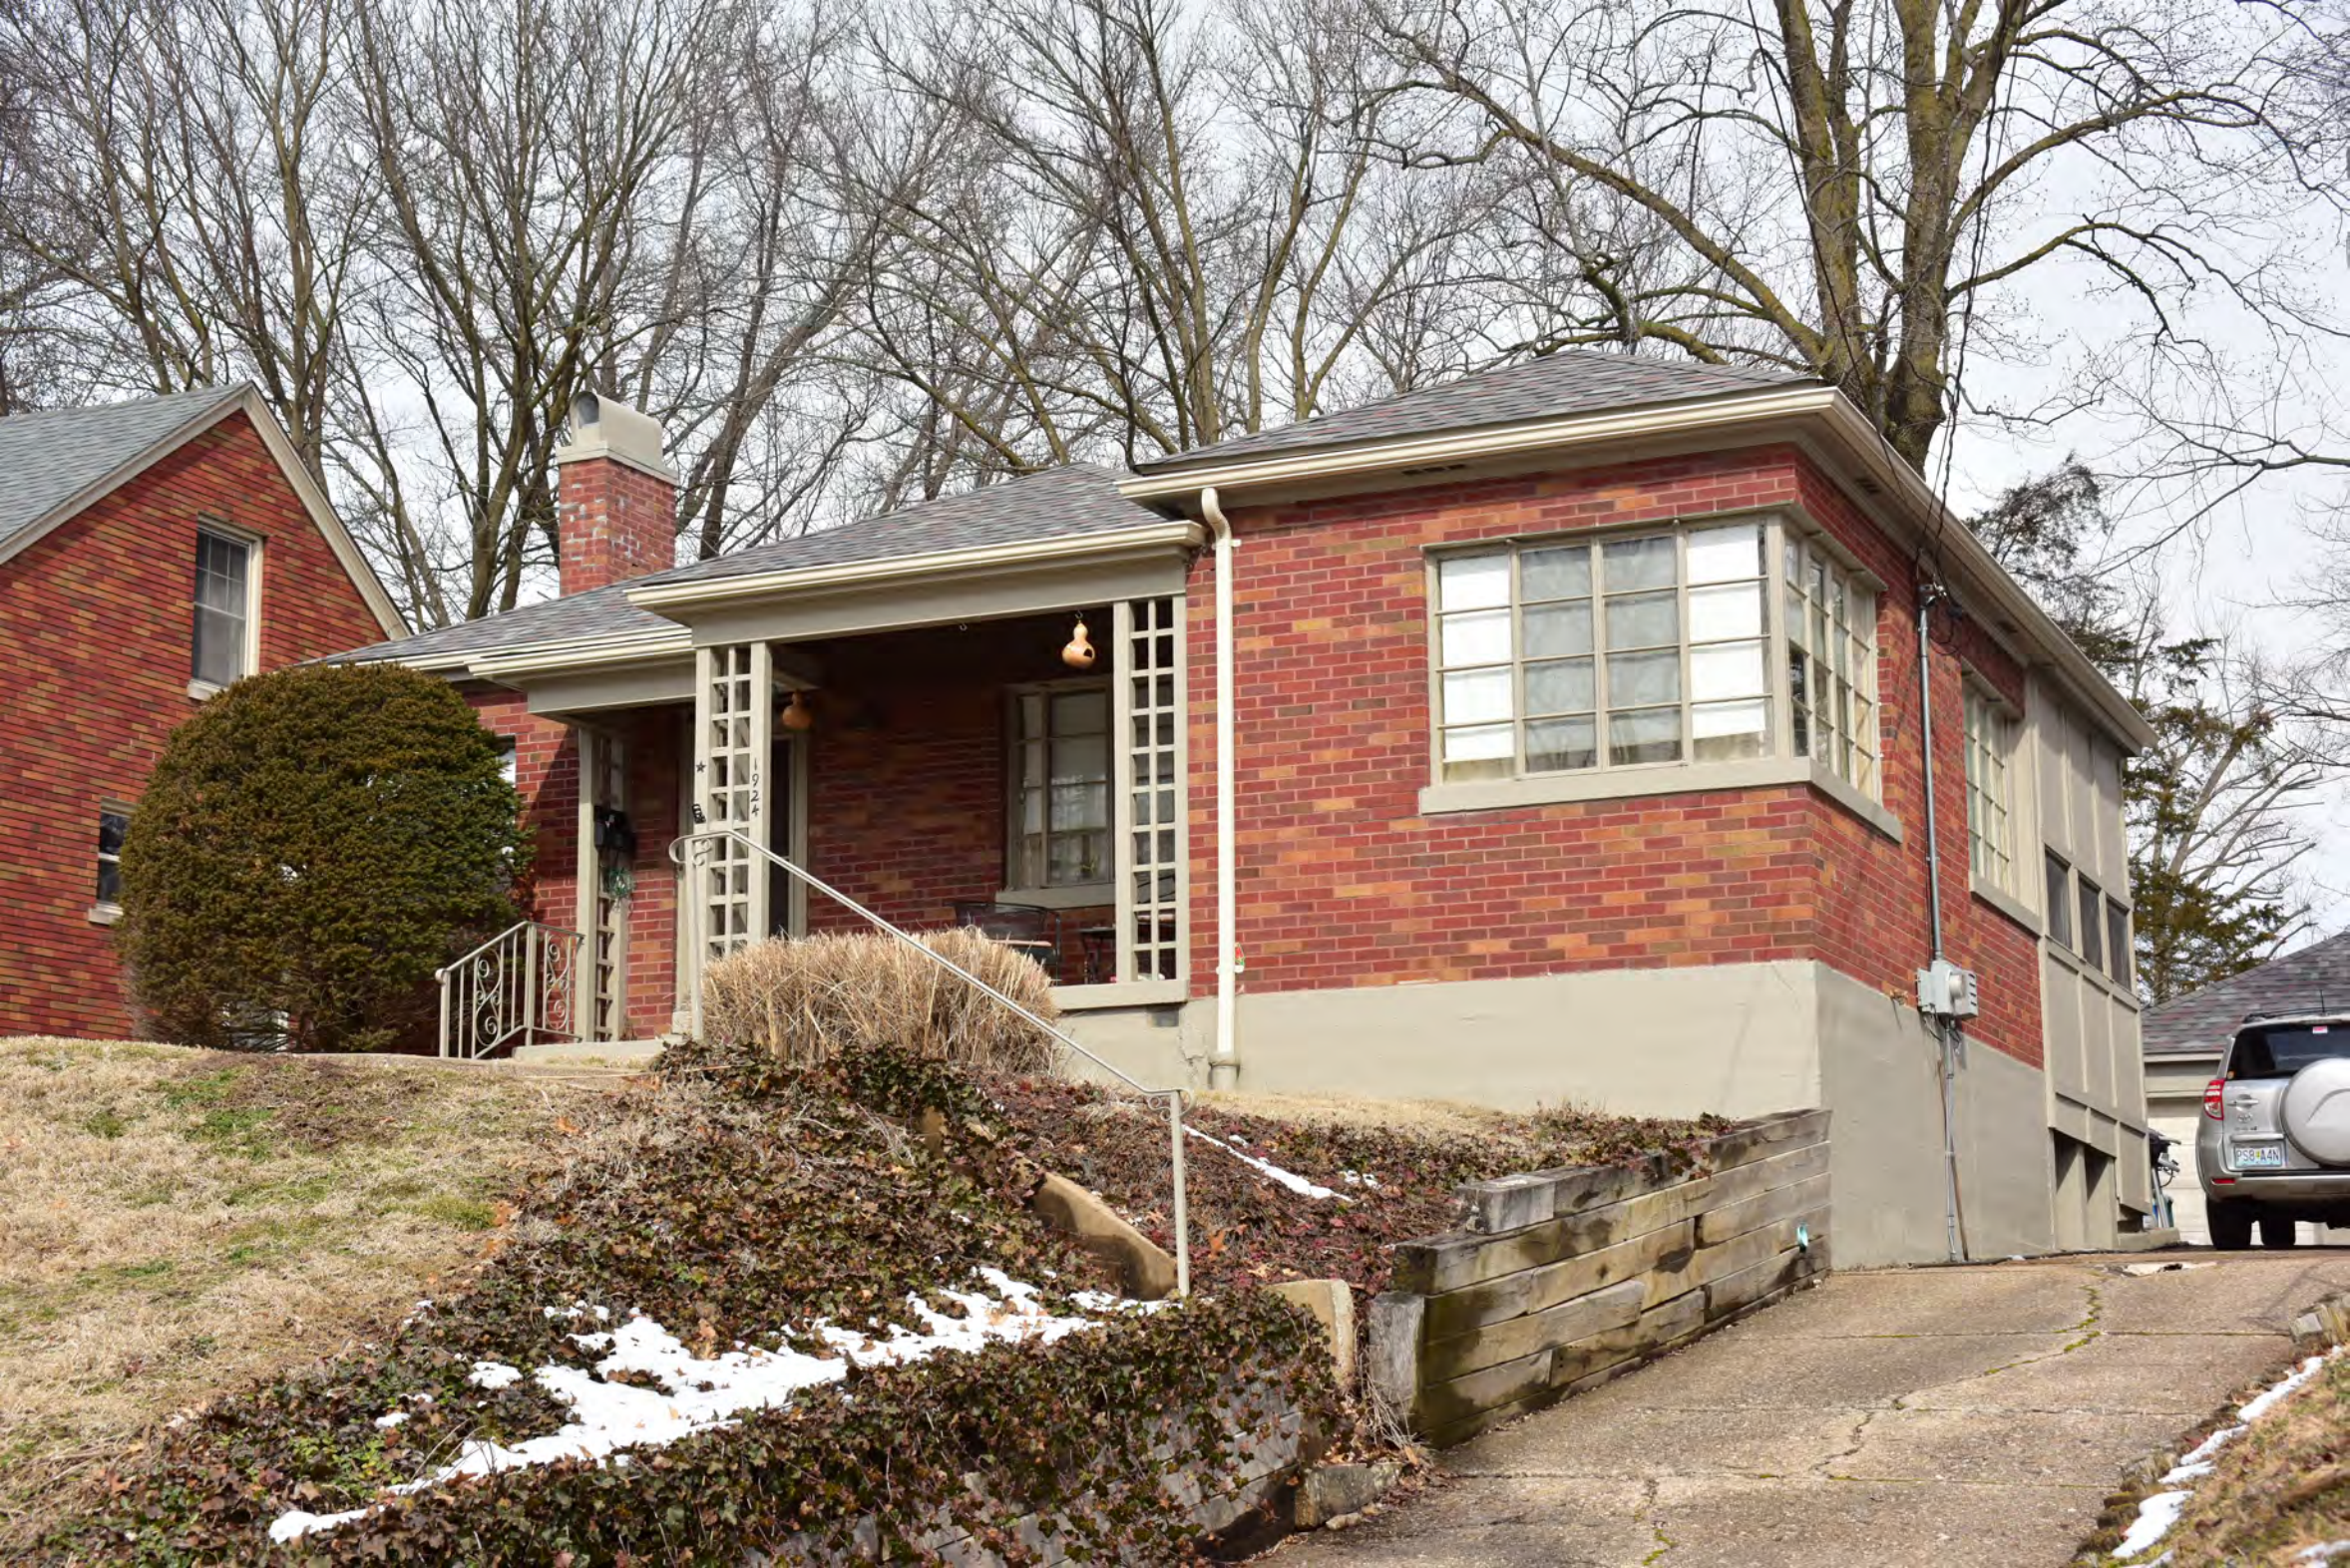
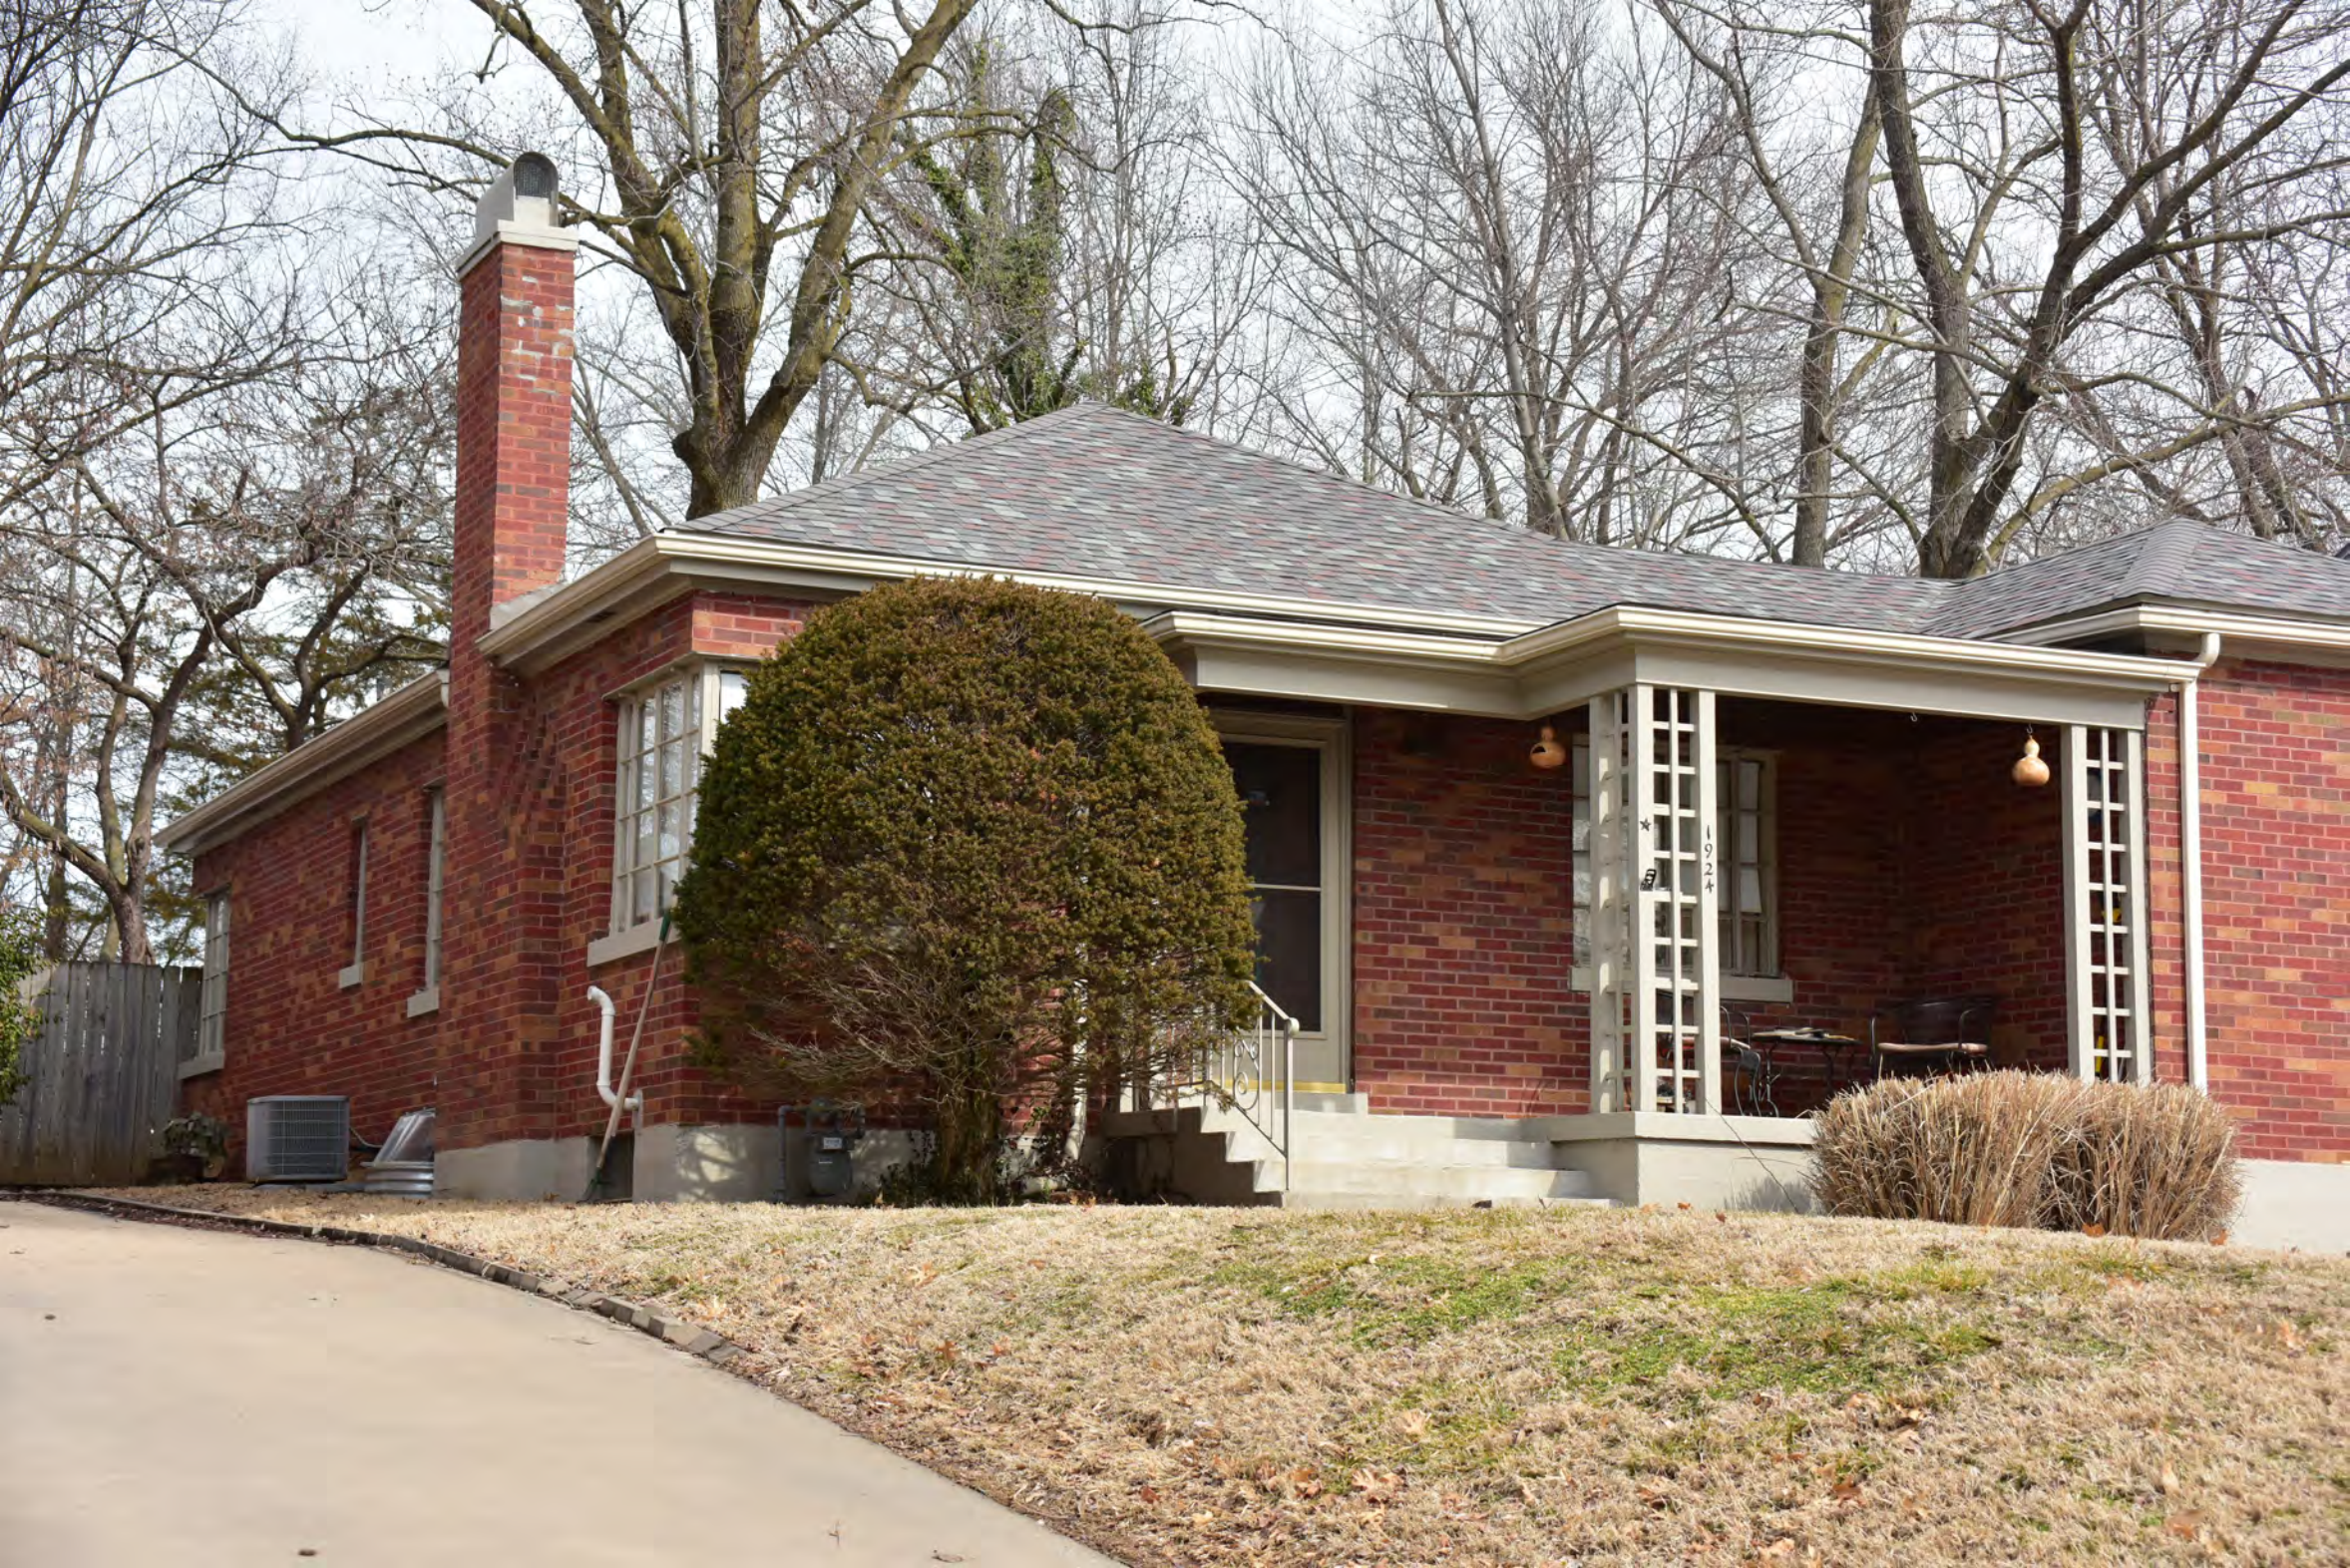
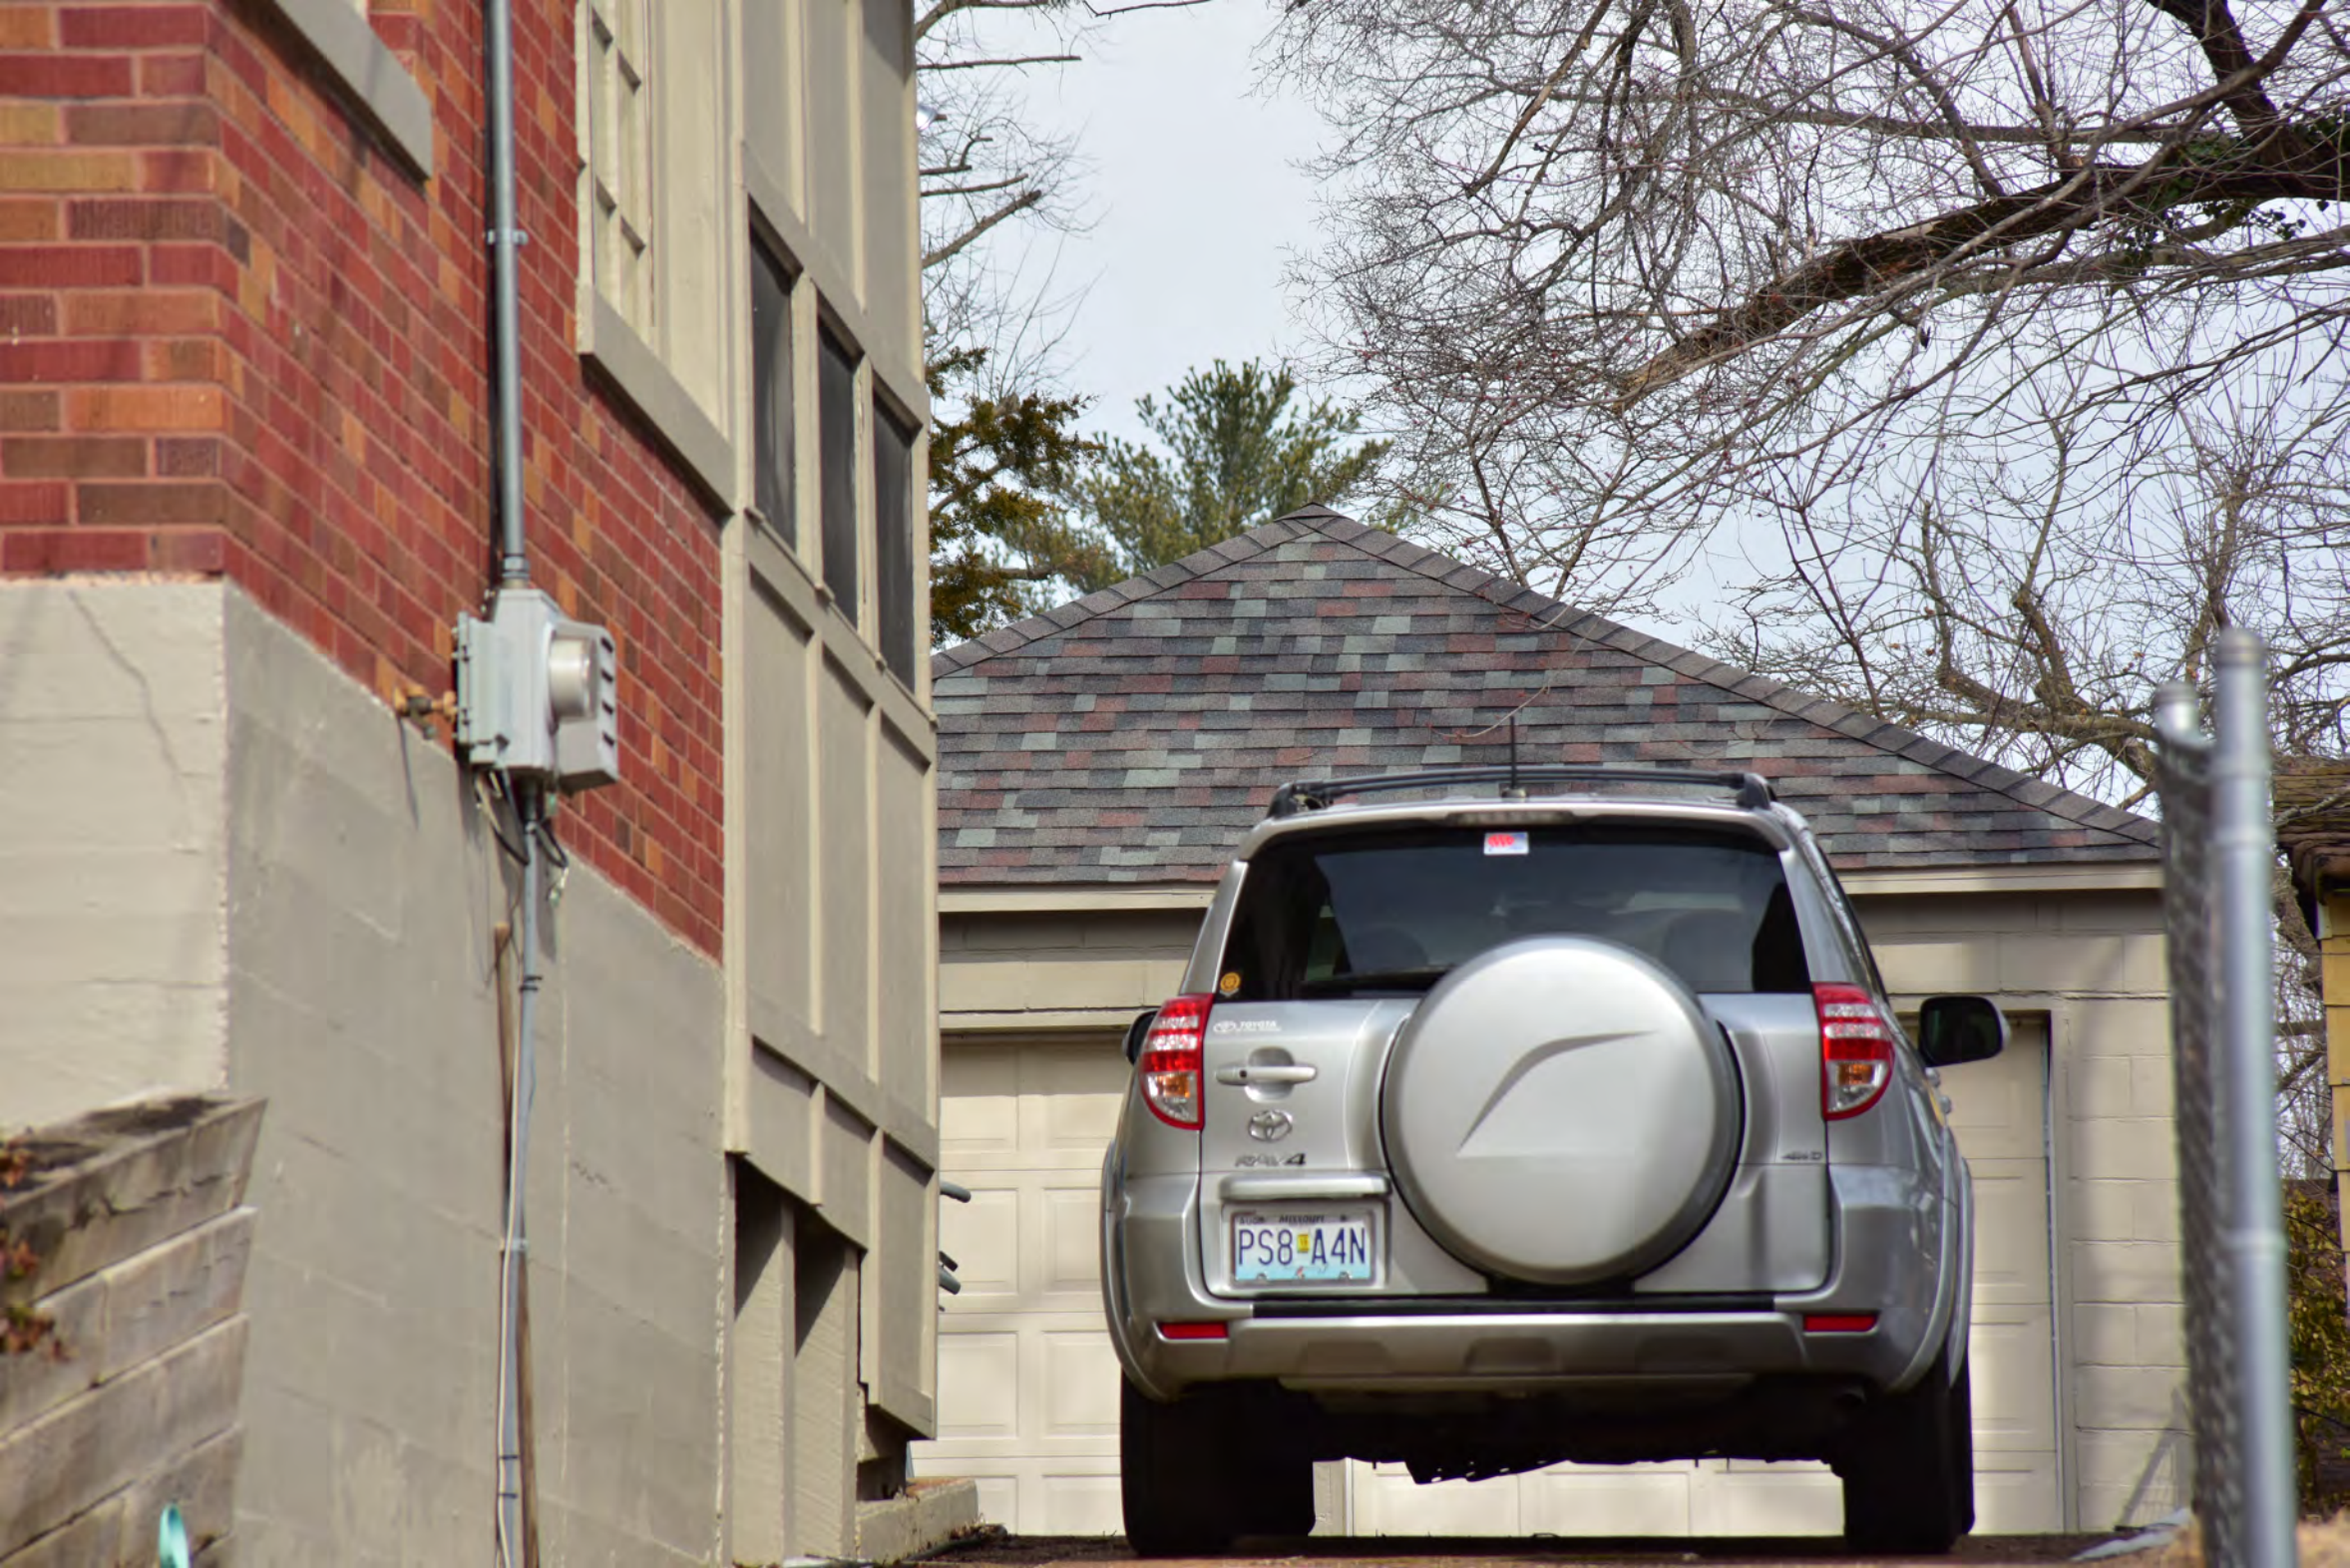
1924 North Circle Drive is a one-story dwelling with an irregular plan. The brick dwelling has a concrete foundation, brick cladding, and hipped asphalt roof. A brick exterior chimney pierces the eave at the west elevation. The dwelling is four bays wide. A hipped-roof ell extends from the southeast corner and contains the fourth bay. Historic wood corner windows with continuous concrete sills define the east and west bays. Wide mullions divide each window at the corner. Each half contains an eight-light casement window flanked by four-light fixed windows. Matching windows are located at the northeast and northwest corners of the dwelling. Historic wood four-light fixed windows flank a center eight-light casement window in the third bay. A historic wood door fills the second bay. A concrete partial-width open porch extends below the second and third bays. A hipped roof with lattice work supports shelters the porch. Concrete steps access the porch at the west end. An enclosed porch with wood cladding fills the juncture between the hipped ell and main mass. A bank of fixed single-pane square windows is centered on the east elevation.

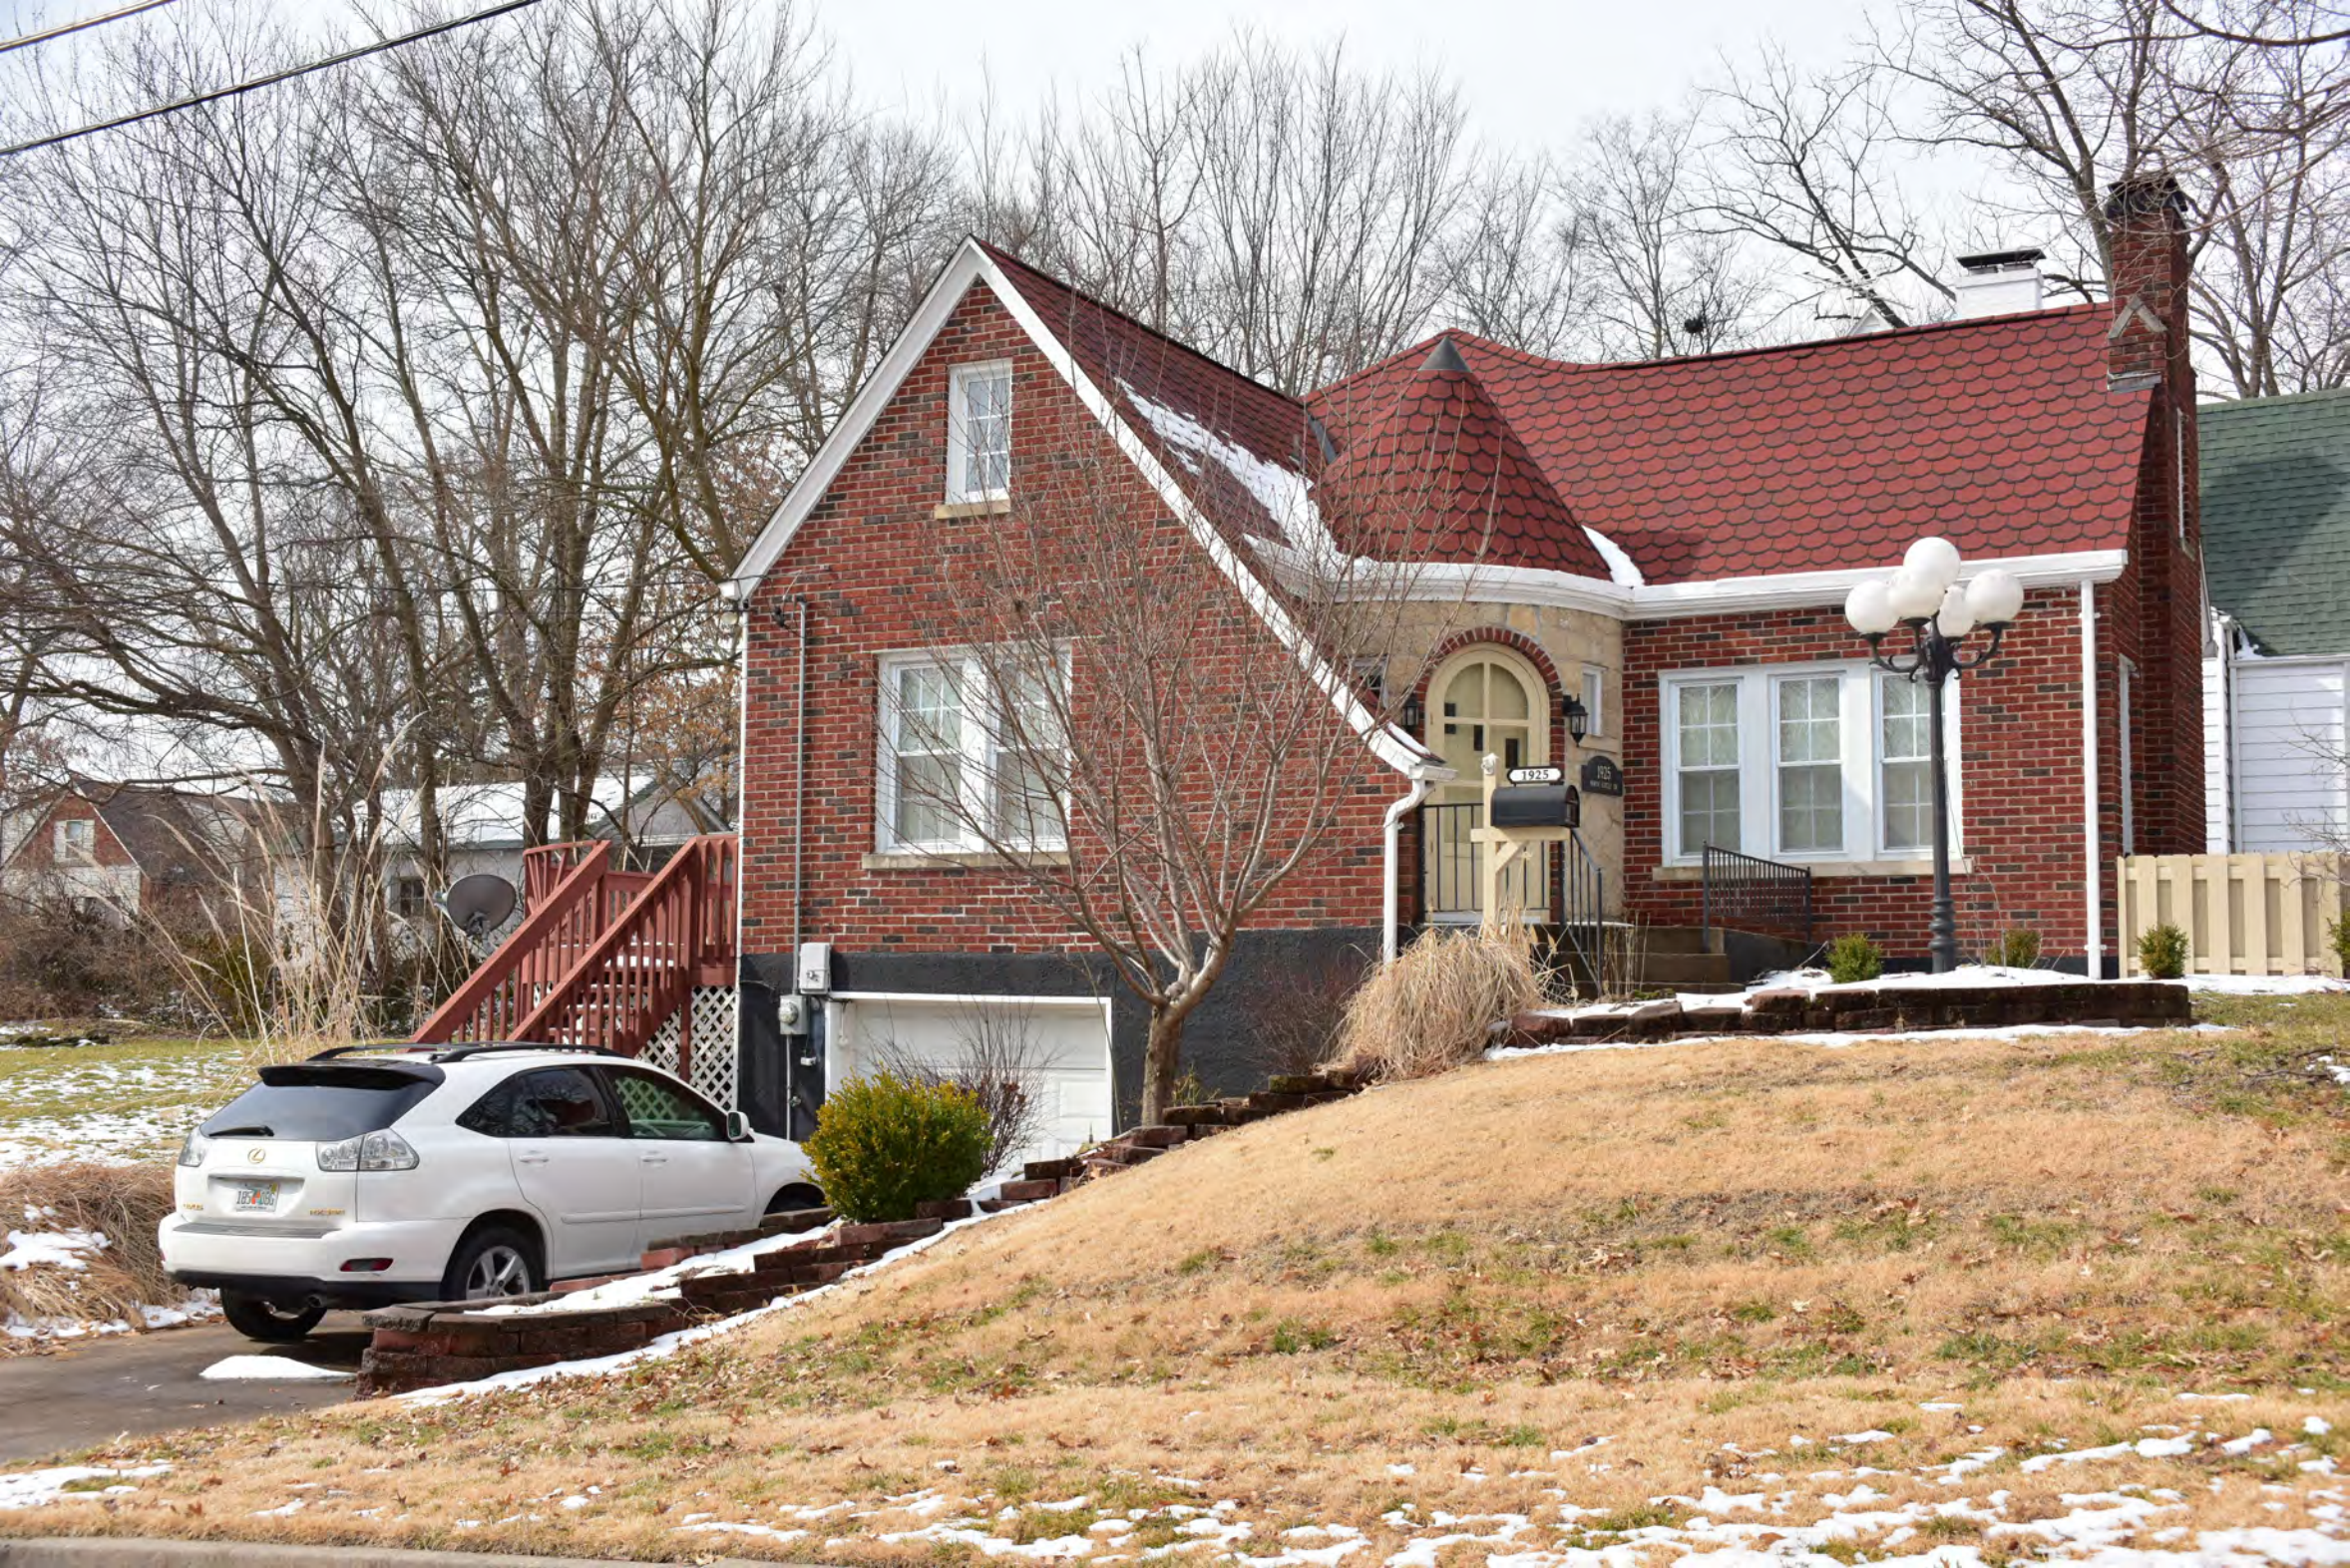
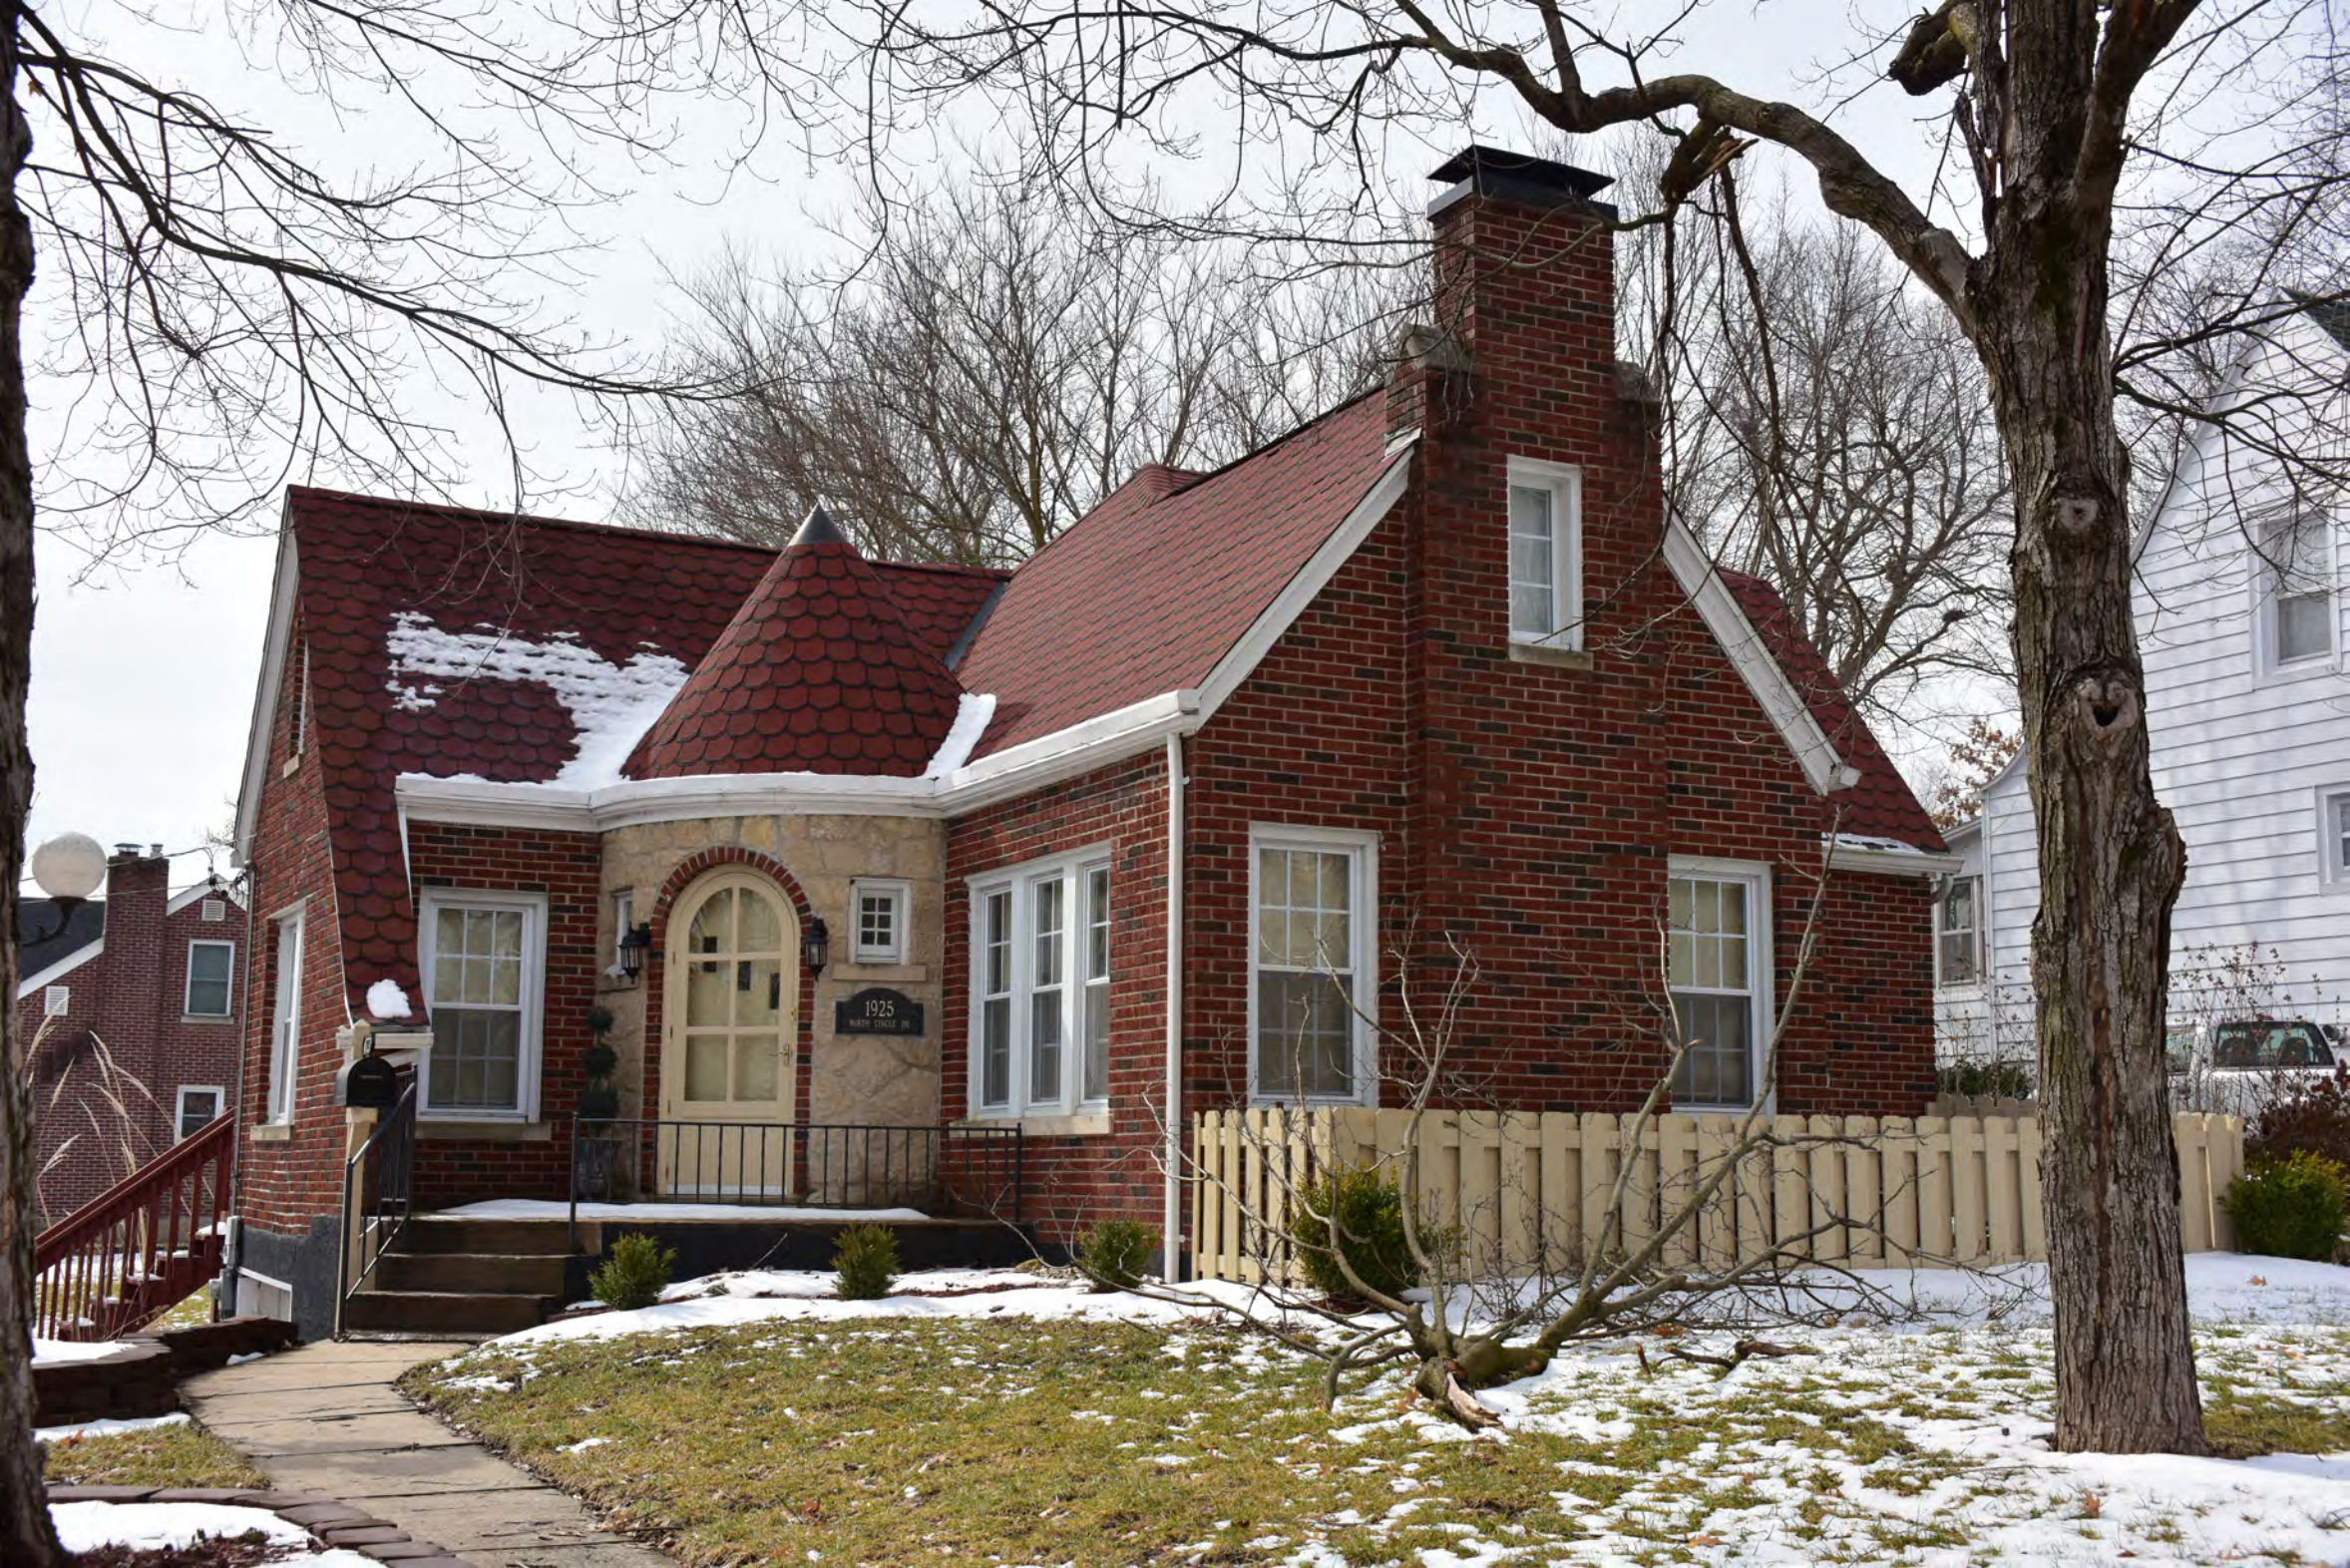
1925
NORTH CINCINNATI ST.

Alterations to 1925 the replacement of historic windows at an unknown date. While the windows are replacements, the fill historic openings and preserve the historic fenestration pattern. 1925 North Circle Drive does not otherwise appear significantly altered and retains good integrity. This resource would be contributing to the potential Walinko Place Historic District, significant in the areas of Architecture and Community Planning and Development in association with the expansion of Jefferson City and increased suburban development during the twentieth century as well as its associations with Walinko Place, a notable suburban development during the Depression and War Years.

1925 North Circle Drive is a one-story brick dwelling with a parged concrete foundation and asphalt intersecting-gable roof. Two perpendicular gabled-ells front North Circle Drive and Lavinia Street while a clipped gable ell extends to the west. A one-story turret with a conical roof is located in the gabled-ell juncture at the east elevation. The stone-clad turret contains the primary entrance. A historic wood door with three-light glazing and a historic wood storm door with six-light glazing fill the arched doorway. Decorative soldier brick lines the opening. Small historic six-light wood windows with cast stone sills flank the entrance. A non-historic 6/6 vinyl window is located to the east while three-ganged 4/4 vinyl windows with a continuous cast stone sill are located to the north in the gabled-ell's east elevation. An open concrete platform porch with historic metal railings extends from the turret. A brick exterior chimney bisects the north elevation of the gabled-ell. Non-historic 6/6 vinyl windows flank the chimney while a narrow three-light fixed window is centered in the chimney near the gable apex. An integrated one-car garage is present at the east elevation at basement level. Two-ganged 6/6 vinyl windows are centered above the vehicular bay while a narrow non-historic six-light fixed vinyl window is centered in the gable apex. A non-historic wood deck extends from the rear elevation.
