1. Survey number: CO-AS-008-001		2. Survey Name: West Main Street Survey	
3. County: Cole		4. Address (Street No.): 100	Street (name): East Circle Drive
5. City: Jefferson City	Vicinity <input type="checkbox"/>	6. Lat / Long:	7. Township/Range/Section: T: R: S:
8. Historic name (if known):		9. Present/other name (if known):	
10. Ownership: <input checked="" type="checkbox"/> Private <input type="checkbox"/> Public		11a. Historic use (if known): Domestic-Single Dwelling	11b. Current use: Domestic-Single Dwelling

MISSOURI DEPARTMENT OF NATURAL RESOURCES
STATE HISTORIC PRESERVATION OFFICE, P.O. Box 178, Jefferson City, MO 65102
ARCHITECTURAL/HISTORIC INVENTORY FORM

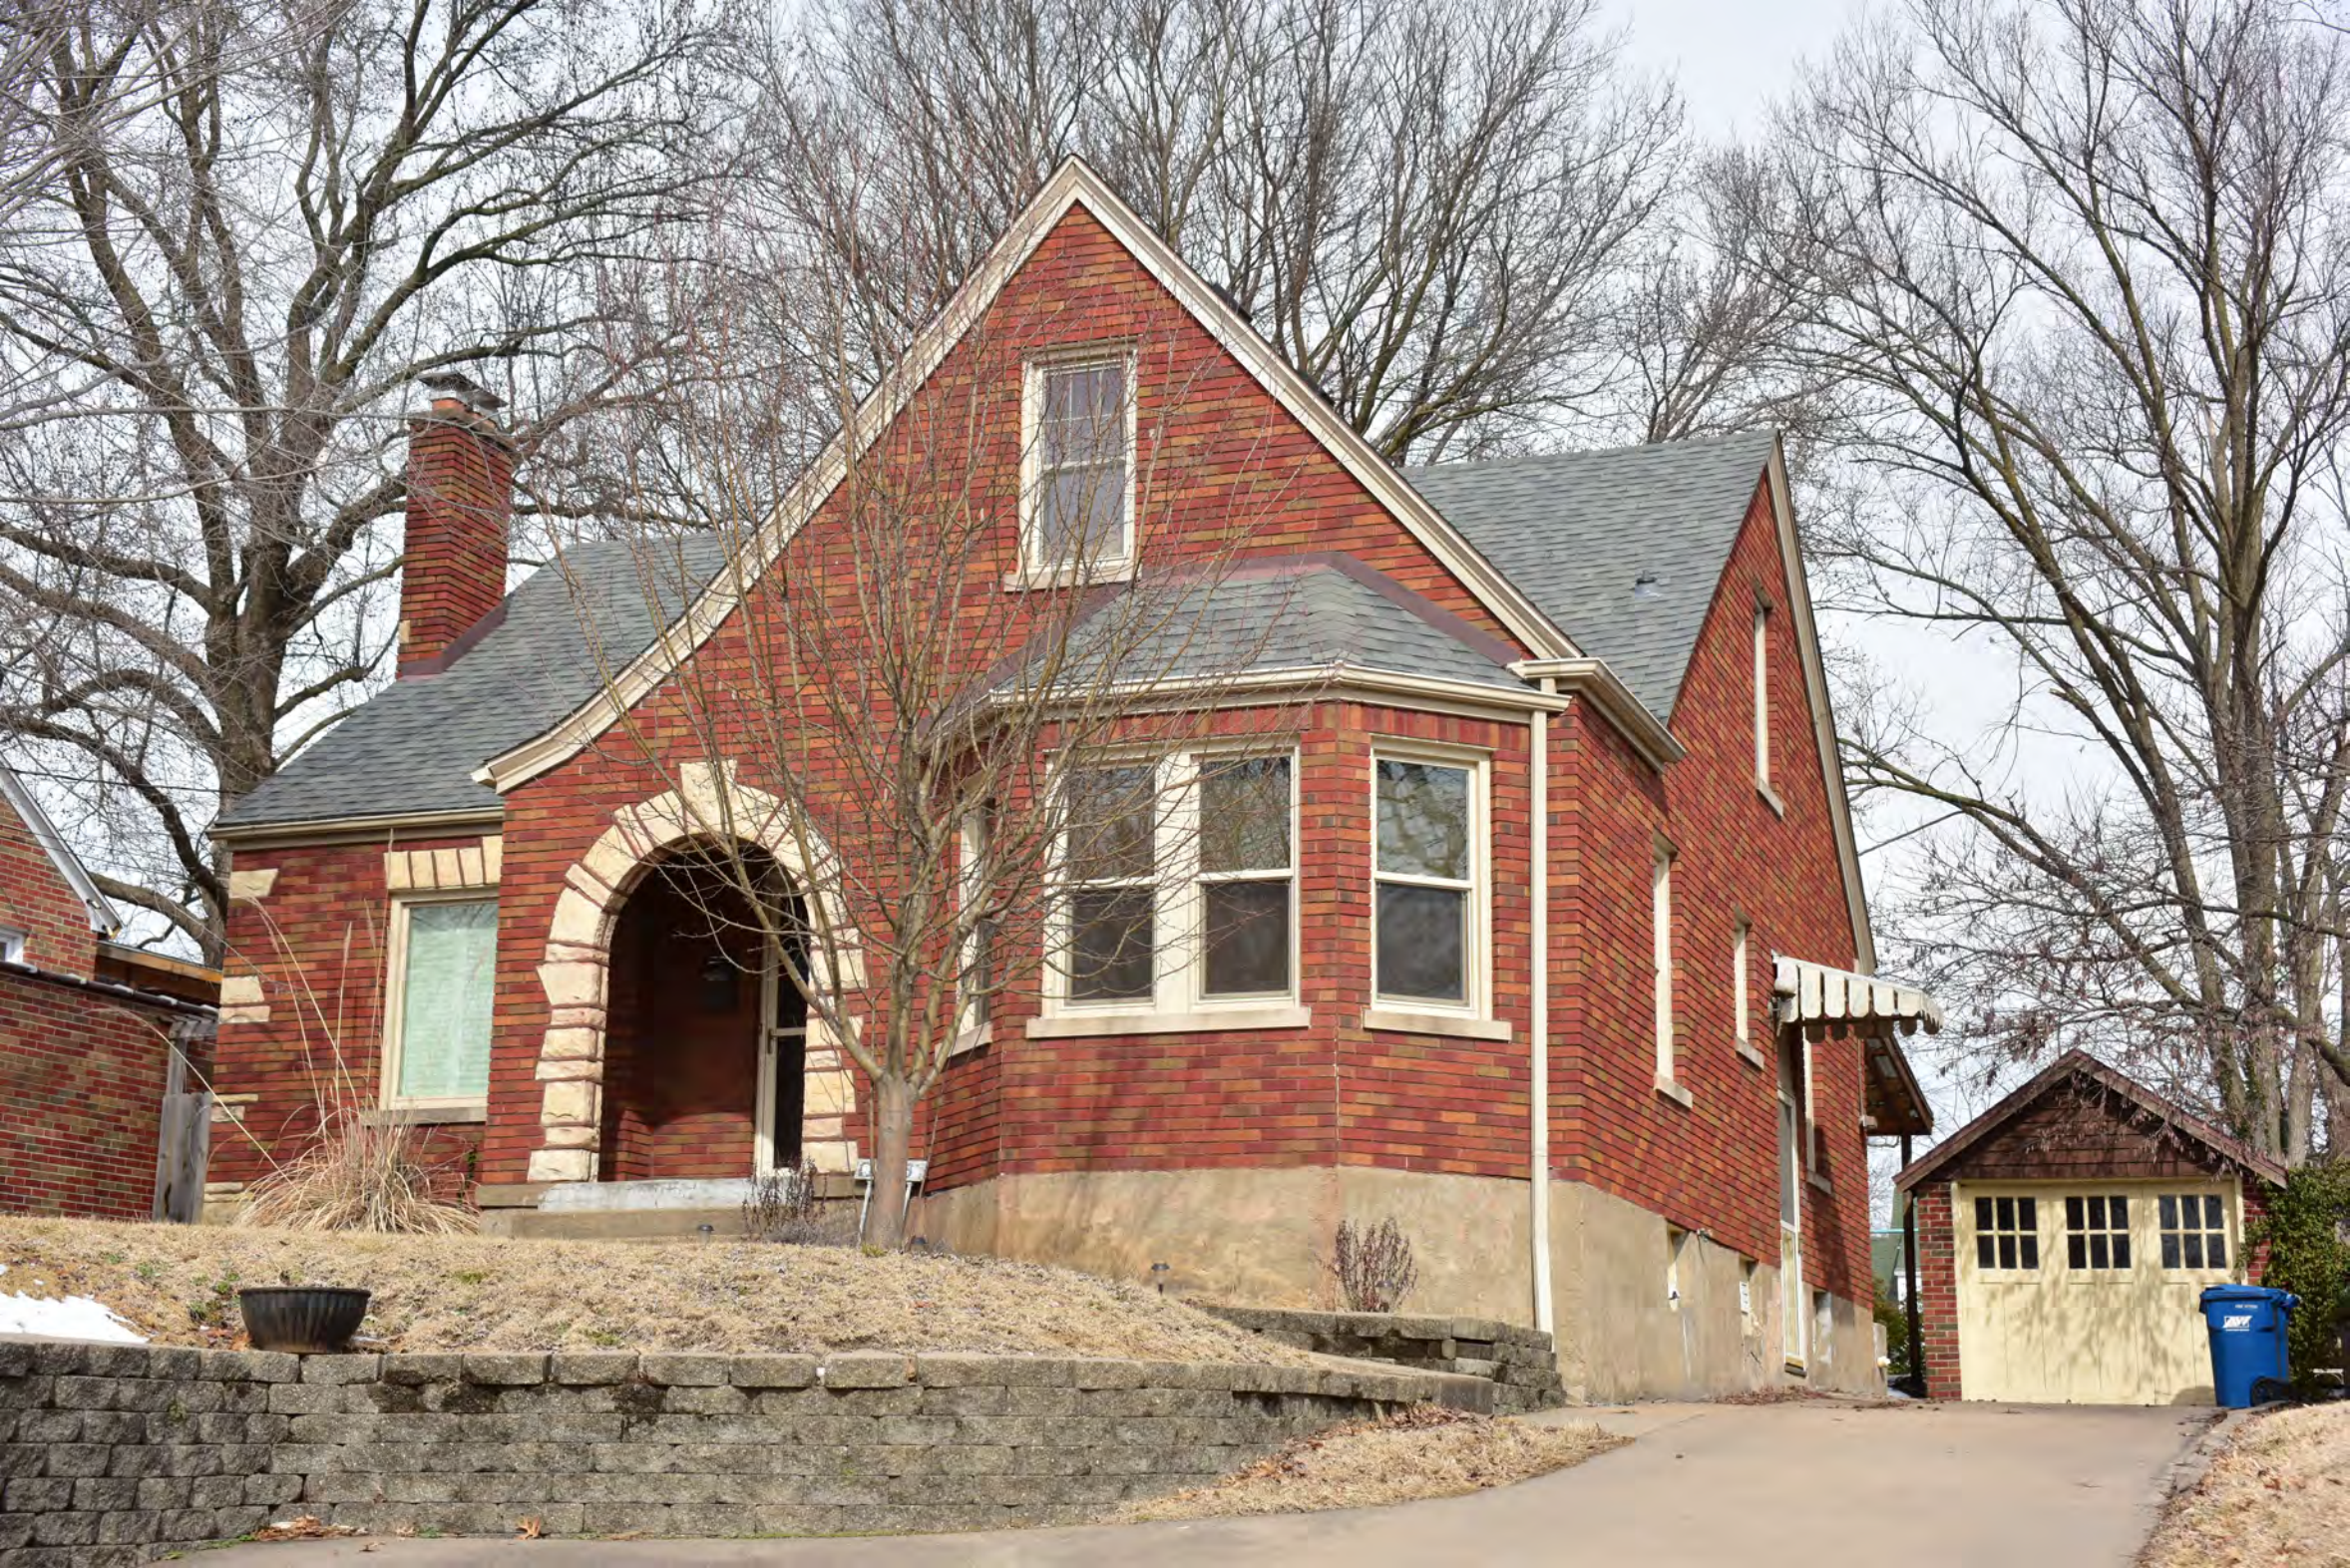
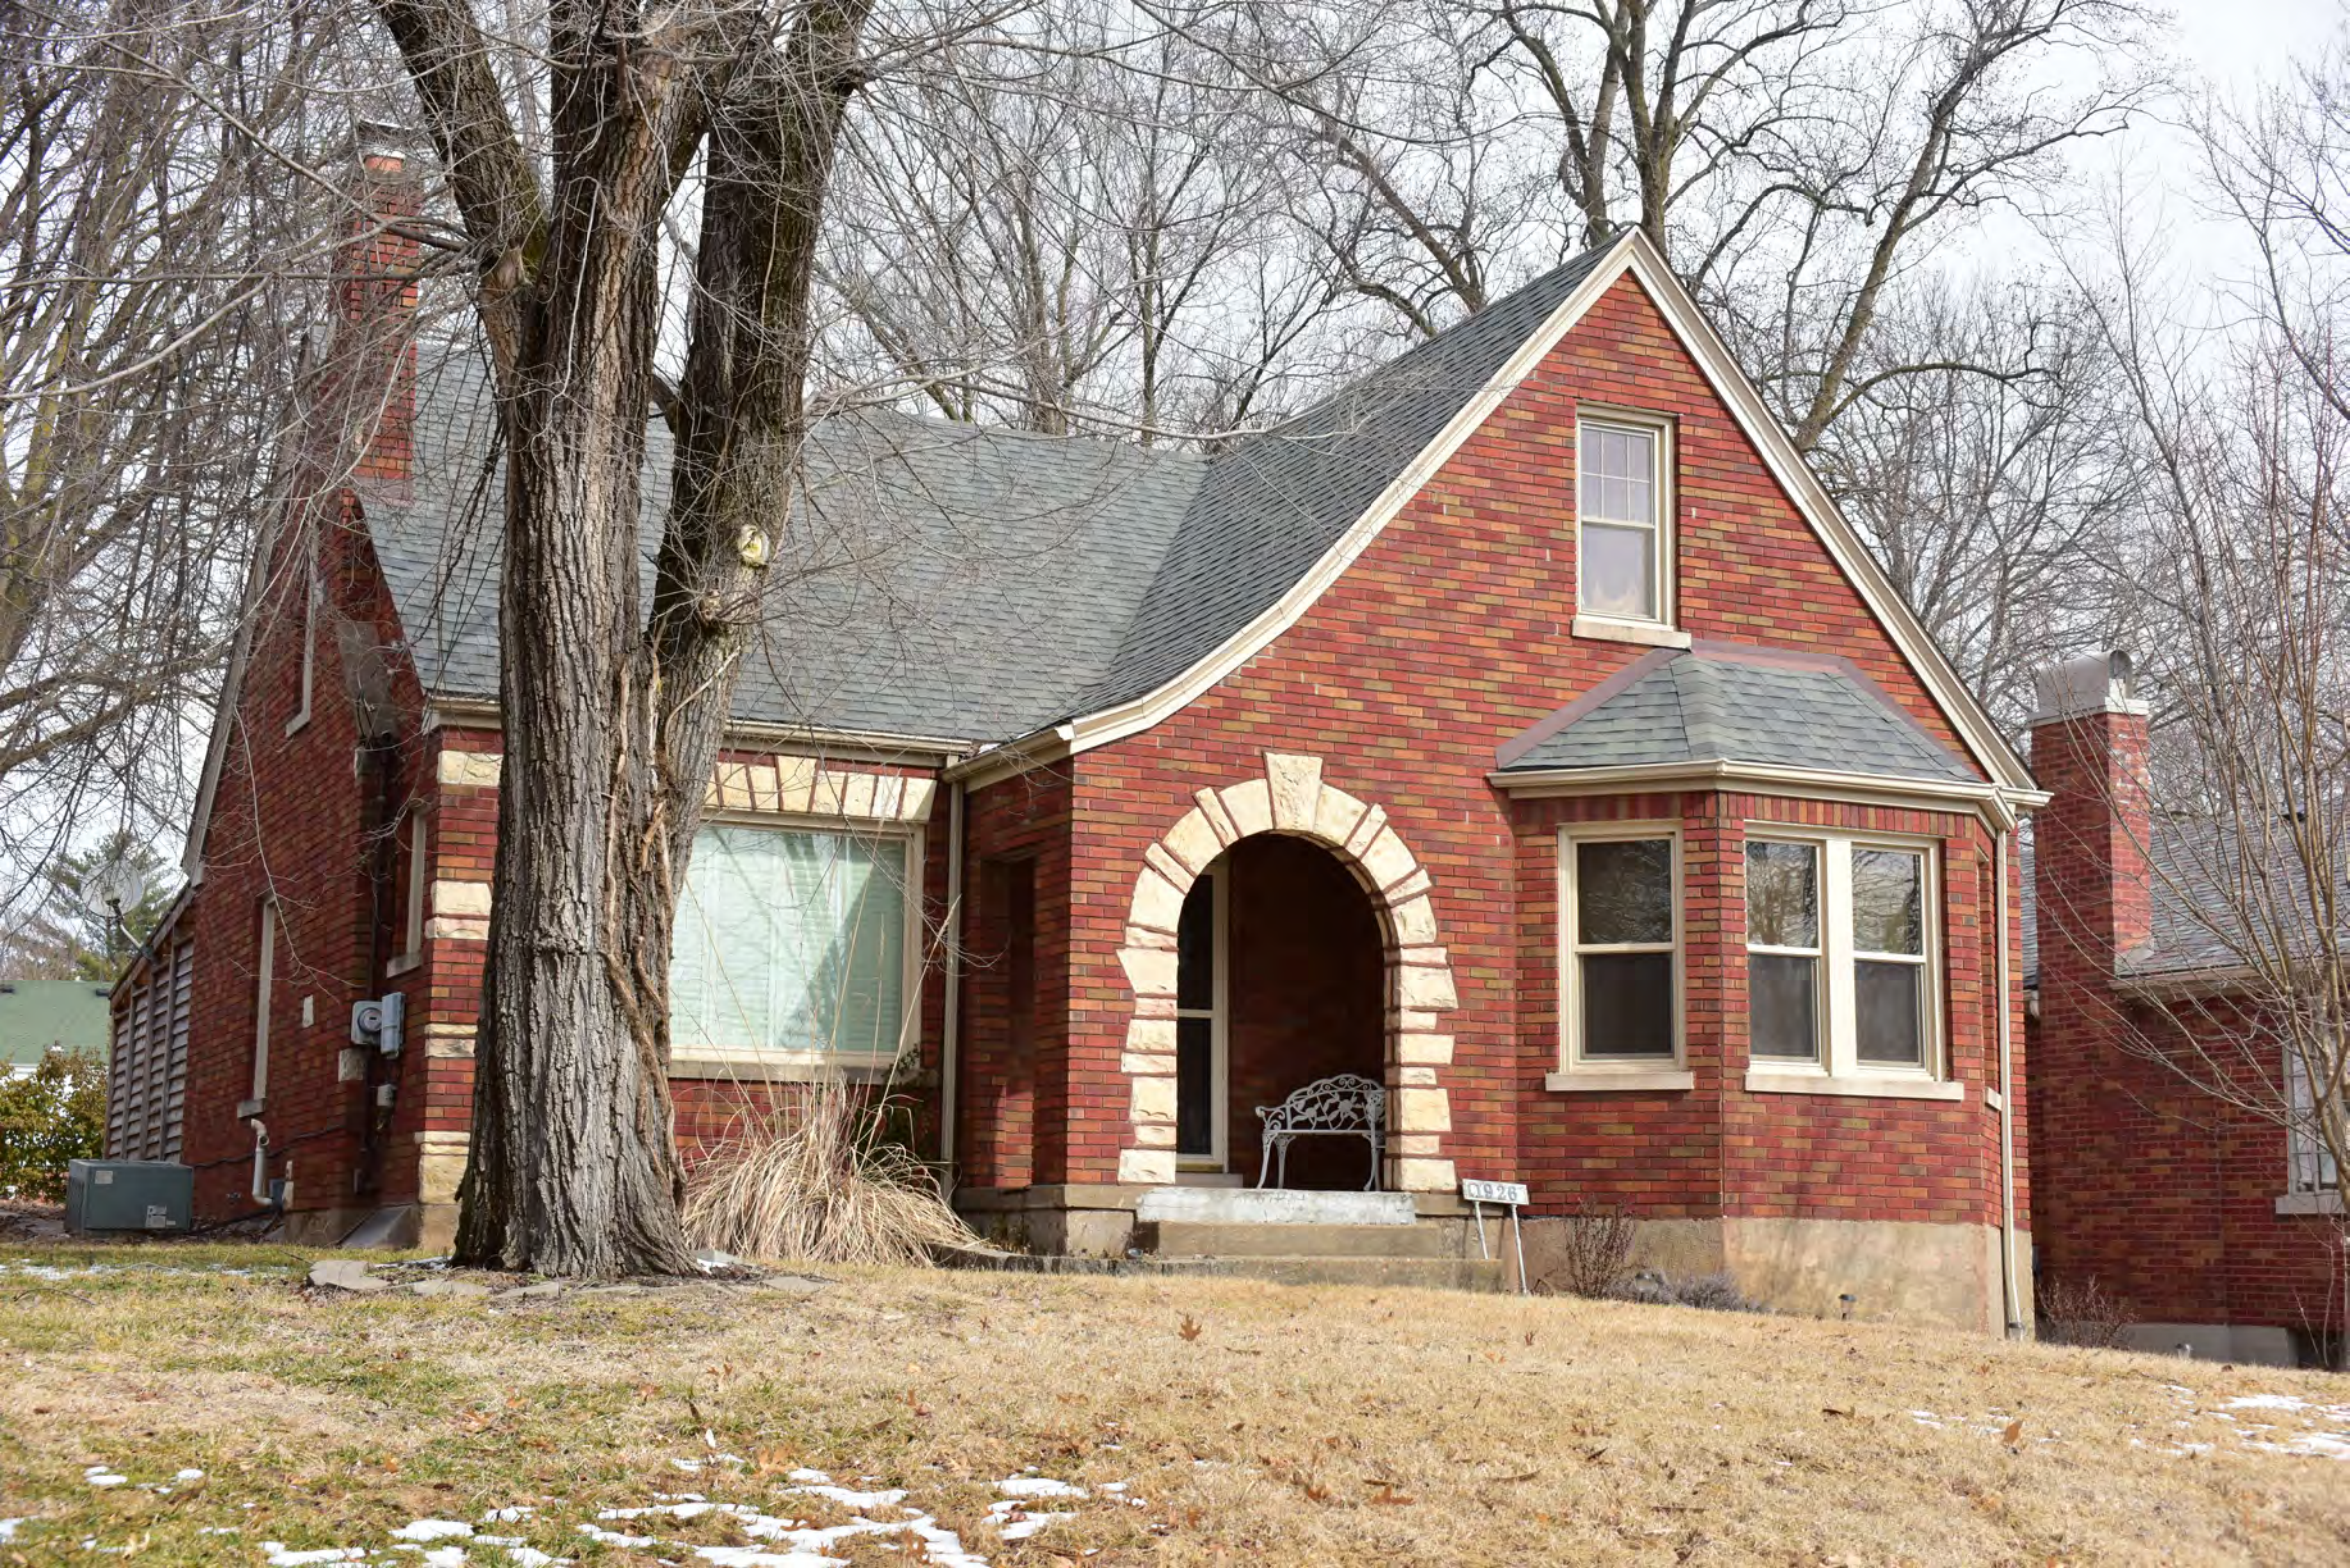
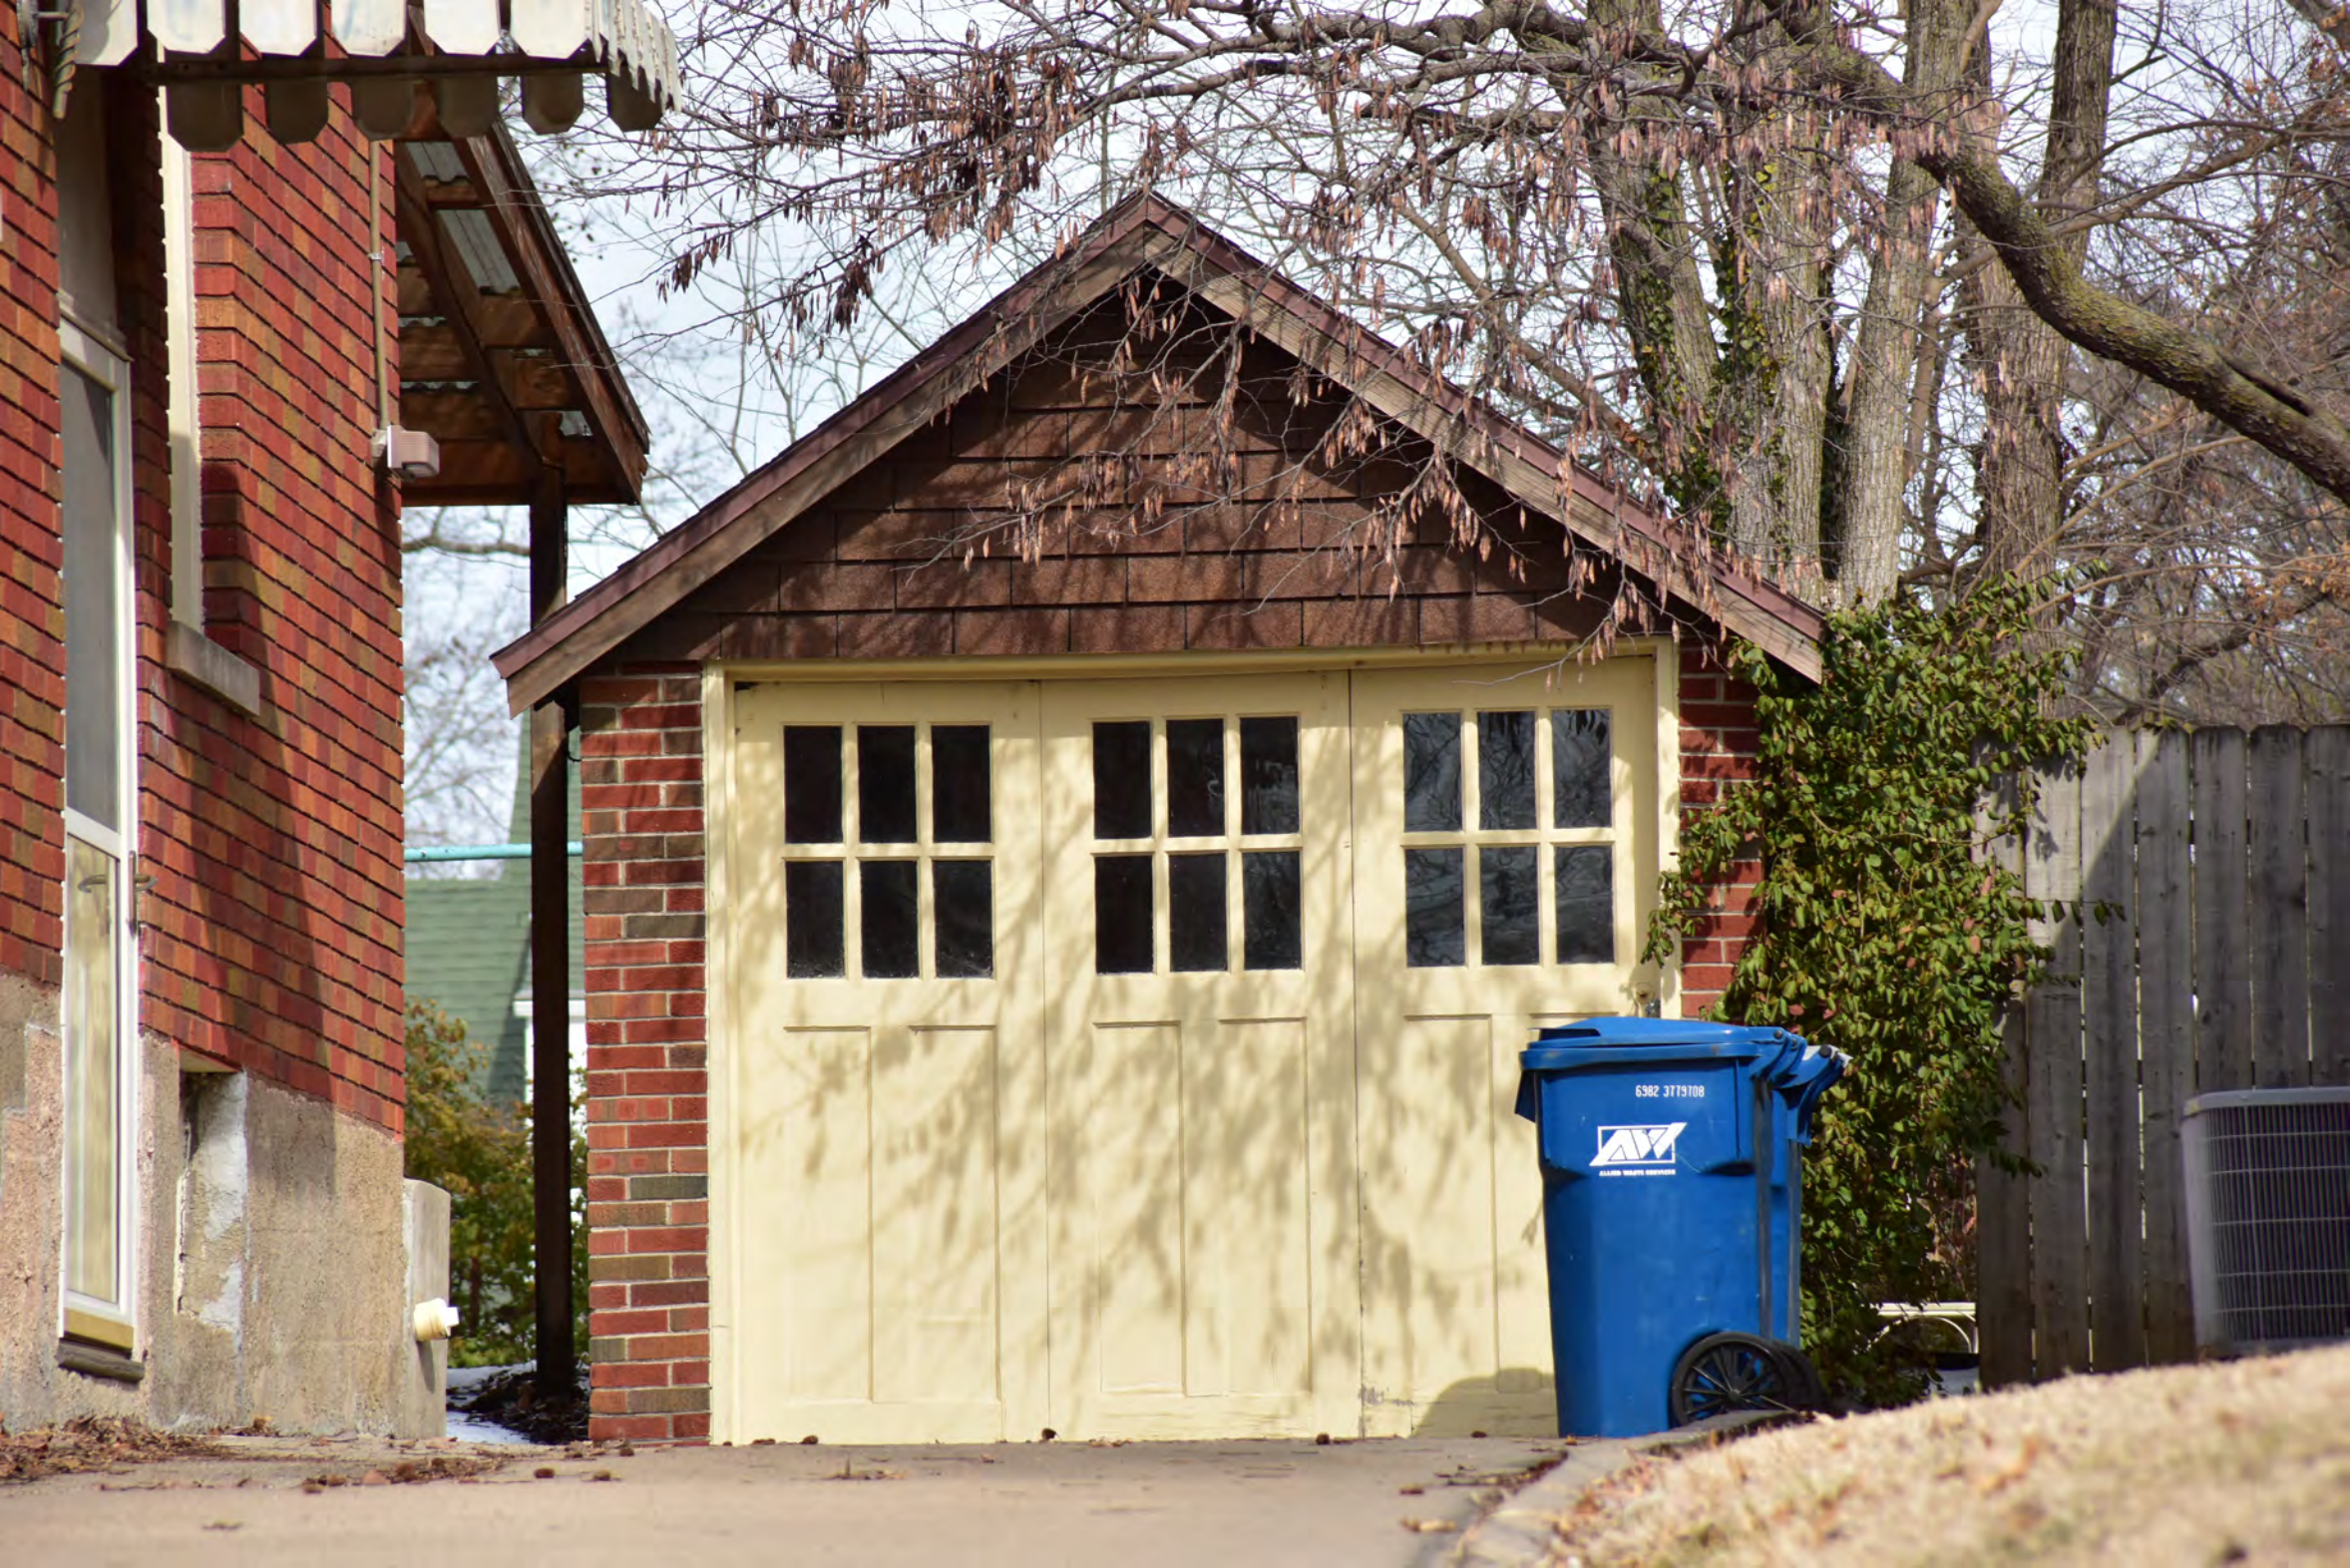
Alterations to 1926 North Circle Drive include the replacement of historic windows at an unknown date and a c. 1965-1991 porch. While the windows are replacements, the fill historic openings. The porch is complimentary in size and scale and is minimally visible. 1926 North Circle Drive does not otherwise appear significantly altered and retains good integrity. This resource would be contributing to the potential Walinko Place Historic District, significant in the areas of Architecture and Community Planning and Development in association with the expansion of Jefferson City and increased suburban development during the twentieth century as well as its associations with Walinko Place, a notable suburban development during the Depression and War Years.

1926 North Circle Drive is a one-story Minimal Traditional brick dwelling with an intersecting gable asphalt roof and concrete foundation. A gable-front ell extends from the east end of the primary elevation and contains the east-two bays. A hipped-roof bay window defines the east bay. The center portion contains non-historic two-ganged 1/1 windows while the side portions contain single 1/1 windows. The center bay recedes and contains the primary entrance. The gable flares to form a partial-width open porch which shelters the entrance. The porch entrance is arched with decorative limestone. A non-historic single-pane picture window fills the remaining primary elevation bay. A brick exterior chimney pierces the eave at the west elevation while a secondary entrance with a historic metal awning is roughly centered on the east elevation. A c. 1967-1991 shed-roof porch spans the rear elevation.
