1. Survey number: CO-AS-008-001		2. Survey Name: West Main Street Survey	
3. County: Cole		4. Address (Street No.): 100	Street (name): East Circle Drive
5. City: Jefferson City	Vicinity <input type="checkbox"/>	6. Lat / Long:	7. Township/Range/Section: T: R: S:
8. Historic name (if known):		9. Present/other name (if known):	
10. Ownership: <input checked="" type="checkbox"/> Private <input type="checkbox"/> Public		11a. Historic use (if known): Domestic-Single Dwelling	11b. Current use: Domestic-Single Dwelling

MISSOURI DEPARTMENT OF NATURAL RESOURCES
STATE HISTORIC PRESERVATION OFFICE, P.O. Box 178, Jefferson City, MO 65102
ARCHITECTURAL/HISTORIC INVENTORY FORM

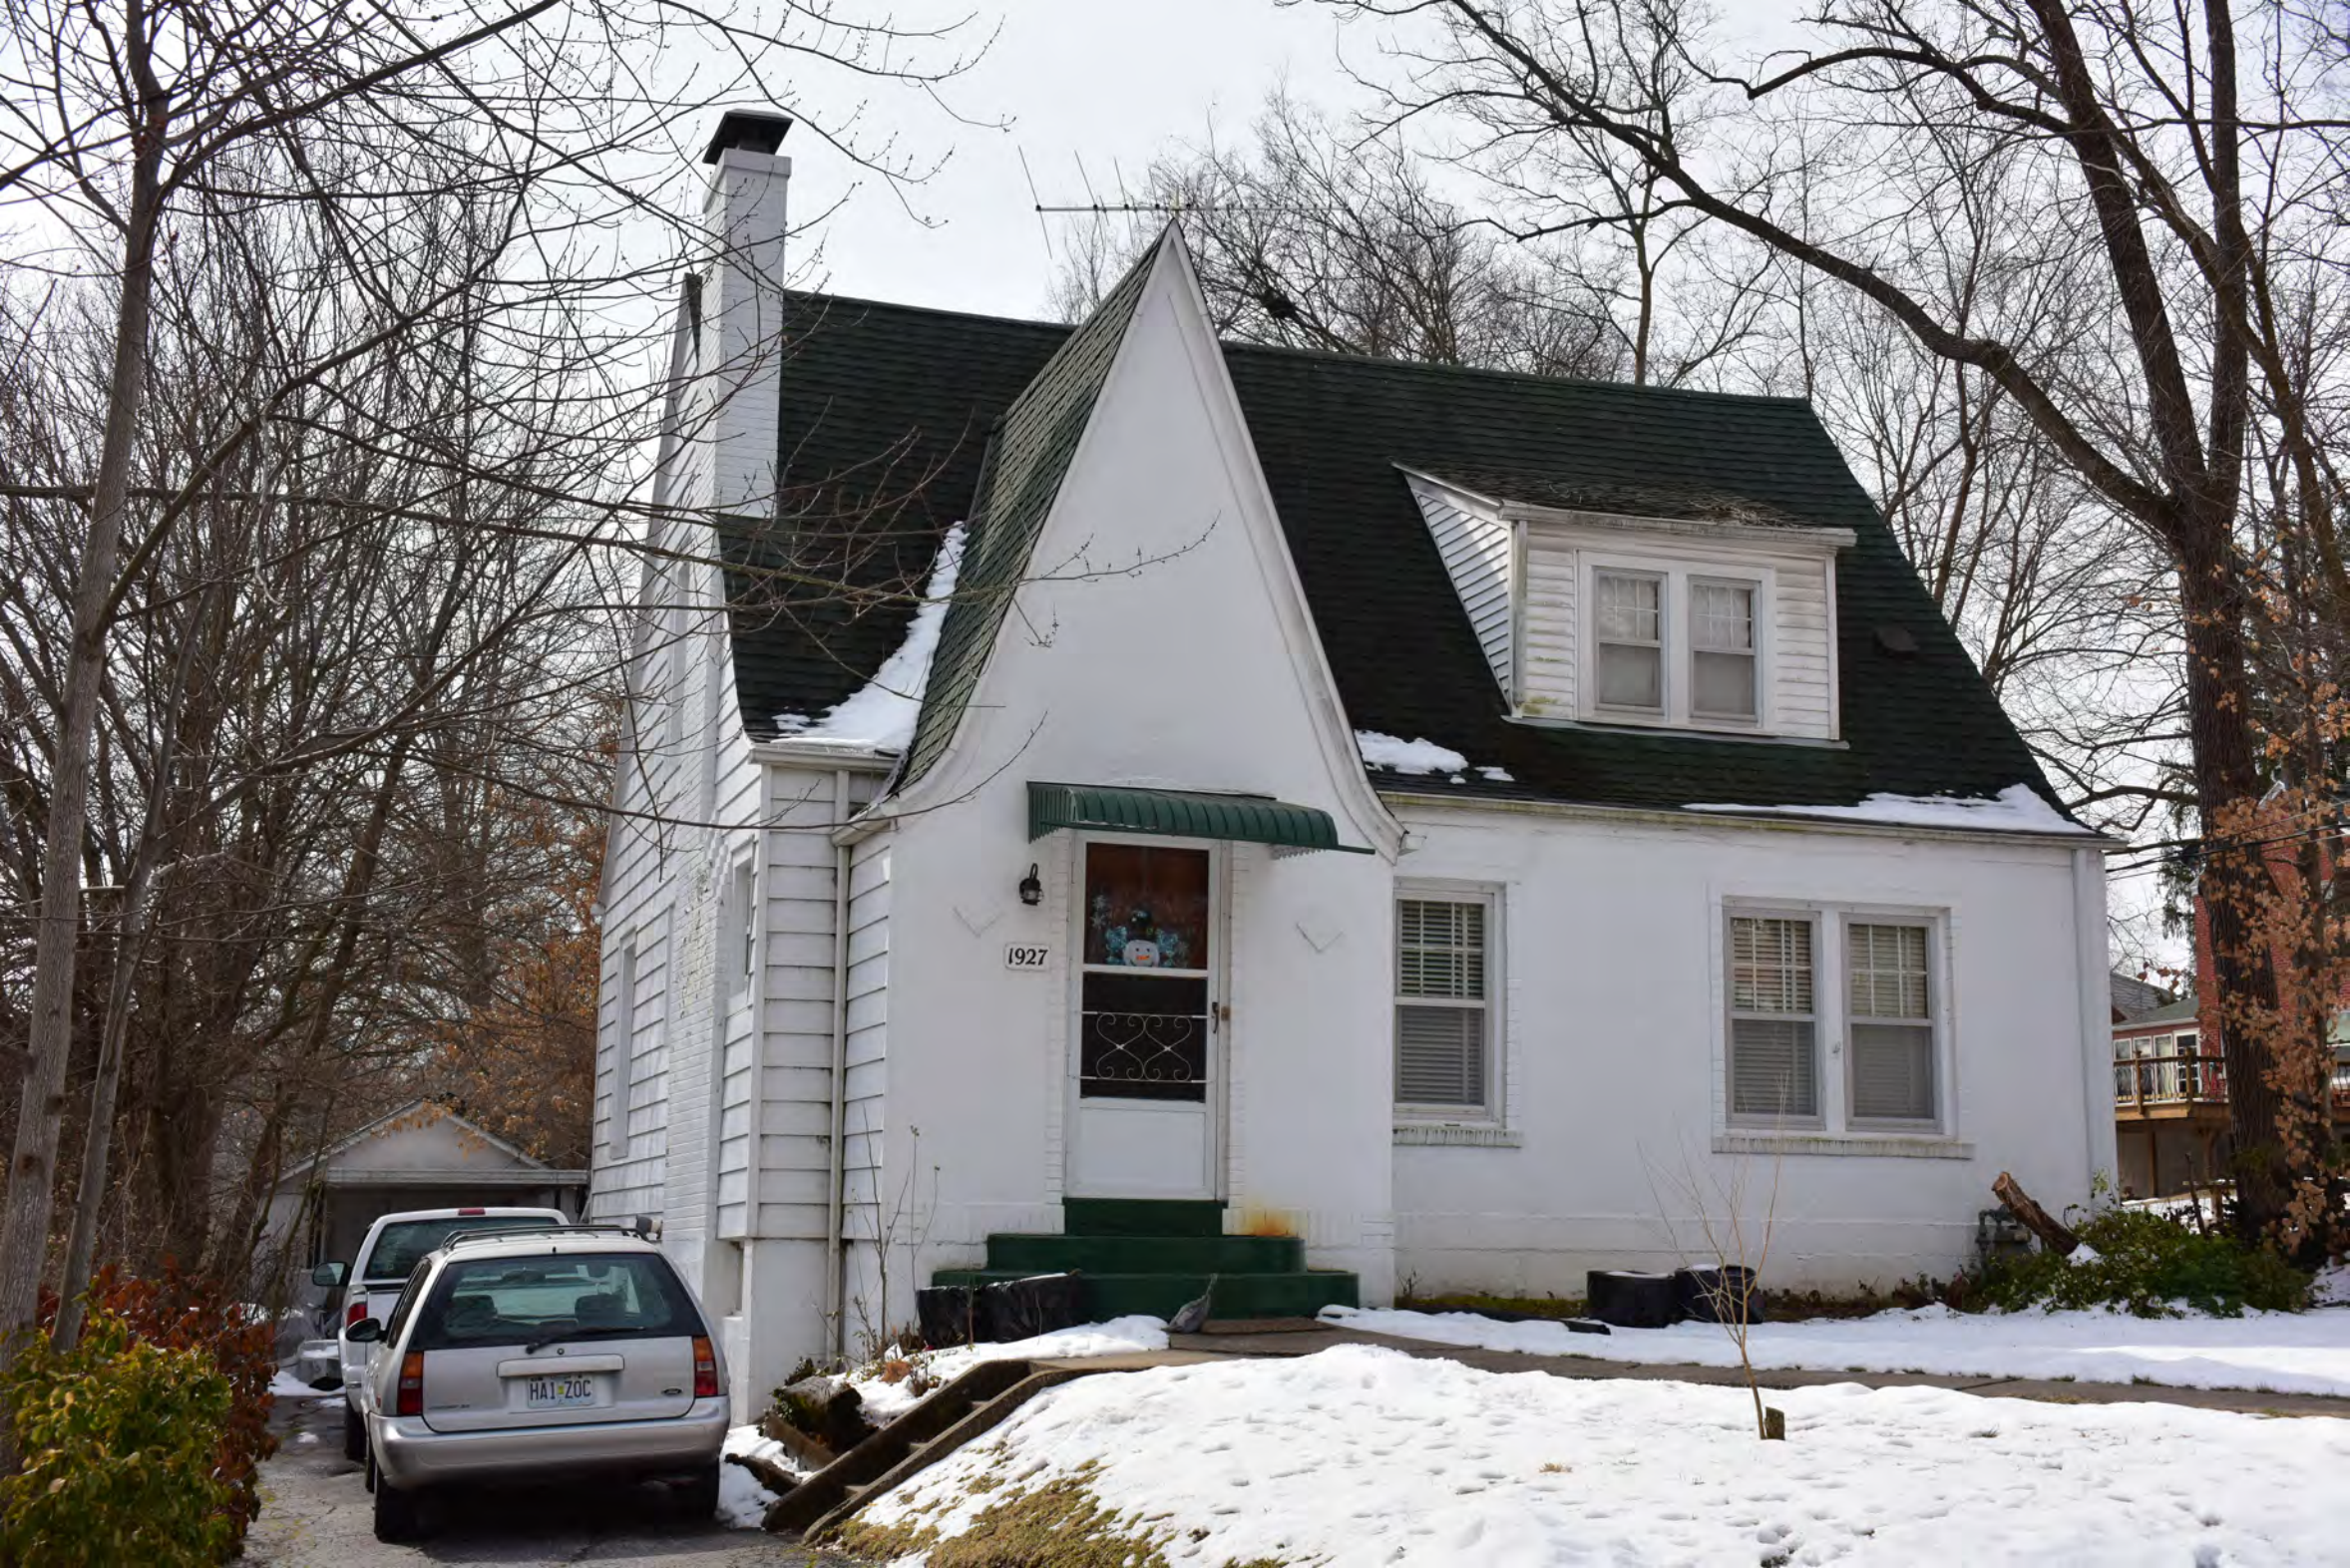
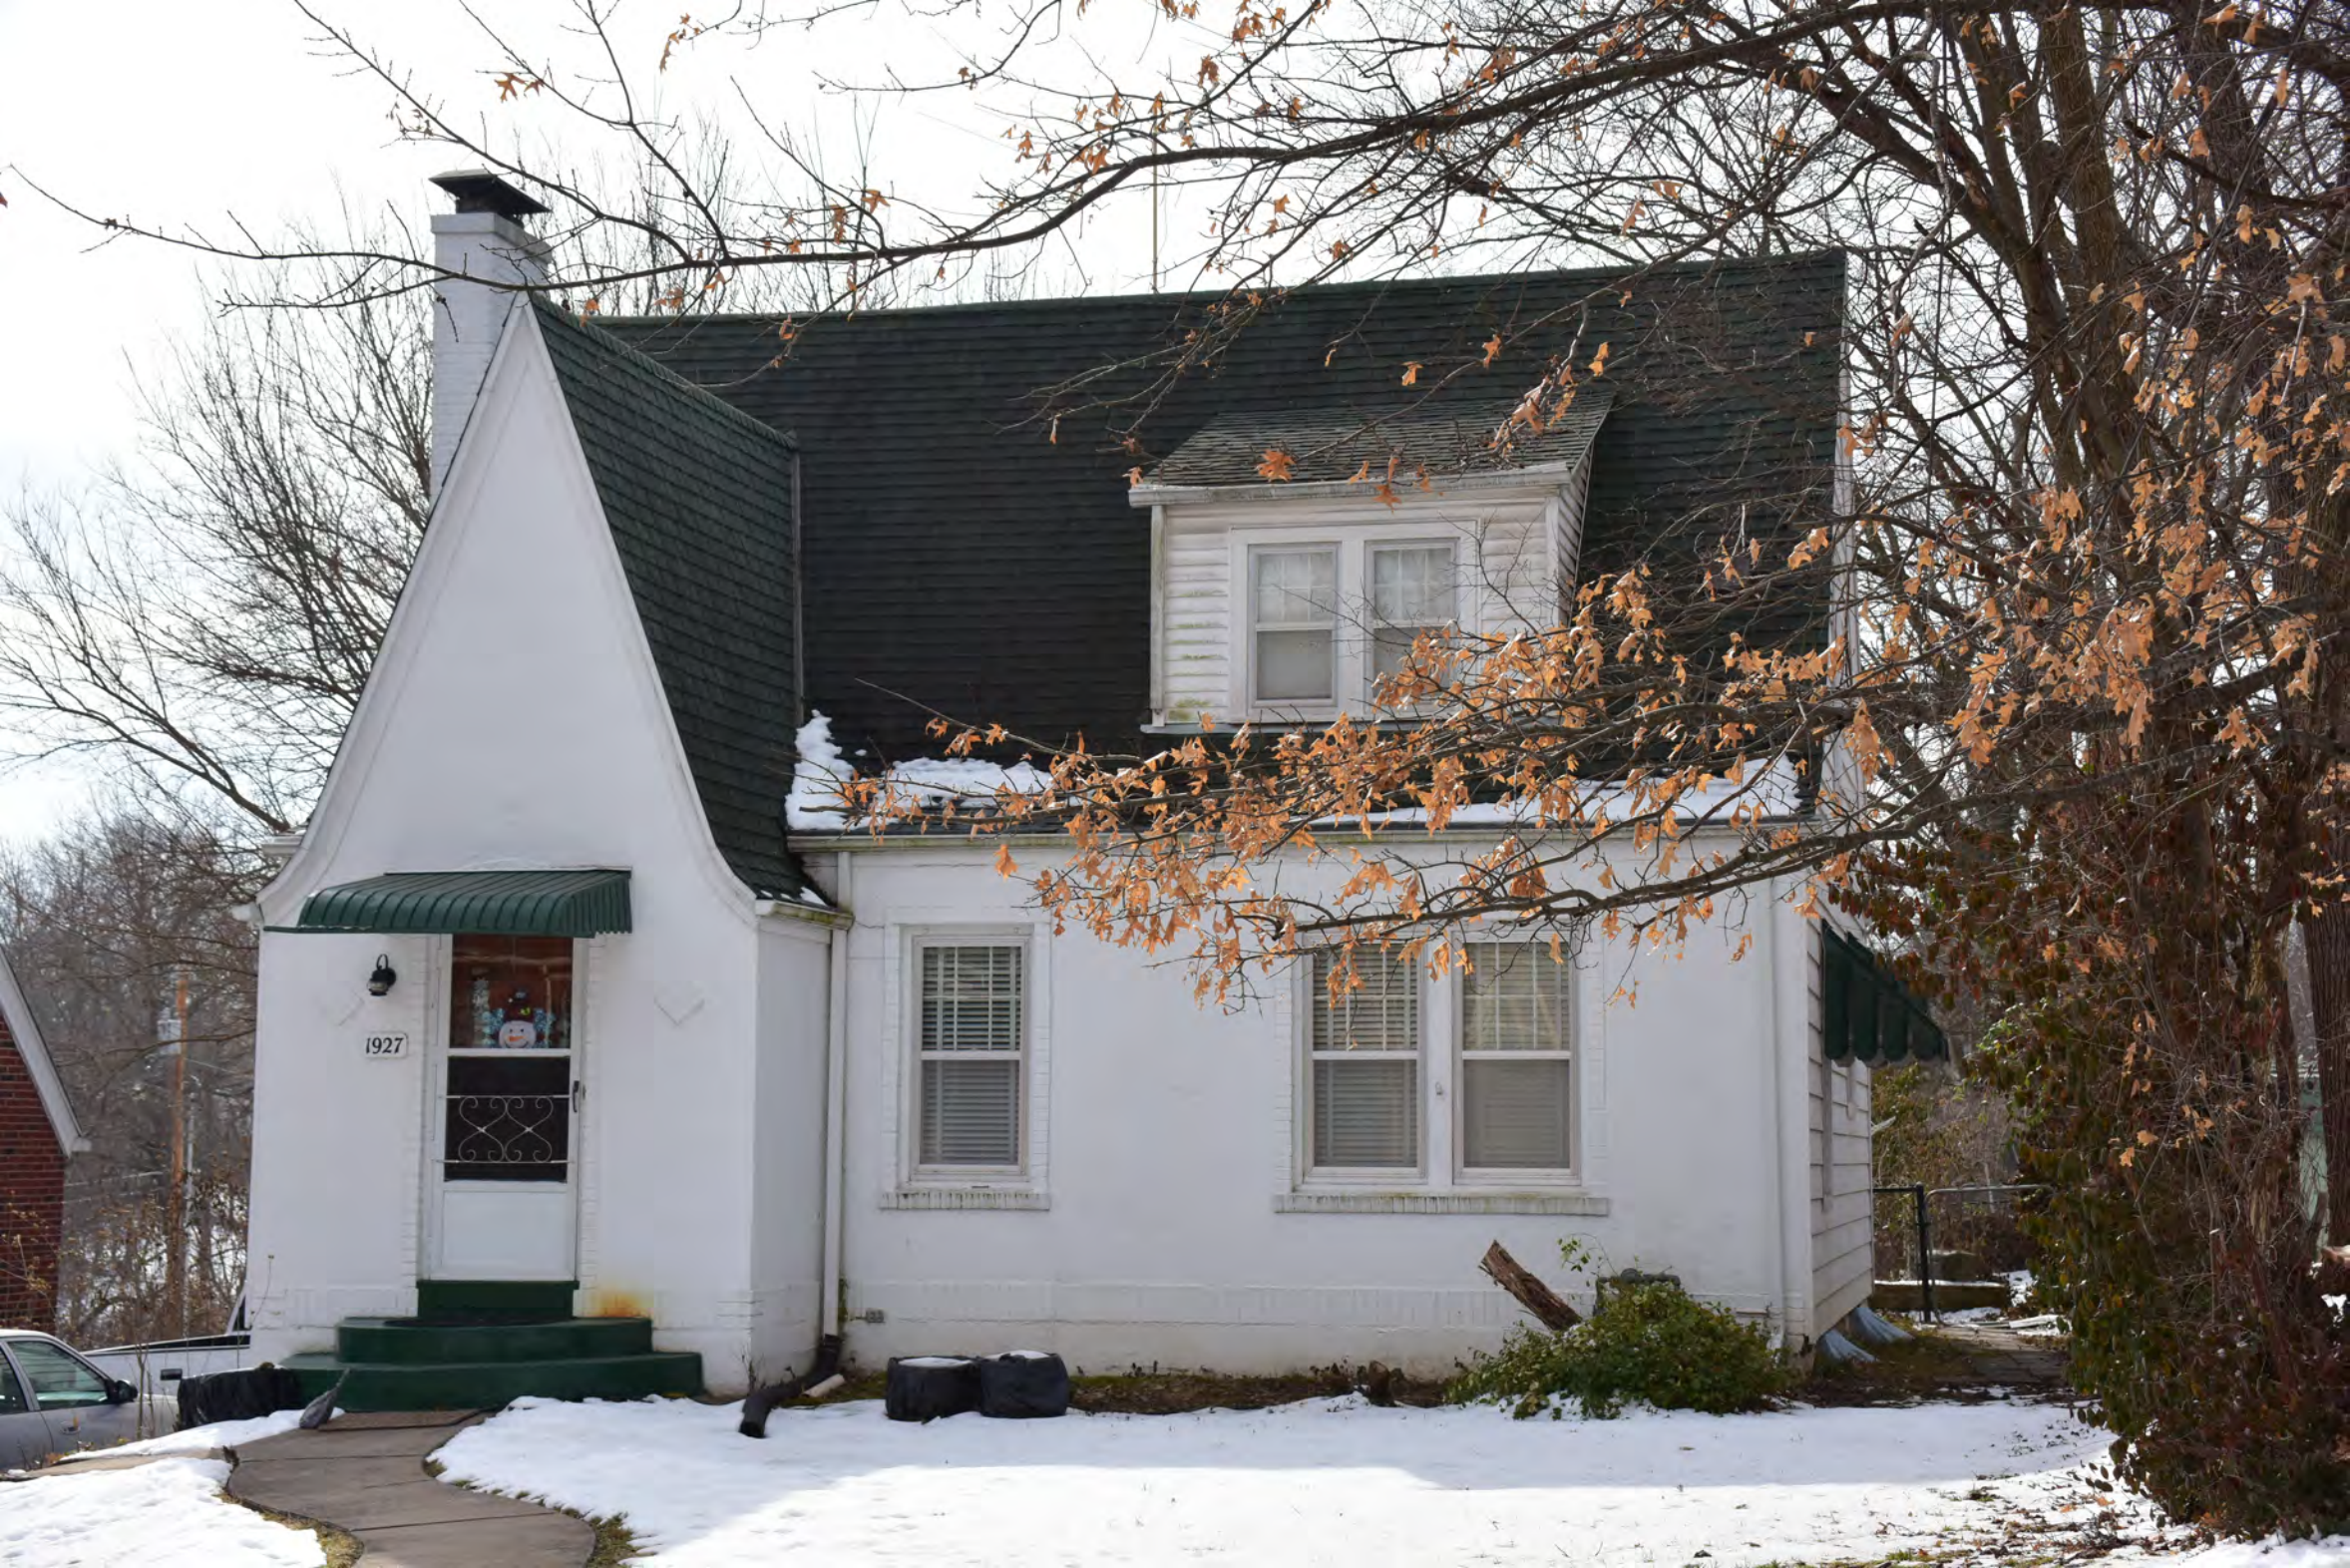
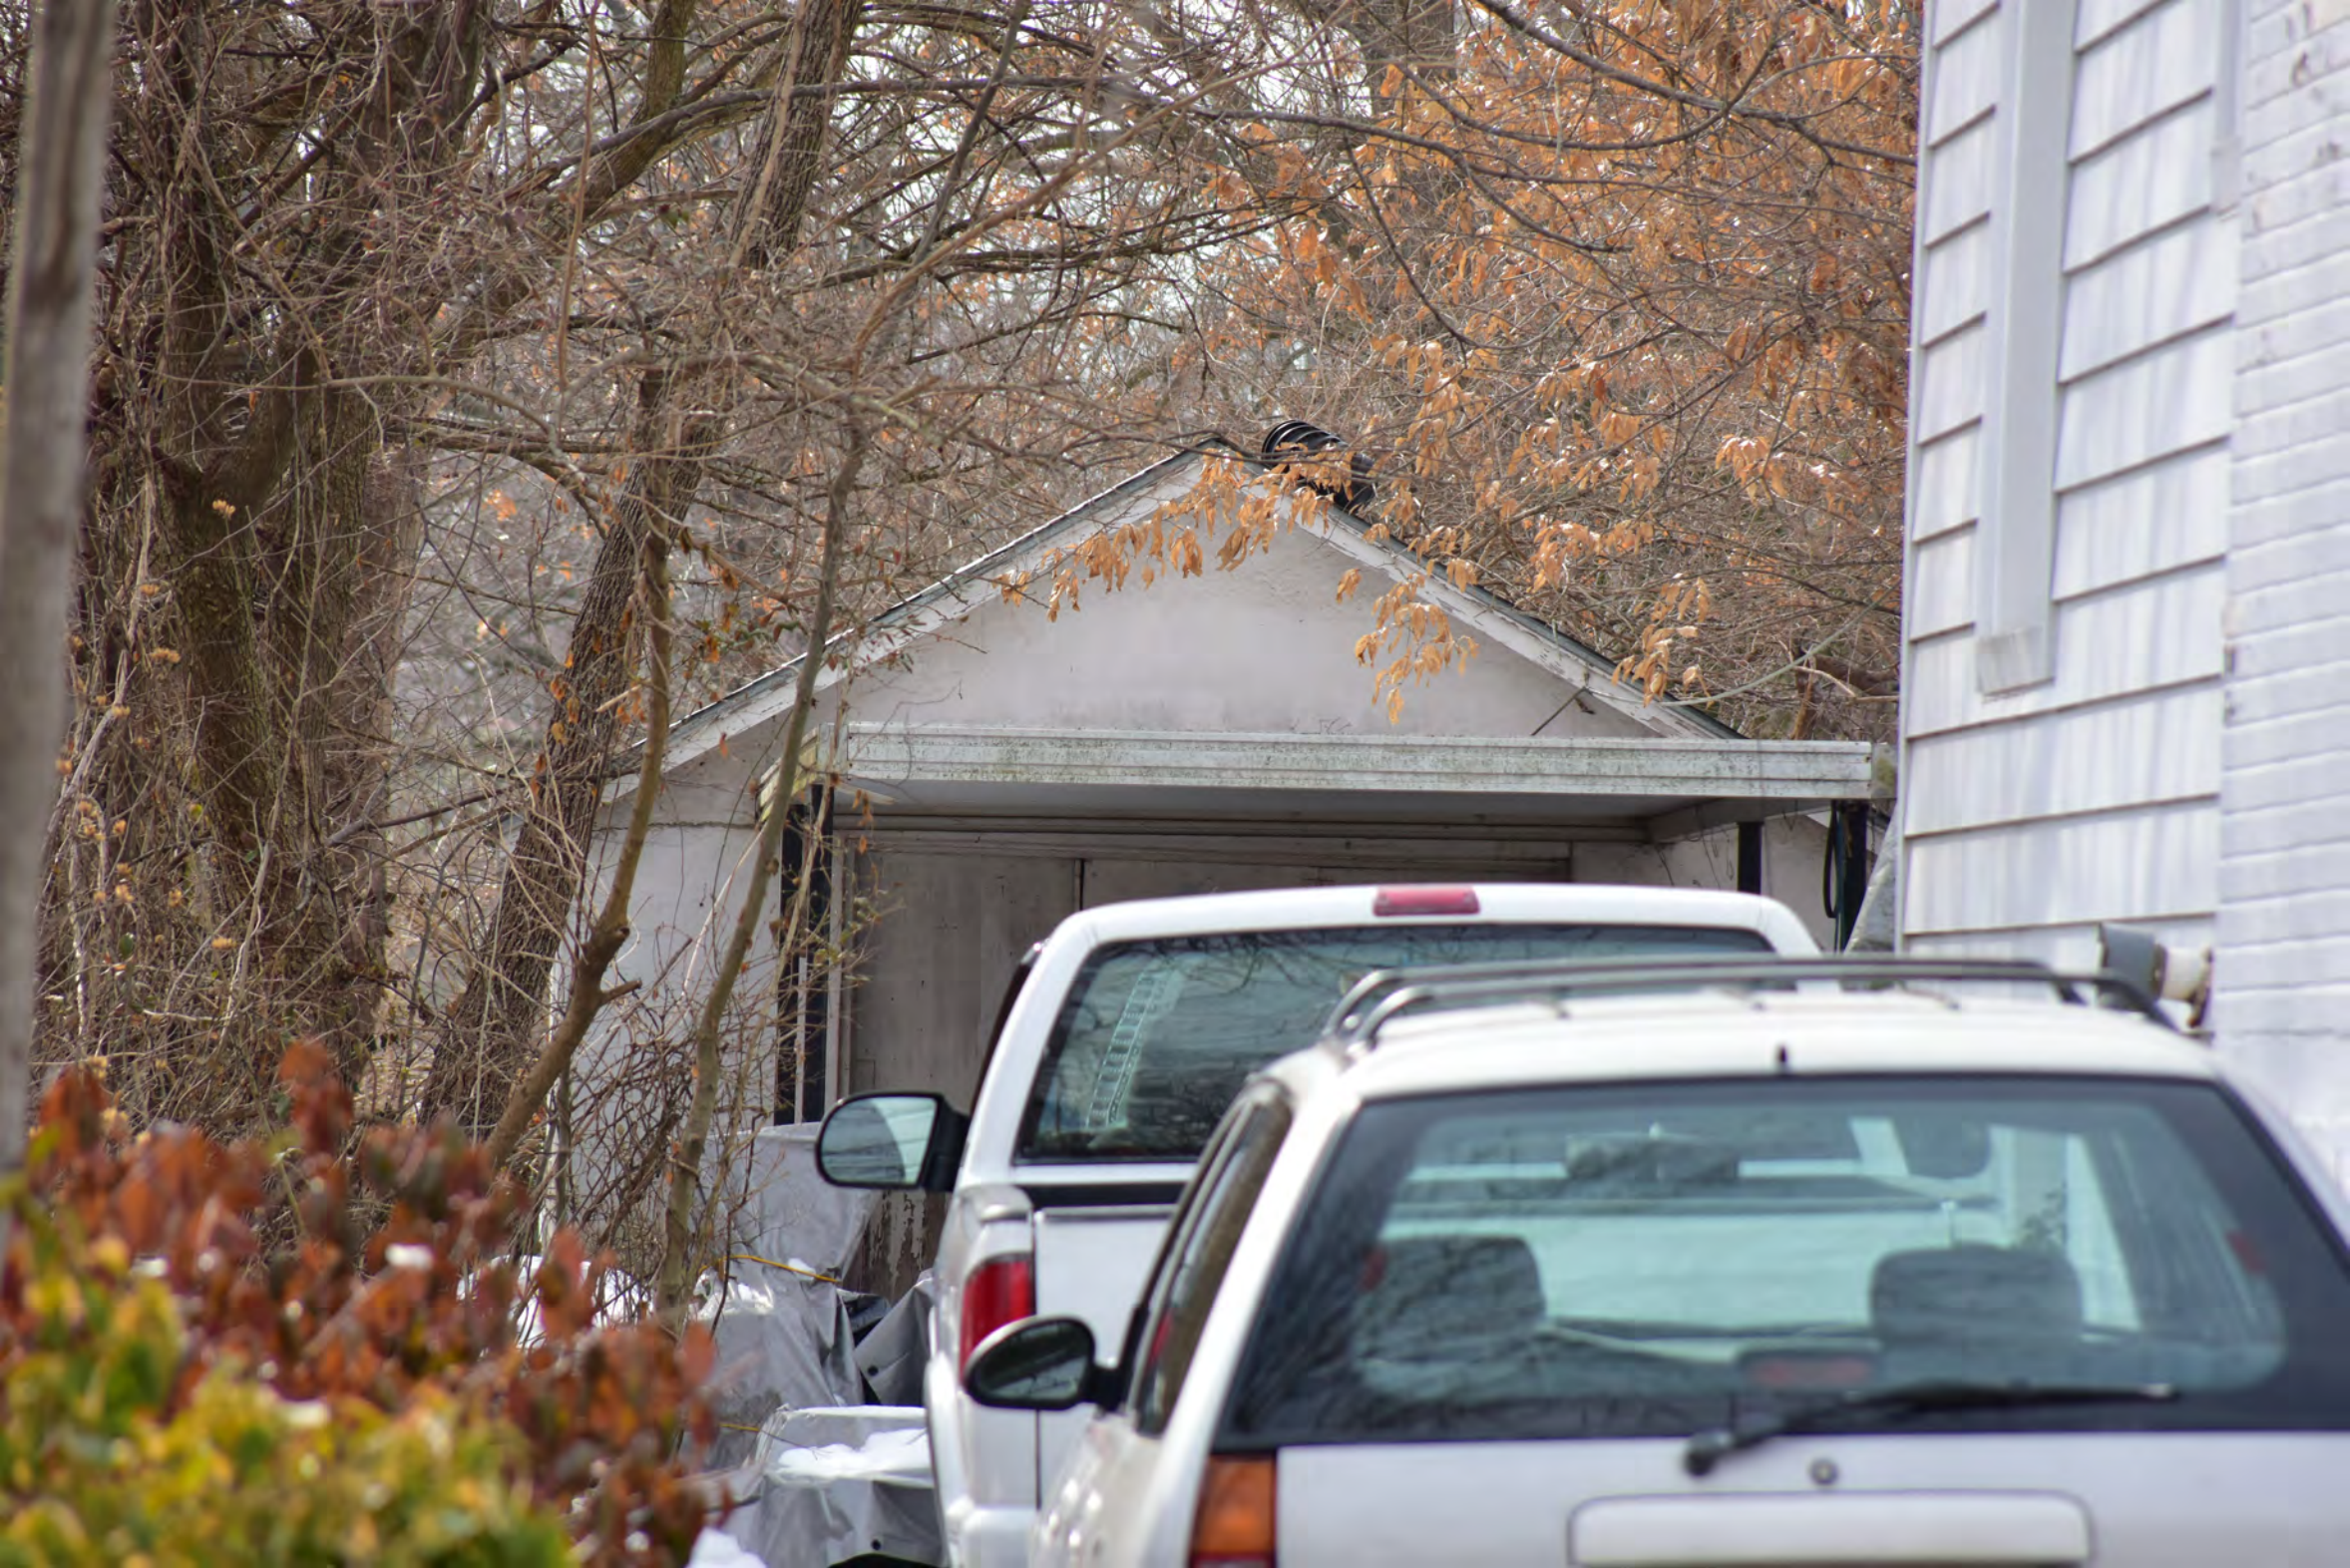
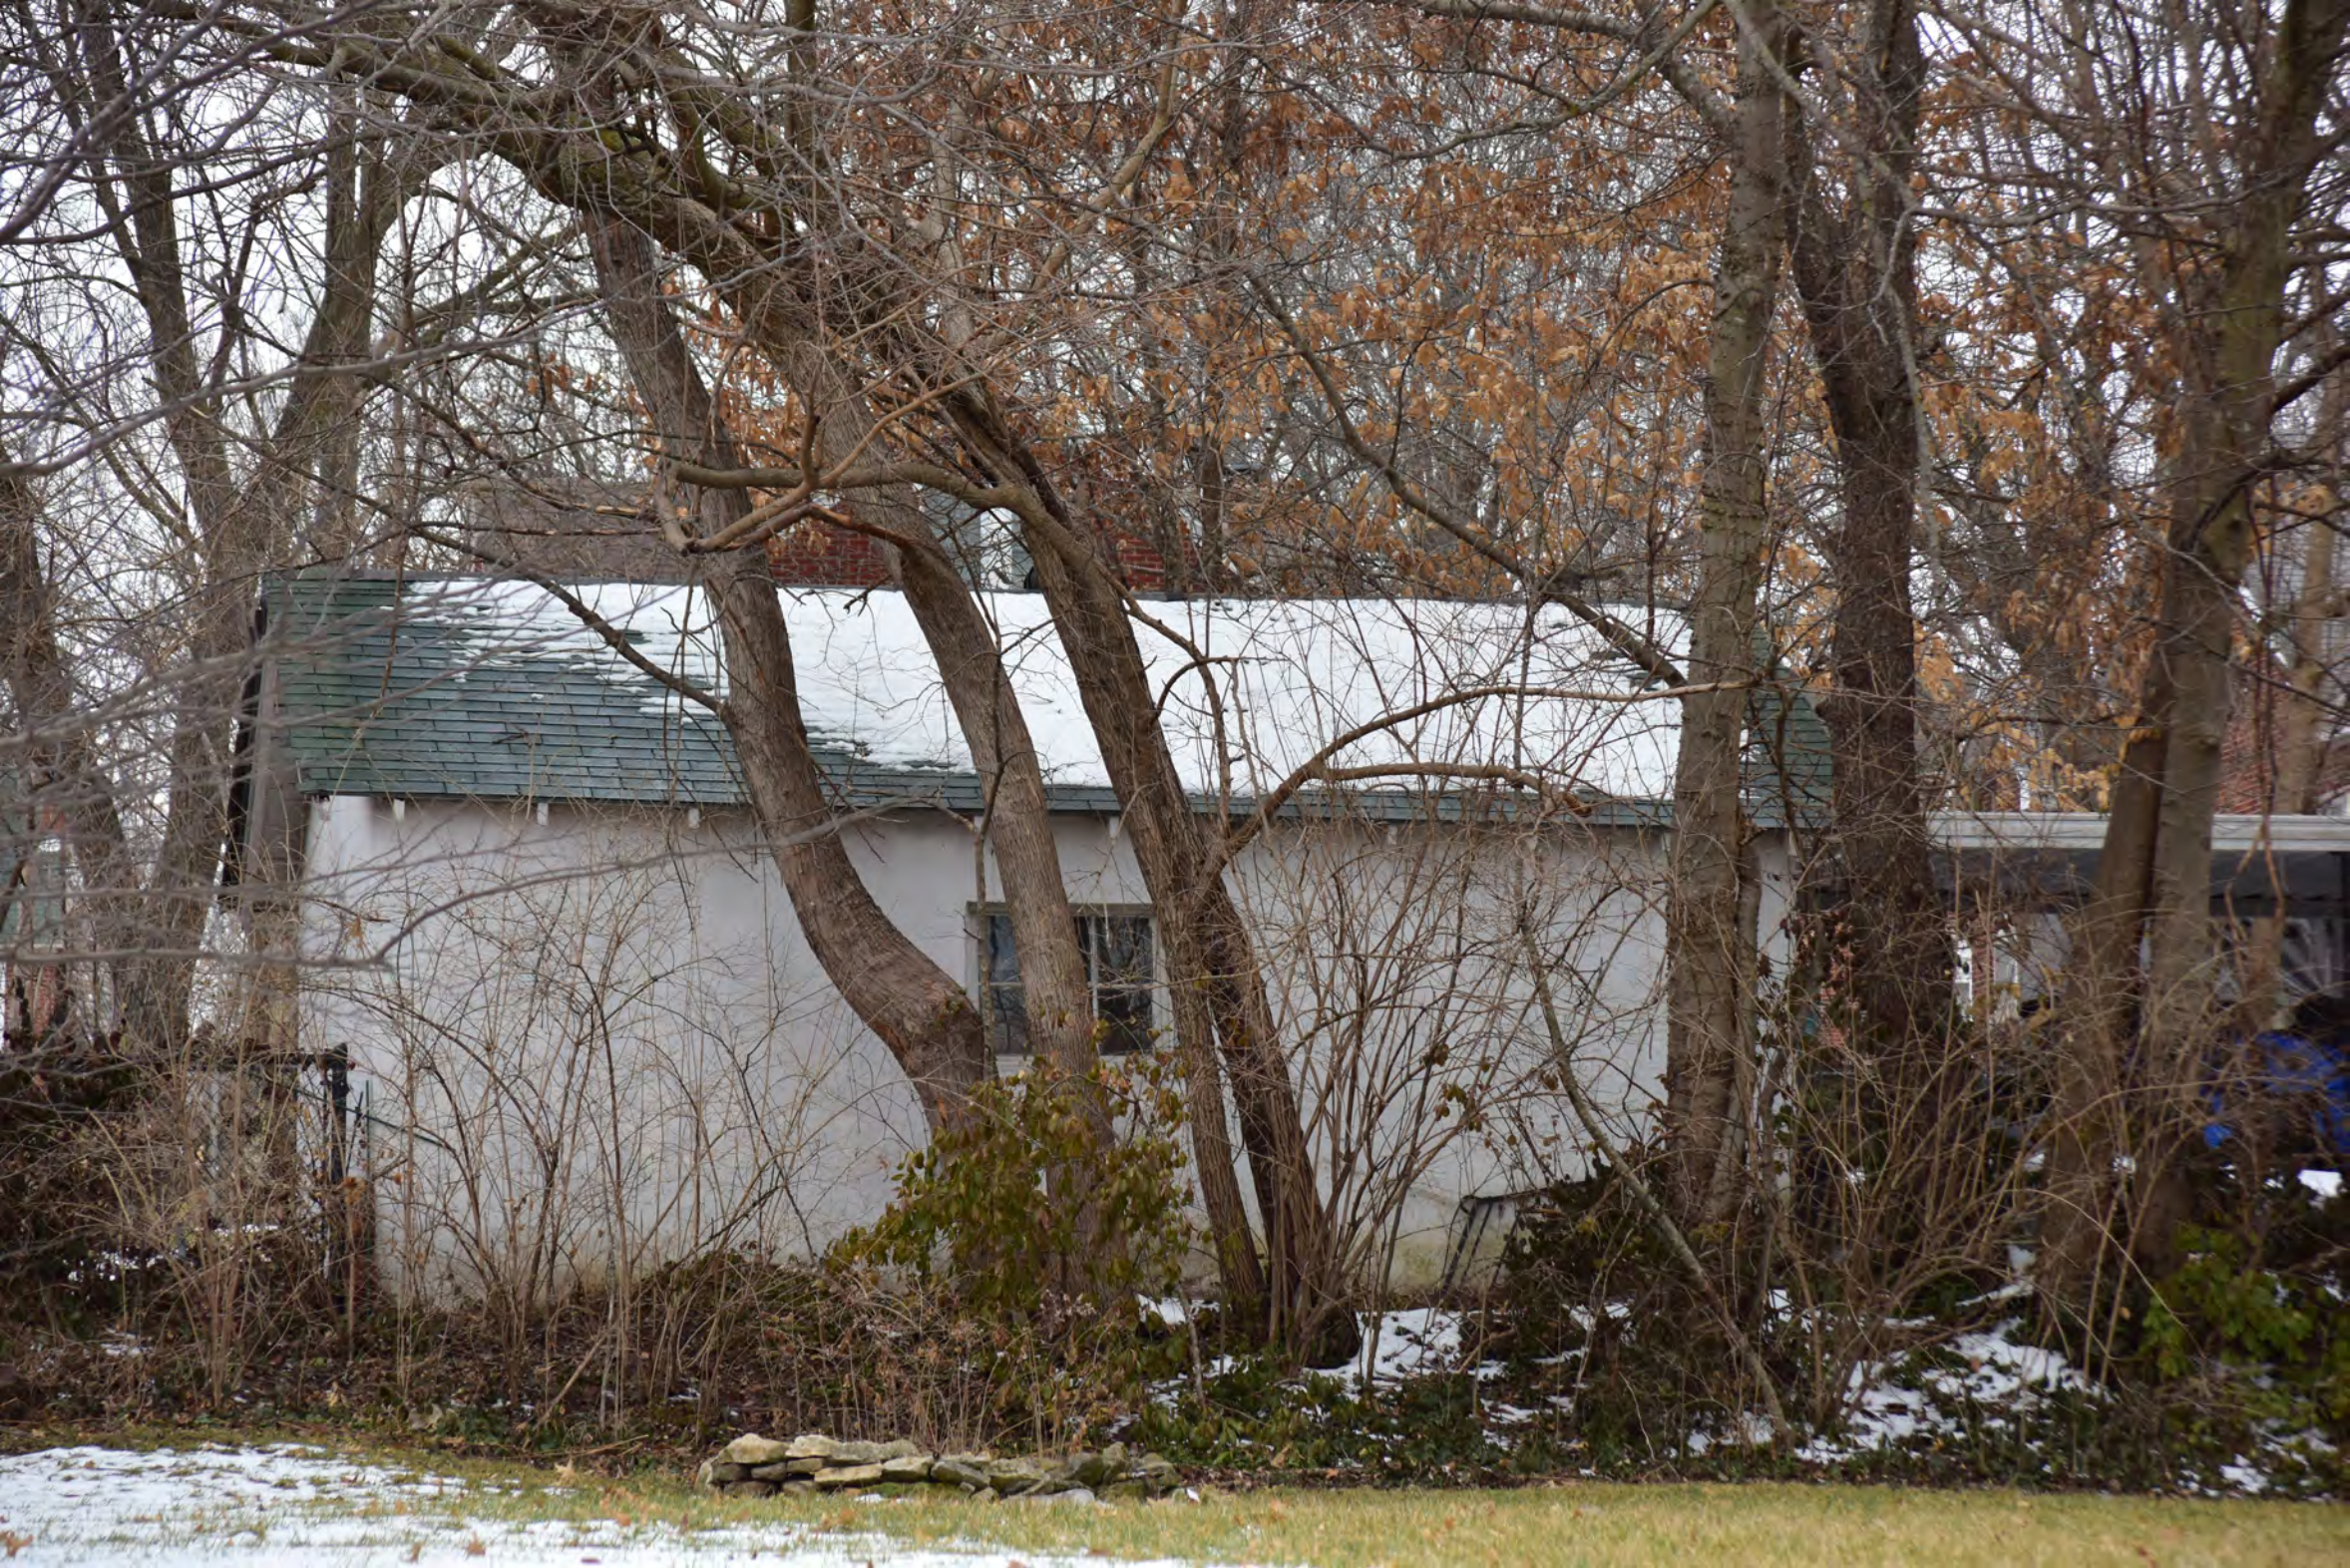
1927 North Circle Drive is a one-and-one-half story dwelling with non-historic stucco and hardboard cladding, a concrete foundation, and intersecting-gable asphalt roof. A brick exterior chimney pierces the west elevation eave. The dwelling is three bays wide. Two-ganged historic 6/1 wood windows with a continuous brick sill fill the west bay while a single historic 6/1 wood window fills the center bay. A shallow gabled-ell with steep pitch projects from the primary elevation. The ell contains a stucco and hardboard-clad vestibule and defines the east bay. The primary entrance is centered in the vestibule and contains an historic wood door with glazing. Soldier brick lines the arched doorway and small diamond embellishments flank the opening. A concrete stoop extends from the entrance and a non-historic metal awning shelters the stop. A shed-roof dormer punctures the roof immediately west of the intersecting gable. The dormer contains two historic 6/1 wood windows.

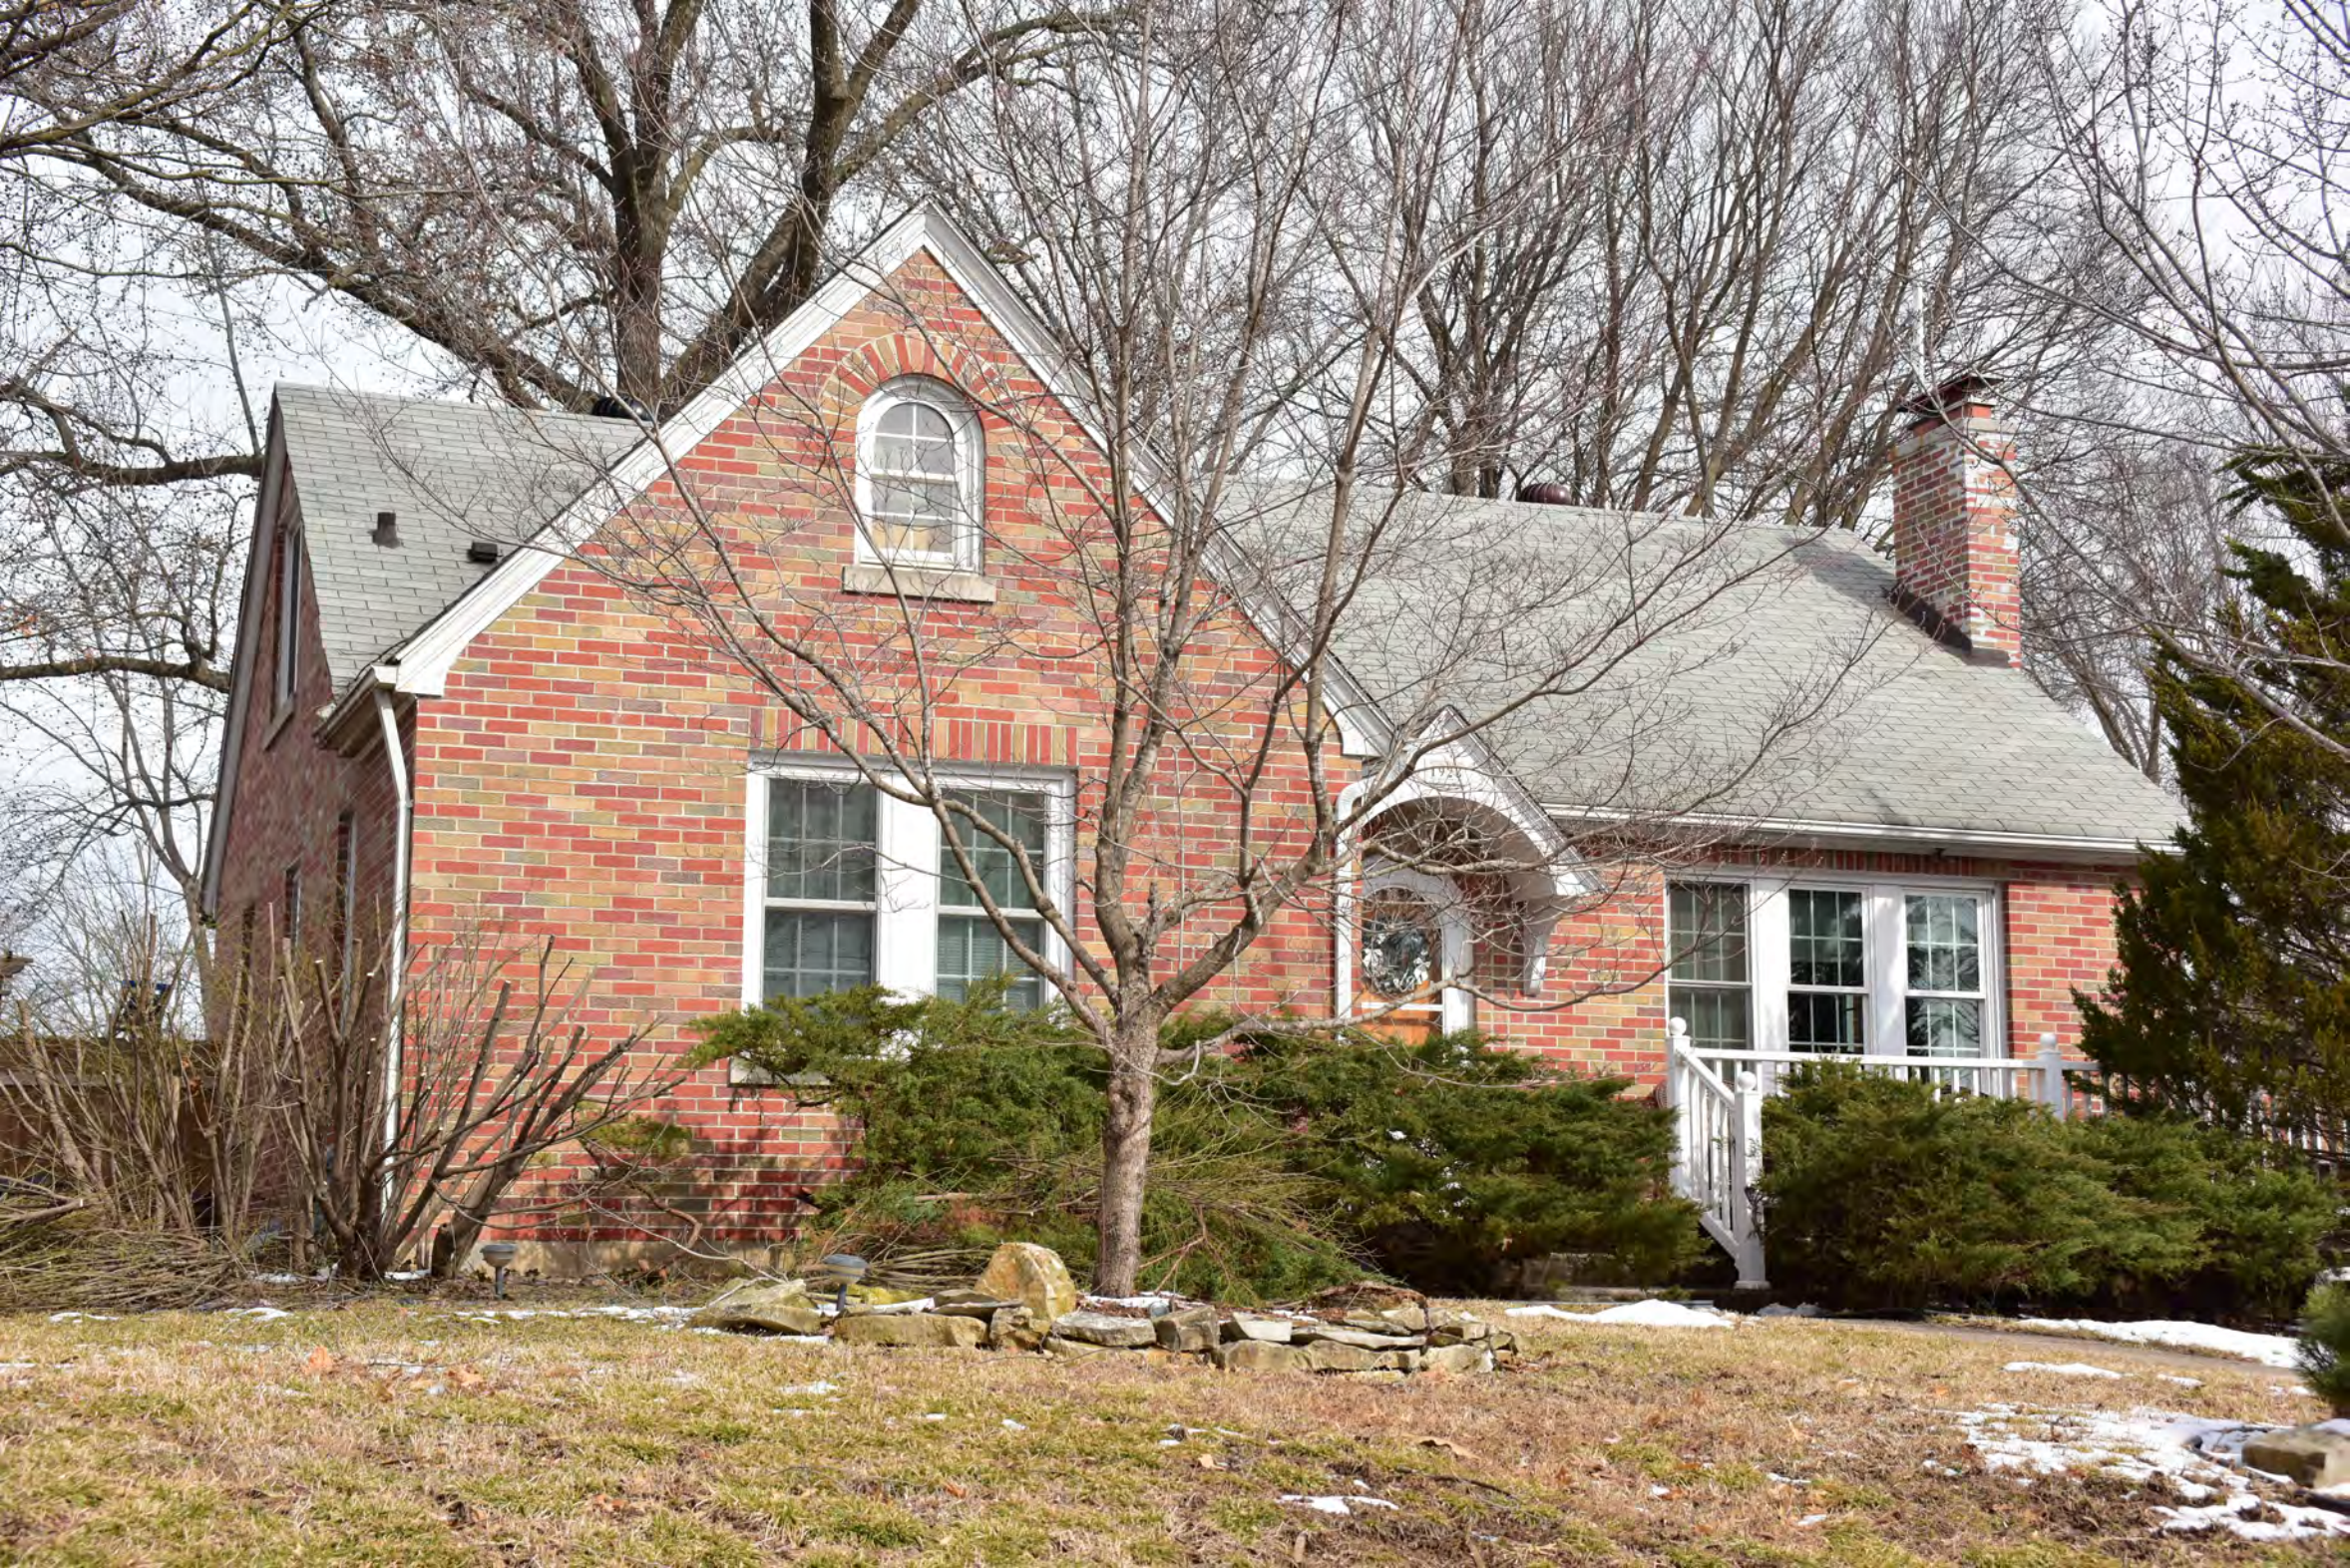
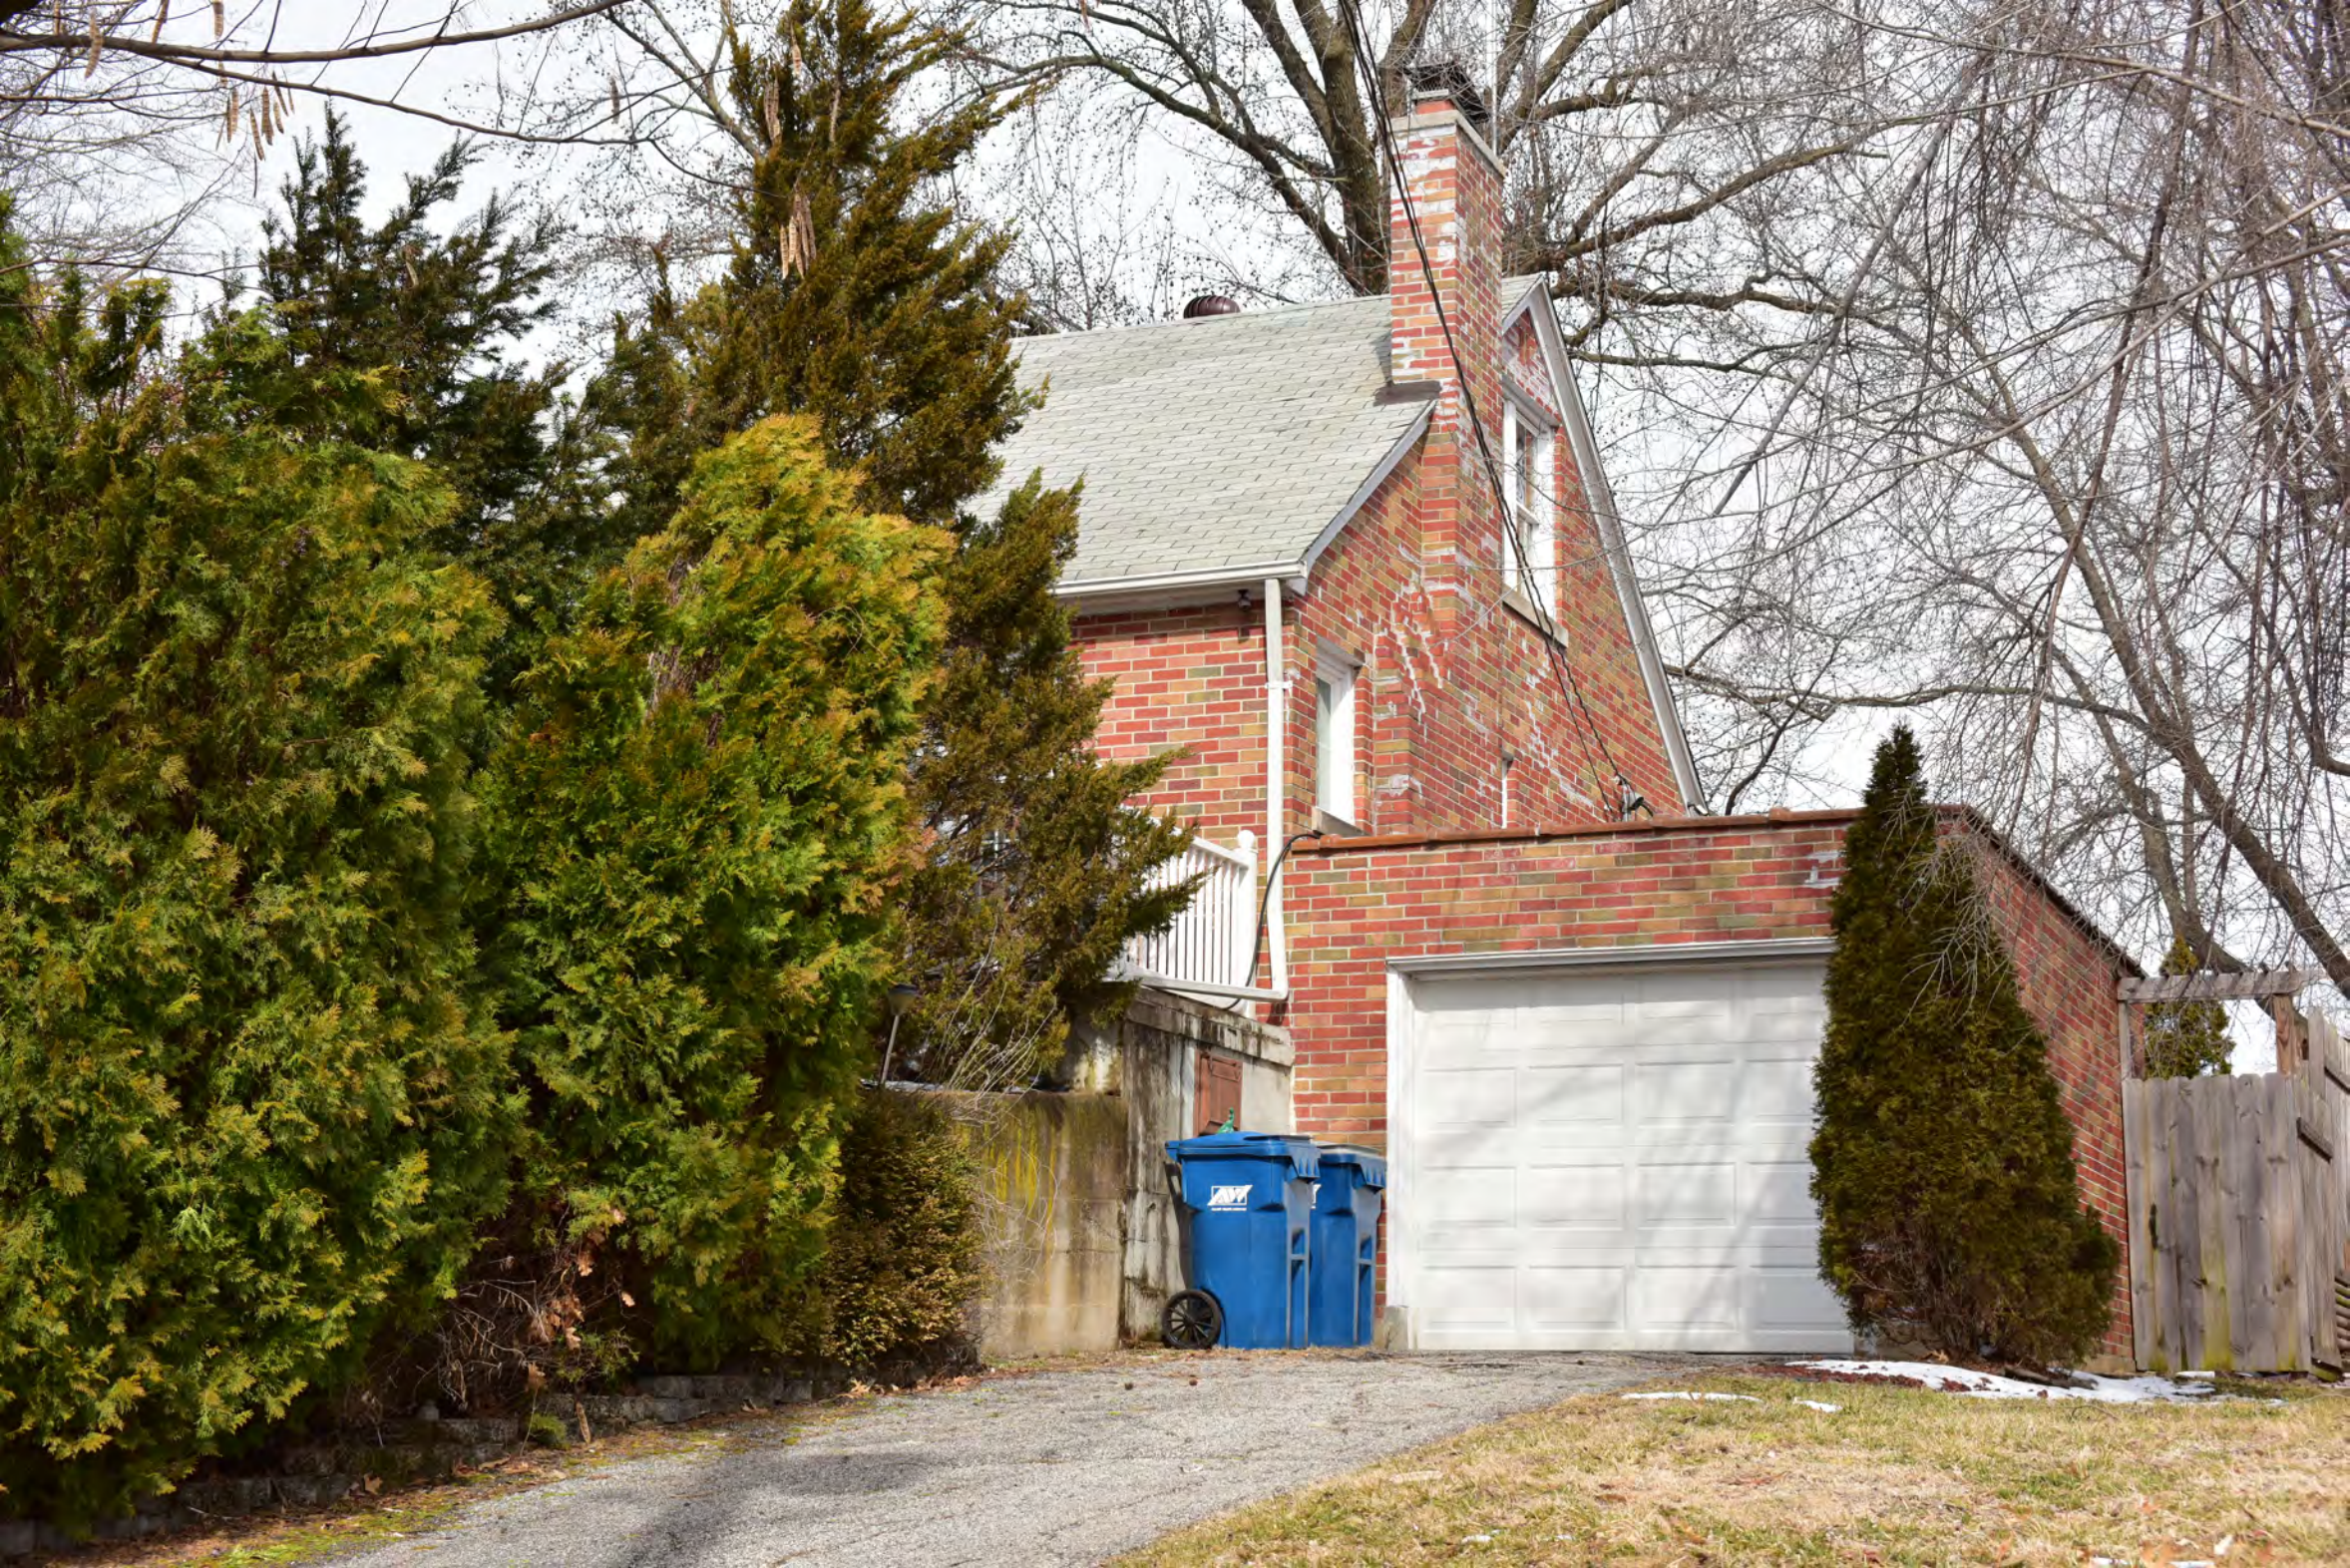
Alterations to 1928 North Circle Drive include the replacement of historic windows. While the windows are replacements, they fill historic openings and are complimentary in style. 1928 North Circle Drive retains good integrity and would be contributing to the potential Walinko Place Historic District, significant in the areas of Architecture and Community Planning and Development in association with the expansion of Jefferson City and increased suburban development during the twentieth century as well as its associations with Walinko Place, a notable suburban development during the Depression and War Years.

1928 North Circle Drive is a one-story Minimal Traditional brick dwelling with an intersecting gable asphalt roof and concrete foundation. A gable-front ell extends from the west end of the primary elevation and contains the west bay. Two-ganged non-historic 6/6 vinyl windows with a continuous cast stone sill and brick lintel fill the bay. A non-historic 4/4 arched window with cast stone sill is centered above the bay in the gable apex. The center and east bays recede. The center bay contains the primary entrance. A historic wood door fills the arched opening. A gable with knee-brackets shelters the entrance. Three-ganged non-historic 6/6 vinyl windows fill the last bay. A partial-width open porch extends beneath the center and east bays. A brick exterior chimney pierces the eave at the east elevation between the dwelling and an attached one-story single-car garage. The garage has matching brick cladding and a flat roof with metal coping. A non-historic overhead door fills the vehicular bay. Aerial images indicate the presence of a partial-width porch at the rear elevation, however this is not visible from the right of way.
