1. Survey number: CO-AS-008-001		2. Survey Name: West Main Street Survey	
3. County: Cole		4. Address (Street No.): 100	Street (name): East Circle Drive
5. City: Jefferson City	Vicinity <input type="checkbox"/>	6. Lat / Long:	7. Township/Range/Section: T: R: S:
8. Historic name (if known):		9. Present/other name (if known):	
10. Ownership: <input checked="" type="checkbox"/> Private <input type="checkbox"/> Public		11a. Historic use (if known): Domestic-Single Dwelling	11b. Current use: Domestic-Single Dwelling

MISSOURI DEPARTMENT OF NATURAL RESOURCES
STATE HISTORIC PRESERVATION OFFICE, P.O. Box 178, Jefferson City, MO 65102
ARCHITECTURAL/HISTORIC INVENTORY FORM

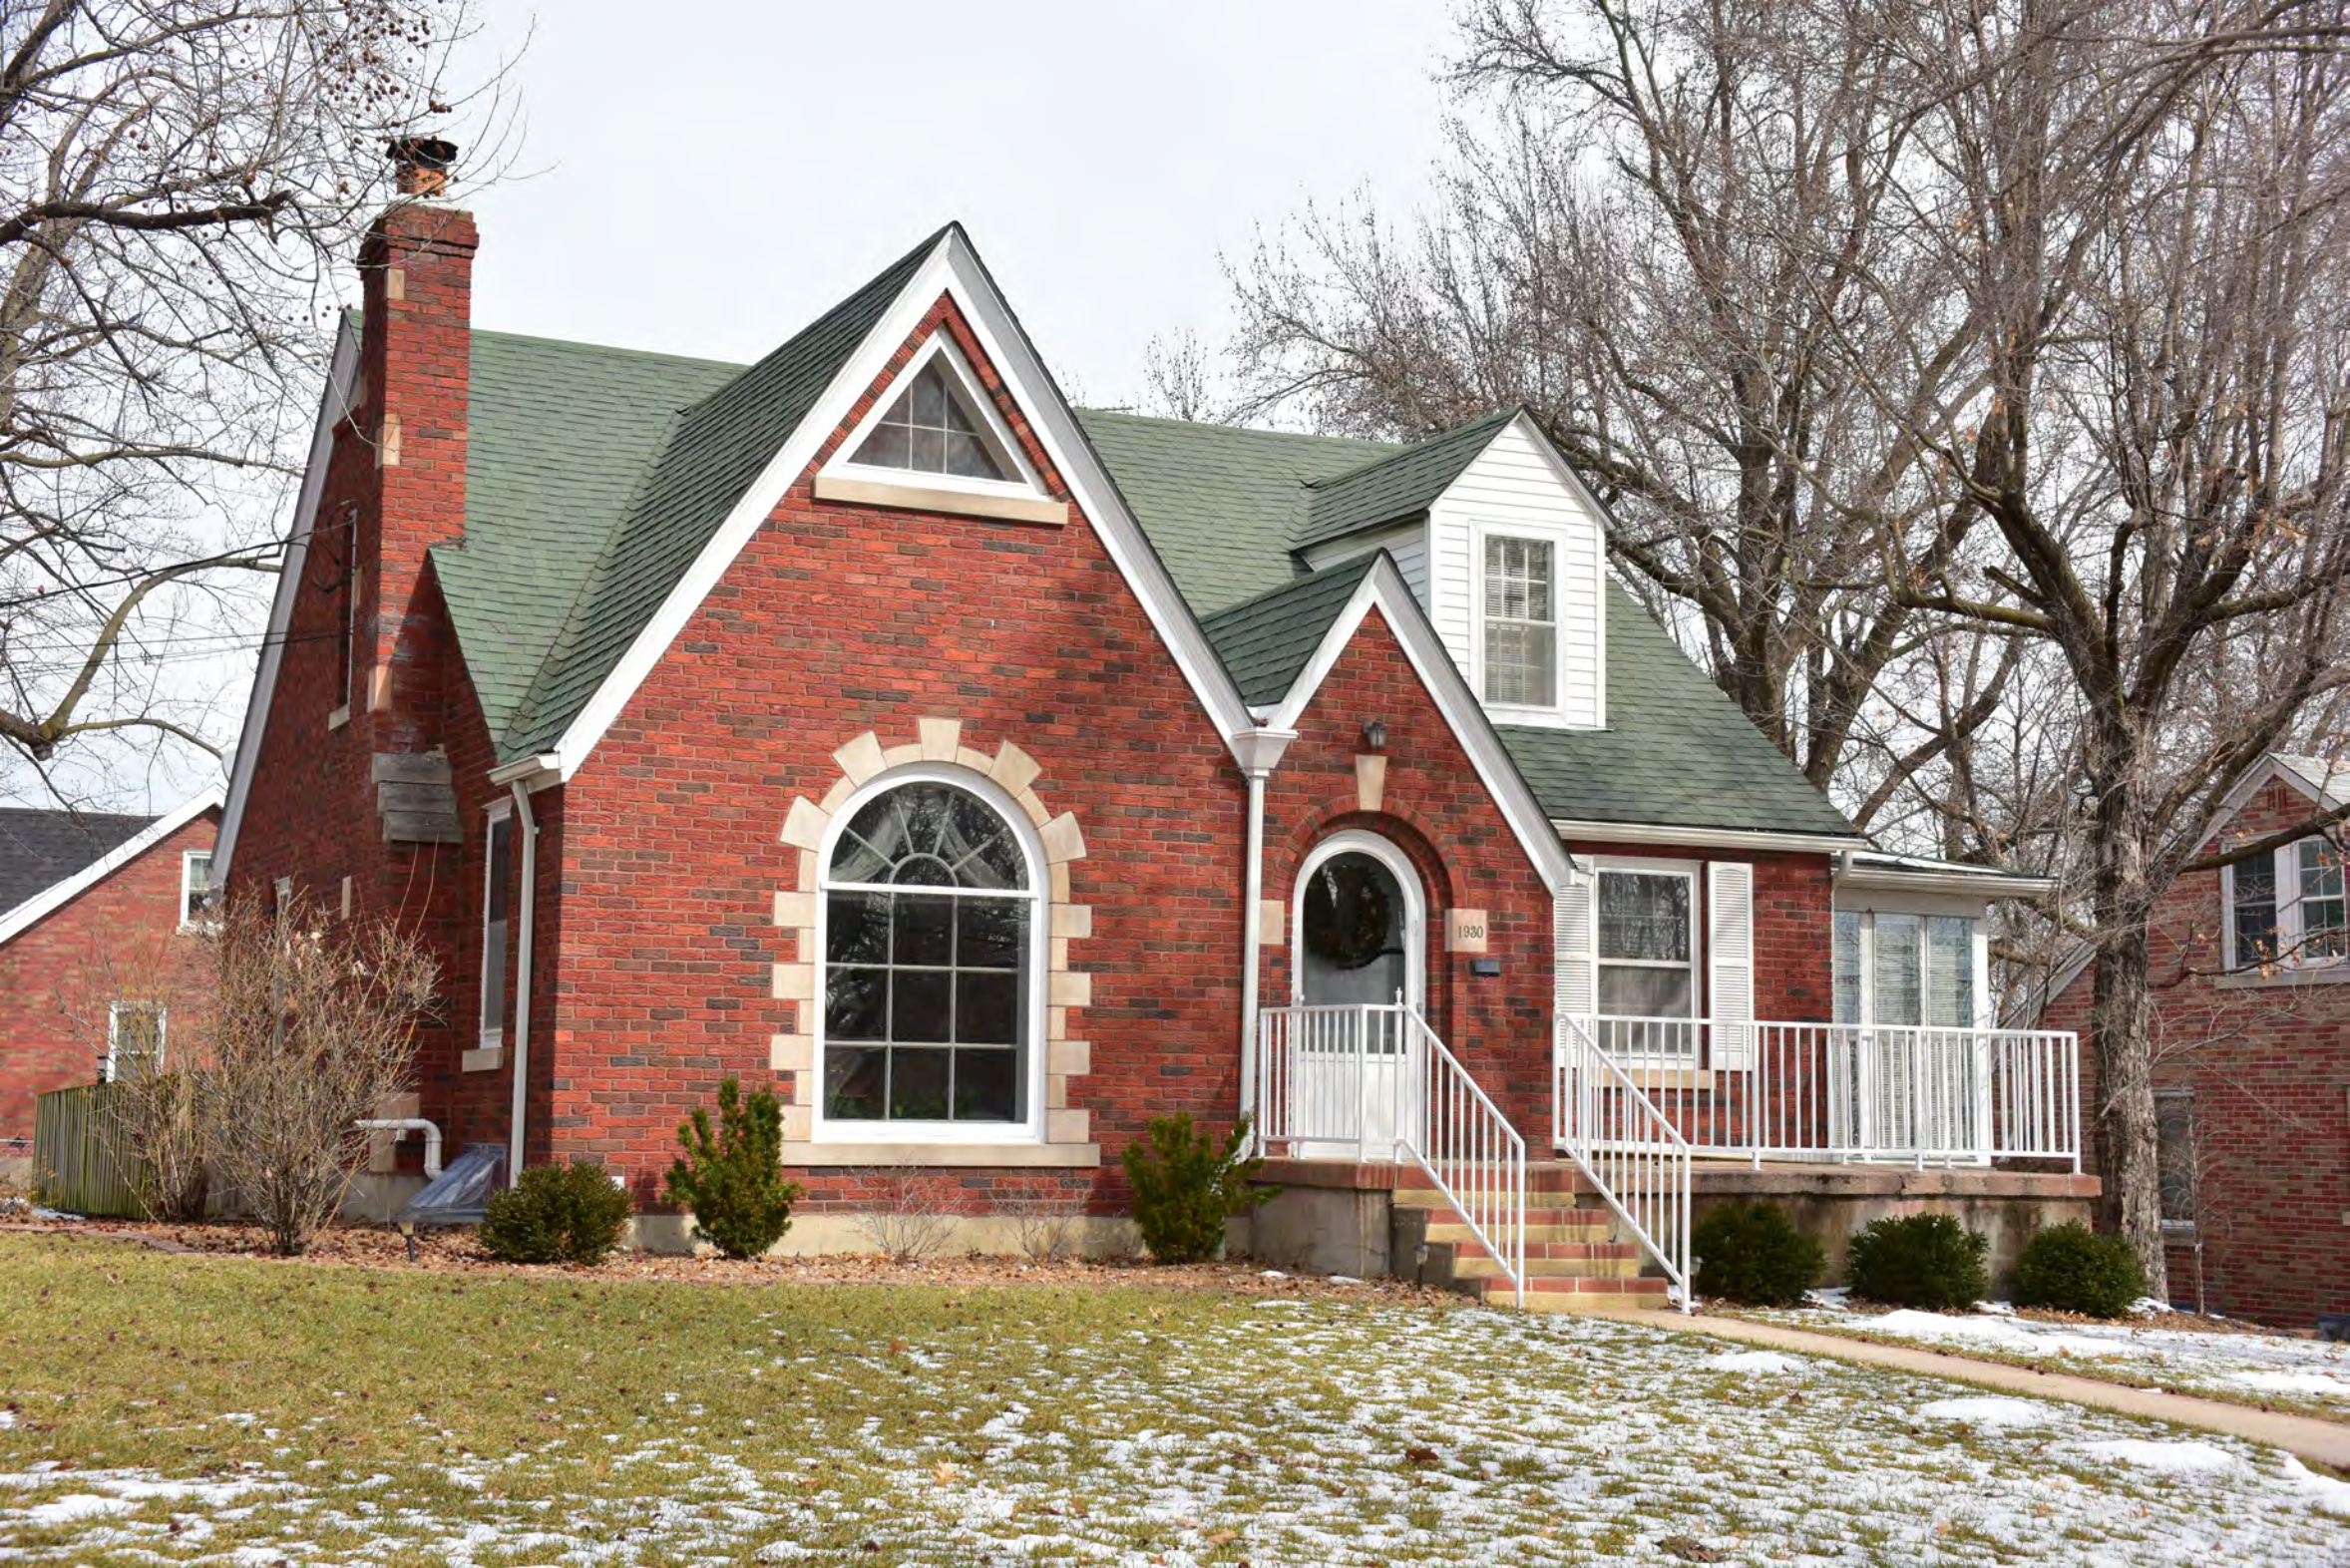
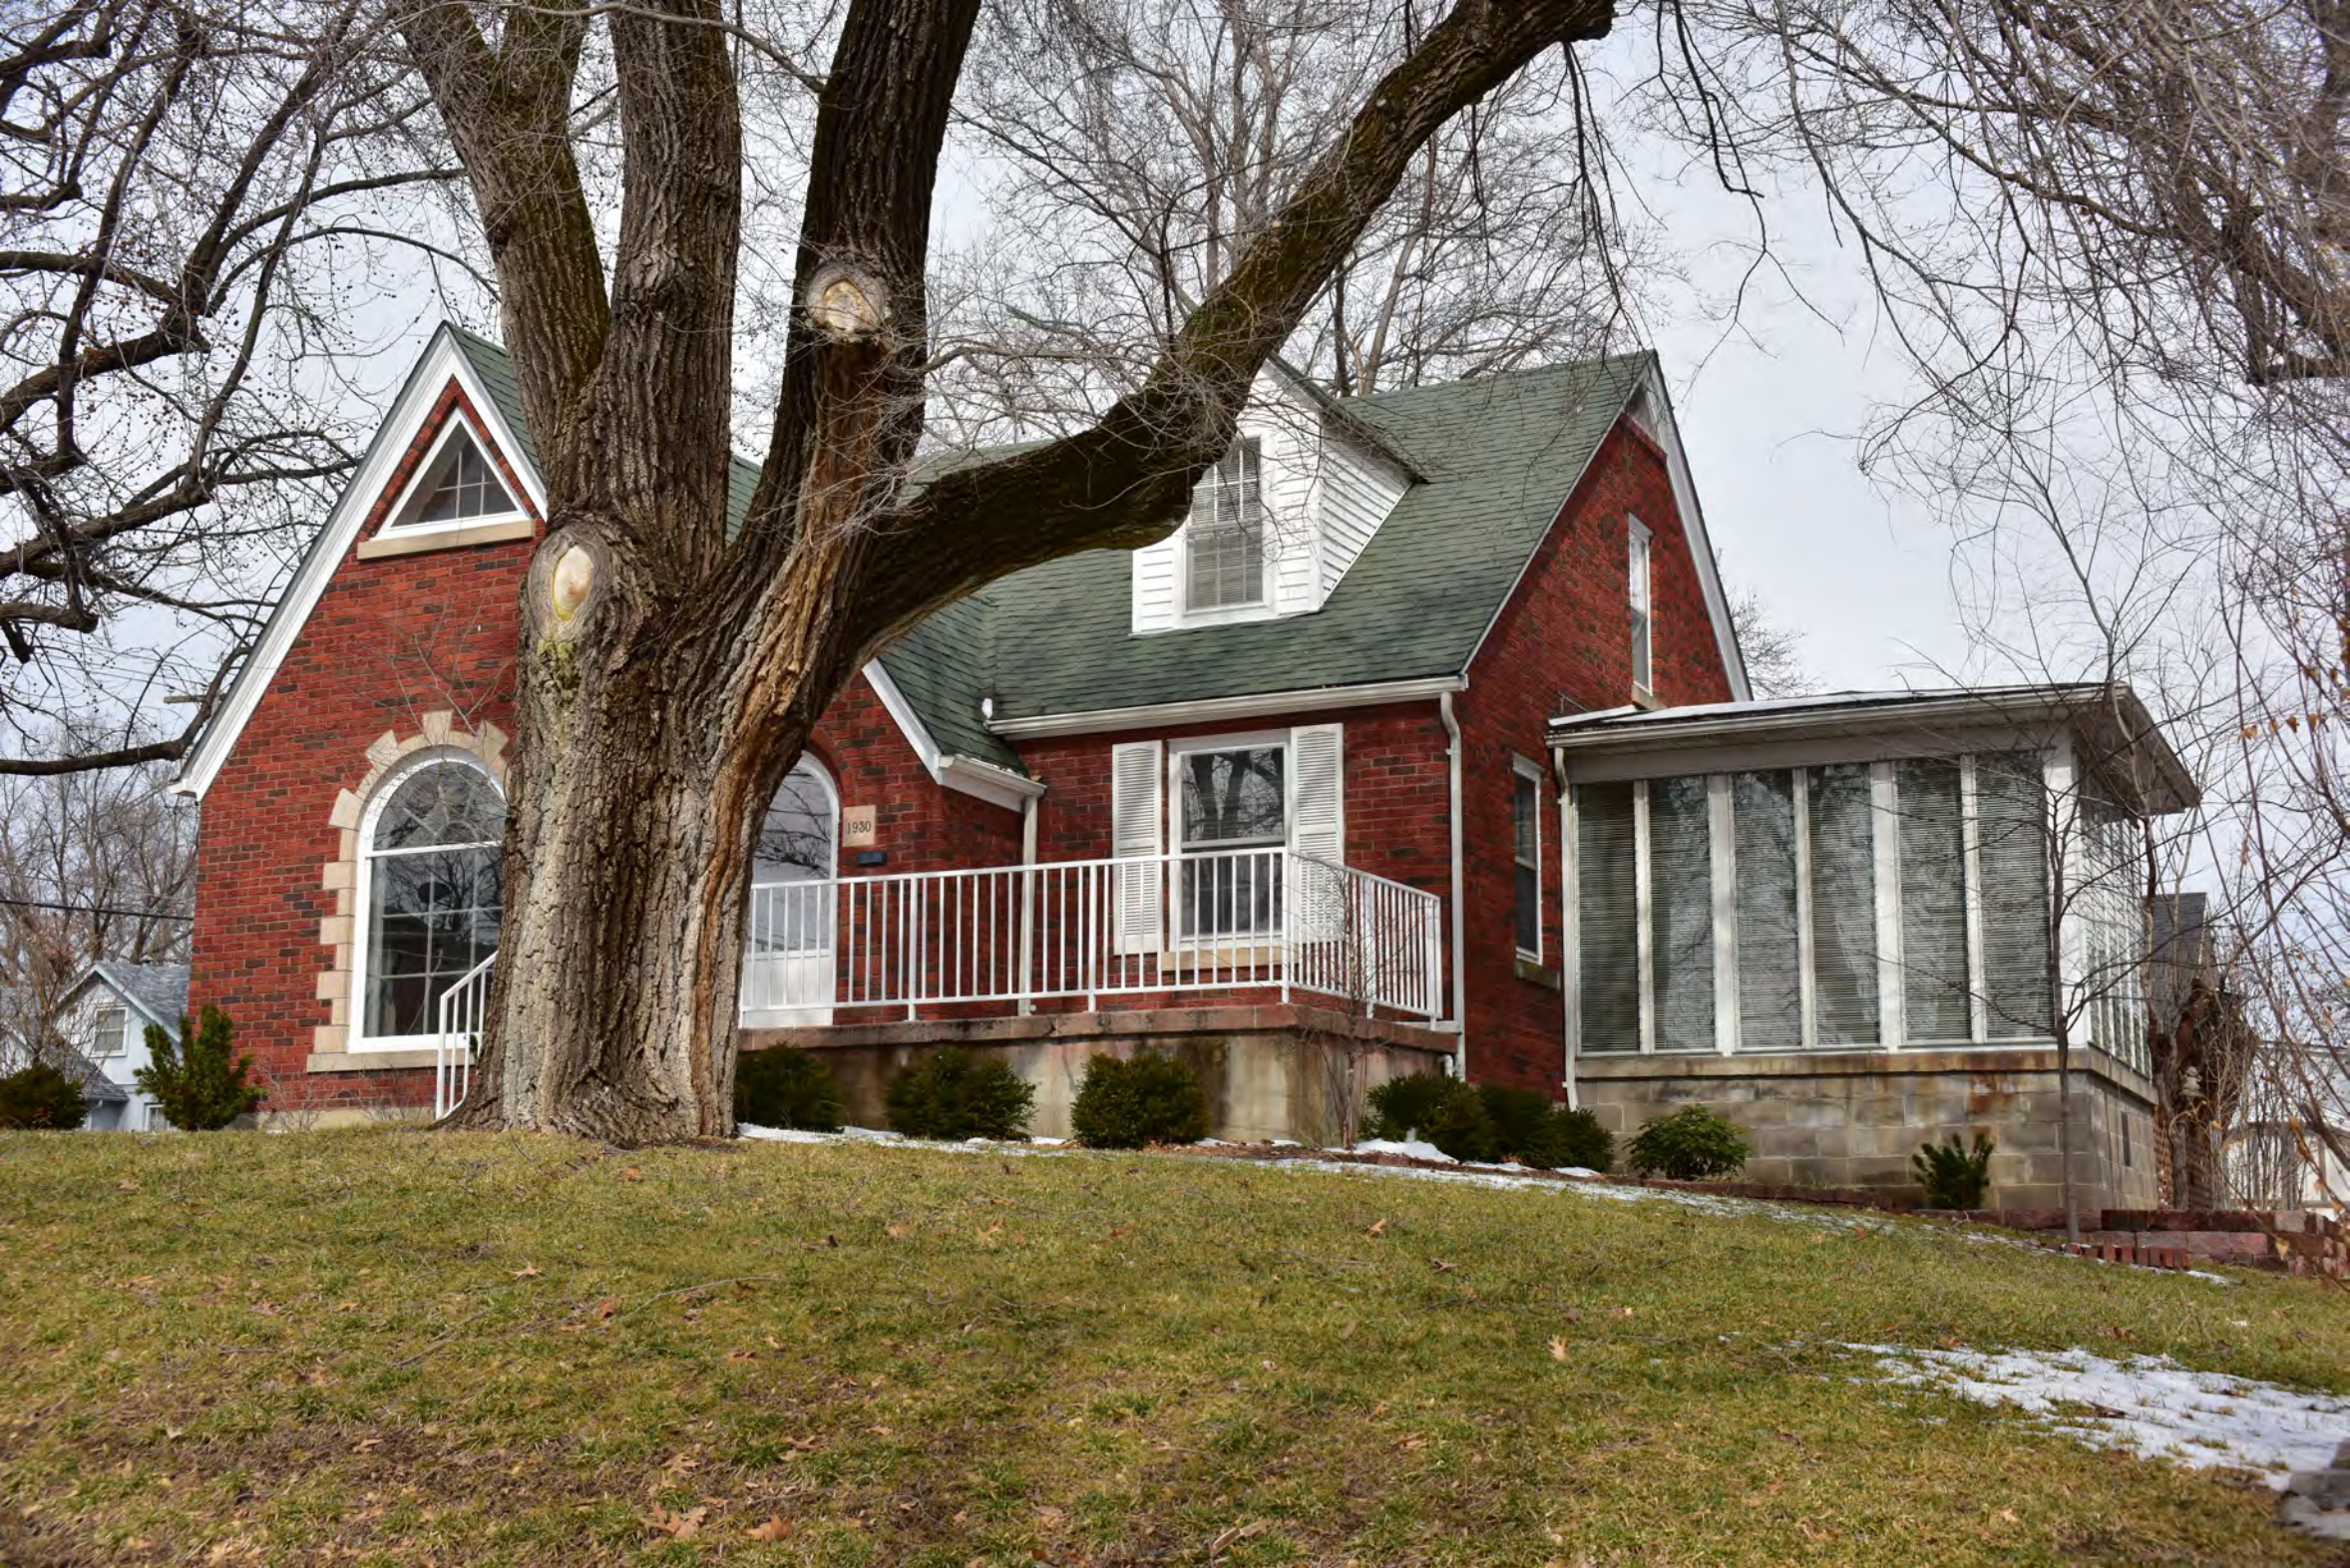
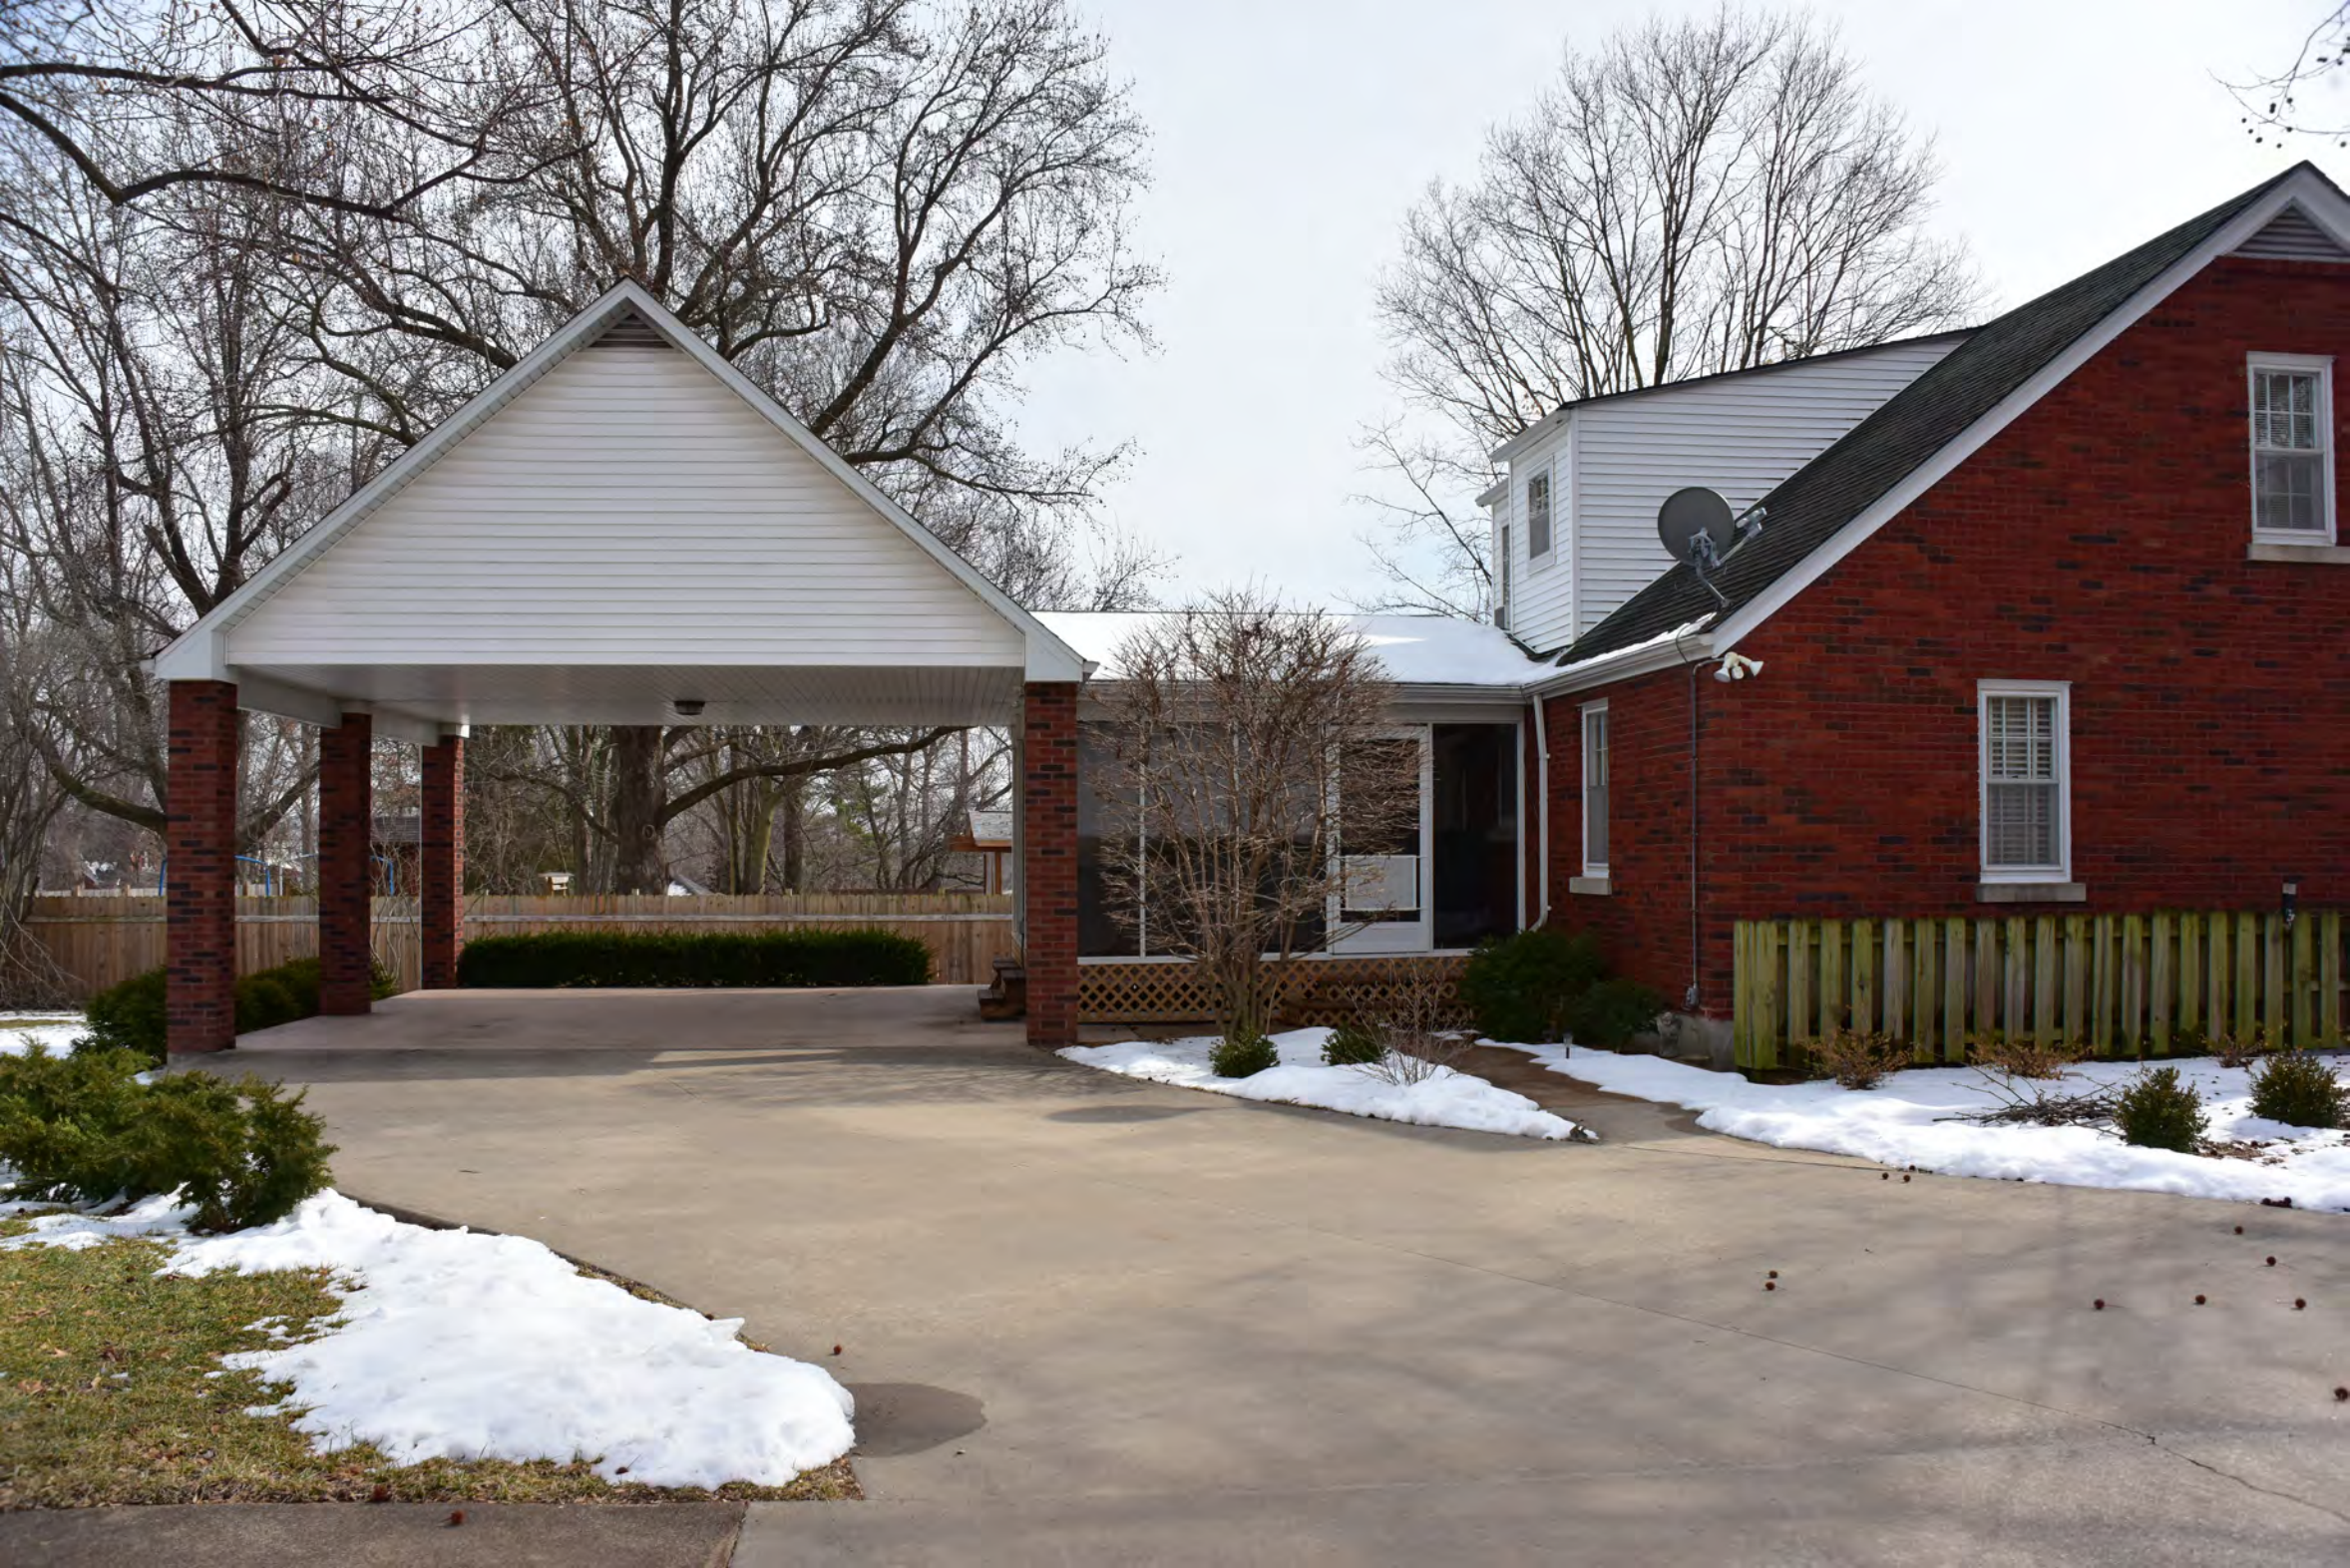
1930 North Circle Drive is a one-and-one-half story Minimal Traditional dwelling with a concrete foundation and brick cladding. It has an intersecting-gable asphalt roof. A brick exterior chimney pierces the gable eave at the west elevation and two large shed-roof vinyl-clad dormers are present at the east half of the rear slope. The dwelling is three bays wide. A shallow gabled-ell projects from the west end of the primary elevation and contains the first bay. A historic nine-light wood window with fanlight transom fills the first bay. Decorative cast stone surrounds the opening. A historic six-light fixed triangular wood window fills the gable apex above the bay. A brick enclosed vestibule abuts the ell to the east. The gabled vestibule contains the primary entrance which features a historic wood door. Decorative brick and cast stone work surround the arched opening. A historic 6/6 wood window defines the east bay. A vinyl-clad gabled dormer with a historic 6/6 wood window pierces the roof above the bay. A partial-width concrete platform with simple metal balustrade extends below the east-two bays. A c. 1949-1965 one-story enclosed sunporch with a concrete block foundation and shallow hipped asphalt roof is roughly centered on the east elevation. Full-height windows form the sunporch elevations. A c. 2005 gable-roof screened porch projects from the rear elevation and connects to a gabled carport. Brick columns support the vinyl-clad gable.

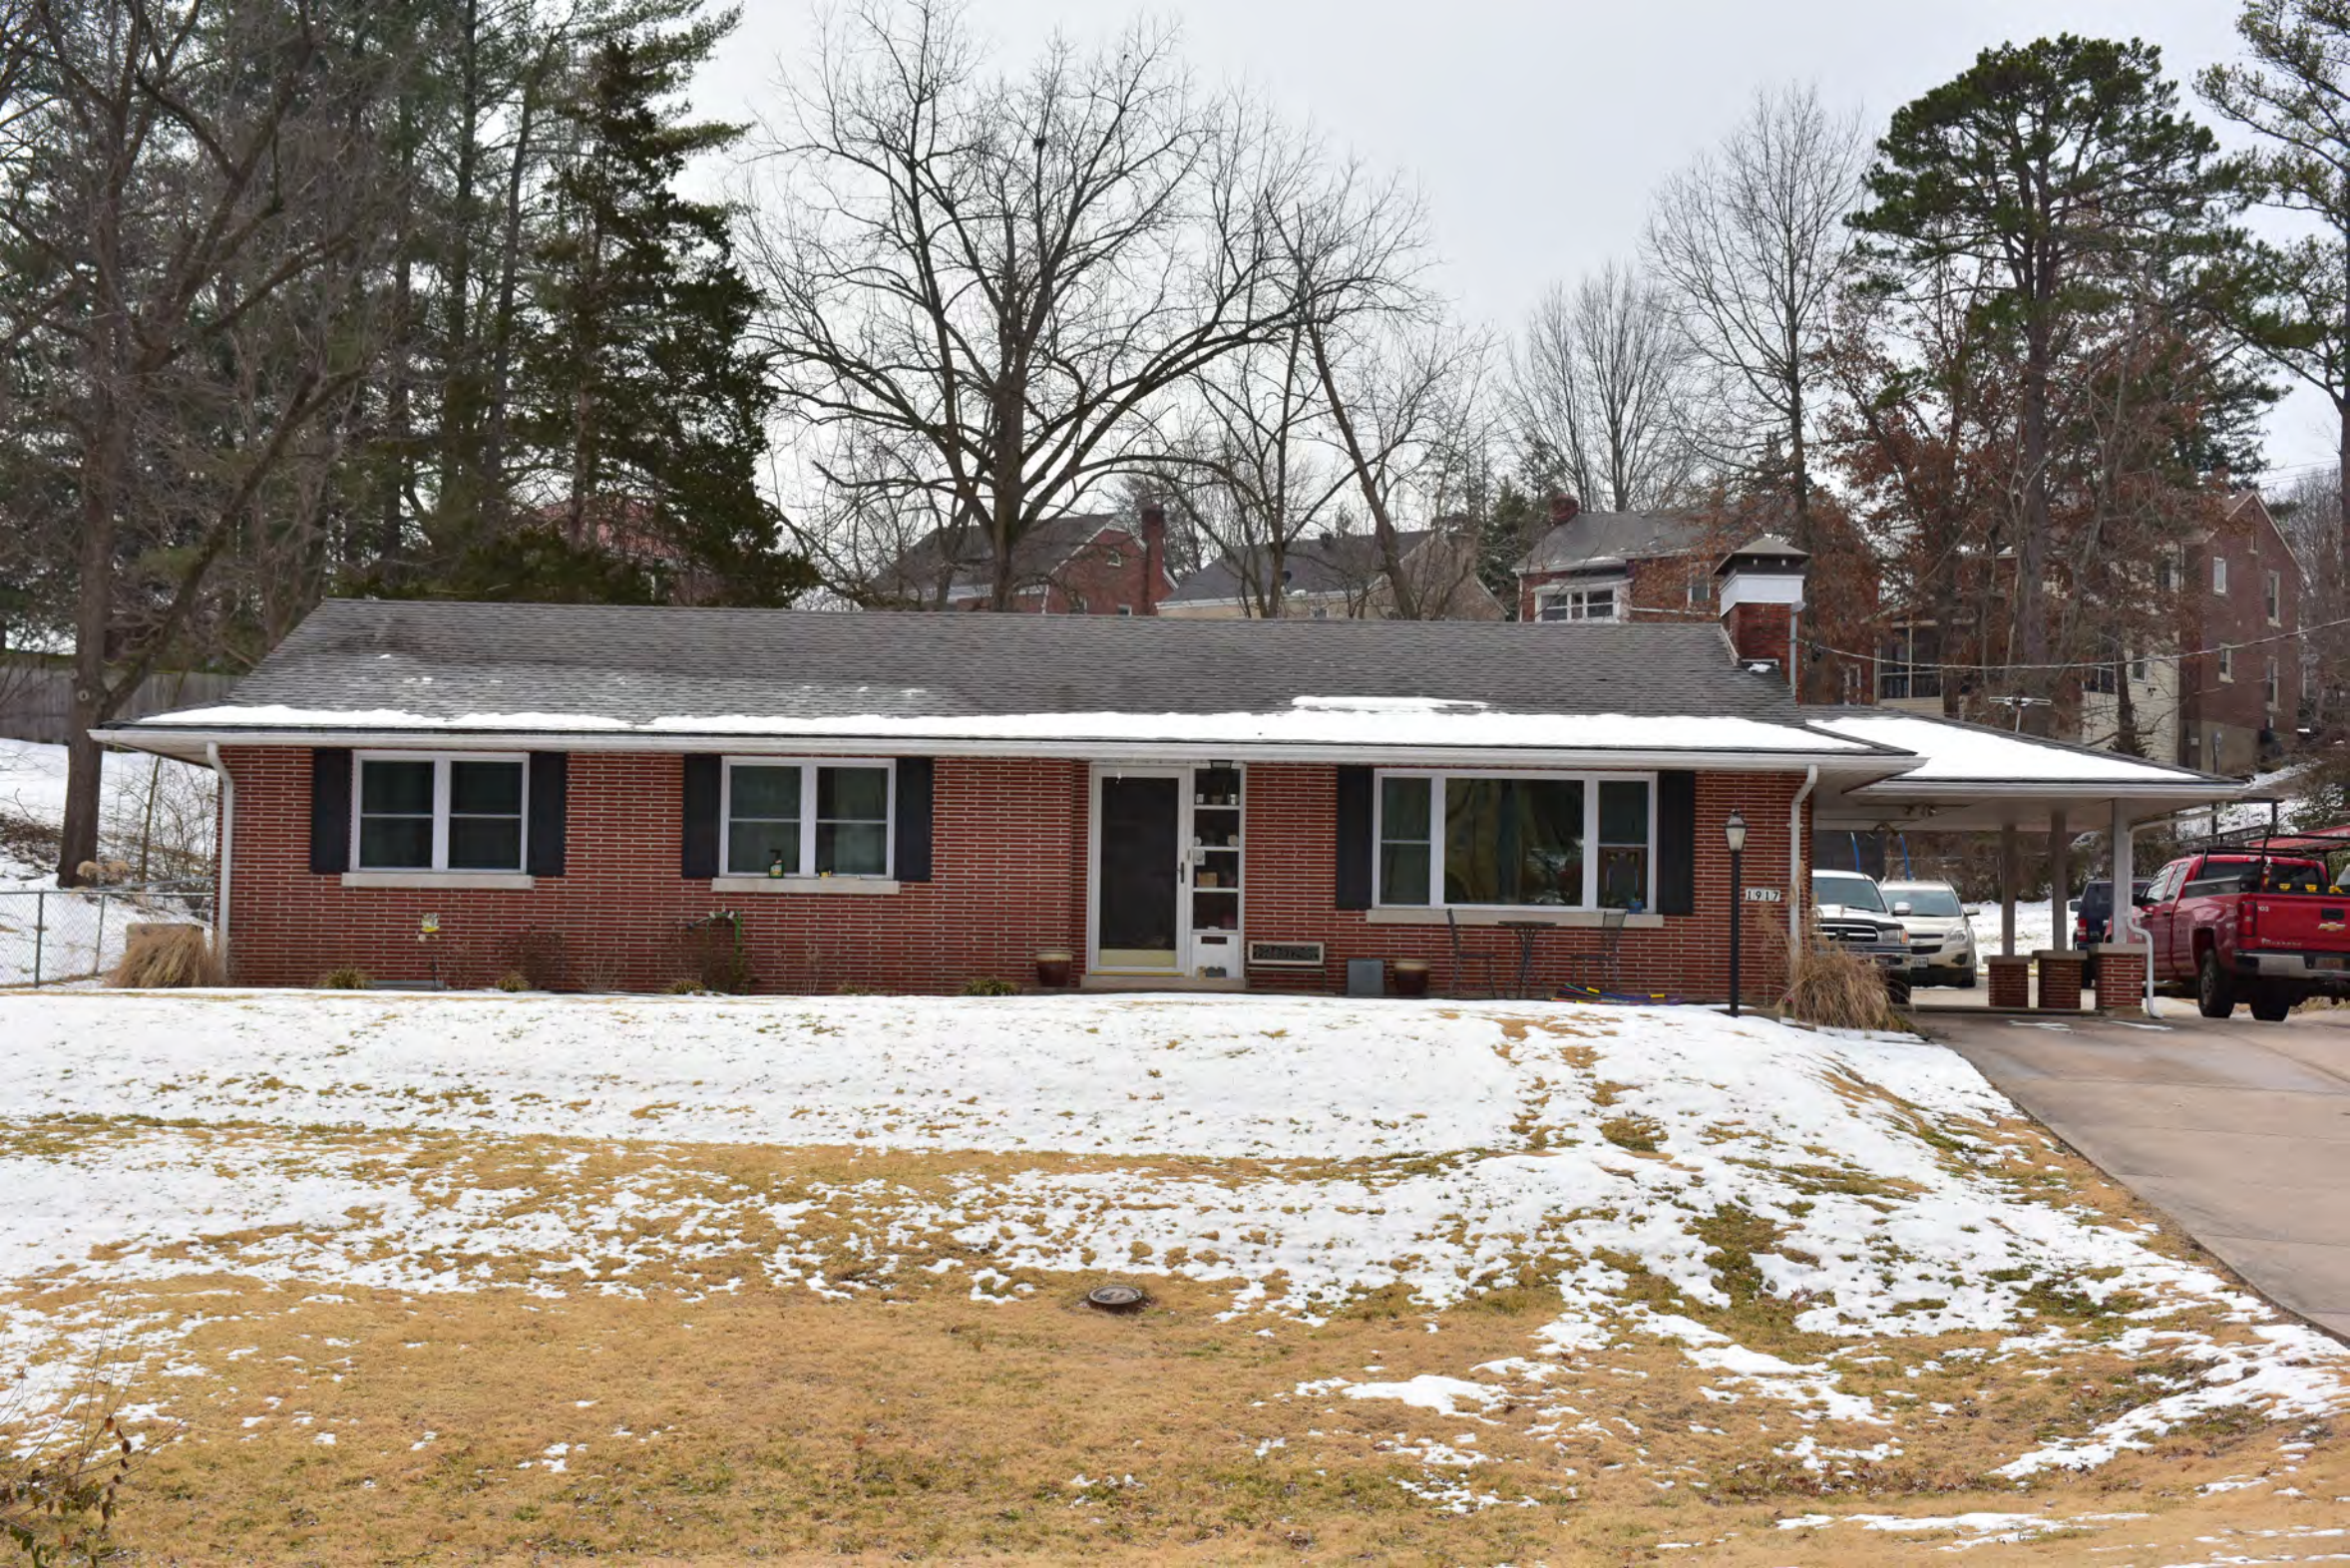
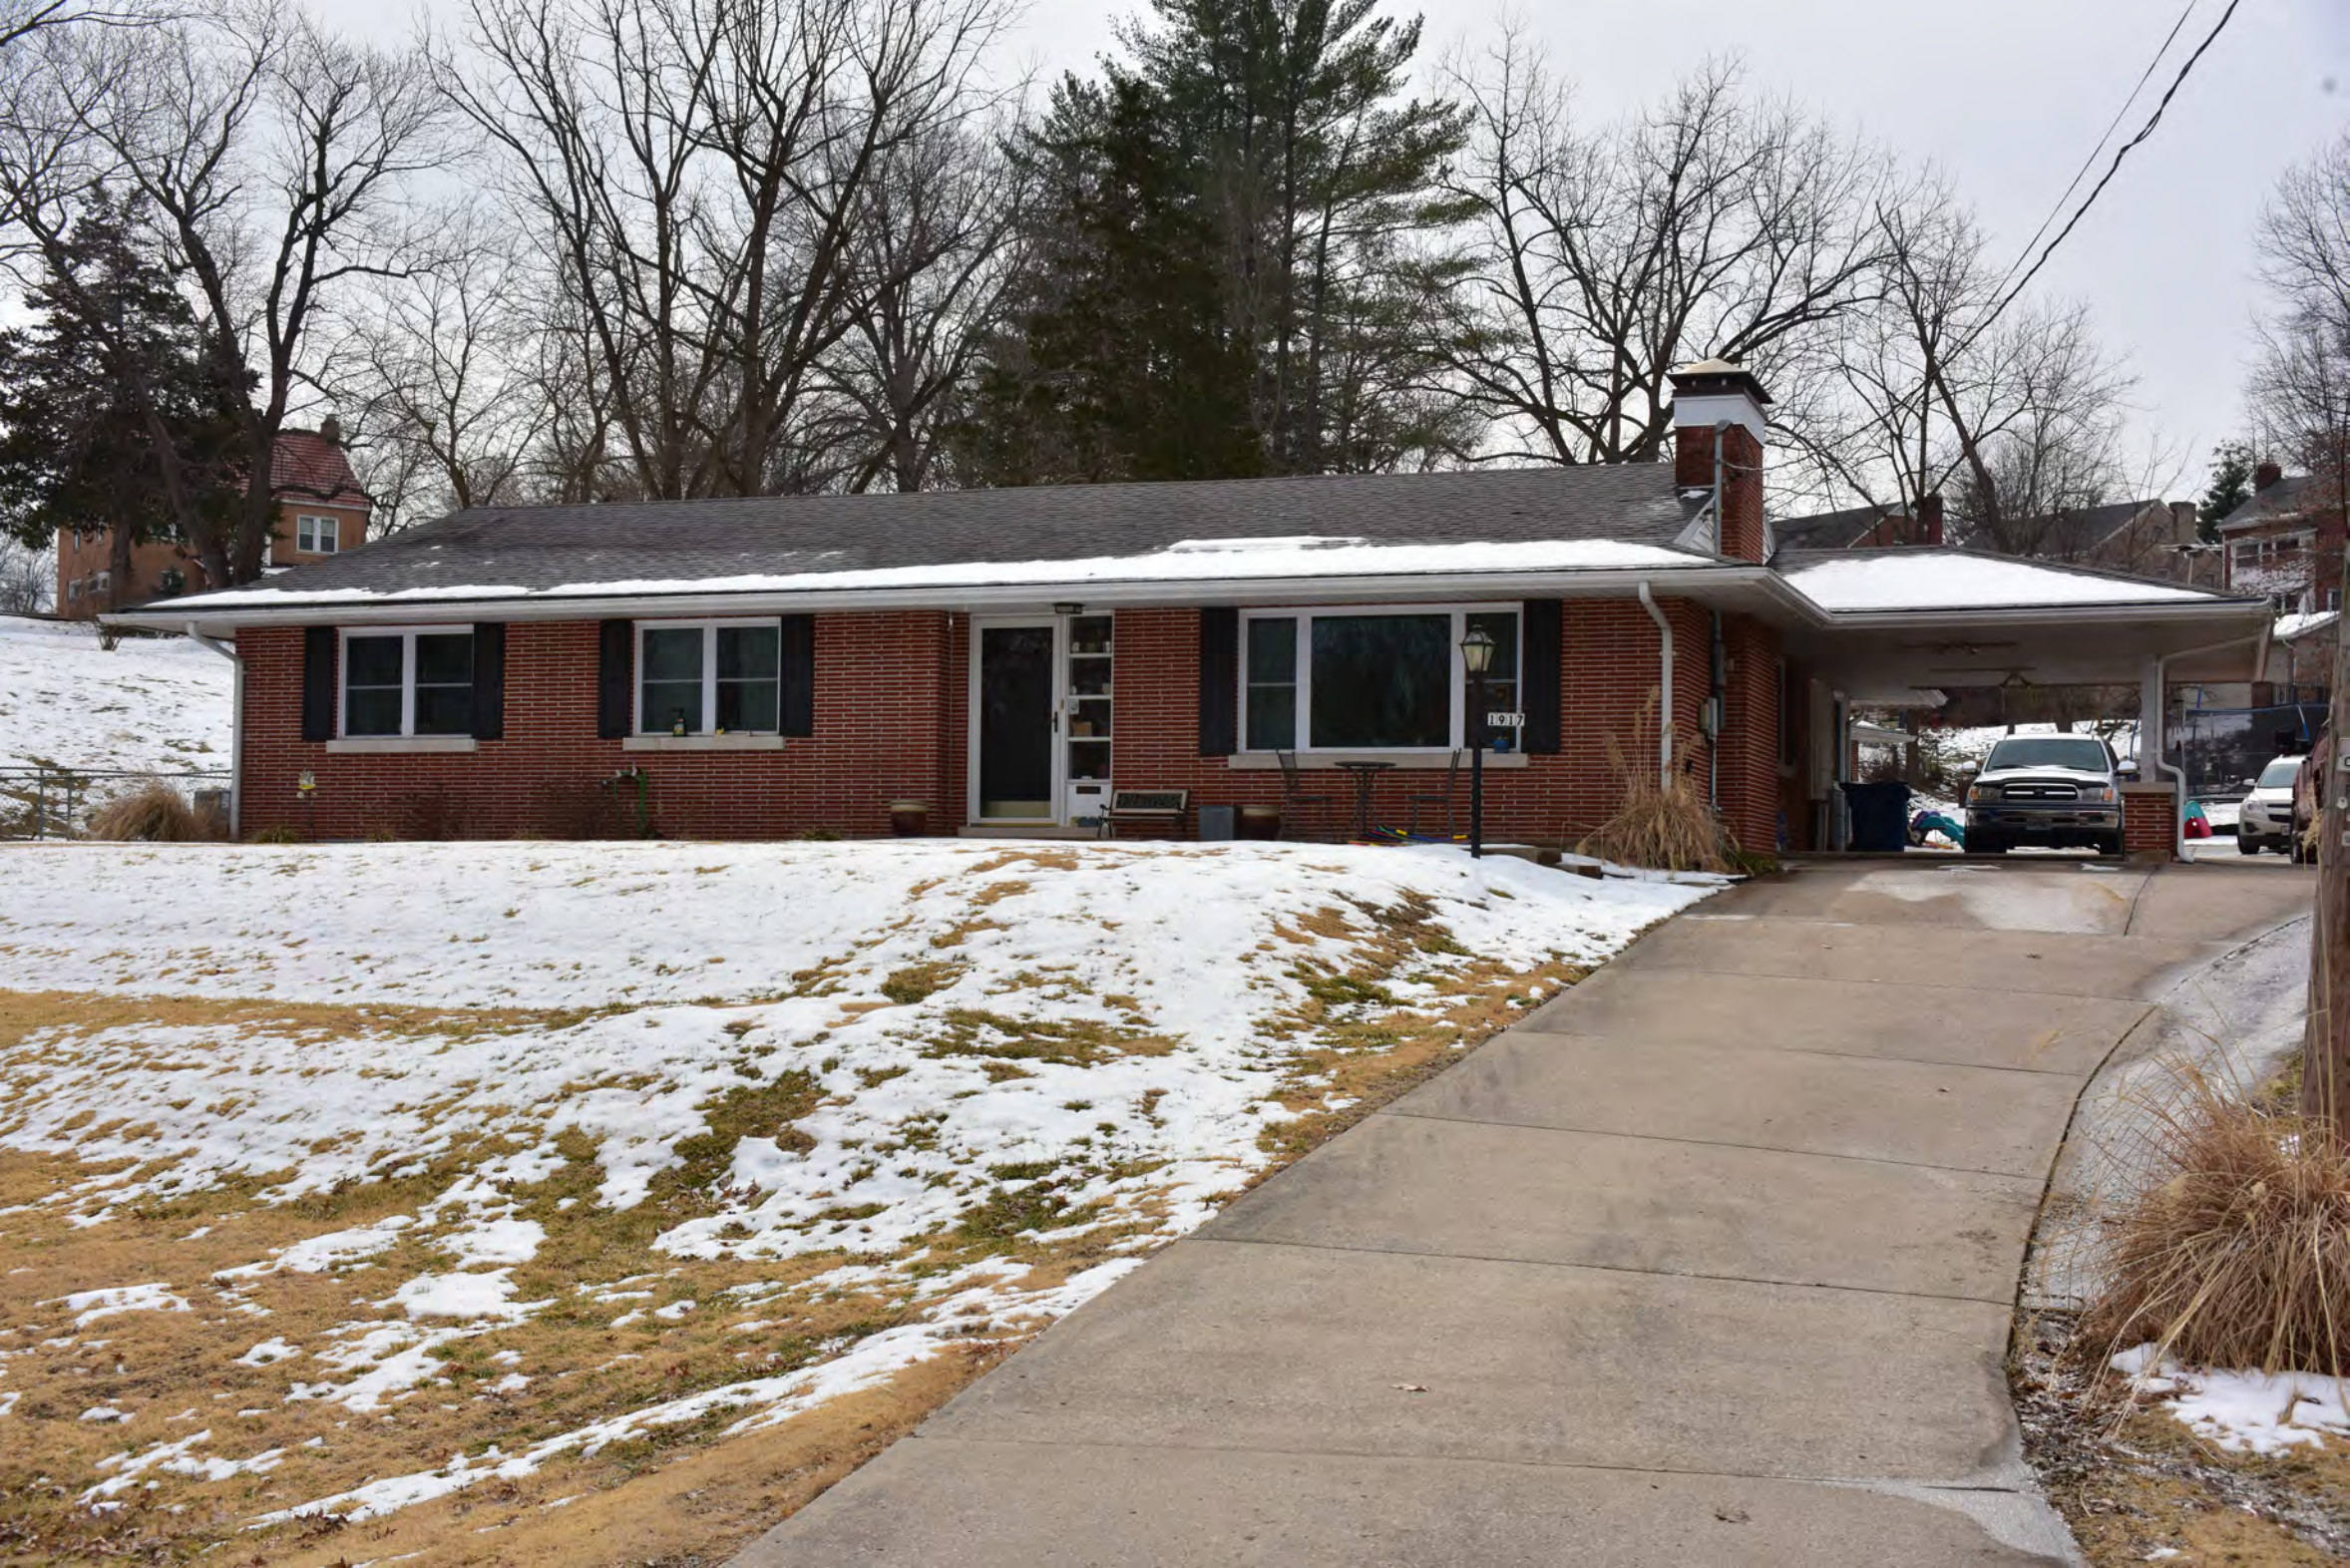
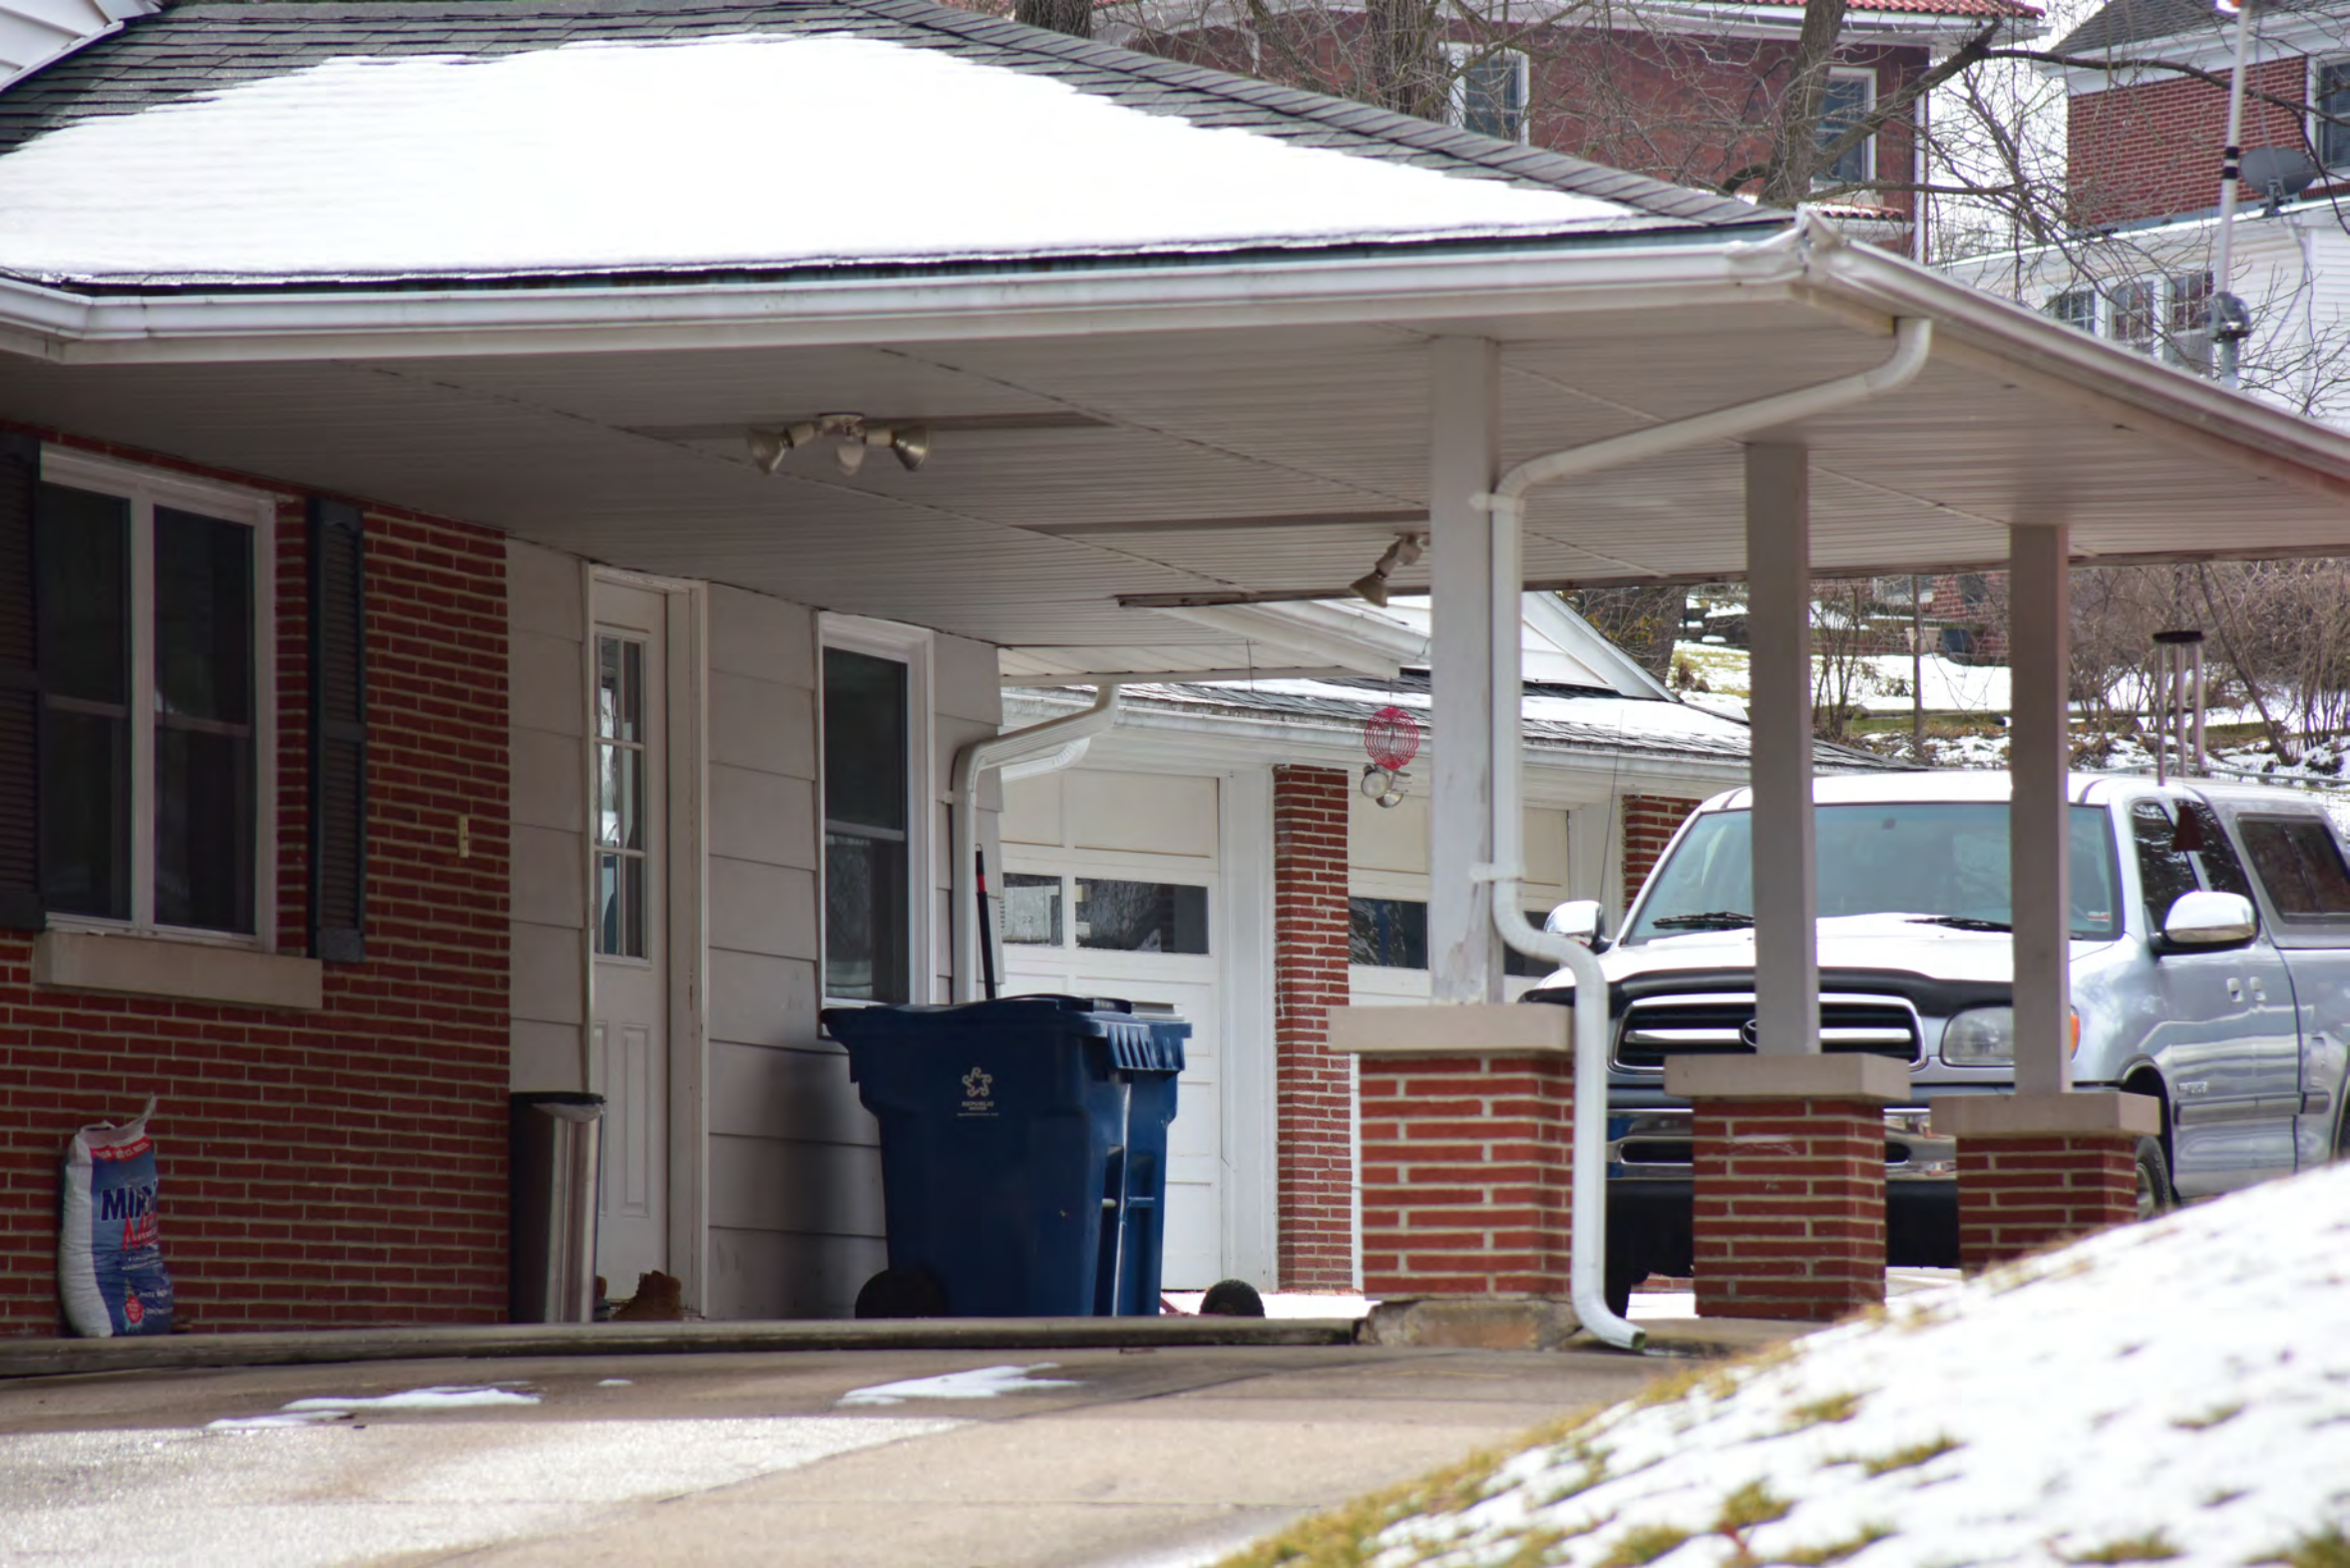
Alterations to 1917 South Circle Drive the replacement of historic windows and a c. 1967 hipped roof addition at the rear. While these windows are replacements, they fill historic openings. Historic aerials indicate the rear addition is a historic alteration and is an extension to a pre-existing ell. 1917 South Circle Drive retains good integrity. This resource would be contributing to the potential Walinko Place Historic District, significant in the areas of Architecture and Community Planning and Development in association with the expansion of Jefferson City and increased suburban development during the twentieth century as well as its associations with Walinko Place, a notable suburban development during the Depression and War Years.

1917 South Circle Drive is a one-story Ranch dwelling. It has brick cladding, a concrete foundation, and an asphalt intersecting-gable roof with wide eaves. The dwelling is four bays wide. Two-ganged 1/1 vinyl windows with continuous concrete sills fill the east-two bays while a vinyl tripartite picture window fills the west bay. Two 1/1 windows flank the center single-pane. The primary entrance defines the remaining bay. It contains a non-historic wood slab door with a brass kickplate and a non-historic aluminum storm door with full-height single glazing. A five-light sidelight lines the west edge of the doorway. The bottom fifth contains a historic mail slot and infill. A hipped roof carport extends from the west elevation and recedes from the primary elevation. Squared wood columns on brick piers with concrete caps support the roof. A c. 1967 hipped-roof ell extends from the rear of the dwelling and abuts the carport. It is clad with wide cementitious siding and contains a secondary entrance in the west wall.
