1. Survey number: CO-AS-008-001		2. Survey Name: West Main Street Survey	
3. County: Cole		4. Address (Street No.): 100	Street (name): East Circle Drive
5. City: Jefferson City	Vicinity <input type="checkbox"/>	6. Lat / Long:	7. Township/Range/Section: T: R: S:
8. Historic name (if known):		9. Present/other name (if known):	
10. Ownership: <input checked="" type="checkbox"/> Private <input type="checkbox"/> Public		11a. Historic use (if known): Domestic-Single Dwelling	11b. Current use: Domestic-Single Dwelling

MISSOURI DEPARTMENT OF NATURAL RESOURCES
STATE HISTORIC PRESERVATION OFFICE, P.O. Box 178, Jefferson City, MO 65102
ARCHITECTURAL/HISTORIC INVENTORY FORM

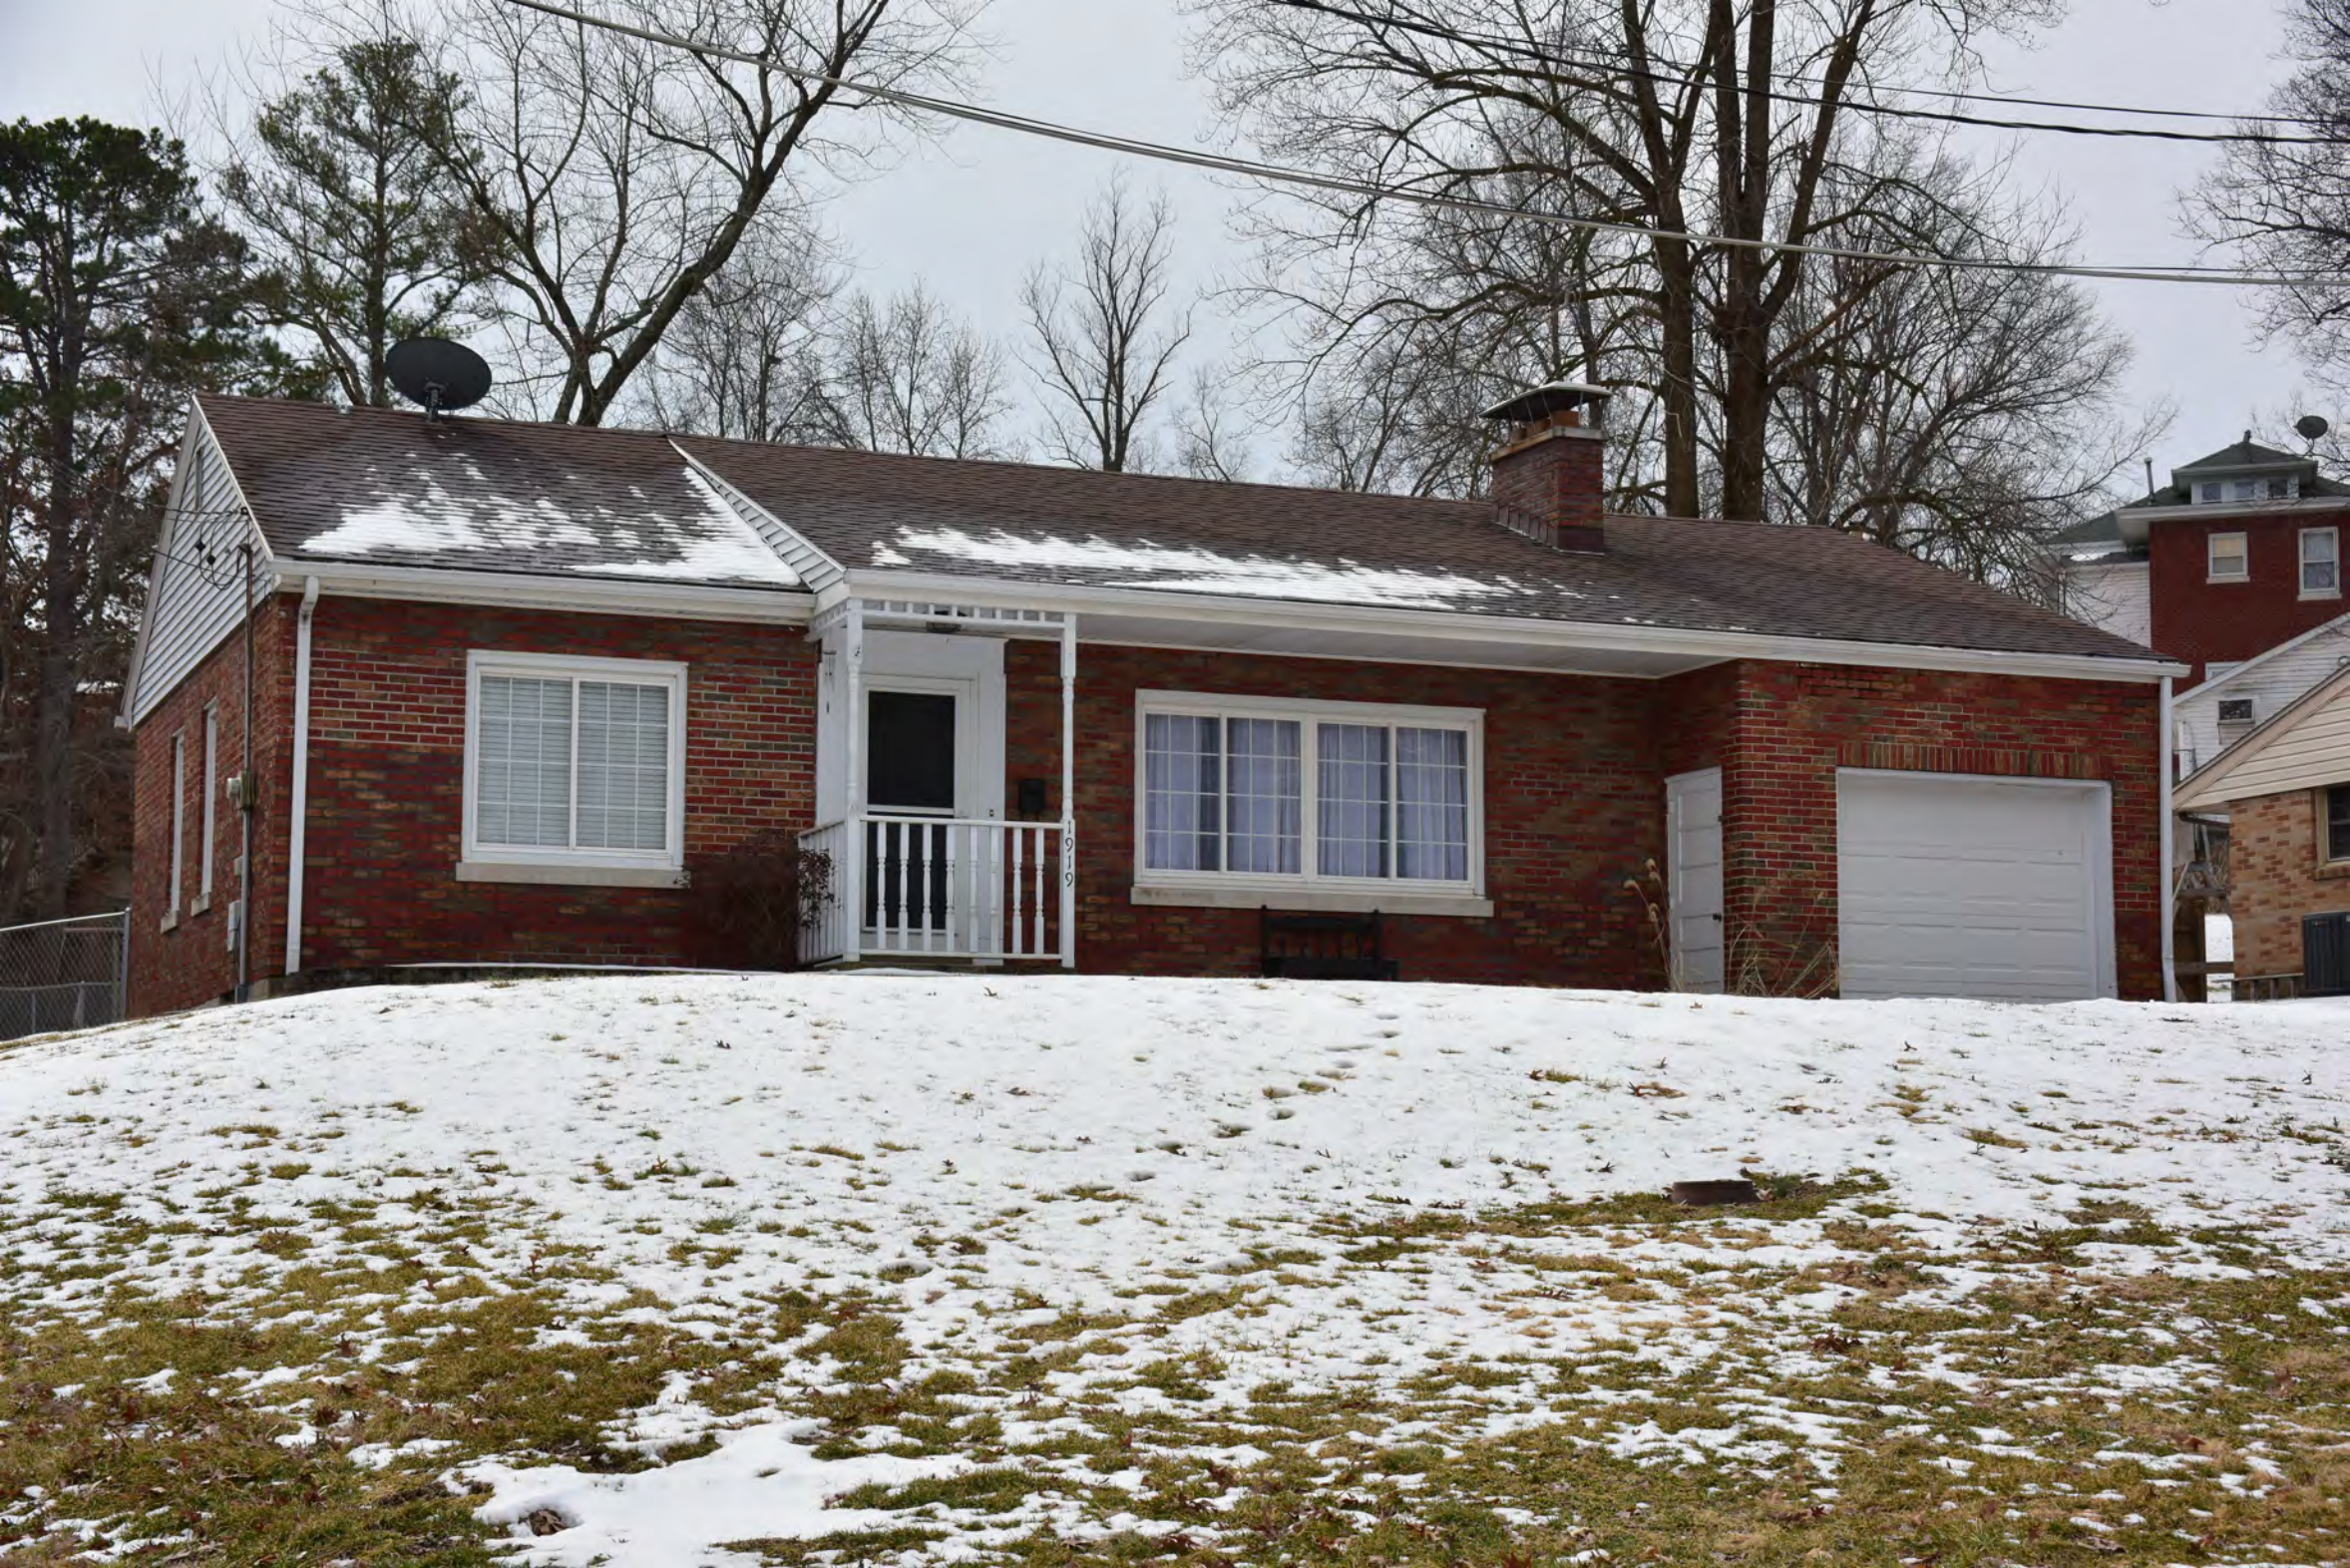
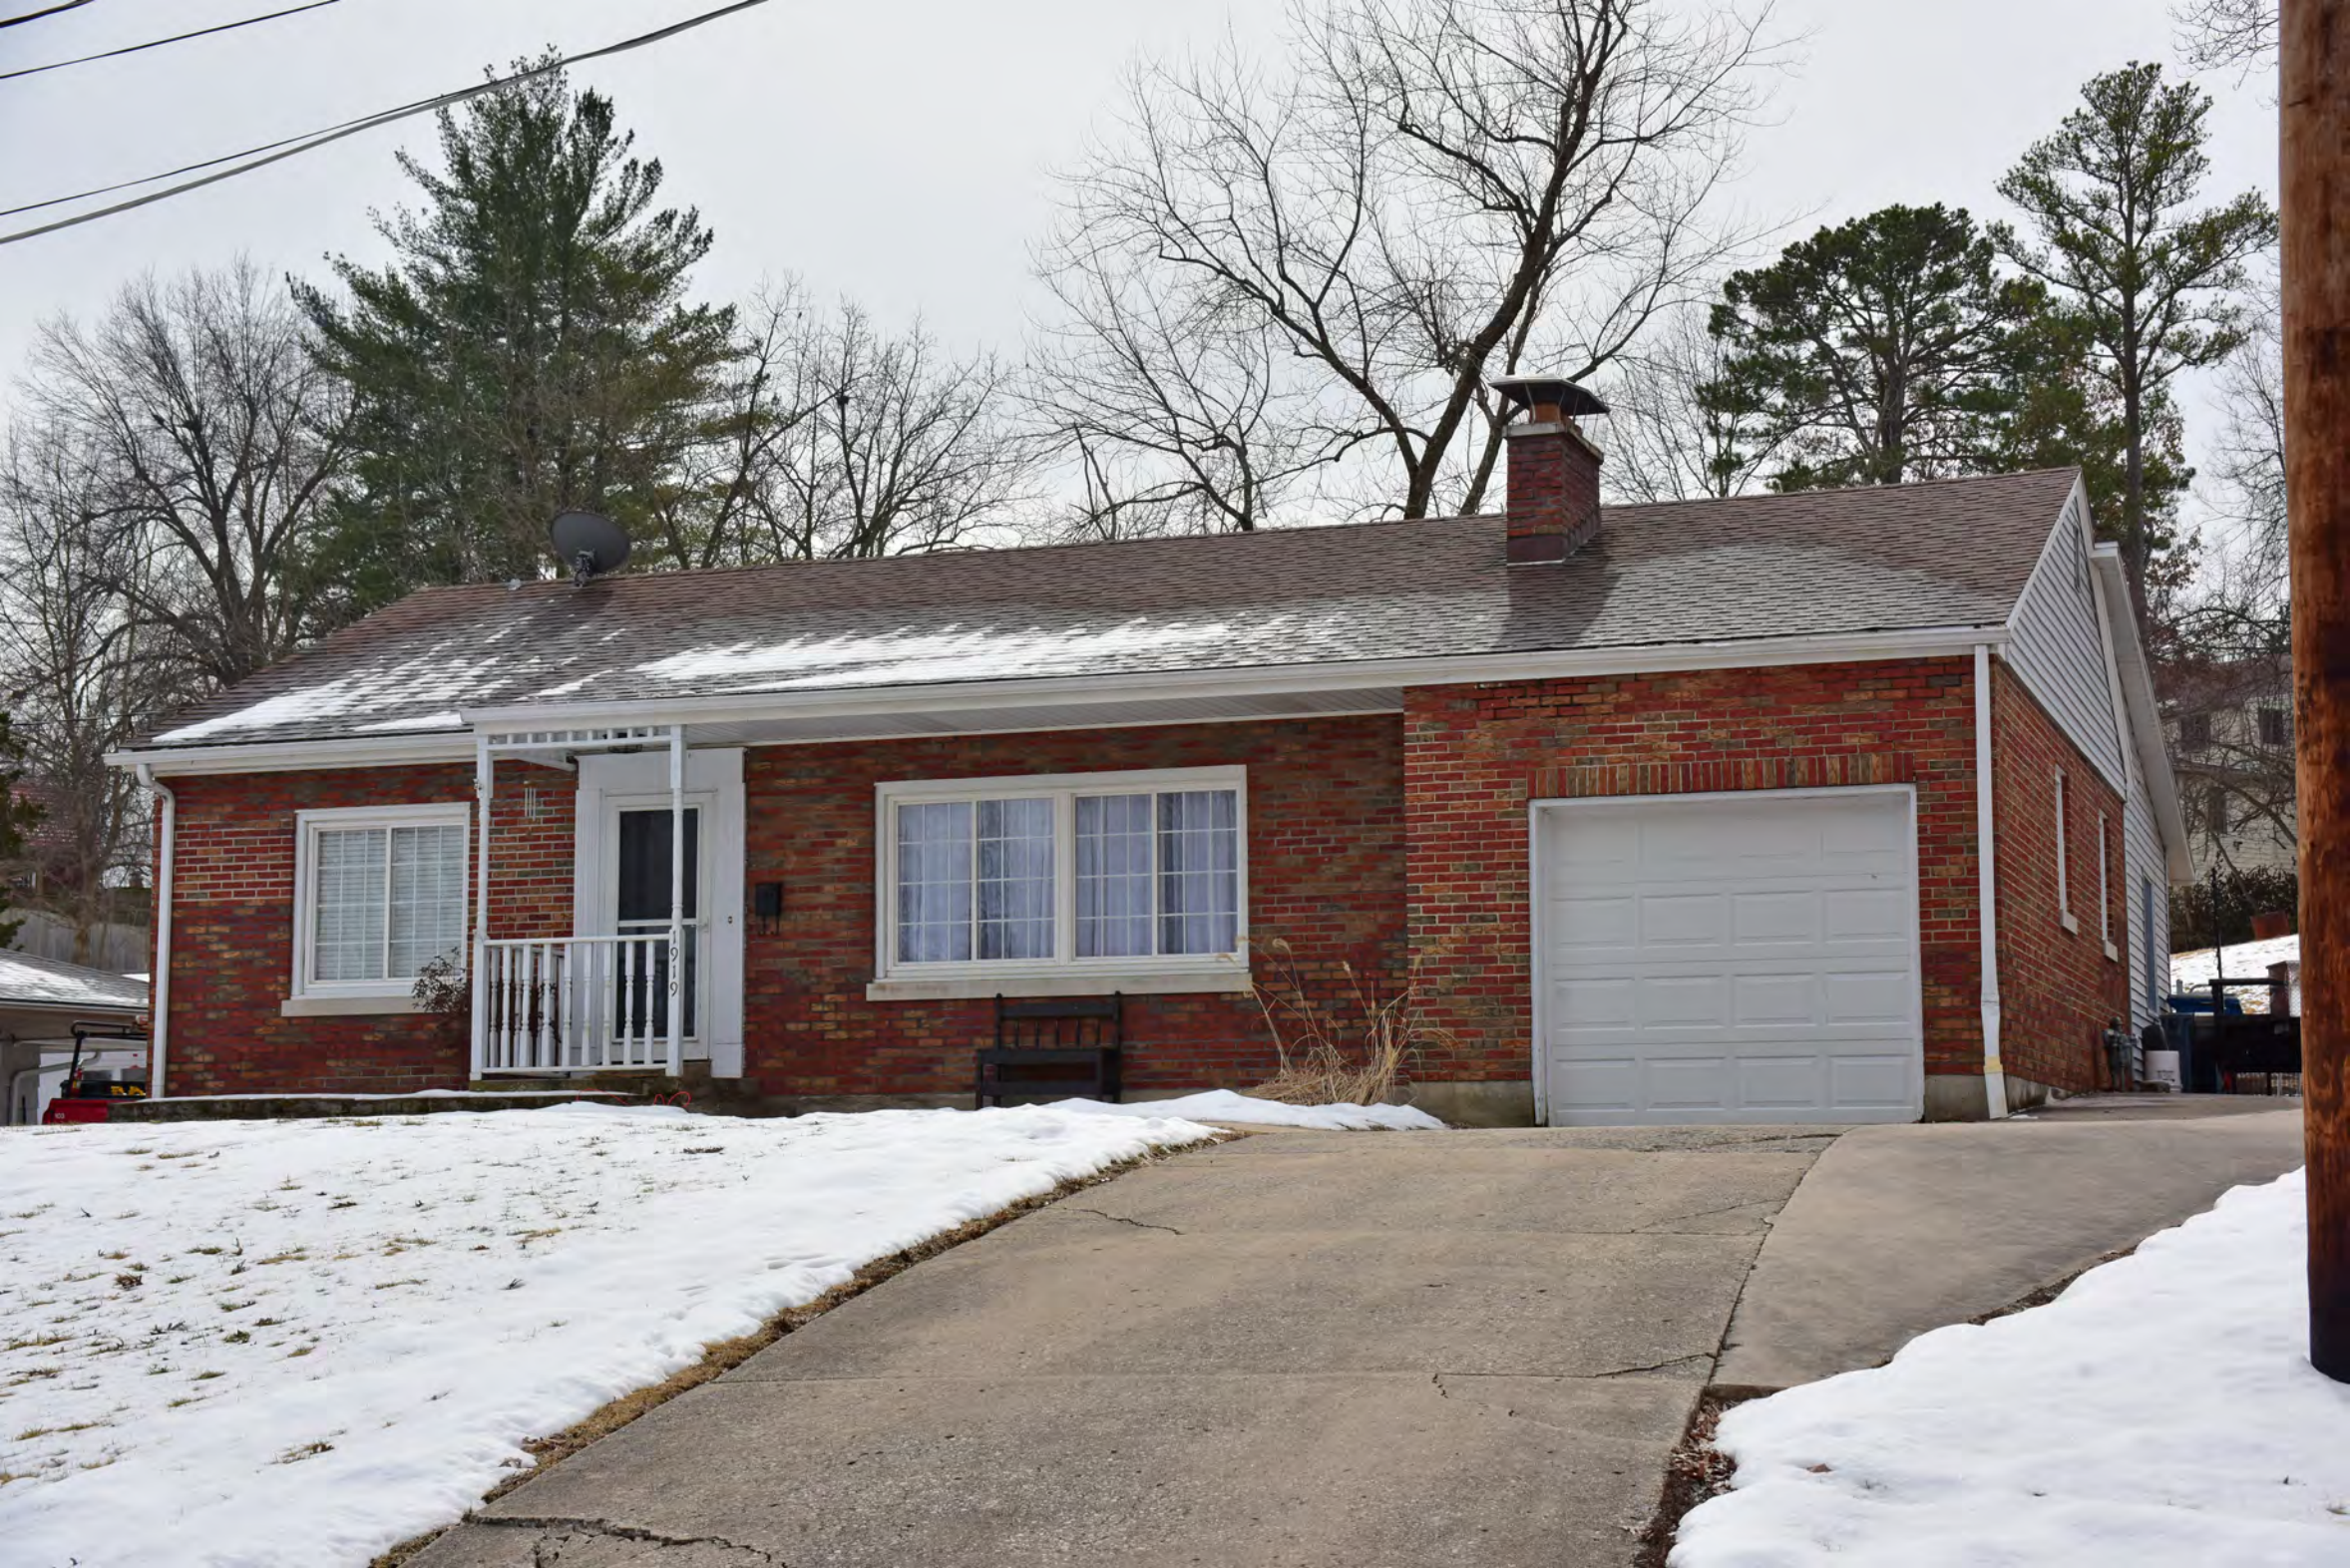
Alterations to 1919 South Circle Drive the replacement of historic windows and a shed-roof addition at the rear. While these windows are replacements, they fill historic openings. The c. 1995 addition is minimally visible from the right of way. This resource retains good integrity and would be contributing to the potential Walinko Place Historic District, significant in the areas of Architecture and Community Planning and Development in association with the expansion of Jefferson City and increased suburban development during the twentieth century as well as its associations with Walinko Place, a notable suburban development during the Depression and War Years.

1919 South Circle Drive is a one-story Ranch dwelling with brick cladding, a concrete foundation, and a side-gable asphalt roof. The east end of the roof is slightly steeper in pitch and vinyl clads the gable ends. A short brick chimney pierces the front slope in the west-third. The dwelling is four bays wide and two bays deep. A twelve-by-twelve light vinyl window with a concrete sill fills the first bay while two-ganged matching windows with a continuous concrete sill fill the third bay. The primary entrance defines the second bay and features a simplified entablature and pilasters. An attached single-car garage defines the fourth bay. A non-historic overhead door fills the vehicular bay while a historic wood door fills a pedestrian entrance in the east wall. The second and third bays recede, forming a partial-width open porch. Turned wood posts support the east end of the porch and a matching balustrade lines the porch corner. A c. 1995 shed-roof addition projects from the southwest corner of the dwelling. The vinyl-clad addition is one bay deep and spans approximately one-third of the elevation.

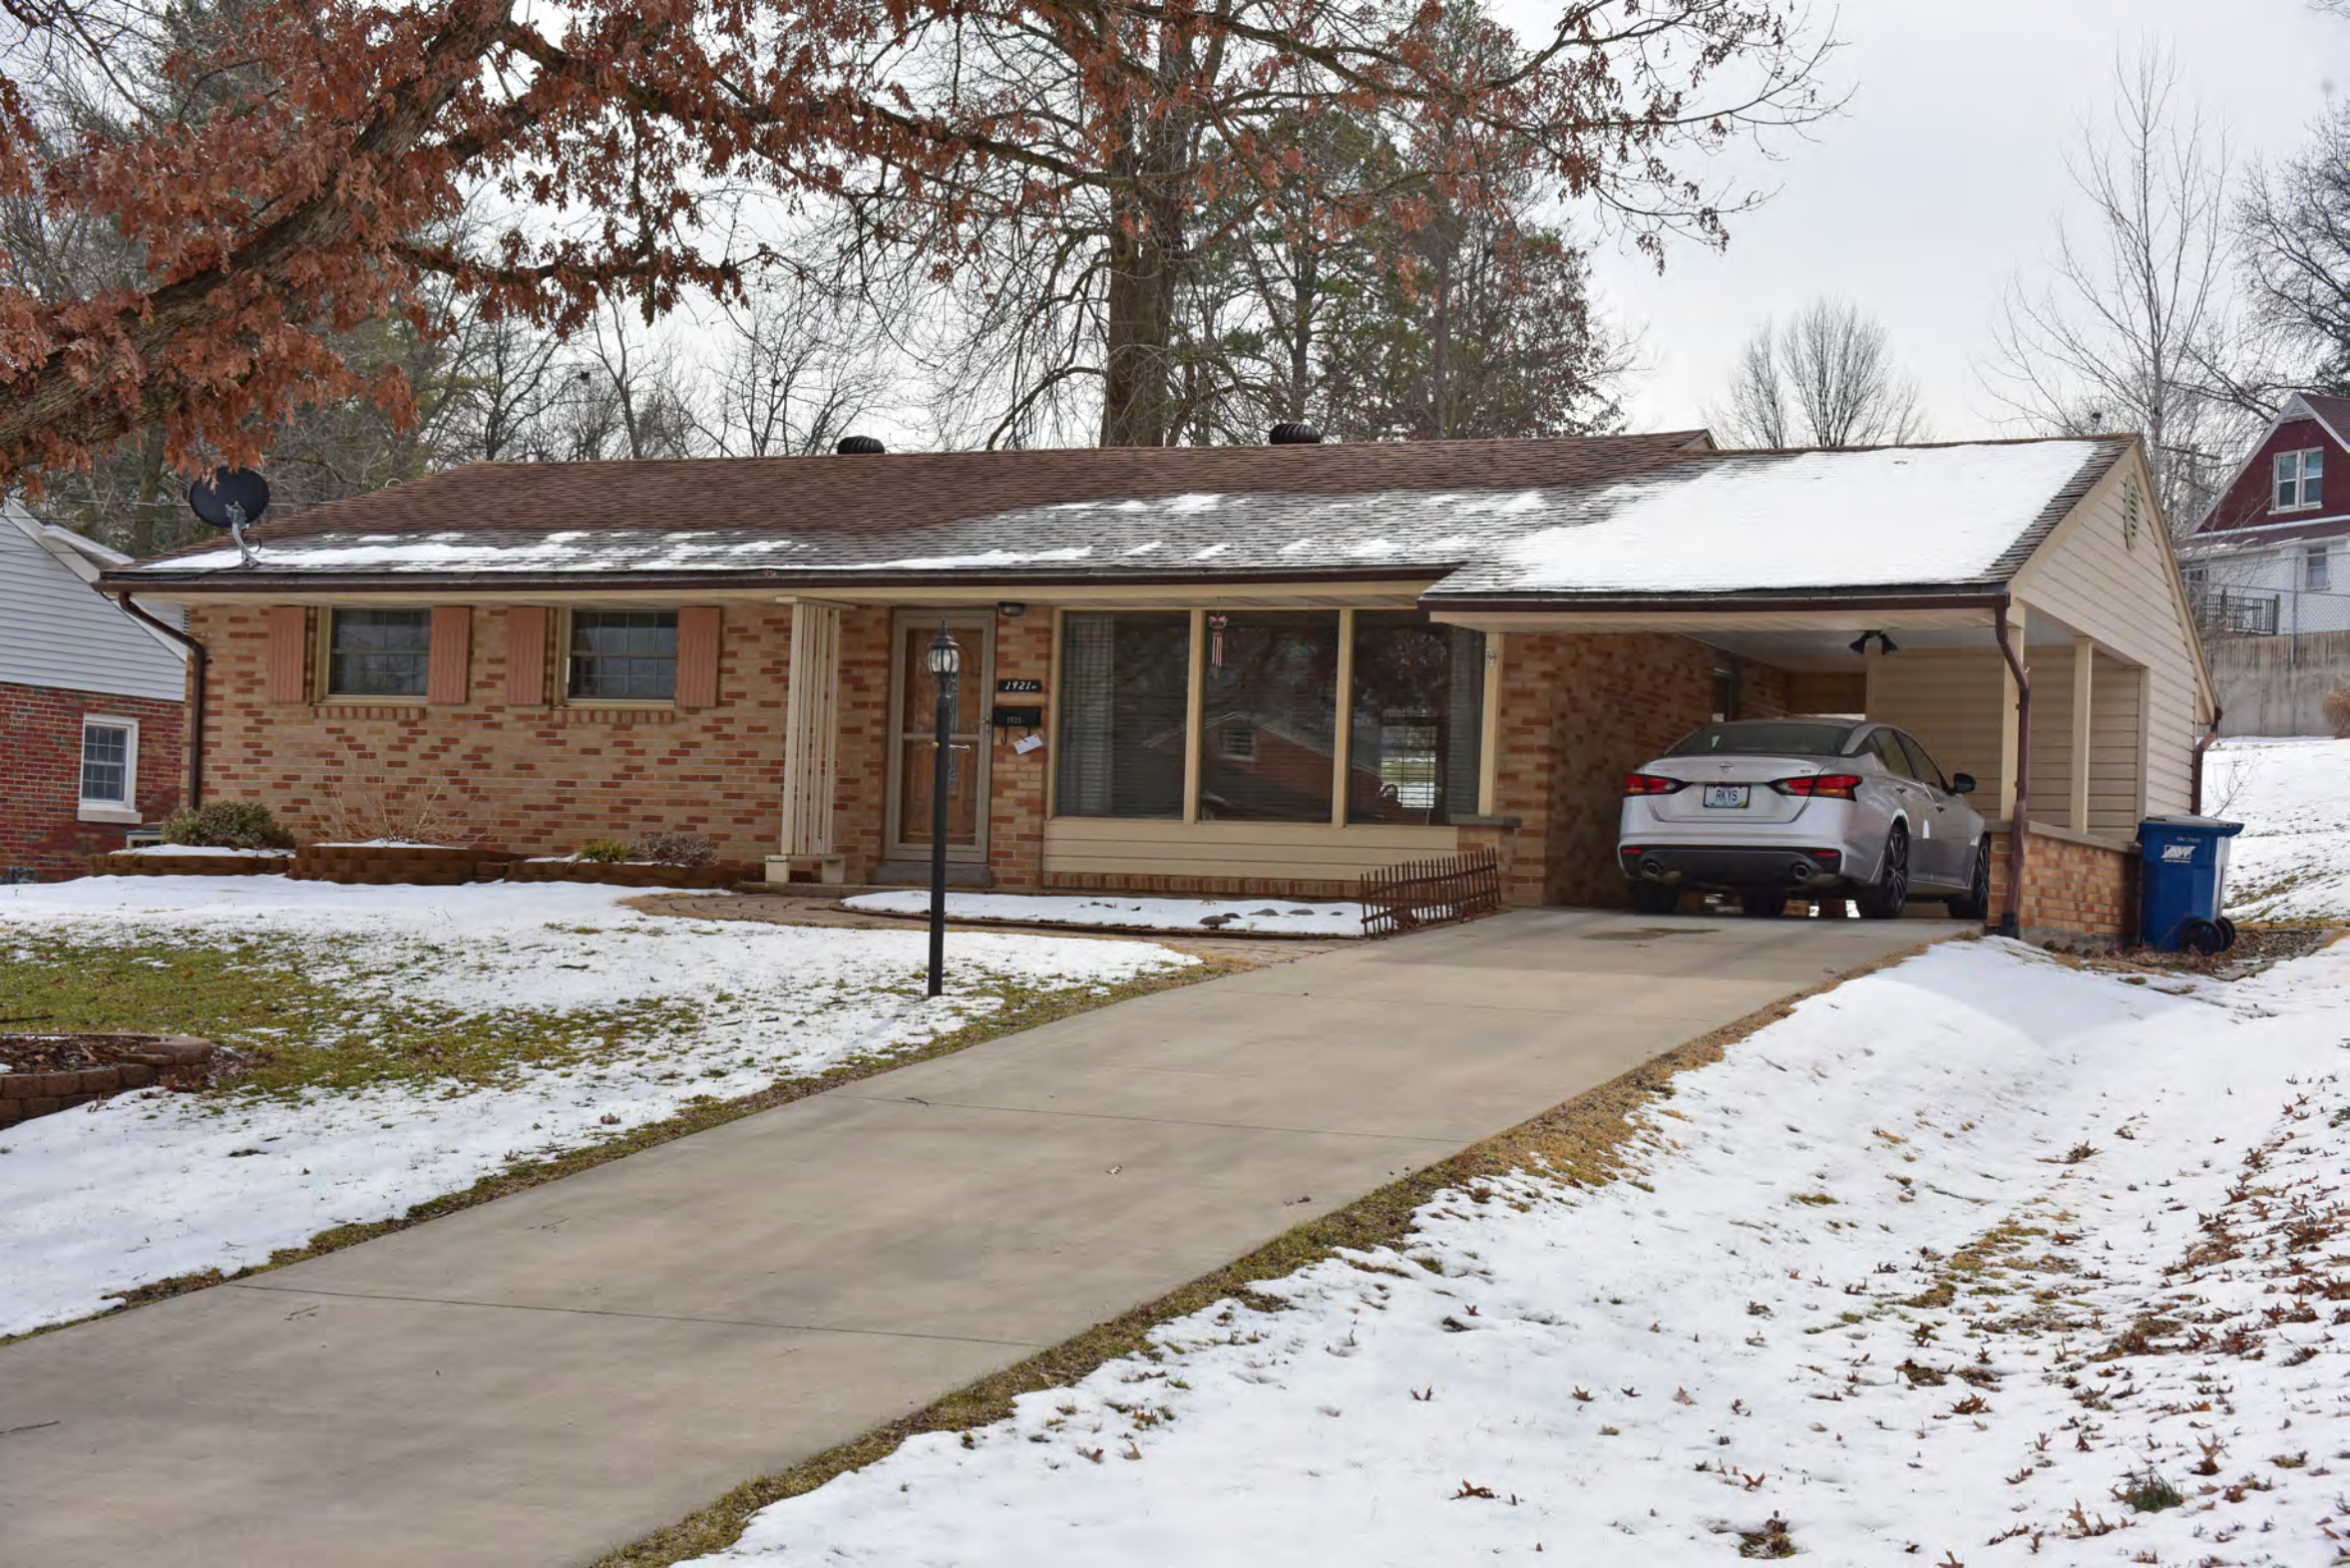
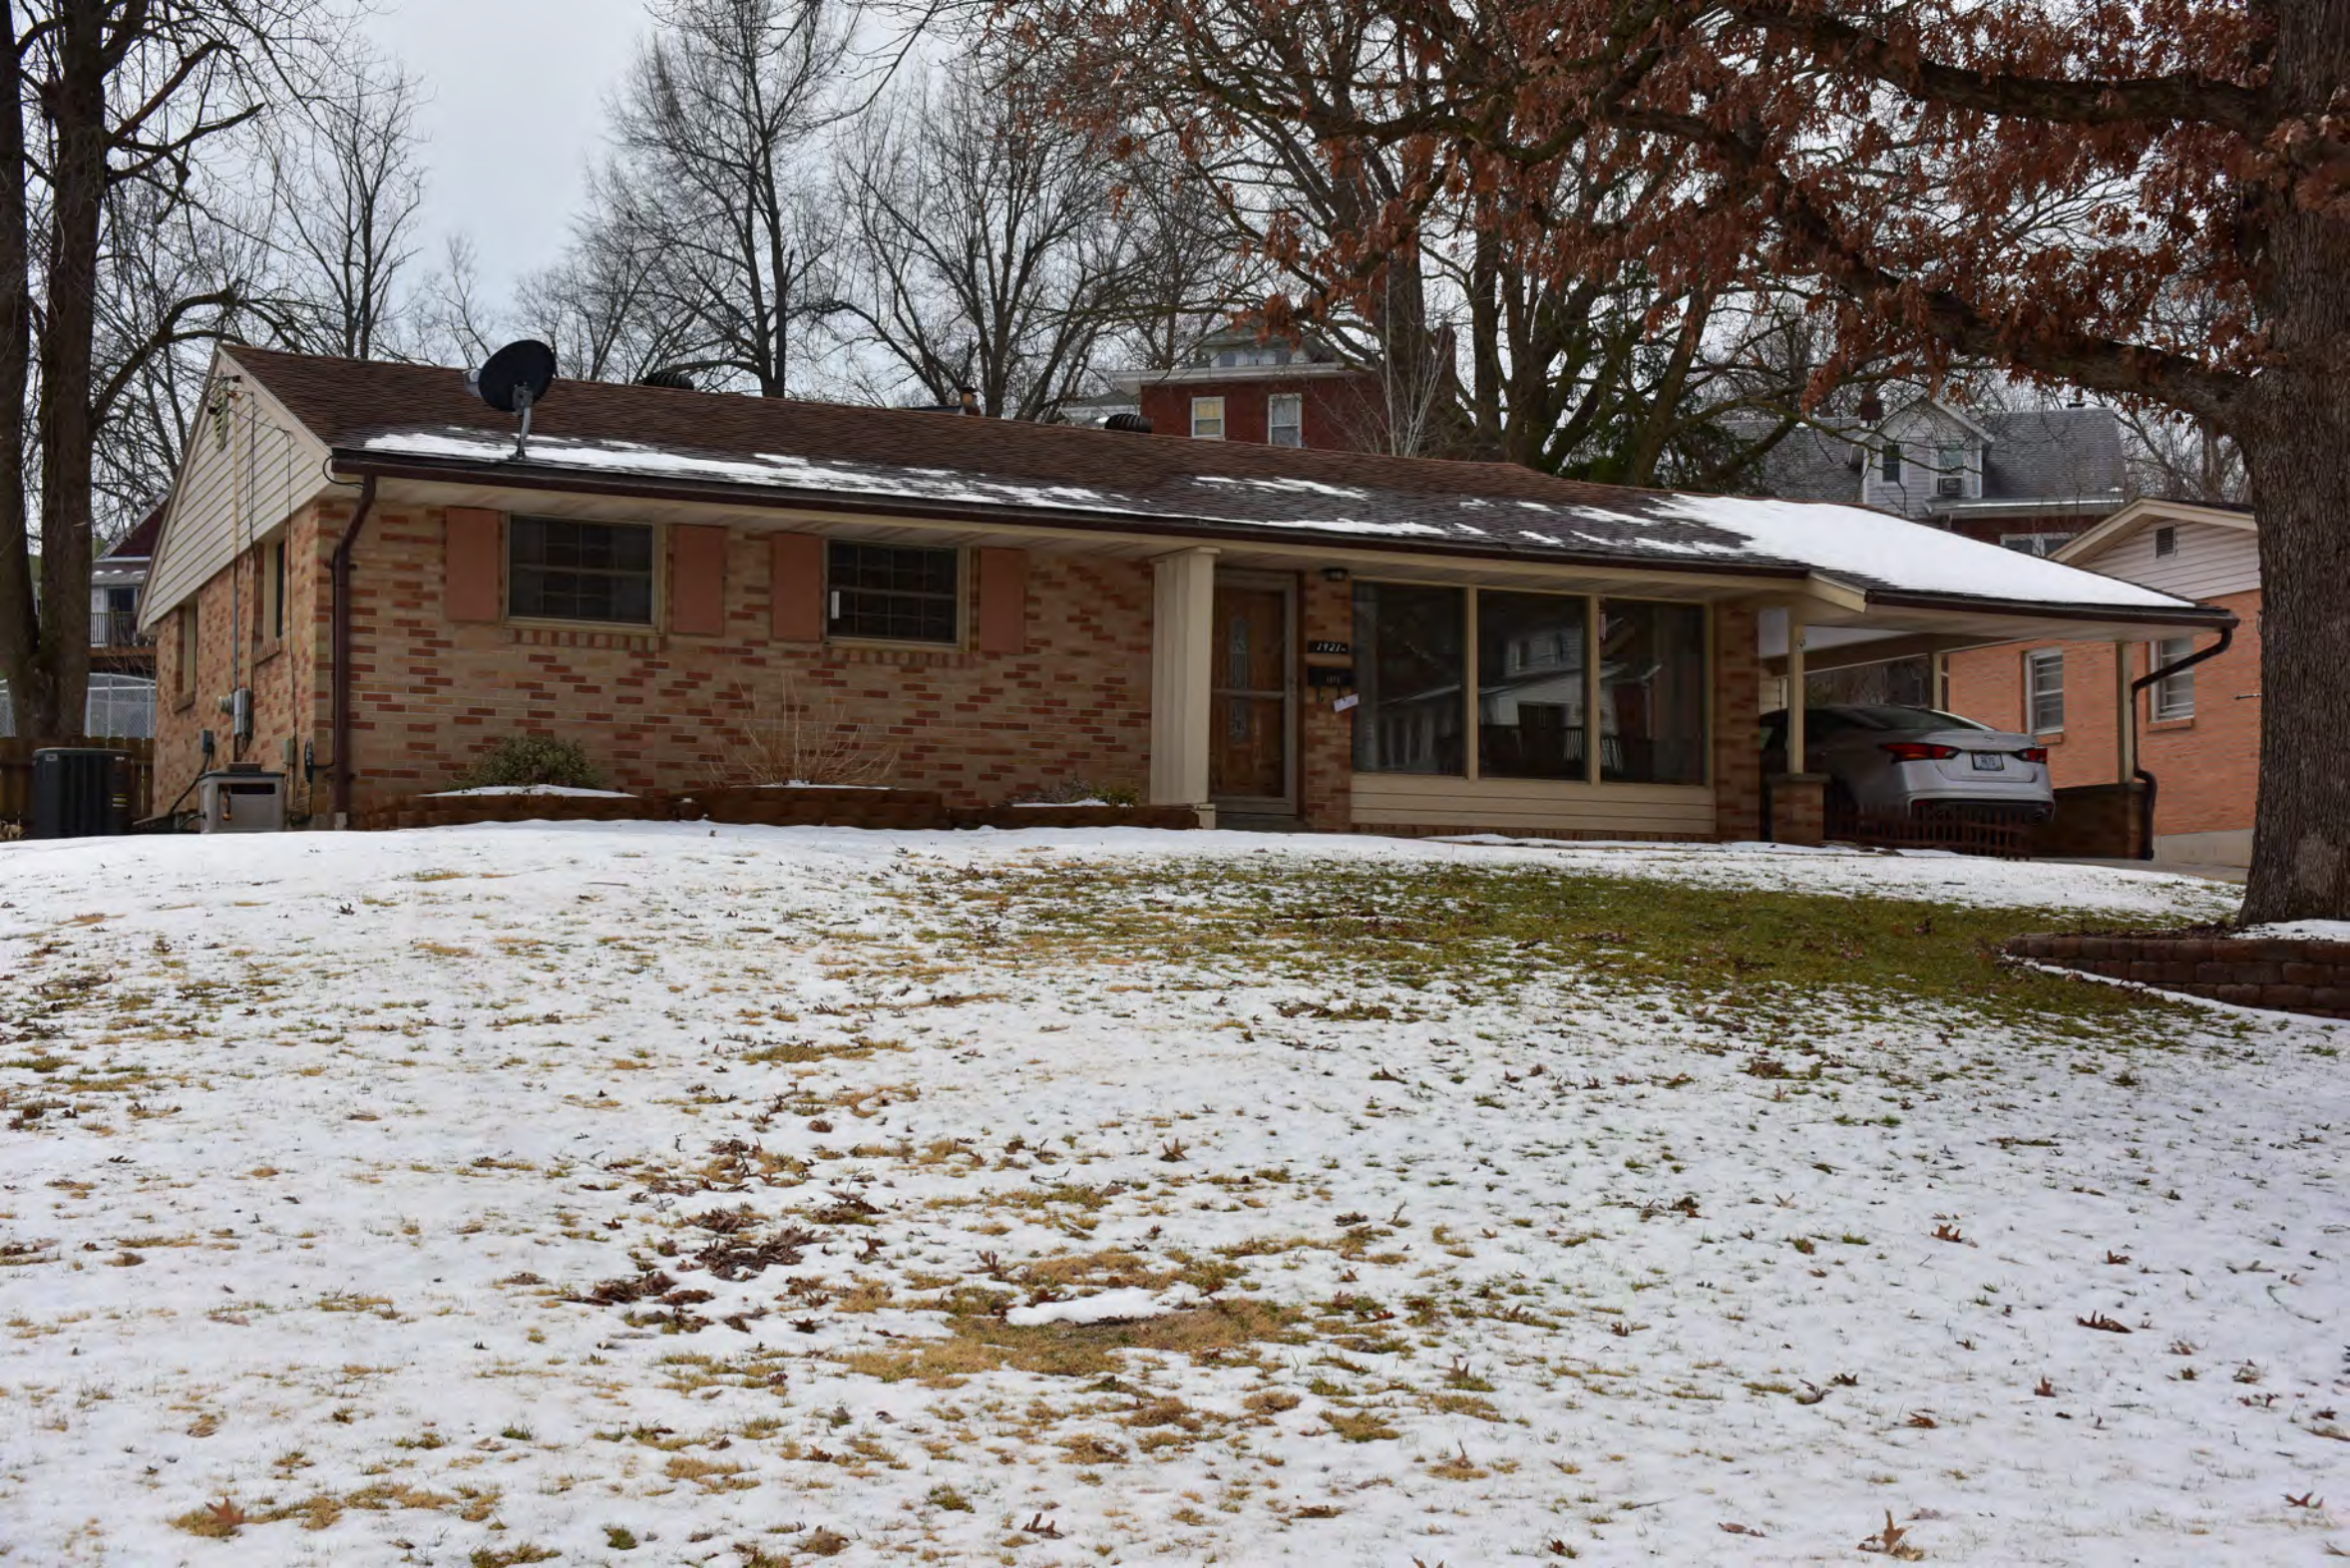
Alterations to 1921 South Circle Drive the replacement of historic windows. The east-two windows fill historic openings; however, infill minor alters the scale of the west bay. 1921 South Circle Drive otherwise retains good integrity. This resource would be contributing to the potential Walinko Place Historic District, significant in the areas of Architecture and Community Planning and Development in association with the expansion of Jefferson City and increased suburban development during the twentieth century as well as its associations with Walinko Place, a notable suburban development during the Depression and War Years.

1921 South Circle Drive is a one-story Ranch dwelling. The dwelling has red and buff brick cladding, a concrete foundation, and asphalt side-gable roof. Metal siding clads the gable ends. The dwelling is four bays wide. Short non-historic 4/4 windows with header brick sills defines the east-two bays. The primary entrance defines the third bay. A non-historic wood door and aluminum storm door fill the bay. A wide full-height window bay with a header brick sill defines the fourth bay. A non-historic tripartite picture window with three fixed panes fills the upper three-quarters of the opening while metal siding infills the bottom quarter. Wide eaves shelter the primary elevation bays, forming a full-width open porch. A historic full-height wood screen at the east edge of the entrance divides the primary elevation in half. A side-gable car port extends from the west elevation and is offset slightly from the dwelling. Historic squared wood posts on a concrete-capped brick knee wall support the carport roof. The rear is partially enclosed with metal cladding.
