1. Survey number: CO-AS-008-001		2. Survey Name: West Main Street Survey	
3. County: Cole		4. Address (Street No.): 100	Street (name): East Circle Drive
5. City: Jefferson City	Vicinity <input type="checkbox"/>	6. Lat / Long:	7. Township/Range/Section: T: R: S:
8. Historic name (if known):		9. Present/other name (if known):	
10. Ownership: <input checked="" type="checkbox"/> Private <input type="checkbox"/> Public		11a. Historic use (if known): Domestic-Single Dwelling	11b. Current use: Domestic-Single Dwelling

MISSOURI DEPARTMENT OF NATURAL RESOURCES
STATE HISTORIC PRESERVATION OFFICE, P.O. Box 178, Jefferson City, MO 65102
ARCHITECTURAL/HISTORIC INVENTORY FORM

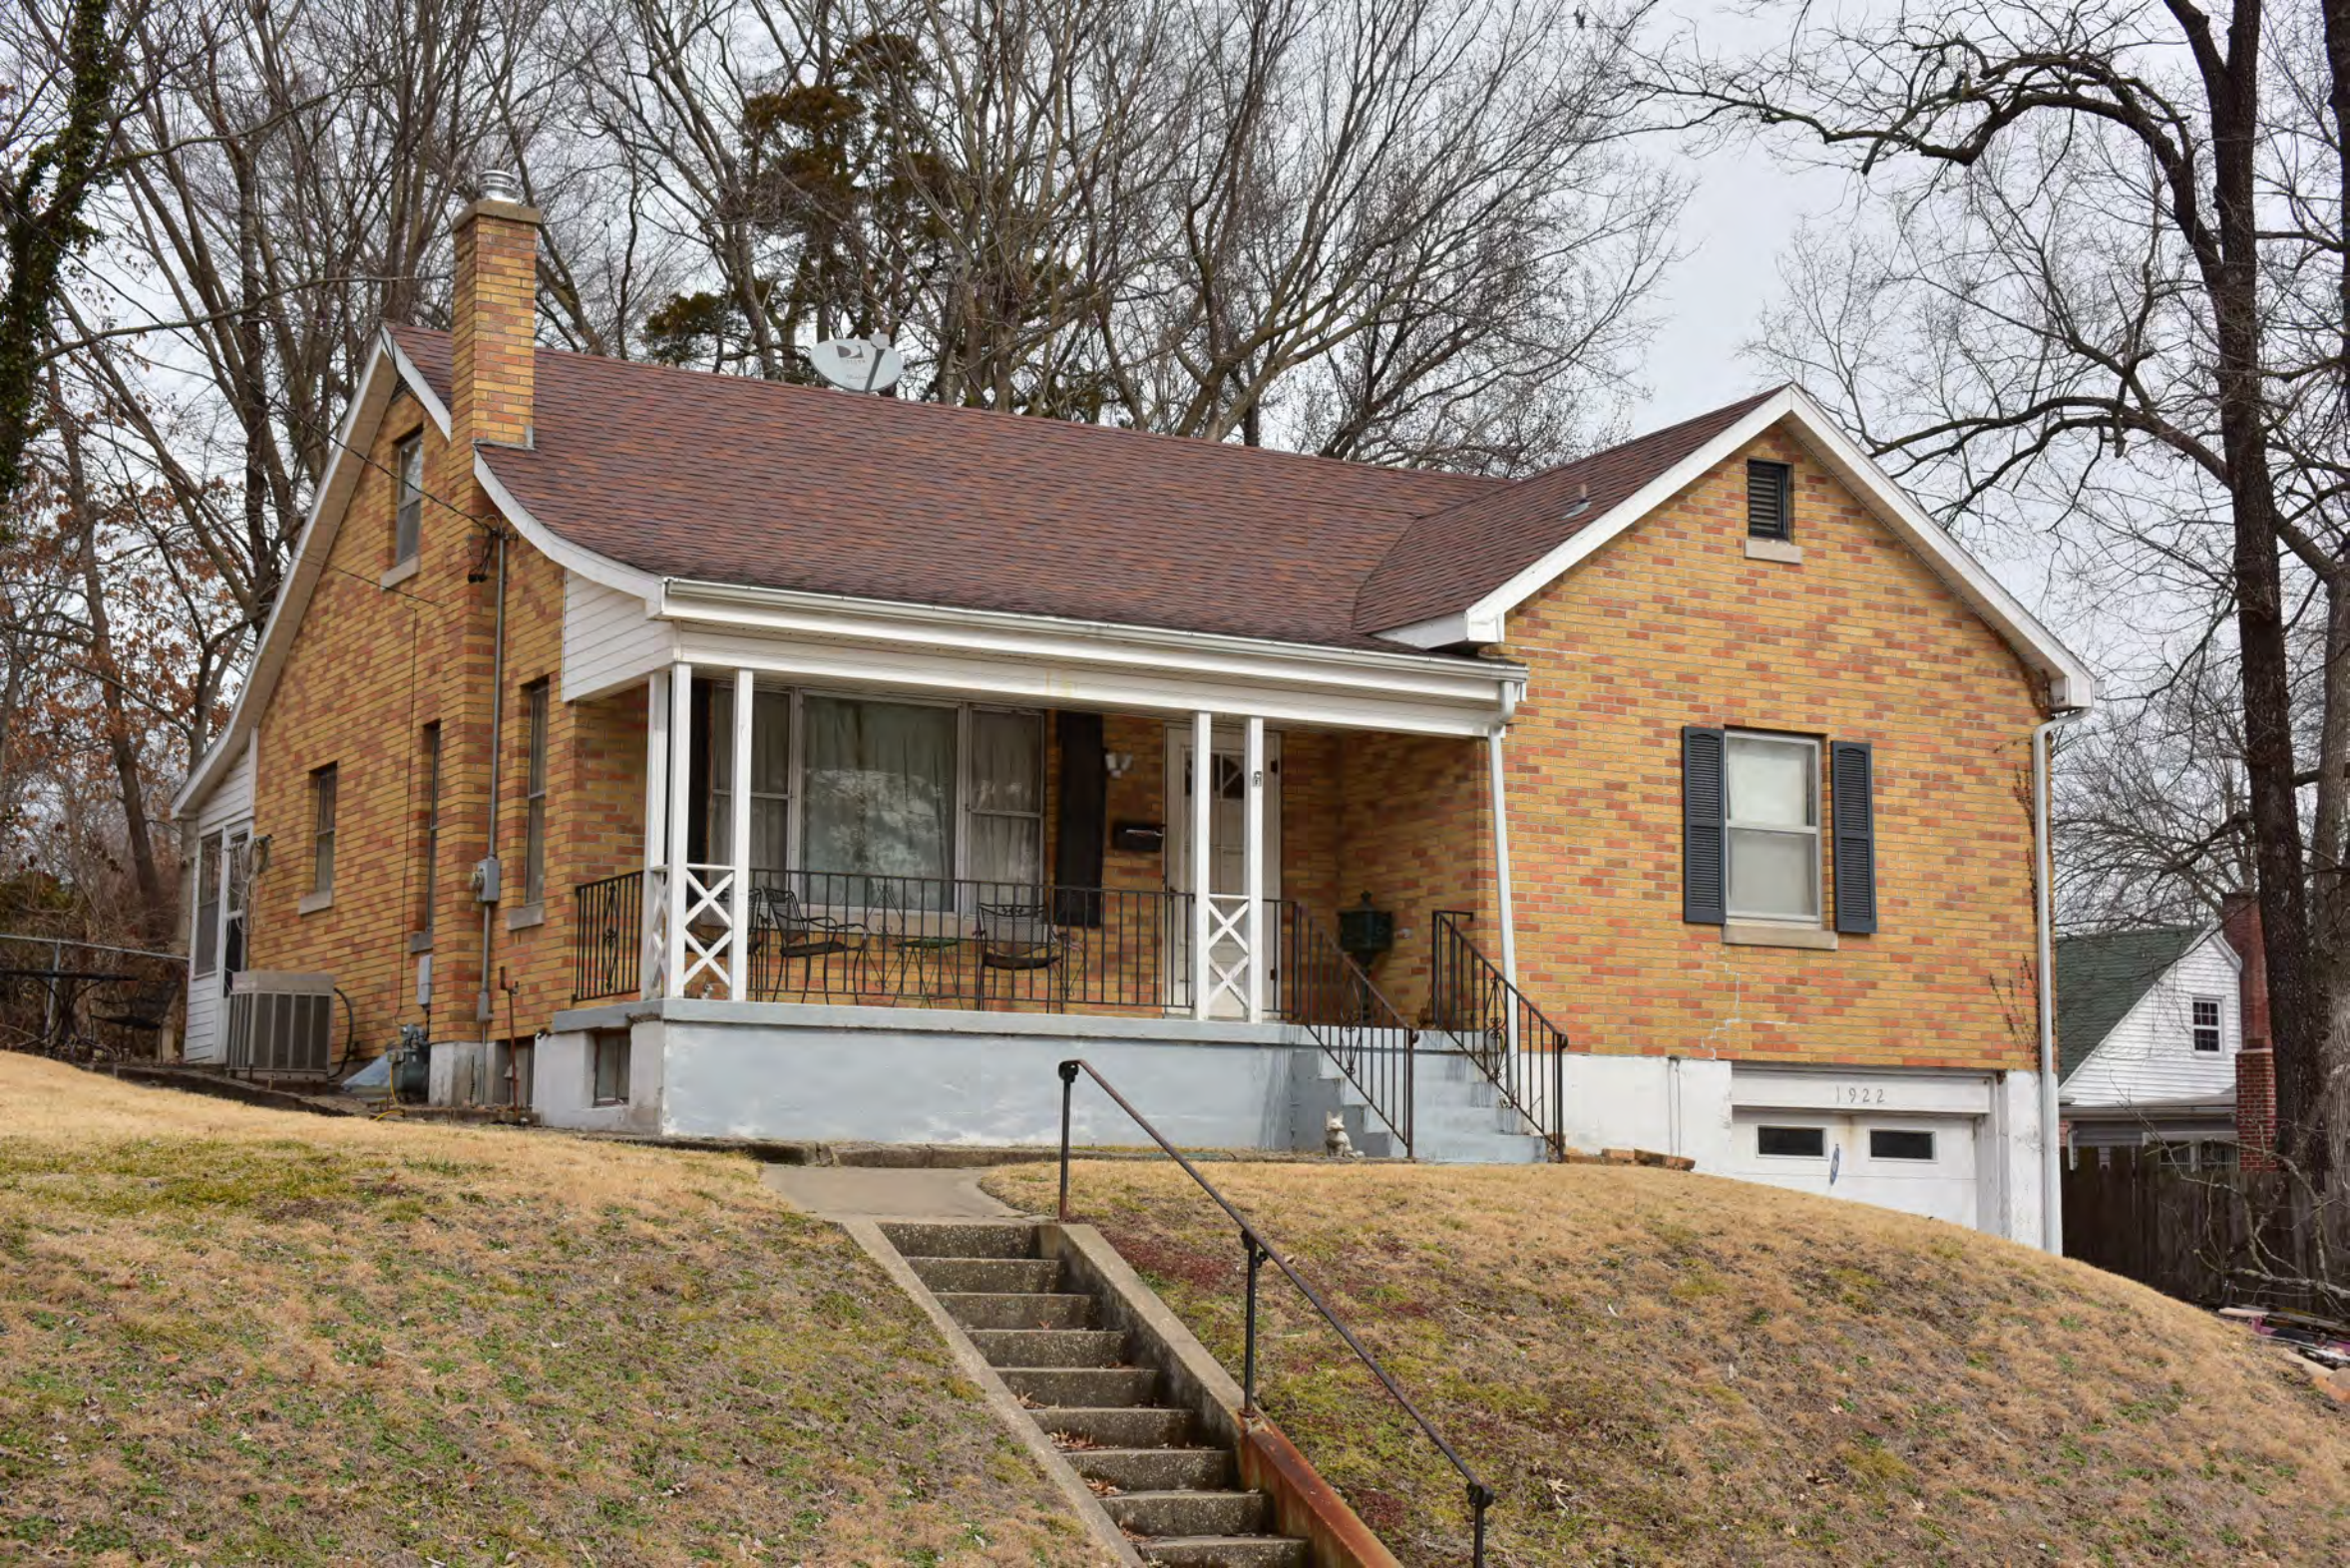
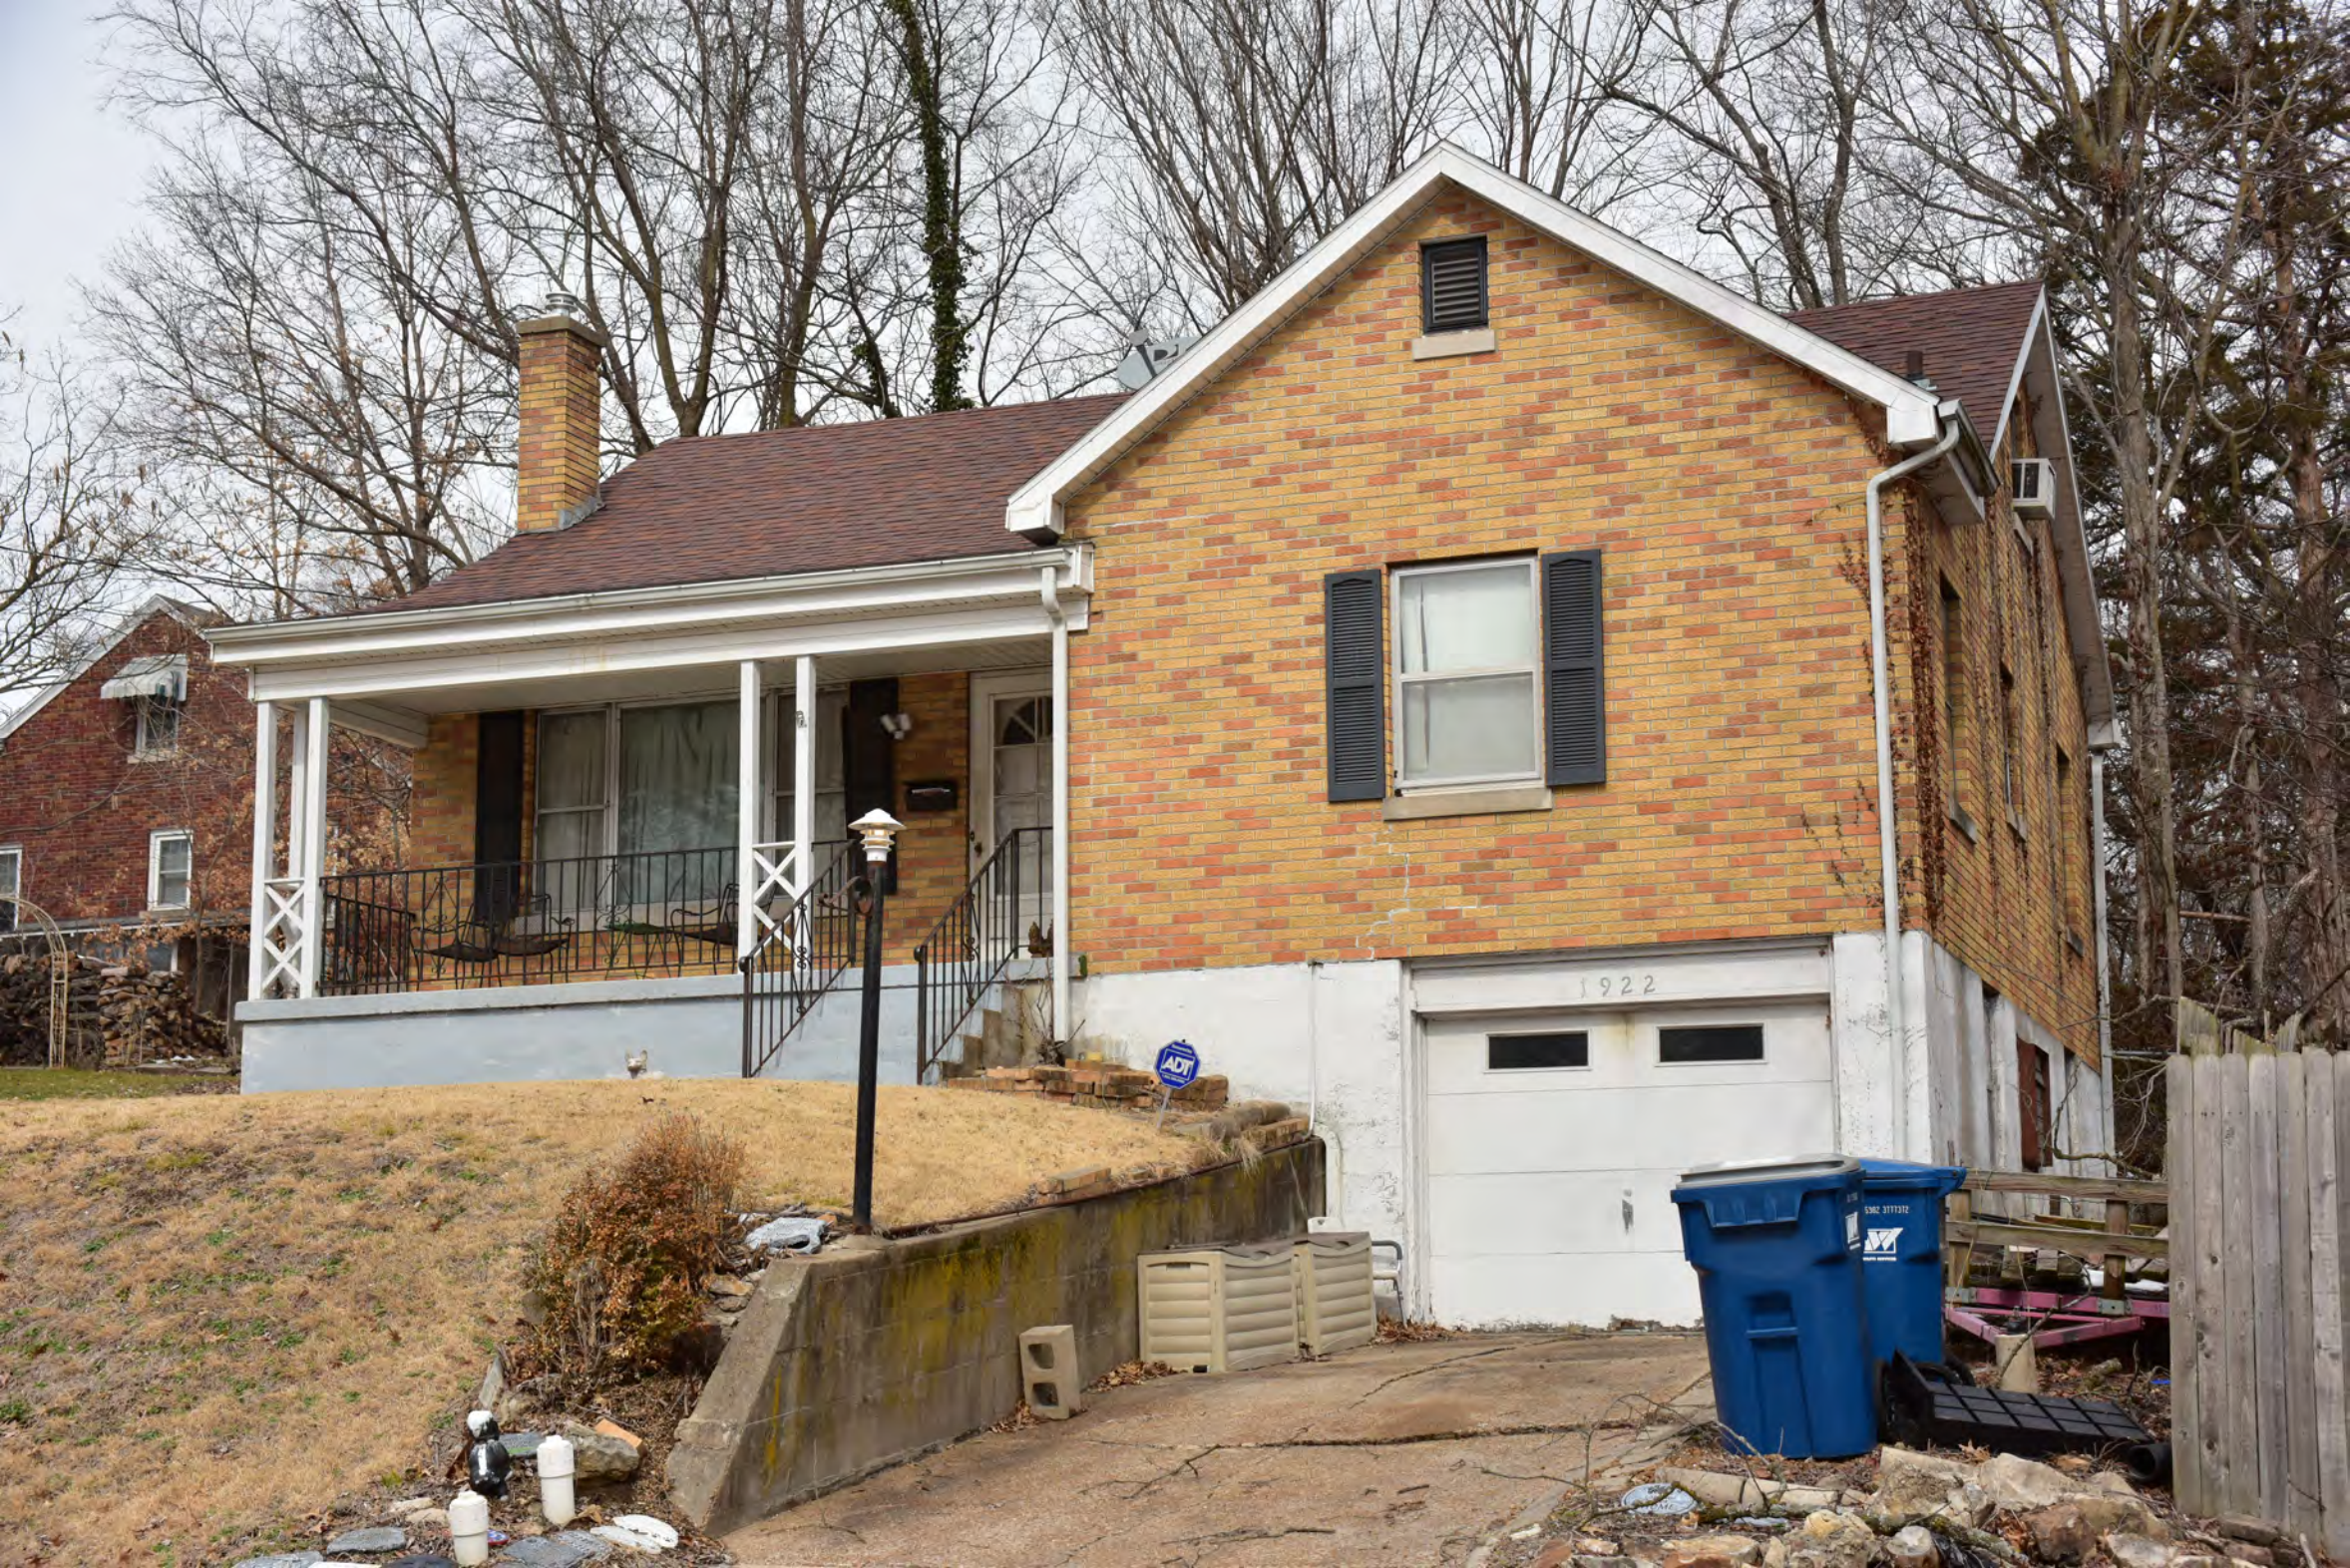
1922 South Circle Drive is a one-story Transitional Ranch dwelling. The dwelling has buff brick cladding, a concrete foundation, and an asphalt intersecting-gable roof. A brick exterior chimney pierces the west gable eave. The dwelling is three bays wide. A tripartite window fills the first bay. Metal 1/1 windows flank a fixed central pane. The primary entrance defines the center bay. A non-historic door fills the opening. A gabled-ell projects at the east end of the primary elevation and contains the third bay. A 1/1 window with concrete sill defines the bay. A square vent with a concrete sill is located directly above in the gable apex. Aluminum storm windows obscure all window sashes. An integrated single-car garage is located in the ell at basement level. A historic overhead door with glazing fills the vehicular bay. A parged concrete partial-width open porch extends below the west-two bays. The roof eave extends to form a shed-roof. Groups of squared wood posts with lattice work support the porch roof and a metal scrolled railing lines the porch perimeter. Concrete stairs access the porch at the east end and feature a matching railing. A shed-roof enclosed porch with vinyl cladding extends from the northwest corner of the dwelling. Historic aerial images indicate the presence of a porch historically; however, it cannot be determined if it was historically enclosed.

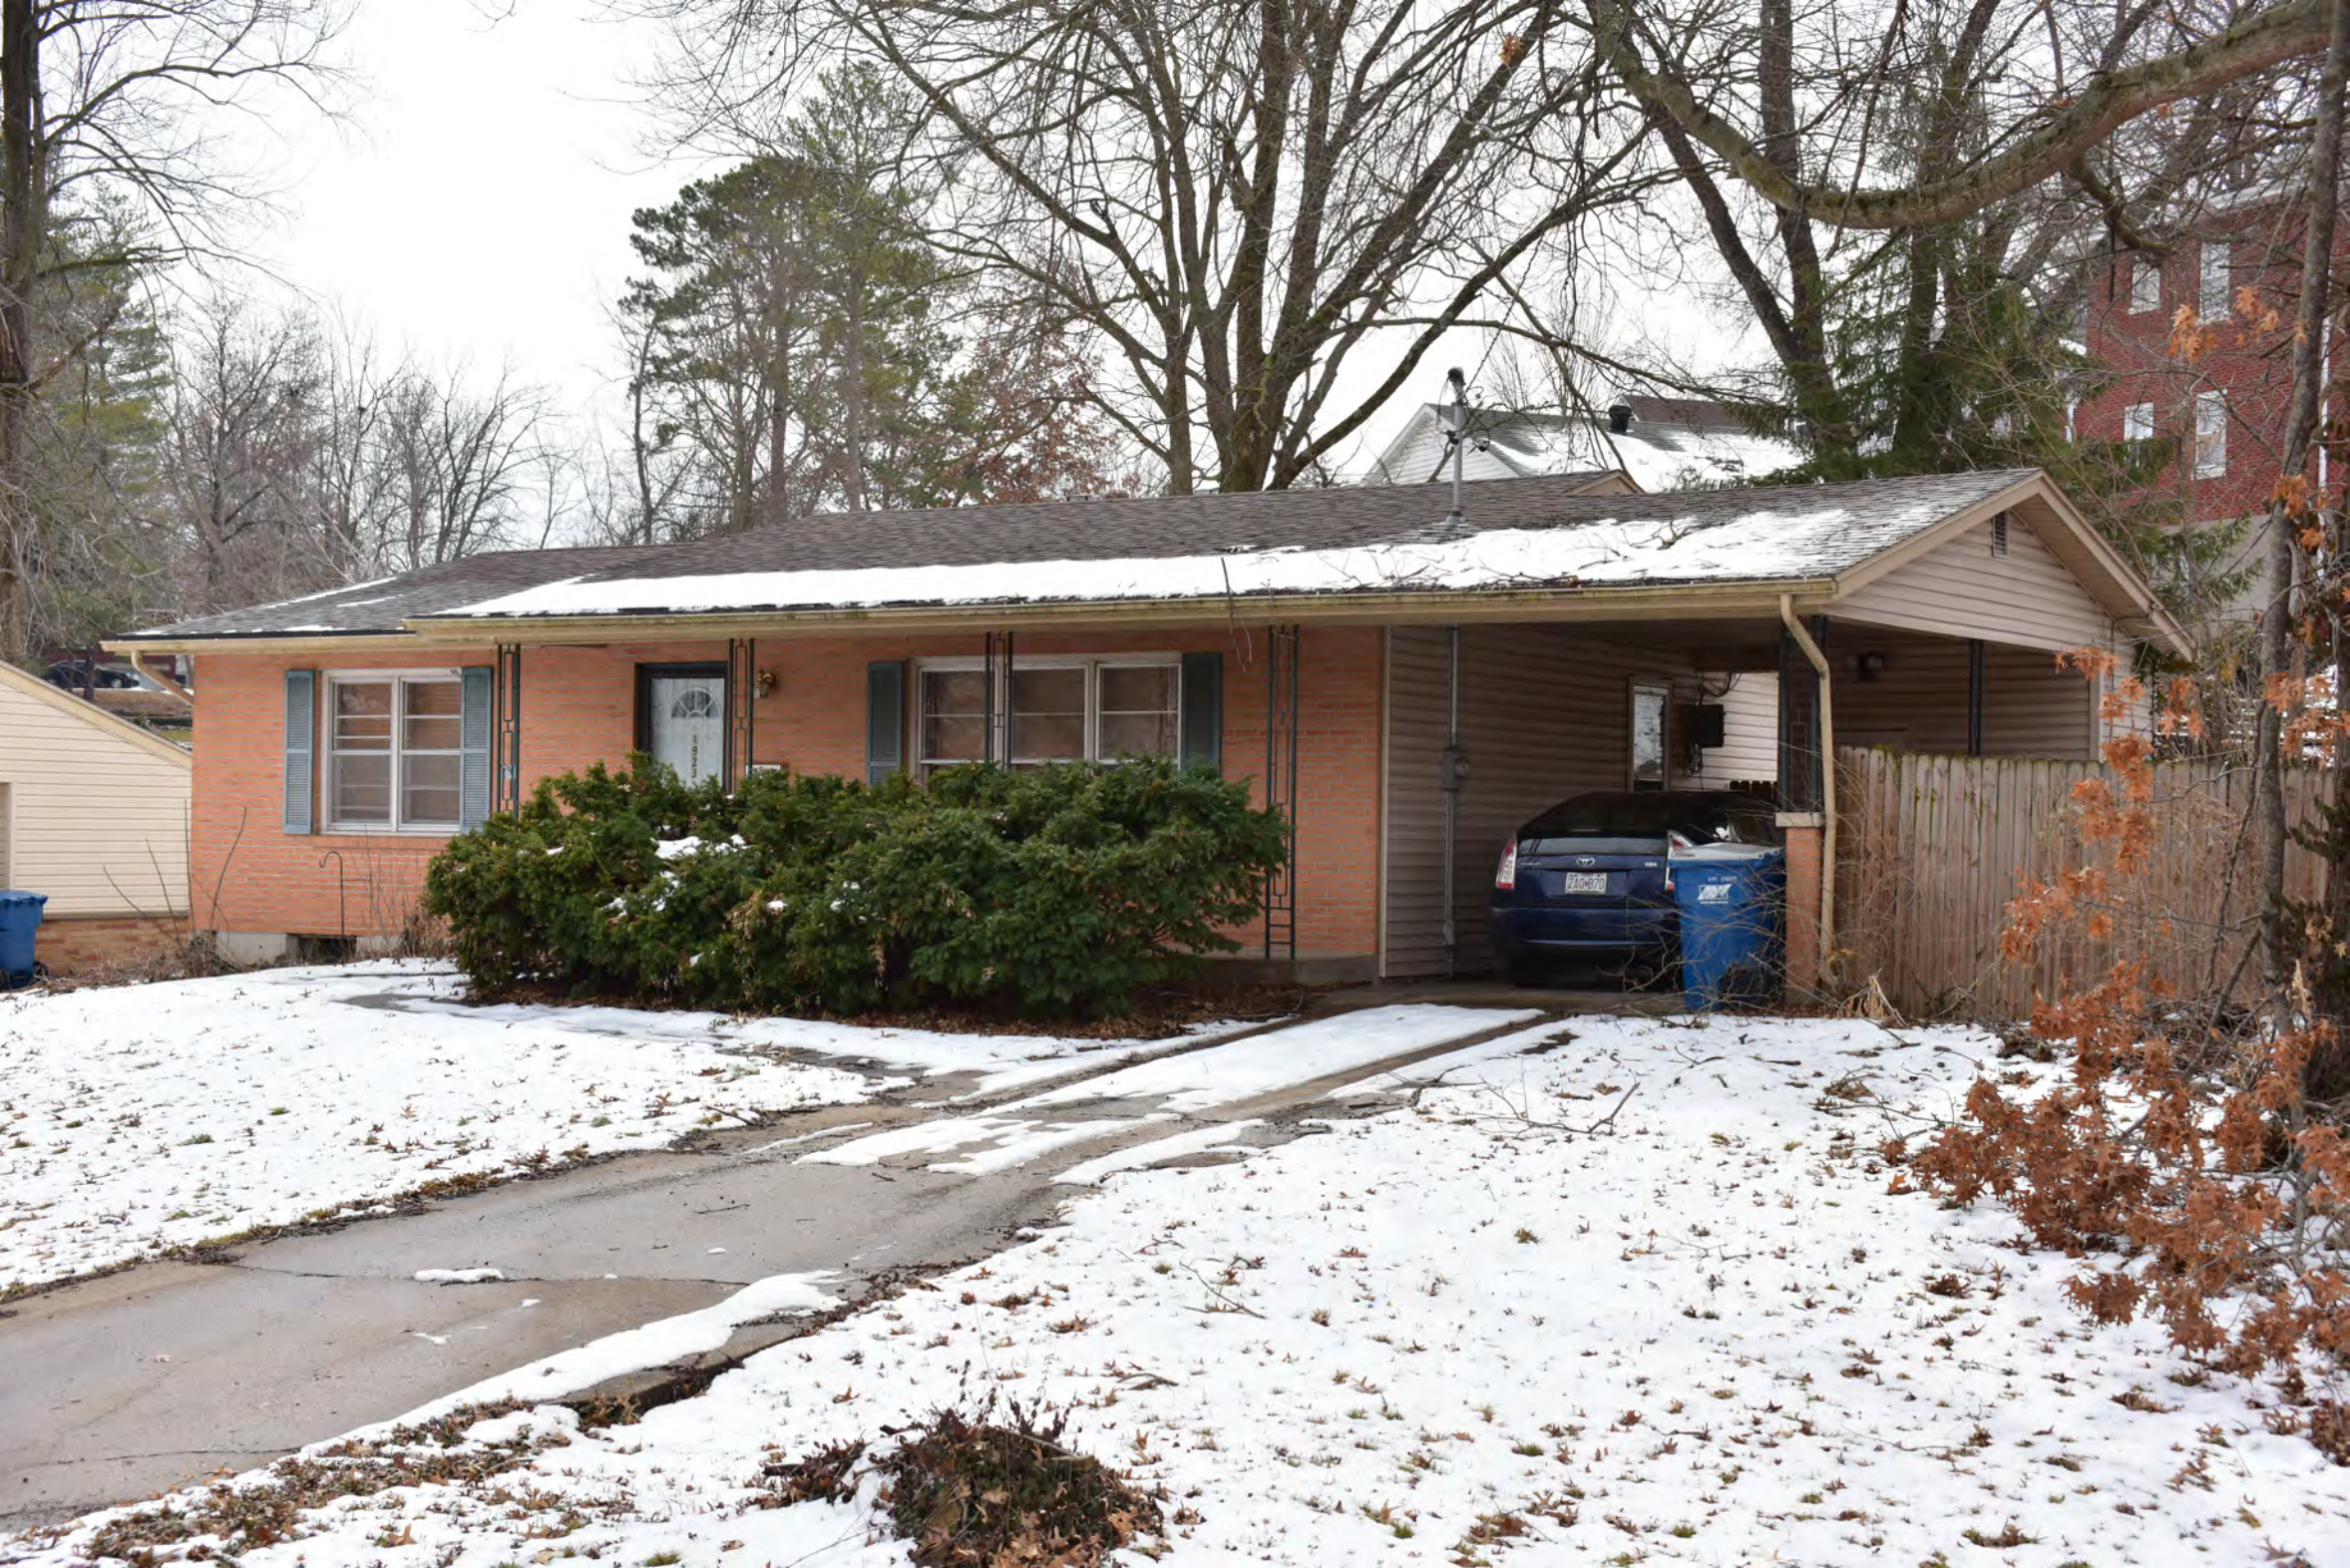
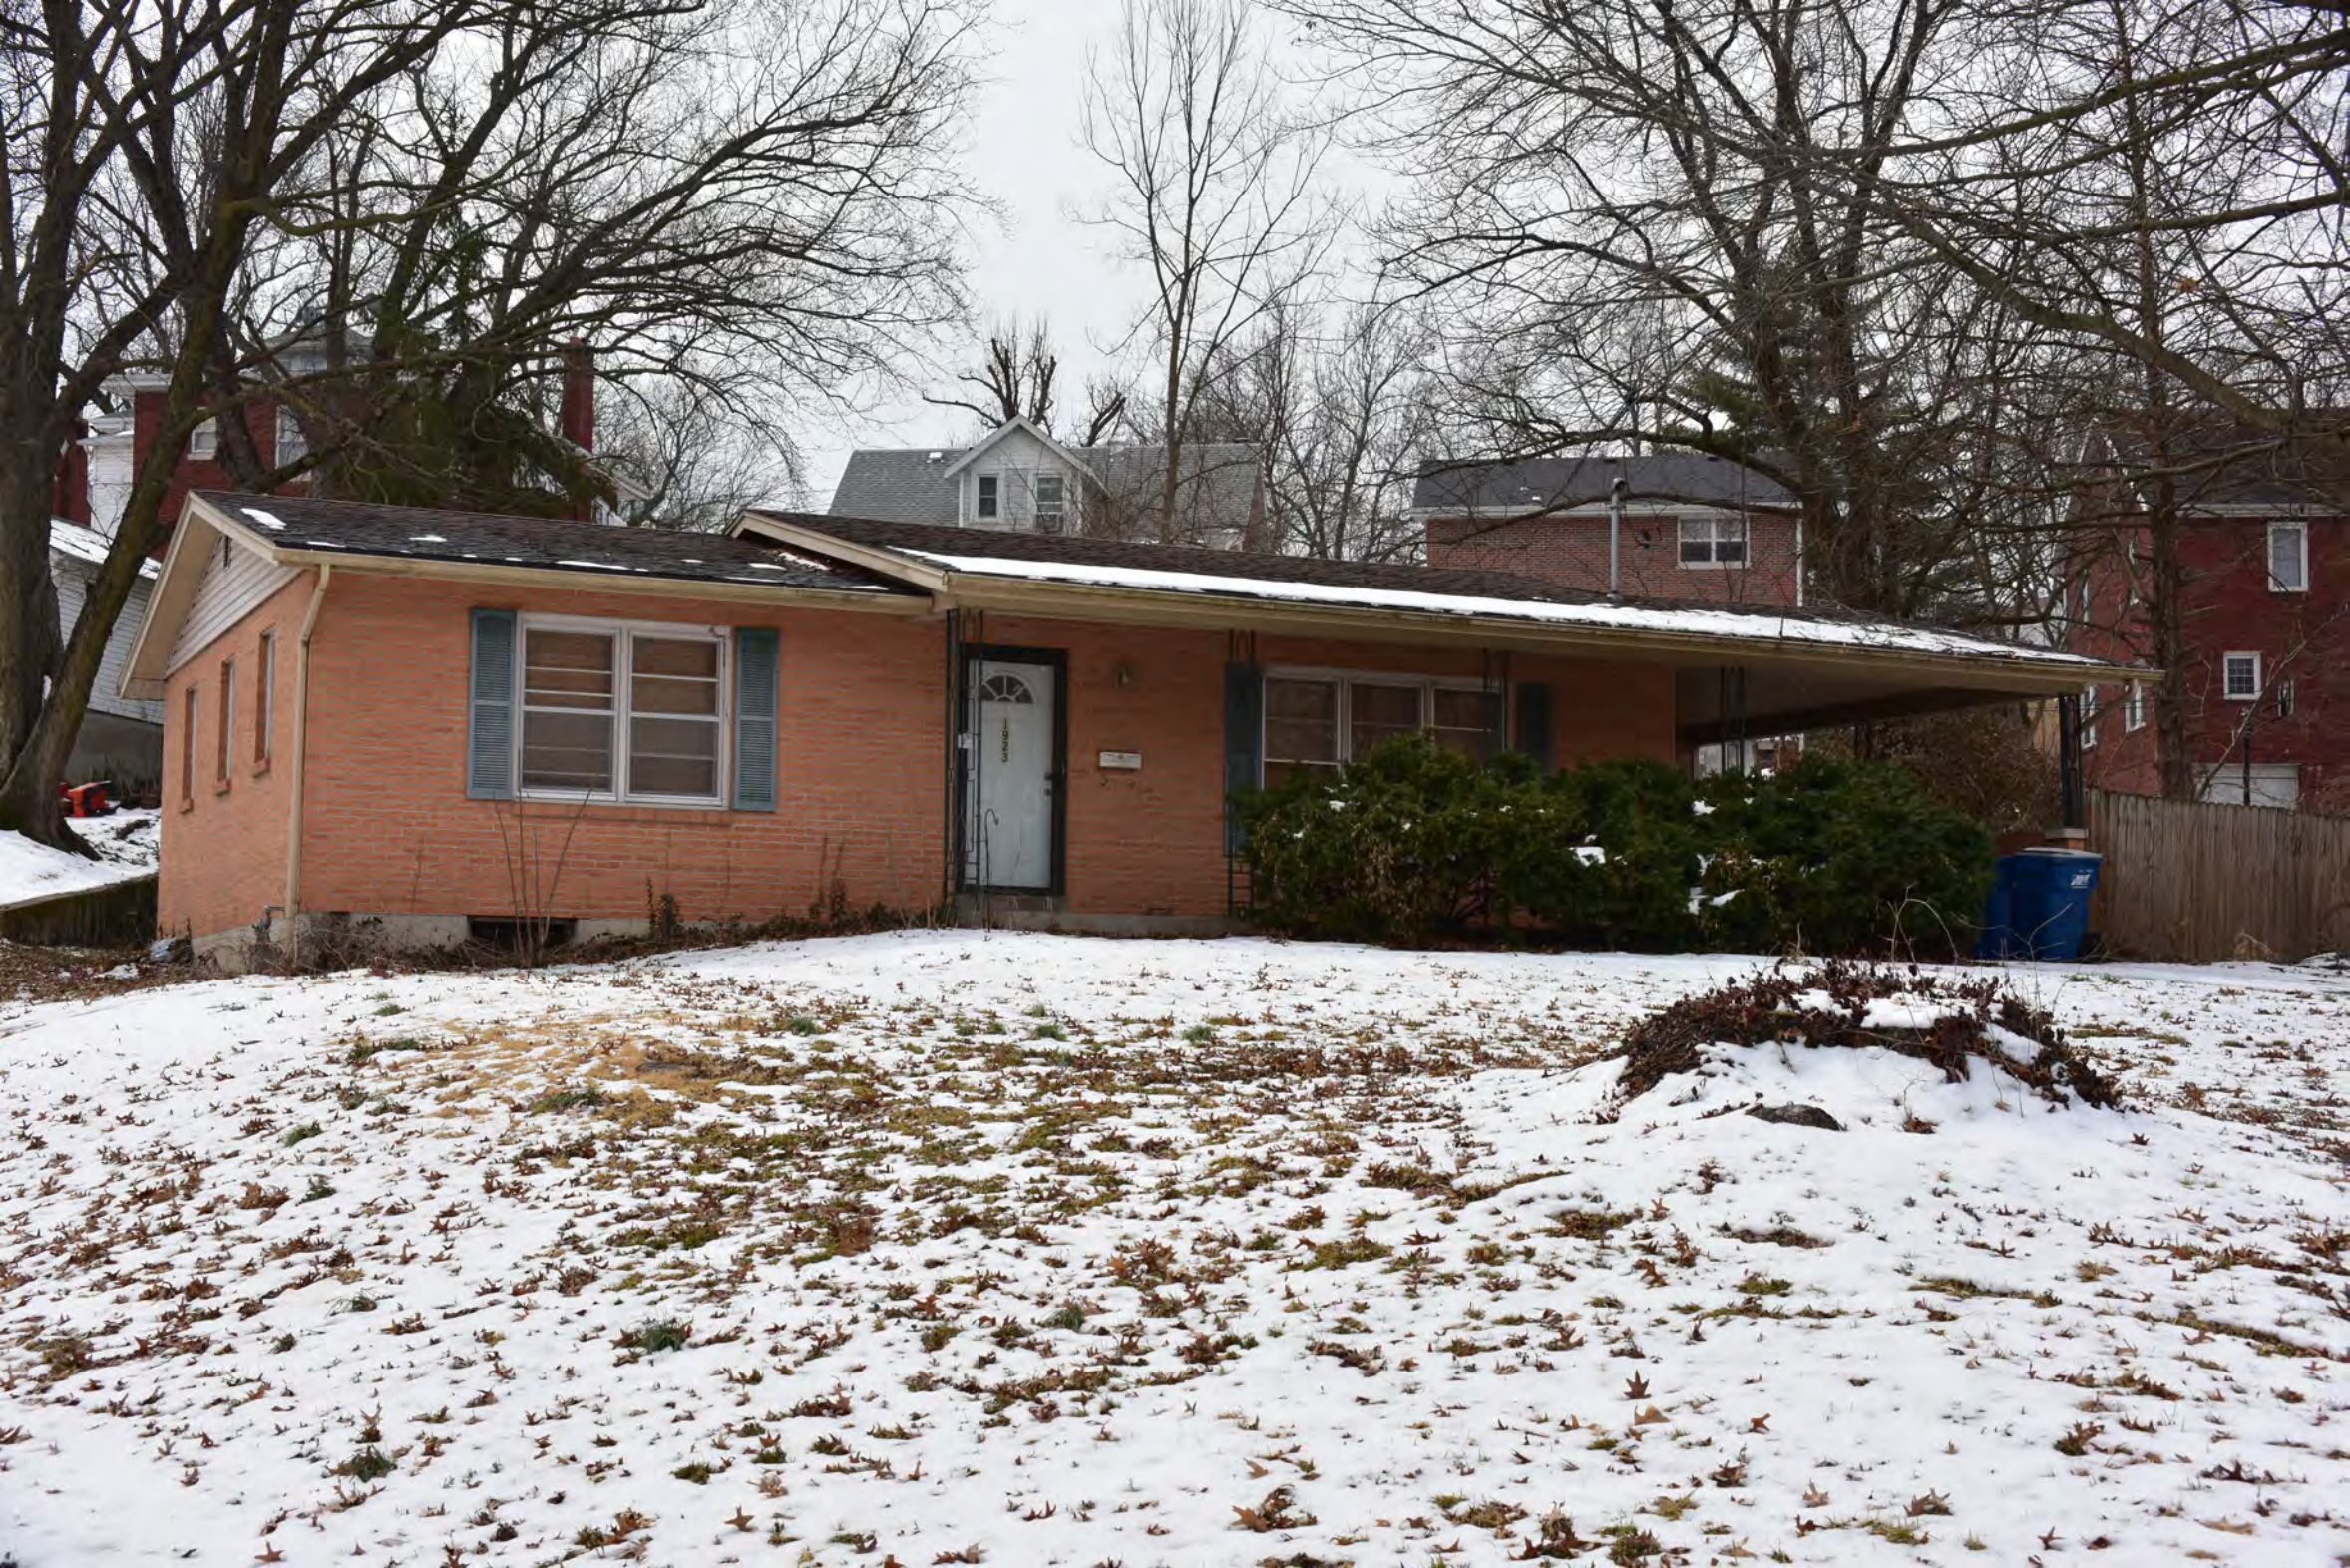
1923 South Circle Drive is a one-story Ranch dwelling. The dwelling has red brick cladding, a concrete foundation, and asphalt side-gable roof. Metal siding clads the gable ends and the west elevation. The dwelling is three bays wide. Two-ganged historic 2/2 wood windows with horizontal muntins and a continuous header brick define the east bay. The primary entrance defines the second bay and contains a non-historic door. Three-ganged historic 2/2 wood windows with horizontal muntins fill the third bay. Wide eaves shelter the west-two primary elevation bays, forming a full-width open porch. Historic metal support posts with a geometric motif support the porch roof. The porch roof conjoins to a side-gable carport at the west elevation. The carport is offset slightly from the dwelling. Historic metal support posts on a concrete-capped brick knee wall support the carport roof. The rear is partially enclosed with metal cladding. A gable-front addition projects from the rear. It is not visible from the right-of way.
