1. Survey number: CO-AS-008-001		2. Survey Name: West Main Street Survey	
3. County: Cole		4. Address (Street No.): 100	Street (name): East Circle Drive
5. City: Jefferson City	Vicinity <input type="checkbox"/>	6. Lat / Long:	7. Township/Range/Section: T: R: S:
8. Historic name (if known):		9. Present/other name (if known):	
10. Ownership: <input checked="" type="checkbox"/> Private <input type="checkbox"/> Public		11a. Historic use (if known): Domestic-Single Dwelling	11b. Current use: Domestic-Single Dwelling

MISSOURI DEPARTMENT OF NATURAL RESOURCES
STATE HISTORIC PRESERVATION OFFICE, P.O. Box 178, Jefferson City, MO 65102
ARCHITECTURAL/HISTORIC INVENTORY FORM

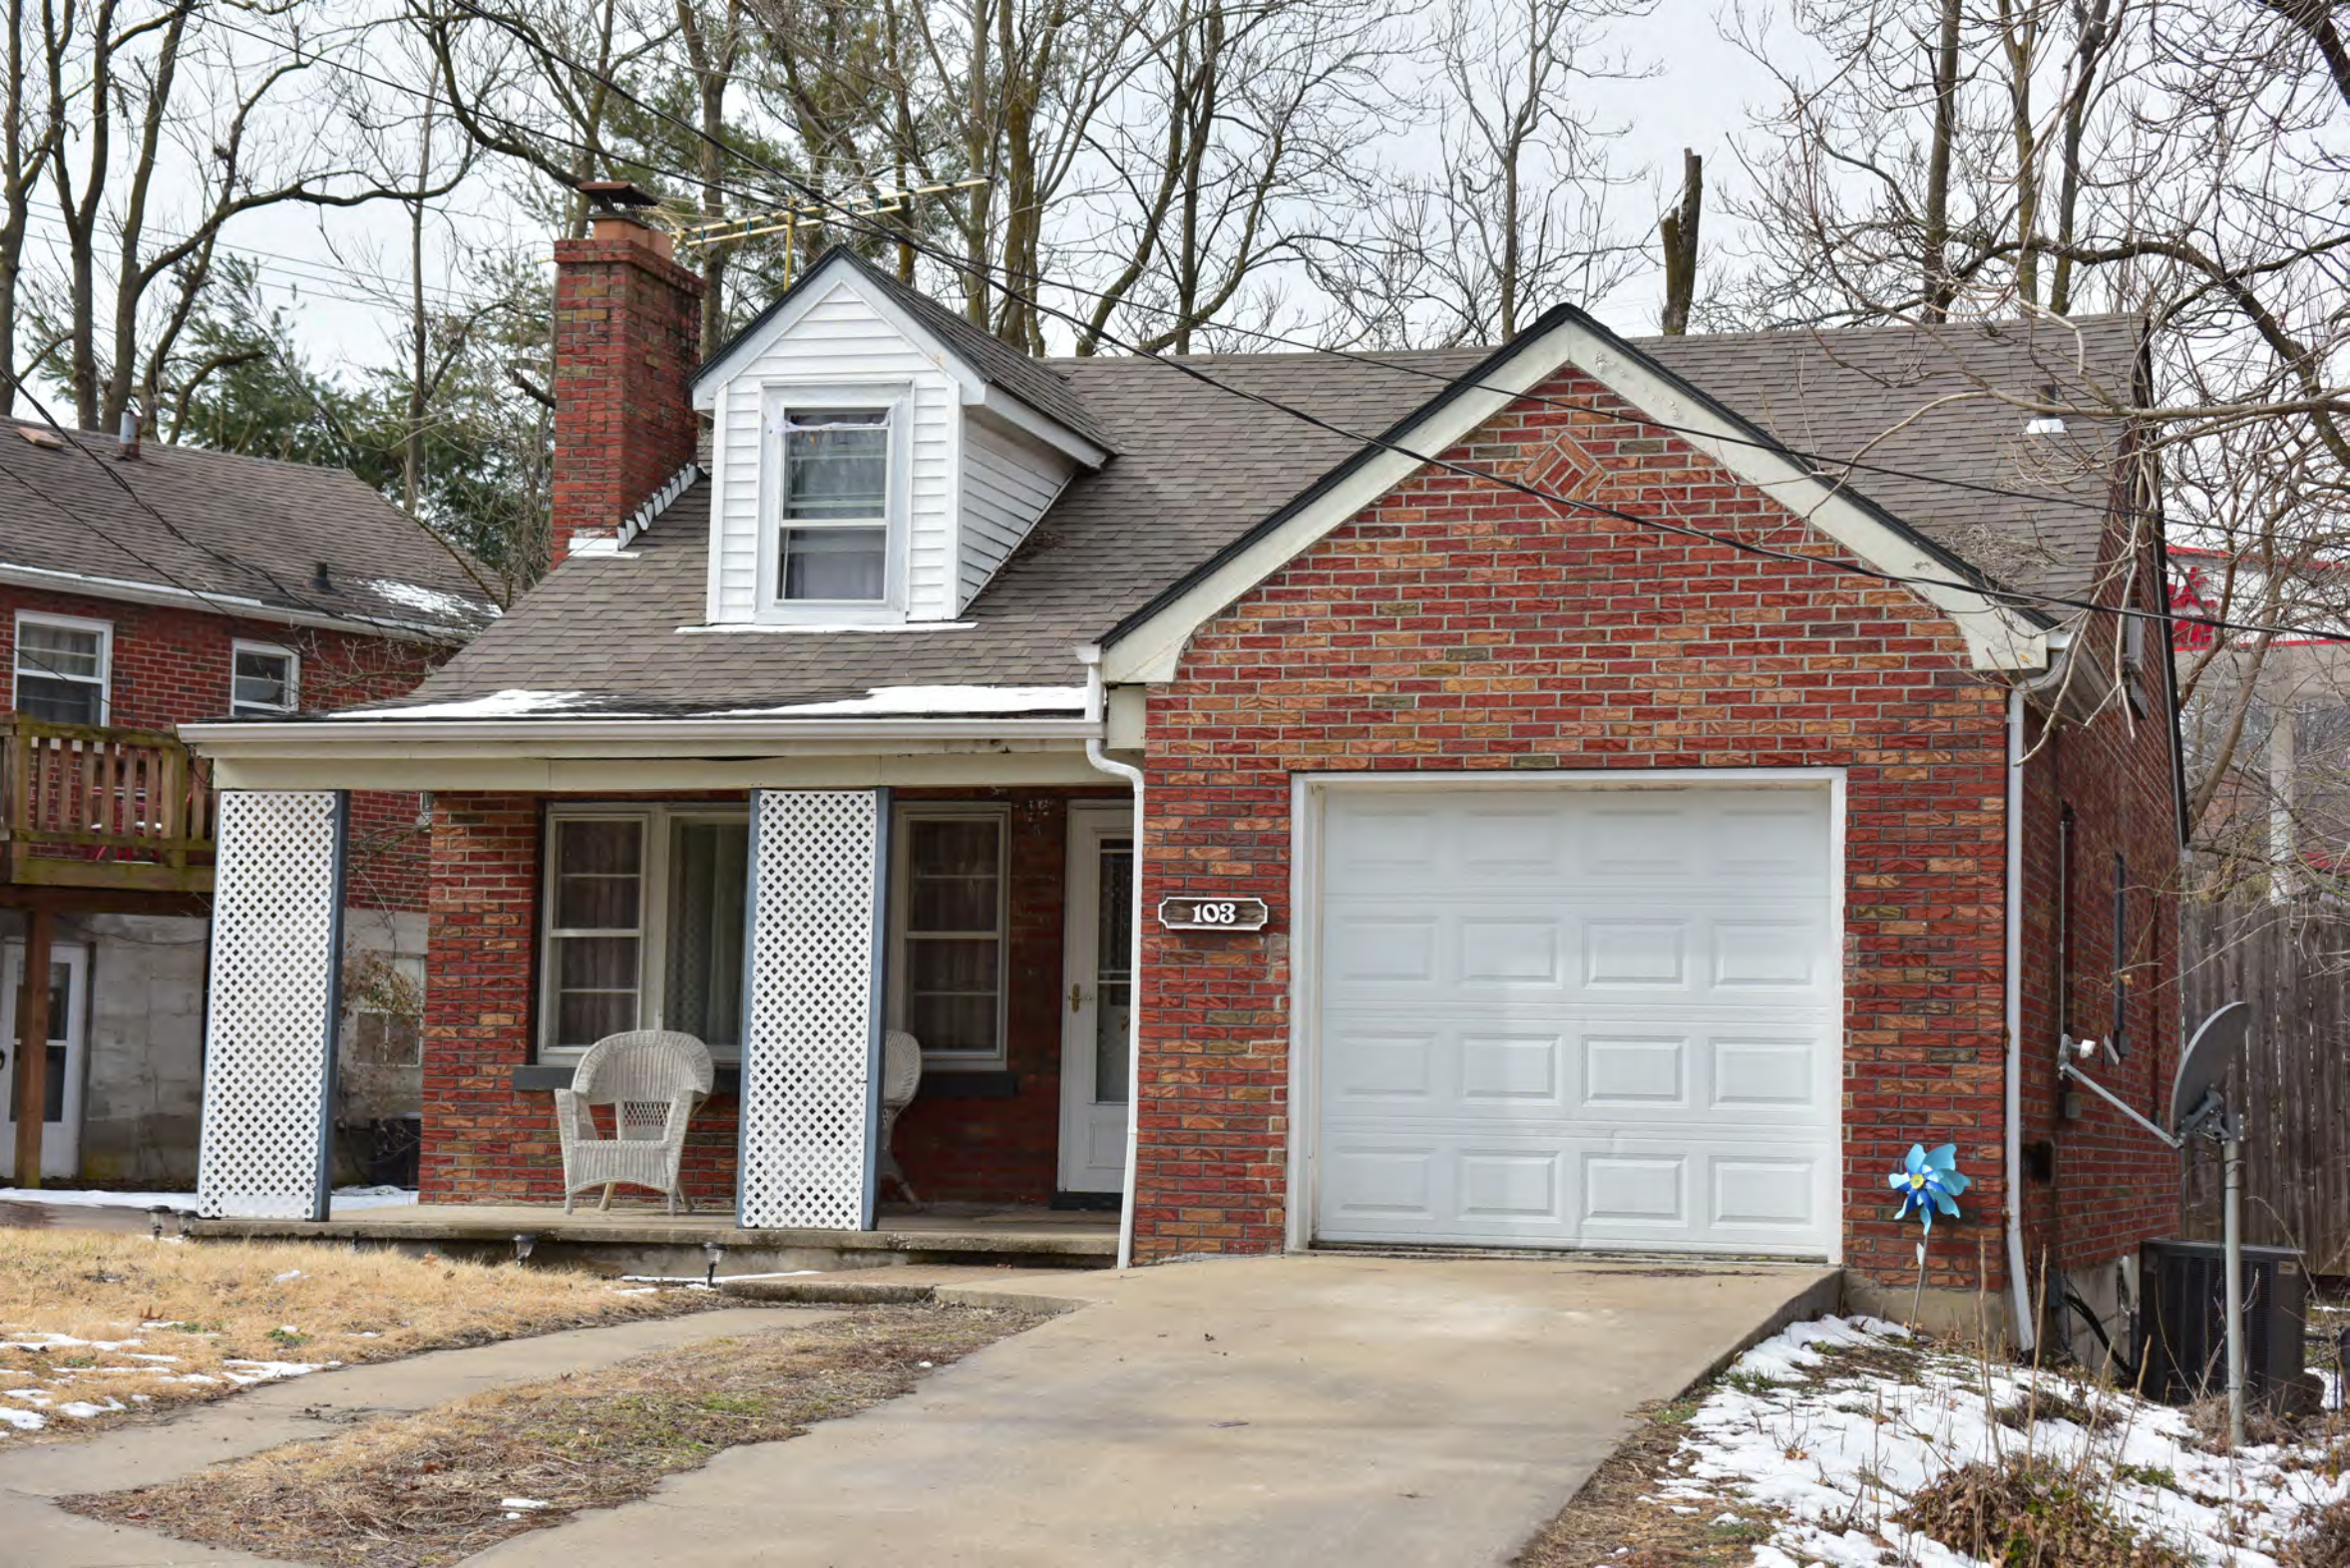
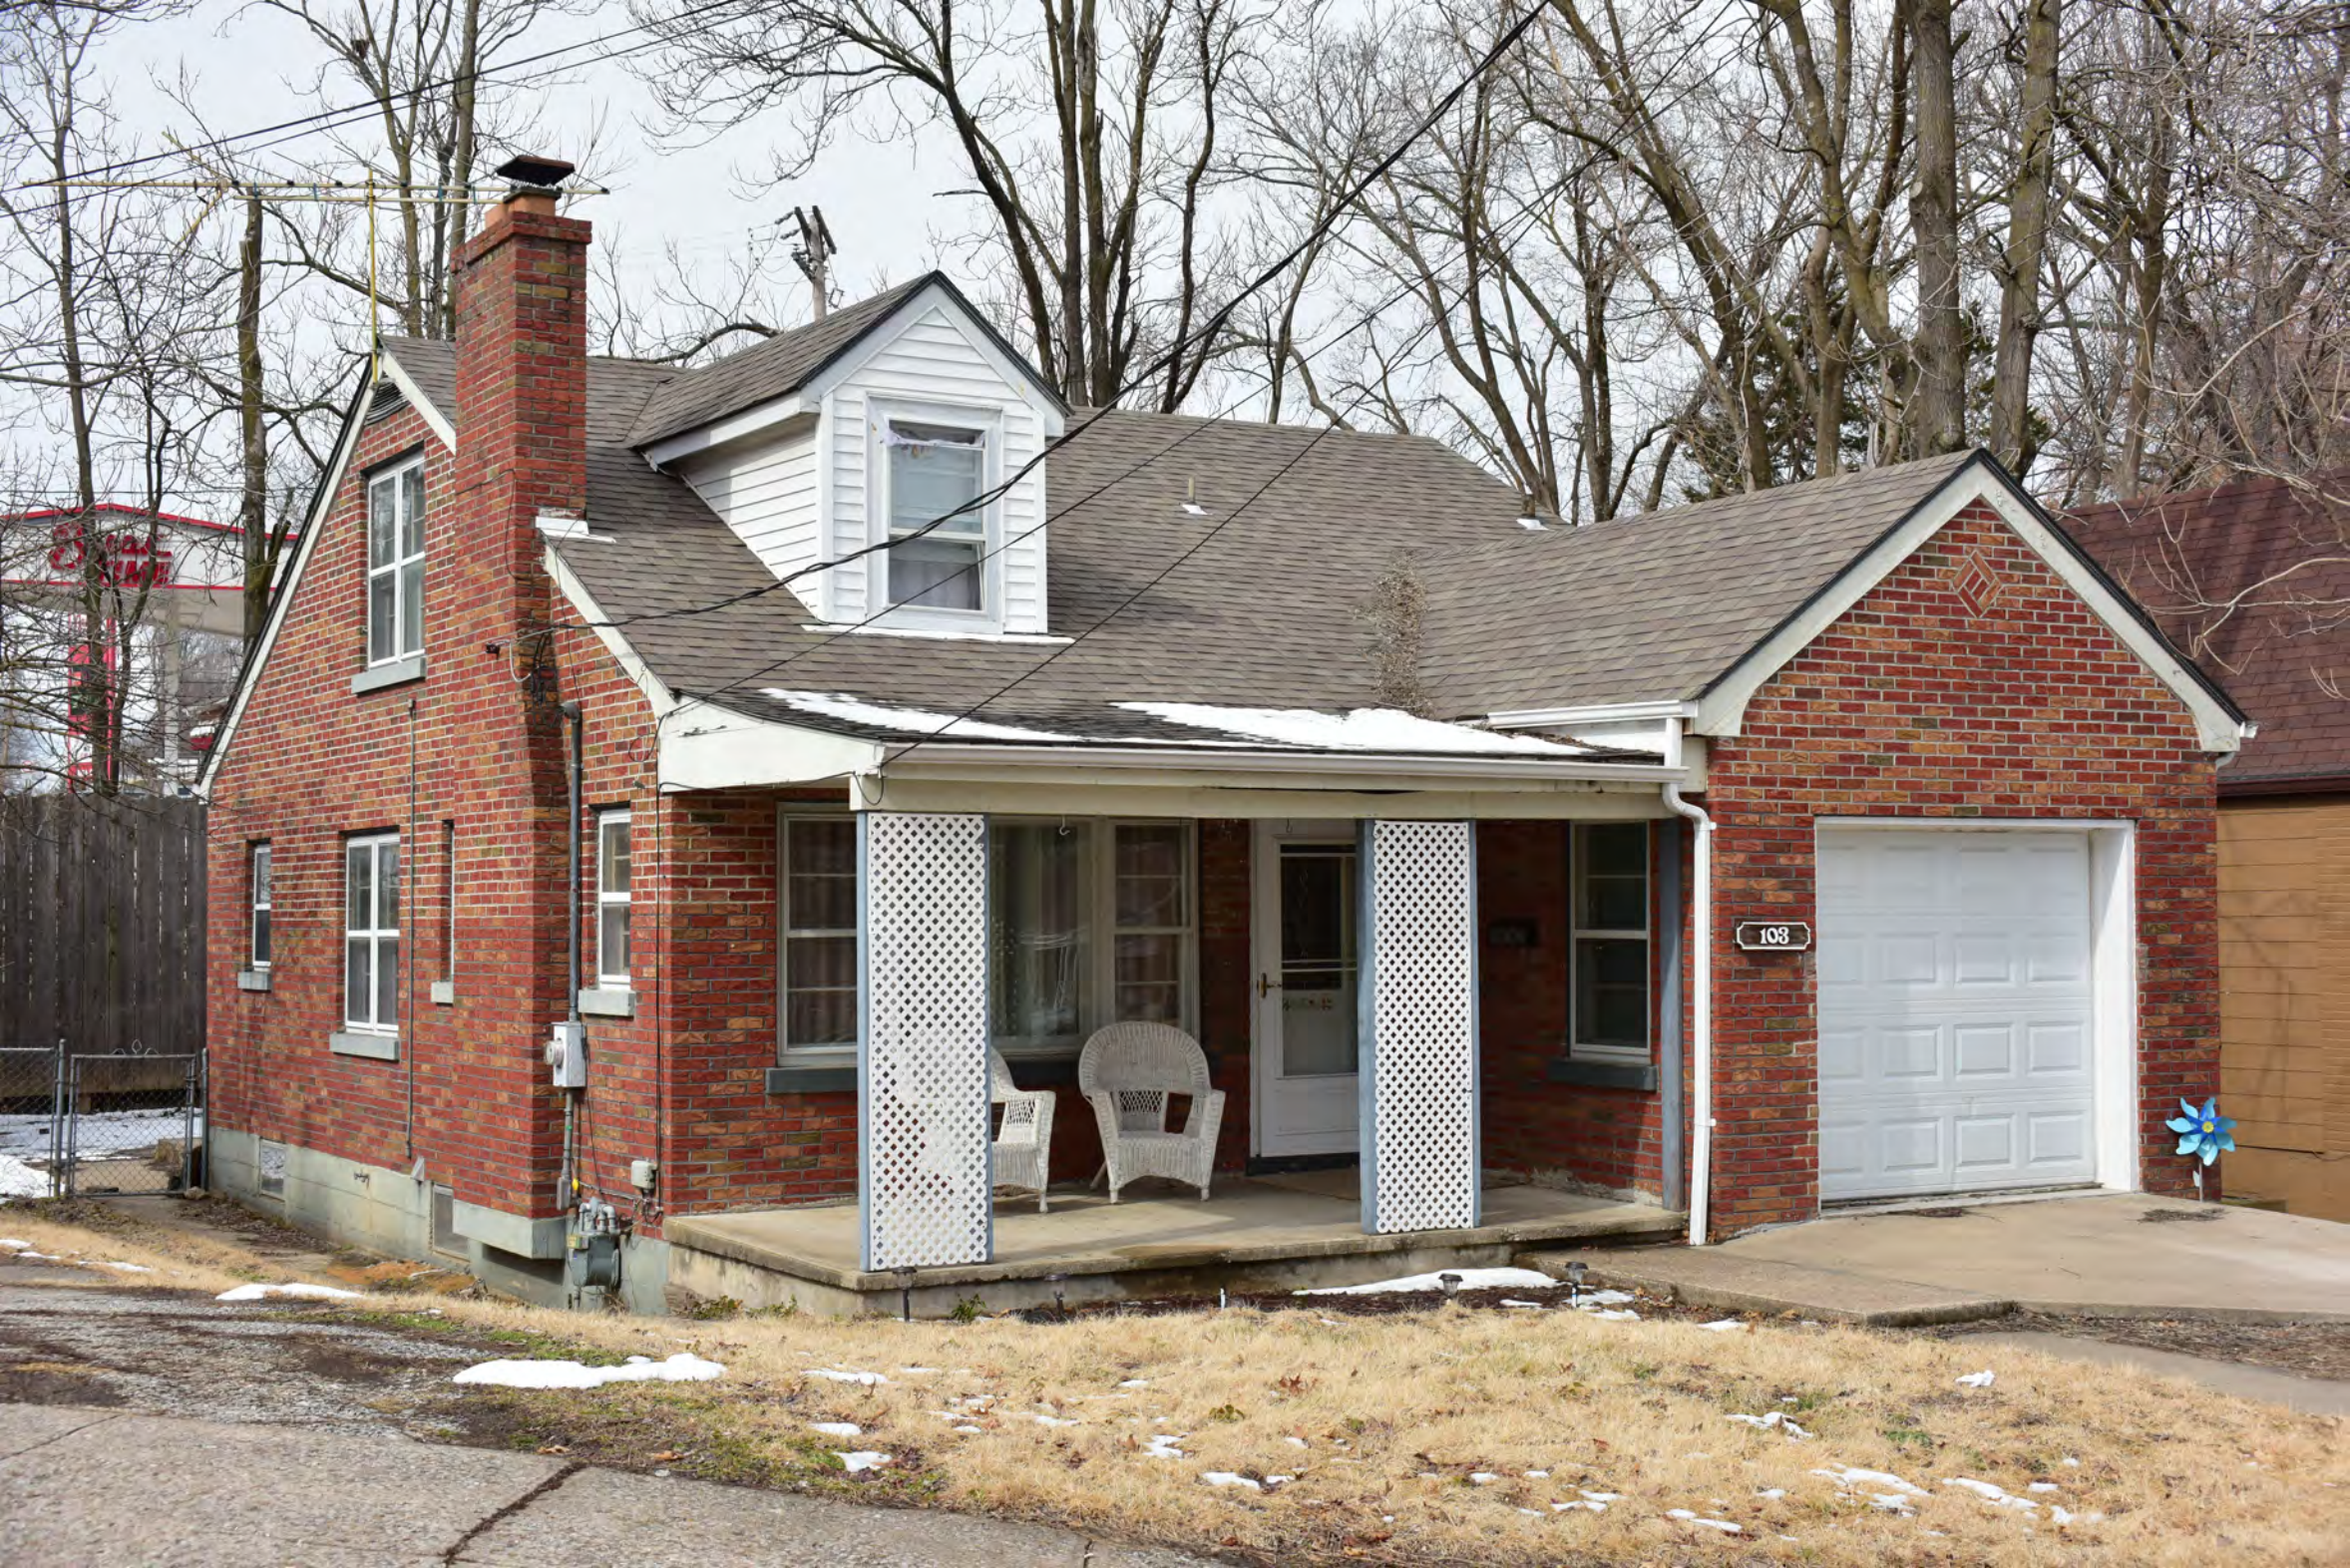
103 West Circle Drive is a one-and-one-half-story Minimal Traditional dwelling. The brick-clad dwelling has a concrete foundation and intersecting-gable roof. A clapboard-clad gabled dormer with a historic 1/1 wood window pierces the front slope at the south half. A brick exterior chimney pierces the south gable front eave. The dwelling is three bays wide. A historic tripartite wood window defines the south bay. Wood 2/2 windows with horizontal muntins flank a fixed center pane. The center bay contains the primary entrance. A gable-front ell projects from the north end of the elevation and contains the garage. A non-historic overhead door fills the vehicular bay. A historic 2/2 wood window with horizontal muntins perforates the south wall of the ell. A shed-roof open porch shelters the south- two bays and abuts the ell. Historic wood posts with non-historic wood lattices support the porch roof. The floor is concrete. Historic 2/2 wood windows with horizontal muntins are present at the north and south elevations. Windows at all visible elevations have concrete sills. A perpendicular gable with a shed-roof dormer extends from the rear elevation.

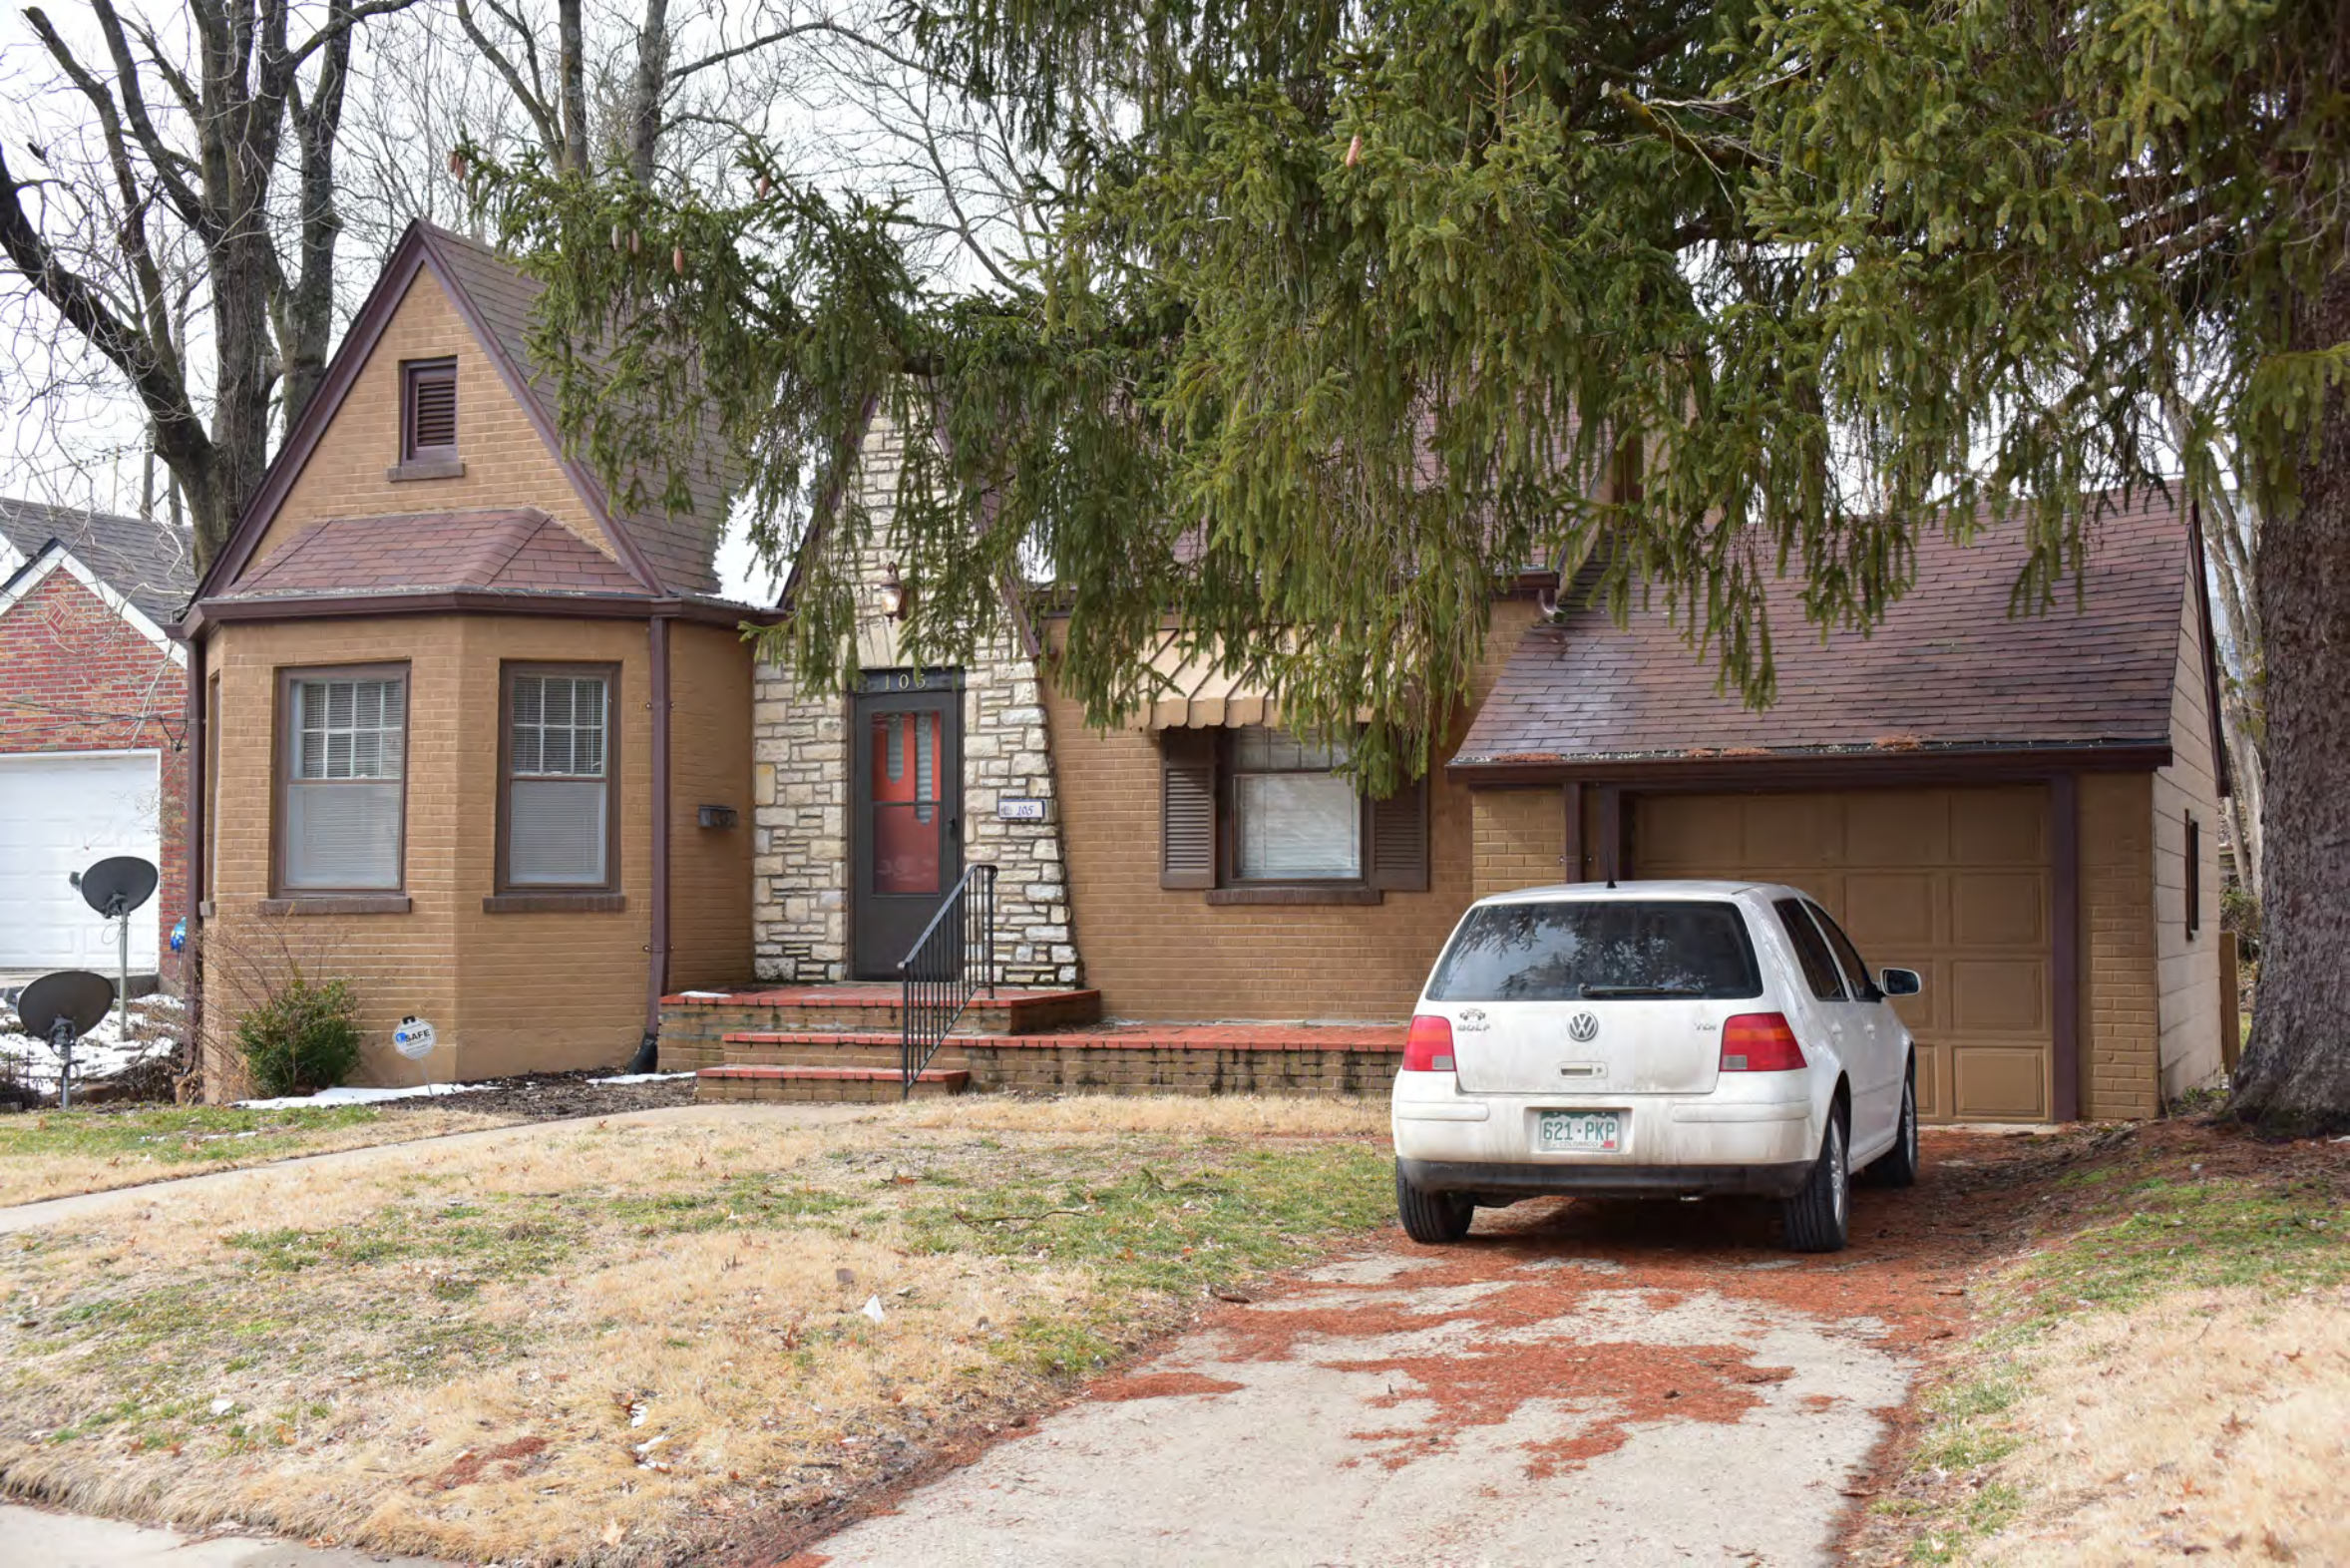
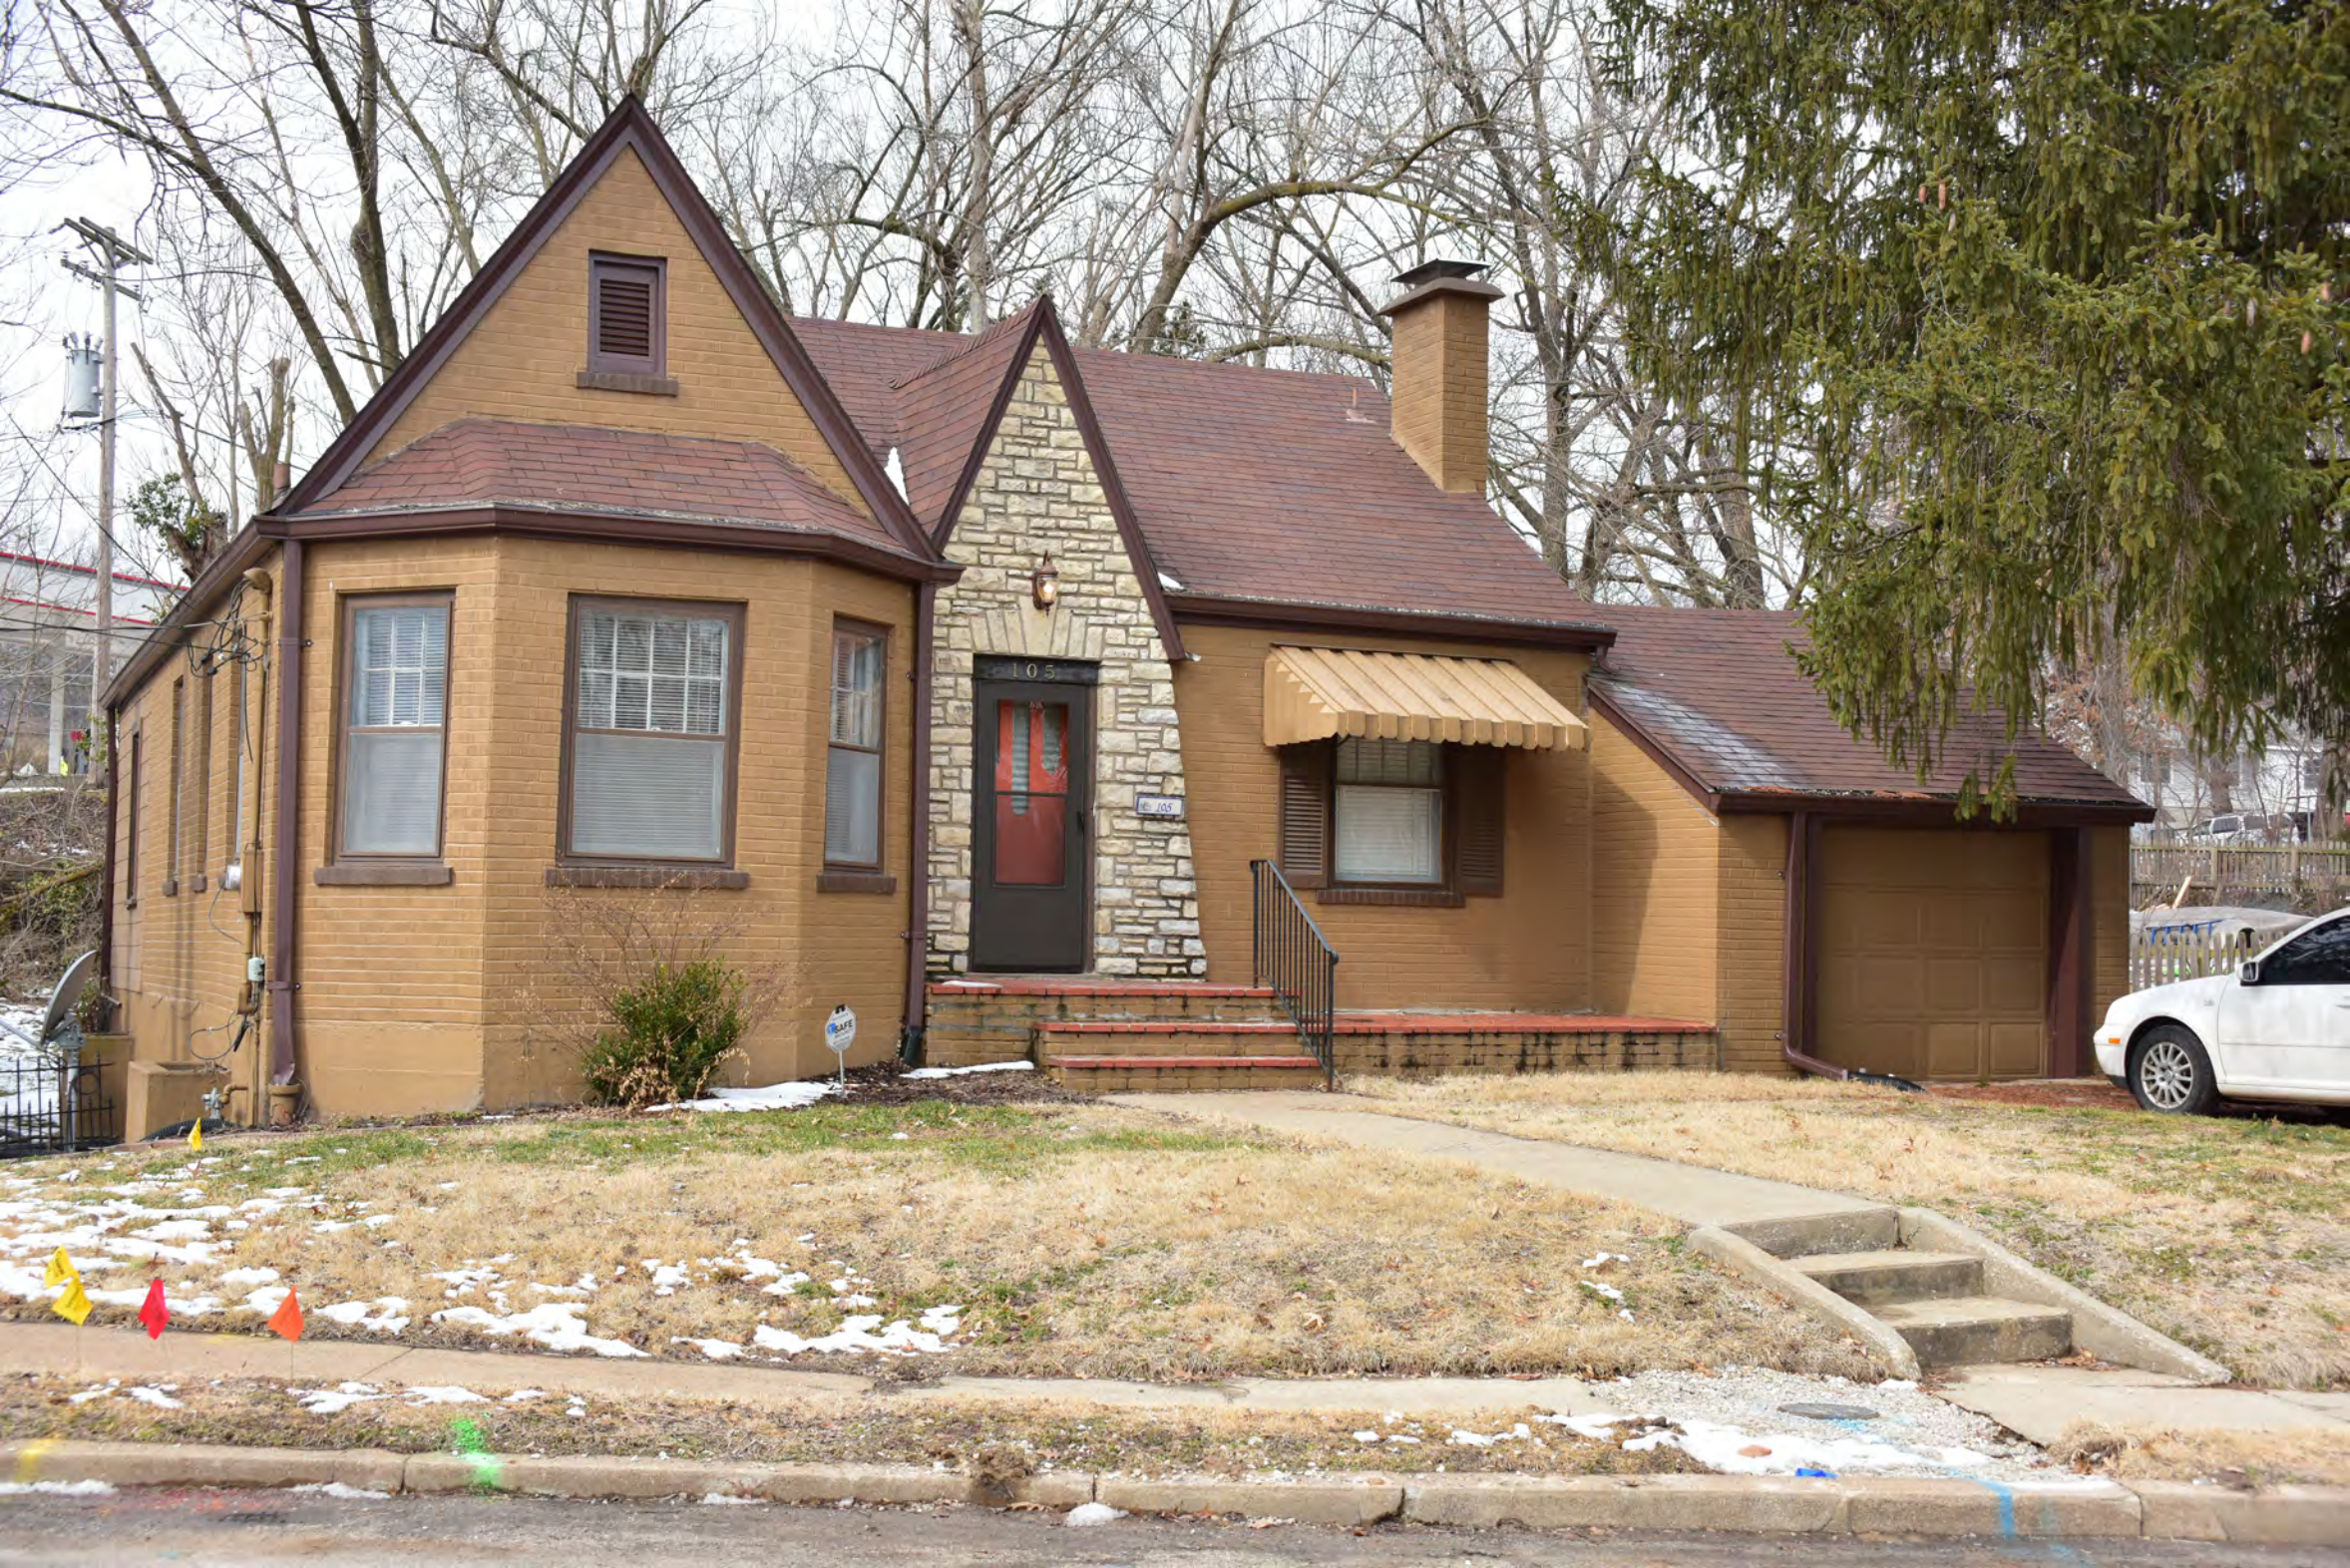
105 West Circle Drive is a one-story Minimal Traditional dwelling with restrained Tudor Revival influences. The dwelling has brick cladding, a concrete foundation, and a complex intersecting-gable asphalt roof. The rear elevation is asbestos-clad and is a c. 1940 addition. A brick exterior chimney pierces the north elevation eave. The dwelling is three bays wide. A hipped-roof bay window defines the south bay. Historic 6/1 wood windows flank the center historic 8/1 wood window. The primary entrance defines the second bay. It is located within a steeply pitched cross-gable and surrounded by limestone and contains a non-historic wood door with geometric glazing and an aluminum storm door with 1/1 glazing. A historic 8/1 wood window fills the last bay. A historic metal awning shelters the window. All windows have storm windows. A brick platform porch extends below the second and third bays. A short run of brick steps with a metal railing accesses the porch. A c. 1940 one-car attached garage projects from the north elevation and is offset slightly east to project from the primary elevation. The brick garage has an asphalt side-gable roof. Asbestos shingle clads the north elevation. A non-historic overhead door fills the vehicular bay.

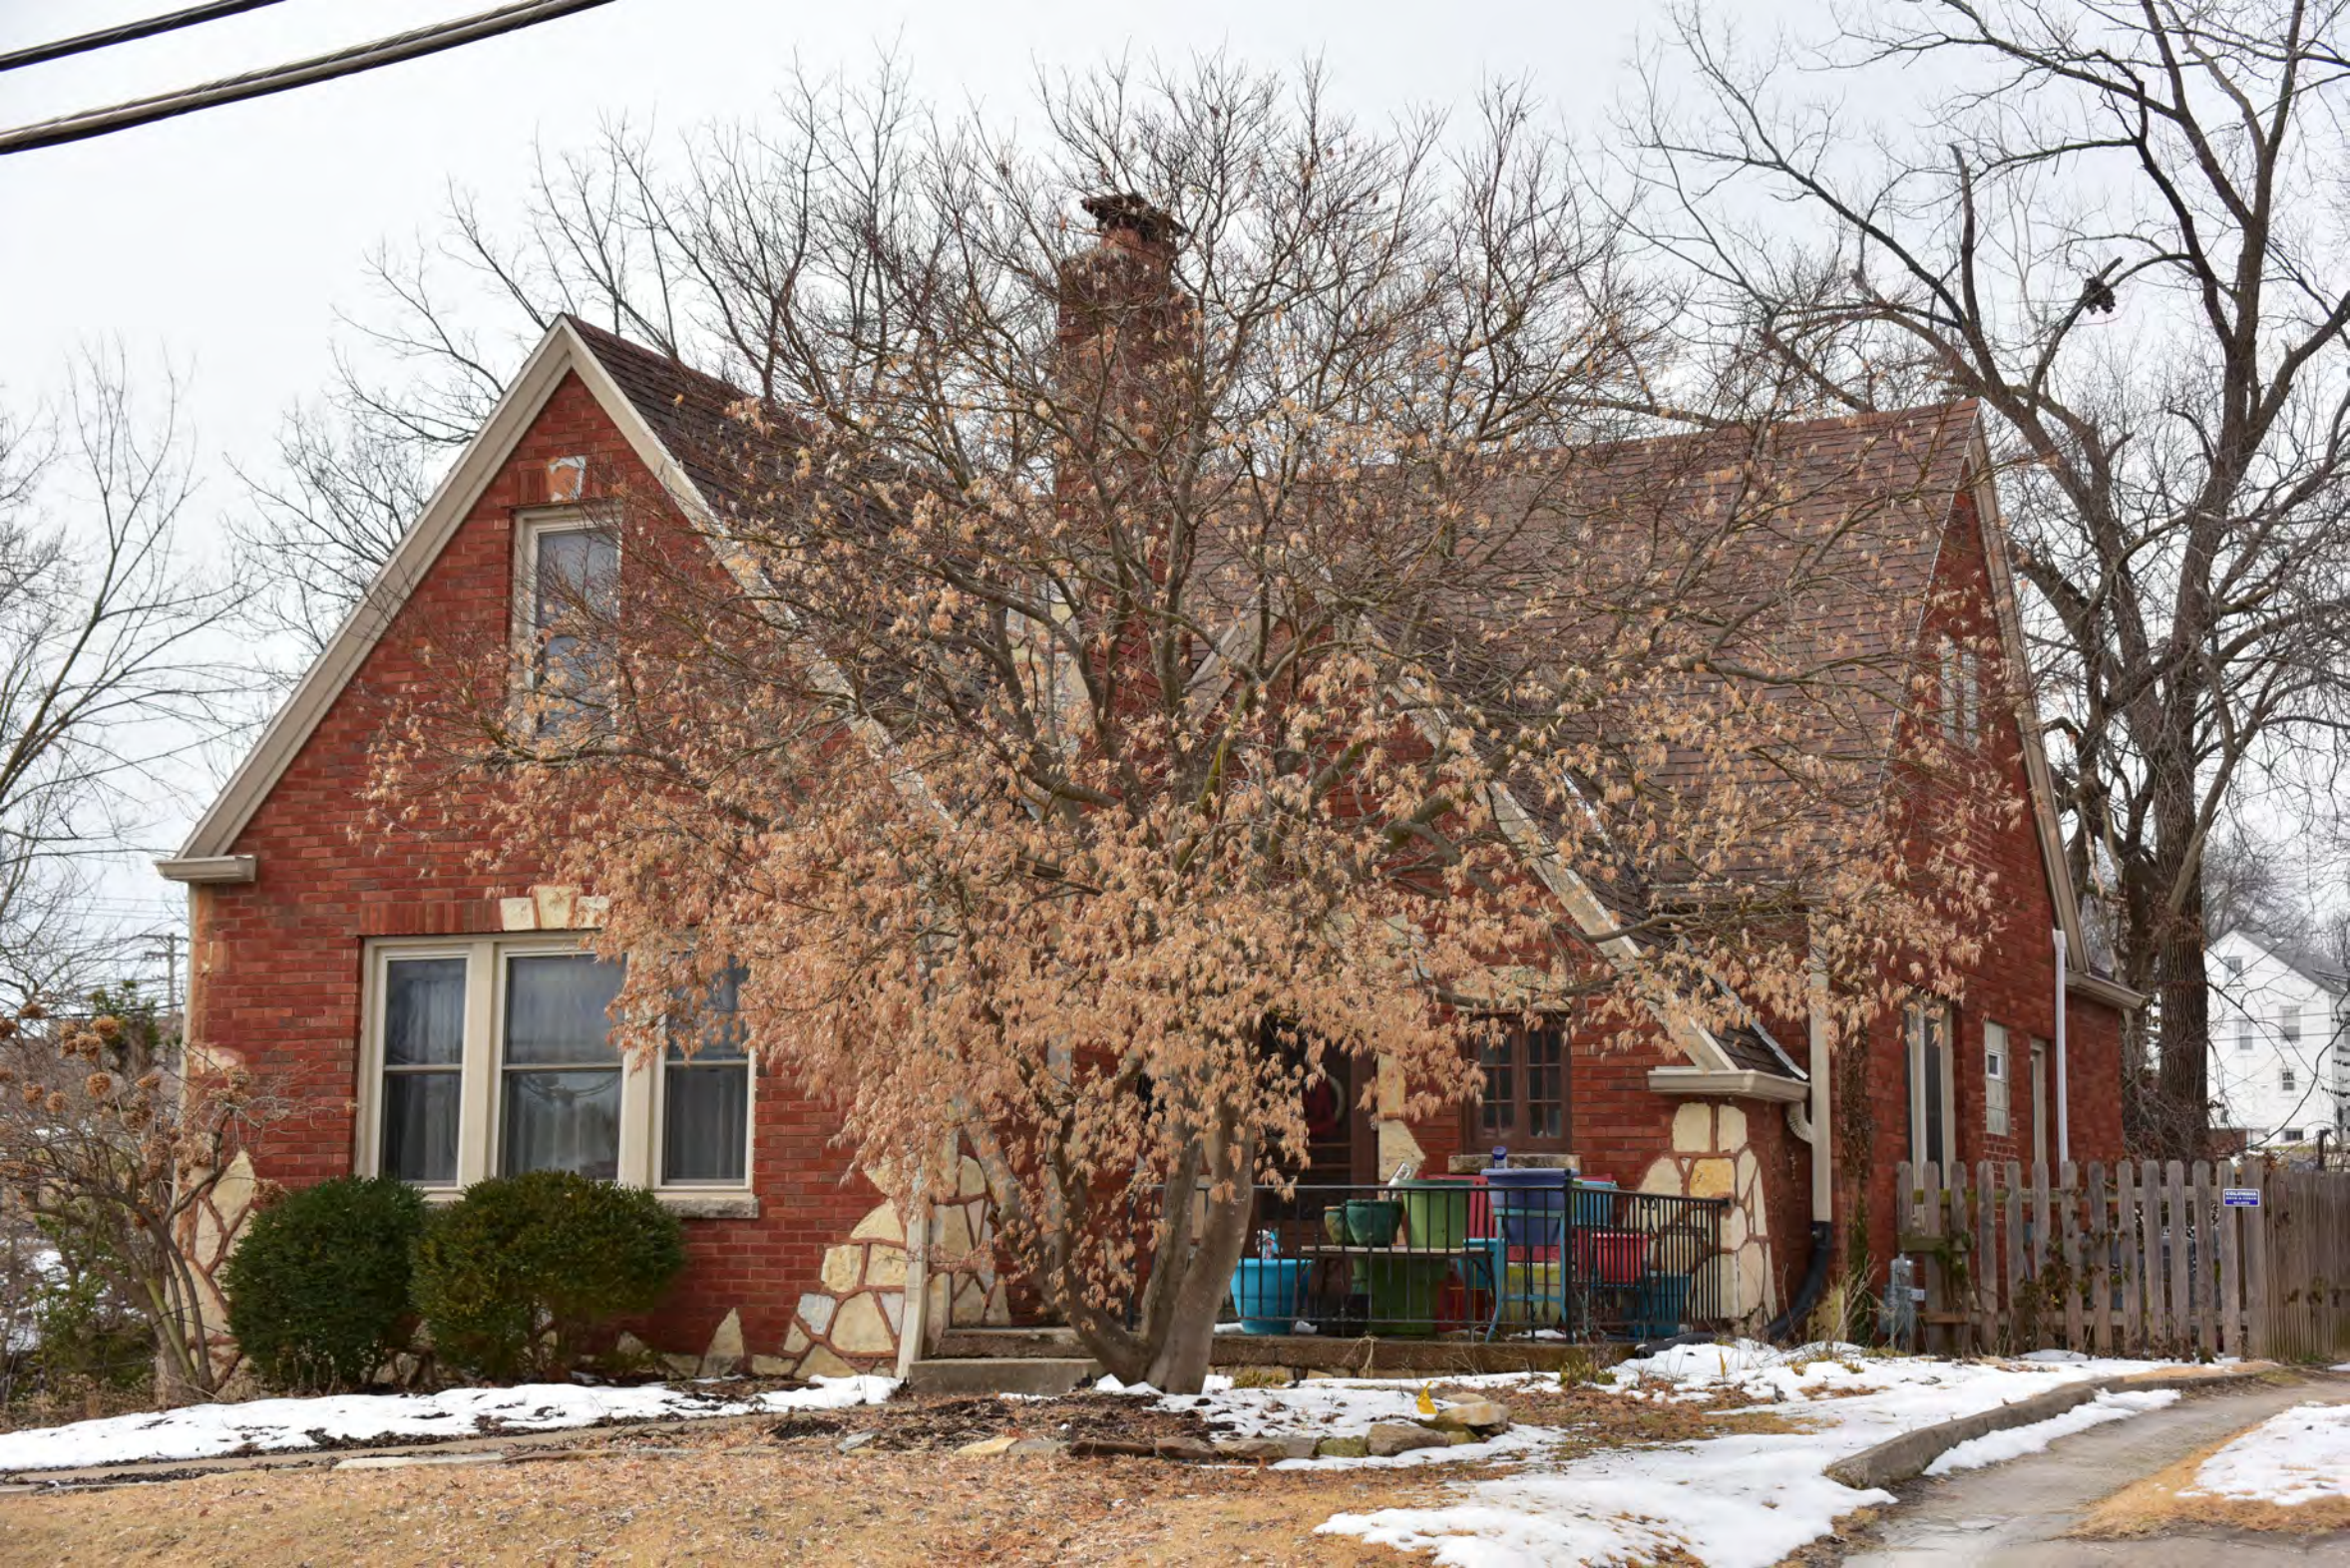
109 West Circle Drive is a one-story Minimal Traditional dwelling. The brick dwelling has an intersecting-gable asphalt roof, concrete foundation, and terra cotta and stone accents. Stone lines the south elevation at basement level and accents the primary elevation corners. A gable-front ell and low cross gable project from the primary elevation. An exterior brick chimney is located at the juncture. The dwelling is three bays wide. A gable-front ell projects from the primary elevation and contains the south bay. A non-historic tripartite window fills the bay. A non-historic 1/1 window is centered above in the gable apex. Both windows have stone sills and brick lintels with terra cotta keystone accents. A low cross-gable projects from the primary elevation to the north and contains the north-two bays. The primary entrance defines the center bay. A historic wood door with six-light glazing fills then bay while terra-cotta accents surround the opening. A truncated twelve-light historic wood casement window defines the north bay. It features a stone sill and terra cotta keystone motif. A concrete platform porch extends between the north-two bays. A scrolled metal railing lines the perimeter. Historic maps and aerial images indicate an integrated garage is located at basement level and accessed at the rear. It is not visible.
