1. Survey number: CO-AS-008-001		2. Survey Name: West Main Street Survey	
3. County: Cole		4. Address (Street No.): 100	Street (name): East Circle Drive
5. City: Jefferson City	Vicinity <input type="checkbox"/>	6. Lat / Long:	7. Township/Range/Section: T: R: S:
8. Historic name (if known):		9. Present/other name (if known):	
10. Ownership: <input checked="" type="checkbox"/> Private <input type="checkbox"/> Public		11a. Historic use (if known): Domestic-Single Dwelling	11b. Current use: Domestic-Single Dwelling

MISSOURI DEPARTMENT OF NATURAL RESOURCES
STATE HISTORIC PRESERVATION OFFICE, P.O. Box 178, Jefferson City, MO 65102
ARCHITECTURAL/HISTORIC INVENTORY FORM

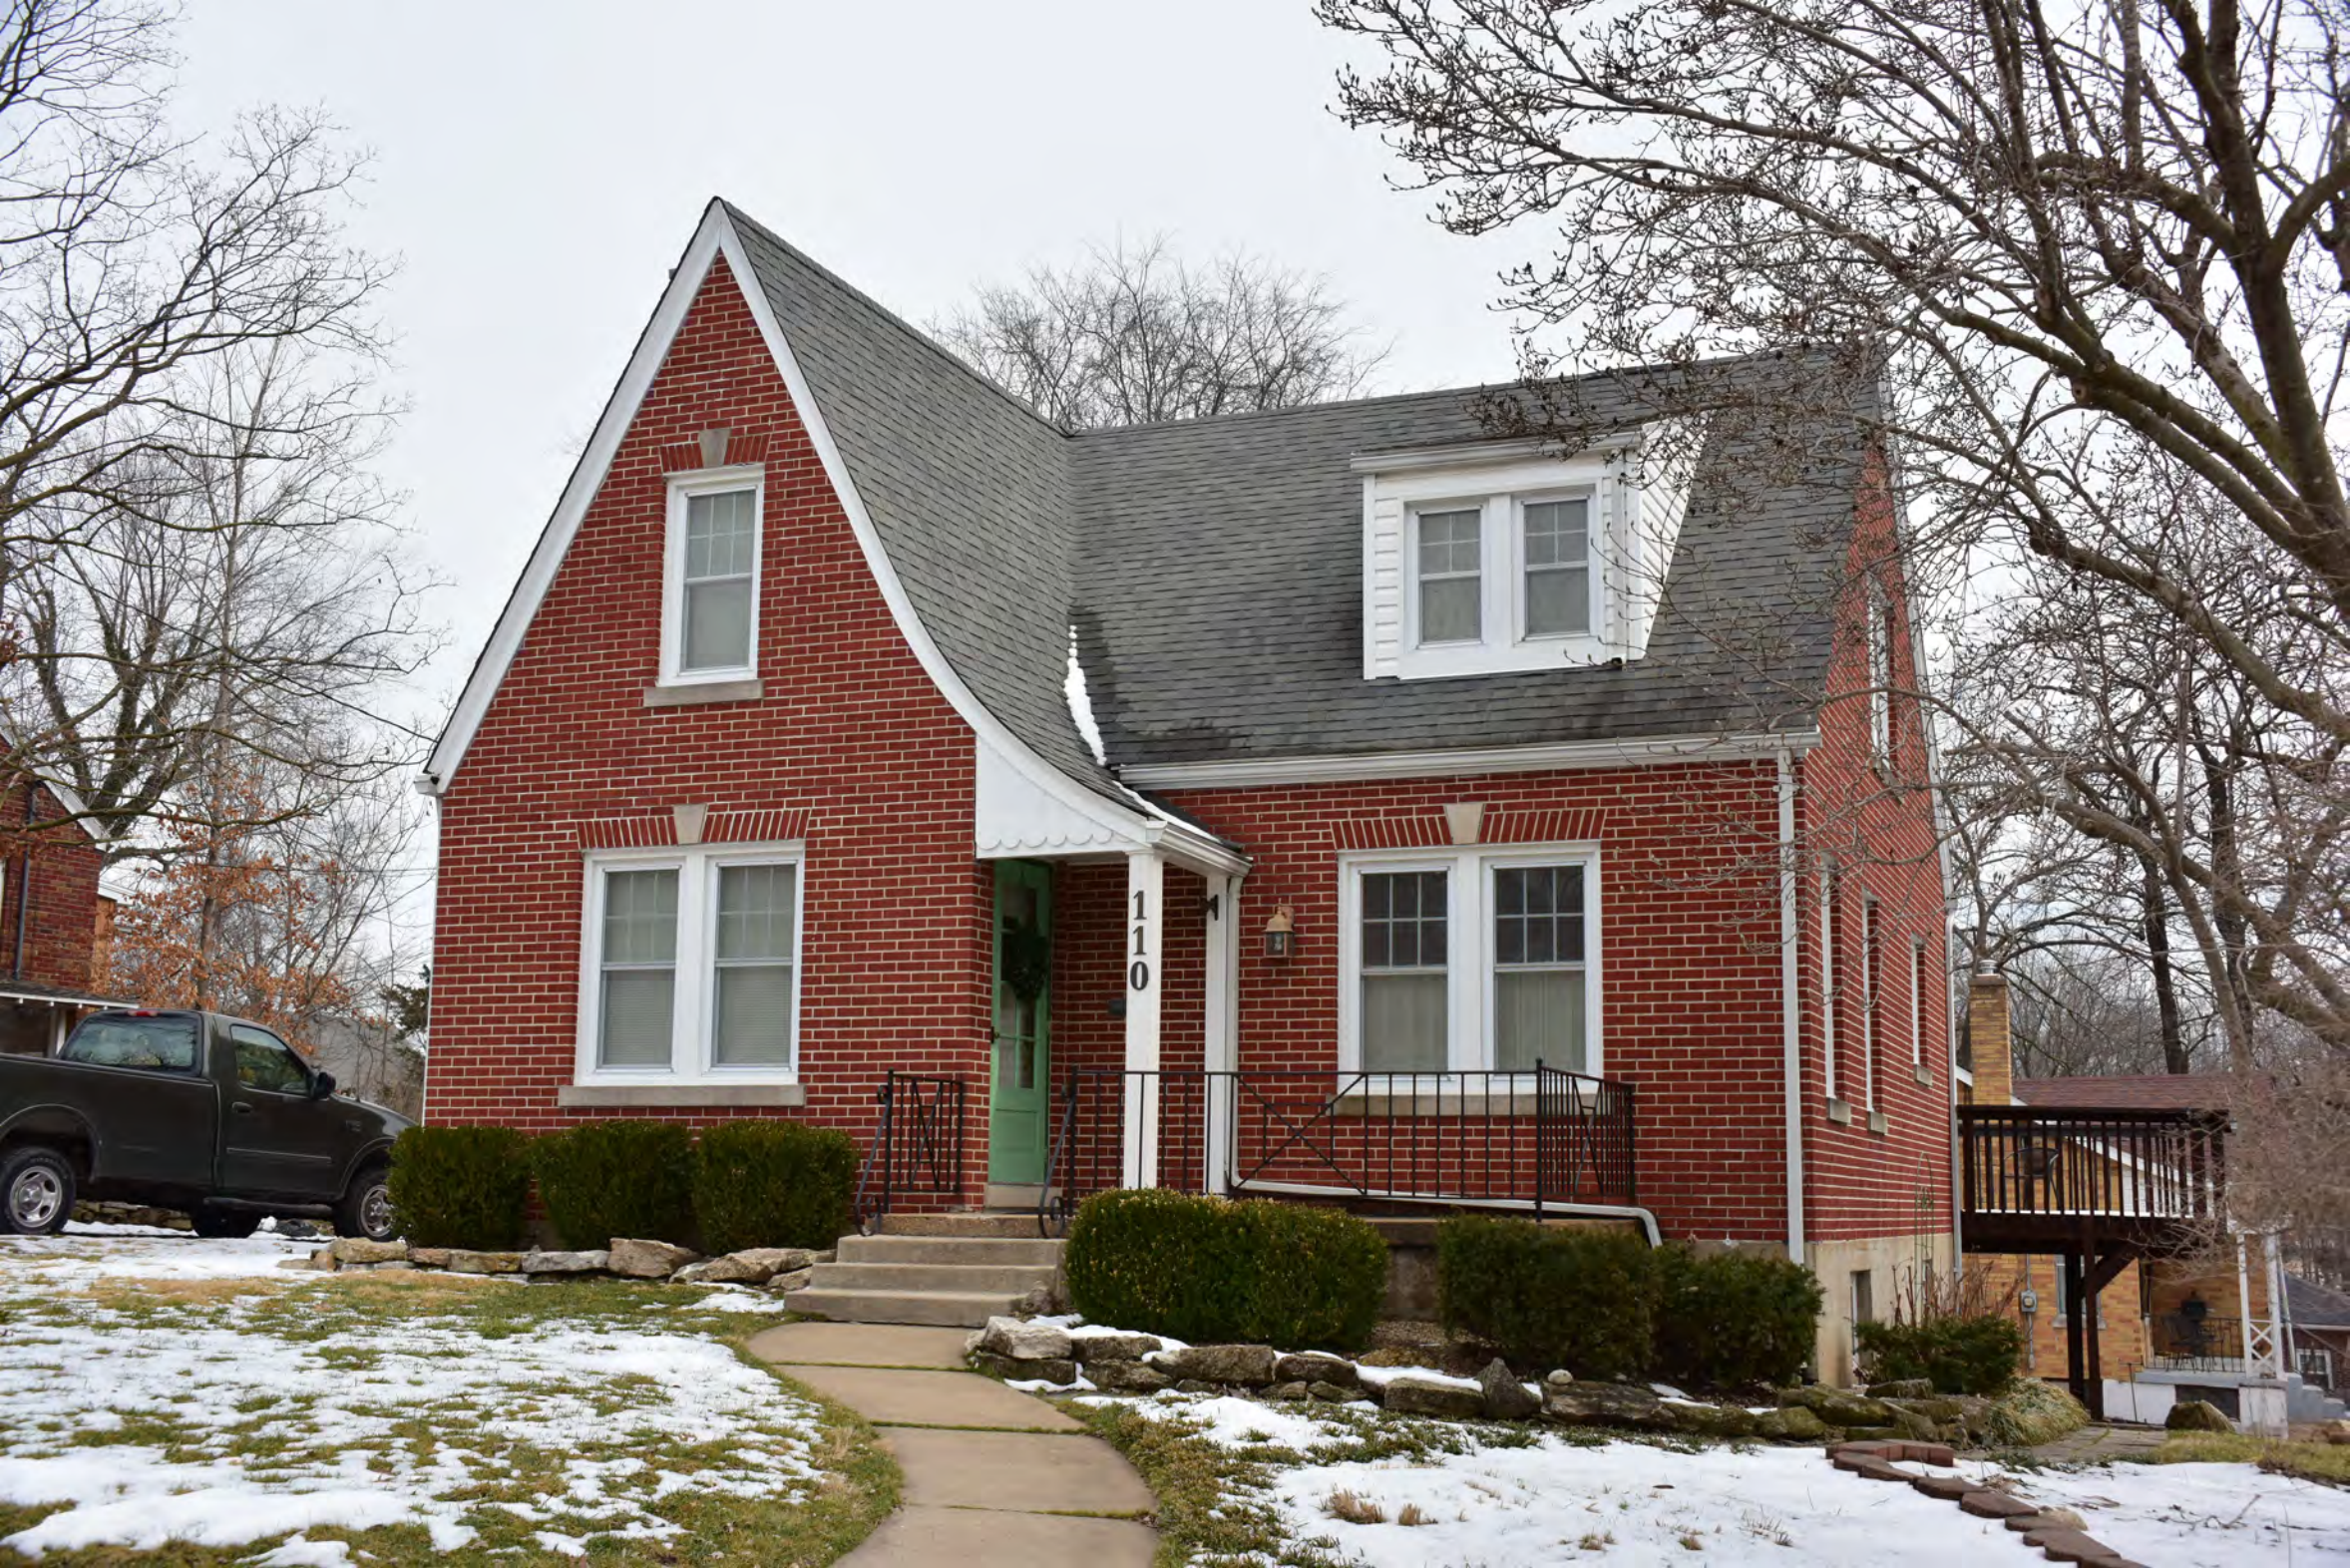
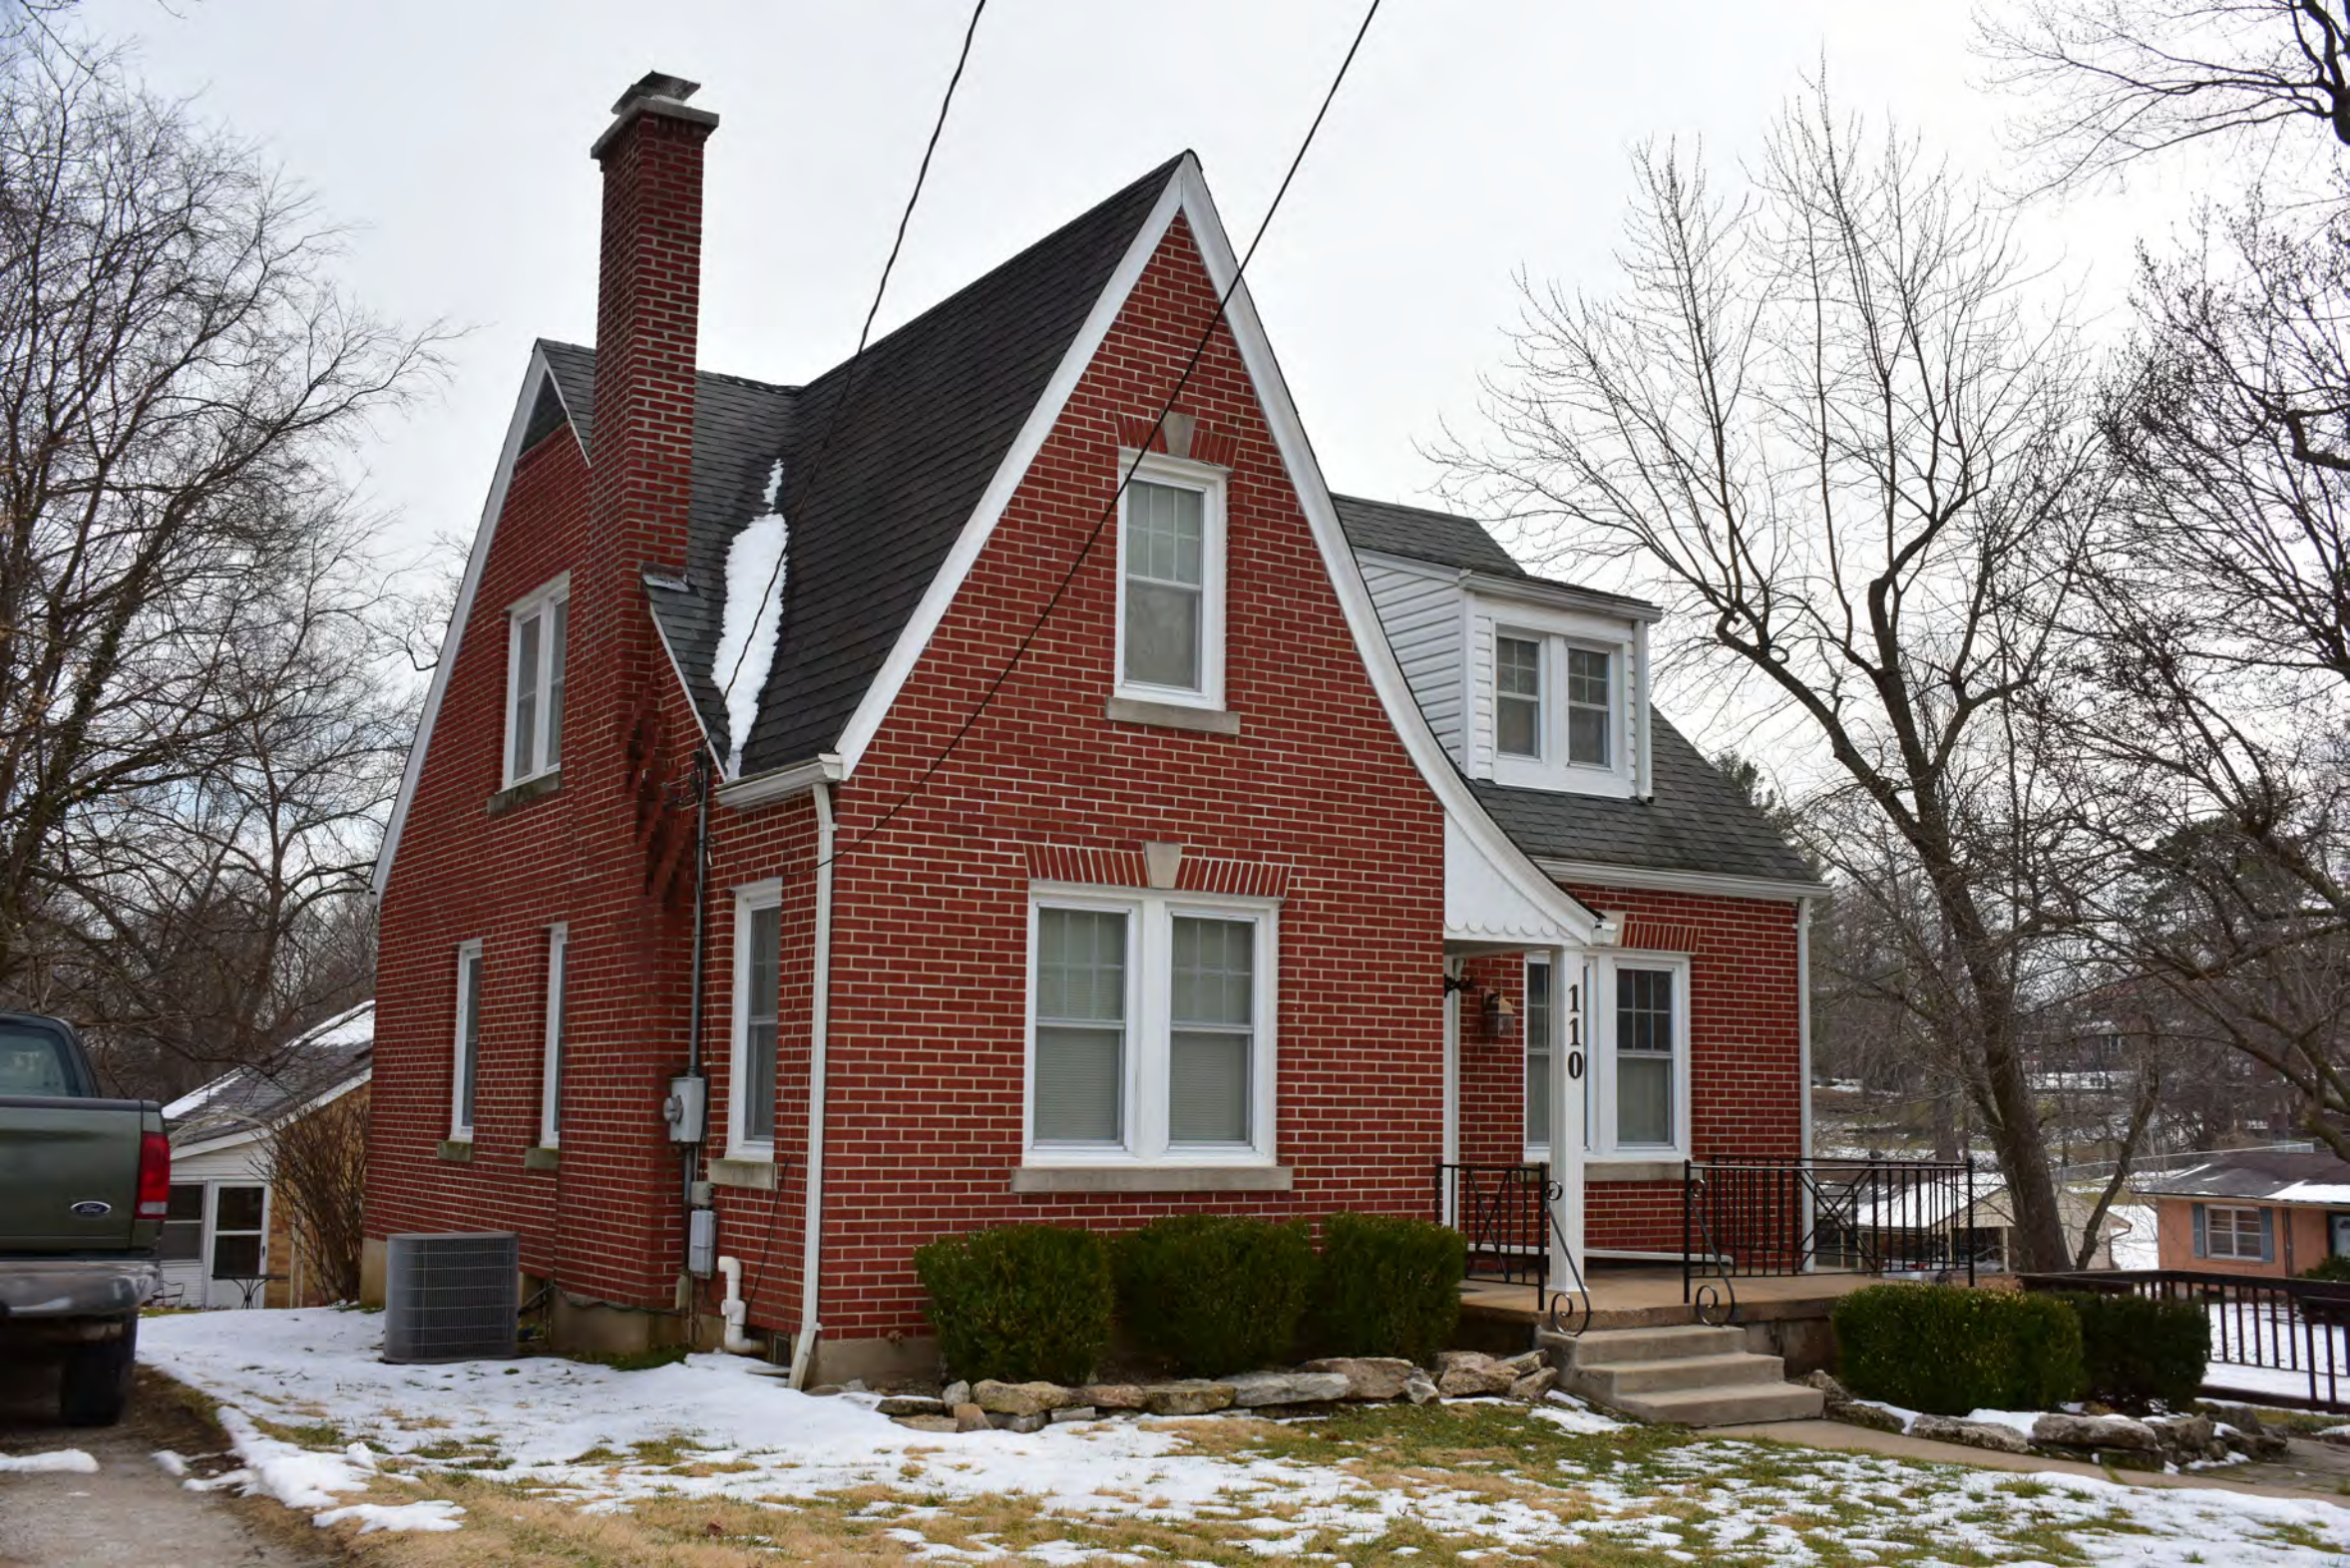
110 West Circle Drive is a one-and-one-half story Minimal Traditional dwelling with brick cladding, a concrete foundation, and intersecting-gable asphalt roof. A brick exterior chimney pierces the north elevation eave. The dwelling is two bays wide. A gable-front ell with steep pitch projects from the north end of the primary elevation and contains the first bay. Two-gabled non-historic 6/1 vinyl windows with a continuous concrete sill fill the bay. A single non-historic vinyl window is centered in the gable apex. Two-gabled non-historic 6/1 vinyl windows with a continuous concrete sill fill the bay. A vinyl-clad shed dormer with two 4/1 vinyl windows pierces the front roof slope above the second bay. Excepting the dormer, all primary elevation windows have concrete sills and angled brick lintels with terra-cotta keystones. The primary entrance is in the south wall of the gable-front ell. It contains a historic wood door with glazing and a historic wood storm door with eight-light glazing. The gable extends and flares to shelter the primary entrance. Scalloped wood fills the gable extensions and historic squared wood columns support it. A concrete platform porch extends below the second bay. A historic metal railing with scroll and geometric motif lines the porch and stairs. An integrated one-car garage is located at the rear at basement level and is accessed from the south. A vinyl-clad shed-roof porch tops the garage. A non-historic wood deck extends from the porch. A large vinyl-clad shed dormer abuts the porch roof.

Alterations to 110 West Circle Drive include the replacement of historic windows and the application of vinyl cladding to both dormers and the enclosed rear porch. Although they are replacements, the windows fill historic openings and are complimentary in style. While the application of vinyl to the dormers and porch slightly compromises the dwelling's material integrity, it otherwise retains good integrity. This resource would be contributing to the potential Walinko Place Historic District, significant in the areas of Architecture and Community Planning and Development in association with the expansion of Jefferson City and increased suburban development during the twentieth century as well as its associations with Walinko Place, a notable suburban development during the Depression and War Years.

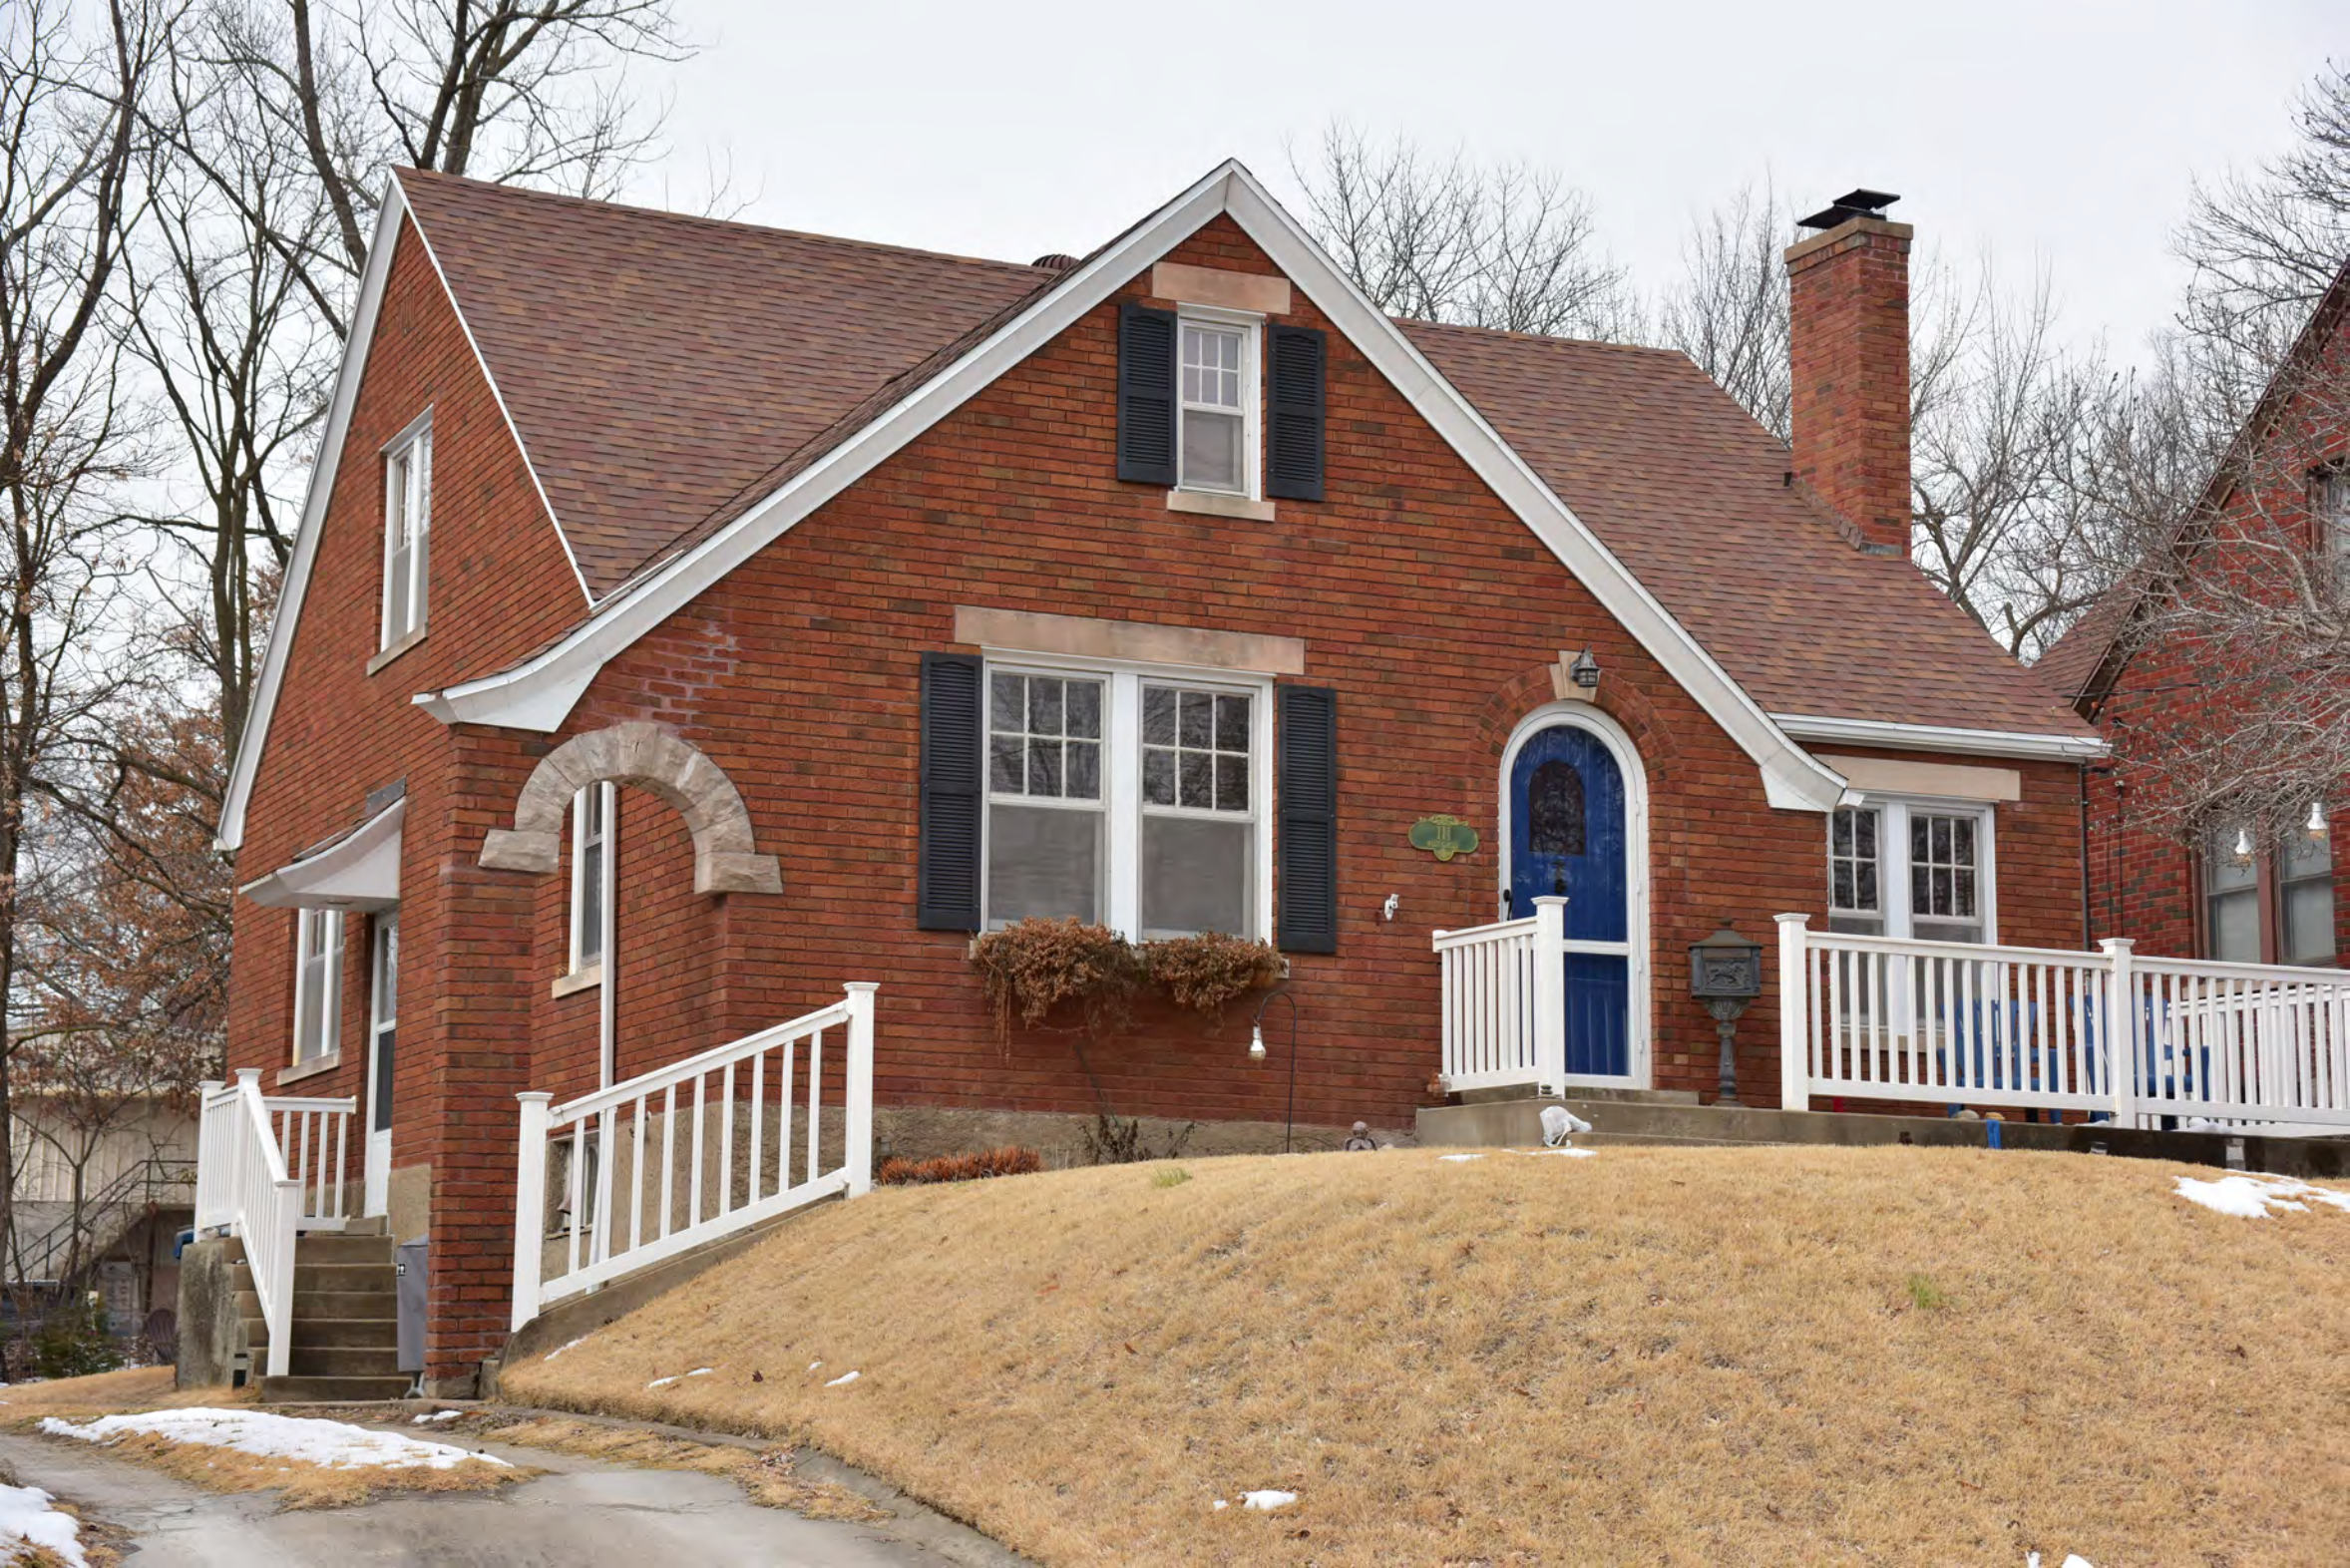
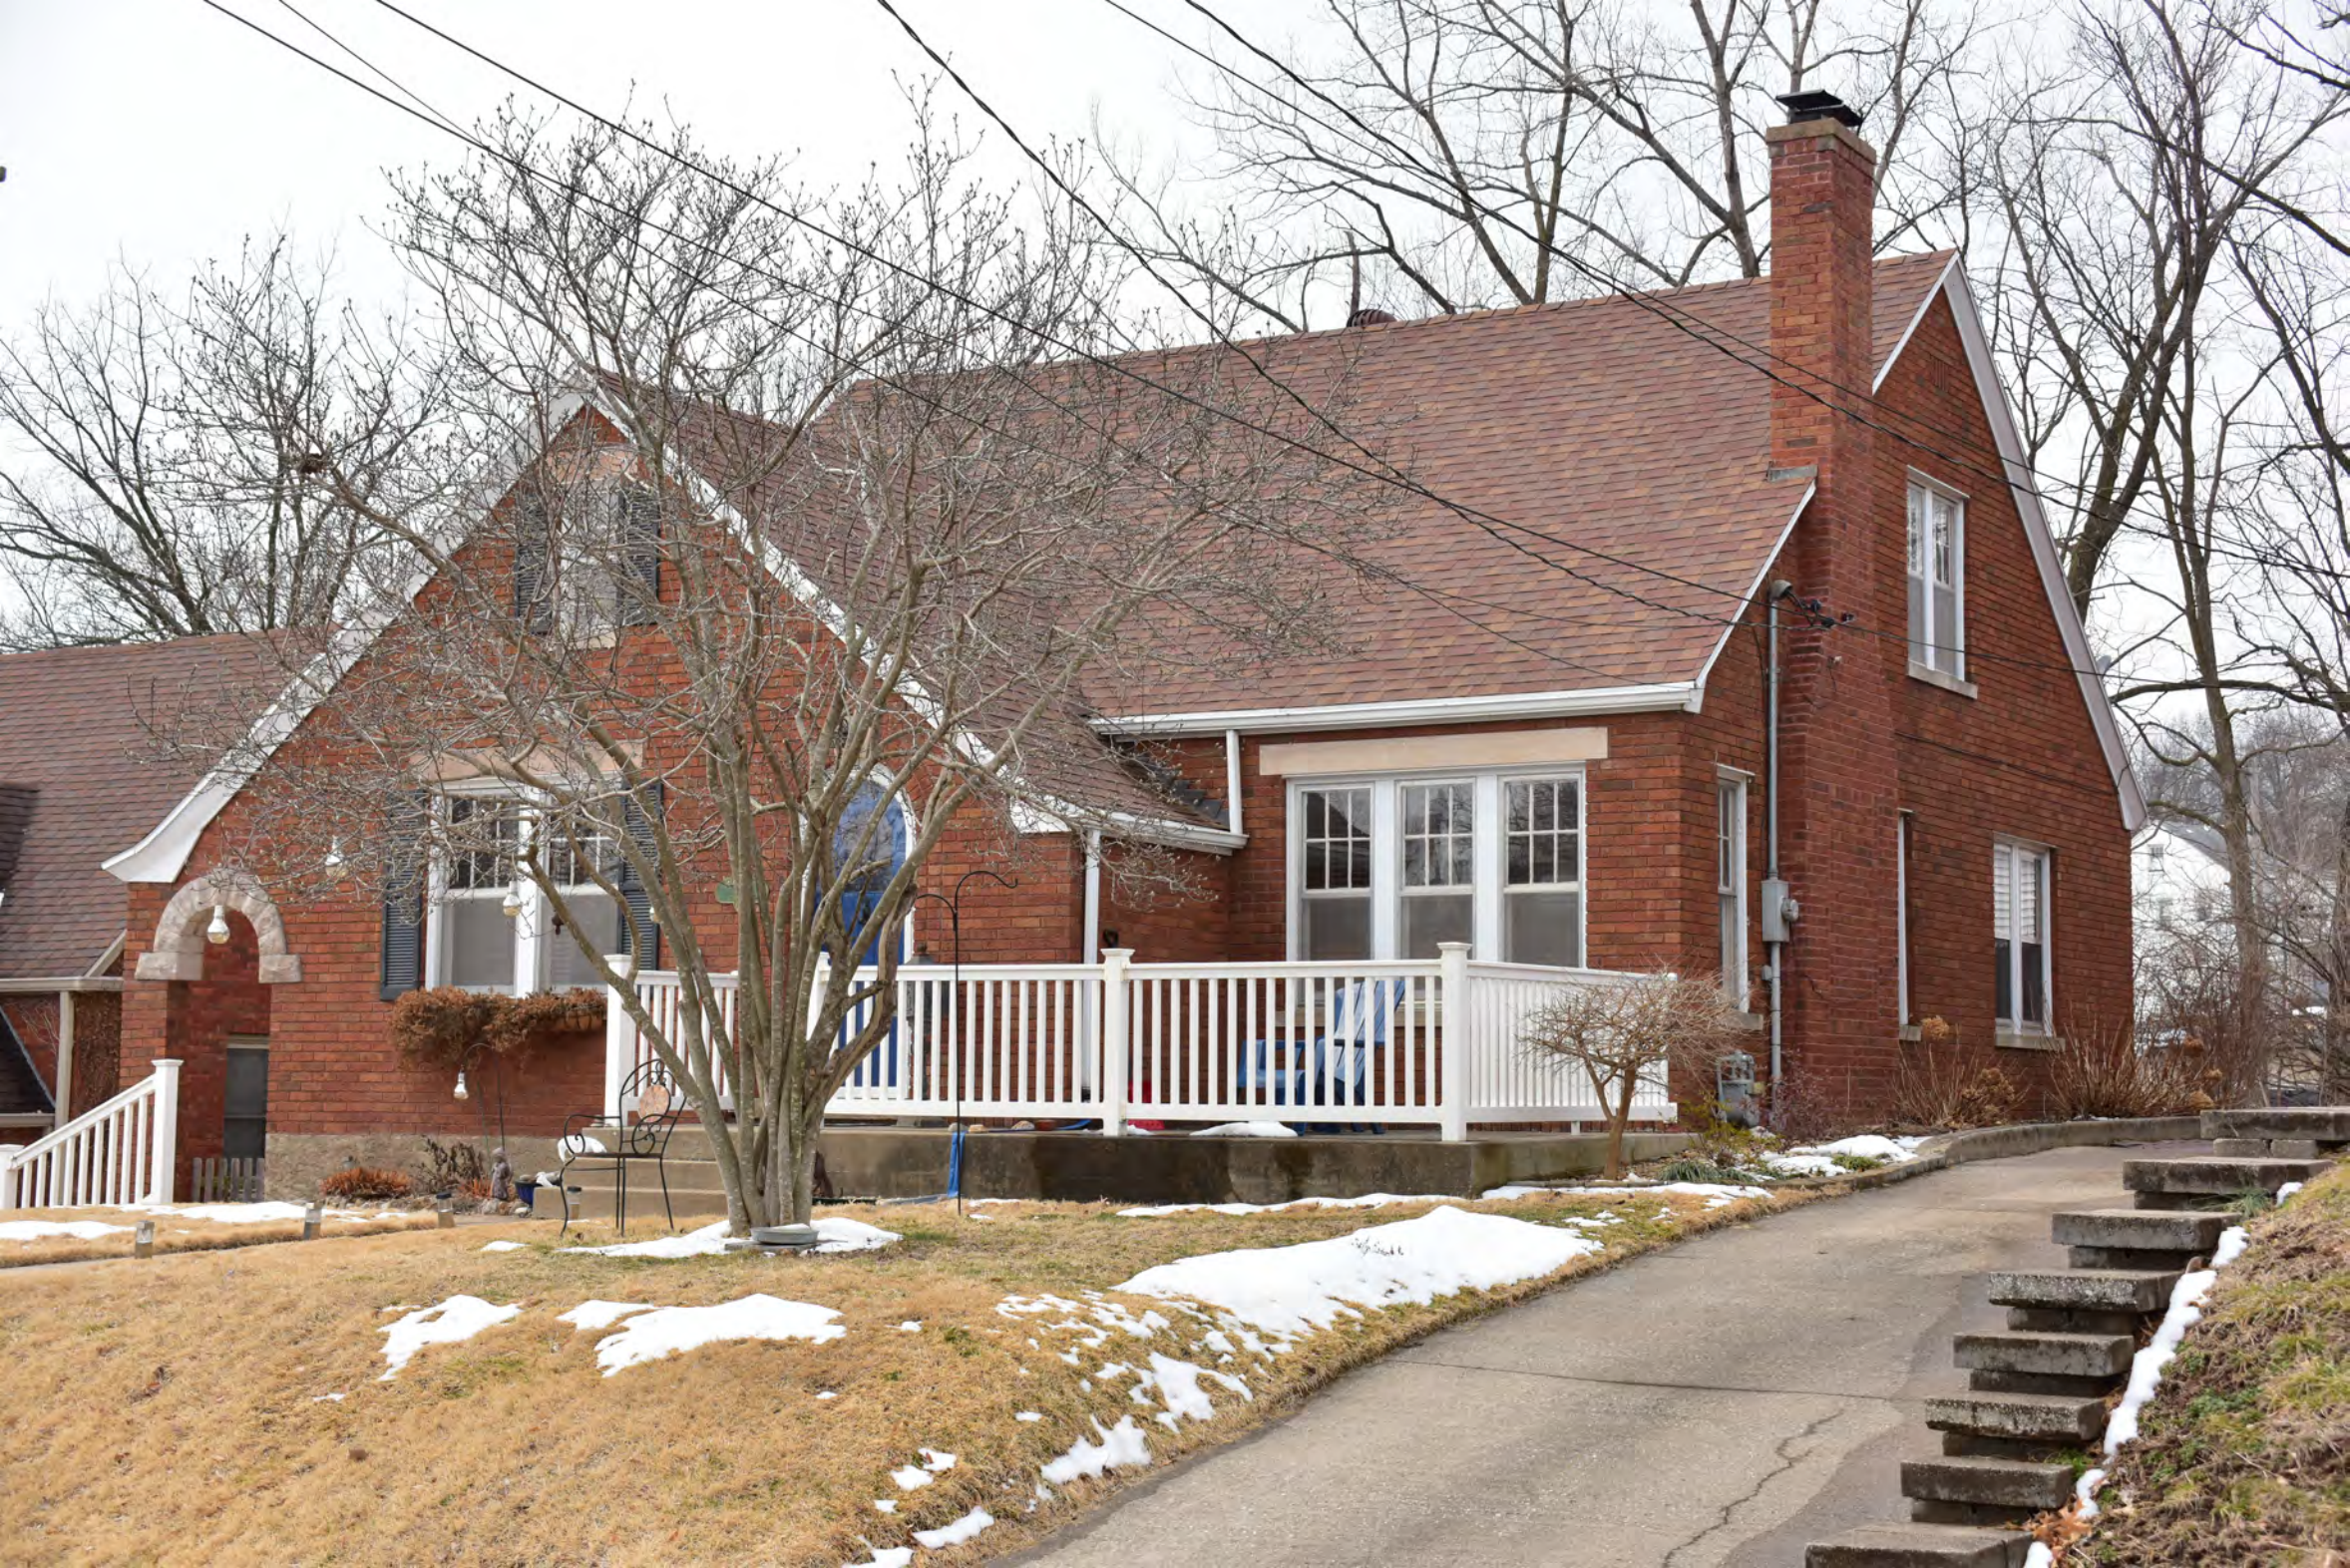
111 West Circle Drive is a one-and-one-half-story Minimal Traditional dwelling with brick cladding, a parged concrete foundation, and an asphalt side-gable roof with a low cross gable at the primary elevation. A brick exterior chimney pierces the north gable end eave. The dwelling is three bays wide. The cross gable contains the south-two bays. Two-ganged historic 6/1 wood windows with a continuous cast stone sill and terra cotta lintel fill the south bay. Matching three-ganged windows define the north bay. The primary entrance defines the second bay. The opening is arched with a decorative brick surround and terra-cotta keystone. A historic wood door with glazing fills the bay. A small historic 6/1 wood window with cast concrete sill and terra-cotta lintel is centered in the cross-gable apex. The cross-gable eave extends south to form a narrow brick wing-wall. An arched opening with cast stone voussoirs pierces the wall. A low concrete platform porch extends from the entrance to the north end of the elevation. A non-historic vinyl balustrade lines the porch. Historic maps and aerial images indicate a garage is located at basement level and accessed at the rear. It is not visible.

Alterations to 111 West Circle Drive include the replacement of historic porch elements with a vinyl balustrade. 111 West Circle Drive otherwise does not appear significantly altered and retains good integrity. This resource would be contributing to the potential Walinko Place Historic District, significant in the areas of Architecture and Community Planning and Development in association with the expansion of Jefferson City and increased suburban development during the twentieth century as well as its associations with Walinko Place, a notable suburban development during the Depression and War Years.
