1. Survey number: CO-AS-008-001		2. Survey Name: West Main Street Survey	
3. County: Cole		4. Address (Street No.): 100	Street (name): East Circle Drive
5. City: Jefferson City	Vicinity <input type="checkbox"/>	6. Lat / Long:	7. Township/Range/Section: T: R: S:
8. Historic name (if known):		9. Present/other name (if known):	
10. Ownership: <input checked="" type="checkbox"/> Private <input type="checkbox"/> Public		11a. Historic use (if known): Domestic-Single Dwelling	11b. Current use: Domestic-Single Dwelling

MISSOURI DEPARTMENT OF NATURAL RESOURCES
STATE HISTORIC PRESERVATION OFFICE, P.O. Box 178, Jefferson City, MO 65102
ARCHITECTURAL/HISTORIC INVENTORY FORM

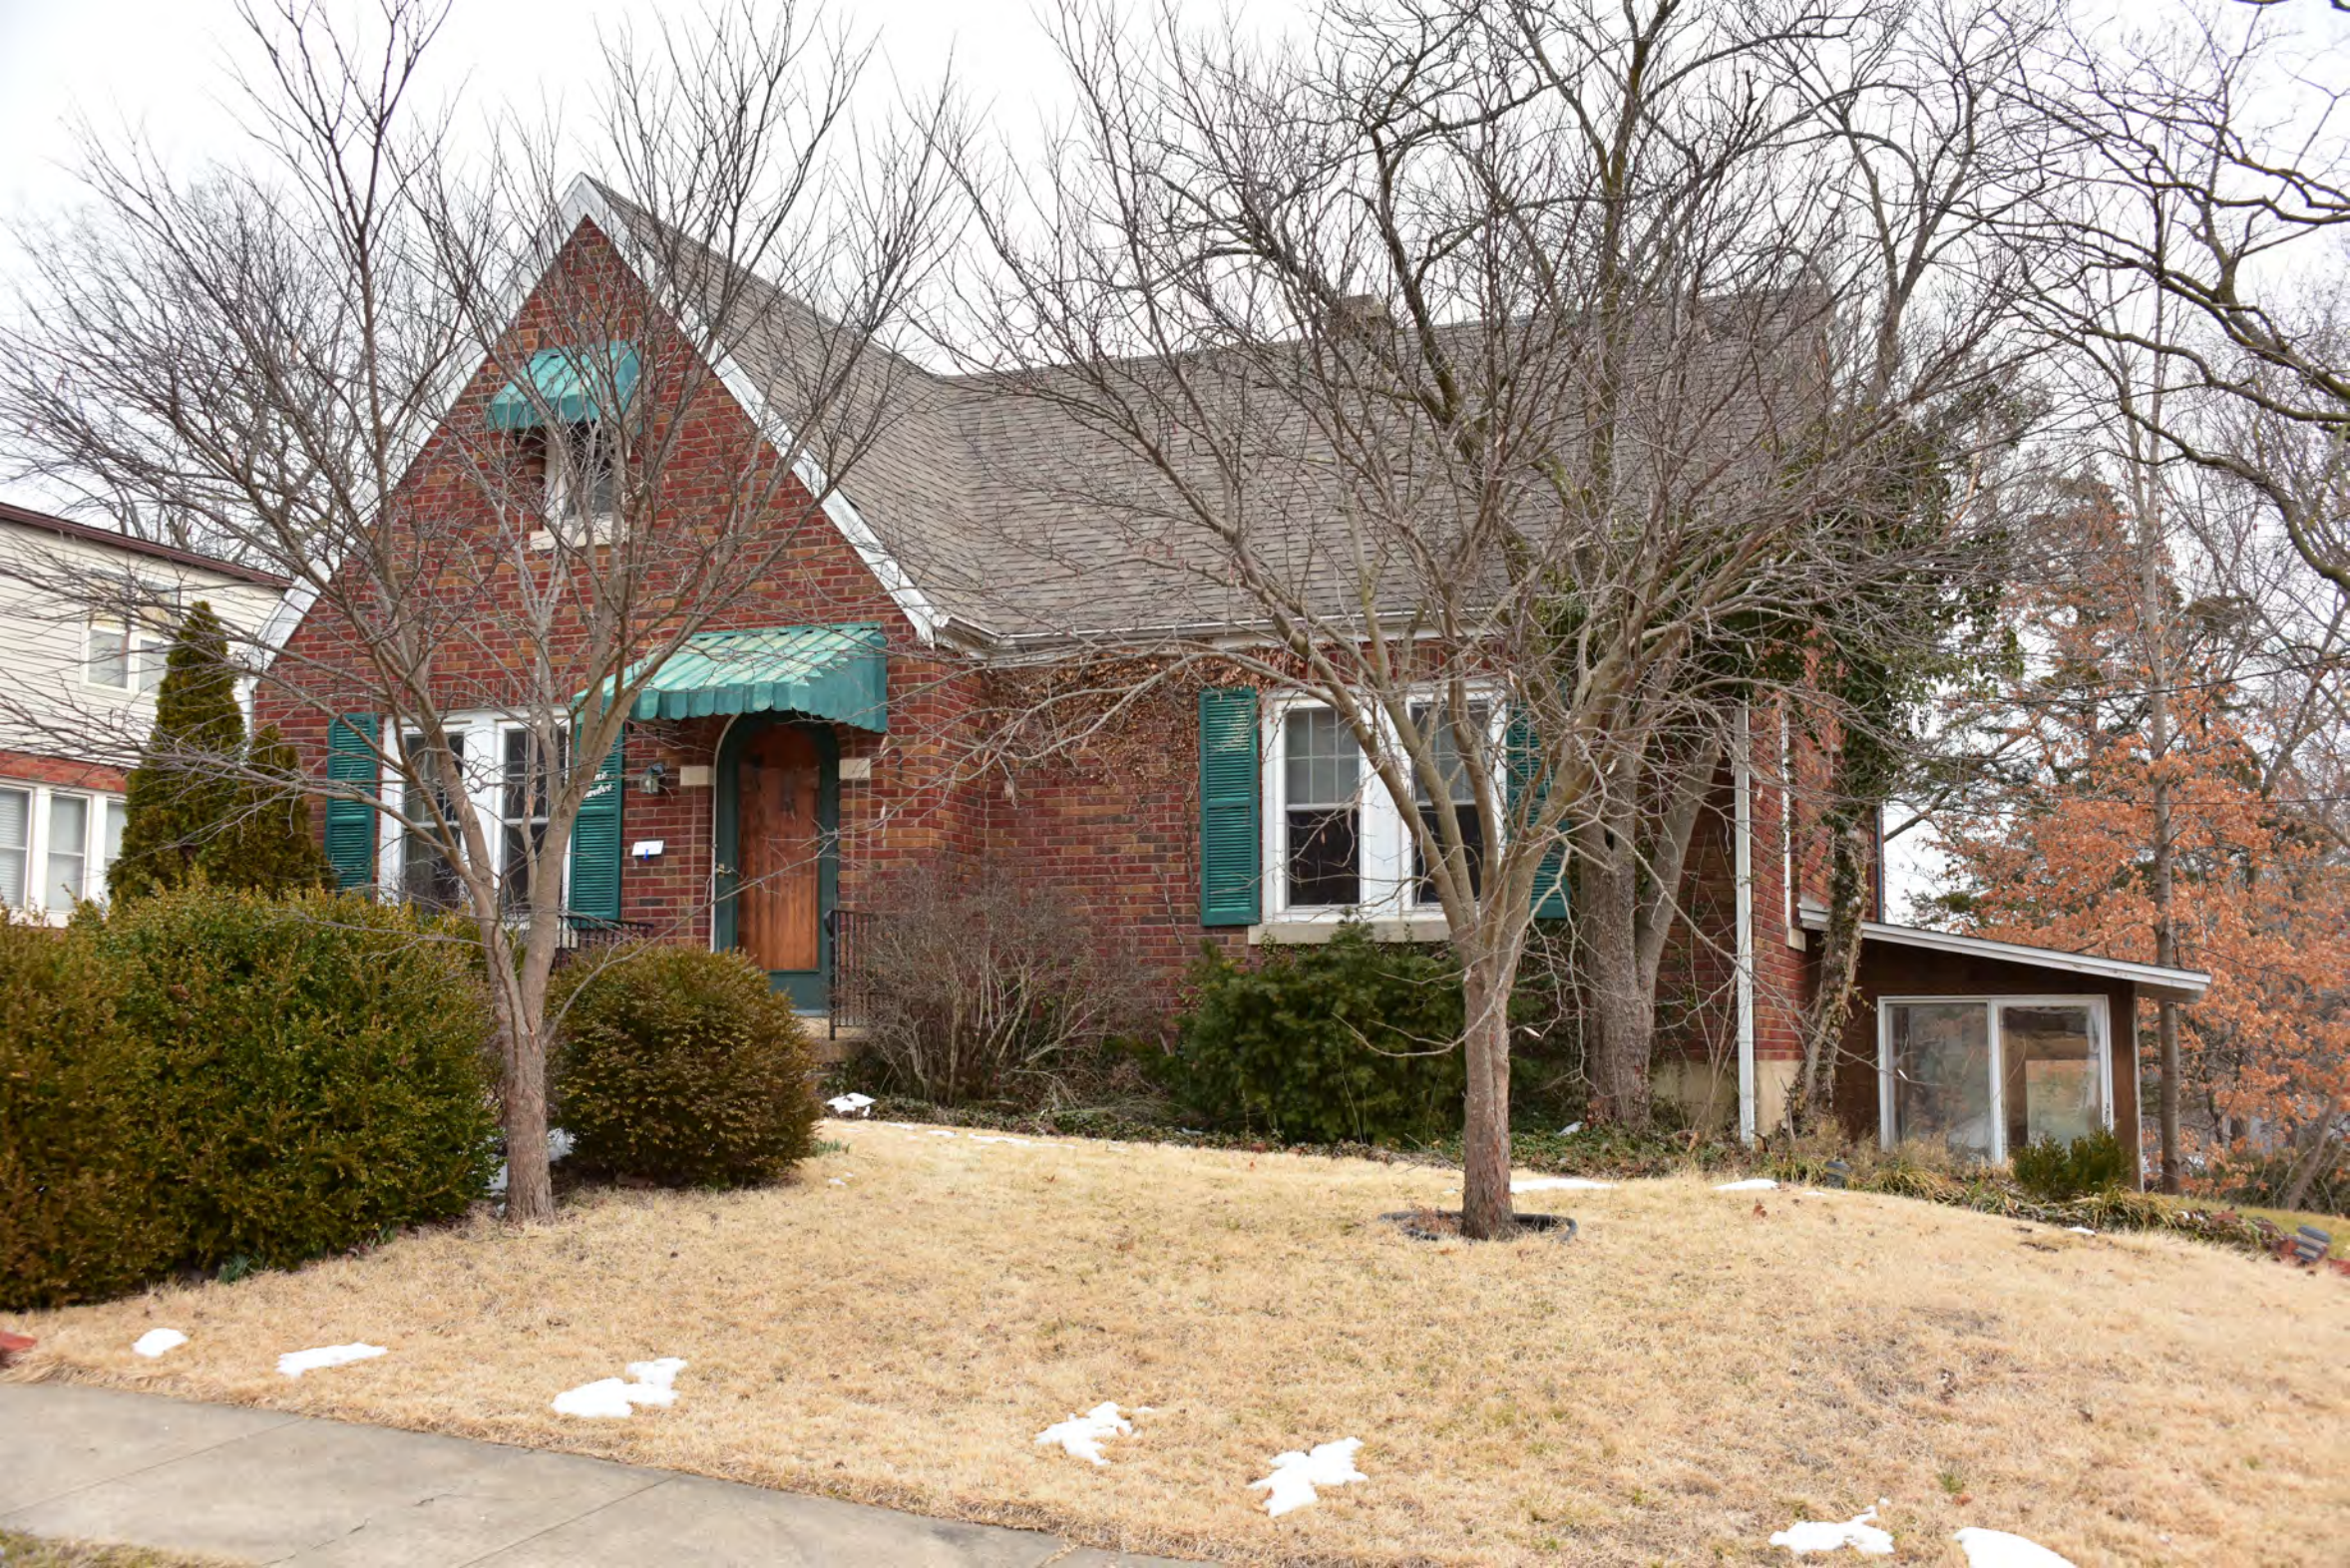
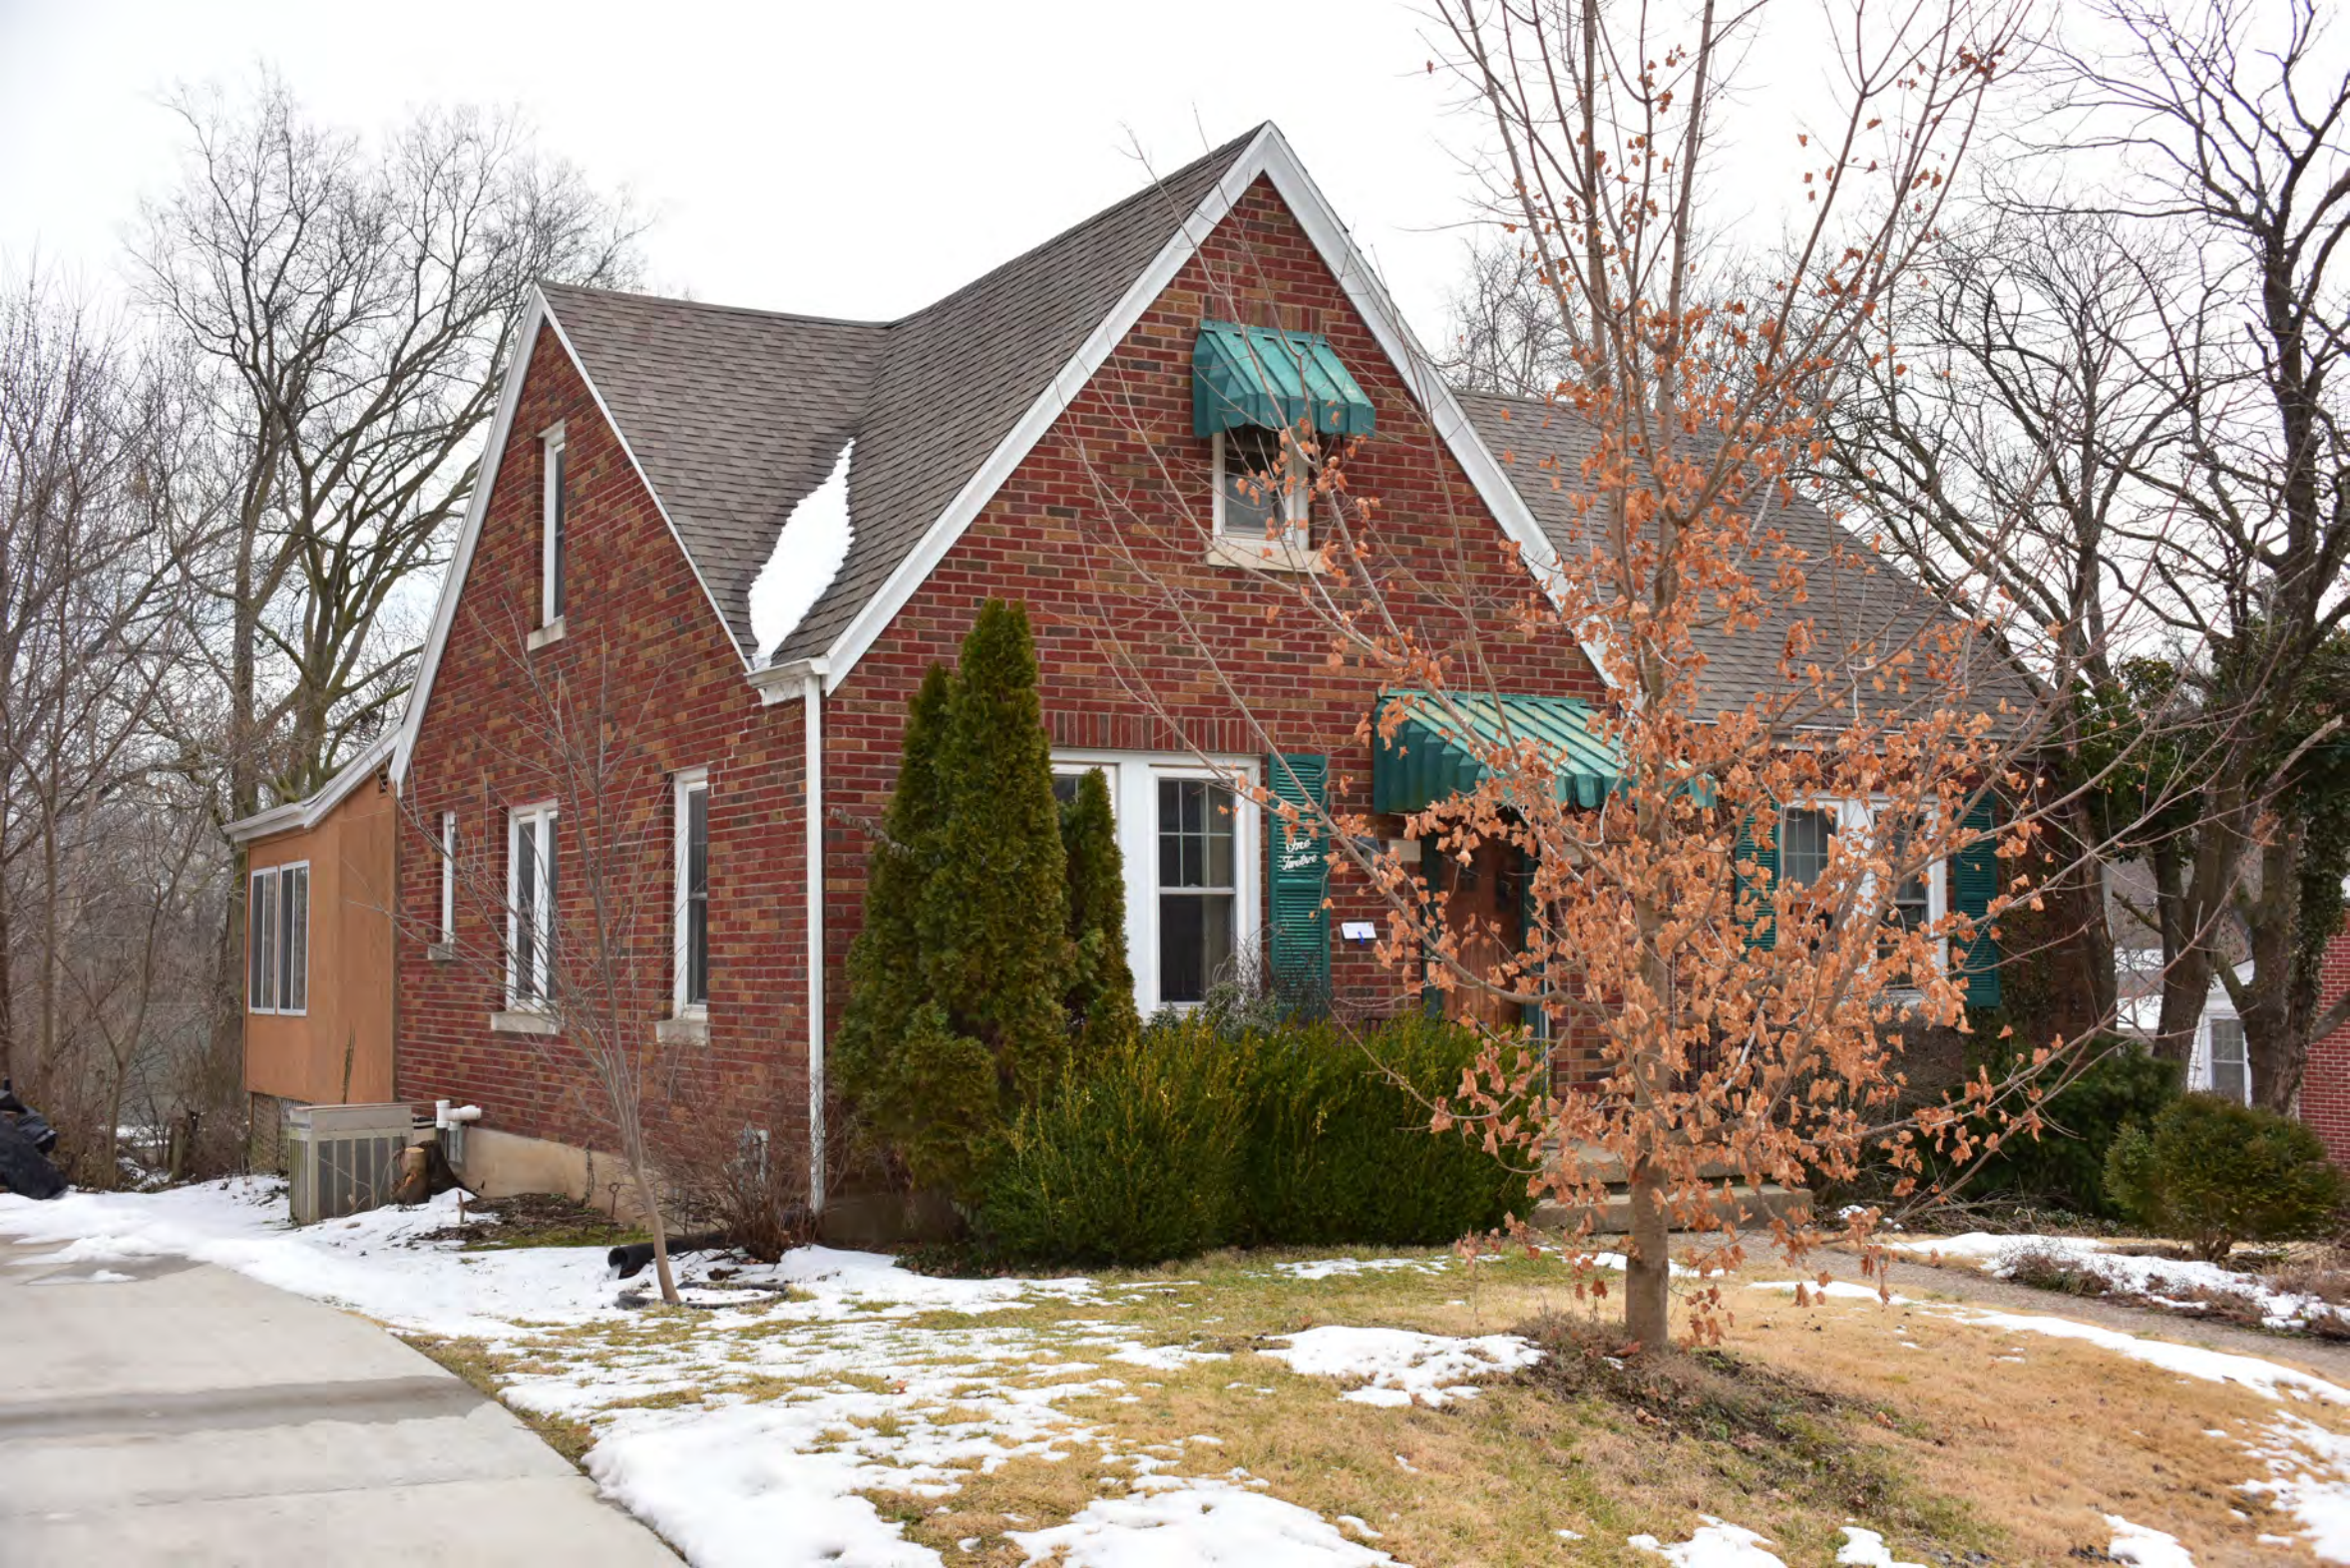
112 West Circle Drive is a one-and-one-half-story Minimal Traditional dwelling with brick cladding, a concrete foundation, and an asphalt side-gable roof with a cross gable at the primary elevation. A short brick chimney pierces the rear slope. The dwelling is three bays wide. The cross gable contains the north-two bays. Two-ganged non-historic 6/1 vinyl windows with a continuous cast stone sill and soldier brick lintel fill the south bay. The primary entrance defines the second bay. The opening is arched with a decorative brick surround and terra-cotta voussoirs. A historic wood door with glazing fills the bay. A small non-historic 6/1 vinyl window with cast concrete sill and soldier brick lintel is centered in the cross-gable apex. Historic metal awnings shelter this window and the entrance. The third bay matches the first. A concrete stoop with metal railings extends from the entrance. Historic maps and aerial images indicate a garage is located at basement level and accessed at the rear. It is not visible. A shed-roof enclosed sunporch addition with vinyl windows and wide vertical wood cladding extends from the south elevation. A shed-roof enclosed porch with narrow vertical wood cladding extends from the northeast corner of the dwelling. A c. 2000 sunporch with vinyl windows extends from the northwest corner of the enclosed porch.

Alterations to 112 West Circle Drive include the replacement of historic windows with vinyl windows and multiple additions. The south sunporch date of construction is unknown; however, it does not appear on historic aerials. Sanborn maps indicate the rear enclosed porch replaces a smaller historic porch and aerial images indicate the rear sunporch was constructed c. 2000. Although these porches are located at the rear, they are visible and alter the historic footprint. However, 112 West Circle Drive retains fair integrity and would likely be contributing to the potential Walinko Place Historic District, significant in the areas of Architecture and Community Planning and Development in association with the expansion of Jefferson City and increased suburban development during the twentieth century as well as its associations with Walinko Place, a notable suburban development during the Depression and War Years.

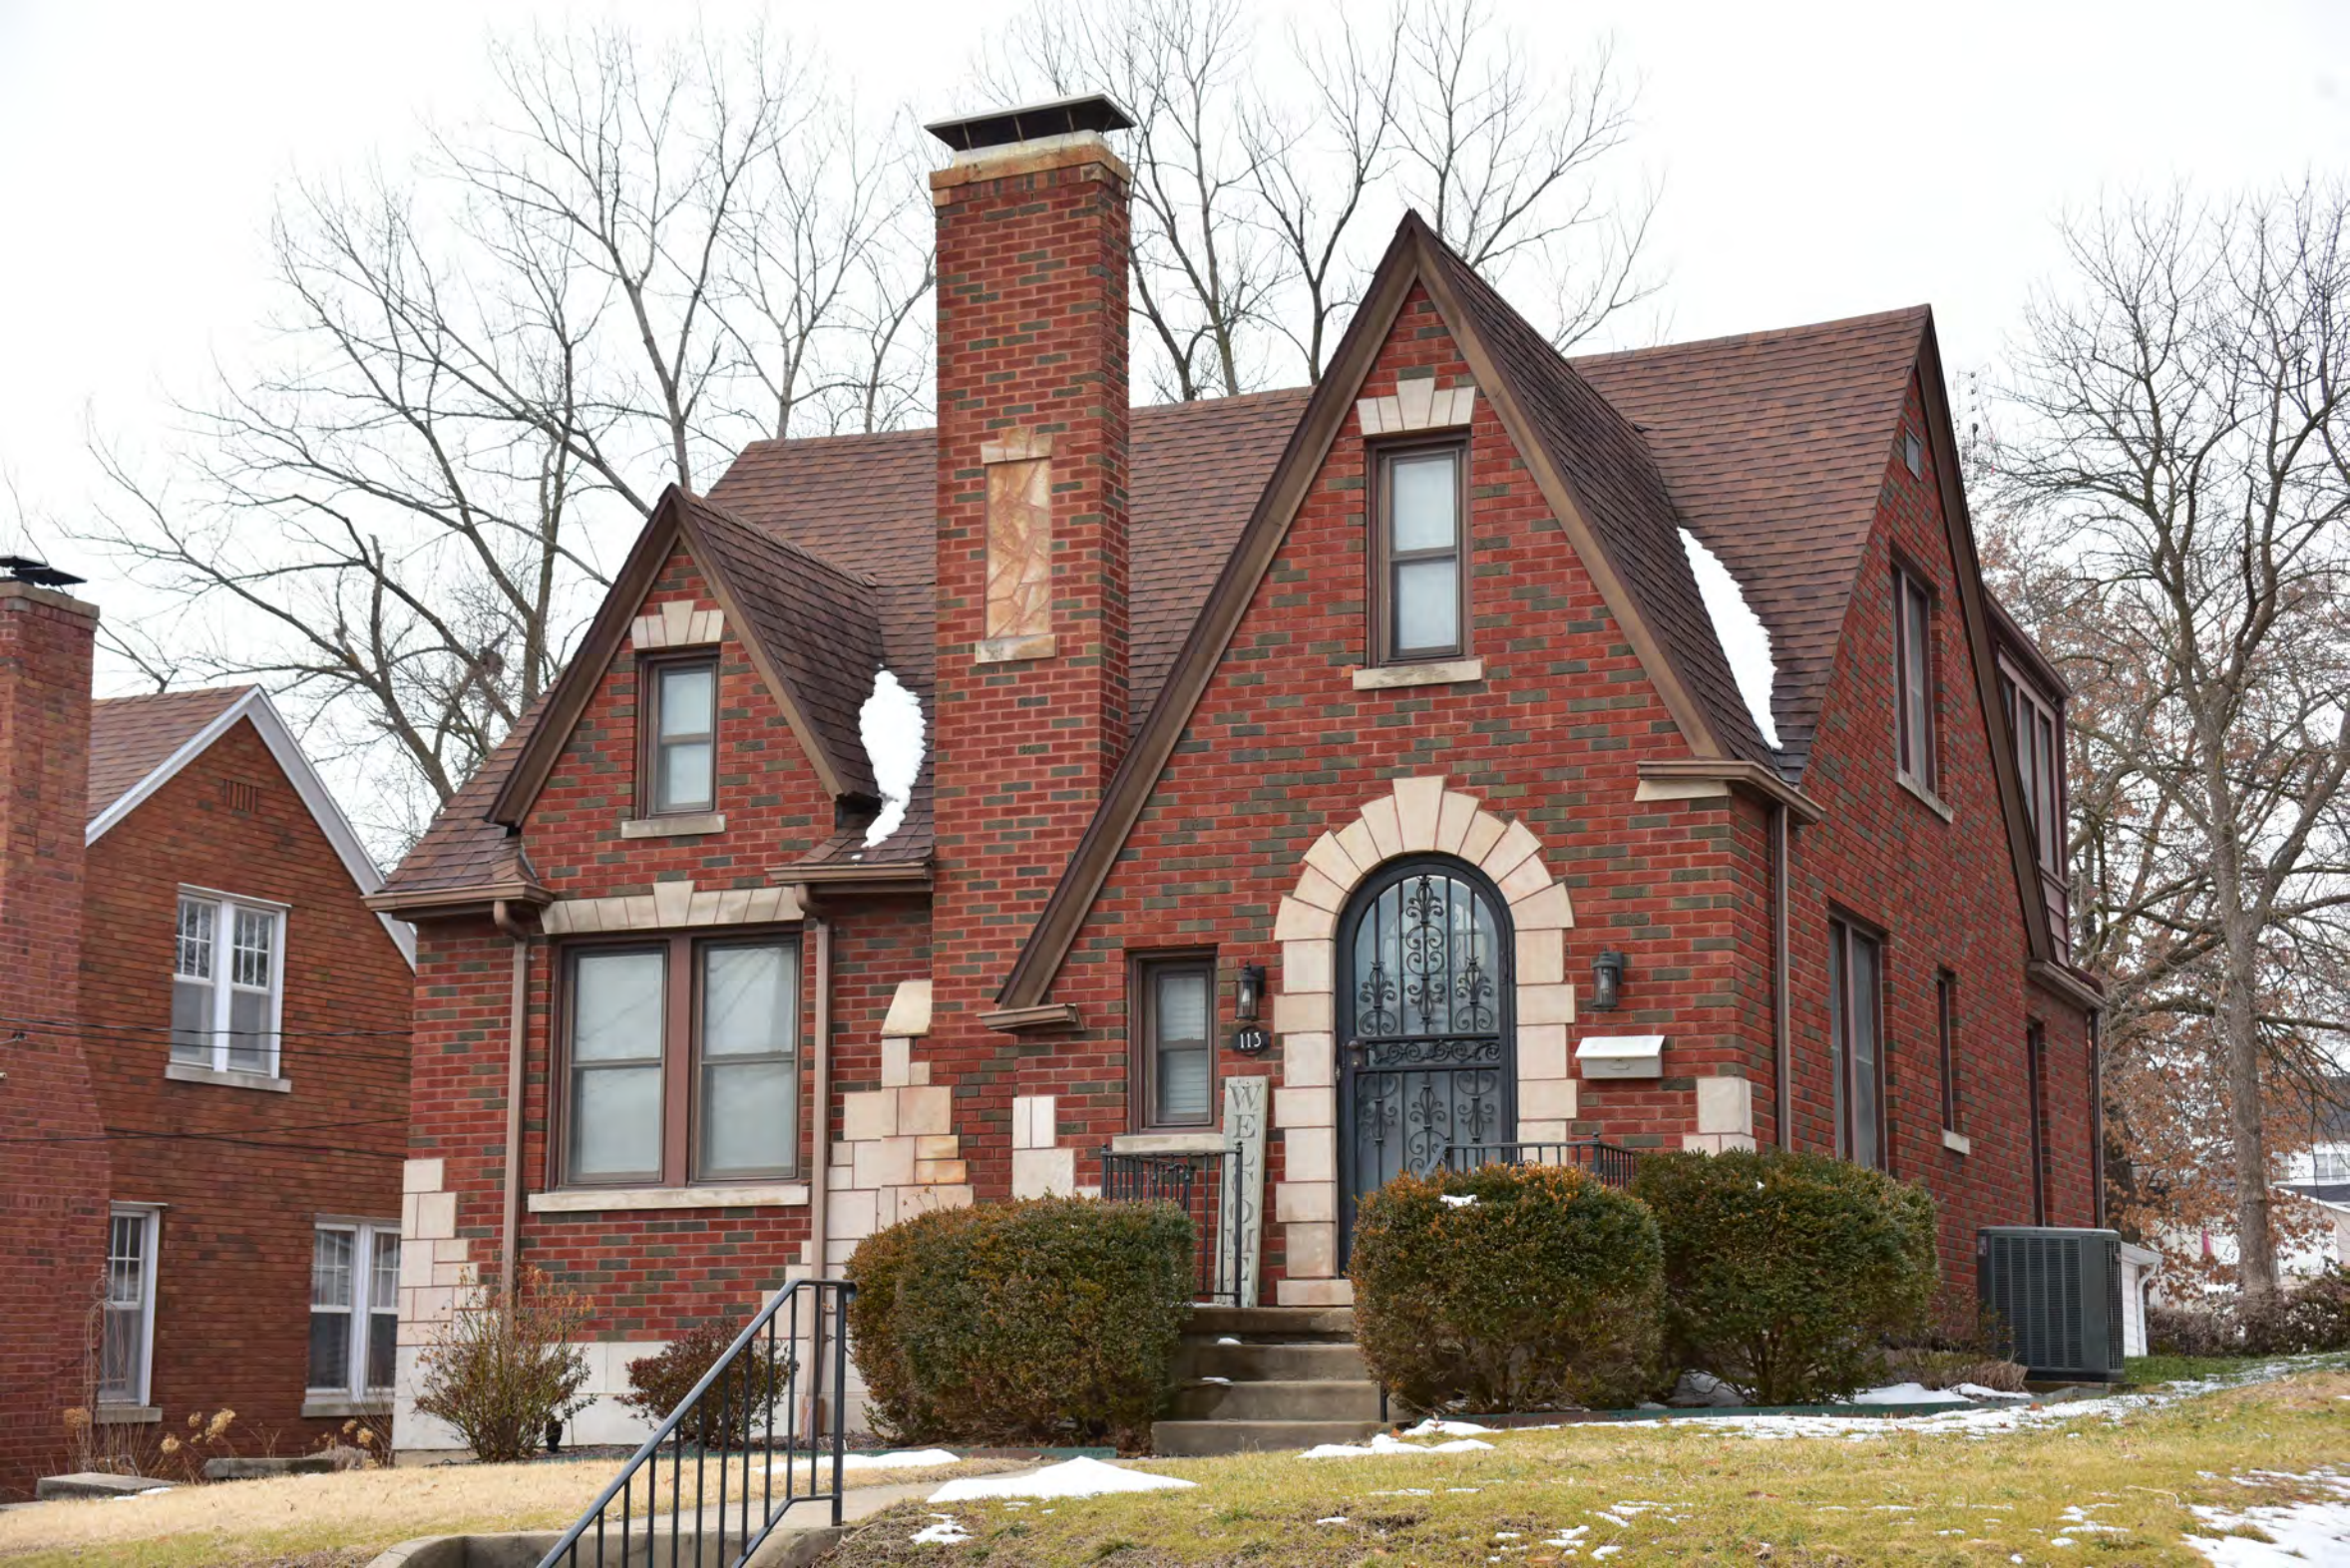
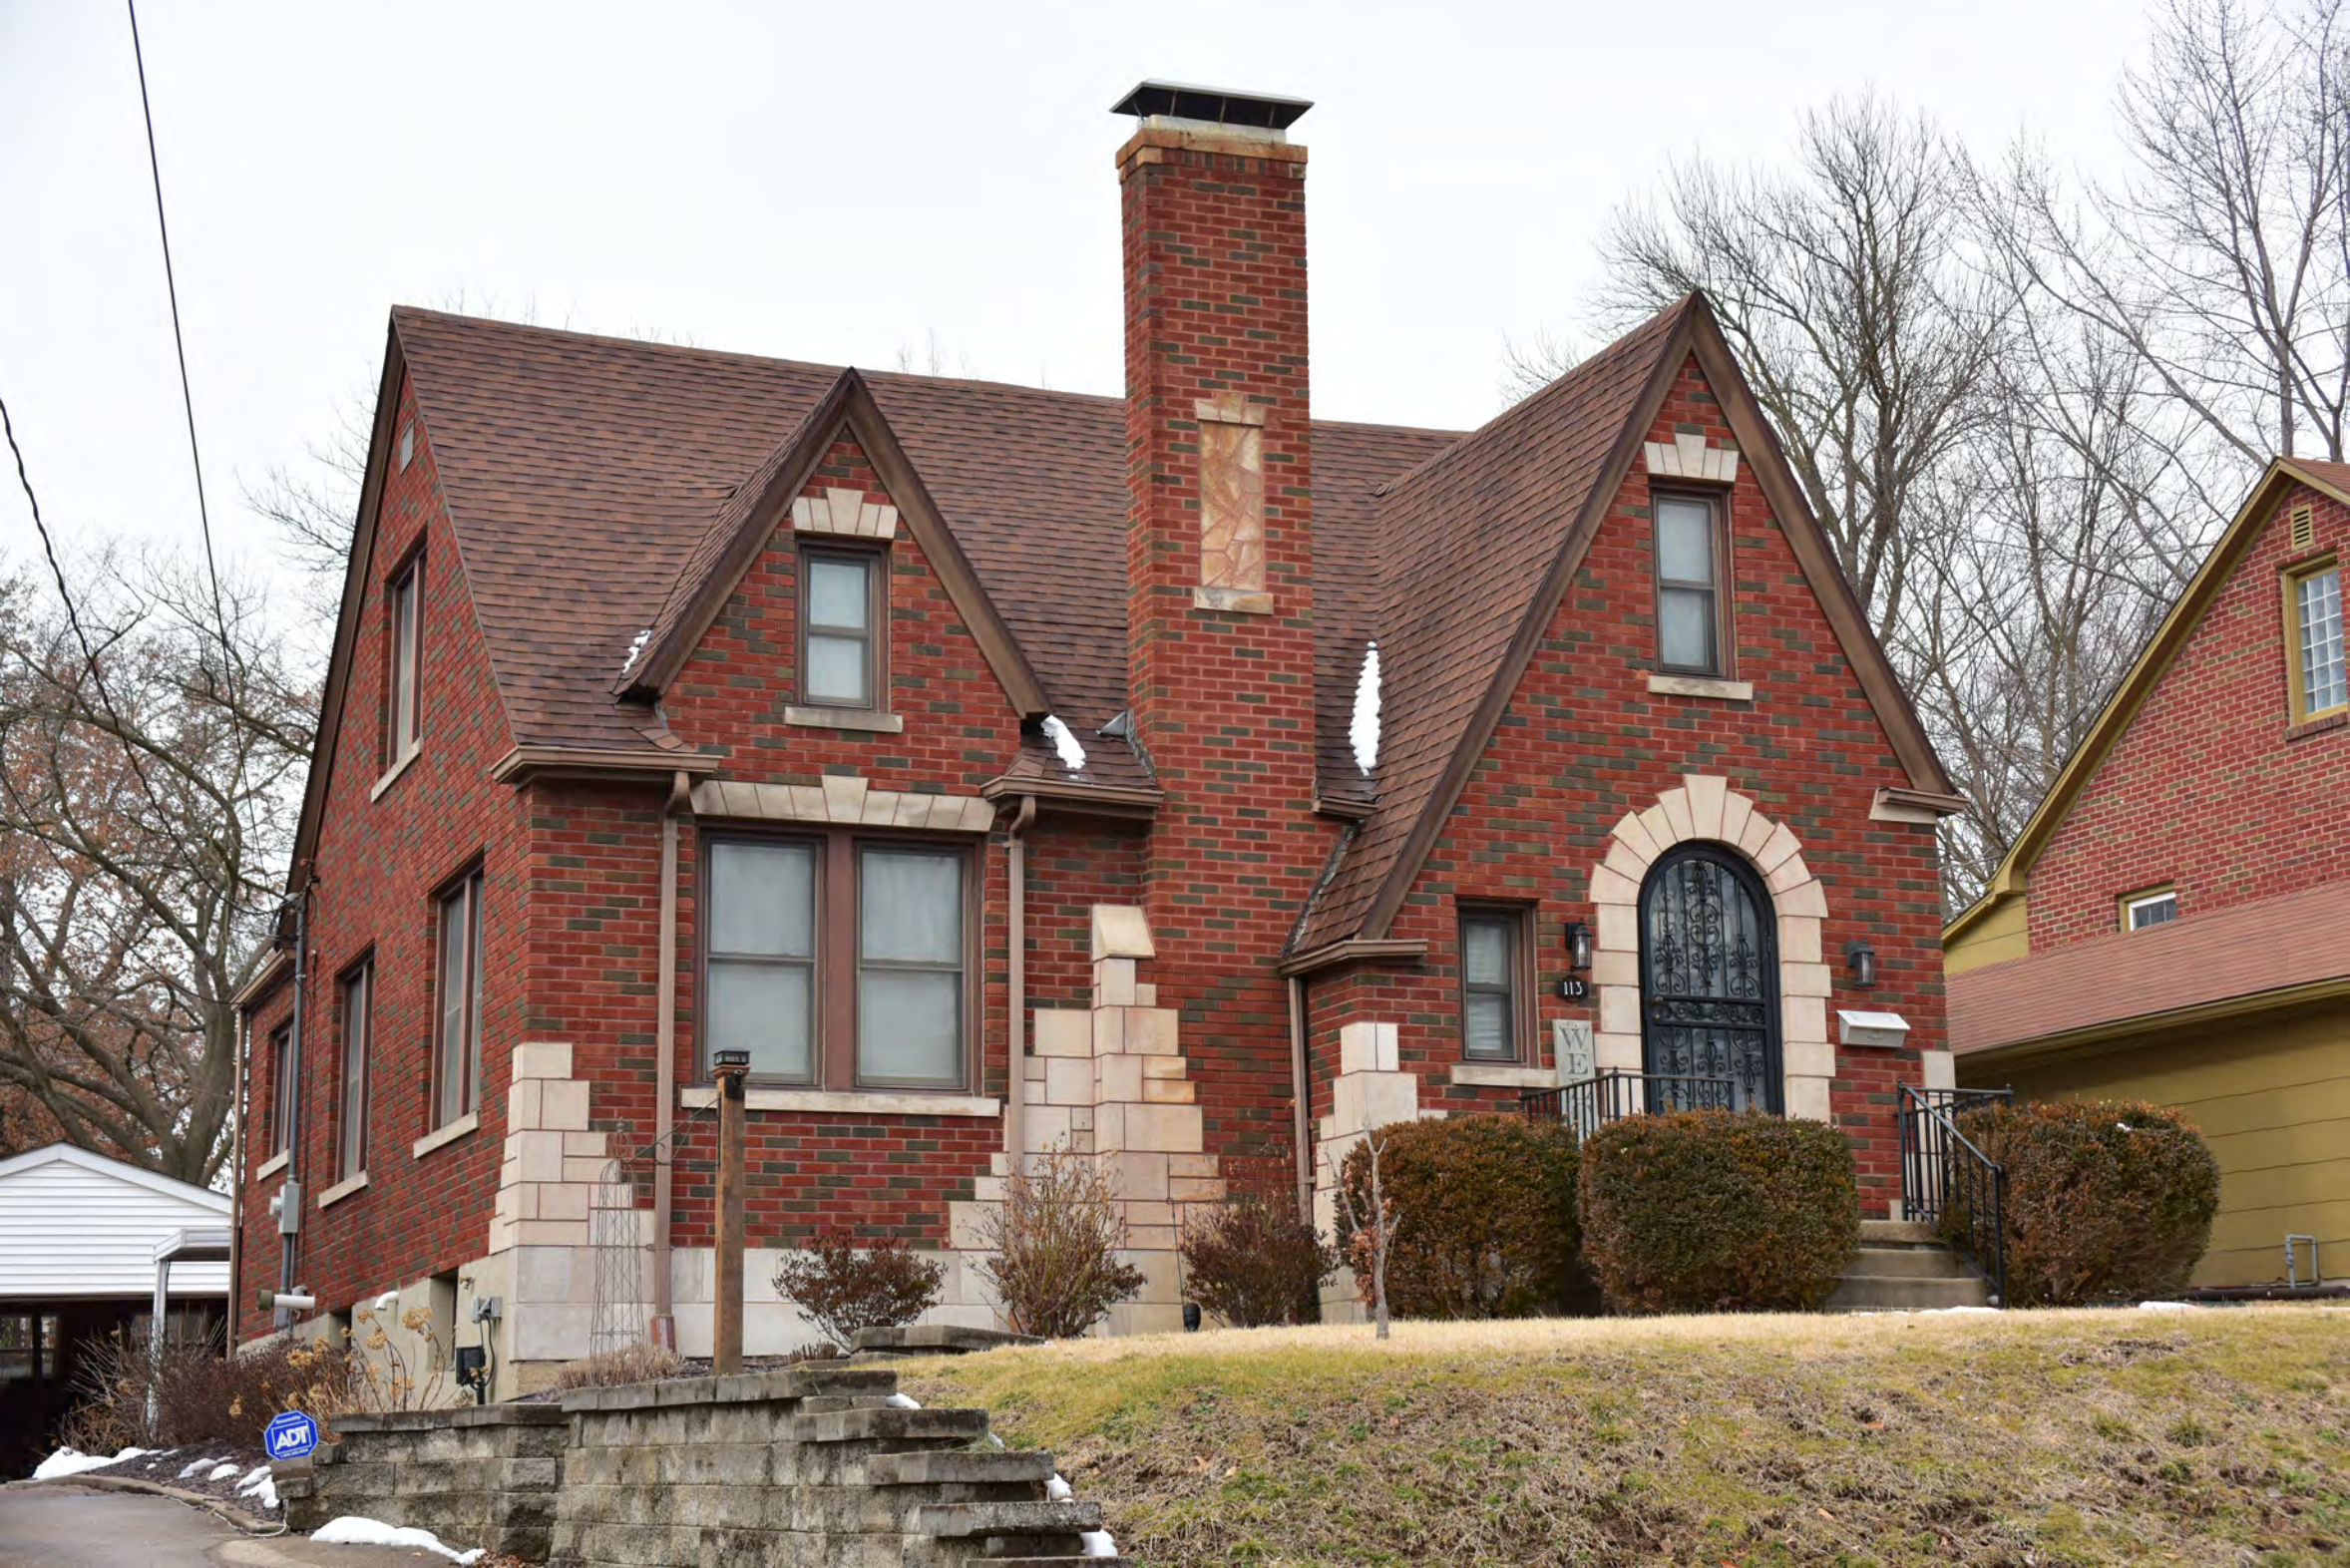
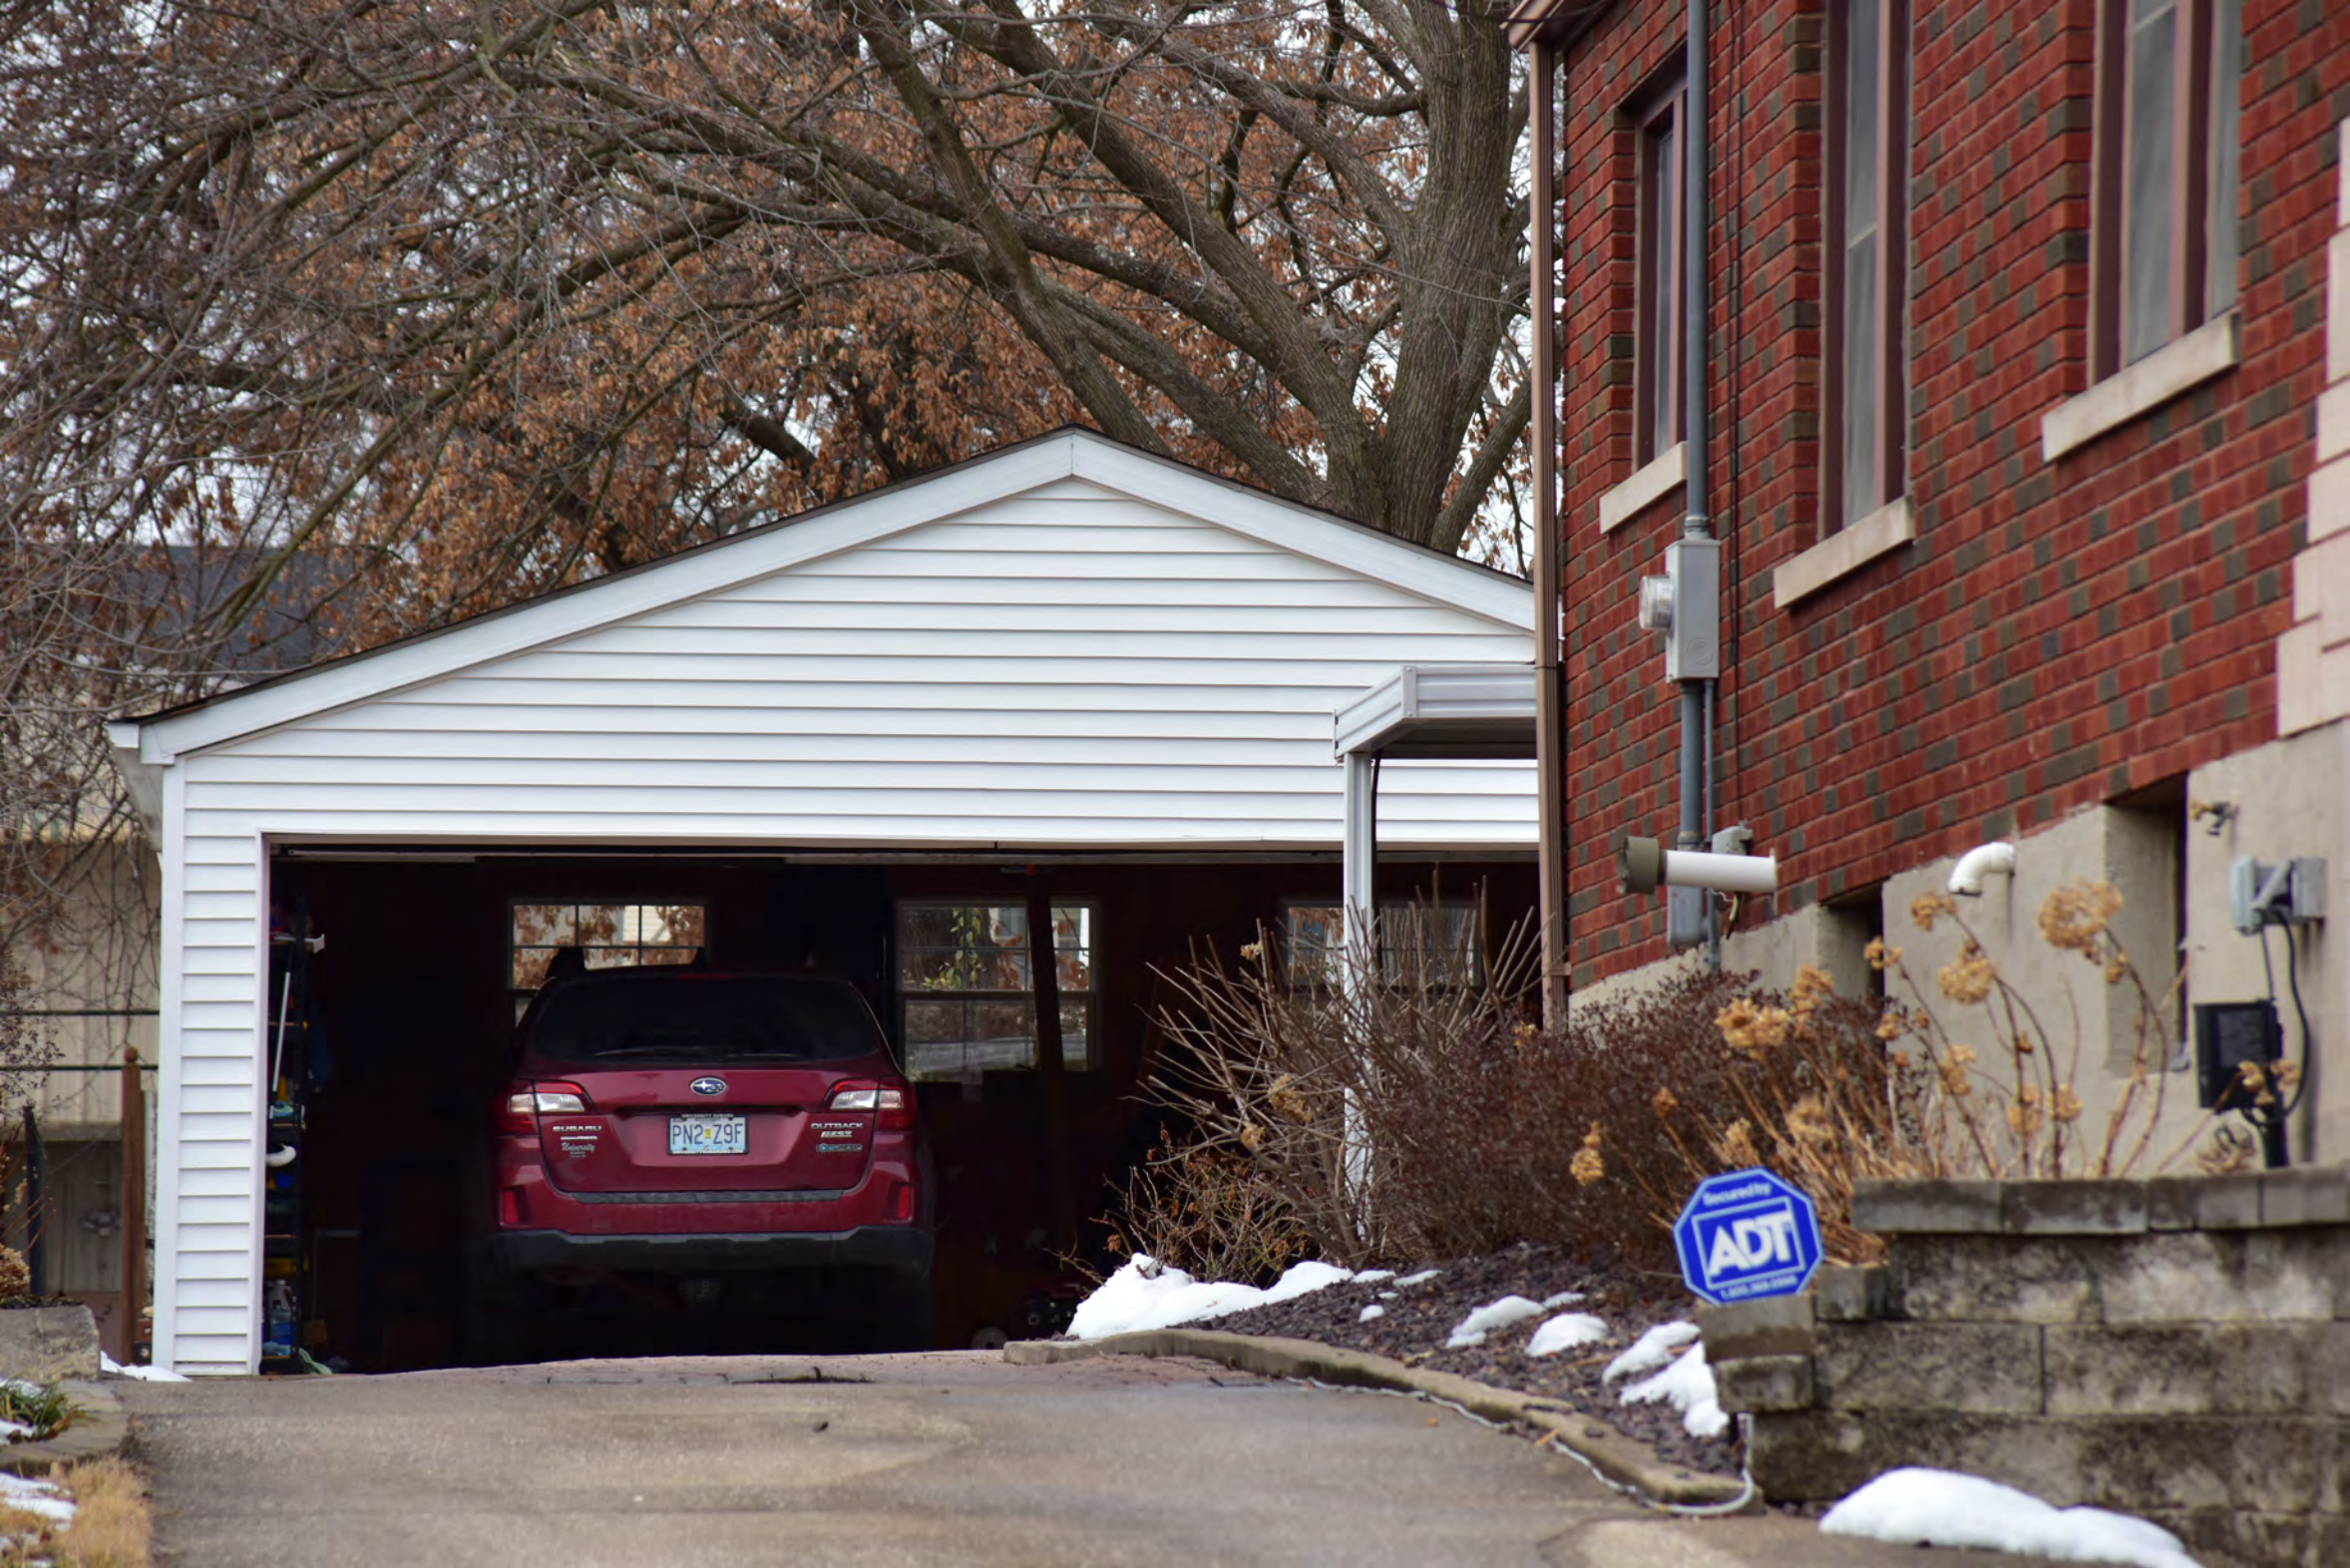
113 West Circle Drive is a one-and-one-half story Minimal Traditional dwelling with restrained Tudor Revival influences. The dwelling has a concrete foundation, asphalt intersecting gable roof, and multi-color brick cladding with cast stone and terra-cotta accents at the primary elevation lower half. A side-gable with lower cross-gable fronts West Circle Drive while a perpendicular gable extends to the rear. A brick exterior chimney with cast stone accents is centered on the primary elevation. The dwelling is three bays wide. Two-ganged 1/1 metal windows with a continuous cast-stone sill and terra-cotta lintel with keystone motif define the south bay. A gabled wall dormer is centered above the bay and contains a small 1/1 metal window with a cast stone sill and terra-cotta lintel with keystone. A cross-gable projects from the north end of the elevation and defines the north bay. It contains the primary entrance which features a historic wood door with glazing. Terra-cotta accents with exaggerated voussoirs surround the arched opening. A small 1/1 metal window is located immediately south of the entrance. A narrow 1/1 metal window with a cast stone sill and terra-cotta lintel with keystone is centered in the gable apex. A concrete stoop extends from the entrance and a scrolled metal railing lines the perimeter. A large metal-clad shed roof dormer with metal windows is partially visible on the north slope of the rear gable. Aerial images indicate a c. 1967 shed-roof addition spans the rear elevation, however it is not visible. Historic maps and aerial images indicate a garage is located at basement level and accessed at the rear. It is not visible.

Alterations to 113 West Circle Drive include the replacement of historic windows with metal windows and a rear addition. While replacements, the windows fill historic openings and are complimentary in style. The rear addition is a historic alteration constructed c. 1967 and is complimentary in size and scale. It is not visible from the right of way and does not obscure the historic form or footprint. 113 West Circle Drive retains good integrity. This resource would be contributing to the potential Walinko Place Historic District, significant in the areas of Architecture and Community Planning and Development in association with the expansion of Jefferson City and increased suburban development during the twentieth century as well as its associations with Walinko Place, a notable suburban development during the Depression and War Years.
