1. Survey number: CO-AS-008-001		2. Survey Name: West Main Street Survey	
3. County: Cole		4. Address (Street No.): 100	Street (name): East Circle Drive
5. City: Jefferson City	Vicinity <input type="checkbox"/>	6. Lat / Long:	7. Township/Range/Section: T: R: S:
8. Historic name (if known):		9. Present/other name (if known):	
10. Ownership: <input checked="" type="checkbox"/> Private <input type="checkbox"/> Public		11a. Historic use (if known): Domestic-Single Dwelling	11b. Current use: Domestic-Single Dwelling

MISSOURI DEPARTMENT OF NATURAL RESOURCES
STATE HISTORIC PRESERVATION OFFICE, P.O. Box 178, Jefferson City, MO 65102
ARCHITECTURAL/HISTORIC INVENTORY FORM

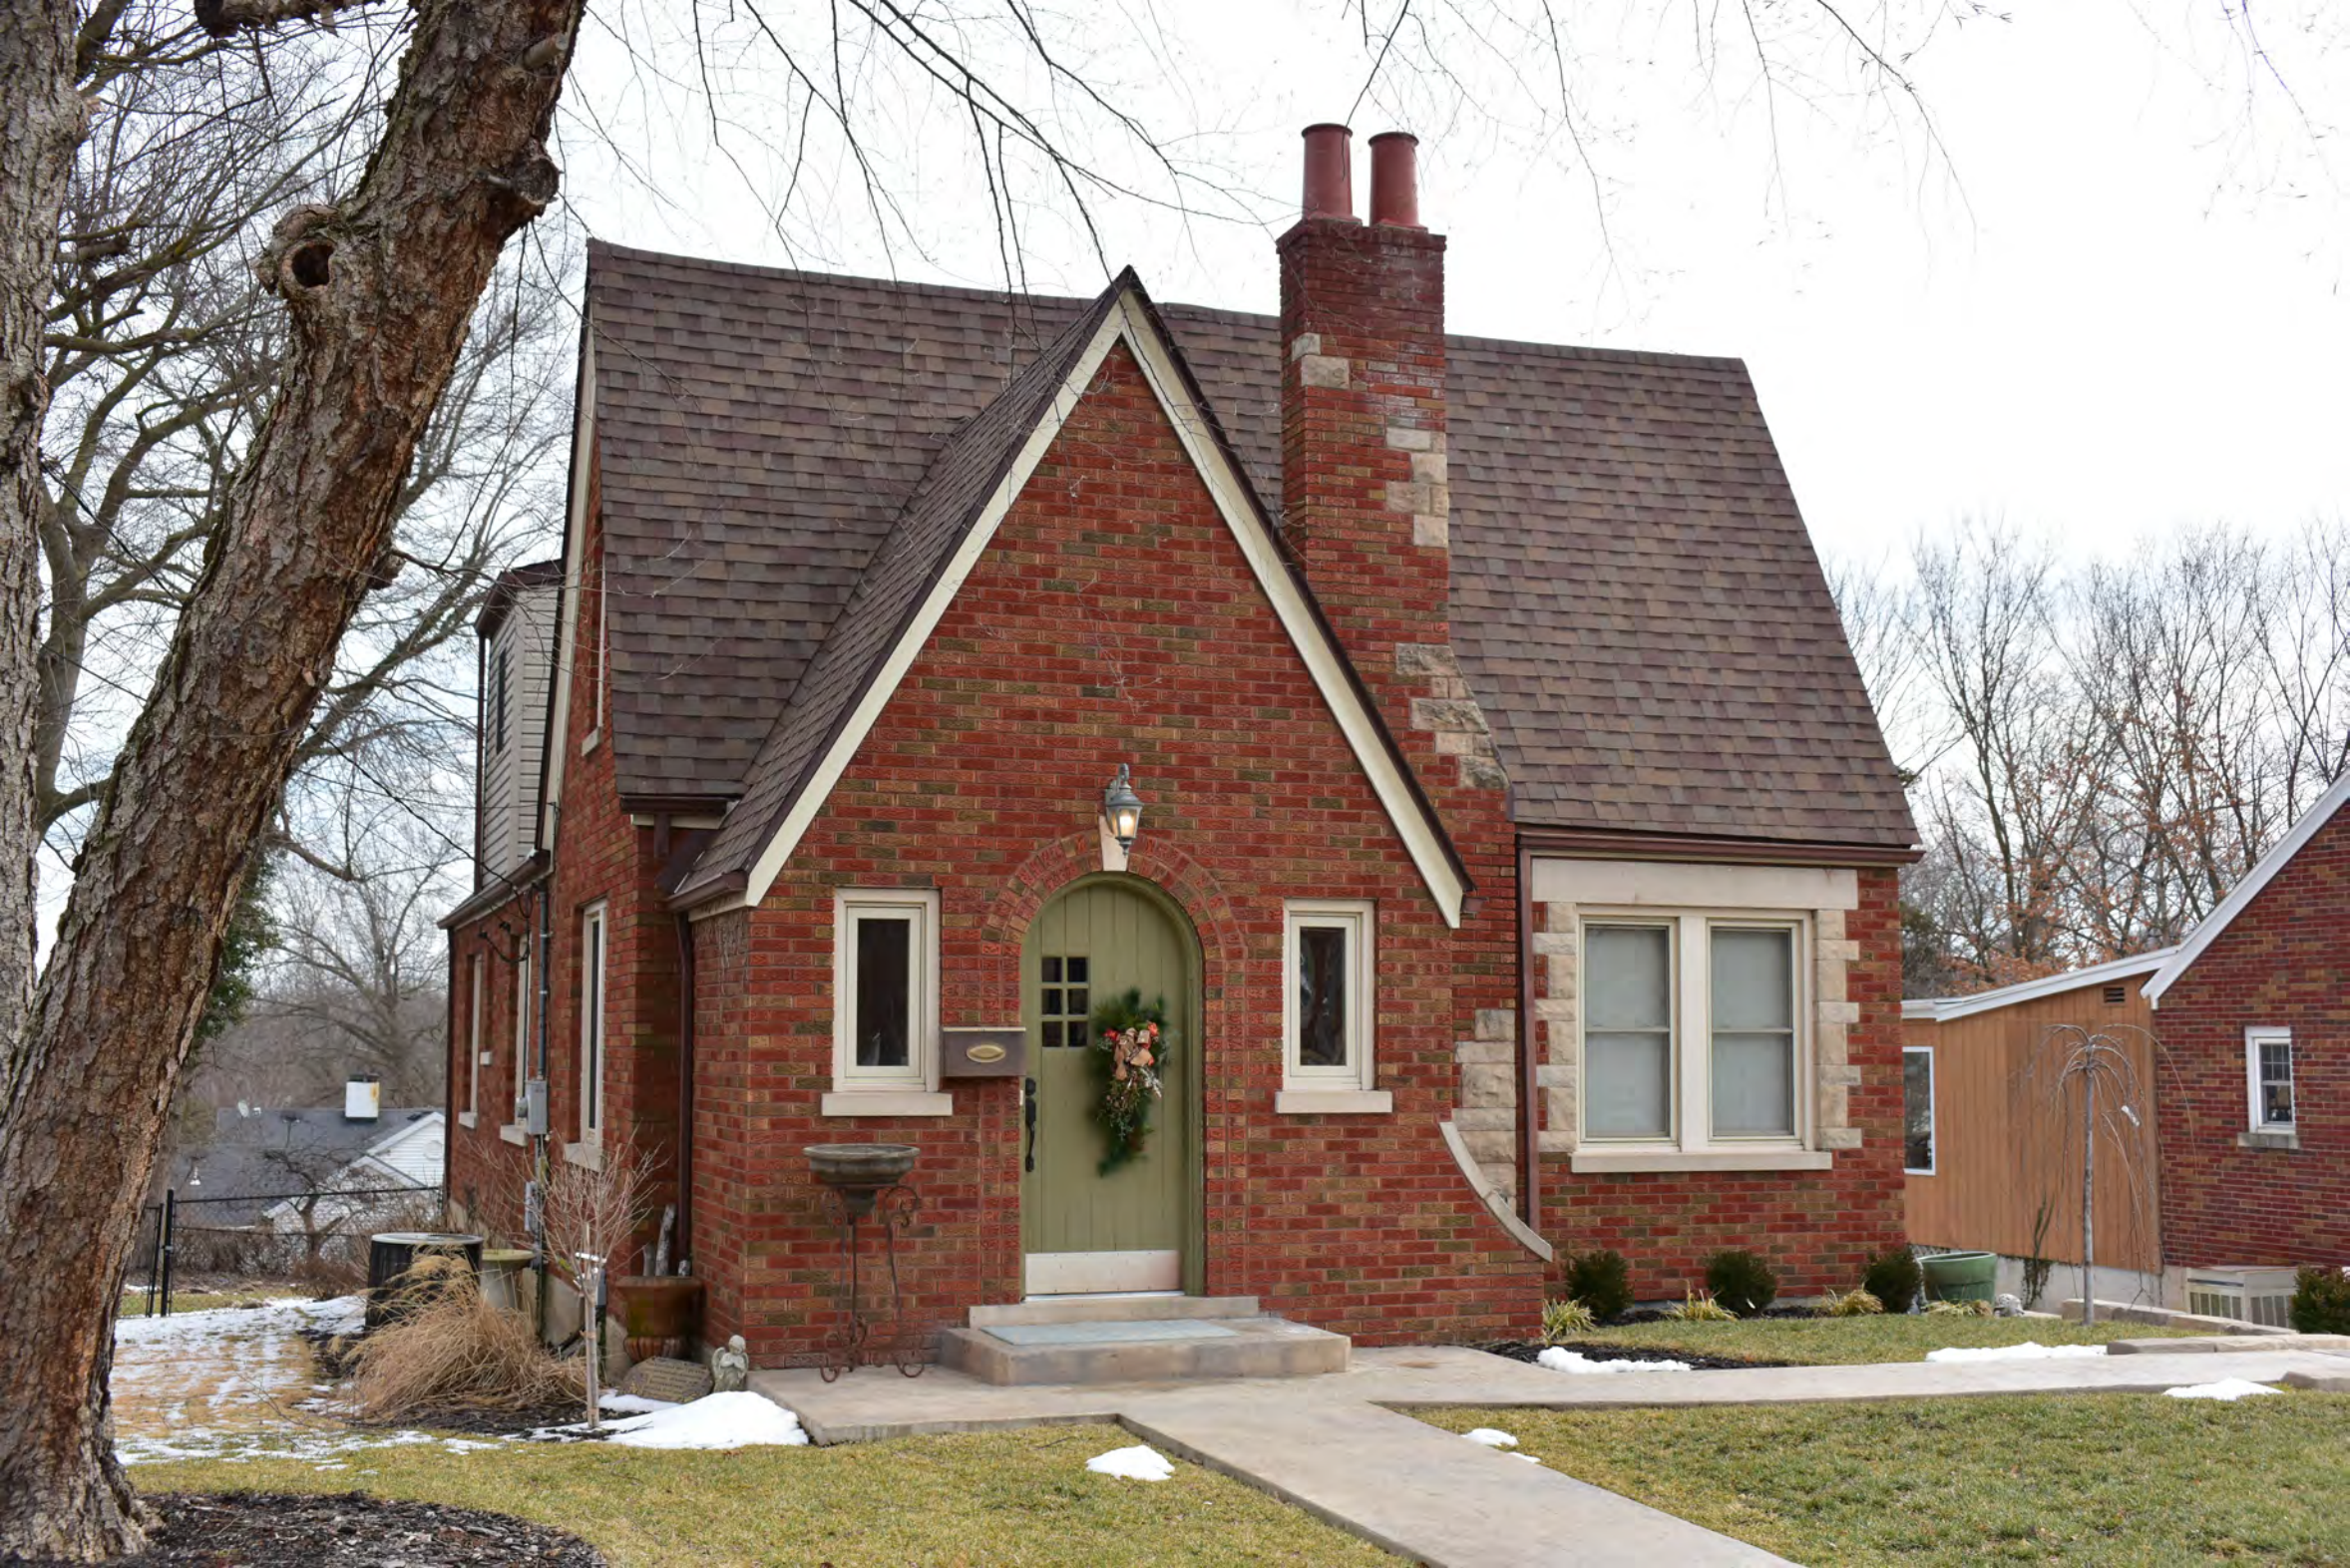
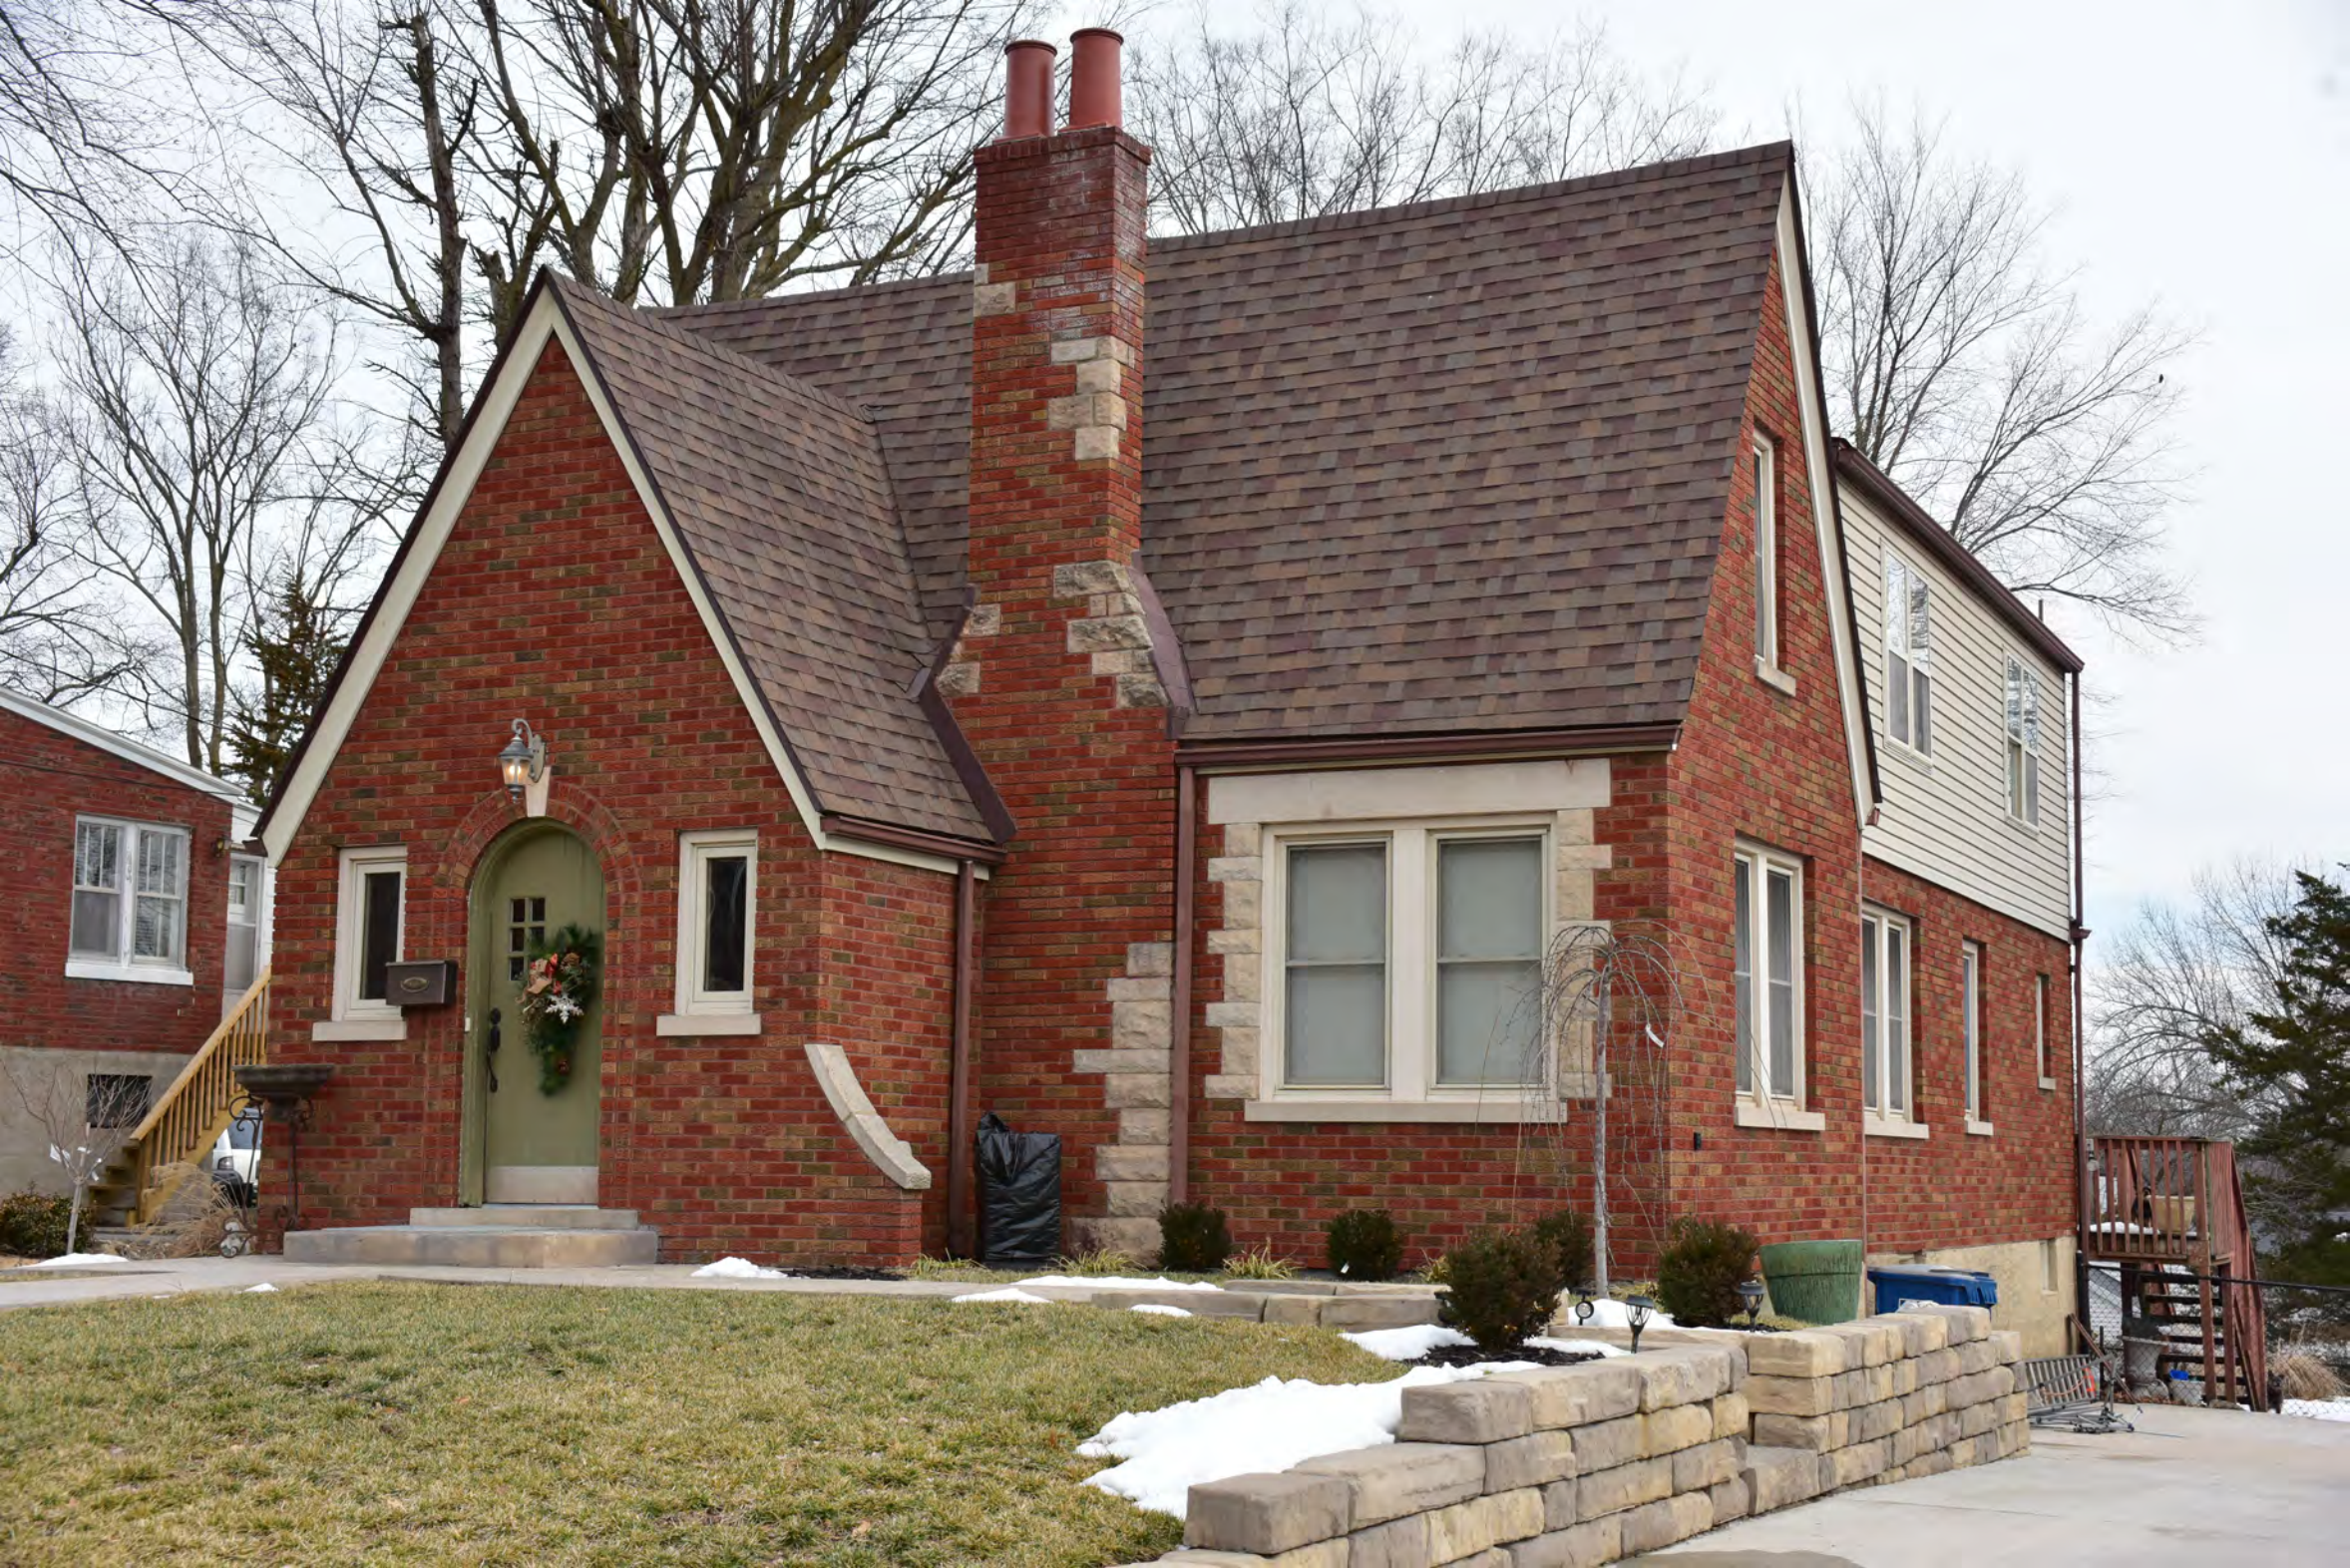
114 West Circle Drive is a one-and-one-half story Minimal Traditional dwelling with restrained Tudor Revival influences. The dwelling has a concrete foundation, asphalt intersecting gable roof, and multi-color brick cladding. A side-gable with lower cross-gable fronts West Circle Drive while a perpendicular gable extends to the rear. A brick exterior chimney with cast stone accents is centered on the primary elevation. The dwelling is two bays wide. Two-ganged 1/1 vinyl windows with a continuous cast-stone sill and lintel define the south bay. Rough cast stone lines the north and south sides. A low cross-gable projects from the north end of the elevation and defines the north bay. It contains the primary entrance which features a historic wood door with six-light glazing. Decorative header brick surrounds the arched opening. A small single-pane vinyl windows with cast stone sills flank the door. A concrete stoop extends from the entrance. Large vinyl-clad shed roof dormers line the rear perpendicular gable. Historic maps, aerial images, and a concrete driveway indicate a garage is located at basement level and accessed at the rear. It is not visible.

Alterations to 114 West Circle Drive include the replacement of historic windows and the application of vinyl cladding to the dormers. While the windows are replacements, they fill historic openings. Due to these alterations 114 West Circle Drive retains fair integrity. This resource would be contributing to the potential Walinko Place Historic District, significant in the areas of Architecture and Community Planning and Development in association with the expansion of Jefferson City and increased suburban development during the twentieth century as well as its associations with Walinko Place, a notable suburban development during the Depression and War Years.

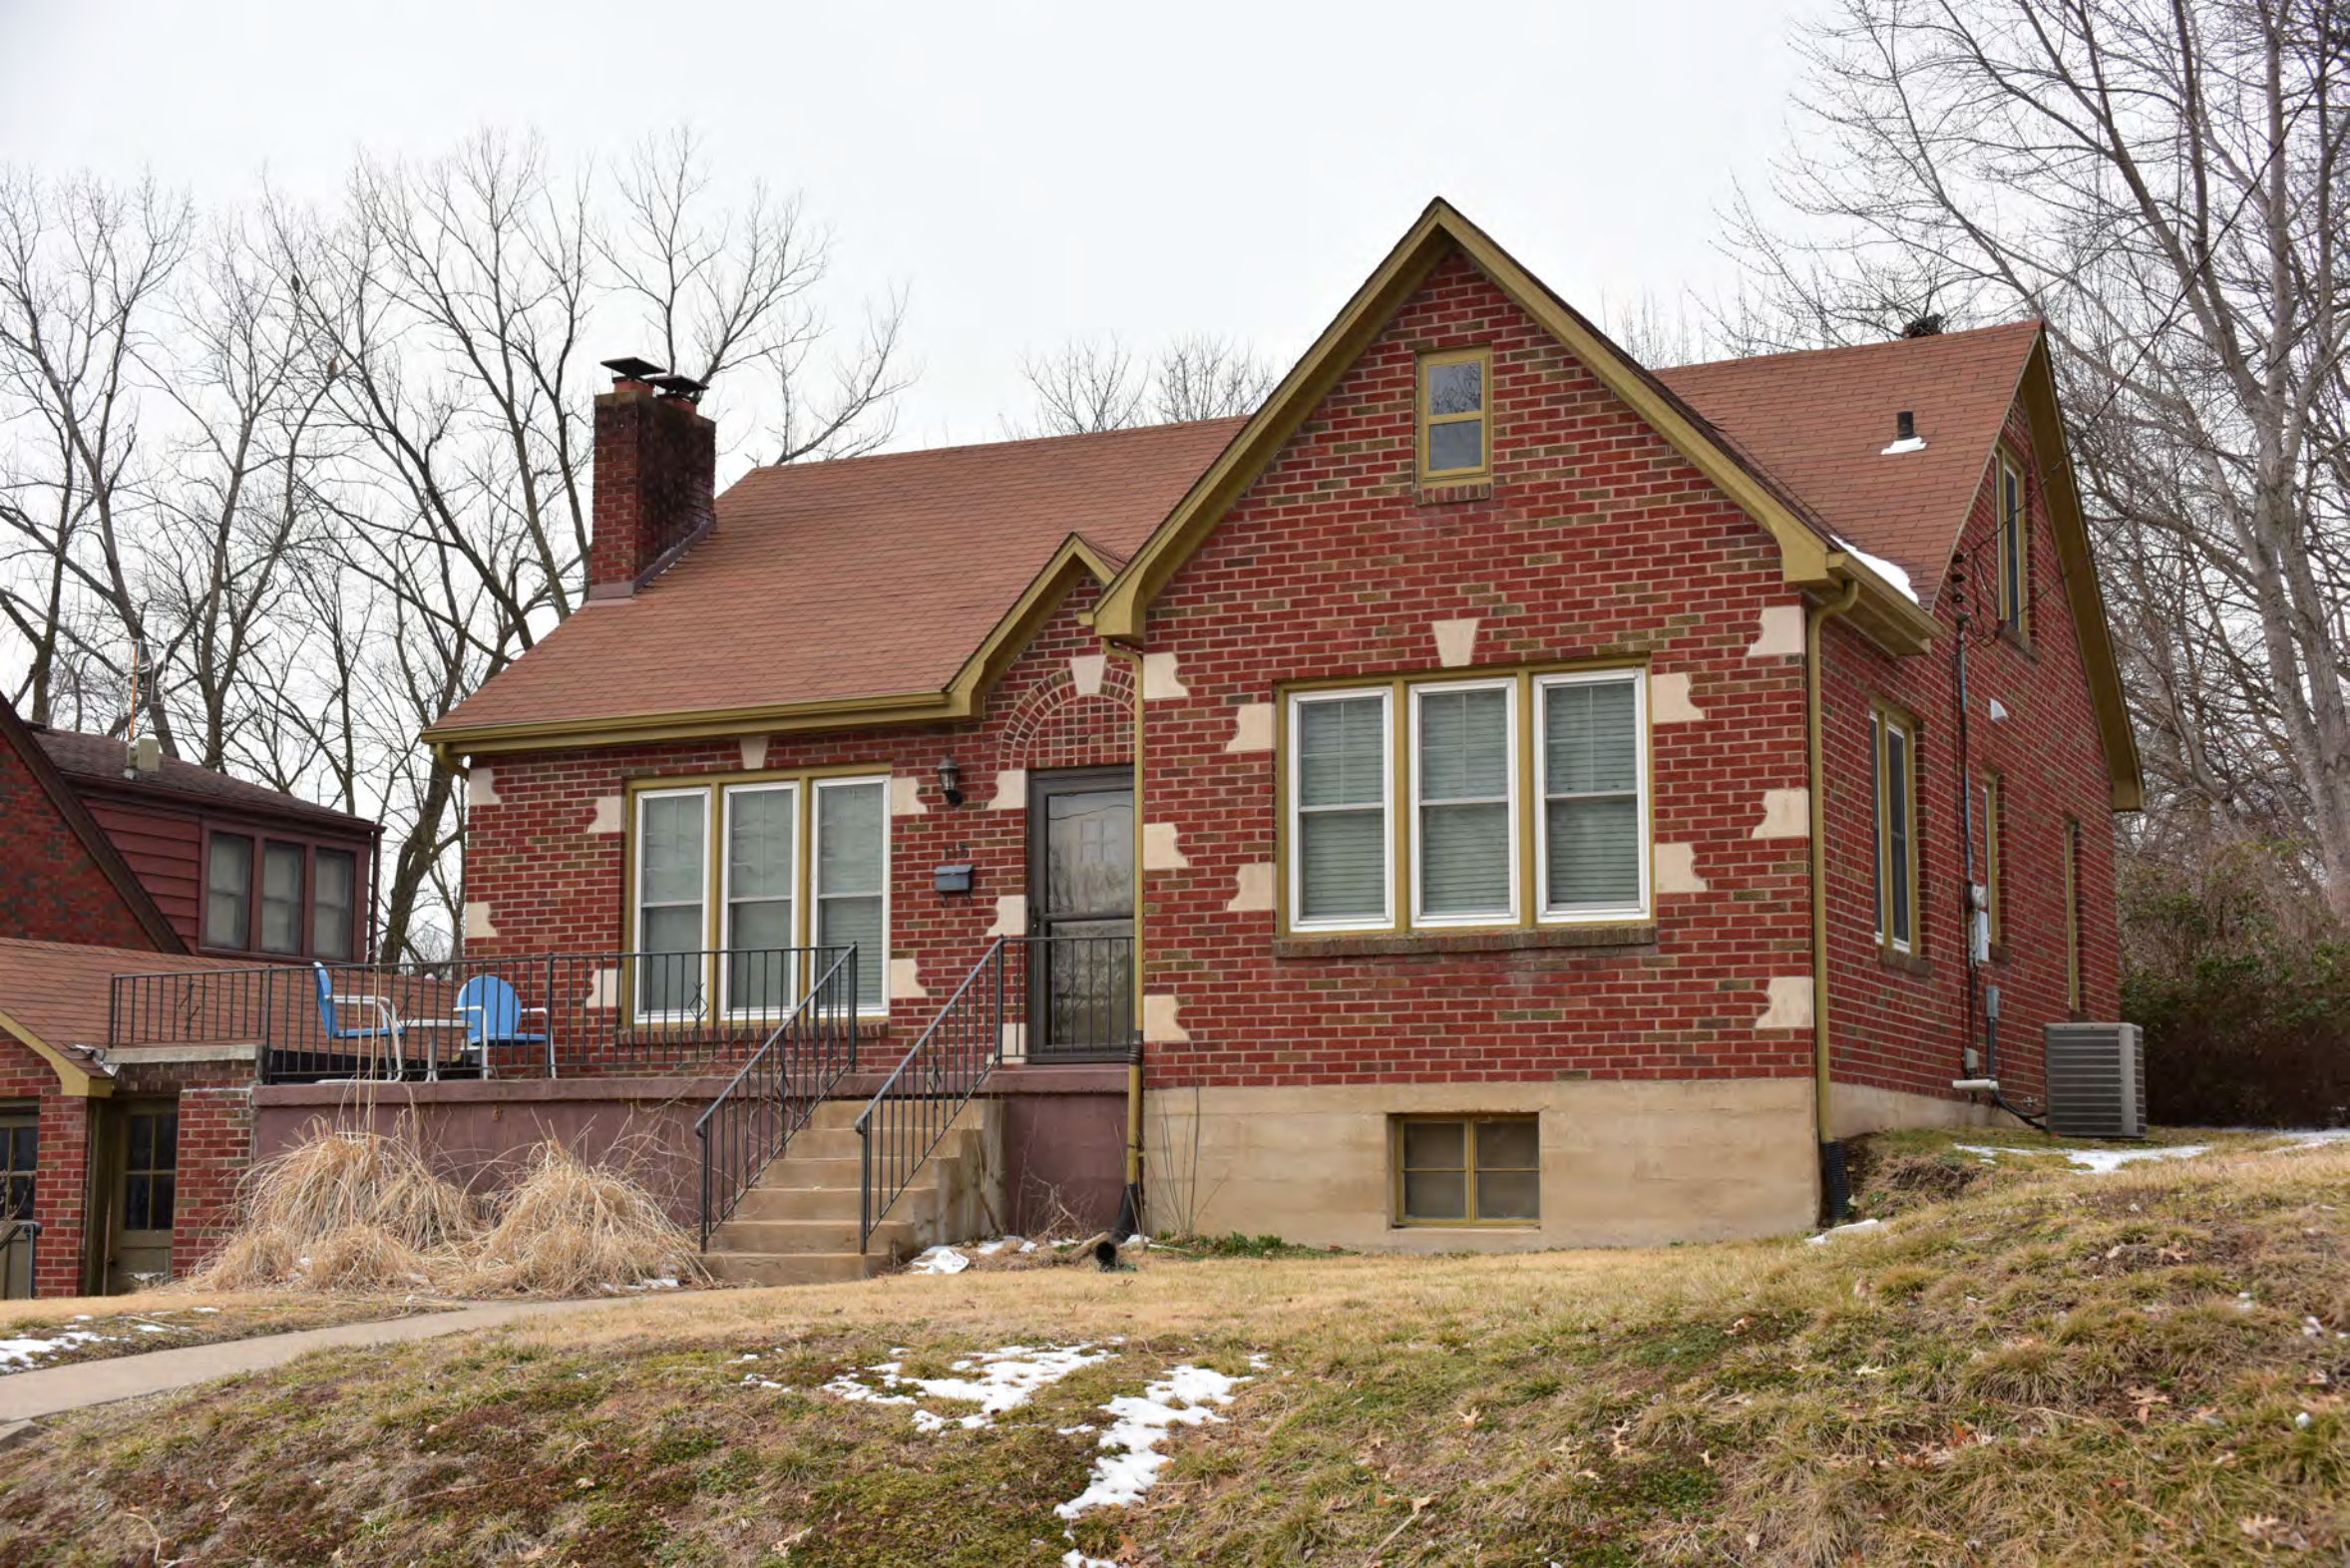
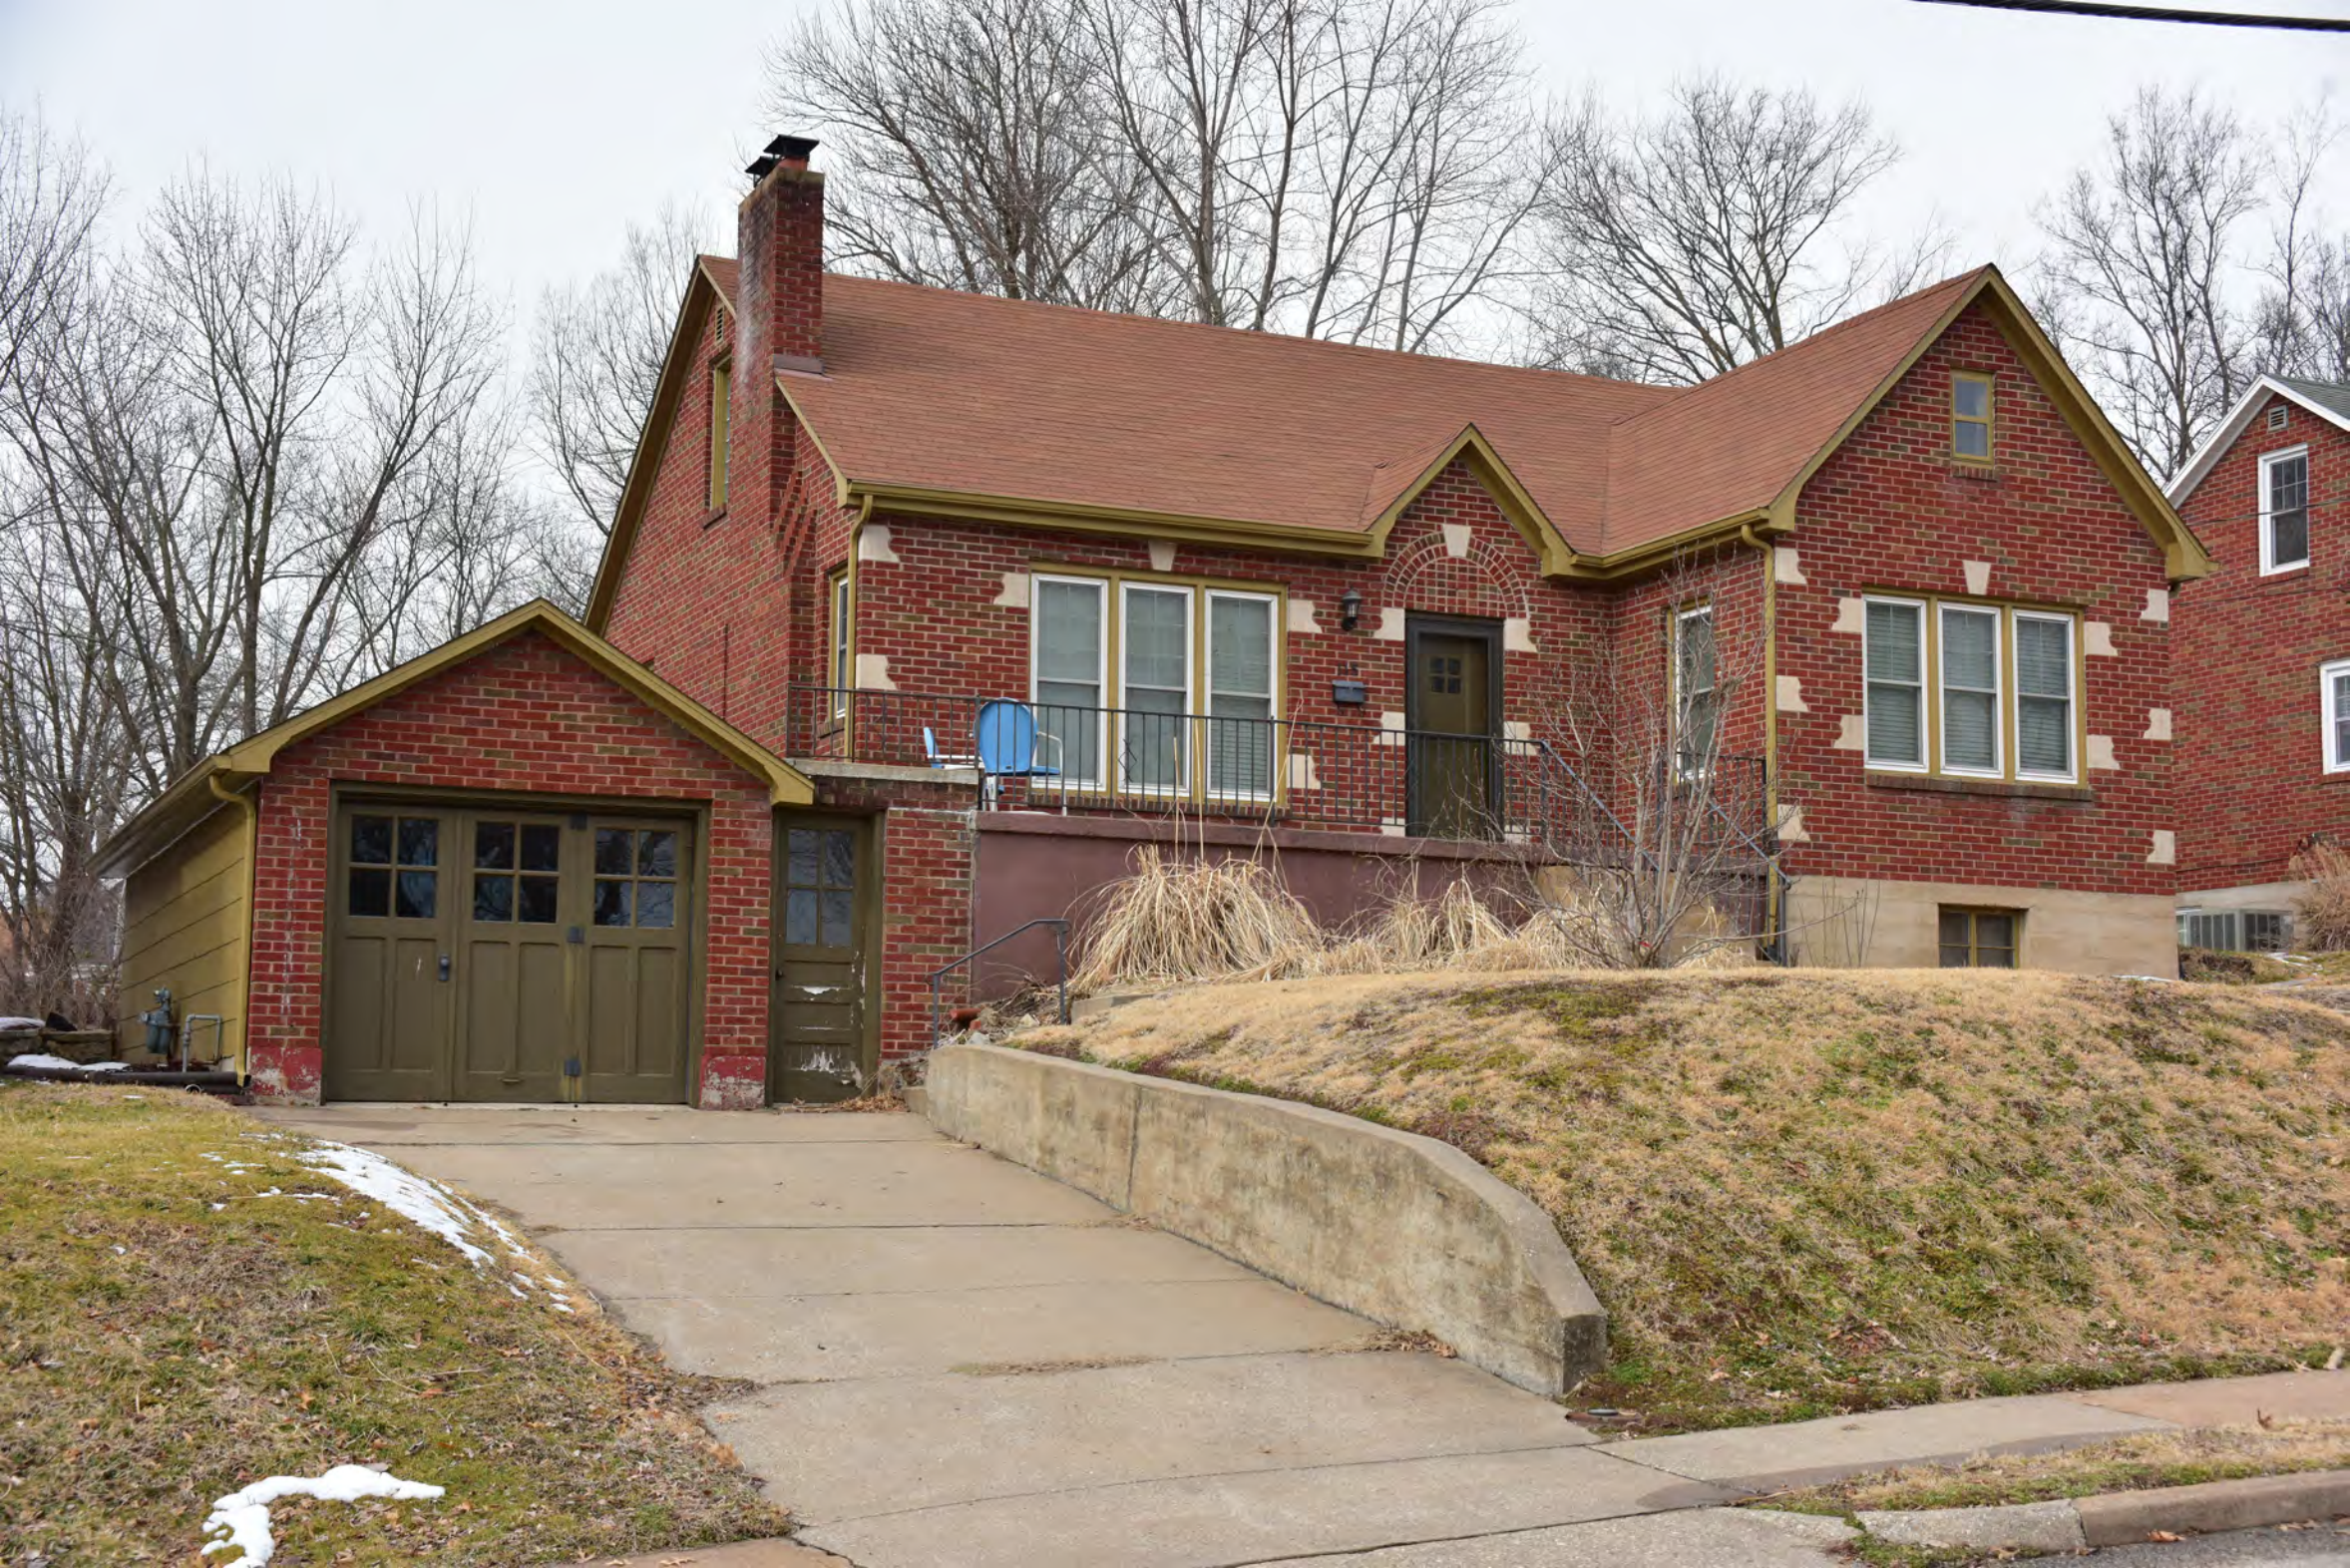
115 West Circle Drive is a one-and-one-half story Minimal Traditional dwelling with a concrete foundation, asphalt side-gable roof, and brick cladding with terra-cotta accents on the primary elevation. A brick exterior chimney pierces the south gable end eave. The dwelling is three bays wide. A low cross-gable wing projects from the north end of the primary elevation and contains the third bay. Three-ganged 6/1 vinyl windows with a continuous header brick sill define the first bay while similar 4/1 windows fill the third bay. A small 1/1 window is centered above the third bay in the north wing gable-end. The center bay contains the primary entrance which features a historic wood door with four-light glazing. Decorative brick and terra-cotta voussoirs surround the arched opening. A small gabled wall dormer is located directly above the entrance. A concrete platform porch extends below the south-two bays. A metal scrolled railing lines the east perimeter. The porch abuts an attached brick garage. The metal railing extends to top the flat roof above the pedestrian entrance which contains a historic wood door with four-light glazing. The roof is gabled above the vehicular bay which contains a historic three-part hinged wooden door with four-light glazing in each part. Asbestos shingle clads the south elevation.

Alterations to 115 West Circle Drive include the replacement of historic windows. While the windows are replacements, they fill historic openings. 115 West Circle Drive otherwise retains good integrity. This resource would be contributing to the potential Walinko Place Historic District, significant in the areas of Architecture and Community Planning and Development in association with the expansion of Jefferson City and increased suburban development during the twentieth century as well as its associations with Walinko Place, a notable suburban development during the Depression and War Years.
