1. Survey number: CO-AS-008-001		2. Survey Name: West Main Street Survey	
3. County: Cole		4. Address (Street No.): 100	Street (name): East Circle Drive
5. City: Jefferson City	Vicinity <input type="checkbox"/>	6. Lat / Long:	7. Township/Range/Section: T: R: S:
8. Historic name (if known):		9. Present/other name (if known):	
10. Ownership: <input checked="" type="checkbox"/> Private <input type="checkbox"/> Public		11a. Historic use (if known): Domestic-Single Dwelling	11b. Current use: Domestic-Single Dwelling

MISSOURI DEPARTMENT OF NATURAL RESOURCES
STATE HISTORIC PRESERVATION OFFICE, P.O. Box 178, Jefferson City, MO 65102
ARCHITECTURAL/HISTORIC INVENTORY FORM

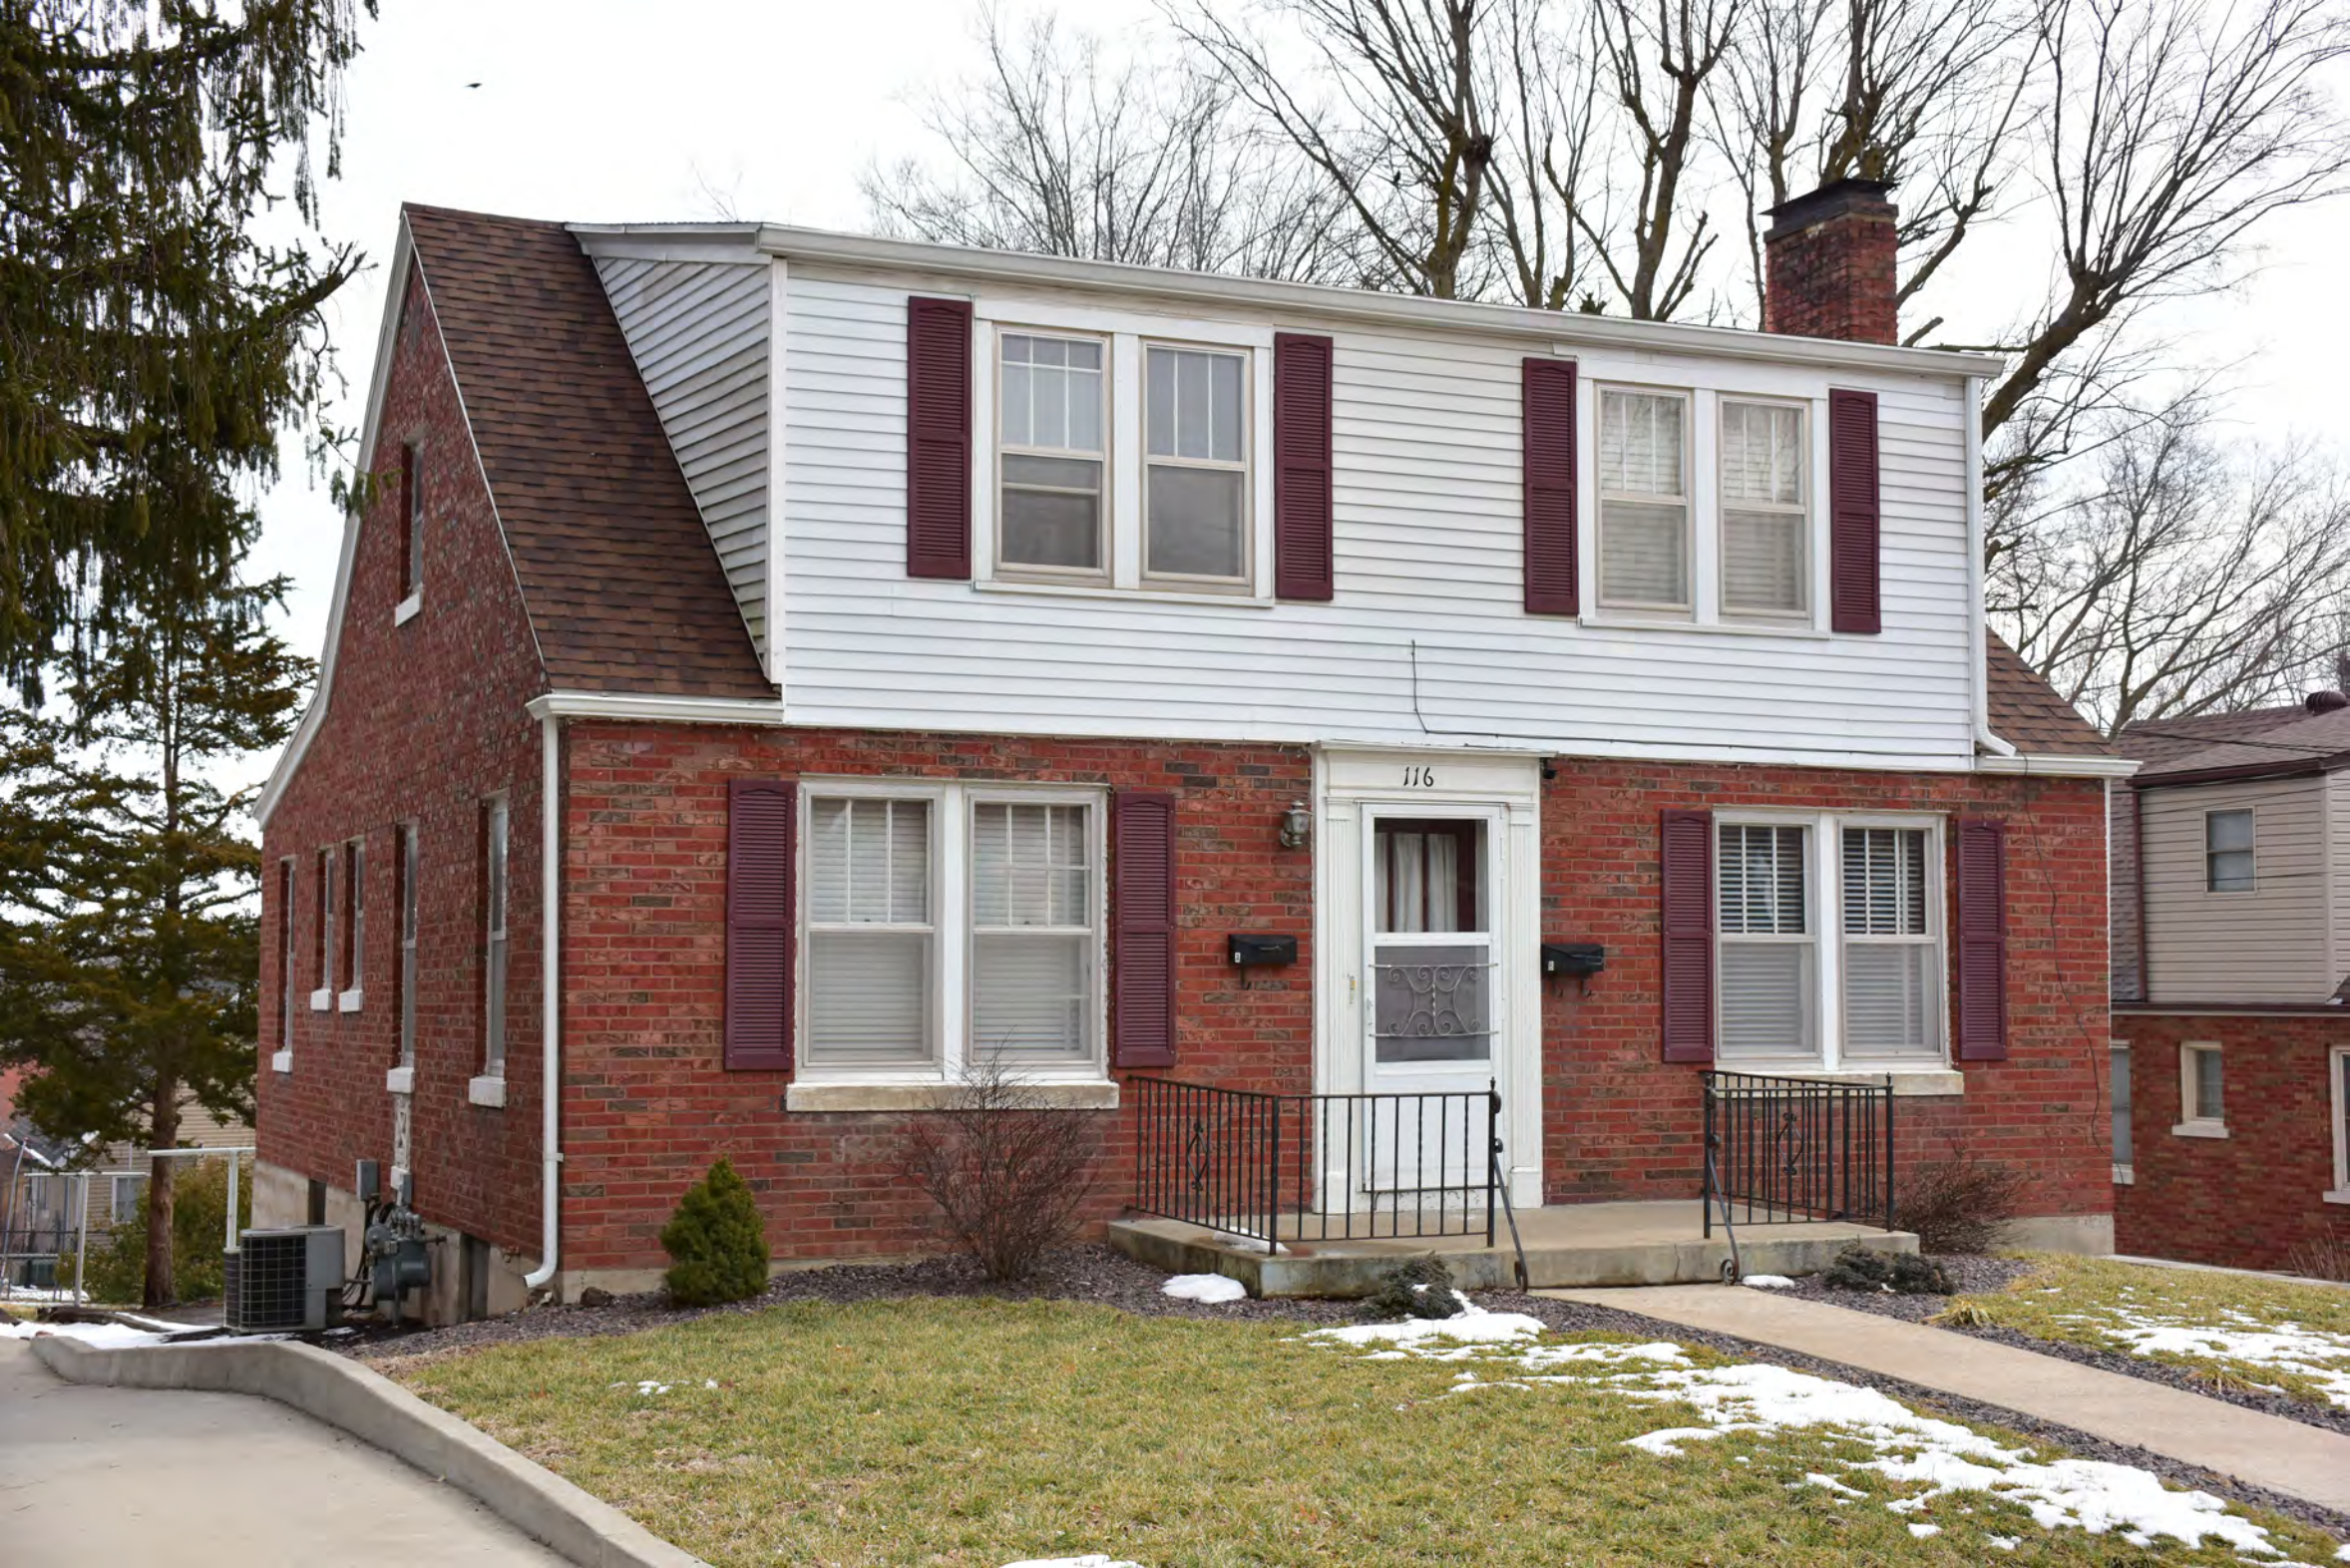
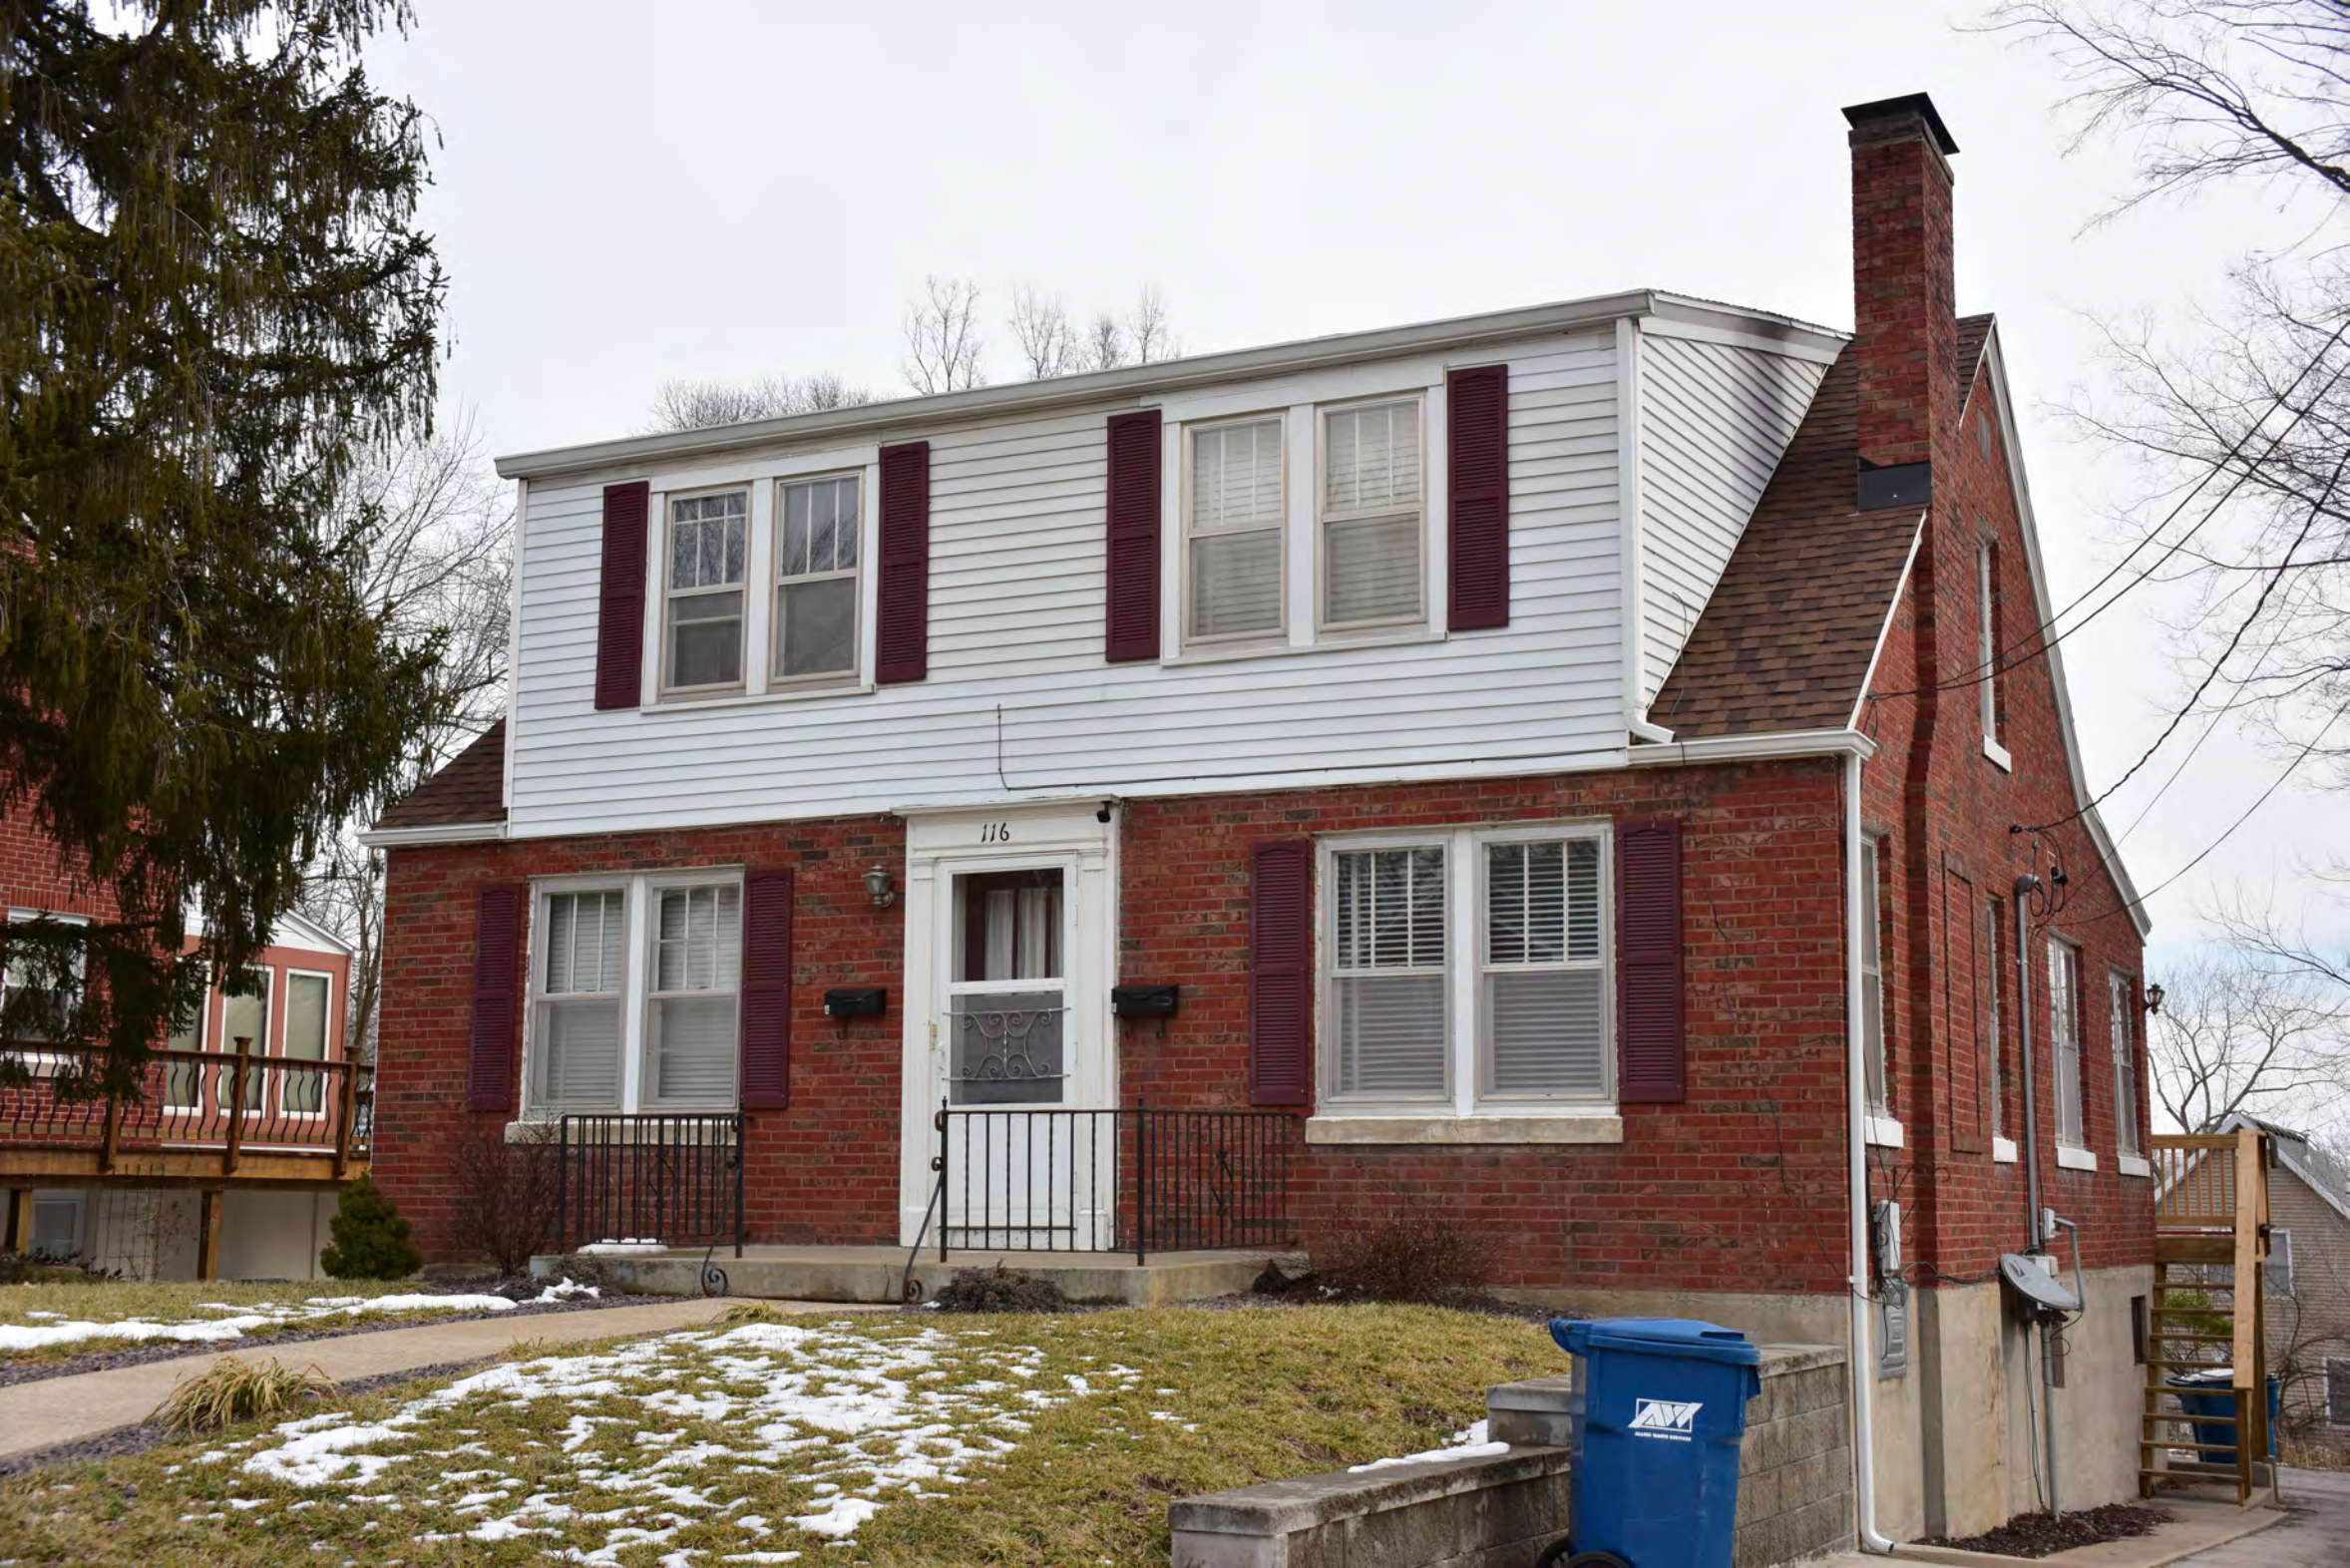
116 West Circle Drive is a one-and-one-half-story Minimal Traditional dwelling with Colonial Revival influences. The brick-clad dwelling has a concrete foundation and an asphalt side-gable roof. The rear slope extends to form a one-story shed-roof which spans the rear elevation. A brick exterior chimney pierces the south gable end eave. The dwelling is three bays wide. Two-ganged historic 3/1 wood windows with cast stone sills flank a center entrance bay. The entrance features a simplified neo-classical surround with pilasters and entablature. A historic wood door with three-light glazing with vertical muntins fills the bay. A concrete stoop extends from the entrance. Scrolled metal railings line the stoop perimeter. A vinyl-clad shed-roof dormer spans much of the front roof slope and is two-bays wide. Two-ganged historic 3/1 wood windows fill the bays. Aerial images indicate an additional vinyl-shed roof dormer is centered on the rear slope, however it is not visible. An integrated garage is located at basement level and accessed at the rear.

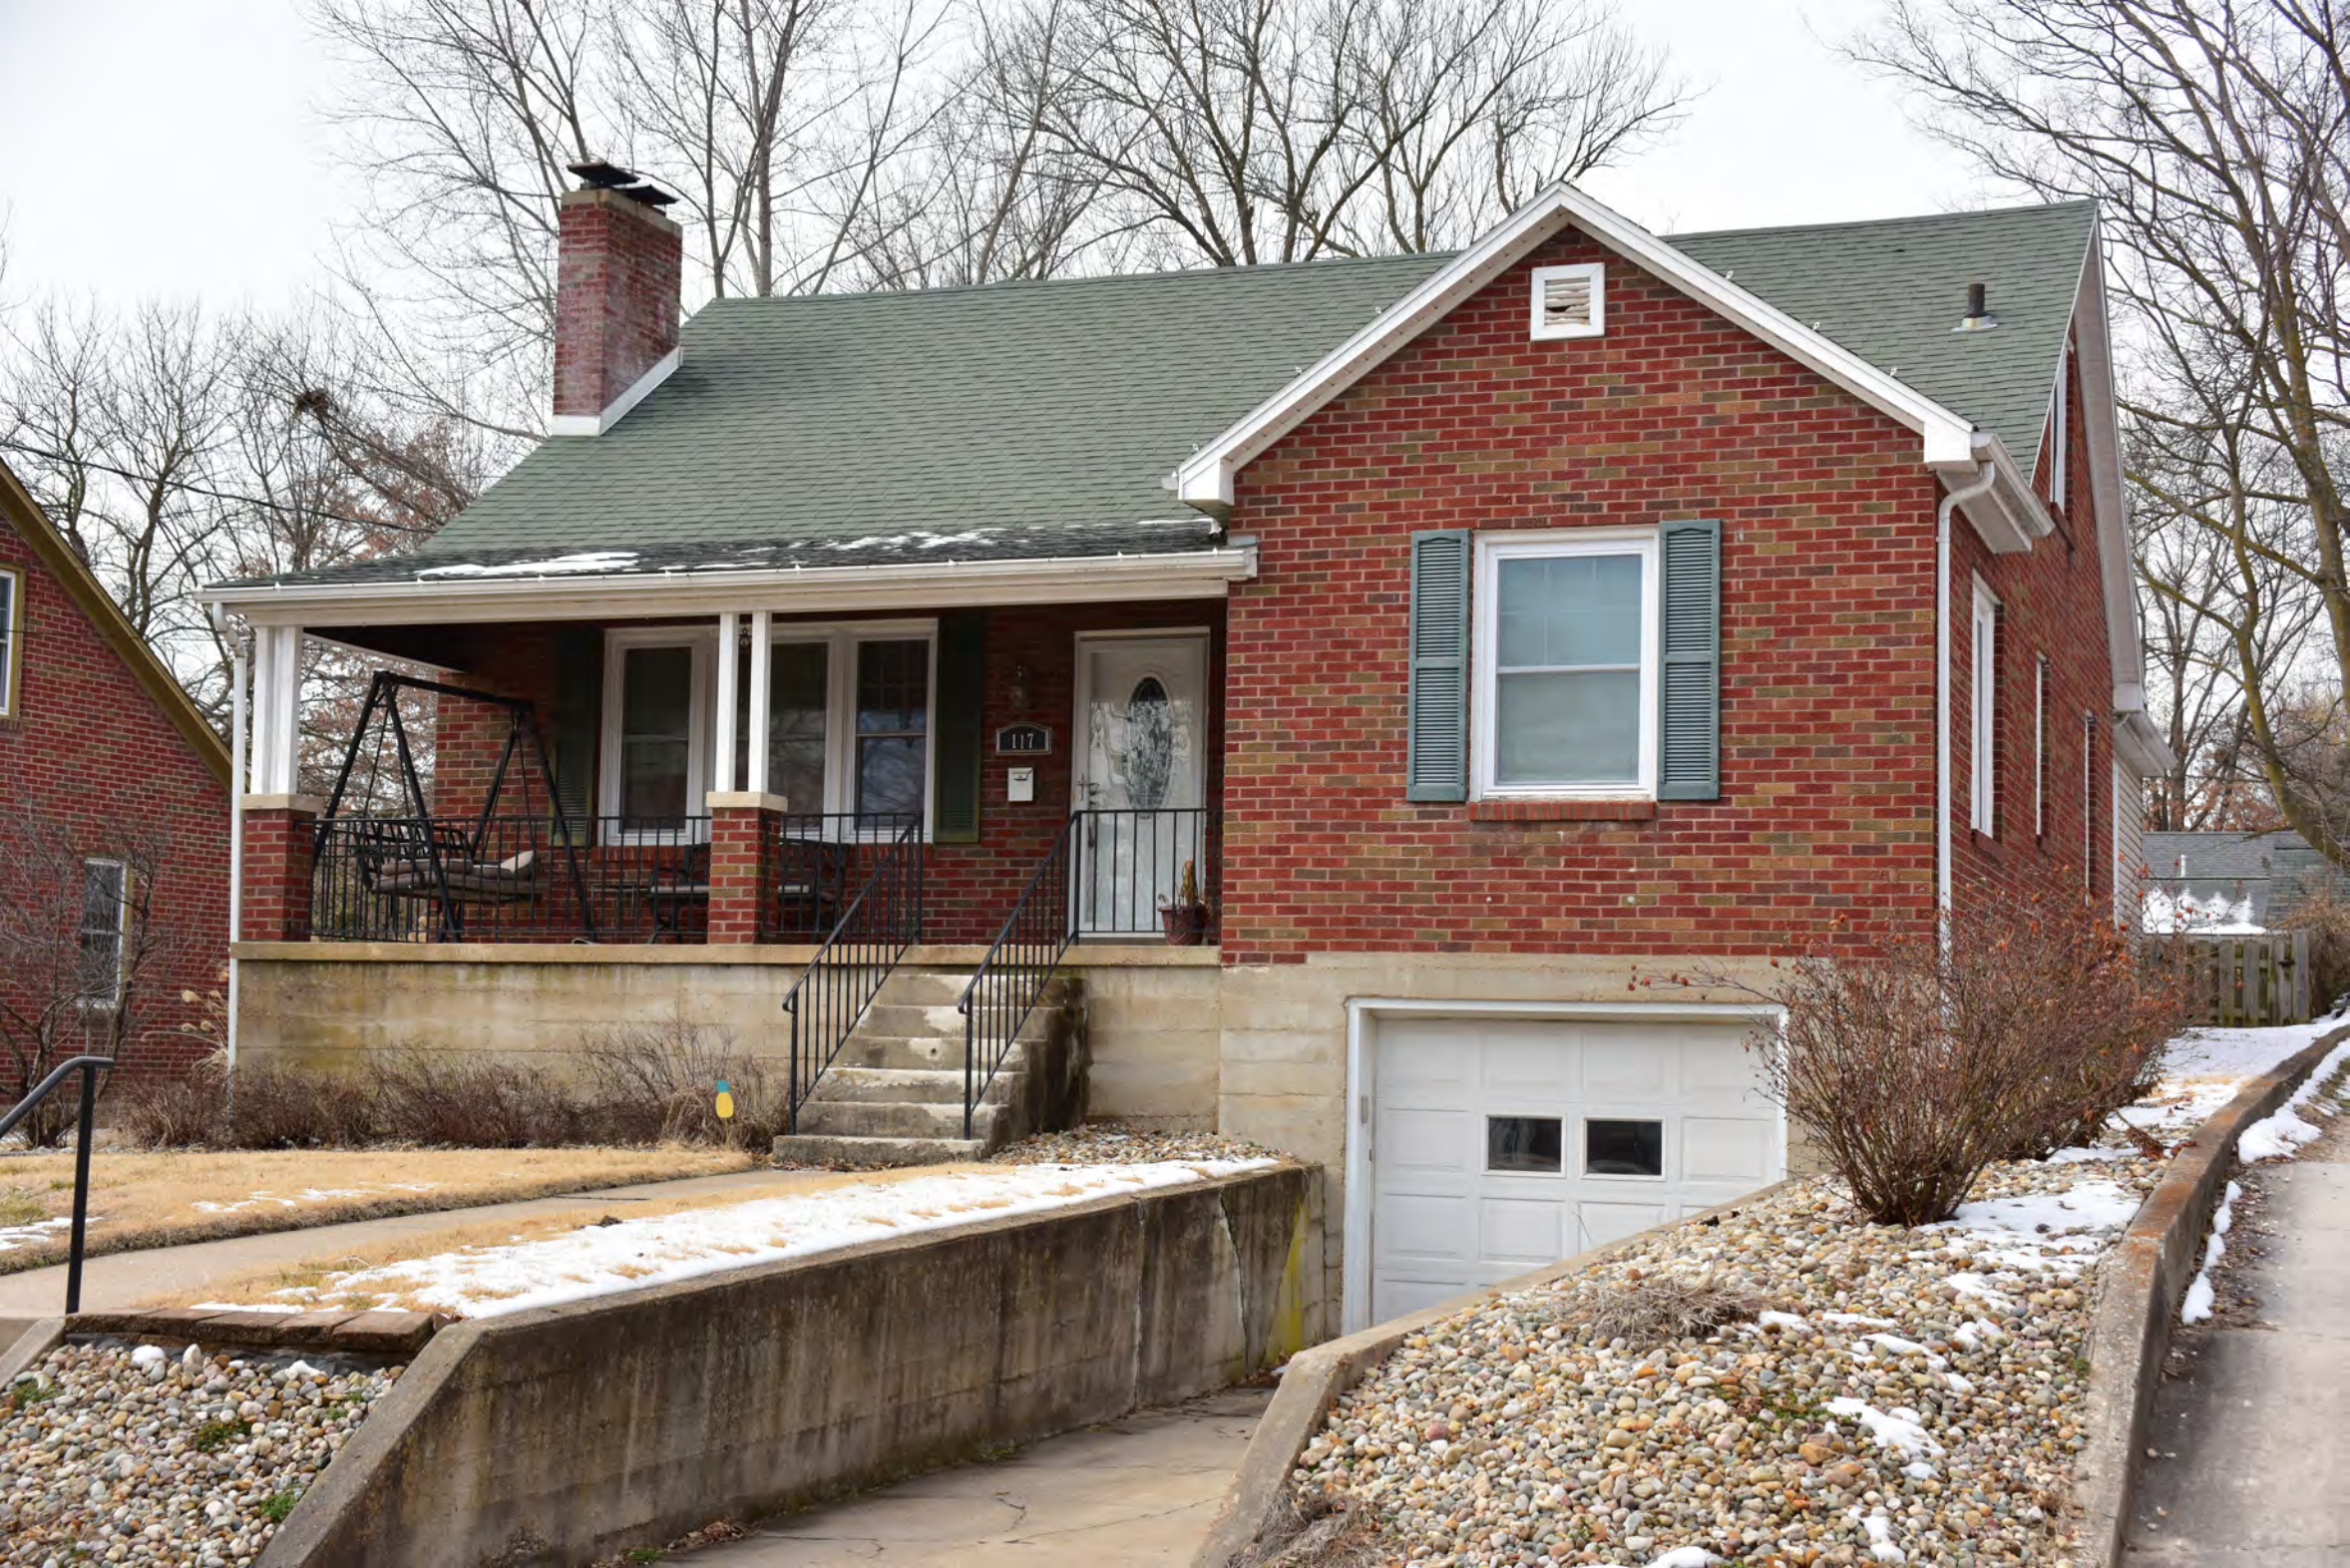
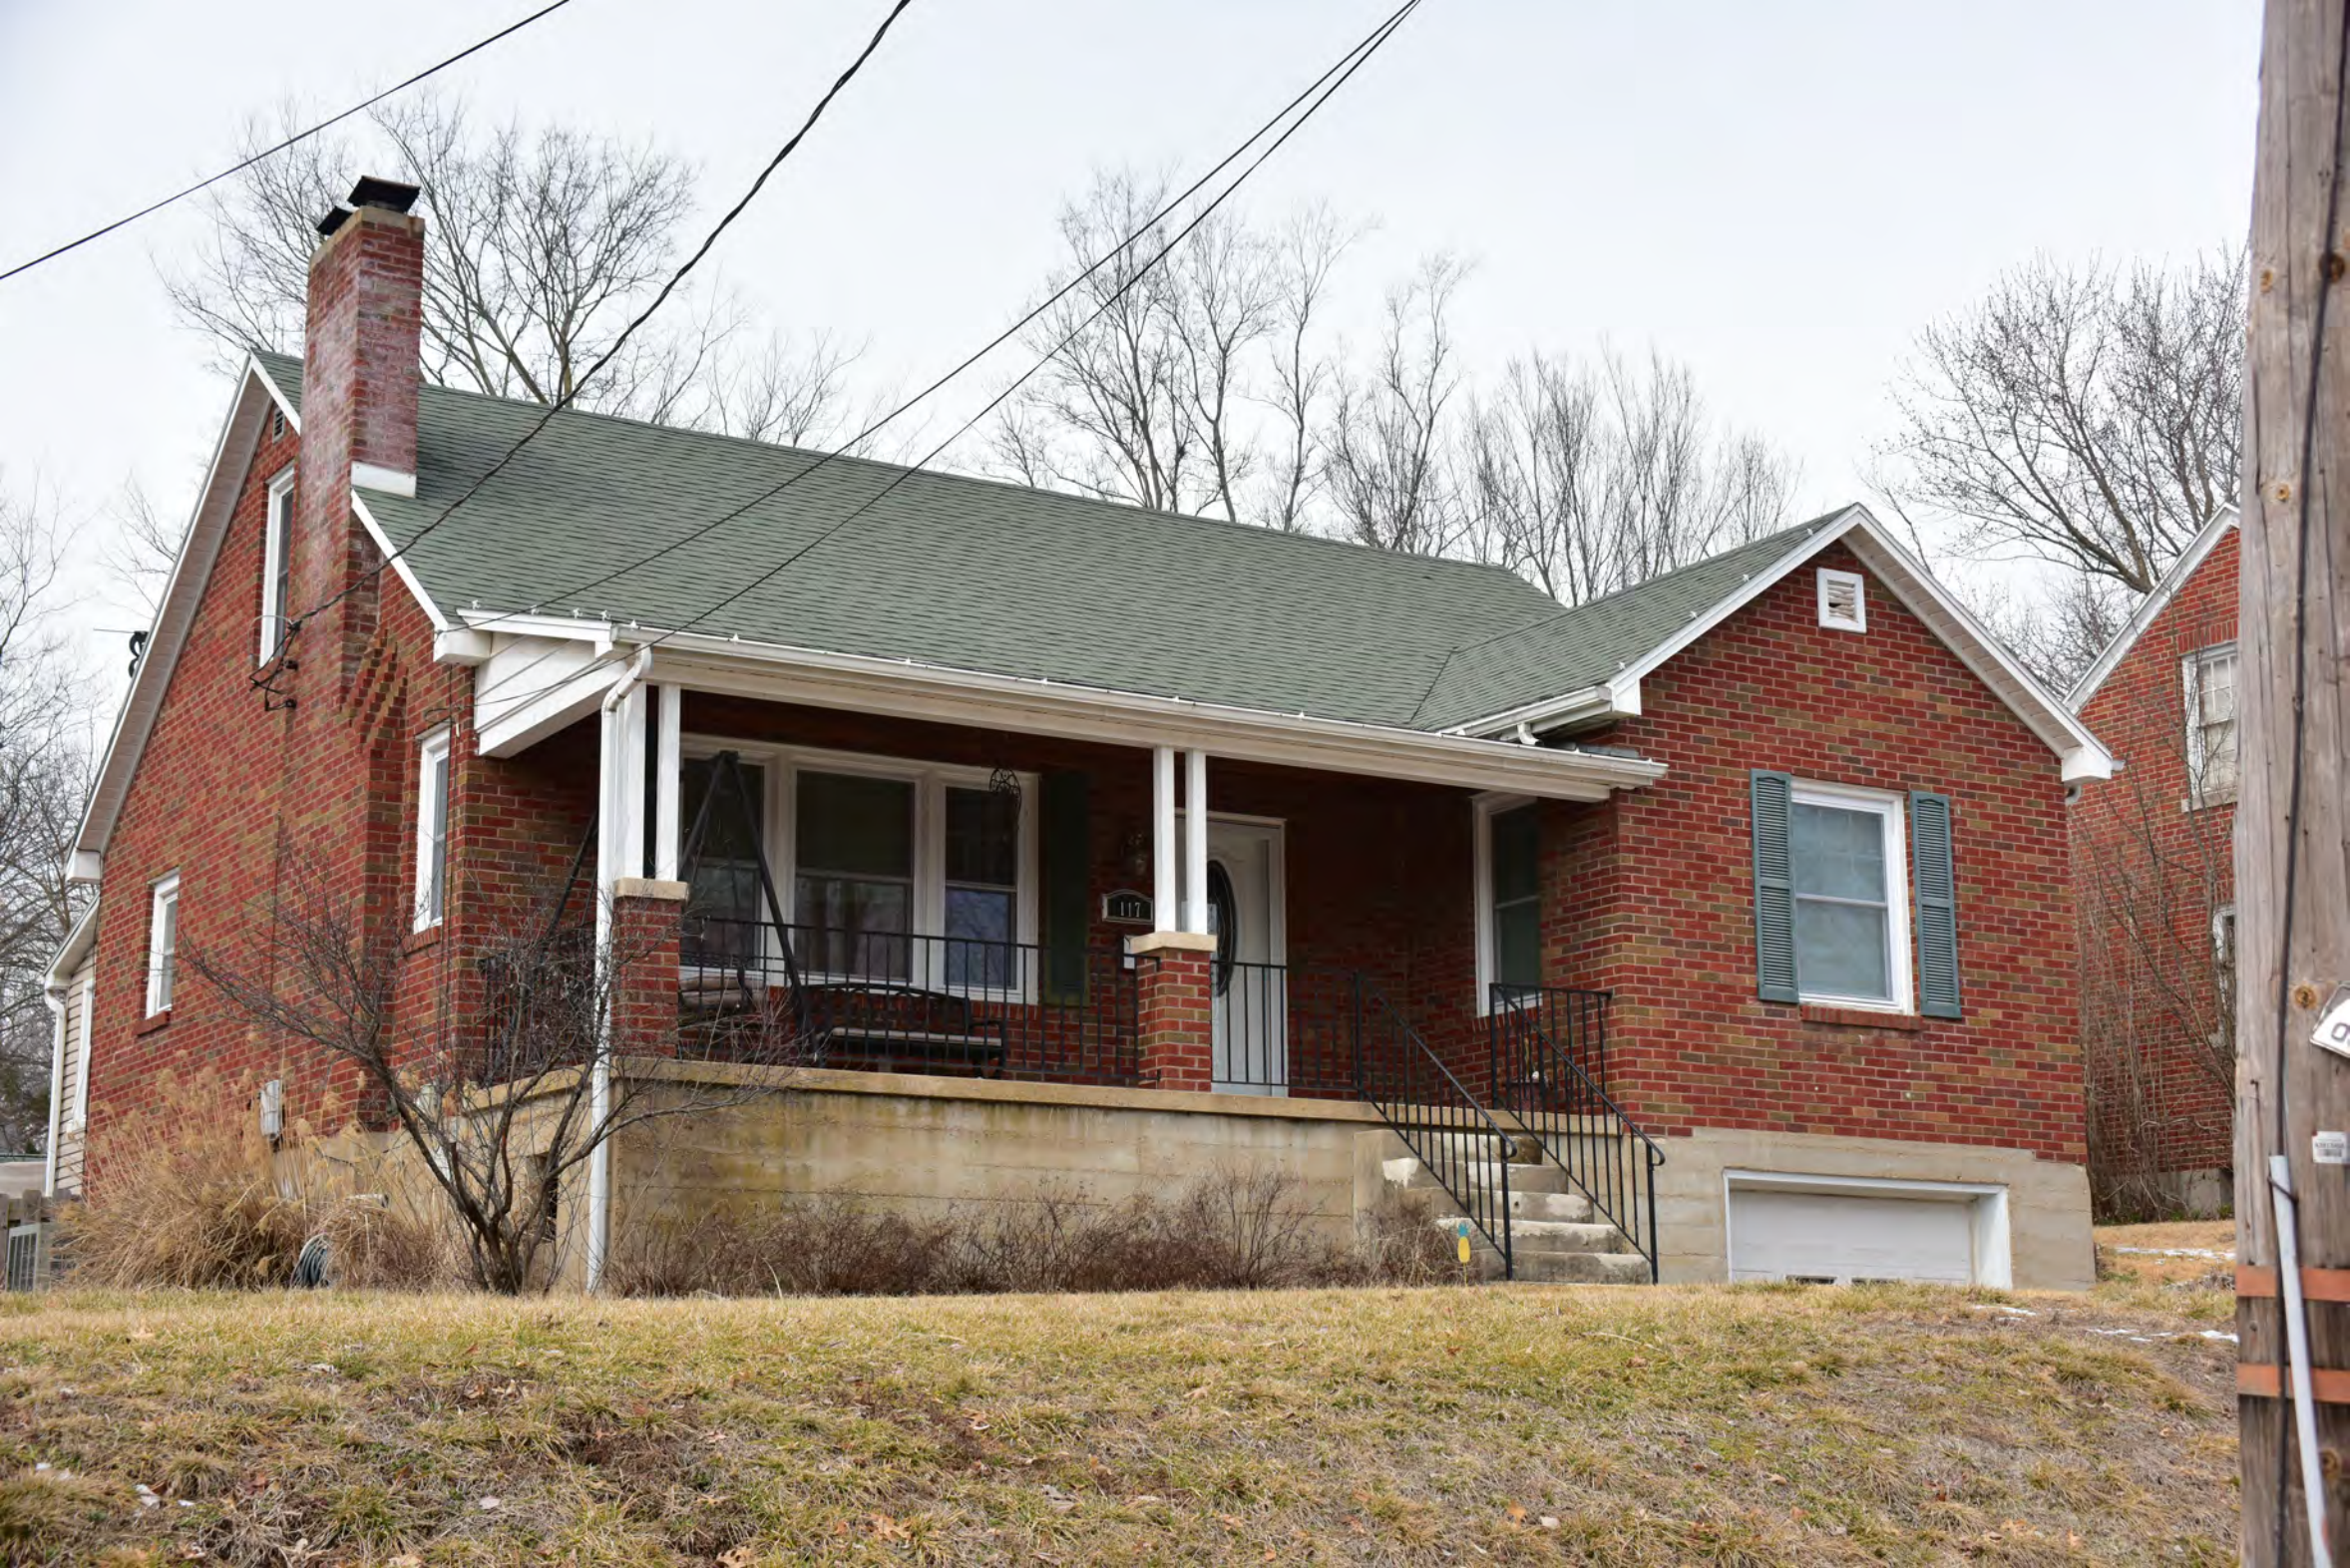
117 West Circle Drive is a one-story Transitional Ranch dwelling. The dwelling has red brick cladding, a concrete foundation, and an asphalt intersecting-gable roof. A brick exterior chimney pierces the south gable eave. The dwelling is three bays wide. A tripartite window fills the first bay. Vinyl 6/1 windows flank an 8/1 central pane. The primary entrance defines the center bay. A non-historic door fills the opening. A gabled-ell projects at the north end of the primary elevation and contains the third bay. A 6/1 vinyl window defines the bay. A square vent centered in the gable apex. An integrated single-car garage is located in the ell at basement level. A non-historic overhead door with glazing fills the vehicular bay. A concrete partial-width open porch extends below the south-two bays. Paired squared wood posts on brick piers support the porch roof and a historic simple metal railing lines the porch perimeter. Concrete stairs access the porch at the north end and feature a matching railing. A vinyl-clad gabled-ell extends from the northwest corner of the dwelling. A shed-roof vinyl-clad enclosed porch spans the rear elevation and abuts the ell.

Alterations to 117 West Circle Drive include the application of vinyl cladding to the rear porch and rear gabled-ell and the replacement of historic windows with vinyl windows. Although they are replacements, the windows fill historic openings. The rear porch and gable are minimally visible. 117 West Circle Drive retains good integrity. This resource would be contributing to the potential Walinko Place Historic District, significant in the areas of Architecture and Community Planning and Development in association with the expansion of Jefferson City and increased suburban development during the twentieth century as well as its associations with Walinko Place, a notable suburban development during the Depression and War Years.
