1. Survey number: CO-AS-008-001		2. Survey Name: West Main Street Survey	
3. County: Cole		4. Address (Street No.): 100	Street (name): East Circle Drive
5. City: Jefferson City	Vicinity <input type="checkbox"/>	6. Lat / Long:	7. Township/Range/Section: T: R: S:
8. Historic name (if known):		9. Present/other name (if known):	
10. Ownership: <input checked="" type="checkbox"/> Private <input type="checkbox"/> Public		11a. Historic use (if known): Domestic-Single Dwelling	11b. Current use: Domestic-Single Dwelling

MISSOURI DEPARTMENT OF NATURAL RESOURCES
STATE HISTORIC PRESERVATION OFFICE, P.O. Box 178, Jefferson City, MO 65102
ARCHITECTURAL/HISTORIC INVENTORY FORM

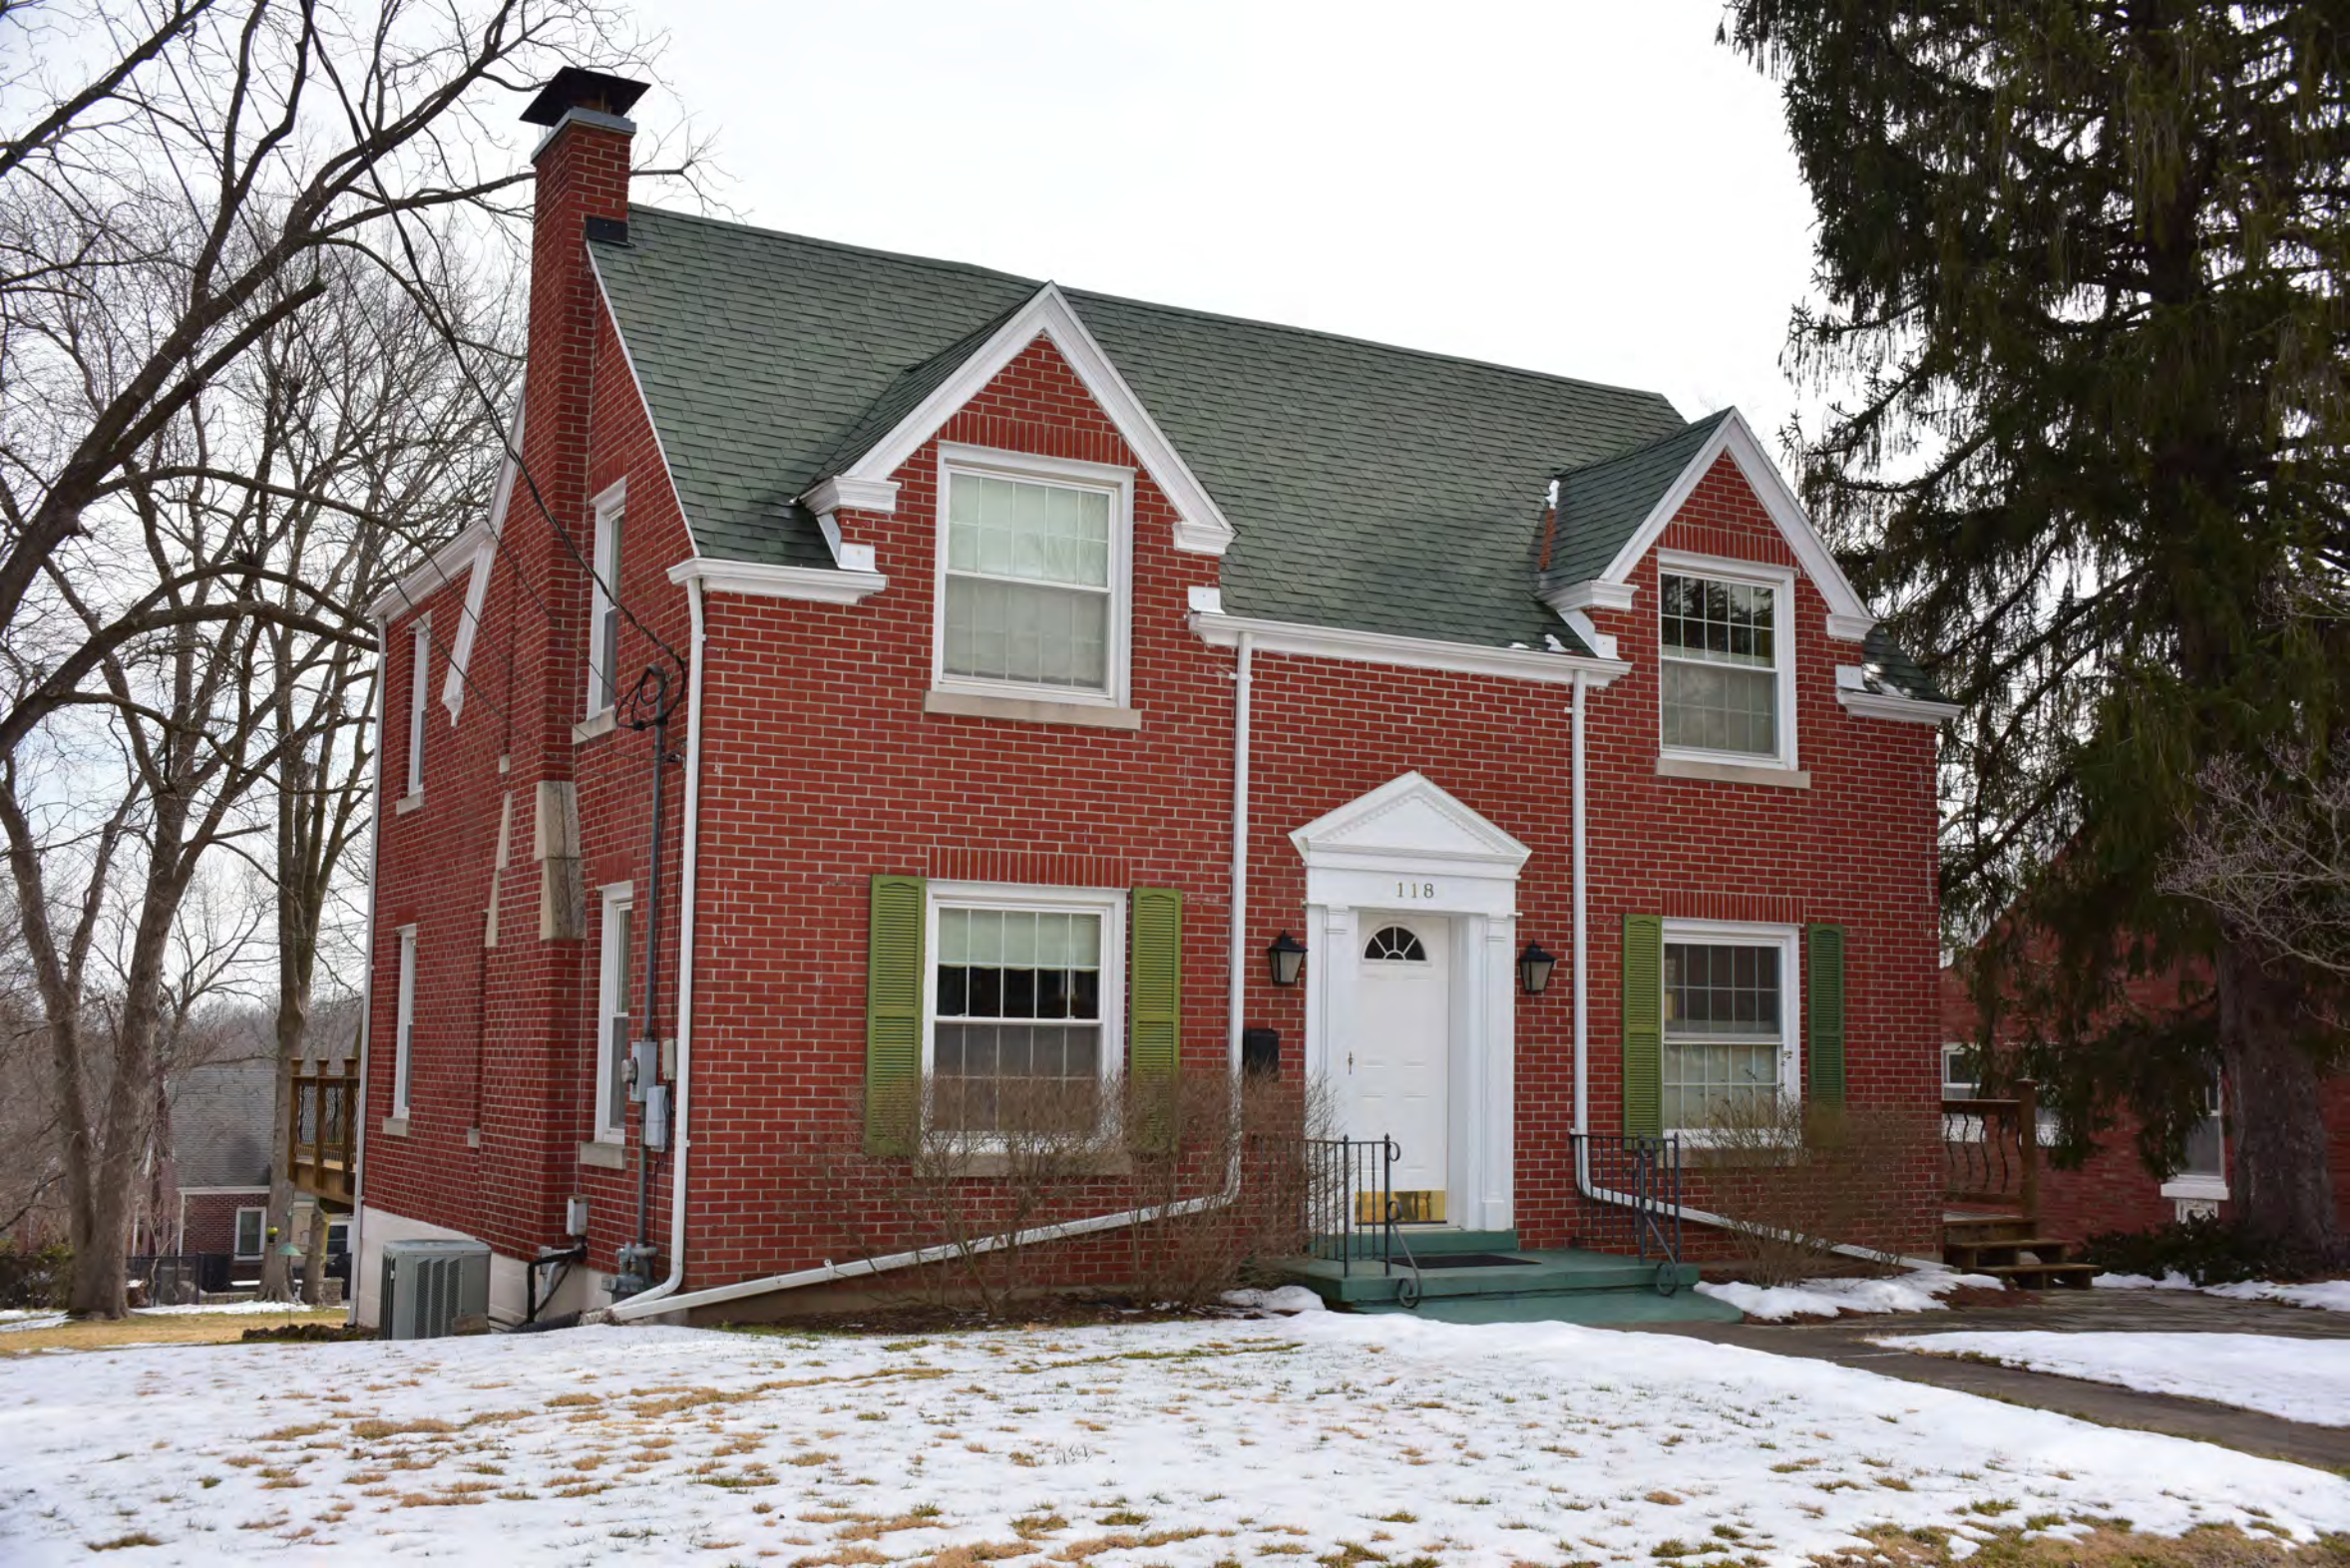
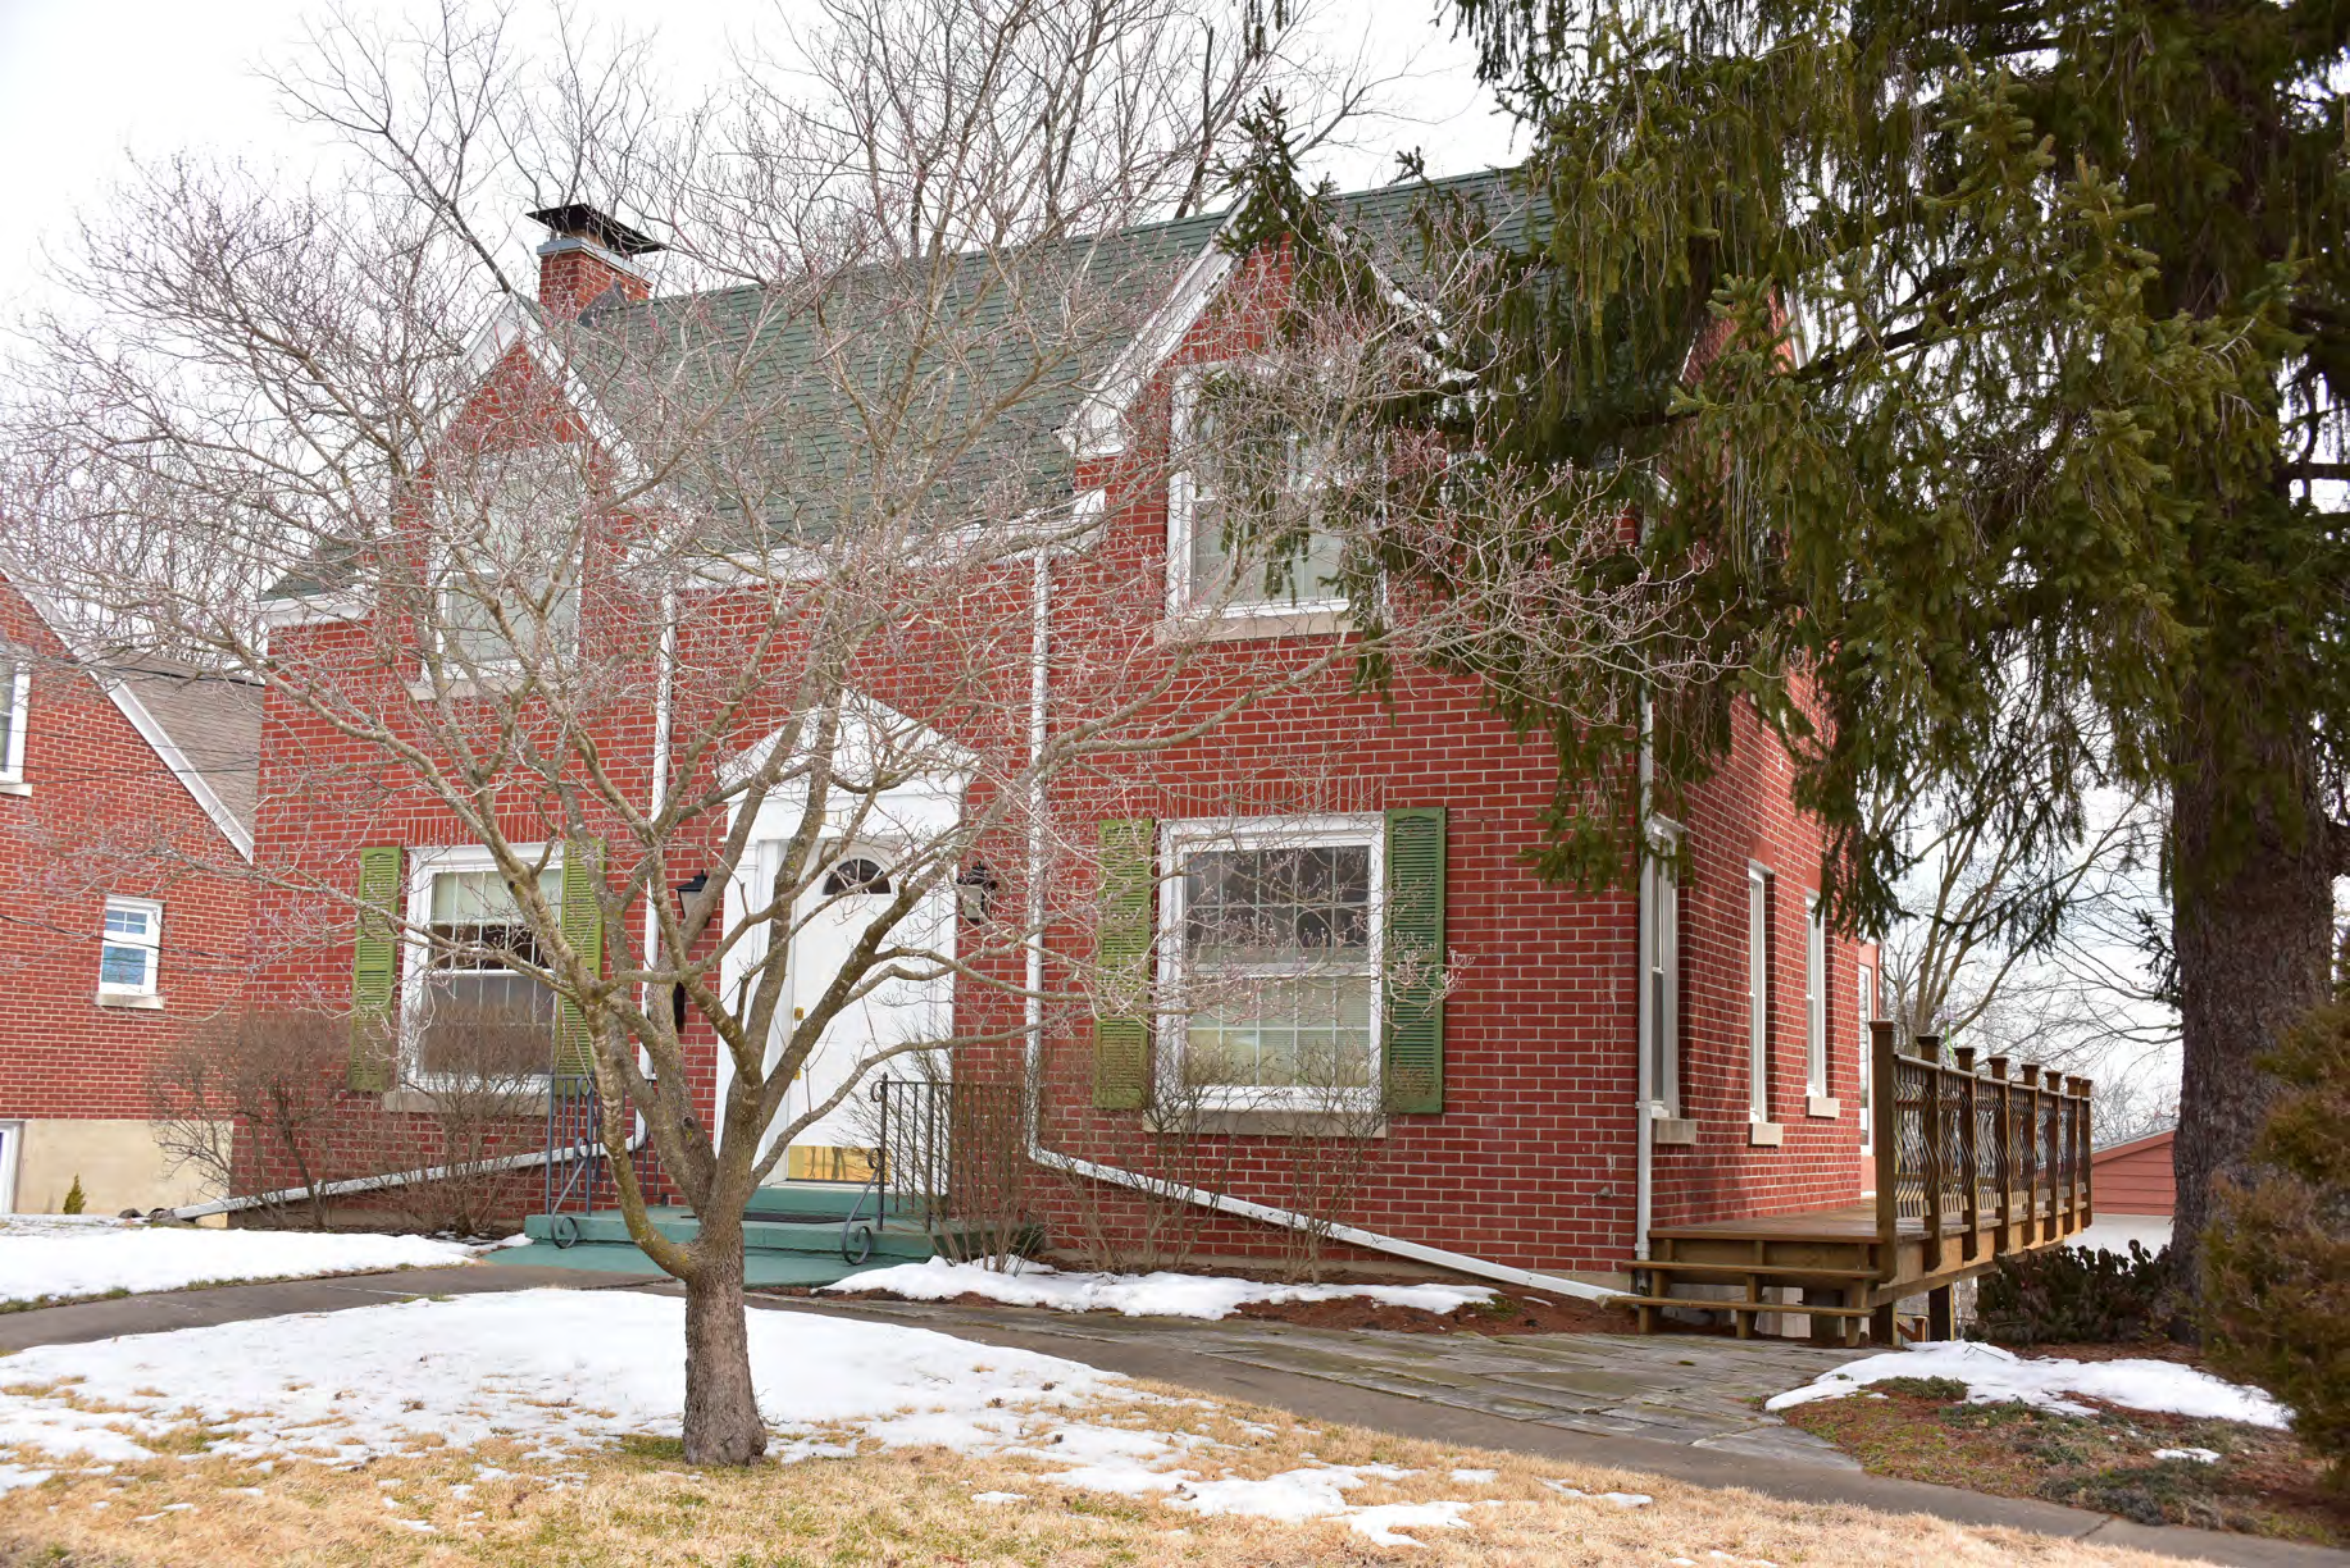
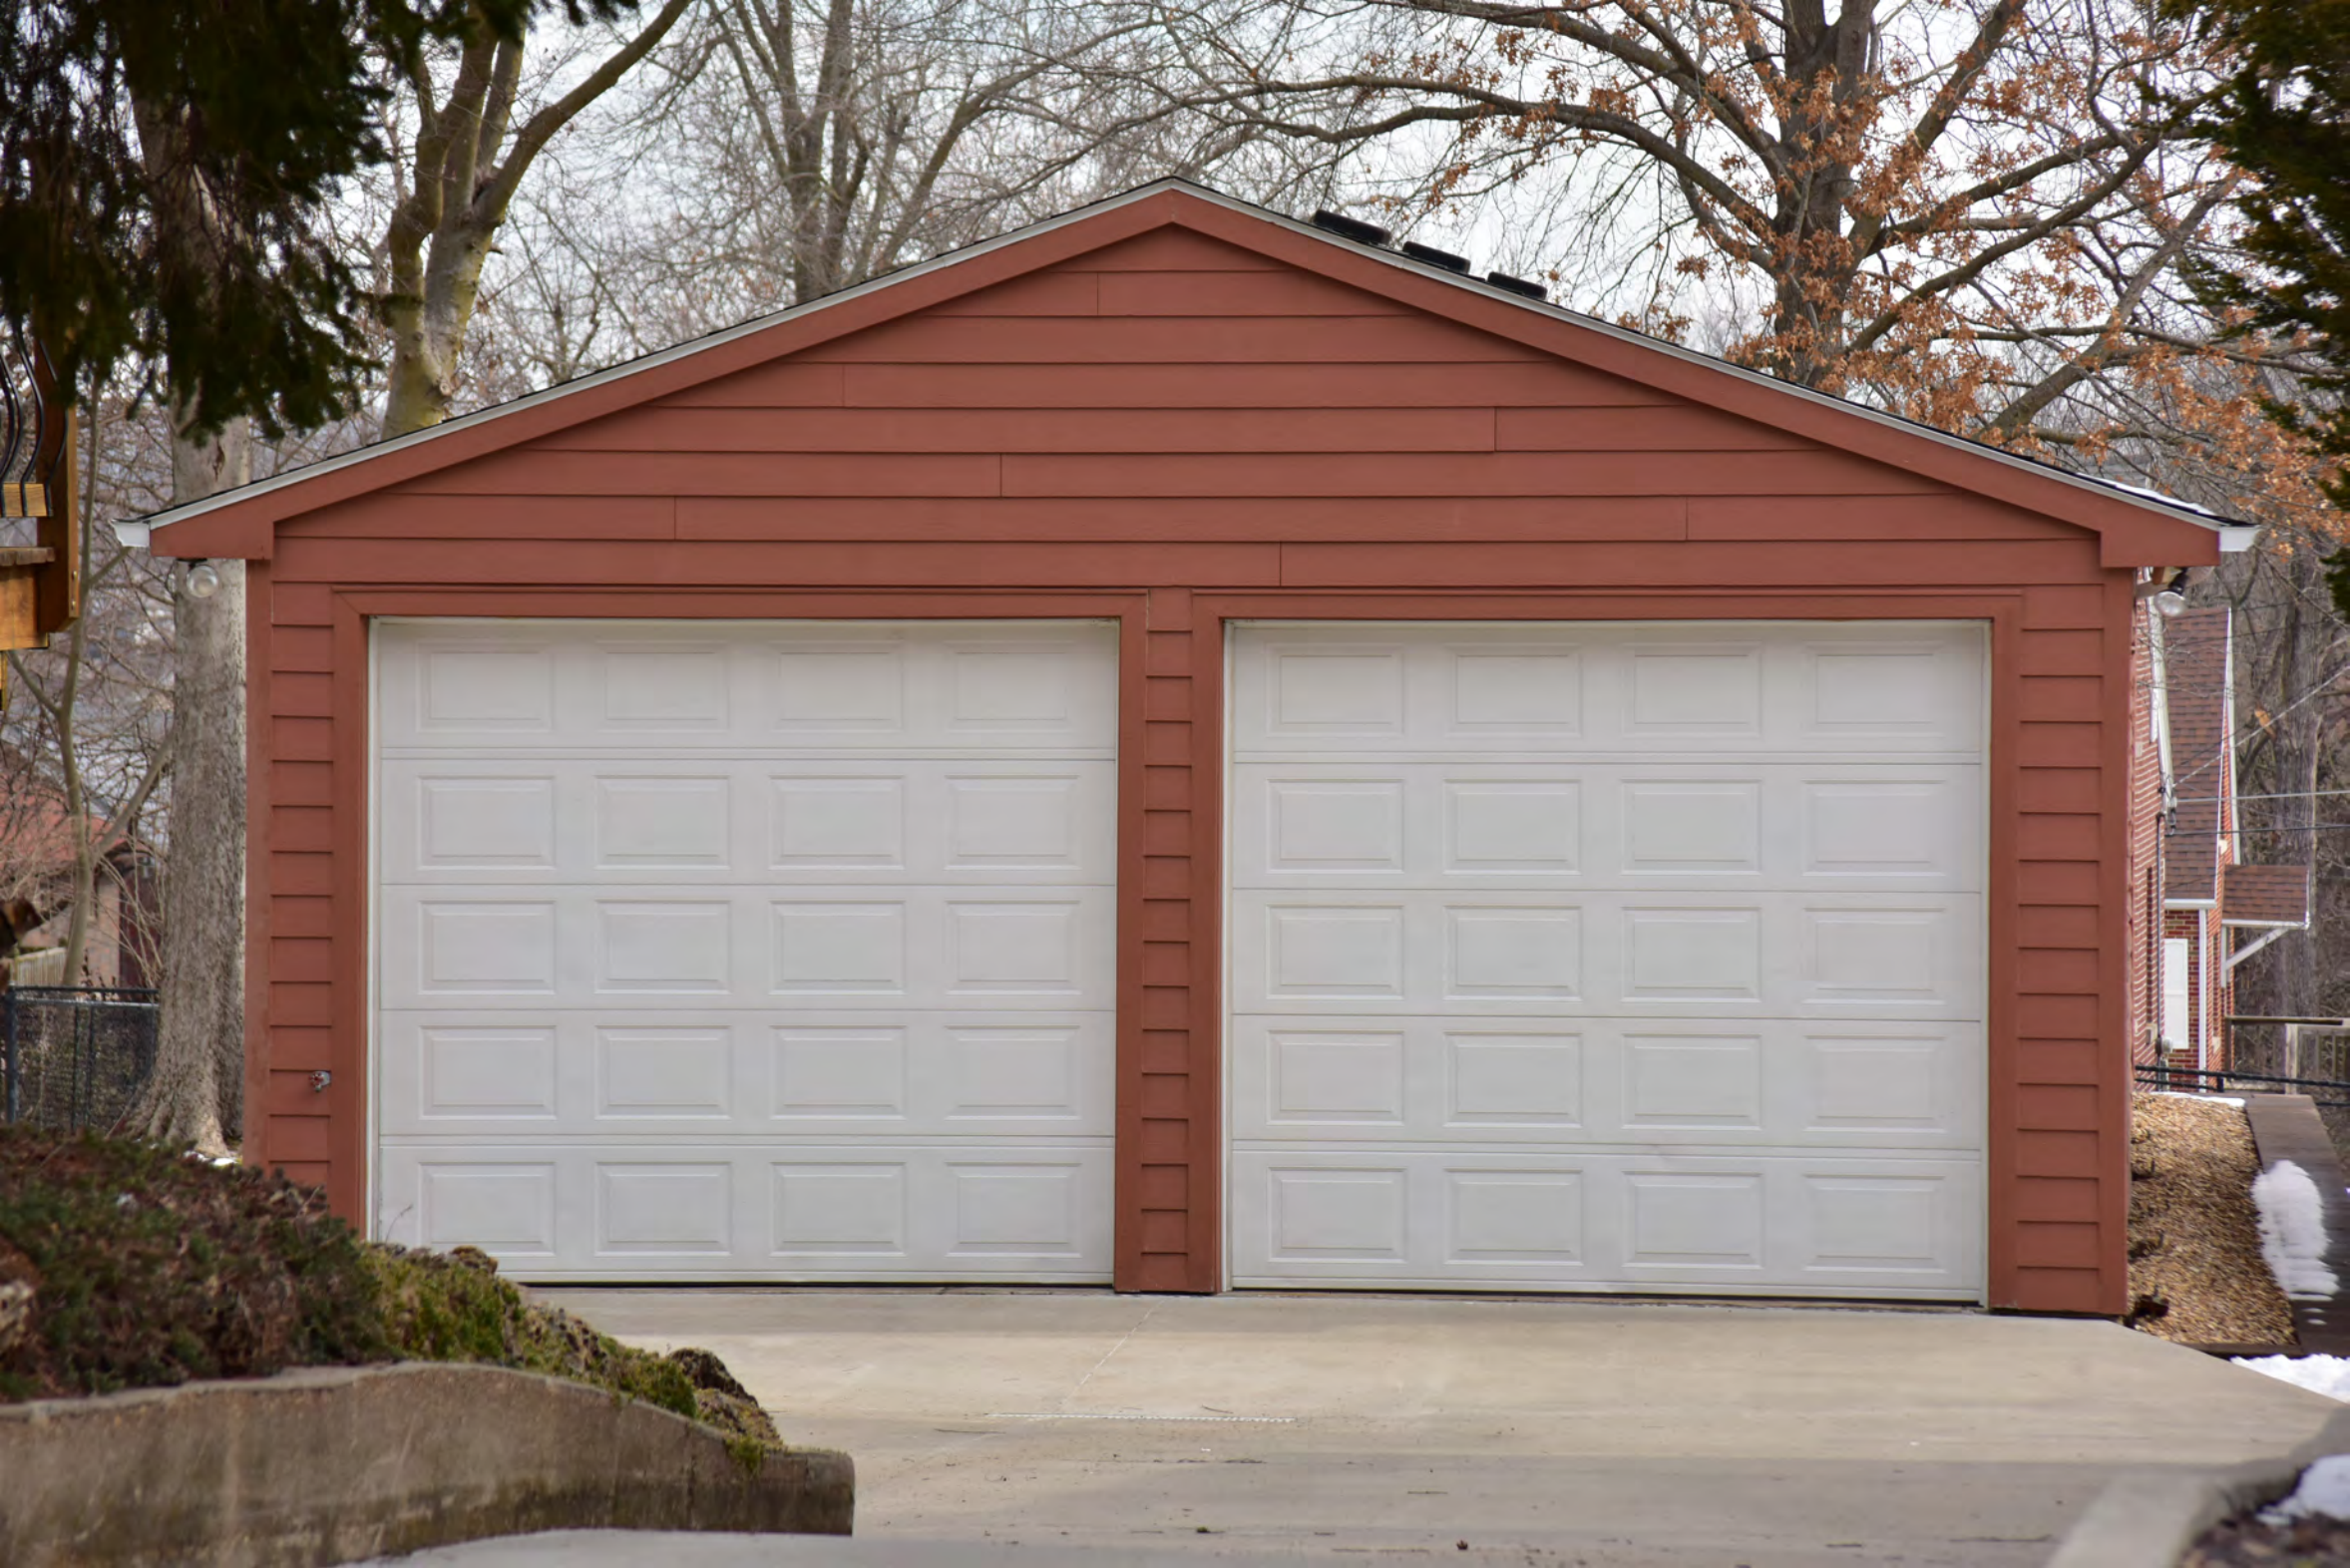
118 West Circle Drive is a two-story Colonial Revival dwelling. The brick-clad dwelling has a concrete foundation and asphalt intersecting-gable roof. A side-gable fronts North Circle drive while a perpendicular gable extends from the rear. A brick exterior chimney pierces the north gable end eave. The dwelling is three bays wide at the first story. Non-historic 10/10 vinyl windows with cast stone sills and solid brick lintels flank the center bay. The primary entrance defines the center bay. It features a non-historic wood door and neo-classical surround with pilasters and pediment. A concrete stoop with scrolled metal railings extends below the entrance. Gabled wall dormers with cornice returns pierce the roof above the outer bays. Each contains a non-historic 10/10 vinyl window with a cast stone sill. A one-story shed-roof enclosed porch fills the juncture between the side-gable and rear ell. It is partially visible and contains vinyl windows. A non-historic wood deck with curved metal balusters lines the south elevation and wraps around the rear of the dwelling. Historic maps and aerial images indicate an integrated garage is present at the basement level at the rear. It is not visible.

Alterations to 118 West Circle Drive include the replacement of historic windows with vinyl windows. Although they are replacements, the windows fill historic openings. 118 West Circle Drive retains good integrity. This resource would be contributing to the potential Walinko Place Historic District, significant in the areas of Architecture and Community Planning and Development in association with the expansion of Jefferson City and increased suburban development during the twentieth century as well as its associations with Walinko Place, a notable suburban development during the Depression and War Years.

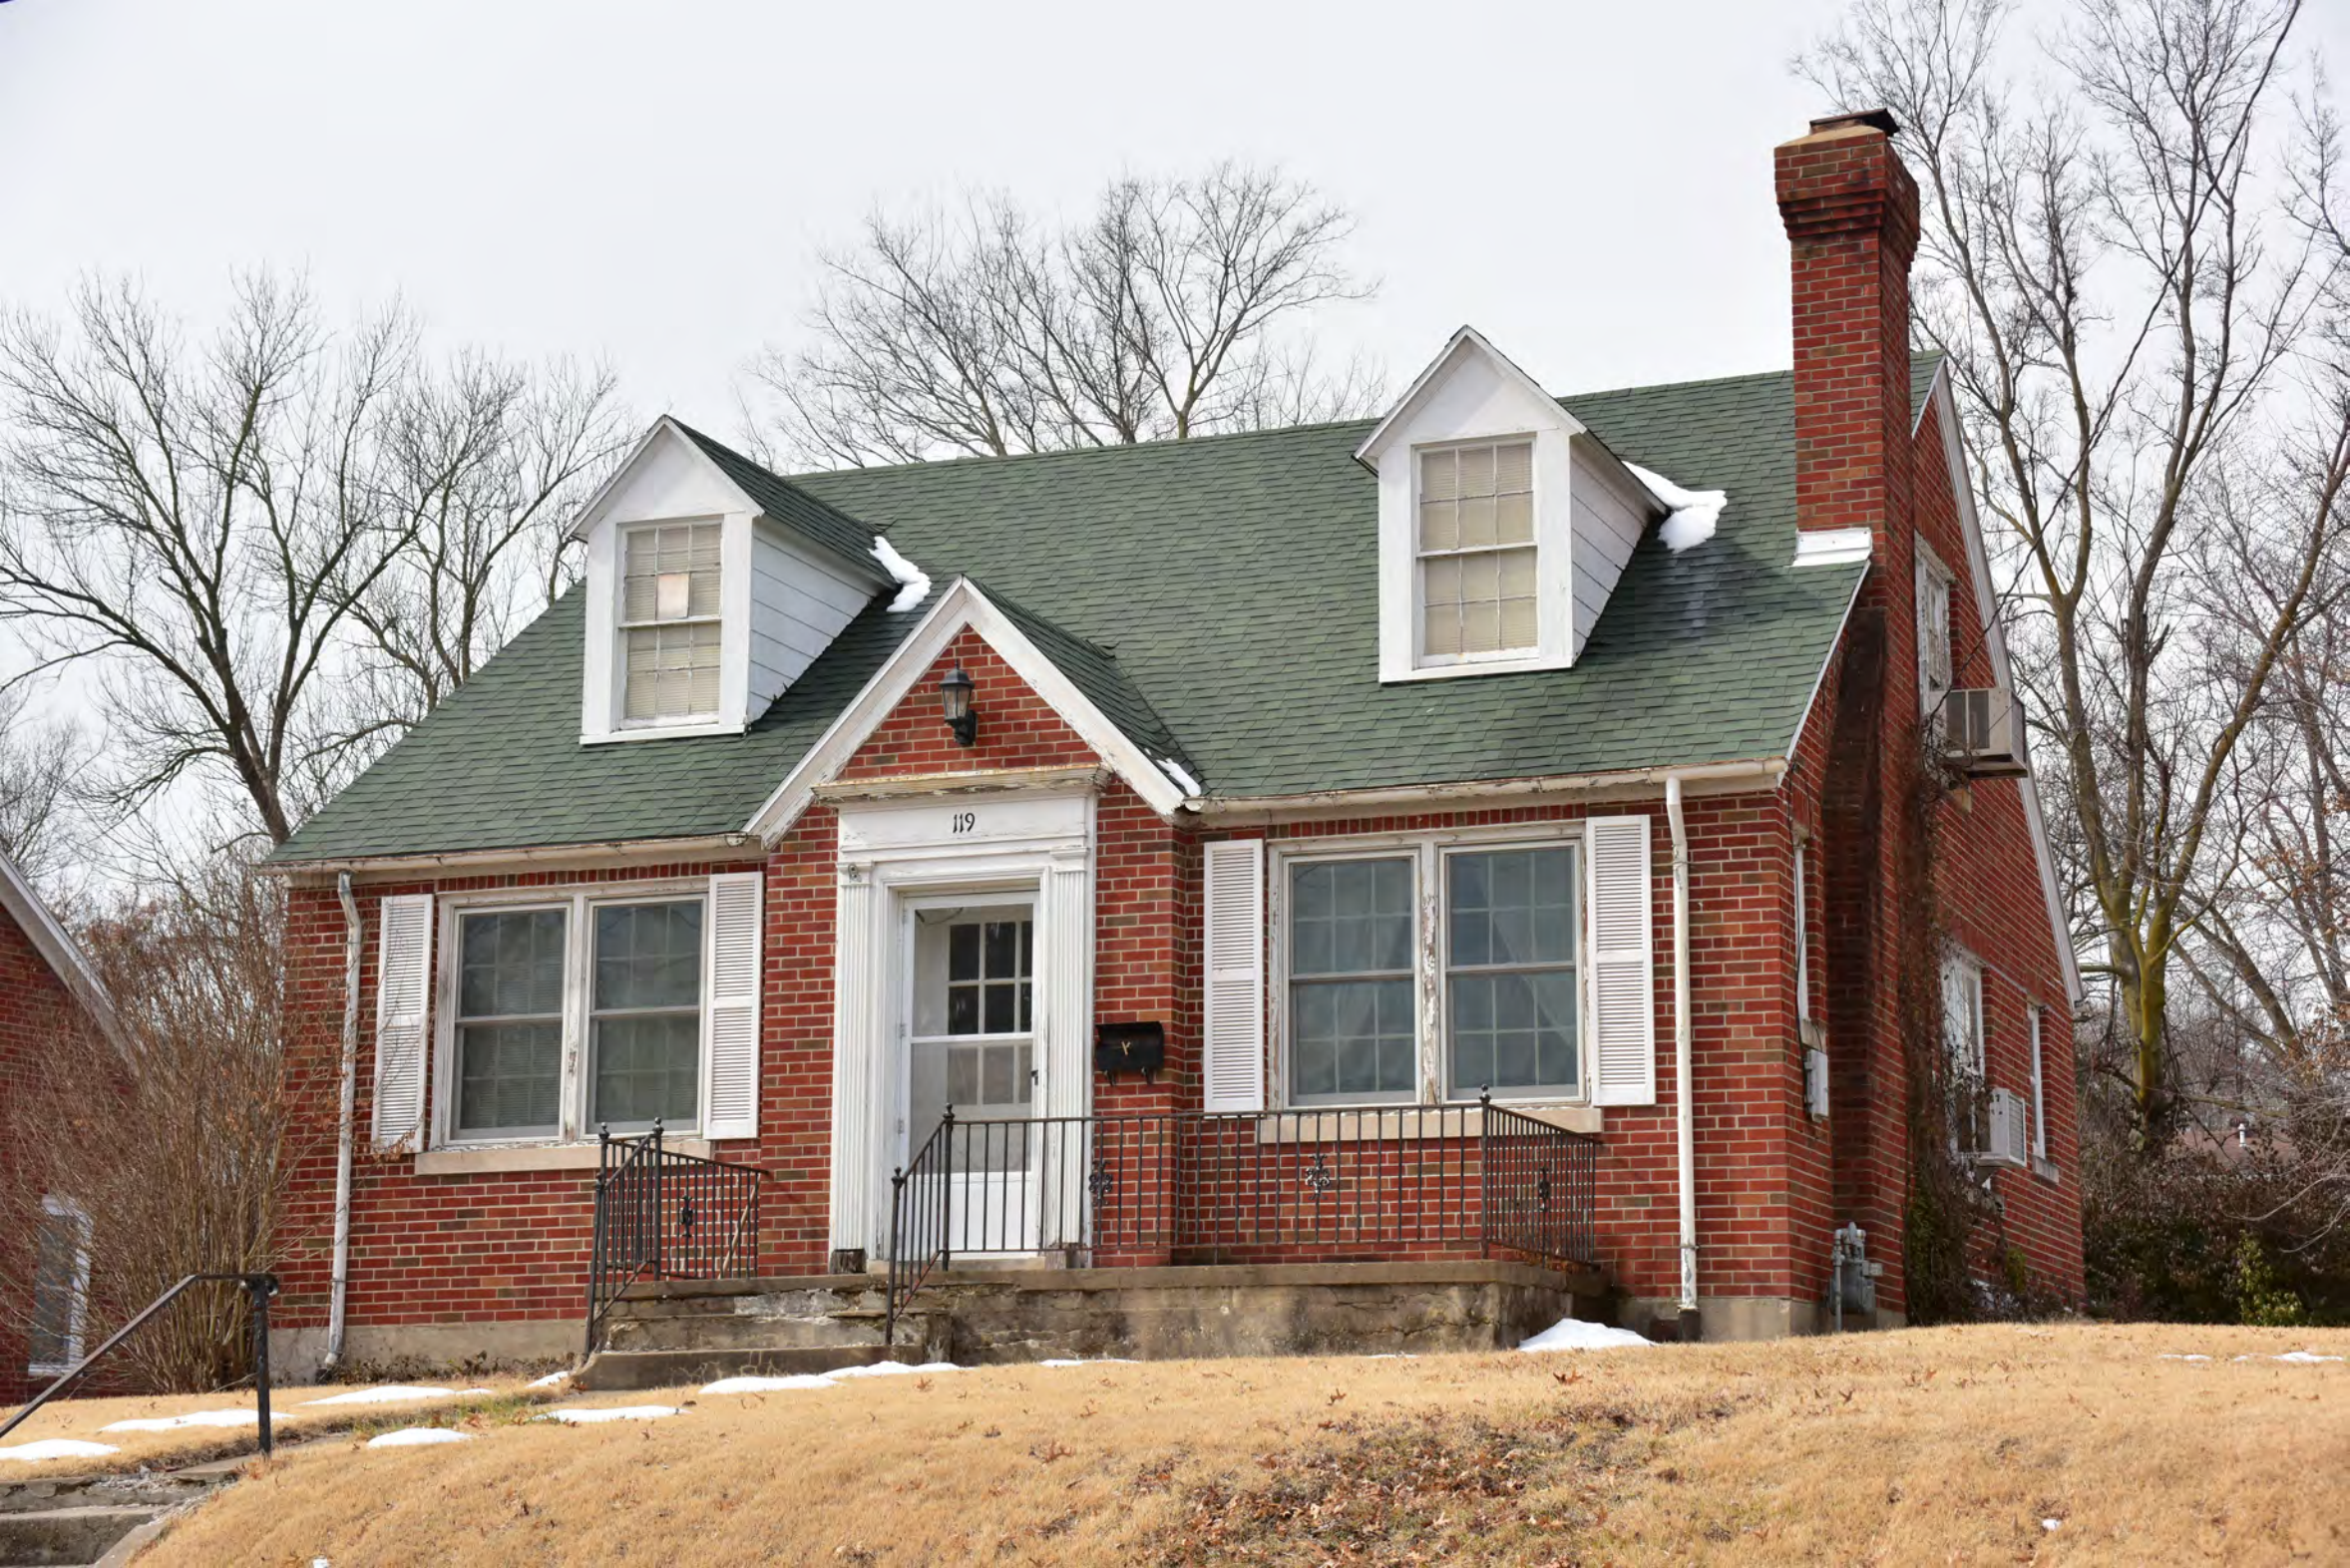
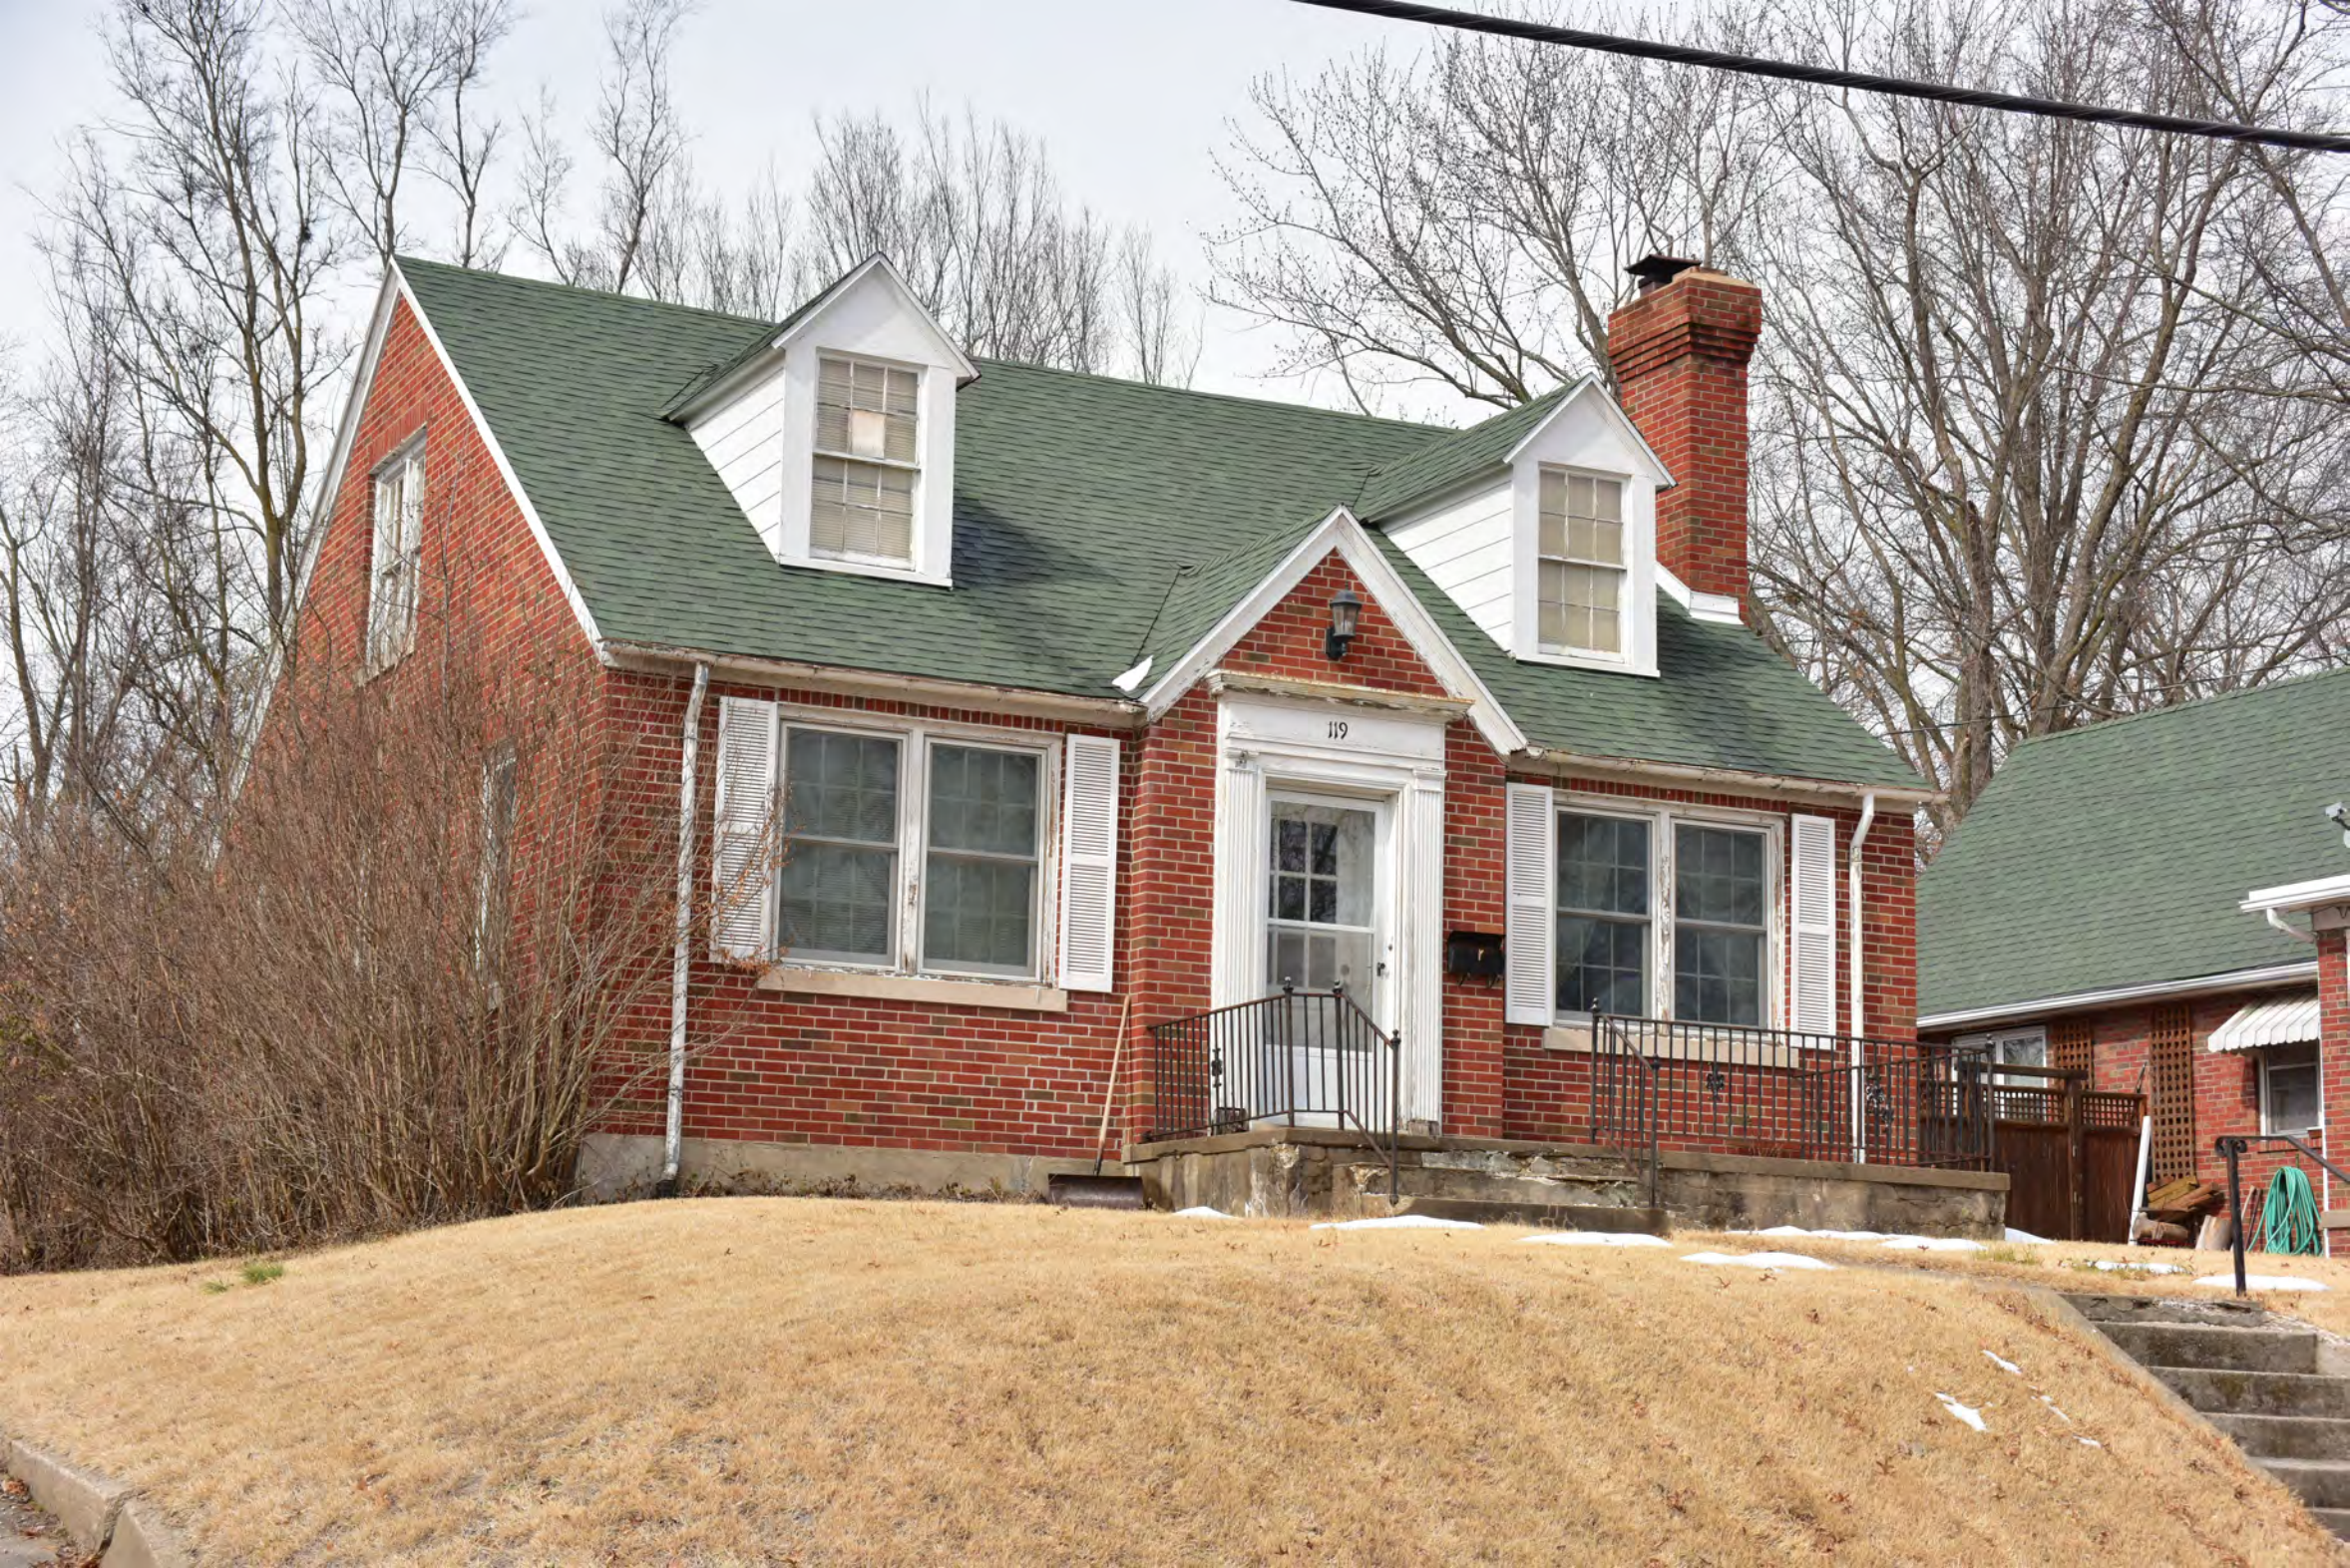
119 West Circle Drive is a one-and-one-half story Minimal Traditional dwelling with restrained Colonial Revival influences. The brick-clad dwelling has a concrete foundation and a side-gable asphalt roof. A brick exterior chimney pierces the north gable end eave. Two gabled dormers with wood lap cladding are located on the front slope and contain historic 6/6 wood windows. The dwelling is three bays wide. Non-historic 6/6 vinyl windows with historic wood casings and concrete sills and false shutters flank the center bay. The center bay projects slightly and is topped with a gablet. It contains the primary entrance which includes features a historic wood door with nine-light glazing and a Colonial Revival surround with pilasters and entablature. A concrete platform porch with historic metal railings extends below the north-two bays. Aerial imagery indicates a large shed dormer is centered on the rear slope and a one-story porch is centered on the rear elevation. Neither are visible. Sanborn maps indicate an integrated garage is located at basement level and accessed at the rear.
