1. Survey number: CO-AS-008-001		2. Survey Name: West Main Street Survey	
3. County: Cole		4. Address (Street No.): 100	Street (name): East Circle Drive
5. City: Jefferson City	Vicinity <input type="checkbox"/>	6. Lat / Long:	7. Township/Range/Section: T: R: S:
8. Historic name (if known):		9. Present/other name (if known):	
10. Ownership: <input checked="" type="checkbox"/> Private <input type="checkbox"/> Public		11a. Historic use (if known): Domestic-Single Dwelling	11b. Current use: Domestic-Single Dwelling

MISSOURI DEPARTMENT OF NATURAL RESOURCES
STATE HISTORIC PRESERVATION OFFICE, P.O. Box 178, Jefferson City, MO 65102
ARCHITECTURAL/HISTORIC INVENTORY FORM

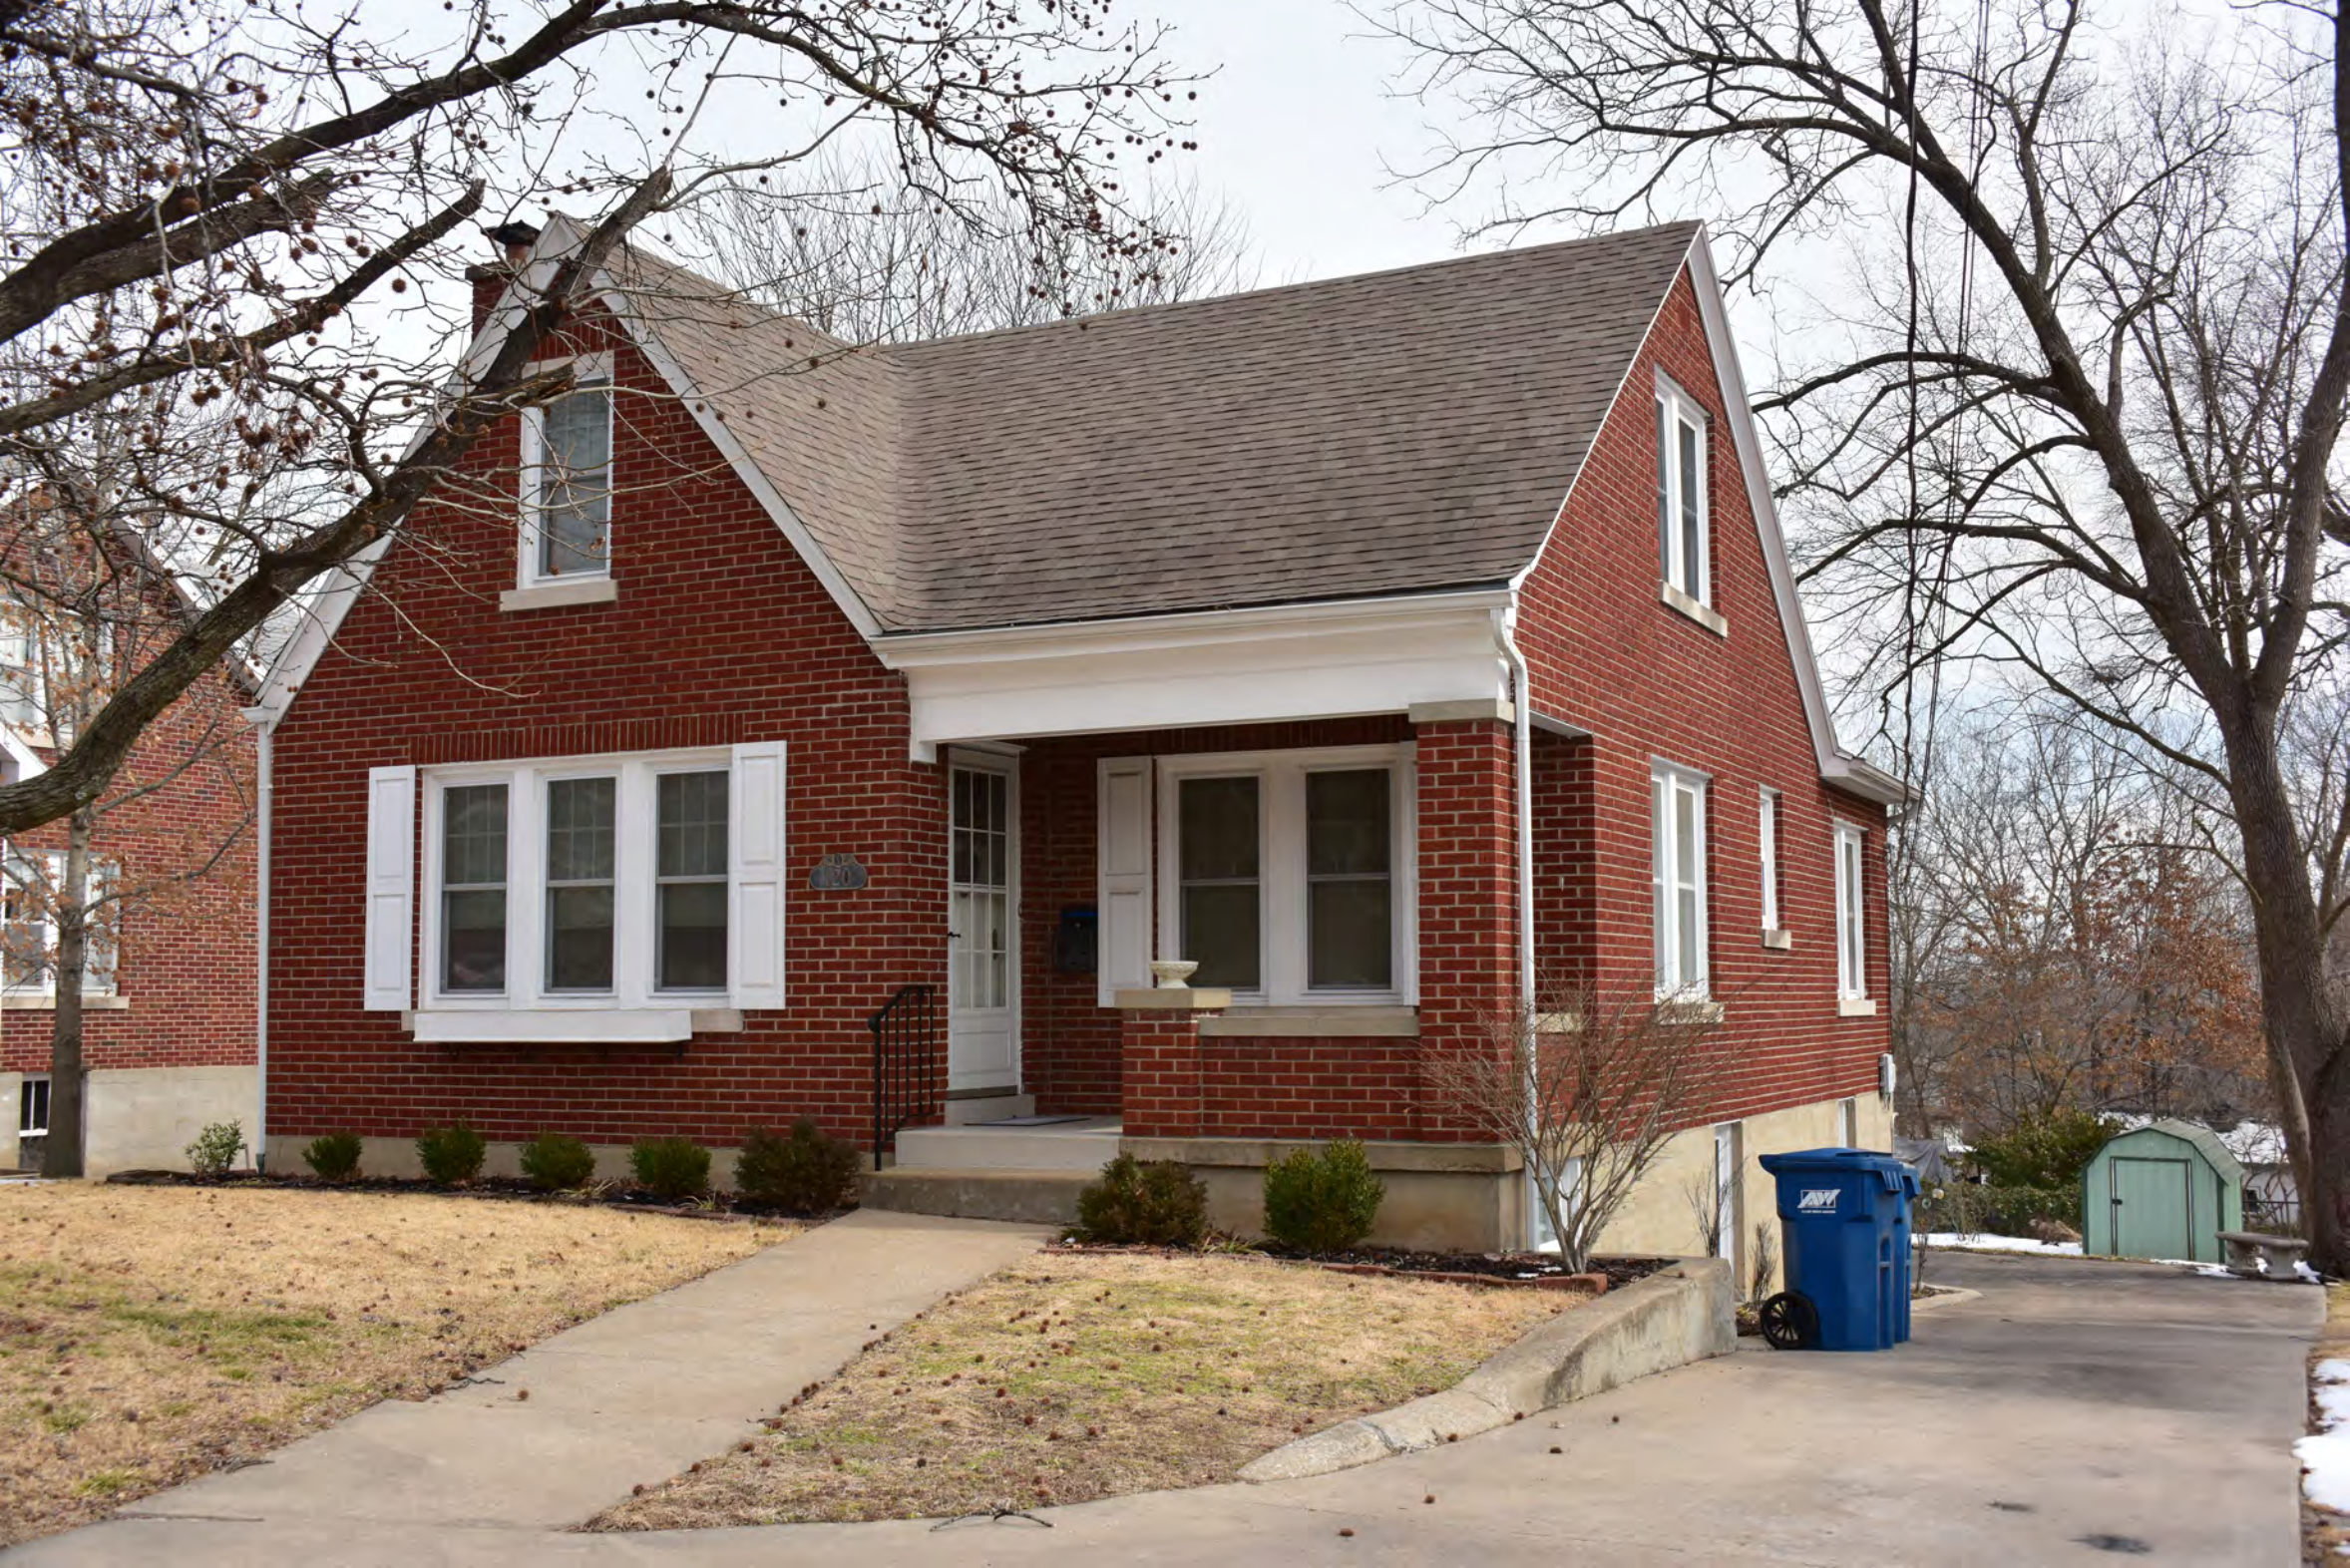
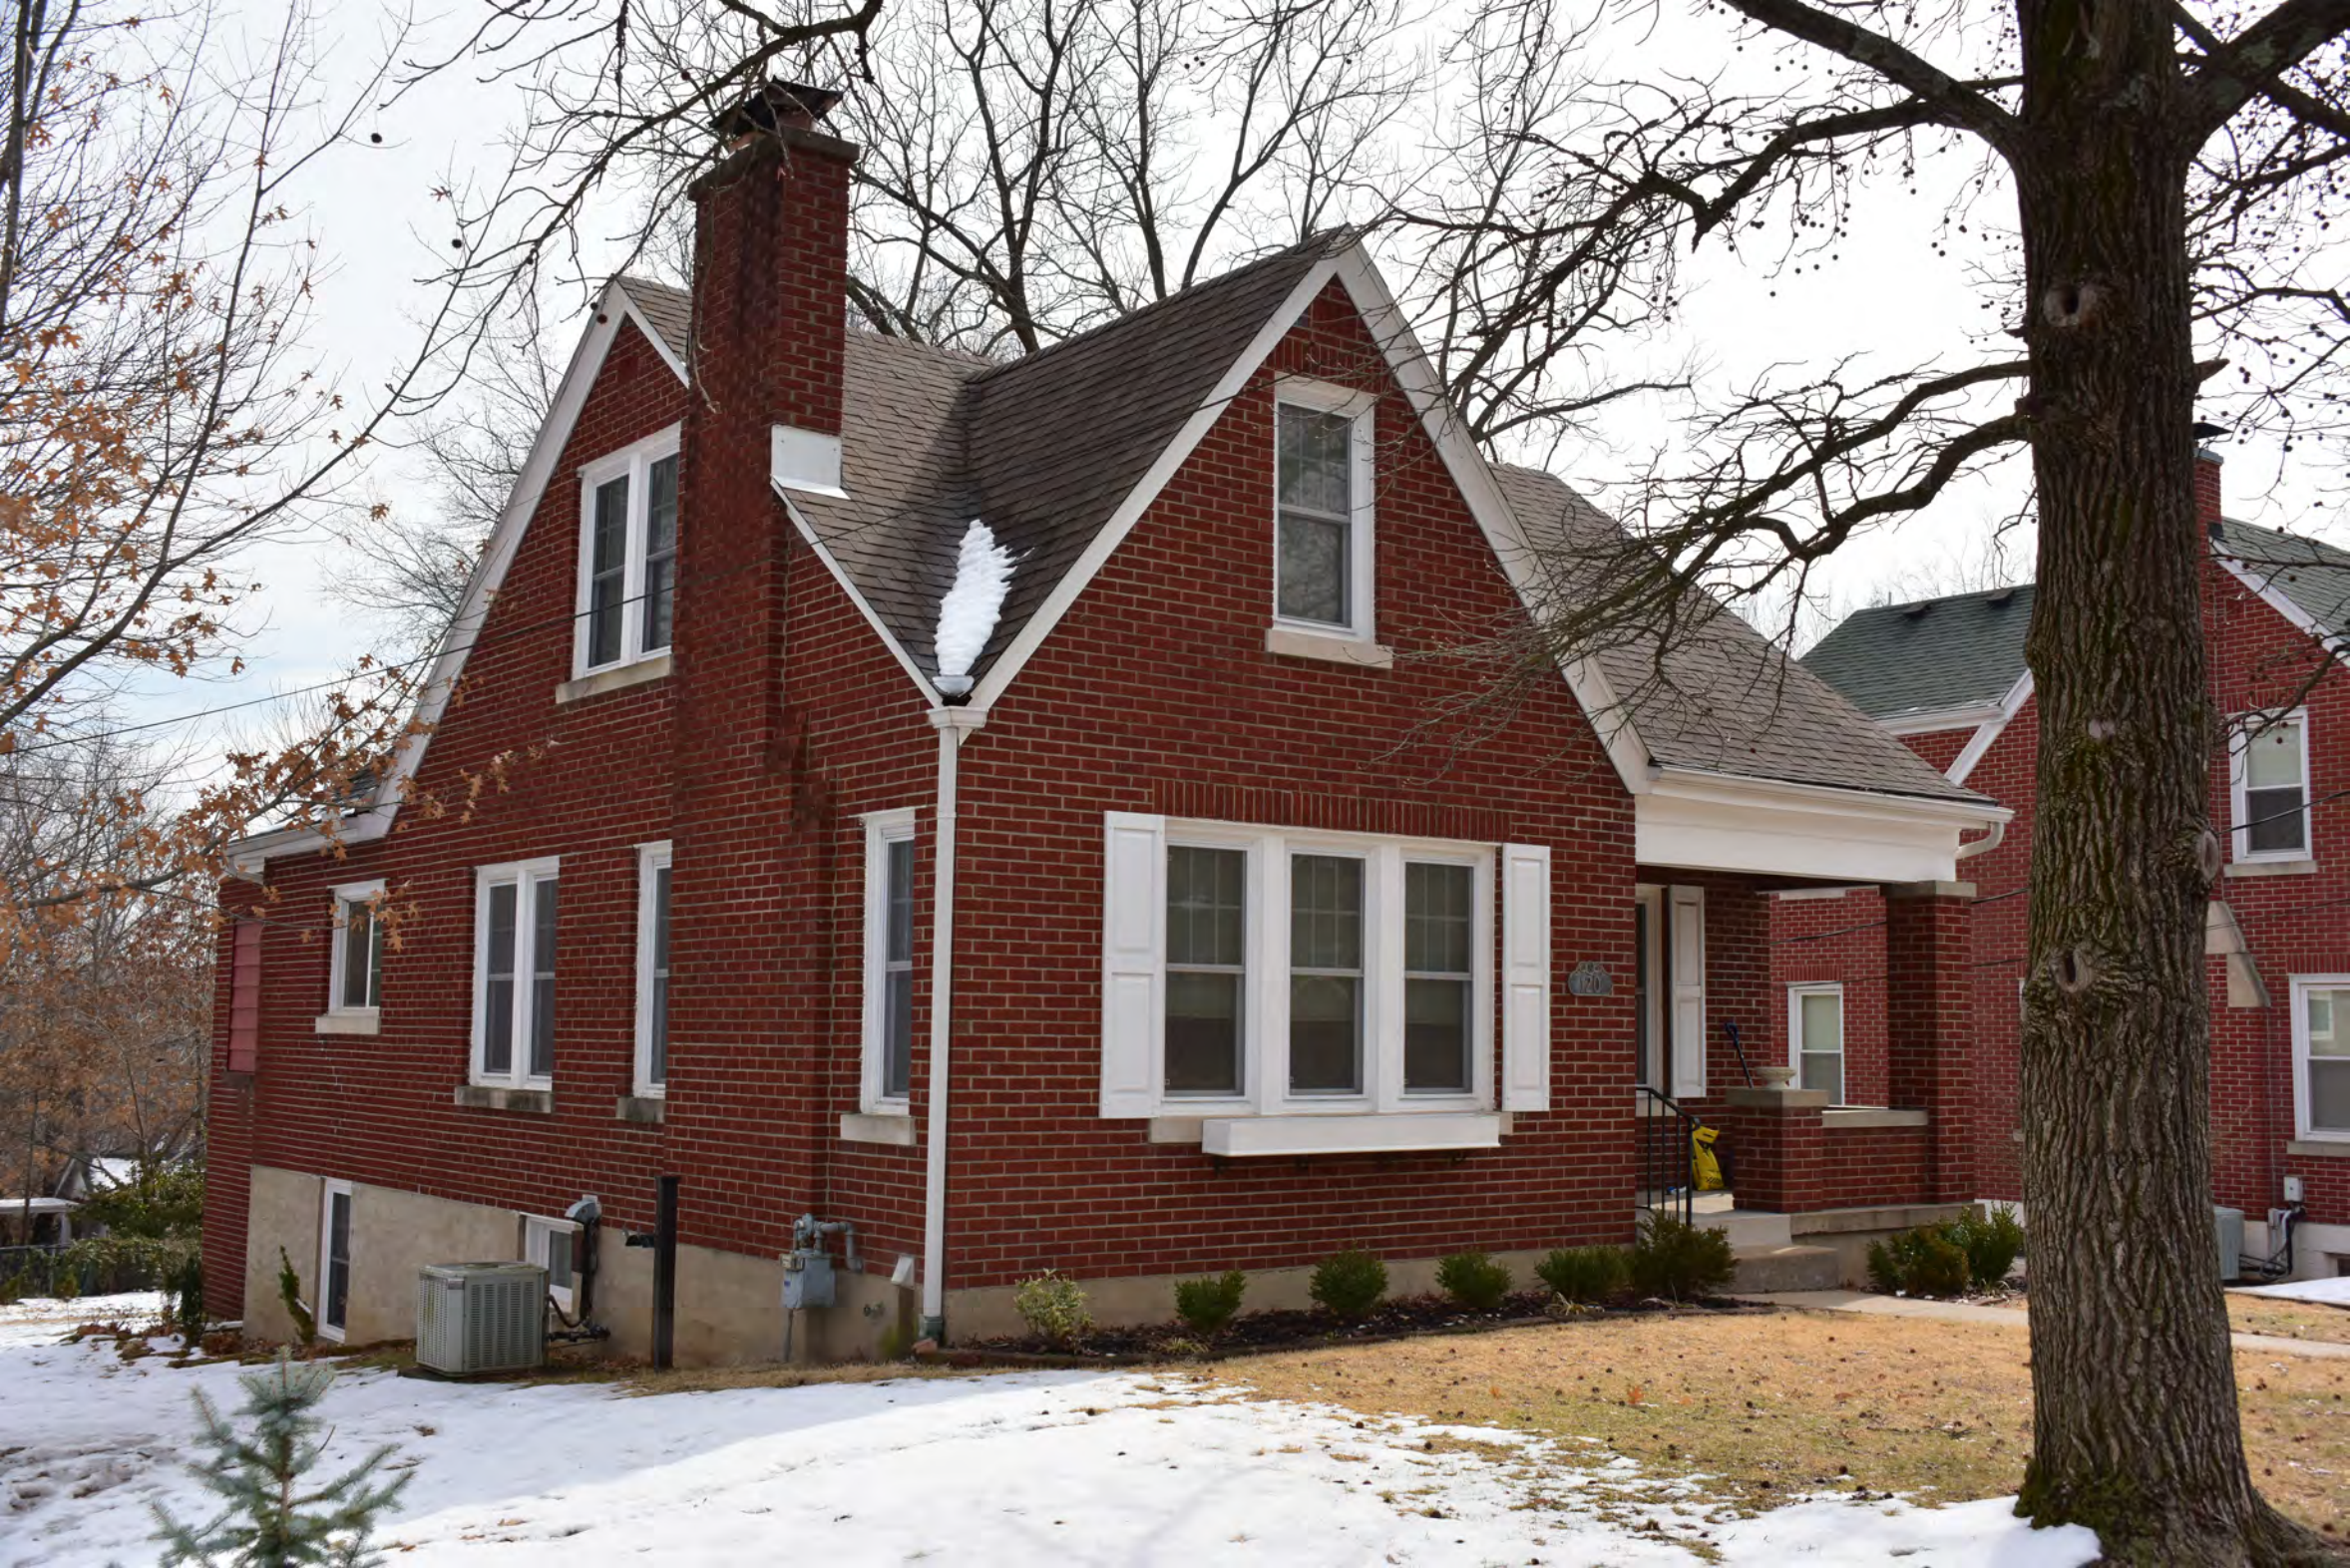
120 West Circle Drive is a one-and-one-half-story Minimal Traditional dwelling. The brick dwelling has a concrete foundation and asphalt intersecting gable roof. A side-gable with cross-gable at the north end fronts West Circle Drive while a perpendicular gable extends from the rear. The dwelling is two bays wide. The cross-gable contains the first bay. Three-ganged non-historic 6/1 vinyl windows with a continuous cast stone sill and soldier brick lintel fill the bay. A non-historic 6/1 vinyl window is centered in the cross-gable apex. The primary entrance is located in the cross-gable south wall. Two-ganged 6/1 vinyl windows with a continuous cast stone sill and soldier brick lintel define the south bay. The side-gable eave extends to shelter the south bay and entrance and forms a partial-width open porch. A brick column with a cast stone pier supports the porch roof and a simplified wood entablature spans the primary elevation above the porch. Brick knee walls with cast stone caps line the porch perimeter. A brick-clad garage and porch extend from the rear. The garage is located at basement level and the porch is located above.

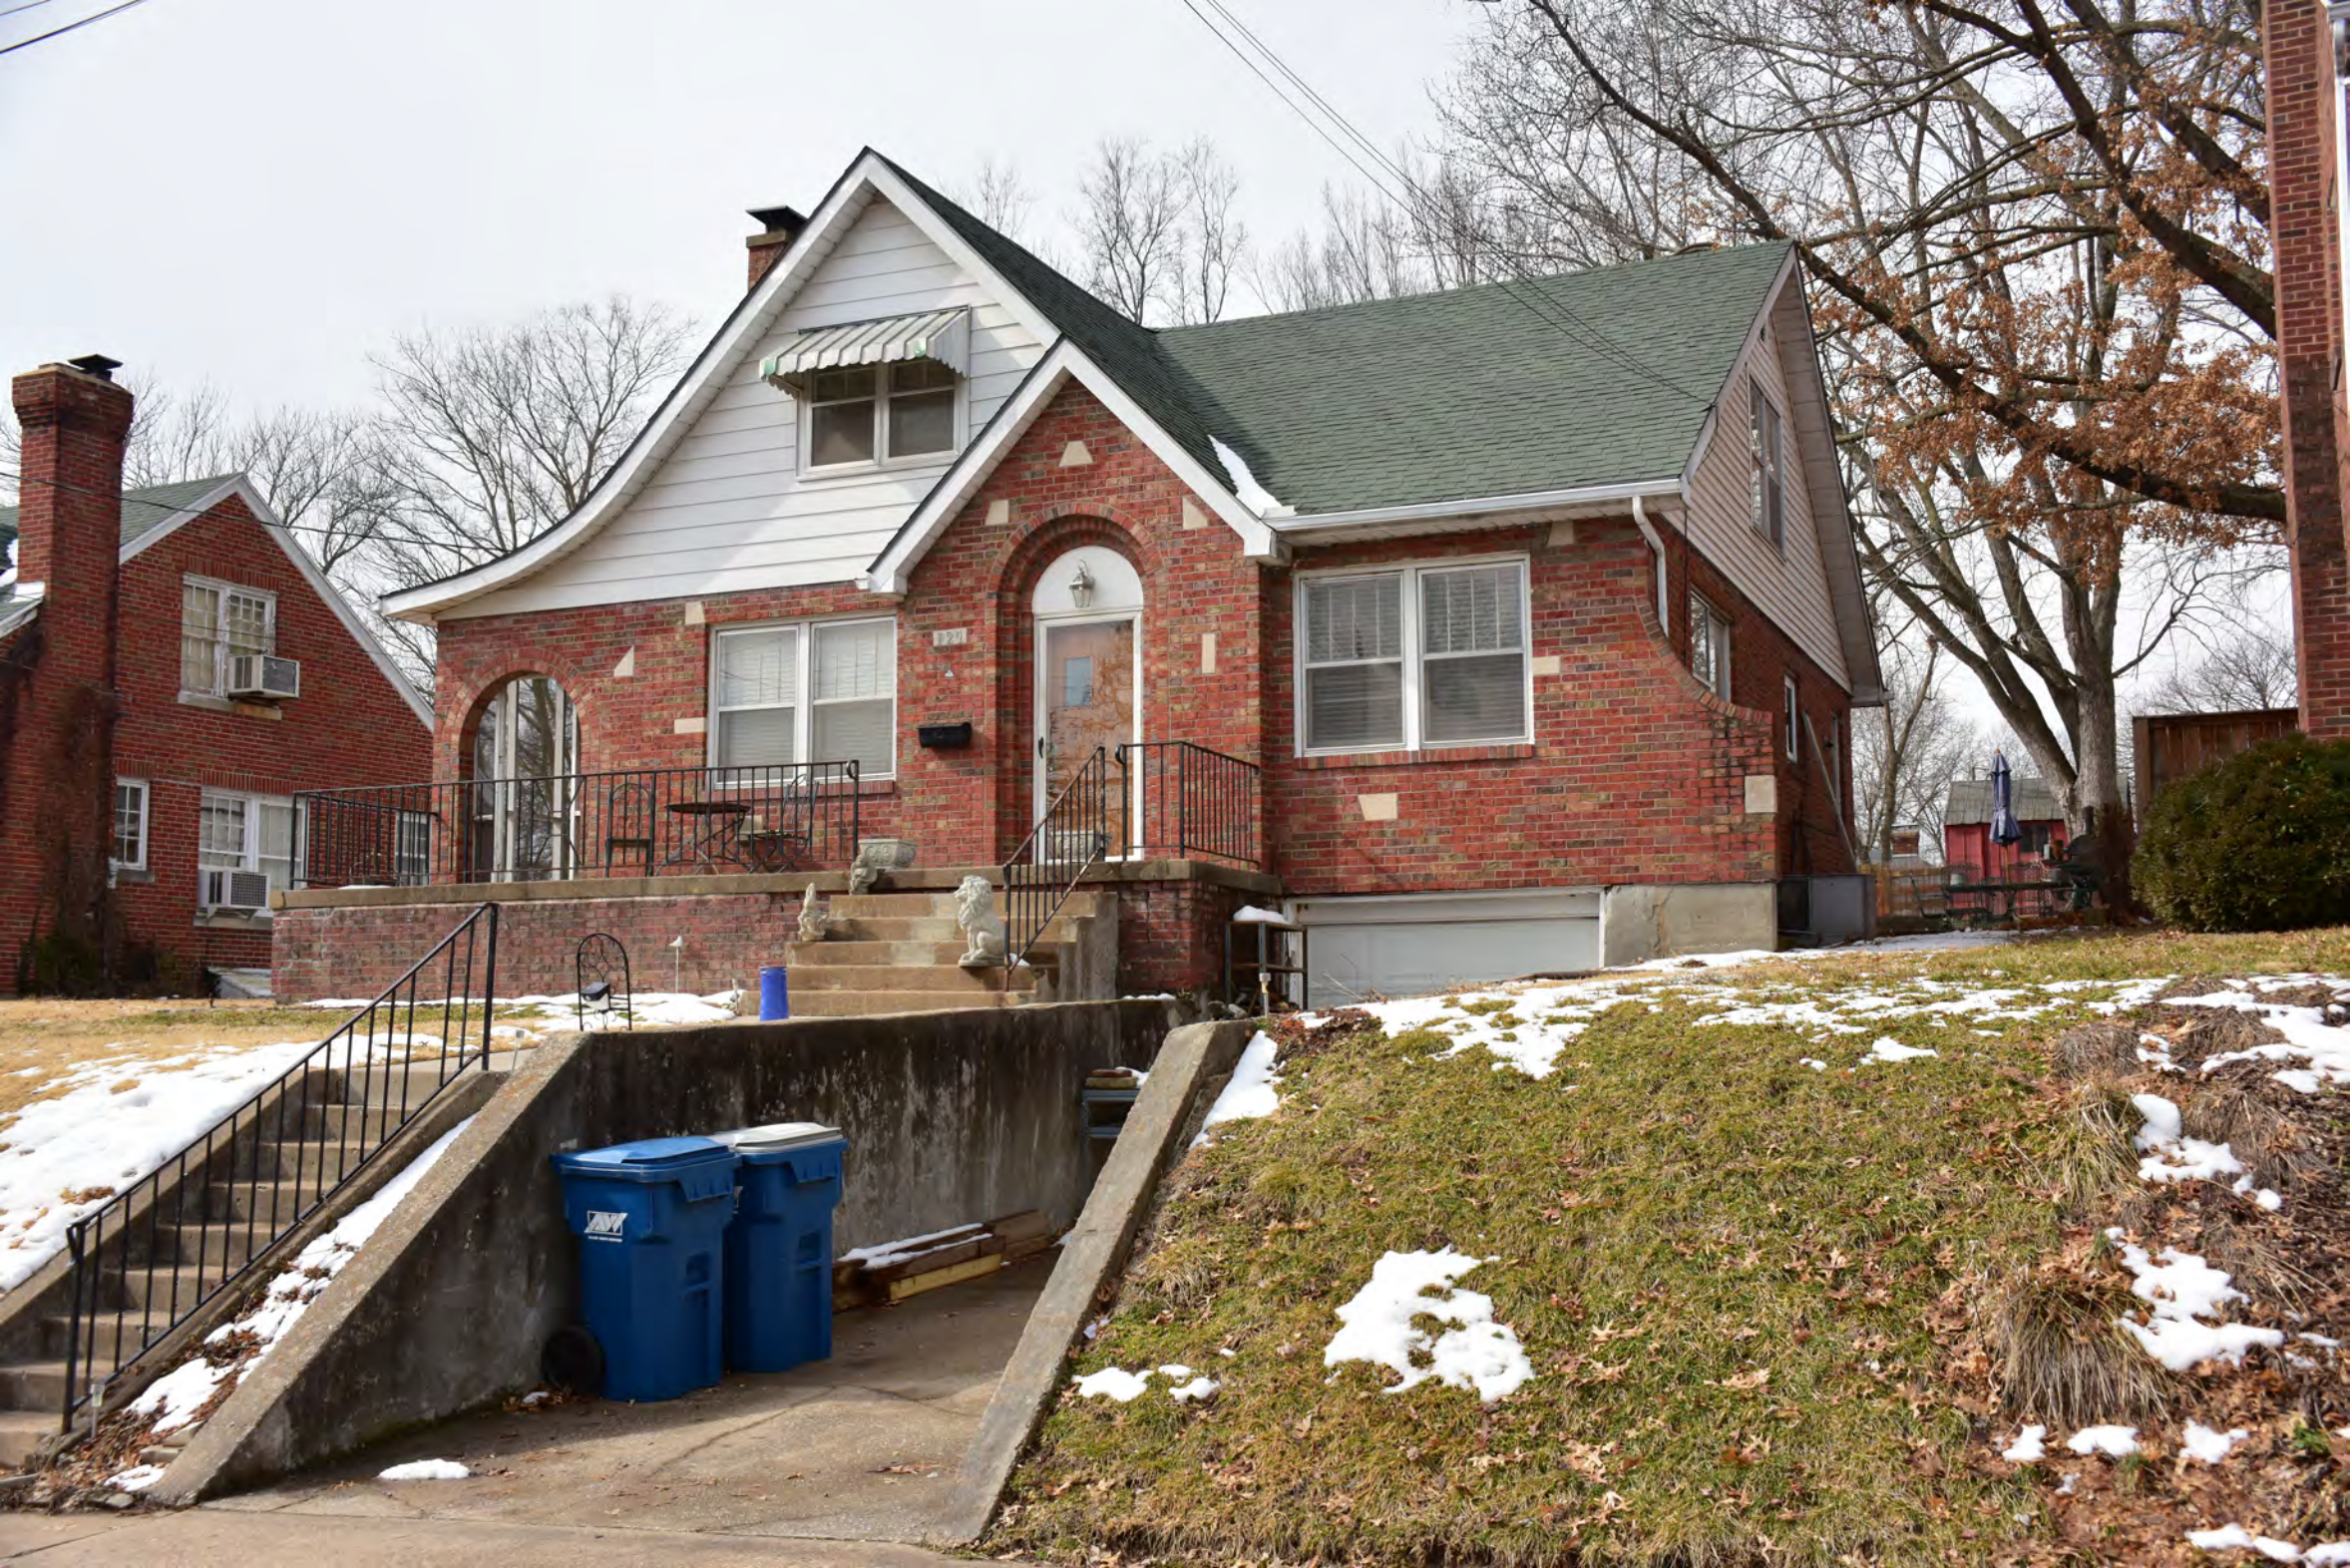
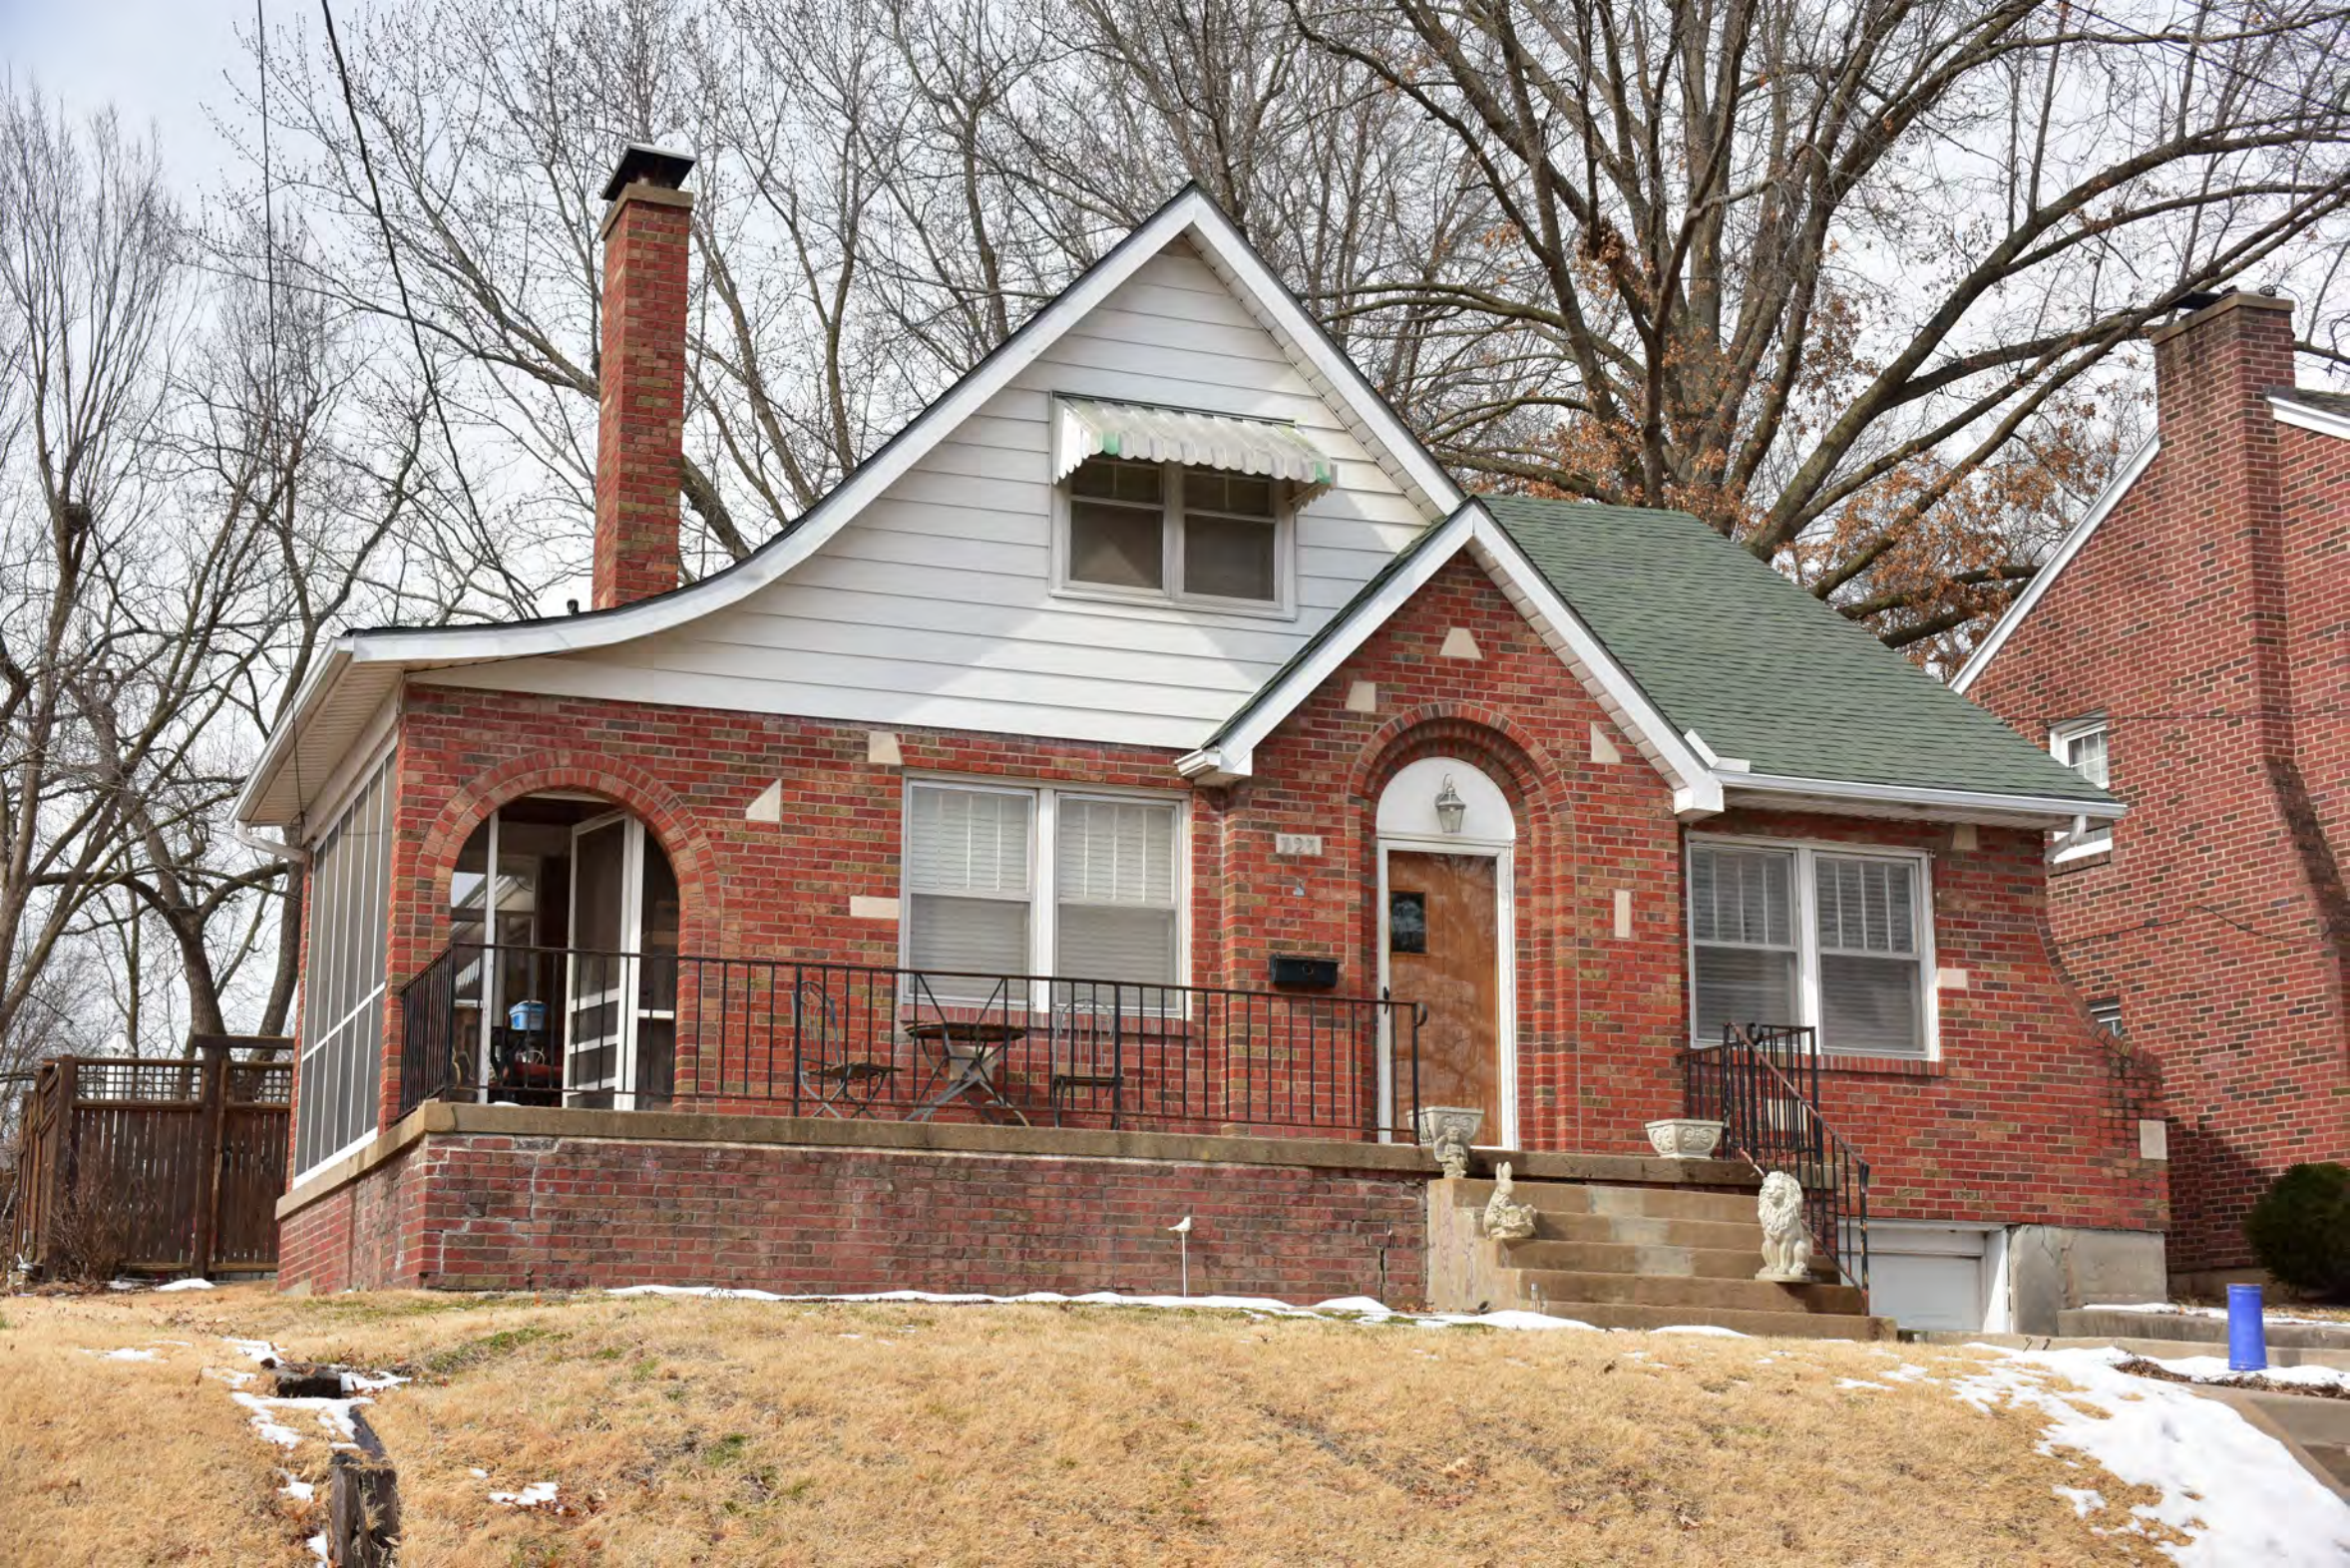
121 West Circle Drive is a one-and-one-half story Minimal Traditional dwelling with restrained Tudor Revival influences. The brick dwelling has a concrete foundation and complex interesting-gable asphalt roof. Vinyl siding clads the gable ends. A side-gable fronts the street while a perpendicular gable extends at the rear. A gable-front ell with brick wingwall projects from the south half of primary elevation. Paired 4/1 historic wood windows with a historic metal awning are centered in the gable apex. end. The wingwall contains a rounded arch which opens to a screened porch. A brick chimney pierces the cross-gable at the south slope. The primary elevation is three bays wide. Paired 4/1 historic wood windows with continuous brick sills define the outer bays while a low nested-gable defines the center bay and contains the entrance. The entrance is recessed slightly and contains a historic arched wood door with single-light glazing. Stepped brick surrounds the opening. A brick platform porch with metal railings extends from the screened porch to the entrance. An integrated historic single-car garage is located at basement level below the north bay. A non-historic overhead door fills the vehicular bay.
