1. Survey number: CO-AS-008-001		2. Survey Name: West Main Street Survey	
3. County: Cole		4. Address (Street No.): 100	Street (name): East Circle Drive
5. City: Jefferson City	Vicinity <input type="checkbox"/>	6. Lat / Long:	7. Township/Range/Section: T: R: S:
8. Historic name (if known):		9. Present/other name (if known):	
10. Ownership: <input checked="" type="checkbox"/> Private <input type="checkbox"/> Public		11a. Historic use (if known): Domestic-Single Dwelling	11b. Current use: Domestic-Single Dwelling

MISSOURI DEPARTMENT OF NATURAL RESOURCES
STATE HISTORIC PRESERVATION OFFICE, P.O. Box 178, Jefferson City, MO 65102
ARCHITECTURAL/HISTORIC INVENTORY FORM

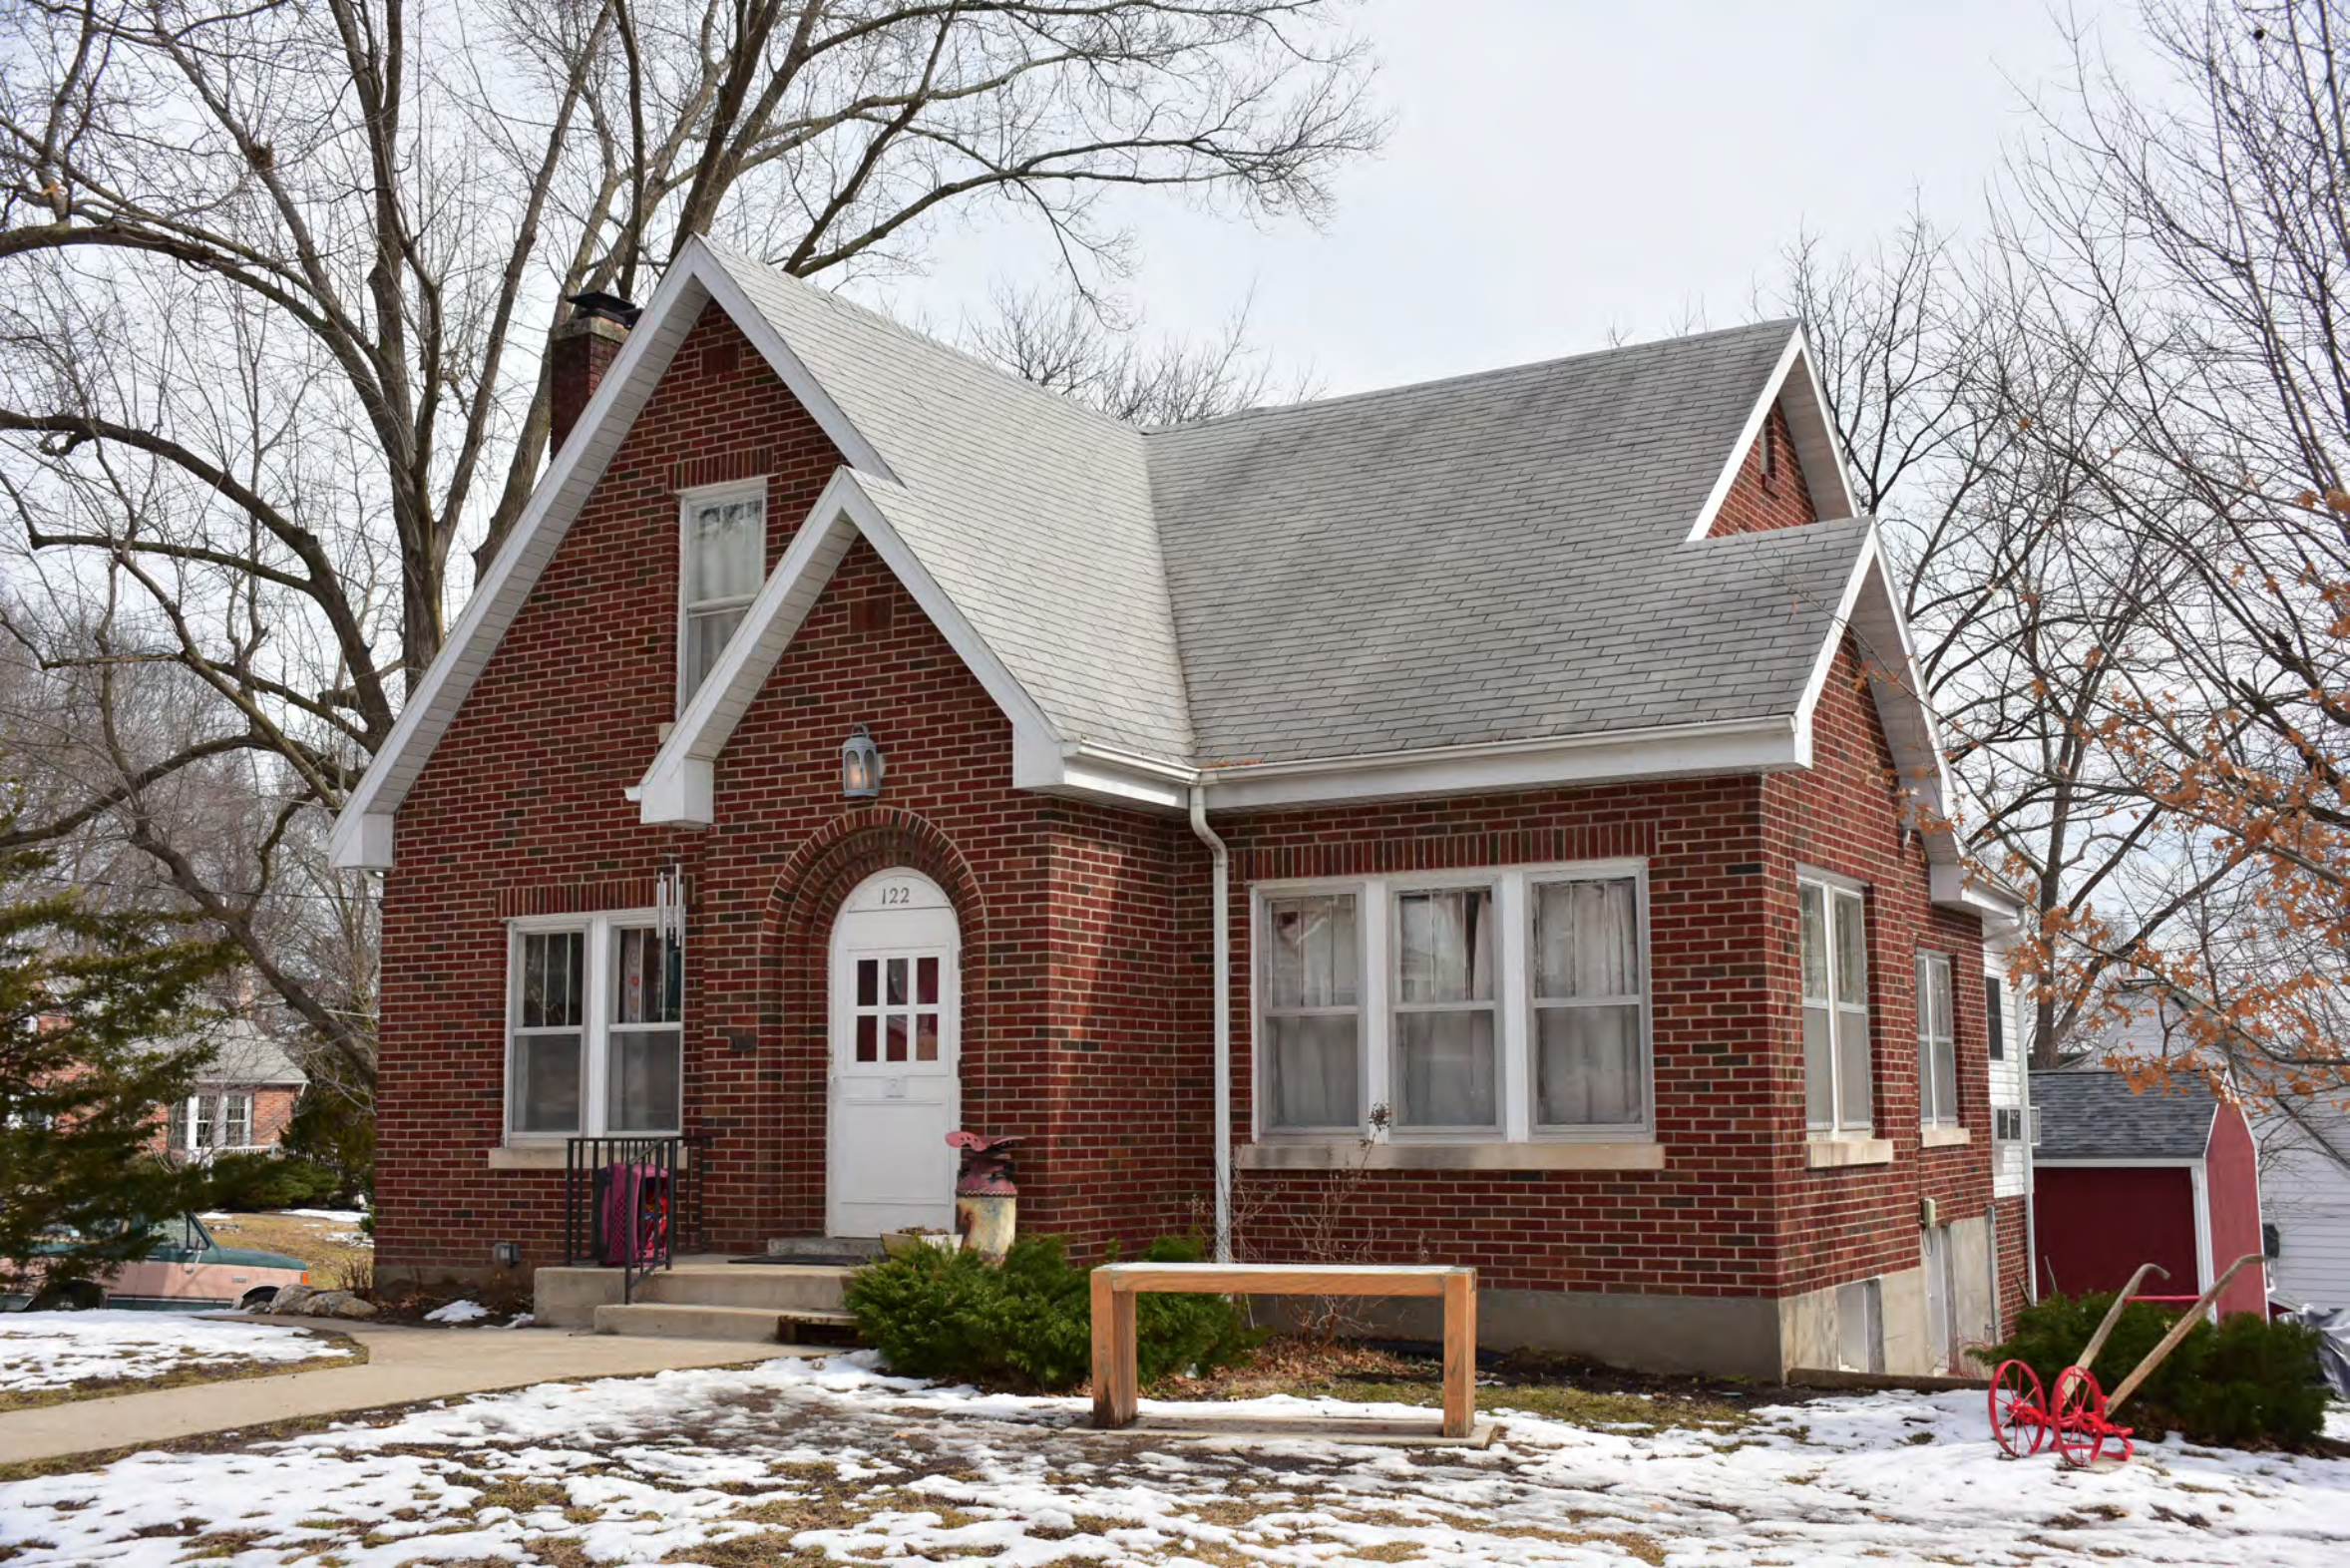
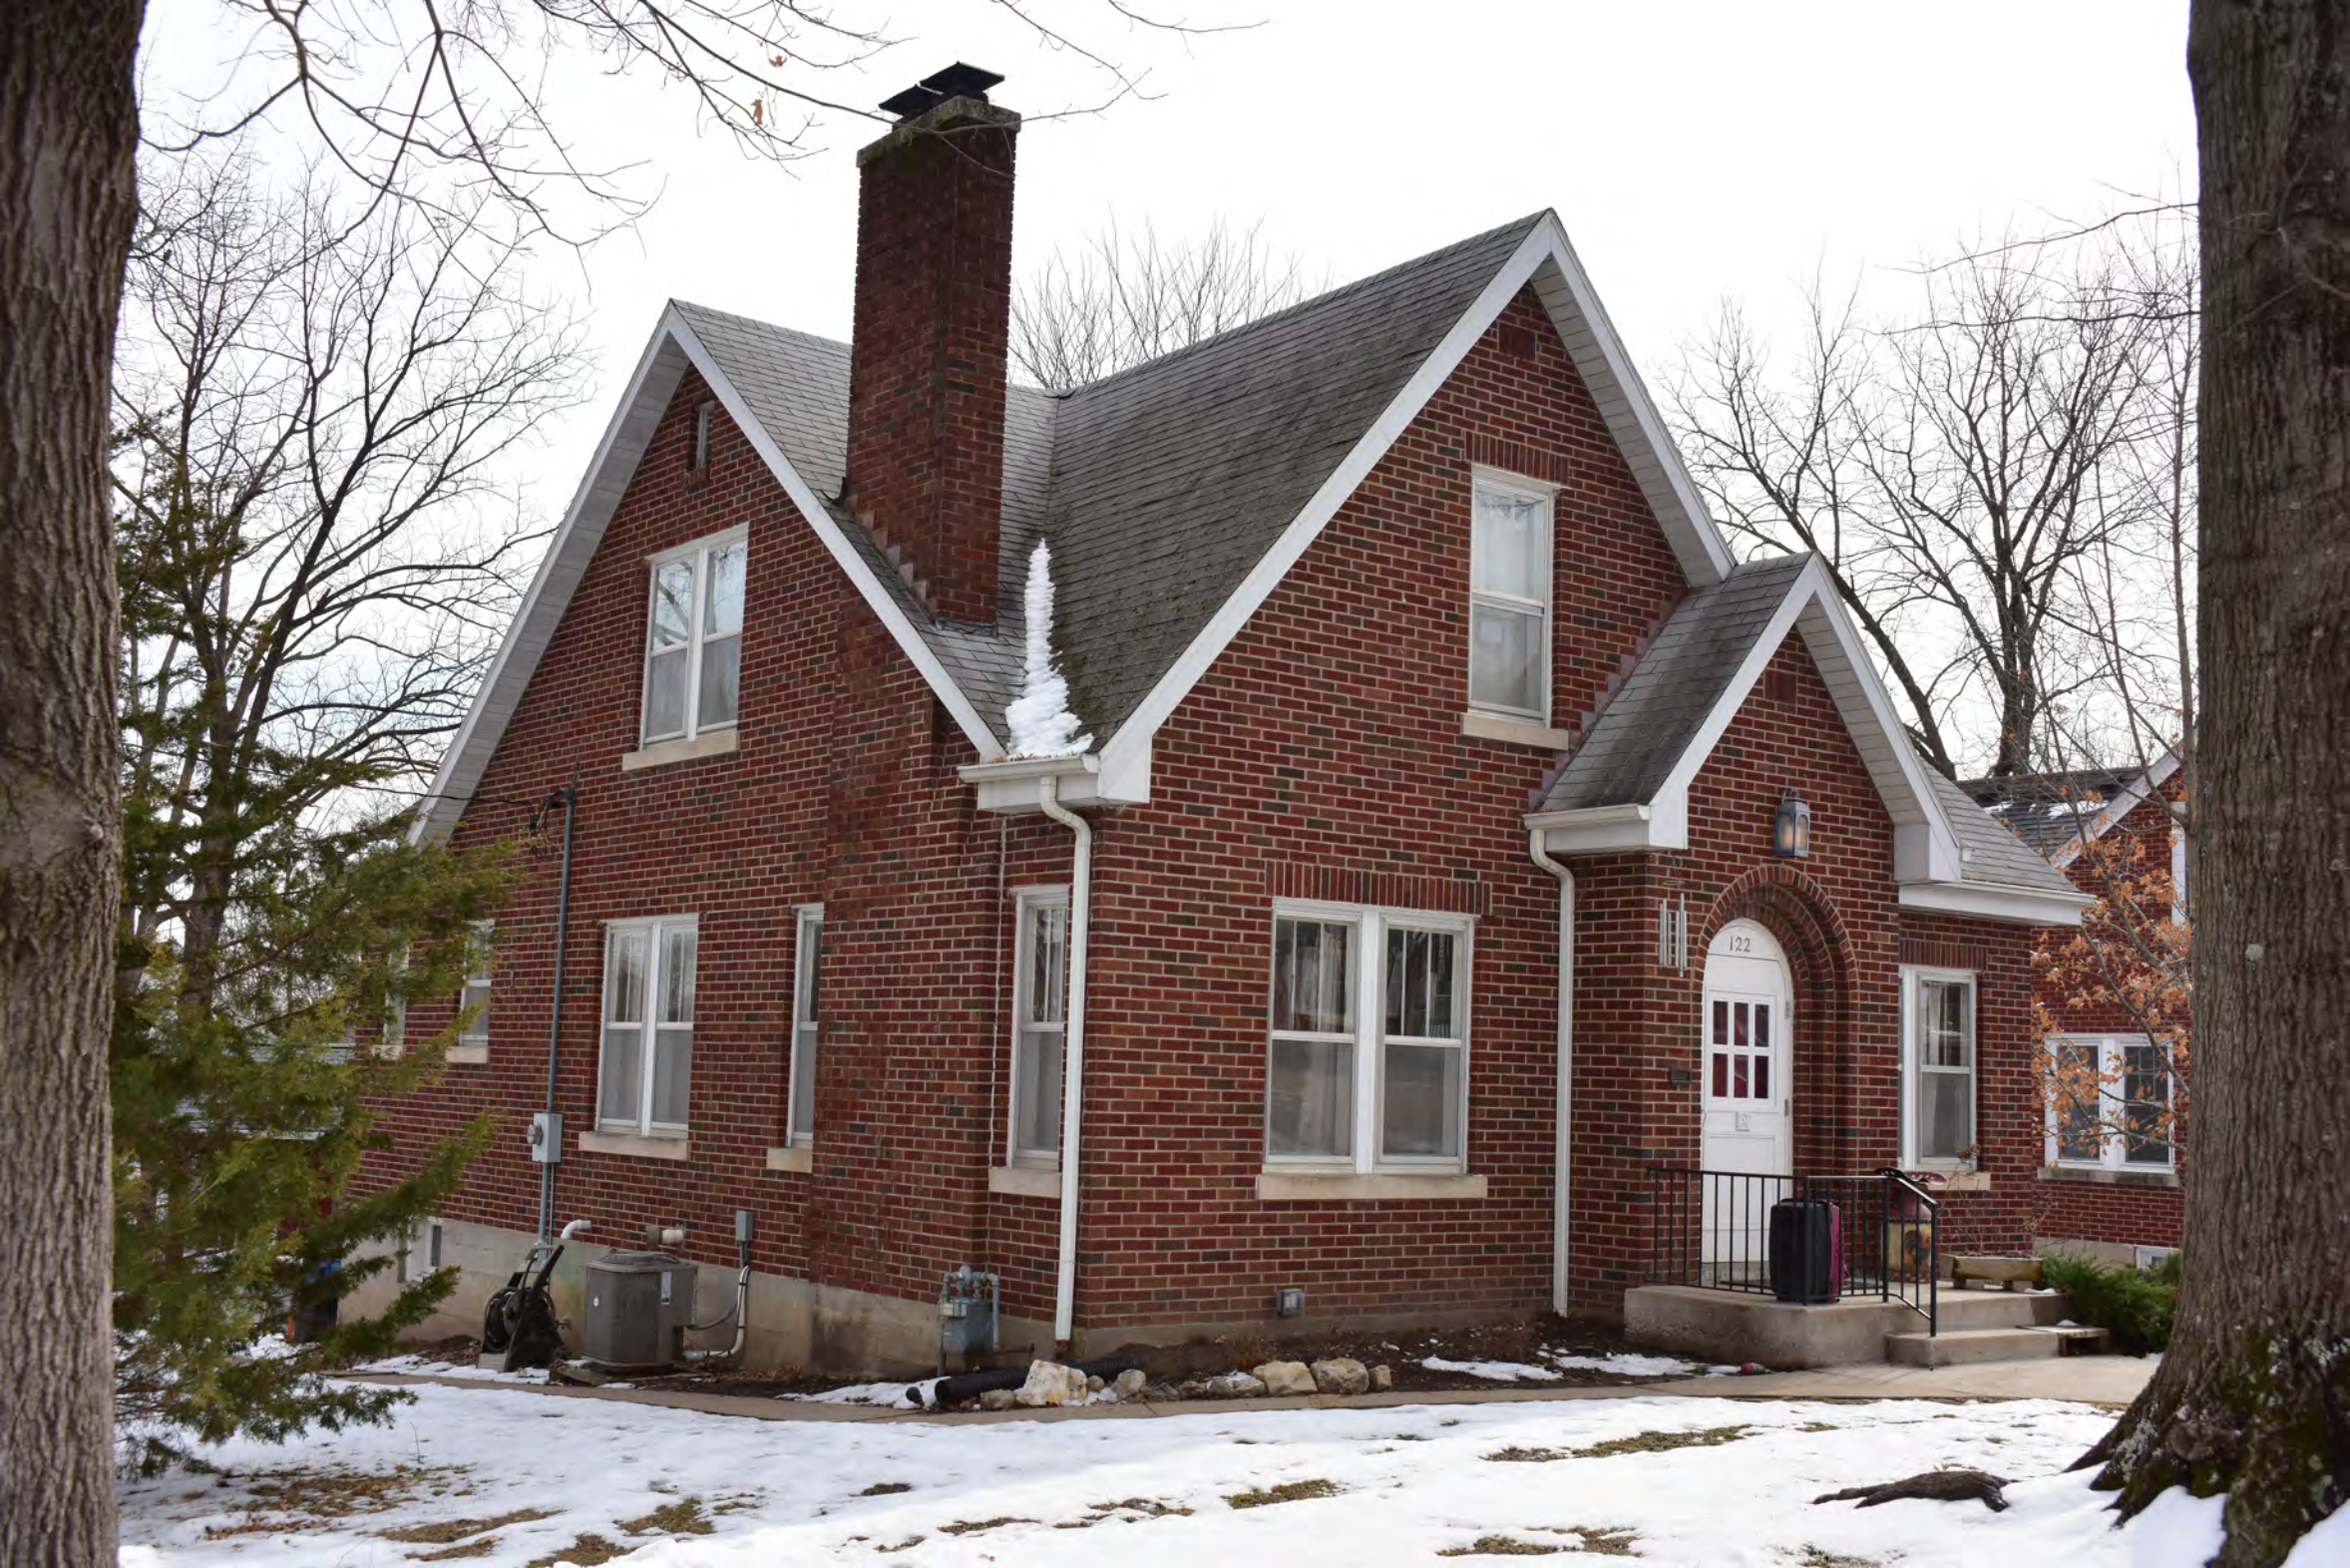
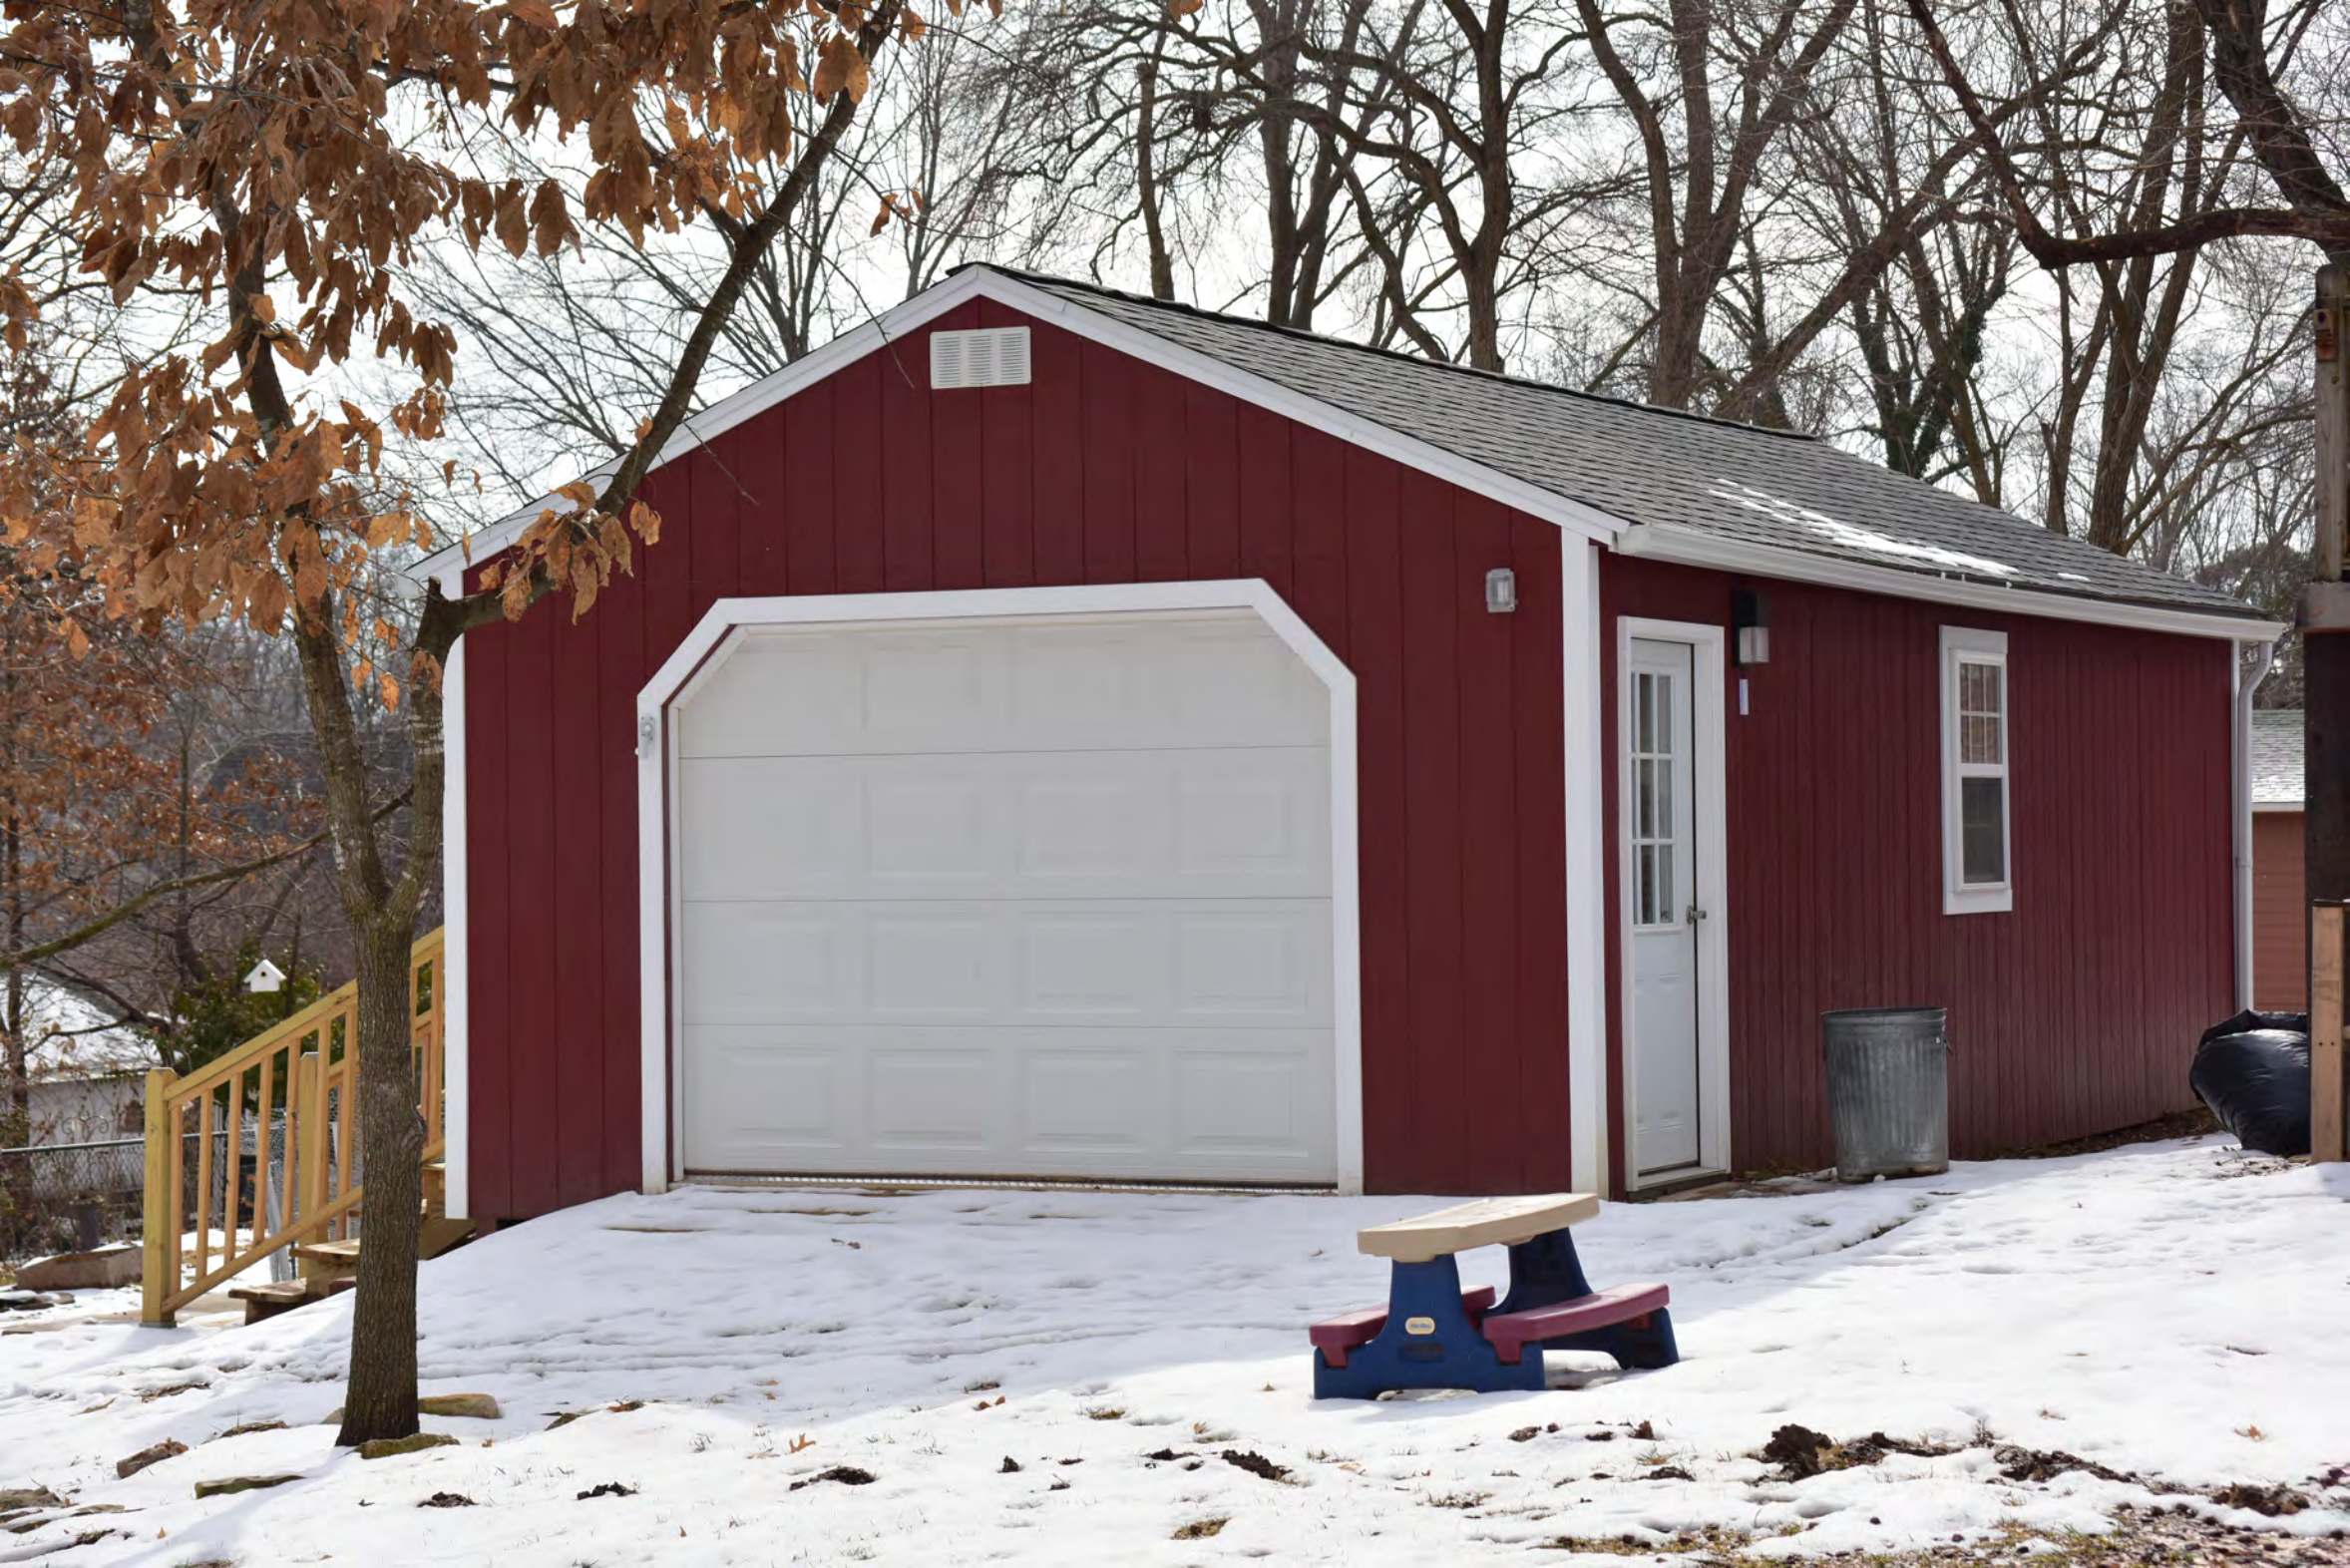
122 West Circle Drive is a one-and-one-half story Minimal Traditional dwelling. It has a concrete foundation, brick cladding, and an asphalt intersecting-gable roof. A side-gable roof with a low cross gable fronts West Circle Drive while a perpendicular gable extends to the rear. A brick chimney pierces the front slope at the north end. The dwelling is three bays wide. The north cross-gable contains the first bay. Two-ganged 3/1 historic wood windows with a continuous cast stone sill and soldier brick lintel define the bay. A nested gable projects from the cross-gable, forming an enclosed vestibule. The entrance to the centered vestibule includes a rounded arch opening with a stepped brick surround. A non-historic wood door fills the bay. Three-ganged 3/1 historic wood windows with a continuous cast stone sill and soldier brick lintel windows define the remaining primary elevation bay. A low concrete stoop with metal railings extends from the vestibule. A vinyl-clad shed-roof enclosed porch tops an integrated historic single-car garage is located at basement level and accessed at the rear.

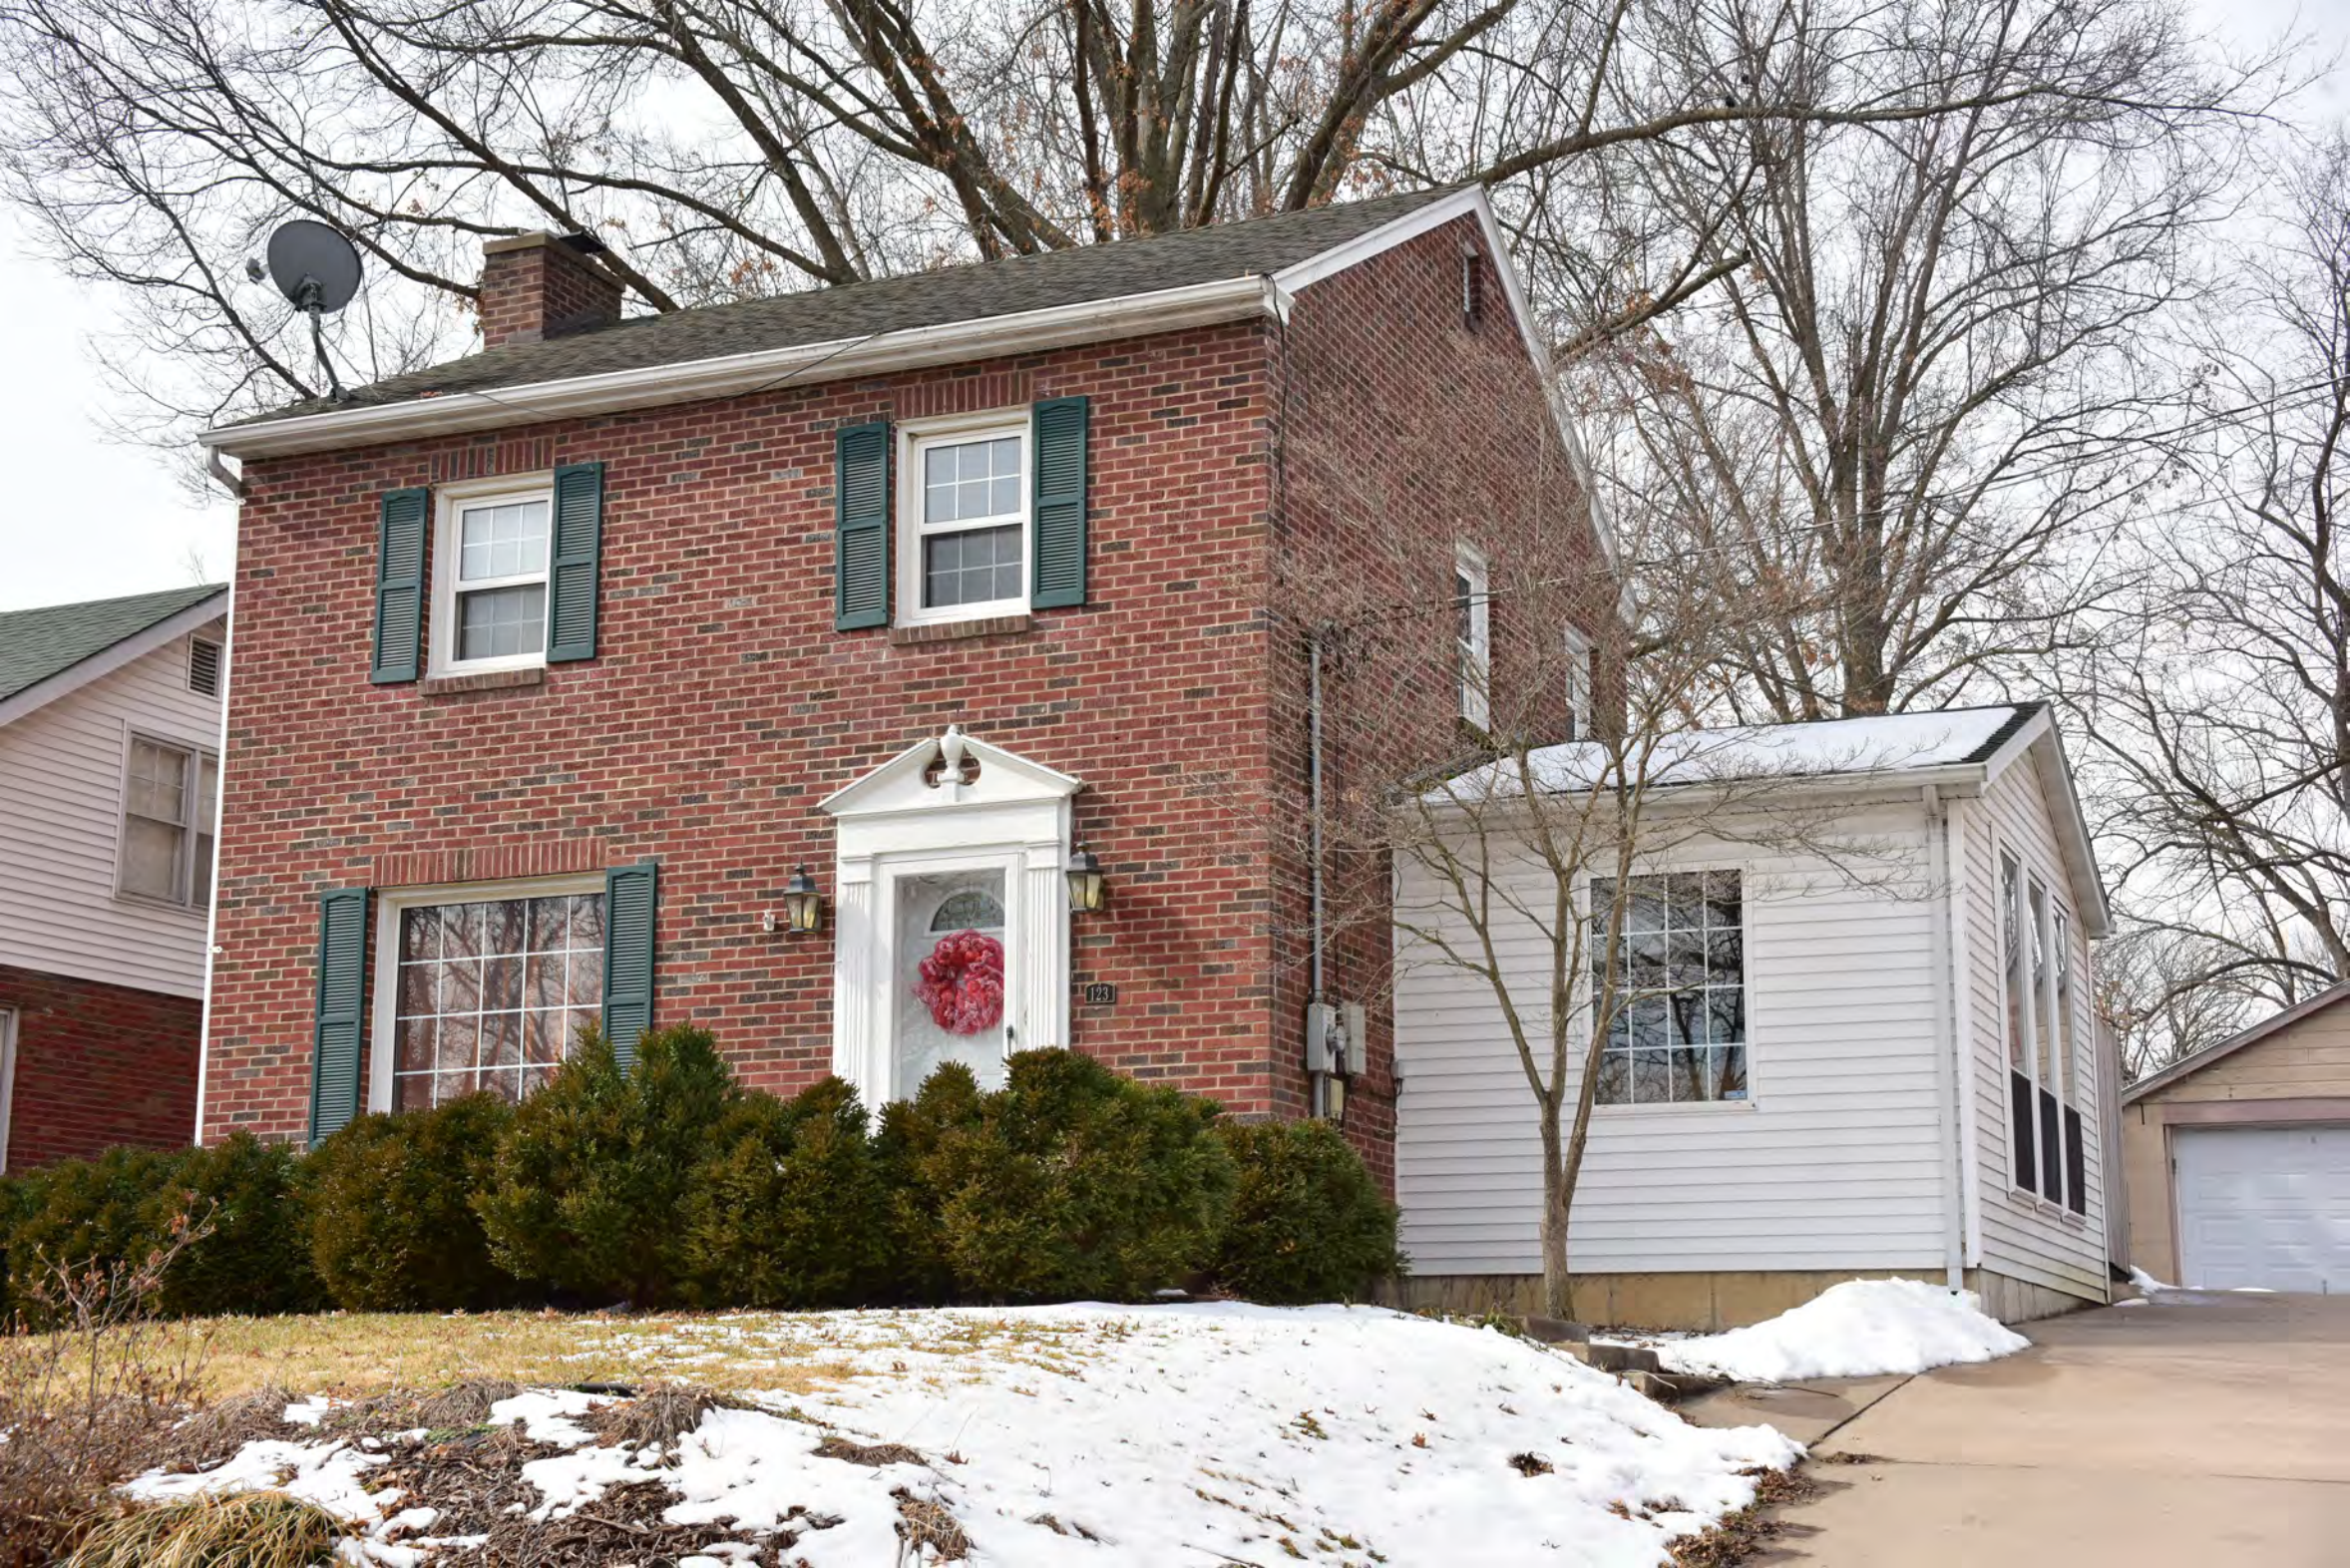
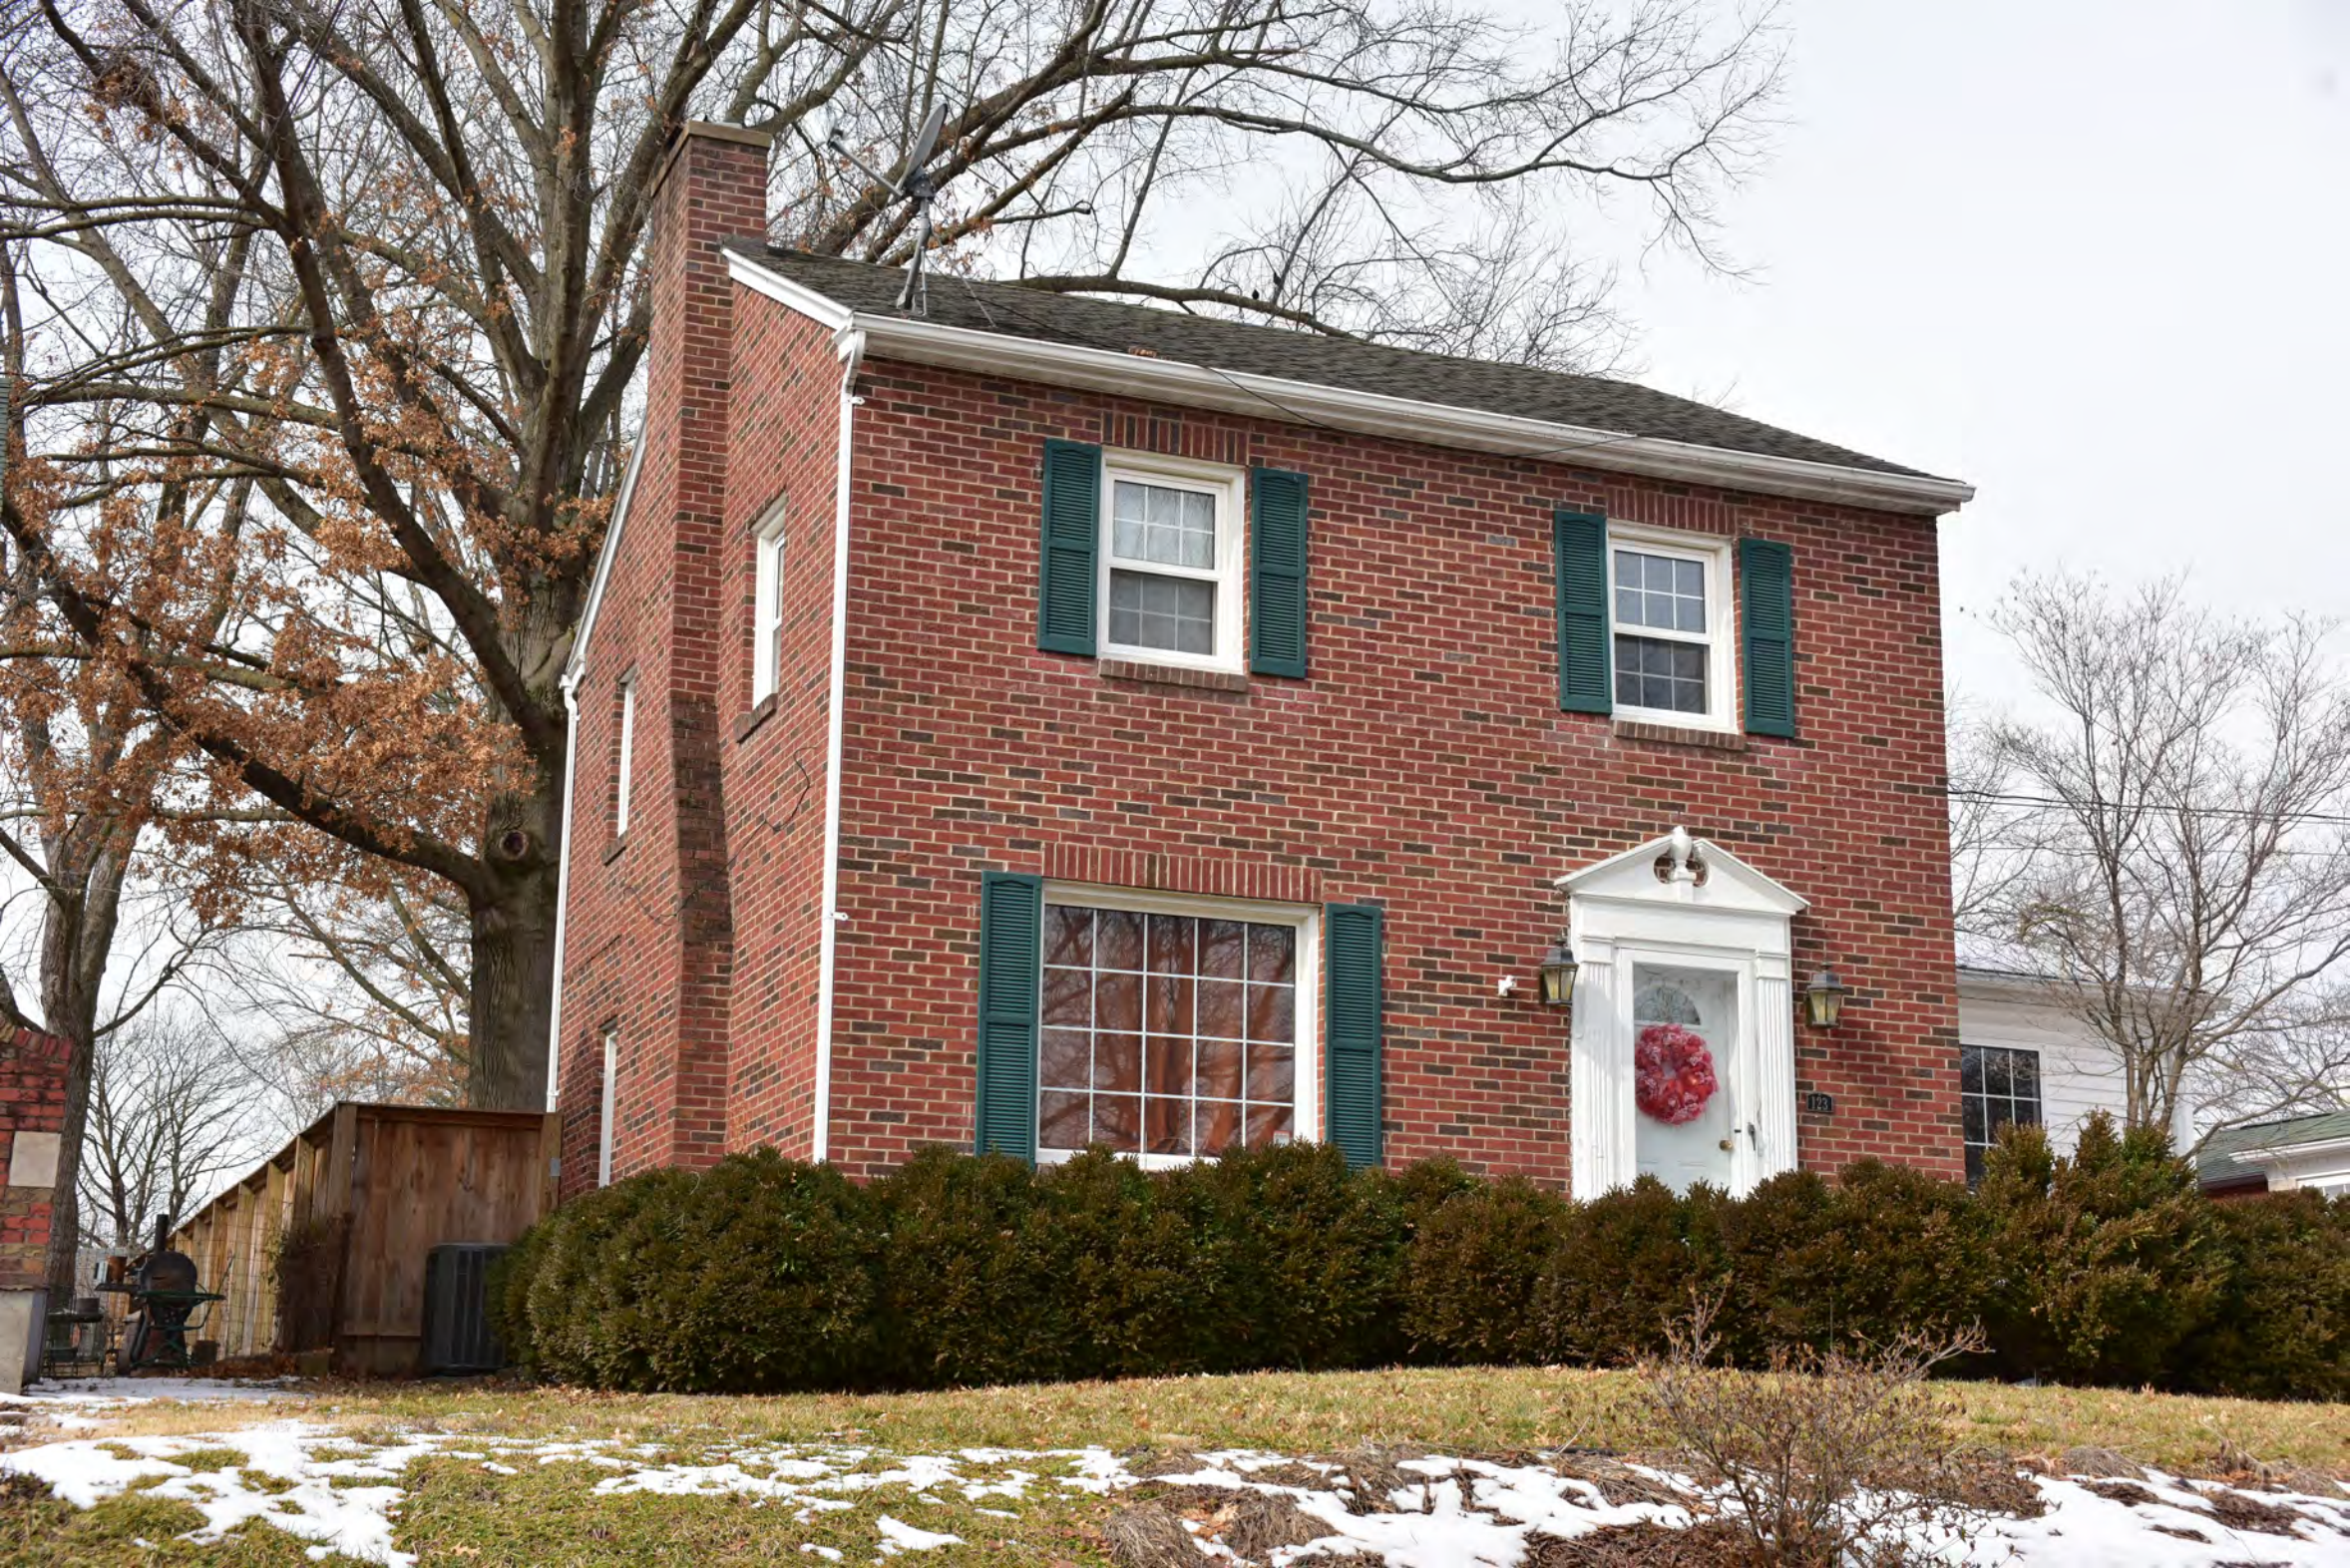
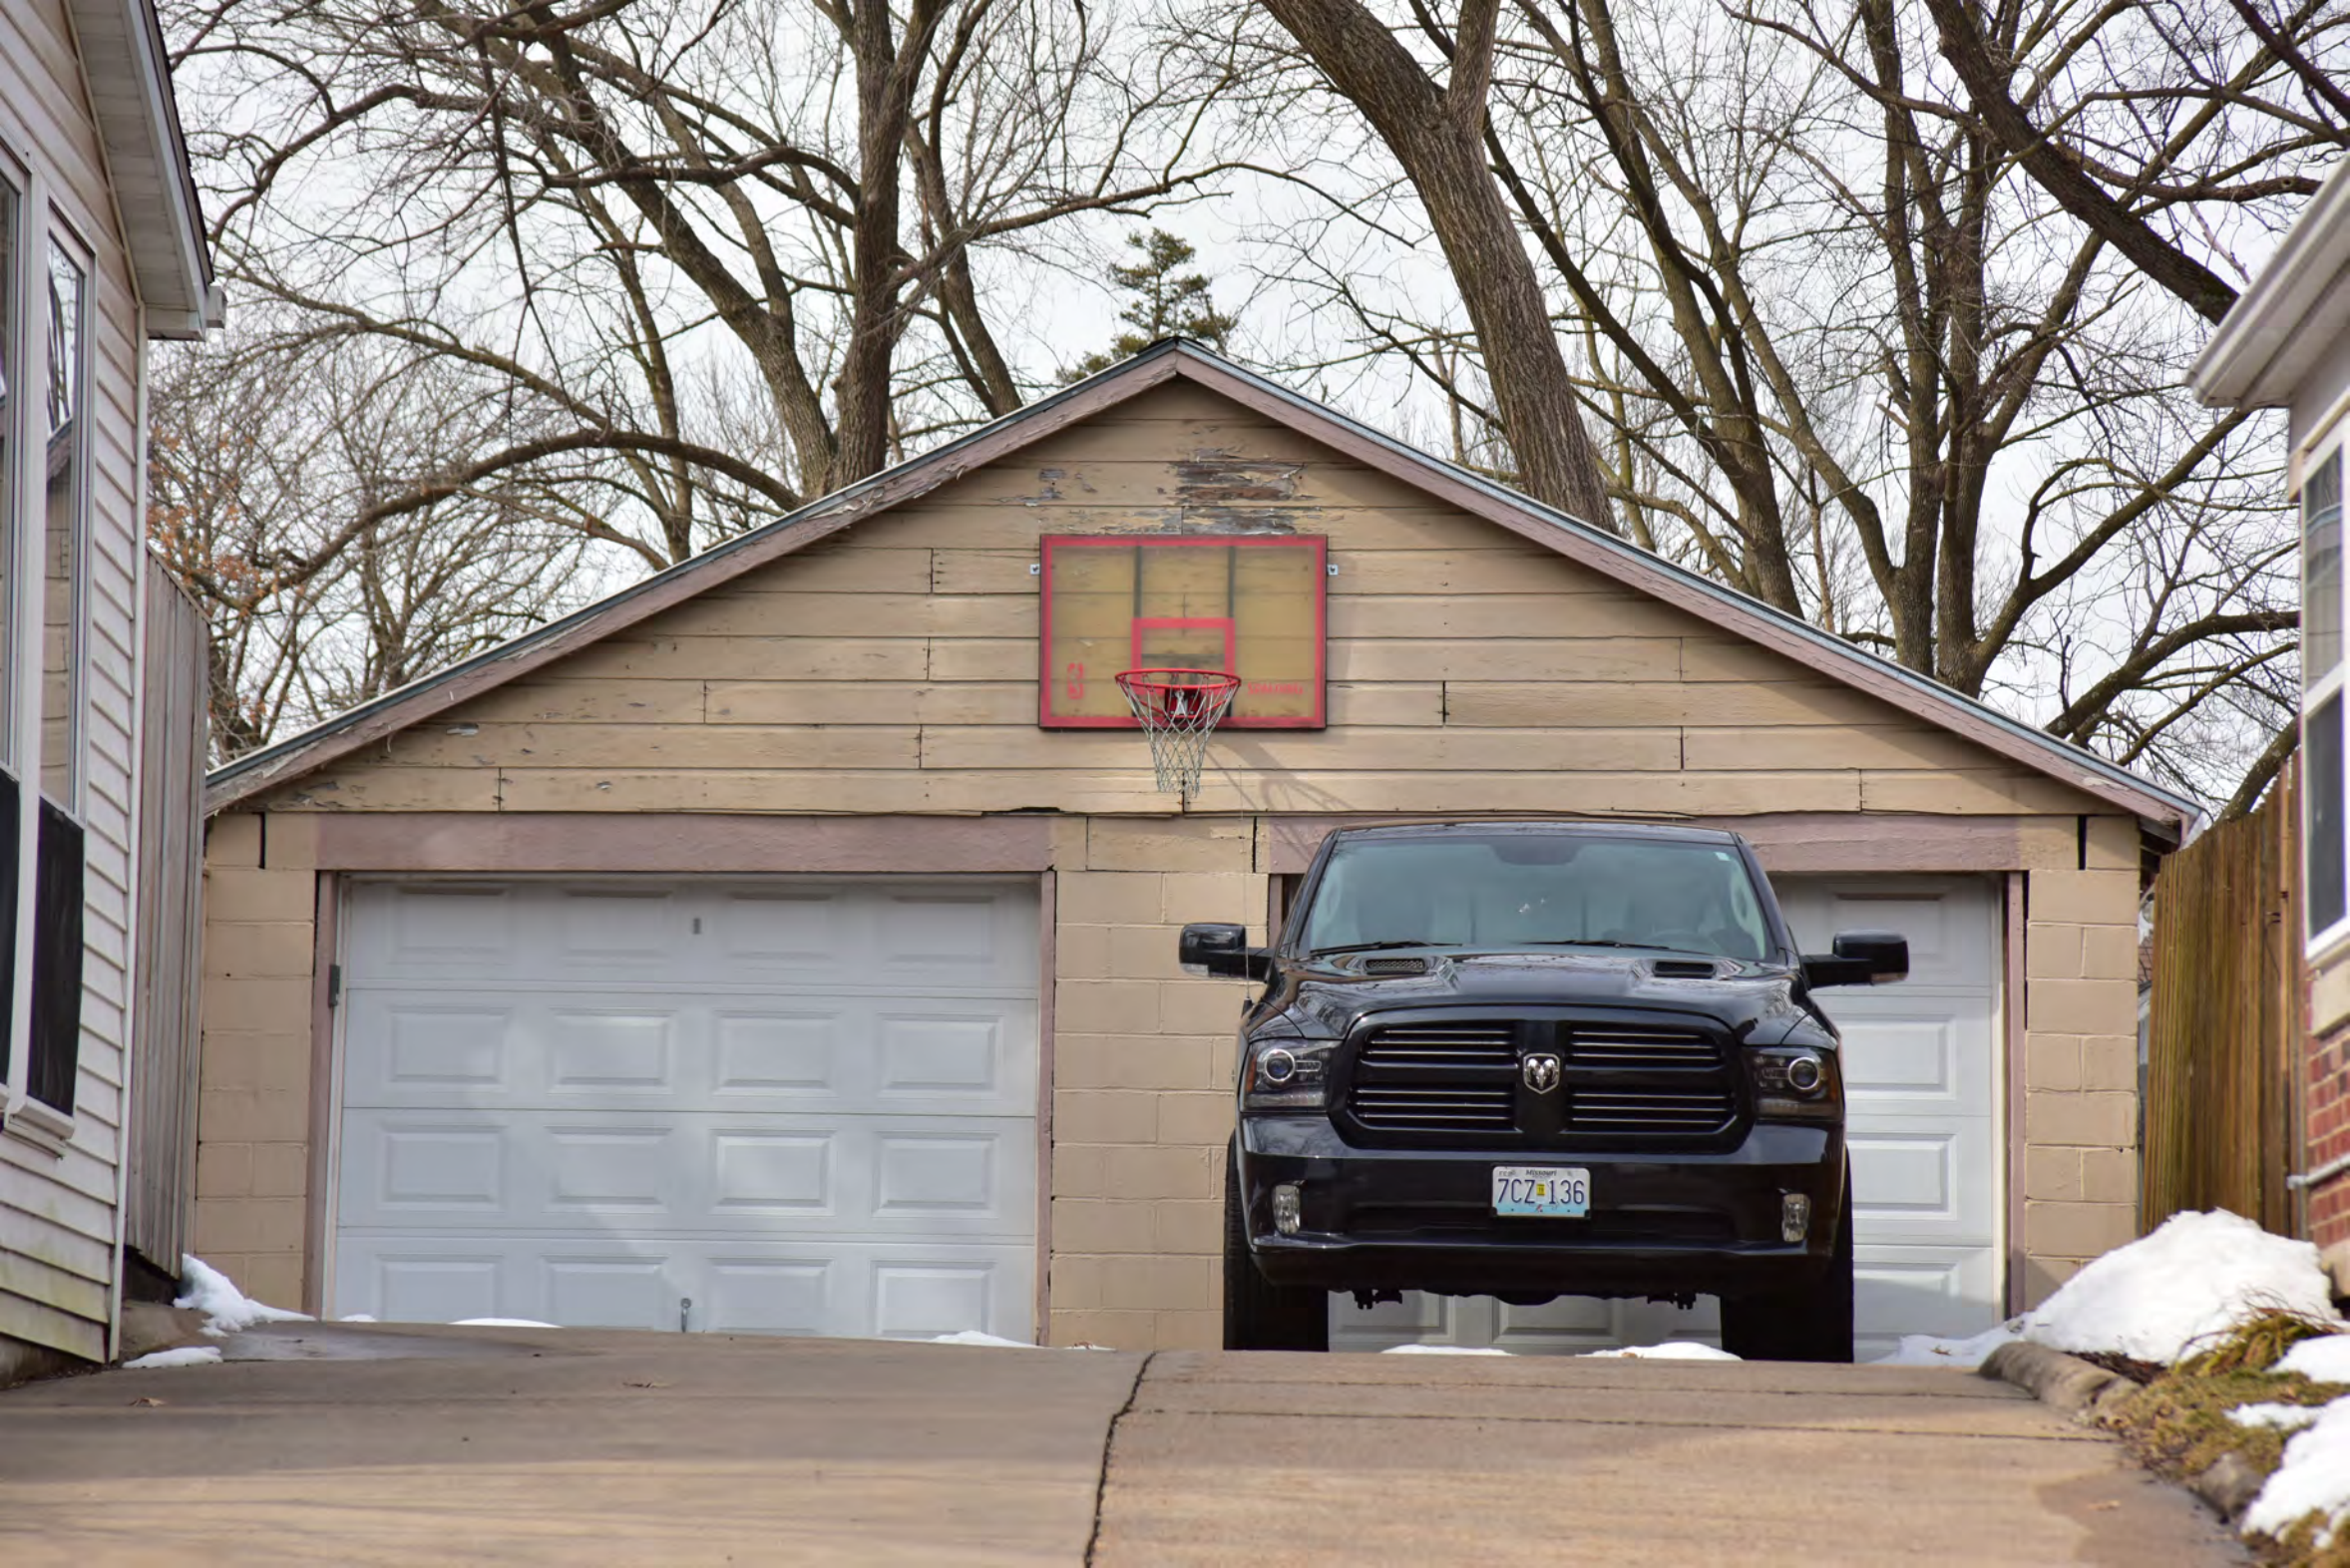
123 West Circle Drive is a two-story Colonial Revival dwelling. The brick-clad dwelling has a concrete foundation and asphalt side gable roof. A brick exterior chimney pierces the south gable end apex. The dwelling is two bays wide. The primary entrance defines the north bay. The entrance features a non-historic wood door and neo-classical surround with pilasters and pediment. A non-historic twenty-light fixed vinyl window with snap-in muntins and soldier brick lintel fills the south bay. Non-historic 6/6 vinyl windows fill both second-story bays. A one-story side-gable enclosed porch projects from the north elevation.
