1. Survey number: CO-AS-008-001		2. Survey Name: West Main Street Survey	
3. County: Cole		4. Address (Street No.): 100	Street (name): East Circle Drive
5. City: Jefferson City	Vicinity <input type="checkbox"/>	6. Lat / Long:	7. Township/Range/Section: T: R: S:
8. Historic name (if known):		9. Present/other name (if known):	
10. Ownership: <input checked="" type="checkbox"/> Private <input type="checkbox"/> Public		11a. Historic use (if known): Domestic-Single Dwelling	11b. Current use: Domestic-Single Dwelling

MISSOURI DEPARTMENT OF NATURAL RESOURCES
STATE HISTORIC PRESERVATION OFFICE, P.O. Box 178, Jefferson City, MO 65102
ARCHITECTURAL/HISTORIC INVENTORY FORM

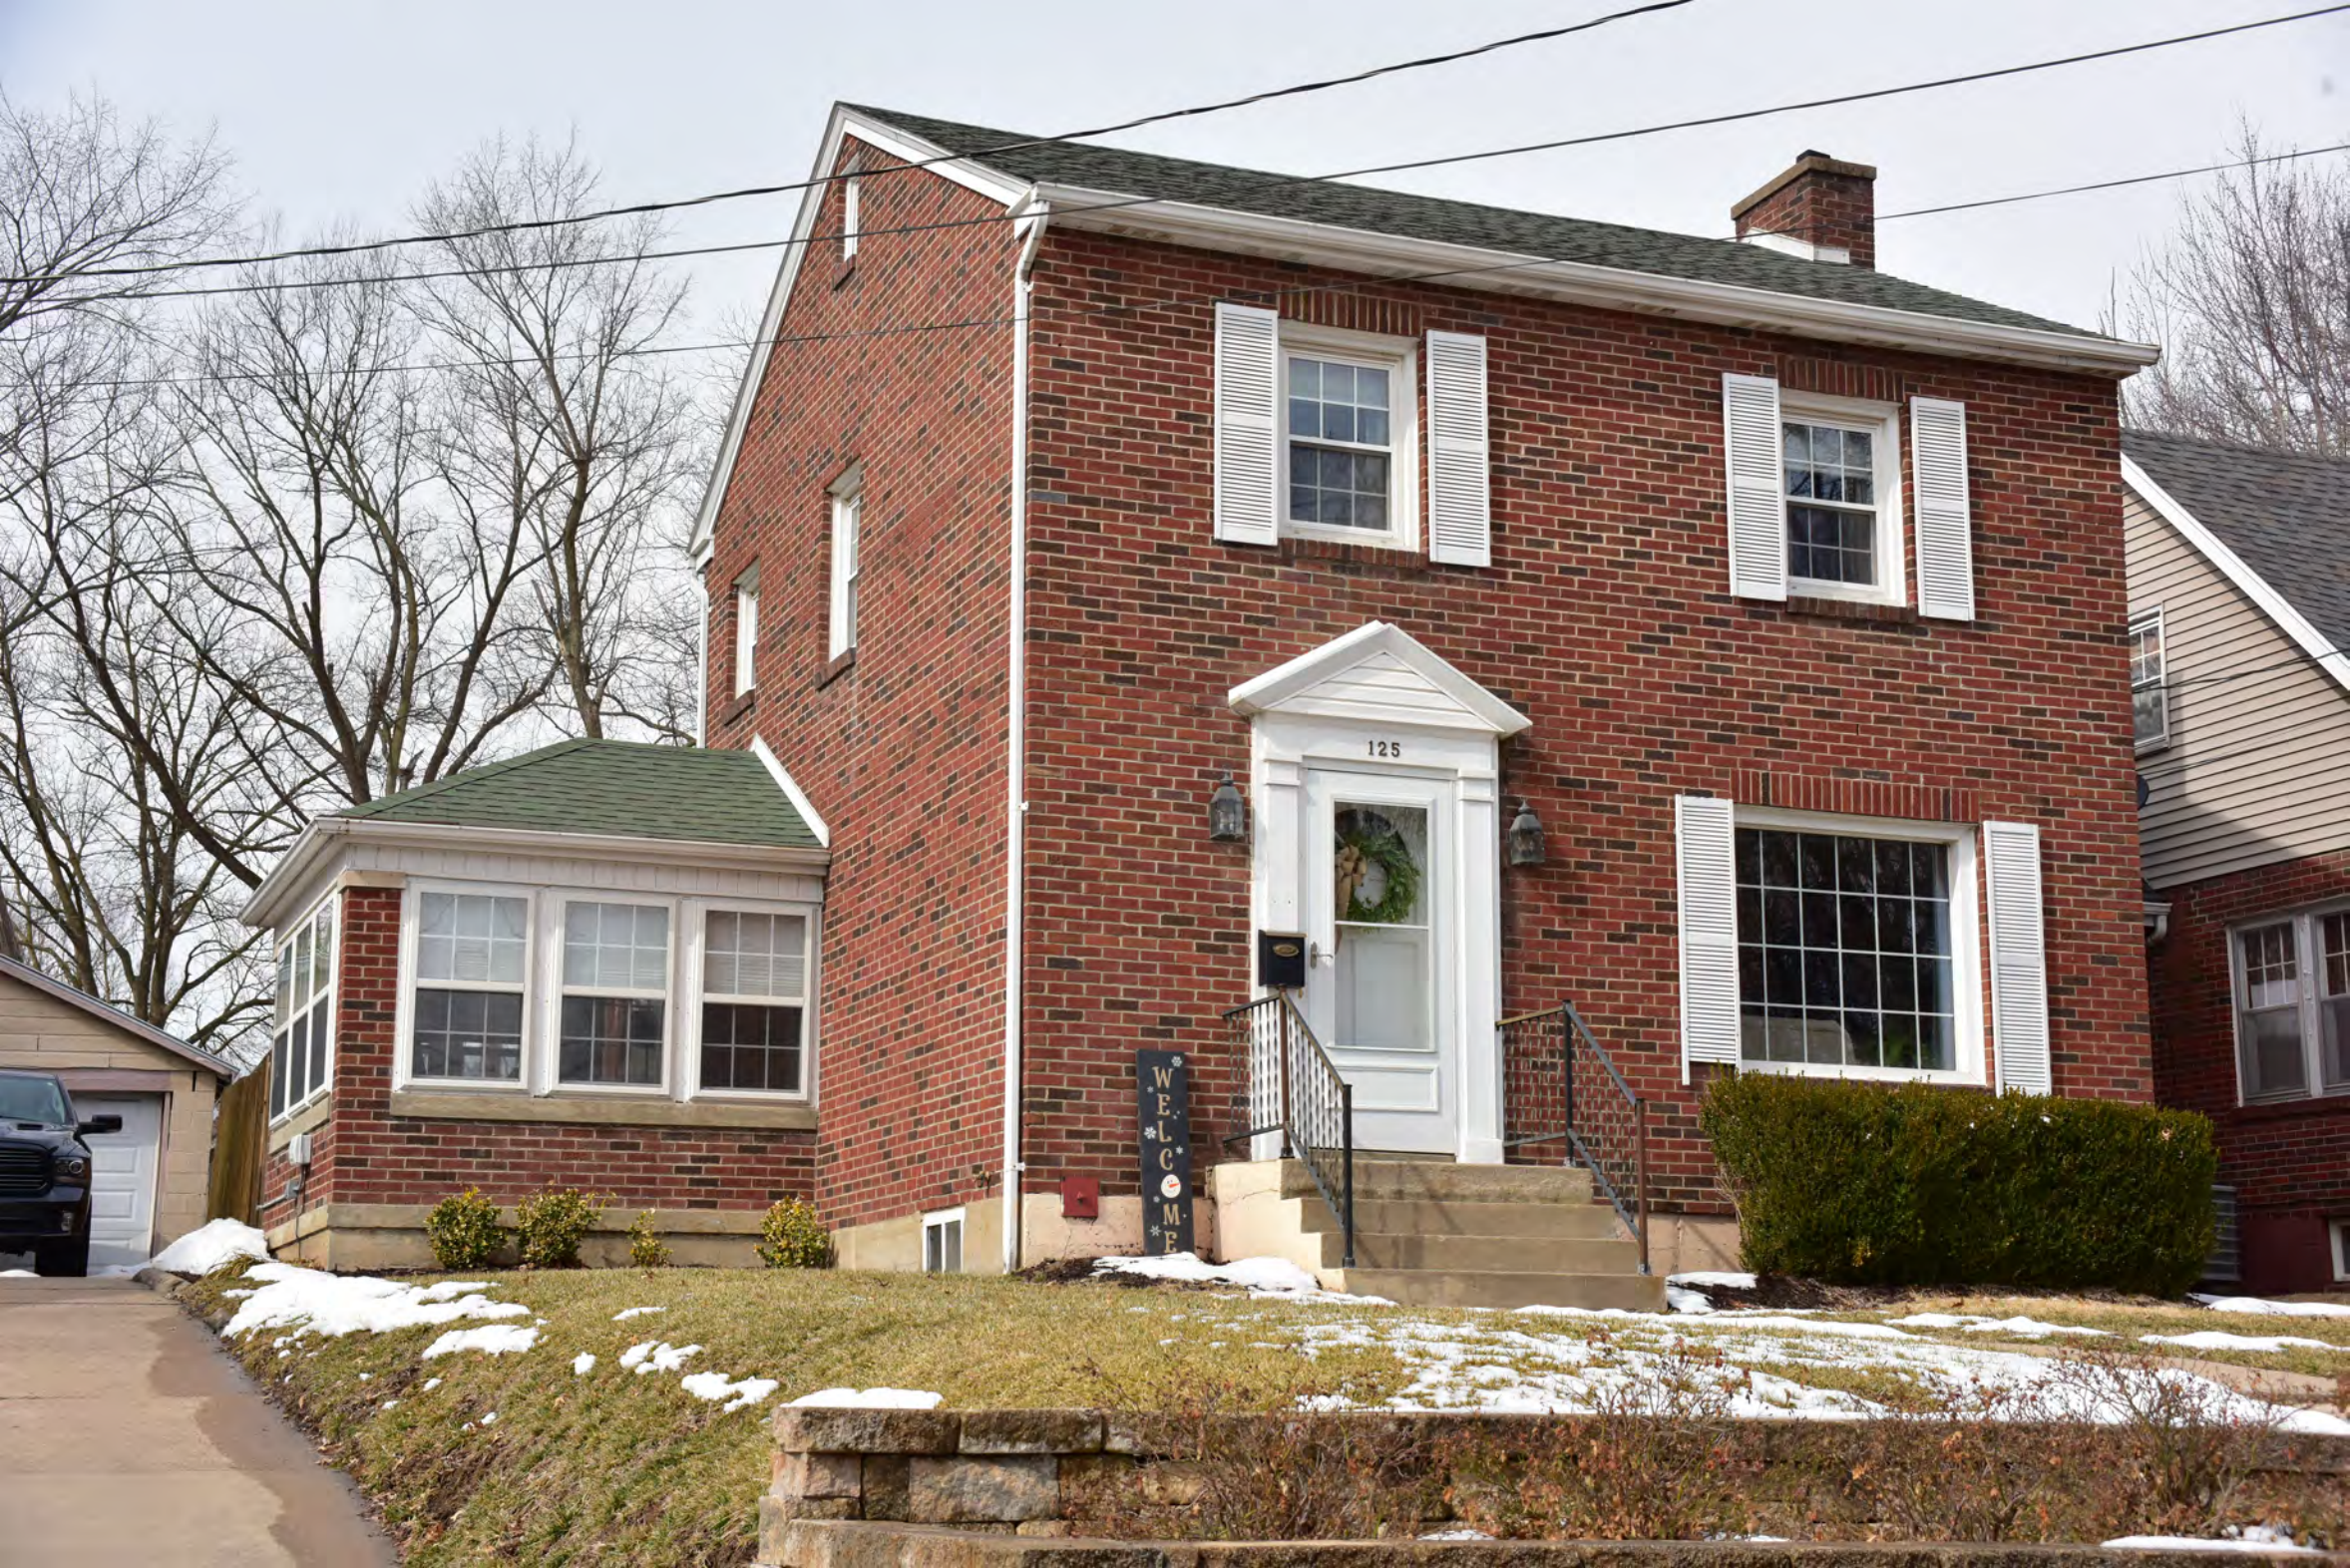
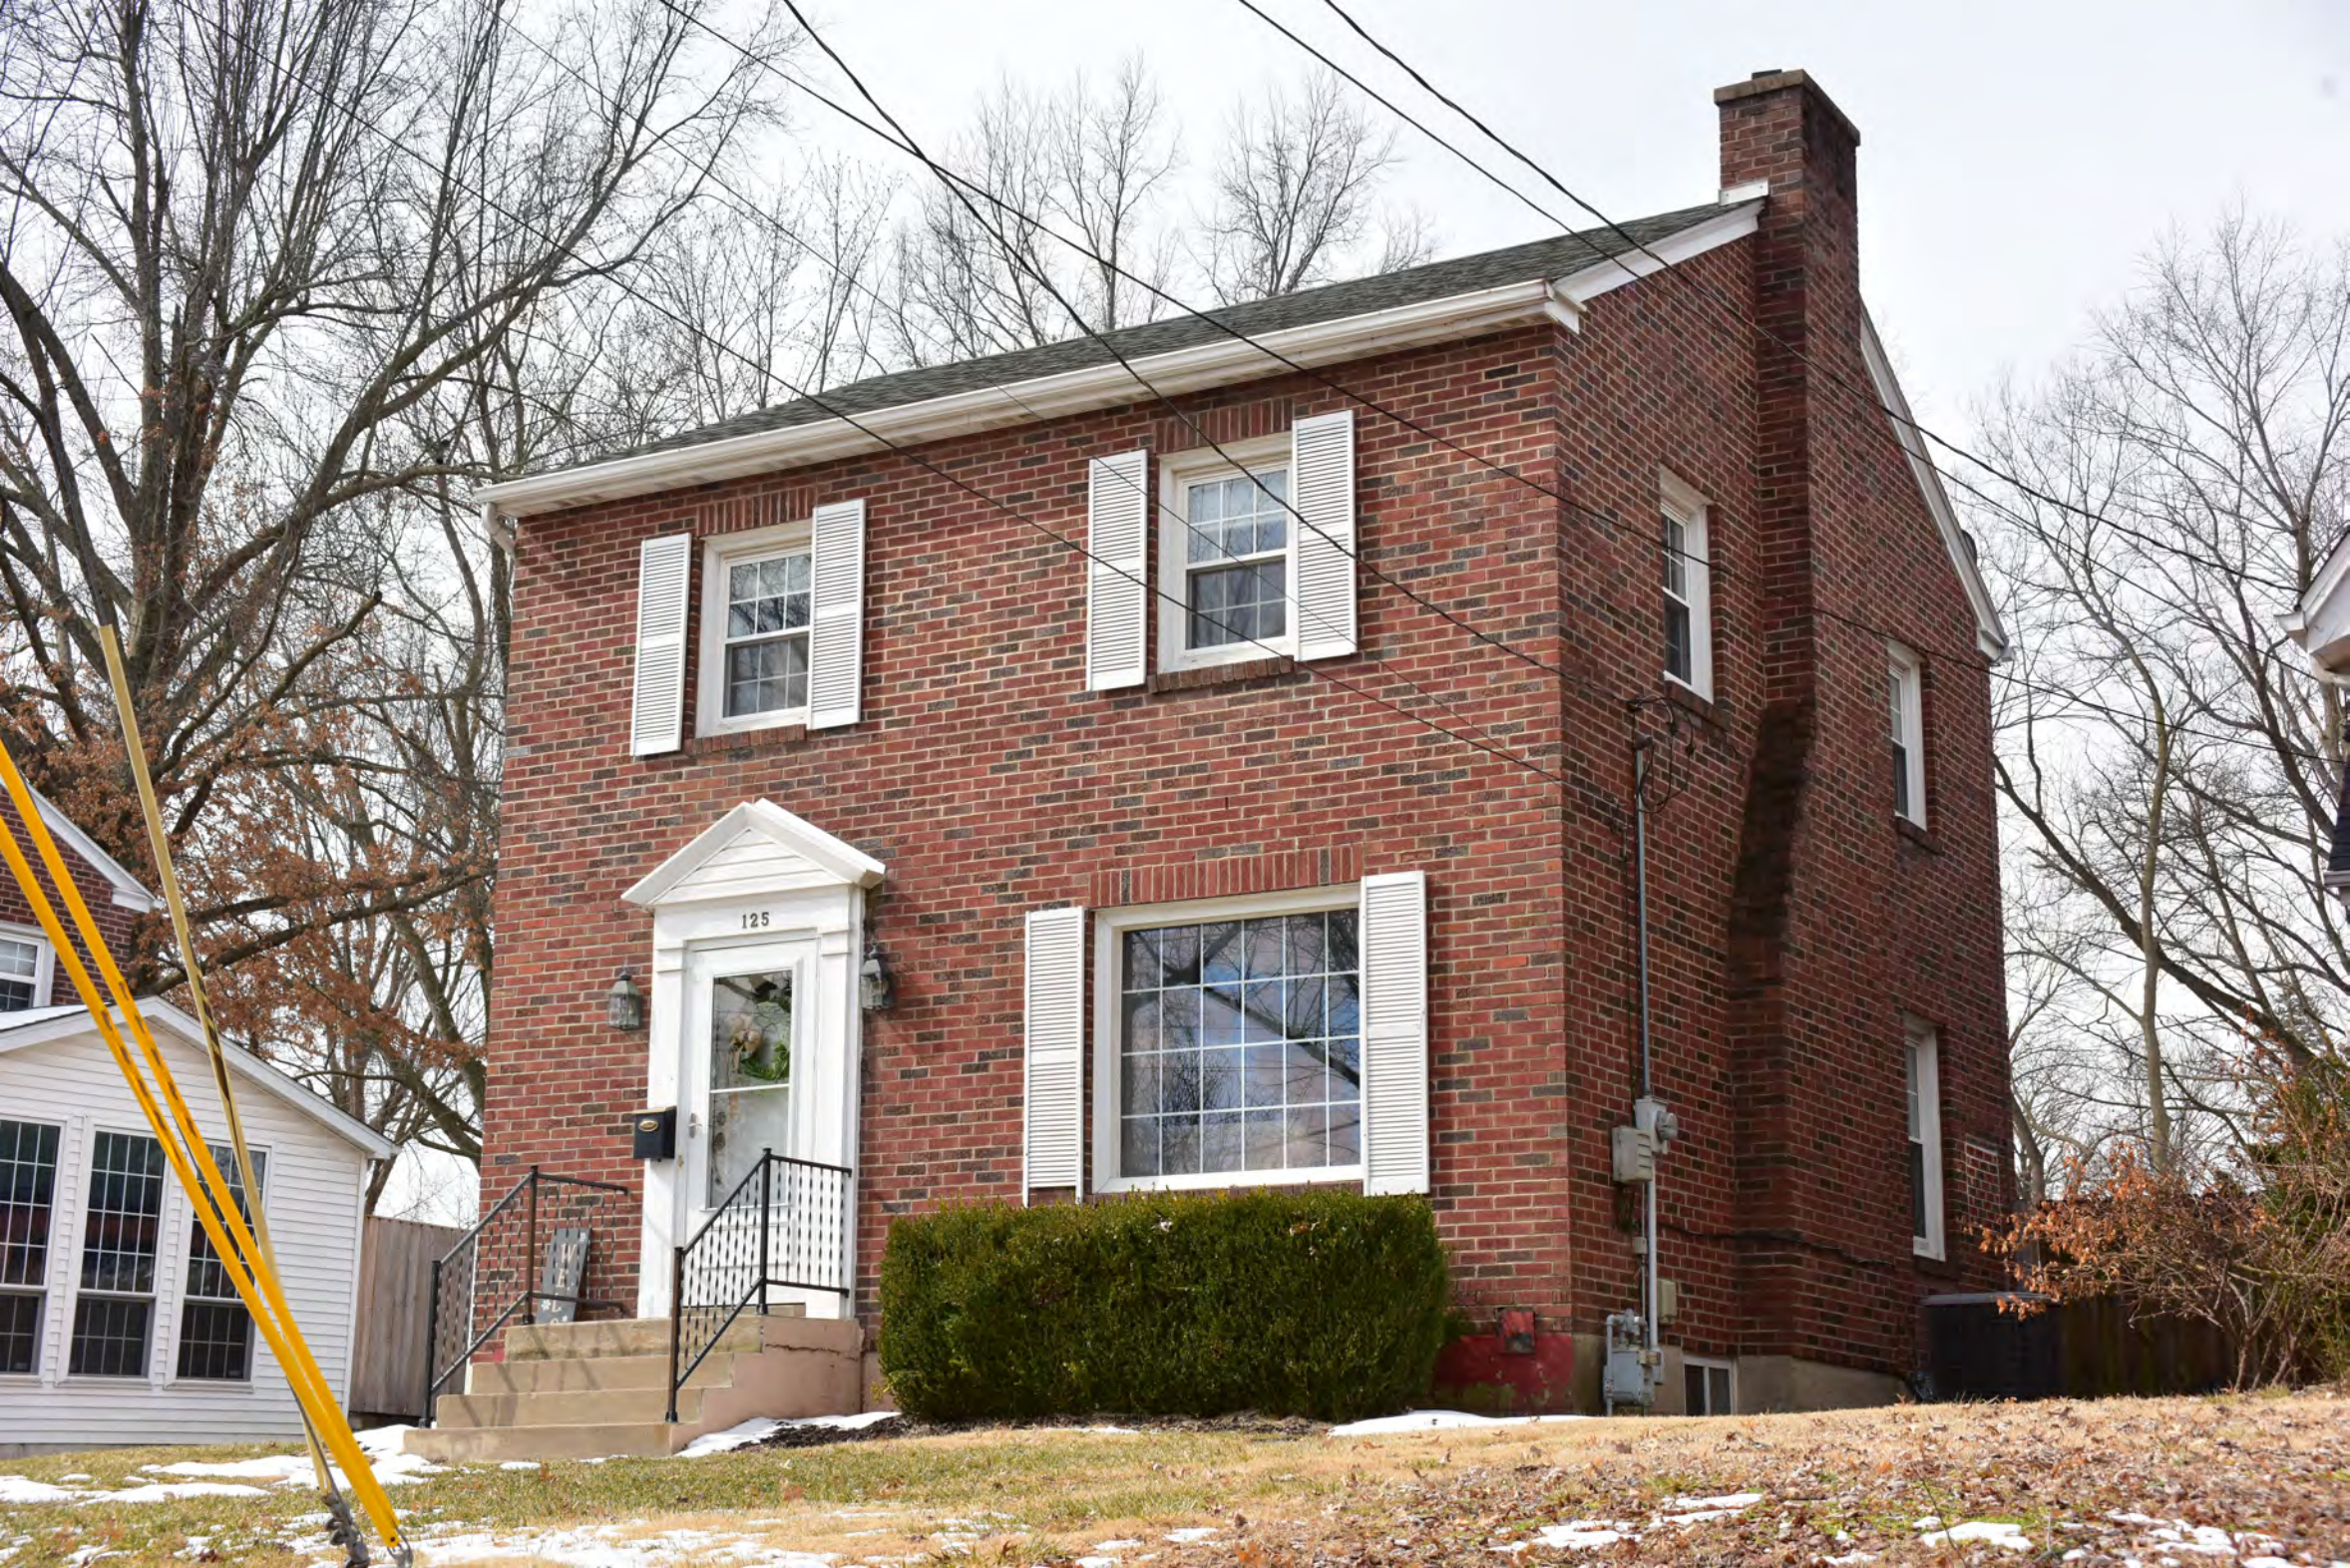
125 West Circle Drive mirrors its neighbor to the south, 123 West Circle Drive. It is a two-story Colonial Revival dwelling. The brick-clad dwelling has a concrete foundation and asphalt side gable roof. A brick exterior chimney pierces the north gable end apex. The dwelling is two bays wide. The primary entrance defines the south bay. The entrance features a non-historic wood door and neo-classical surround with pilasters and pediment. A concrete stoop with metal railings extends below the entrance. A non-historic twenty-light fixed vinyl window with snap-in muntins and soldier brick lintel fills the south bay. Non-historic 6/6 vinyl windows fill both second-story bays. A one-story hipped-roof enclosed porch projects from the south elevation. The brick-clad porch has a concrete foundation. Three-ganged 6/6 vinyl windows with continuous cast stone sills fill the visible bays. A c. 2010 gable-front addition extends from the rear; however, it is not visible from the right of way.

Alterations to 125 West Circle Drive the replacement of historic windows with vinyl replacements windows and a c. 2010 rear addition. 125 West Circle Drive retains fair integrity. This resource would be contributing to the potential Walinko Place Historic District, significant in the areas of Architecture and Community Planning and Development in association with the expansion of Jefferson City and increased suburban development during the twentieth century as well as its associations with Walinko Place, a notable suburban development during the Depression and War Years.

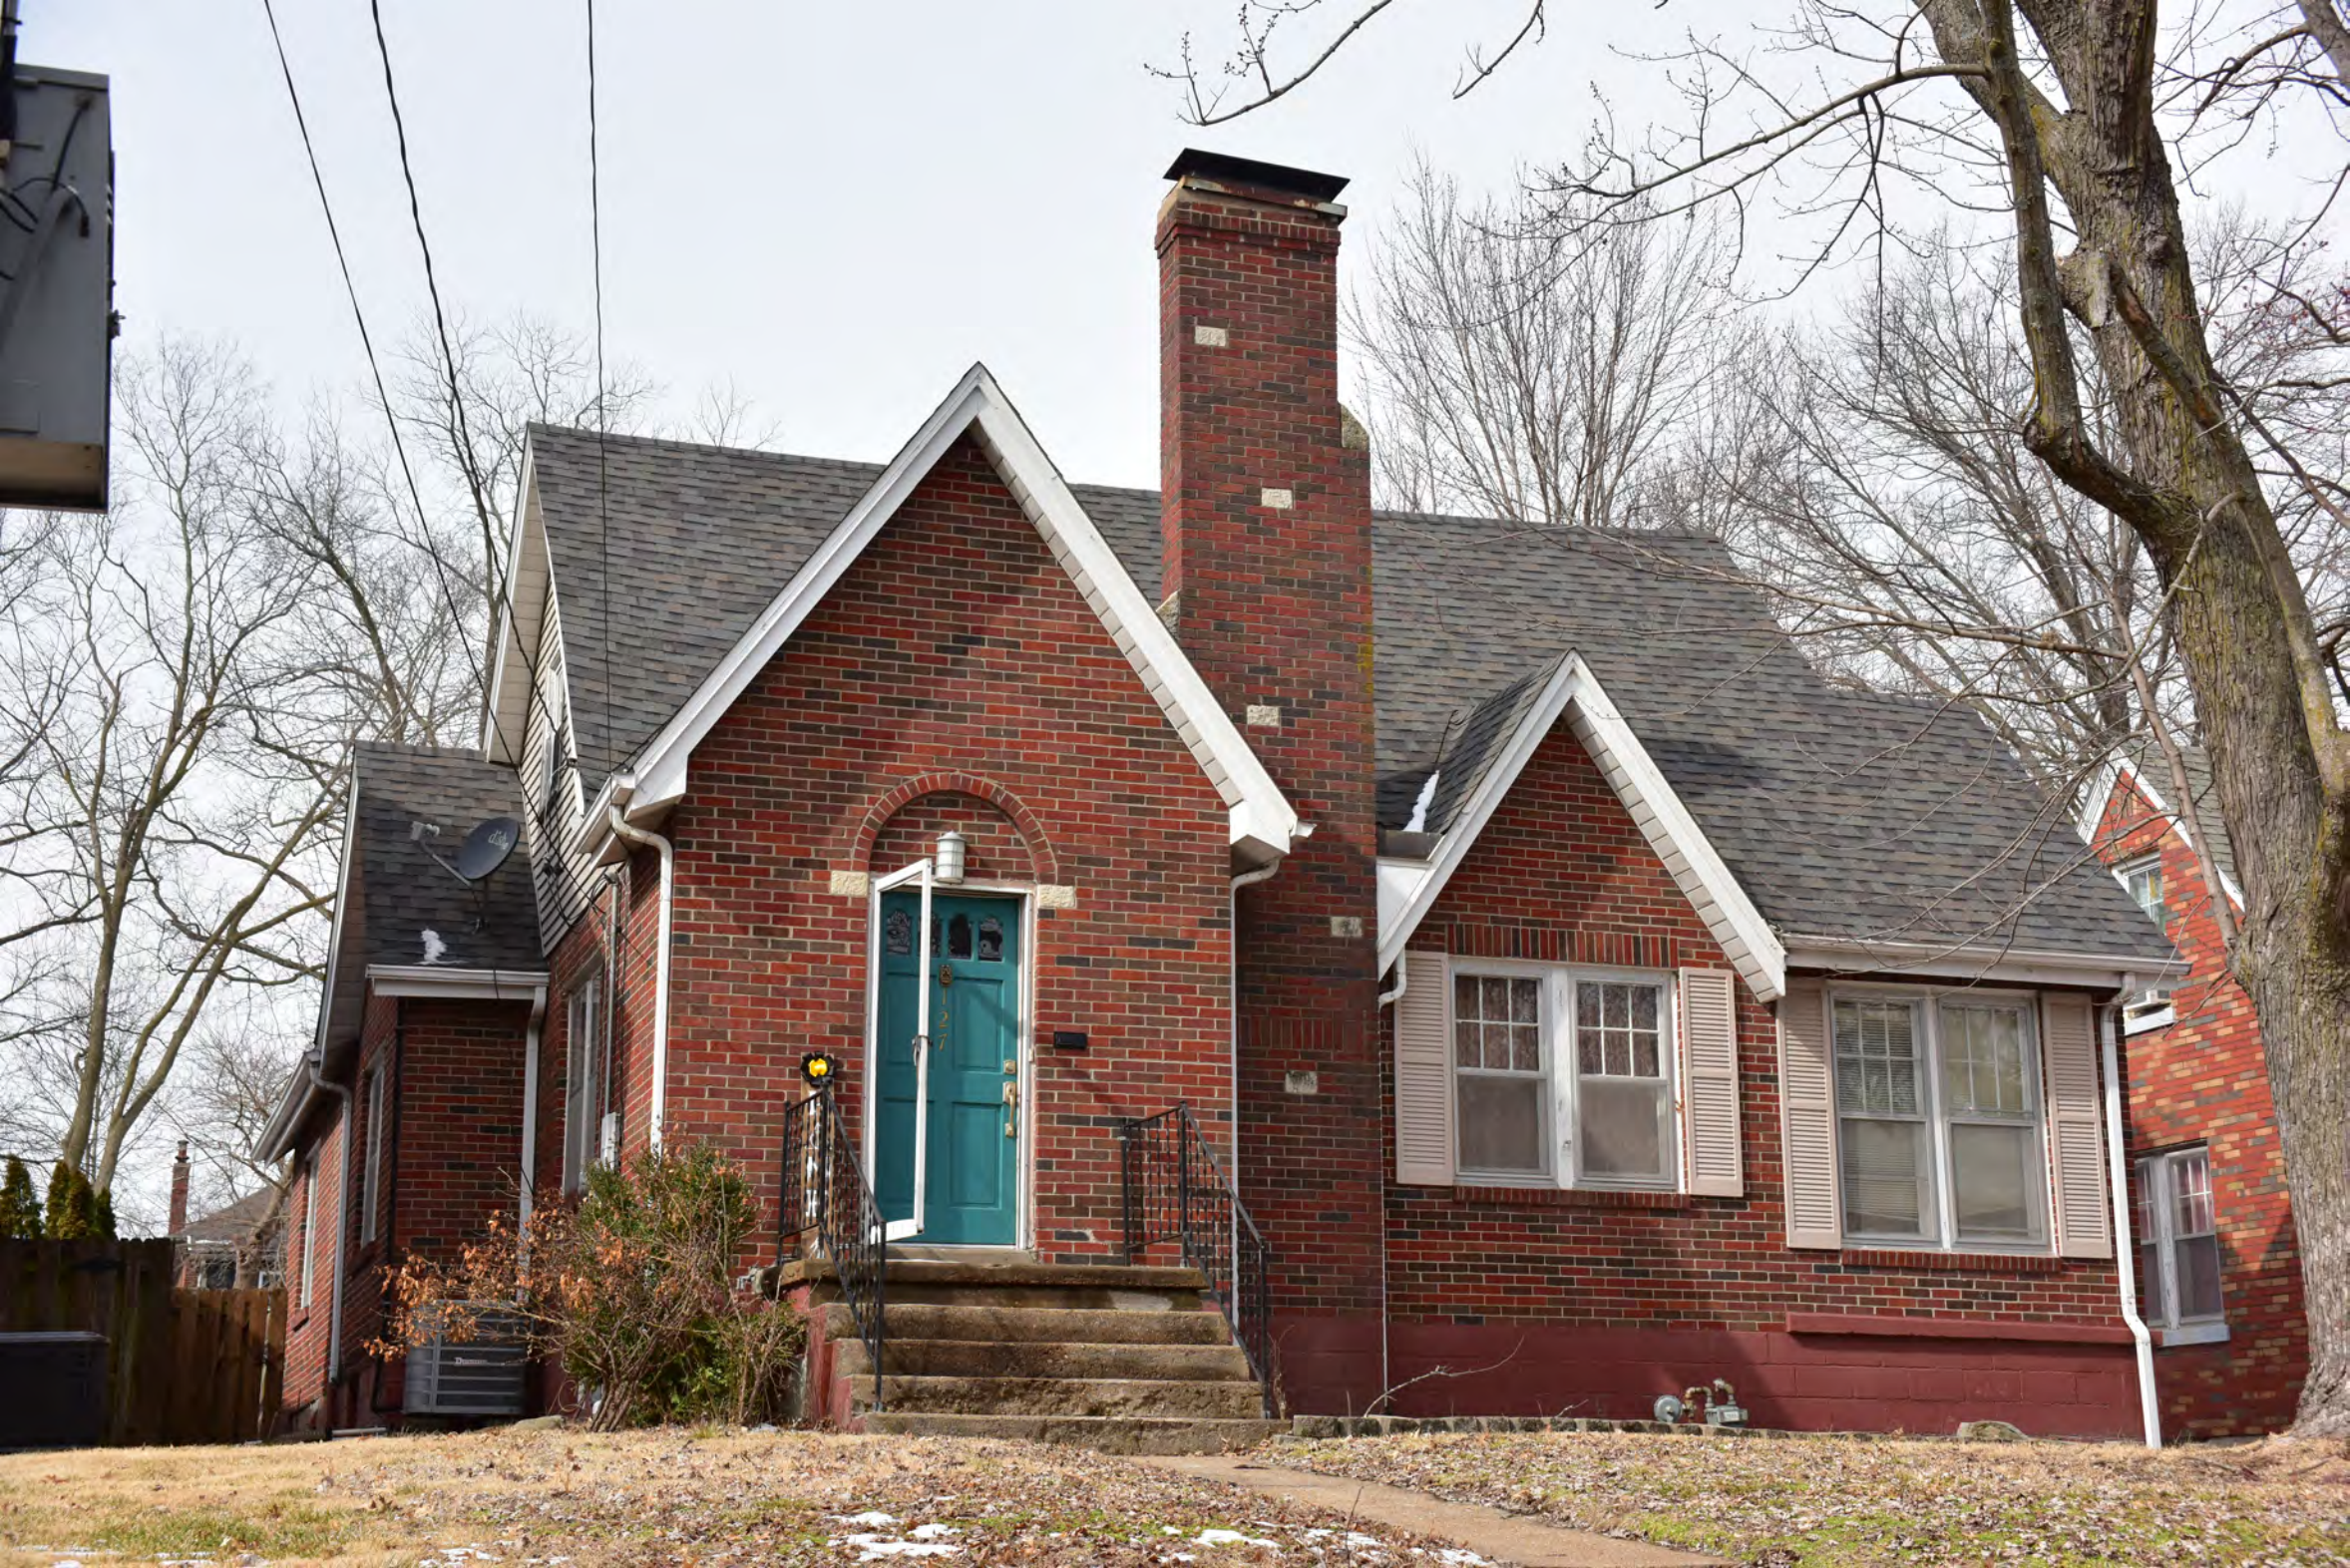
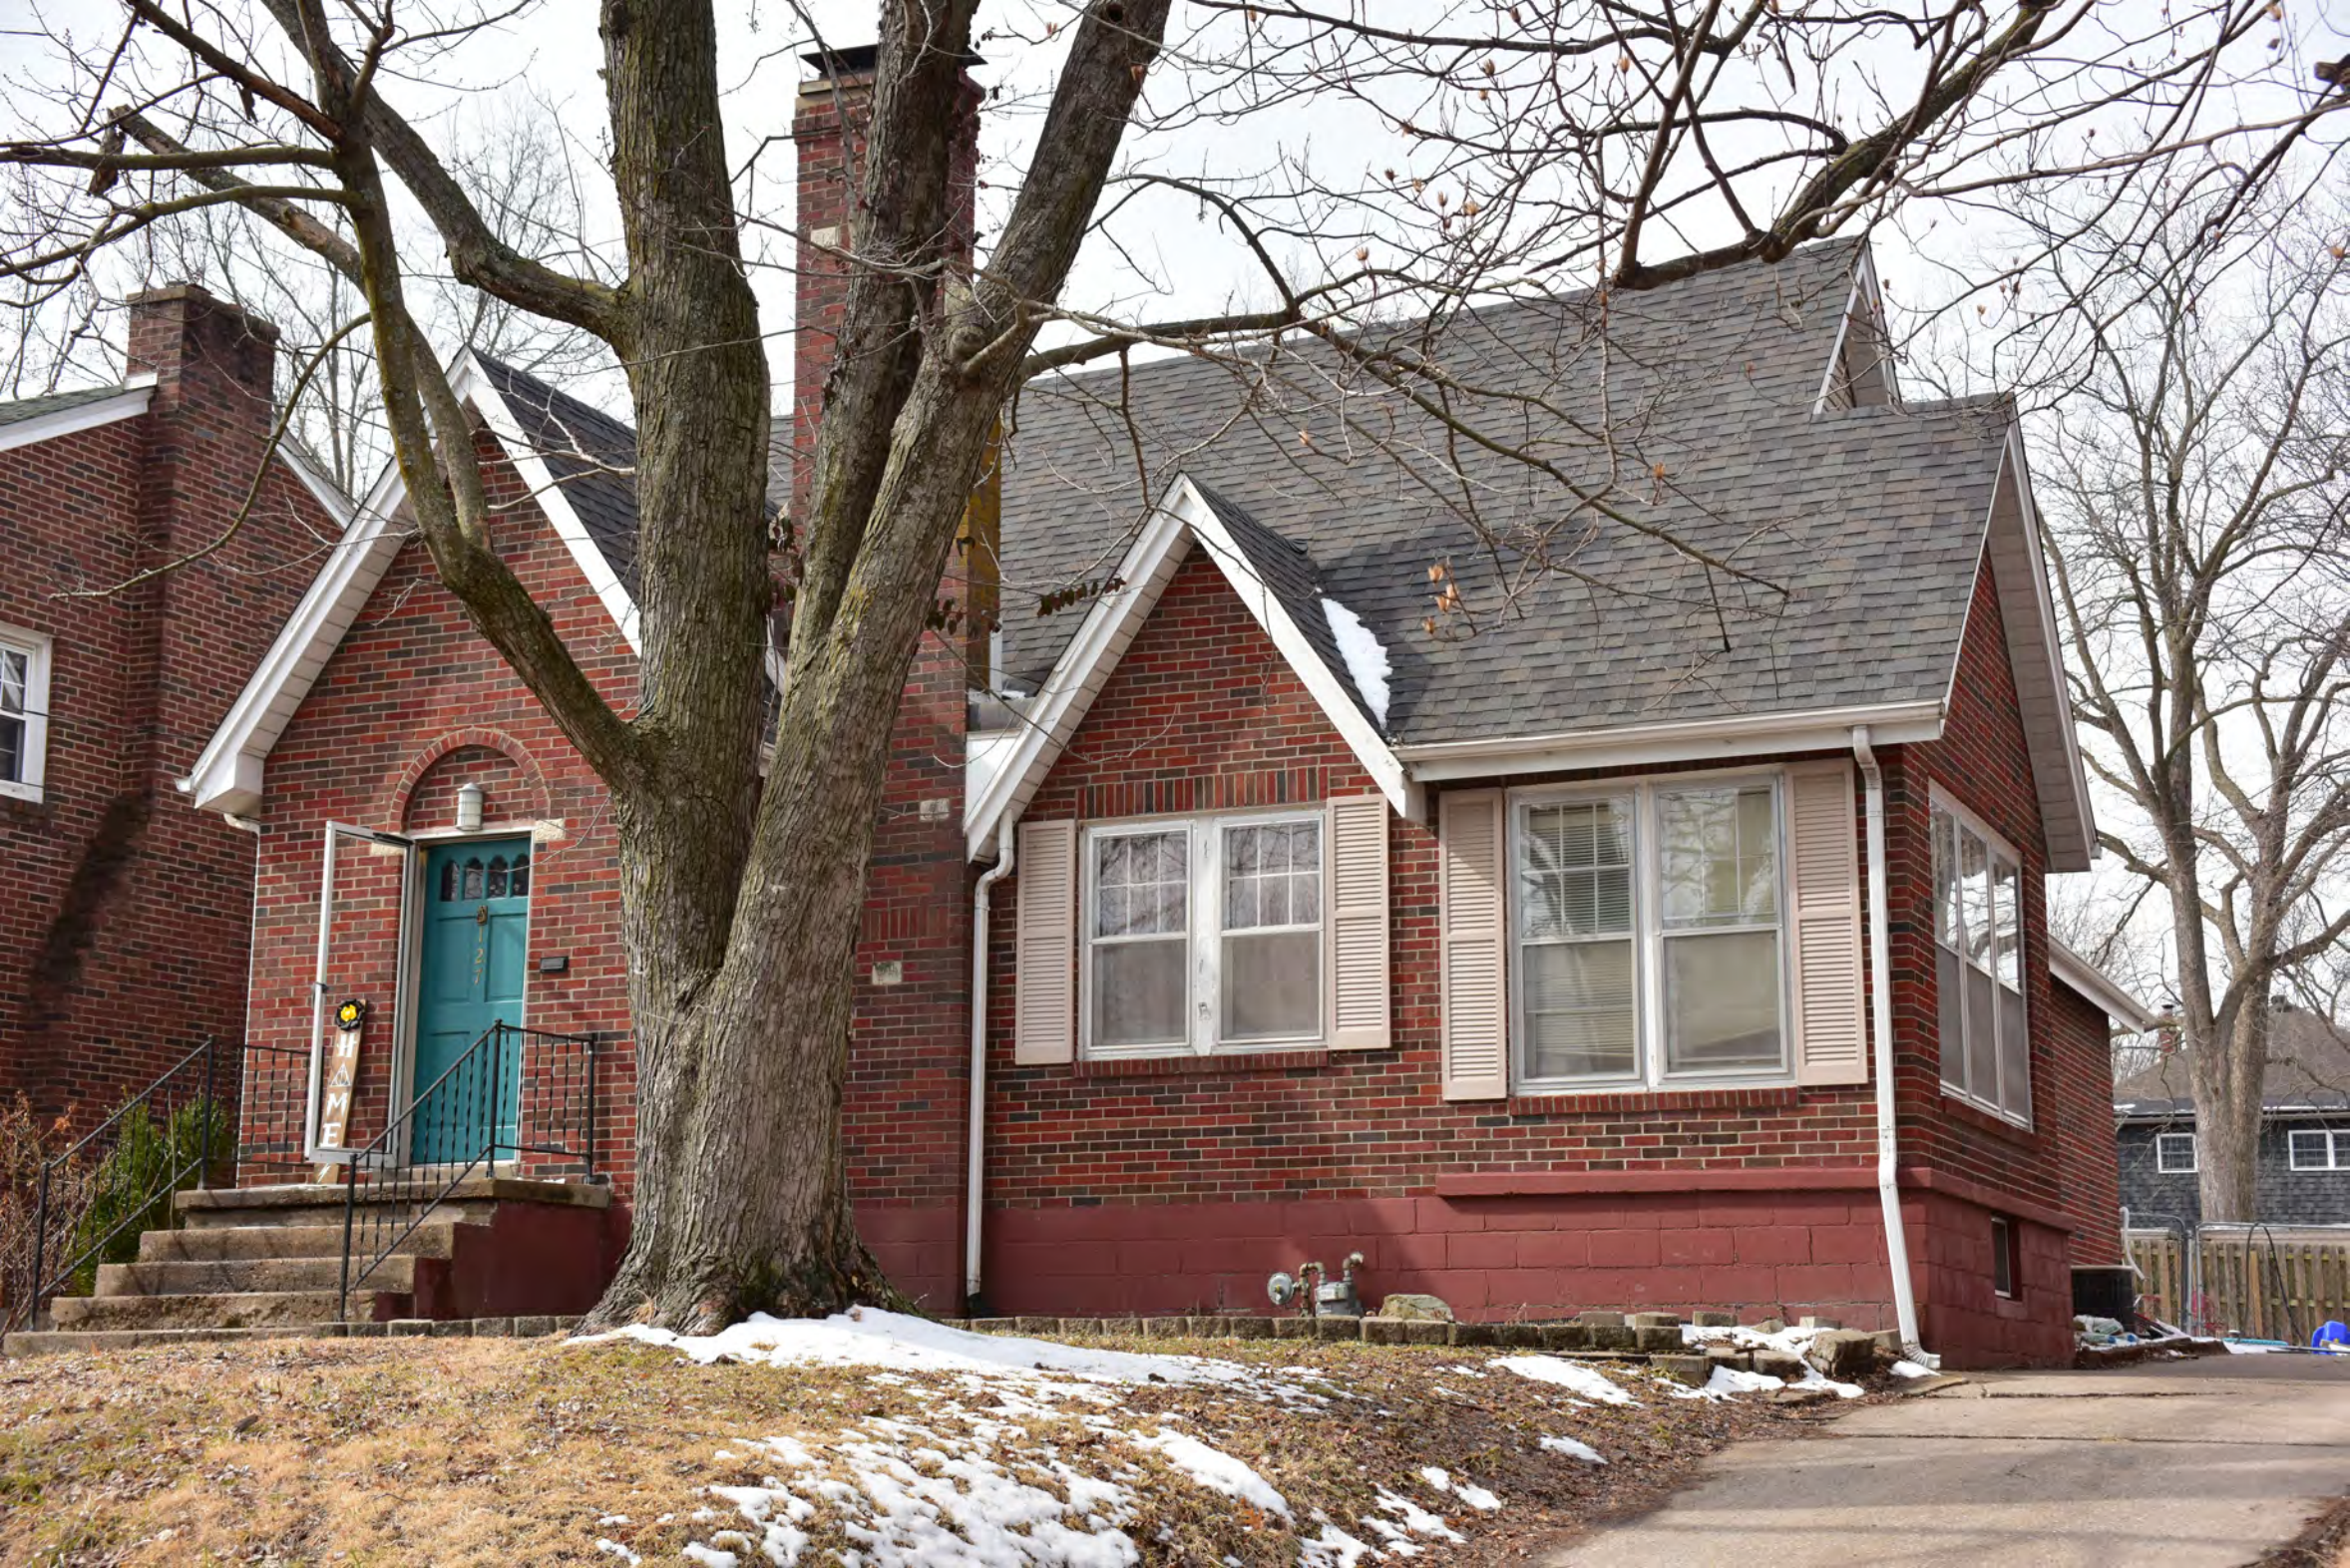
127 West Circle Drive is a one-and-one-half-story Minimal Traditional dwelling. The brick-clad dwelling has a concrete block foundation and asphalt intersecting gable roof. A side-gable with a low cross-gable at the south end fronts West Circle Drive while a perpendicular gable extends from the rear. Vinyl clads the gable ends. A brick exterior chimney is roughly centered on the primary elevation. The dwelling is three bays wide. The south bay is located in the cross-gable and contains the primary entrance. A non-historic wood door with glazing fills the bay. Decorative stone and brick accent the arched top. A gabled wall dormer tops the second bay. Two-ganged 6/1 historic wood windows with a continuous header brick sill and soldier brick lintel define the bay. Matching windows fill the final bay. Historic maps and current aerial images indicate a shed-roof porch is centered on the rear elevation, however it is not visible from the right of way.
