1. Survey number: CO-AS-008-001		2. Survey Name: West Main Street Survey	
3. County: Cole		4. Address (Street No.): 100	Street (name): East Circle Drive
5. City: Jefferson City	Vicinity <input type="checkbox"/>	6. Lat / Long:	7. Township/Range/Section: T: R: S:
8. Historic name (if known):		9. Present/other name (if known):	
10. Ownership: <input checked="" type="checkbox"/> Private <input type="checkbox"/> Public		11a. Historic use (if known): Domestic-Single Dwelling	11b. Current use: Domestic-Single Dwelling

MISSOURI DEPARTMENT OF NATURAL RESOURCES
STATE HISTORIC PRESERVATION OFFICE, P.O. Box 178, Jefferson City, MO 65102
ARCHITECTURAL/HISTORIC INVENTORY FORM

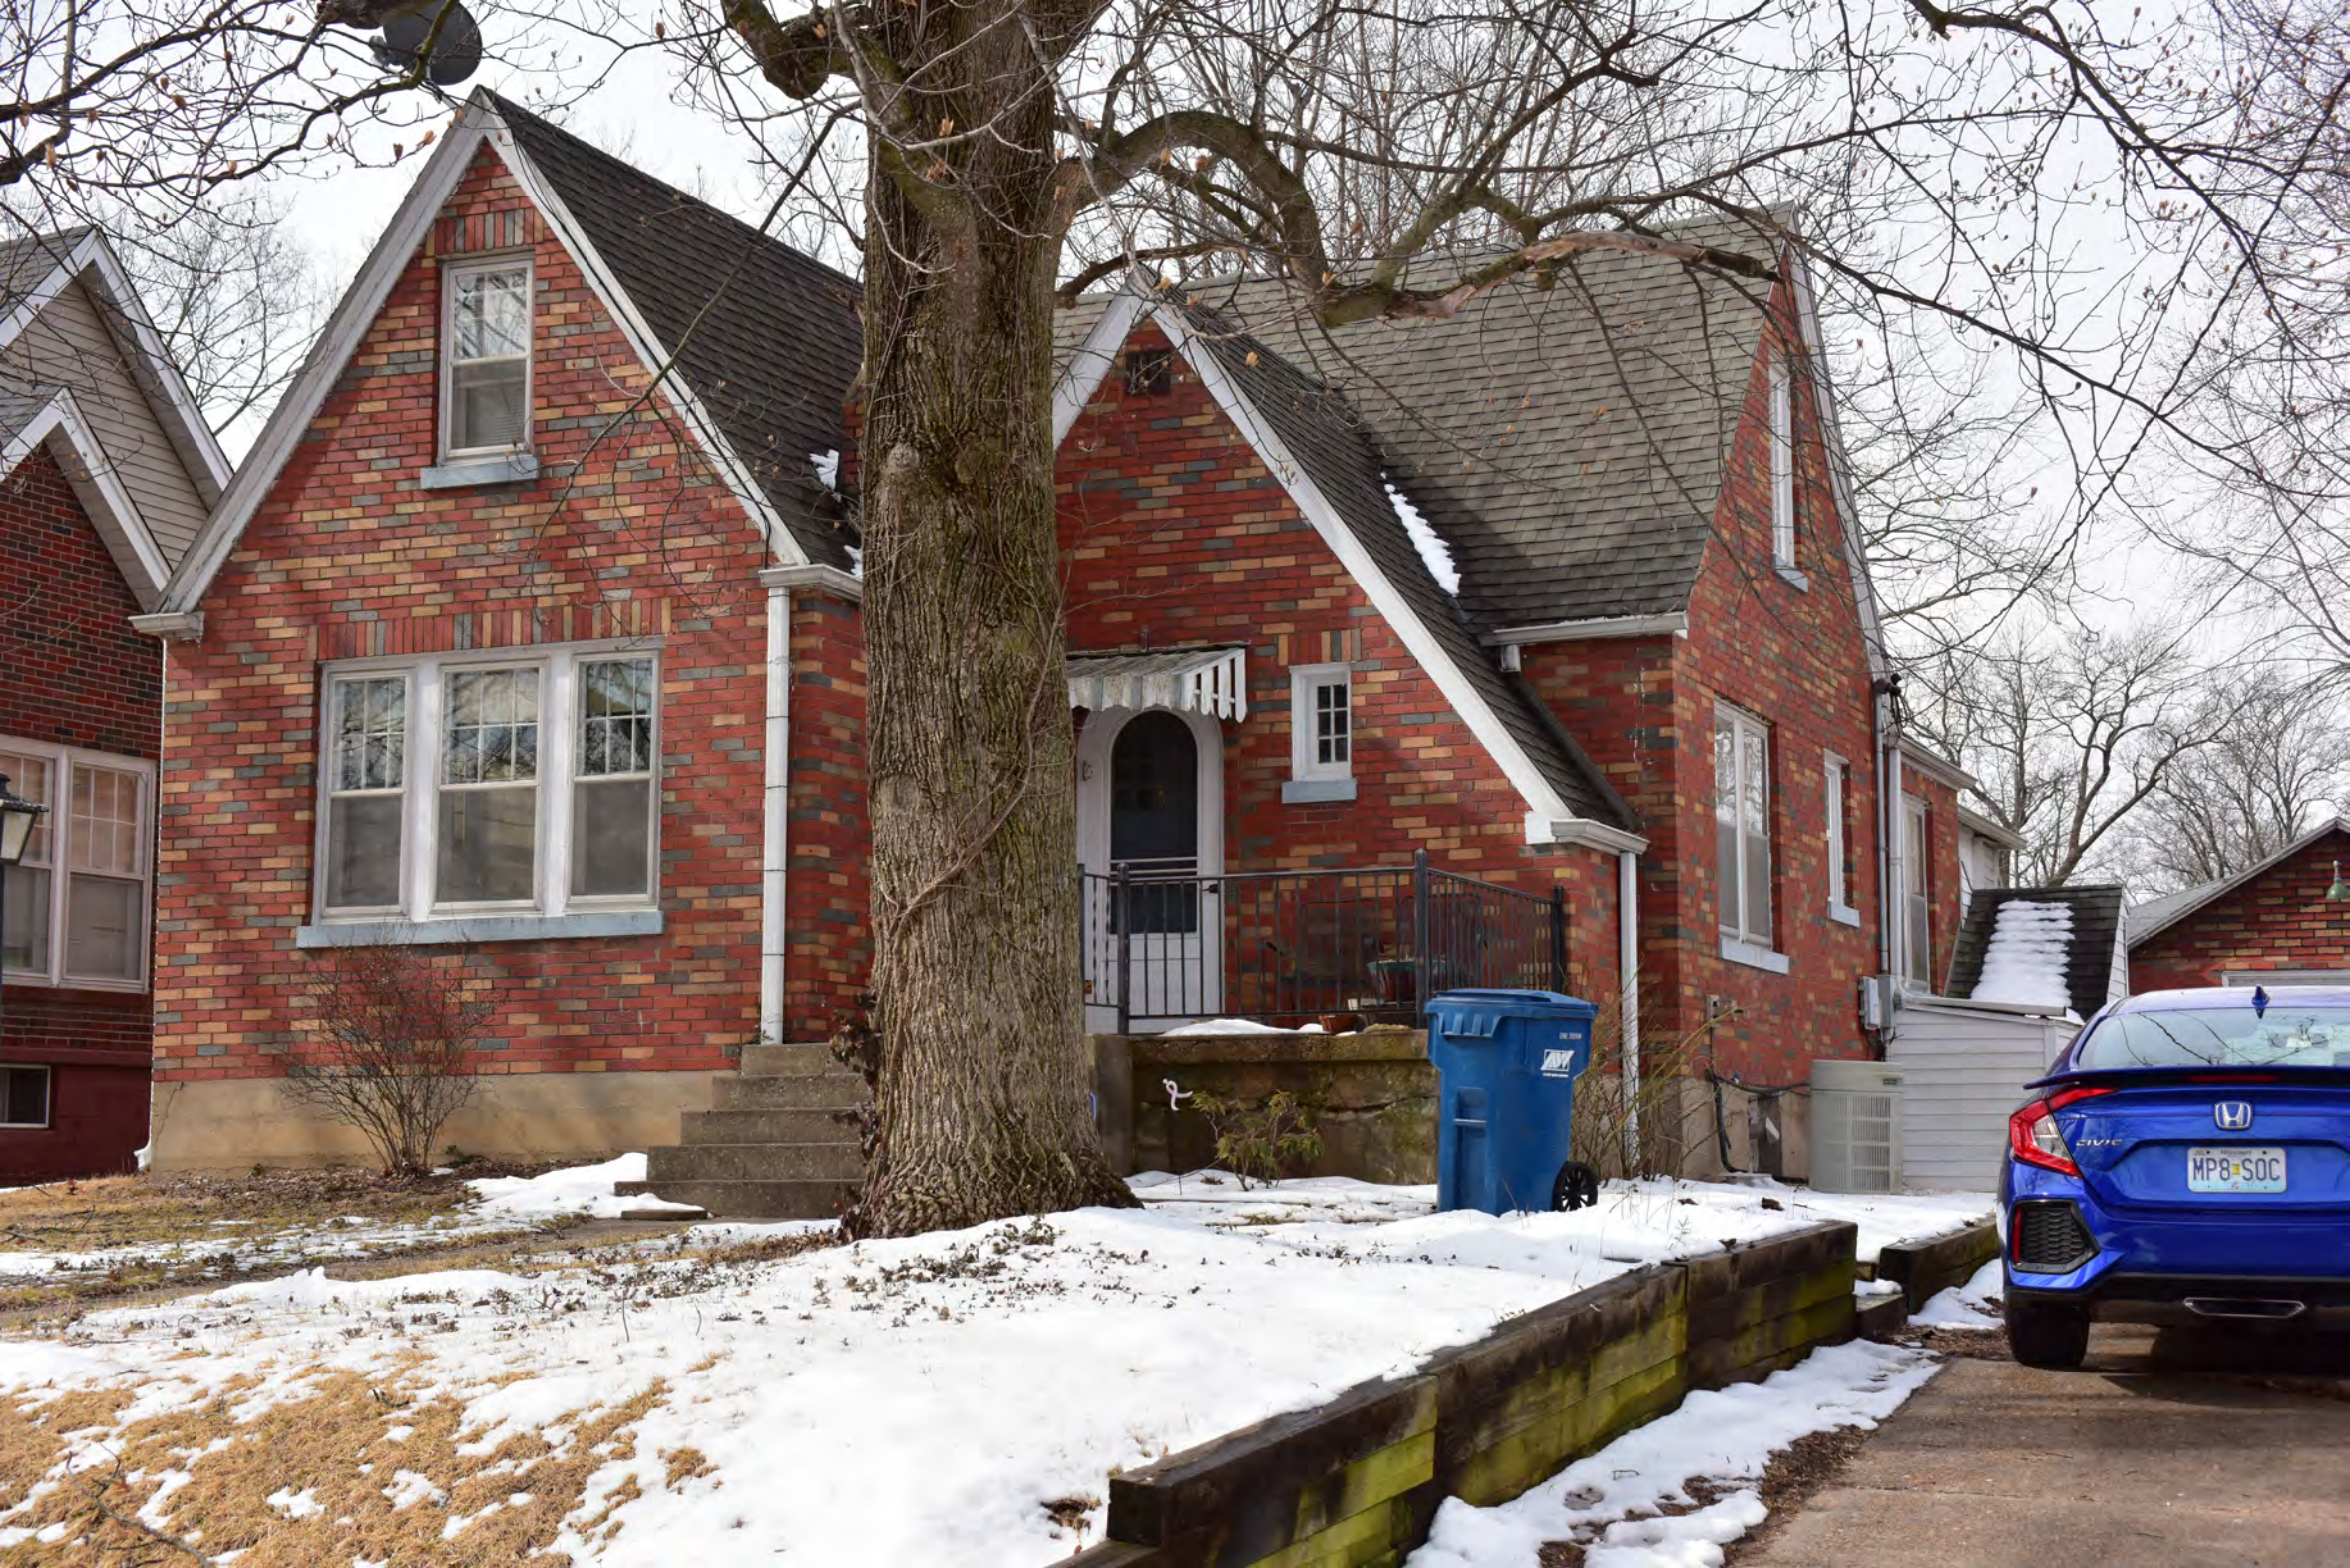
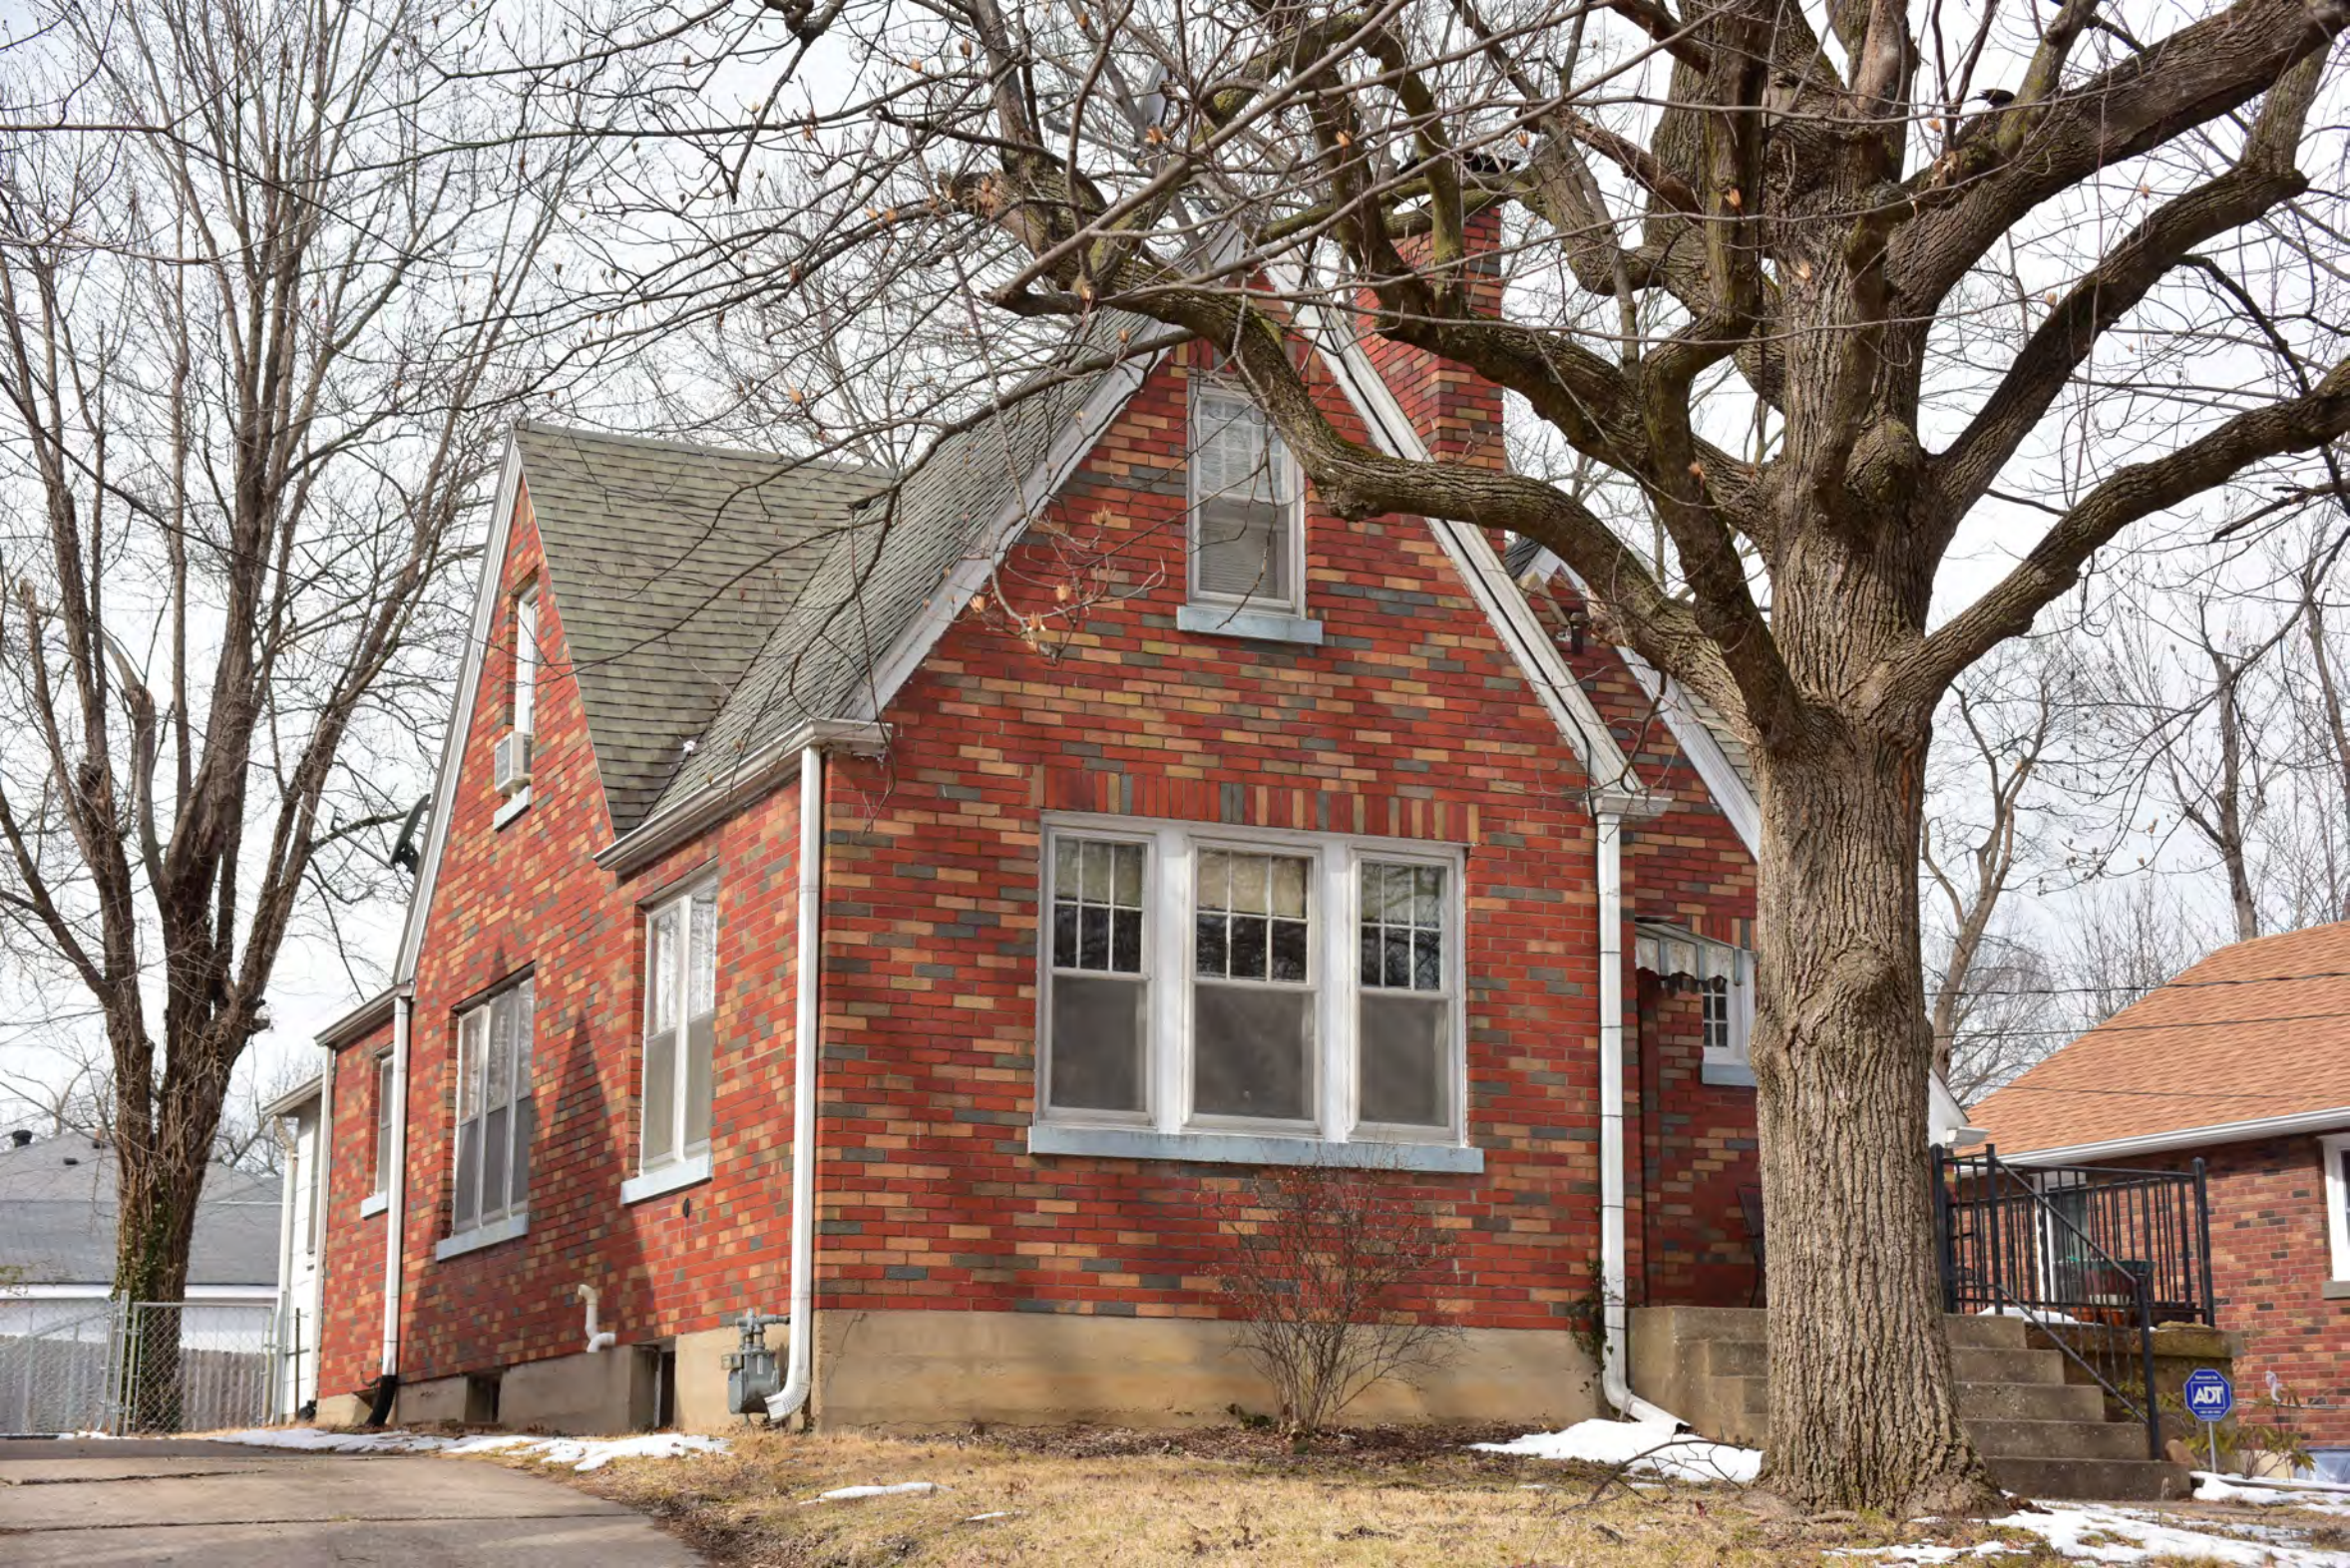
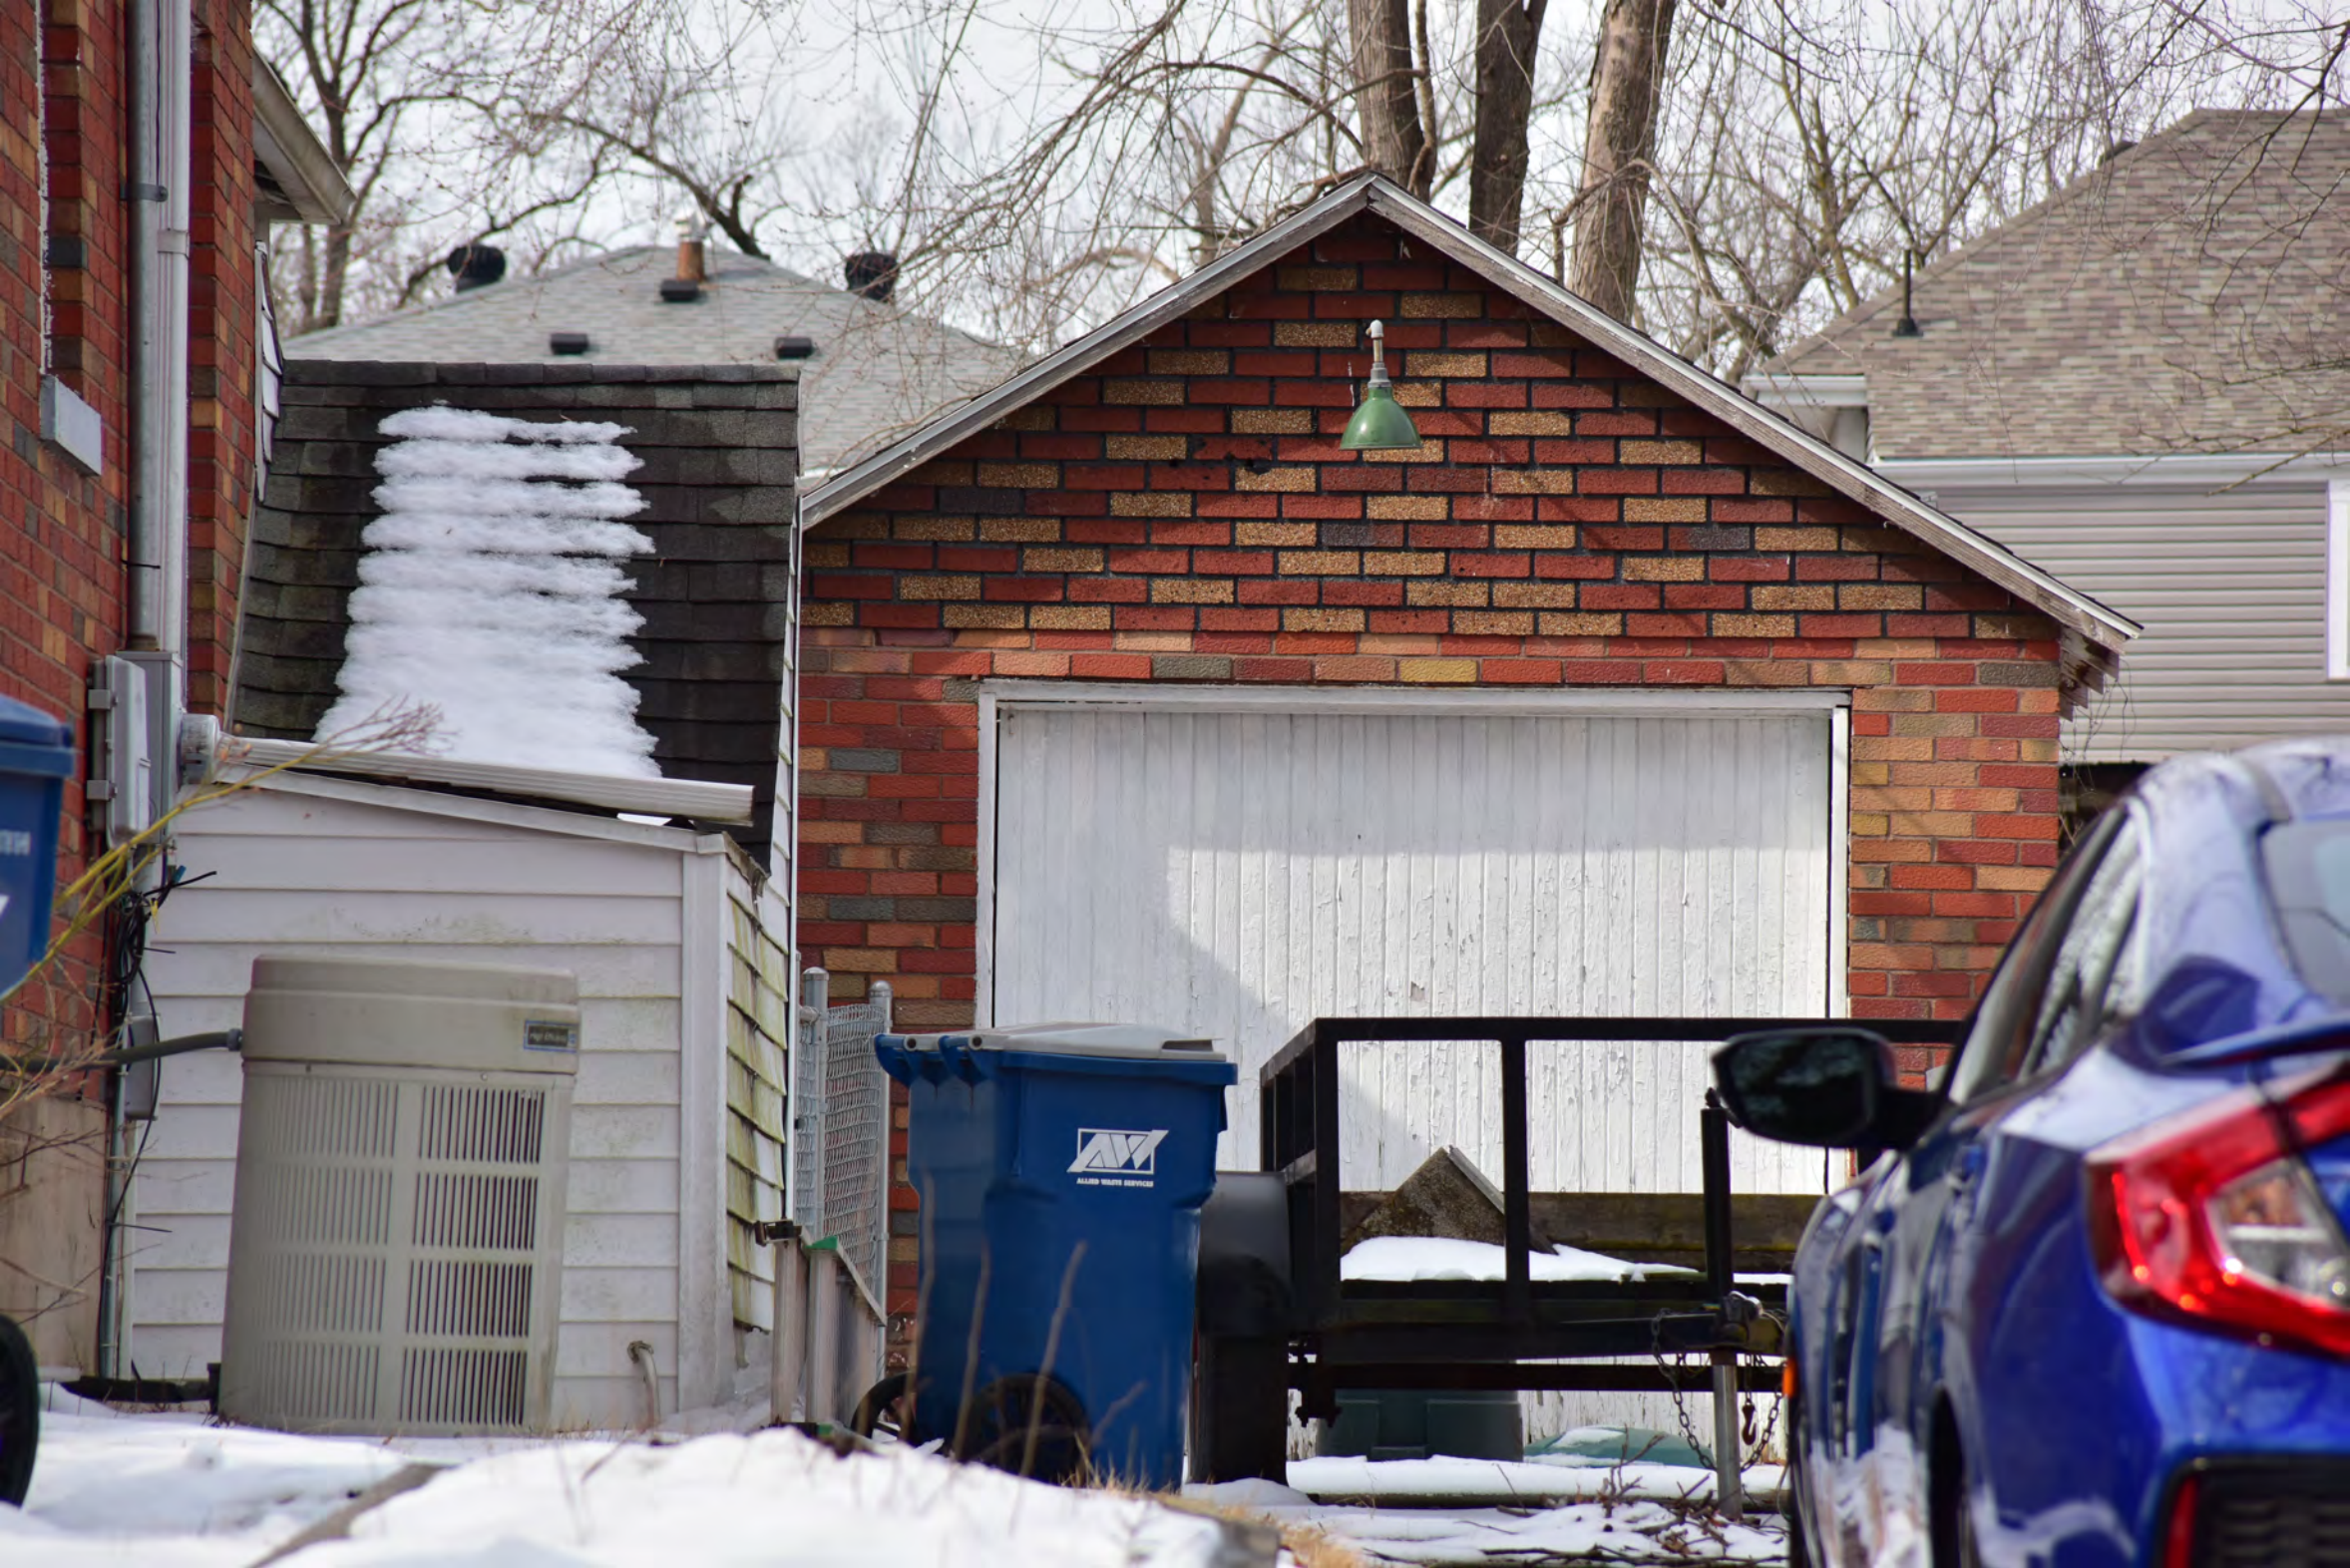
129 West Circle Drive is a one-story Minimal Traditional dwelling. The brick dwelling has an intersecting-gable asphalt roof and concrete foundation. A gable-front ell and low cross gable project from the primary elevation. An exterior brick chimney is located at the juncture. The dwelling is two bays wide. A gable-front ell projects from the primary elevation and contains the south bay. Three-ganged historic windows with a continuous cast stone sill and solid brick lintel fills the bay. Narrow historic 6/1 wood windows flank a wider 6/1 historic wood window. A historic 6/1 wood window is centered above in the gable apex. A low cross-gable projects from the primary elevation to the north and contains the north bay. The primary entrance defines the north bay. A historic wood door with six-light glazing fills the bay. Historic metal awning shelters the arched opening. A small six-light historic wood fixed window is positioned north of the entrance. A concrete platform porch extends from the entrance. A metal railing lines the perimeter. A hardboard-clad hipped-roof addition spans the rear elevation.

Alterations to 129 West Circle Drive include a hardboard addition at the rear. Sanborn maps indicate this addition replaces a small rear porch. The date of construction is unknown; however, it post-dates 1967. The addition does not obscure the historic form and is minimally visible from the right of way. 129 West Circle Drive retains good integrity and would be contributing to the potential Walinko Place Historic District, significant in the areas of Architecture and Community Planning and Development in association with the expansion of Jefferson City and increased suburban development during the twentieth century as well as its associations with Walinko Place, a notable suburban development during the Depression and War Years.

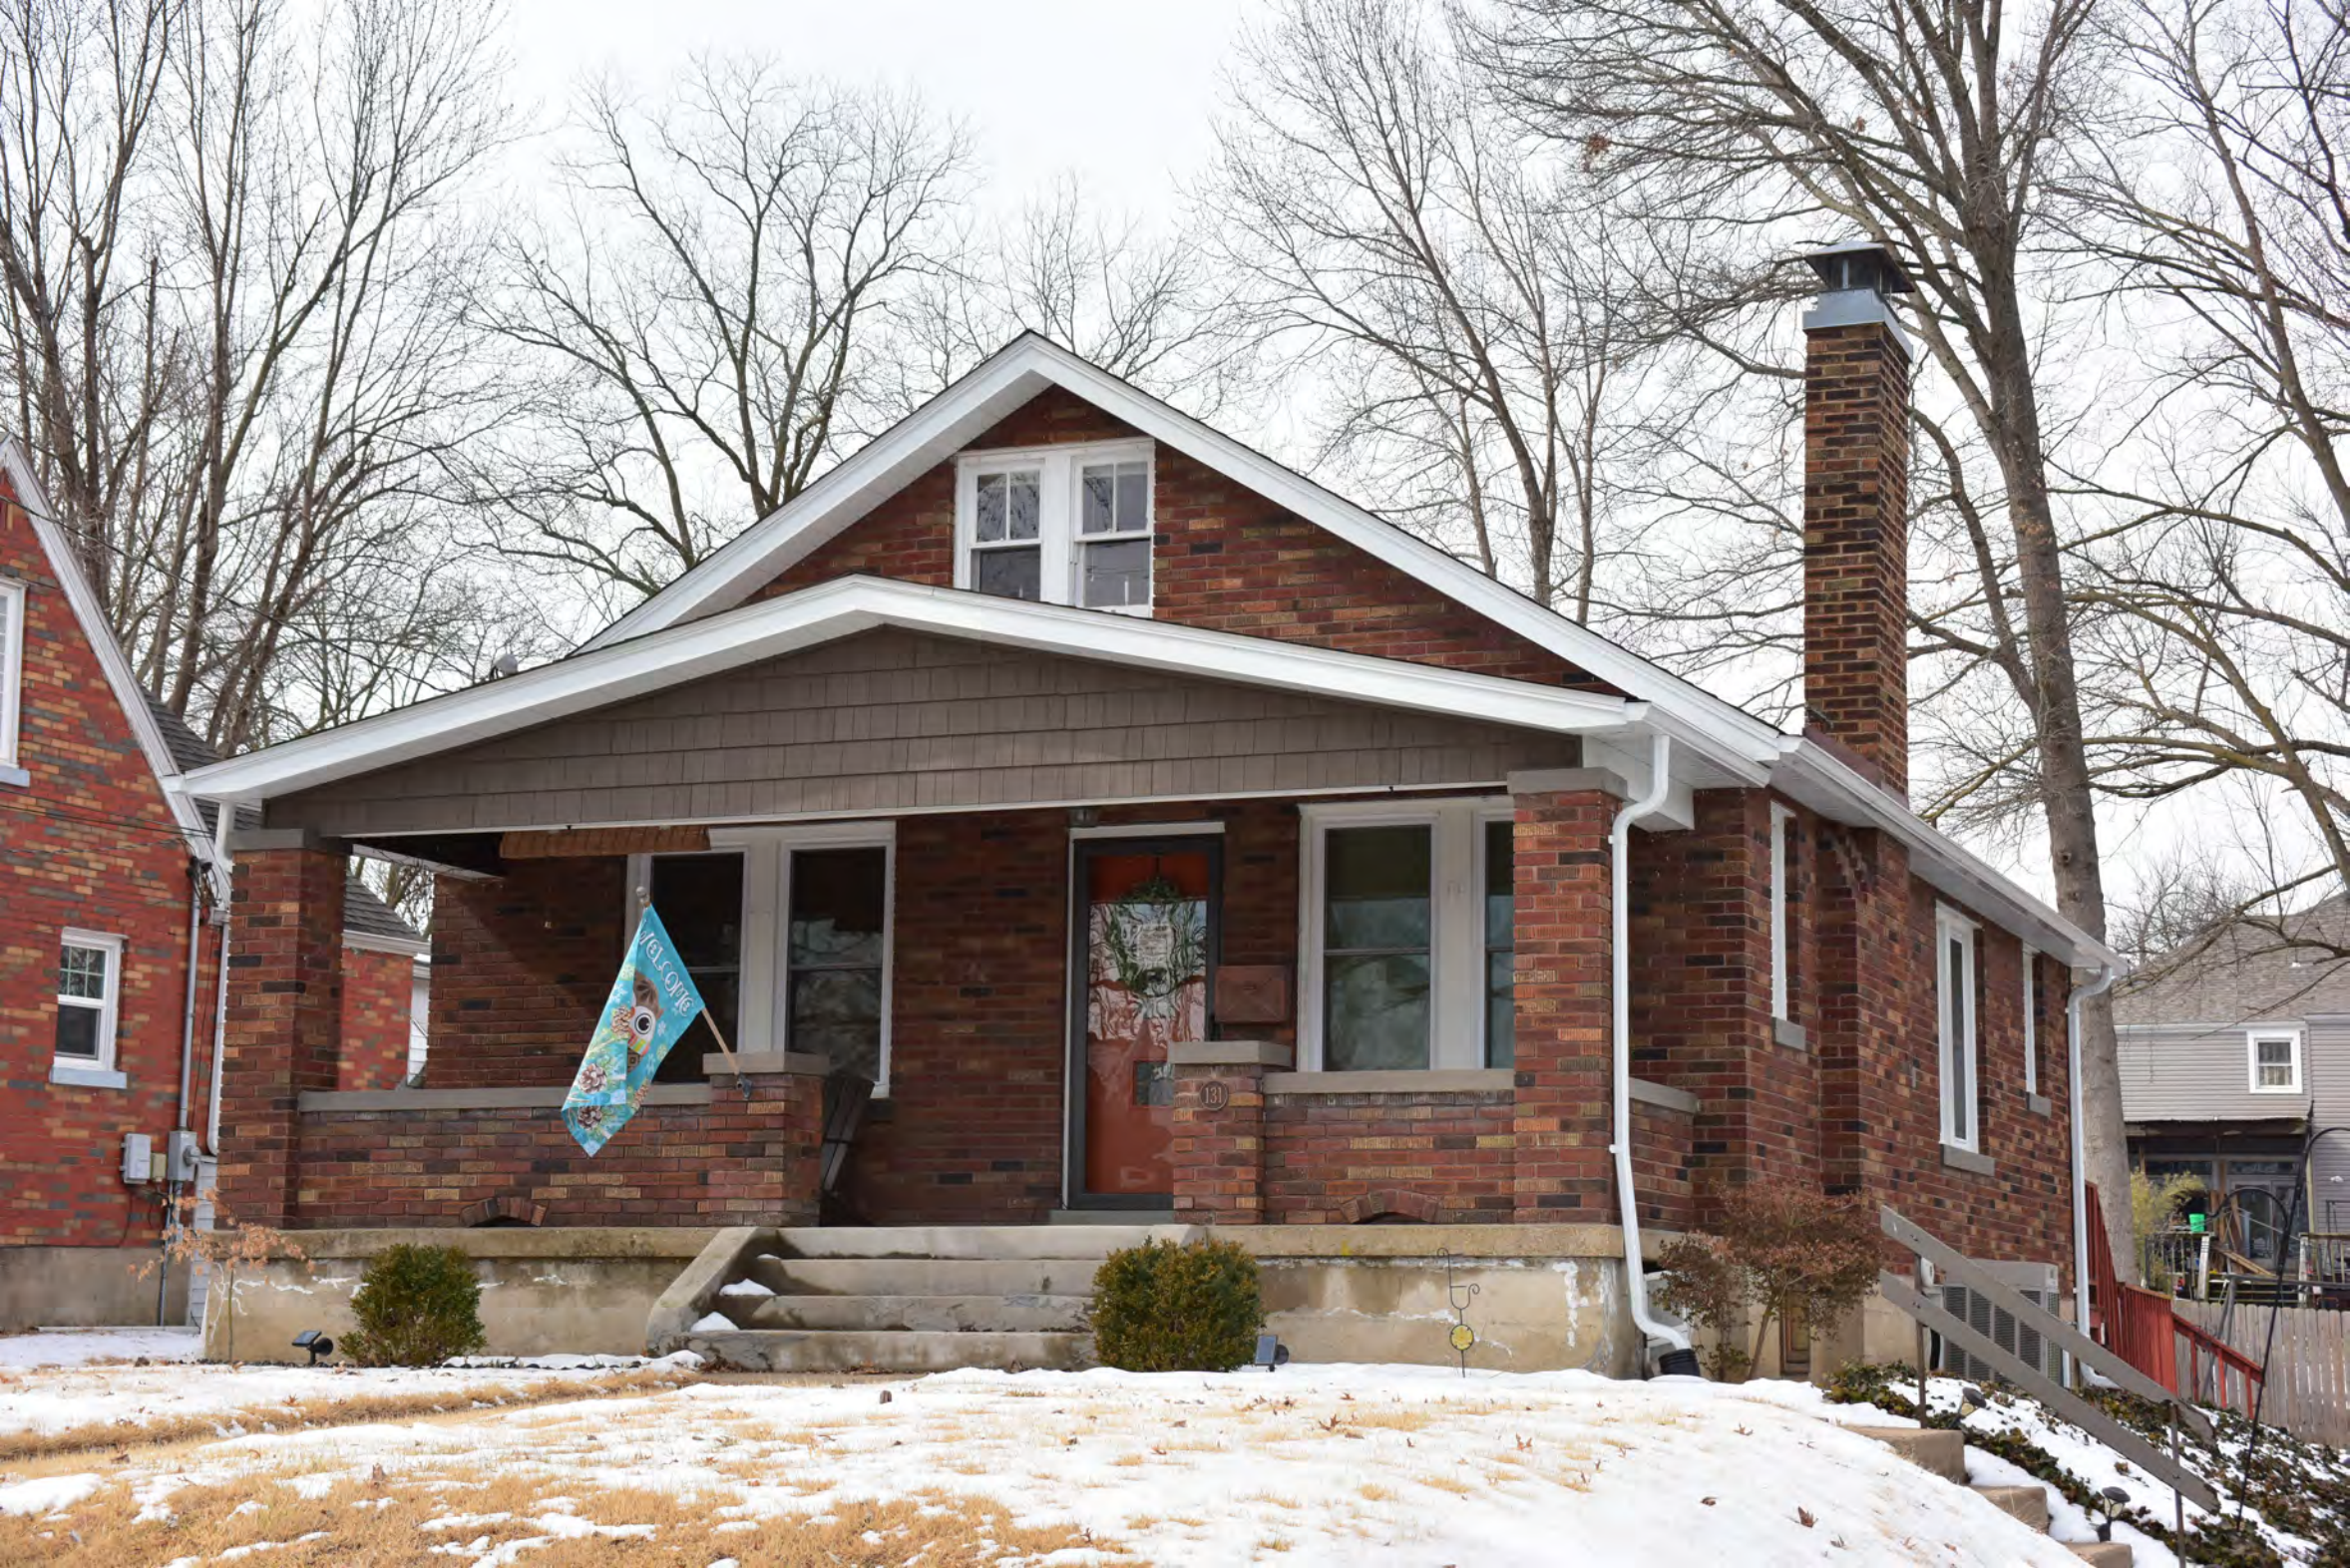
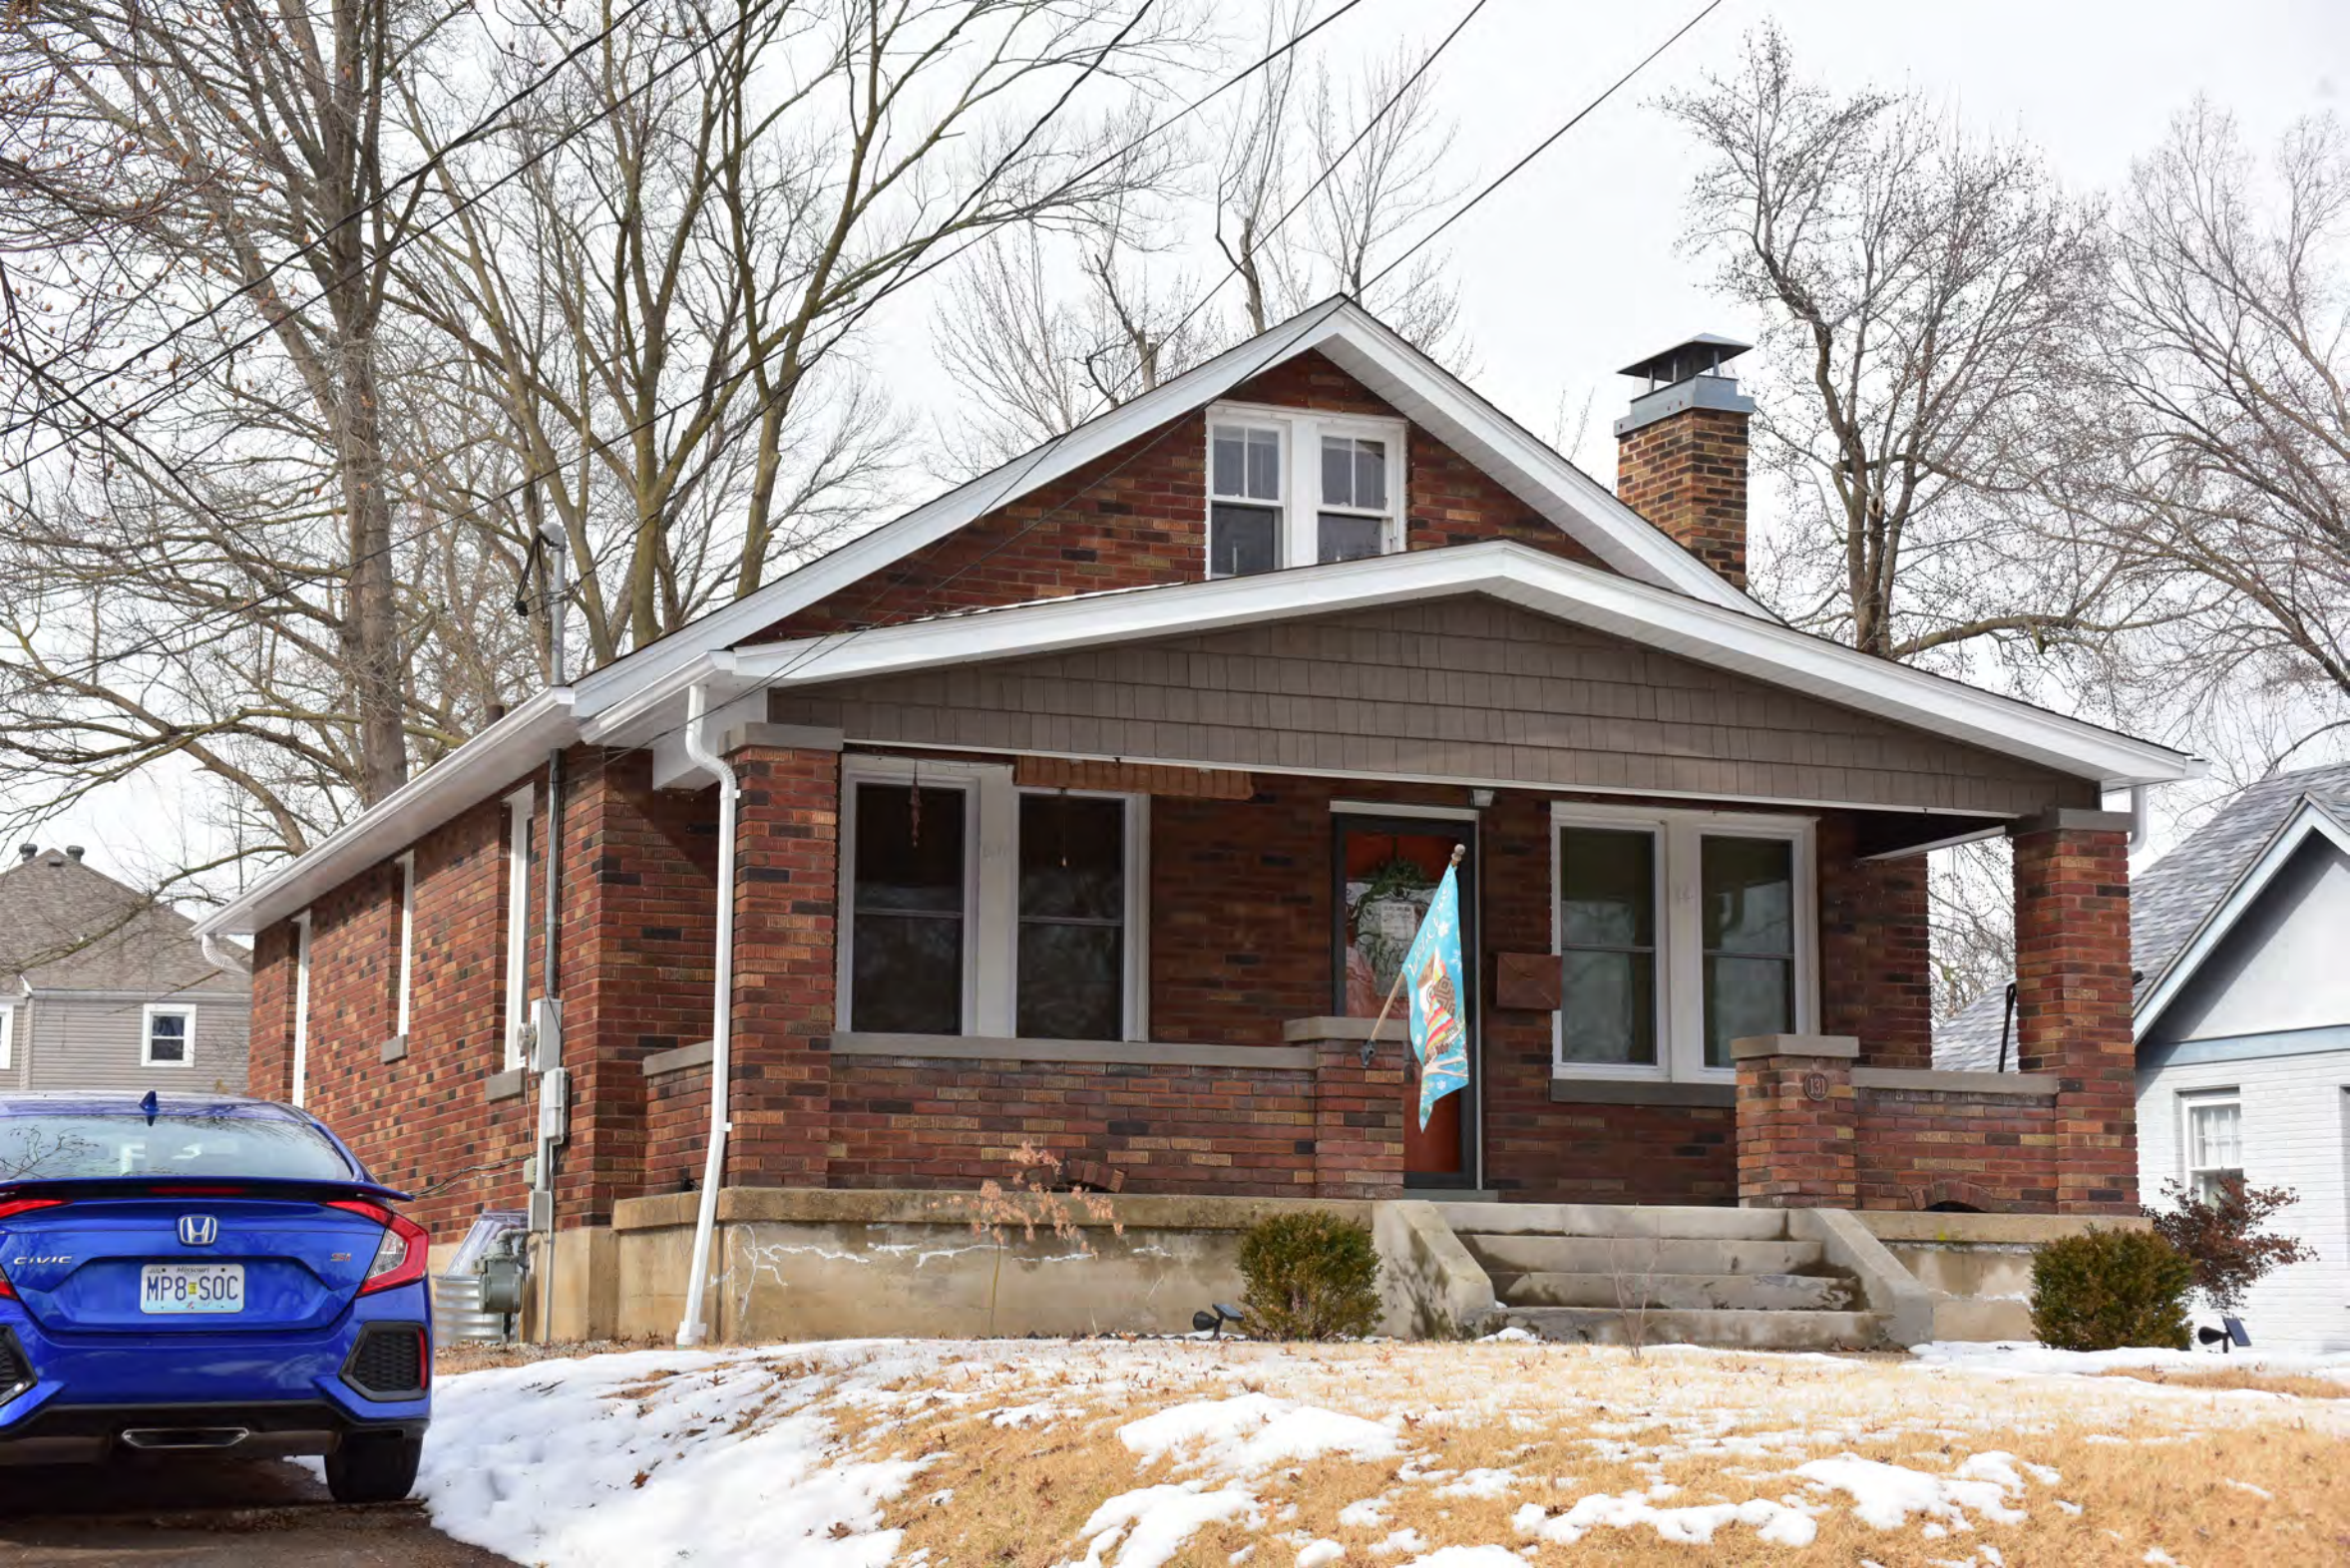
131 West Circle Drive is a one-story Bungalow dwelling. The brick-clad dwelling has an asphalt gable-front roof and concrete foundation. A brick exterior chimney pierces the north elevation eave. Paired 2/1 historic wood windows are centered in the gable end. The dwelling is three bays wide. Two-ganged 1/1 vinyl windows flank the center entrance bay. A non-historic historic door fills the entrance bay. An open porch spans the primary elevation. Brick columns with cast stone caps support the gable roof. Matching knee walls line the perimeter. Wood shingle fills the gable. A shed-roof porch is centered on the rear elevation. A non-historic wood deck extends from the porch.

Alterations to 131 West Circle Drive include the replacement of historic windows with vinyl windows. 131 otherwise does not appear significantly altered. This resource retains good integrity and would be contributing to the potential Walinko Place Historic District, significant in the areas of Architecture and Community Planning and Development in association with the expansion of Jefferson City and increased suburban development during the twentieth century as well as its associations with Walinko Place, a notable suburban development during the Depression and War Years.
