1. Survey number: CO-AS-008-001		2. Survey Name: West Main Street Survey	
3. County: Cole		4. Address (Street No.): 100	Street (name): East Circle Drive
5. City: Jefferson City	Vicinity <input type="checkbox"/>	6. Lat / Long:	7. Township/Range/Section: T: R: S:
8. Historic name (if known):		9. Present/other name (if known):	
10. Ownership: <input checked="" type="checkbox"/> Private <input type="checkbox"/> Public		11a. Historic use (if known): Domestic-Single Dwelling	11b. Current use: Domestic-Single Dwelling

MISSOURI DEPARTMENT OF NATURAL RESOURCES
STATE HISTORIC PRESERVATION OFFICE, P.O. Box 178, Jefferson City, MO 65102
ARCHITECTURAL/HISTORIC INVENTORY FORM

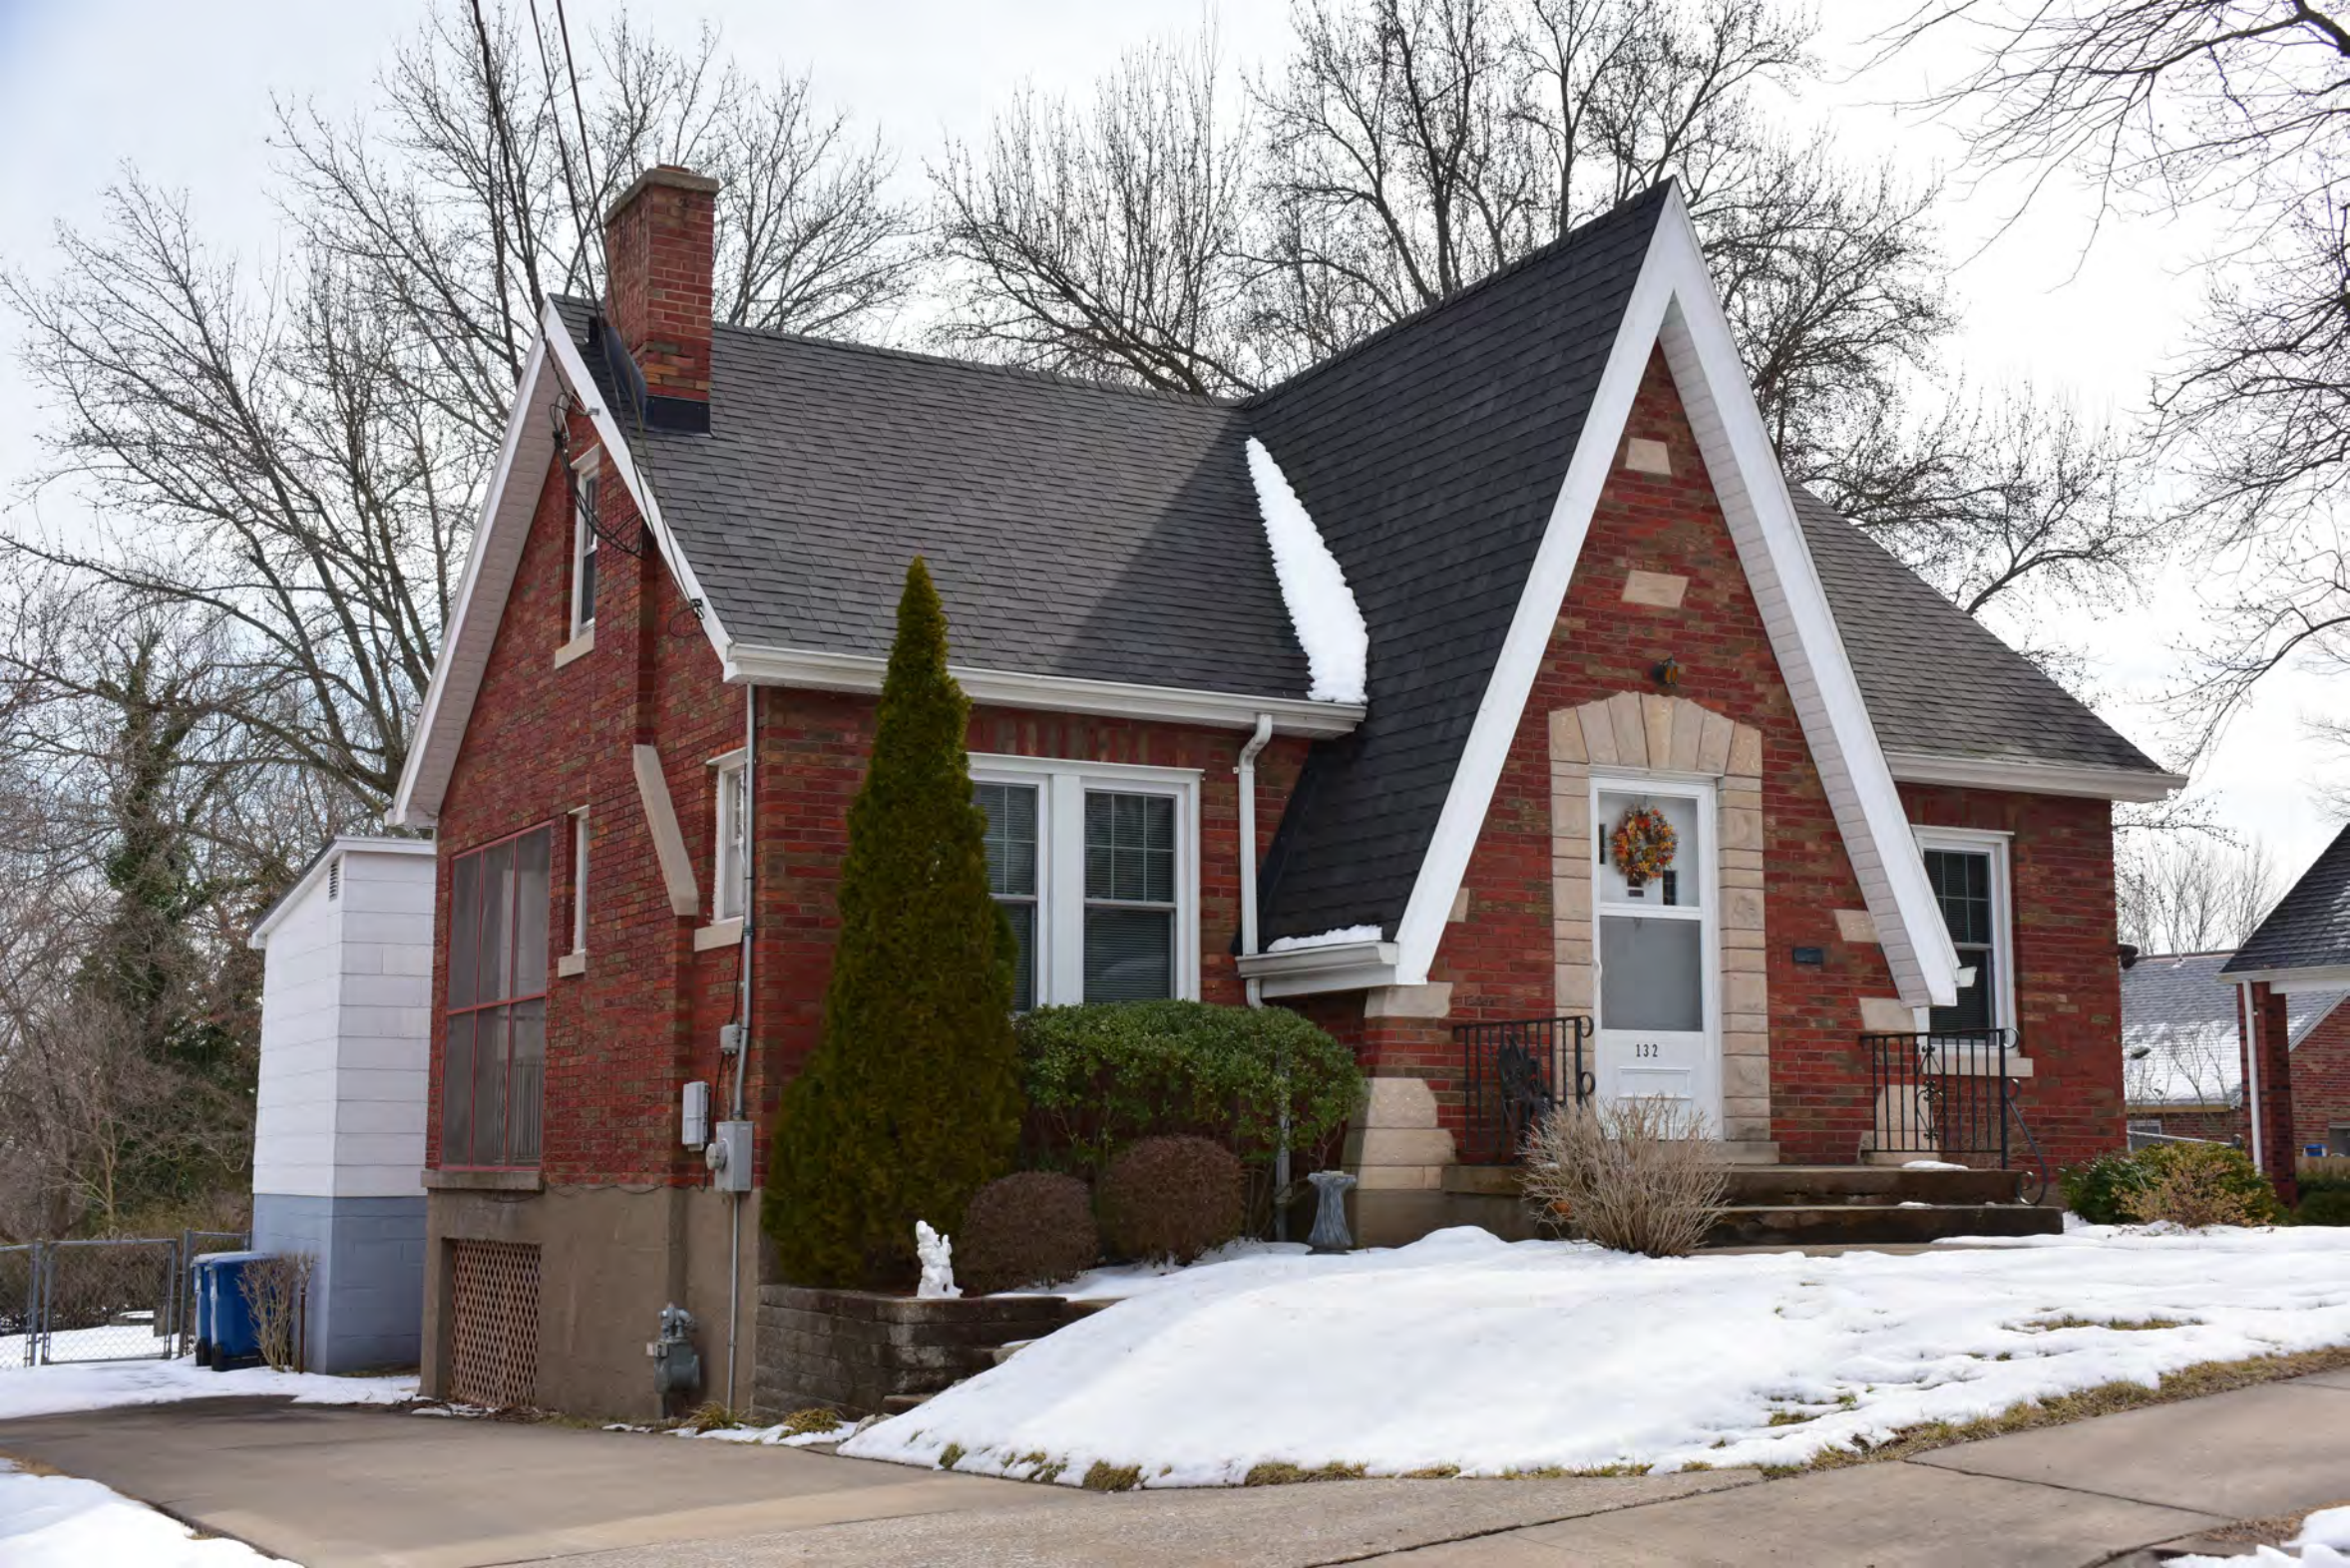
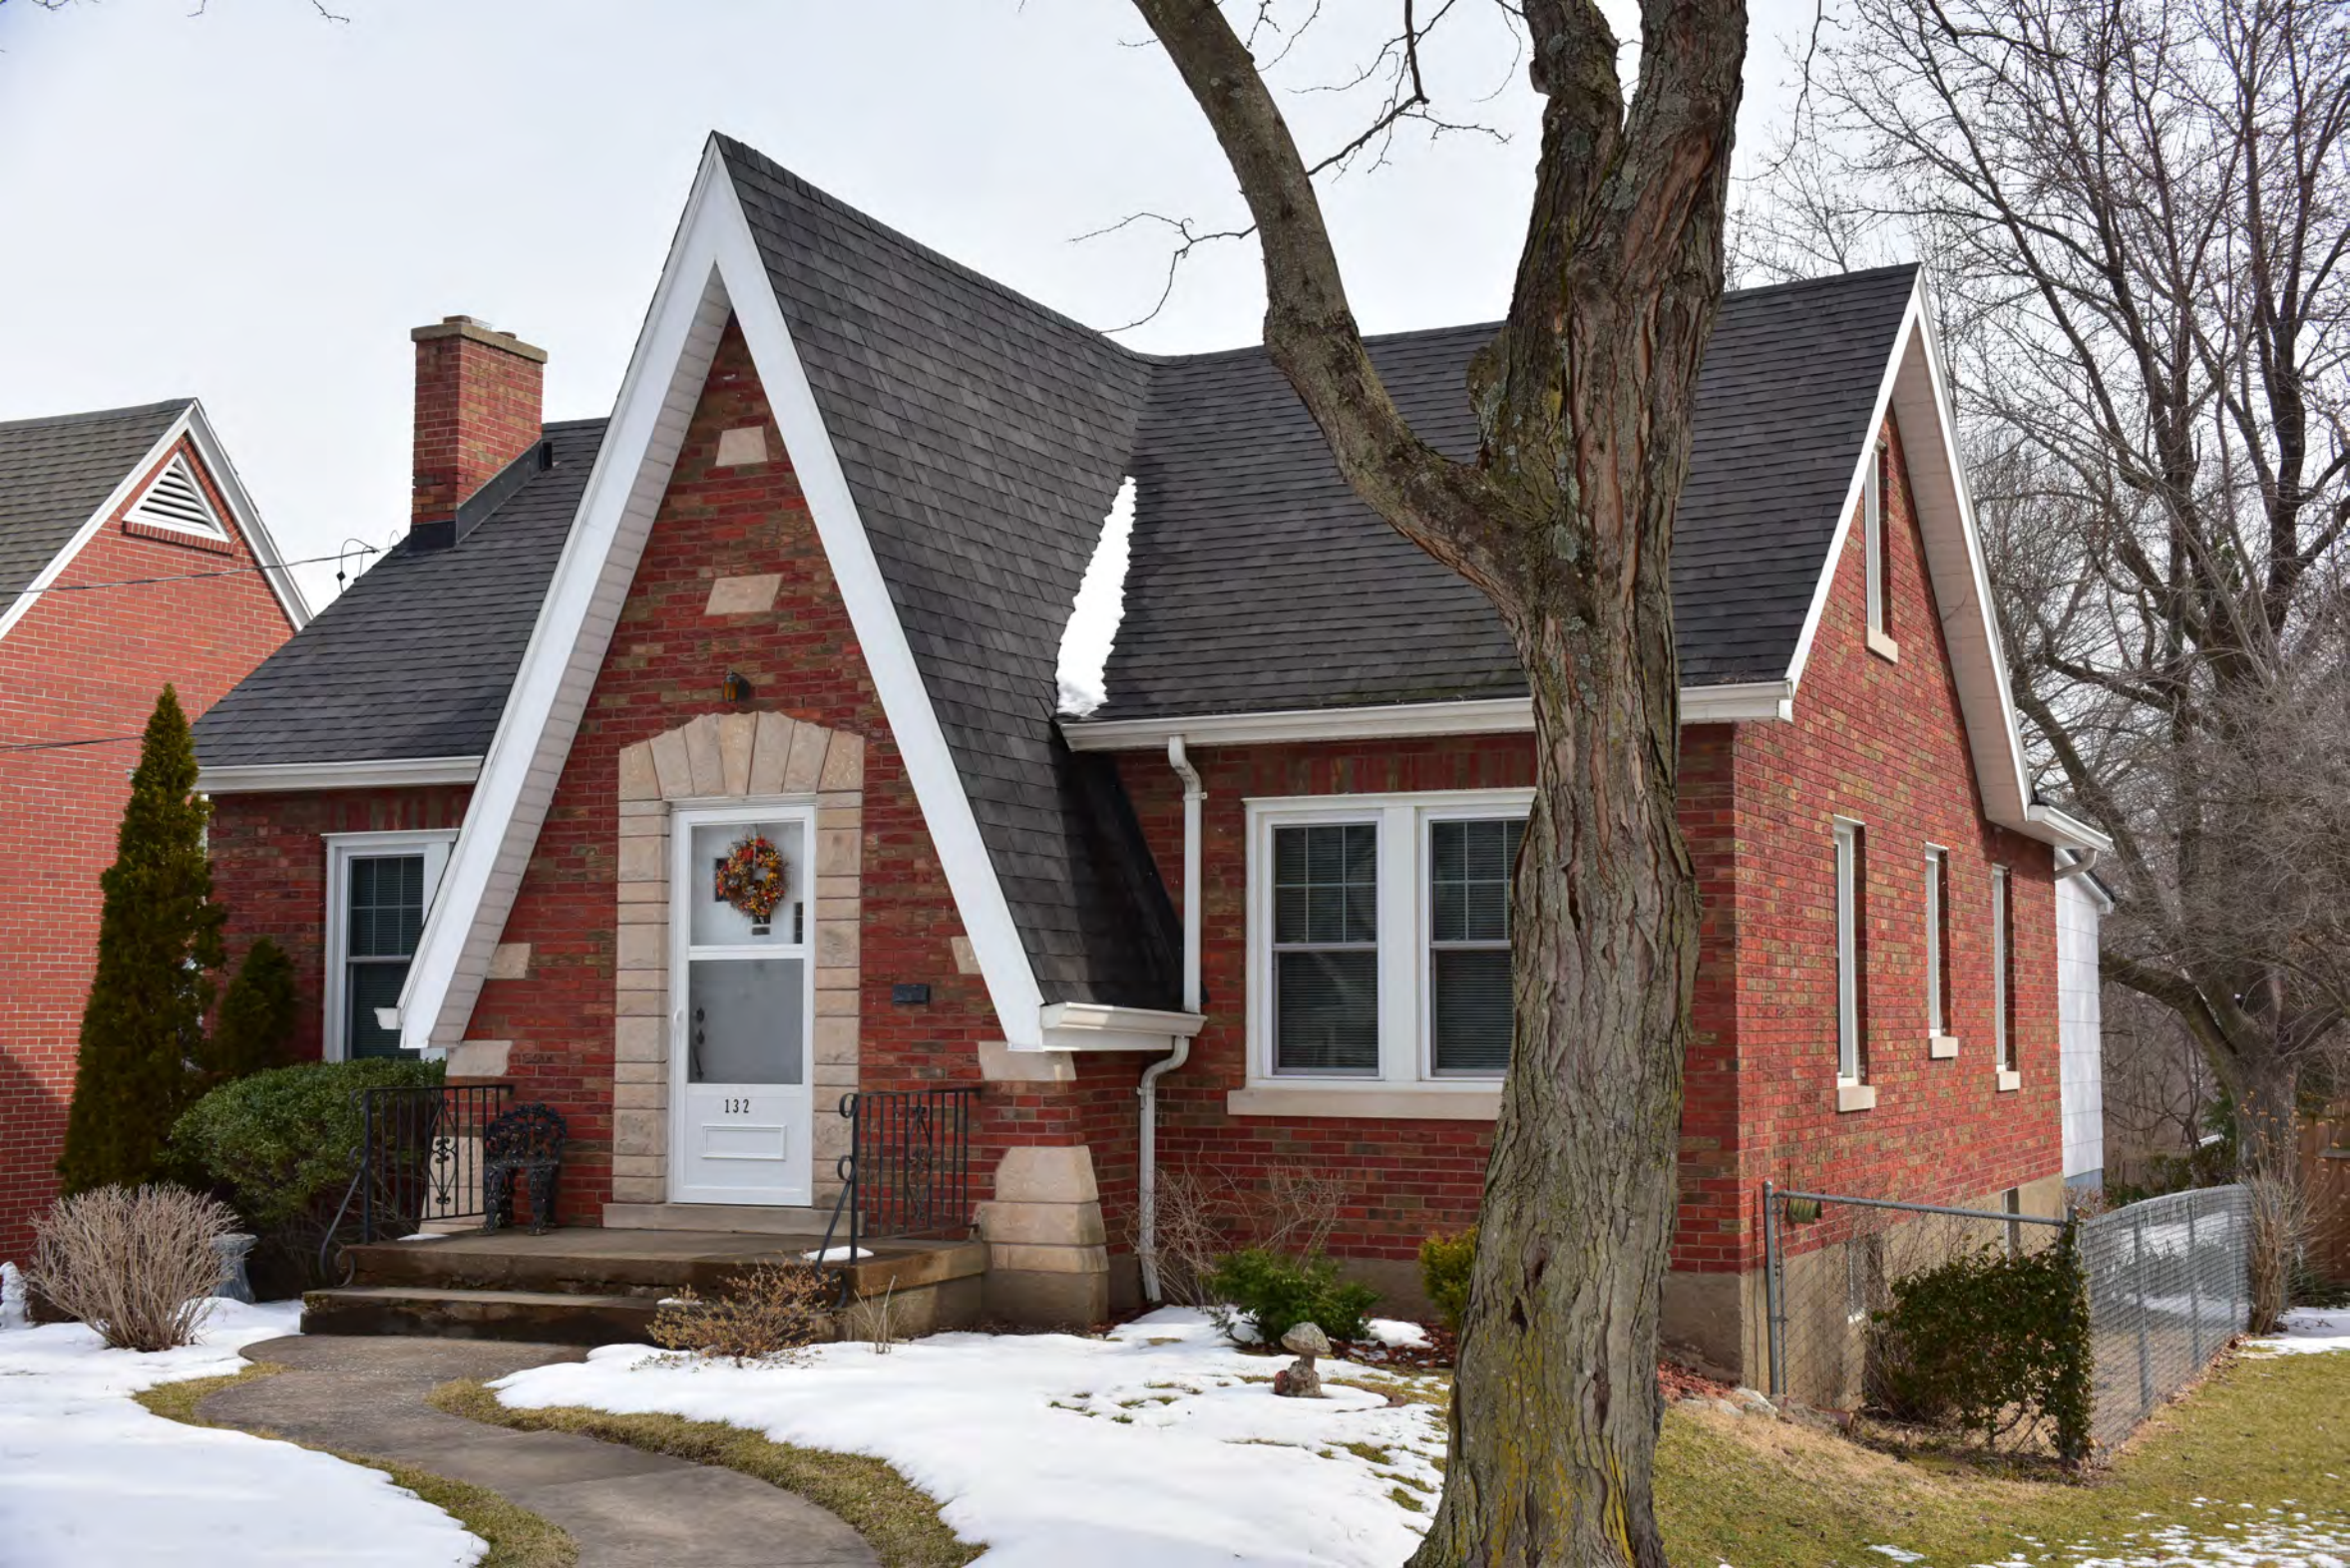
132 West Circle Drive is a one-and-one-half-story Minimal Traditional dwelling with restrained Tudor Revival influences. The brick-clad dwelling has a parged concrete foundation and an asphalt intersecting gable roof. A side gable with center cross gable fronts West Circle Drive while a perpendicular gable extends to the rear. A brick exterior chimney pierces the north gable end eave. The dwelling is three bays wide. Two-ganged non-historic 6/1 vinyl windows with a continuous cast stone sill and simple rolled moldings fill the north and south bays. The cross gable contains the center bay. The primary entrance defines the bay and features a historic wood door with glazing. Limestone accents surround the bay. A concrete stoop with scrolled metal railing projects from the entrance. A screened porch with wood frame occupies the northeast corner of the dwelling. A c. 1965 shed-roof addition with a concrete block foundation and asbestos cladding spans the rear.

Alterations to 132 West Circle Drive include the replacement of historic windows with vinyl windows and a c. 1965 rear addition. While the windows are replacements, they fill historic openings. The rear addition is a historic alteration that is complimentary in size and scale, located at a tertiary elevation, and minimally visible. Field observations indicate resources of a similar vintage and good integrity may lie to the north and east. If future surveys in this area identify a potential historic district 132 West Circle Drive would likely be contributing.

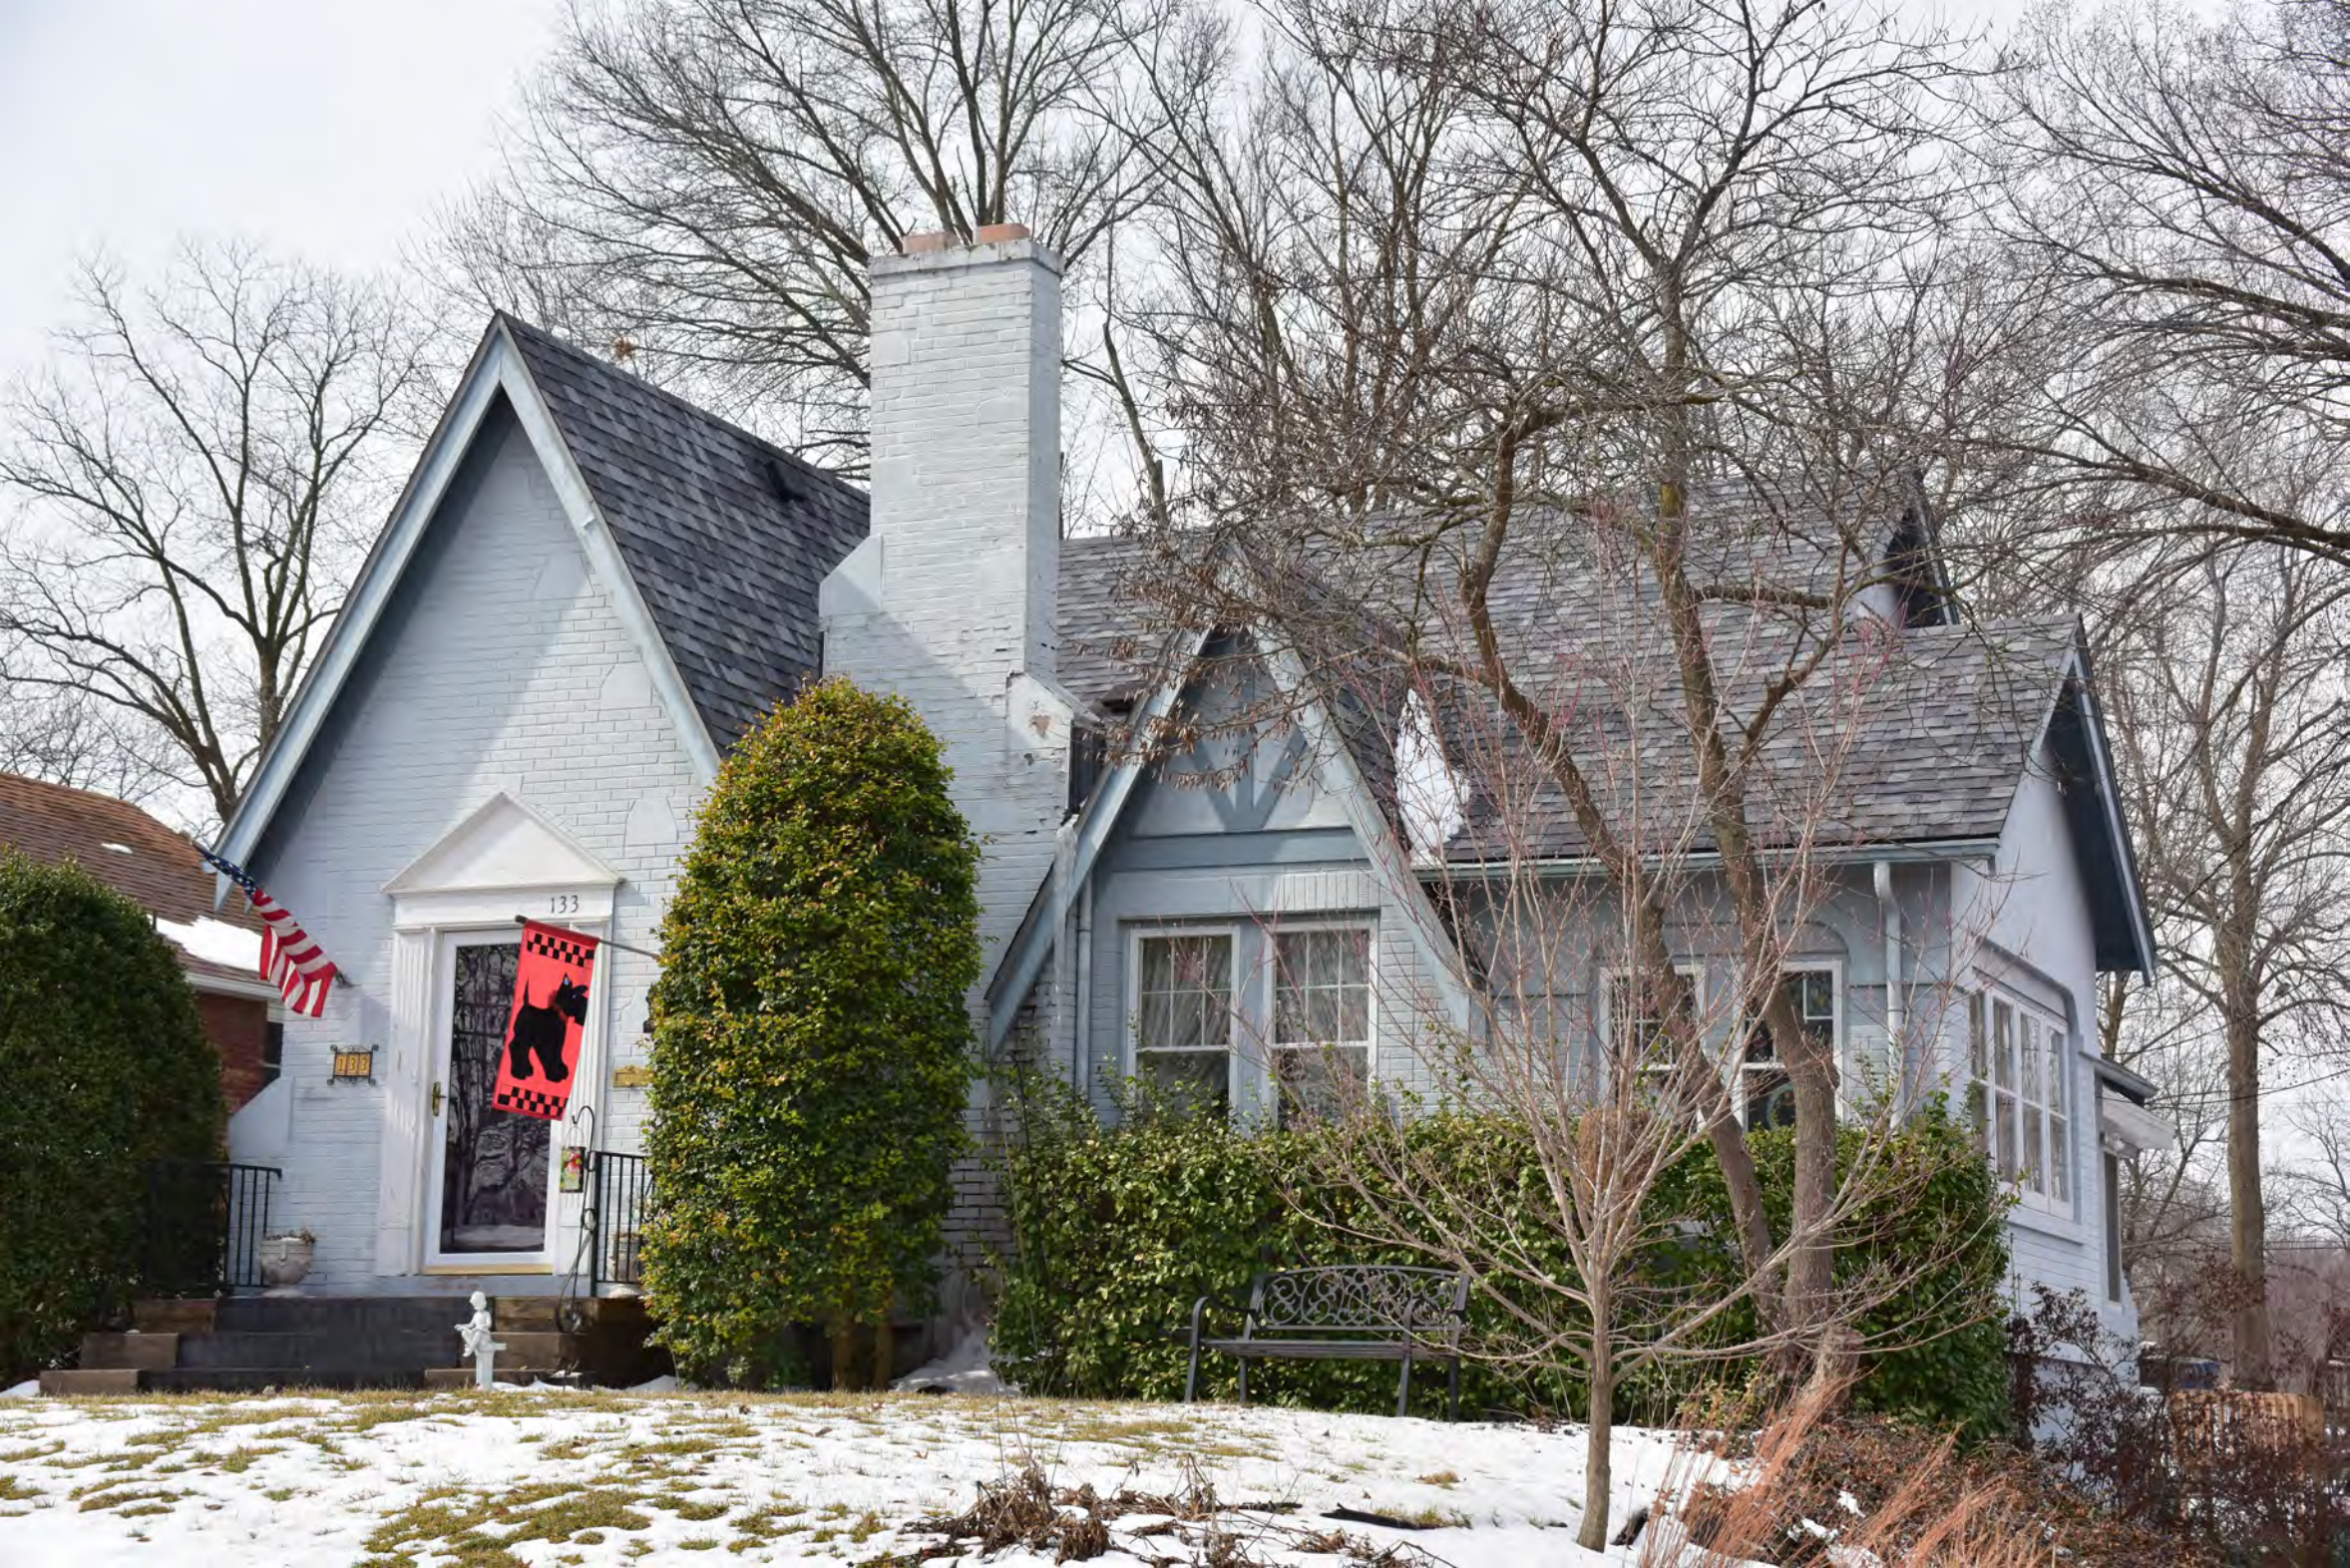
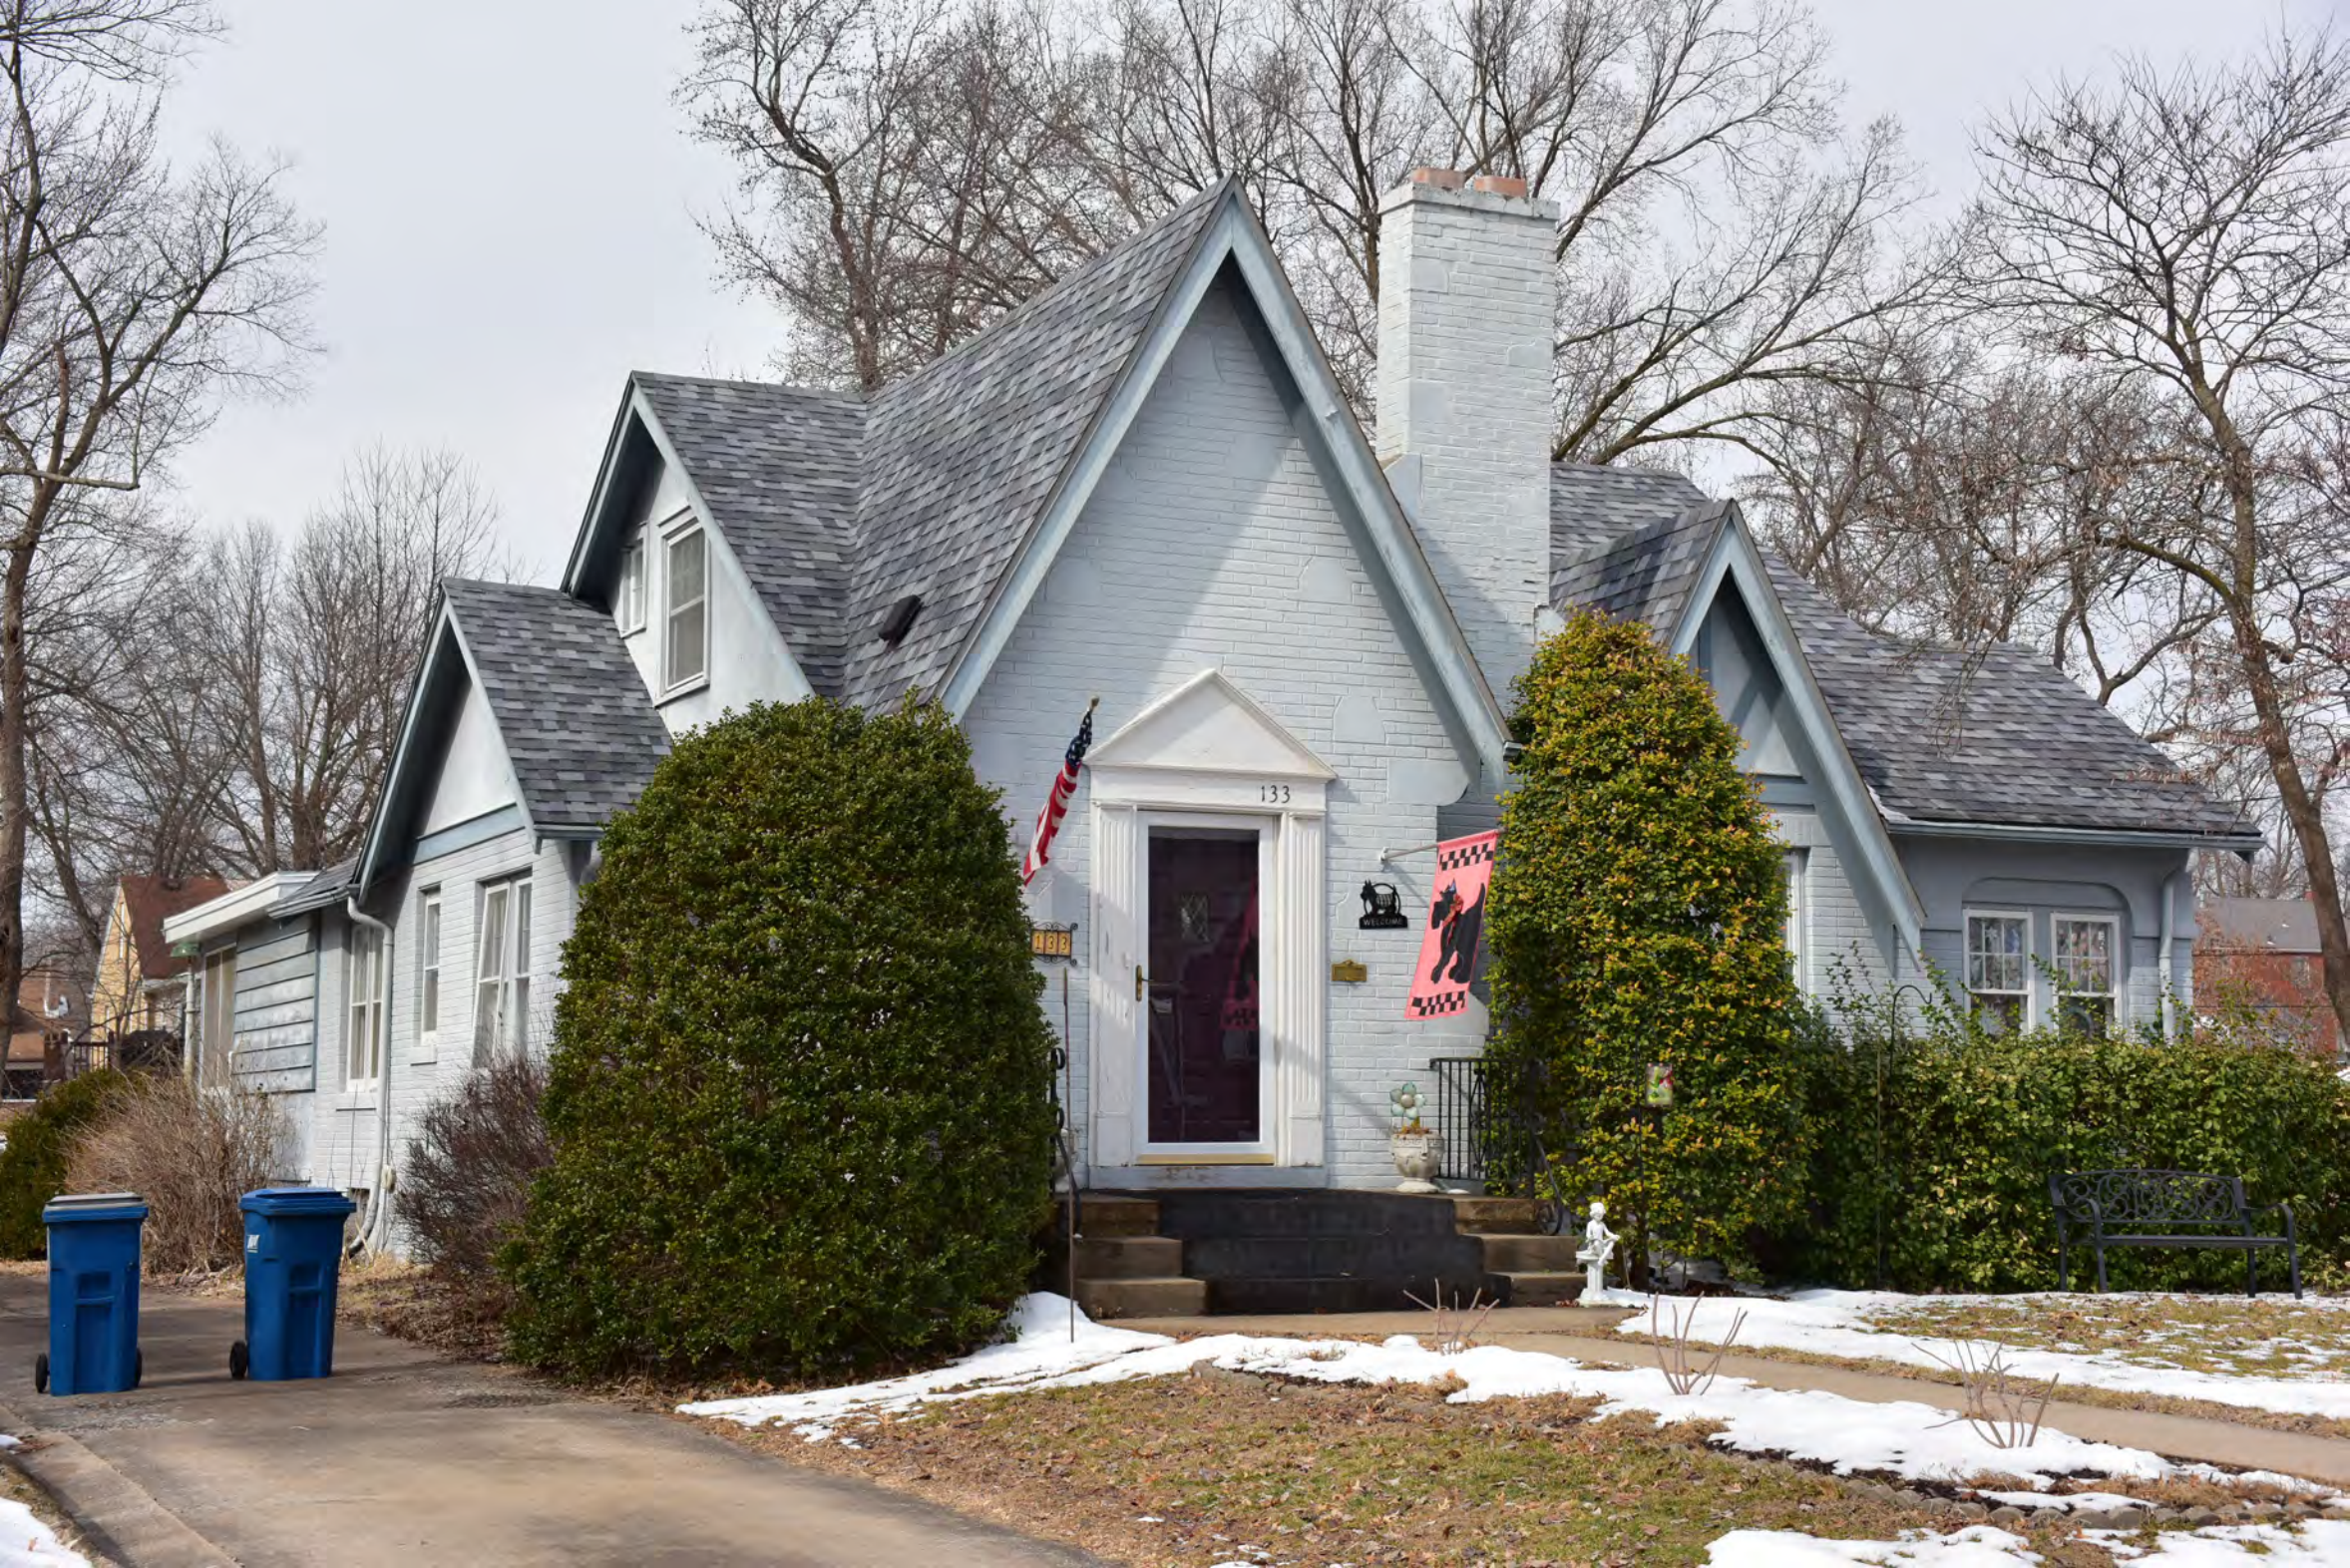
133 West Circle Drive is a one-and-one-half-story Minimal Traditional dwelling with restrained Tudor Revival influences. The painted brick-clad dwelling has a parged concrete foundation and an asphalt intersecting gable roof. Terra cotta inlays accent the south gable and chimney. A side gable with cross-gables fronts West Circle Drive while a perpendicular gable extends to the rear. A brick exterior chimney is located between the two cross-gables. The dwelling is three bays wide. The south cross-gable contains the primary entrance. The primary entrance defines the bay and features a historic wood door with glazing. The original arched opening has been altered with a neo-classical surrounded with pilasters and a pediment. The smaller north cross-gable contains the center bay. Two historic 6/1 wood windows fill the bay. Stucco and false-timbering fill the gable end. A sunporch contains the third bay. Two 6/1 vinyl windows define the third bay. The windows and stucco infill fill the wide segmental arch bay. A concrete stoop with scrolled metal railing projects from the entrance. A post-1967 shed-roof screened porch addition with a concrete block foundation and hardboard cladding spans the rear.

Alterations to 133 West Circle Drive include a replacement door surround, replacement sun porch windows and infill, and a rear addition. The date of construction for the addition is unknown, however aerial images indicate it occurred between 1967 and 1991. 133 West Circle Drive retains fair integrity and, consequently, would likely be contributing to a historic district should one be formed.
