1. Survey number: CO-AS-008-001		2. Survey Name: West Main Street Survey	
3. County: Cole		4. Address (Street No.): 100	Street (name): East Circle Drive
5. City: Jefferson City	Vicinity <input type="checkbox"/>	6. Lat / Long:	7. Township/Range/Section: T: R: S:
8. Historic name (if known):		9. Present/other name (if known):	
10. Ownership: <input checked="" type="checkbox"/> Private <input type="checkbox"/> Public		11a. Historic use (if known): Domestic-Single Dwelling	11b. Current use: Domestic-Single Dwelling

MISSOURI DEPARTMENT OF NATURAL RESOURCES
STATE HISTORIC PRESERVATION OFFICE, P.O. Box 178, Jefferson City, MO 65102
ARCHITECTURAL/HISTORIC INVENTORY FORM

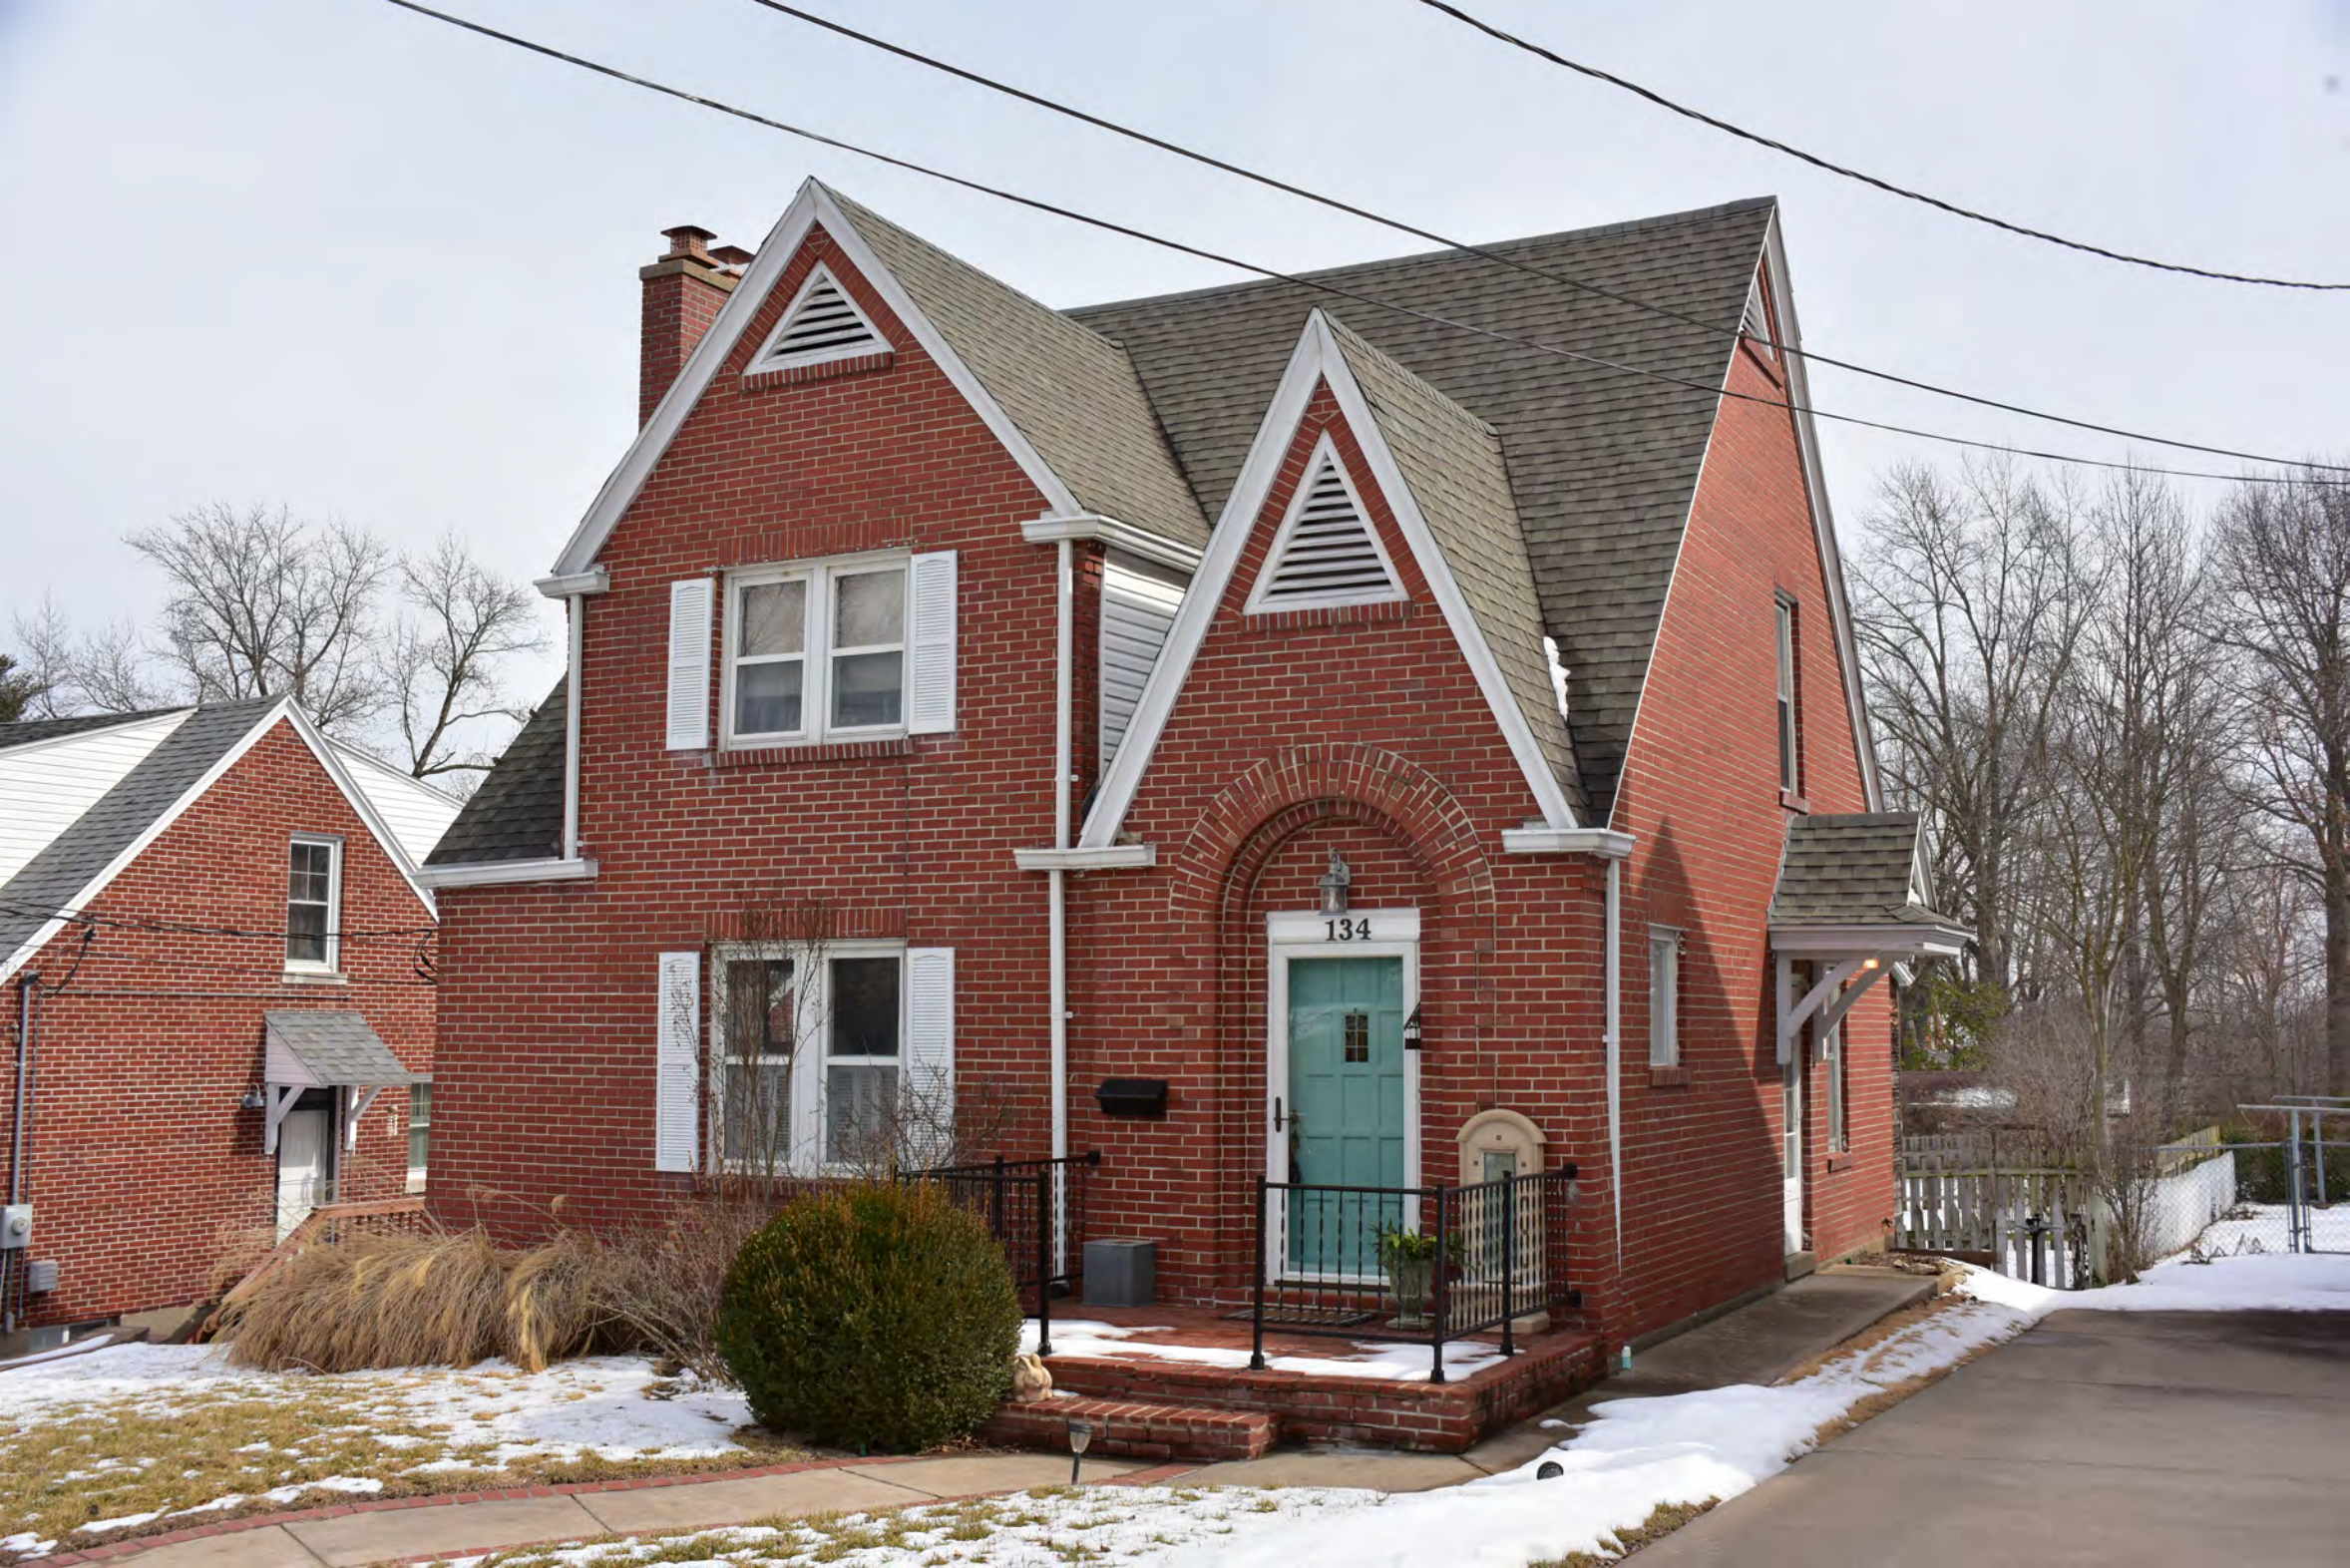
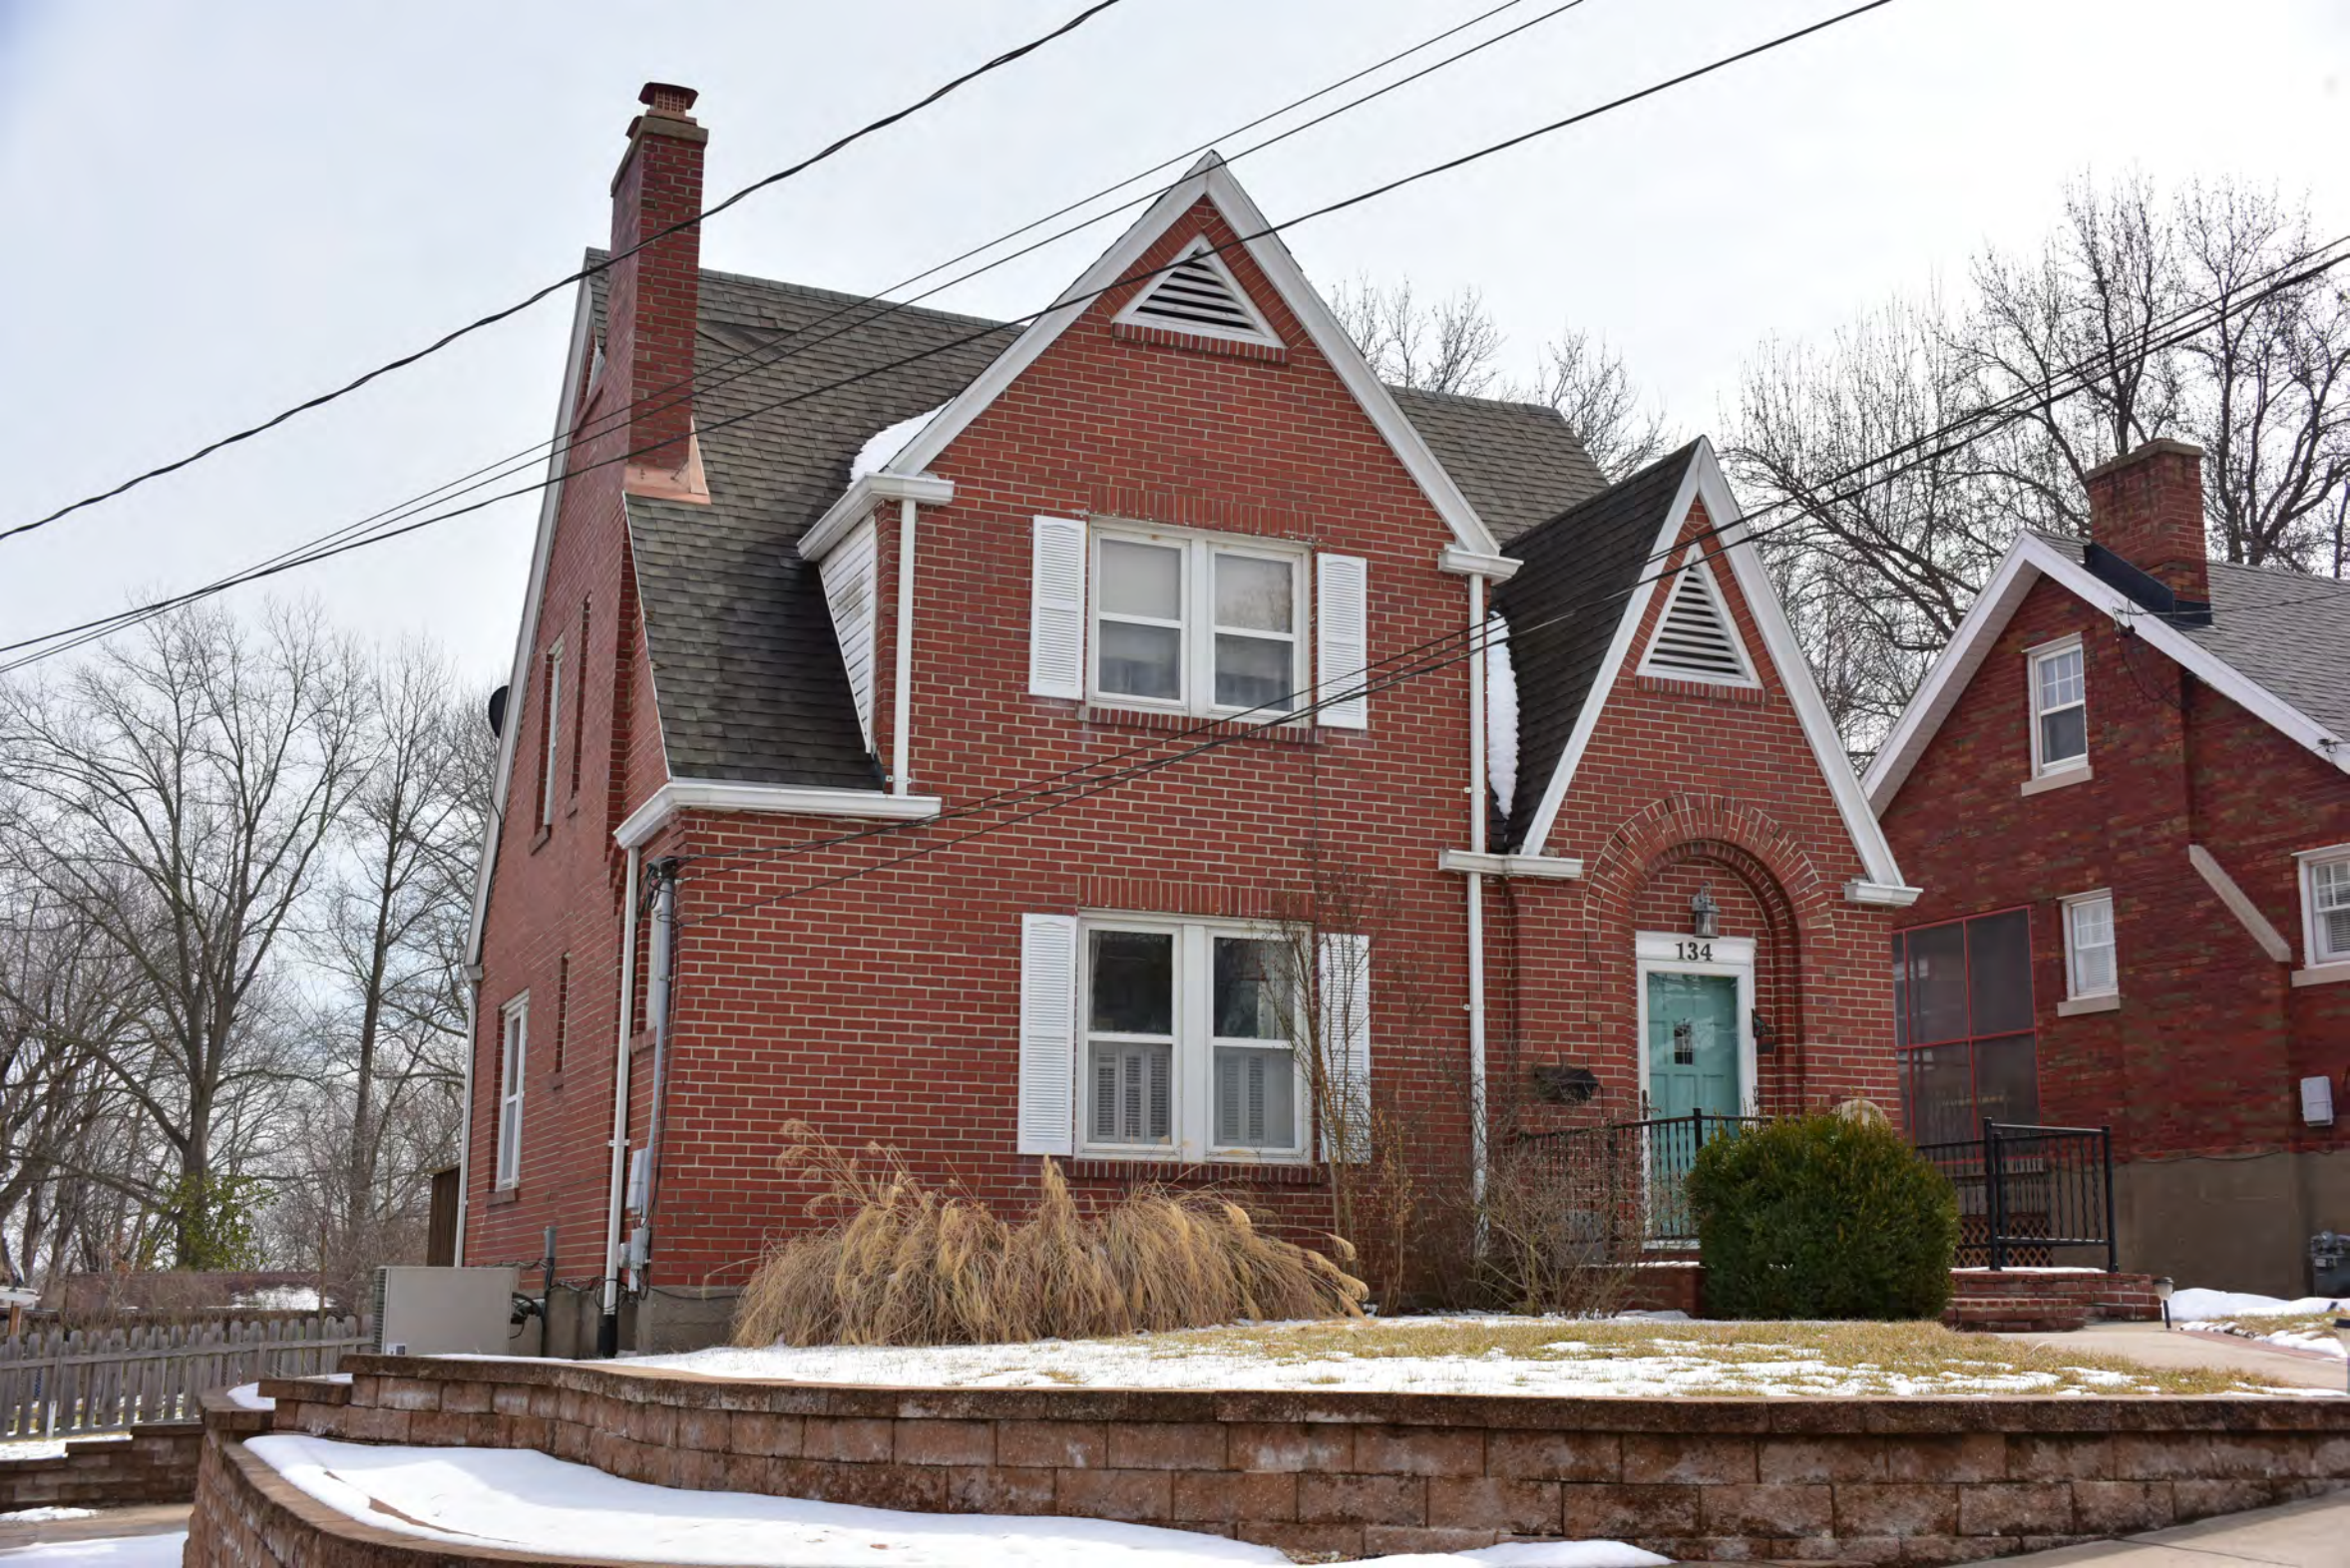
134 West Circle Drive is a two-story Minimal Traditional dwelling. The brick-clad dwelling has a parged concrete foundation and an asphalt cross-gable roof. A brick exterior pierces the north gable-end eave. The dwelling is two bays wide. Two-ganged 1/1 historic wood windows with a continuous header brick sill and soldier brick lintel defines the first bay. A gabled wall dormer pierces the roof above the first bay and contains two-ganged 1/1 wood windows. Vinyl clads the dormer sides. A low cross-gable contains the second bay. The primary entrance defines the bay and contains a historic paneled wood door with six-light glazing. A simplified entablature tops the bay. The entrance is inset into a brick arch. A brick stoop with historic metal railings projects from the entrance. A secondary entrance is centered on the south elevation. A gable with wood knee brackets shelters the entrance. An integrated one-car garage is located on the north elevation at basement level. A narrow, one-story wood-clad ell extends from the southeast corner of the dwelling at the rear. Historic triangular wood vents are in all visible gable ends.

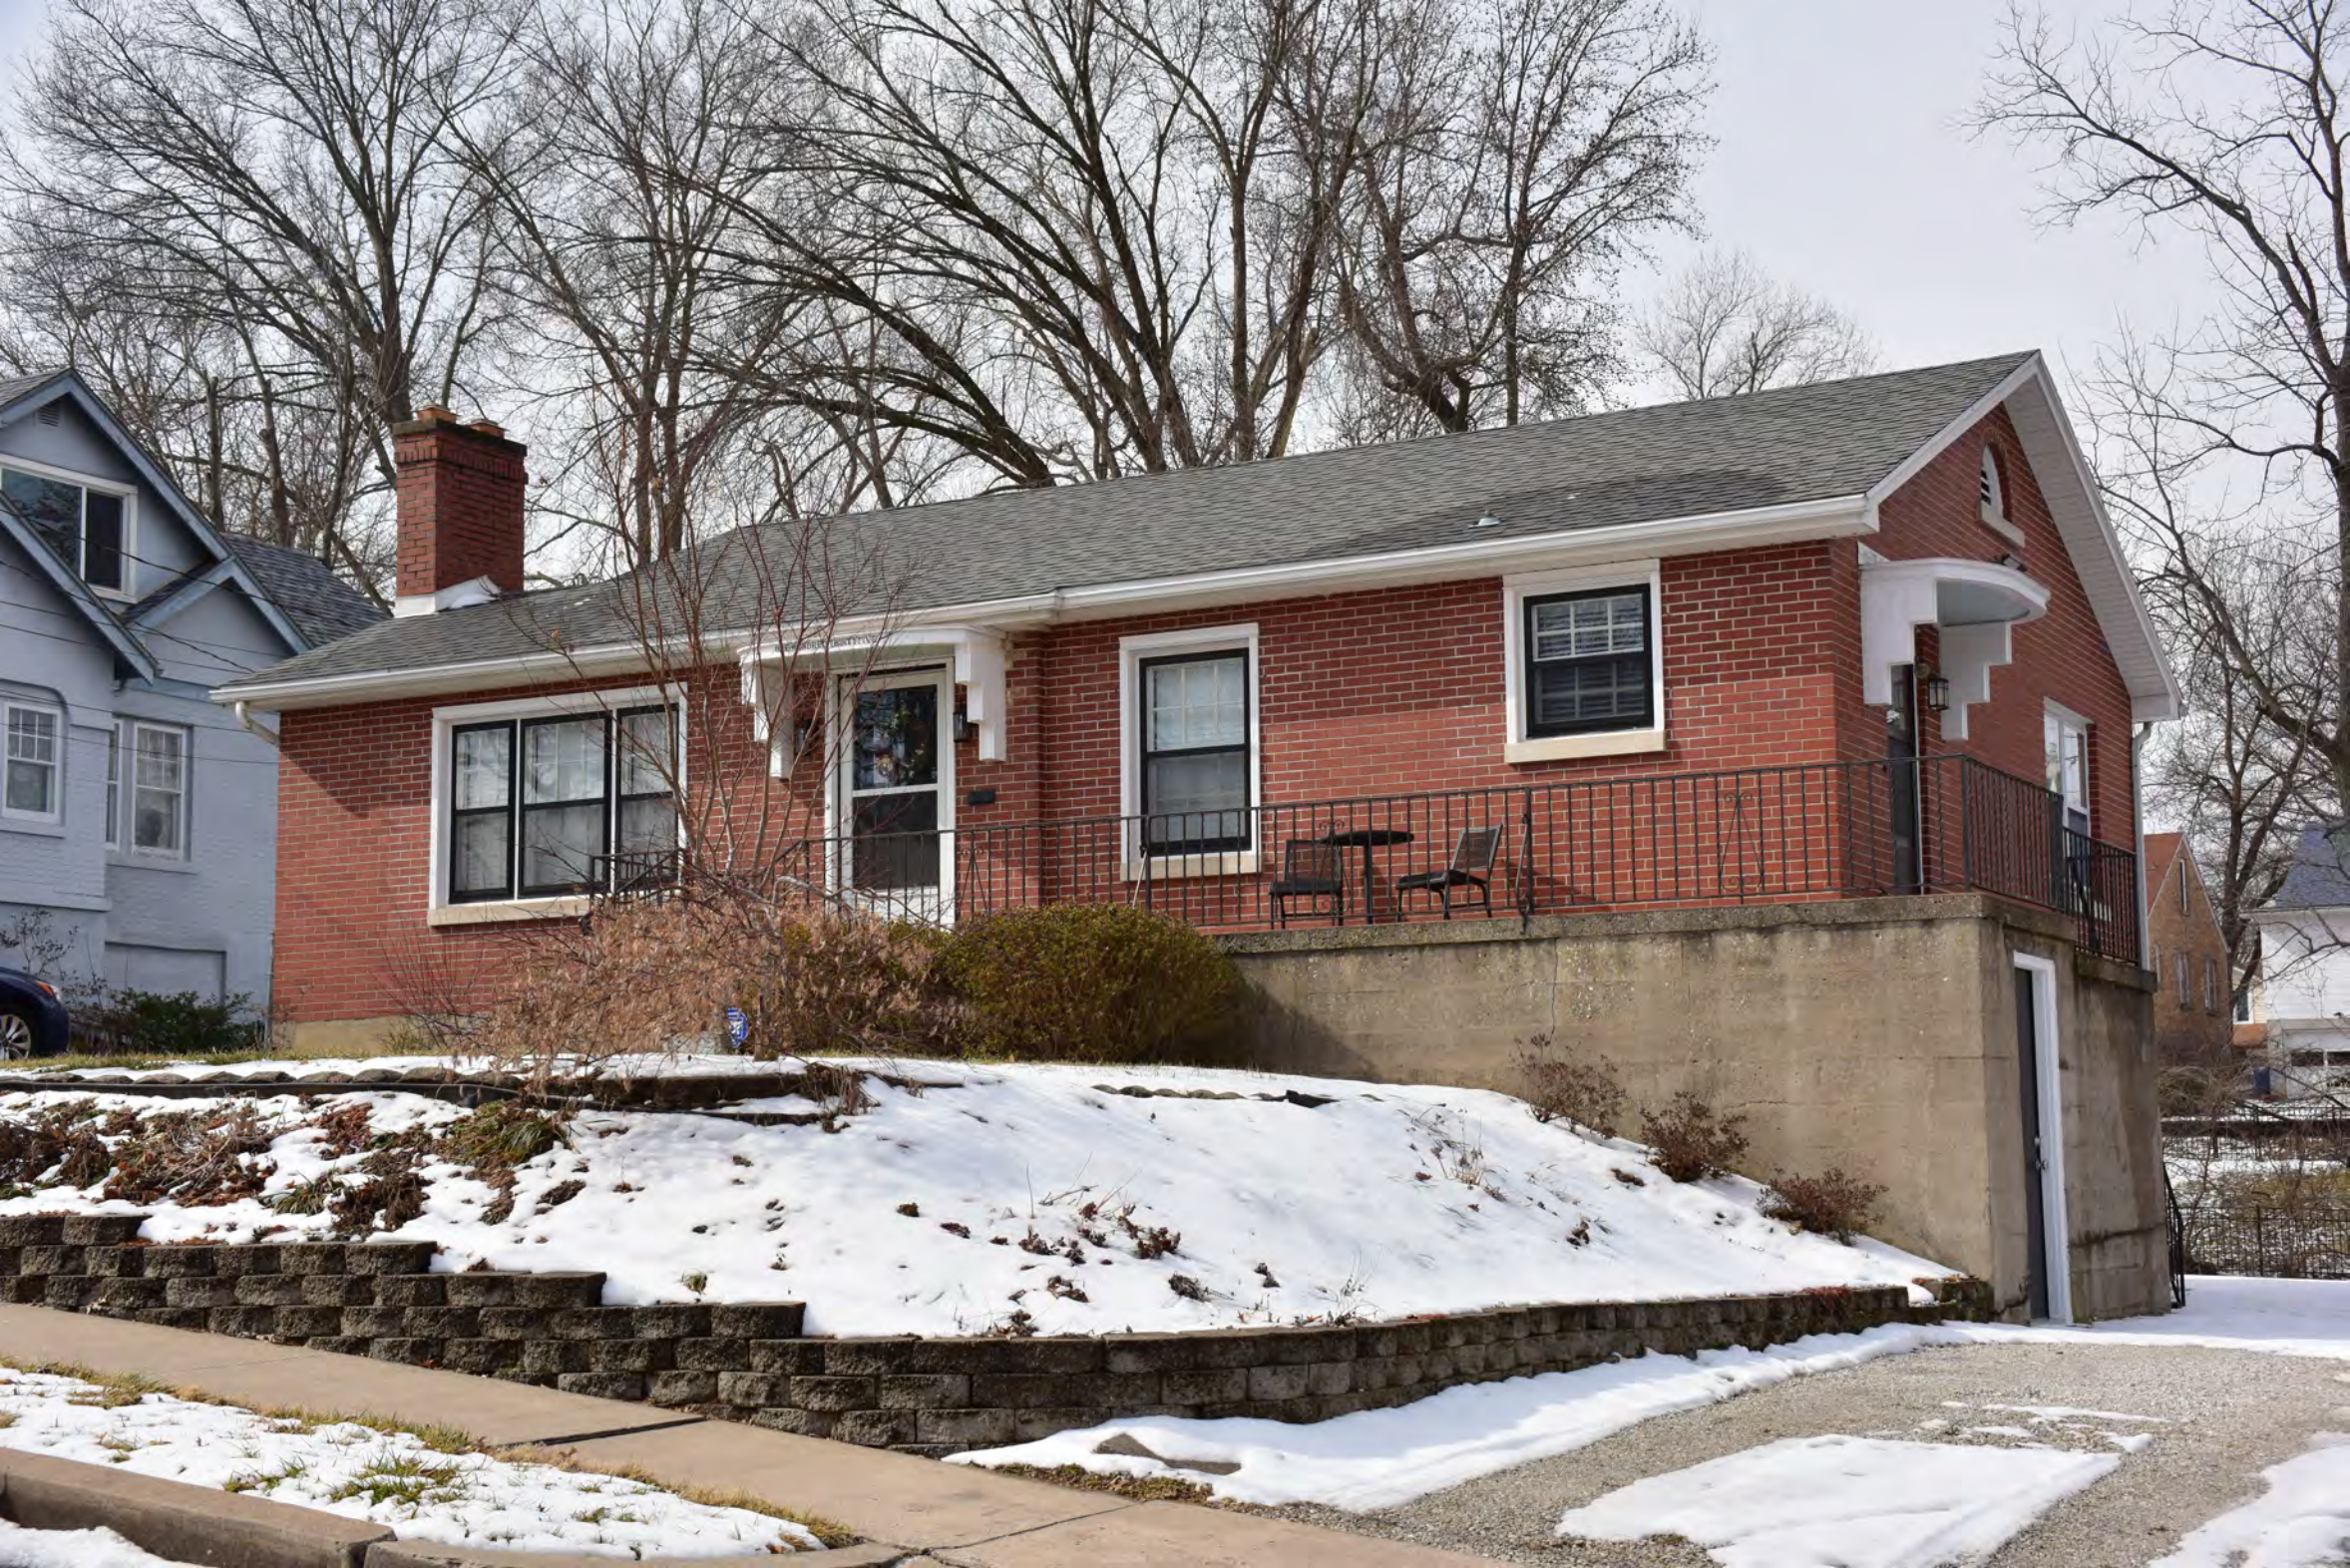
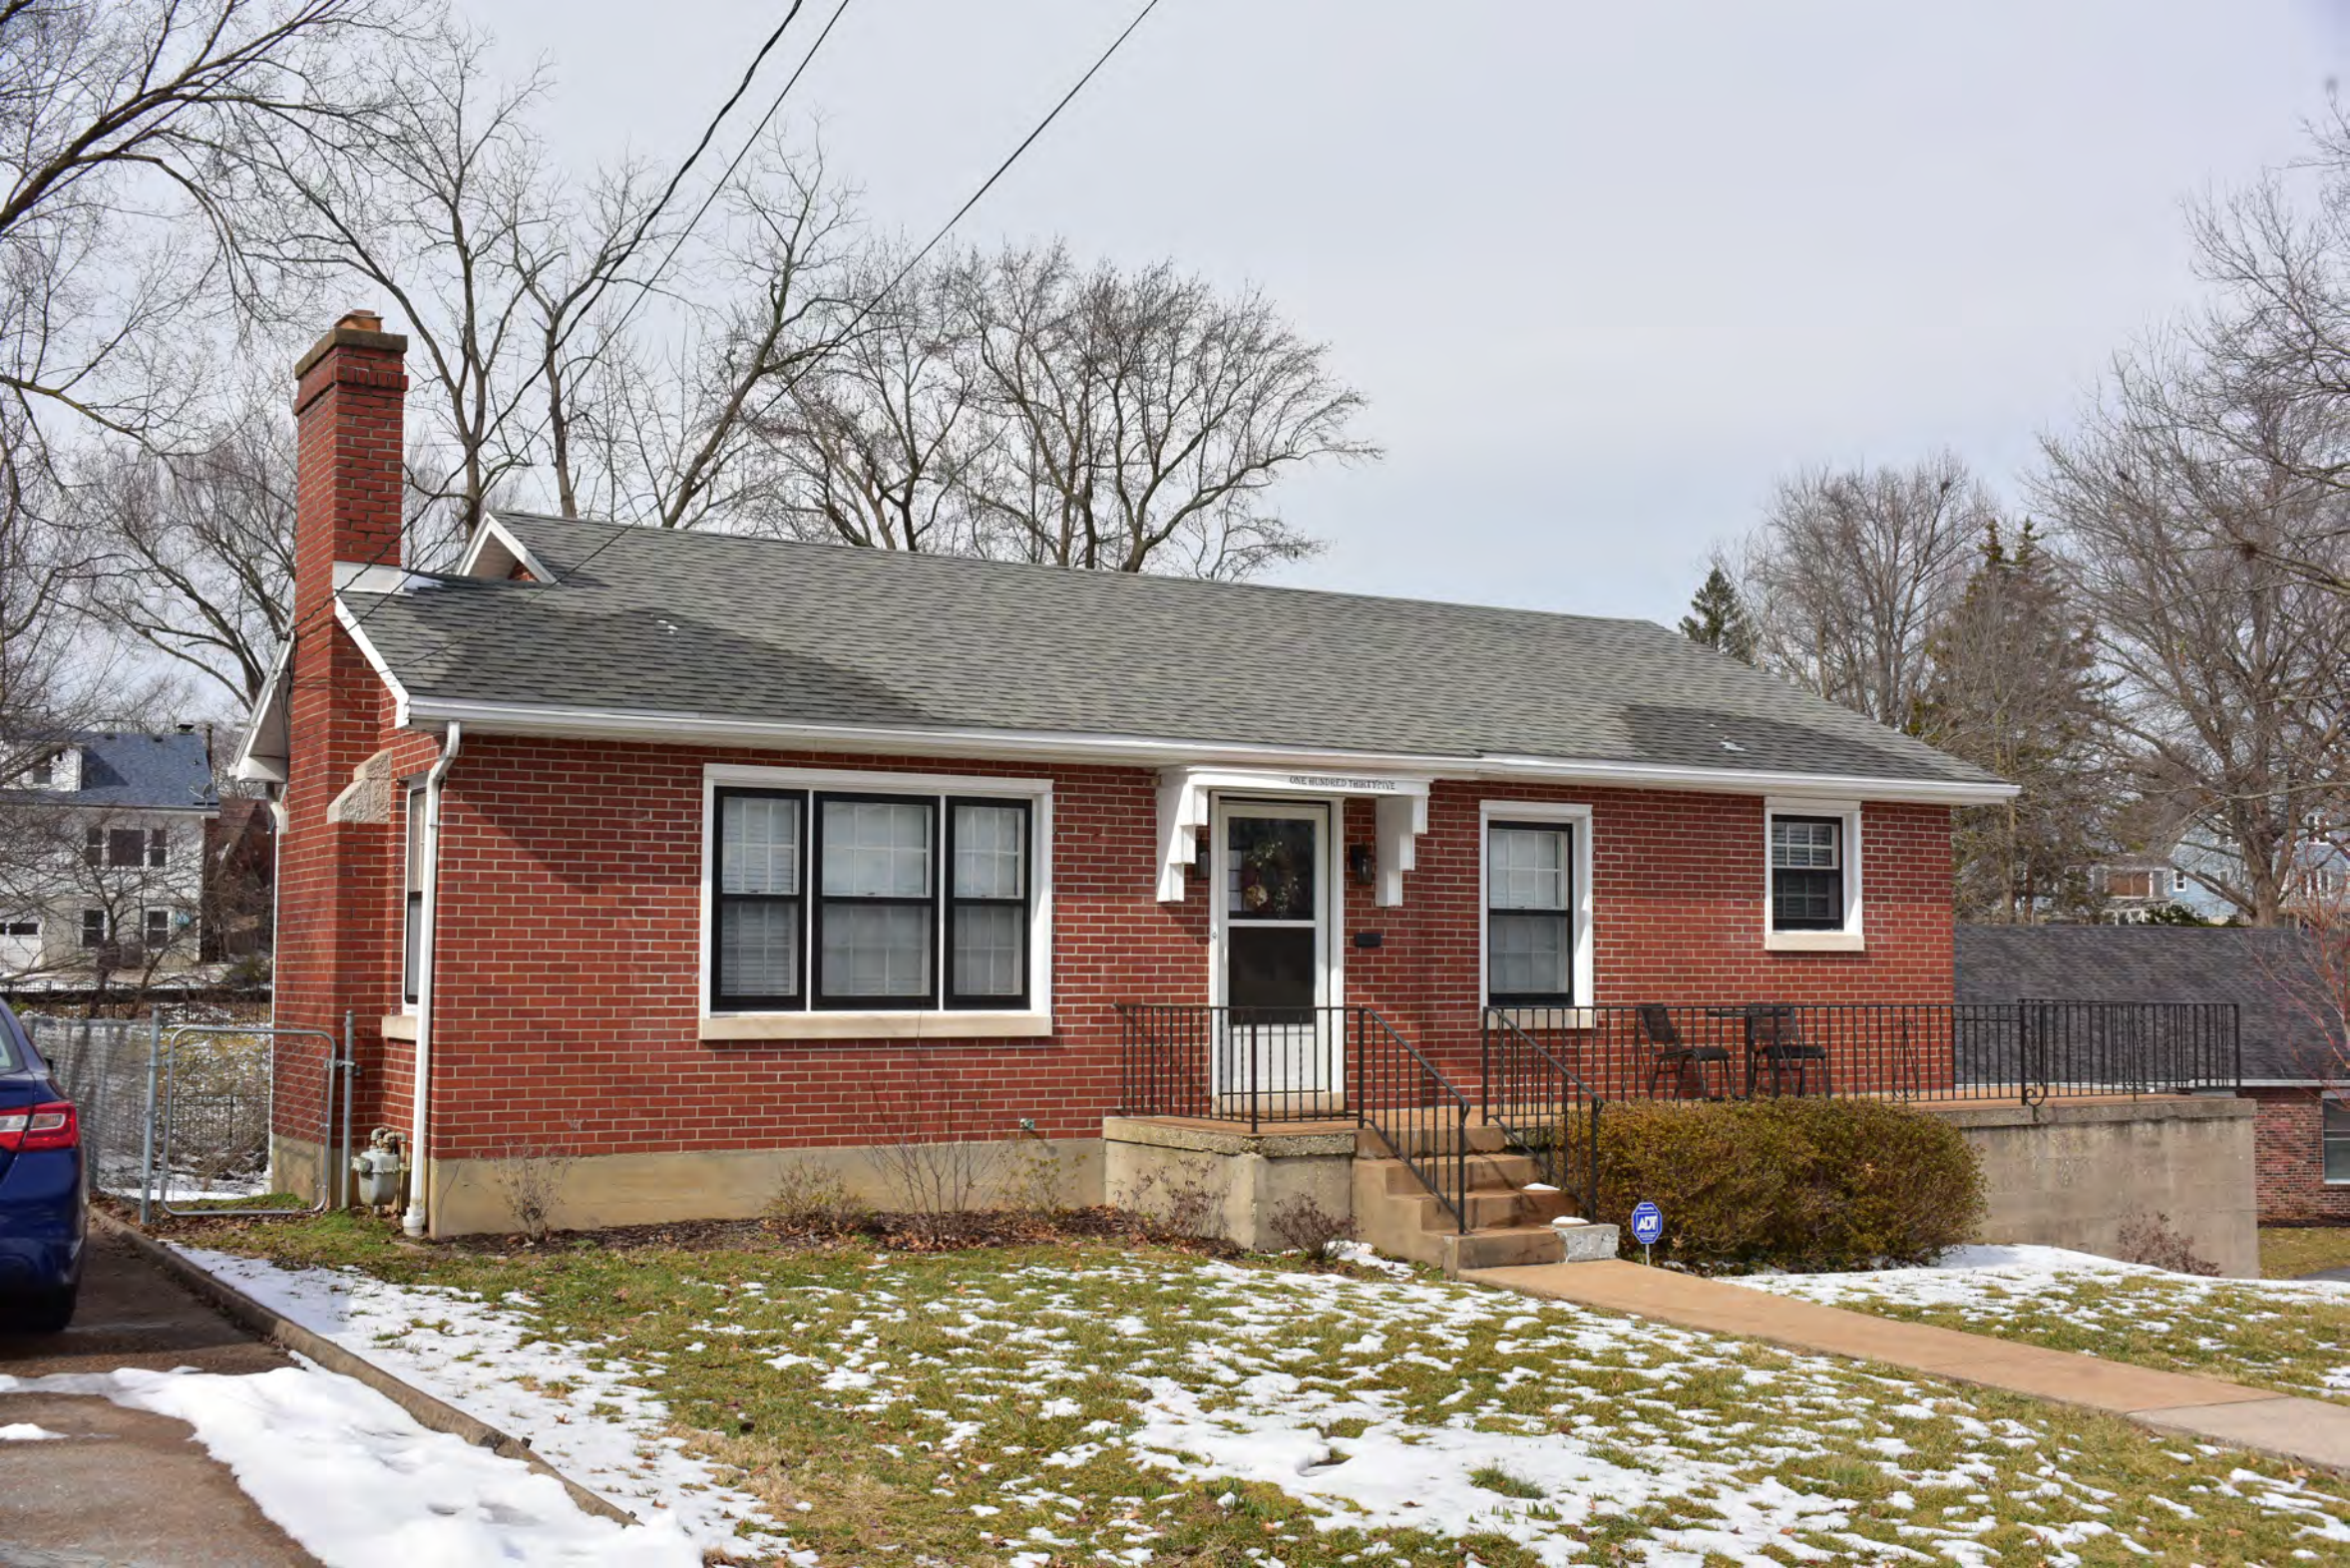
135 West Circle Drive is a one-story Transitional ranch dwelling. The brick-clad dwelling has a concrete foundation and asphalt side-gable roof. A brick exterior chimney is located at the south elevation. The dwelling is four bays wide. Three-ganged 6/6 historic wood windows with a continuous cast stone sill and simple crown moldering fill the first bay. The center window is wider than the outer windows. The primary entrance defines the second bay. A historic wood window with multi-light glazing fills the bay. A modern canopy with boxy brackets shelters the entrance. A historic 6/6 wood windows define the third and fourth bays. The fourth window is smaller and abuts the eave. Both have cast stone sills and simple crown molding. A partial-width open porch extends from the primary entrance and wraps around the north elevation. A metal railing with scrollwork lines the porch. A secondary entrance at the north elevation opens to the porch. It features a canopy matching the primary elevation canopy. A second entrance is located below at the basement level. An integrated garage is located at basement level and accessed at the rear.

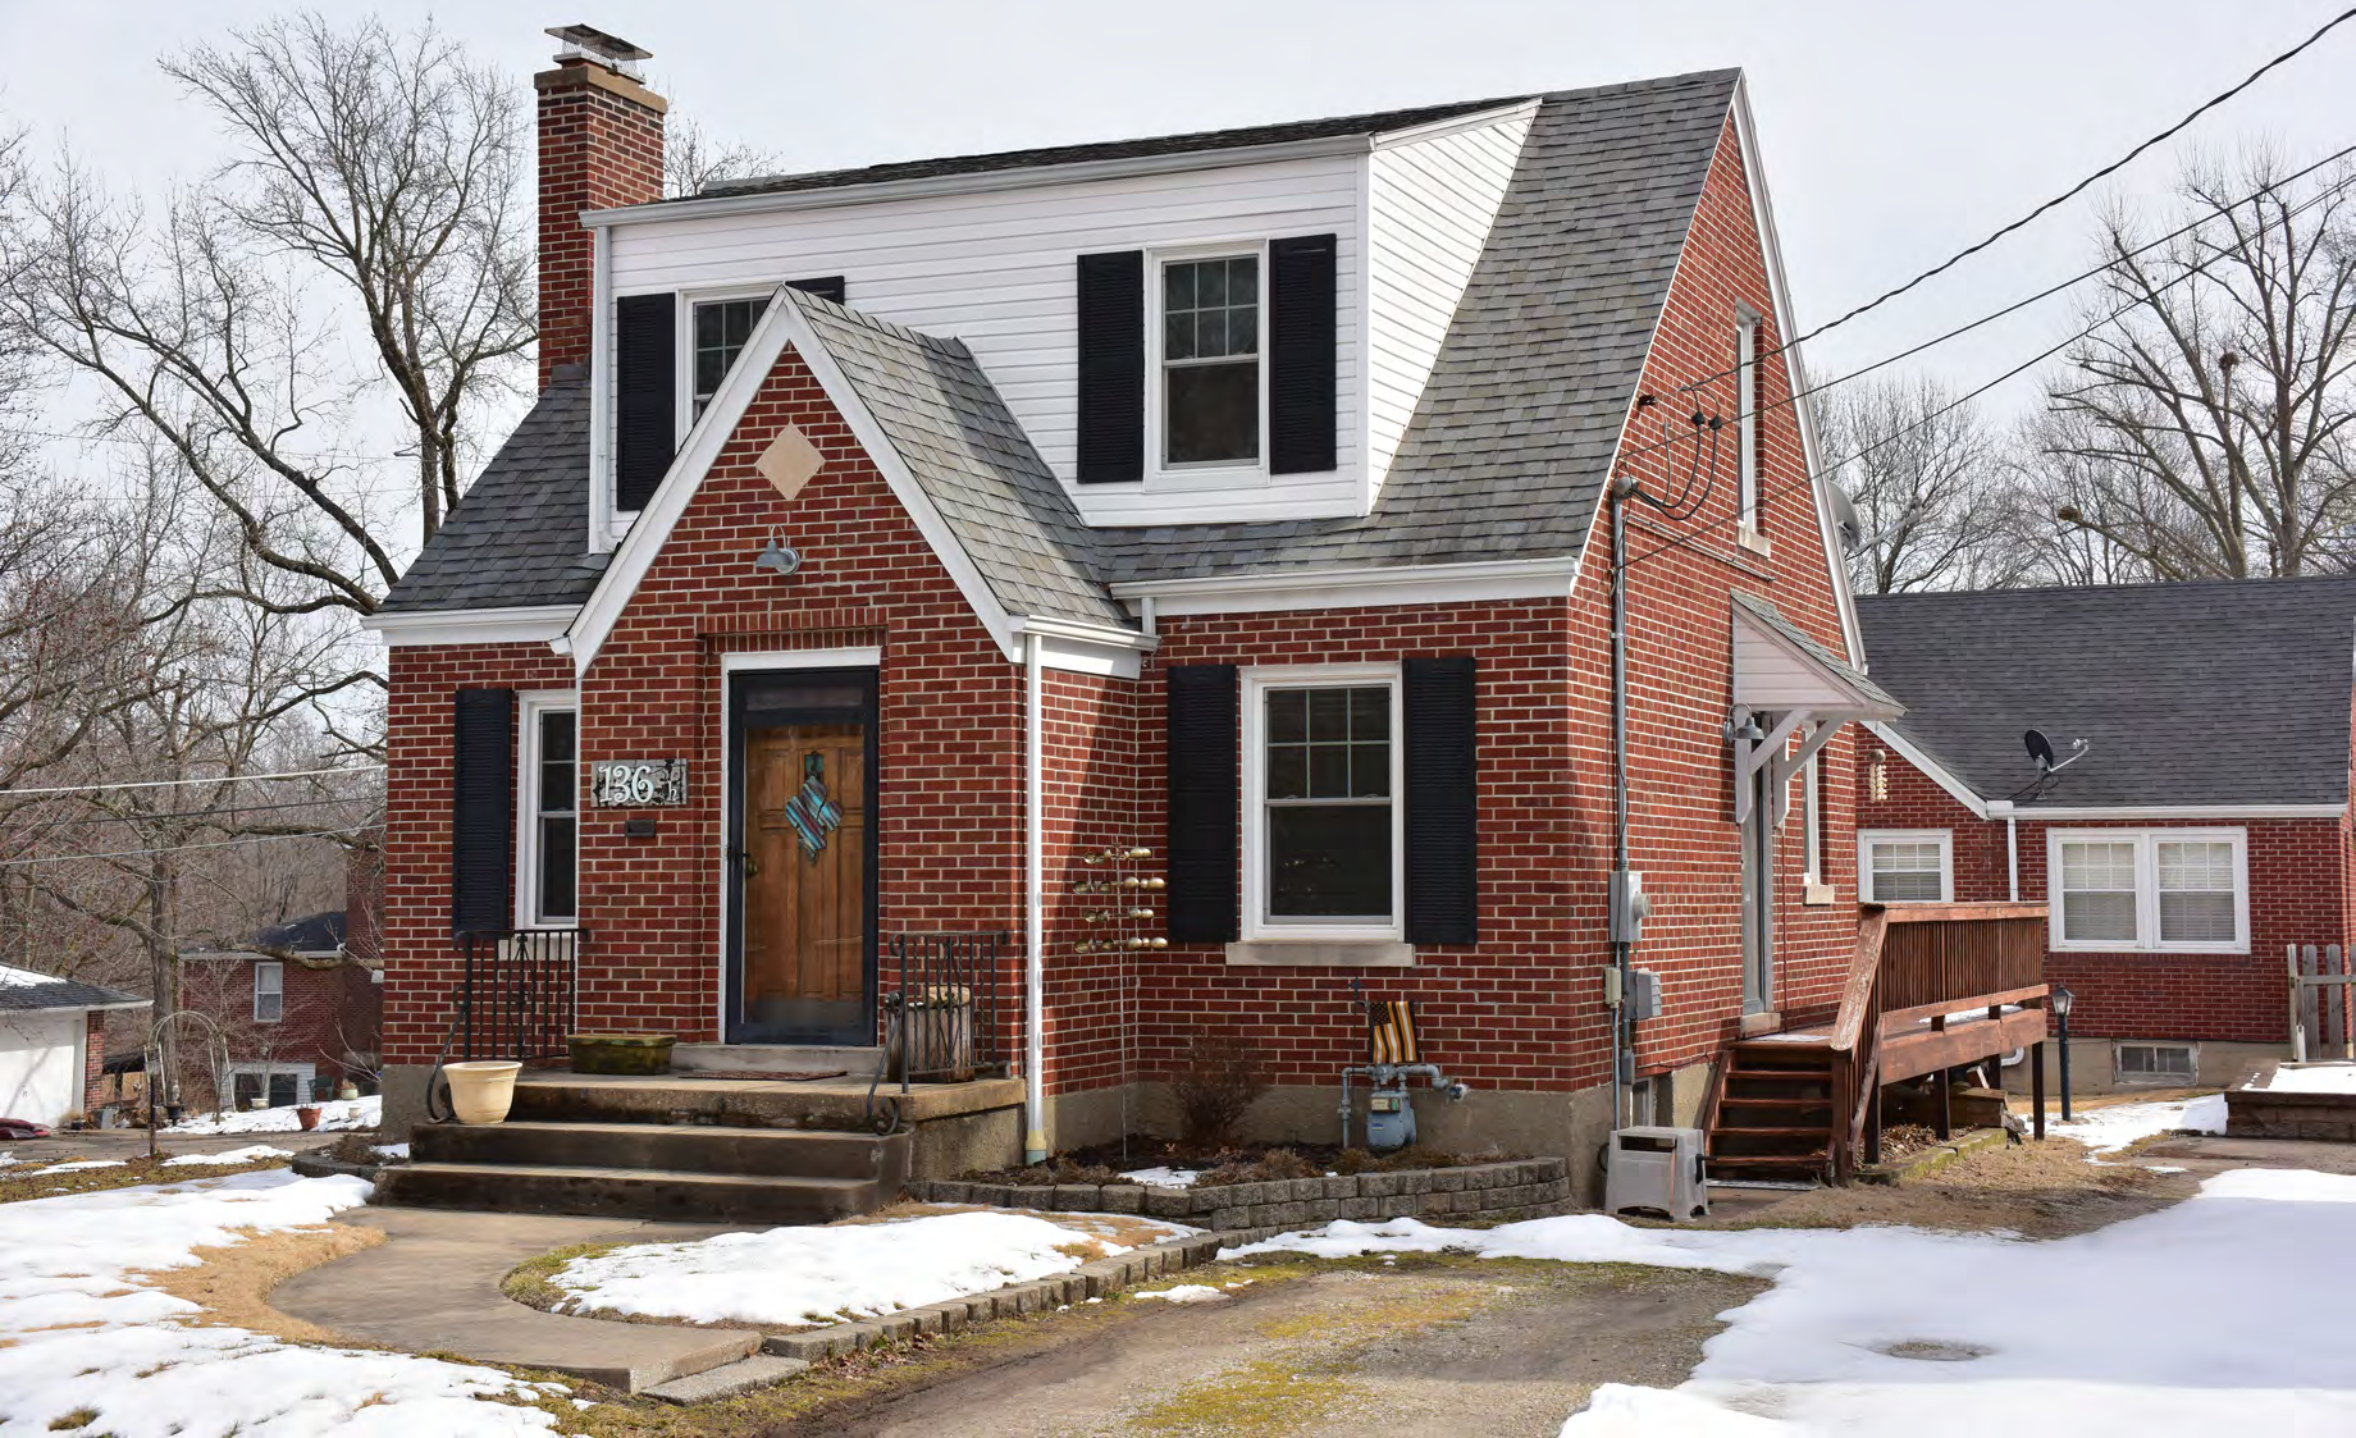
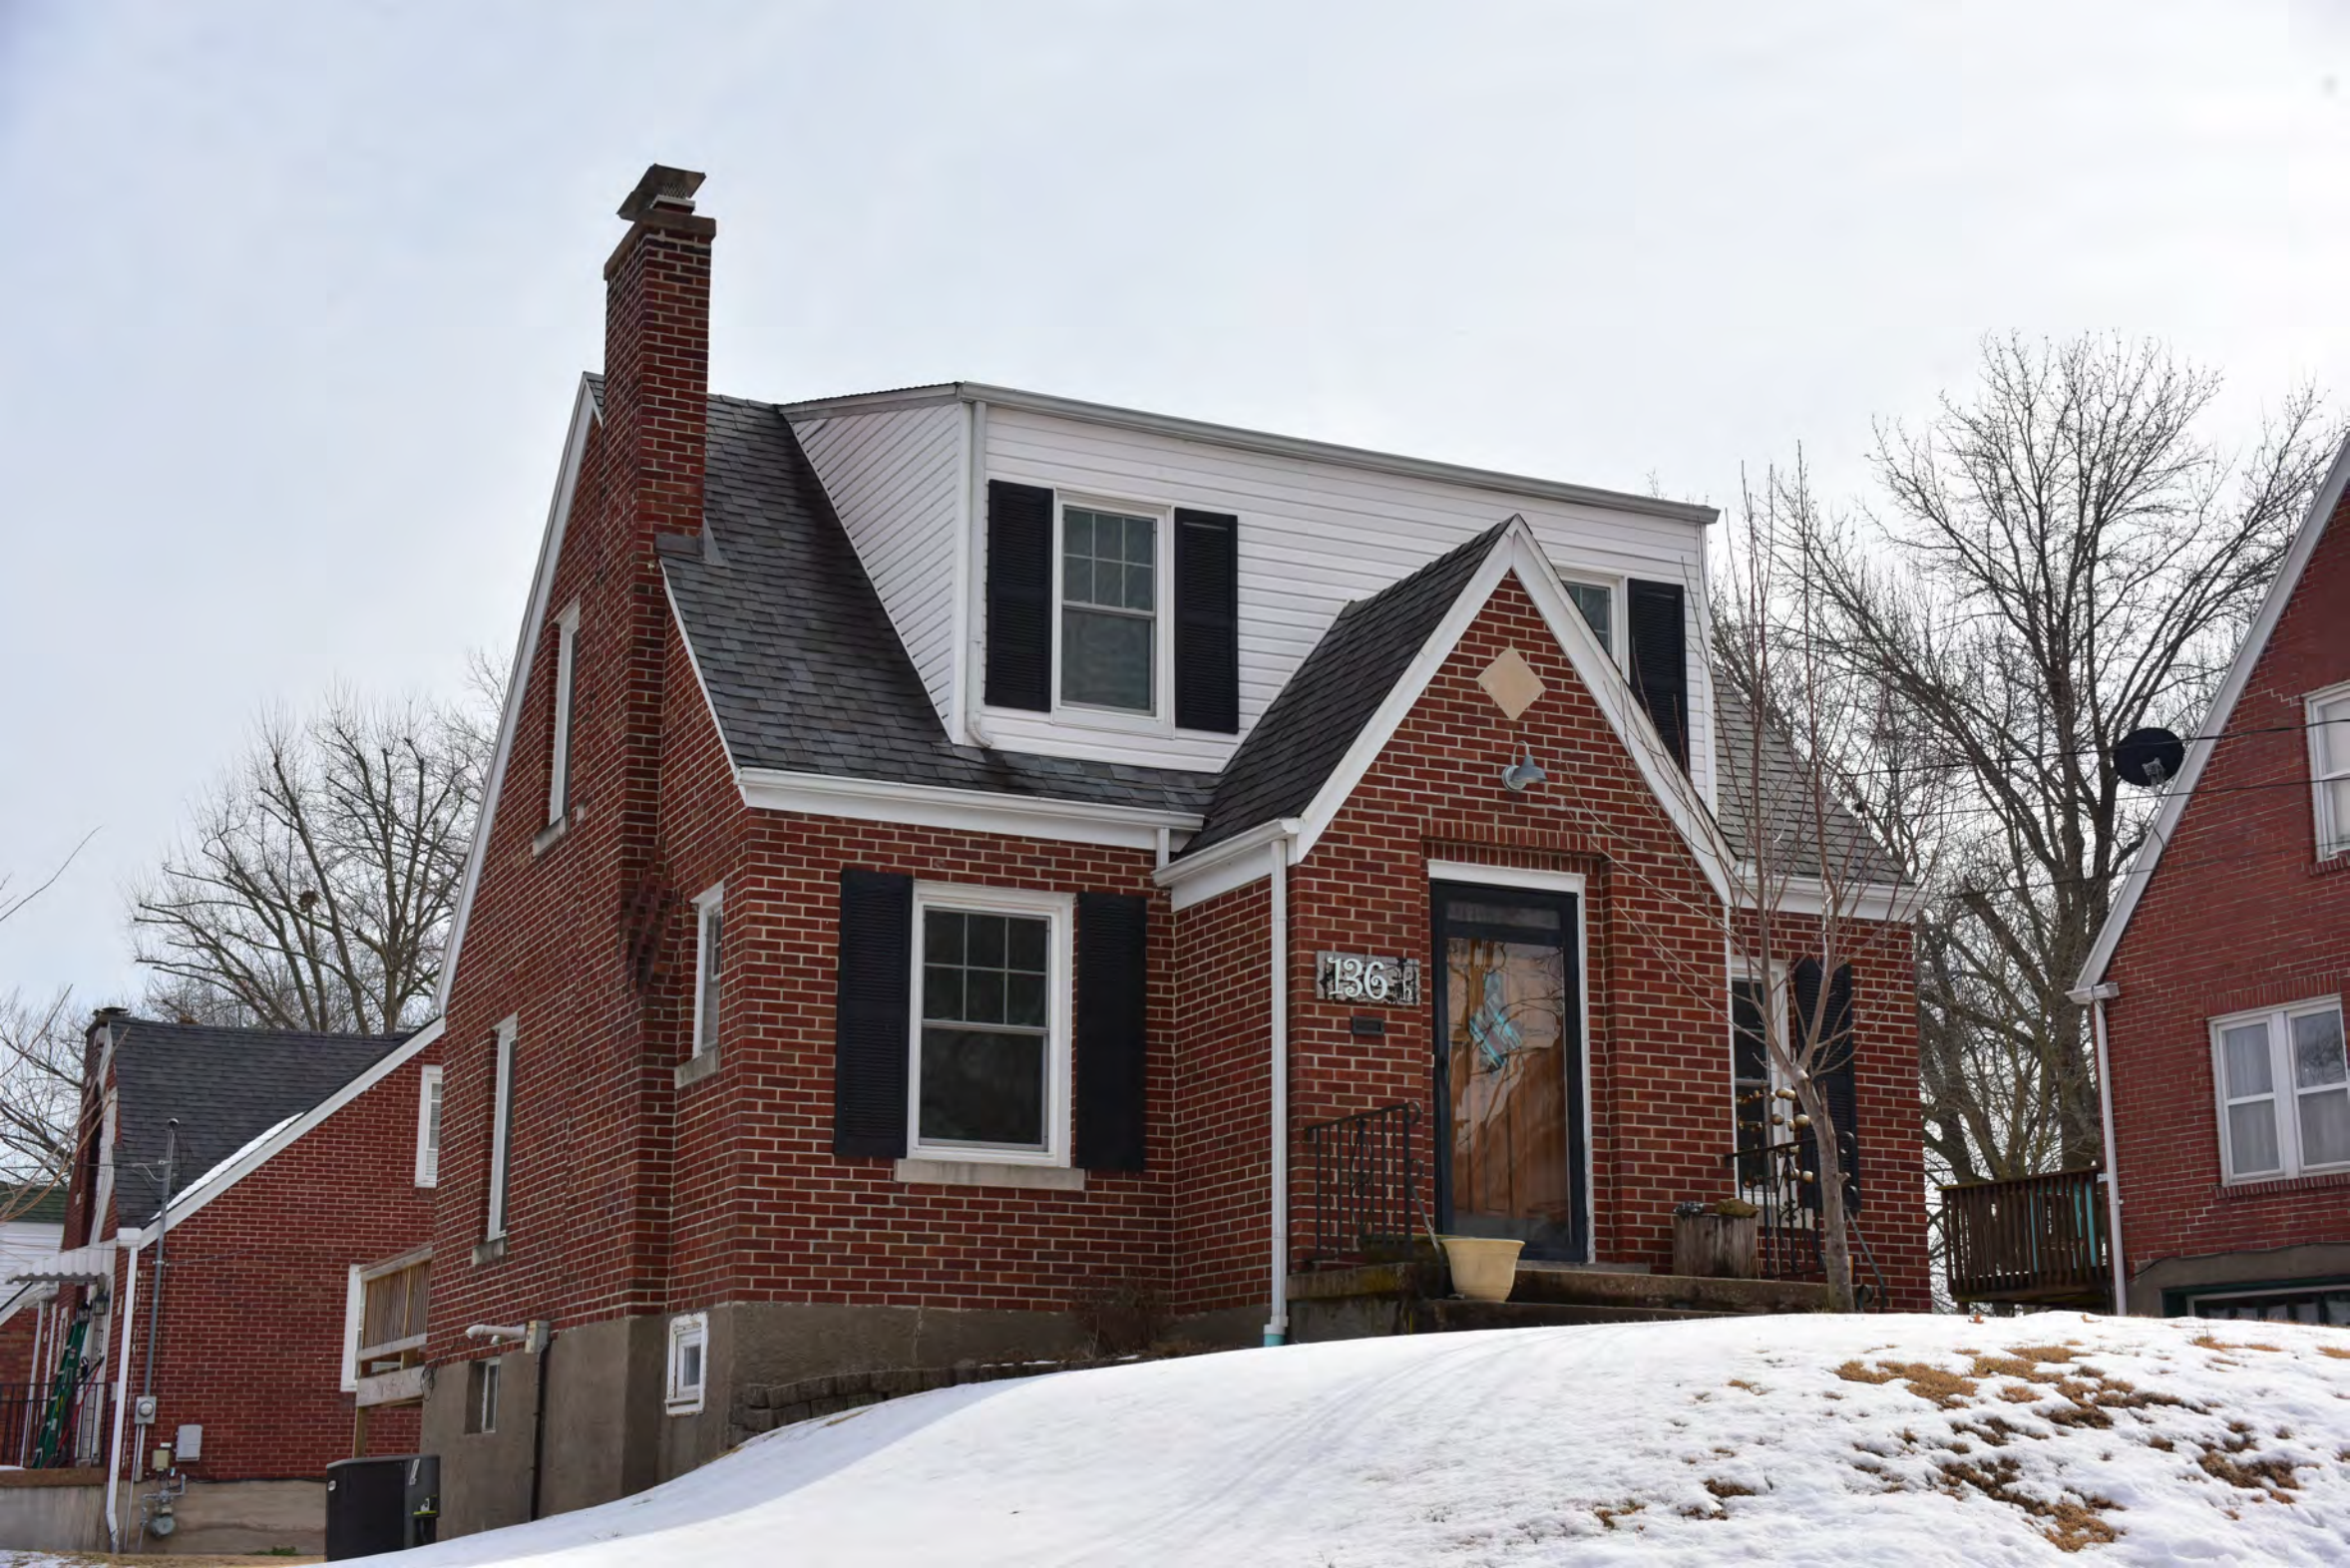
136 West Circle Drive is a one-and-one-half-story Minimal Traditional dwelling with Colonial Revival influences. The brick-clad dwelling has a parged concrete foundation and an asphalt side-gable roof. A brick exterior chimney pierces the north gable end eave. The dwelling is three bays wide. Non-historic 6/1 vinyl windows with cast stone sills flank a gabled brick vestibule which contains the primary entrance. The entrance is slightly recessed from the wall face. A concrete stoop extends from the entrance. Scrolled metal railings line the stoop perimeter. A vinyl-clad shed-roof dormer spans much of the front roof slope and is two-bays wide. Non-historic 6/1 vinyl windows fill the bays. An additional vinyl-clad shed roof dormer is centered on the rear slope. A secondary entrance is centered on the south elevation. A she-roof with wood knee brackets shelters the entrance. A non-historic wood deck extends below the entrance and wraps around the rear. An integrated garage is located at basement level and accessed at the rear. Paired non-historic doors with glazing fill the vehicular bay.

Alterations to 136 West Circle Drive include the application of vinyl siding to both dormers and the replacement of historic windows with vinyl windows. While replacements, the windows fill historic openings. 136 West Circle Drive does not appear significantly altered and retains good integrity. Field observations indicate resources of a similar vintage and good integrity may lie to the north and east. If future surveys in this area identify a potential historic district 136 West Circle Drive would likely be contributing.
