1. Survey No. JO-AS-007-0058		2. Survey name: GROVER & BROAD STREETS ARCHITECTURAL/HISTORICAL SURVEY	
3. County: JOHNSON		4. Address (Street No.) 400	Street (name) GROVER
5. City: WARRENSBURG	Vicinity: <input type="checkbox"/>	6. Geographical Reference: 35.76143 / -93.73367	7. Township/Range/Section: T: 46 R: 26 S: 24
8. Historic name (if known):		9. Present/other name (if known):	
10. Ownership: <input checked="" type="checkbox"/> Private <input type="checkbox"/> Public		11a. Historic use (if known): SINGLE DWELLING	11b. Current use: SINGLE DWELLING

HISTORICAL INFORMATION

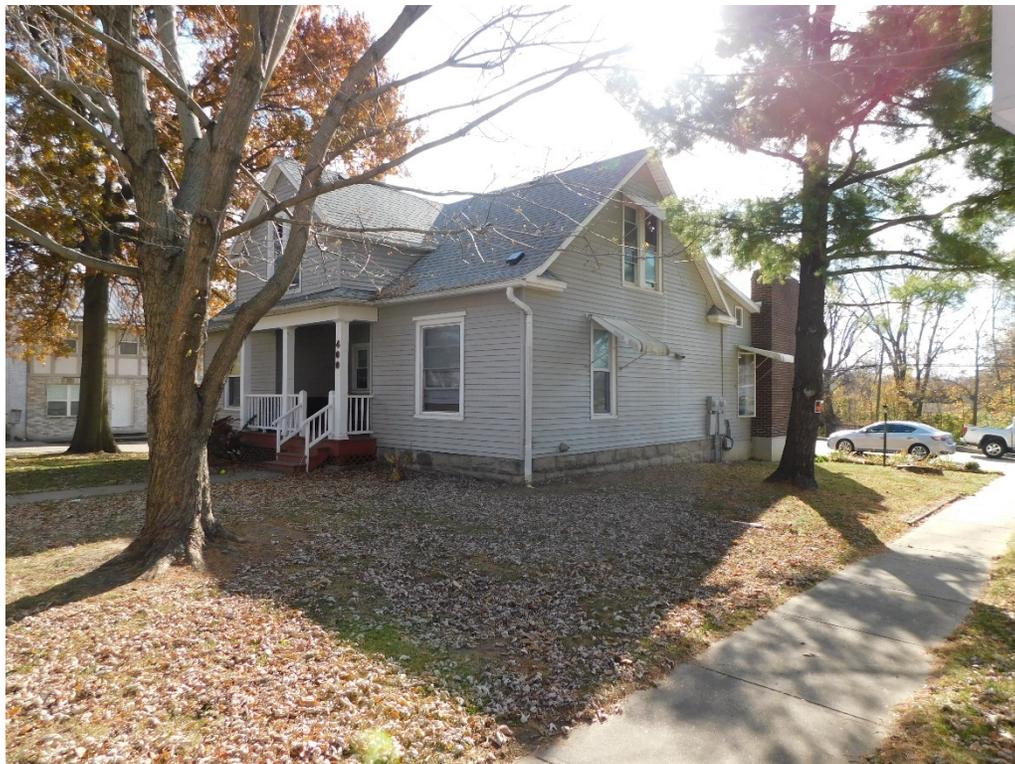
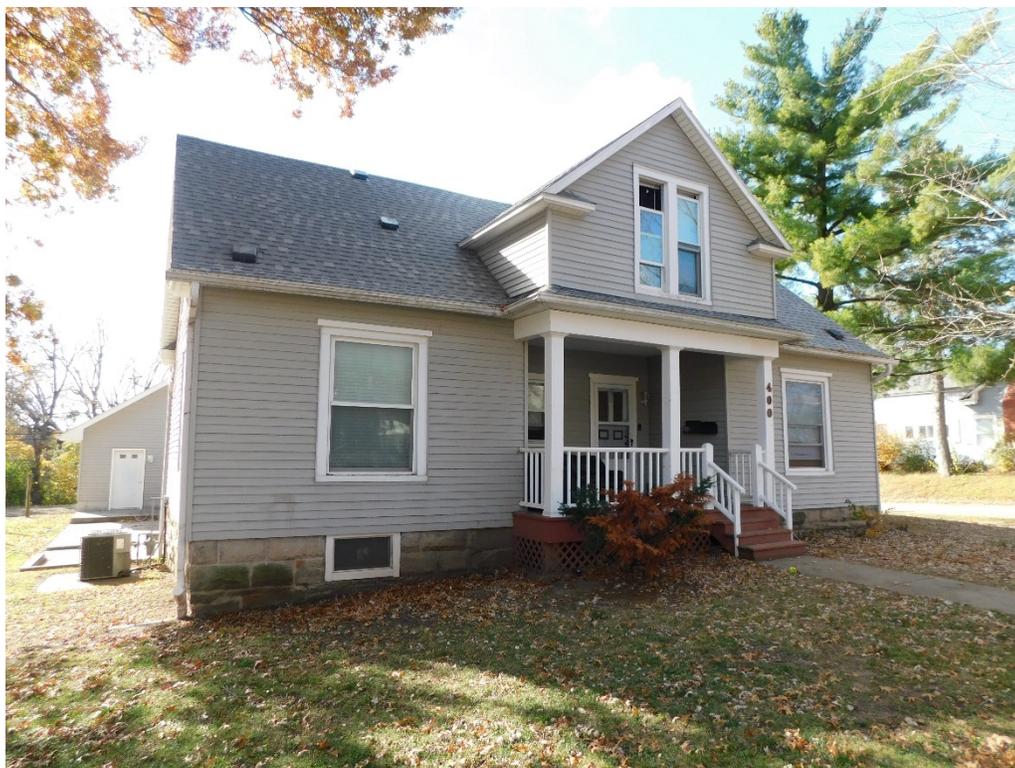
Description:
LOOKING SOUTHEAST

Description:
LOOKING SOUTHWEST

This one-and-an-half story front-gable-and-wing house features a concrete foundation and vinyl exterior walls. The façade is four bays wide with one-over-one double-hung wood windows in the first and last bay. The center bays feature a partially recess porch with boxed wood columns and wood railing. The second bay has a one-over-one double-hung wood window, and the third bay has a wood paneled door with two-lights. The roof features a cross gable with a center gable over the recessed porch. The center gable features vinyl siding and paired one-over-one double-hung wood windows. The side elevations feature matching windows with paired windows in the gable-ends. This building is not eligible due to alterations to the siding and fenestration.

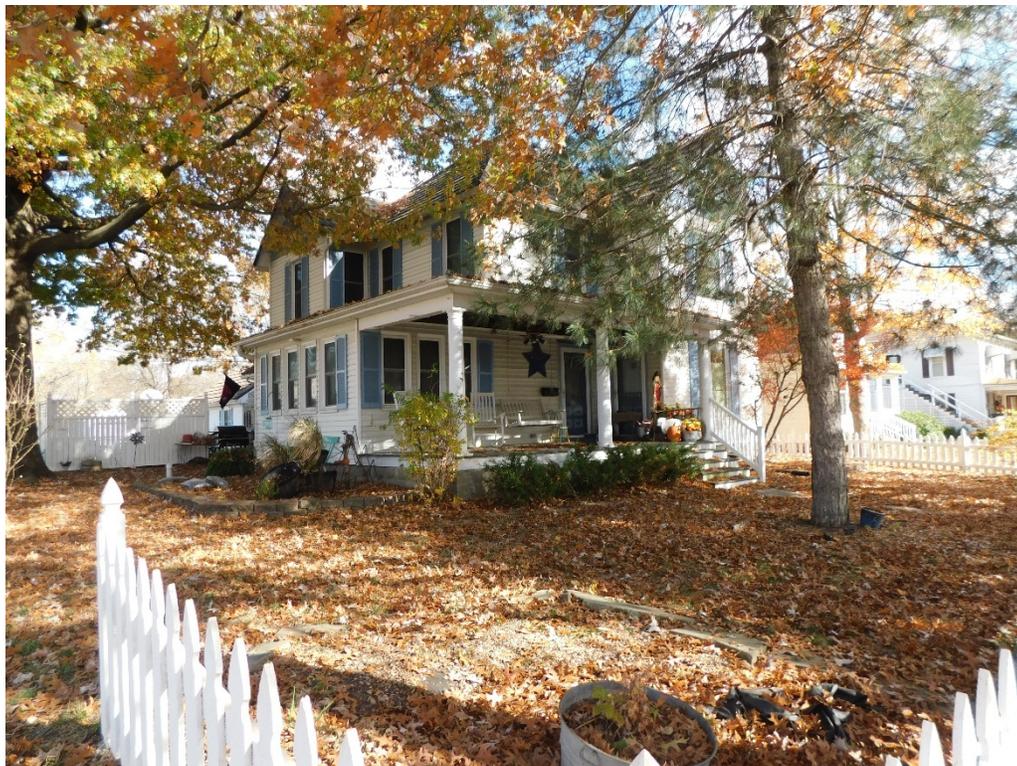
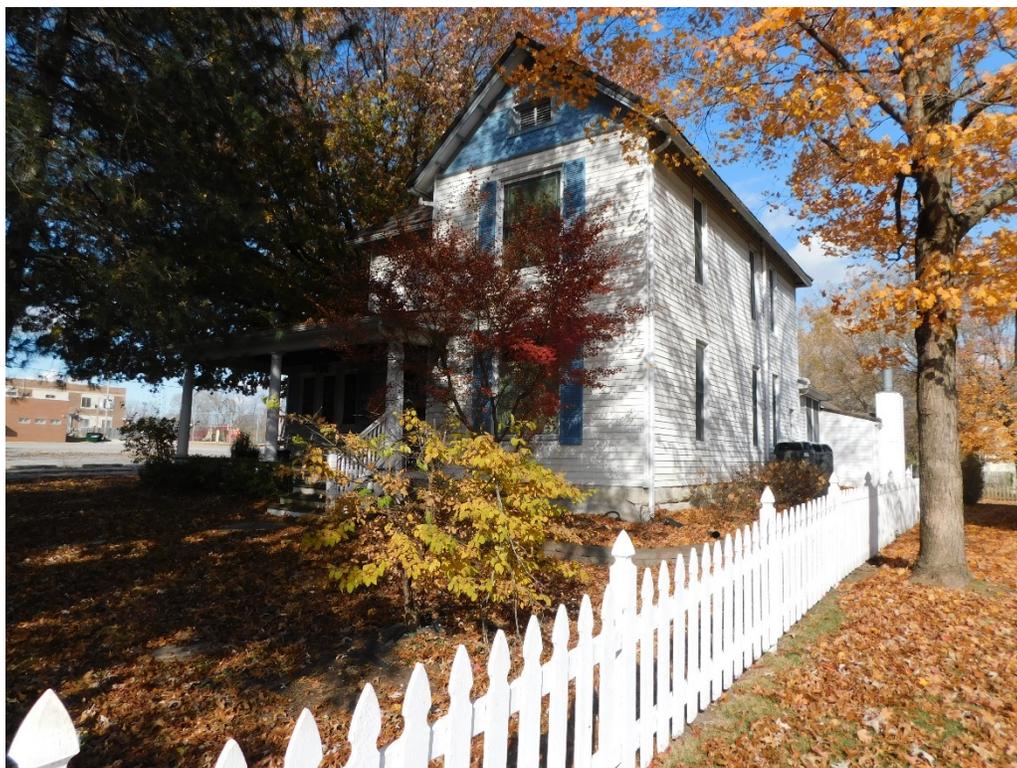
Photographer: KAREN HICKLIN	Date: 11/8/2020	Description: LOOKING NORTHEAST
--------------------------------	--------------------	-----------------------------------

Photographer: KAREN HICKLIN	Date: 11/8/2020	Description: LOOKING NORTHWEST
--------------------------------	--------------------	-----------------------------------

This two-story house is the hipped roof with lower cross gable subtype of Queen Anne with fishscale shingle and a paired wood vents in the gable-ends. The house resides on the corner of S. Charles St. and Grover St., and it features a sandstone foundation, vinyl exterior walls, one-over-one double-hung wood windows, and non-original shutters. The partial-width porch is the focal point of the building with classical columns and no railing. The building is six bays wide with entrances in the fourth bay facing Grover St, and in the fifth bay facing S. Charles St. The remaining bays are filled with one-over-one sash windows. The second story features additional one-over-one sash windows. There is an attached garaged located on the rear facing the north. The garage features a concrete foundation, vinyl exterior walls, one-over-one vinyl windows and a gable roof. On the north elevation, there are two metal paneled garage doors.

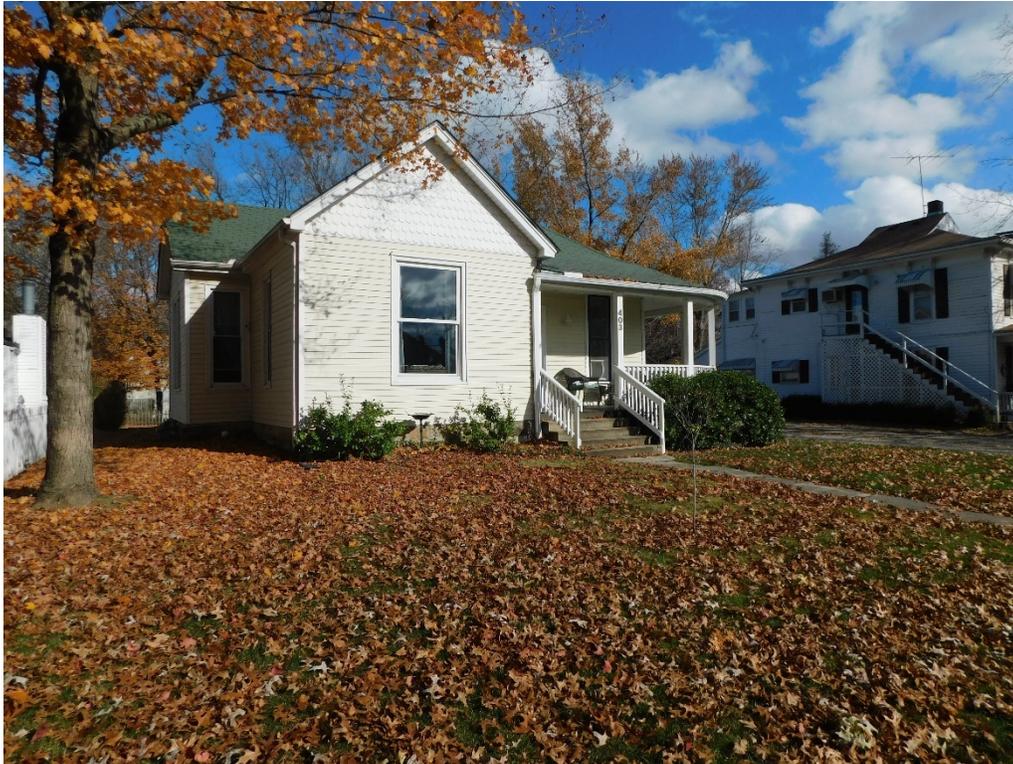
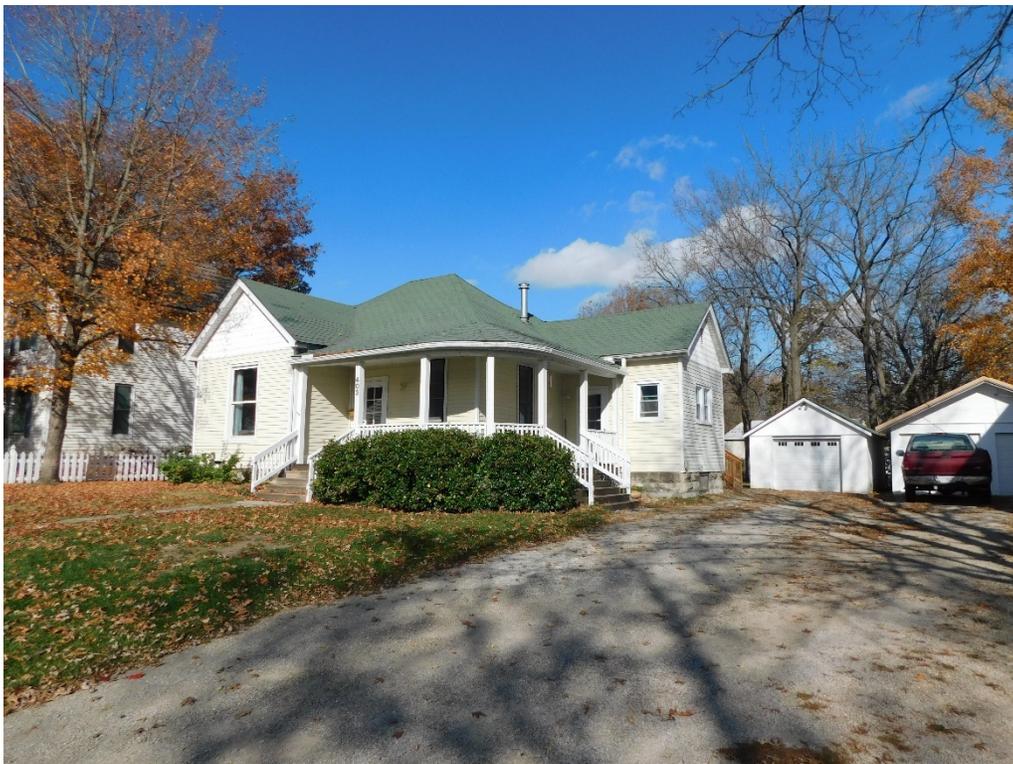
Description:
LOOKING NORTHEAST

Description:
LOOKING NORTHWEST

This one-story house is the hipped roof with lower cross gable subtype of Queen Anne style. The roof has asphalt shingles and fishscale shingles in the gable-ends. The house features a sandstone foundation, vinyl exterior walls, one-over-one double-hung wood windows, and one-over-one hung vinyl windows. The building is six bays wide with six-light doors in the second bay facing Grover St, and in the fifth bay facing Grover St. The remaining bays are filled with one-over-one sash windows. The curvilinear wraparound porch located on the southeast corner extends from gable-end to gable-end. The porch features boxed wood columns, a wood railing, and steps in front of the second and fourth bays. This building is not eligible due to alterations to the siding and fenestration.

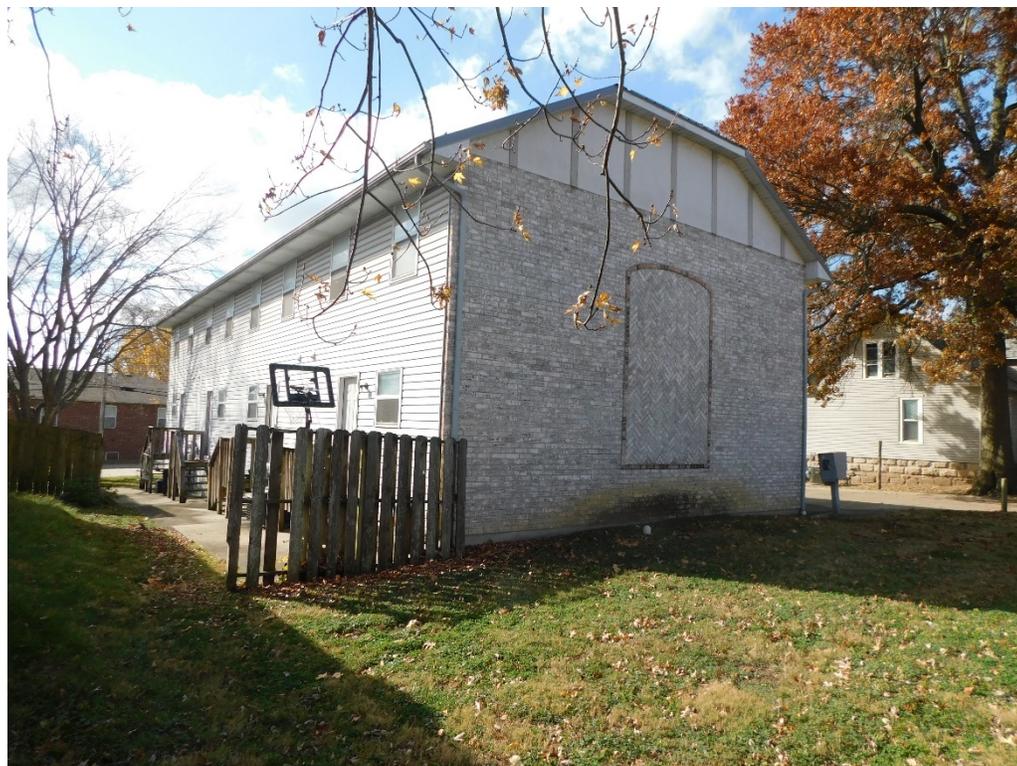
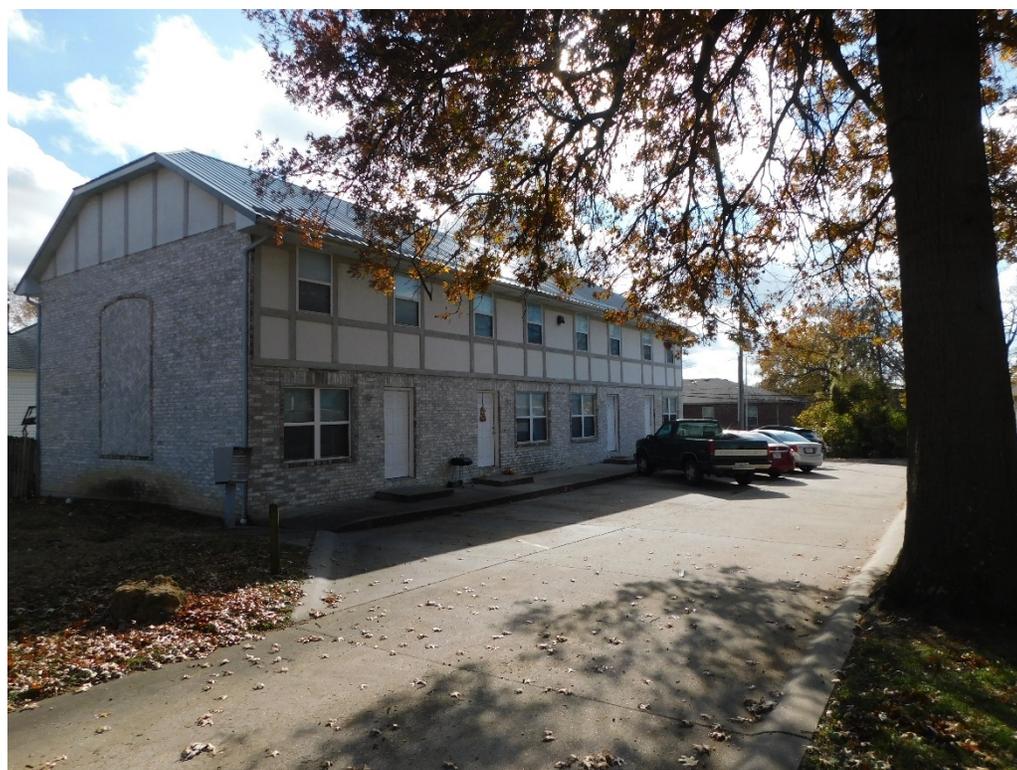
Description:
LOOKING SOUTHWEST

Description:
LOOKING SOUTHEAST

This two-story multi-family apartment building faces the concrete parking lot on the west side of the property. The building features a concrete foundation and a metal hipped roof with a gablet. The building is eight bays wide with the first story featuring light-colored brick walls and every two bays having paired one-over-one vinyl windows and a slab door. The second story features half-timbering and one-over-one hung vinyl windows in each bay. The side elevation facing Grover Street features matching brick with a brick bracket in the center. The gable-ends features half-timbering. The building is not eligible since it does not meet the 50-year threshold.

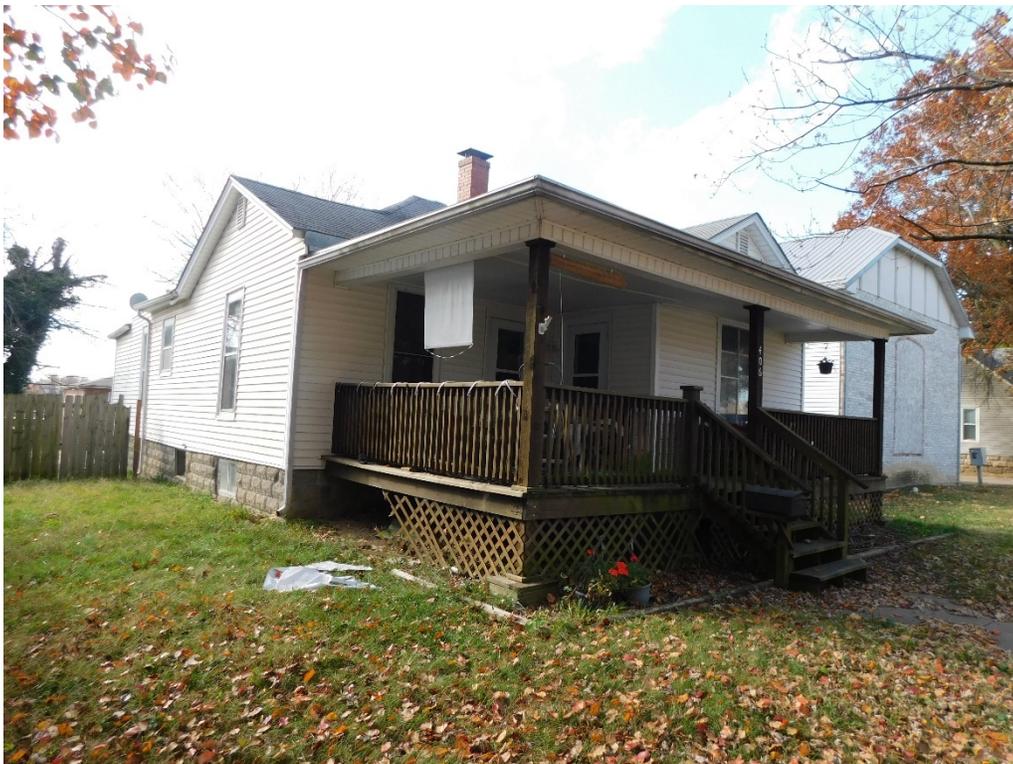
Description:
LOOKING SOUTHWEST

This one-story house features a stone foundation and vinyl exterior walls. The building is three bays wide. There is with a full-width pre-1980 porch with wood columns, wood railing and a wood deck. The porch roof is flat. The first bay has a one-over-one hung window, a door in the second bay, and a six-light window in the third bay. The side elevations have one-over-one double-hung windows. The main building has a cross hipped roof with a red brick chimney on the front center slope. This building is not eligible due to alterations to the siding, fenestration, and porch.

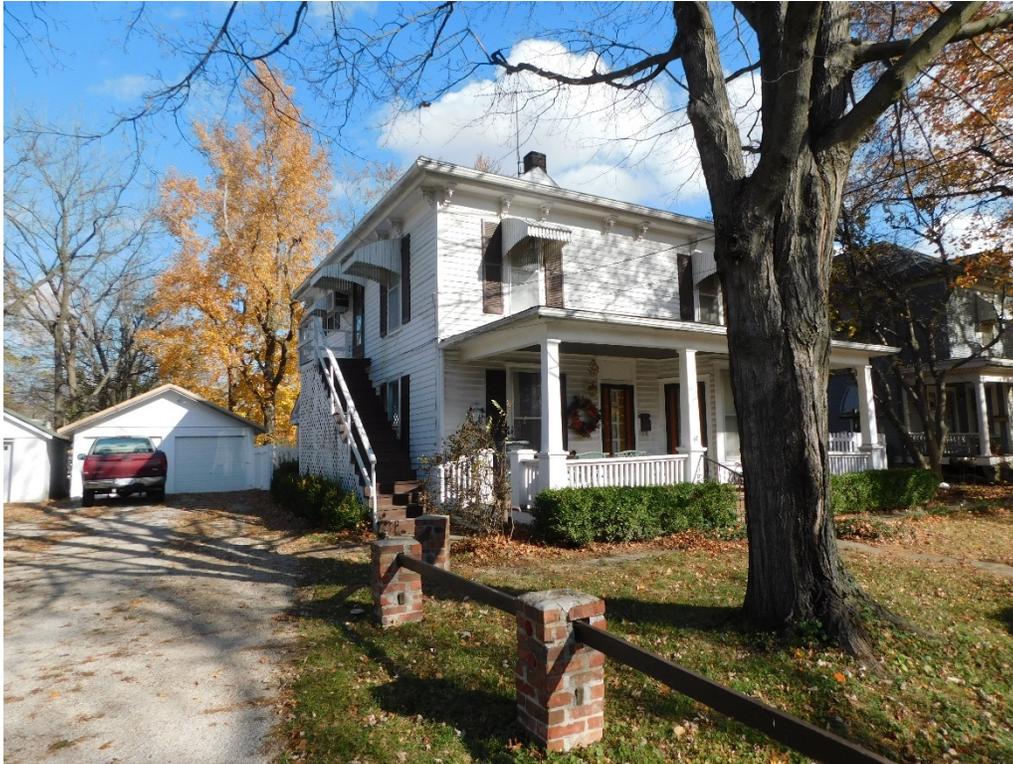
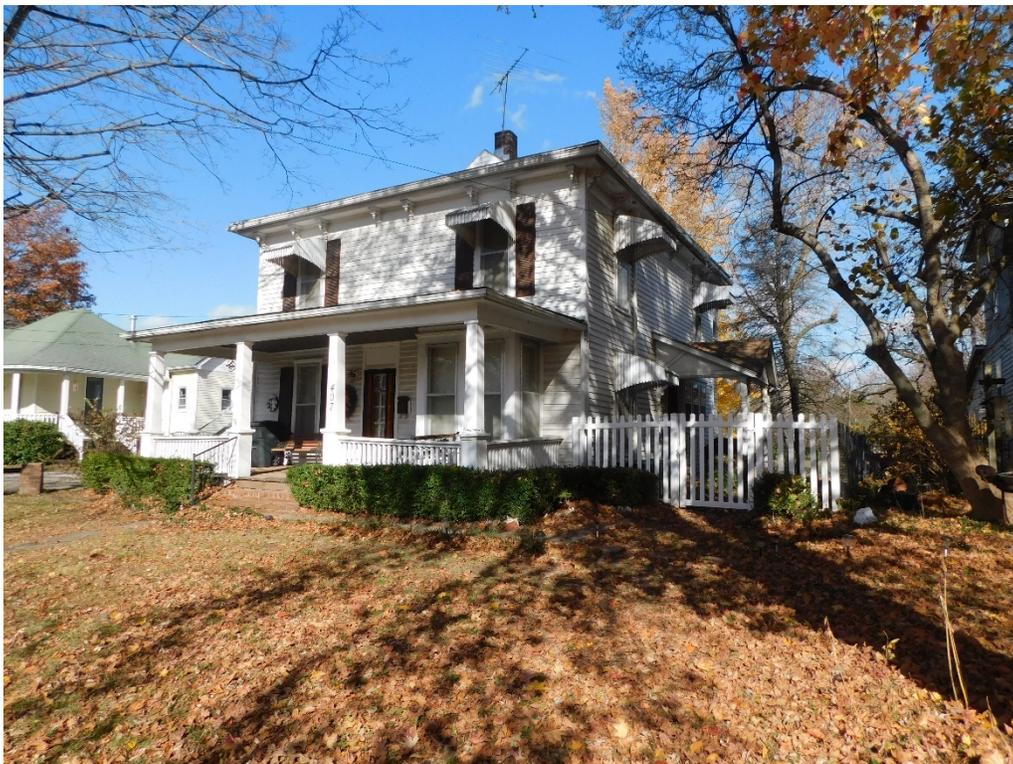
Description:
LOOKING NORTHEAST

Description:
LOOKING NORTHWEST

This two-story Italianate features a stone foundation, wood exterior walls, and a hipped roof with a gablet. The façade is four bays with an original one-over-one double-hung wood window in the first bay, and a multi-light entry door in the second bay. The third bay is filled with a canted multi-light entry door, and the fourth bay is filled with three original one-over-one double-hung wood windows in a rectangular projecting bay. The second-story features original one-over-one double-hung wood windows with aluminum awnings. There is a full-width one-story porch with a hipped roof, wood columns, wood railing, and wood decking. The west elevation features original one-over-one double-hung wood windows, and a wood stairway with lattice leading to a second-story door. The east elevation features original one-over-one double-hung wood windows with aluminum awning. There is a one-story, one bay open porch with a gable roof and Victorian columns. Other features include decorative eave brackets, and a brick chimney straddling the ridge.

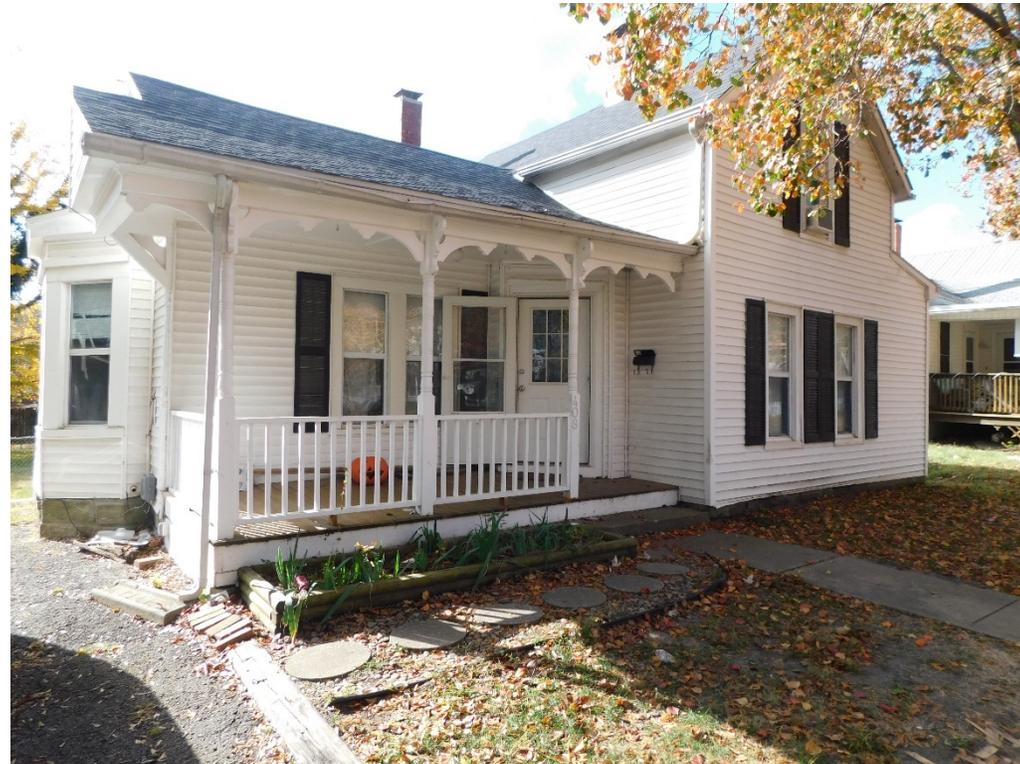
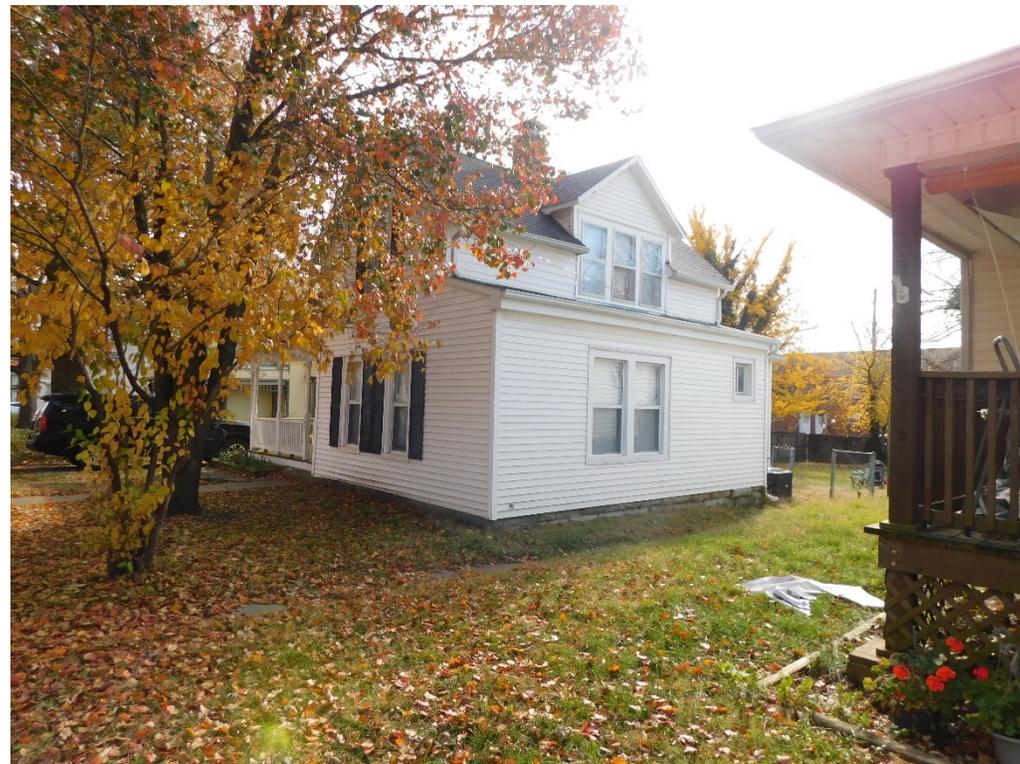
Description:
LOOKING SOUTHWEST

Description:
LOOKING SOUTHEAST

This one-and-a-half story front-gable-and-wing features a stone foundation, vinyl exterior walls, and a cross gable roof. The façade is four bays with the first and second bay located within a recess porch. The first bay is filled with paired original one-over-one double-hung wood windows, and the second bay is filled with a canted solid entry door. The final bays are located two-story gable-end filled with two original one-over-one double-hung wood windows. There is a single original one-over-one double-hung wood window in the second story. The recessed porch features wood decking, wood railing, and Victorian columns and brackets. The east elevation features original one-over-one double-hung wood windows and a half-hexagonal bay with original one-over-one double-hung wood windows. The west elevation features paired original one-over-one double-hung wood windows on the first story, and there is a gable wall dormer with three original one-over-one double-hung wood windows.

SAY ORG WINDOW BUT 2008 SURVEY CALLS THEM VINYL REPLACEMENT; SEEMS TO HAVE OD SHAPE-ADDITION OR ALTERATIONS TO THE ROOFLINE AT WEST

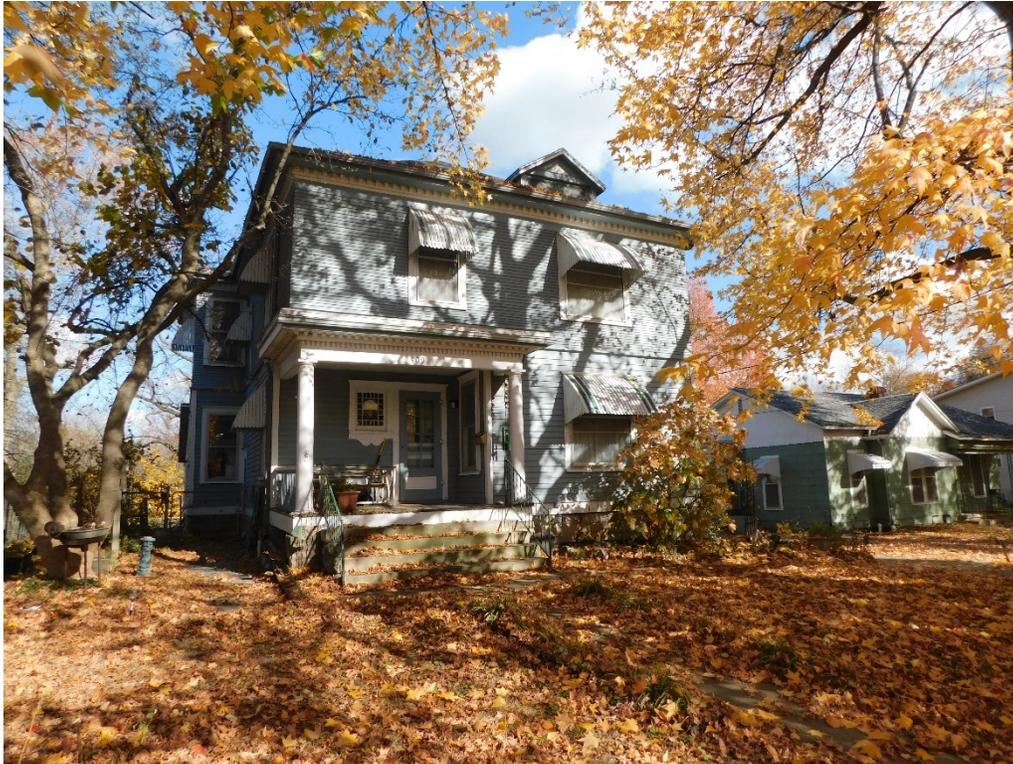
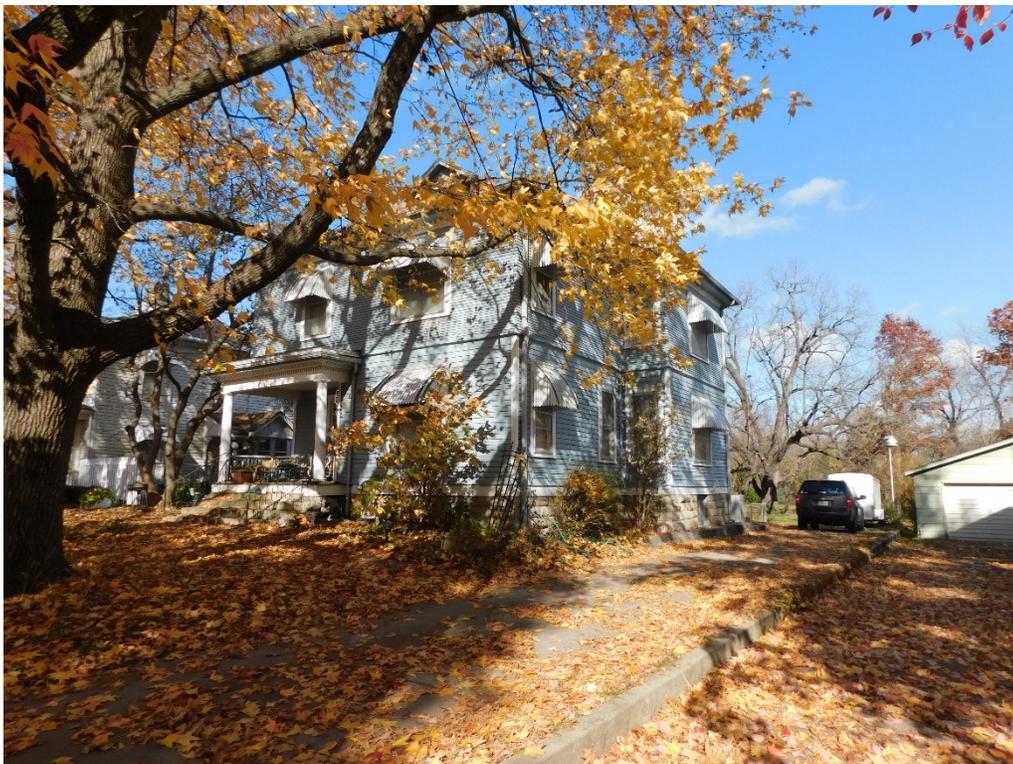
Description:
LOOKING NORTHEAST

Description:
LOOKING NORTHWEST

This two-and-a-half story Colonial Revival features a stone foundation, wood exterior walls, and a hipped roof. The façade is two bays with the first bay filled with a multi-light door and a square multi-light stained glass window. The first bay is located within a recessed porch with two Doric columns, wood decking, and cornice with dentil trim. There is an original one-over-one double-hung wood window on the side wall. The second bay is filled with an original one-over-one double-hung wood window with an aluminum awning. The second-story features two original one-over-one double-hung wood windows. The windows are different sizes and have aluminum awnings. The second-story wood siding features a smaller exposure than the first story which continues around the building. The cornice feature dentil trim. There is an off-centered gable dormer with an original two-light window. Both elevations feature original one-over-one double-hung wood windows with and without the aluminum awnings. The side elevations feature a two-story projecting rectangular bay towards the rear.

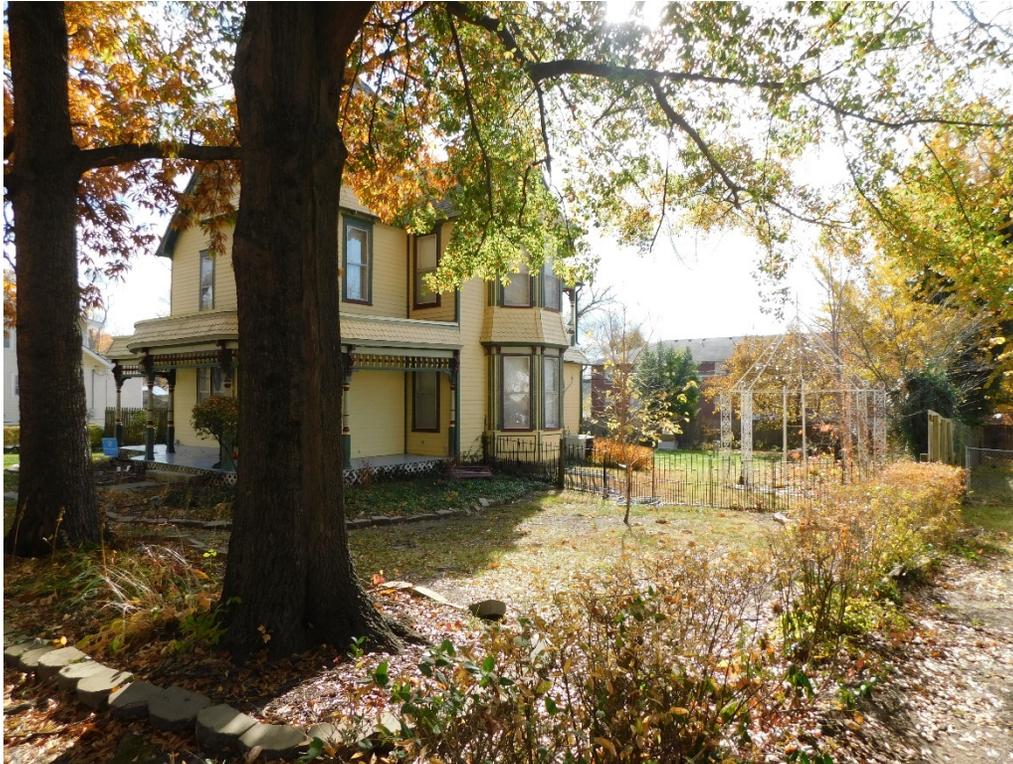
Description:
LOOKING SOUTHEAST

This two-and-a-half Queen Anne features a stone foundation, wood exterior walls, and a cross gable roof with a pyramidal tower in the northwest corner of gable ends. The façade is two bays from east to west with wood lap siding. The first bay feature paired original one-over-one double-hung wood windows on the first and second stories. There is decorative spindle work in the gable peak. The second bay is the base of the three-story tower with a projecting half-hexagonal bay on the first story and projecting rectangular bay on the second story. The first features a northeast-facing door and original one-over-one double-hung wood windows. The second story features original one-over-one double-hung wood windows and a roof eave with brackets. The third story is square with a mix of scalloped and square wood shingles, and there are original one-over-one double-hung wood windows. A pyramidal roof adorns the top of the tower. There is a one-story full-width porch that has a partial wraparound to the west. The porch features a mansard roof with a circular eave over the second bay and the wraparound with wood shingles. Other features include eave brackets, spindle work, decorative porch columns, and a wood foundation. The west elevation features original one-over-one double-hung wood windows on the first and second stories. There is a projecting gable end with a two-story half-hexagonal bay. The half-hexagonal bay features original one-over-one double-hung wood windows, a flared wood shingle eave between the stories, and eave brackets. The east elevation features original one-over-one double-hung wood window and wood lap siding. There is a one-story section with a scalloped wood shingle mansard roof, wood lap siding, historic one-over-one double-hung wood windows, and historic fixed wood windows with stained glass. This property shares a driveway with 414 Grover St.

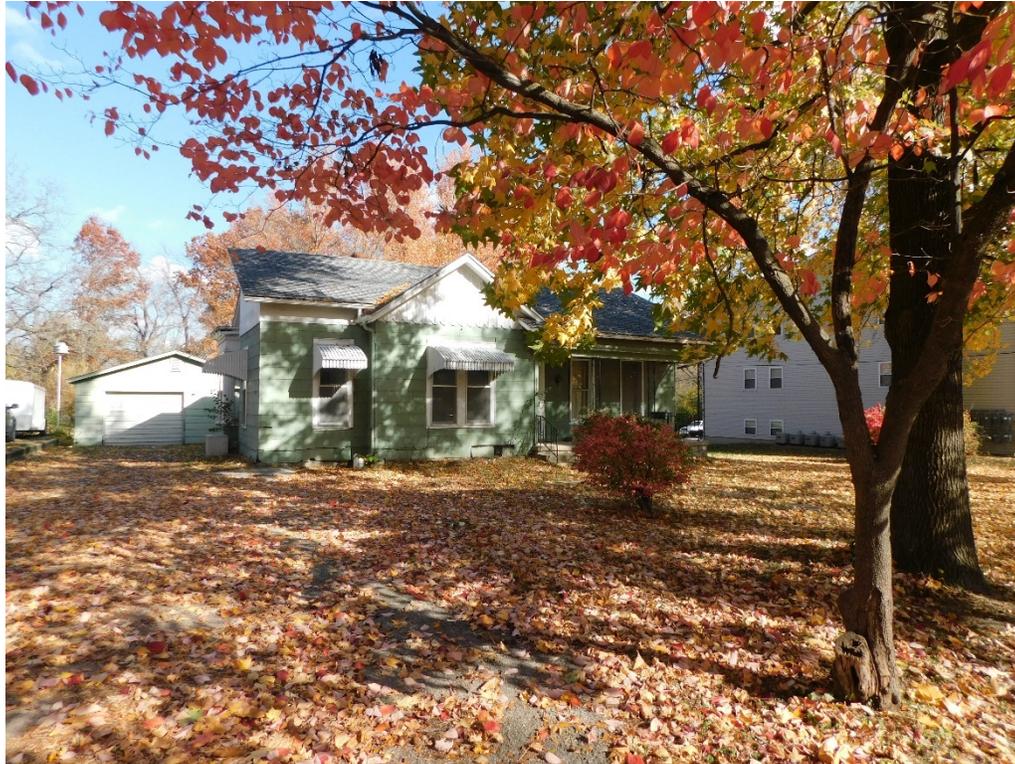
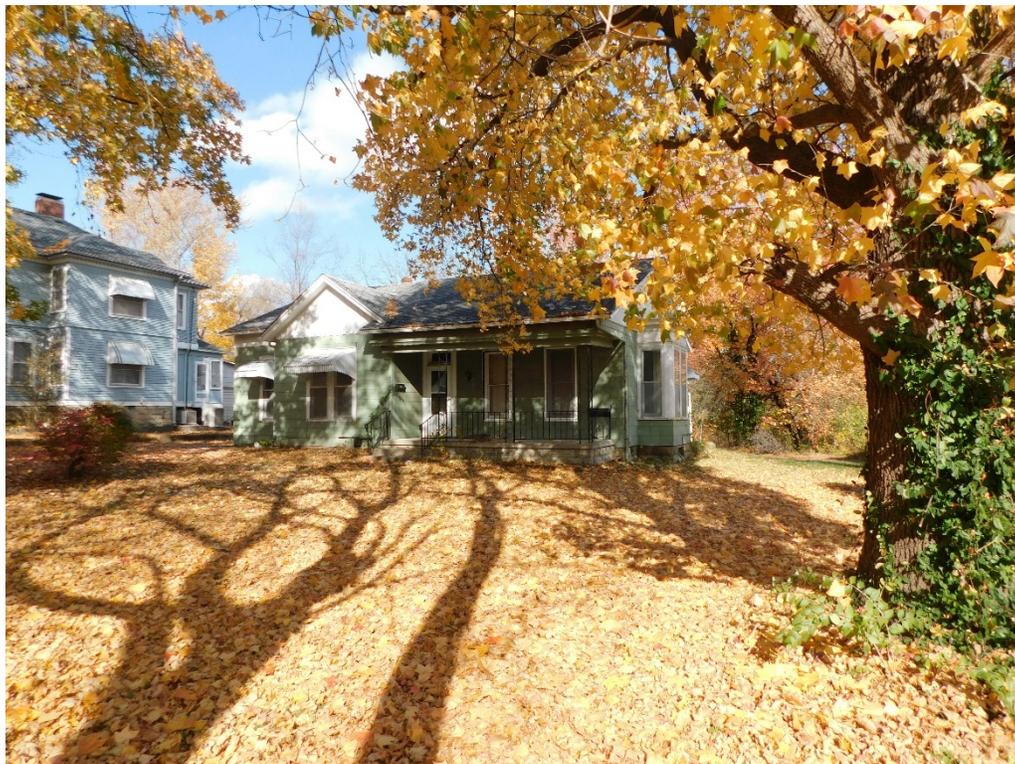
Description:
LOOKING NORTHEAST

Description:
LOOKING NORTHWEST

This one-story house features a stone foundation asbestos siding, and a cross gable roof. The façade is five bays features an original one-over-one hung wood window in the first bay with an aluminum awning. The second bay features a slightly projecting gable-end with scalloped wood siding in the gable-end and paired original one-over-one hung wood window with an aluminum awning. There is a wood door with a one-light transom in the third bay, and original one-over-one hung wood window in fourth and fifth bays. A recessed porch covers the third, fourth, and fifth bays with decorative metal columns, metal railing and a stone foundation. The east elevation features scalloped wood siding in the gable-end and a projecting rectangular bay with original one-over-one hung wood windows. The west elevation features scalloped wood siding in the gable-end, an original one-over-one hung wood windows with aluminum awning, and a projecting rectangular bay with original one-over-one hung wood windows.

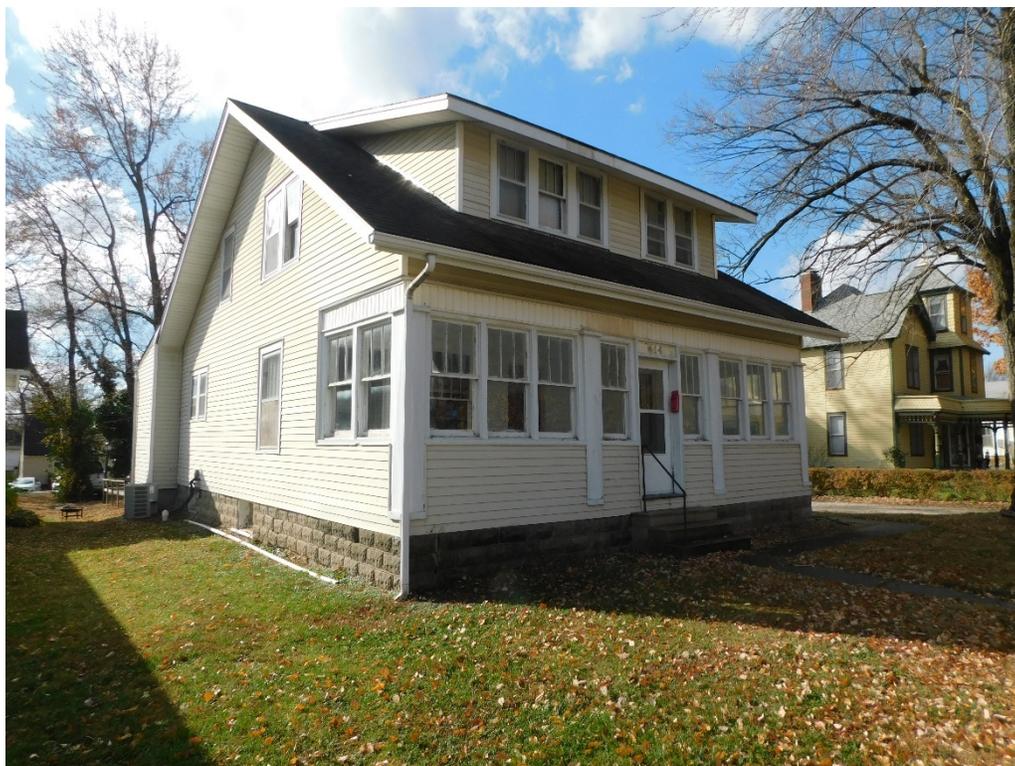
Description:
LOOKING SOUTHWEST

This one-and-a-half story Bungalow/Craftsman features a stone foundation, vinyl exterior walls, and a side gable roof. The façade is three bays and features a historically enclosed porch. The first and last bays feature historic three-over-one jailhouse style hung wood windows in groups. The centered second bay feature a two-light storm door with a historic three-over-one jailhouse style hung wood window on either side. There are historic three-over-one jailhouse style hung wood windows on the sides of the enclosed porch. The original wood columns are visible and separate the bays. There is vinyl siding above and below the door and windows. There is a shed dormer with vinyl siding, grouped historic three-over-one jailhouse style hung wood windows and replacement paired six-over-one hung wood windows. The side elevations feature single and paired four/five-over-one jailhouse style under windows in the first and half story. There is a shed dormer located on the rear partially visible from the public-right-of-way. There is a partial brick-paved driveway. This property shares a driveway with 410 Grover Street.

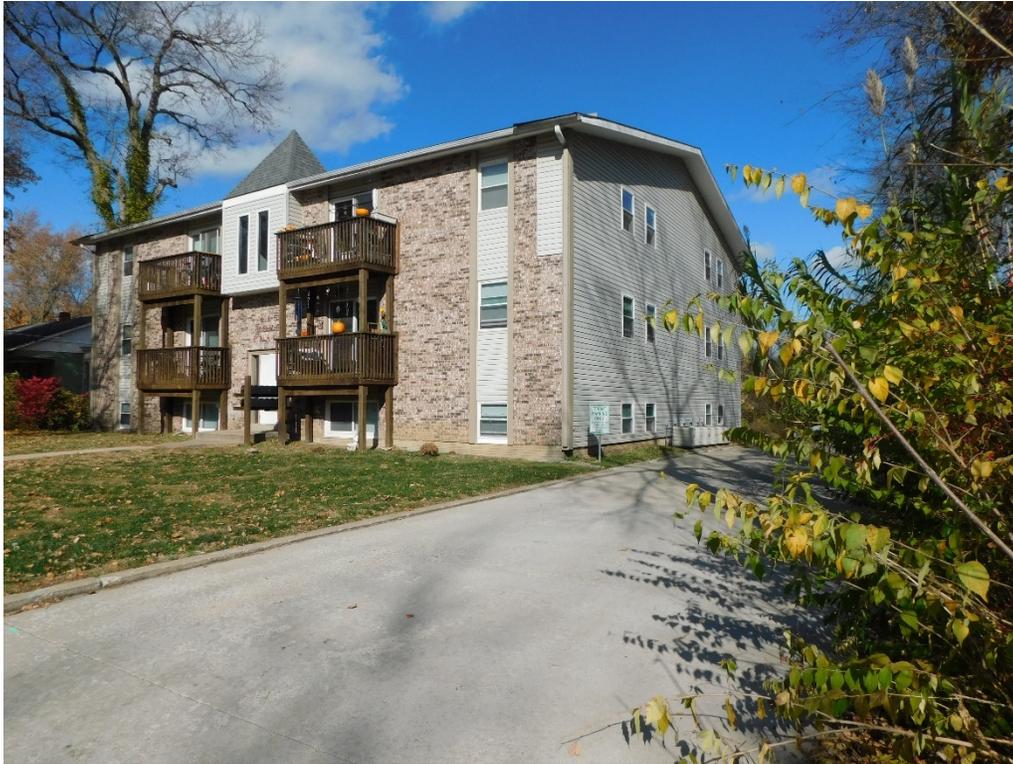
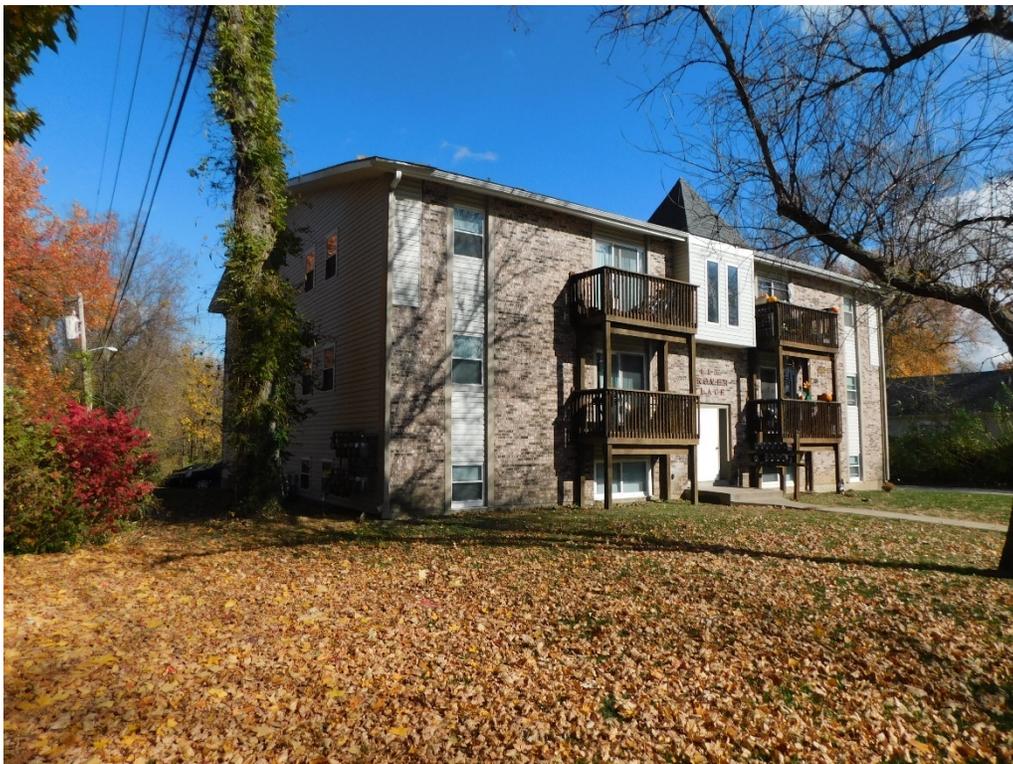
Description:
LOOKING NORTHWEST

Description:
LOOKING NORTHEAST

This three-story apartment building features a concrete foundation, brick and vinyl siding, and a side gable roof with a centered pyramidal roof. The façade is five bays. There is brick siding where there are no openings except in the upper corners of the façade where the original projecting window bays were removed, and the former openings were covered in vinyl. There are replacement one-over-one hung vinyl windows in the first and last bay with vinyl spandrels separating the stories. The second and fourth bays feature replacement sliding vinyl door with wood balconies except the first floor is part-subterranean and features replacement sliding vinyl windows. The centered third bay features a metal door with sidelights. Above the door, there is a projecting rectangular bay with a pyramidal roof, vinyl siding and two replacement, narrow fixed vinyl windows. The side elevations feature vinyl siding and groups of two, replacement one-over-one hung vinyl windows. This building is not eligible due to alterations to the siding and fenestration as well as it does not meet the 50-year threshold.

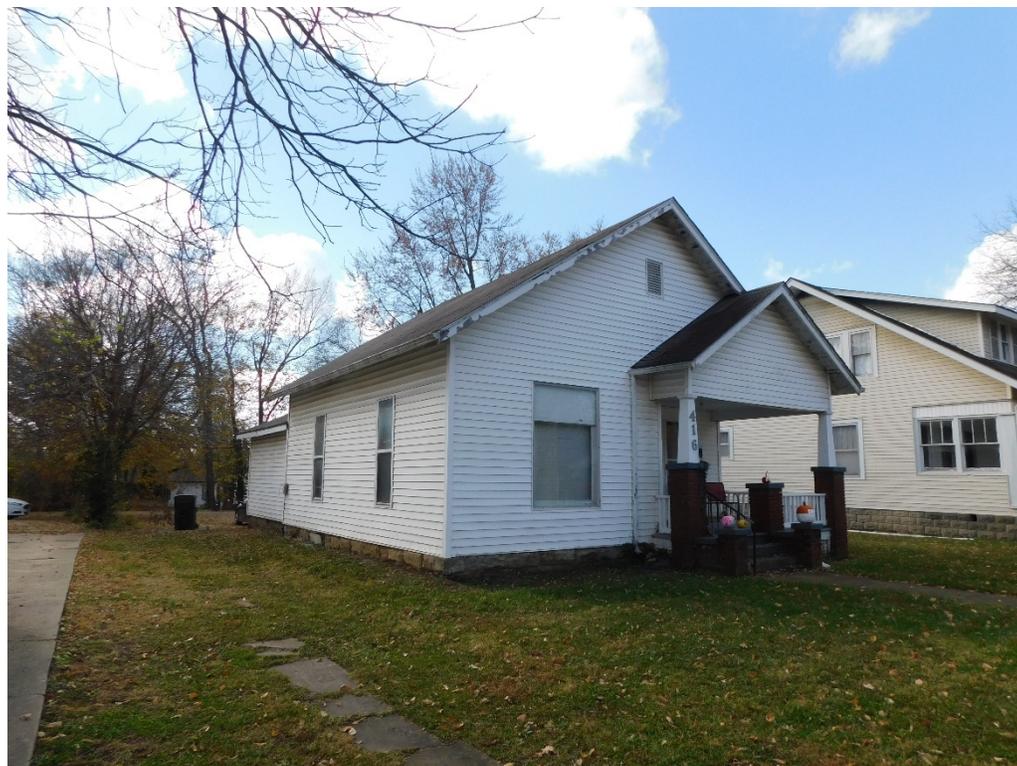
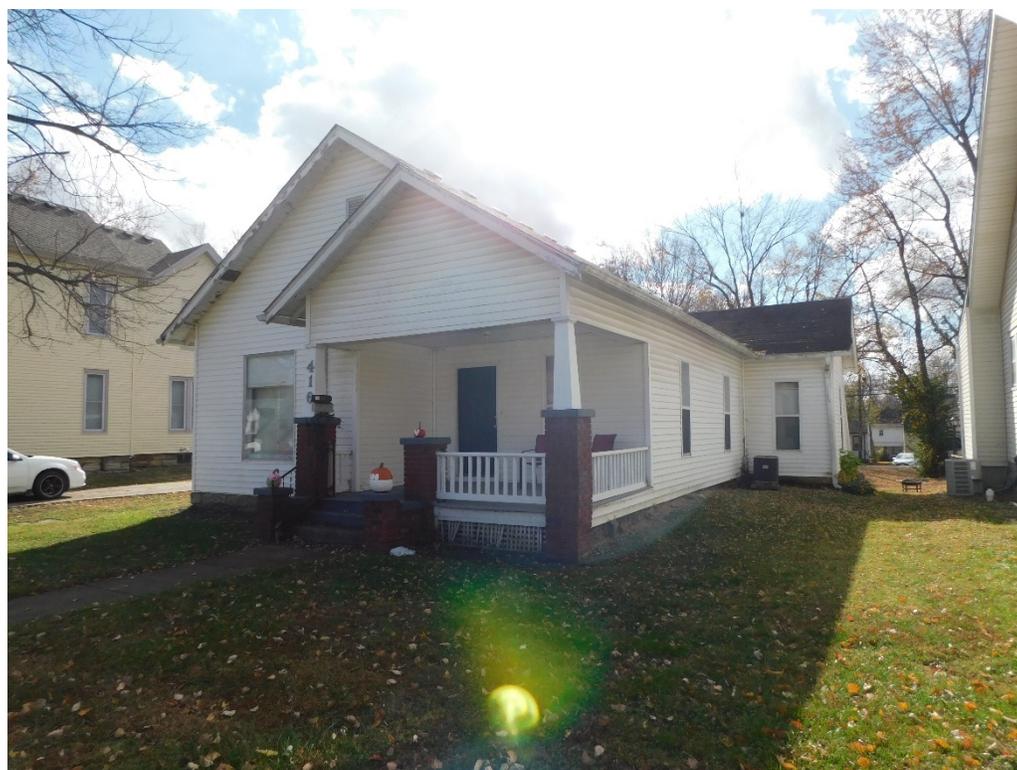
Description:
LOOKING SOUTHWEST

Description:
LOOKING SOUTHEAST

This one-story gable-front house features a stone foundation, vinyl siding, and cross gable roof. The façade is three bays with an original one-light fixed wood window with a board along the top in the first bay, a wood door in the second bay, and an original one-over-one window in the third bay. There is a circa 1920s, partial-recessed gable porch covering the second and third bays. The porch features a front gable roof, vinyl siding in the gable-end, tapered wood columns, brick piers, wood railing, and a wood deck. The east elevation features two original one-over-one windows, and the former rear porch has been enclosed with vinyl siding. The west elevation features original one-over-one windows and a projecting gable-end with original one-over-one windows. This building is not eligible due to alterations to the siding and fenestration.

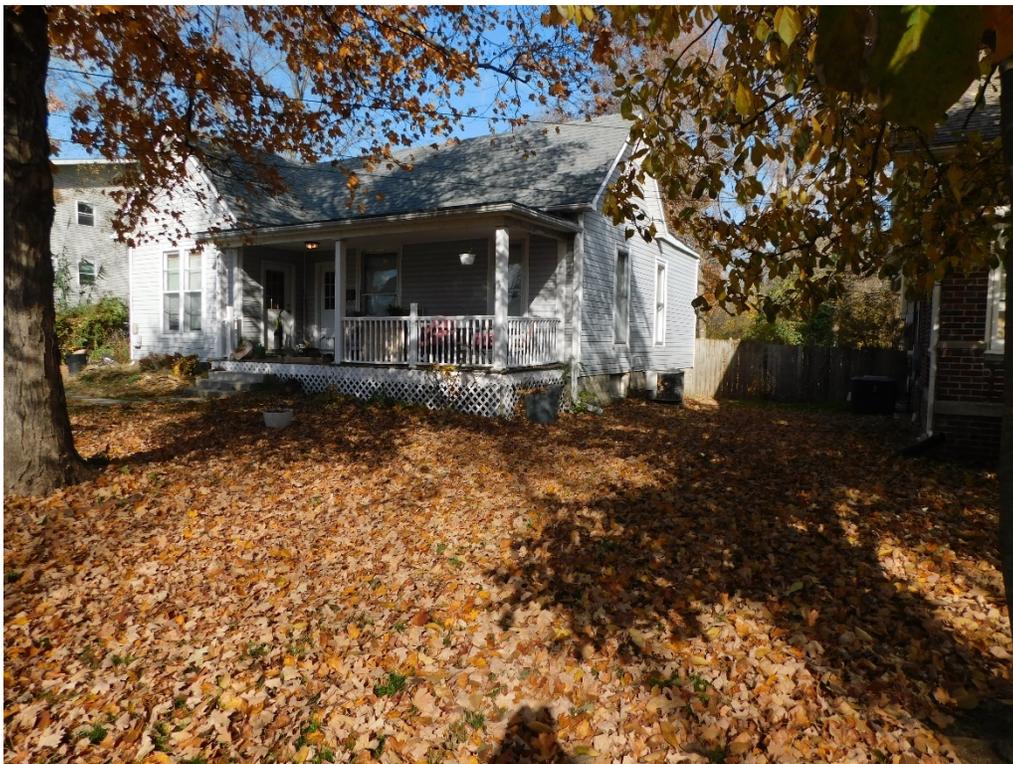
Photographer: KAREN HICKLIN	Date: 11/8/2020	Description: LOOKING NORTHWEST
--------------------------------	--------------------	-----------------------------------

This one-story front-gable-and-wing house features a stone foundation, vinyl exterior walls, and a cross gable roof. façade is four bays. The first bay features paired original one-over-one hung wood windows in the projecting gable-end. The second bay features a nine-light wood door, and there is another nine-light wood door on the interior wall of the first bay. The third and fourth by feature original one-over-one hung wood windows. A porch covers the second, third, and fourth bays, and it features wood box columns, wood railing, and wood decking. The east elevation features vinyl siding and two original one-over-one hung wood windows. The west elevation features vinyl siding and four original one-over-one hung wood windows.
