1. Survey No. JO-AS-007-0058		2. Survey name: GROVER & BROAD STREETS ARCHITECTURAL/HISTORICAL SURVEY	
3. County: JOHNSON		4. Address (Street No.) 400	Street (name) GROVER
5. City: WARRENSBURG	Vicinity: <input type="checkbox"/>	6. Geographical Reference: 35.76143 / -93.73367	7. Township/Range/Section: T: 46 R: 26 S: 24
8. Historic name (if known):		9. Present/other name (if known):	
10. Ownership: <input checked="" type="checkbox"/> Private <input type="checkbox"/> Public		11a. Historic use (if known): SINGLE DWELLING	11b. Current use: SINGLE DWELLING

HISTORICAL INFORMATION

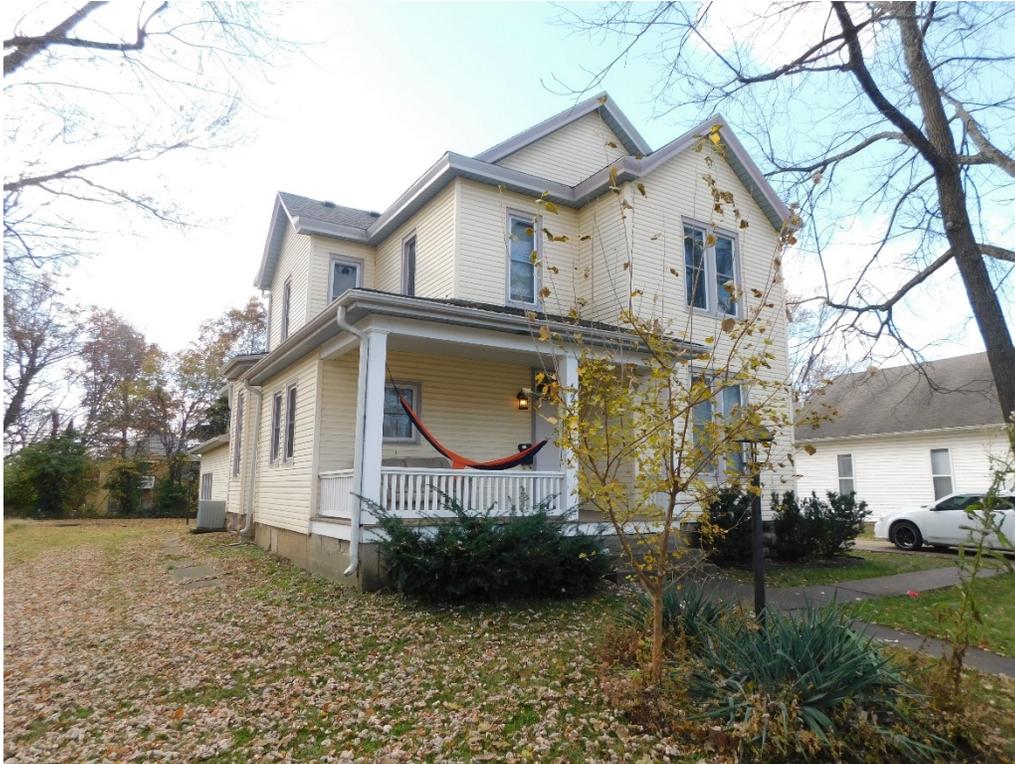
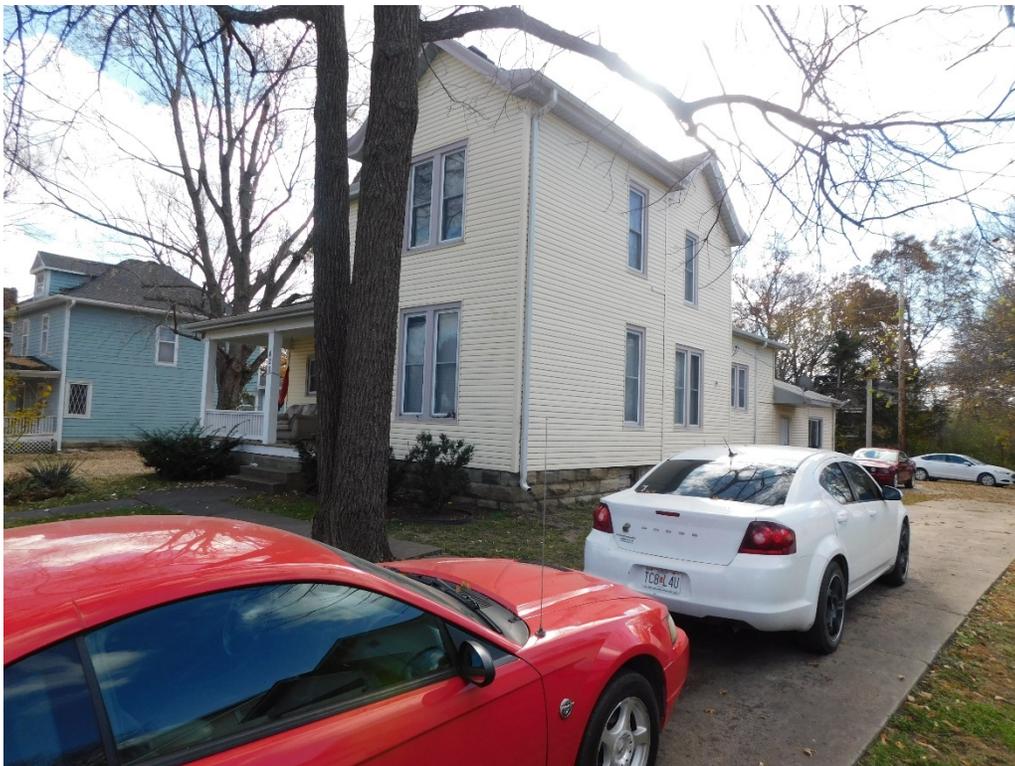
Photographer: KAREN HICKLIN	Date: 11/8/2020	Description: LOOKING SOUTHWEST
--------------------------------	--------------------	-----------------------------------

Photographer: KAREN HICKLIN	Date: 11/8/2020	Description: LOOKING SOUTHEAST
--------------------------------	--------------------	-----------------------------------

This two-story Queen Anne features a stone and concrete block foundation, vinyl siding, and a cross gable roof with tiered front gables. The façade is three bays with a small non-historic one-over-one hung vinyl window in the first bay, a wood door in the second bay, and a paired replacement one-over-one hung wood windows in the third bay. There is a recessed porch over the second and third bays with boxed wood columns, wood railing, and a wood deck. The porch was originally a partial wraparound, and the side enclosed after 1945. The second-story is recessed from the northeast corner and features an replacement one-over-one hung wood window over the second bay, and a paired one-over-one hung wood windows over the third bay. The east elevation features one-over-one hung wood windows on the first and second story as well as a slightly projecting half-hexagonal bay with replacement one-over-one hung wood windows. The west elevation features single and paired replacement one-over-one hung wood windows in the first and second stories. There is a one-story post-1945 rear addition that is greatly stepped from the original building with a wood door, shed porch canopy, and a picture window.

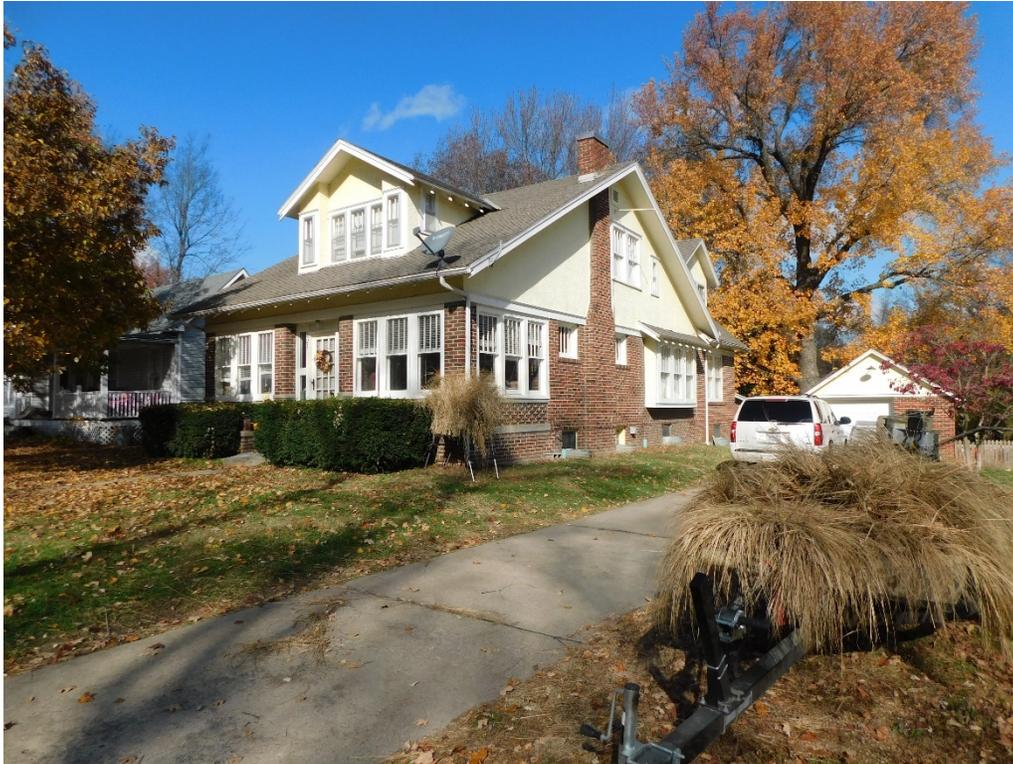
Description:
LOOKING NORTHWEST

This one-and-a-half-story Bungalow/Craftsman features a brick foundation, brick and stucco exterior walls, and a cross gable roof with exposed rafter tails. The façade is three bays and features a historic enclosed porch with grouped historic four-over-one jailhouse style hung wood windows in the first and last bay. The second bay is slightly recessed with a 15-light wood door and two-light sidelights. The façade features a brick foundation, brick railing, and the bays are separated by brick columns to a wood cornice. The side enclosures of the porch include grouped historic four-over-one jailhouse style hung wood windows. There is a gable dormer on the front roof slope with exposed rafter tails and stucco siding. It features four original three-over-one jailhouse-style hung wood windows with the three interior windows recessed. There is an original three-over-one jailhouse-style hung wood window on the sides of the dormer. The east elevation features original fixed four-light jailhouse-style windows separated by an exterior brick chimney that pierces the roof. There is paired original four-over-one jail-house style hung windows, and a projecting rectangular bays with a shed roof, exposed rafter tails, and grouped three-over-one jailhouse-style hung wood windows. The gable-end features stucco siding paired original four-over-one jail-house style hung windows, and a smaller one-over-one hung woo window. here is a gable dormer on the front roof slope with exposed rafter tails. stucco siding and paired original three-over-one jailhouse-style hung wood windows. The west elevation features different sixed single and paired original four/three-over-one jailhouse style hung wood windows. There is a projecting rectangular bay with a shed roof, exposed rafter tails, and an original four-over-one jailhouse style hung window. There is stucco in the gable-end with four different-sized original four/three-over-one jailhouse hung windows.

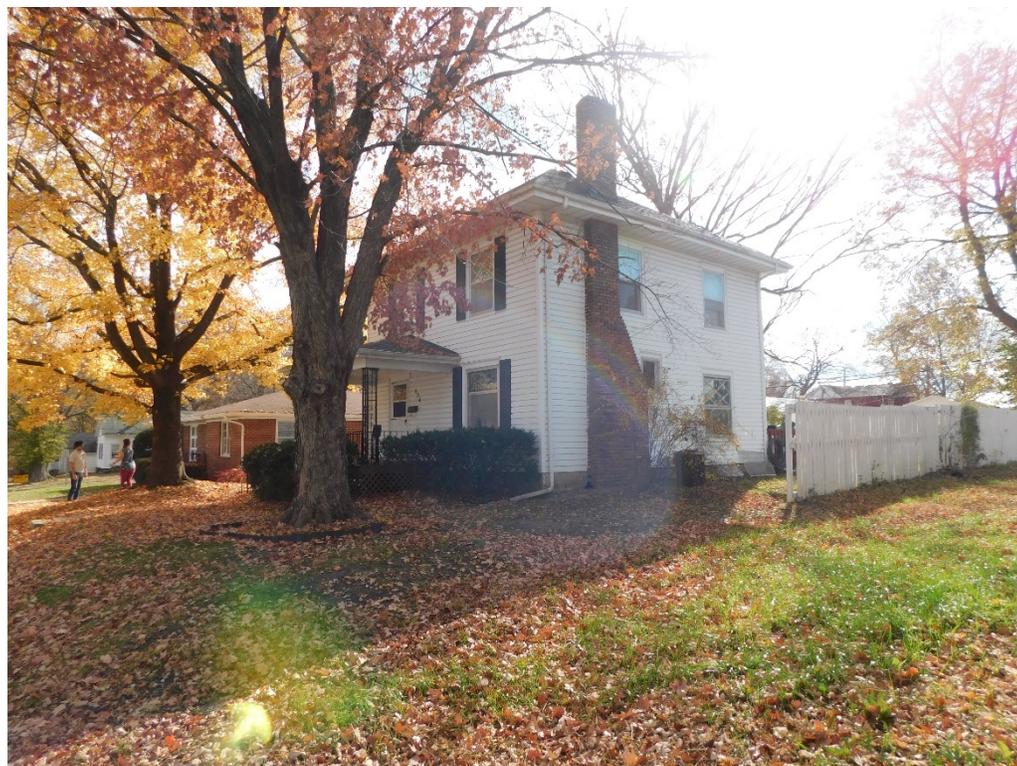
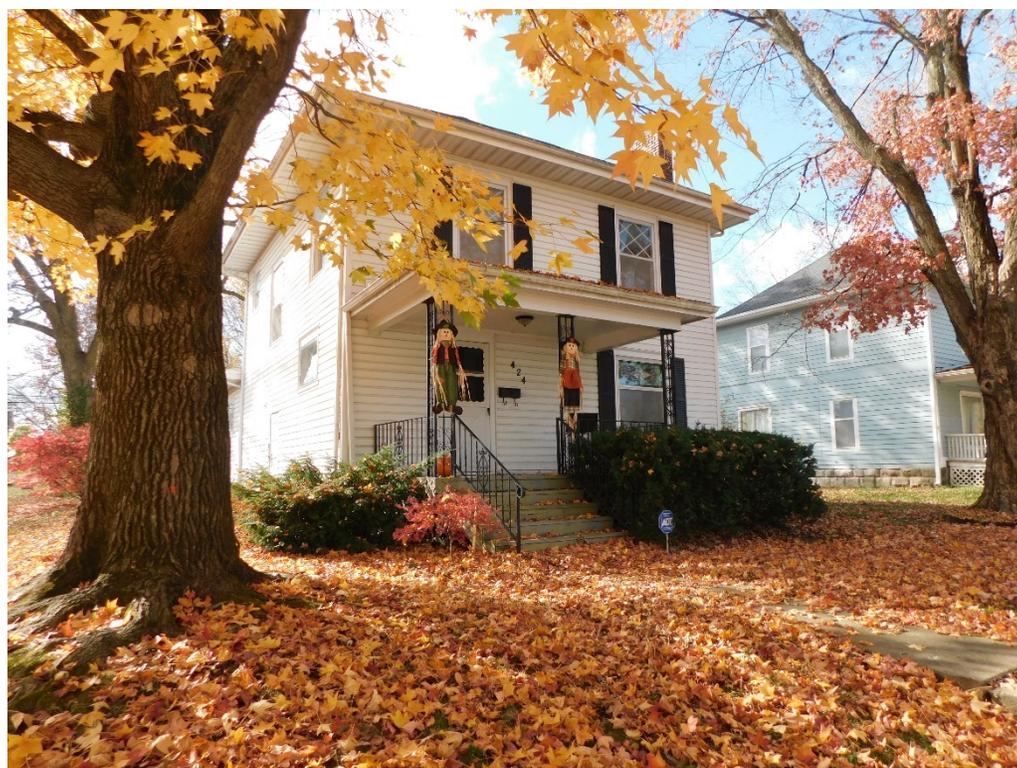
Photographer: KAREN HICKLIN	Date: 11/8/2020	Description: LOOKING SOUTHEAST
--------------------------------	--------------------	-----------------------------------

Photographer: KAREN HICKLIN	Date: 11/8/2020	Description: LOOKING SOUTHWEST
--------------------------------	--------------------	-----------------------------------

This two-story foursquare house features a stone foundation, wood siding, and a hipped roof. The façade is two bays with a wood door in the first bay and an original one-over-one hung wood window with stained glass in the upper sash in the second bay. There is a hipped porch covering the first bay with a wood cornice, decorative metal columns, decorative metal railing, and a wood landing. The second-story story features original diamond-pane-over-one hung wood windows. All the windows on the façade feature faux shutters. The east elevation features original diamond-pane-over-one hung wood windows, original awning diamond-pane wood window, and a wood door. The west elevation features an exterior brick chimney what pierces the roofline, an original fixed wood window, and original diamond-pane-over-one hung wood windows.

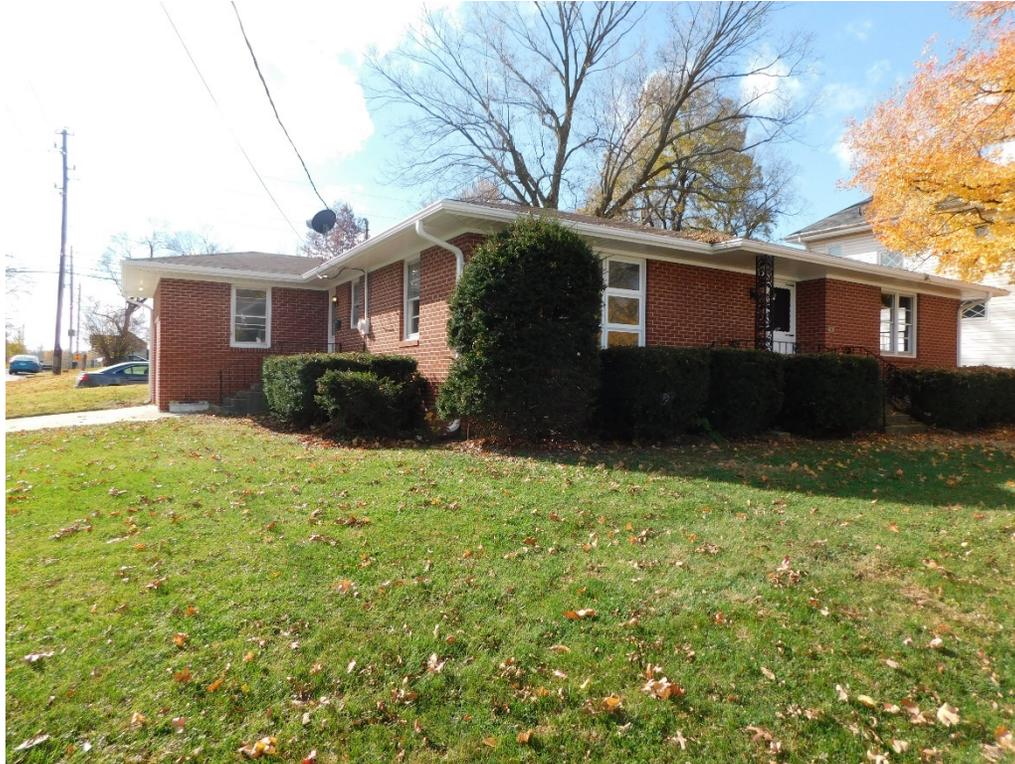
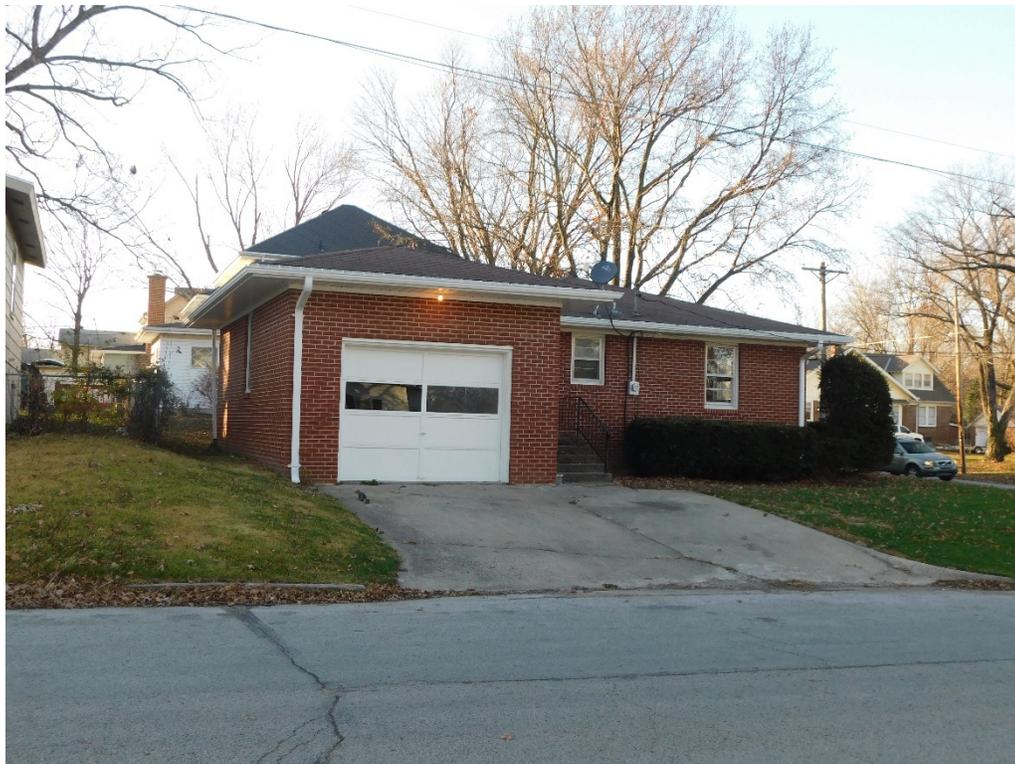
This one-story ranch features a concrete foundation, brick exterior walls, and a hipped cross gable roof with a moderate eave overhang. The façade is three bays an assemblage of six original wood awning windows stacked is two columns in the first bay. The second bay features a wood door, and it is recessed under the wide eave with a decorative metal column, decorative metal railing, and a concrete foundation. The third bay is filled with paired two-over-two hung wood windows with horizontal panes. The east elevation faces Zoll Street with a two-light wood paneled garage door in the projecting bay, a wood door with a decorative metal railing and concrete stoop, and two original two-over-two hung wood windows with horizontal panes. The west elevation features two original two-over-two hung wood windows with horizontal panes.

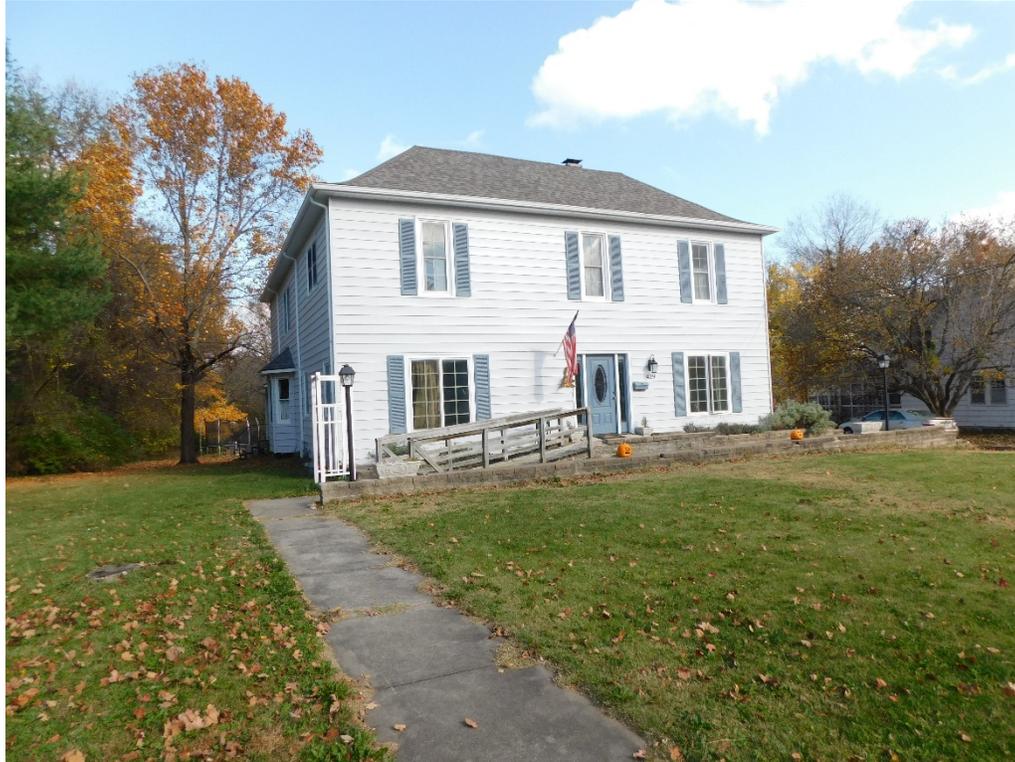
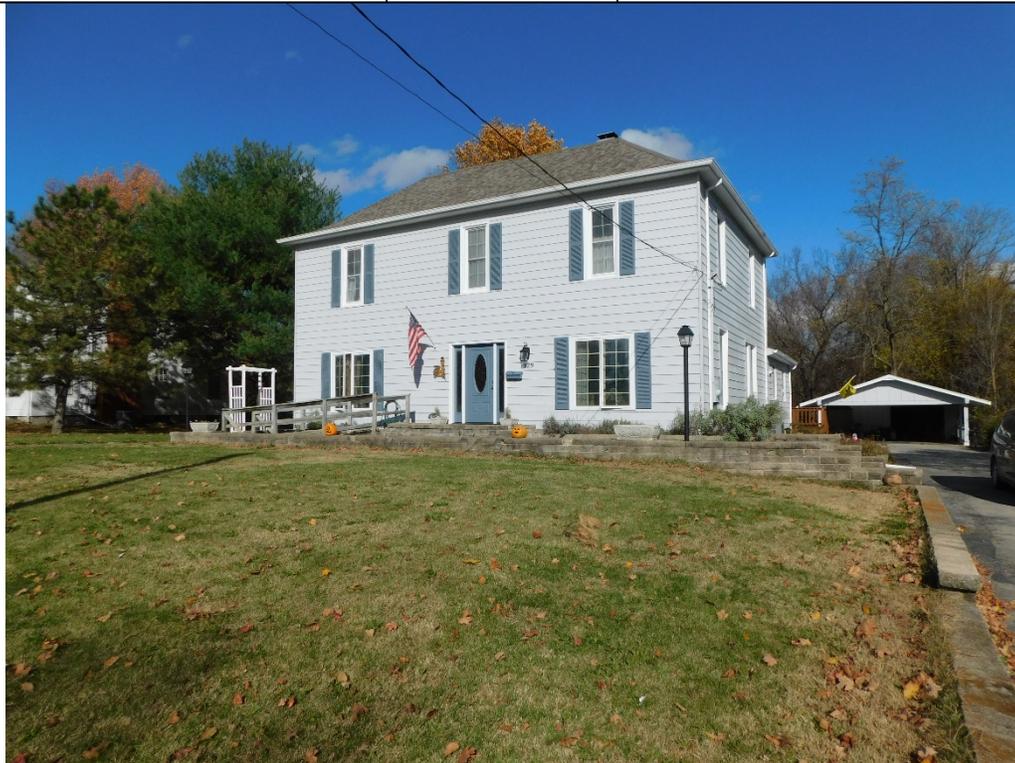
This two-story Colonial Revival features a stone foundation, aluminum exterior walls, and hipped gable porch. The façade is three bays with replacement ten-light double casement windows with faux shutters in the first and last bay. The second bay is filled with an oval-light door and one-light sidelights. There is a stone landing with a c. 2002 wood ramp with a wood railing. The second-story features three replacement four-over-four hung vinyl windows with faux shutters. The east elevation features single and paired replacement four-over-four hung vinyl windows. The west elevation features paired and single replacement four-over-four hung vinyl windows. There is a one-story half-hexagonal bay with original one-over-one hung wood windows.

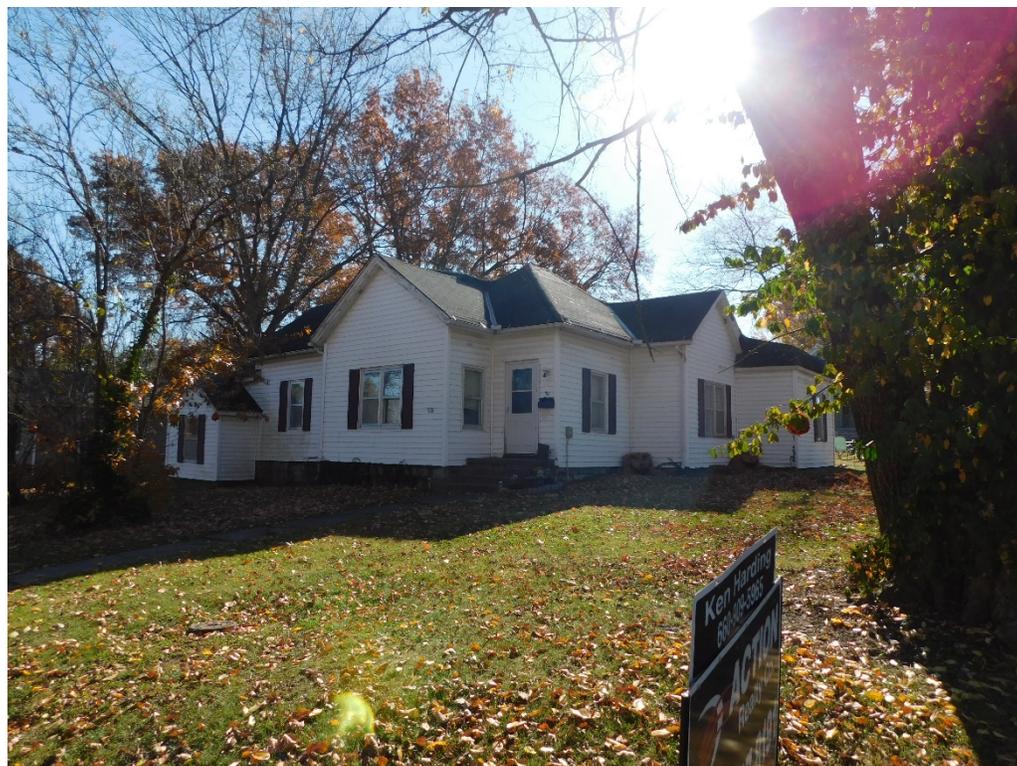
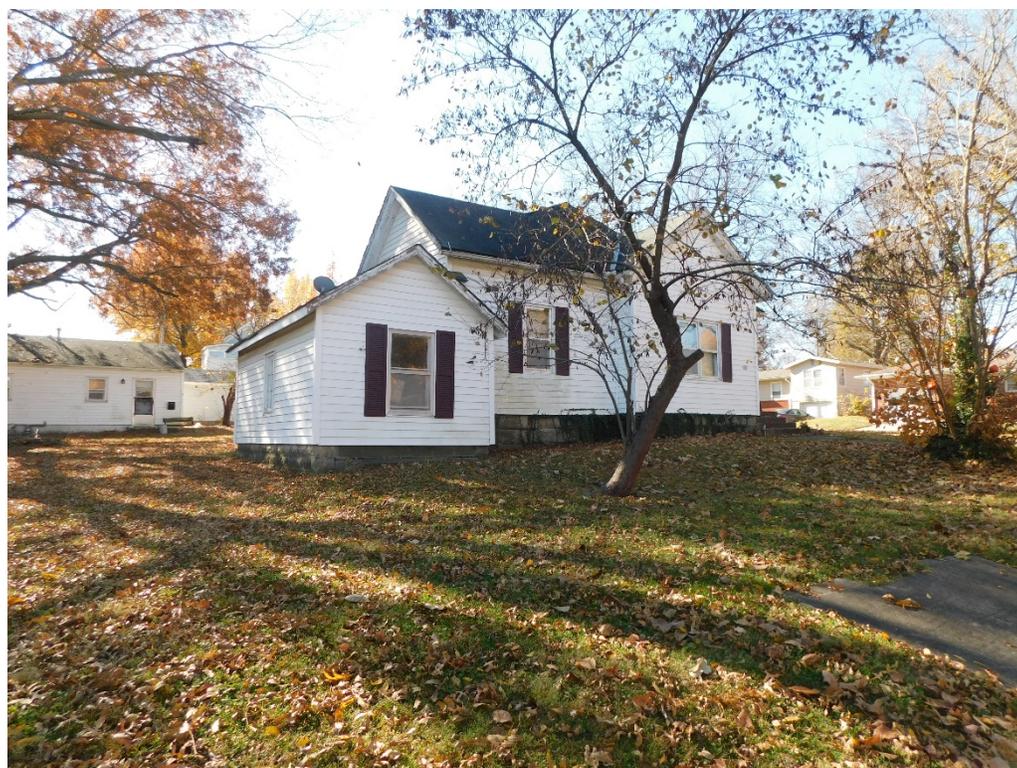
This one-story house features a stone foundation, vinyl exterior walls, and a complex hipped, cross gable roof. The façade is four bays with projecting gable-end with an original one-over-one hung wood window with faux shutters in the first bay, an original one-over-one hung wood window with faux shutters, in the second bay, paired original one-over-one hung wood windows with faux shutters in the third bay, and a wood door in the fourth bay. The west elevation features tiered and stepped hipped and cross gable-end; in addition, there are single or paired original one-over-one hung wood window with faux shutters. The east elevation features original one-over-one hung wood windows. This building is not eligible due to alterations to the siding and fenestration.

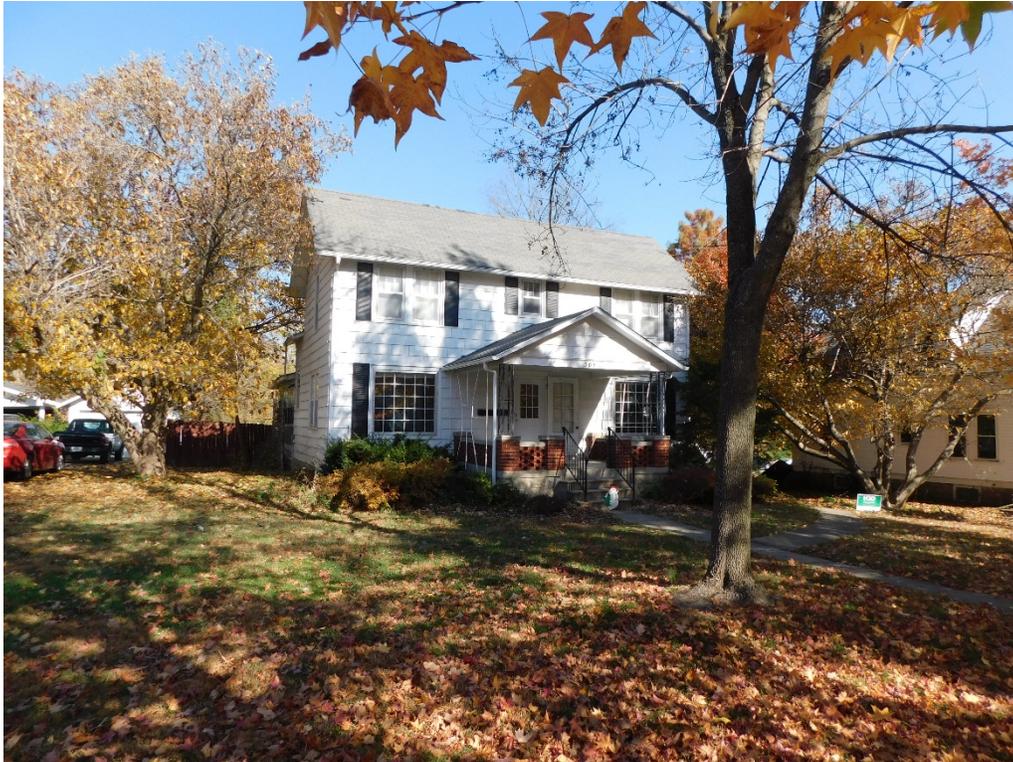
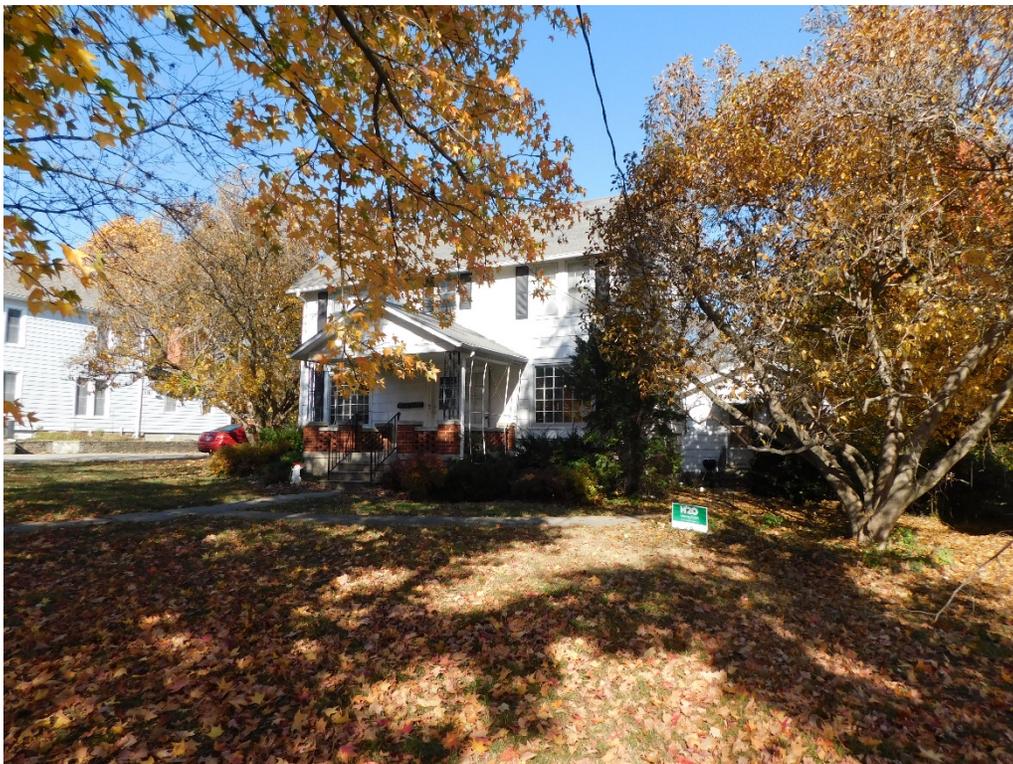
This two-story Colonial Revival features stone foundation, wood shingle exterior walls, and a cross gable roof. The façade is three bays with original 30-light fixed wood windows with faux shutters in the first and last bay. The second bay is filled with a nine-light wood door. The second story features original paired three-over-one jailhouse-style hung wood windows with faux shutters in the first and last bay. There is a smaller original three-over-one jailhouse-style hung wood window with faux shutters in the center. There is partial-width front gable porch with wood shingle, decorative metal columns, and brick railing and piers, and a stone foundation. The west elevation features paired and single original three-over-one jailhouse-style hung wood windows on the first and second story. The east elevation features original three-over-one jailhouse-style hung wood window on the first and second story. There is a historic post-1945 addition located on the northeast corner of the house. From the public-right-of-way, it appears as a detached structure, and it does not detract from the character of the original structure.

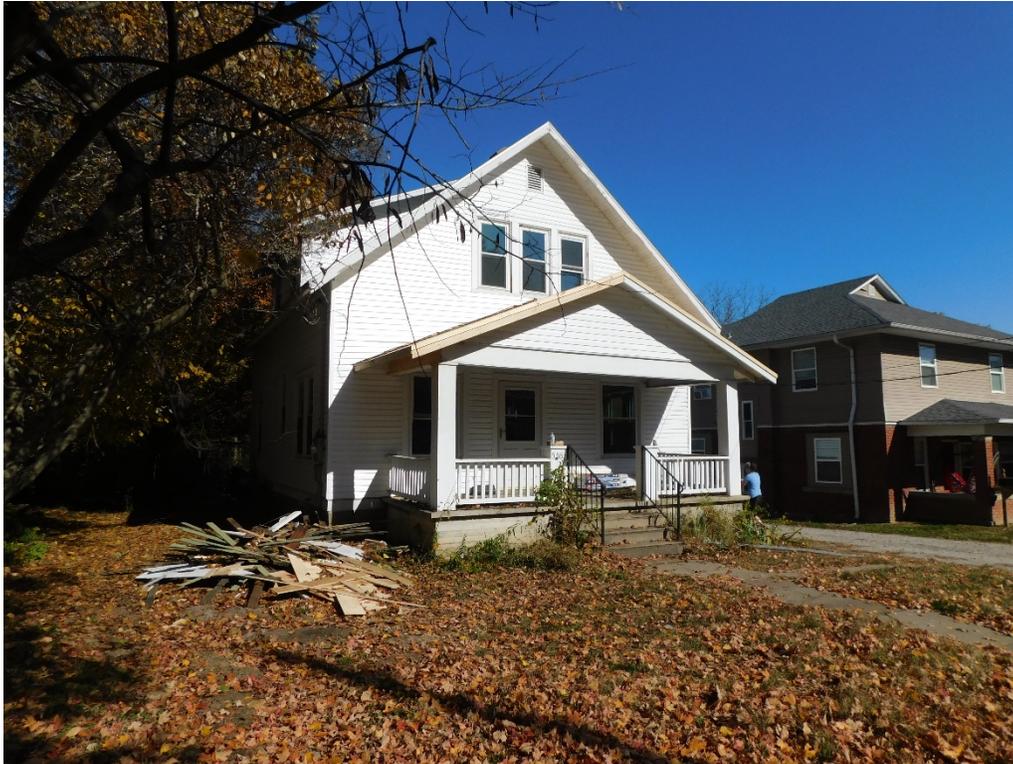
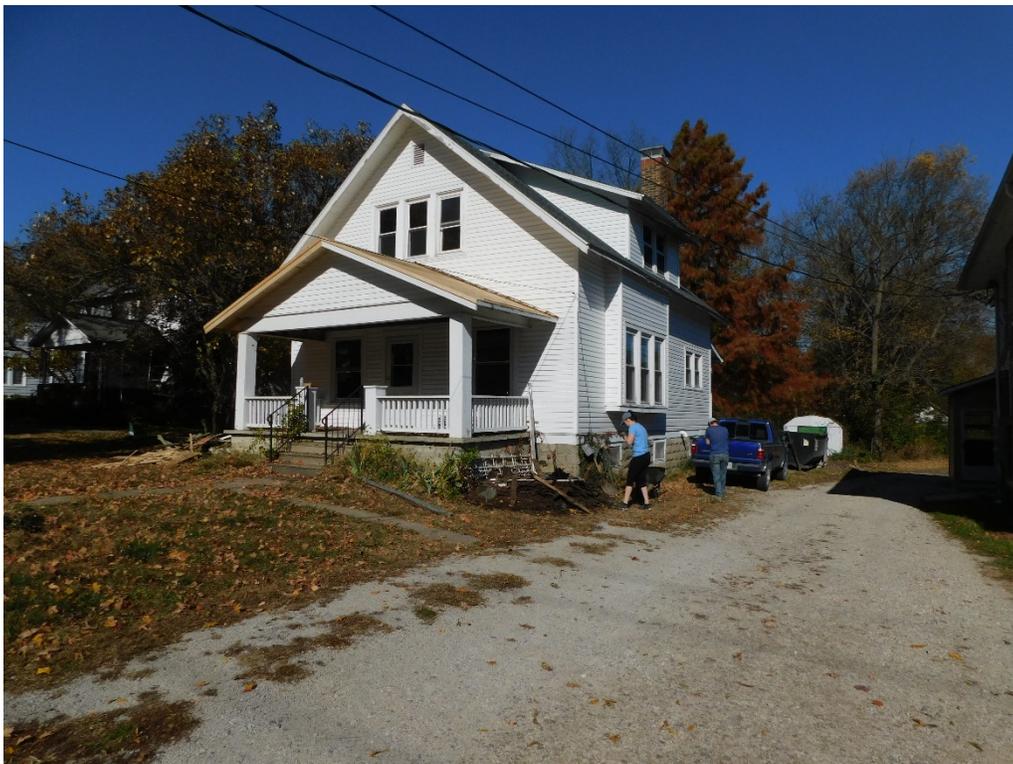
This one-and-a-half-story Bungalow/Craftsman features a stone foundation, vinyl exterior walls, and a front gable roof. The façade is three bays three bays with replacement one-over-one hung vinyl windows in the first and last bay and a wood door in the second bay. There is partial-width, centered front gable porch with vinyl siding, wood box columns, wood railing, and a wood landing. The half-story features grouped replacement one-over-one hung vinyl windows. The east elevation features a paired replacement one-over-one hung vinyl windows and a projecting rectangular bay with grouped one-over-one hung vinyl windows. The west elevation features paired and single replacement one-over-one hung vinyl windows. There is a shed roof on the east and west roof slopes with vinyl siding and paired replacement one-over-one hung vinyl windows. There is a interior brick chimney on the east roof slope.

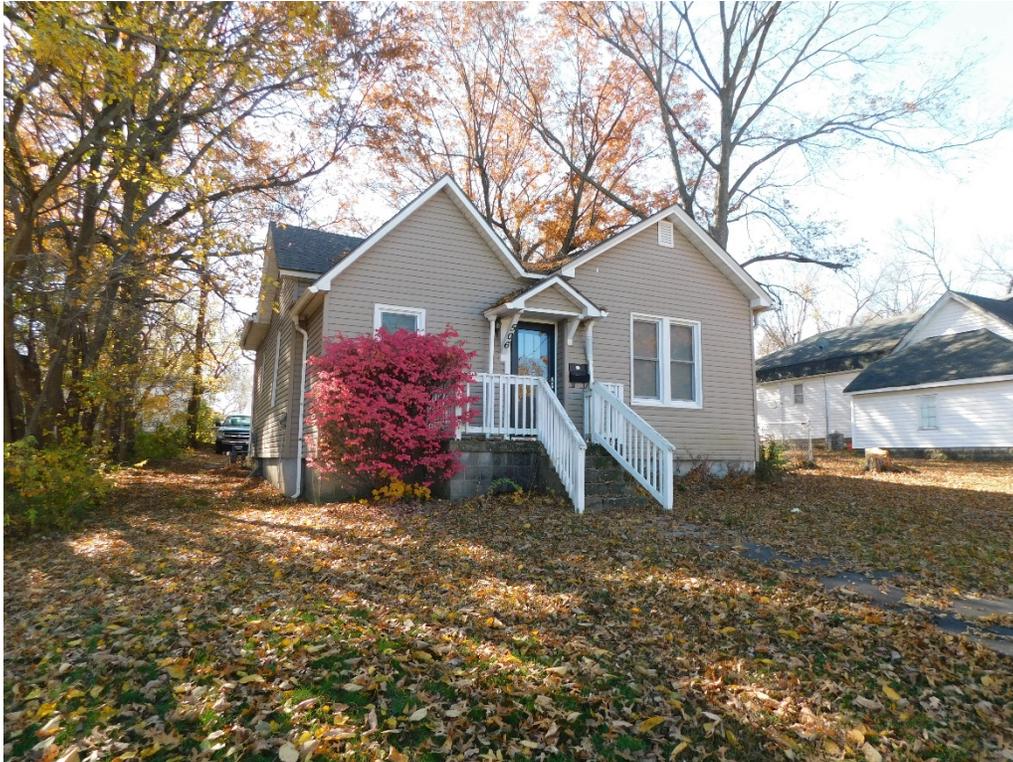
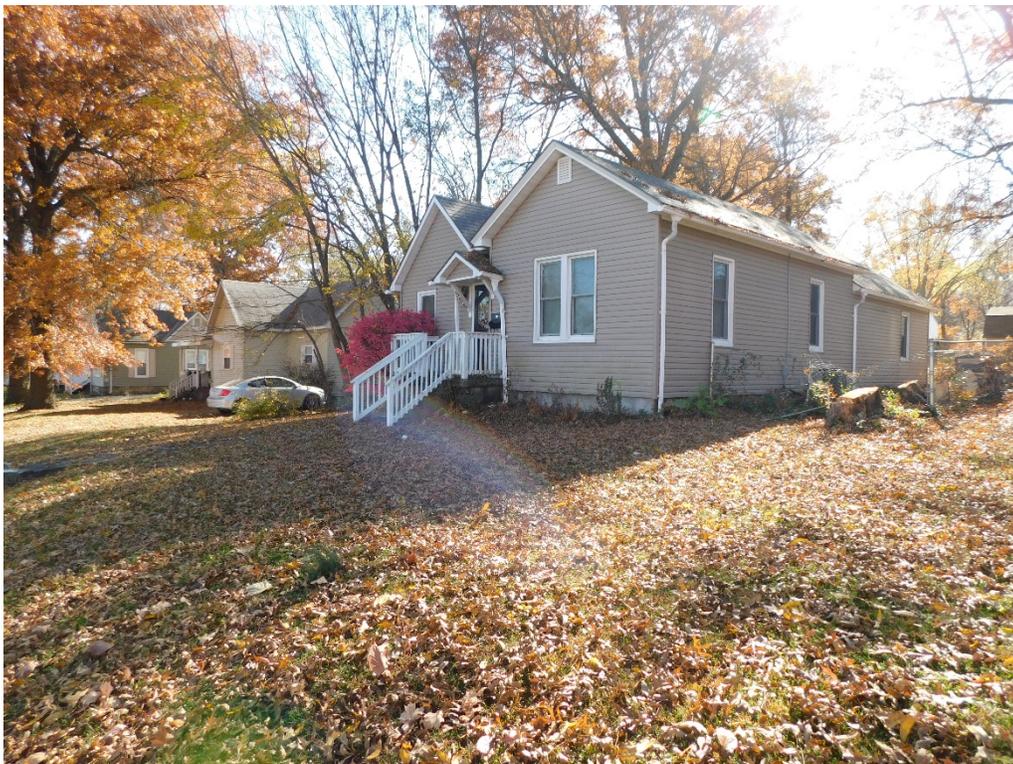
This one-story front-gable-and-wing-house features a concrete foundation, vinyl exterior walls, and a cross gable roof. The façade is three bay and double gable-ends. The first bay features a replacement one-over-one hung vinyl window. The second bay is filled with a three-wood door and a gabled porch canopy with boxed eaves, eave brackets, and a vinyl siding. The final bay features paired replacement one-over-one hung vinyl windows. There is partial-width concrete block platform with a wood railing in front of the second bay and part of the first bay. The west bay features three replacement one-over-one hung vinyl windows. The east bay features two replacement one-over-one hung vinyl windows.

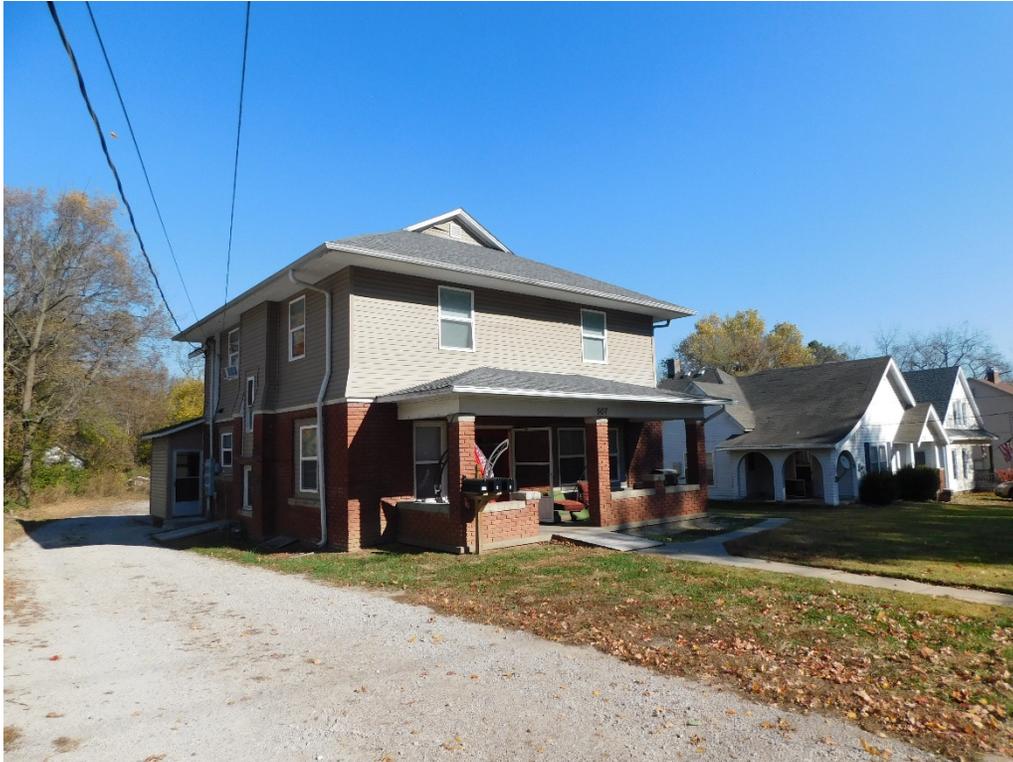
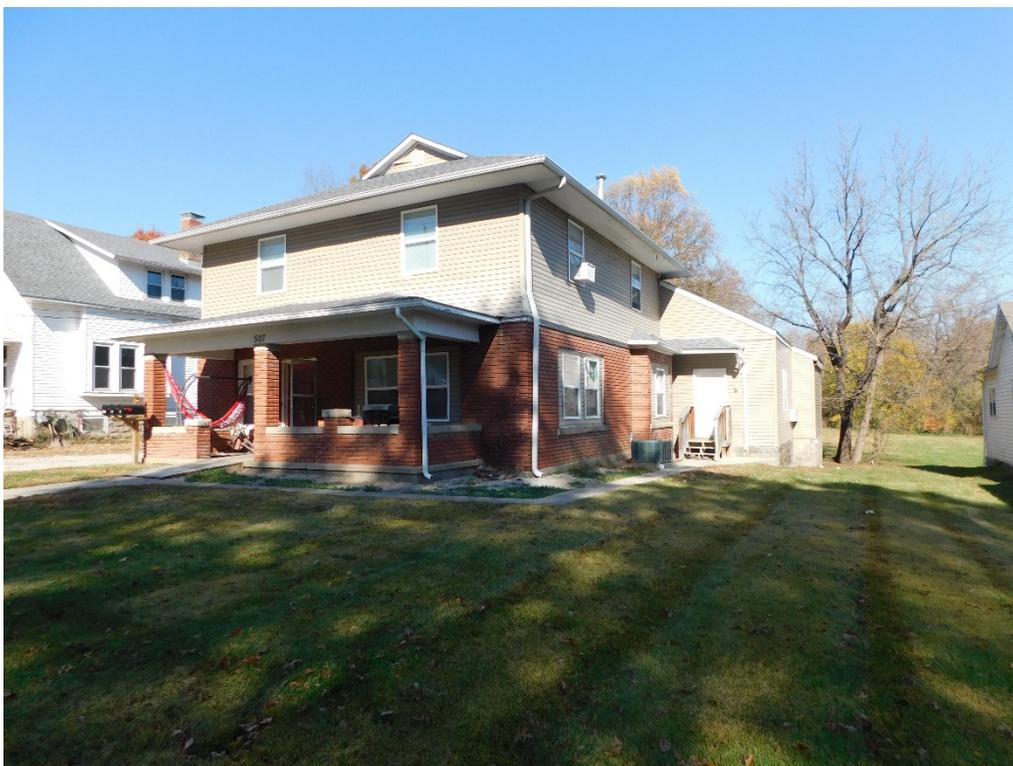
This two-story foursquare house features a brick foundation, brick and vinyl exterior walls, and gable hip roof. The façade is three bays and features brick siding on the first story and vinyl siding on the second story. The first bay features an infilled window opening with a replacement one-over-one hung vinyl window and vinyl siding. The second bay is filled with a 12-light wood door, and the third infilled window opening with a replacement paired one-over-one hung vinyl window and vinyl siding. The second story features two replacement one-over-one hung vinyl windows. There is a centered one-story porch with a hipped roof, brick columns, brick railing, and a concrete foundation. The side elevations feature brick siding on the first story and vinyl siding on the second story. There are infilled window openings with a replacement one-over-one hung vinyl window and vinyl siding on the first story, and replacement one-over-one hung vinyl windows on the second story. This building is not eligible due to alterations to the siding and fenestration.

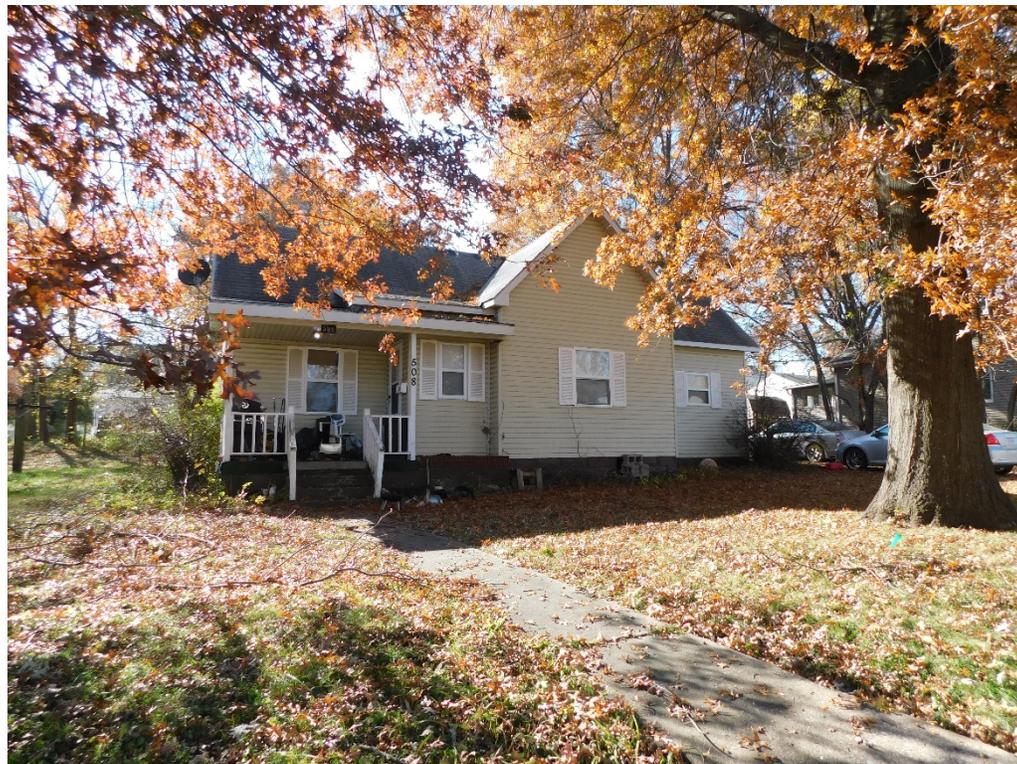
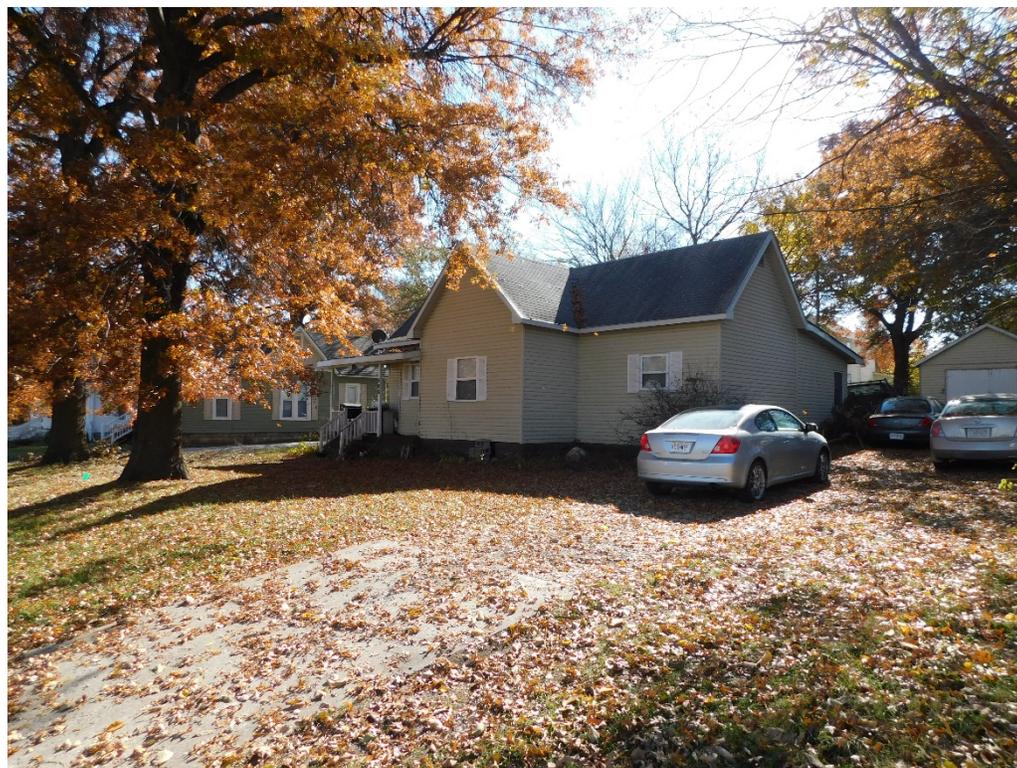
There is a contributing, c. 1950 detached garage is located in the rear. This one-story garage features a concrete foundation, vinyl siding and a front gable roof. The façade is one bay with wood garage double-doors.

This one-story front-gable-and-wing house features a stone foundation, vinyl exterior walls, and a cross gable roof. The façade is four bays with replacement one-over-one hung vinyl windows with faux shutters in all the bays and with varying sizes. There is a recessed porch in the first bay with wood posts, wood railing, and a concrete foundation. A wood door is located on the interior side. The third bay is located in the front gable-end. The west elevation features vinyl siding and a wood door. The east elevation features vinyl siding and two replacement one-over-one hung vinyl windows. This building is not eligible due to alterations to the siding and fenestration.

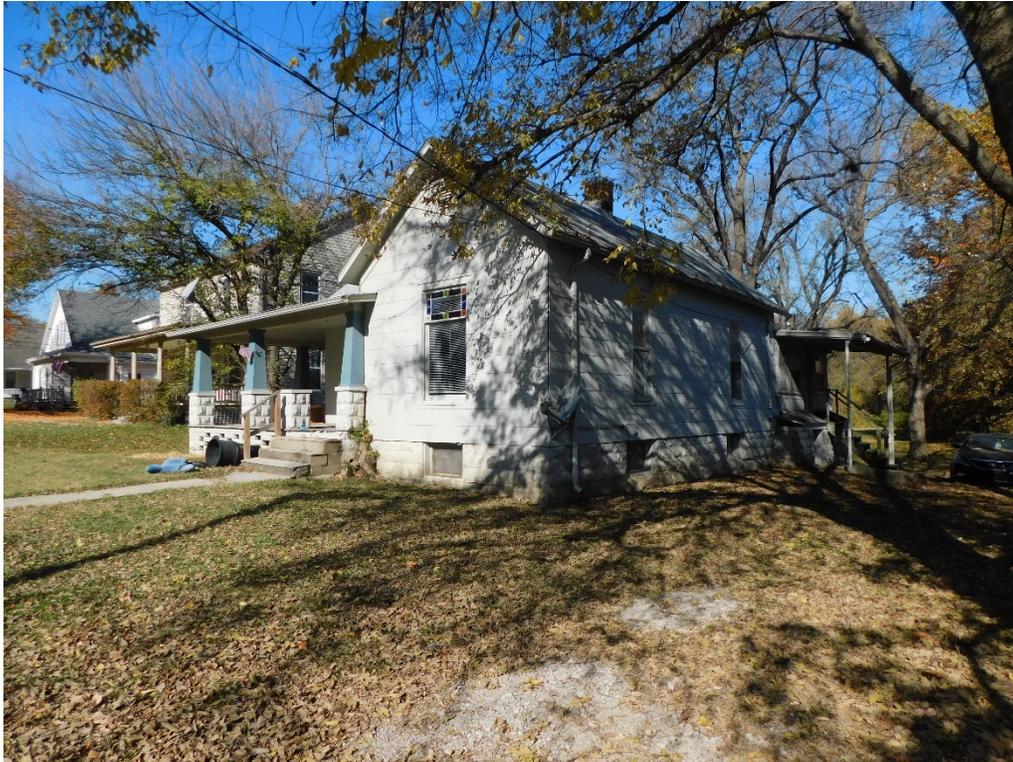
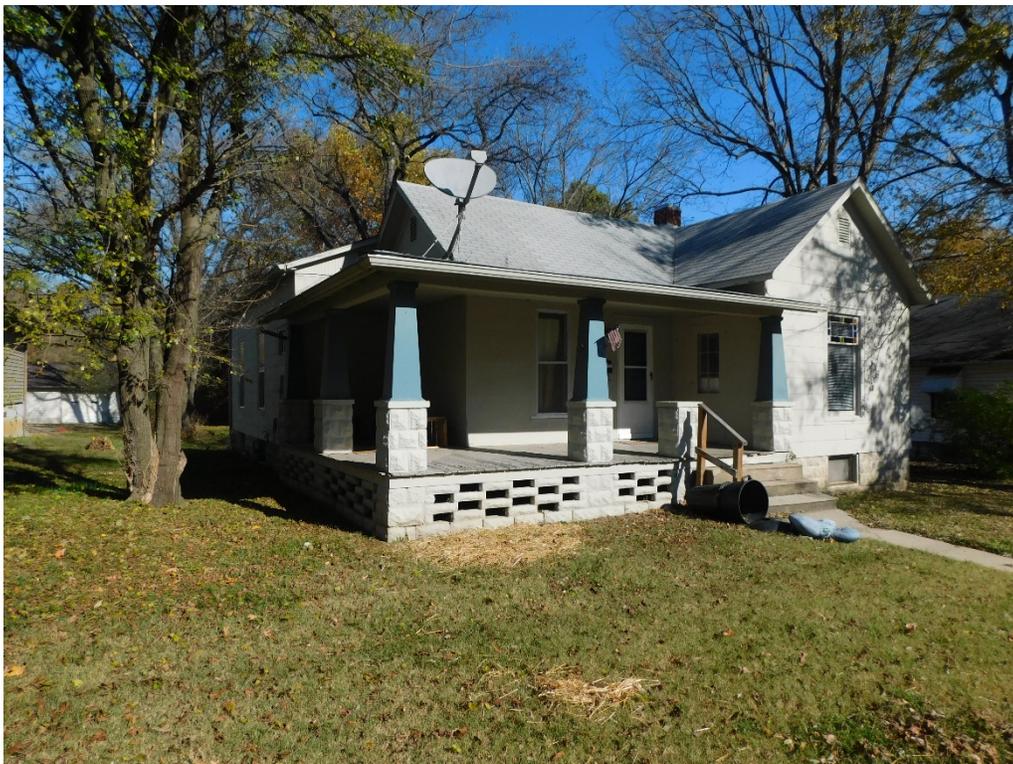
Description:
LOOKING NORTHWEST

Description:
LOOKING NORTHEAST

This one-story front-gable-and-wing house features a stone foundation, asbestos exterior walls, and a cross gable roof. The façade is three bays with an original one-over-one double-hung wood window in the first bay and a wood door in the second bay. The third bay is located in the projecting gable-end with an original one-light fixed wood windows with a stained glass transom, and there is a wood door locate on the interior side of the gable. There is a circa 1920 partial wraparound porch with a hipped roof, tapered wood columns, stone piers, and a stone foundation. The east elevation features two original one-over-one double-hung wood windows, and there is a one-story addition located on the rear. The west elevation features original one-over-one double-hung wood windows.
