1. Survey No. JO-AS-007-0058		2. Survey name: GROVER & BROAD STREETS ARCHITECTURAL/HISTORICAL SURVEY	
3. County: JOHNSON		4. Address (Street No.) 400	Street (name) GROVER
5. City: WARRENSBURG	Vicinity: <input type="checkbox"/>	6. Geographical Reference: 35.76143 / -93.73367	7. Township/Range/Section: T: 46 R: 26 S: 24
8. Historic name (if known):		9. Present/other name (if known):	
10. Ownership: <input checked="" type="checkbox"/> Private <input type="checkbox"/> Public		11a. Historic use (if known): SINGLE DWELLING	11b. Current use: SINGLE DWELLING

HISTORICAL INFORMATION

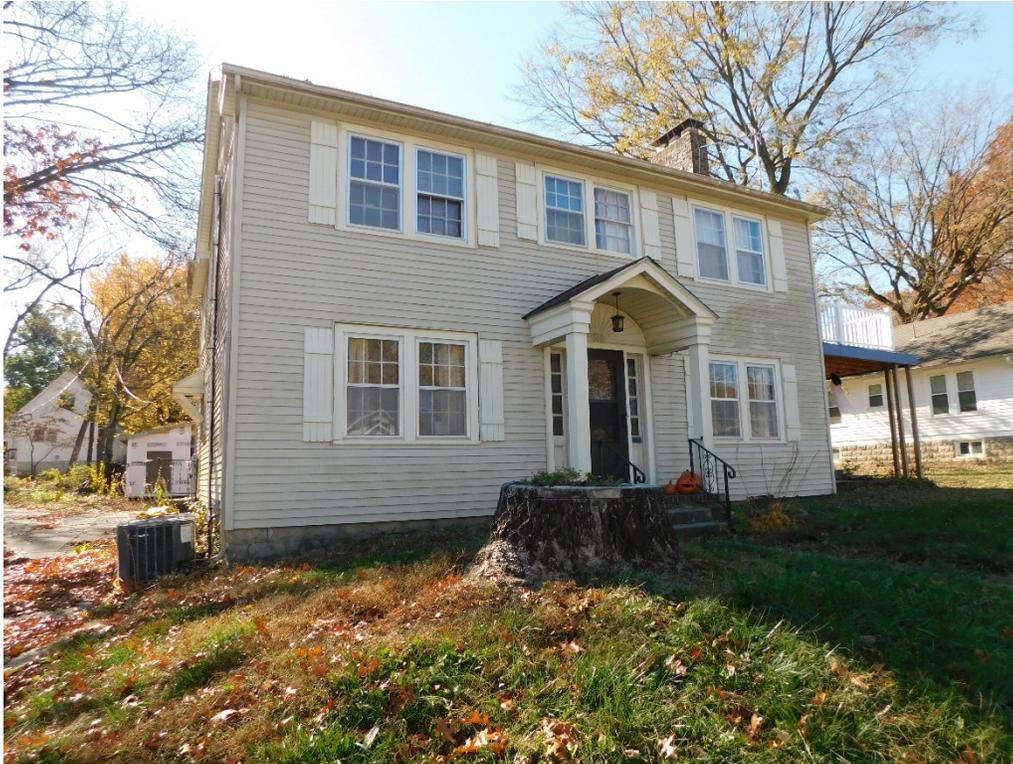
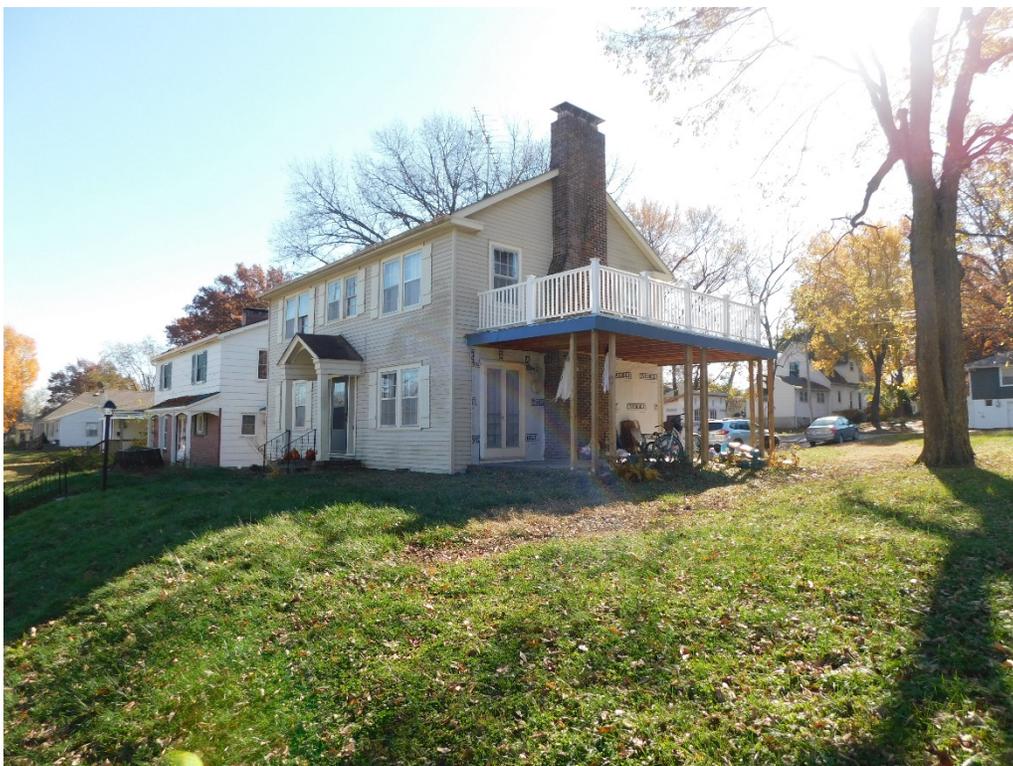
Description:
LOOKING SOUTHWEST

Description:
LOOKING SOUTHEAST

This two-story Colonial Revival feature a stone foundation, wood exterior walls, and a side gable roof. the façade is three bays with paired original six-over-six double-hung wood windows with faux shutters in the first and last bay. The second bay features a wood door with four-light sidelight and fan motif above the three. There is an one-bay porch from a gable roof with a segmented arch underneath, wood columns, and a brick landing with a metal railing. The second story features three sets of paired original six-over-six double-hung wood windows with faux shutters with the middle set being slightly smaller. The east elevation features paired original six-over-six double-hung wood windows on the first and second story, and a wood door with a shed porch canopy, concrete landing, and metal railing. On the west elevation, the porch and balcony reconstruction is underway with replacement multi-pane double doors, exterior brick chimney, and original six-over-six double-hung wood windows on the second story. The porch features a concrete landing, wood posts, and a wood railing on the balcony.

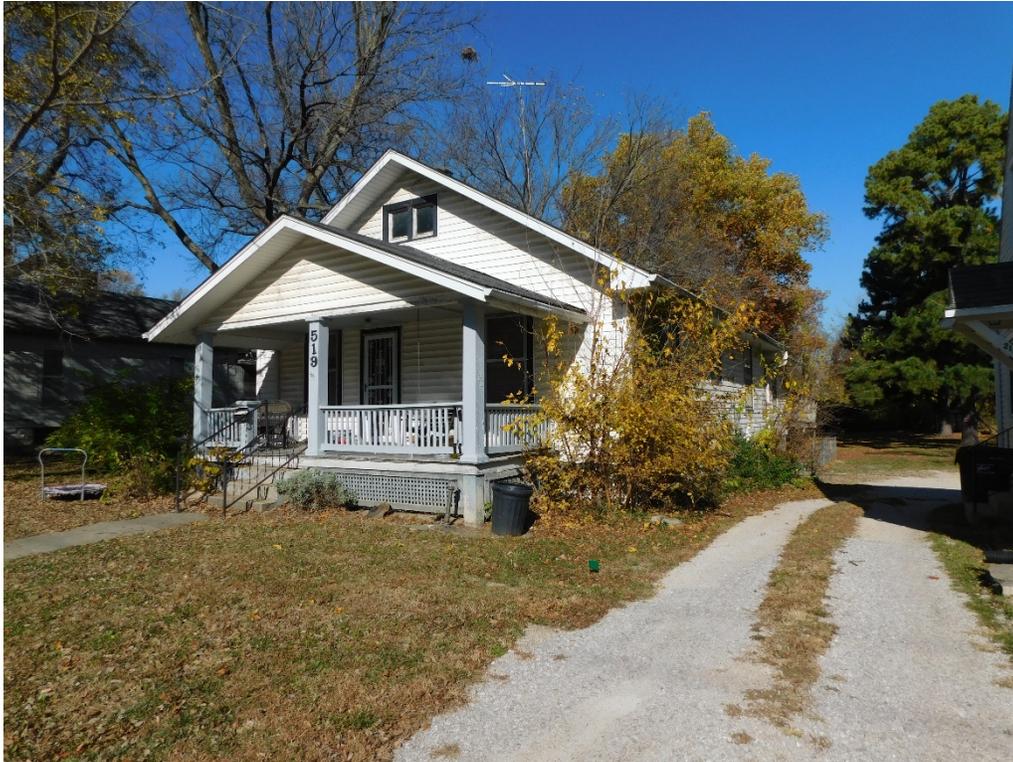
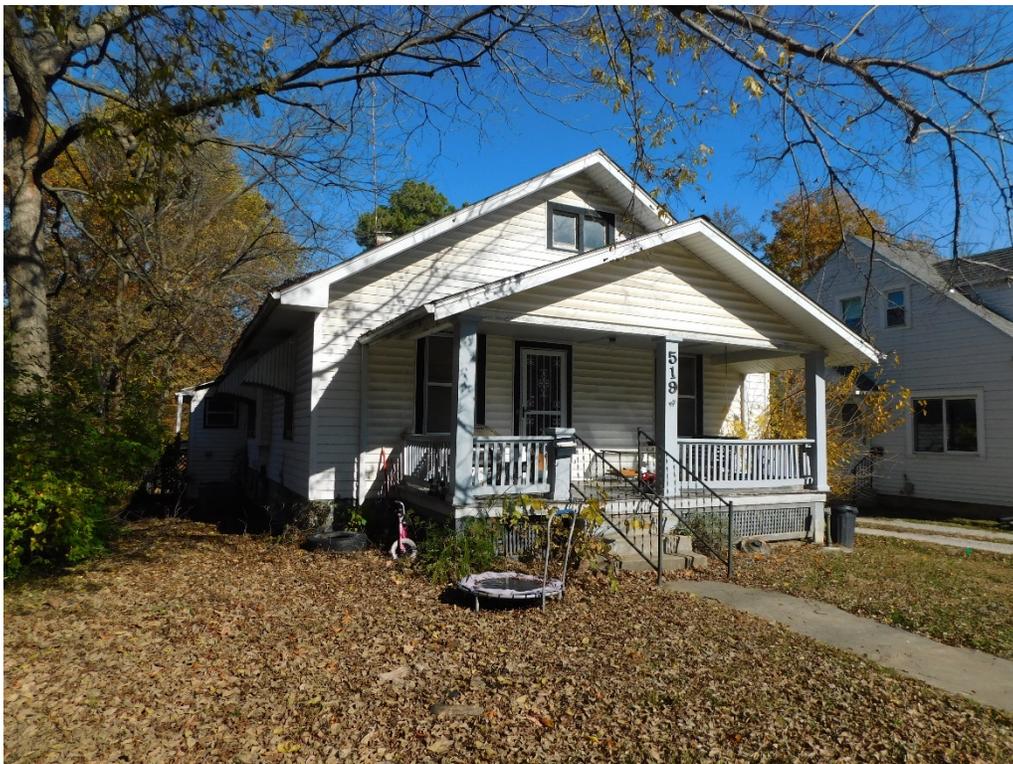
Description:
LOOKING NORTHWEST

Description:
LOOKING NORTHEAST

This one-and-a-half-story Bungalow/Craftsman features a stone foundation, vinyl exterior walls, and a front gable roof. The façade is three bays with original one-over-one double-hung wood windows in the first and last bays. There is a slightly off-centered wood door in the second bay, and a two-light fixed wood window in the peak of the gable-end. There is a partial-width porch with a gable roof and vinyl siding in the gable-end. There are wood columns, railing and decking with concrete stairs as well. The side elevations features original one-over-one double-hung wood windows.

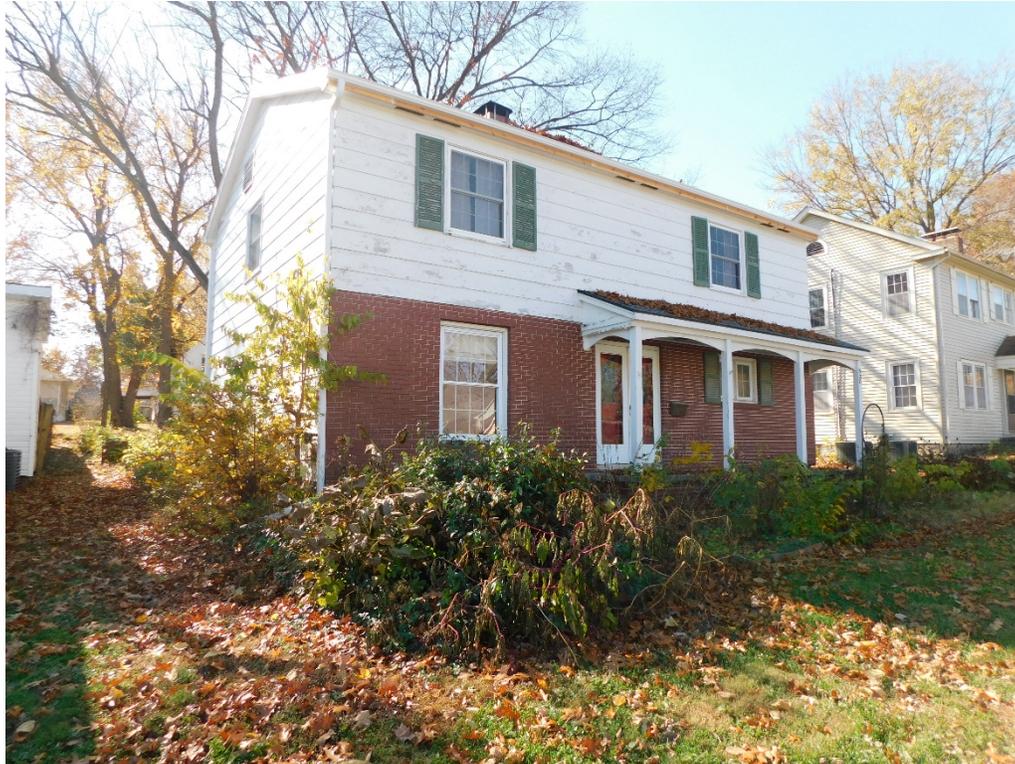
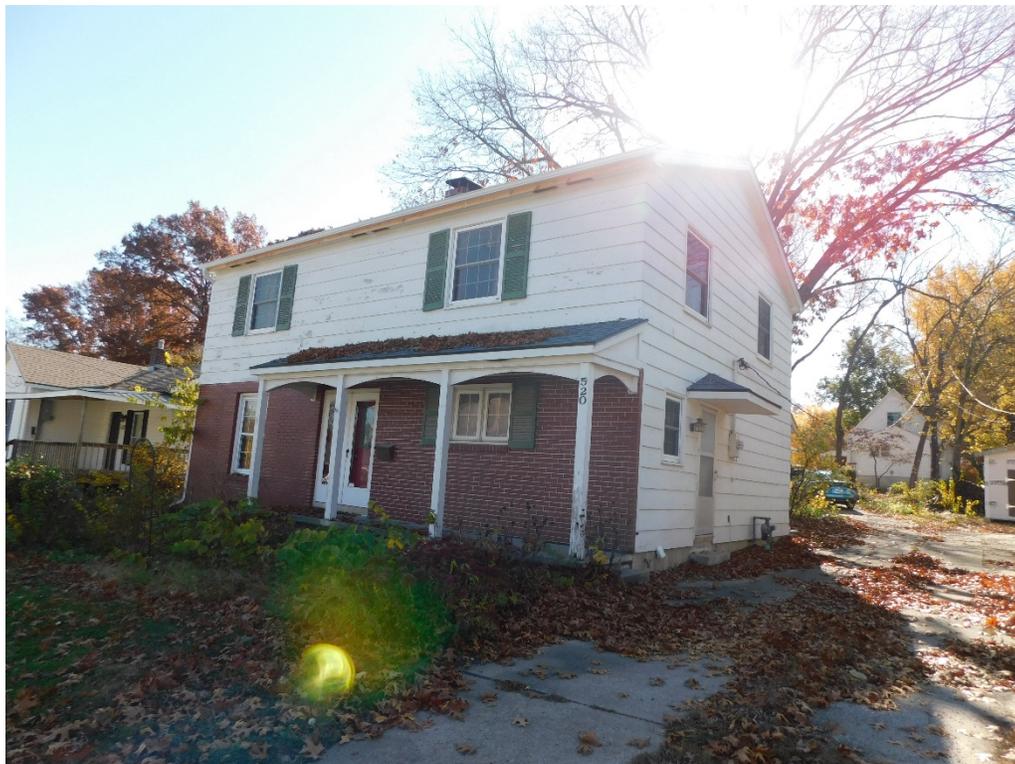
Description:
LOOKING SOUTHWEST

Description:
LOOKING SOUTHEAST

This two-story Colonial Revival features a concrete foundation, brick and weatherboard exterior walls, and a side gable roof. The façade is three bays with brick siding on the first story and weatherboard siding on the second story. There is a replacement eight-over-eight hung vinyl window in the first bay, one-light wood double doors in the second bay, and a paired replacement four-light vinyl casement windows with faux shutters in the third bay. There is a narrow porch over the second and third bay, and it features a shed roof with segmented arches, wood columns, and a brick landing. The second story features two replacement eight-over-eight hung vinyl windows with faux shutters. The side elevations feature weatherboard siding. The east elevation has a replacement eight-over-eight hung vinyl window in the second story. The west elevation has a wood door with a hipped porch canopy and a replacement six-over-six hung vinyl window on the first story and two replacement eight-over-eight hung vinyl windows in the second story.

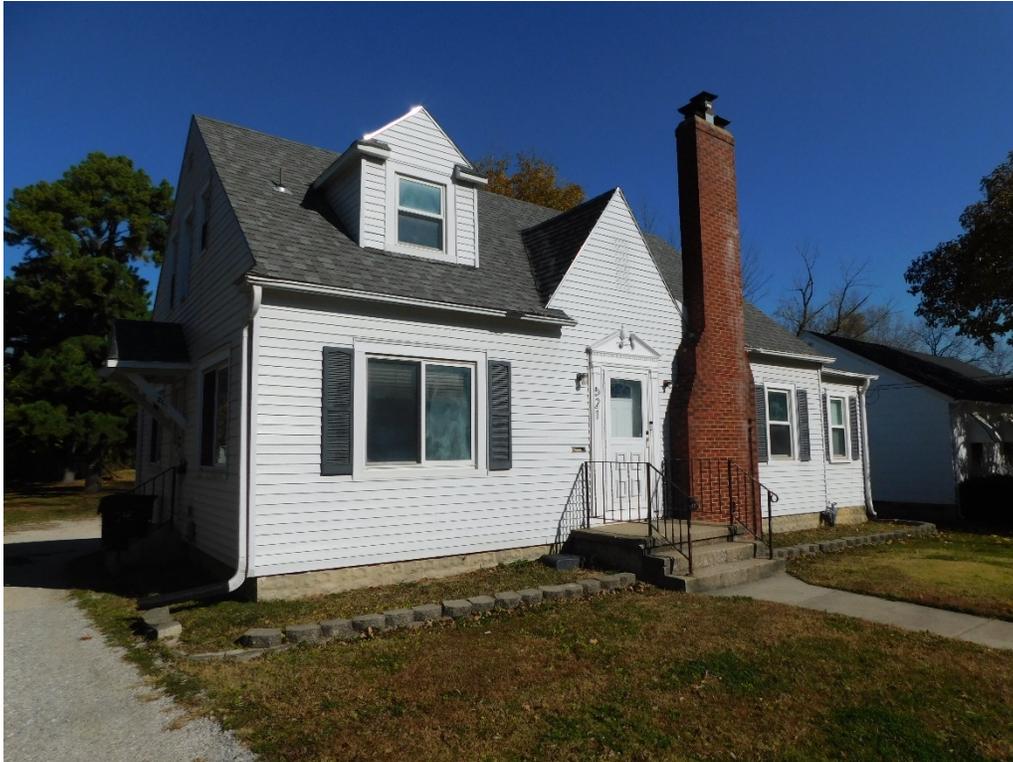
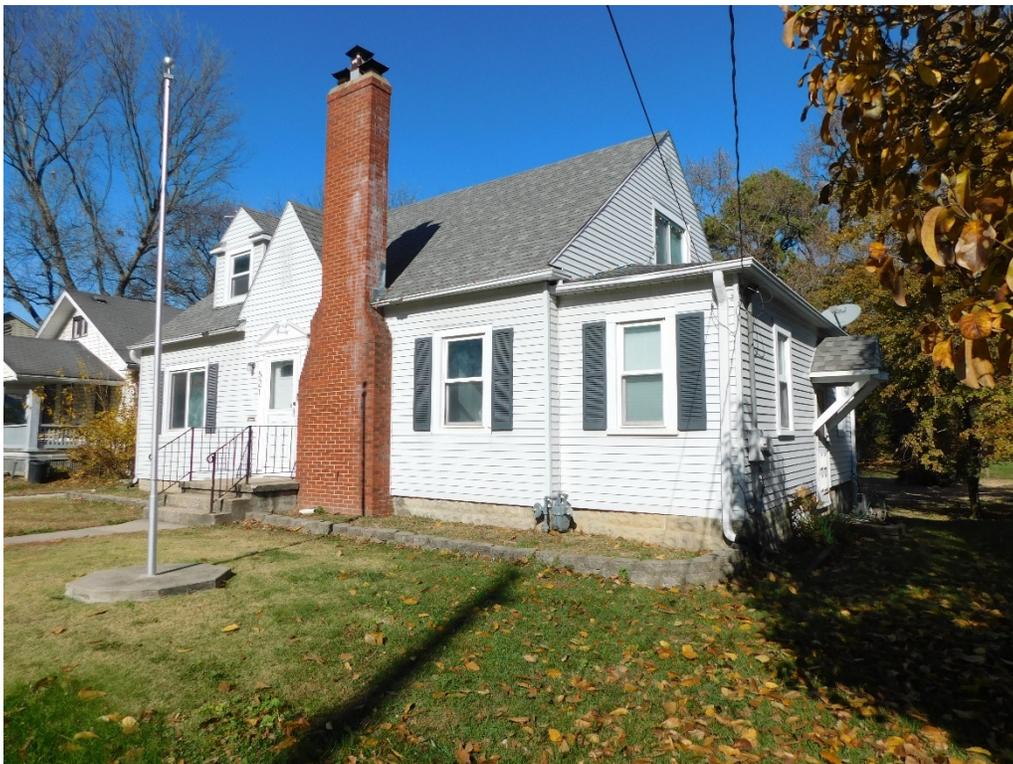
Description:
LOOKING NORTHEAST

Description:
LOOKING NORTHWEST

This one-and-a-half-story Tudor Revival features a stone foundation, vinyl exterior walls, and a side gable roof. The façade is four bays with a replacement sliding vinyl window with faux shutters in the first bay, and replacement one-over-one hung vinyl windows in the third and fourth bays. The second bay is located in a projecting gable-end with an one-light wood door with pilasters and classical cornice in the second bay. There is a concrete platform and metal railing, and an exterior brick chimney separates the second and third bay. There is a gable dormer over the first bay with vinyl siding and a replacement one-over-one hung vinyl window. The west elevation features a wood door with a gable porch canopy, wood brackets, concrete stairs, and a metal railing. The wood is flanked on either side by replacement sliding vinyl windows, and there are three replacement one-over-one hung vinyl windows in the half-story. The east elevation features a projecting one-story bay with a hipped roof. There is a wood door with a gable porch canopy with wood brackets. It is flanked on either side by a replacement one-over-one hung window. A replacement sliding vinyl window is located in the side gable-end.

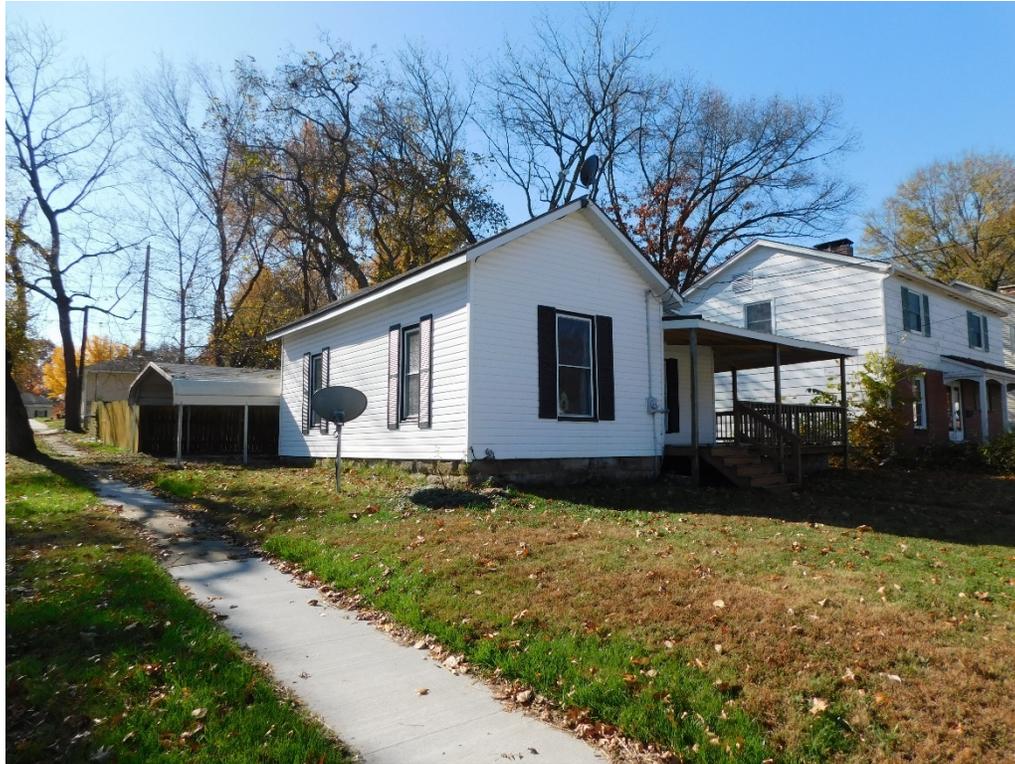
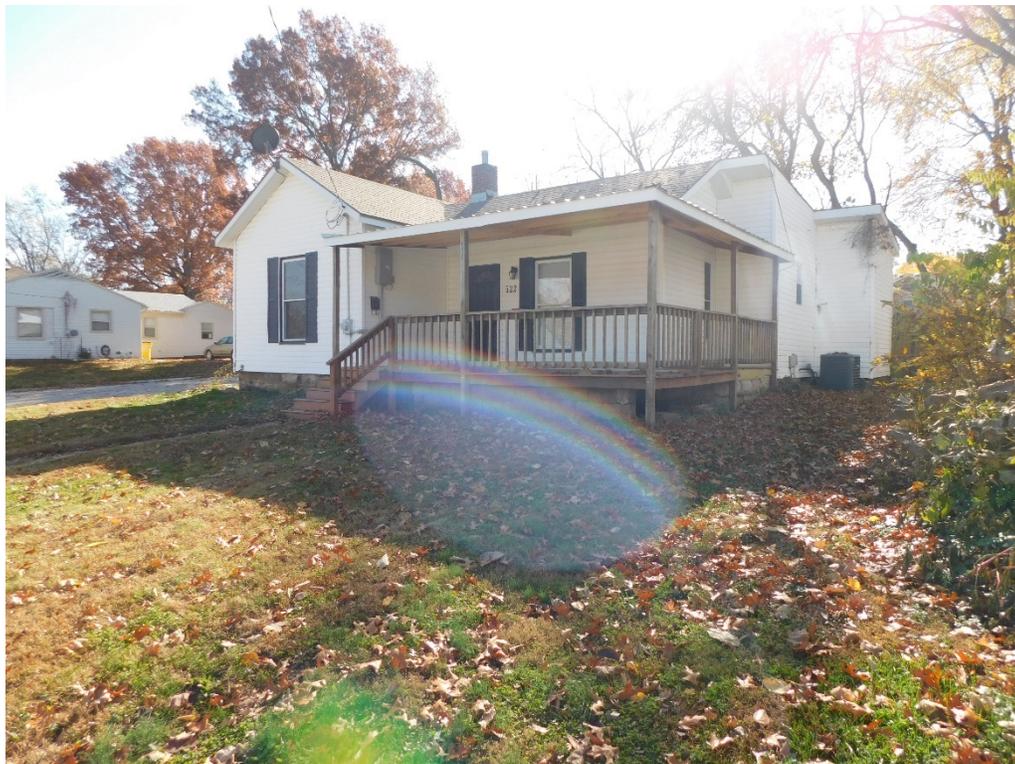
Description:
LOOKING SOUTHWEST

Description:
LOOKING SOUTHEAST

This one-story front-gable-and-wing house features a stone foundation, vinyl exterior walls, and a cross gable roof. The façade is three bays, and the first bay is located in the projecting gable-end with a replacement one-over-one hung vinyl window with faux shutters in the first bay. The second bay features an arched four-light wood door, and a replacement one-over-one hung vinyl window with faux shutters in the third bay. There is a circa 2002 partial wraparound porch over the second and third bay with a shed corrugated metal roof, wood posts, railing and decking. A brick chimney is located on the roof ridge near the gable intersection. The east elevation features two replacement one-over-one hung vinyl window with faux shutters, and the west elevation features two replacement one-over-one hung vinyl windows. This building is not eligible due to alterations to the siding, fenestration, and a porch.

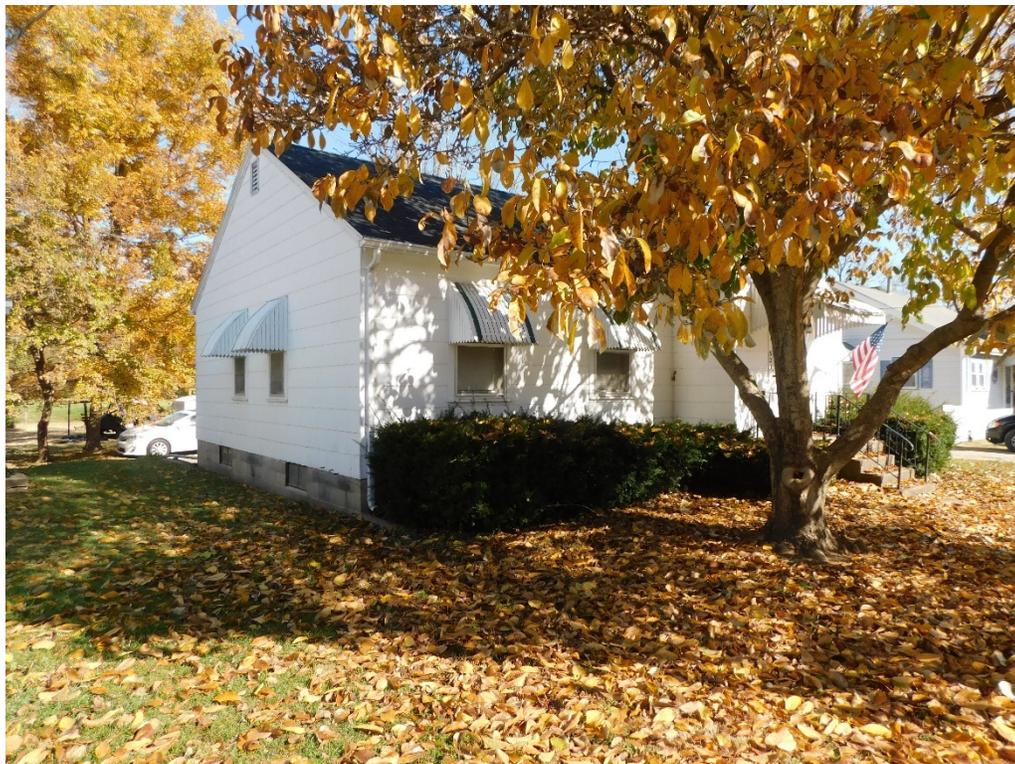
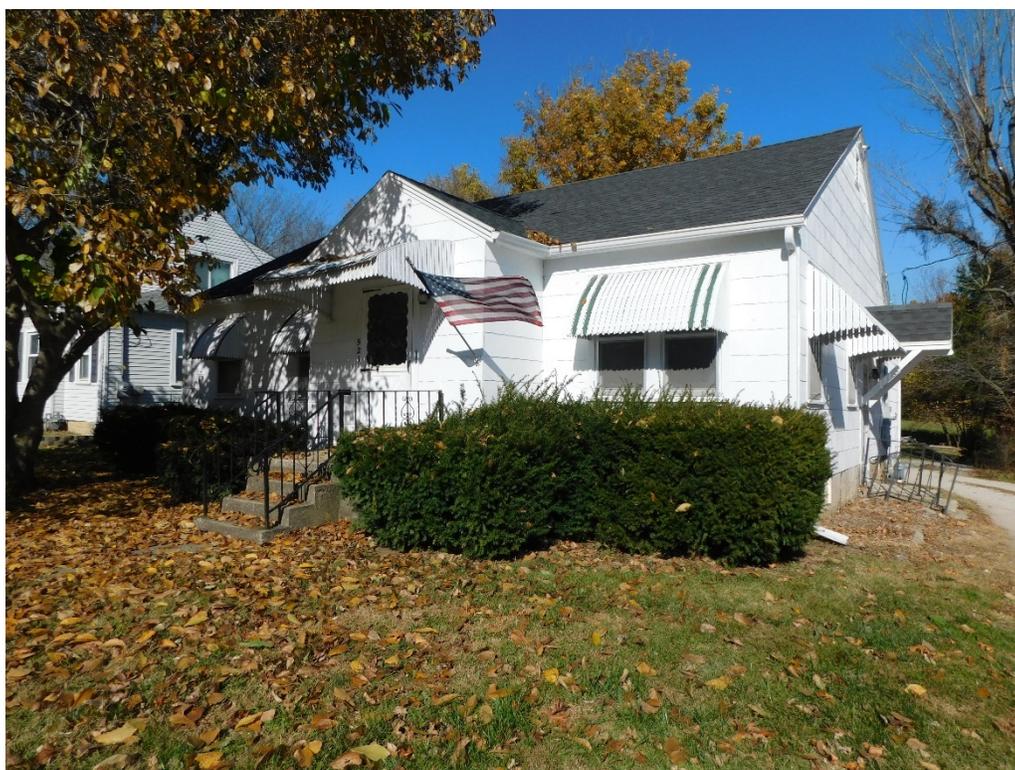
Description:
LOOKING NORTHEAST

Description:
LOOKING NORTHWEST

This one-story minimal traditional house features a concrete foundation, asbestos exterior walls, and a cross gable roof. The facade is four bays with two original one-over-one hung wood windows with aluminum awnings. The second bay is located in a projecting gable-end with a wood door, aluminum awning, metal railing, and concrete landing. The final bay is filled with paired original one-over-one hung wood windows with an aluminum awning. The west elevation features two original one-over-one hung wood windows with aluminum awnings. The east elevation features two original one-over-one hung wood windows with aluminum awnings and a wood door with a gabled porch canopy, wood brackets, metal railing, and a concrete landing.

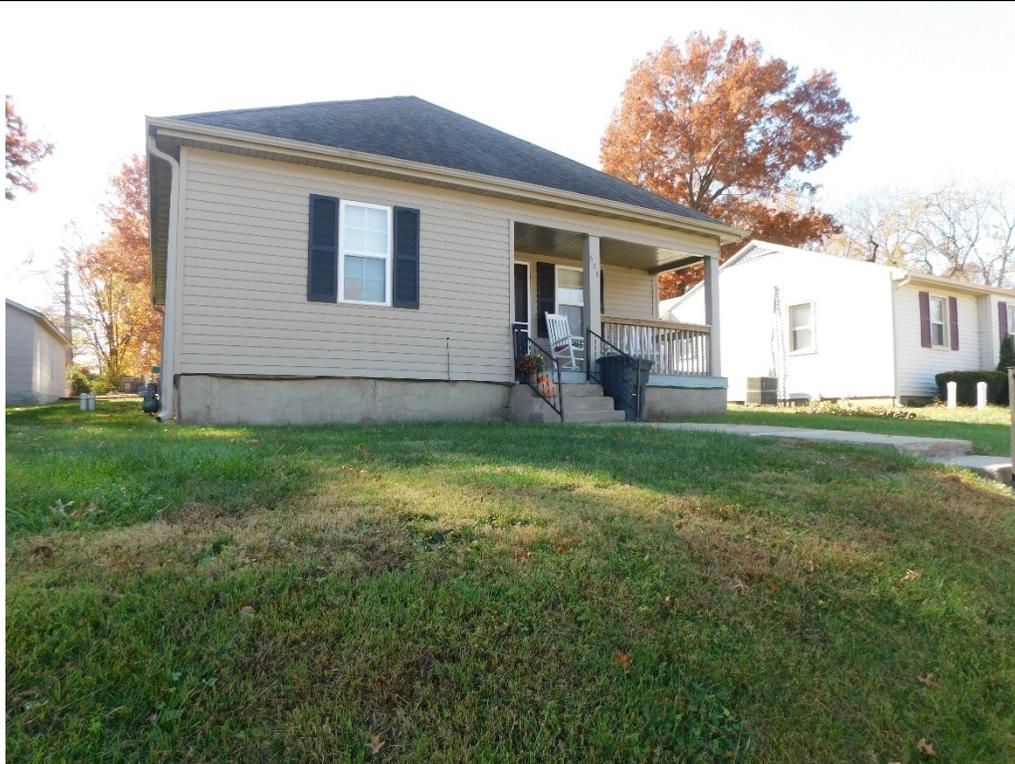
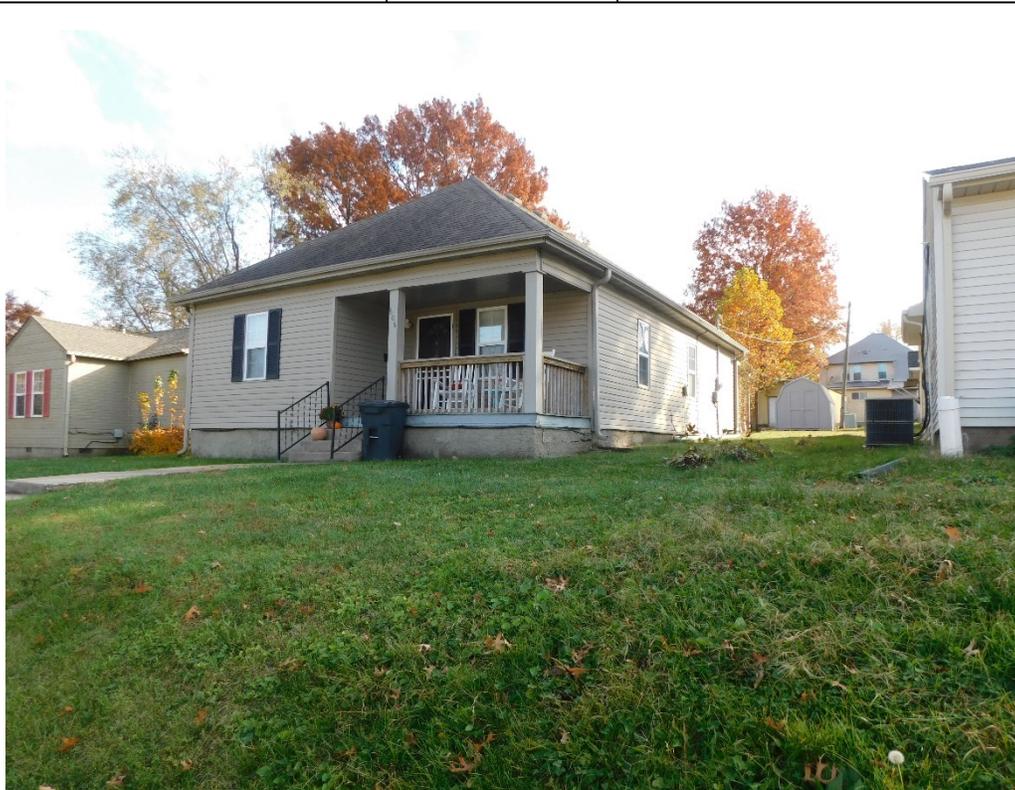
This one-story pyramidal house features a concrete foundation, vinyl exterior walls, and a steeply pitched hipped roof. The façade is three bays with a replacement four-over-four hung vinyl window with faux shutters. The second and third bay are located under a partial-width recessed porch with a concrete foundation, wood railing, and wood box columns. A wood door fills the second bay, and a replacement four-over-four hung vinyl window with faux shutters in the third bay. The east and west elevations feature two replacement four-over-four hung vinyl windows.

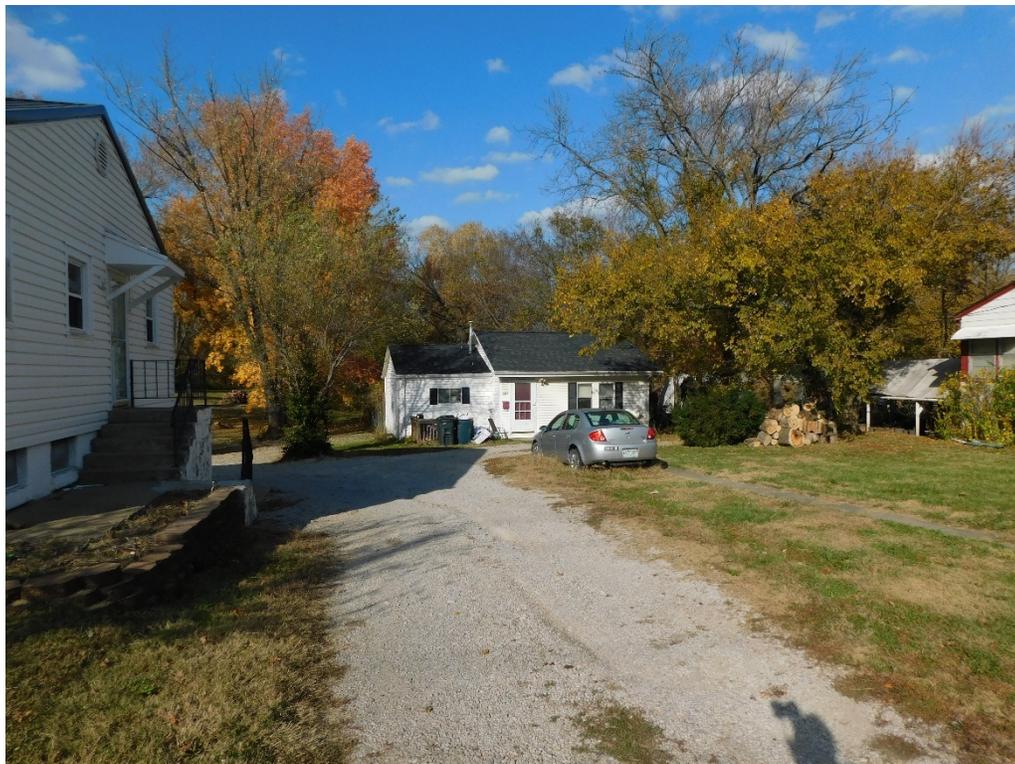
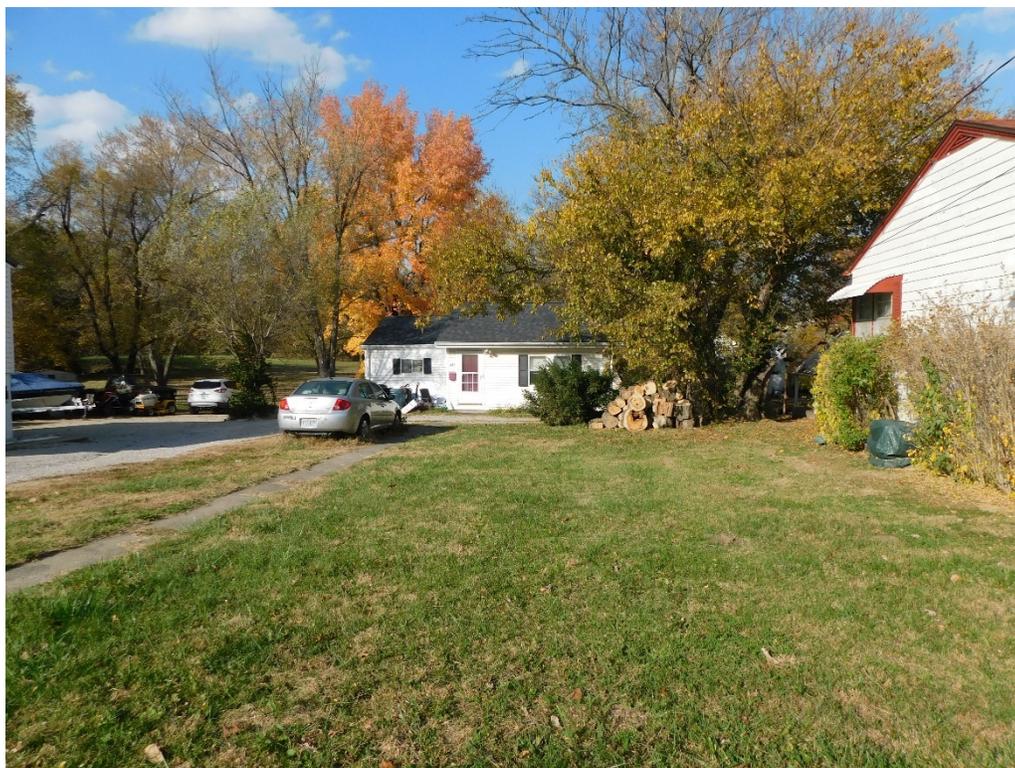
This one-story Minimal Traditional house features a concrete foundation, vinyl exterior walls, and a side gable roof. The façade is three bays with the first bay slightly recessed with original siding wood window and non-historic faux shutters. There is wood door in the second bay, and a two original one-over-one hung wood windows with faux shutters in the third bay. The west elevation features an original one-over-one hung wood windows, and the east elevation is not visible from the public-right-of-way.

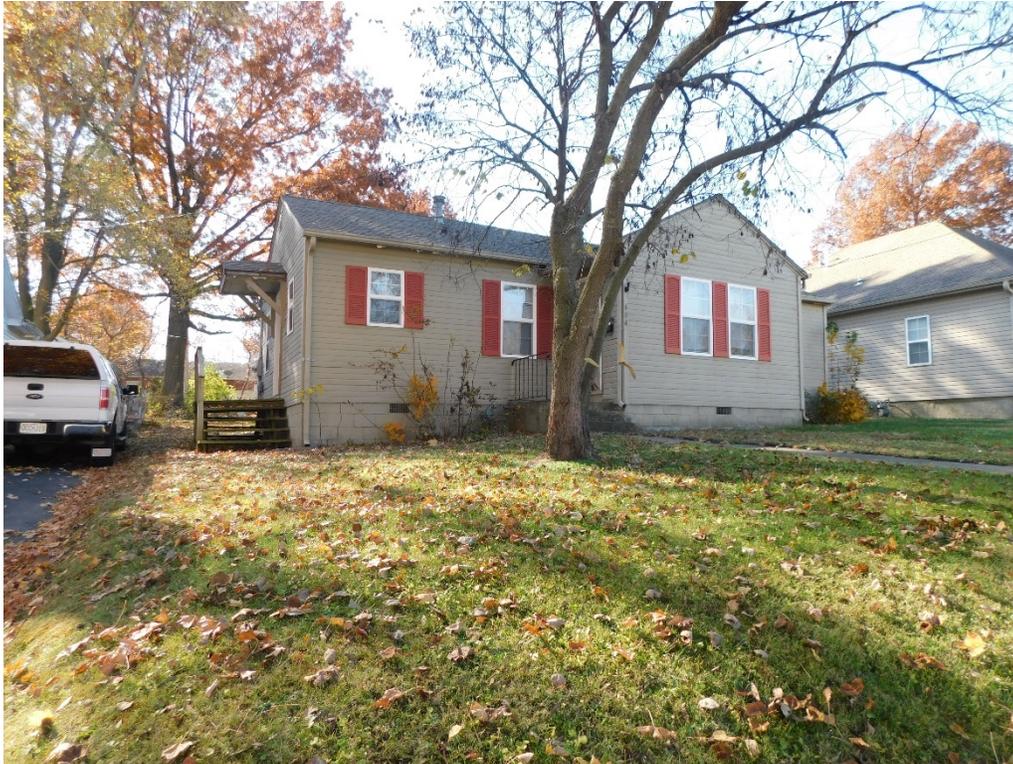
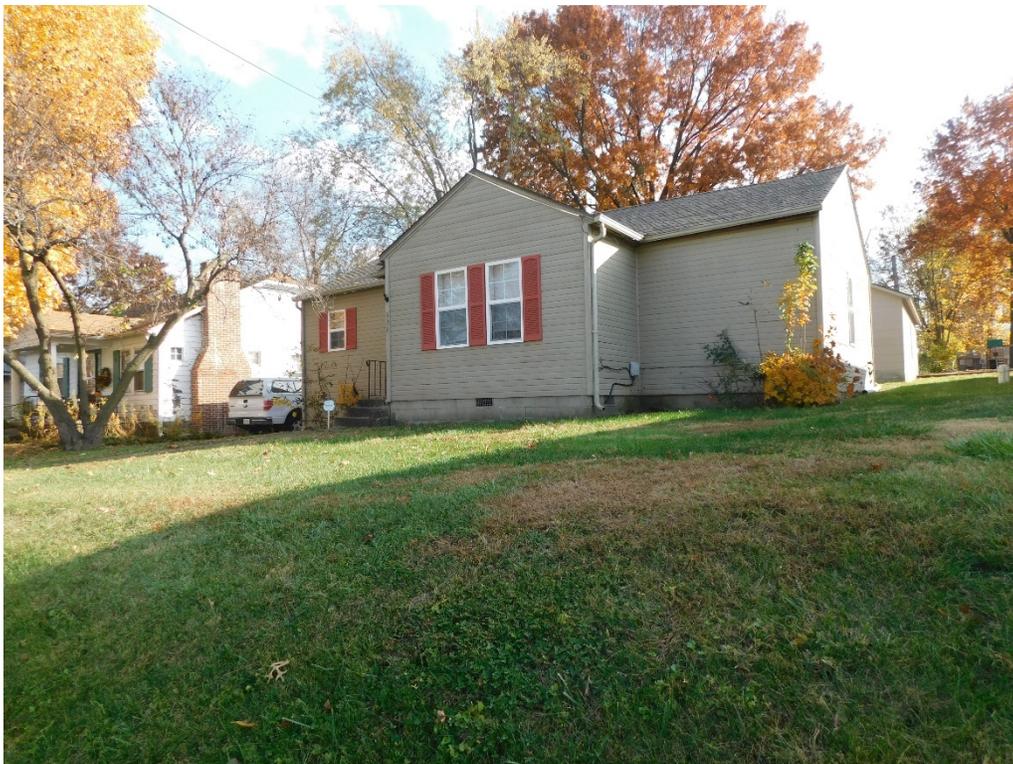
There is a contributing, c. 1950 detached garage is located in the rear. This one-story garage features a concrete foundation, wood siding and a front gable roof. The façade is one bay with a wood garage door facing towards the rear alley.

This one-story Minimal Traditional house features a concrete (CMU) block foundation, vinyl exterior walls, and a cross gable roof. The façade is four bays with two replacement four-over-four hung vinyl windows with faux shutters. The first window is smaller than the second. The third bay is located in the projecting gable-end with two replacement four-over-four hung vinyl windows with faux shutters. The wood door entry is located east side of the projecting gable and have a concrete platform and metal railing. The final bay is features vinyl siding over a previous opening. The east elevation features two replacement four-over-four hung vinyl windows. Between the windows is a wood door with a gable porch canopy and wood platform. The west elevation features a replacement four-over-four hung vinyl windows. This building is considered non-contributing due to the removal of historic windows and siding with replacement materials and covering window openings.

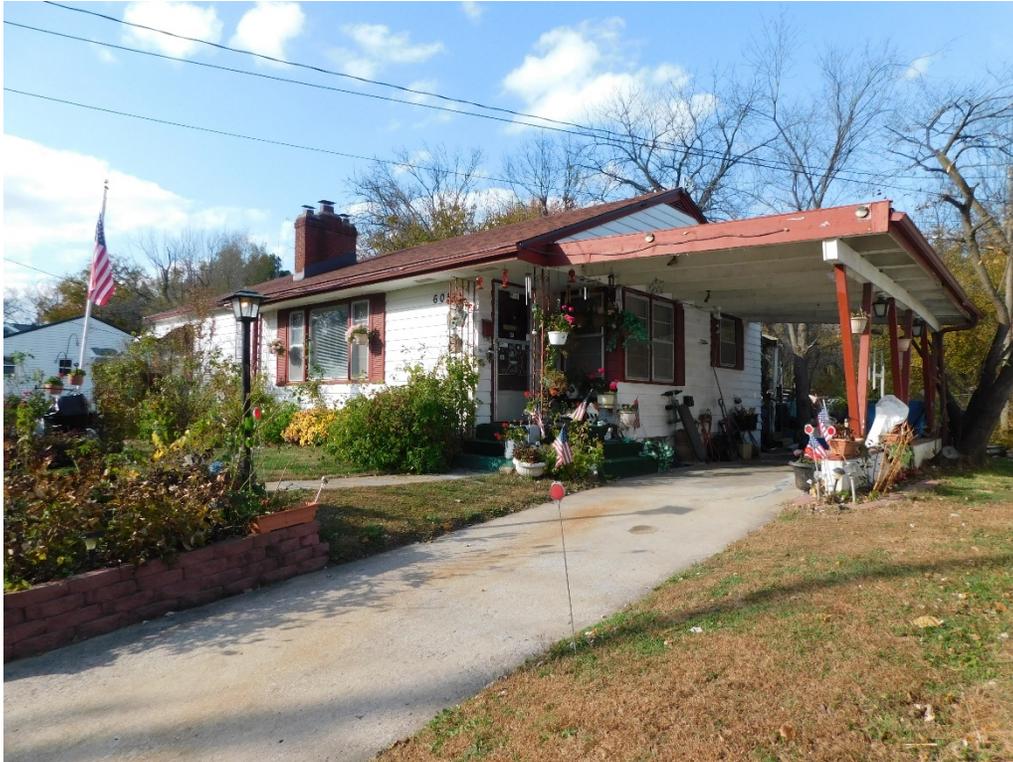
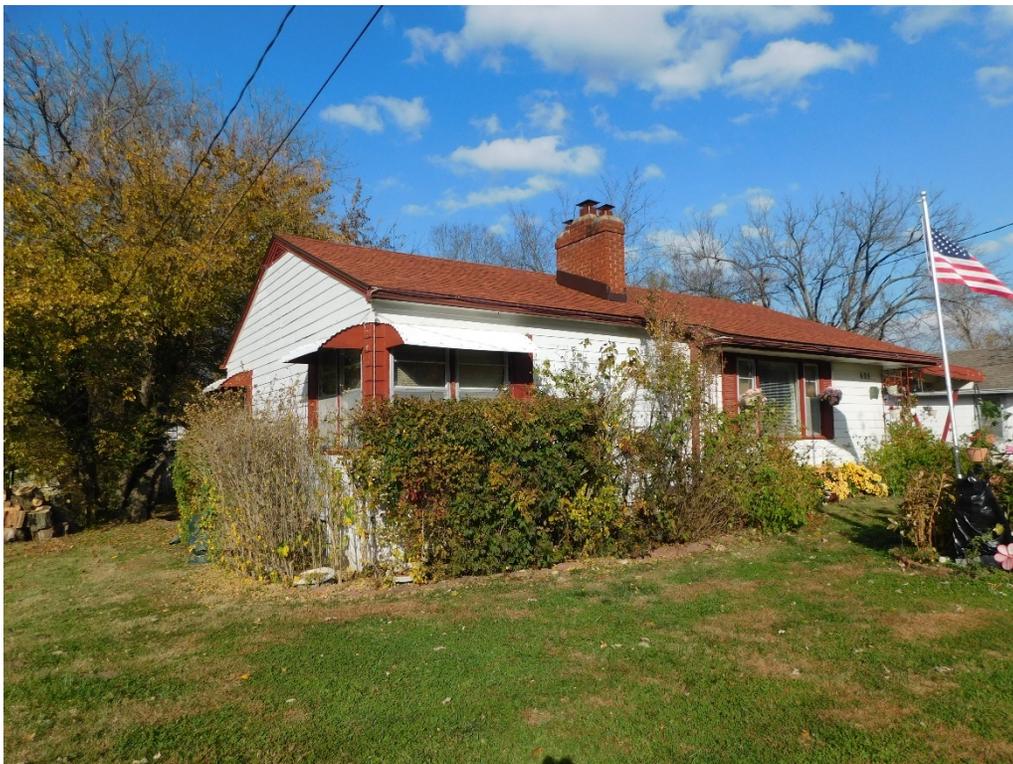
This one-story Minimal Traditional house features a concrete foundation, weatherboard exterior walls, and a side gable roof. The façade is two bays with paired original two-over-two hung wood windows with horizontal panes, a faux shutter and a metal awning. The second bay is filled with an original one-light wood pictures window with two-over-two windows and faux shutters. Located on the east elevation is an attached wood carport with wood "V" supports and beam. In addition, the entry is recessed on the southeast corner with a concrete landing, and there are paired original two-over-two hung wood windows with horizontal panes and faux shutters for the remainder of the elevation. The west elevation features original two-over-two hung wood windows with horizontal panes, faux shutters and metal awnings. Other features include a rectangular chimney located off-center on the front slope, and a c. 2002 rear addition not visible from the public right-of-way.

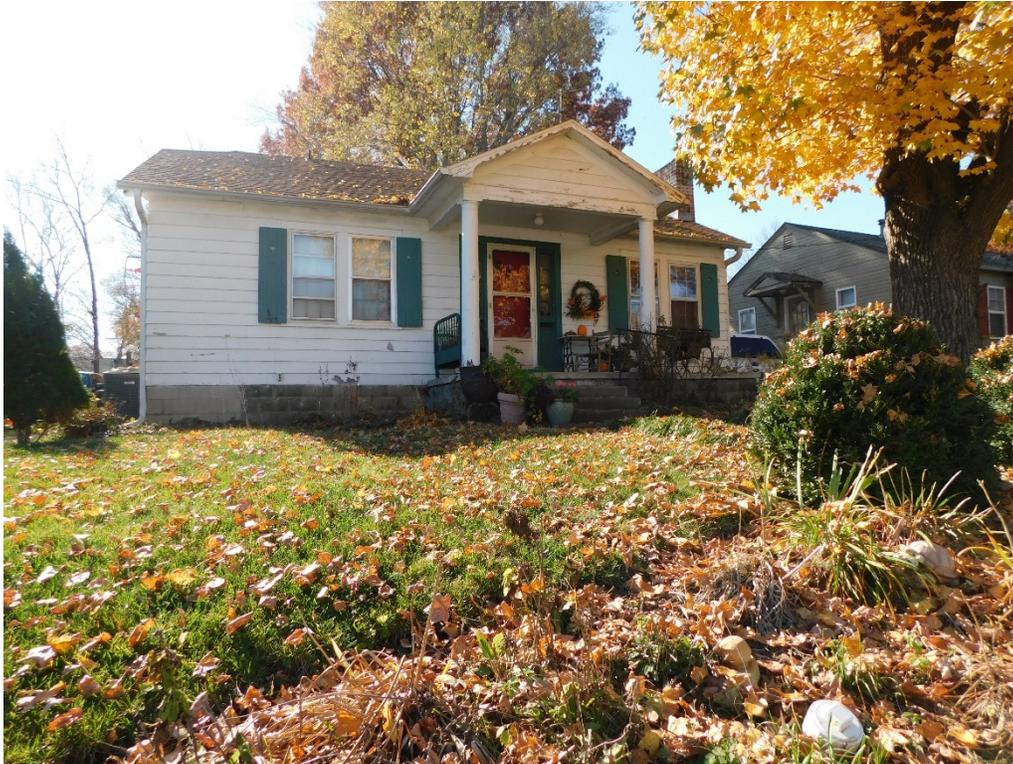
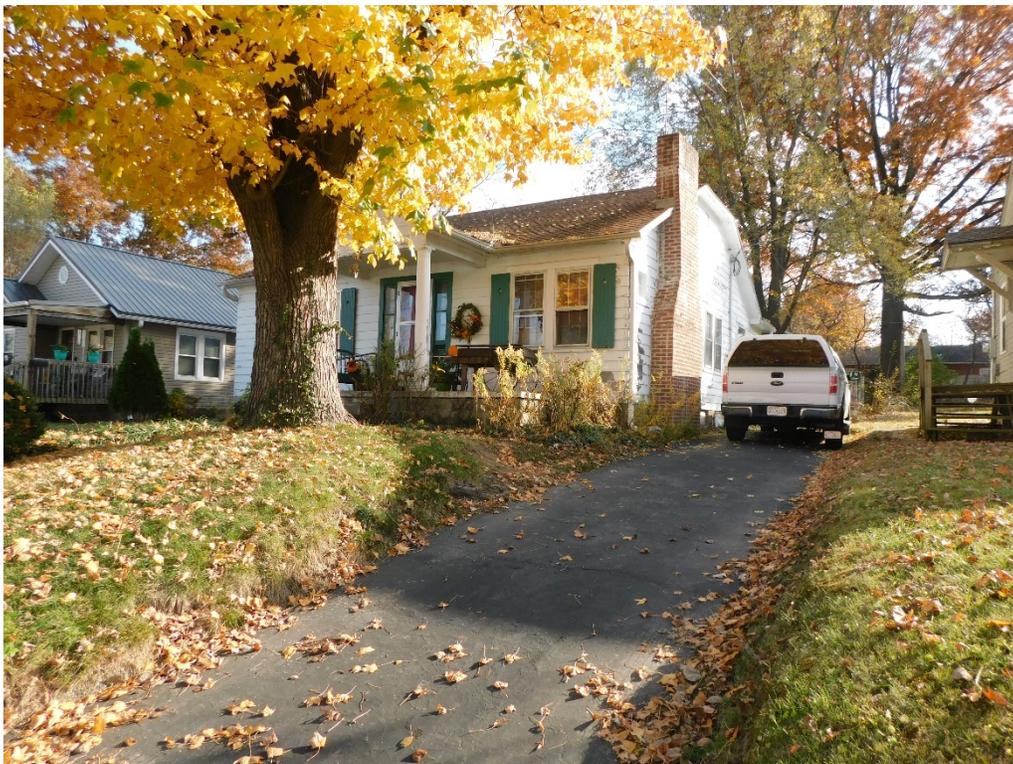
This one-story Colonial Revival features a stone foundation, wood lap exterior walls, and a cross gable roof. The façade is three bays with a paired original six-over-six double-hung wood windows with wood shutters in the first and last bay. The center bay is filled with a three-light wood door with four-light sidelights. There is a one bay porch over the entry. The porch features a stone foundation extends partially into the third bay, wood Doric columns, and a gable roof with boxed eaves. The west elevation features an exterior brick chimney, single and paired original six-over-six double-hung wood windows. The east elevation features two original six-over-six double-hung wood windows and one smaller original one-over-one double-hung wood window.

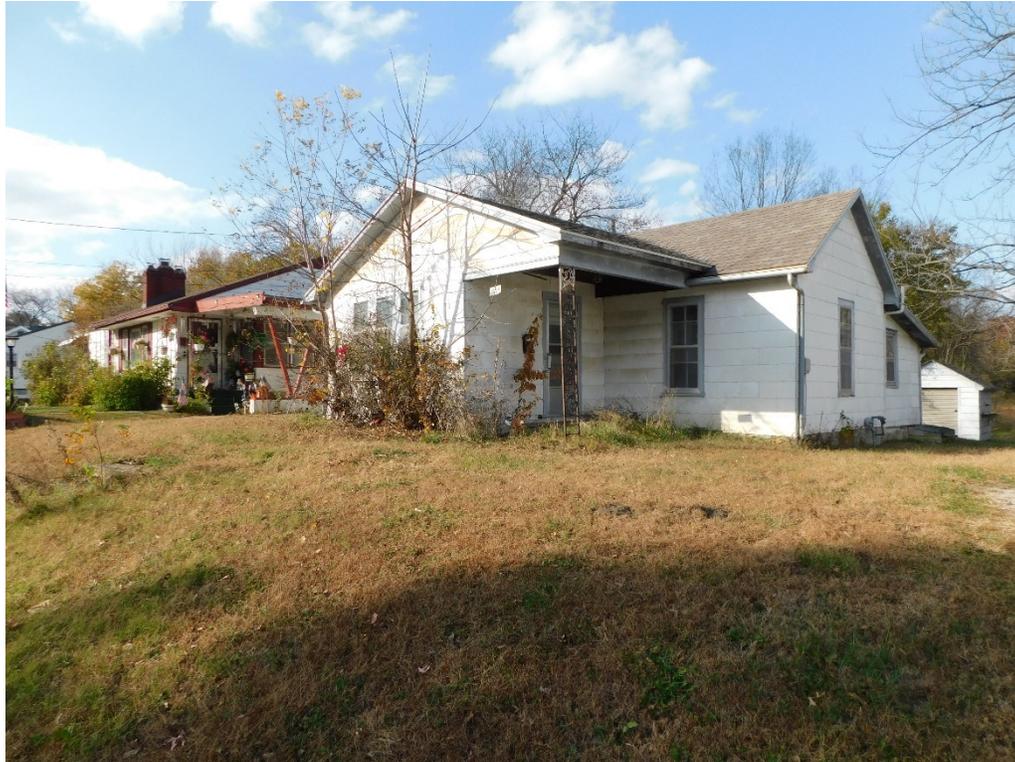
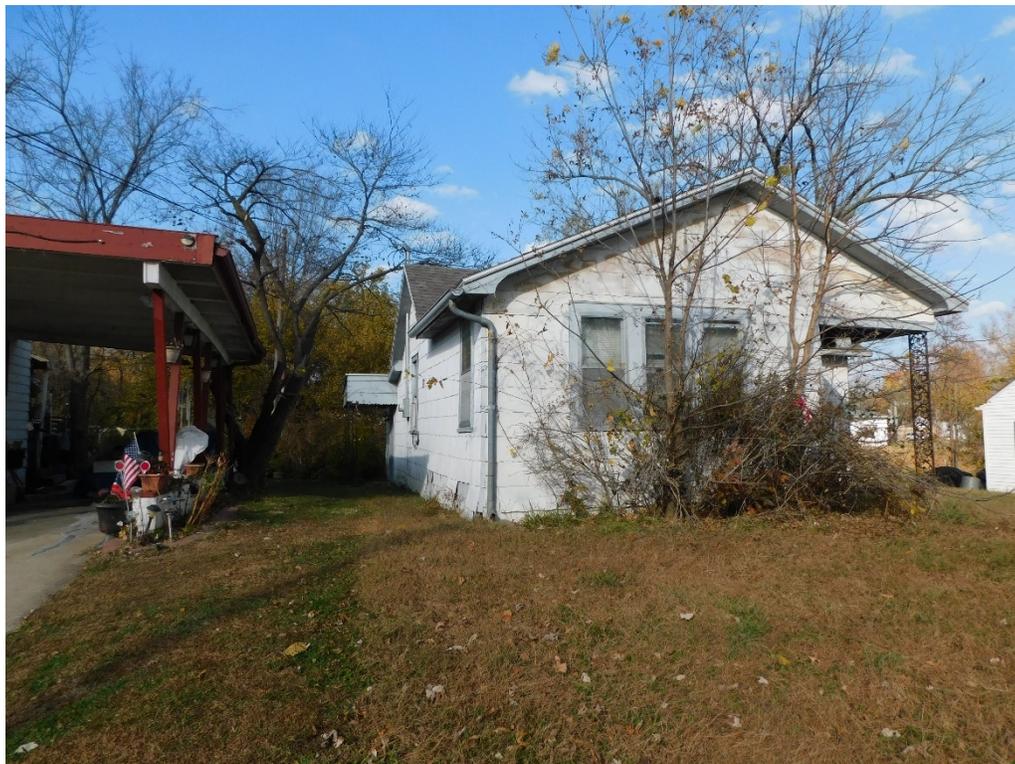
There is a contributing, c. 1970 detached garage is located in the rear. This one-story garage features a concrete foundation and a front gable roof and aluminum siding. The façade is one bay with a metal rolling garage door.

This one-story gable-front-and-wing house features a stone foundation, asbestos exterior walls, and a cross gable roof. The façade is two bays with grouped original two-over-two double-hung wood windows in the projecting gable-end. In addition, the gable-end features a recessed porch with one metal column, and the one-light wood door is located on the interior side of the gable. The second bay features one original two-over-two double-hung wood window. The east elevation features an original two-over-two double-hung wood window and an original one-over-one double-hung wood window. The west elevation features an original two-over-two double-hung wood window and original one-over-one double-hung wood windows.
