1. Survey No. JO-AS-007-0058		2. Survey name: GROVER & BROAD STREETS ARCHITECTURAL/HISTORICAL SURVEY	
3. County: JOHNSON		4. Address (Street No.) 400	Street (name) GROVER
5. City: WARRENSBURG	Vicinity: <input type="checkbox"/>	6. Geographical Reference: 35.76143 / -93.73367	7. Township/Range/Section: T: 46 R: 26 S: 24
8. Historic name (if known):		9. Present/other name (if known):	
10. Ownership: <input checked="" type="checkbox"/> Private <input type="checkbox"/> Public		11a. Historic use (if known): SINGLE DWELLING	11b. Current use: SINGLE DWELLING

HISTORICAL INFORMATION

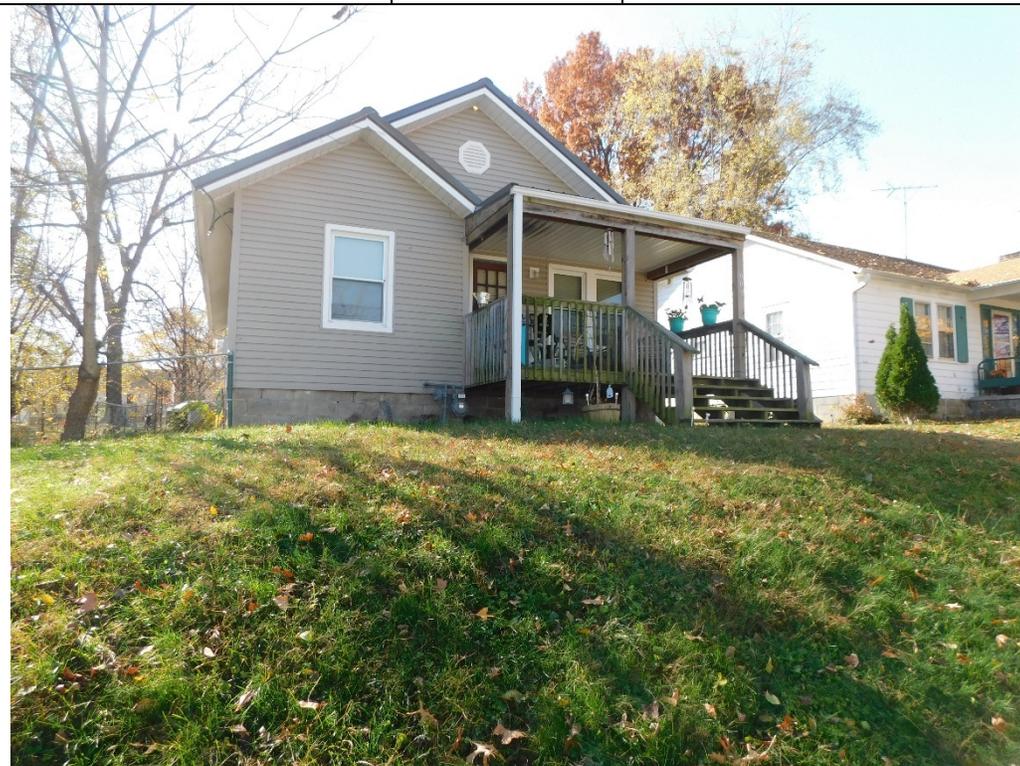
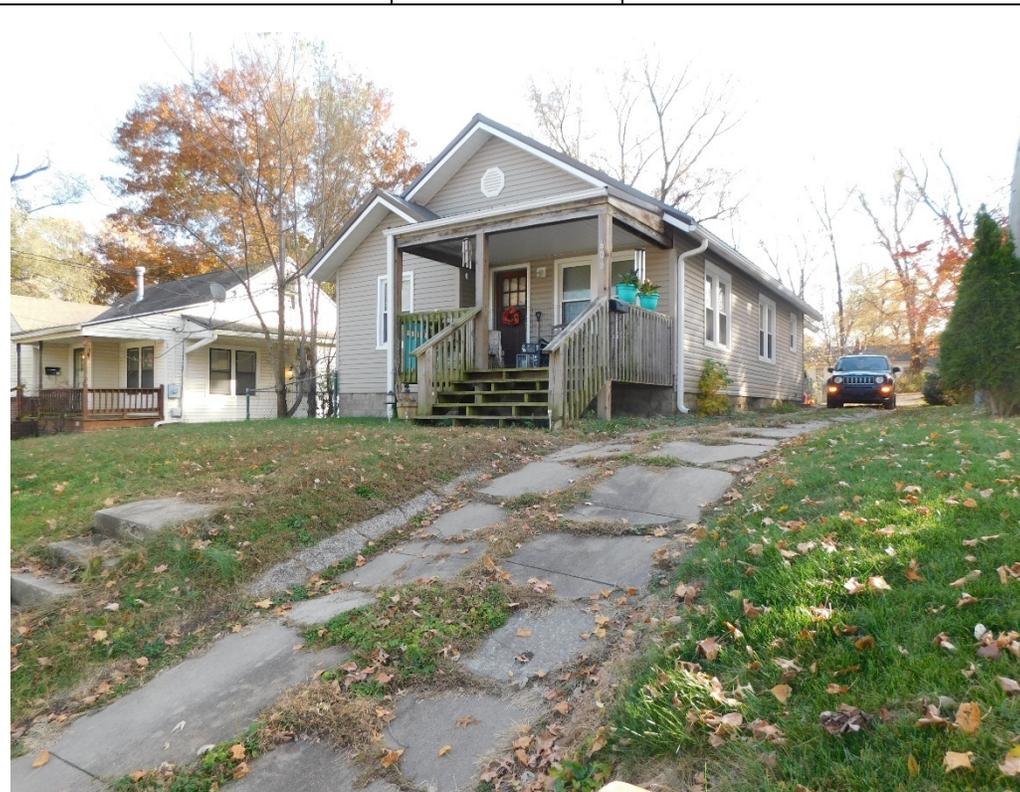
This one-story Bungalow/Craftsman features a stone foundation, vinyl exterior walls, and a metal multi-front gable roof. The façade is three bays with a replacement six-over-six hung vinyl window in the first bay, six-light wood door in the second bay, and paired replacement six-over-six hung vinyl windows in the third bay. There is a c. 2012 replacement porch over the last two bays with a metal shed roof and wood decking, railing, and columns. The west elevations features two set of paired replacement six-over-six hung vinyl windows and one single replacement six-over-six hung vinyl window. The east elevation features four replacement six-over-six hung vinyl windows. This building is not eligible due to alterations to the siding and fenestration.

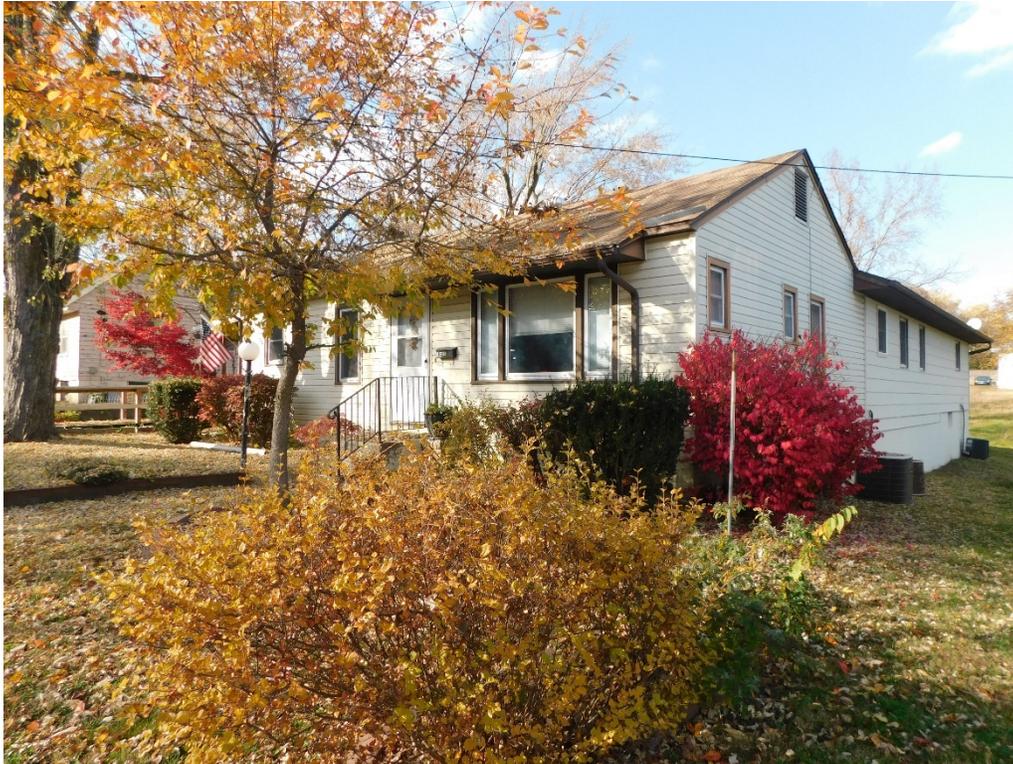
Description:
LOOKING NORTHWEST

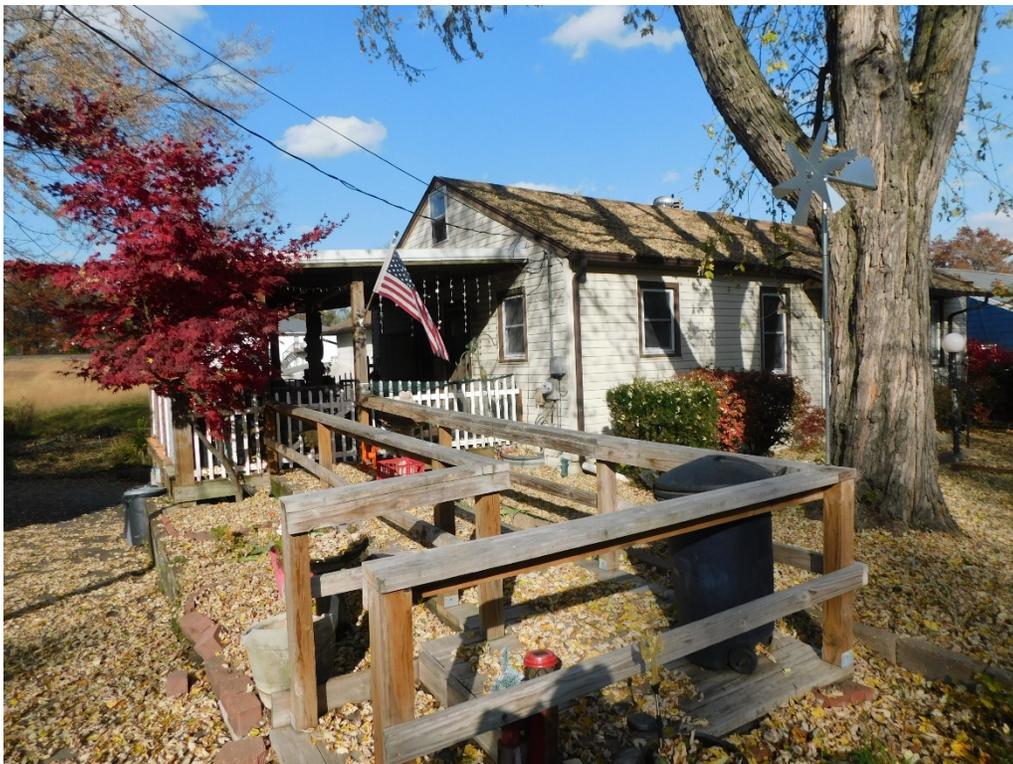
Description:
LOOKING NORTHEAST

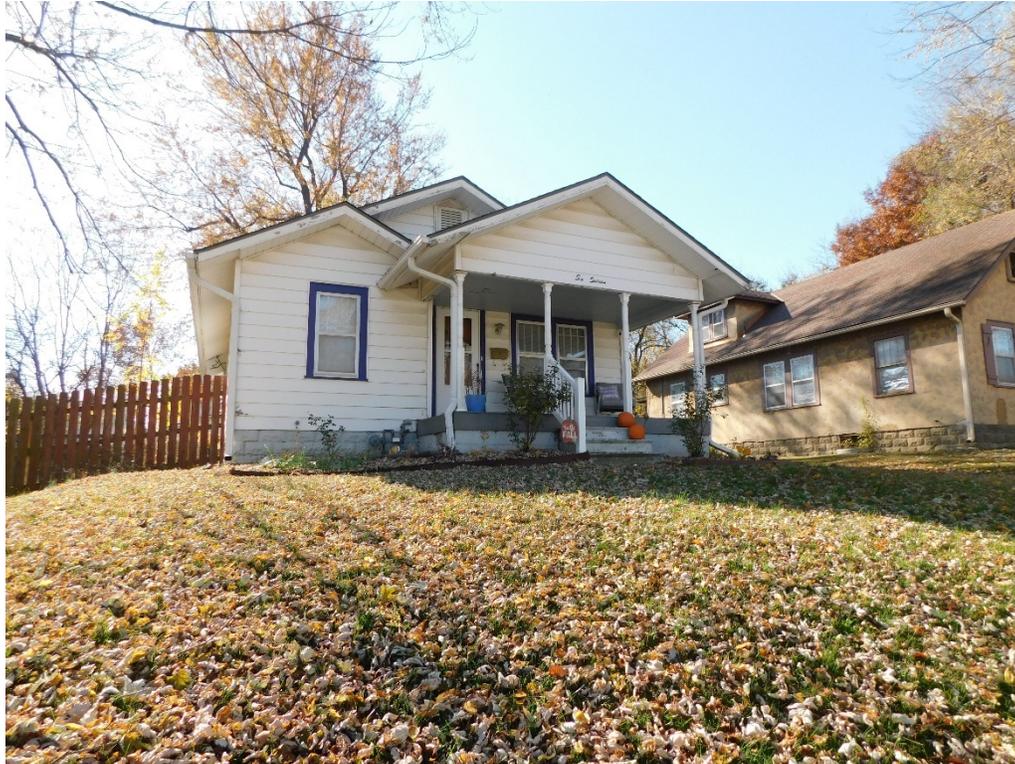
Description:
LOOKING SOUTHWEST

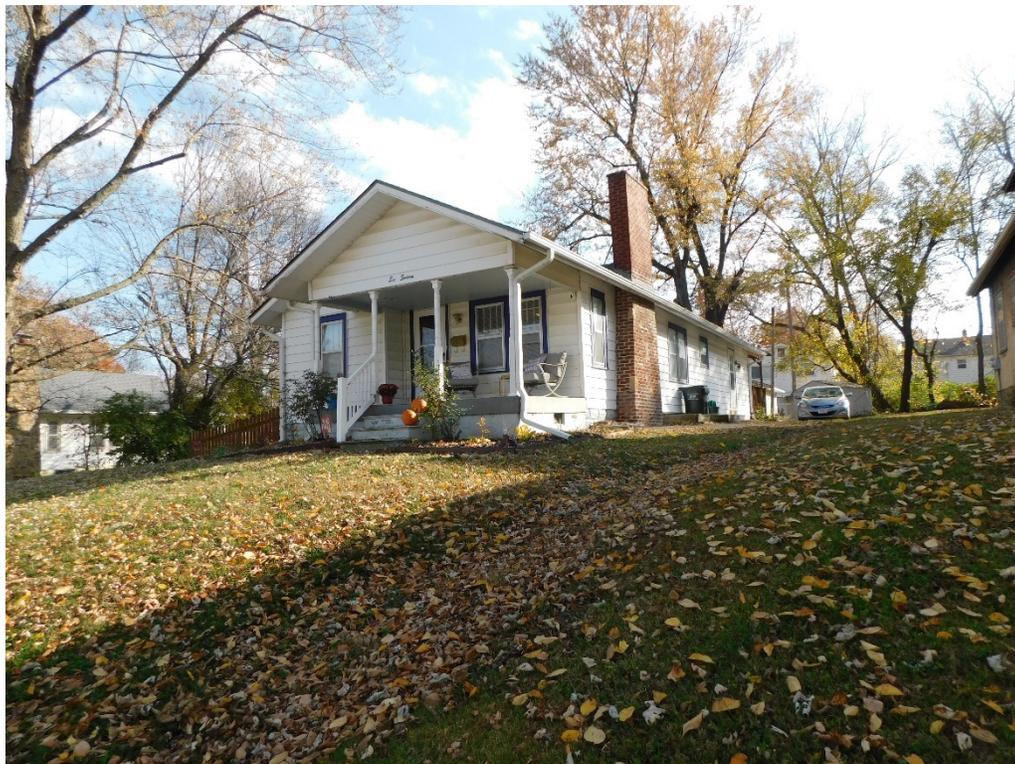
Description:
LOOKING SOUTHEAST

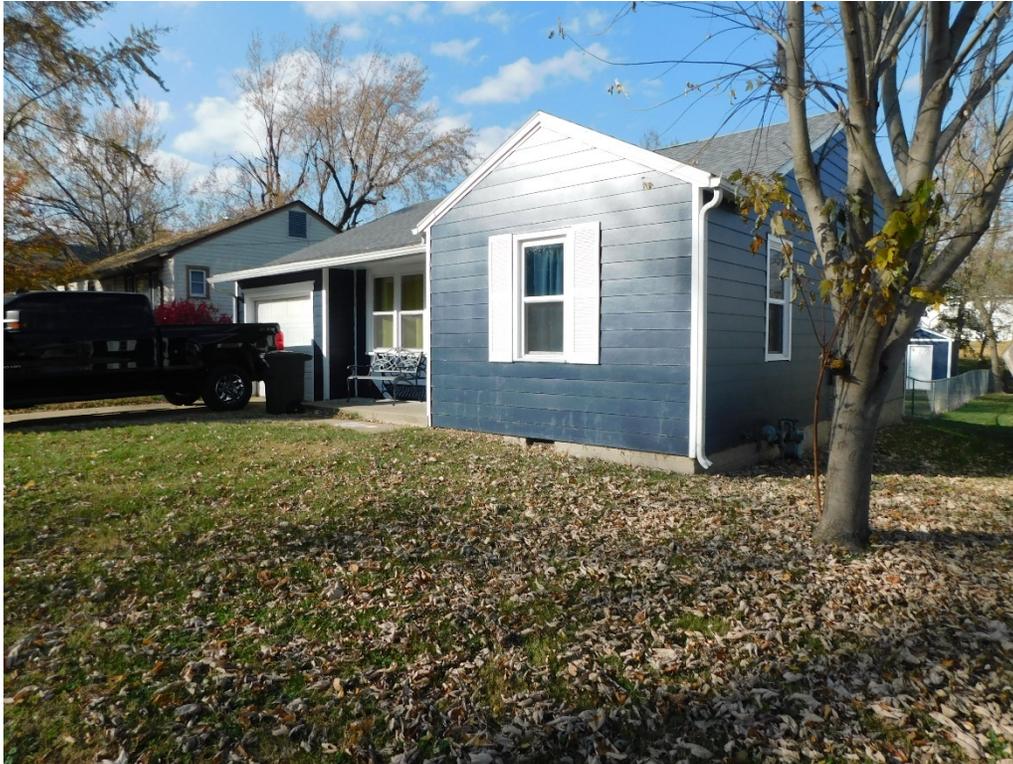
Description:
LOOKING NORTHWEST

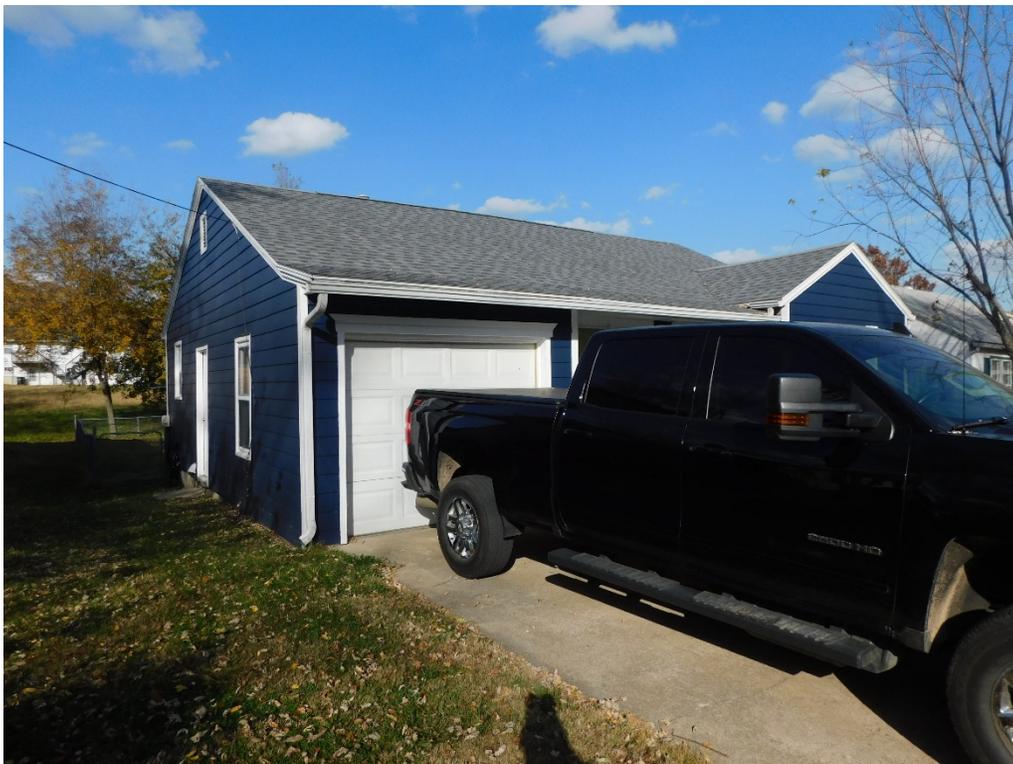
Description:
LOOKING NORTHEAST

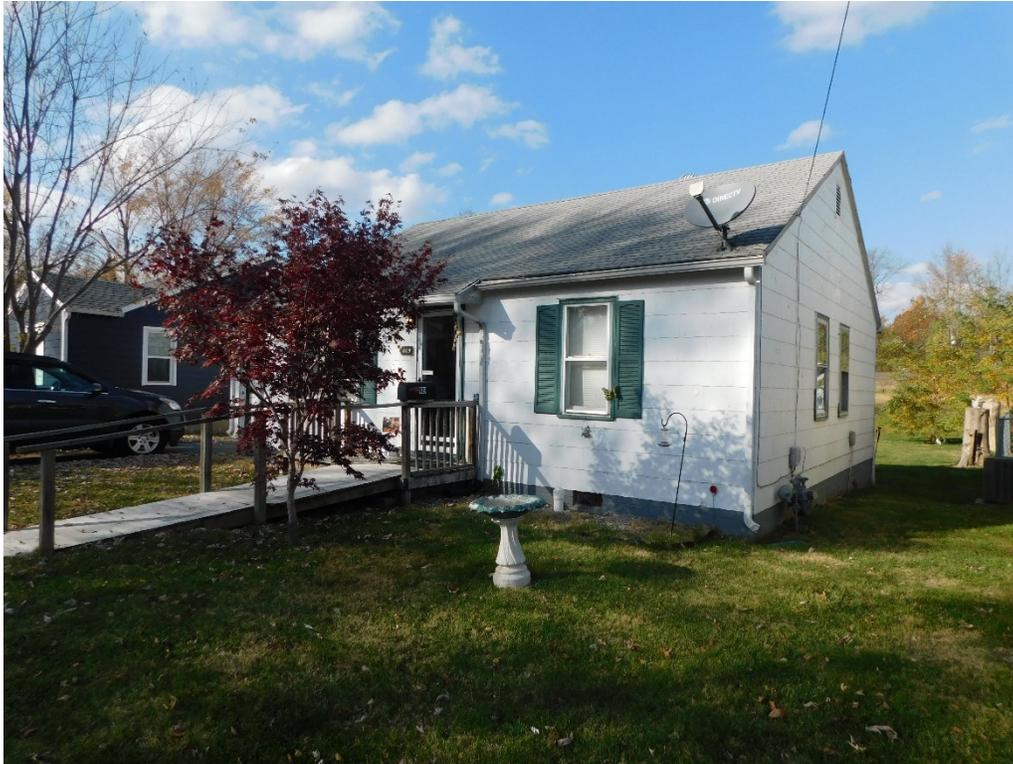
Description:
LOOKING NORTHWEST

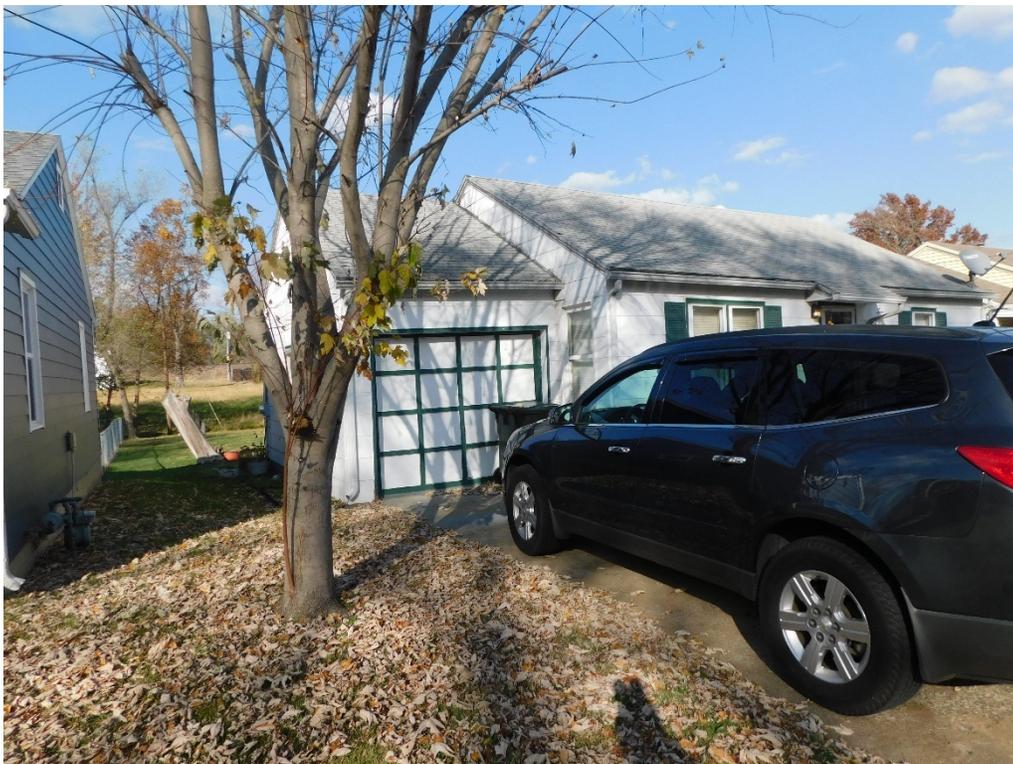
Description:
LOOKING NORTHEAST

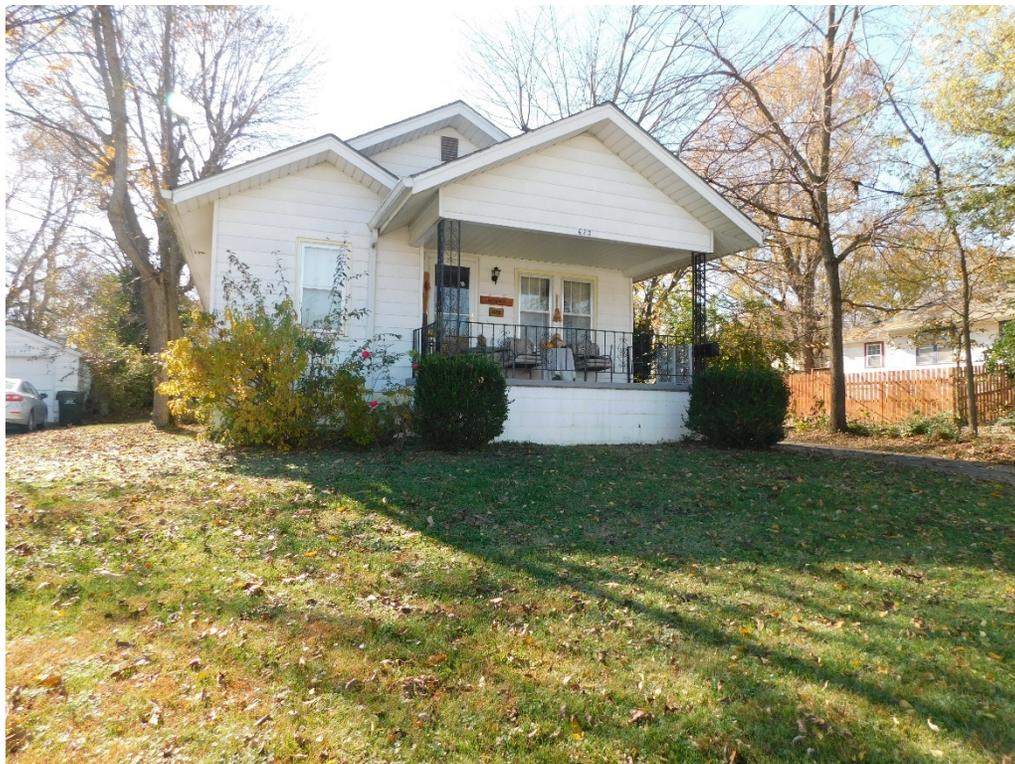
Description:
LOOKING SOUTHWEST

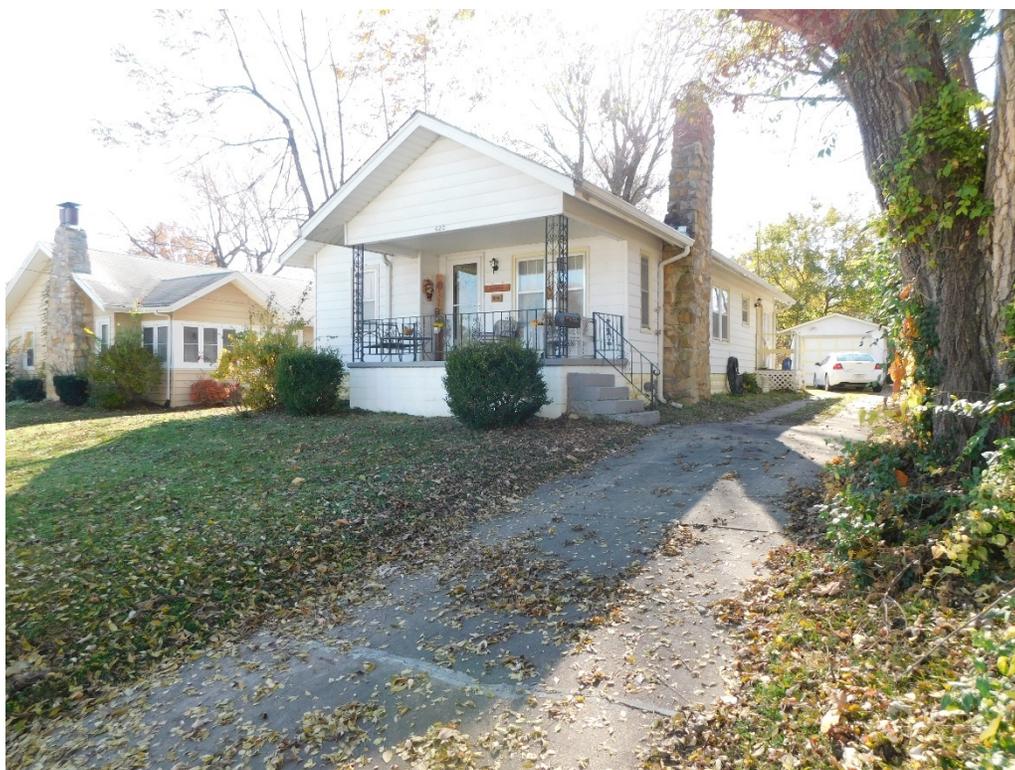
Description:
LOOKING SOUTHEAST

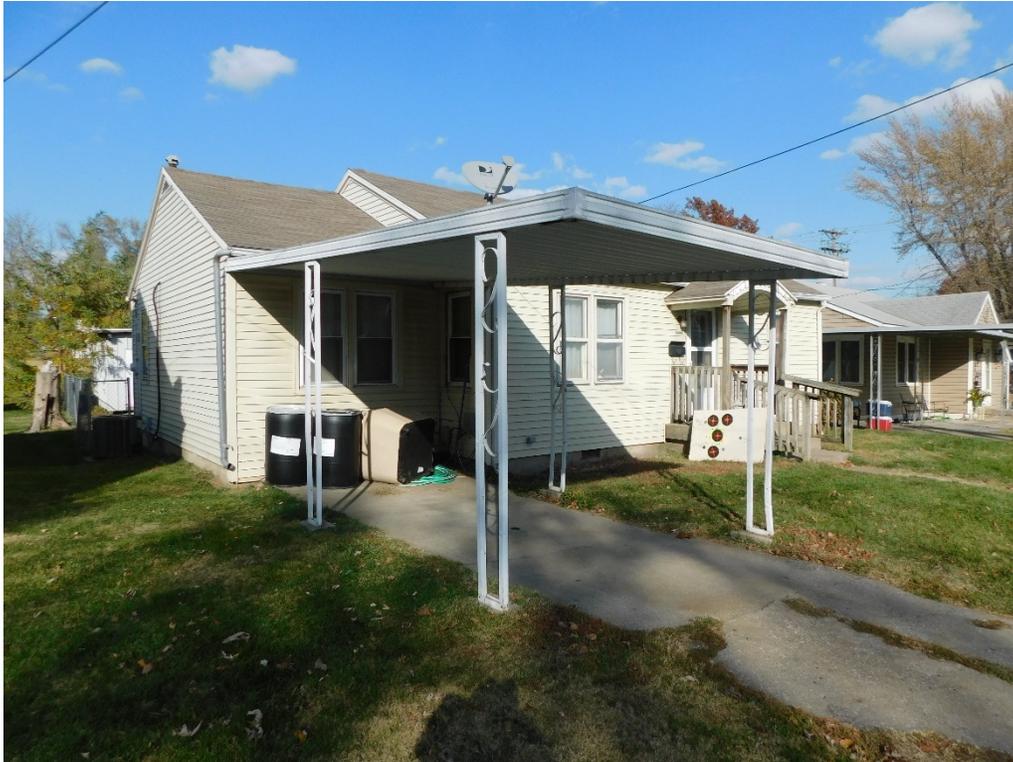
Description:
LOOKING NORTHEAST

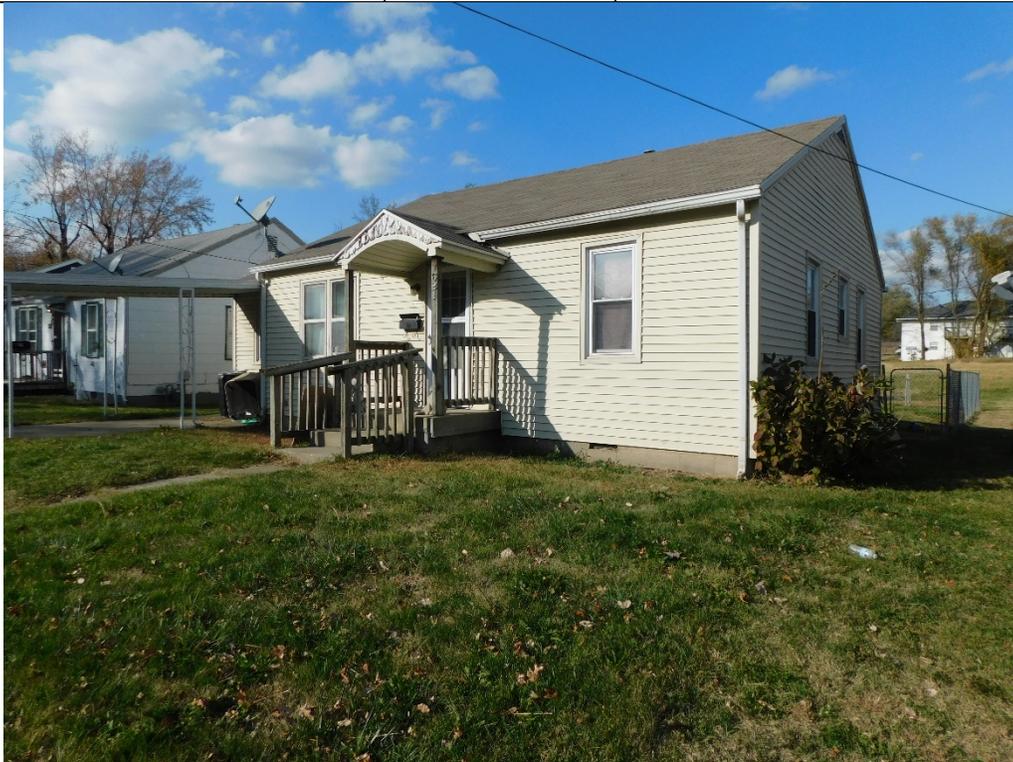
Description:
LOOKING NORTHWEST

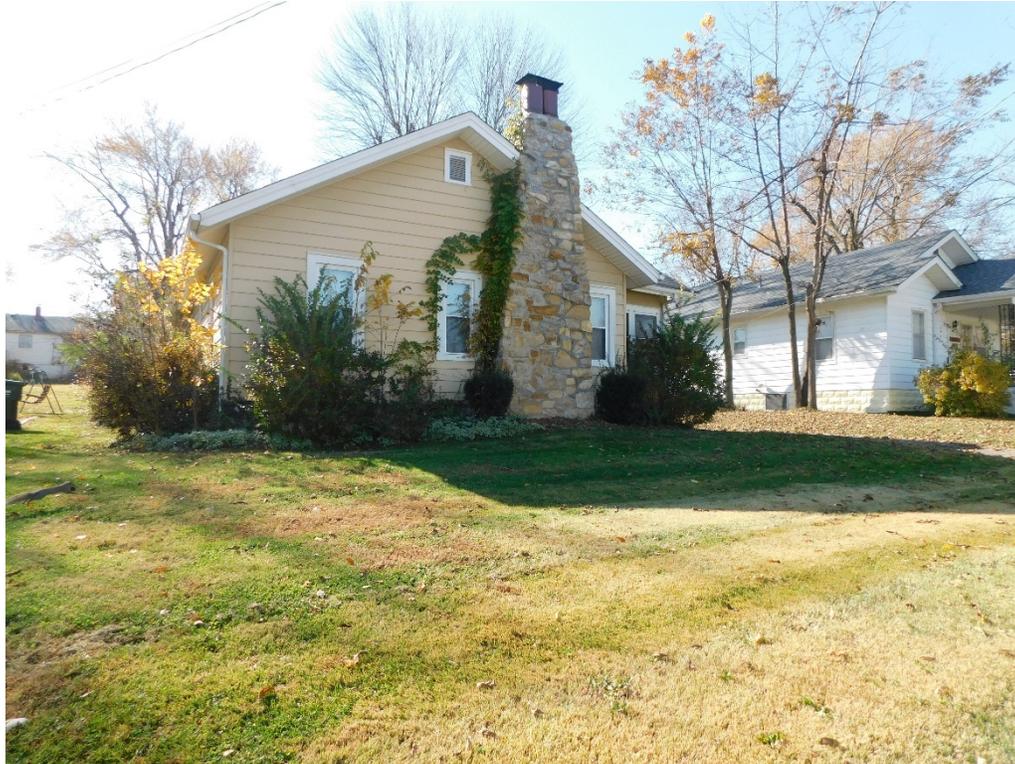
Description:
LOOKING SOUTHWEST

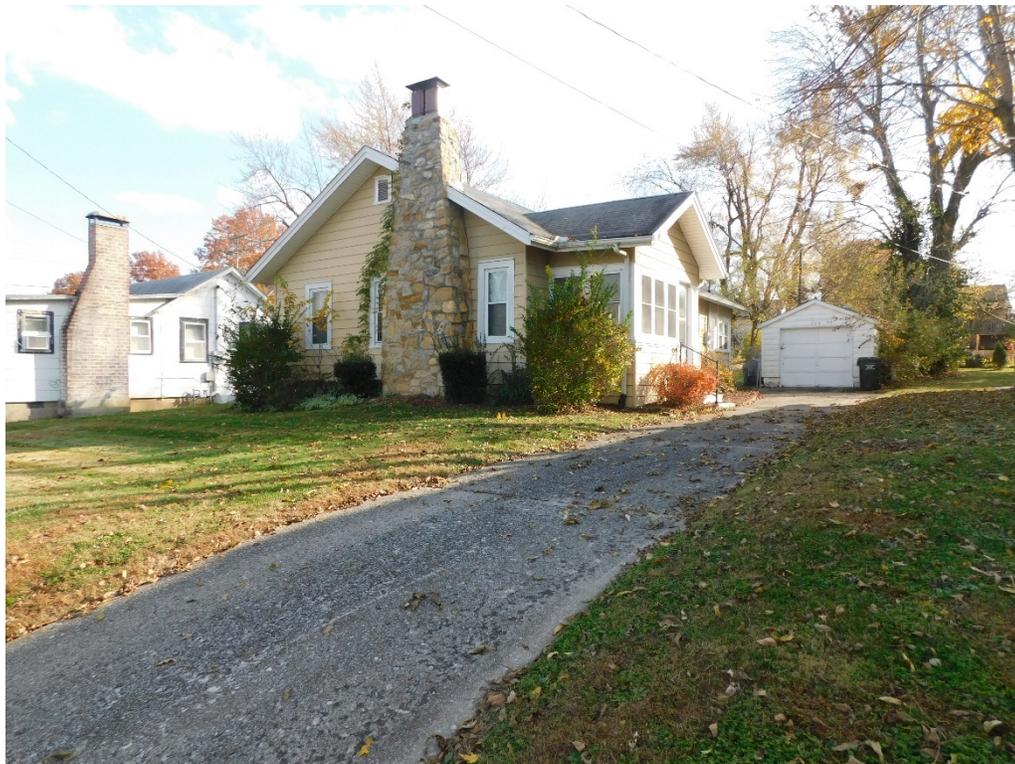
Description:
LOOKING SOUTHEAST

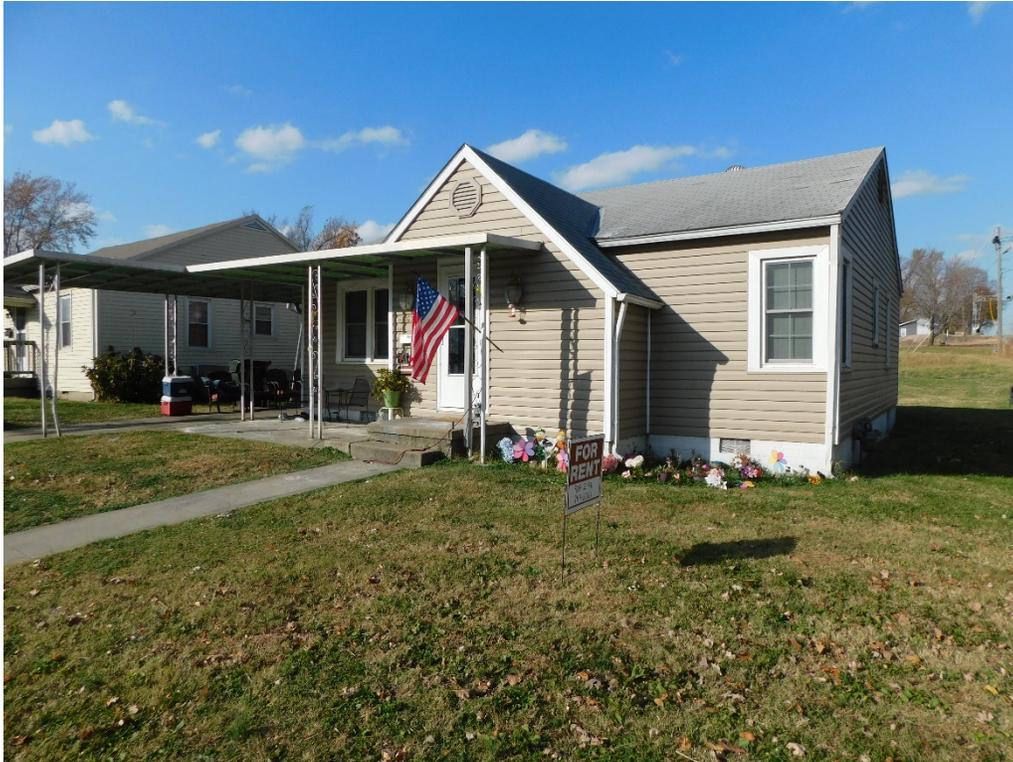
Description:
LOOKING NORTHWEST

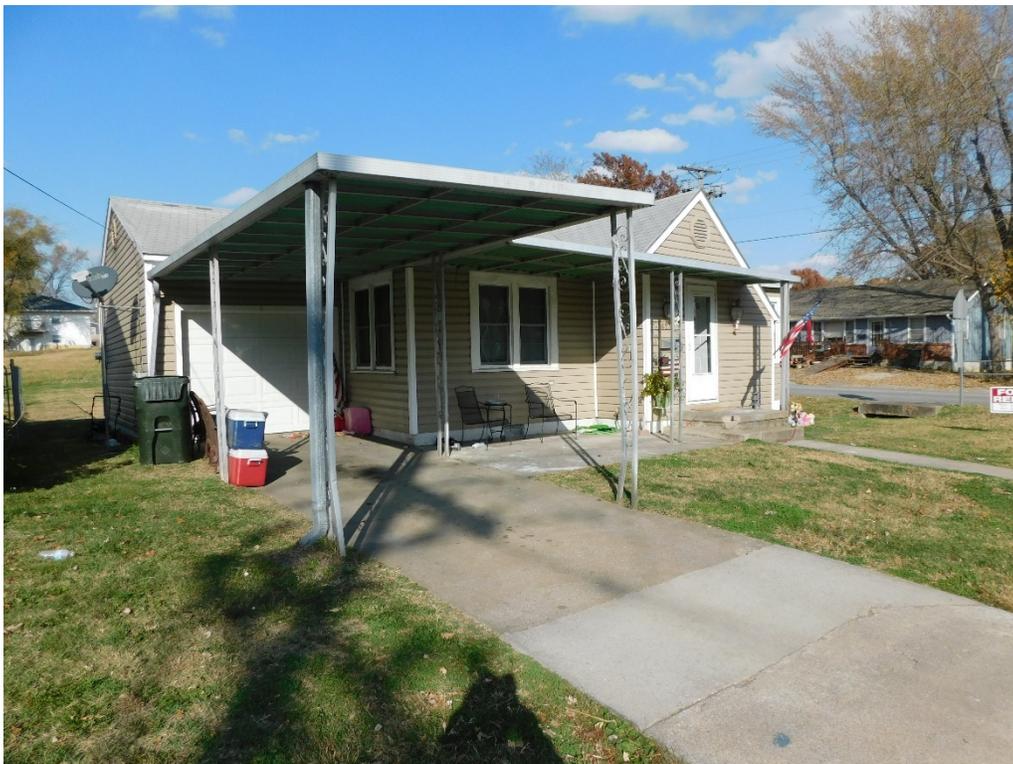
Description:
LOOKING NORTHEAST

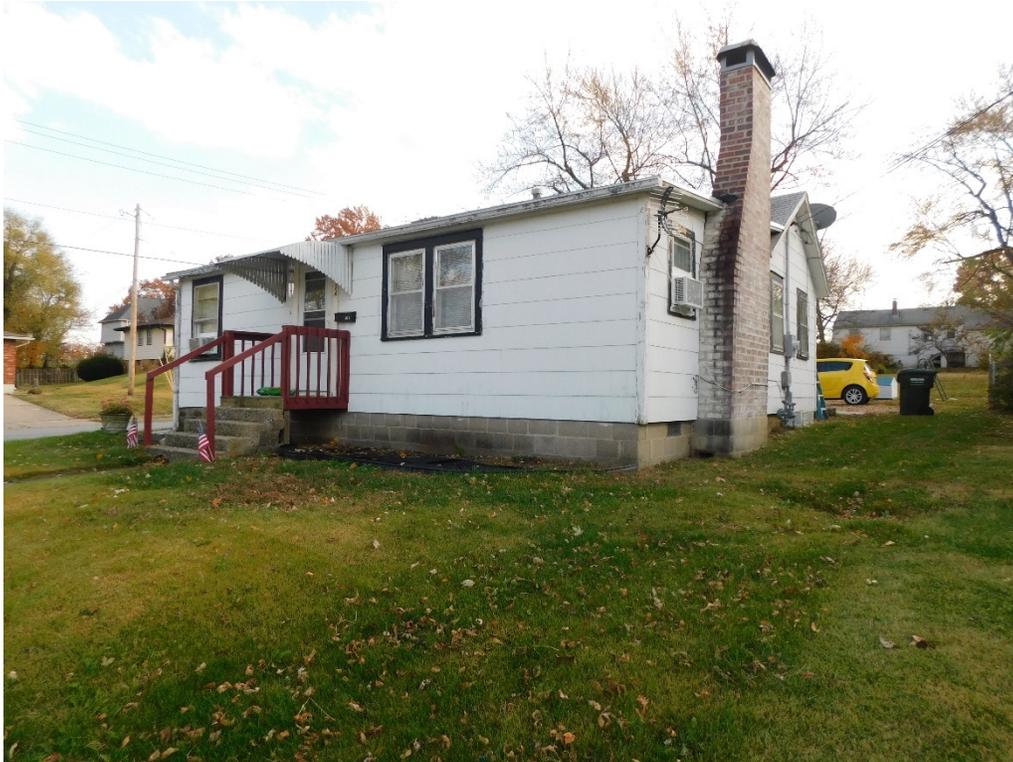
Description:
LOOKING SOUTHEAST

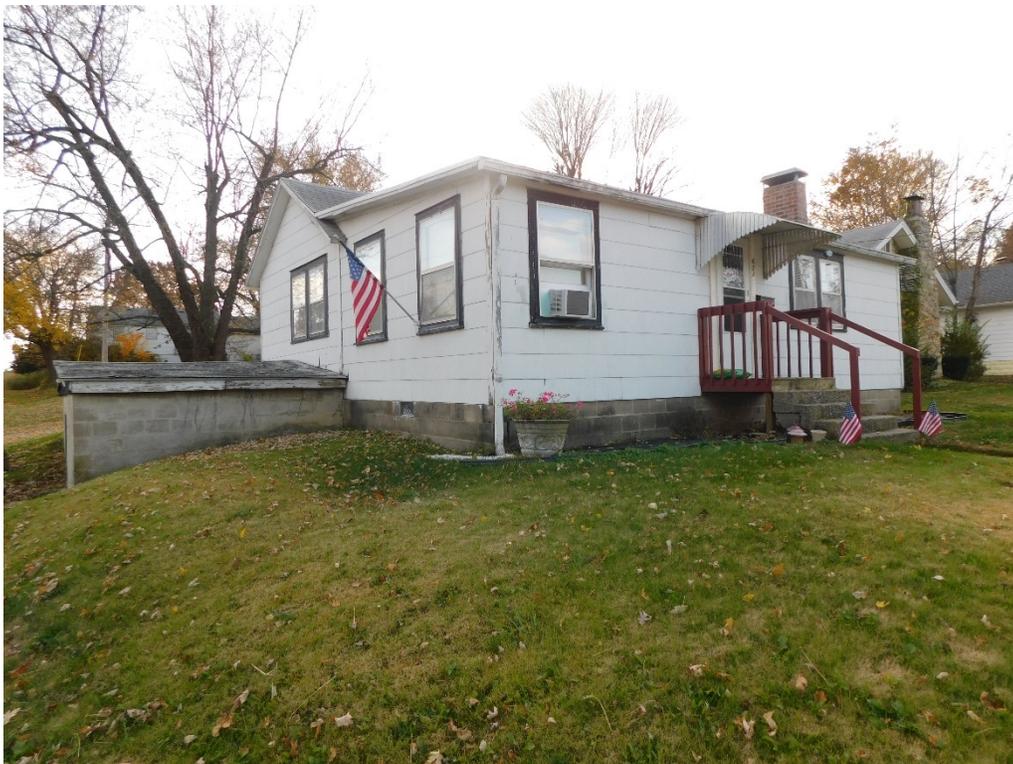
Description:
LOOKING SOUTHWEST
