1. Survey No. JO-AS-007-0122	2. Survey name: GROVER & BROAD S	STREETS ARCHITECTURAL/HISTORICAL SURVEY			
3. County: JOHNSON	4. Address (Street No.)	Street (name) S MITCHELL APA	ARTMENTS A-D	RTMENTS A-D

•	·			
1. Survey No. JO-AS-007-0123		2. Survey name: GROVER & BROAD STREETS ARCHITECTURAL/HISTORICAL SURVEY					
3. County: JOHNSON		4. Ad	ddress (Street No.)	Street (name) S MITCHELL AP	PARTMEN

1. Survey No. JO-AS-007-0126			2. Survey name: GROVER & BROAD STREETS ARCHITECTURAL/HISTORICAL SURVEY				
3. County: JOHNSON		4. Address (Street No.) Street (name) 300 SMITCHELL

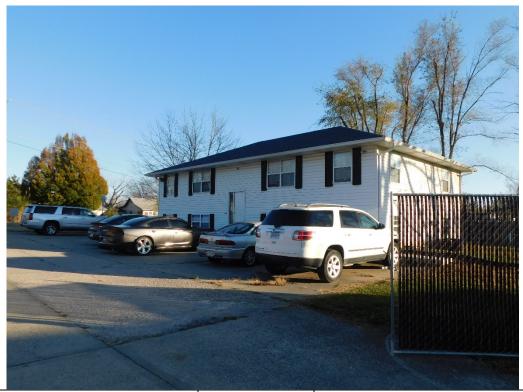
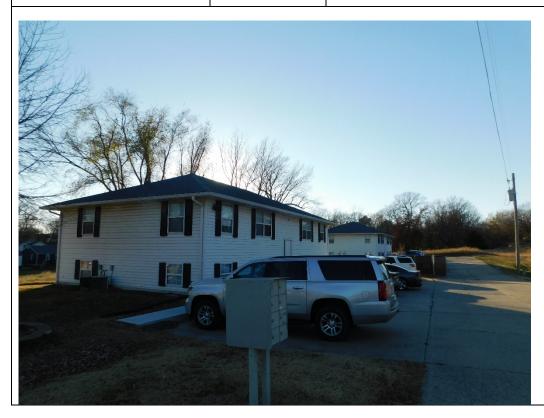
Photographer: Date: Description:
KRISTIN DYER 11/17/2020 LOOKING SOUTHEAST

Description: LOOKING SOUTHWEST

41. (cont.) Description of primary resource. Expand box as necessary, or add continuation pages.
This two-story apartment building features a concrete foundation, vinyl exterior walls, and a hipped gable roof. The façade faces north towards the railroad tracks. The façade is five bays with original paired six-over-six hung vinyl windows with faux shutters is the all the bays except the third centered bay. The third bay features a wood door with one, one-light sidelight, and concrete steps. The second story windows are larger than the first story windows. There are single original six-over-six hung vinyl windows with faux shutters over the first and last bay, and there are original paired six-over-six hung vinyl windows with faux shutters over the second and third bay. The side elevations feature two original six-over-six hung vinyl windows on the first and second story. The building is not eligible since it does not meet the 50-year threshold.

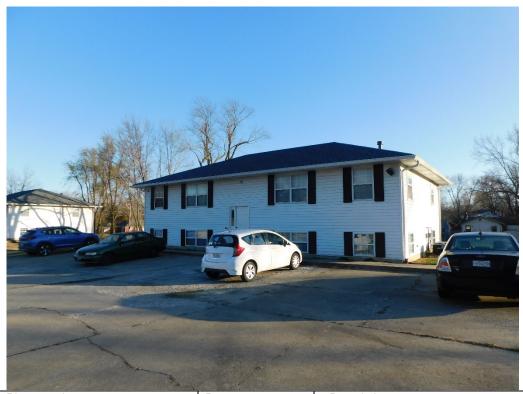
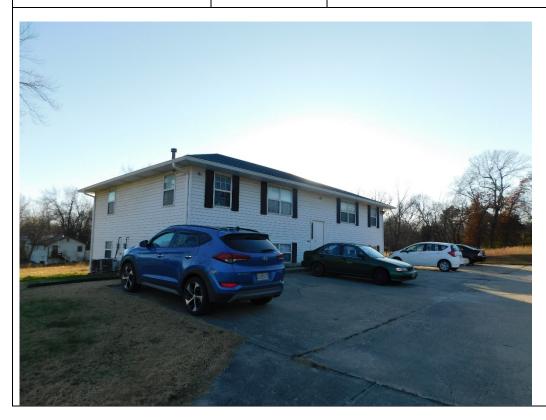
Photographer: Date: Description:
KRISTIN DYER 11/17/2020 LOOKING SOUTHEAST

Date: 11/17/2020 Description: LOOKING SOUTHWEST

41. (cont.) Description of primary resource. Expand box as necessary, or add continuation pages.
This two-story apartment building features a concrete foundation, vinyl exterior walls, and a hipped gable roof. The façade faces north towards the railroad tracks. The façade is five bays with original paired six-over-six hung vinyl windows with faux shutters is the all the bays except the third centered bay. The third bay features a wood door with one, one-light sidelight, and concrete steps. The second story windows are larger than the first story windows. There are single original six-over-six hung vinyl windows with faux

shutters over the first and last bay, and there are original paired six-over-six hung vinyl windows with faux shutters over the second and third bay. The side elevations feature two original six-over-six hung vinyl windows on the first and second story. The building is

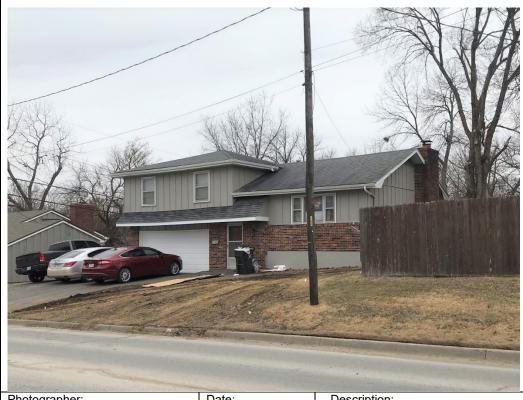
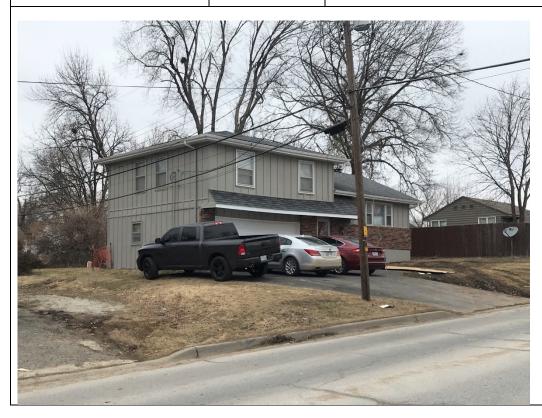
Photographer: Date: Description:
KRISTIN DYER 02-26-2021 LOOKING SOUTHWEST

Description: LOOKING NORTHWEST

41. (cont.) Description of primary resource. Expand box as necessary, or add continuation pages. This one-story split-level features a concrete foundation, wood and brick exterior walls, and a side gable roof with a hipped cross gable. The façade is three bays. The first bay is located in the two-story section with brick siding and a metal paneled garage door on the first story. There is a board and batten-style wood siding and original two one-over-one hung wood windows with horizontal panes on the second-story. The first bay features the hipped roof, and there is a shed eave overhang dividing the first and second stories as well as covering the second bay. The second bay features brick siding and a wood door. The third bay features board and batten-style wood siding with a brick wainscot. There is a wood picture window with original two one-over-one hung wood windows with horizontal panes. The side elevations feature board and batten-style wood siding and original one-over-one hung wood windows. There is an exterior brick chimney on the north elevation. This building remains it integrity, and it is considered non-contributing since it less than 50 years old.

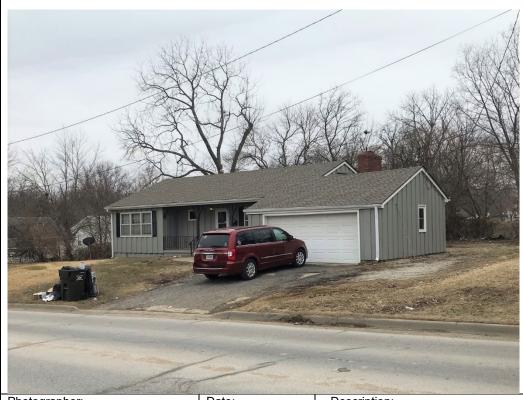
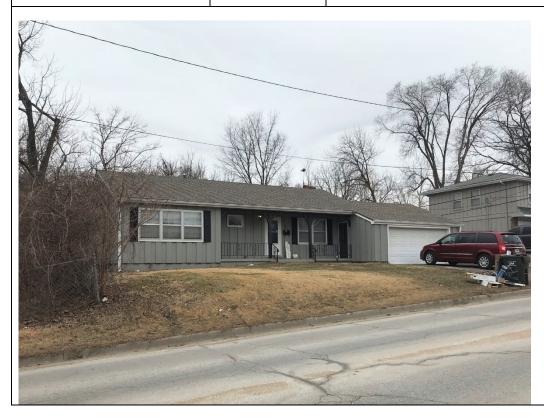
Photographer: Date: Description:
KRISTIN DYER 02-26-2021 LOOKING SOUTHWEST

Date: 02-26-2021 Description: LOOKING NORTHWEST

21. (cont.) History and significance. Expand box as necessary, or add continuation pages.
 (cont.) Sources of information. Expand box as necessary, or add continuation pages. 1955, 1957 City Directory; WARRENSBURG CULTURAL RESOURCES SURVEY PHASE I AND PHASE II
40. (cont.) Description of environment and outbuildings. Expand box as necessary, or add continuation pages.
There are no outbuildings at this location.
41. (cont.) Description of primary resource. Expand box as necessary, or add continuation pages.
This one-story ranch features a concrete foundation, vertical wood siding, and a side gable roof. The façade is fives bay. There first bay features grouped original six-over-six hung wood windows. The second, third, and fourth bays are located under a recessed

porch. The second bay is filled with an original one-light windows. The third bay features a wood door, and the fourth bay features paired original two-over-two hung wood windows with horizontal panes. The porch features wood columns, metal railing, and a concrete foundation. There is a wood door located on the interior wall of the fifth bay. The fifth bay features a tiered roof and a metal paneled garage door. The side elevations feature vertical wood siding, and there is an exterior brick chimney on the north elevation.

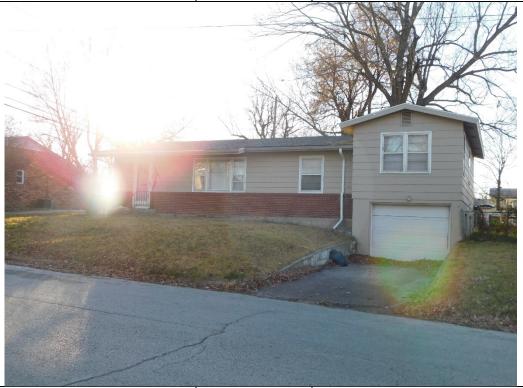
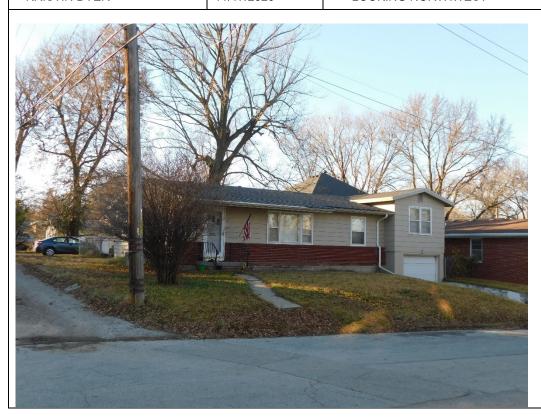
Photographer: Date: Description:
KRISTIN DYER 11/17/2020 LOOKING WEST

Photographer: KRISTIN DYER Date: 11/17/2020 Description: LOOKING NORTHWEST

41. (cont.) Description of primary resource. Expand box as necessary, or add continuation pages. This one-and-a-half story split-level house features a concrete foundation, brick and weatherboard siding and a cross gable roof. The façade is four bays with weatherboard siding and a brick wainscot. The first bay features a wood door with a concrete landing and metal railing. The second bay features an original wood picture window with two-over-two hung wood windows with horizontal panes. There is an original two-over-two hung wood windows with horizontal panes in the third bay, and the fourth bay features two-stories with a metal paneled garage door in the first story with concrete walls and paired original two-over-two hung wood windows with horizontal panes in the second-story gable-end with weatherboard siding. The north and south elevations feature two original two-over-two hung wood windows with horizontal panes and weatherboard siding.

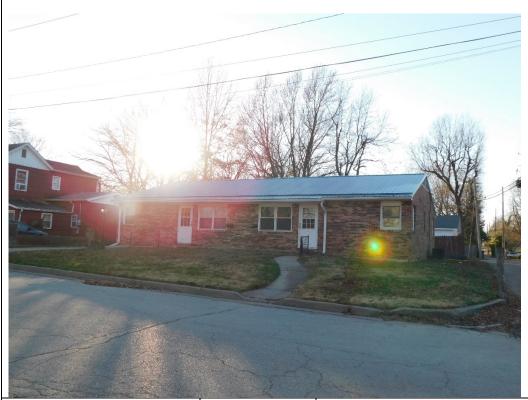
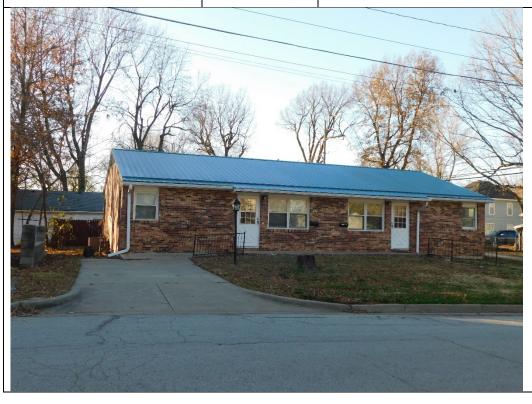
Photographer: Date: Description:
KRISTIN DYER 11/17/2020 LOOKING SOUTHWEST

Date: 11/17/2020 Description: LOOKING NORTHWEST

41. (cont.) Description of primary resource. Expand box as necessary, or add continuation pages.
This one-story duplex features a concrete foundation, brick exterior walls, and a metal side gable roof. The façade is six bays with a replacement one-over-one hung vinyl window in the first and last bay, 12-light wood door in the second and fifth bay, and paired replacement one-over-one hung vinyl windows in the third and fourth bay. There is a concrete walkway in front of the duple with a metal railing on the sloped areas. The side elevations feature brick siding with three replacement one-over-one hung vinyl windows.

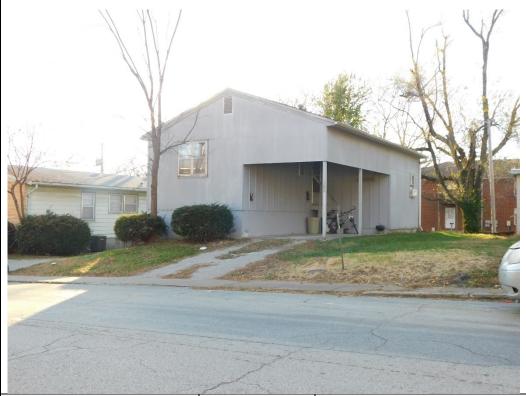
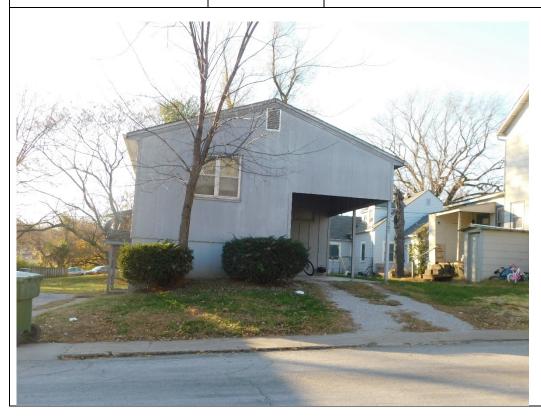
Photographer: Date: Description: LOOKING SOUTHWEST

Date: 11/17/2020 Description: LOOKING WEST

41. (cont.) Description of primary resource. Expand box as necessary, or add continuation pages.
This one-story split vernacular house features a concrete foundation, wood exterior walls, and a front gable roof. The façade is two bays with paired original one-over-one double-hung wood windows in the first bay. The second is located in a recessed carport with wood posts, and board-and-batten interior walls. Along the rear of the interior side wall, there is a wood door with wood stairs and railing. The remaining north elevation features an original one-over-one double-hung wood window. The south elevation features

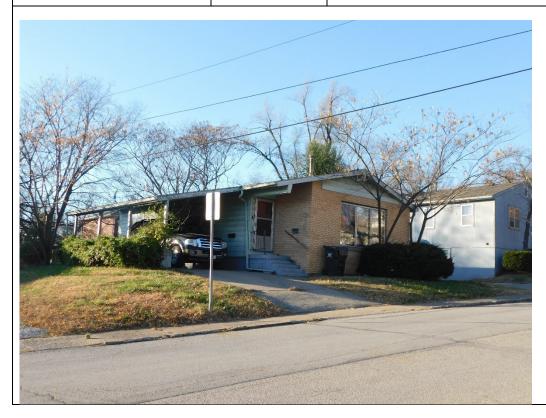
Photographer: Date: Description: KRISTIN DYER 11/17/2020 LOOKING NORTHWEST

This one-story contemporary house features a T-plan with a concrete foundation, brick and vinyl exterior walls, and a low-pitch front gable roof. The façade is two bays with a recessed one-bay porch with an entry door in the first bay and grouped original wood casement windows with vinyl siding above the windows. The south elevation features an attached lean-to carport extending from the roof with wood columns and concrete piers. There is vinyl siding and original two-over-two hung woods windows with horizontal panes along the south wall. The north elevation features vinyl siding and original two-over-two hung woods windows with horizontal panes.

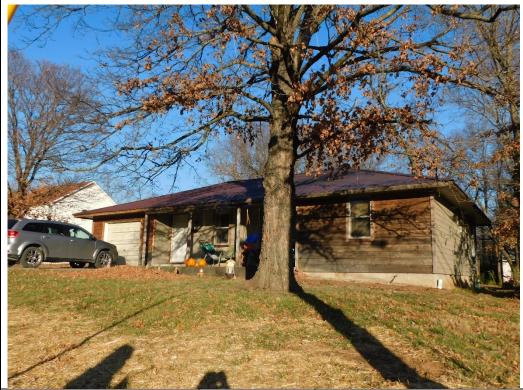
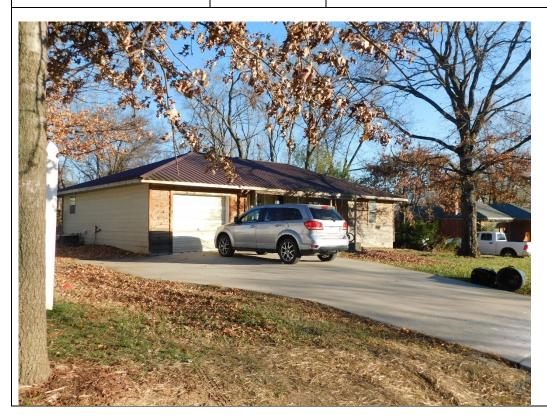
Photographer: Date: Description:
KRISTIN DYER 11/17/2020 LOOKING NORTHEAST

Date: 11/17/2020 Description: LOOKING SOUTHEAST

41. (cont.) Description of primary resource. Expand box as necessary, or add continuation pages.
This one-story ranch features a concrete foundation, wood and vinyl siding, and a hipped corrugated metal roof. The façade Is five bays and features rustic wood siding. The first bay features a metal paneled garage door. The second, third, and fourth bays are located under a recessed porch with wood columns and a concrete foundation. There is a wood door in the second bay, and replacement one-over-one hung vinyl windows. The fifth bay features a replacement one-over-one hung vinyl window. The side

elevations feature vinyl siding and replacement one-over-one hung vinyl windows. The house was remodeled after 2013 with new siding and alterations to the windows; therefore, this building is not eligible due to alterations to the siding and fenestration.
