PRESERVING

HISTORIC

SEDALIA

# A STUDY OF SEDALIA'S ARCHITECTURAL AND HISTORICAL HERITAGE

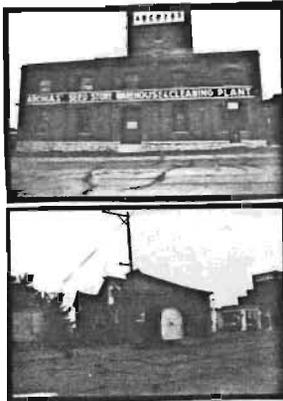
Archias Warehouse - 600-610 West Main

18. This is a part of the former Moerschel Brewery. Even though this building is well out of the heart of downtown, it is a significant building both architecturally and historically. The Moerschel business complex actually consisted of several buildings. The largest, occupied by Archias, is a multiple story building that retains much of its original looks. Shake shingles have been added near the top, but otherwise the changes are minor. The smaller building on the corner also has minor changes. The brewery's stable was at 110 S. Missouri.

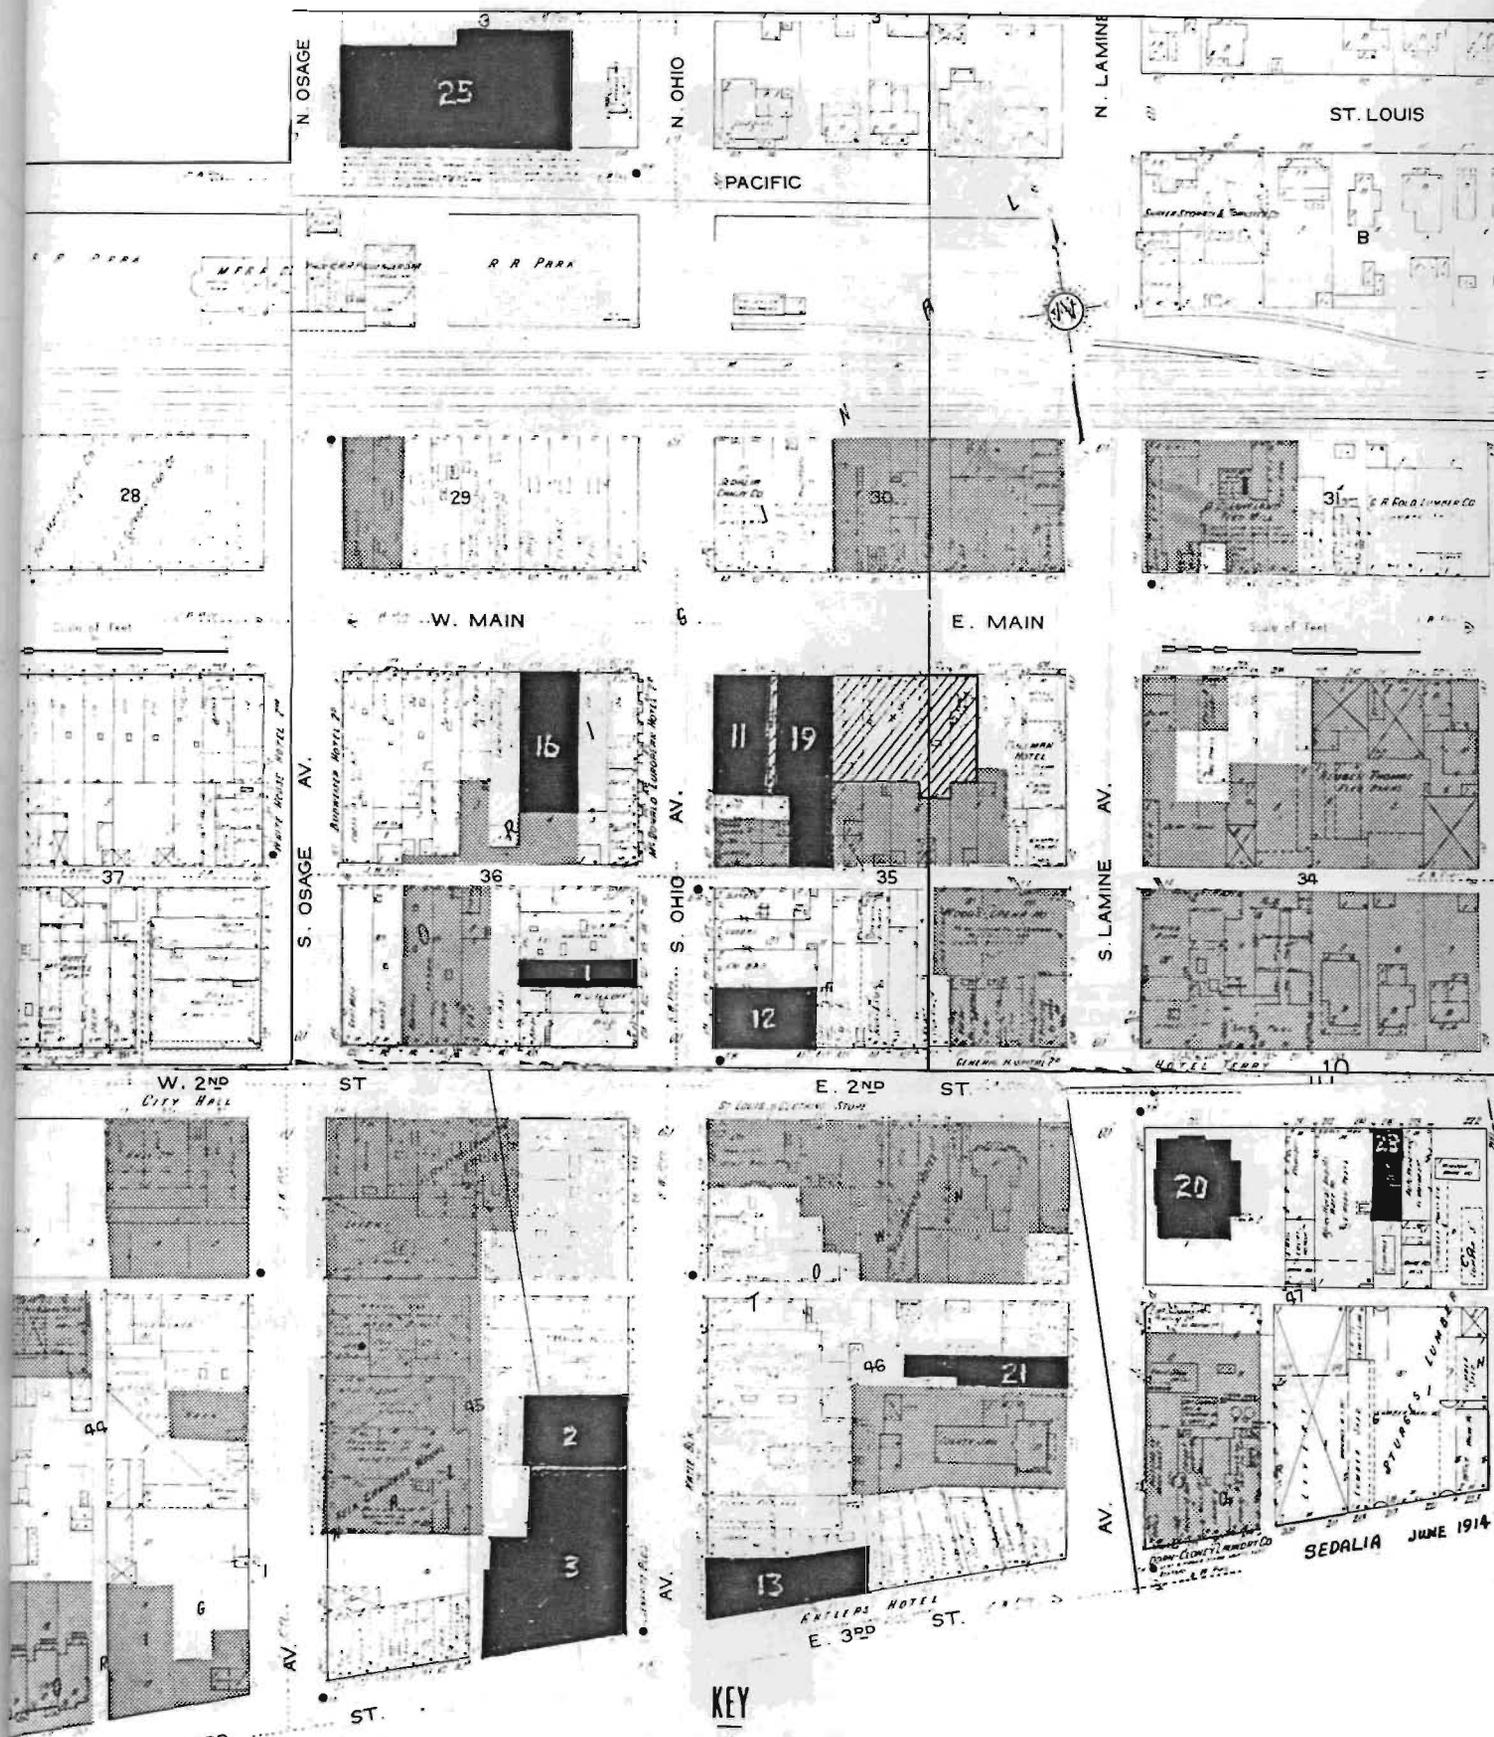
Plate D

- KEY**
- = OPEN LOTS
  - = PRIORITY BUILDINGS
  - = HISTORIC DISTRICT POTENTIAL
