### NATIONAL REGISTER OF HISTORIC PLACES REGISTRATION FORM

historic name South Side National Bank

street & number 3606 Gravois Avenue not for publication N/A  
city or town St. Louis vicinity N/A  
state Missouri code MO county St. Louis [Independent City] code 510  
zip code 63116

South Side National Bank  
St. Louis [Independent City], Missouri

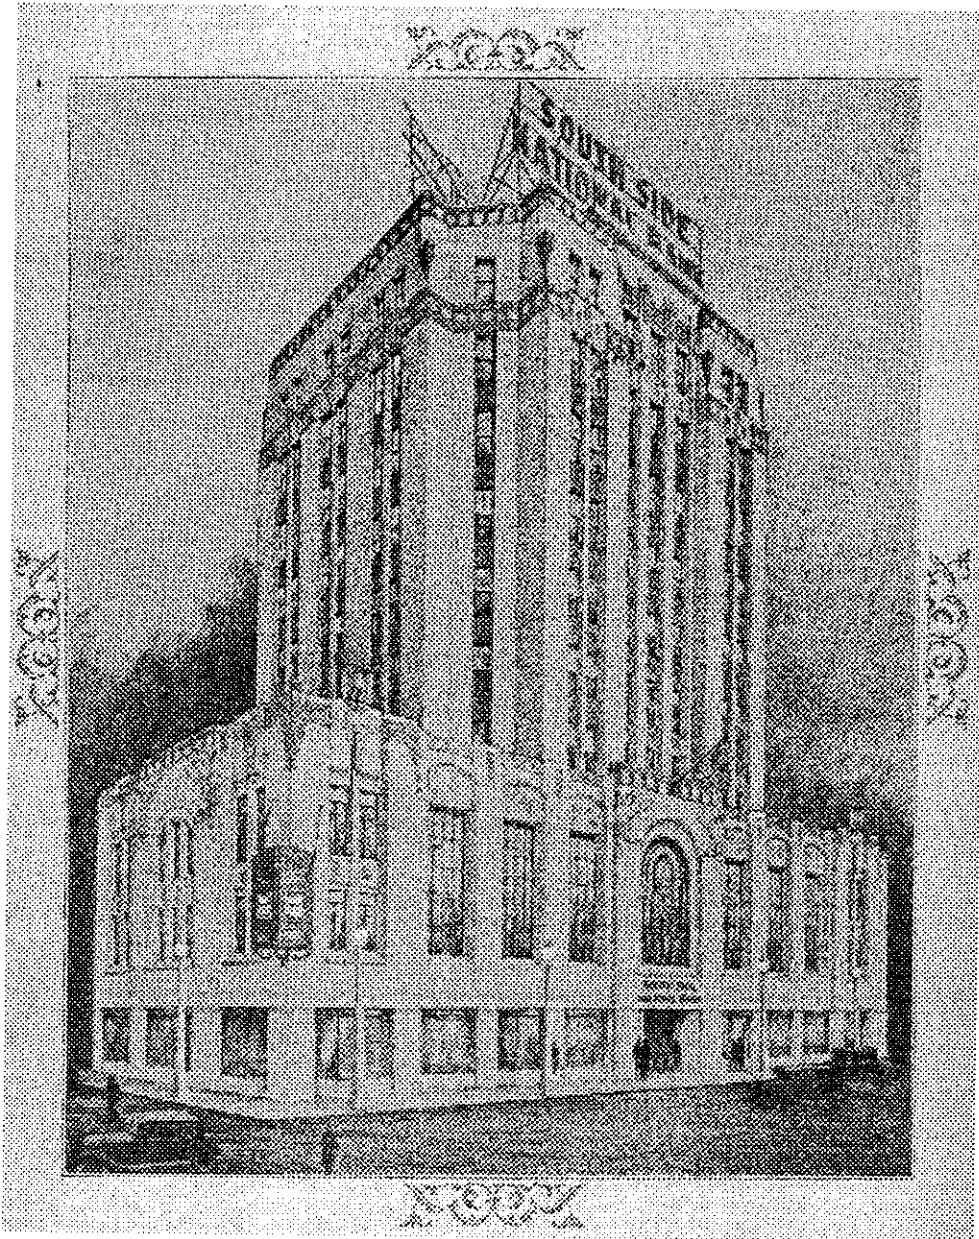
**Figure 3: Perspective of South Side National Bank, 1929. Source: "The Dawn of a New Day for Grand and Gravois" opening day brochure.**

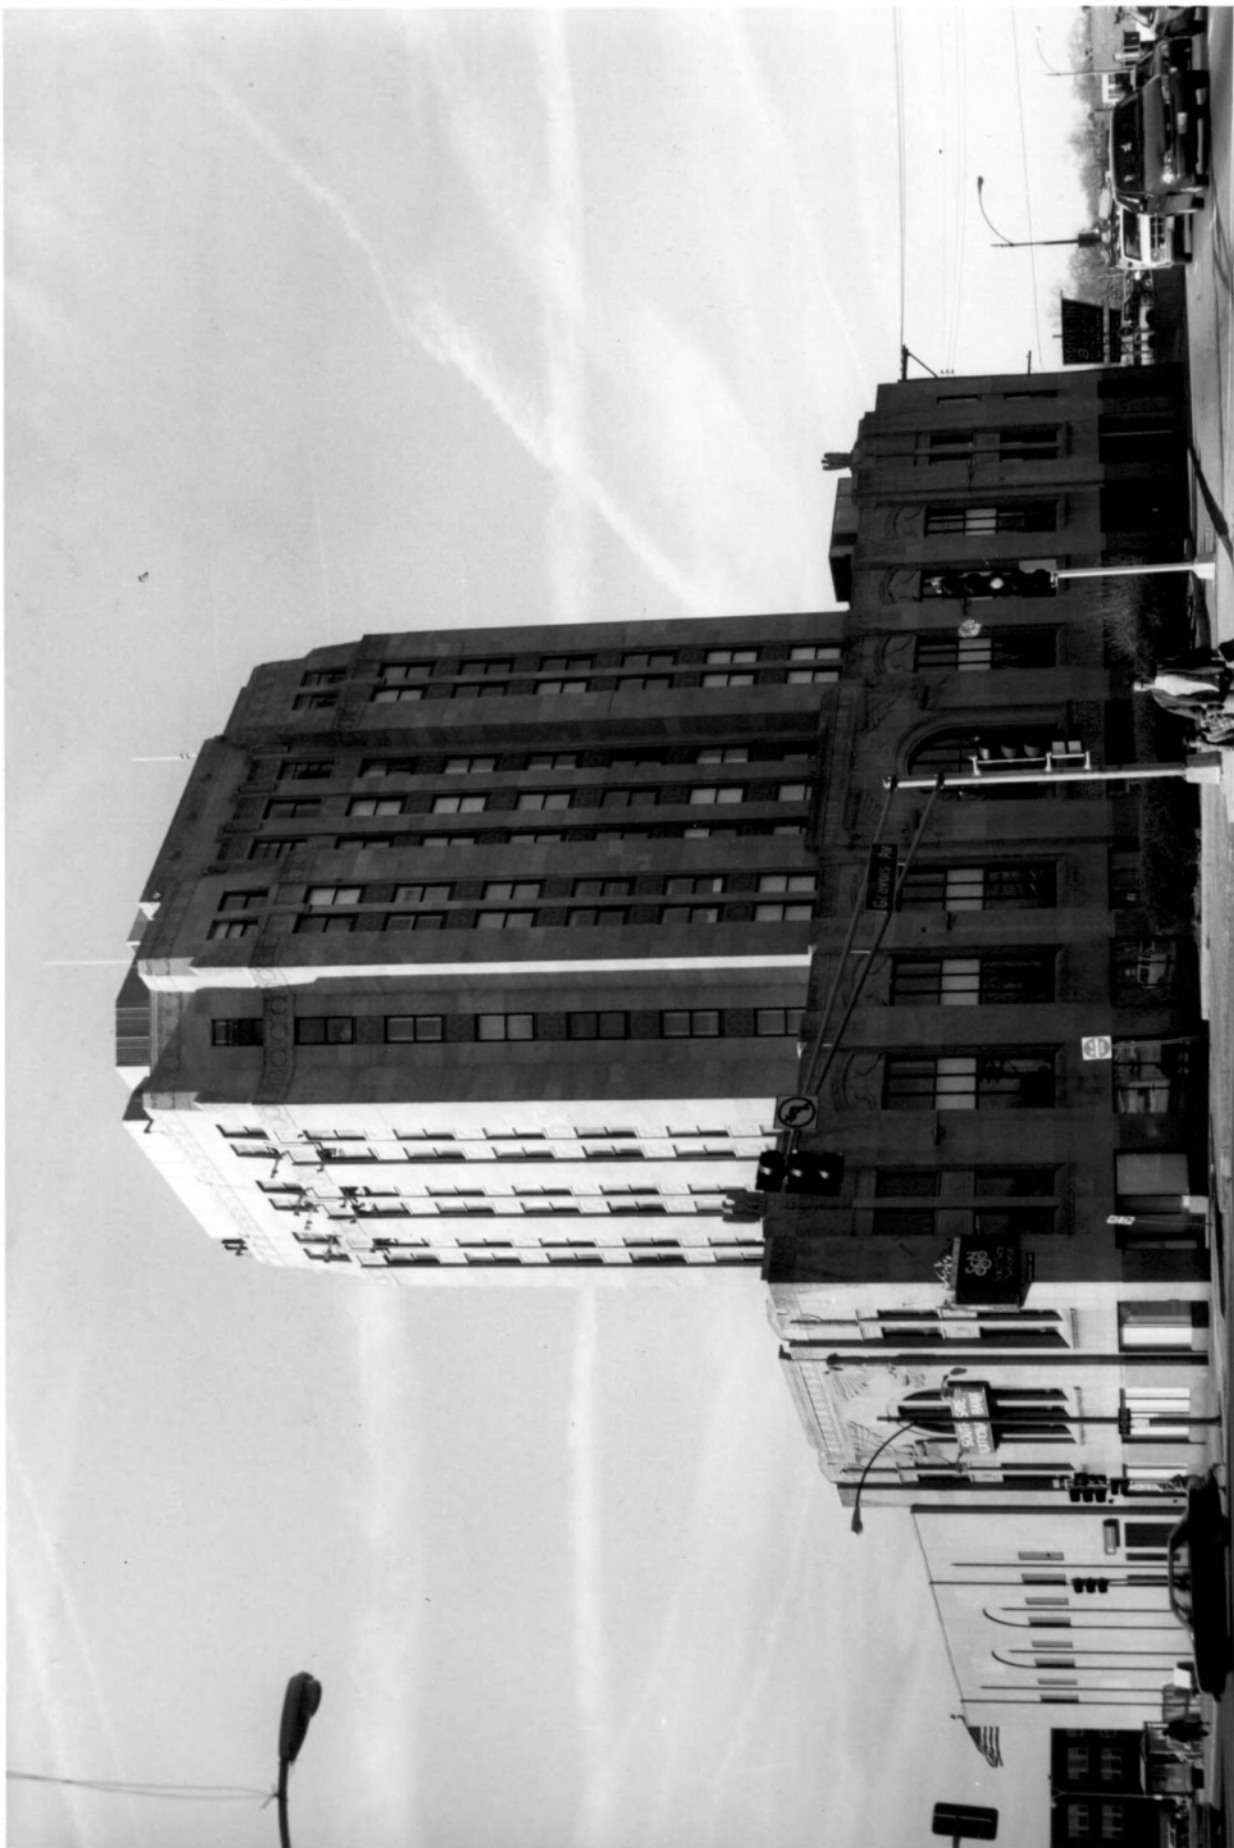
Photo #1

neg: Landmarks Assoc. of St. Louis  
East & north elevations; camera facing SW

The bank's north-facing facade has a ten-bay base which is three stories high (Photo #1). Nine bays of the base are symmetrical around a monumental entrance bay; an additional bay at the western end of the facade is set back so as to not interrupt the symmetrical composition. At the first story, gray granite is the primary surface material. Windows are almost full height; as with the rest of the exterior windows, these are non-historic replacements. There is a cut-away corner entrance (now non-operable) at the northeast corner of the building. Originally, the corner entrance led to a storefront (historically occupied by a drugstore); in 1969 the bank occupied the first floor as offices.

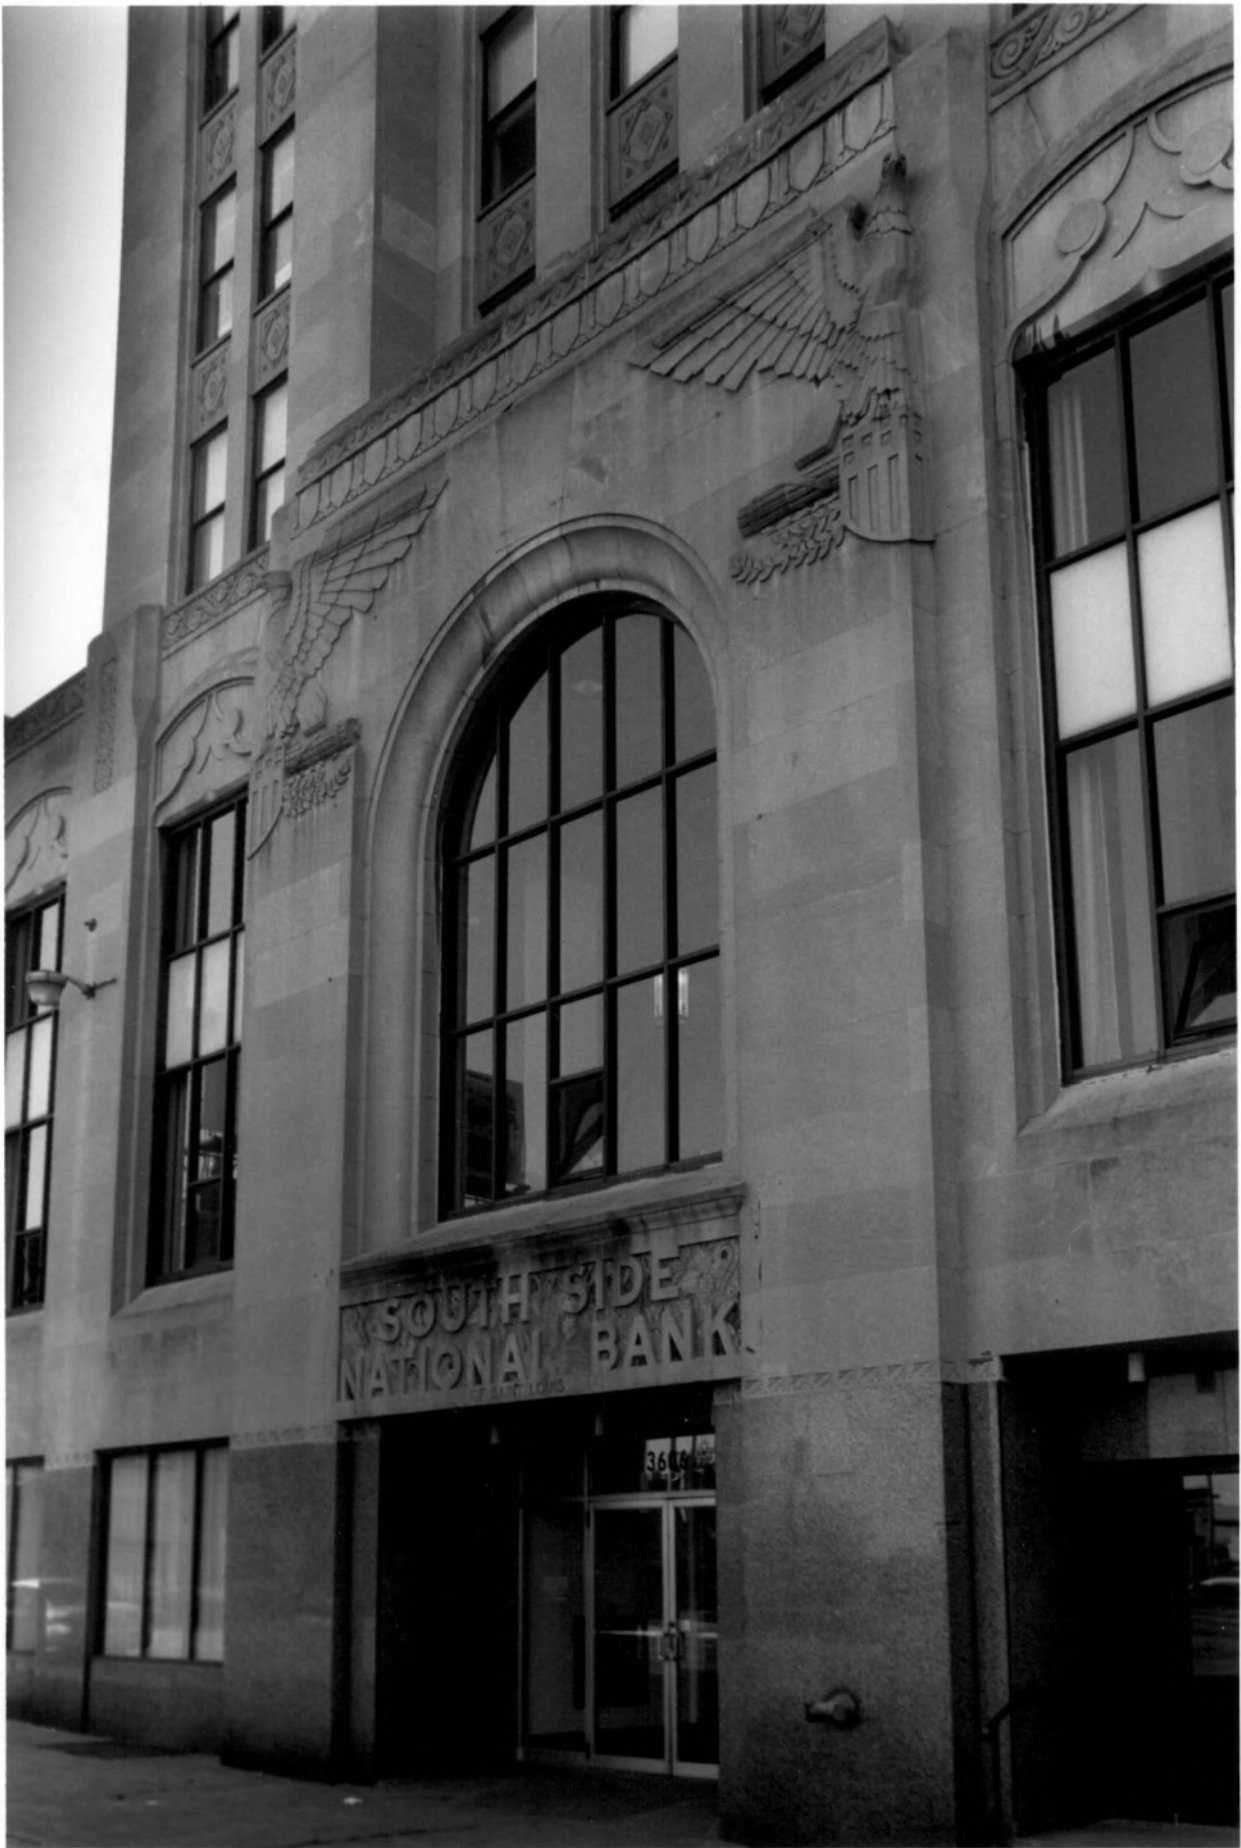
north elevation - main entrance, camera facing SE  
Photo #2

The main entrance is centered at bay five; "South Side National Bank" is proclaimed over the door in large raised letters (Photo #2). A secondary entrance in the sixth bay accesses elevators to the tower. There is a single door at the ninth bay. None of the doors on the north side of the bank are currently used due to security concerns.

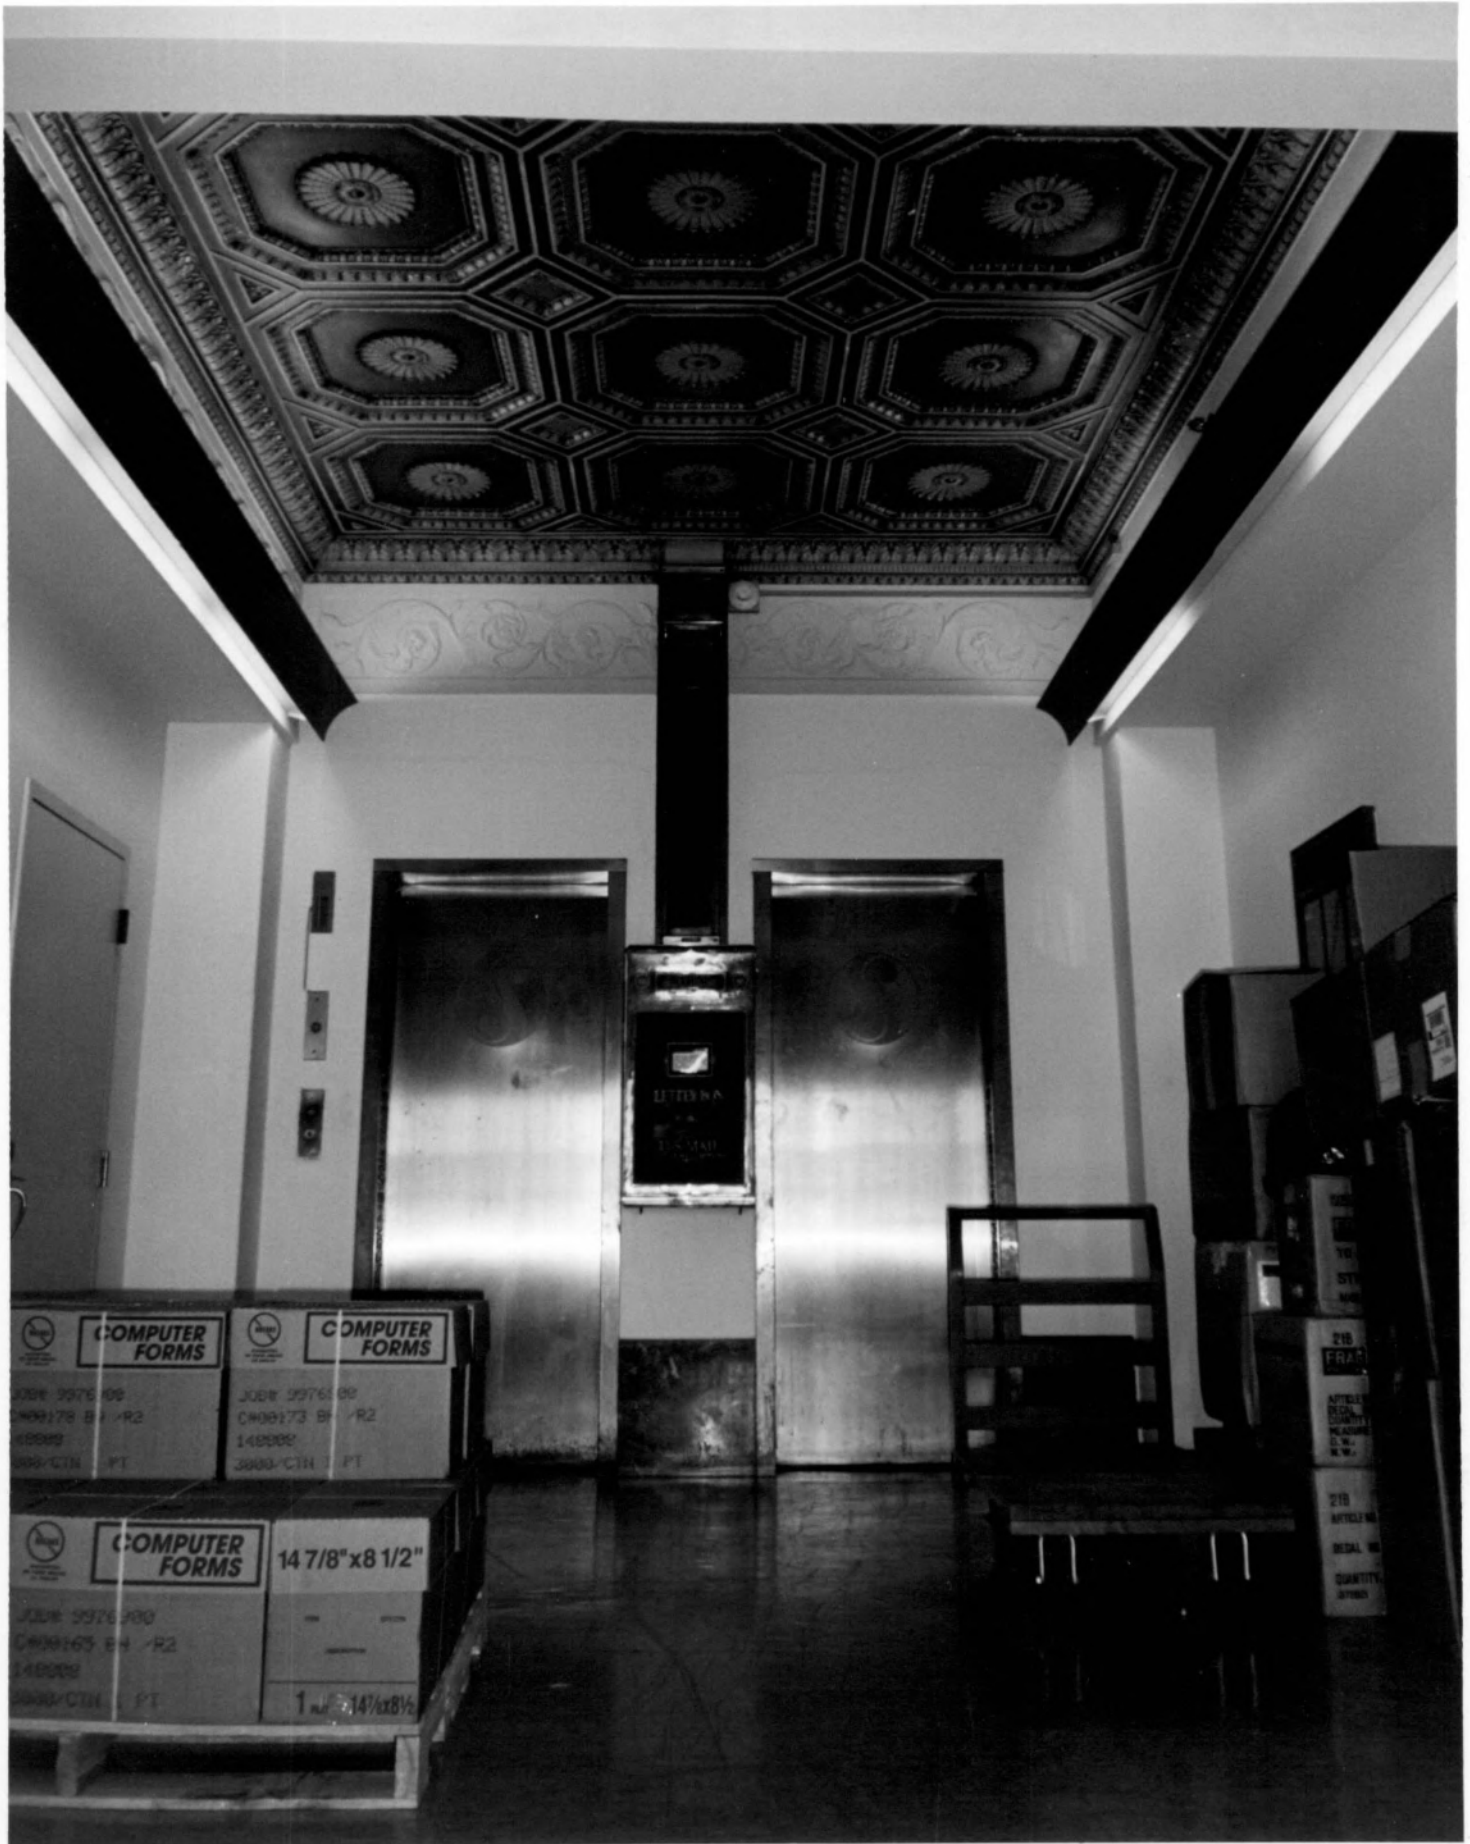
Photo # 5

Elevator lobby - camera facing S  
(ground floor)

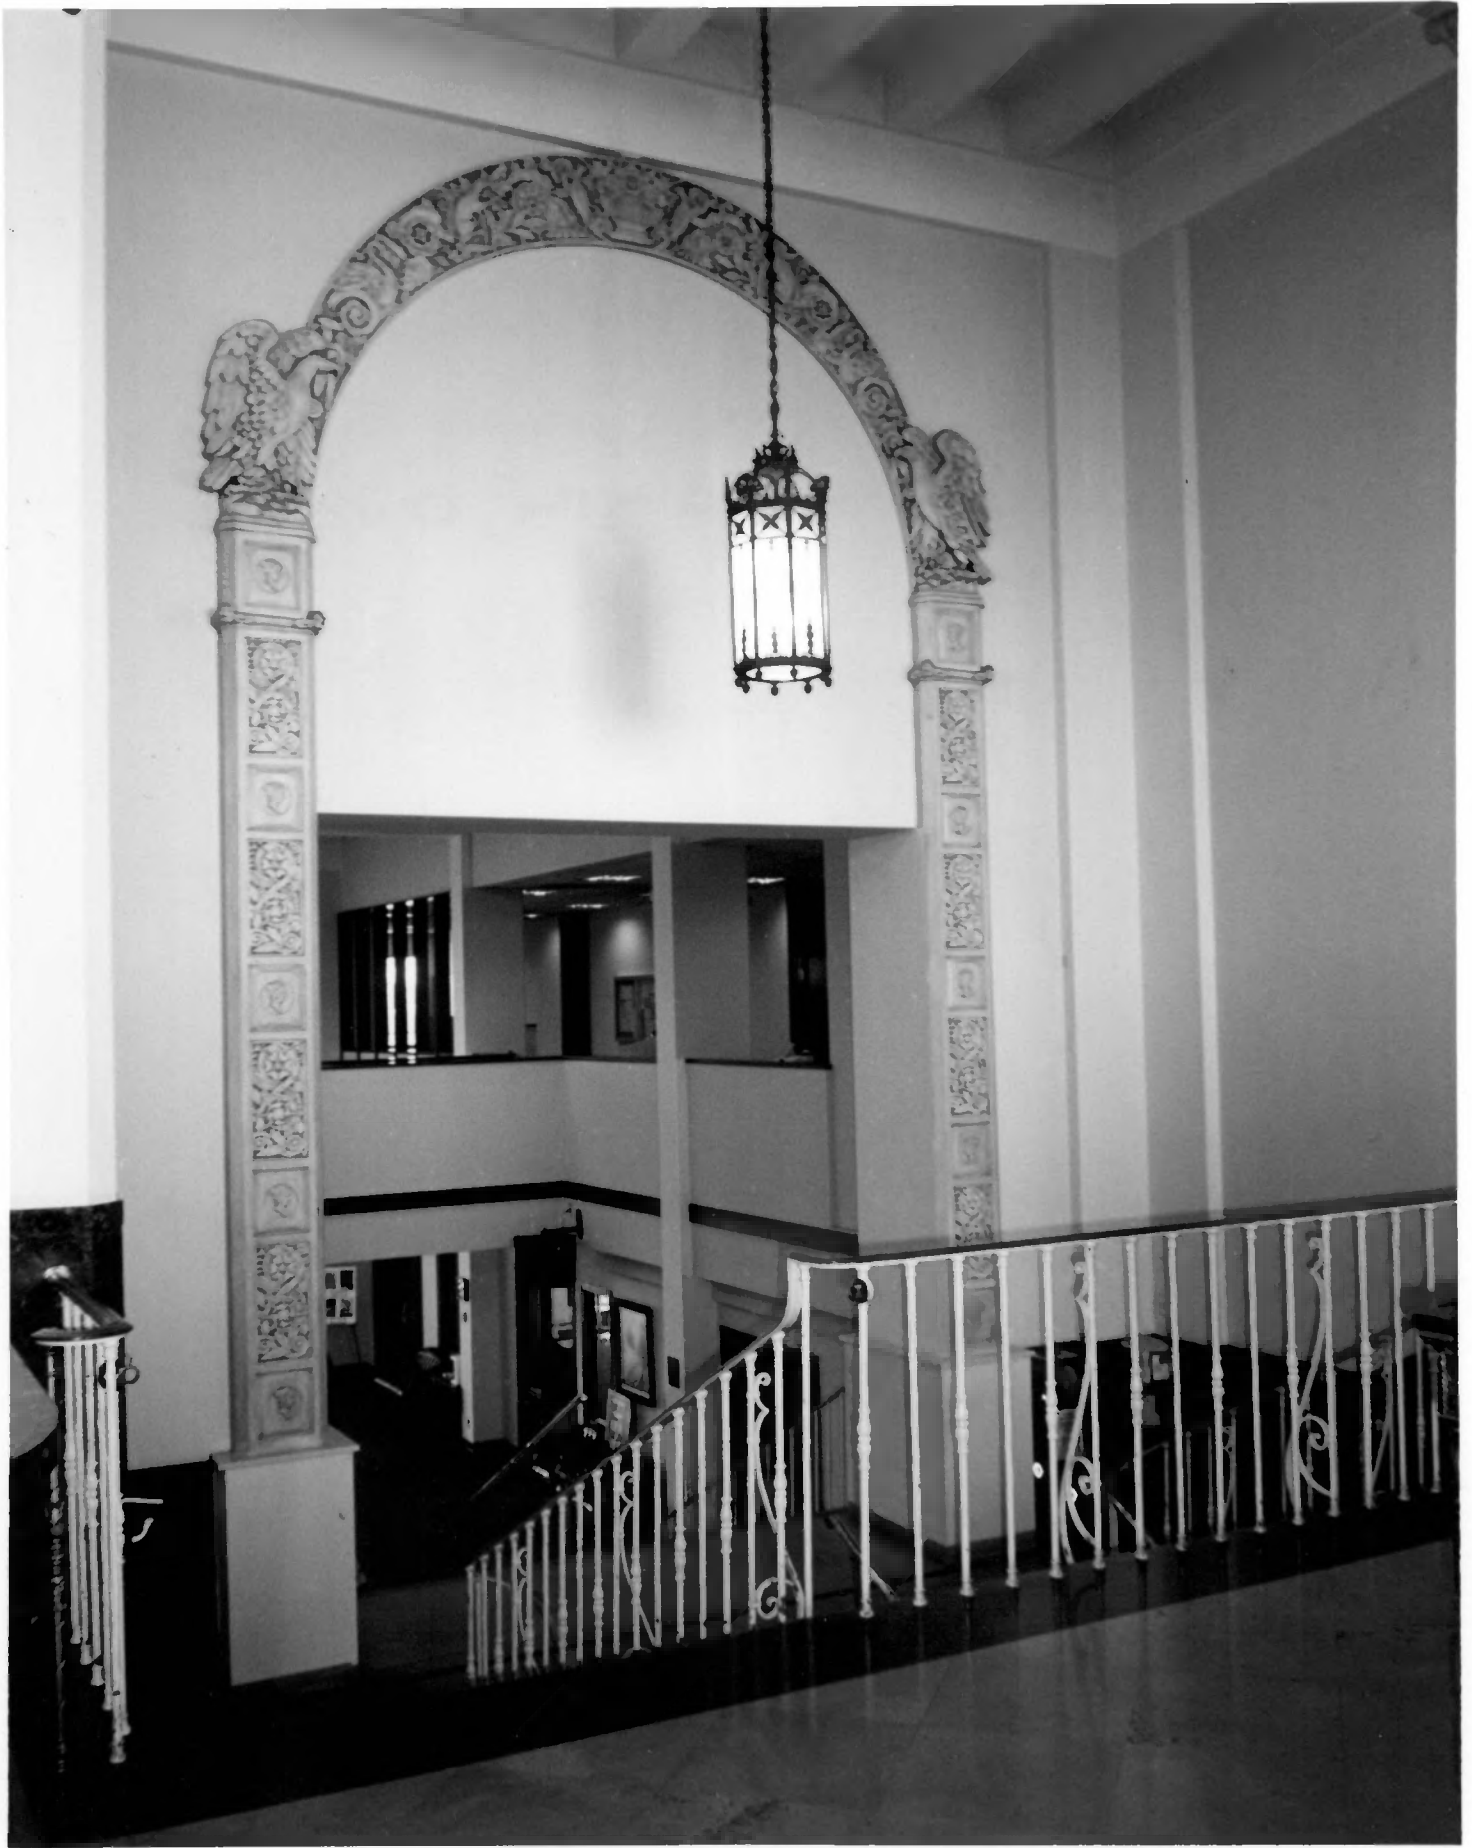
Photo 6

view from banking hall down main  
staircase into addition, camera  
facing SW

mezzanine level includes additional offices. Directly opposite the main entrance, a flight of stairs leads through a wide opening in the bank's former exterior wall to a landing, part of the original building. Here the stairs from the addition meet the stairs from the front (north) lobby. Viewed from the landing, the opening to the addition is the lower part of a large arch, the top of which is blind (Photo #6). The arch's plaster surround empanels floral and abstract geometric designs in the legs and uses similar motifs in running ornament at the arch. Atop the impost blocks, muscular eagles face into the opening. Like almost all of the plaster ornament in the room, the designs are washed in a peach-colored paint. This arch originally housed a large mirror, which was removed to provide access from the addition.
