ARCHITECTURAL/HISTORIC INVENTORY FORM

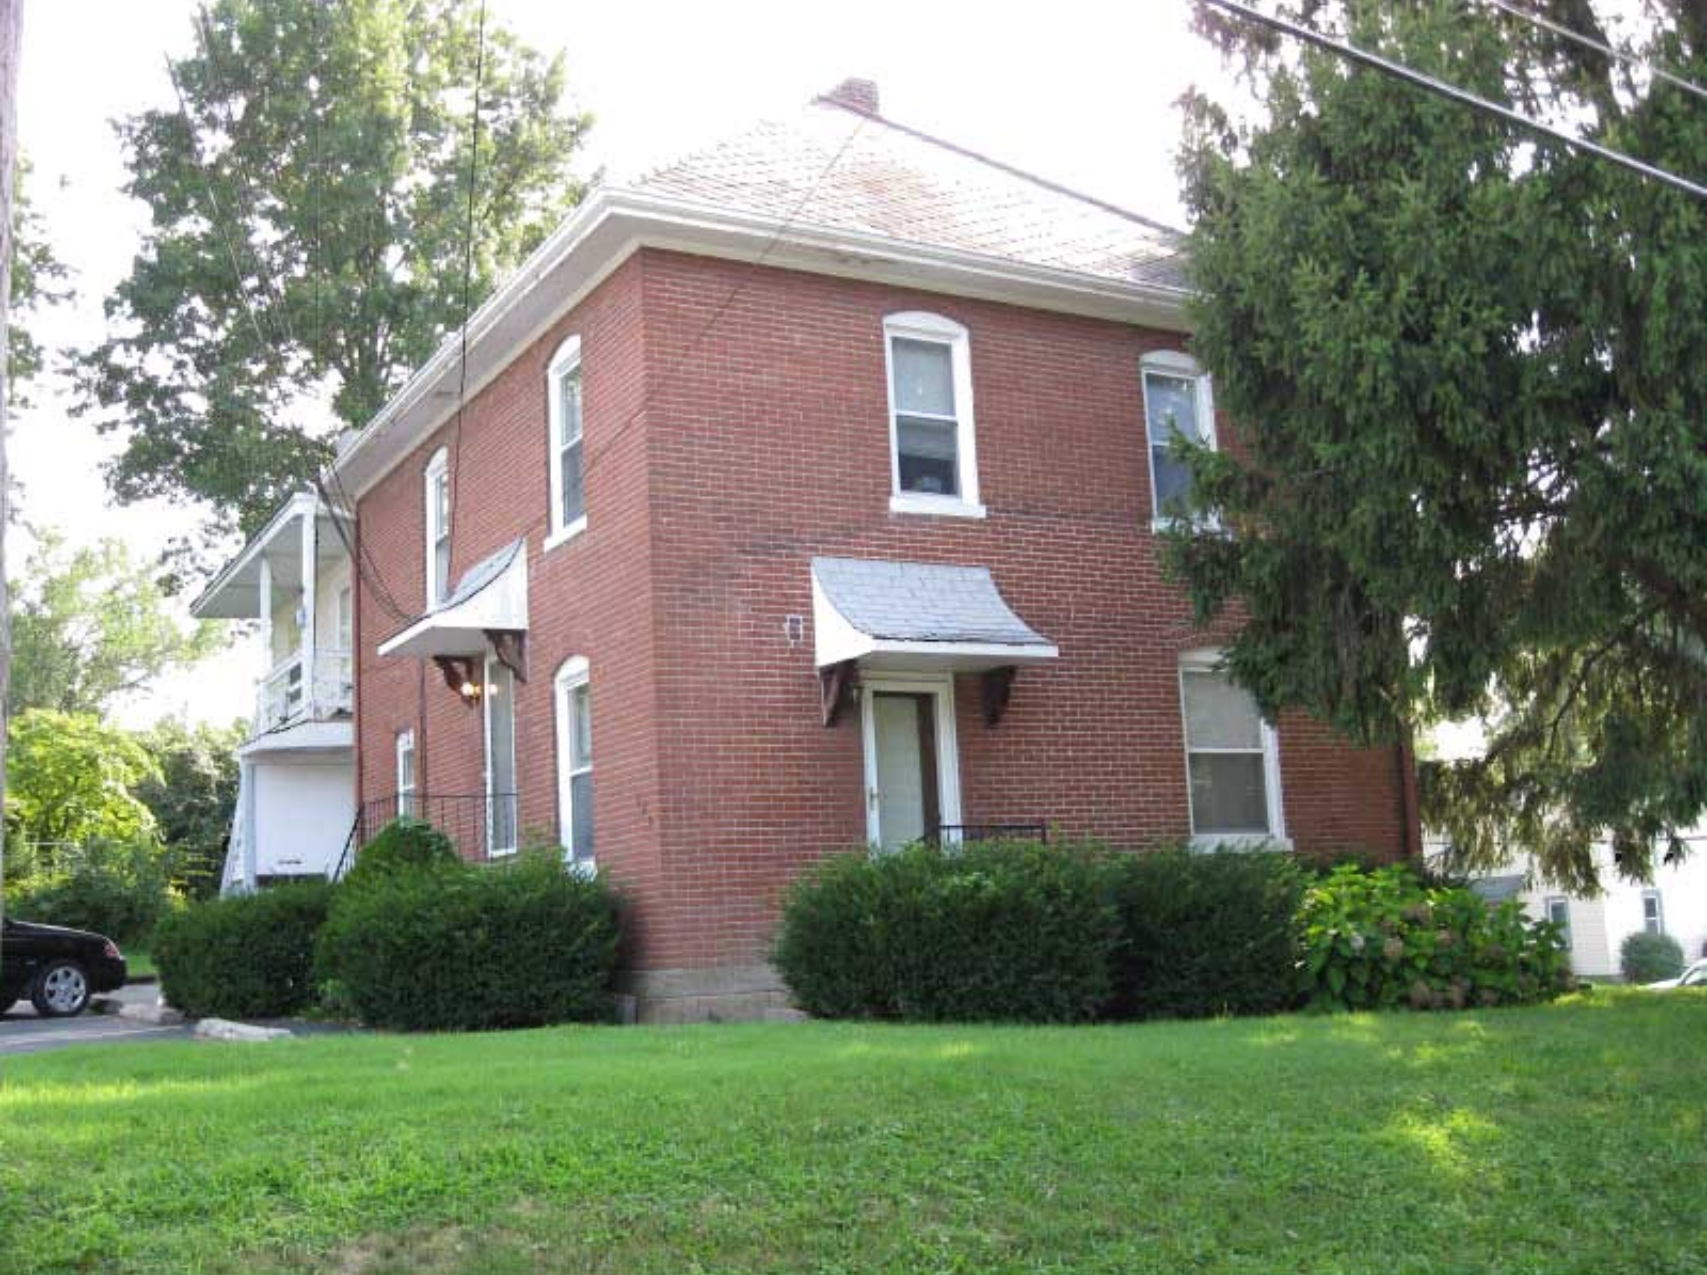
Built between 1909 and 1917, this red brick Four Square house has the typical two-bay facade and pyramidal roof, but only a shadow on the facade remains of the original hipped roof, full width porch. It now has a simple, concrete entry stoop with wrought-iron railings and a shed-roof supported by small brackets. This same stoop and roof detailing is used on the side entry, but that entry was initially created around 1929 since that is the first year it appears on the fire insurance map (and in 1928 the home was still listed in city directories under the husband, Gustave Weber, but in 1931 it was listed with his widow and had an apartment). The rear has a large, two story, frame addition that was completed in 1979 according to city records. This addition spans nearly two-thirds of the rear wall with the exterior stairs incorporated under the roof, extending the remaining third to the east. It has a nearly flat, hipped roof and has vinyl siding. The original Four Square house has a scored concrete foundation with 2-light basement windows. The original segmental arched window openings have replacement vinyl windows, sized slightly smaller than the original windows. The house retains its original full light wood door that is covered by a metal storm door. Near the peak of the roof is a brick chimney.

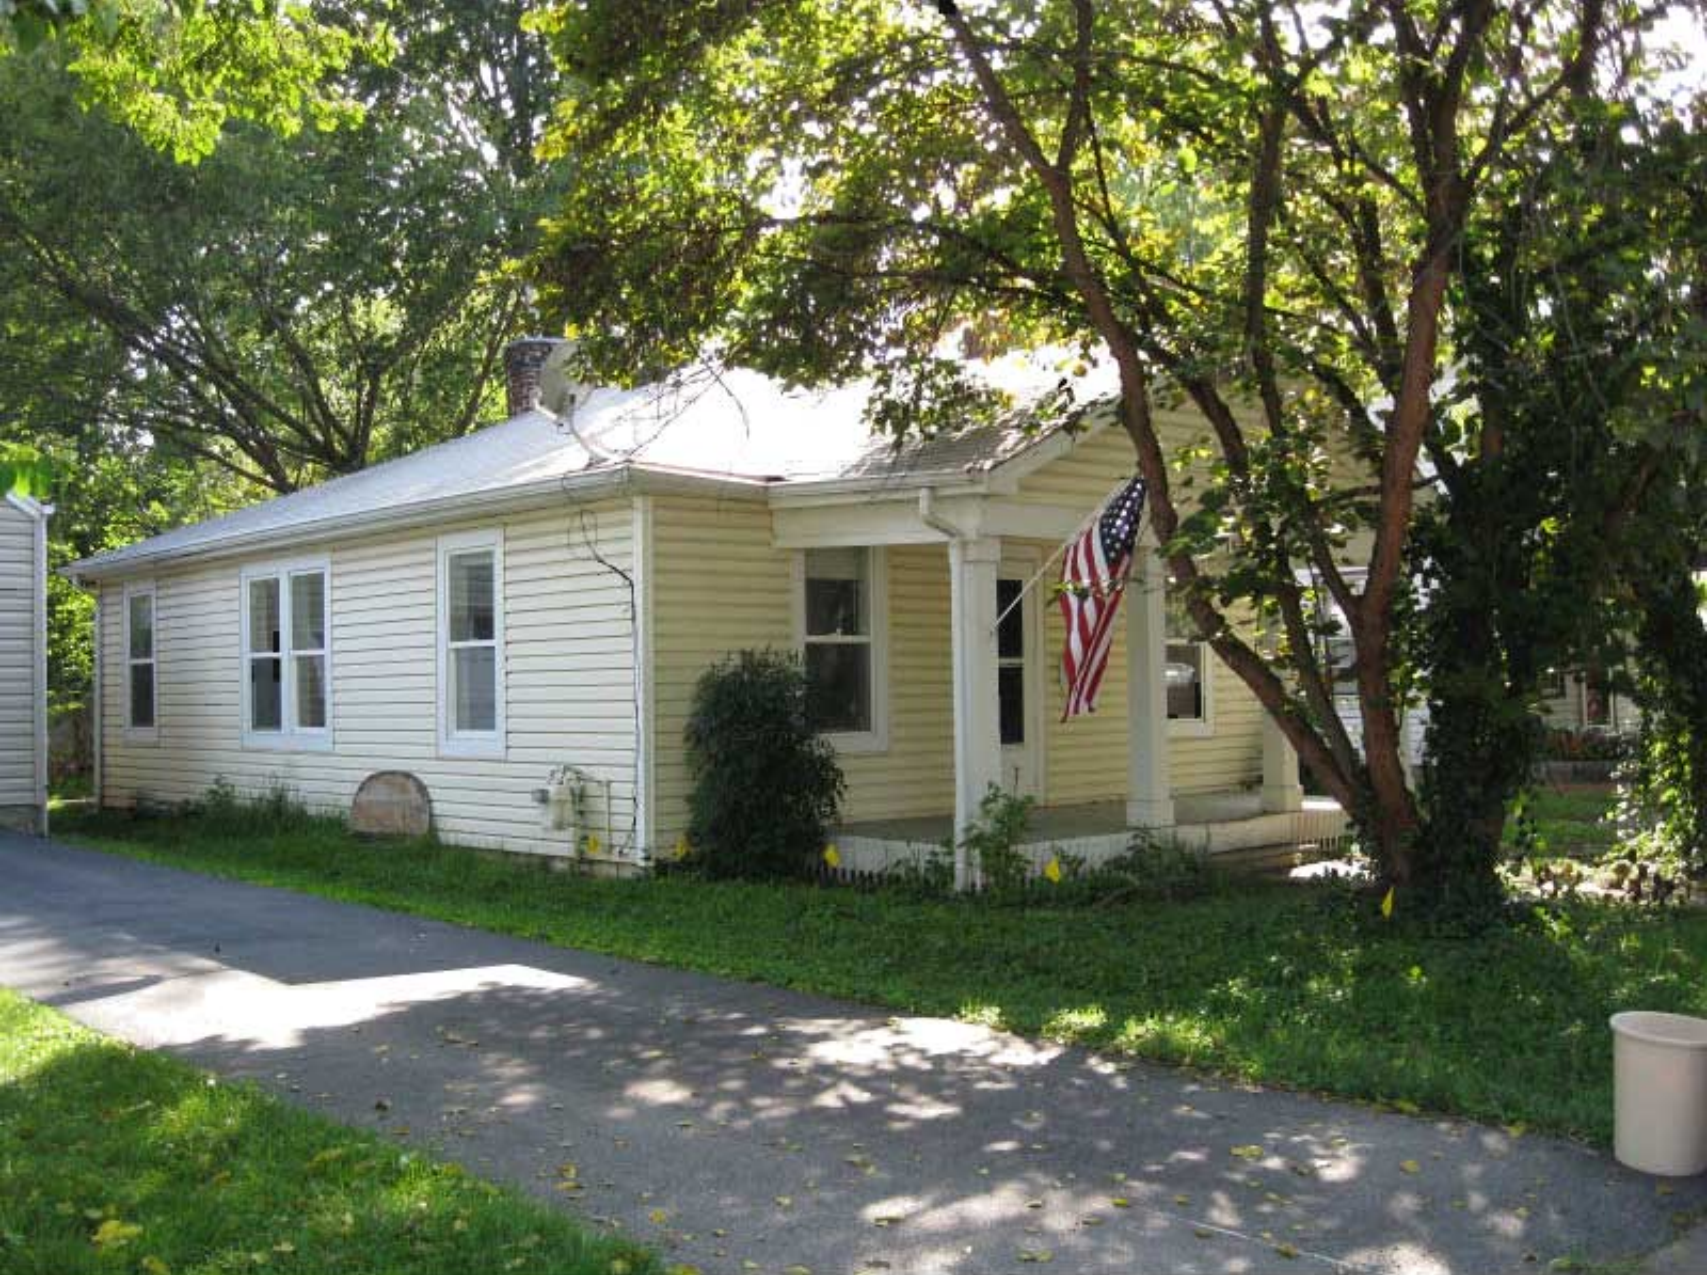
This one story, hipped roof house has a large, gabled, full width porch spanning most of the façade. The porch is supported by a series of square posts, which appear to either be replacement posts or to have been modified with a new cap and base that have a simple boxy detail. The porch floor is concrete, raised slightly on piers that have recently been surrounded by pickets that extend from the top of the slab to the ground. The house is sided with vinyl siding and has replacement vinyl 1/1 windows. The facade is divided into three bays with the door in the center bay. The wood door has a fanlight in the upper portion of the door, a style of door that became popular in the 1950s, so this is a replacement door.

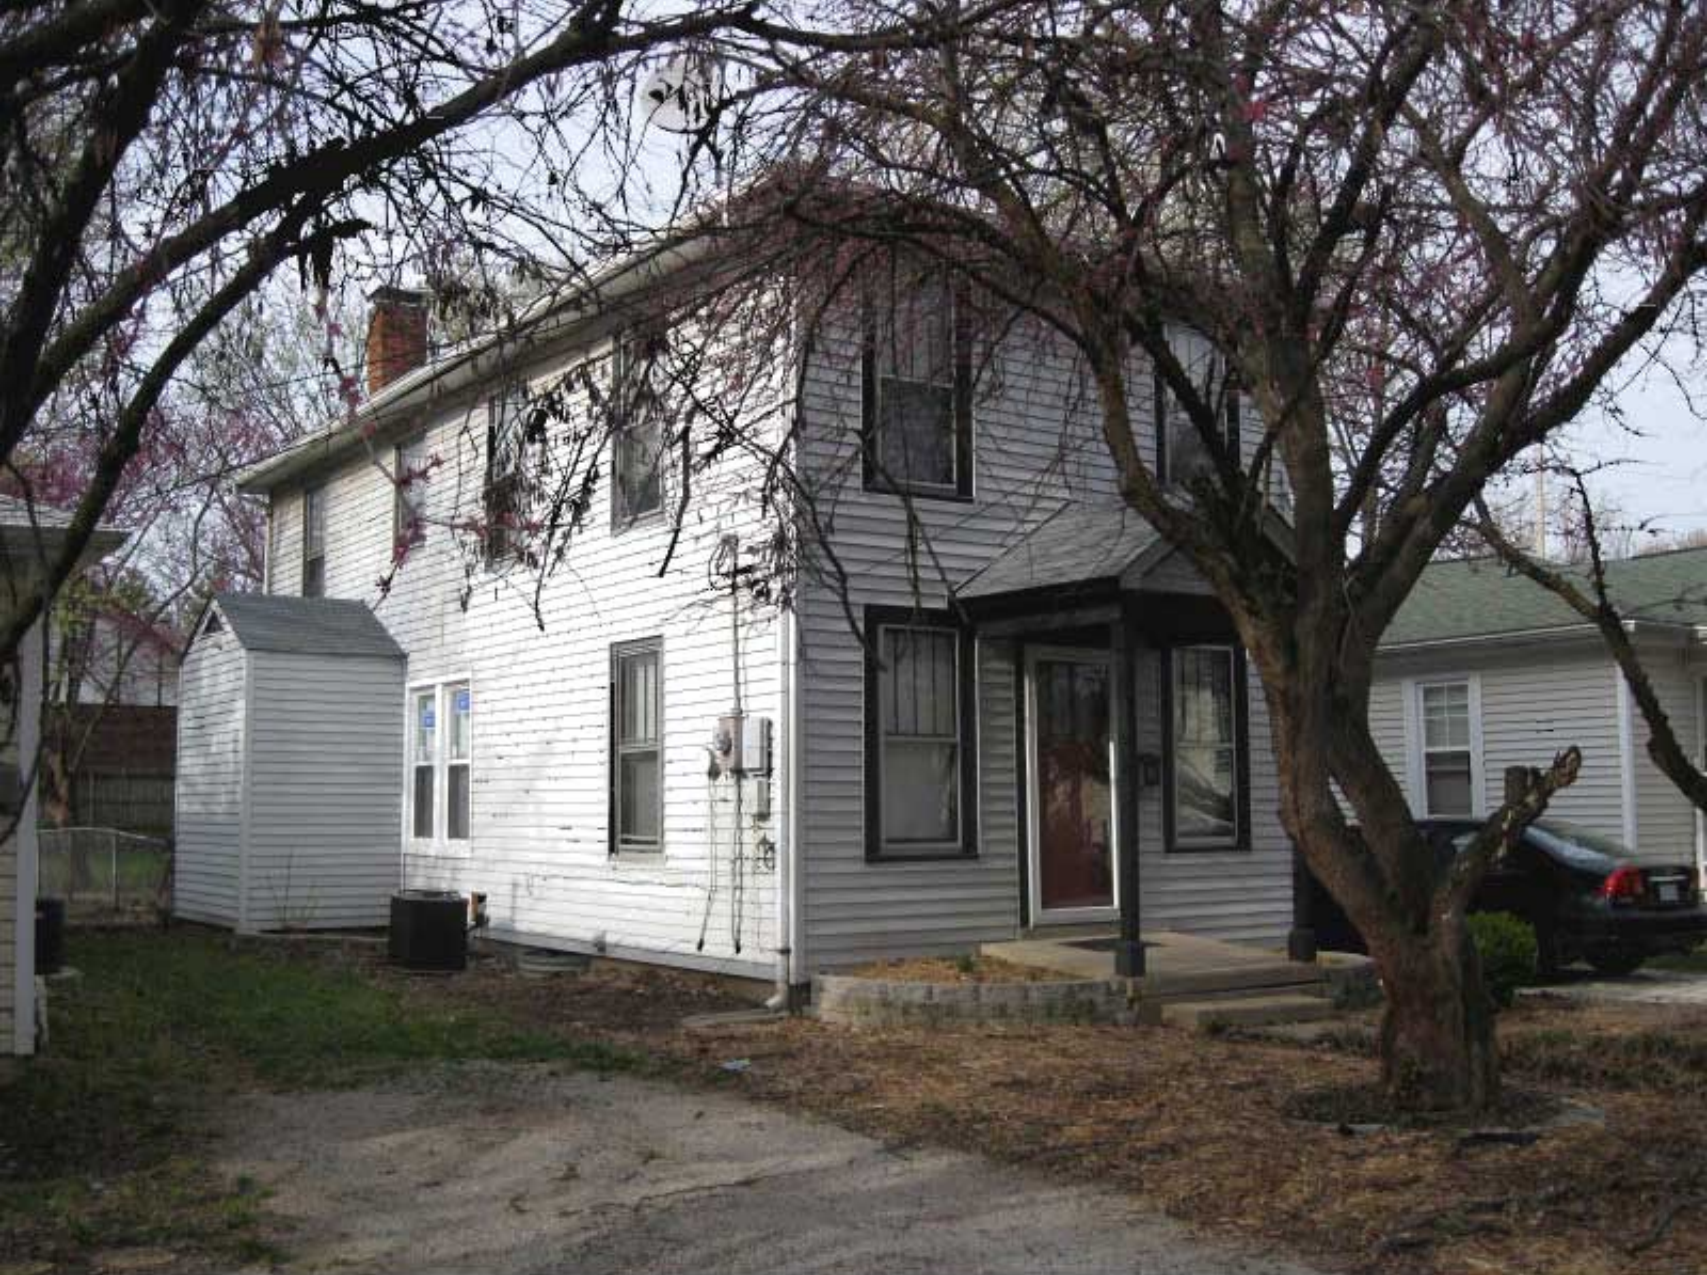
This two story, hipped roof, Craftsman house has a three bay first floor façade, with the door centered between the two windows, which are aligned with the two windows on the second floor. These windows are the original 4/1 wood sashed windows that help define it as a Craftsman style house. The door is also Craftsman, being a wood door with 3 lights over a large panel. The windows on the other elevations are similar vertical light upper sashed windows. The house has been clad with vinyl siding, around the original exterior window trim, but the fire insurance maps indicate that this originally had a full-width front porch. After 1947, there was a small, enclosed, one story, gabled roofed addition added to the east side, near the rear, and on the west side, there is a shed roofed porch with simple corner posts over a side entry door positioned next to the driveway. There is a full-width one story wing on the rear that is shown on both the 1929 and 1947 fire insurance maps, indicating it is original to the house. It currently has a small gabled roof porch supported by simple square posts resting on a low concrete porch floor with one concrete step. If the porch can be documented as dating within the period of significance, then this house would be a contributing building to the historic district, but this represents a major alteration to the facade and as such it is currently identified as noncontributing.

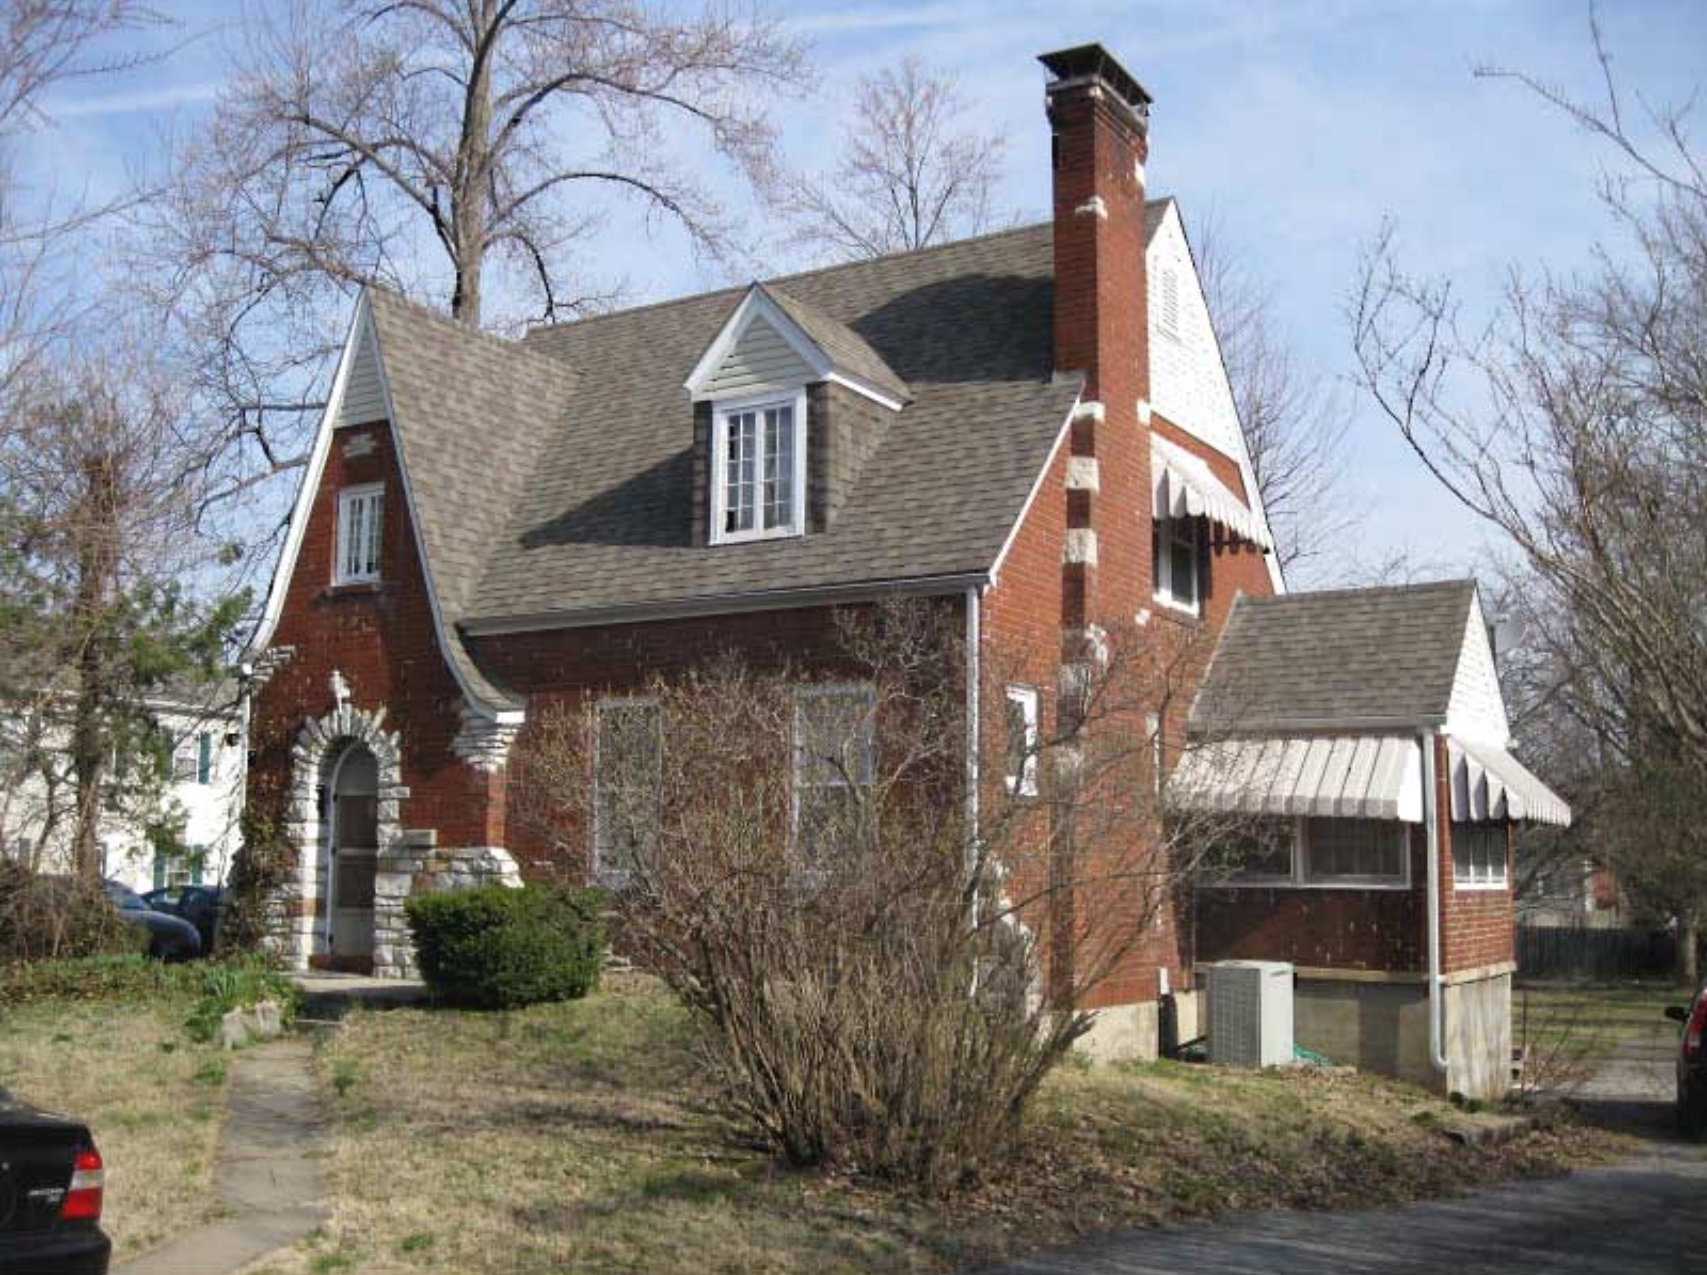
Built between 1931 and 1936, this 1.5 story, raked red brick, Tudor Revival cottage has a steeply pitched asphalt shingle roof. The facade is divided into three bays, with the west bay having a large, 1.5 story cross gabled, slightly projecting entry vestibule. Rock-faced, ashlar limestone detailing highlights the base of each side of the asymmetrical roofline of this vestibule, with the east side curving down to the first floor. Additional stone climbs the lower facade and frames the round arched door opening. The door appears to be a wood plank door with a small rectangular light, but it is partially obscured by the aluminum storm door. There is a shallow concrete stoop in front of the door. Above the door, there are paired 8-light casement windows on the second floor with a small detail of rock-faced stone above the windows. The peak of the gable end is detailed with lap siding. Stone continues to form an irregular foundation on the facade, and the east corner has a wing wall of tiered stone. The other two bays of the facade have 9/9 wood sashed windows (covered with storm windows) with soldier course brick lintels. Centered above these windows is a gabled dormer with paired 10-light casement windows. On the east side, there is a tiered end wall brick chimney with scattered stones decorating the chimney that is flanked by small, diamond patterned, art glass windows. Above, the second floor of this elevation has paired, 9/1 sashed windows and the gable end is clad with lap siding. There is a small, enclosed, one story, side gabled, brick wing near the rear of the east elevation which appears to be original to the house, although the 1947 fire insurance map identifies it as an open porch. The windows of the sunporch are also wooden, multi-light windows. On the side elevation, the decorative rock face of the facade foundation is not continued and it is a simple poured concrete foundation. There is another gabled dormer on the rear of the house as well as a shed roofed porch. The only visible alterations, besides the storm windows and storm door, are the addition of aluminum awnings to the east side second floor window and the sunporch.

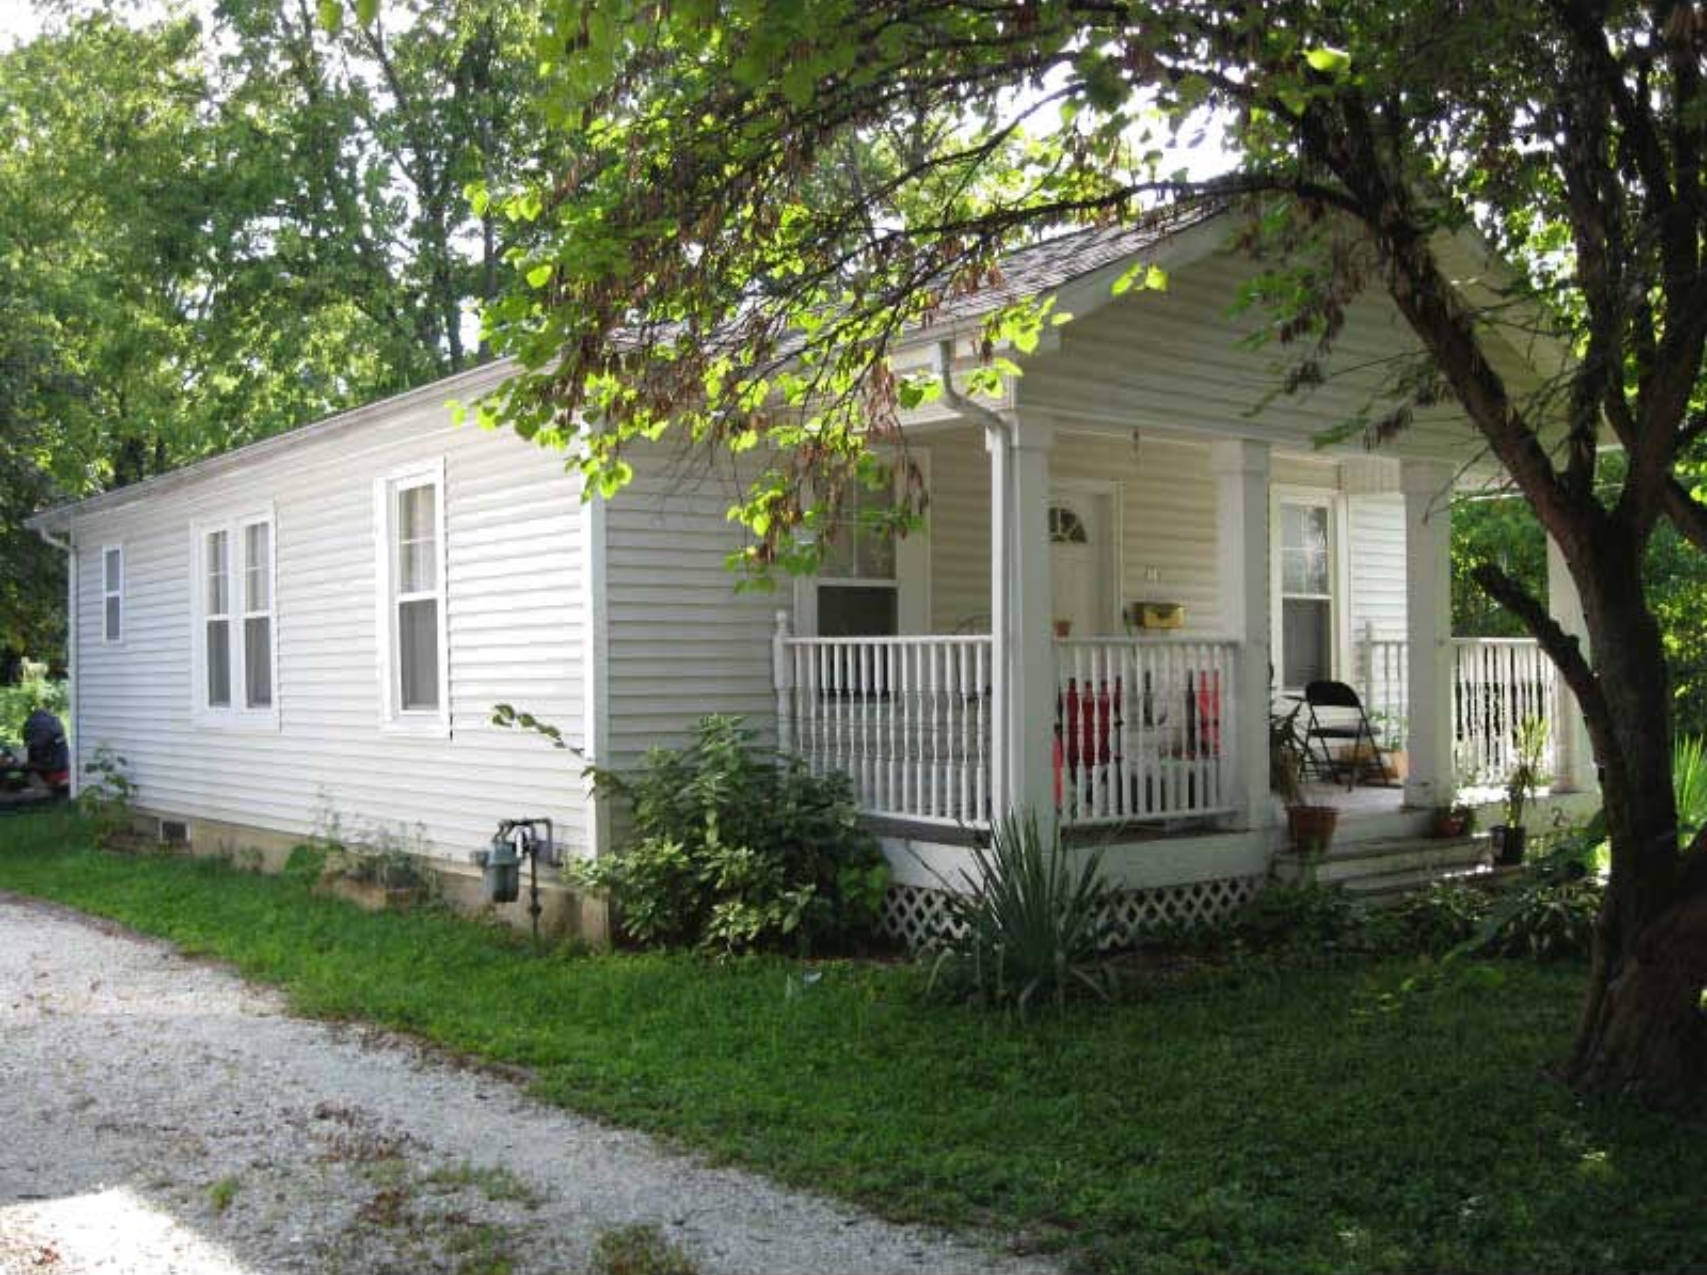
Built between 1925 and 1928, this one story, frame, hipped roof Craftsman bungalow was close to demolition in 1990 when the owner applied for a demolition permit that documents the original features of the house, which was remodeled in 2001 with new 4/1 vinyl windows (grid pattern upper sashes), vinyl siding, replacement porch posts and turned replacement porch railings. Prior to this, the gabled, nearly full width front porch had battered, square corner posts and simple flat balusters on the railings spanning to the square newel posts on either side of the central steps. The windows were originally 4/1 vertical light upper sashed windows. The current paneled steel door is a replacement, and what was apparently the other front door that was adjacent to this door has been eliminated.

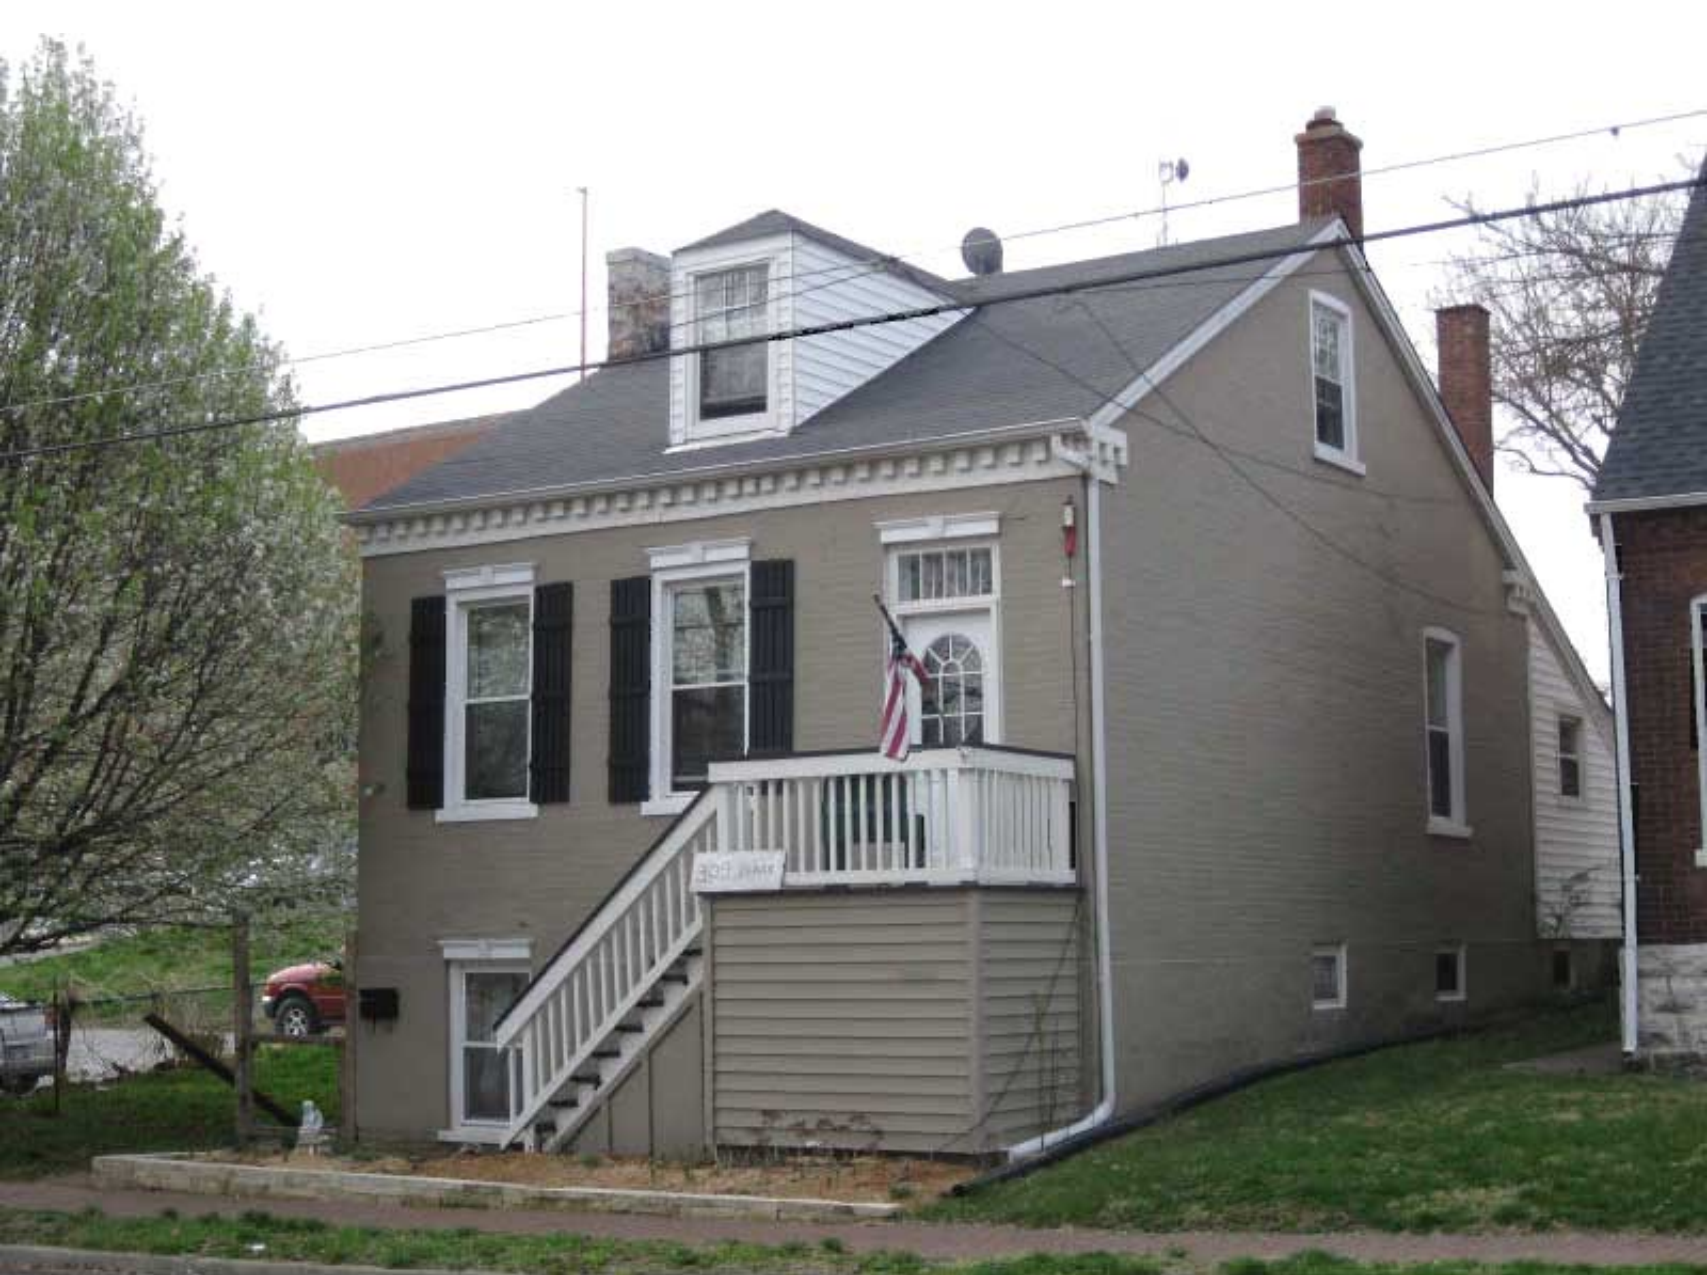
This side gabled brick house is typical of late nineteenth century German house construction with its simple form and flanking end wall, interior chimneys. Under the eaves, there is a brick dentil course on the façade that creates a return to the side elevations and supports the gutter. Centered on the facade and rear elevations are hipped dormers with vinyl siding and replacement 6/6 vinyl sashed windows. The facade is divided into three bays with two 1/1 windows east of the simple doorway. The openings appear to have either wood or stone flat headed lintels that are now overlaid with projecting lintels with keystones. There are vinyl shutters on the windows, which appear to be 1/1 replacement windows. The door is a recent replacement, with a half-round light in the upper half of the door, and above the door is a four light transom that is covered with a four-light storm window. Below, the basement windows are fully exposed sashed windows, with the east window having a similar lintel with keystone overlaid on top of the original lintel. The middle bay basement window has been infilled with siding with the stairs paralleling the facade extending in front of this opening. The wood staircase leading to the front entry has a replacement wood railing and the area under the stairs and landing has been covered with siding. Windows on the first floor of the other elevations appear to be 1/1 replacement windows with 6/6 vinyl windows on the second floor. The side elevations have segmental arched window openings (two on the first floor and one centered in the gable end of the second floor), helping to indicate that this is a late nineteenth century design since earlier homes would have had flat headed openings. On the rear is a shed roofed, one story, frame addition that replaced the earlier porch between 1917 and 1929, and the west half of the rear elevation has a shallow pitched shed roofed addition behind this that was added sometime after 1947. These frame additions are also clad in vinyl siding, like the dormers.

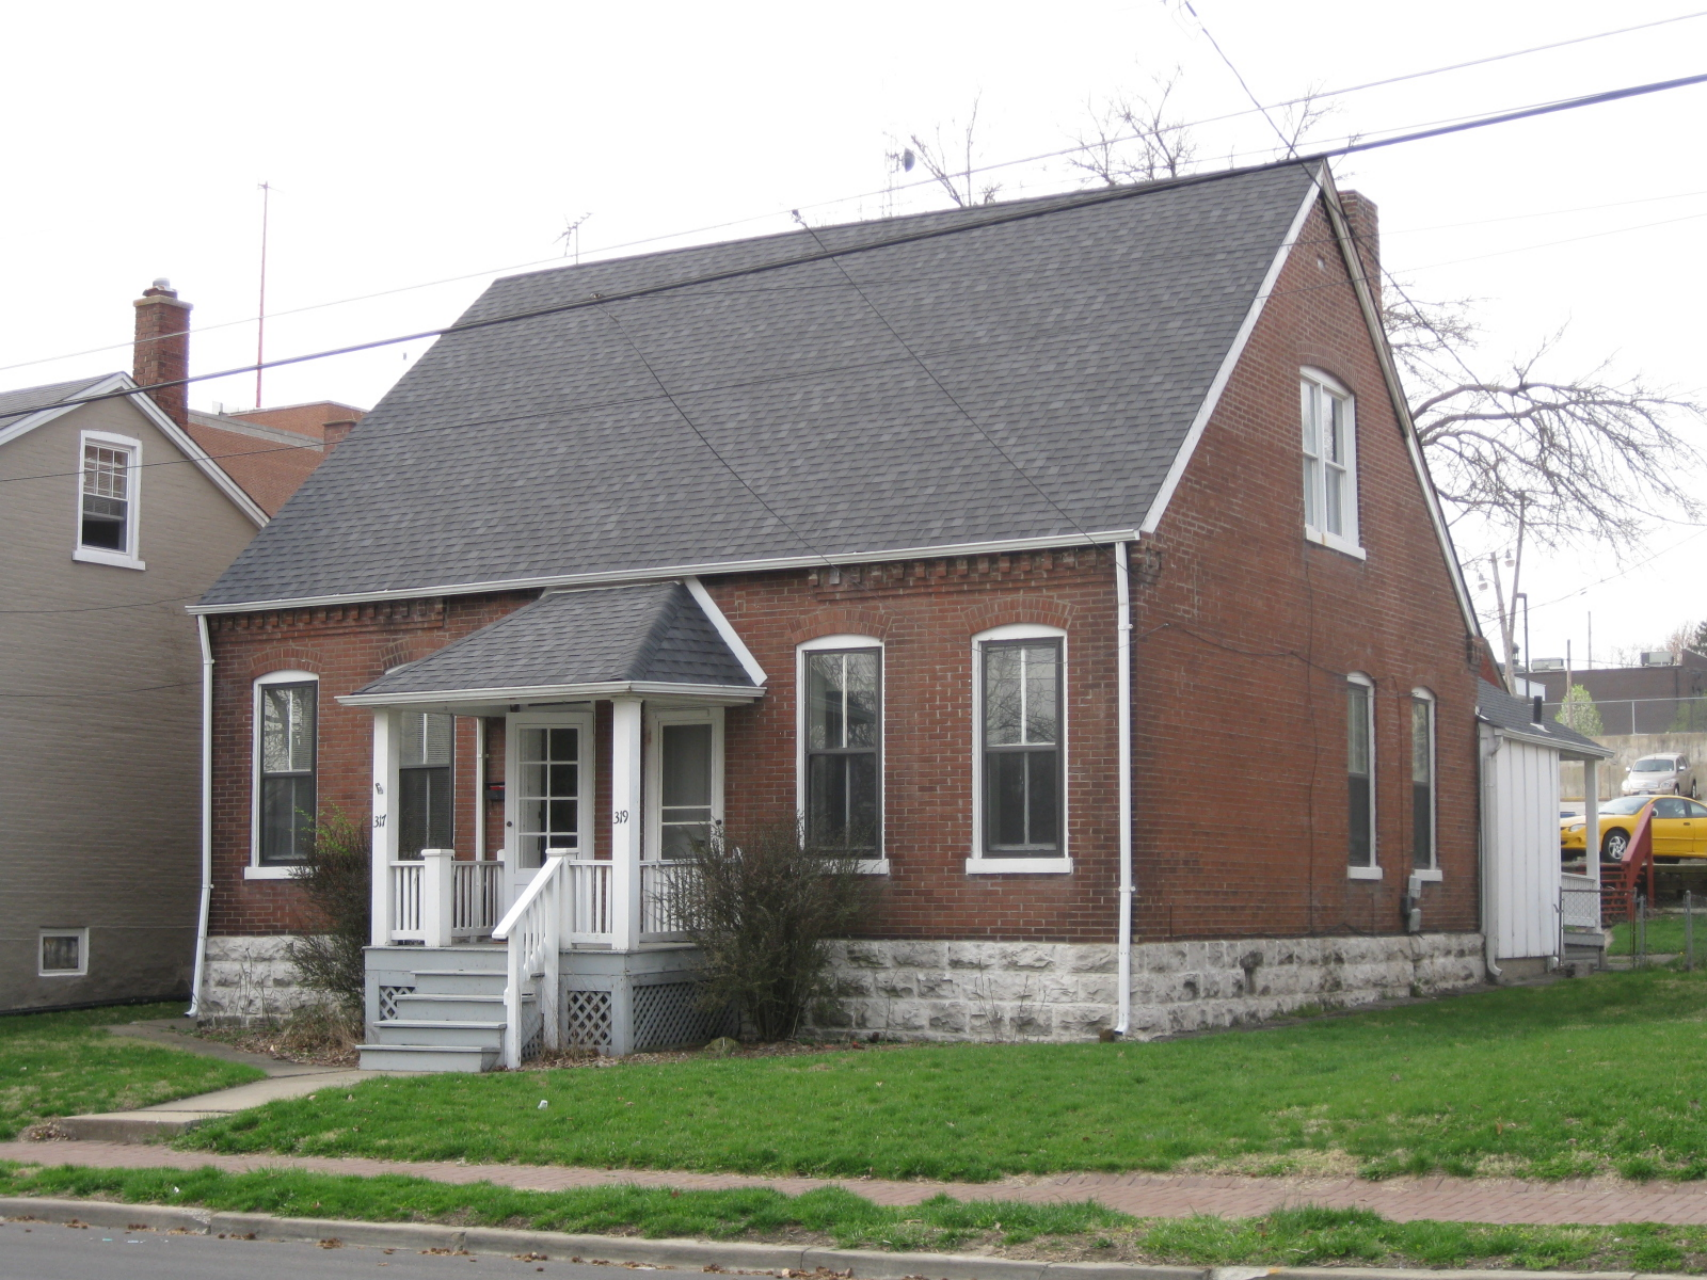
This 1.5 story, red brick (running bond), side gabled duplex has a brick dentil course under the front eave. The facade is divided symmetrically into six bays, with the outer bays having segmentally arched 2/2 wood sashed windows while the inner two bays have the segmental arched doorways to the two apartments. The doors are the original four panel wood doors with single light transoms. One door has a wooden 8-light storm door but the other one has a screen door. The hipped roof porch spans the center two bays with simple square corner posts and a simple wood balustrade. The porch may represent a later design since the dentil brickwork stops short of the hipped roof on the porch. At the rear, there is an intersecting cross gabled one story, brick wing that has two sets of paired 2/2 wood sashed windows. Incorporated under the gabled roof, on each side is a shallow porch with simple corner posts and a low, wood porch floor, but a small section of each porch, against the front wing, has been enclosed with board and batten siding. There are brick chimneys on each side, behind the front ridge. Storm windows have been added to the house.

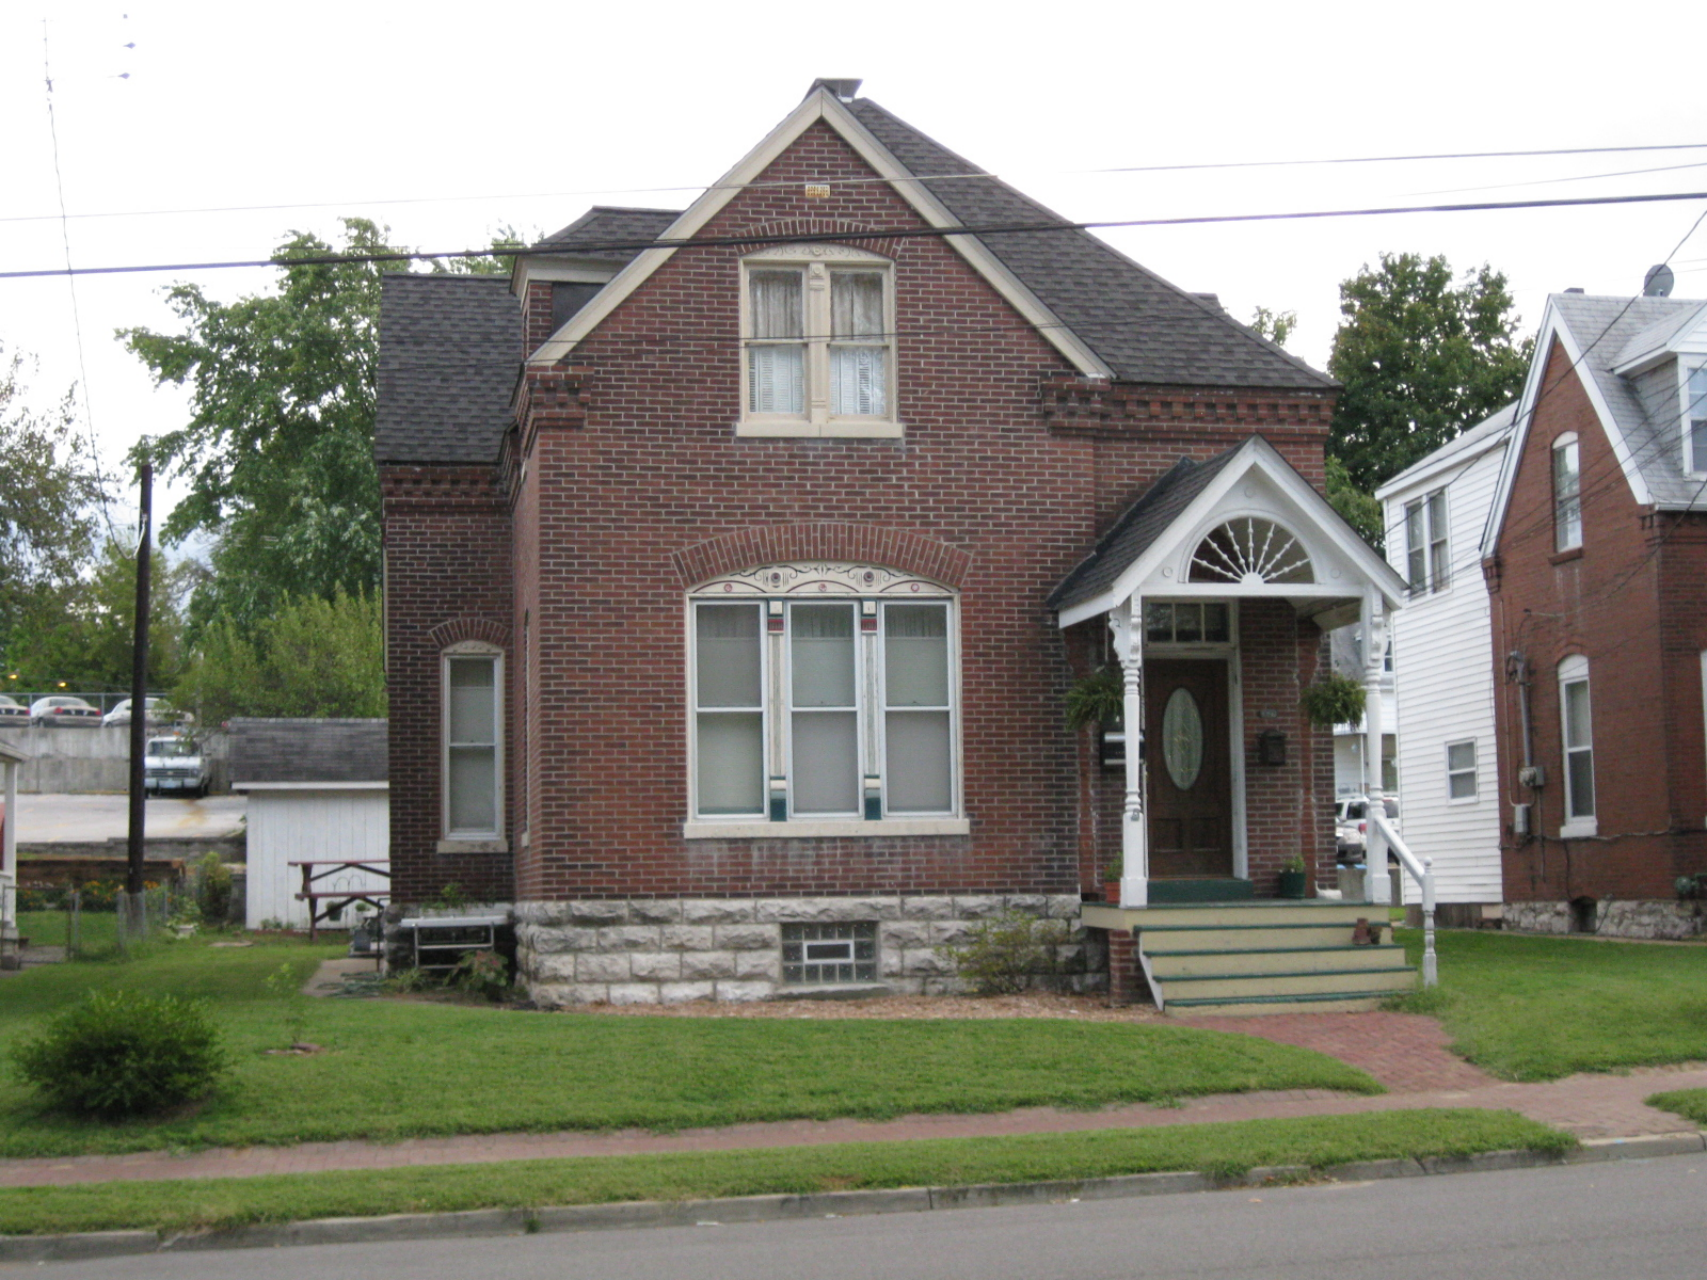
This Folk Victorian, red brick house has a large hipped roof with cross gabled 1.5 story bays on each side as well as the facade. The facade cross gabled bay only projects slightly across the east two-thirds of the facade. There is a hipped wall dormer on the east side of the gabled bay and a gabled wall dormer on the west side. The roofline of the house is accentuated by the brick dentil cornice. The coursed, rusticated limestone foundation forms a high water table (basement window openings punched in this area are now infilled with glass block). The facade gabled bay has a large, segmental arched triple window on the first floor and a segmental arched double window on the second floor, both with decorative incised panels in the arches above the square headed windows. Between these 1/1 wood sashed windows on both levels are fluted and bracketed pilaster strips. The entry bay is slightly recessed and has a gable roofed porch with turned posts and decorative brackets. Given the shadows on the brick wall, there apparently were similarly shaped pilasters and brackets up against the facade that are currently missing. The underside of the porch roof is arched and lined with beadboard and there is a spindlework half round opening in the gable end as well as decorative dahlia shaped details that has led the current owner's daughter, Lauren Brand, to call this the Dahlia House. The front door appears to be a replacement, given the brass coming in the oval light of the wood paneled door, but the single light transom remains intact (covered by a three light wooden storm) as does the incised arched panel above the transom that fills the segmental arched opening. On each side of the house the windows are also segmental arched with the incised panels above the window, and the paired windows on the first floor of each side's cross gabled bay also have the fluted and bracketed pilaster strip between the paired windows. Across the back the slope of the roof has been extended as a shed roof on the frame addition, which is probably an enclosure of what was originally the full-width rear porch. Above there are two hipped dormers with 2/2 wood sashed windows. The enclosure occurred after 1947 (the last fire insurance map update), but the walls are wood lap siding and the windows are 2/2 wood sashed windows. In the center of the house there is what appears to be a newer brick chimney with a metal cap, but there is an older, corbelled brick chimney flue in the rear addition on the west end.

The front porch appears to be the original, and is shown on the 1900 fire insurance map; there appears to have been an error on the 1909 and 1917 maps that show an additional front porch on the east side, but that would have covered a portion of the first floor window and by 1929 the map shows just the small porch at the west end again.
