ARCHITECTURAL/HISTORIC INVENTORY FORM

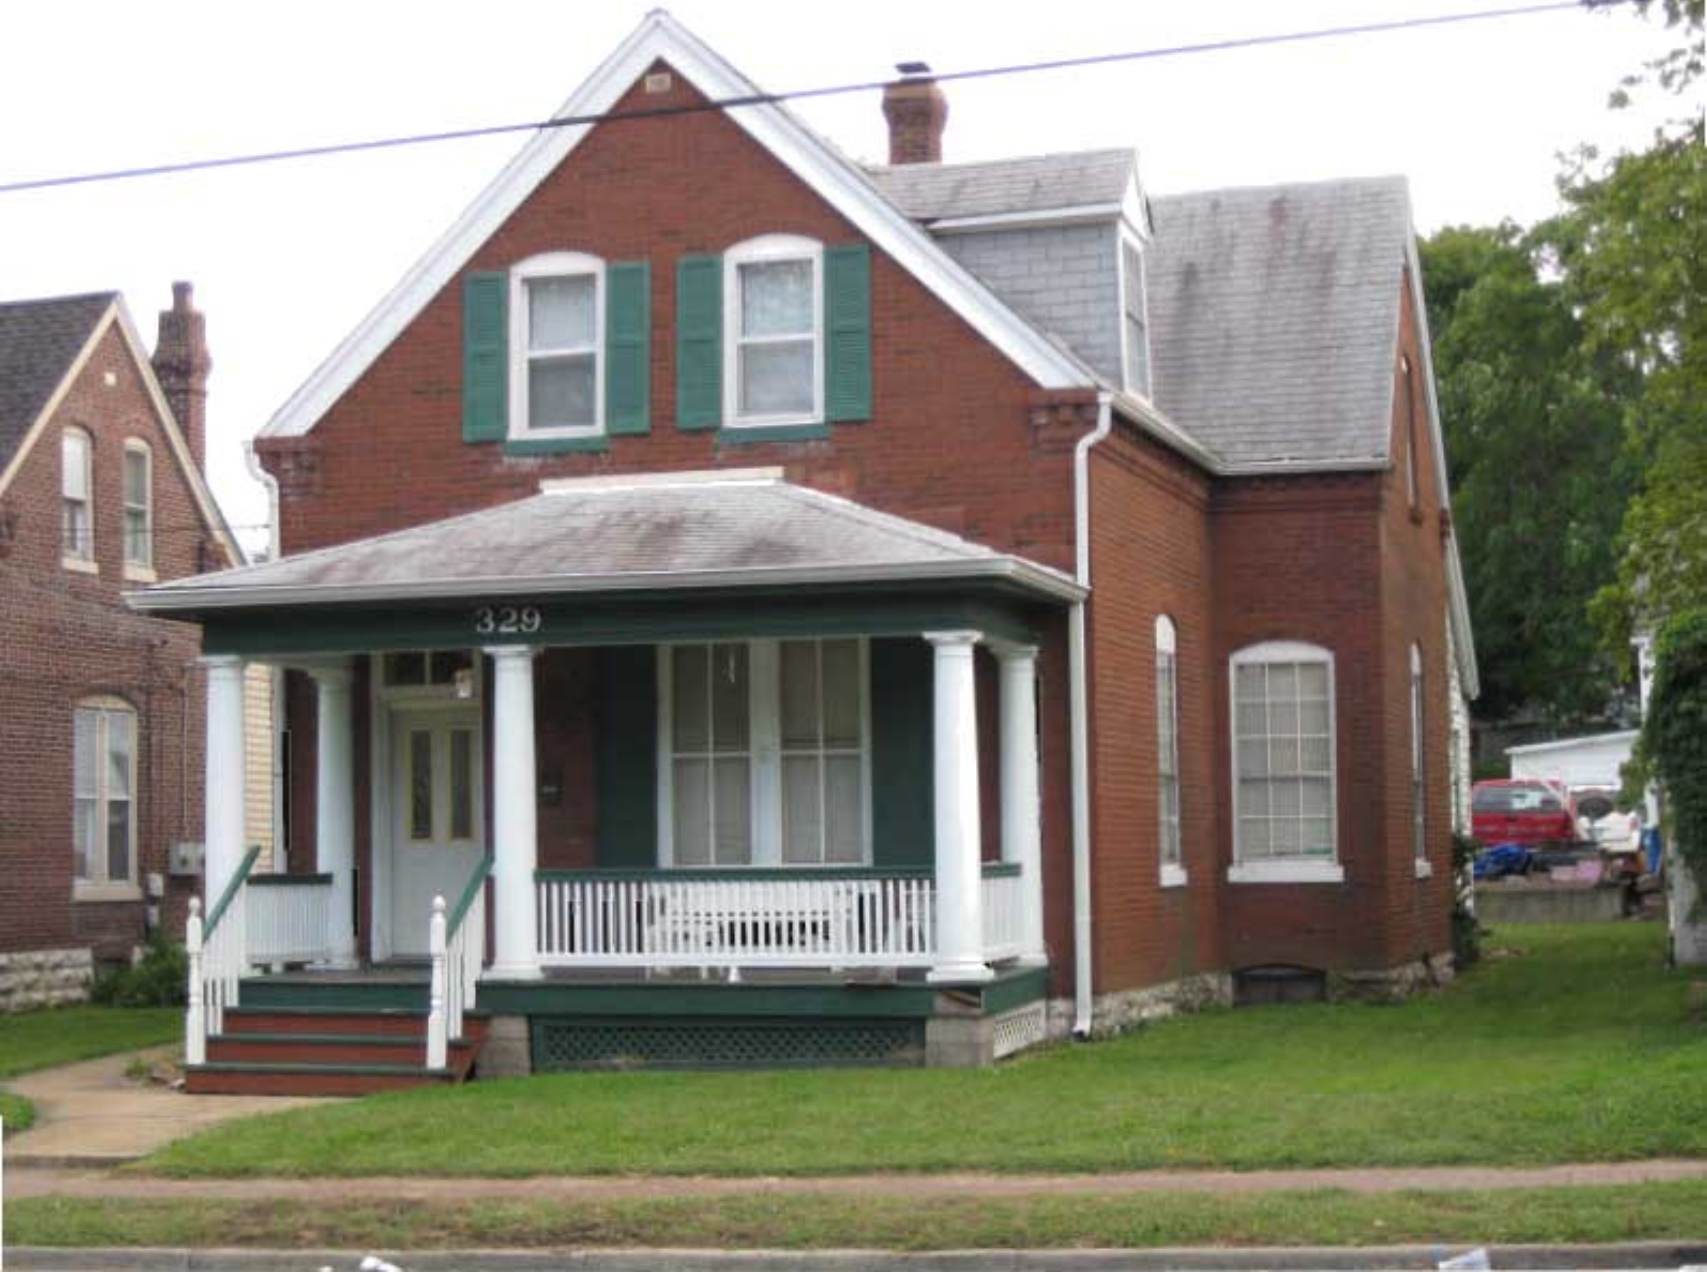
This nineteenth century, cross gabled, T-shaped, brick house has Colonial Revival stylistic details, most notably the porch columns, the brick dentil course under the eaves and pedimented dormers. The house has a rock faced, ashlar limestone foundation. The base of the T forms the front gable end with a full width hipped roof porch that was added to the house between 1909 and 1917. The wood porch floor (and steps) rests on rusticated ashlar limestone piers with latticework between the piers. The porch has three Doric columns across the front of the porch, but the center column is off-center to frame the stairs and doorway in the east bay. There is a plain entablature surrounding the porch. There are additional Doric pilasters against the house. The porch retains its original balustrade, but the railings on either side of the steps are most likely a recent alteration since historic porches typically did not have railings on the steps. The 2-vertical light, 2 vertical panel door is a recent replacement, but the segmental arched doorway retains its transom with its 2-light wooden storm. The west bay has a large, brick segmental arched lintel with paired, segmental arched windows. The area between the brick lintel and the windows has incised detailing and there is a bullseye detail on the mullion between the windows. The historic windows are 1/1 wood sashed windows, but the wooden segmental arched storms are 4-light. Flanking the window opening are what appear to be wooden shutters. On the second floor of the facade are two segmental arched 1/1 windows that may be replacements since they appear too short for the openings, but the shutters appear to be wooden. On either side of this front gabled wing are pedimented dormers with replacement multipaned sashed windows. There is a large pedimented dormer on the east facade of the rear cross gabled section of the house with a 1/1 wood sashed window in a segmental arched opening. On the west side of the front wing, as well as on the facade of the west gabled wing, there are two more segmental arched windows, both with multipaned replacement windows (replacement windows probably installed in 1980 after the 1979 fire). The east and west elevations of the rear cross gabled wing have vertically aligned segmental arched sashed windows as well. Across the rear is a large frame addition, portions of which appear to have been the enclosure of the rear porch (west end) completed by 1929, but sometime after 1947 the one story addition on the east half was enlarged and became a two story gabled addition with a shed roofed porch added to the west with a shed roof dormer centered on the back side of the cross gable. This frame section of the house is now sided with vinyl siding. The house retains its corbelled brick chimney centered near the ridge of the house. Although some windows have unfortunately been replaced with non-matching windows, from the facade the house appears to retain most of its historic features.

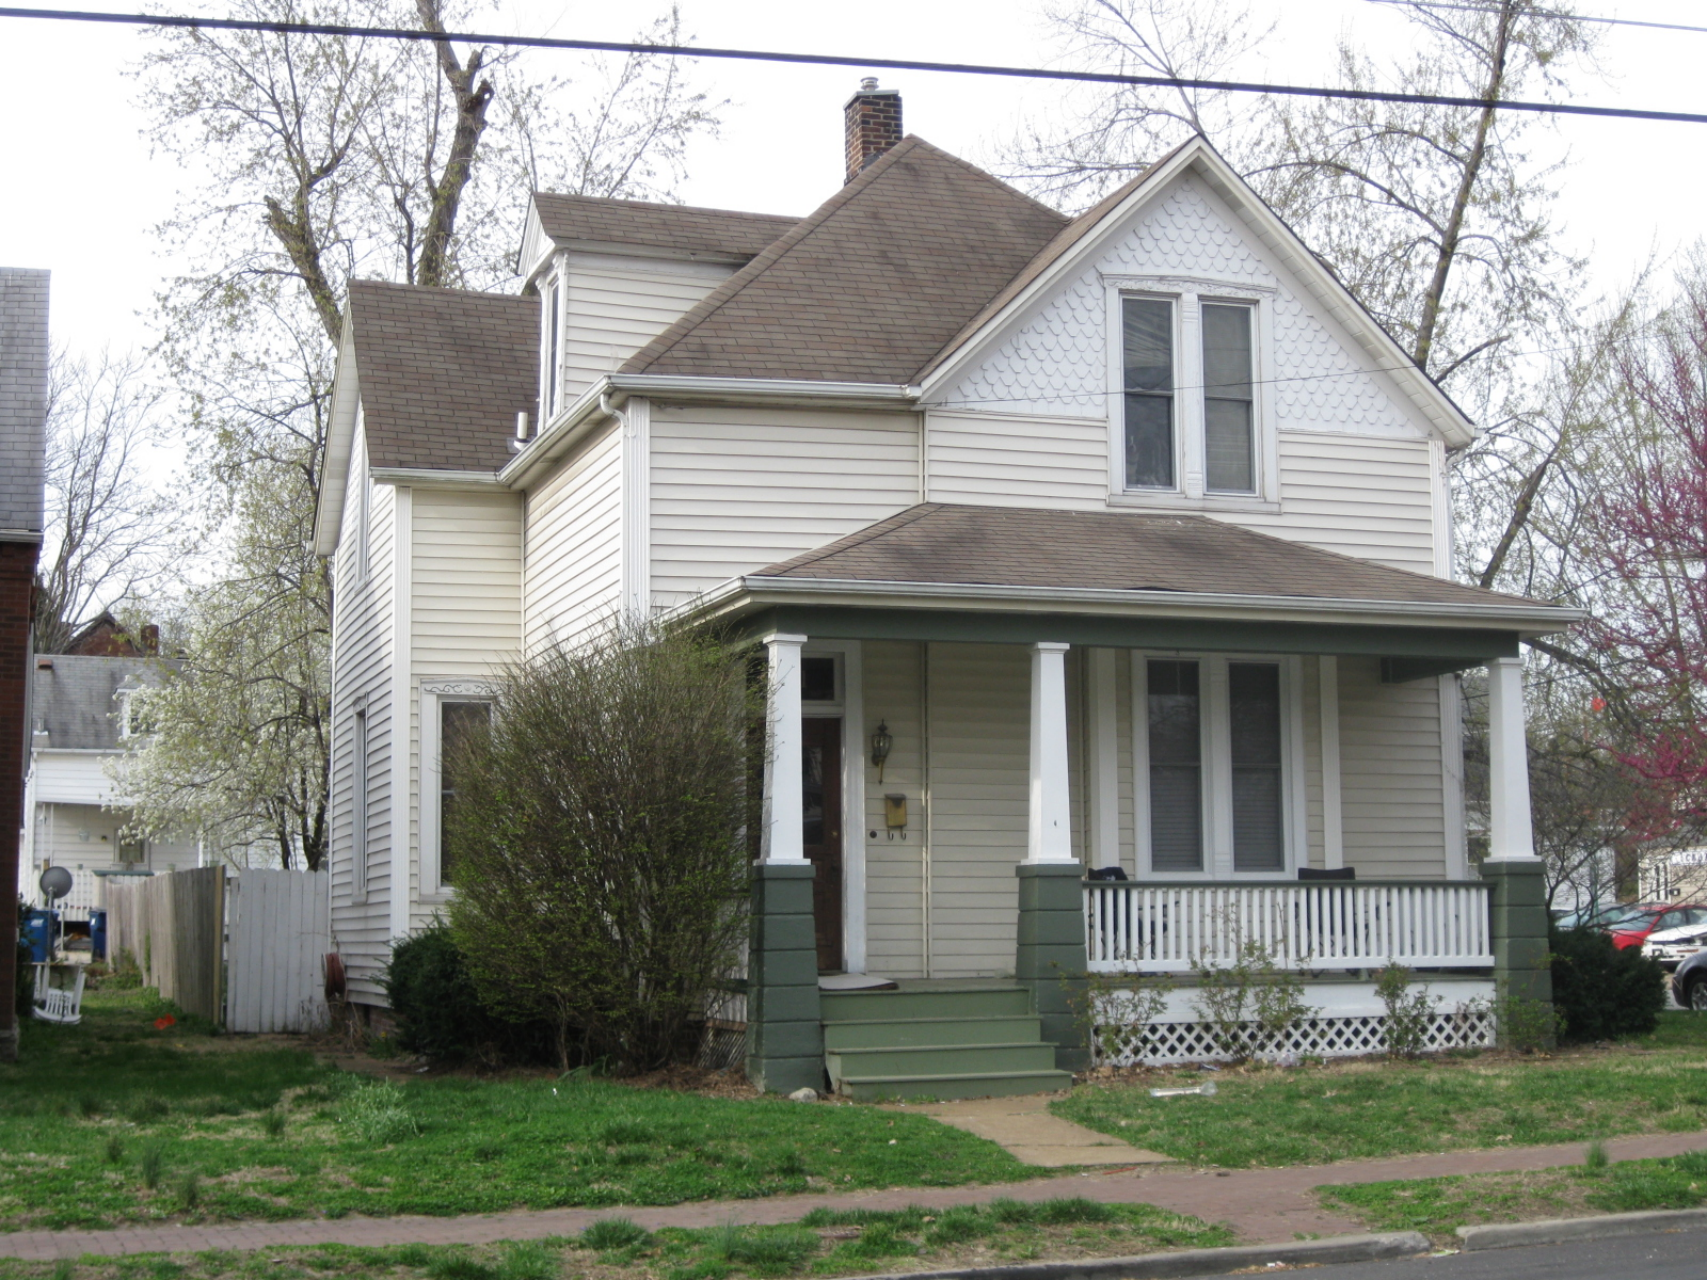
This hipped roof, 1.5 story frame house has a large gabled bay spanning the west half of the facade that projects slightly from the main facade wall. The gable end is clad in fishscale shingles and has paired 1/1 windows with a slight point to the crowned lintel with embossed detailing below the lintel and a decorative pilaster strip between the windows. Directly below, there is a boxed bay with paired windows that have a similar decorative pilaster strip between the narrow 1/1 windows. In the east bay of the first floor is the transomed doorway. The door is a half glazed wood door with a narrow horizontal panel between the glass and the wide horizontal panel near the base of the door. Around the glass and lower panel is incised wavy patterned trim with bullseye corner blocks and there is a basket of flowers in the lower panel. The full width, hipped roof porch spans the entire facade and dates to between 1917-1929 when the fire insurance maps show that the previous single bay porch was replaced to update the facade with Craftsman detailing. The porch is supported by battered boxed half columns resting on scored concrete battered piers that extend to the ground, and there is latticework below the wood porch floor and a simple wood balustrade. On the east side of the hipped roof is a pedimented dormer with decorative pilaster strips on either side of the sashed window. The rear of the house has a two bay wide, hipped roof porch with plain wood posts with what appears to be two transomed doors. On the second floor of the rear elevation are two 2/2 sashed windows. Although some of the windows appear to have been replaced and the walls have been clad with vinyl siding (which replaced the previous replacement siding of asphalt shingles shown in the 1988 survey photo), the Victorian detailing and window trim was carefully left exposed. There is a red brick chimney flue at the peak of the hipped roof.

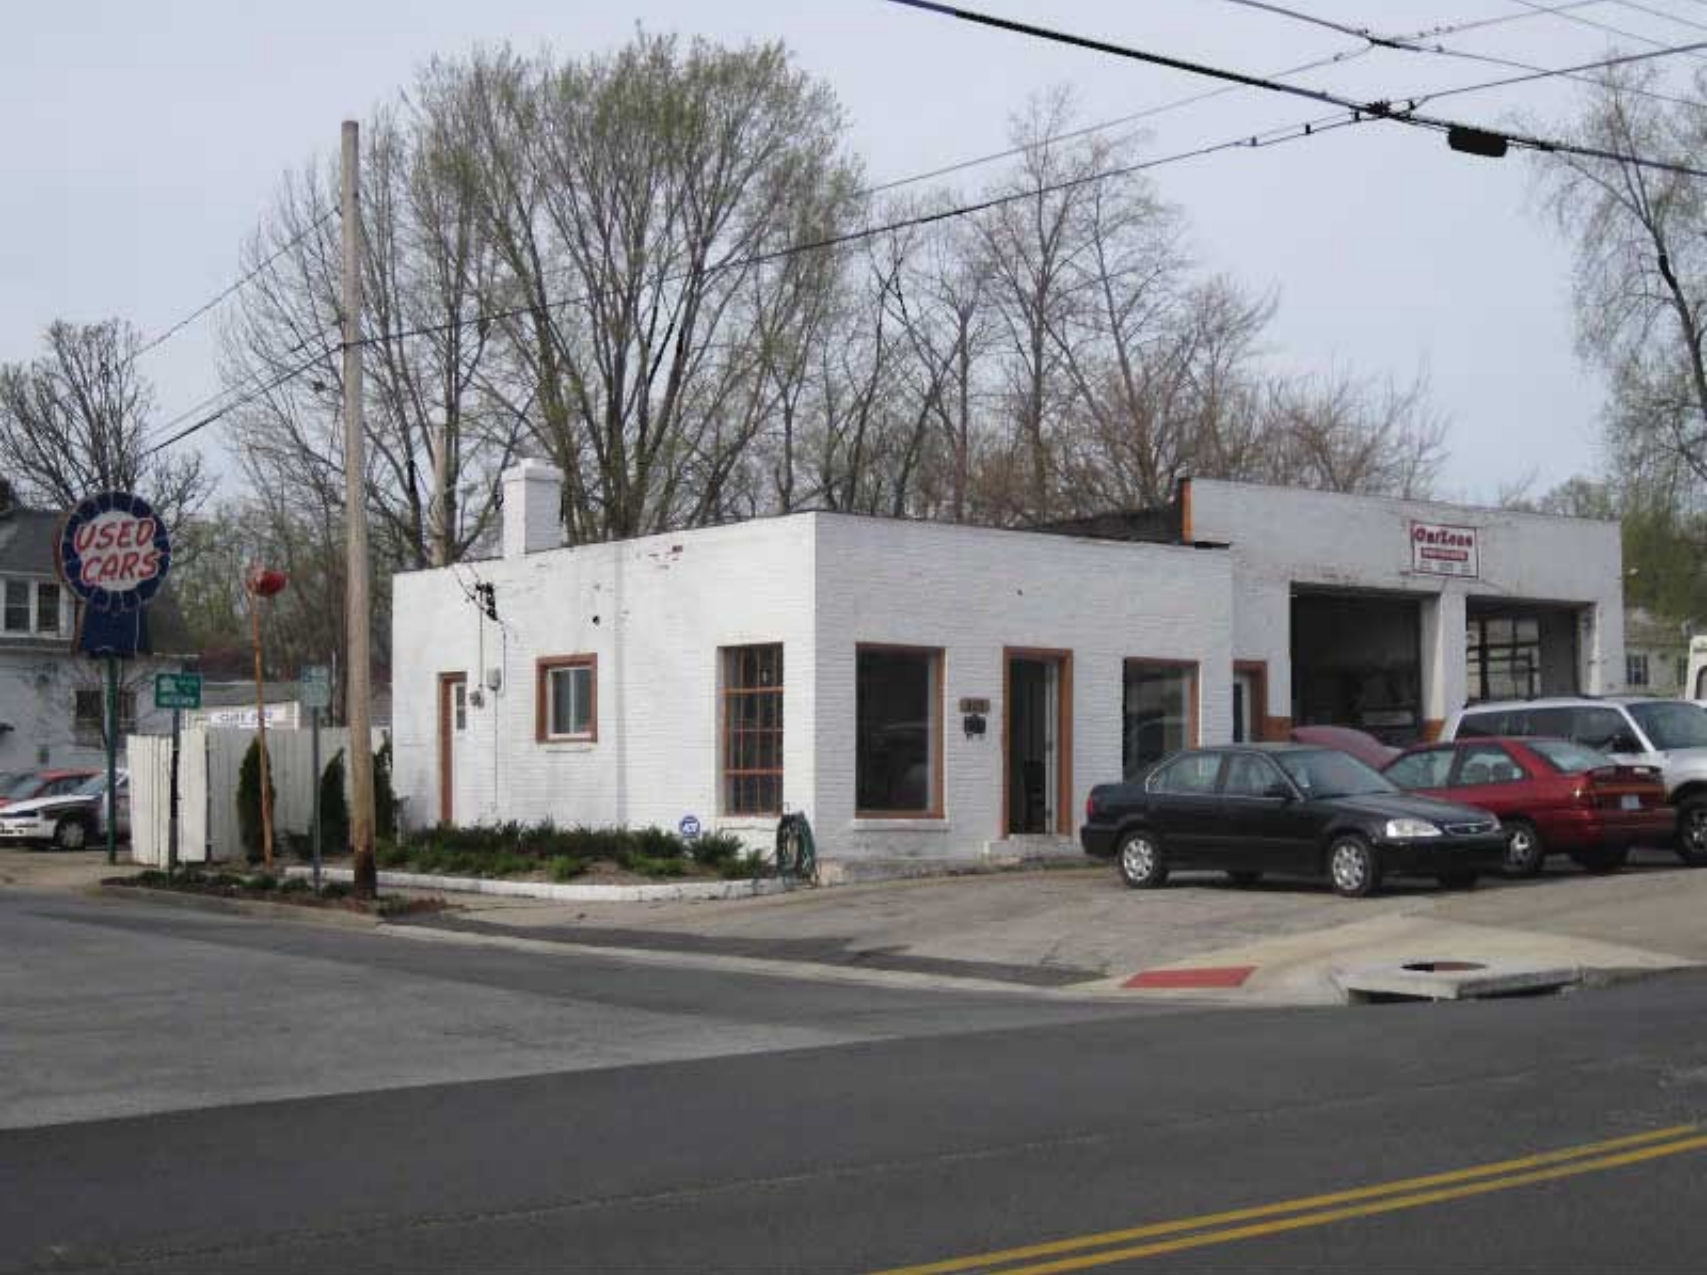
This one story, flat roofed, brick garage has been painted white, but retains most of its historic features. The building is set back in the lot and built in two rectangular parts, with the garage bays having a slightly higher flat roof with a brick false parapet, and it is set back slightly from the three bay garage office. In the east half of the facade, the door is centered between large plate glass windows with brick sills. The upper third of the door is glazed (4 lights) and there are two tall vertical panels below. The west half of the facade consists of two large overhead doors, both multipaneled with all but the bottom row being glass. To the east of these doors is another man door, which is a full light wood framed door. On the east side elevation there is a large industrial steel window on the north end, near the façade, and a high horizontal window mid-building that appears to be a replacement sliding window. In the southern bay of the east elevation is a secondary door with 4 lights in a small square opening above tall vertical panels. On the rear (south) elevation, there are two high, horizontal industrial steel windows on the west portion of the garage and in the east portion, which has a shorter roofline, there are three smaller windows (two of which have been boarded in, but the easternmost one retains its industrial steel sash).

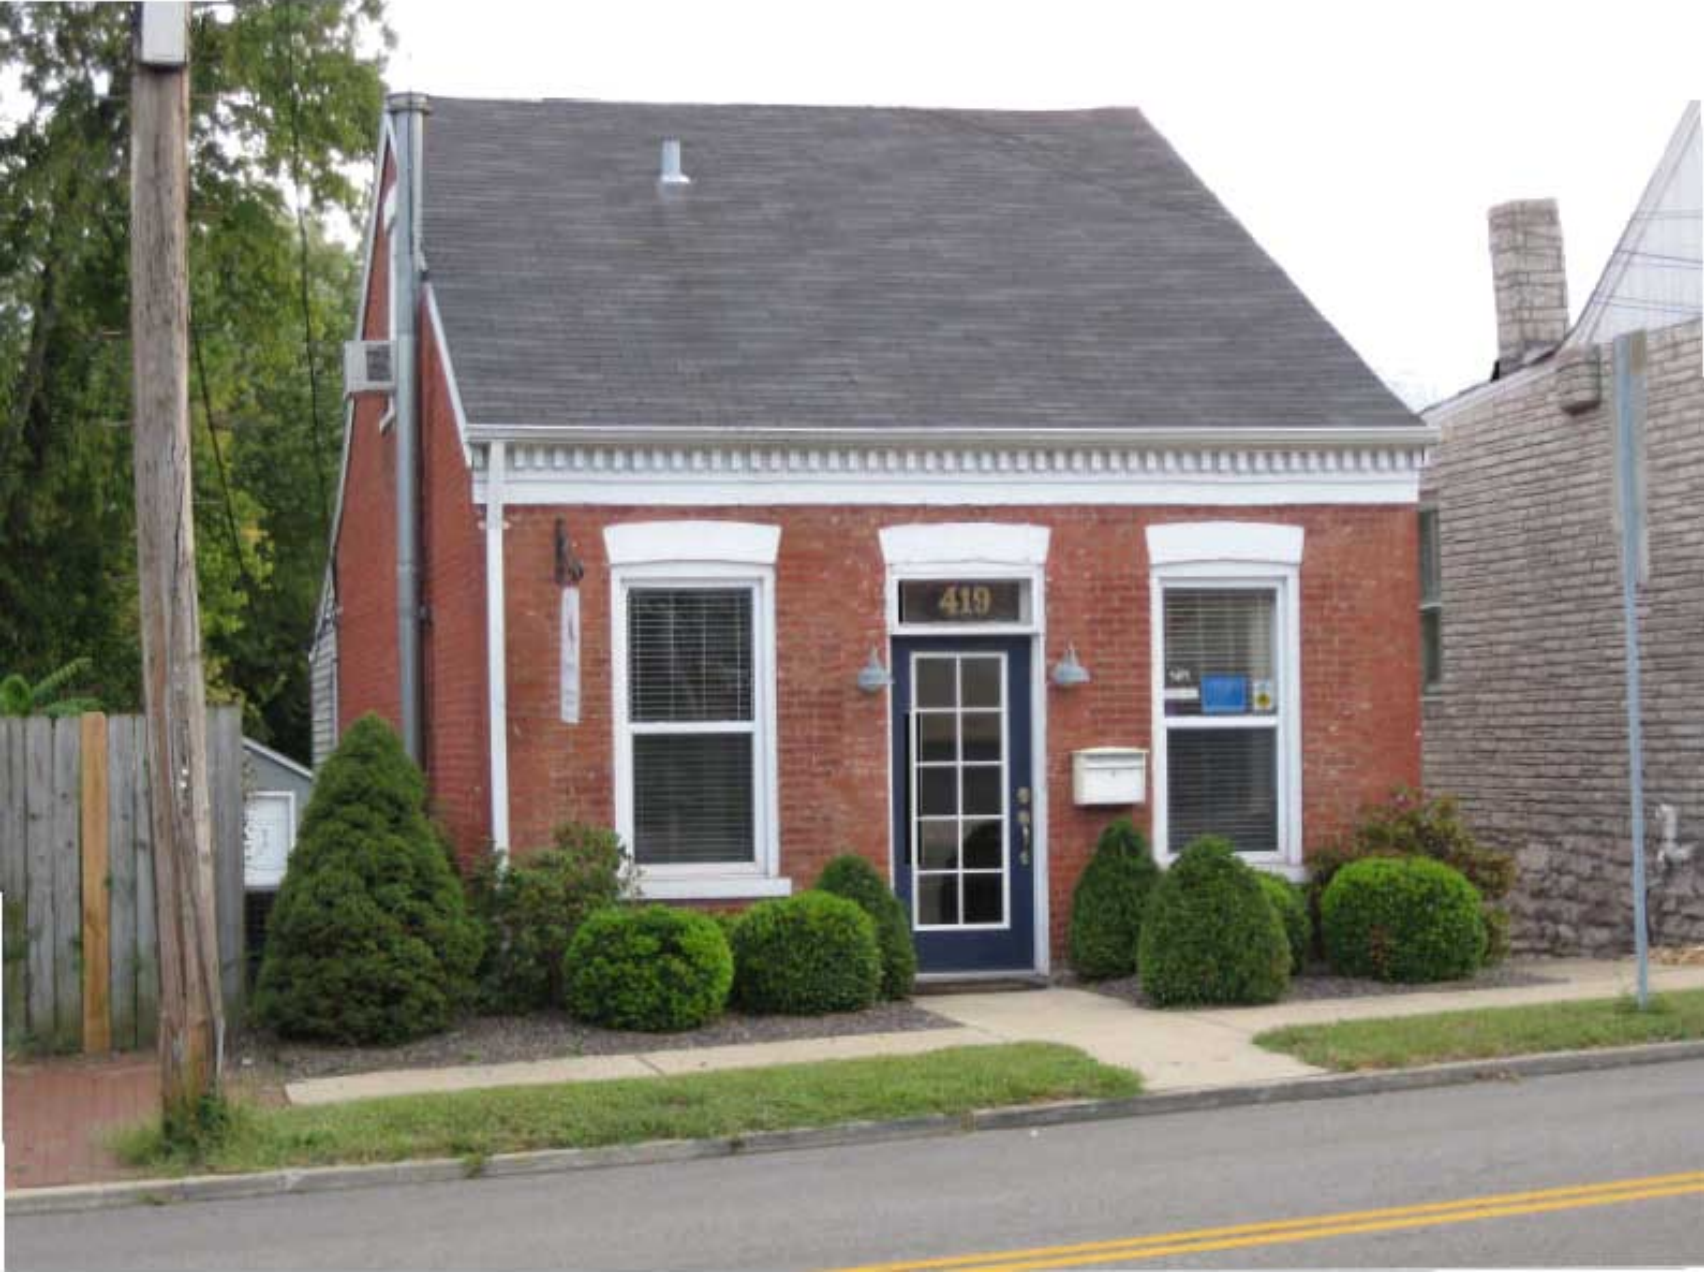
This simple, 1.5-story, side gabled brick house has a brick dentil cornice and symmetrical facade, with a window on either side of the central doorway. This simple design is a common early Colonial Revival design, one that would be popularized in the mid-twentieth century again as the Cape Cod style. The windows on this house have brick segmental arches, indicating it was a late nineteenth century design (since earlier brick houses would have used stone lintels). The brick is laid in a 7-course common bond and appears to have a color wash, a common practice historically, not an alteration. However, the dentil course and the segmental arched bricks have been painted white recently. The windows have been replaced with 1/1 vinyl windows and the front door has been replaced with a multipaned door, but still retains an older single light transom. The entry is at grade, with a concrete sidewalk leading to the door. On each side elevation, there are two windows on the first floor and one centered on the second floor, all segmental arched openings with 1/1 vinyl windows. On the east side, there is an exterior, galvanized flue. On the rear, the east half of the original full width porch has been enclosed and sided with vinyl siding. The contrasting paint, while easily reversible, does impact historic integrity. The replacement windows may mirror the original window pattern, but more likely they were 2/2 windows given the era of the building. Despite the alterations, the basic style and features such as the roofline, the dentil molding, and the original window and door openings that identify this as a simple, late nineteenth century Colonial Revival house are still intact, and as such it is minimally contributing to the historic district.

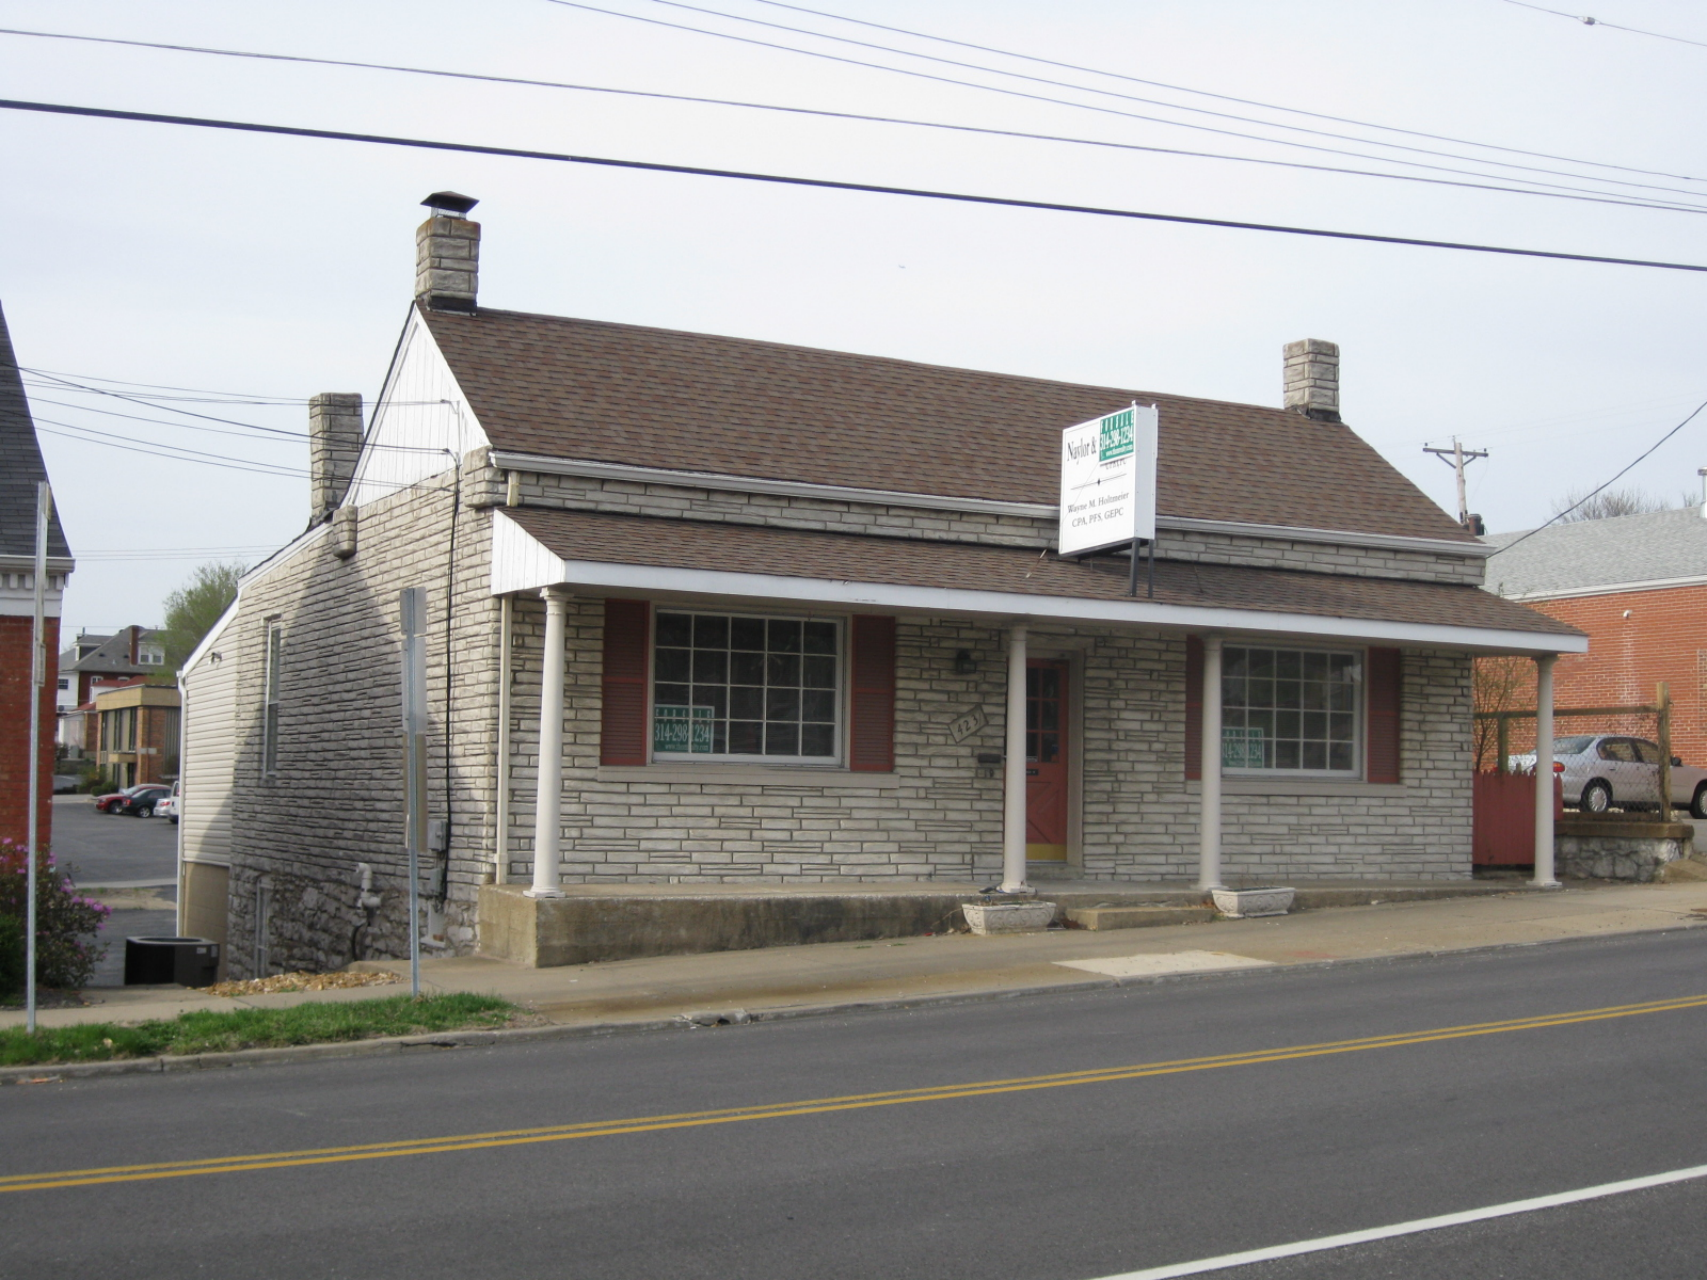
This one story, side gabled house appears to have been altered drastically, although it retains its two end wall chimneys that help define it as an early design. What were most likely brick walls are now clad with permastone, and there is a full width, shed roofed, front porch that is supported by a series of four modern Doric columns that rest on a poured concrete porch floor, but this porch is not shown on fire insurance maps, indicating it is a post-1947 addition. The building has a cross-gabled wing on the rear, west end, with a shed roofed, one story section on the east half of the rear, both of which appear to date to at least 1893 when they appear on the fire insurance map. The back walls have been clad with vinyl siding. At least a few of the 2/2 windows appear to be the historic wood sashed windows, but the front windows are multipaned display windows, probably altering the original window openings. After 1947, a shed roofed addition was added on the rear, east half. Because of changes in elevation, on the rear the building is nearly two stories above grade. There is a metal carport added to the west side on the rear as well.

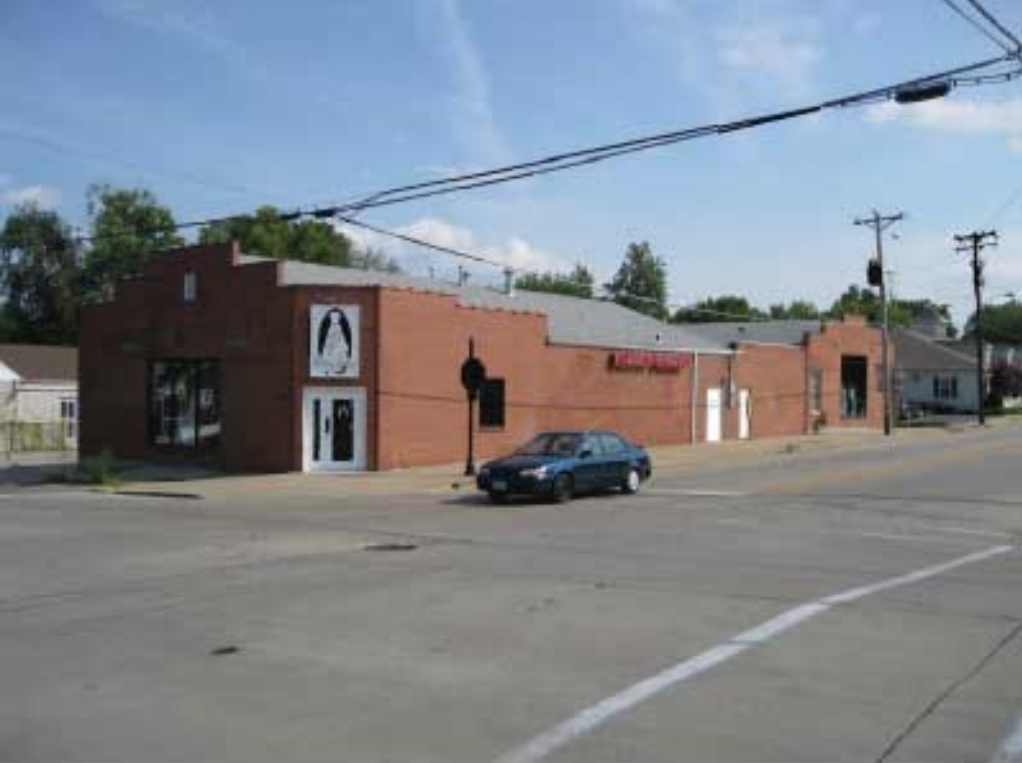
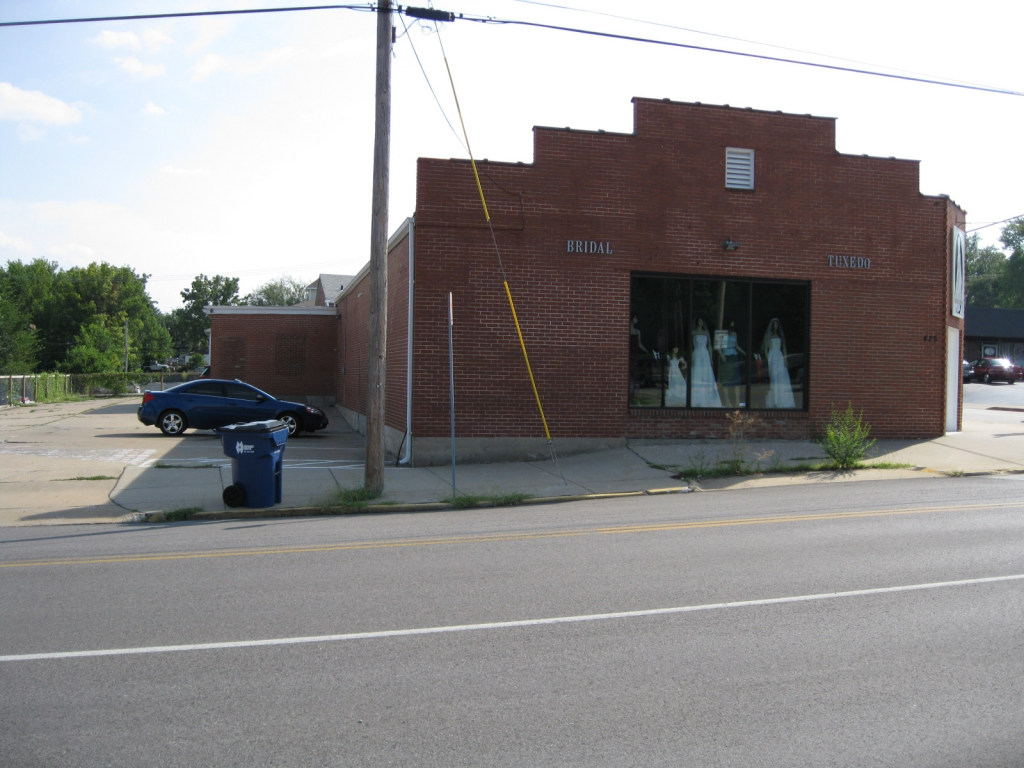
The current red brick building was originally built as two separate buildings and at some point after 1947, the two were connected by an addition. The north building, facing Clark, is a one story, brick commercial building with a stepped, false parapet extending above the end gabled roof. Centered on the facade there is a large opening that in 2008 housed an overhead door, but was probably a display window originally since this was a grocery store. In 2008 it once again became a display window, and this window is metal framed and divided into three panes by metal mullions. The northwest corner (facing the street intersections at Clark and Fifth) of the facade is angled with the interlaced brick providing a decorative detail on each corner and framing the simple doorway which housed paired, nonhistoric, glazed aluminum framed doors in 2008. These doors were replaced with a wood framed full light door and full light sidelight. The parapet continues to step down on the west, street elevation to the back of what would have been the original rear wall, where there is a simple window opening (now plate glass) with a brick sill. This wall now continues as a brick wall with a side gabled roof of what appears to be the first addition to the supermarket. At the south end is a simple doorway with a flush door. Behind the gabled roofed addition, there is another addition, a one story addition with a short parapet facing Fifth that has another simple flush door, but appears to have had a sashed window that has since been bricked in. This addition connects to the other original section of the building, a stepped parapet facade facing Fifth in front of an end-gabled roof. Centered in this facade is another metal framed display window that replaced an overhead door in 2008, but this overhead door may have been original since this was originally a freestanding building that was used as a welding shop. To the north side, there is an original multipaned steel window. The parapets on both original sections retain the original clay tile copings. The foundations are poured concrete. On the east side, the rear addition just north of the old welding shop building extends deeper toward the east (into the area used as a parking lot); it has a flat roof with soldier course lintels over what were two windows that have been bricked in. Because the additions connect what were historically two separate buildings, this building cannot be a contributing building to the historic district unless the precise date of the additions can be documented as falling within the period of significance for the district.

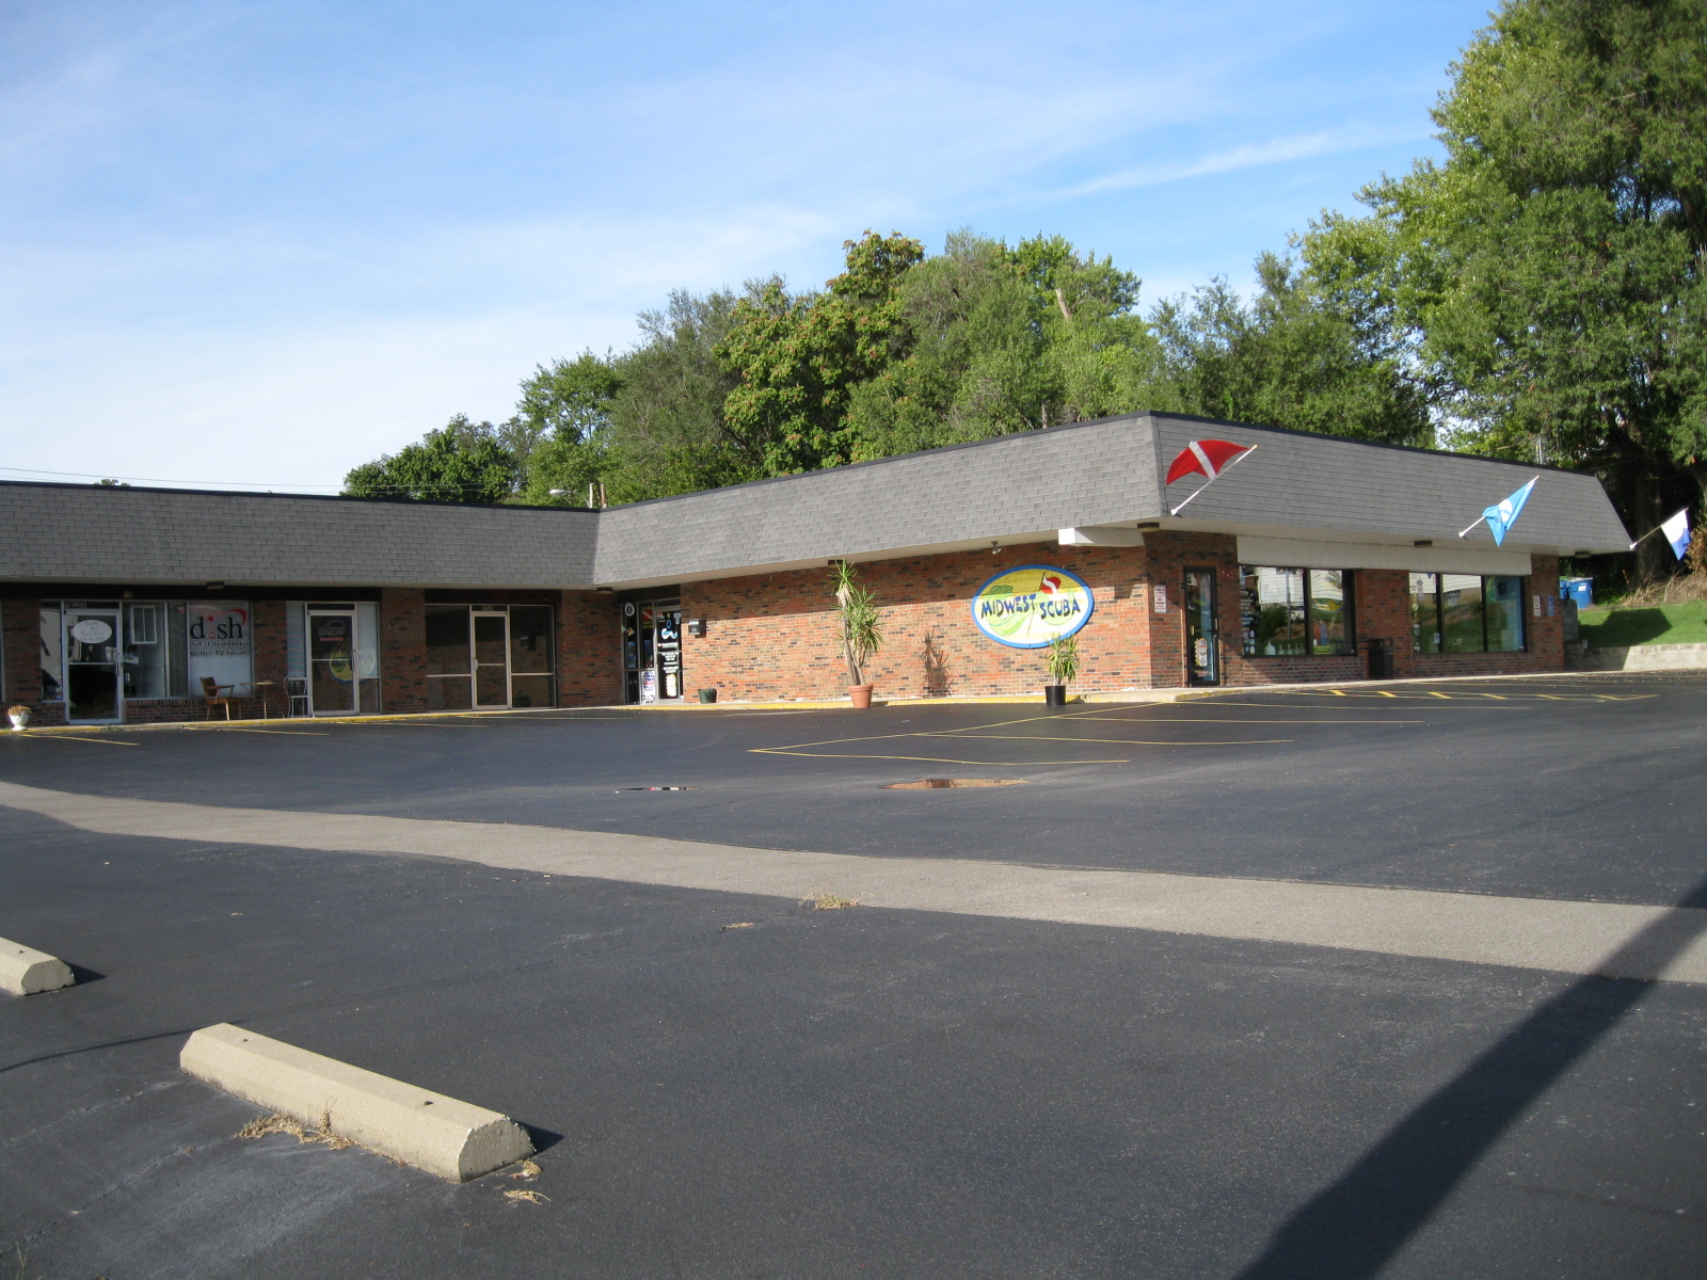
This one story, flat roofed, salmon colored brick strip shopping center is laid out in an L-shaped plan with the parking lot on the interior of the L, facing the intersection of Fifth and Clark. There are three storefronts in the south leg of the L, facing north, each with a display window and door, all aluminum framed glass. The walls facing Fifth are devoid of fenestration and there is one aluminum framed door facing east in the interior corner of the complex. The west leg of the L is used for one business and has two large display windows, aluminum framed, and an aluminum framed doorway, facing north onto Clark. The building appears to have been modified from its 1970 design since it has large mansard awnings with asphalt shingles on each street elevation. This is noncontributing to the historic district because of its age but it would also be noncontributing due to this major alteration.

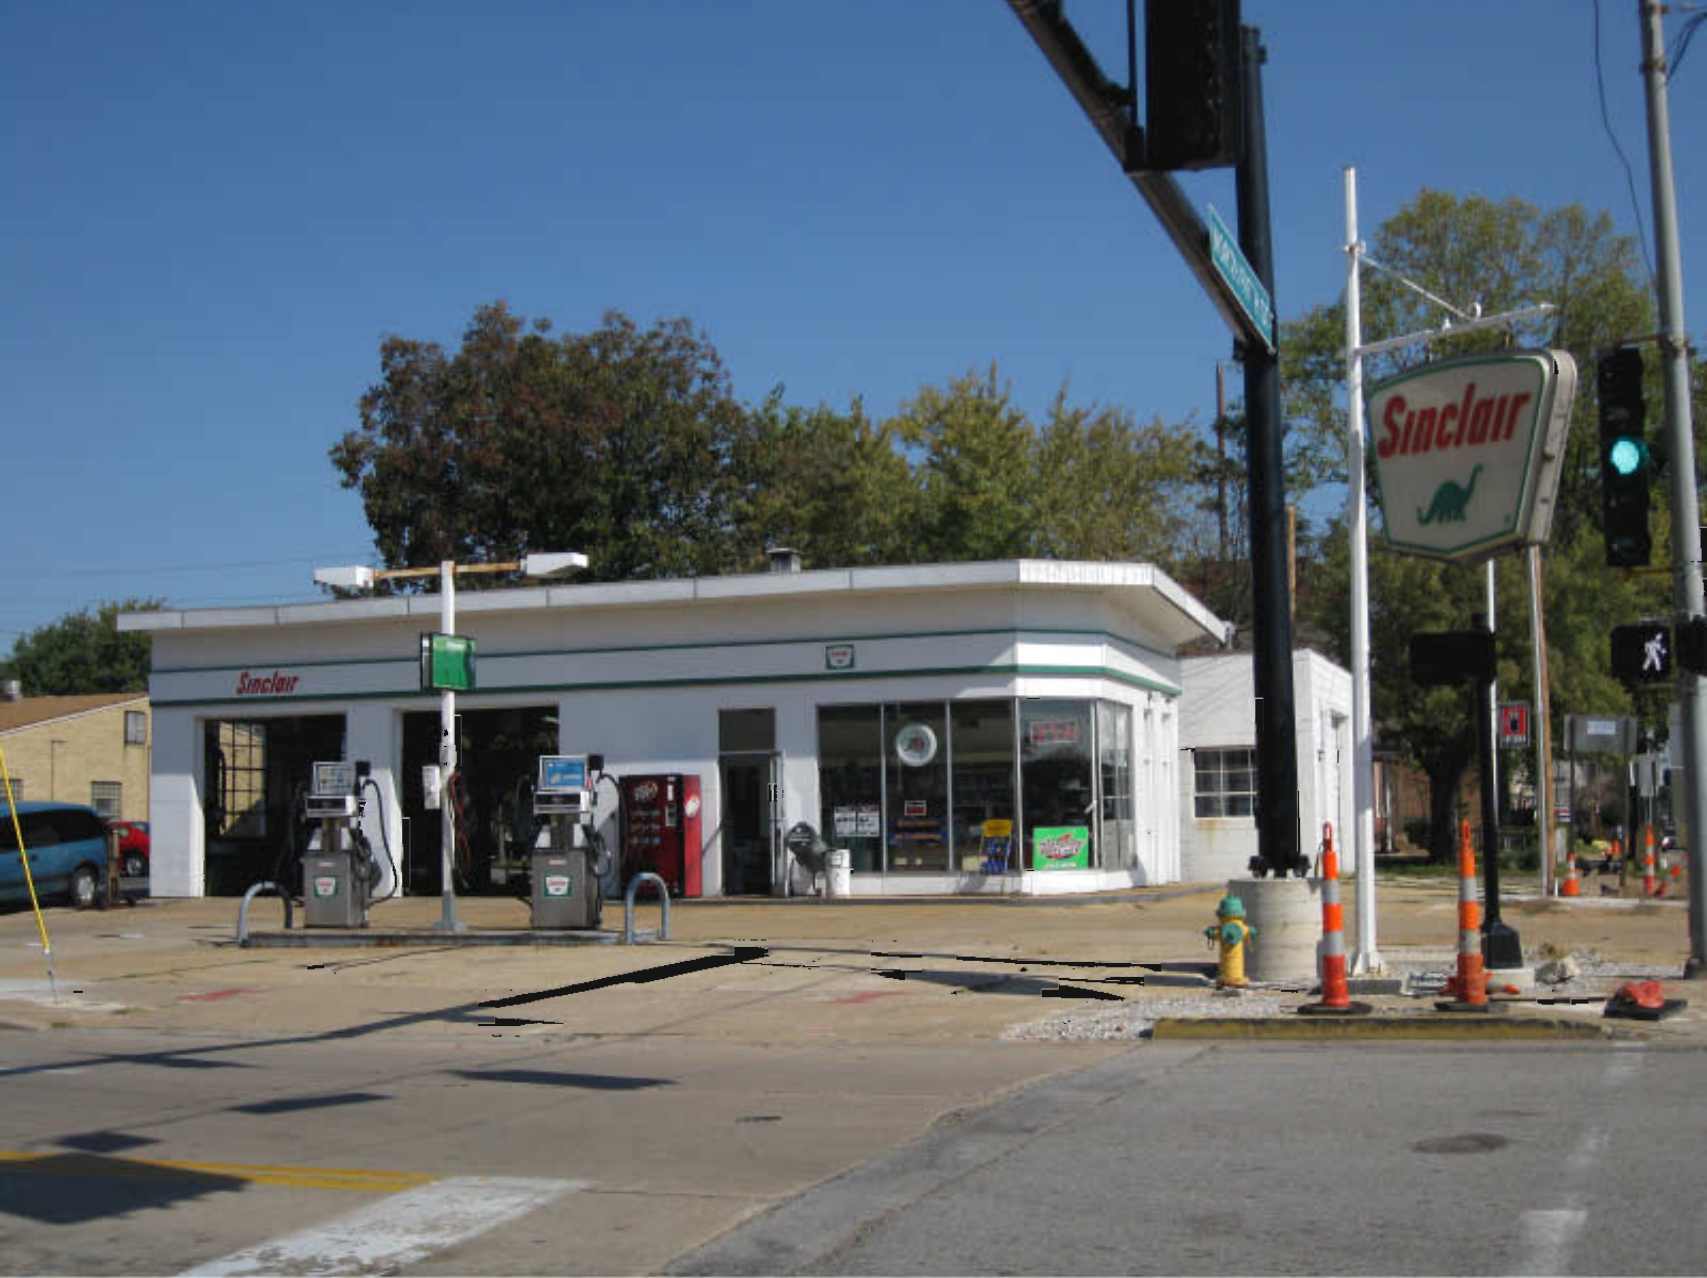
This one story, flat roofed service station is laid out basically in an L-shaped plan, although the short leg of the L is offset slightly to form a projecting garage bay facing Fifth. The main facade faces First Capitol. The building is built of concrete block with the street elevations of the main building clad in enameled steel panels, a distinctive 1950s material. Most of the panels are white, but the area above the windows incorporates two narrow bands of green to separate the horizontal bands. This main building has a clipped corner, facing the intersection, giving it the appearance of a rounded corner as does the flat, projecting canopy that surrounds the street elevations of the main building. On the west half of the façade are two large garage bays with aluminum-framed, overhead doors that are mostly panels of glass (12 lights per door with a narrow bottom row of panels). Wrapping the corner on the east end is a large display window, divided into vertical panels by aluminum mullions. To the west of this window is a transomed, aluminum framed, full light commercial door. On the remainder of the east elevation of the main building there are two man doors, probably to the restrooms which were characteristics of the new model of service station in the 1950s. On the west elevation of the main building there are two industrial windows. At least one of the garage bays is a pass-through service bay with a garage door on the rear, north elevation of this main building. The rectangular wing that is offset and that creates the leg of the L-shaped plan has an additional garage door facing east, with a window to the north and a series of matching windows on the north elevation. There is also one additional window facing south where this wing projects slightly from the main building. The windows are 12 horizontal light aluminum framed windows. Except for damage to the enameled steel panels in the canopy, the building appears to have no alterations; even the aluminum-framed doors and windows are original to the design, as is the pole light over the two gas pumps (although the pumps are newer). The pole sign with the Sinclair sign hanging from the arm appears to be a slighter newer than the ca. 1955 construction, but it too appears to be very old given its styling.

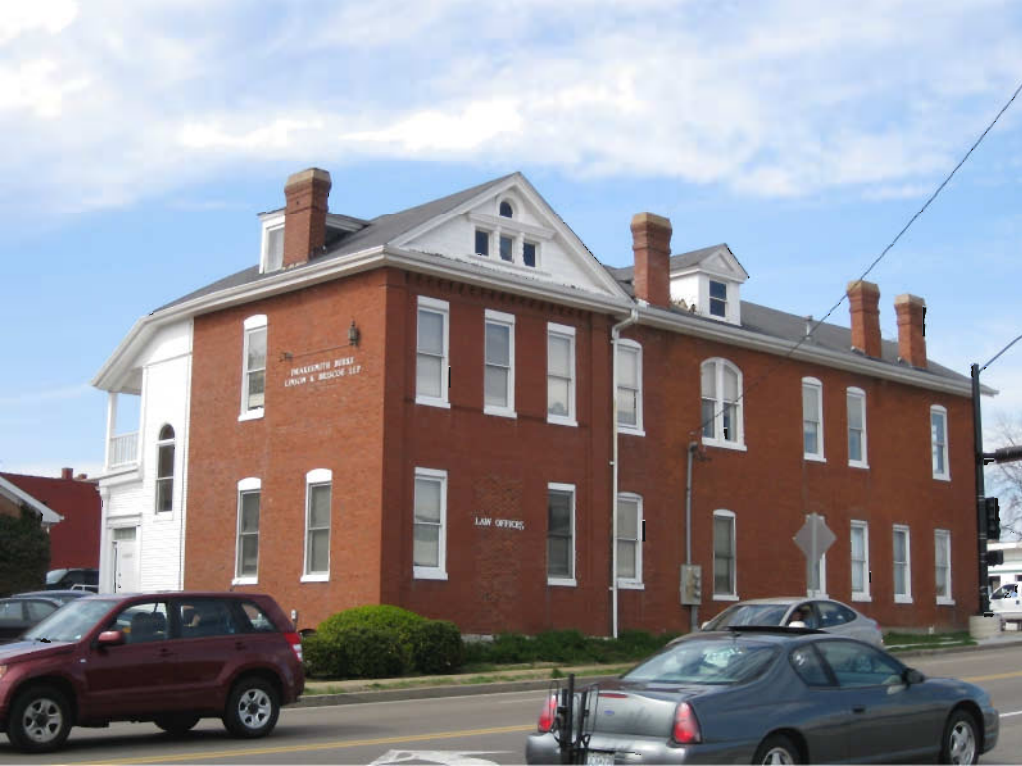
The building has had windows replaced and a number of the openings on the east street elevation modified, as well as entries added to the west elevation, but the building still retains much of its historic integrity and is still contributing to the historic district.
