ARCHITECTURAL/HISTORIC INVENTORY FORM

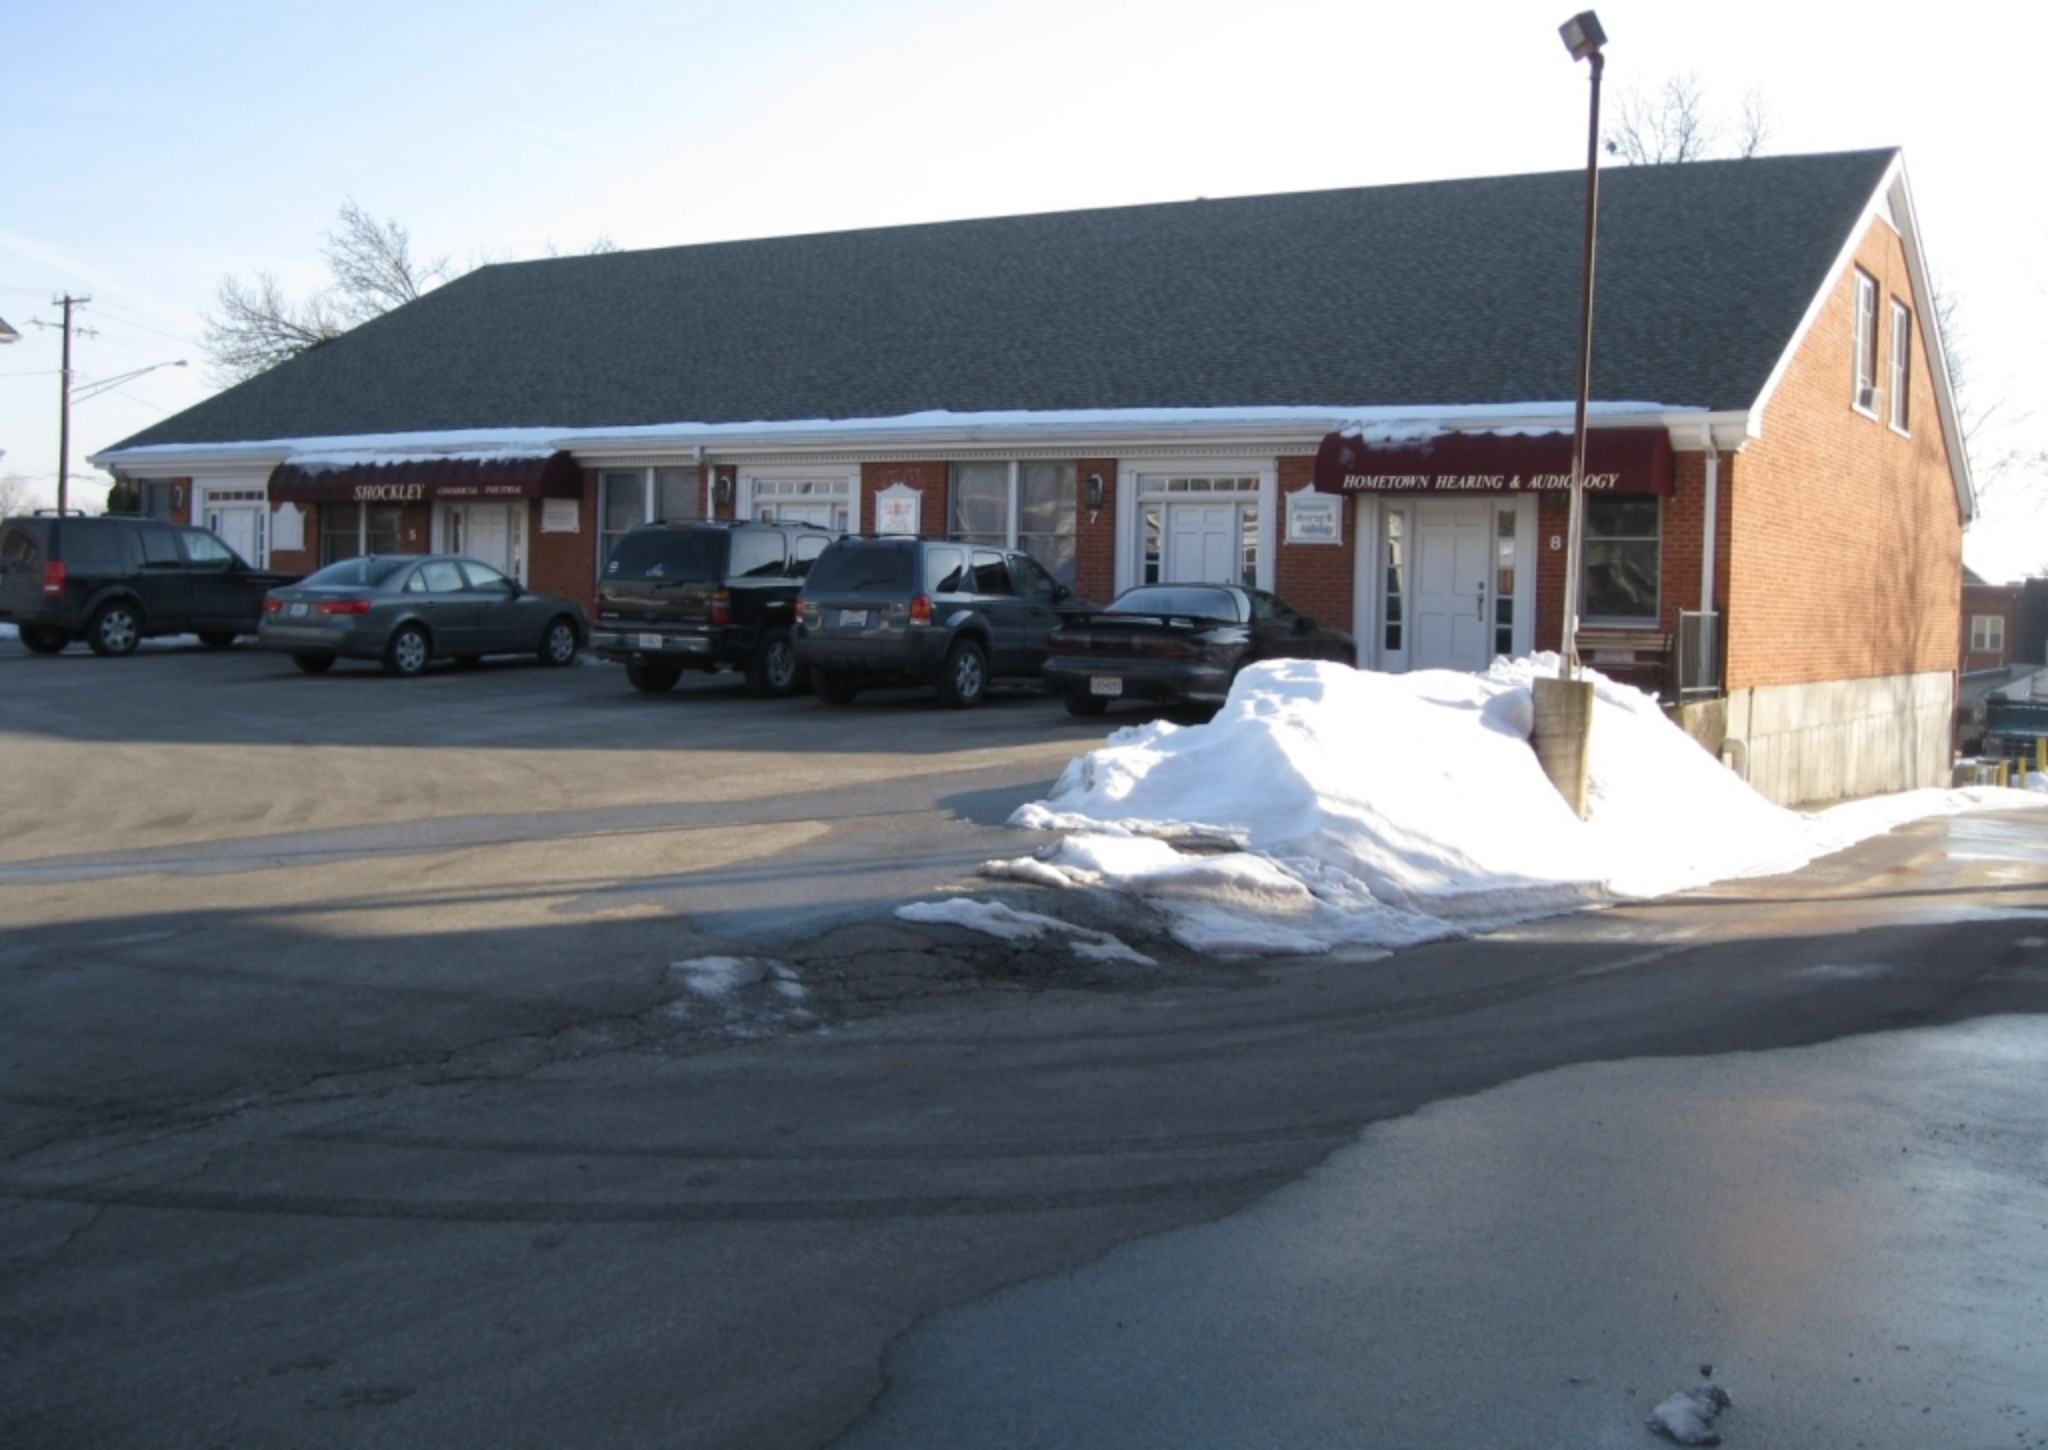
This side gabled, 1.5 story, red brick building is divided into a series of five businesses, each with a paneled door flanked by 5-light sidelights and spanned by 5-light transoms with simple pilasters and entablatures. The outer bays on each end have a 1/1 sashed window while the other three bays have paired 1/1 sashed windows. The side elevation on the west slopes downhill, exposing the concrete foundation. Both side elevations have two paired 1/1 windows on the second floor. On the rear there are scattered sashed windows on both levels and an exit door.

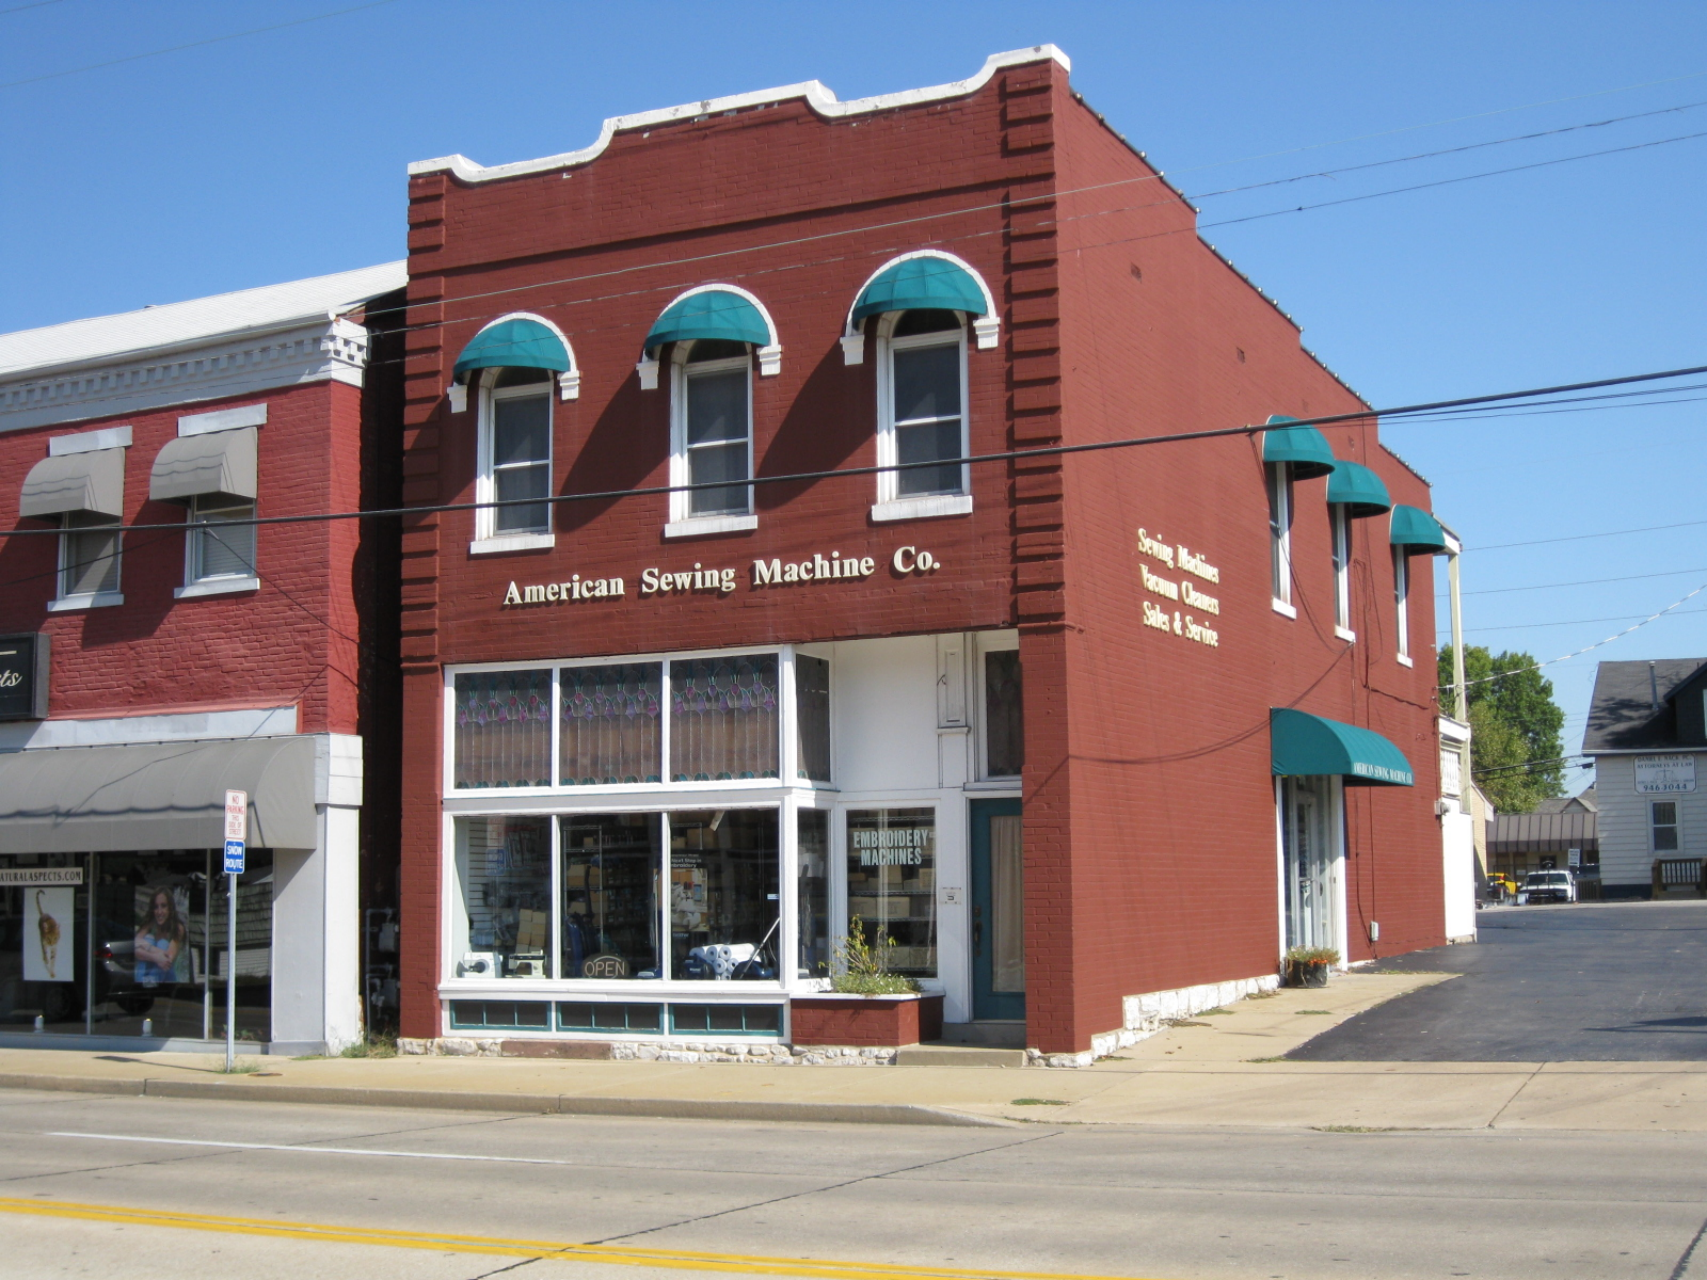
appears there are not transoms. A small portion of the rock-faced, coursed limestone foundation is visible below the facade display windows and along the east elevation. The two story, full width porch on the rear was partially enclosed on the west end between 1917 and 1929. More recently the east end on the first floor has been enclosed. The porch appears to have an internal staircase and a wood railing on the second floor that was replaced by the current owner (the original balustrade had plain balusters). The conversion of one of the doorways into a display window on the facade, the newer entry on the east side, the addition of nonhistoric half round awnings, and the minor alterations recently to the porch are the only noticeable alterations, other than the possible alteration is the stained glass transoms.

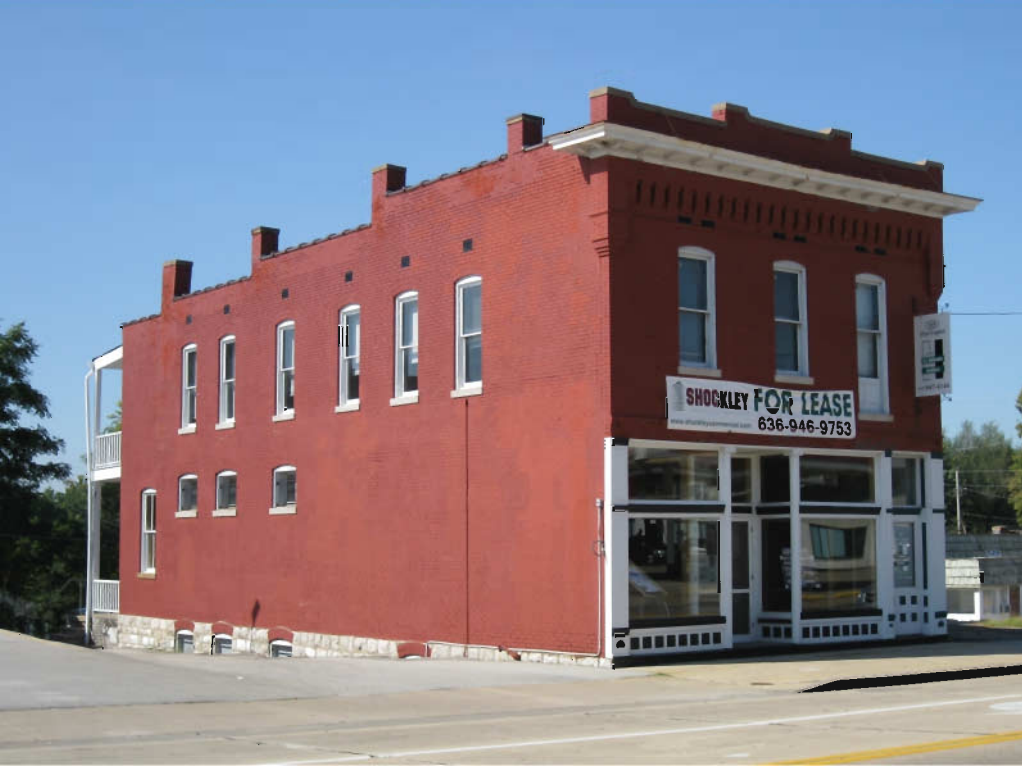
entry is centered between transomed display windows that have bulkheads with small recessed panels. There are paired screen doors in the entry (obscuring the view of the doors). The 1991 photo on file with the city address files, prior to the renovation, show that the transoms and kickplates had been covered over with wood paneling at that time, but the other elements were still intact, including the doors. On the second floor of the east elevation there are also a series of segmental arched 1/1 wood sashed windows with dressed stone sills and there are small brick vents above each window. On the first floor, aligning with the rear three second floor windows, there are high, segmental arched openings with dressed stone sills that have deeply recessed awning windows. Behind these windows there is a lower, segmental arched, 2/2 wood sashed window with a dressed stone sill. The rock faced, ashlar pattern, limestone foundation is visible and there are three basement windows aligned with the casement windows (as well as a partial basement window opening nearer the façade), each within the stone foundation level, but with brick segmental arched lintels. The basement windows appear to be boarded in. On the west elevation, there are 1/1, segmental arched wood sashed windows on both floors near the facade and there are three sashed window openings on the second floor near the rear (middle one is smaller), as well as vertically aligned casement windows on the first floor. The rear of the building is still spanned by the shed roofed, two story porch that is divided by simple wooden posts into three bays with simple baluster wood railings on both floors. Although the 1929 and 1947 map show that the stairs were outside the porch, the way the drawing was done they look disconnected from the porch, possibly trying to indicate that they were internal to the porch as they are today. From 1909, the first map to show the building and in 1917, the Sanborn maps note that the first floor of the rear two-story porch was clad with tin and that the second floor porch was open, but the notations for the tin were removed on the 1929 map. While some of the elements on the rear porch appear to be reconstructions, the remainder of the building appears to be the original historic fabric, restored shortly after the 1991 photo was taken.

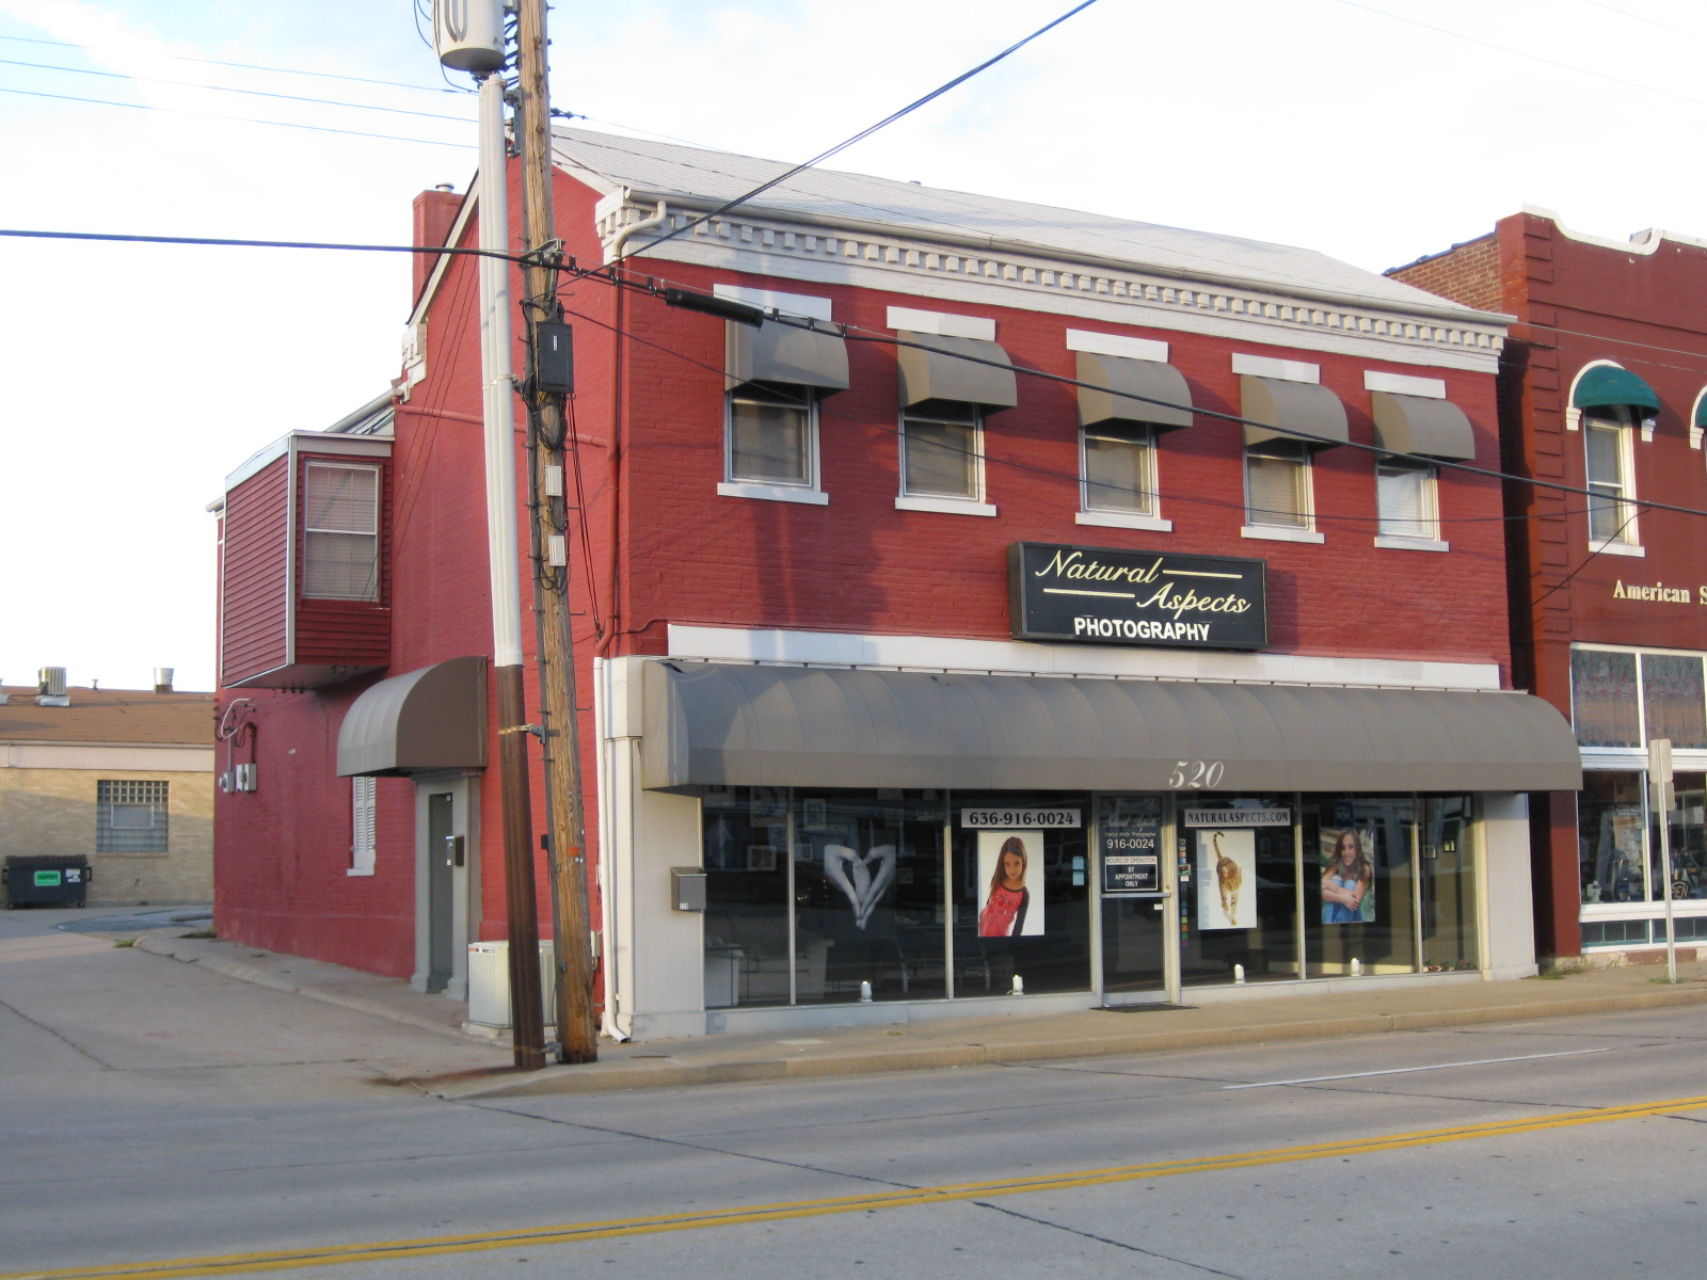
This two story, side gabled, painted brick building was originally built and used as a dwelling. Its Adamesque styling is characteristic of the mid-nineteenth century houses in St. Charles, with its symmetrical facade and its brick dentil cornice front and rear. The upper facade is divided into five bays with stone lintel and sills (painted) on the 1/1 wood sashed windows (which now are covered by aluminum storms and nonhistoric rounded, canvas awnings). The building was converted to commercial use between 1917 and 1929 according to the Sanborn maps and it is likely that is when the first floor first became a commercial storefront with the concrete lintel that spans between the piers, but the shallowly angled storefront is indicative of a later design, most likely redesigned after World War II since it has aluminum framing and tall display windows with a minimal bulkhead. The piers on either end were also modified, clad in painted wood. Along the west side is an intersecting, two story, gabled wing that now has a boxed oriel window on the second floor directly behind the front portion of the building. There is also a chimney at the back of the front gable on this end of the building and there is a side entry door into the west elevation of this front side gabled section. There is a first floor window below the oriel window. Nestled behind the east half of the front side gabled original building, and next to the two story west wing, is a large, one story addition. Although the first floor storefront has been modified and there are nonhistoric awnings on the second floor, the building is still clearly a mid-nineteenth century design and as such a contributing building in the historic district.

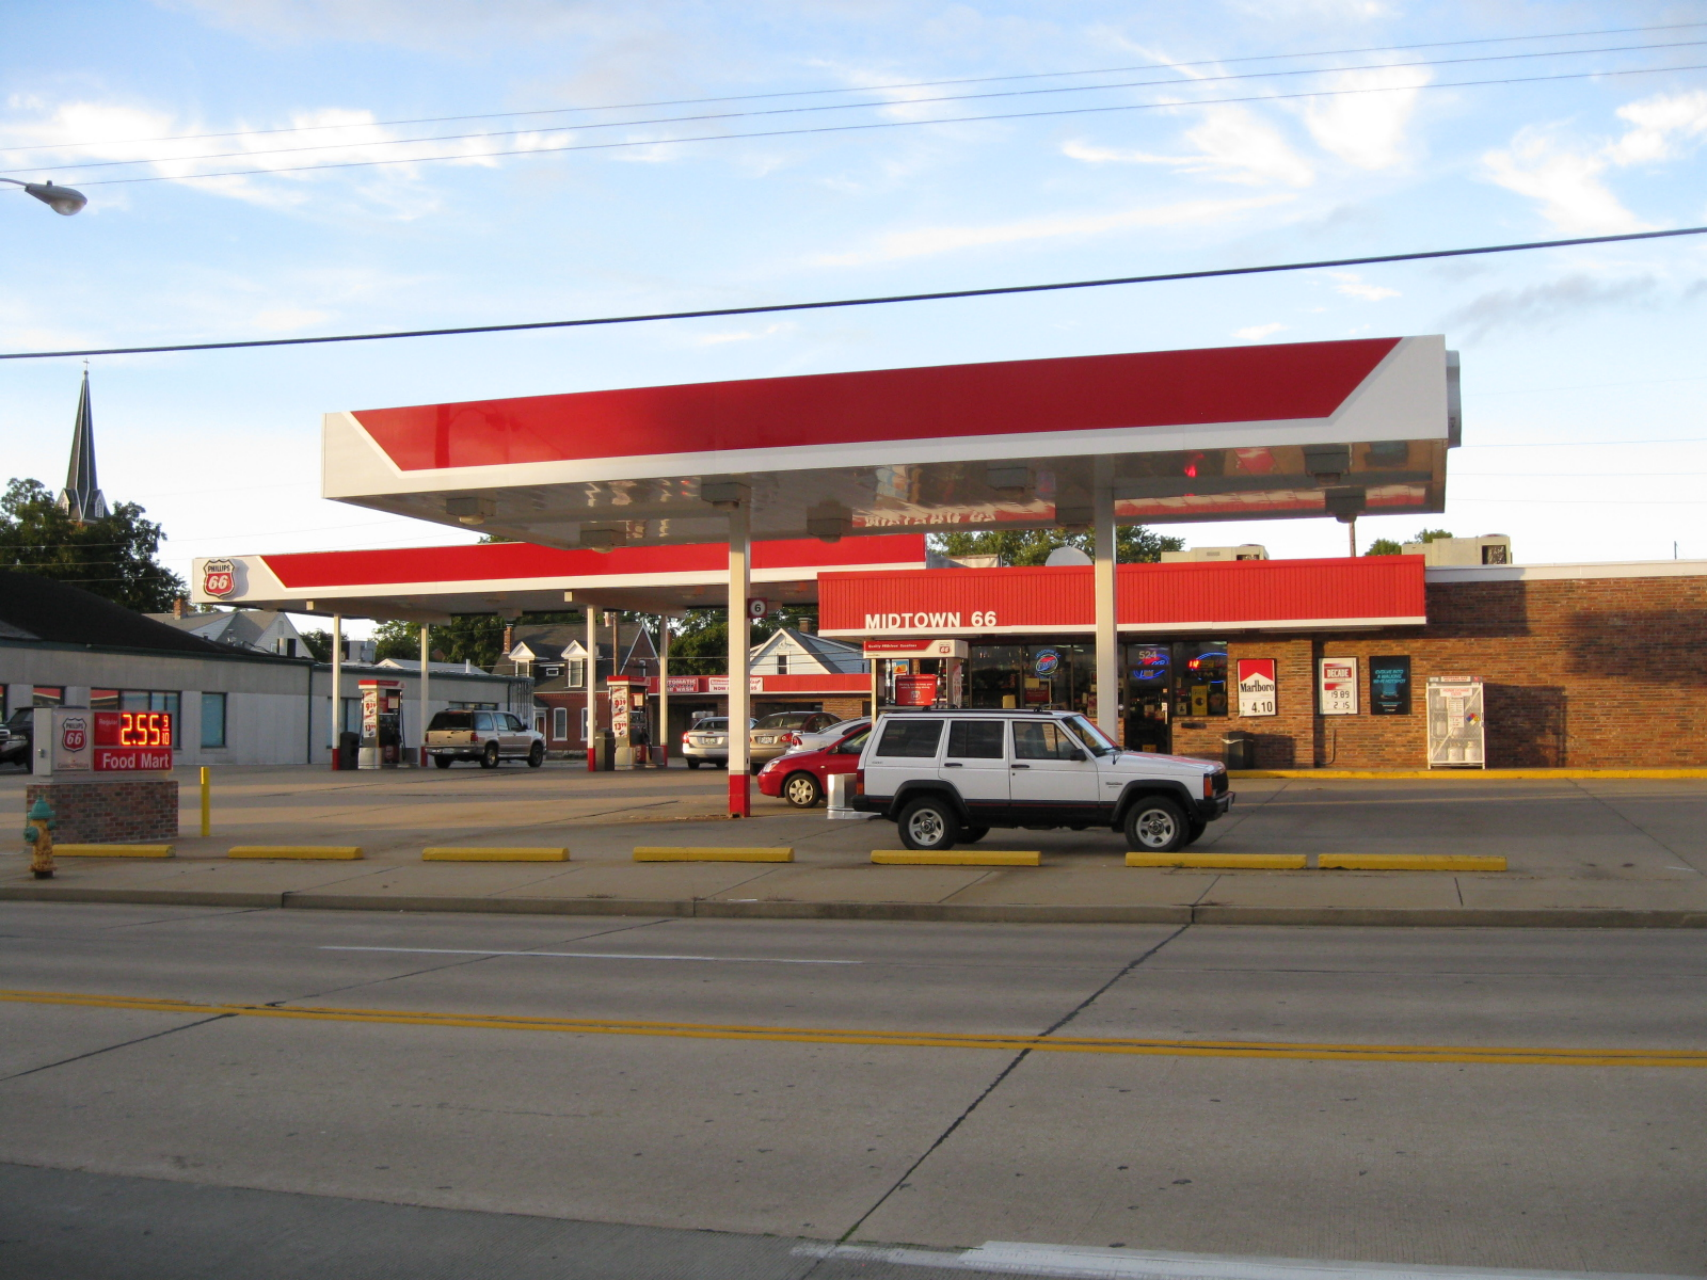
The one story, flat roofed commercial building has an attached flat roofed, metal canopy supported by steel I-beam poles that extends to the west. There is an anodized aluminum framed doorway and flanking display windows on the west end of the building. There is an additional doorway and display window on the west elevation under the canopy.

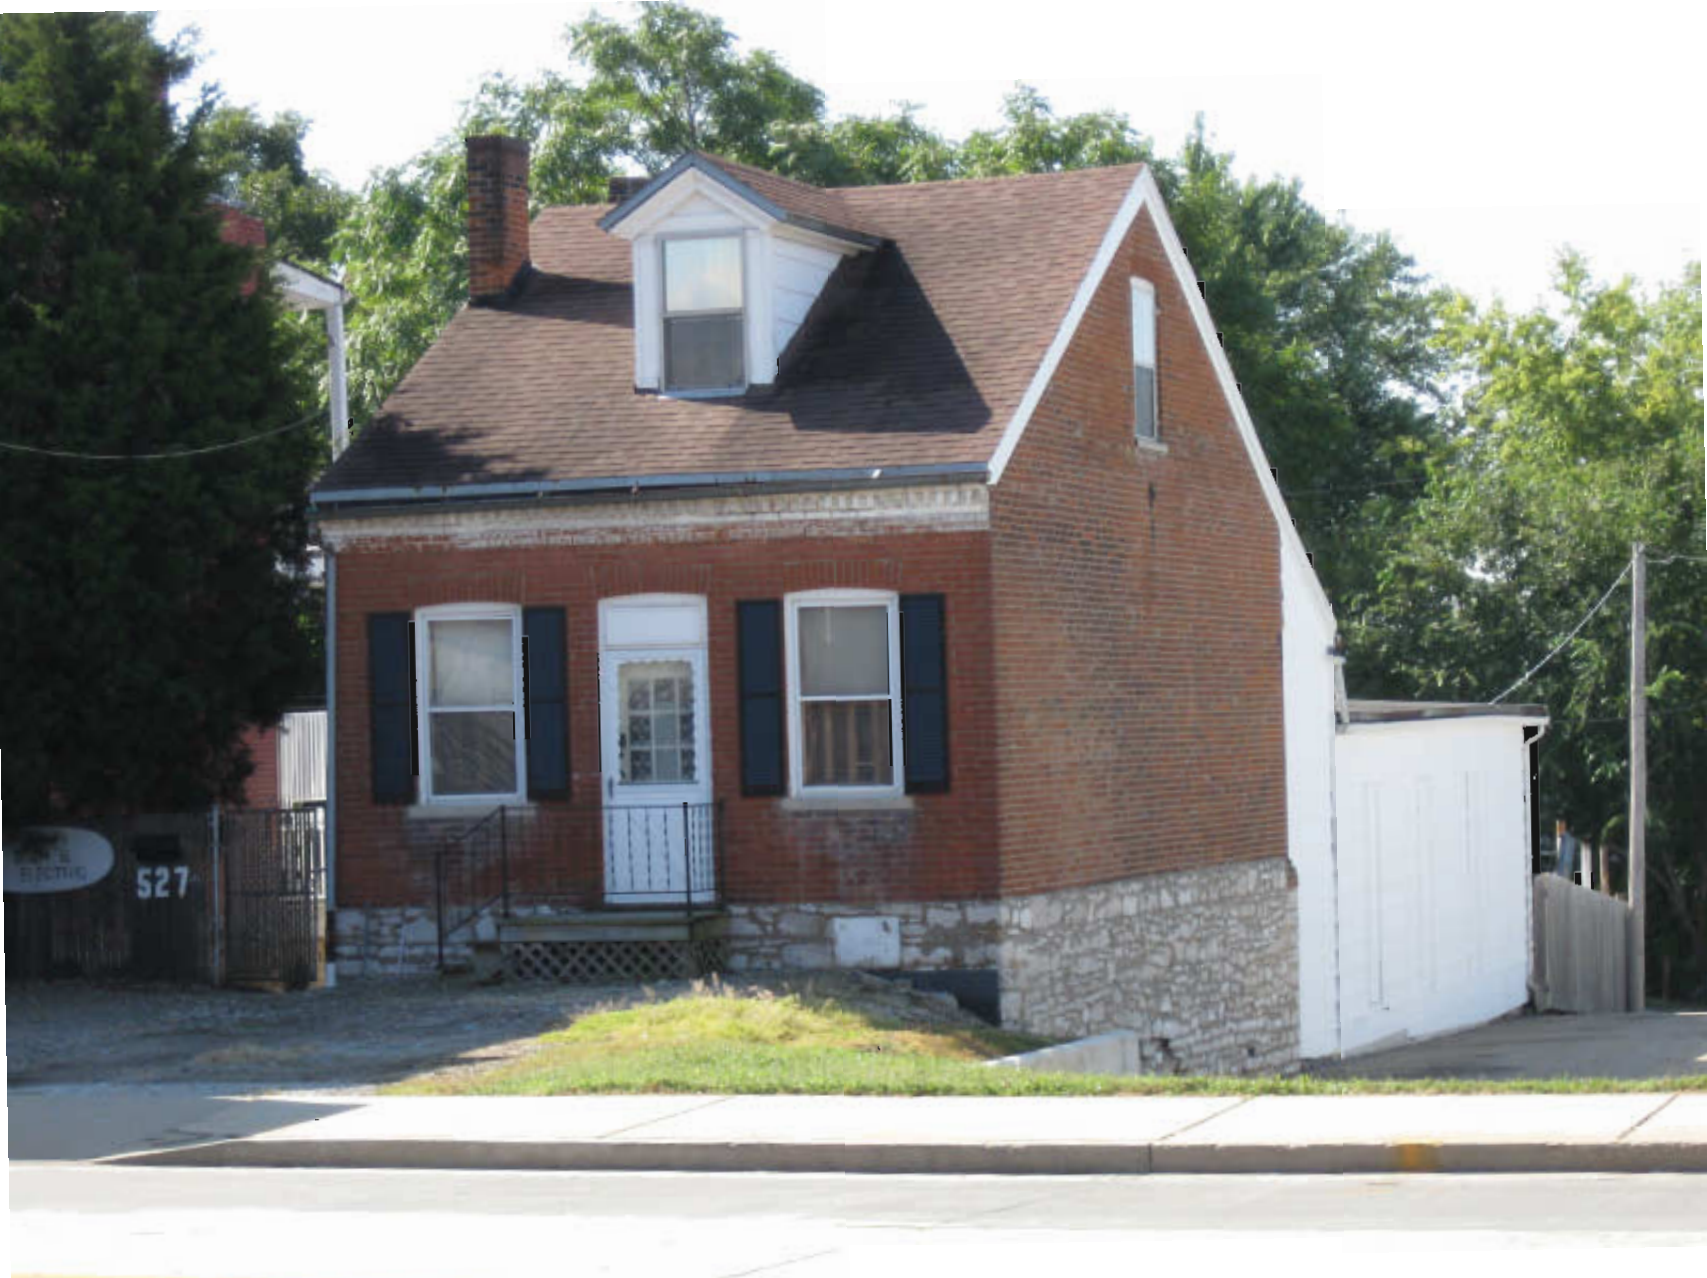
these are frame additions were built after 1947 since they do not appear on that Sanborn map. They are covered with wide lap siding, and it appears that the west elevation was originally an open porch since there are vertical board divisions between the panels of siding.

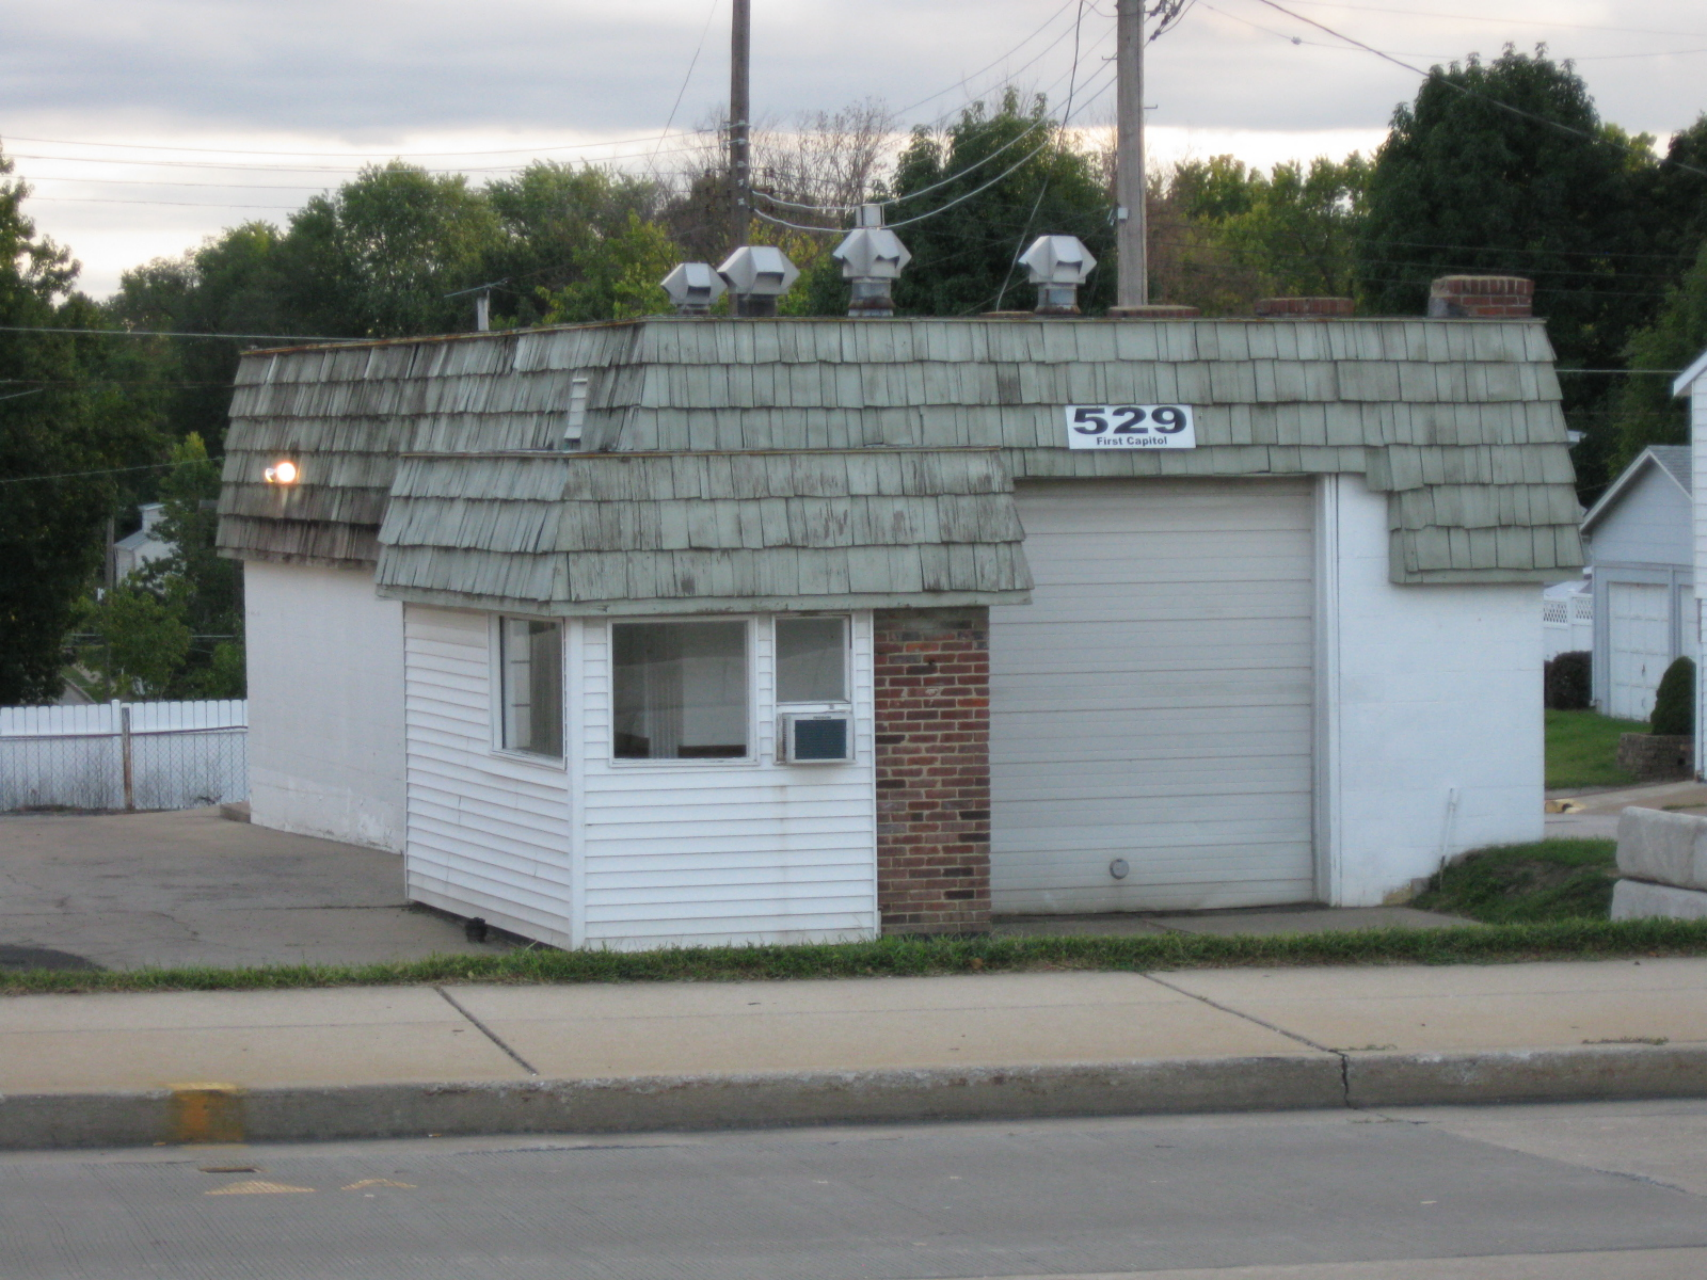
The building is positioned near the alley and facing S. Benton although the property is addressed on First Capitol Drive. This one story, concrete block garage has a single metal overhead door facing S. Benton. The original building has been modified with a shake shingle mansard awning and has a small vinyl-sided room added at the northwest corner, projecting both to the west and north of the main elevations. There are plate glass windows on the upper half of the walls in this wing, but the remaining building appears to have no windows. The building was built after the period of significance of the proposed district and has been modified, so it is not contributing to the proposed historic district.

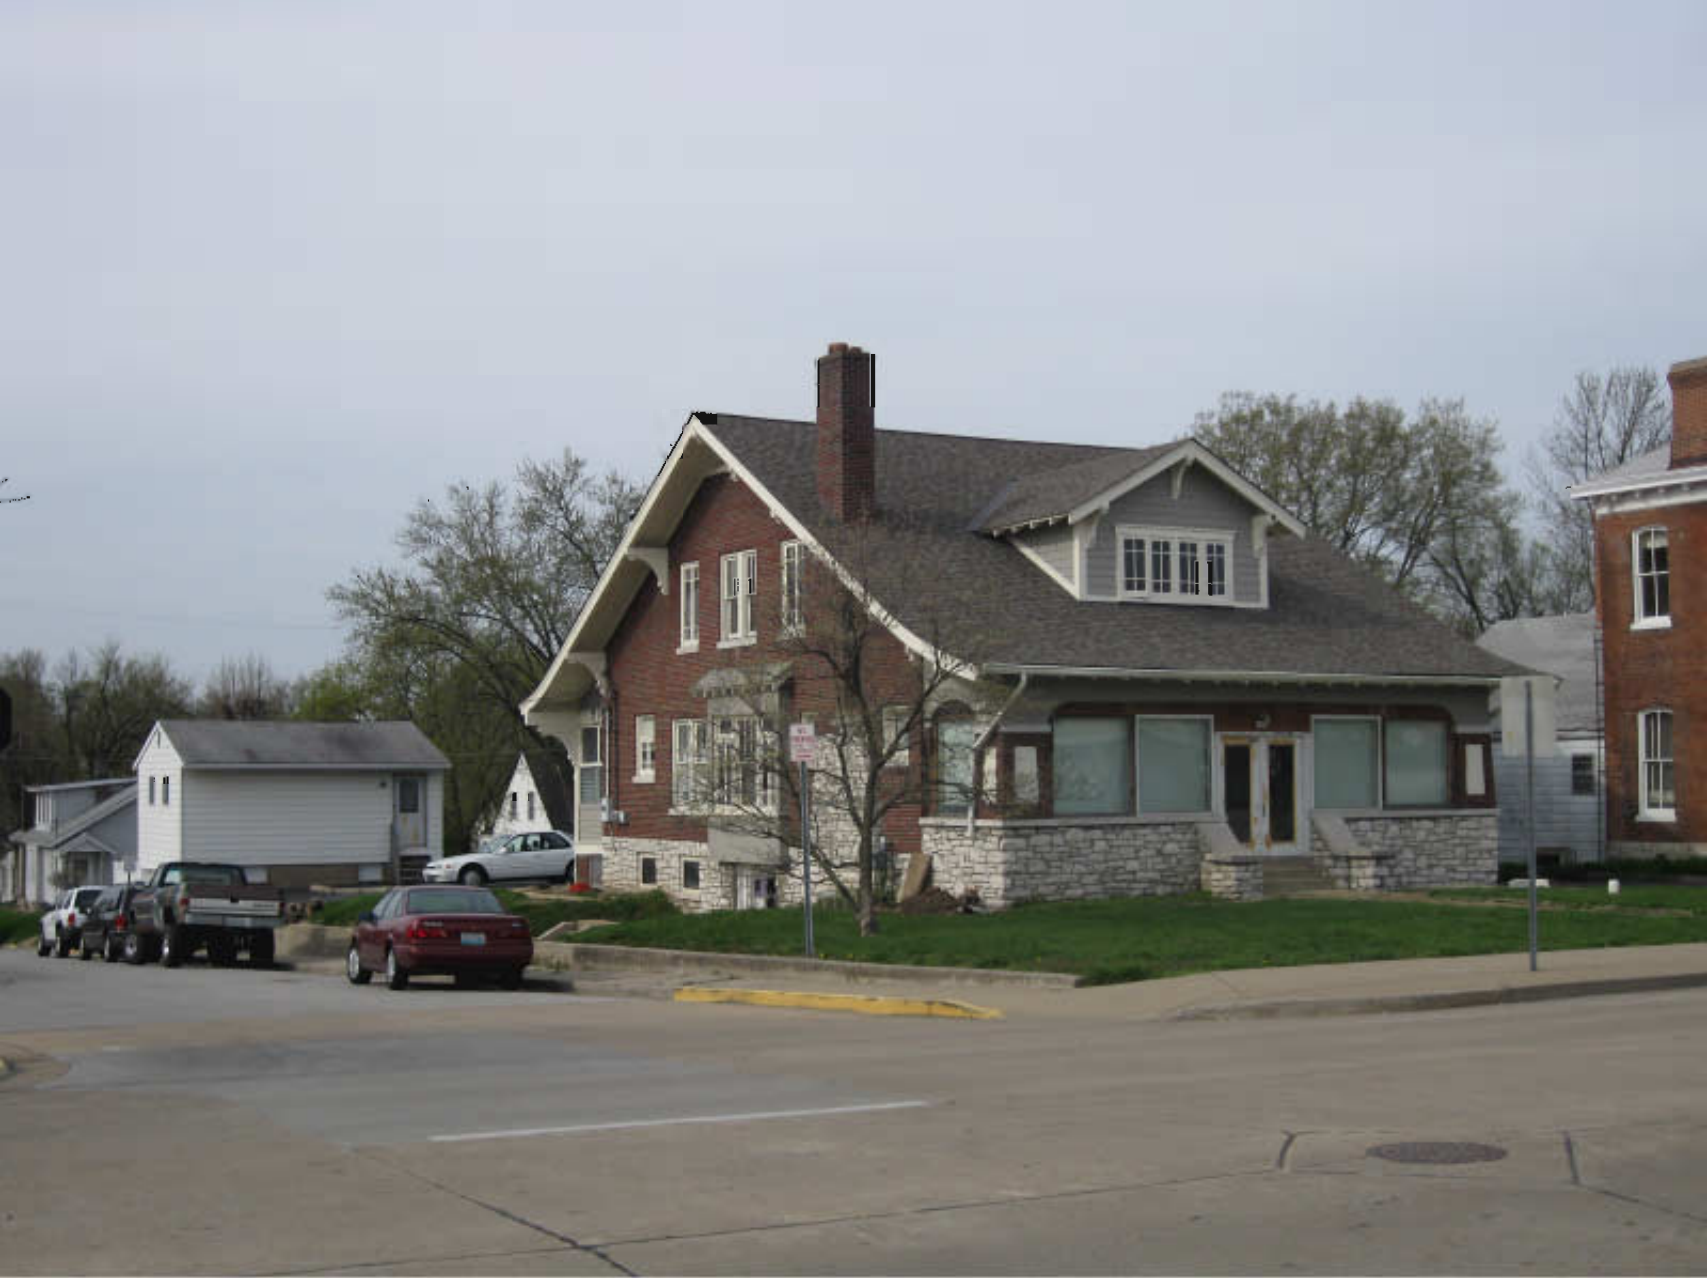
fixed light windows near the facade with a triple window unit of 4/1 wood sashed windows. Behind this is a small sashed window and a single sashed window on the first floor. On the second floor, there are paired casement windows flanking a paired sashed window unit like the east elevation. The basement has additional windows on the west elevation. On the rear there is a full-width porch enclosed with what were probably originally 2/2 storm windows or sashed windows, but the bottom half of some of the windows have been modified with jalousie windows. The porch has a lap siding half wall railing and it is incorporated into the bell cast roof of the house and has knee braces similar to the main house. The dormer on the rear is deeper than the one on the facade, extending to the edge of the porch roof, and it has windows wrapping the sides and serves as a second floor sleeping porch. There is an exterior entry to the basement near the east end of the rear porch. The only visible alteration (besides the jalousie porch windows) has been the enclosure of the front porch which has been framed in with large plate glass windows, two on either side of the front entry steps and one on each side elevation. The narrow area above these windows is infilled with wood siding and there are paired full light doors at the top of the steps. While this enclosure impacts the historic integrity of the Craftsman bungalow, the overwhelming integrity of the other elements on the house, especially the intact original windows with their distinctive muntin pattern, the rafter tails and knee braces continue to make this a contributing building in the proposed historic district.

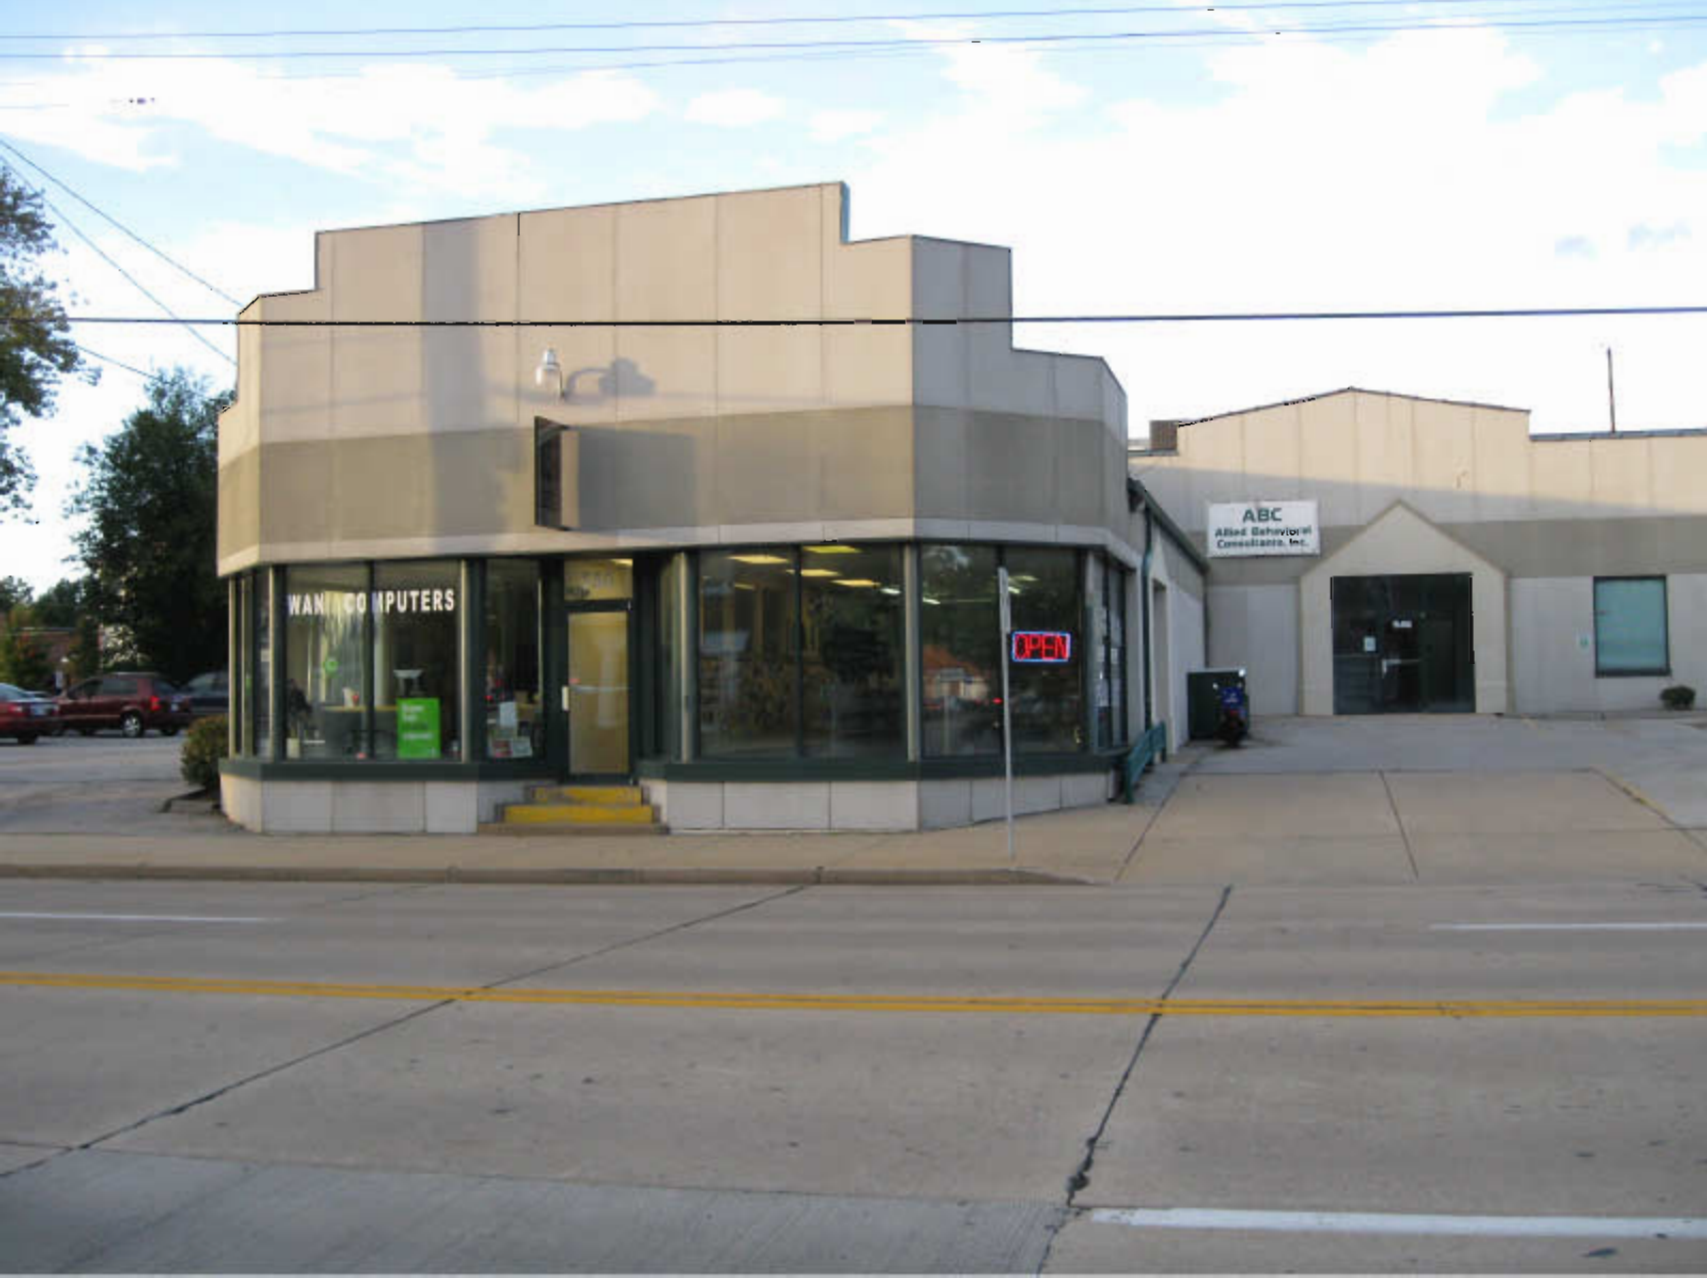
The one story, concrete block building with brick veneer has a barrel-shaped roof oriented sideways that is hipped on both ends. Across the facade is a stepped parapet, pointed at the middle of its original facade. Attached to the west end of the facade is an intersecting, long, barrel vaulted, one-story showroom with a stepped parapet that wraps the clipped corners of the facade showroom and display windows. On the rear, there is a one story, flat roofed wing that spans across the eastern portion of the main building. A portion of the brick rear wing was original to the building, but it was extended after 1947 with a clipped corner at the northwest corner. The facades have been covered recently with synthetic stucco (Dryvit) that appears to be applied to the face of the original wall finishes, but conforming to the original parapet and most of the original openings. Most of the overhead door openings have been converted into glass with aluminum framing as commercial entries with false Dryvit gable surrounds. Without the Dryvit, even with the modifications to the overhead door openings, this would probably be a contributing building in the historic district as one of the commercial enterprises that developed to serve the neighborhood along First Capitol.
