ARCHITECTURAL/HISTORIC INVENTORY FORM

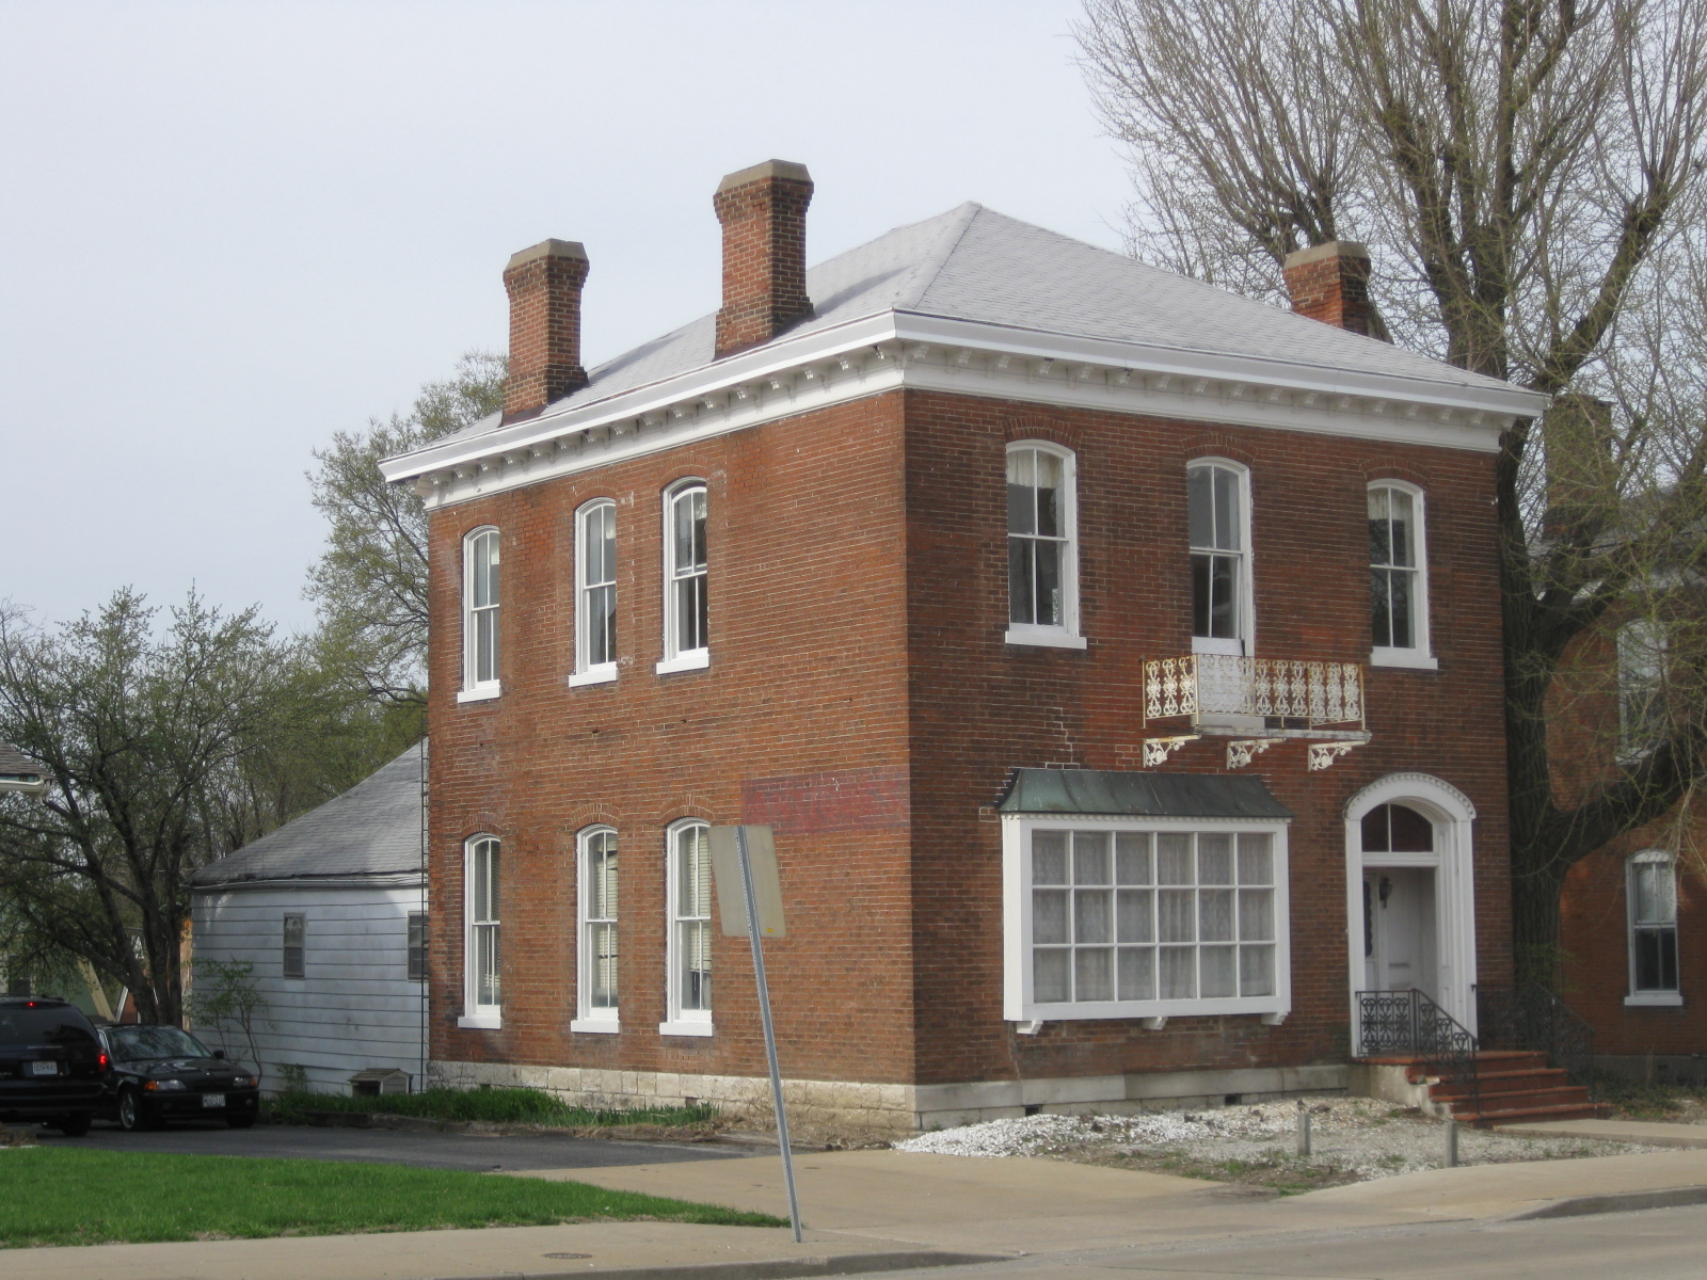
Although there are alterations to the house, most notably the front stoop, bay window, and the rear wing, these all occurred during the period of significance of the historic district and the building is identified as contributing to the historic district as a result. The house retains the shadows on the brick walls of the original, functional wood shutters but they are missing at present.

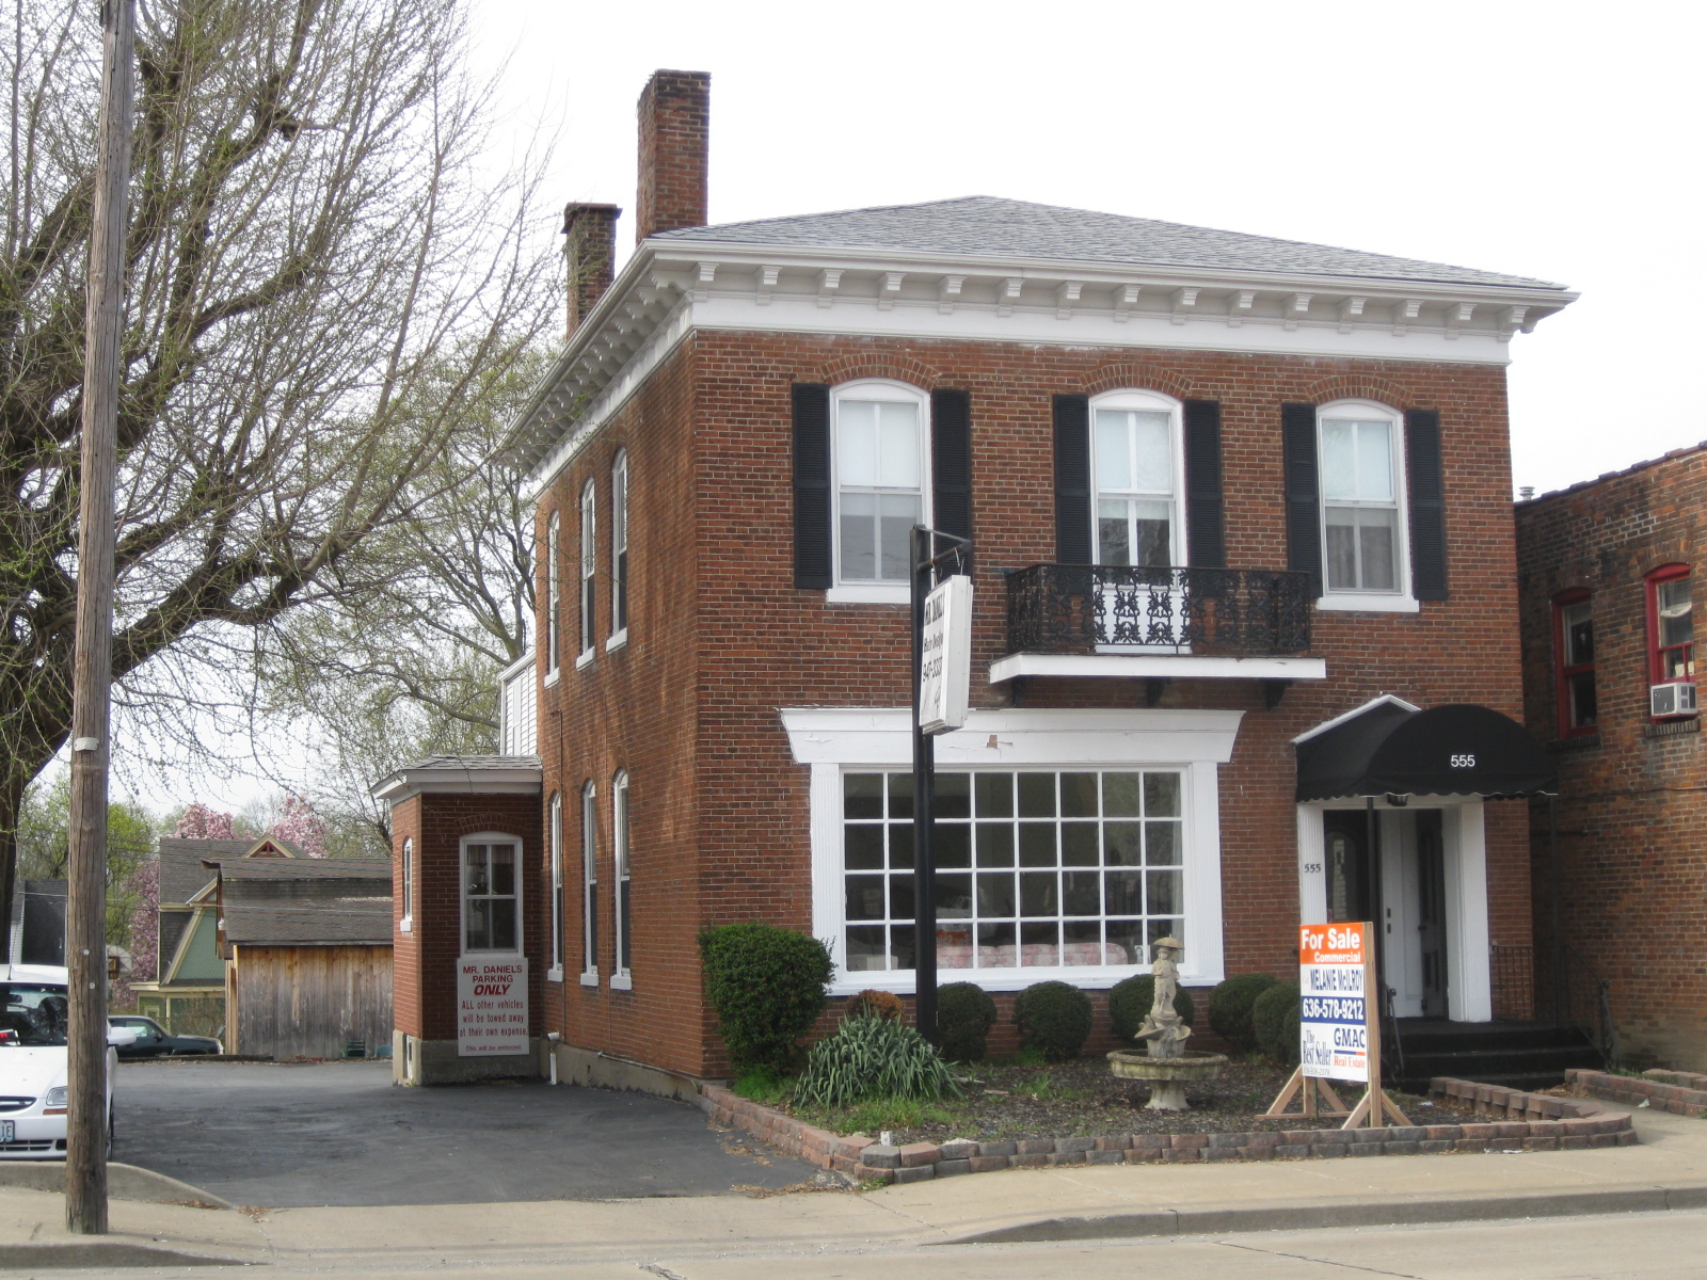
This two story, shallow hipped roof house has a series of closely spaced modillions under the eaves with a wide fascia board. There are paired interior brick chimneys on the east elevation and no indication that there were matching chimneys on the other side of the house although the sister building at 547 had them on both sides of the house. The facade is divided into three bays with segmental arched openings on the second floor, each with 2/2 flat headed wood sashed windows with shutters (the shutters may be replacements but are correctly positioned and sized). Like the other windows on the house, these have painted, dressed stone sills. The center window is actually a Jefferson window with attached wood panels below the lower sash that allows it to operate as a jib door to the metal balcony on the facade. This balcony is supported by metal brackets and has a decorative metal railing. It is not clear if the railing is the original, but the brackets appear original. On the first floor, the recessed entry is located in the west bay with a transom at the outer opening where there are paired, four panel doors (the top long panels are round arched). The main door at the back of the vestibule has a round arched half light wood paneled door. On either side of the outer openings there are fluted pilasters, and there appears to be a pediment over the opening, but there is a half round awning that obscures the transom and the top of the entry. Most likely, the fluted pilasters and pediment are part of the alterations completed circa 1945-48 along with the large multipaned picture window that also has fluted pilaster strips and a splayed wood lintel. The east elevation has three bays of segmental arched 2/2 wood sashed windows with painted stone sills on both the first and second floor. There is an additional bay of matching windows on the first and second floor at the rear of the west elevation. On the rear is a two story, gabled, brick wing with a full width shed roofed extension on the two story porch on the east elevation. Behind this wing is a slightly narrower, one story brick wing with a small one story addition on its east side next to the two story porch that was added between 1900 and 1909. Both of these wings are shown on the 1886 Sanborn map as is the two story porch. The small one story addition (1900-1909) appears to be a structure added and since altered to accommodate stairs to the upper level of the porch. There are two windows on the rear of the two story wing and one on the rear of the one story wing. There is a doorway and a set of stairs on the east elevation of the one story wing. There are two windows on the second floor, and a paired window and single window unit on the first floor of the west elevation of the two story wing as well as one window on the west elevation of the one story wing. The second floor of the two story porch has been enclosed and a small flat roofed, one story brick wing added east of this porch at some point after 1947. Most of the alterations appear to have been made during the period of significance of the historic district, except for the canvas awning on the entrance and the aluminum storm windows, and as such the building is contributing to the district.

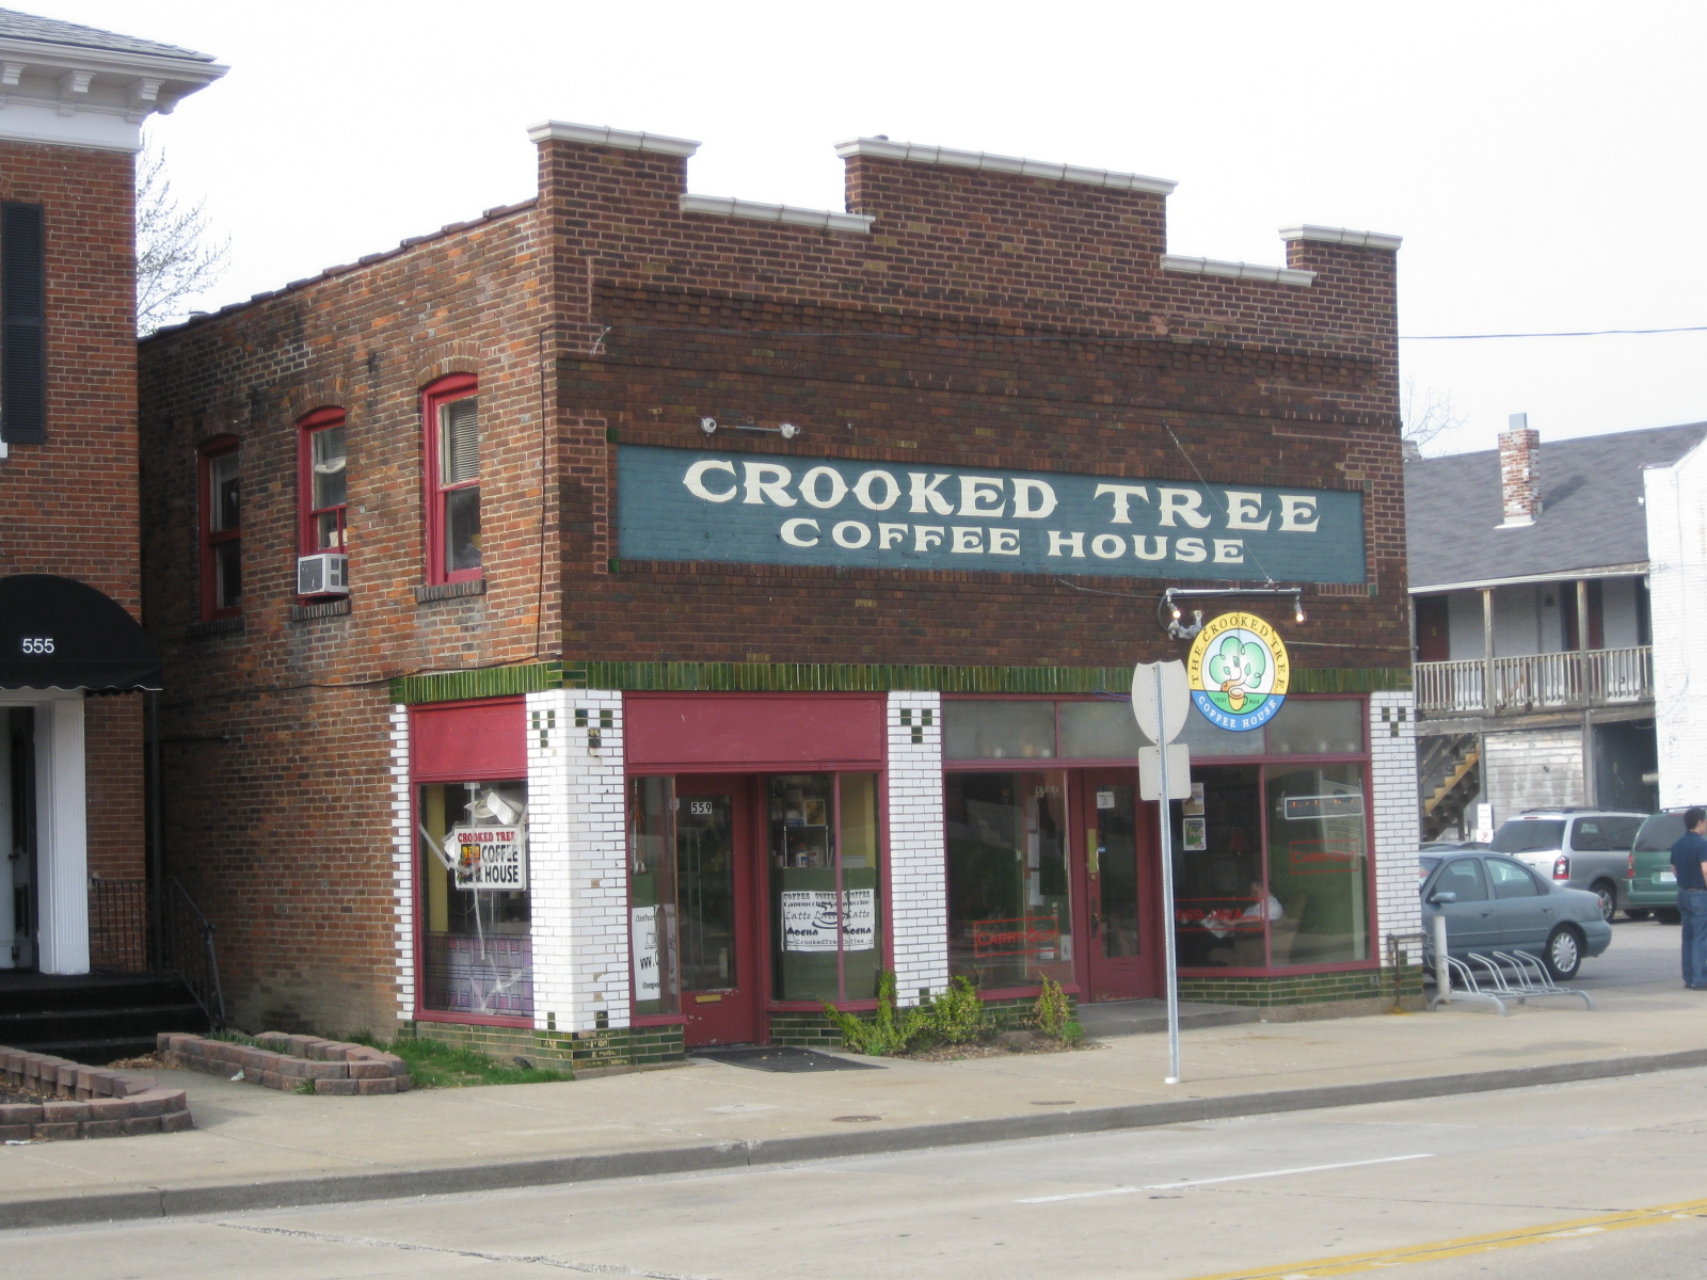
Built in the mid-1920s, this two-story, brick, double storefront, commercial building has a stepped parapet with glazed white terra cotta caps (while the side parapets are simple clay coping tiles). The facade is unusual since it appears to be a tall one-story building, without second floor windows. It has a tiered dentil course of brick at the base of the parapet that does not extend to the corners and considerably below that is a brick frieze that spans most of the facade that serves as a sign panel. At the top of the storefronts is a soldier course continuous lintel of glazed green bricks that wraps the east corner where there is another display window since this building is positioned at the sidewalk but the adjacent residence is recessed into the lot with a small front yard. Below the display windows there is a low bulkhead of brick which appears to have been glazed green brick as well, but most of the glazing has fallen off. The two storefronts are different sizes, with the west one spanning nearly two-thirds of the facade and separated from the other storefront by a glazed white brick pier that matches the two corner piers. These piers have contrasting squares of brick as decorative details near the base and near the top of each pier. Both storefronts appear to retain the original brass framing around the display windows and the west storefront retains the textured glass in the transom, although the east storefront transoms are covered. Both have central recessed entries with full light wood doors, but the west storefront has paired doors. On the east elevation, there is another display window and above are four, 1/1 wood sashed windows with segmental arched openings and brick sills. The building is L-shaped, because of the large wing on the rear that is aligned on the west side, allowing for a series of windows on the east and rear elevation of this wing. The one-story rear wing that was shown on the 1929 and 1947 fire insurance maps as an open porch, has been removed. The facade has had some poorly matching repointing work done, which may indicate some alteration to the brickwork, but it does not appear to have ever had windows.

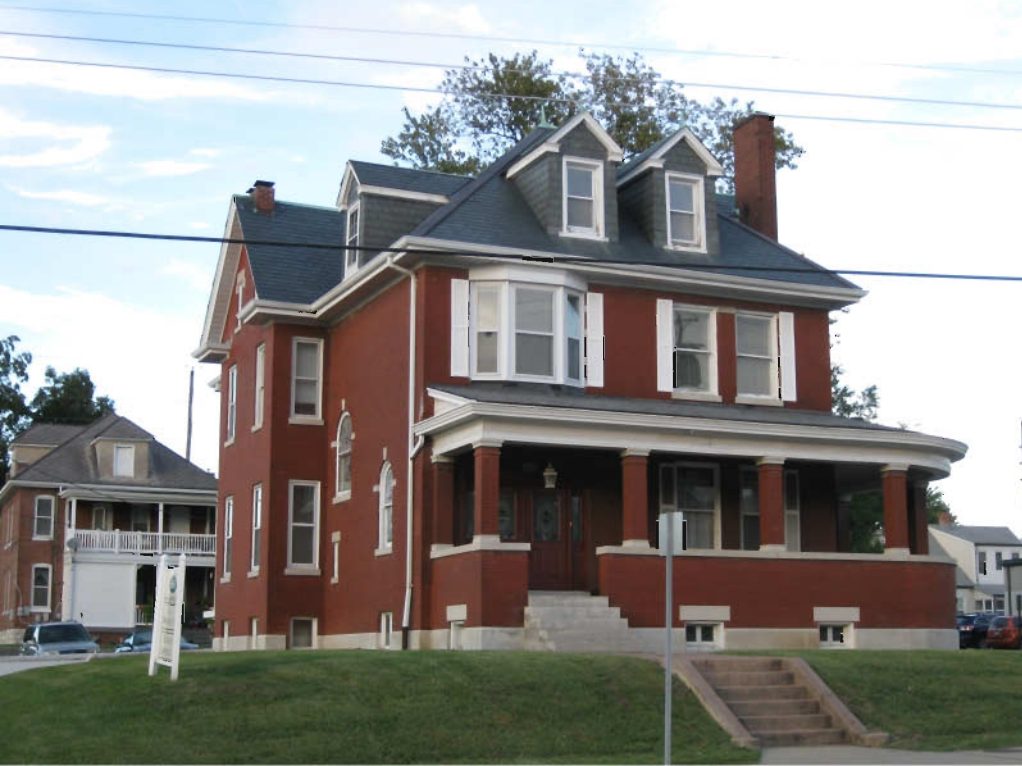
sashed windows. At the northwest corner, behind the cross gabled bay there is a two story porch and on the rear there is a small
hipped roof enclosed porch. The roof is slate as are the sides of the dormers.

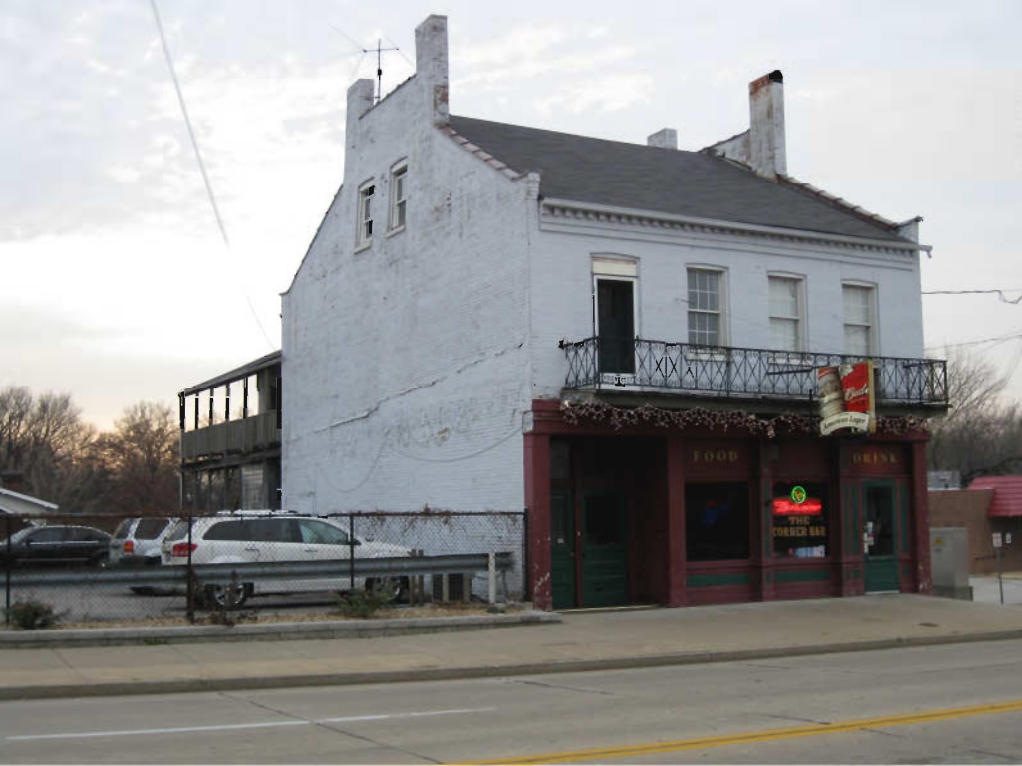
There is an intersecting gabled 2 story wing on the west edge of the building with a two story, shed roofed, galleried porch along the east side of this rear wing. This wing was shown on the 1869 Birds Eye View as a single story cross gabled wing with a one story porch facing east, but between 1869 and 1886 it was changed into a two-story cross gabled wing with a two story galleried porch facing east. On the west elevation of this wing there are two sets of two sashed windows on both levels. The galleried porch is shown on the 1886 map, but the current railing is a recent replacement that does not match the historic balusters that would have been used.

The windows have been replaced with a mixture of 6/6 and 1/1 windows and the brickmold wrapped. There were one story wings attached to the back of both the galleried porch and the rear wing from 1886 through at least 1947 (and possibly the same intersecting gabled structures shown on the Bird's Eye View), but these have been torn down. Given the age of this building, these alterations are minor.

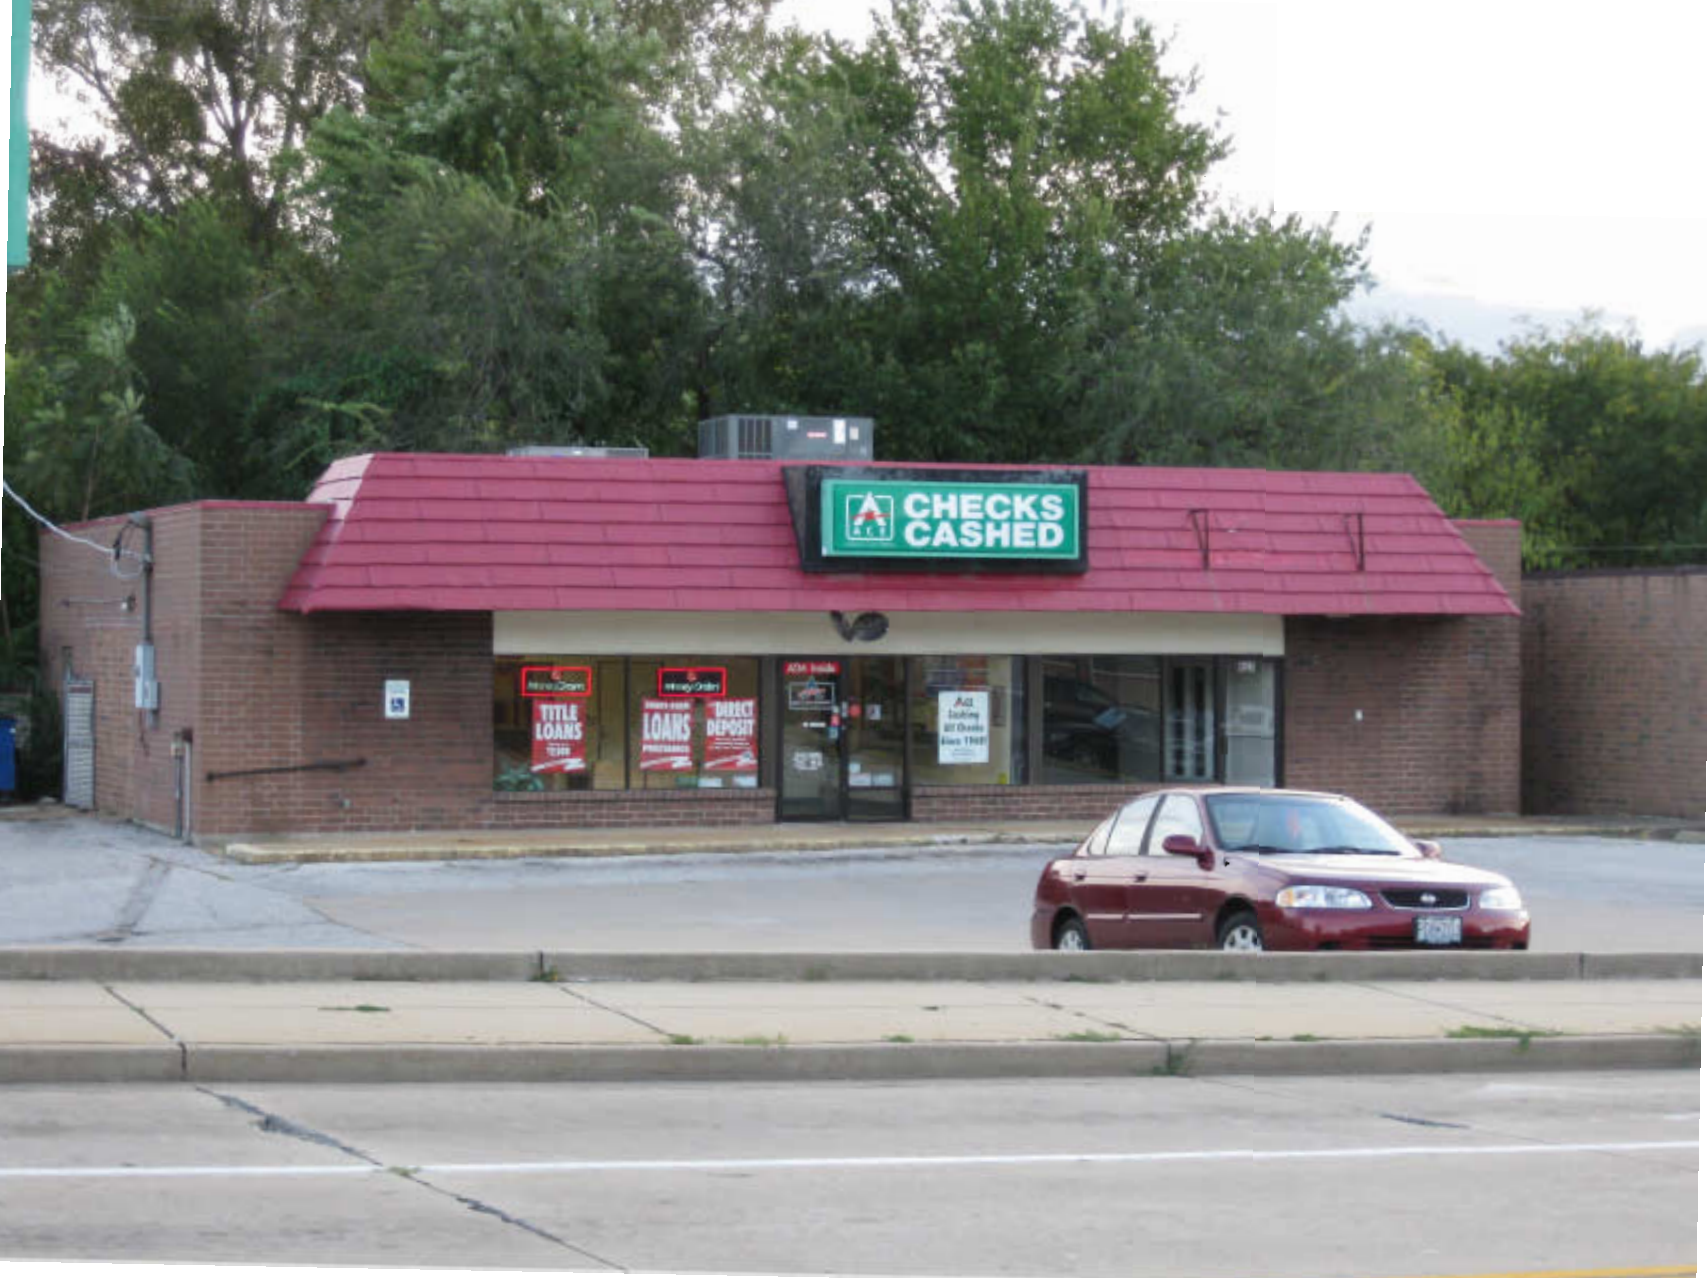
This one story, flat roofed, brick building has a clay tile parapet cap and a false mansard awning that spans most of the facade and projects through the brick facade and parapet. There is an anodized aluminum storefront system centered on the facade between wide expanses of brick facade walls. It consists of two panes of glass in a display window to the east of the paired full light doors. To the west are two more panes of glass in another display window and at the west end there is another full light door. Below the display windows are brick bulkheads and in front of the building is a concrete sidewalk.

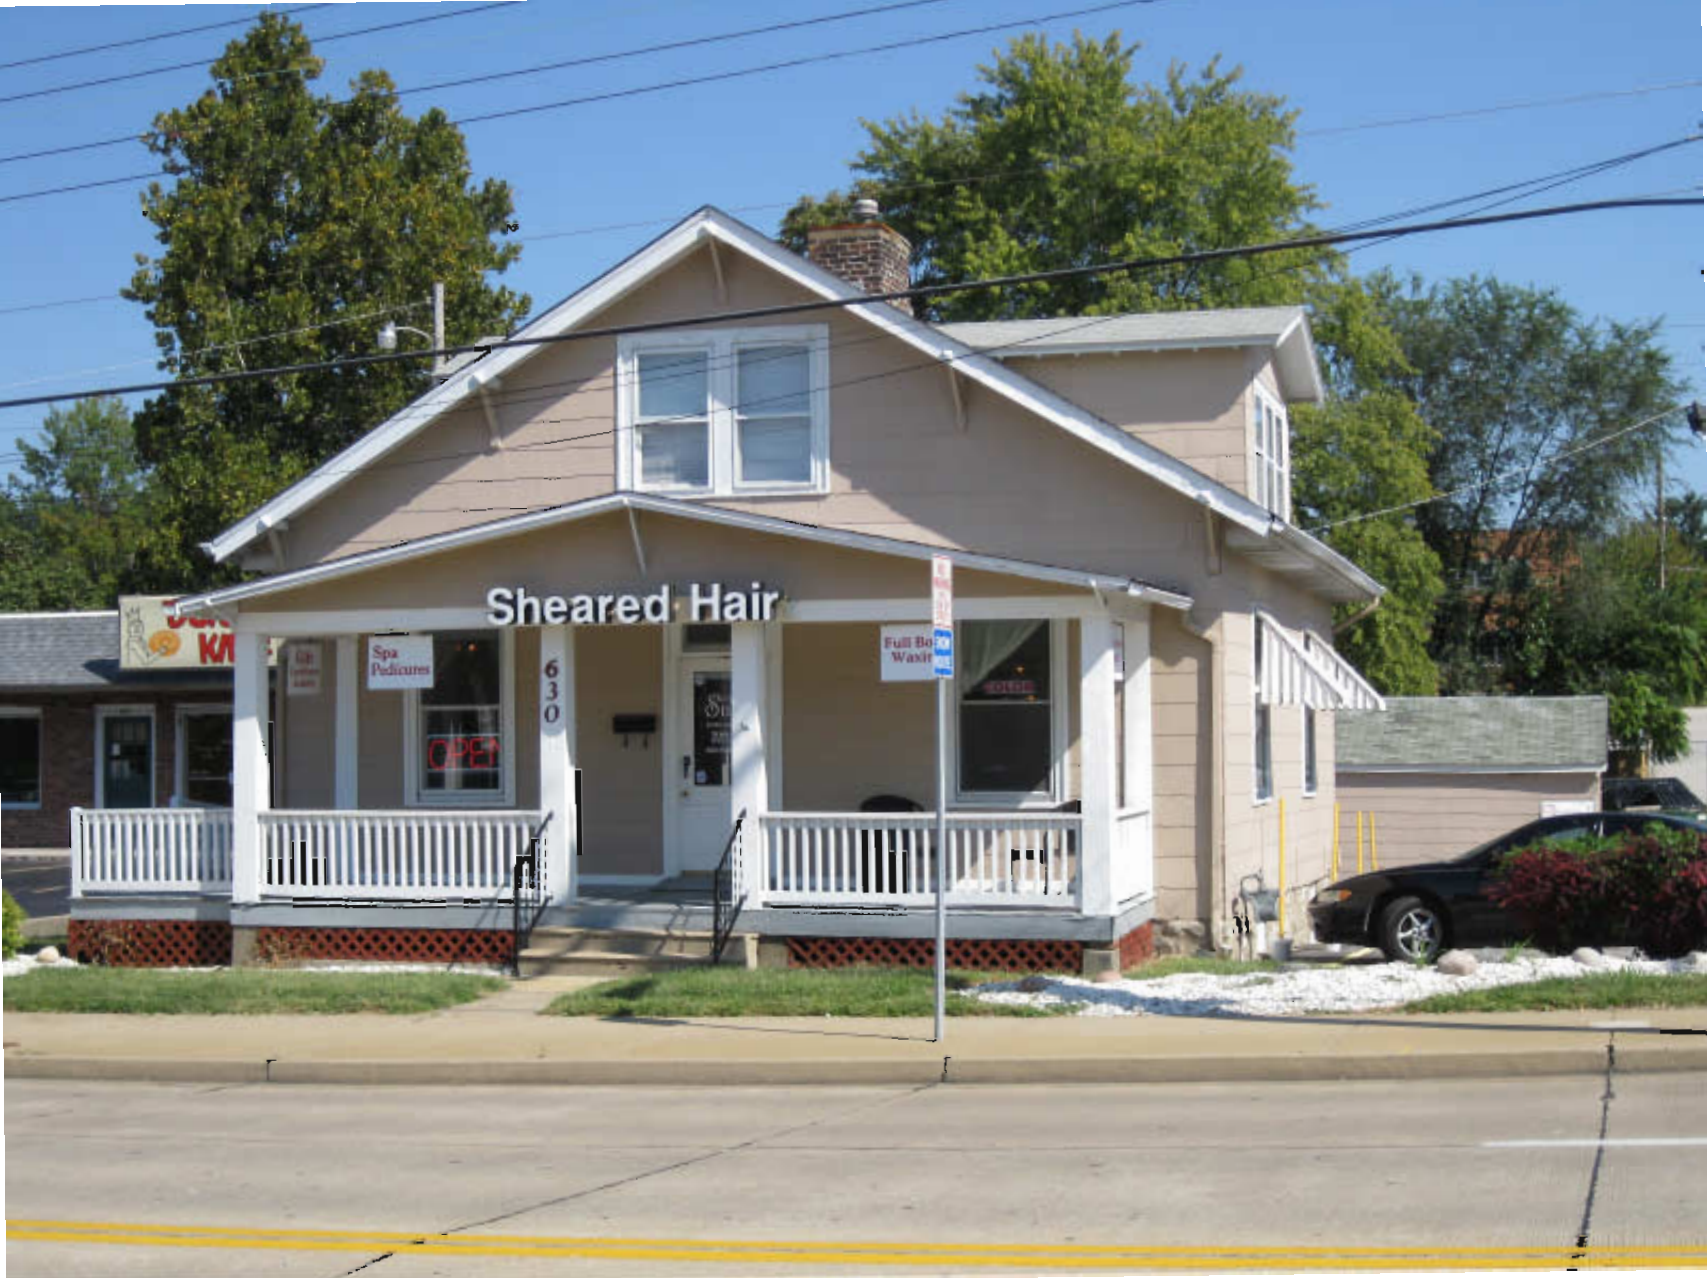
The end gabled, 1.5 story, frame, Craftsman bungalow has exposed rafters on the wide eaves that are supported in the gable end by knee braces. There is a full width, shallower pitched, gabled roof front porch that is supported by large square posts at the corners (and pilasters against the facade), as well as additional square posts flanking either side of the central entry and concrete porch steps. The porch has a wood porch floor and a simple baluster railing with lattice work below the porch and between the stone piers. The porch floor and railing have been extended an additional bay to the west to accommodate a wheelchair ramp along the west elevation. The first floor facade was divided into three bays with a large, 1/1 wood sashed window on either side of the central transomed doorway. The half light paneled door appears to be a replacement. Centered above the porch are paired, 1/1 wood sashed windows. On either side of the house is a large gabled dormer with exposed rafters and wide eaves; the east dormer has a triple window unit of 1/1 wood sashed windows while the west dormer has paired 1/1 wood sashed windows. On the first floor of both the east and west elevations there are two 1/1 wood sashed windows but there is also a side entry on the west elevation at the rear with a gabled roofed, enclosed porch. Besides the front entry door and the aluminum storm windows, the only obvious alteration is the asbestos cement tile siding, which was probably added in the early 1950s since that material was not in production in 1919-1921 when this house was built.

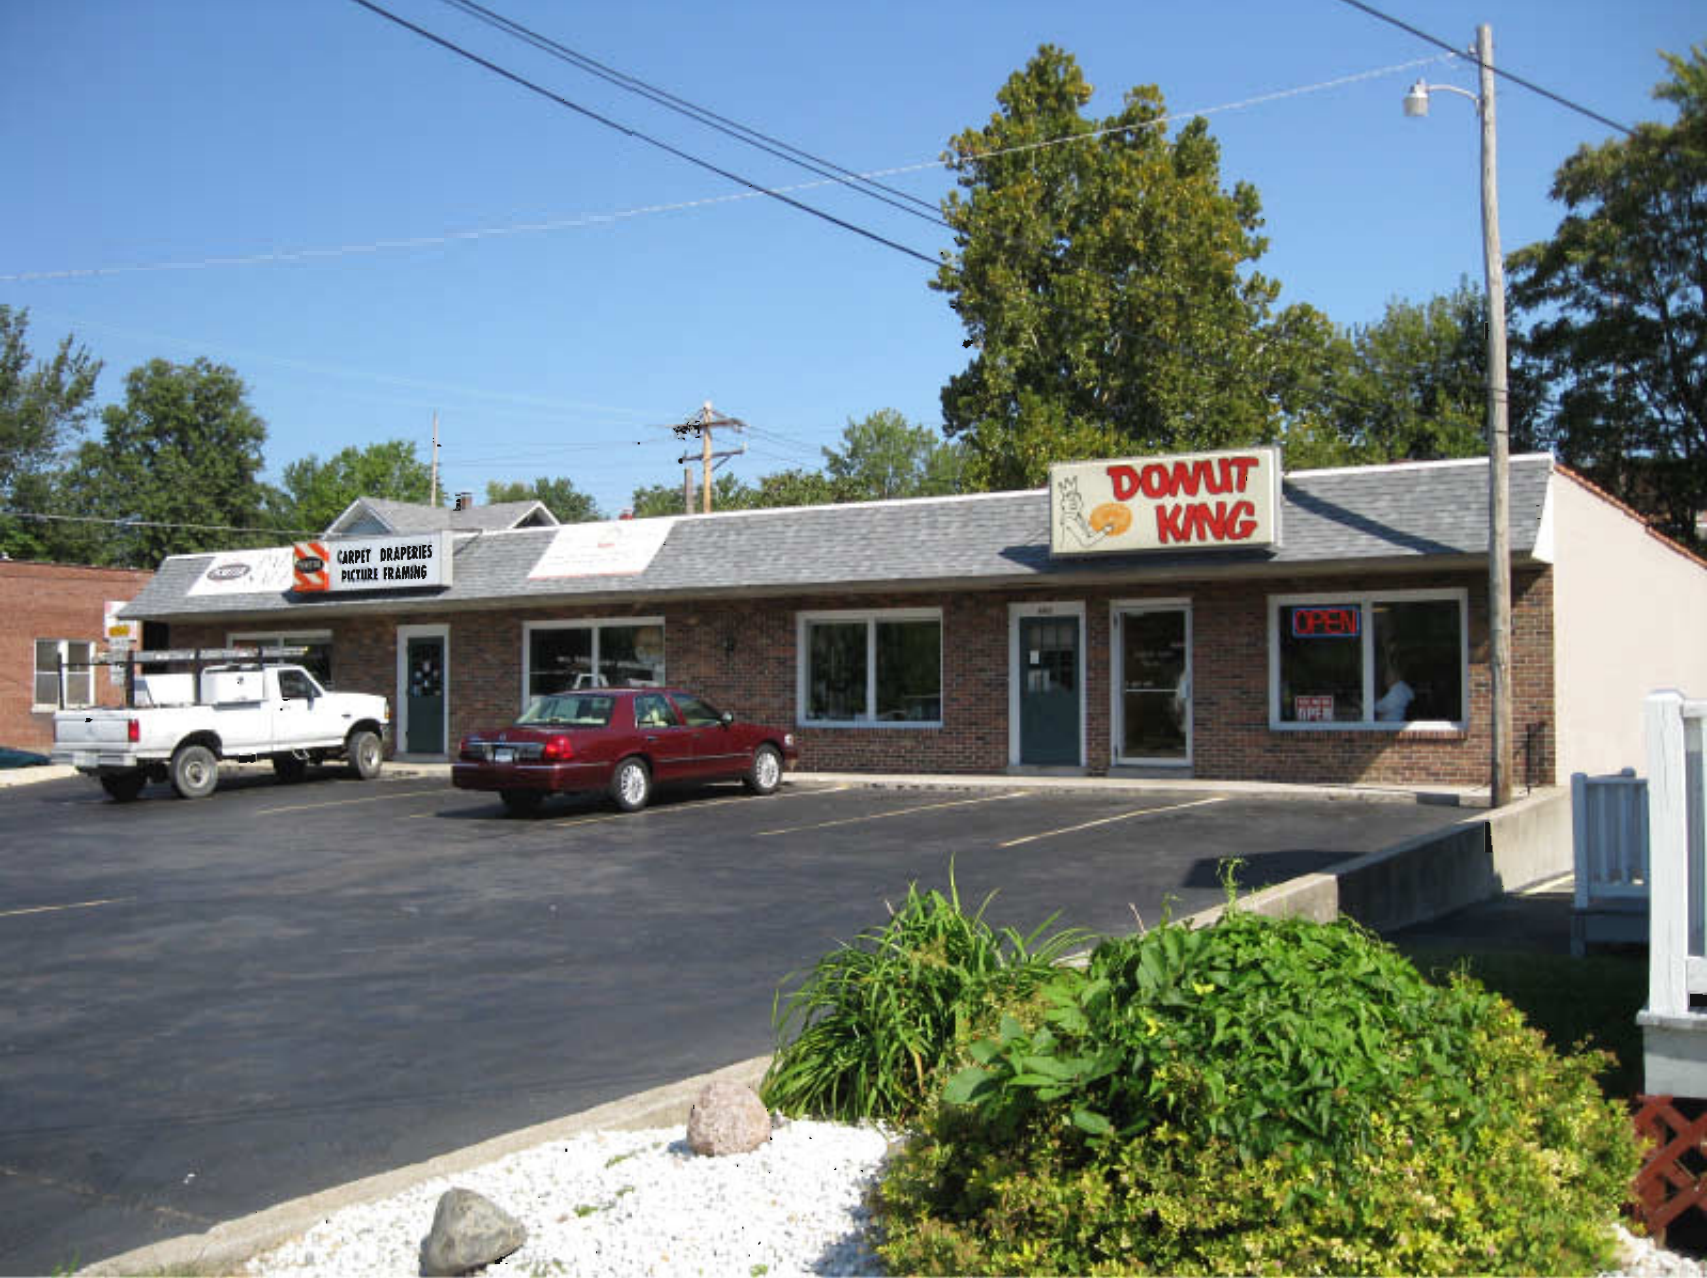
This one story, flat roofed commercial building is built on the lower grade of the rear of the lot with the parking lot across the front and the front entries raised to the higher grade along First Capital Drive. The building is basically a concrete block building with a false mansard awning across the facade which is brick veneer. The facade is divided into six bays, with a single entry door in the second bay and two doors in the fifth bay. The remaining facade bays have two-light picture windows. On the west elevation there is an additional display window. Two of the entry doors are half-light replacement doors and the other is a full light aluminum framed door.

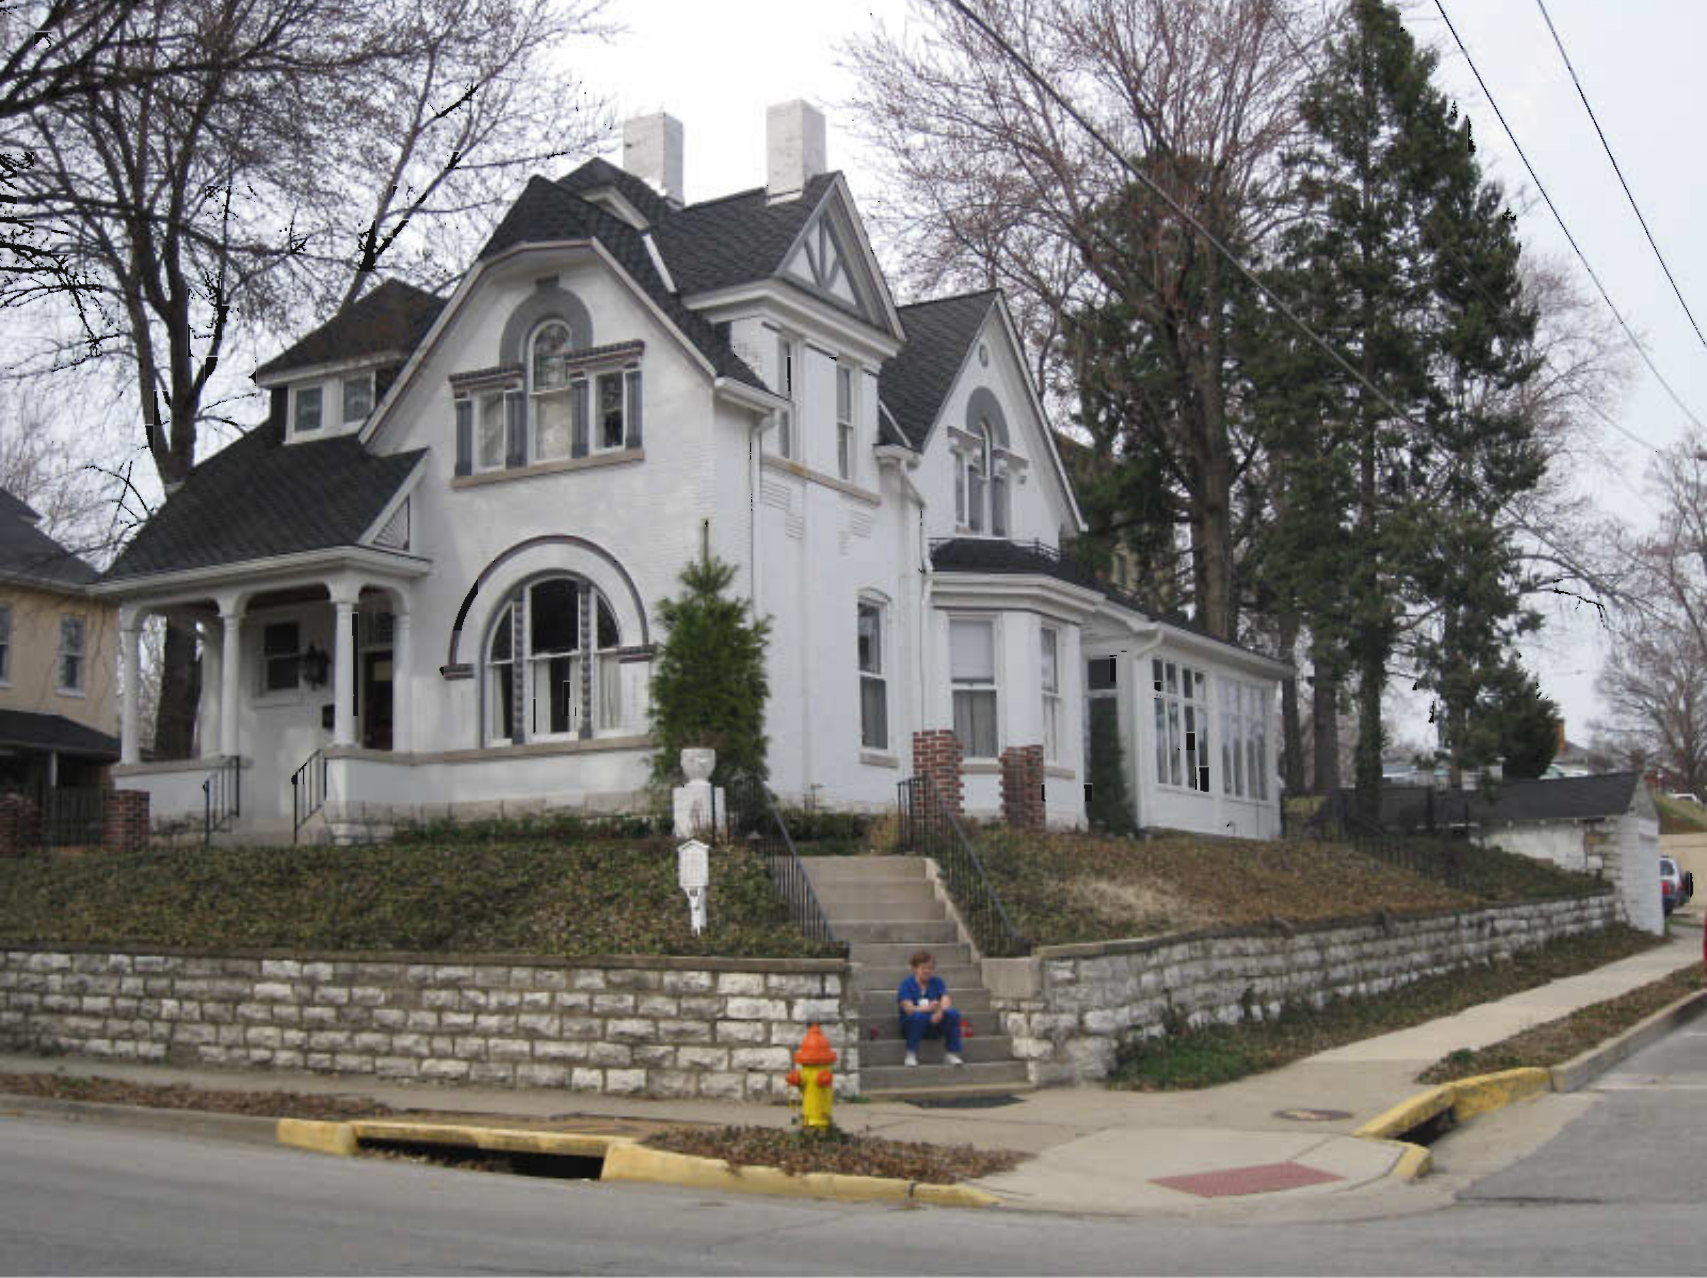
On the east elevation, to the north of the gabled wing, there is a clipped, pediment dormer with a arched light. The shed roof over the first floor enclosed room has dentil molding under the eaves and appears to have originally been another open porch although it was enclosed in 2003 with four pairs of casement windows (the concrete stairs to the public sidewalk still extend up to this bay). To the south of the gabled wing, there is a gabled wall dormer with two slender 1/1 sashed windows. The pediment in the gable end is clad with half-timbered stucco and the peak is pierced by a brick end wall chimney. On the north elevation, on the north side of the gabled bay is a hipped dormer and there is another 1.5 story cross gabled bay on the rear, north elevation that extends behind the enclosed shed roofed porch.

An undated photograph in the St. Charles County History Society's photograph collection shows that the brick walls were originally unpainted but otherwise the details, especially on the porch (columns, spandrels, brick knee walls), appear unaltered. By 1976, the brick had been painted and the porch had full-height ornate cast iron posts with spandrels. The porch was restored in 2003.

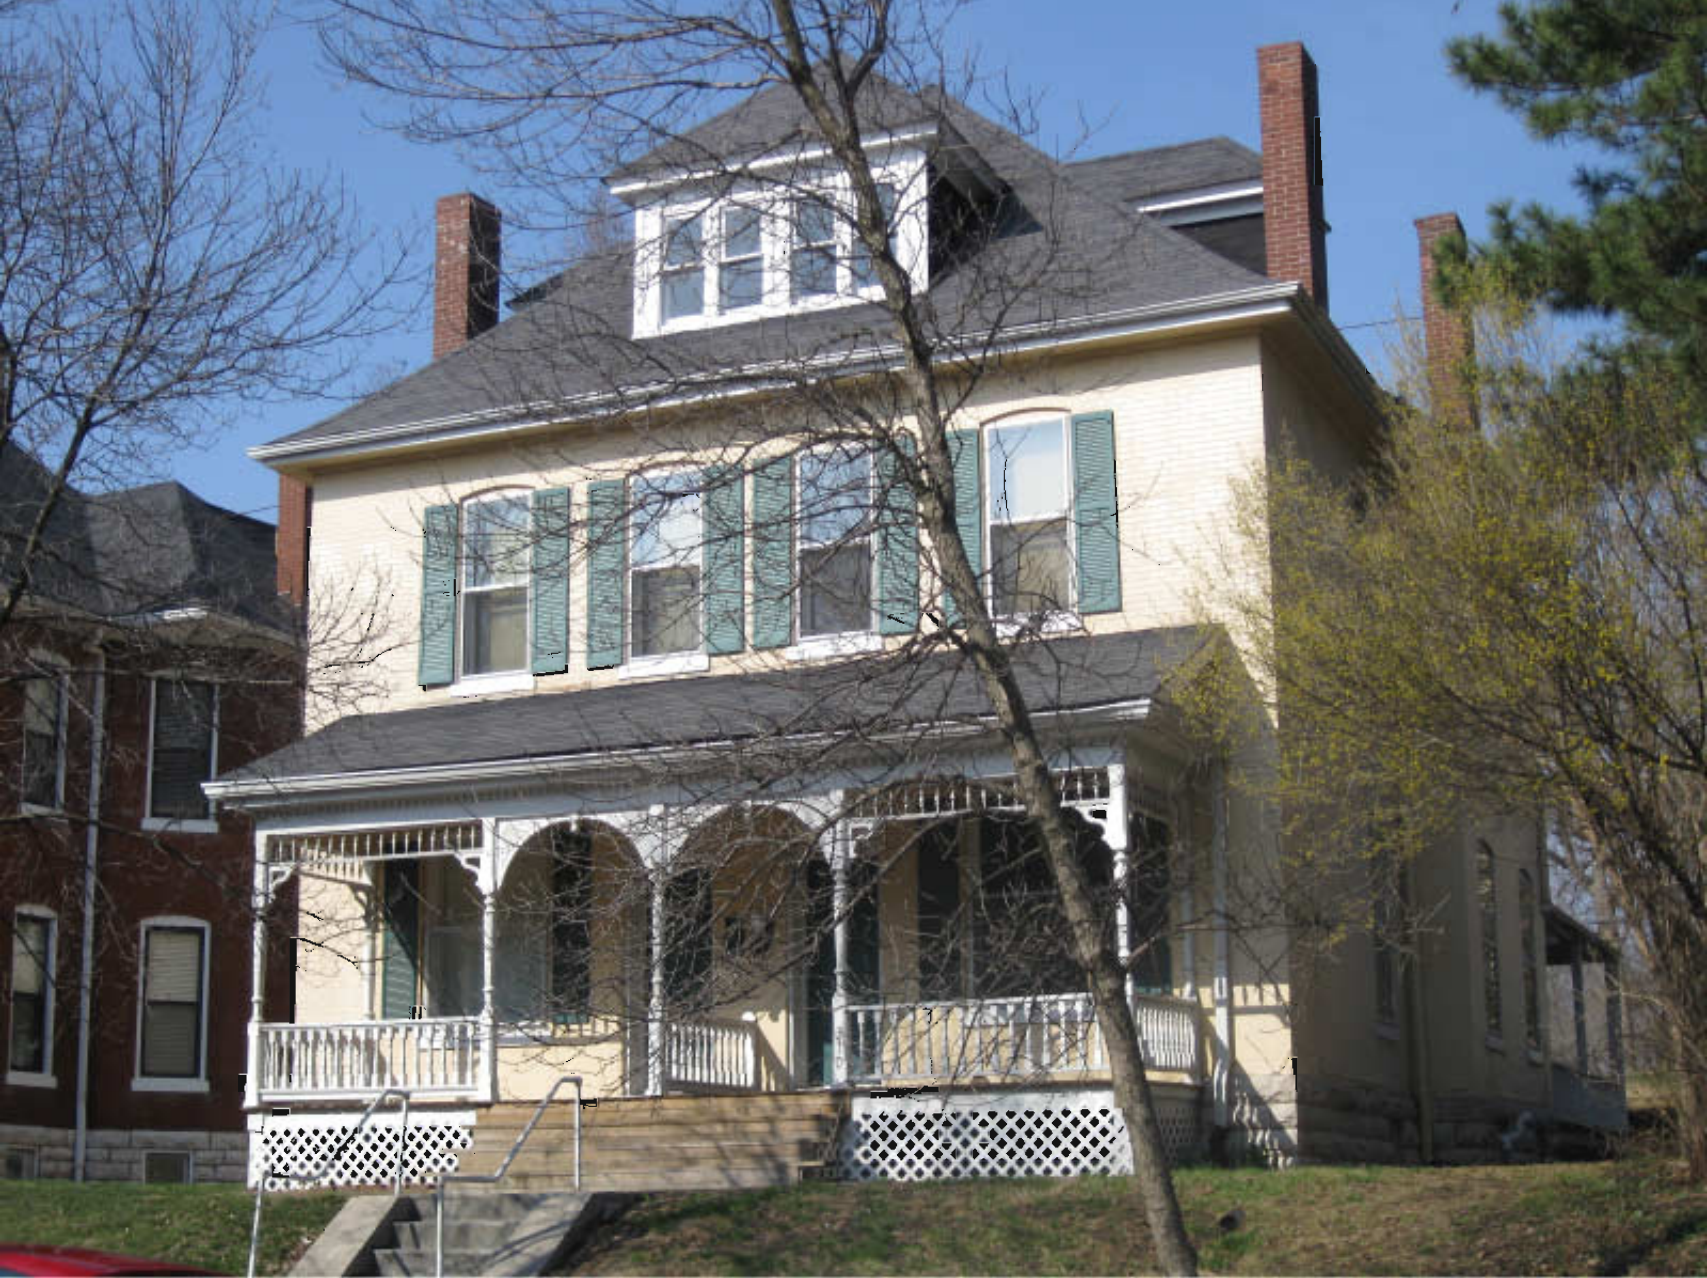
Built around 1903, this Folk Victorian, brick, two story residence is basically a cross plan building with a hipped roof, but the front wing is nearly as wide as the cross wings. It has a full width, shed roofed porch supported by five turned posts, three of which are clustered at the center to flank the two entries (and the wide set of wooden steps that spans both openings), and have sunburst detailing in the round arched spandrels of the two porch openings. The remaining porch openings have spindlework spandrels and turned baluster railings. There is a dentil course under the eaves and lattice work below the wood floor. There are sunburst patterns on each side wall of the shed roofed porch. There is a wide 1/1 sashed window in each outer bay on the first floor with the segmental arched, transomed door openings in the center two bays. The transoms have been boarded in and the 6-panel metal doors are replacements. On the second floor there are four, segmental arched, 1/1 windows. All the facade windows have vinyl shutters and it is unlikely that the original Victorian design had shutters. The wide hipped dormer on the facade has four 1/1 wood sashed windows separated by inverted frieze panels. Above the windows is what appears to be a small, rectangular infill panel, seeming to indicate that these are replacement windows or that they had small transoms at one time. On the other elevations, there are segmental arched, 1/1 wood sashed windows and on each side there is a hipped dormer with similar 1/1 windows with panels above. The dormers on the sides have a single window while the rear dormer has paired windows. There are four tall interior brick chimneys, two on each side of the house. On each side, behind the cross bay, is a one story hipped roof porch with the original flat baluster railing, simple square corner posts and wood porch floors. The foundation is rock faced ashlar limestone. Besides the shutters and front doors, the only obvious alteration is that the brick walls have been painted.
