ARCHITECTURAL/HISTORIC INVENTORY FORM

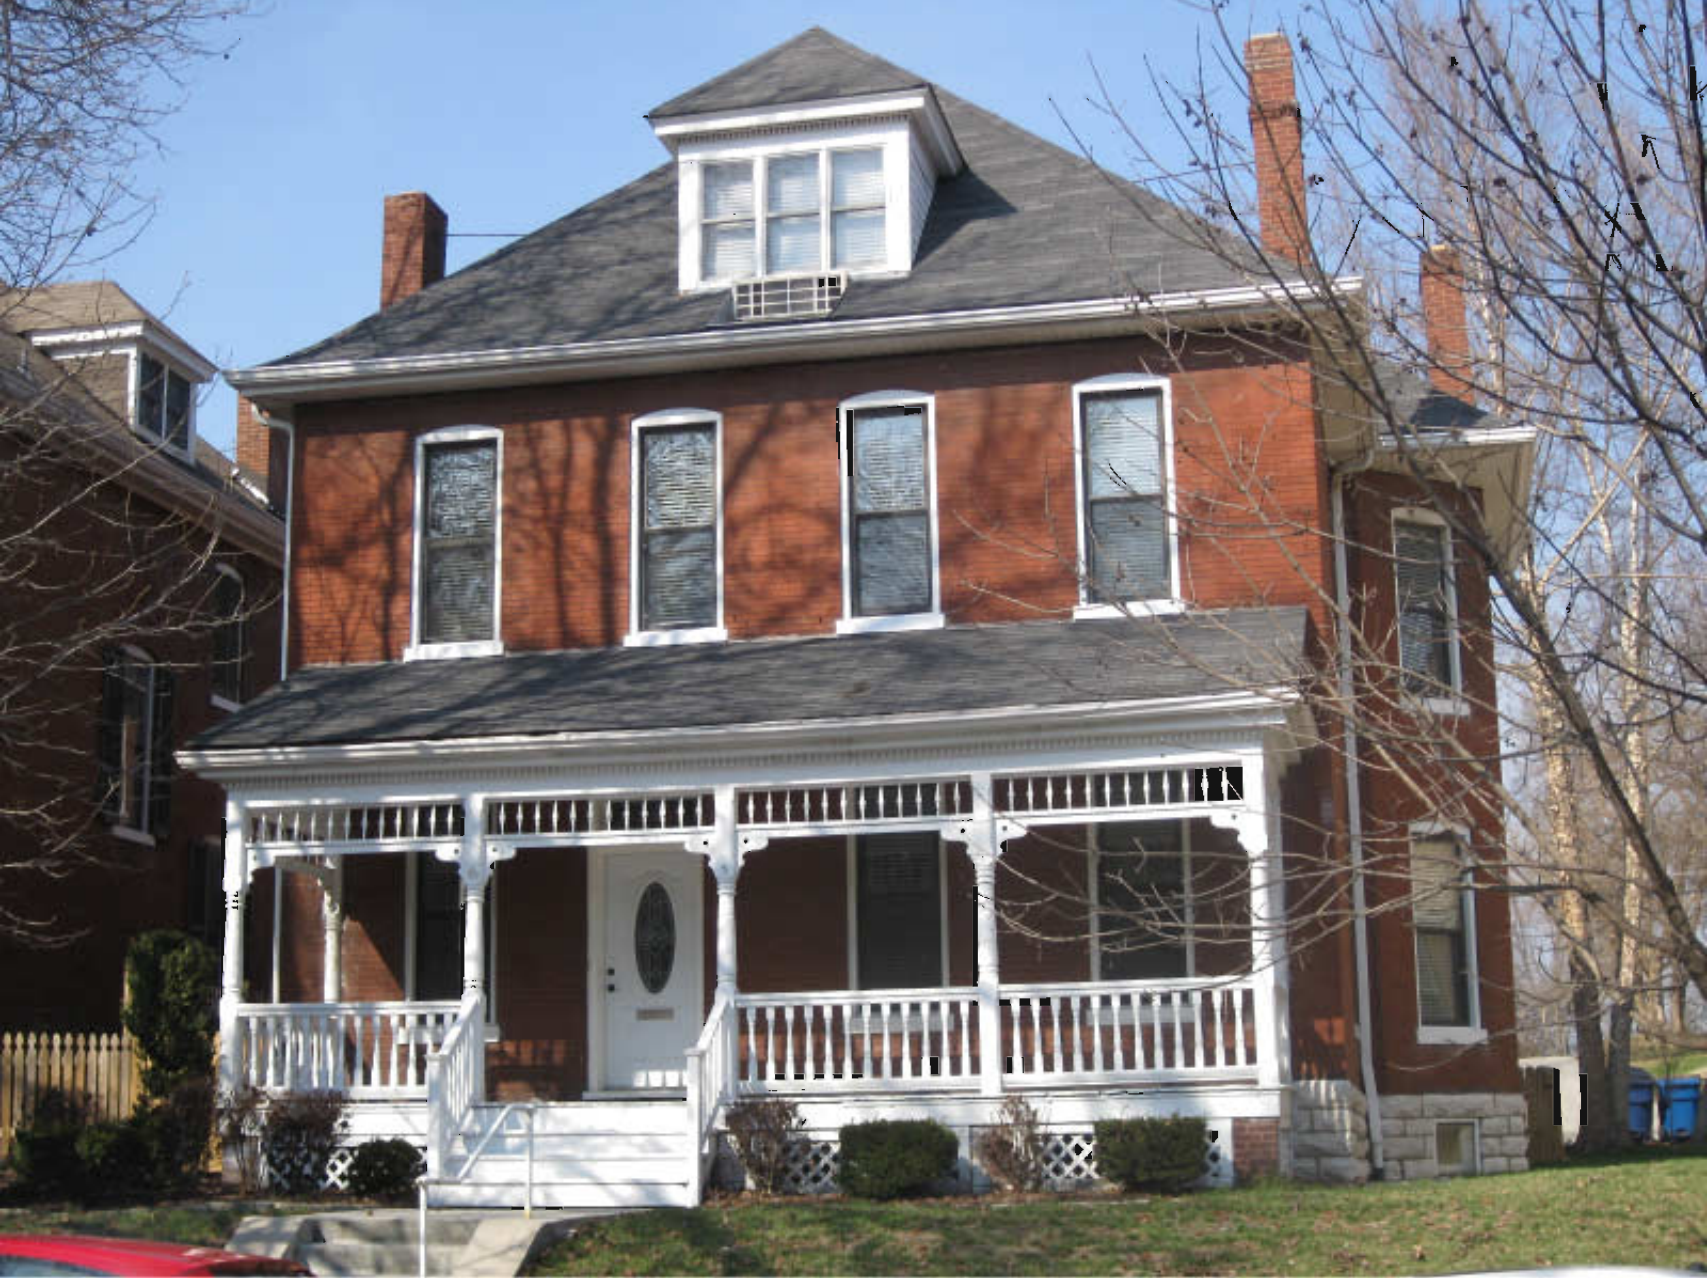
This, two-story, red brick, hipped roof, Folk Victorian house has a four-bay facade with a hipped dormer on the facade. It has a rock faced, coursed limestone foundation. The dormer has three 1/1 wood sashed windows. Across the facade is a shed roofed porch with sunburst panels on each side of the shed roof and turned posts spanned by spindlework spandrels supported by decorative brackets at each post. The balustrade also has turned balusters. There is dentil molding under the porch eaves. The porch has a wood porch floor with lattice work between the brick piers. The porch steps are positioned in line with the front door which is in the second bay from the west. The oval light door is a replacement with metal canes, but it is in the original opening with a single light transom above in the segmental arched opening. In each of the other first floor openings on the facade as well as in all four bays on the second floor there are 1/1 sashed windows and similar windows are found on the other elevations. There is a hipped roof, two story, canted bay on the east elevation. There are three brick chimneys, two flank the canted bay and one is on the west side. On the rear is what appears to be the original two story porch that wraps the corner from the back side of the east bay and extends across two-thirds of the rear elevation. It has vertical board, half wall railings on both levels and an internal staircase that accesses the first and second floor rear doors, both transomed, replacement metal doors. In 1992, the attic was converted into livable space and the rear porch and stairs were extended to the third floor where a door was installed in what may have originally been a gabled dormer, but now has a side shed roof spanning the rear elevation of the porch (next to the rear brick chimney). The spindlework brackets on the rear porch appear to be replacement features added recently. As part of this third floor conversion, it appears that a ventilation panel was cut below the front dormer. One window on the first floor has been replaced with a smaller window and infilled. The soffits have been clad with vinyl.

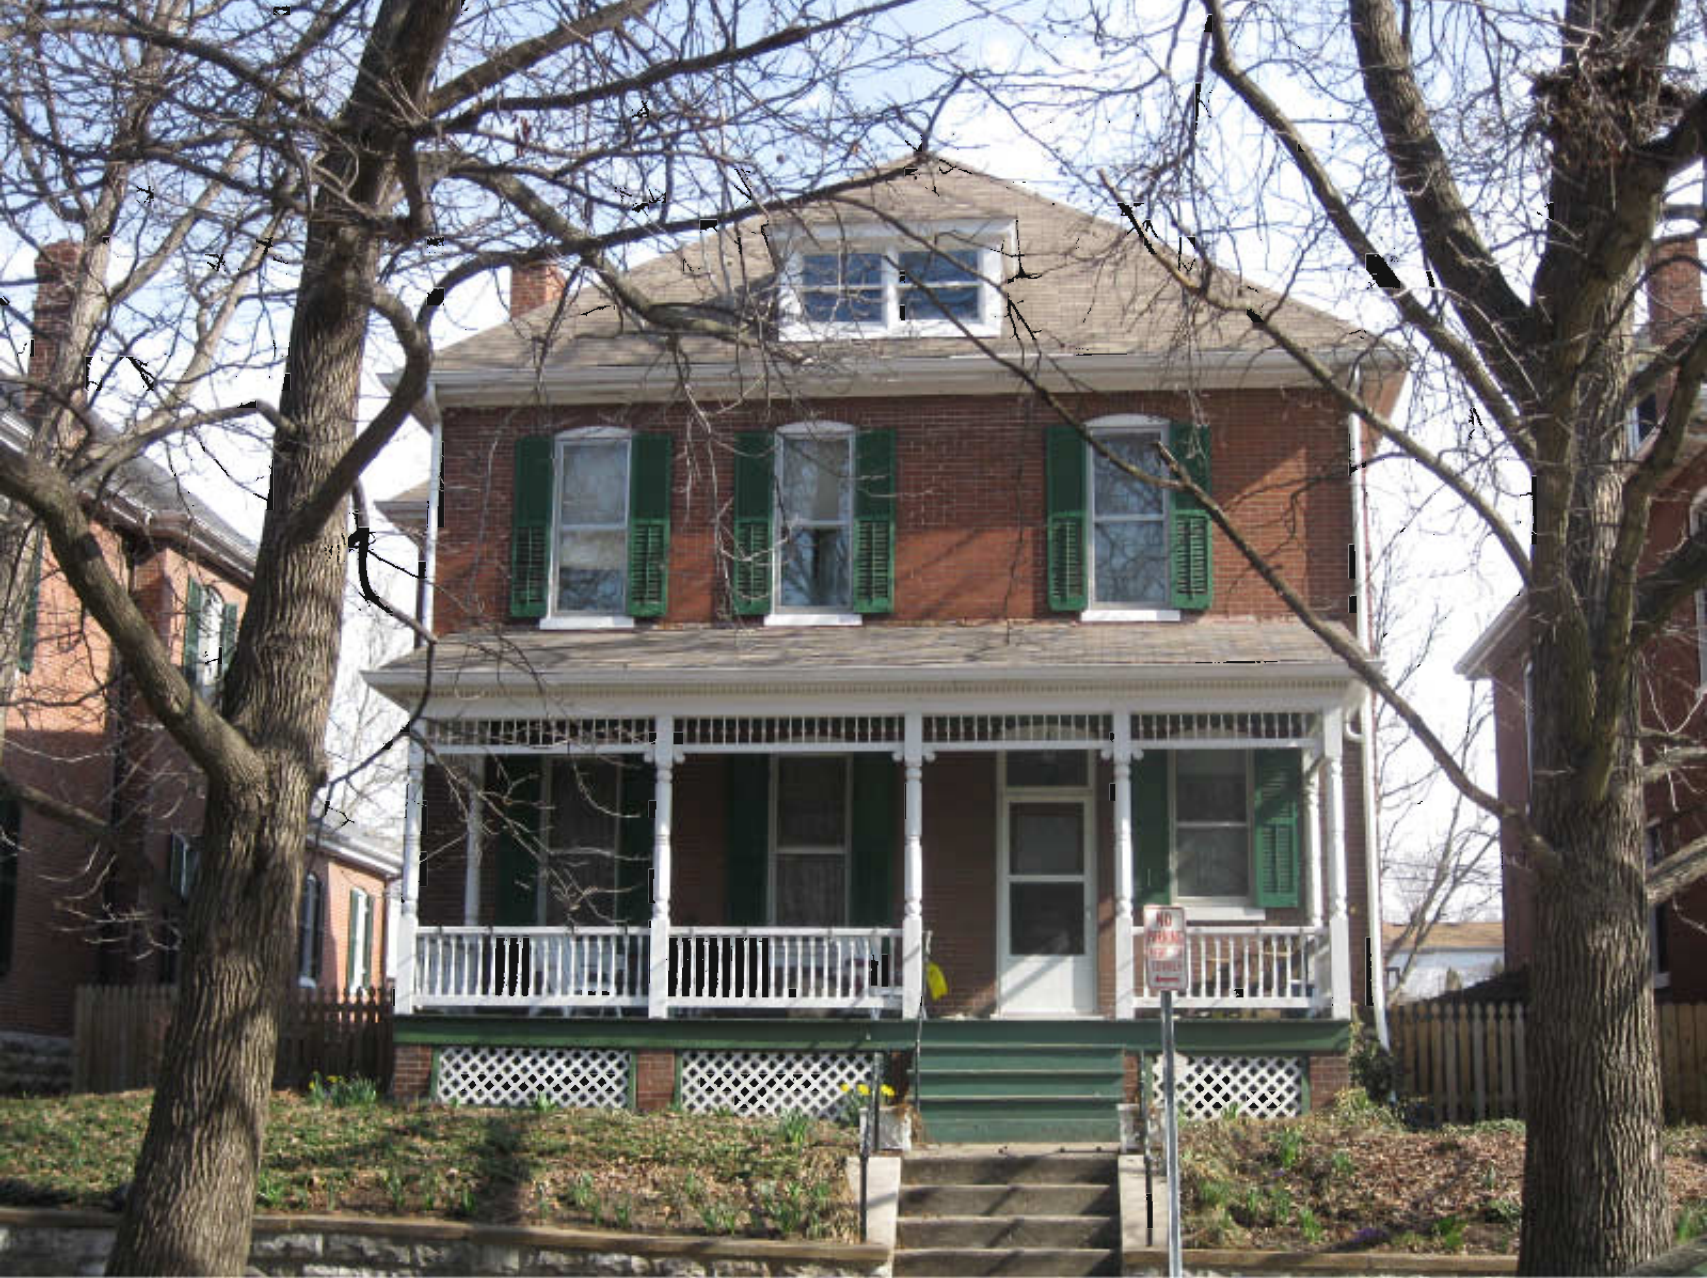
This two story brick house has a hipped roof and a two story, hipped roof, boxed bay on the west side. On both the facade and rear there are hipped dormers with paired 1/1 sashed windows. The facade is divided into four irregular bays on the first floor and spanned by a full width spindlework porch with a shed roof that has sunburst panels on each side and dentil molding under the soffits. There are spindlework spandrels and curled brackets at each of the turned posts as well as a spindlework balustrade. The five posts across the front of the porch are also placed asymmetrically to frame the windows and door opening. The posts align with the brick piers under the wood porch floor and there is lattice work between the piers and wood porch steps that extend to a sidewalk and concrete steps down to the public sidewalk. The window and door openings have segmental arches. The windows are 1/1 wood sashed windows. The transomed wood front door is half glazed and covered by a storm door and storm transom. On the south end of the east elevation is a double-hung, stained glass stairway window. The rectangular bay on the west side has two windows on the west elevation and one window on the front and back of the bay. The house has a raised, rock faced limestone foundation and the brick is laid in a running bond pattern. The soffits are wood and the facade windows have wooden shutters. On the rear, there is a one story, flat roof porch that has simple square columns with capitals. Although most of it is missing, the half newel posts against the brick walls indicate that there used to be a rooftop railing. There is a transomed door with shutters that opens onto the rooftop of this porch and the flanking 1/1 windows have shutters (one is missing). The first floor railings of the porch now support a series of wooden shutters that enclose the porch and tall paired shutters cover the entry to the porch. It appears that most windows had shutters, since some on the east side still are intact as well, but it is possible that the missing shutters on windows are actually the shutters now located on the rear porch. The shutters are louvered and functionally hinged.

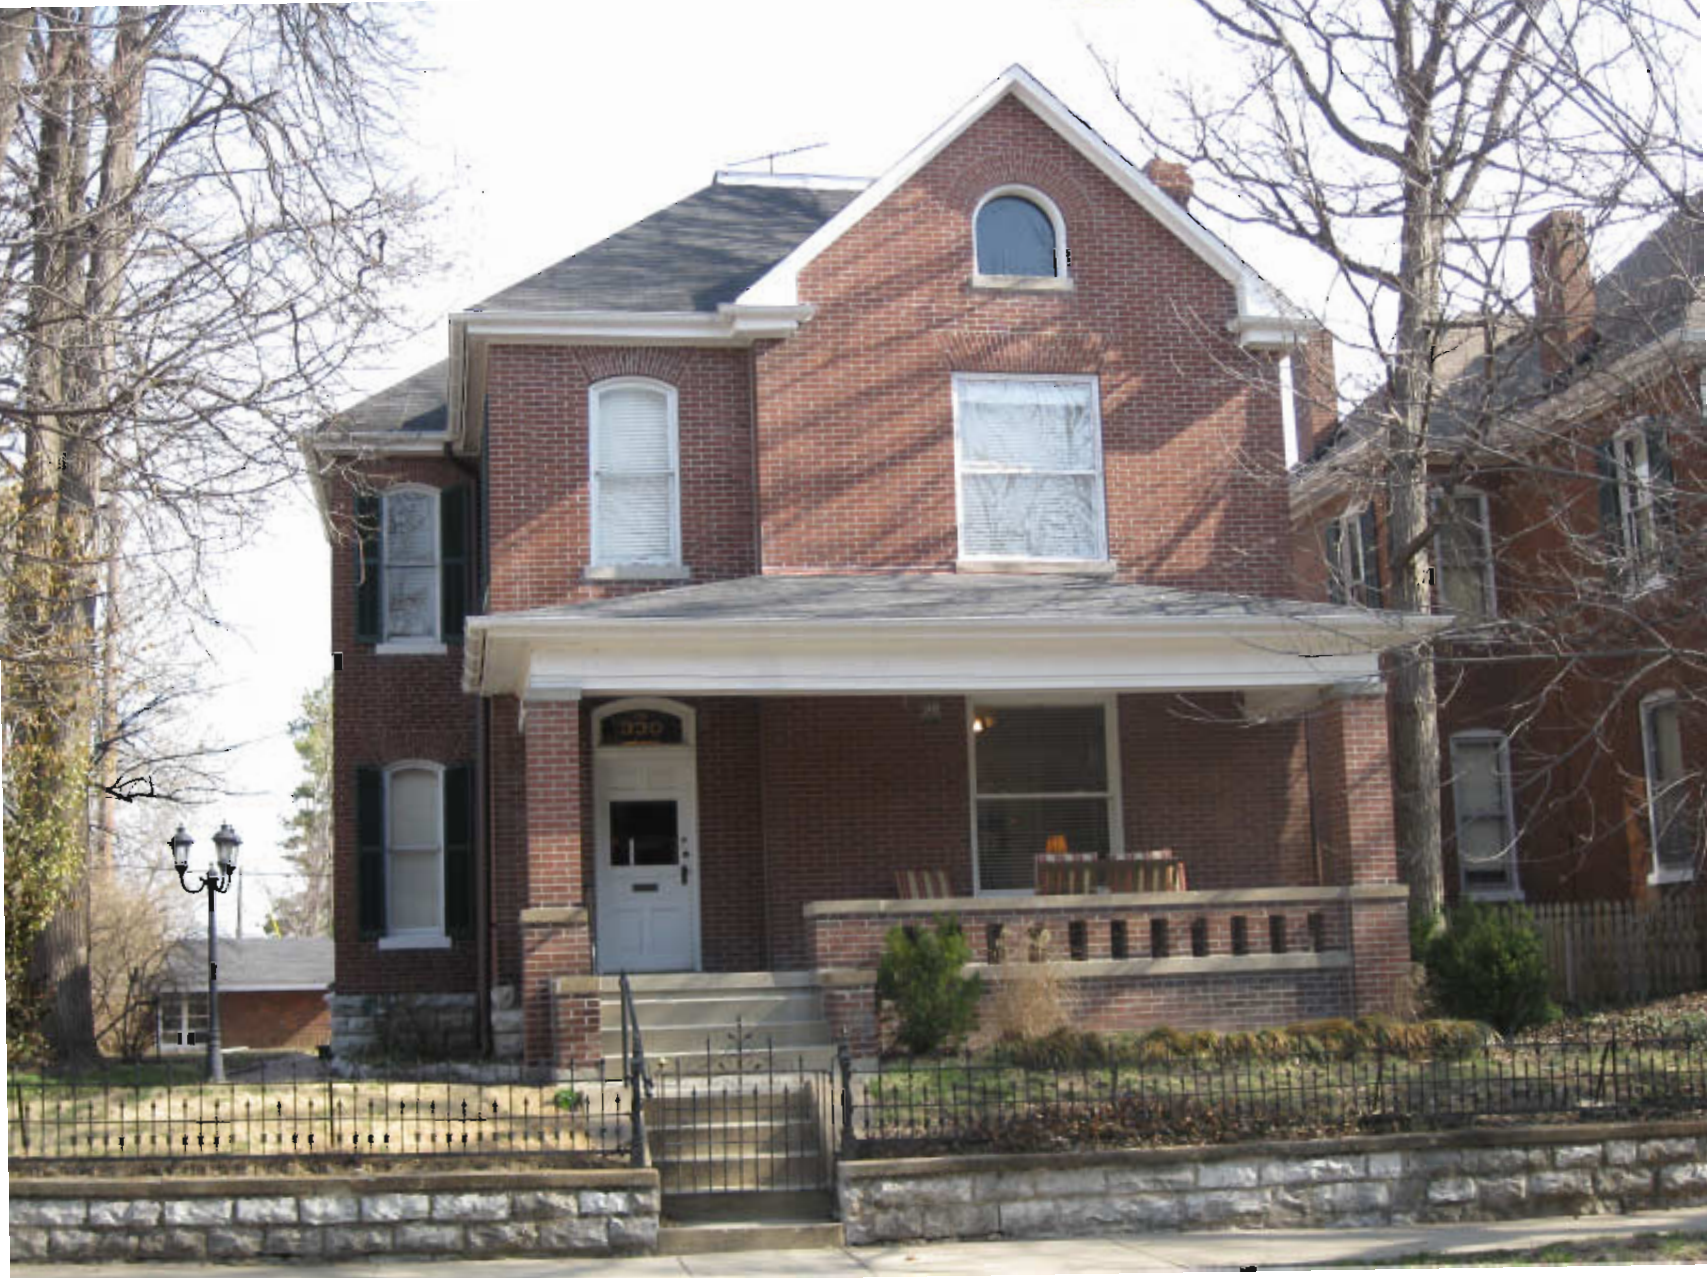
This two story, brick house has a truncated hipped roof with a cross gabled bay projecting slightly and spanning the east two-thirds of the facade. Across the rear is a hipped roof, two story section that extends wider than the truncated hipped roof section, creating a narrow two story hipped bay on the east and a slightly wider hipped two story bay on the west side of the house. The house has a rock-faced, coursed limestone foundation and a tall corbelled brick chimney on the east side. The facade originally had a one-bay porch (shown on the 1909 and 1917 fire insurance maps), but between 1917 and 1929, the current, full width, shallow hipped roof porch was added to the facade. The porch roof has an entablature-like fascia surrounding the porch and brick corner piers that extend to the ground, but the concrete cap to the brick pierced half-wall railing continues through the brick piers. The poured concrete foundation forms another course which stops at the piers but continues as the cap to the brick wing walls on either side of the concrete steps. Below the porch floor, the brick continues as the porch foundation between the piers. Most of the window openings and the front door have segmental arched openings. Most windows have 1/1 segmental arched top sashed windows and many still have what appear to be original wooden louvered shutters. The transomed, wood paneled door has a panel above a square light and a horizontal panel and paired vertical panel below the light. The door is located in the west bay of the two bay facade and there is a 1/1 sashed segmental arched top window above the door. The east bay has flat headed brick lintels on the broad 1/1 sashed windows that are aligned on the first and second floor. Centered above, in the gable end is a half round window with a replacement single light. From the rear, two additional corbelled chimneys are available, one near the top of the truncated hip and the other at the point where the hipped roof is intersected by a 1.5 story cross gabled wing that spans the rear of the house. There is a nonhistoric wooden staircase that was added in 1997 extending up to a doorway on the second floor of this rear wing (created to provide access to what is now a secondary fire exit). There is a small, red tile, mansard roof, 1-story screened porch room extending off to the west side of the rear wing.

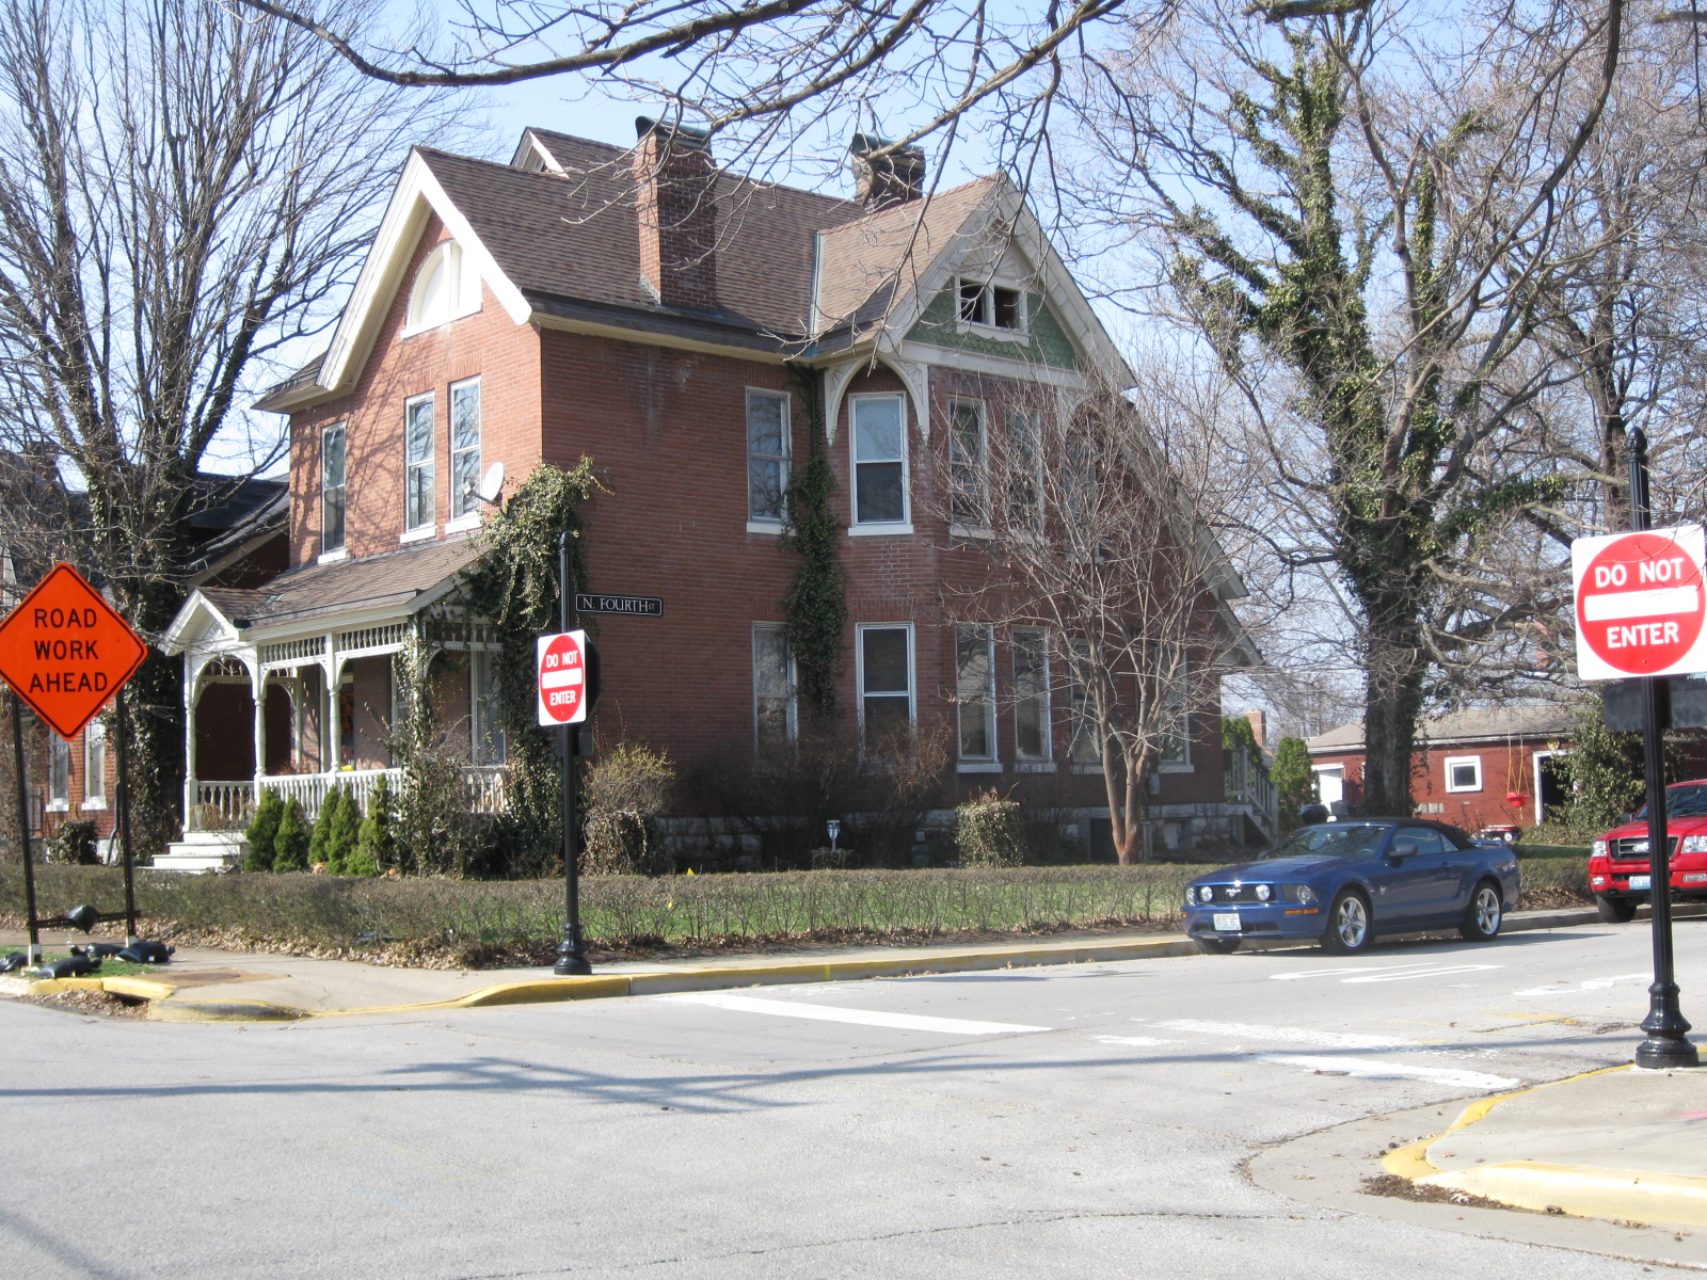
attic windows. Most of the windows on this house have flared brick lintels and stone sills. The walls are laid with running bond brick. The only noticeable alteration are the metal storm windows, but the vines growing on the house and the missing attic windows indicate that the house is being neglected and could deteriorate rapidly if unattended.

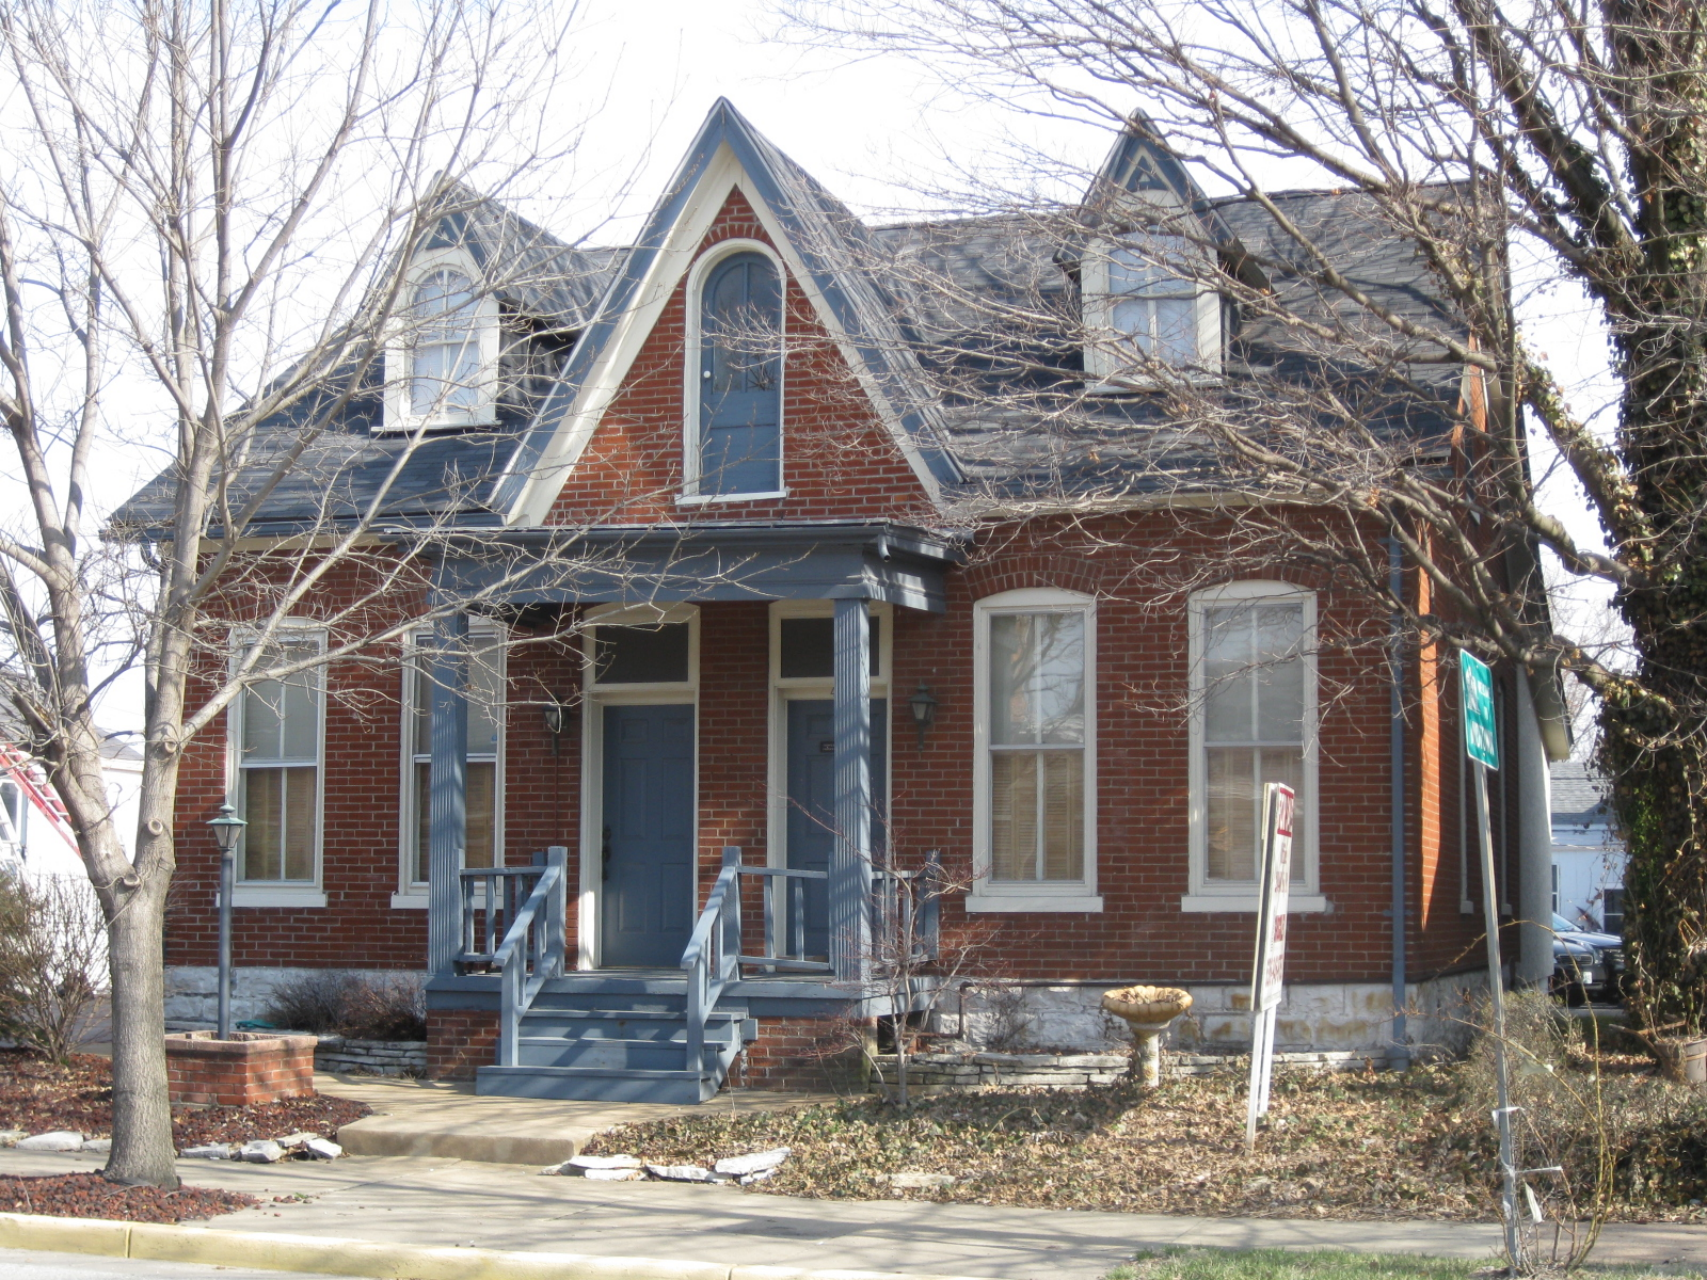
This side gabled, 1.5 story, red, running bond brick house has a symmetrical facade with a cross gable centered over the porch. The gable has a round arched doorway opening onto the flat topped porch roof. Historic photos show that at one time there was a railing around this rooftop, but it is missing now. The door is a round-arched, paneled, half-light door with four panes of glass. There are two transomed doorways below that have single light transoms, but the six panel doors are replacement metal doors. The porch has a beadboard ceiling and wood porch floor, but the fluted corner posts and the railings are recent replacements. The foundation creates a high watertable of coursed, rock faced stone. On either side of the porch, there are two segmental arched, 2/2 windows and a gabled dormer with a round arched 2/2 window. The side elevations have 2/2 flat headed windows and at least the second floor window on the west side is a 6/6 replacement window. On the back of the house, there are two hipped roof dormers with flat headed 2/2 windows. Historically at each side, the rear corners were open porches but these have been enclosed since 1947. The flat boards framing the windows on the west side appear to be a modern application.

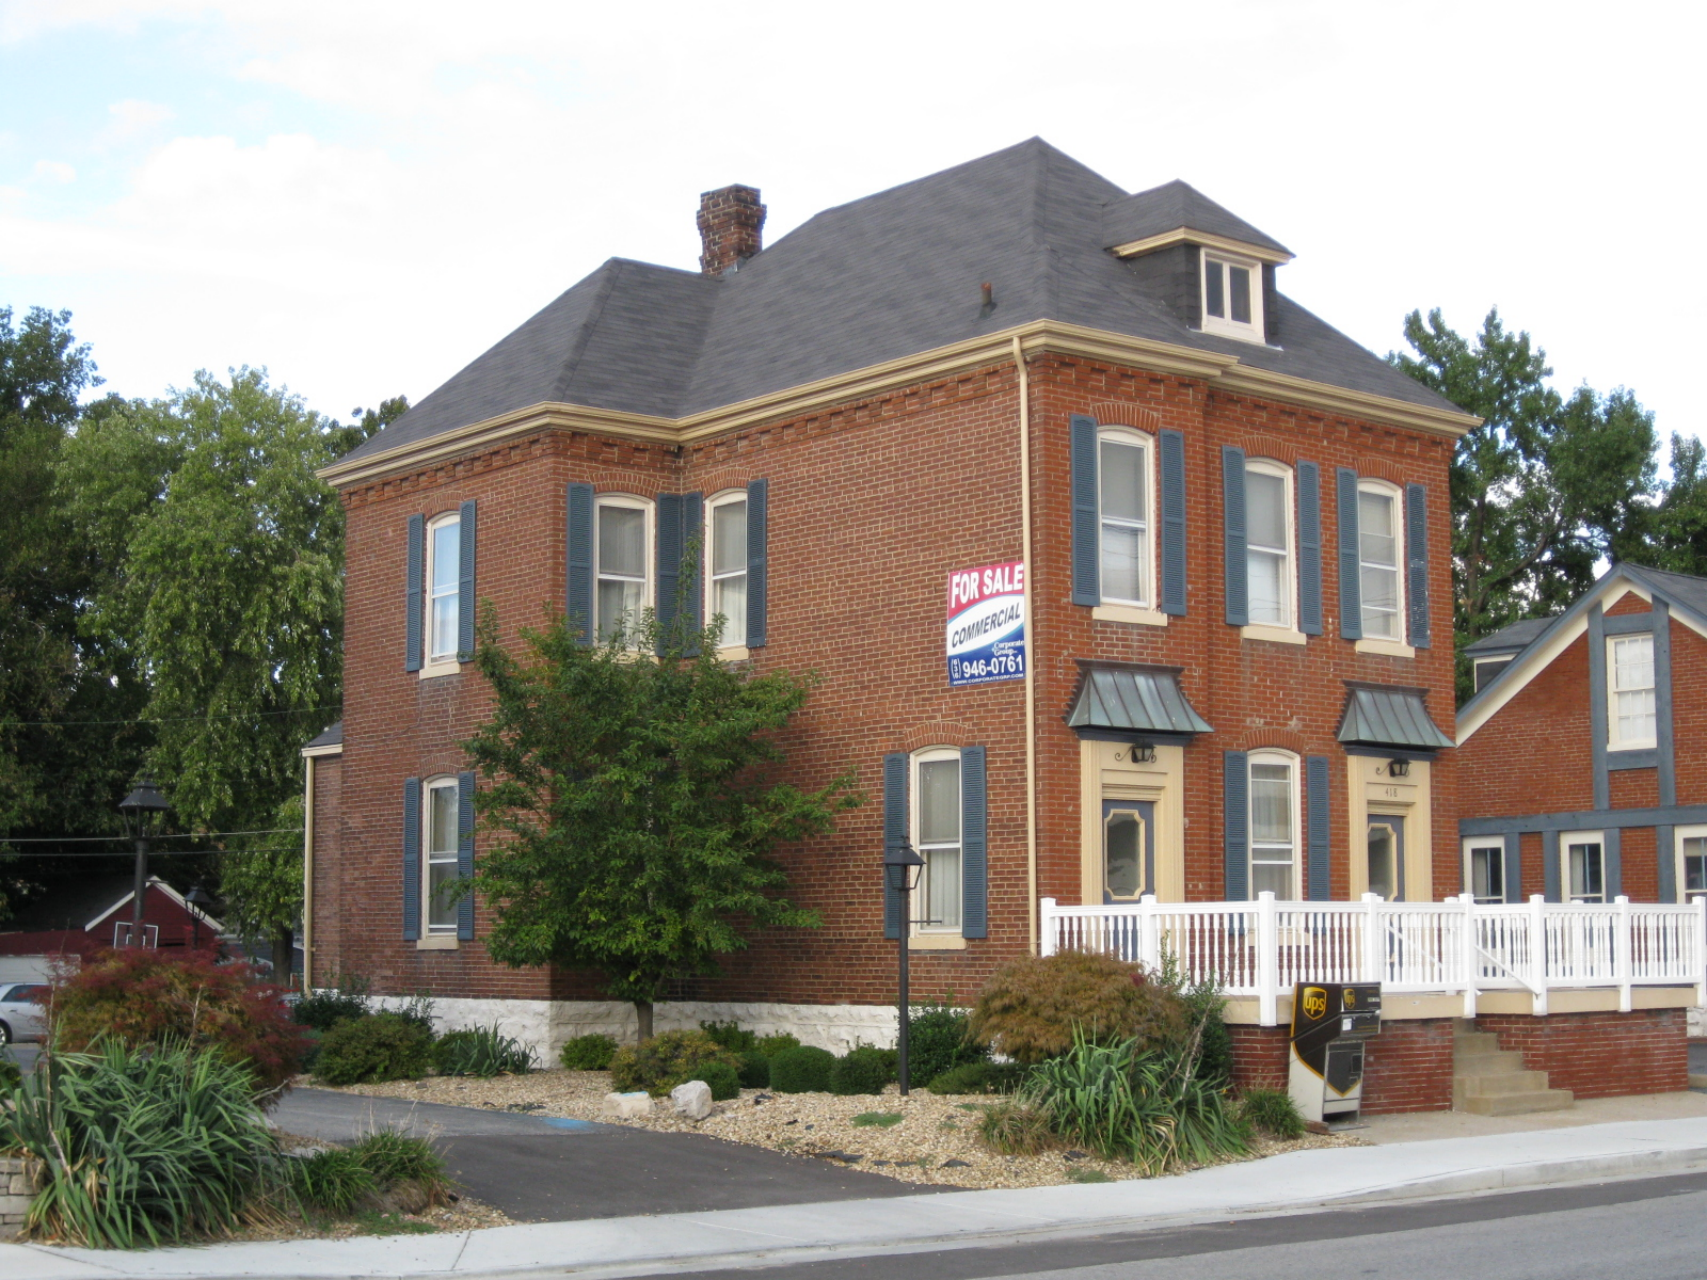
ridge and small, segmental arched 1/1 windows facing the rear. On the west side, what was historically an open porch has been enclosed with modern vertical board siding. There is another hipped dormer on the rear of the two story section of the house and there is a corbelled brick chimney behind the hipped dormer near the crest of the roof. The chimney on the east side has been reduced in height.

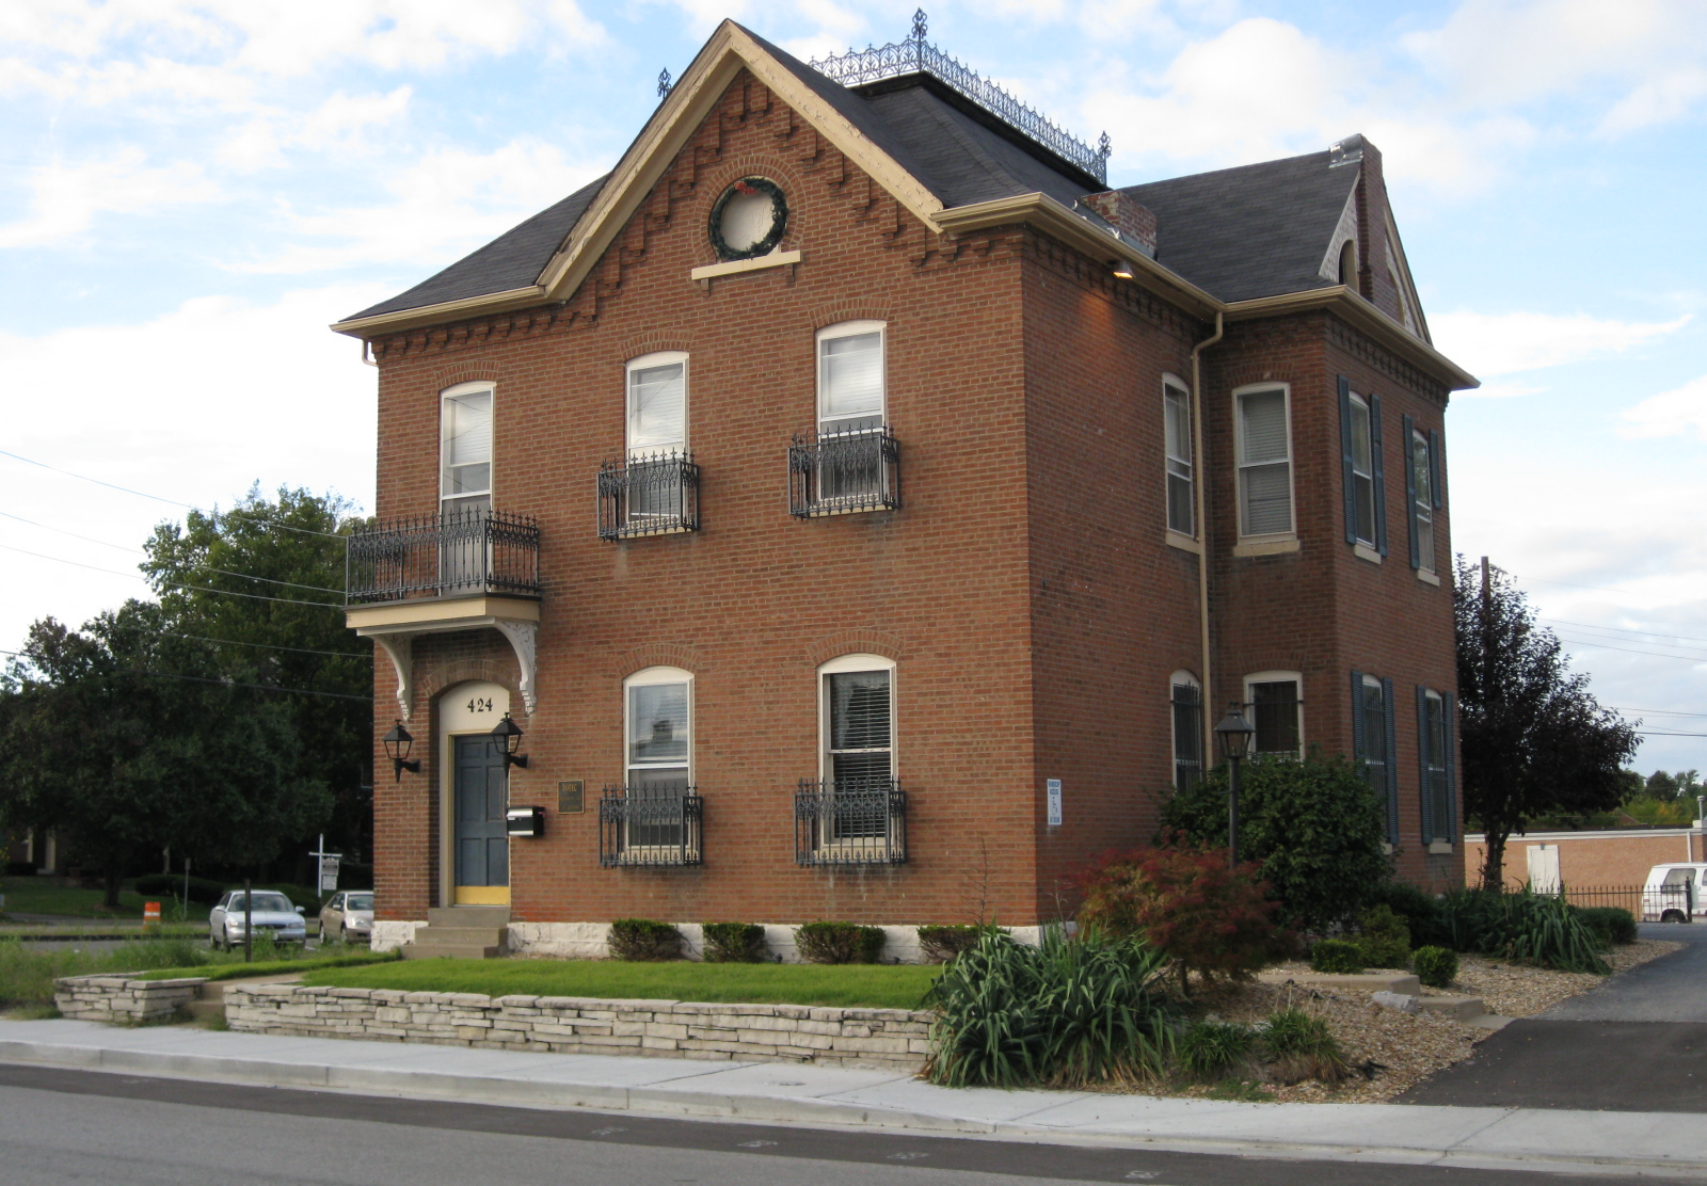
This two story, truncated hipped house has metal cresting around the top of the roof. The brick walls are laid in a five-course common bond pattern and it has a painted limestone foundation with beaded joints. The facade is divided into three bays with a cross gable extending across the eastern two bays. This gable and the eaves around the house are accentuated by a crenellated brick course. There is a round arched window with a lugged stone sill that is framed by horseshoe arched brick in the gable end. Most windows are segmental arched, 1/1 wood sashed windows, now covered with aluminum storm windows (it appears the windows have segmental arched sashes, but the storms are flat headed) and decorative iron security bars. The window in the west bay appears to be a tall sashed, Jefferson window, extending to the small balcony with an iron railing which forms the rooftop over the porch, supported by curved, incised brackets. The segmental arched doorway originally would have had a transomed door, but portions of the doorway have been infilled and a smaller 6-panel replacement door installed. Three small concrete steps lead up to the doorway. The other facade windows have faux iron balconies. On the east side, there is a cross gabled bay which is split by an end wall brick chimney. Like the other chimney in front of this bay, the tops of the chimneys are missing. The gable end is clad with fishscale shingles and there are two sashed windows in the bay. In the gable end, there are quarter-round windows (boarded in) flanking the chimney. On the rear of the house, there is a two-story, hipped roof wing with the same crenellated brickwork under the eaves. On the east side of this wing is a two-story, hipped roof porch. The porch is shown on historic maps, but the current porch supports and railings are beefier than would have been there historically and a wheelchair ramp has been installed along with iron bar railing balusters. The fire insurance maps through 1917 do not show a porch, but the 1929 and 1947 maps show a one story porch in this bay, probably simply a different interpretation by the mapmakers since the balustraded and bracketed roof over the doorway appears stylistically to date from the construction of the house. The small one-story, shed roofed wing added to the rear of the two story hipped rear wing was added between 1900 and 1909.

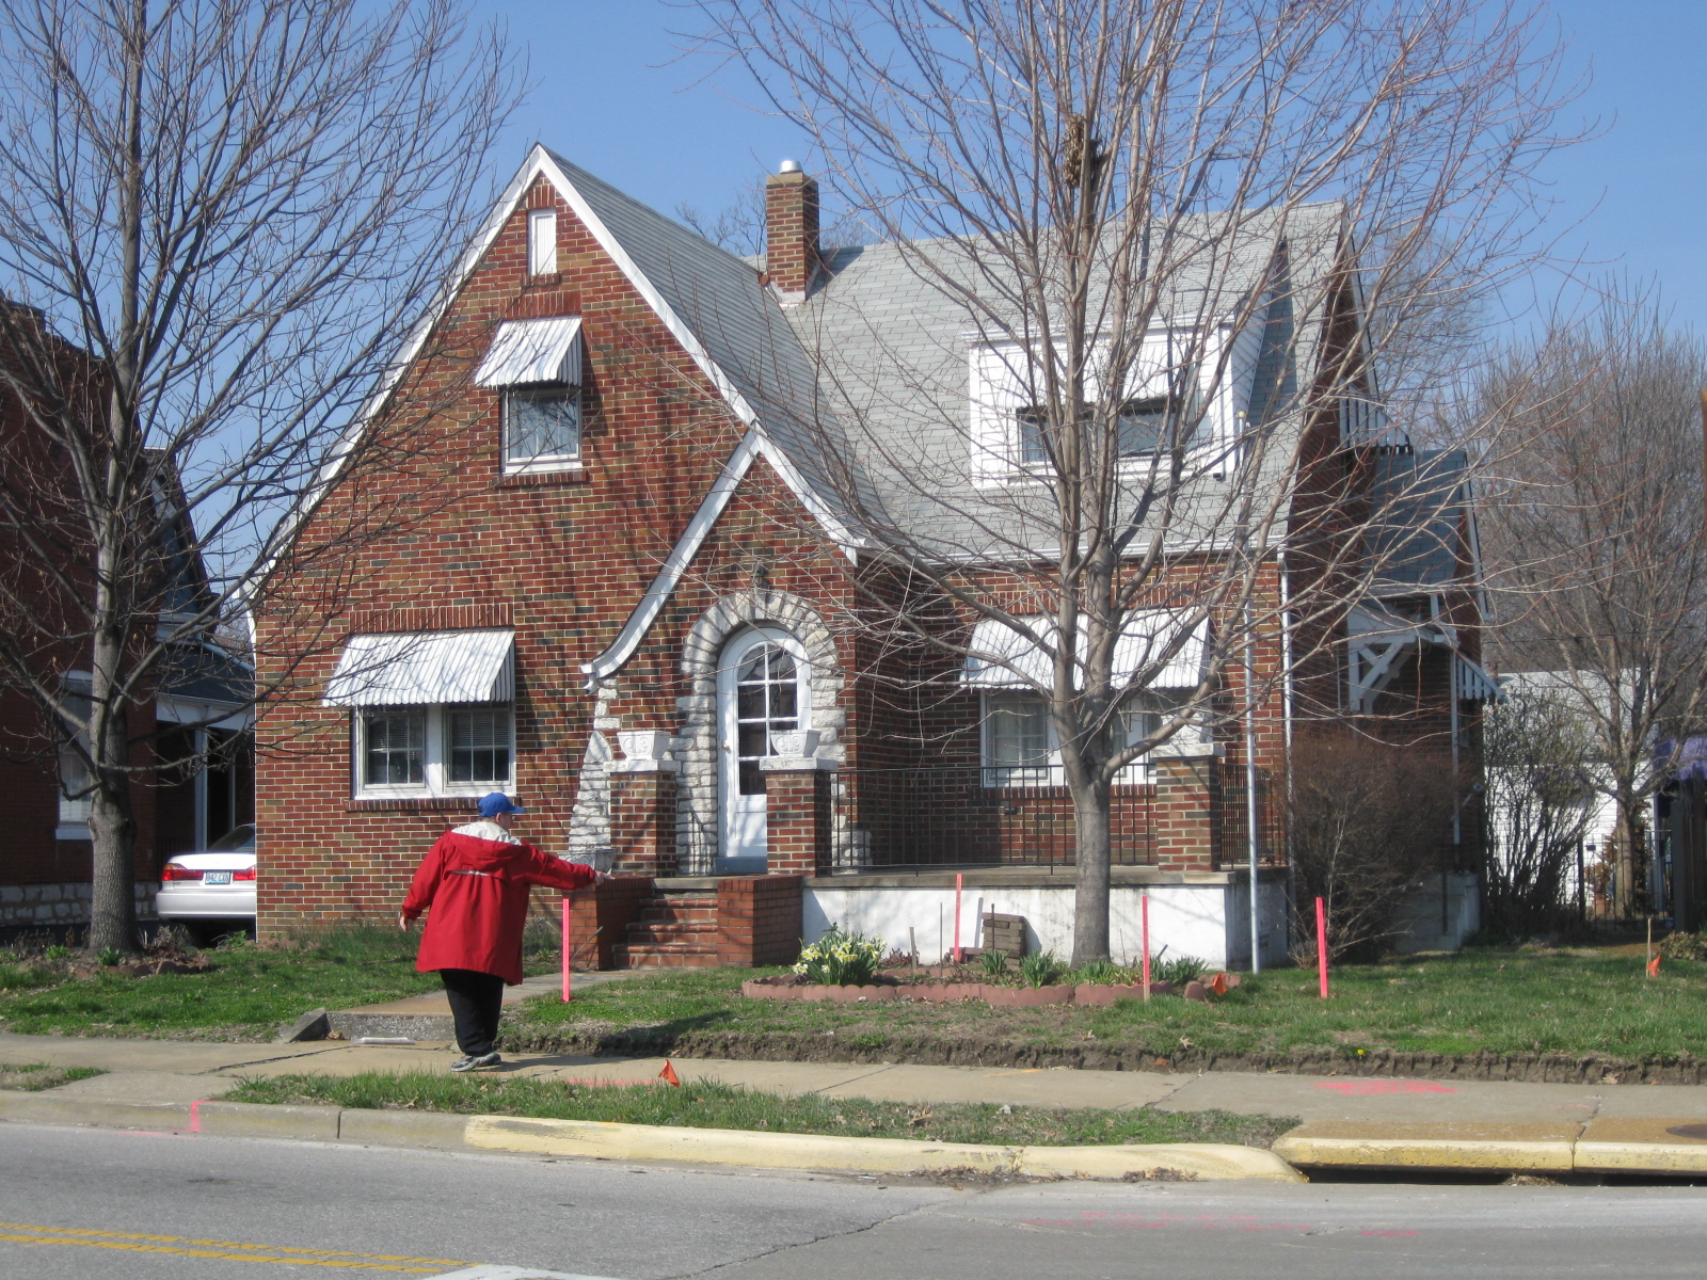
On the rear there is a large shed roofed dormer and a shed roofed enclosed porch.

Storm windows have been added to the house and aluminum awnings have been added to most windows. Otherwise the house appears unaltered.
