ARCHITECTURAL/HISTORIC INVENTORY FORM

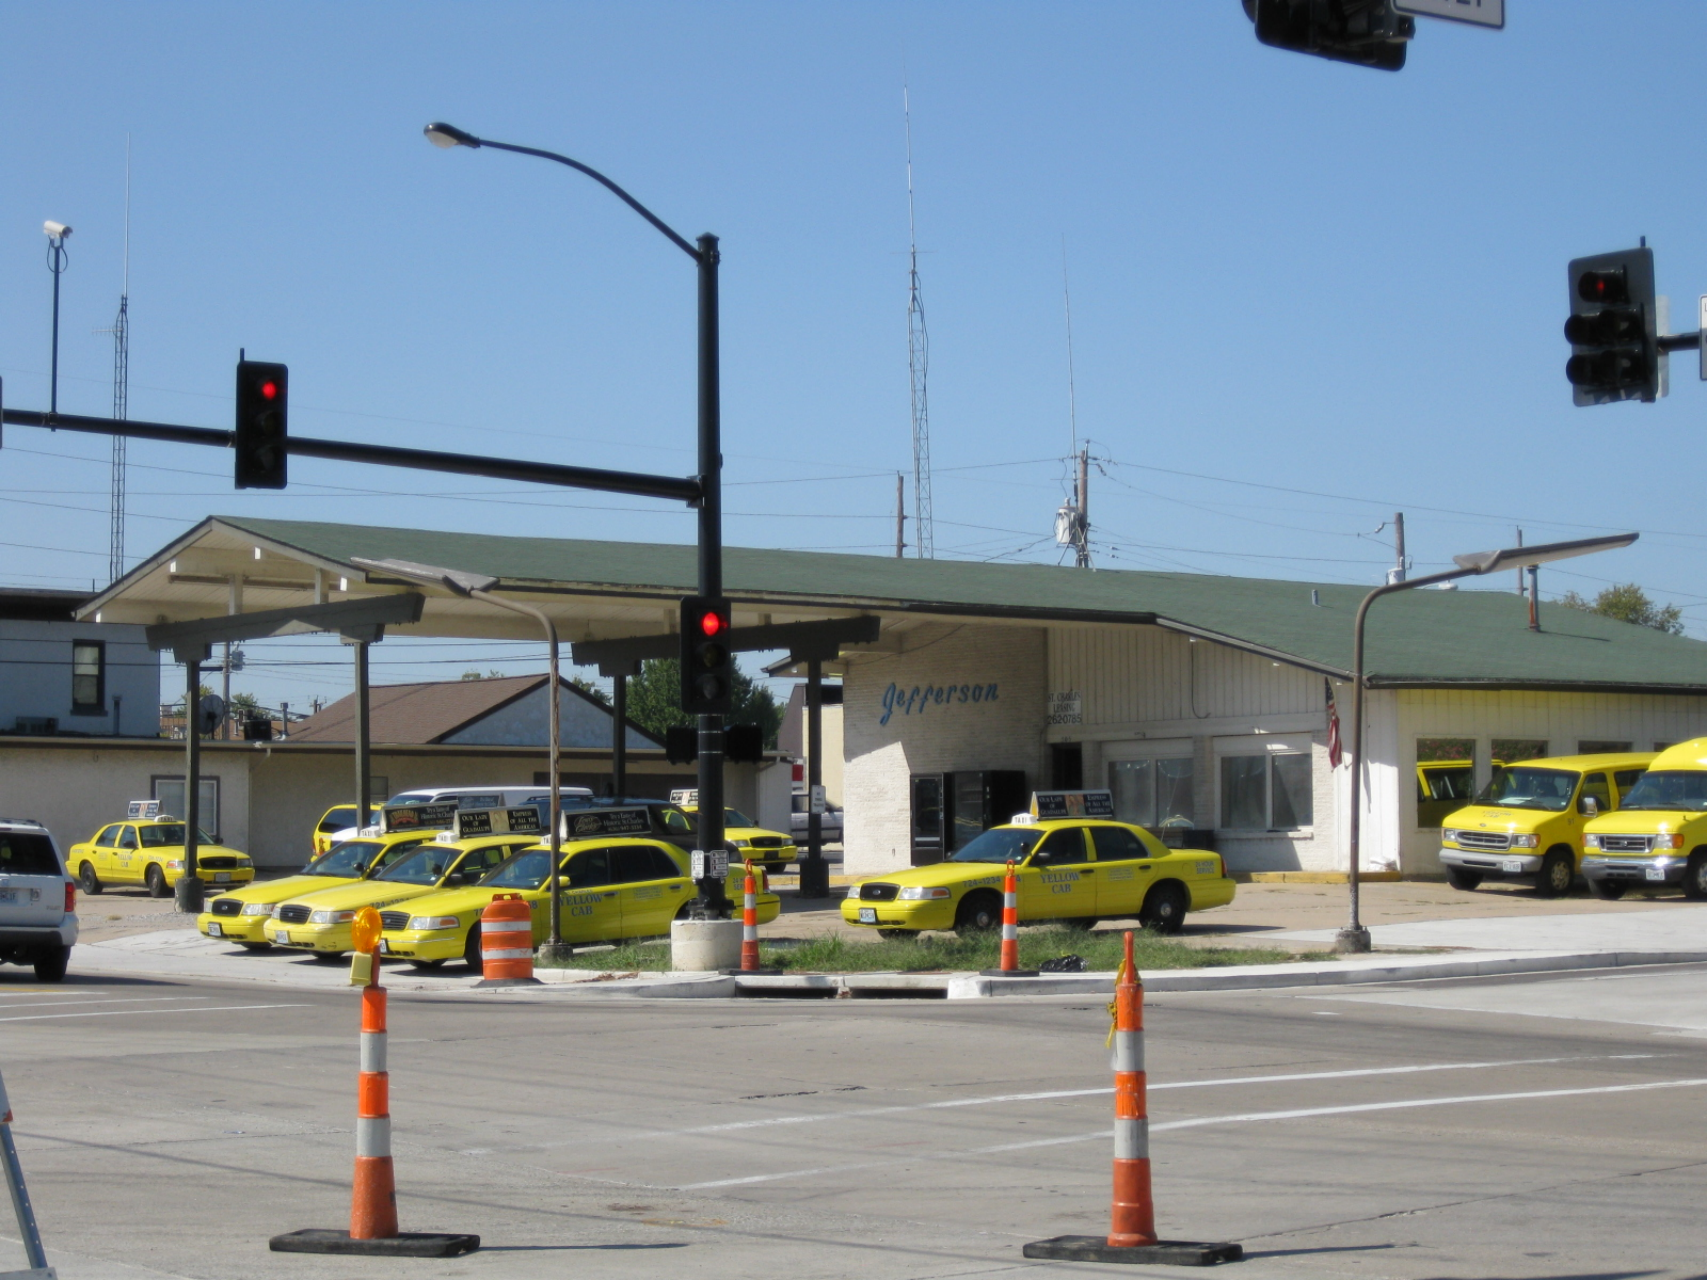
This large, side gabled, light beige brick service garage has a service bay, gable roofed canopy that extends from the main roof of the garage (which is nearly centered on the lot) to the street to the east. The canopy is supported at the outer corners by large square columns. The gable end of the north half of the east elevation above the two plate glass windows as well as the north elevation walls are made of vertical board siding. On the east elevation, there are brick piers and brick half walls below the plate glass windows. South of the southernmost brick pier is a slightly recessed doorway with a full light wood framed door. The south half of this elevation is all brick. The underside of the gabled canopy roof has its exposed wood beams piercing the east wall as well as the exposed wood board roof decking. On the north elevation, there are five bays, four of which have simple plate glass windows, and the westernmost bay is an overhead garage door. The south and west elevations are also brick. On the west elevation there are small beam extensions supporting the gabled roof overhang and the brick wall is unadorned. On the south elevation there are two overhead doors, the one on the west is an original 12-light metal framed door and the other door is a replacement metal paneled door. The bay to the east has two paneled doors to the restrooms. The east elevation plate glass windows have been replaced with the openings partially infilled and smaller paired plate glass windows installed. The plate glass windows on the north elevation appear to be replacements and may actually be infill in what was originally garage door bays. Although this is not a contributing building in the historic district and is not old enough to be considered for individual listing in the National Register either, it is an interesting period piece, one that seems to be a relatively intact example of 1970s architectural design features applied to a service station.

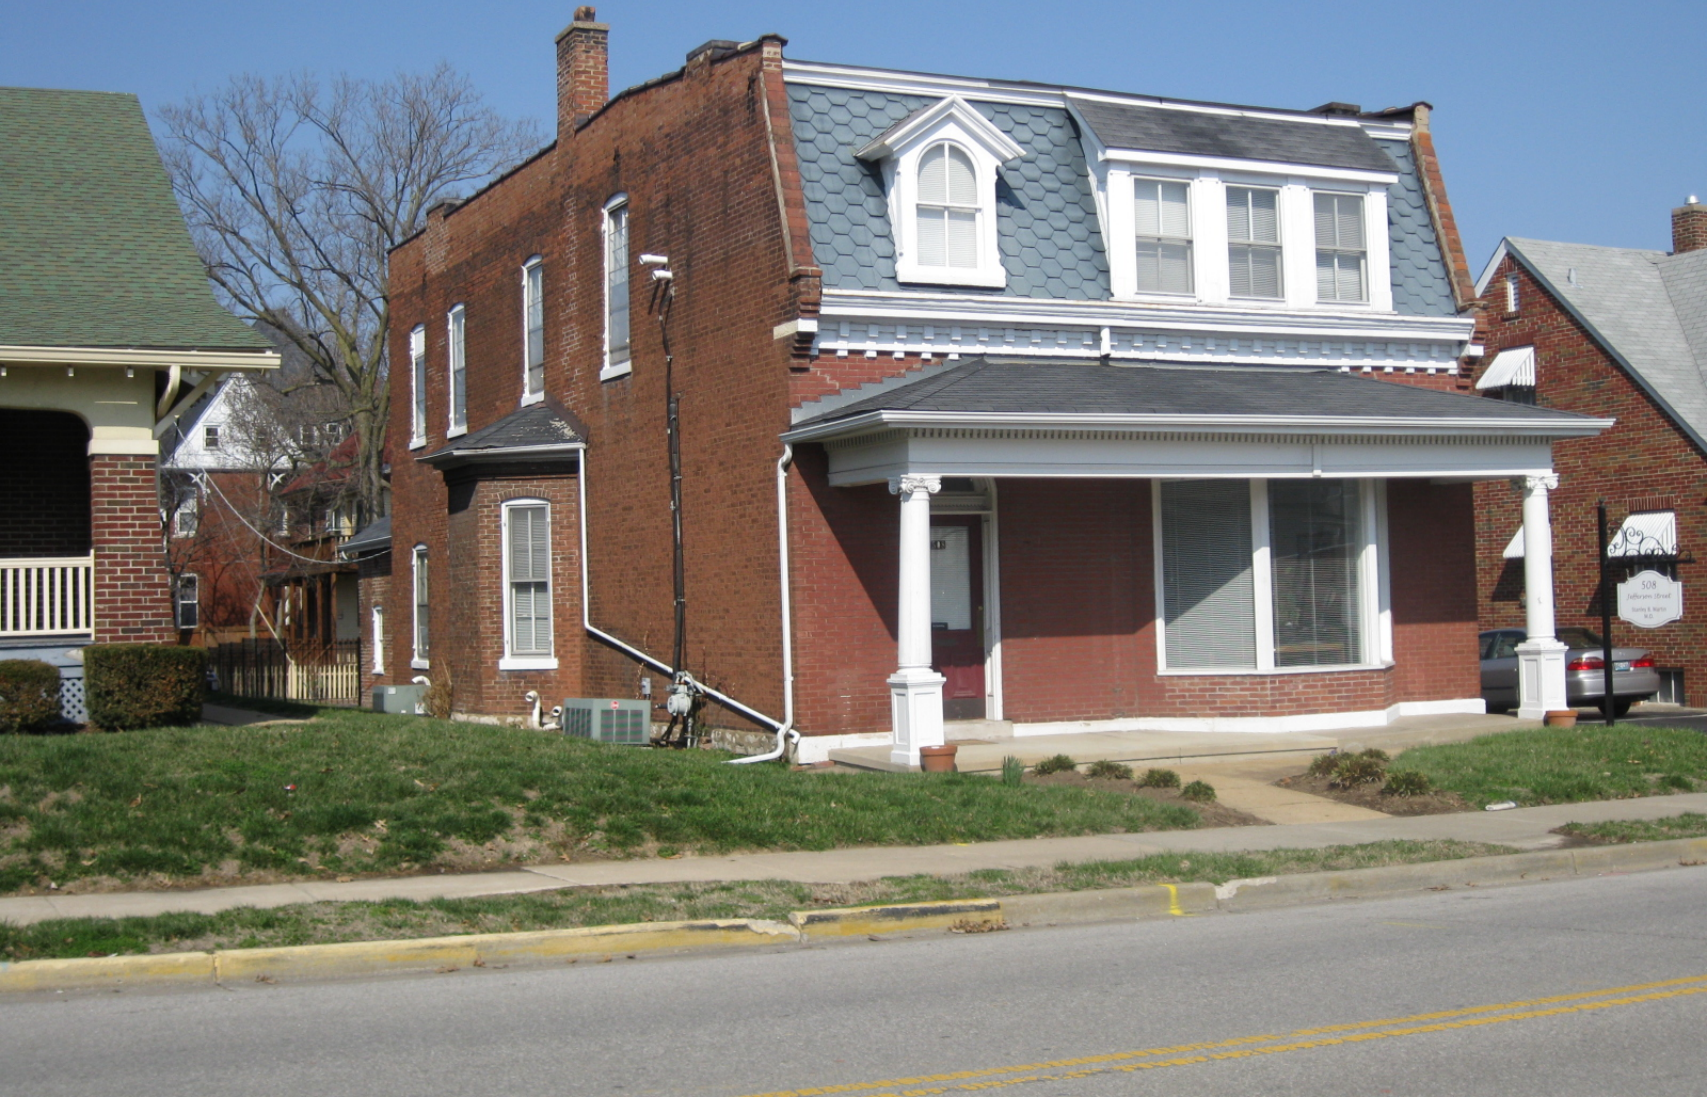
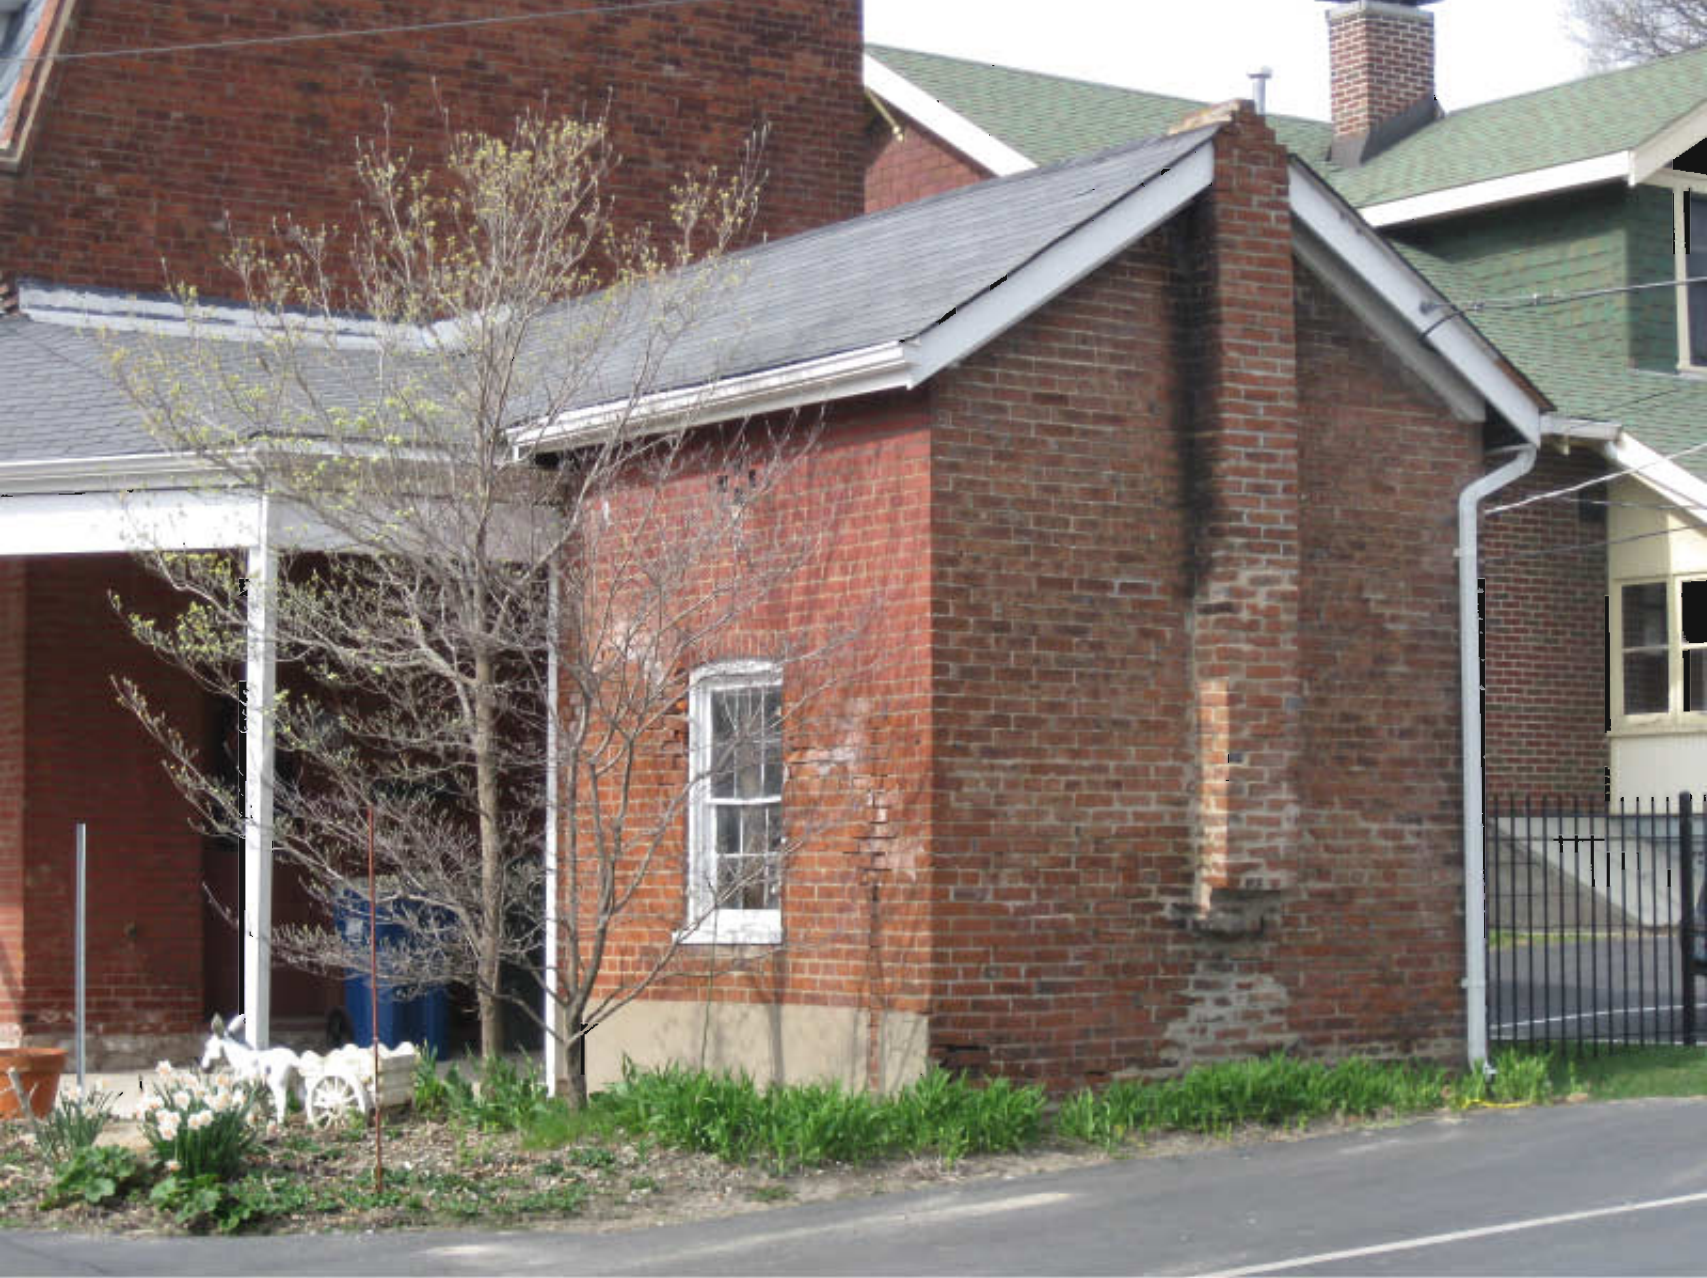
the outbuilding has an end wall brick chimney and there is a single 6 over 6 window with a slightly arched brick lintel on the east and west elevations. There is a segmental arched doorway facing south under the breezeway. Since there are pierced brick vents near the top of each elevation, and a lack of windows, it appears this might have been an old smokehouse.

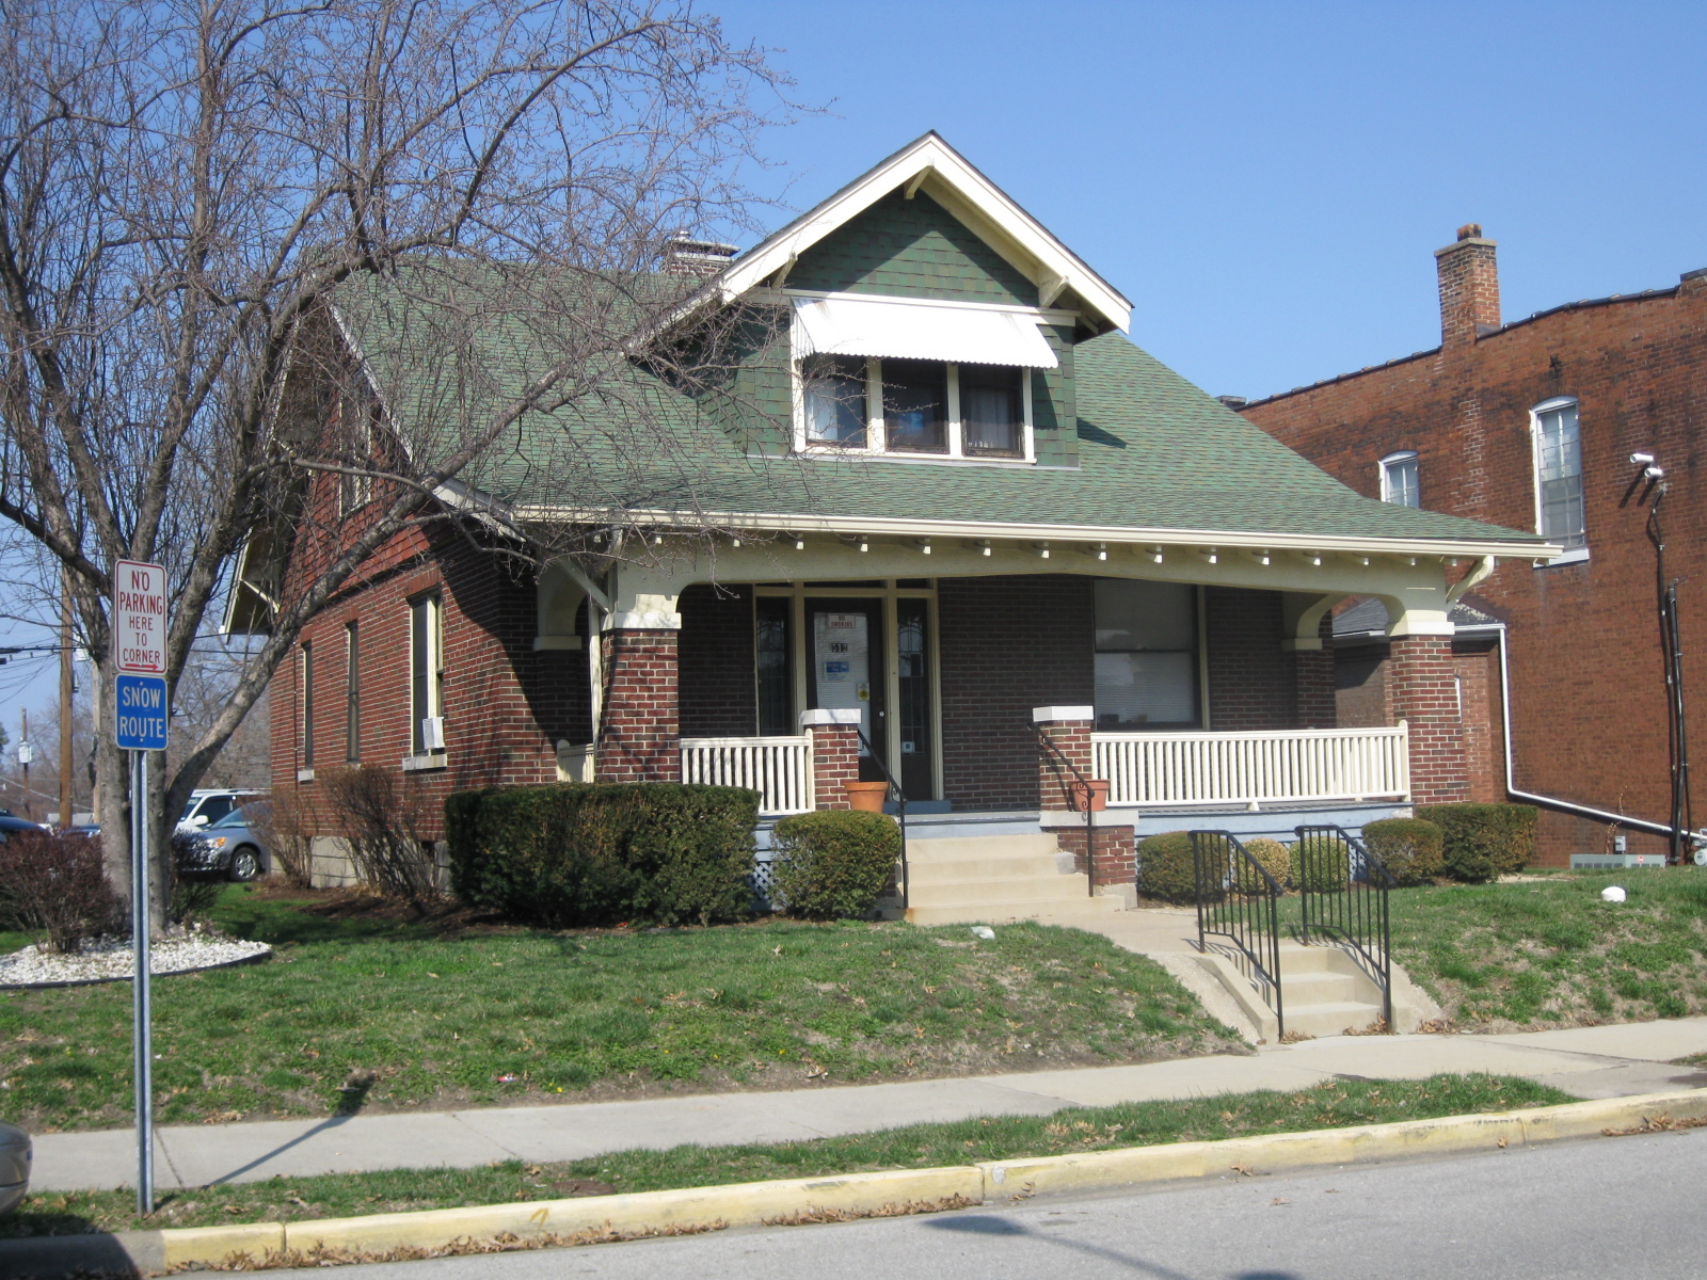
This 1.5 stories, red brick, side gabled Craftsman bungalow has broad gabled dormers on both the front and rear elevations, each with three 1 over 1 windows below a continuous sill. Like the main roof, the dormers have wide eaves with knee braces. The full width porch has a shed roof that extends at a shallower pitch off the main roof, and it has rafter tails notched with deep slits. At each corner there are battered brick piers which connect to the shallow Tudor arched beams that span the openings. The brick piers extend to concrete bases at ground level and have concrete caps as well. The wood porch floor retains its latticework in-fill between the porch piers and its original flat baluster porch railings that extend to brick newel posts on either side of the broad entry stair, which is offset to the west of center in line with the entry door. The door is a full light wood door with leaded glass, full light sidelights, and a transom is over the door and each of the sidelights. There is a large 1 over 1 wood sashed window in the east bay of the facade and a small, elevated, leaded glass window at the west end of the facade (probably positioned at a stair landing). On each side of the house, the gable ends are clad with asphalt, faux brick siding, which may not be original to the house since that product was probably not widely used until the 1930s, but it is an alteration within the period of significance of the district. The second floor has paired, 1 over 1 windows and the first floor has additional 1 over 1 windows with dressed stone sills. On each side, the scored concrete foundation is visible as a raised water table pierced by the vertical light, awning windows in the basement. On the east elevation, there is also a canted bay window with a wide eave shed roof. It has a 1 over 1 window on the front facet but not on the east side. The brick chimney is centered on the rear slope, but it has a newer metal chimney cap. On the rear, there is a partial width enclosed porch that has a shed roof that is an extension of the main roof, and there are notched exposed rafters in the wide eaves. It has a beadboard railing/wall with a series of wooden storm windows enclosing the porch. It has lattice work below the wood porch floor. The rear door is still the 4 pane, half light wood door. To the east of the porch is a wood, sloped, trap door entry to the basement. Both the front and rear porch have concrete steps which appear to be replacements. The gutters are not historic. The green asphalt shingles on the roof and the dormer walls are probably replacements, but may be the same material as was used originally.

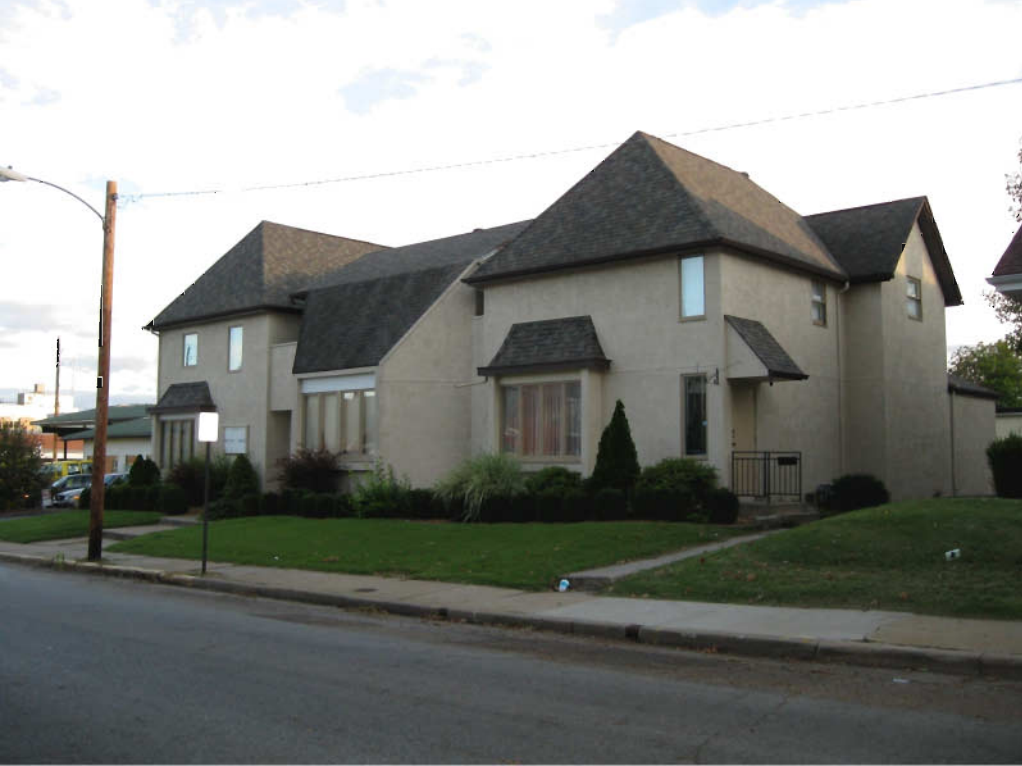
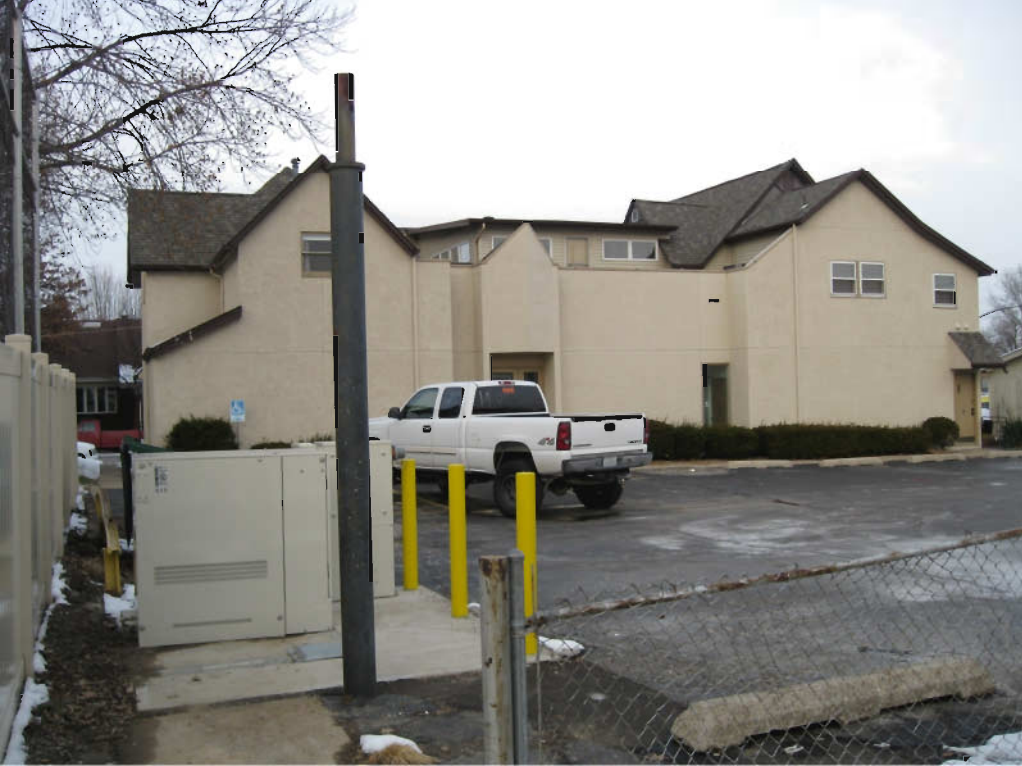
The current building is a combination of two separate, two story historic houses with a large addition spanning between them. While the hipped roofs and cross gables appear to be original, the windows have been relocated and all the sashes replaced with casements or fixed windows. The walls have been coated with synthetic stucco. The houses no longer retain their architectural or historical integrity and as such this building is noncontributing in the historic district.

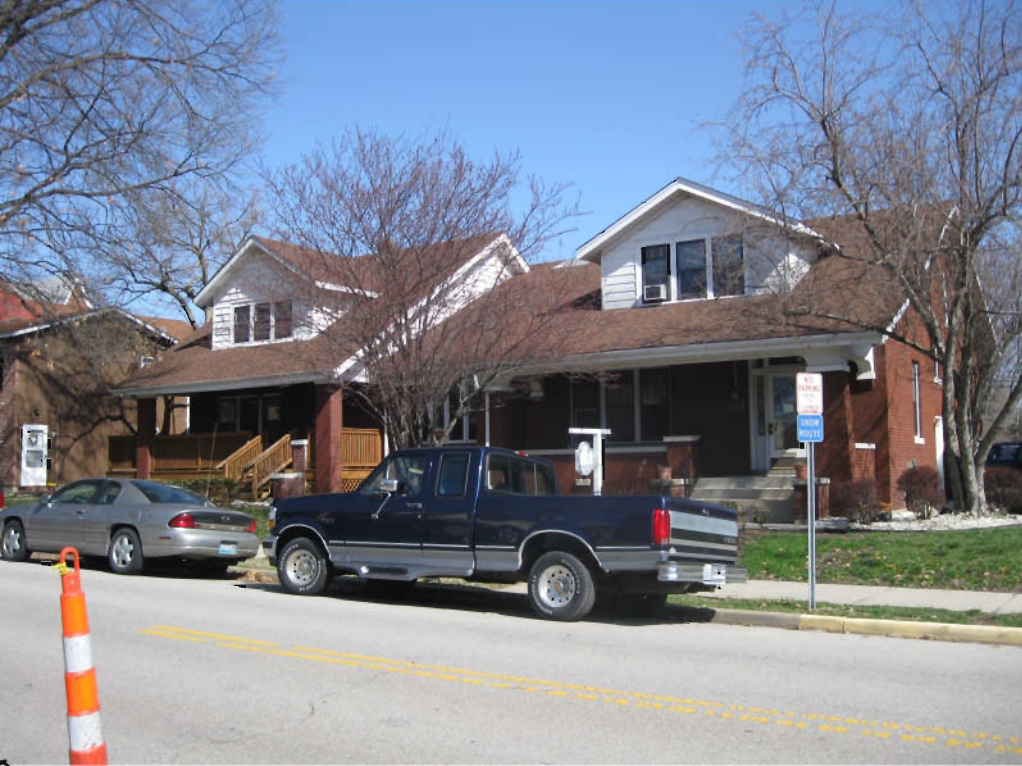
This was originally two separate 1.5 story, red brick, Craftsman bungalows. Both of the original buildings are side gabled, with wide eaves and a front facing dormer, and both of the broad gabled dormers have triple, sashed windows. The east bungalow has 3 over 1 sashes while the west bungalow has 1 over 1 sashes. Both have full width porches, with the roofs being an extension of the main roof, and both porches are supported by brick corner piers, although the piers on the east bungalow are battered and it has a brick half-wall railing. The porch floor and wood railings on the west porch have been replaced. The east building has a transomed full light door with stained glass sidelights while the west bungalow has a full light door and transom. Both have replacement siding on the dormers (front and rear) and the eaves have been sided as well. The shorter, 1 story, connection between the two historic bungalows is also side gabled and has brick walls. On the facade it has a bowed bay window consisting of 5 casement windows. On the rear it has a large gabled dormer and there is a one story addition on the rear that spans most of the complex and has similar bowed bay windows. While individually the two bungalows would have been considered contributing to the historic district, as a single complex it has lost enough of its historic integrity by the change in massing that it is noncontributing to the historic district.

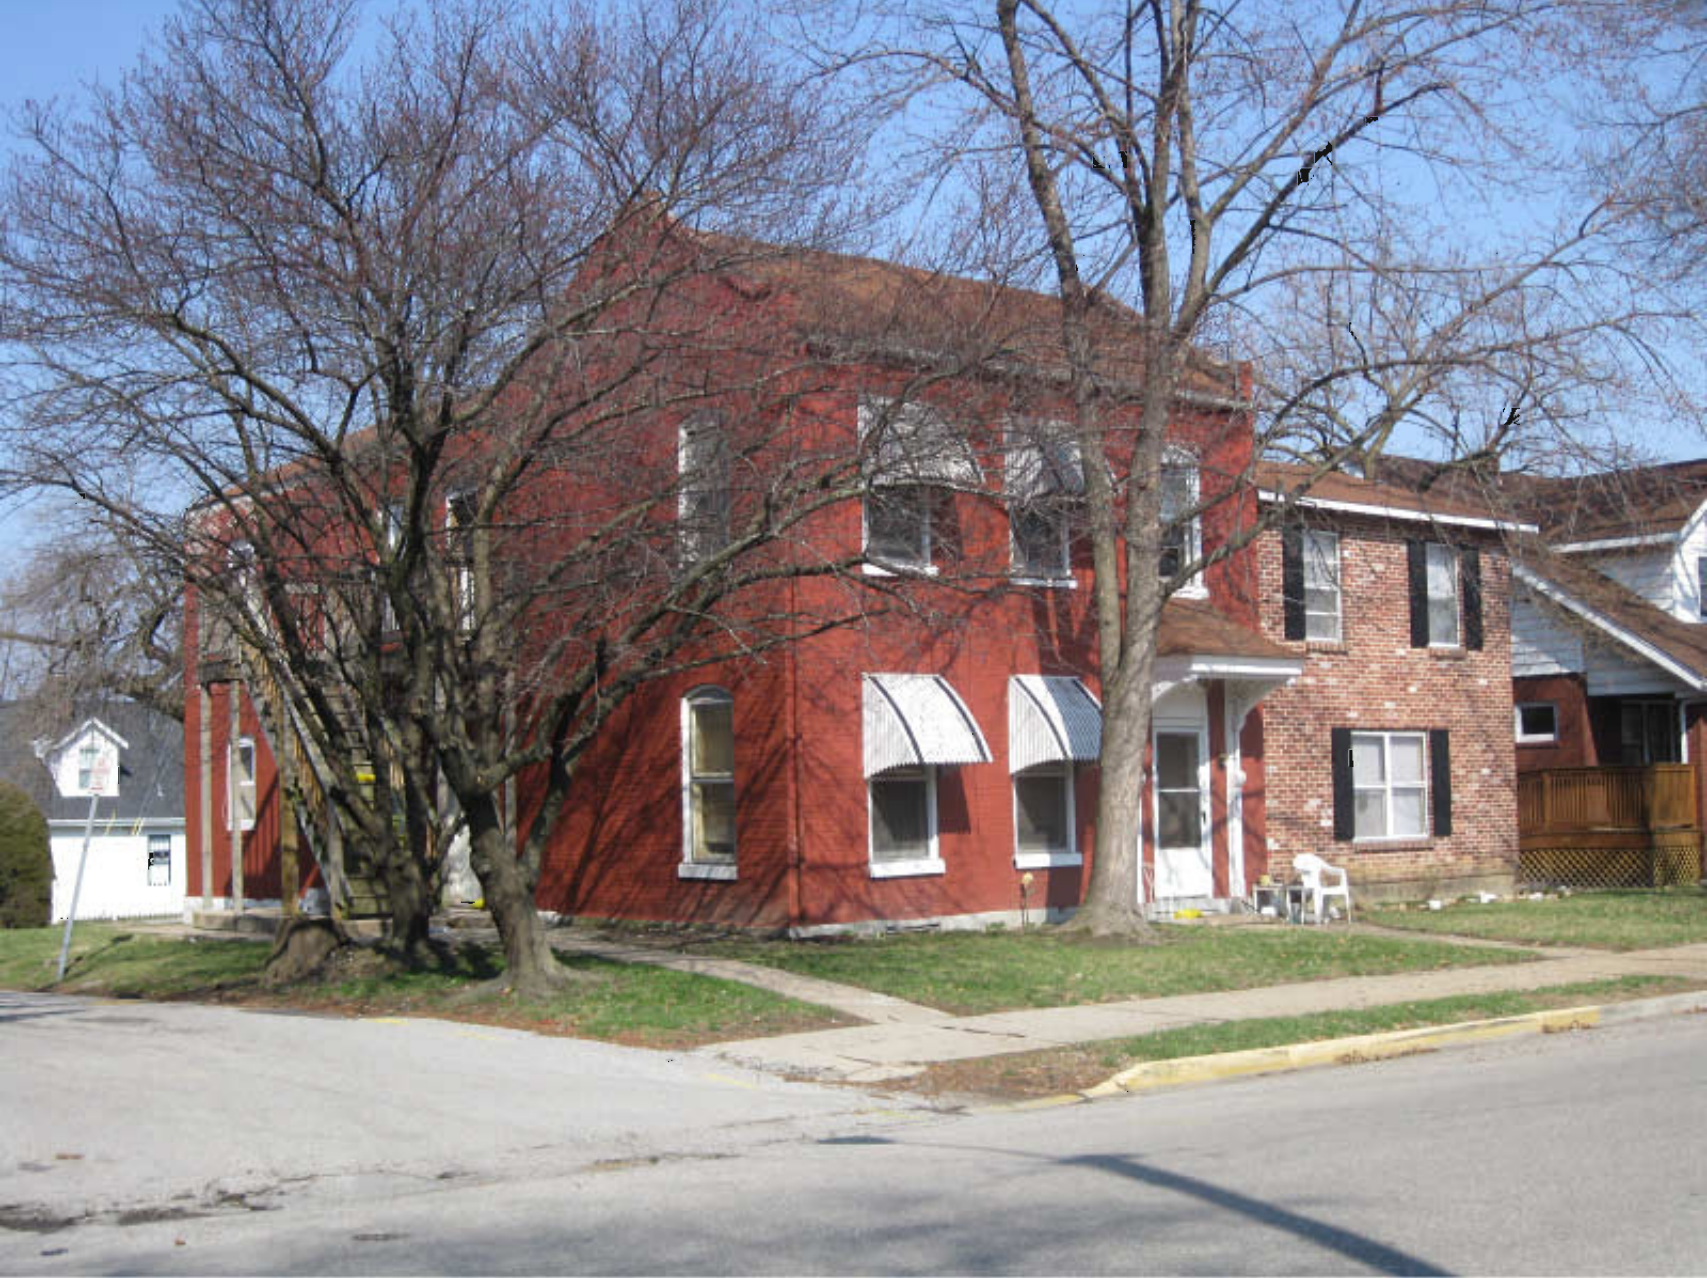
other elevations frame, finished with vertical board siding. The east elevation has a paneled door near the front wall and a bay of sashed windows at the rear of its gabled section. There is a separate, more recent addition with a flat roofed, second floor mansard that is attached to the east side of the enclosed two story gallery porch of the original building where there are doors on both levels and a large set of stairs. It is also clad with vertical board siding. This smaller addition is separated and set back from the front addition, creating a narrow passageway between the two additions, leaving the east windows of the historic building still exposed at the end of this passageway. The rear of the mansard has one bay of sashed windows. The rear wall of the front portion has another paneled door. The front facade of the historic poriton of the building is obscured by the metal awnings on the windows. Because of the alterations and additions, this is noncontributing to the historic district.

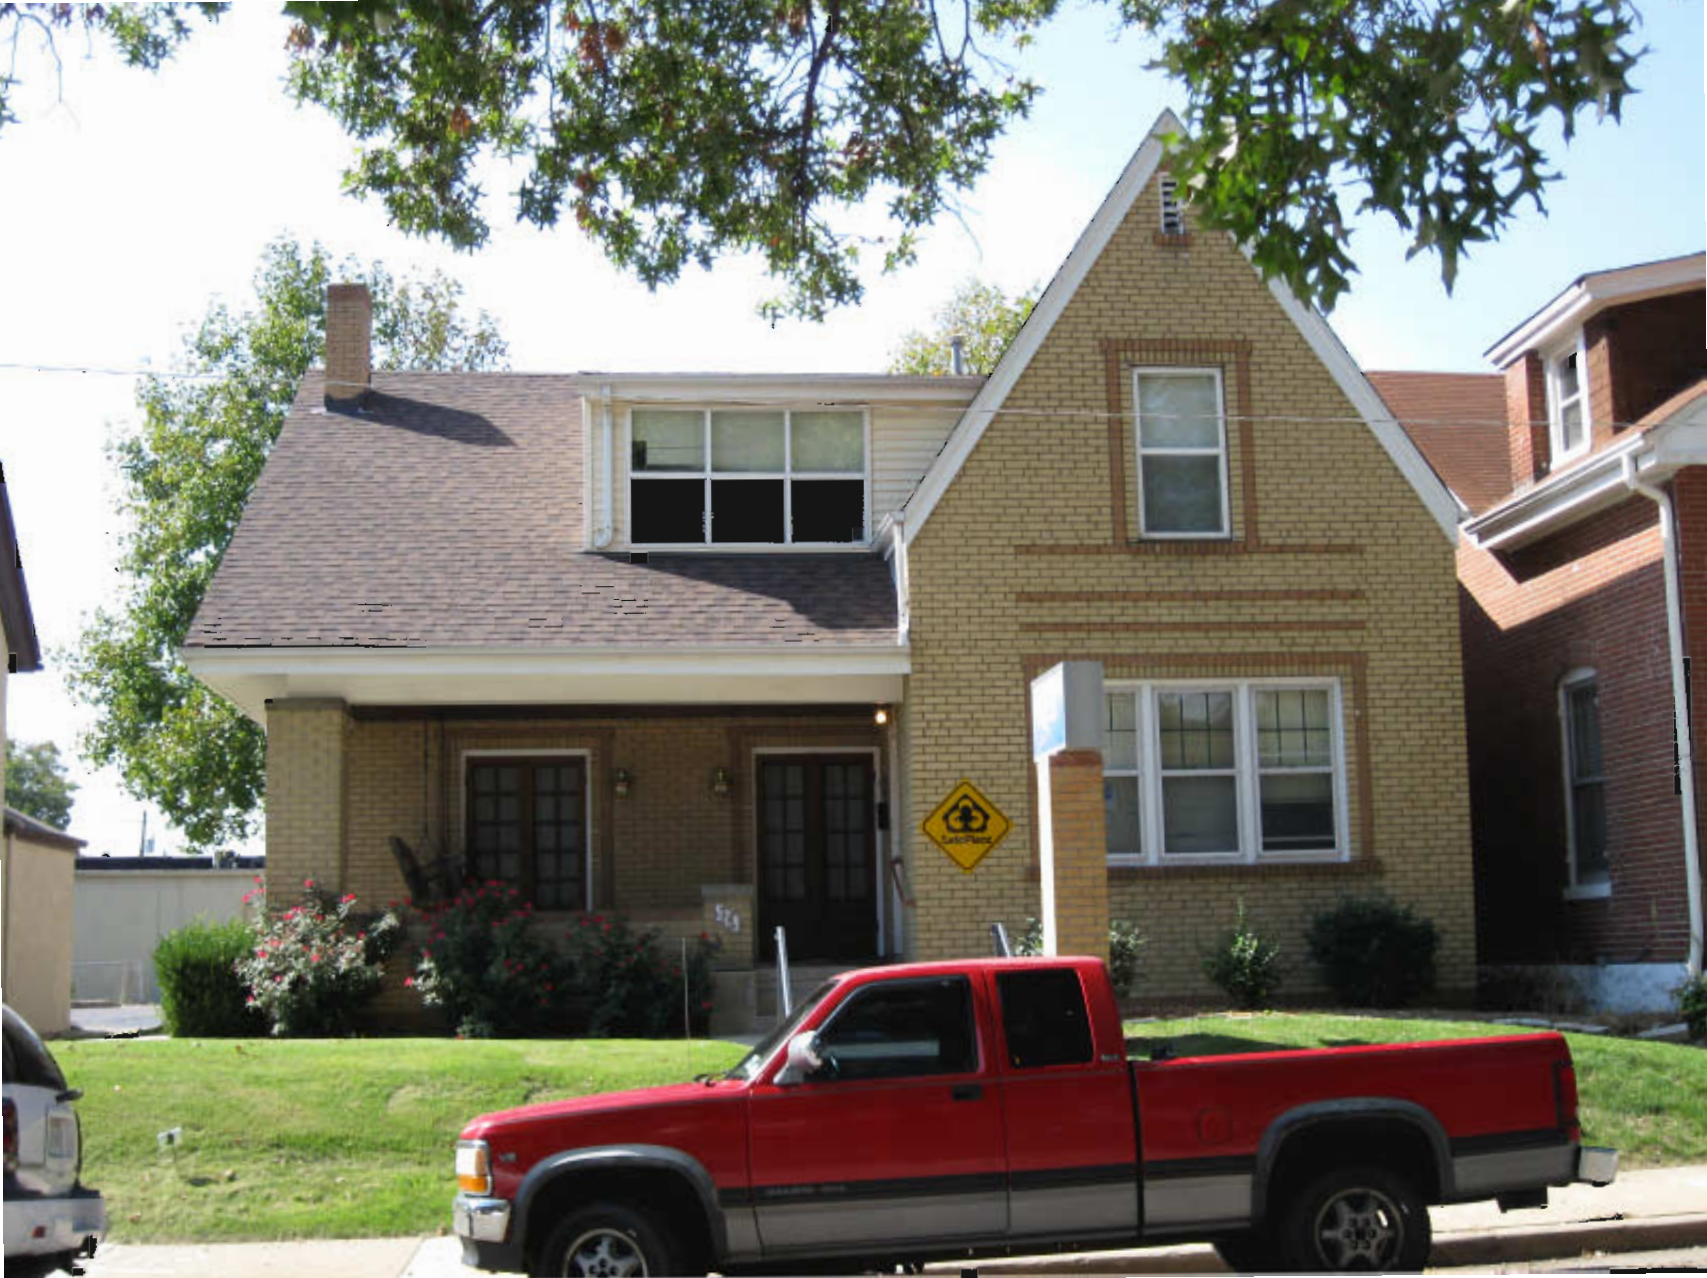
siding, but the west bay of the rear elevation retains the original paired, 9 over 1 wood sashed windows. The front gabled bay and the brick veneer were probably added with the new owner in 1939-41, within the period of significance, but the rear alterations, including the vinyl siding, replacement 1 over 1 windows, the larger rear dormer, and the stairs/ramp, were recent alterations, but because they only minimally impact the elevations visible from the street, the house is still a contributing building in the historic district.

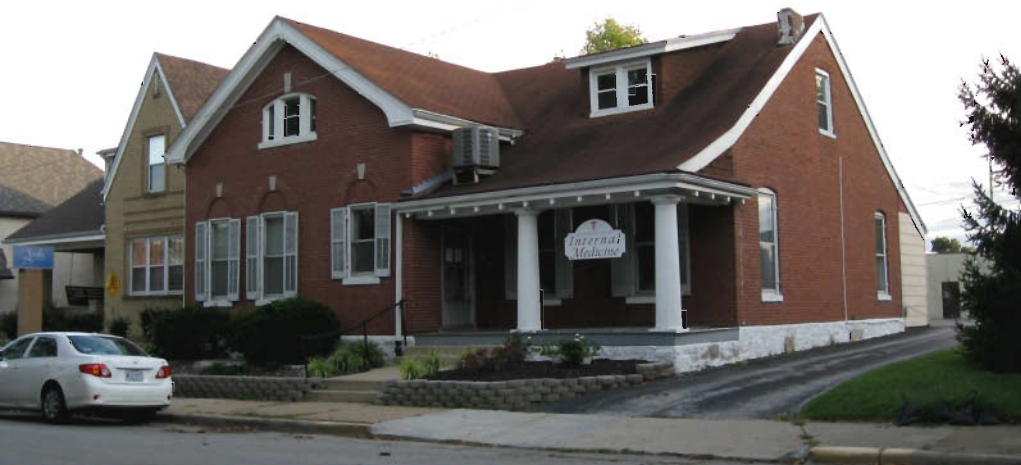
end of this elevation the roof extends over an enclosed shed roofed wing that spans about two-thirds of the rear elevation and the asbestos siding (which was probably a c. 1955 replacement siding, possibly part of the renovations done when a third apartment unit was created within the house) covers both the west and south side of this rear wing added around 1929. There are two doors on the rear elevation into this rear wing, the west door is a multi-paned, half light replacement door but the east door appears to be an original 4-paned, half light, wood paneled door. To the east end of the rear elevation is a porch, which is nestled up against the rear of the brick house, with a nearly at-grade concrete floor and simple porch posts supporting the shed roof extension of the main roof. There is a transomed rear door and a tall 1 over 1 window on the first floor. The roof edge of the porch is framed by a pierced wood skirting. There are two shed roofed dormers on the rear elevation, a large one above the porch with two sashed windows and the other centered on the rear roof with two square light windows. Both dormers have broad eaves. There is also a brick chimney floor between these dormers near the ridge.

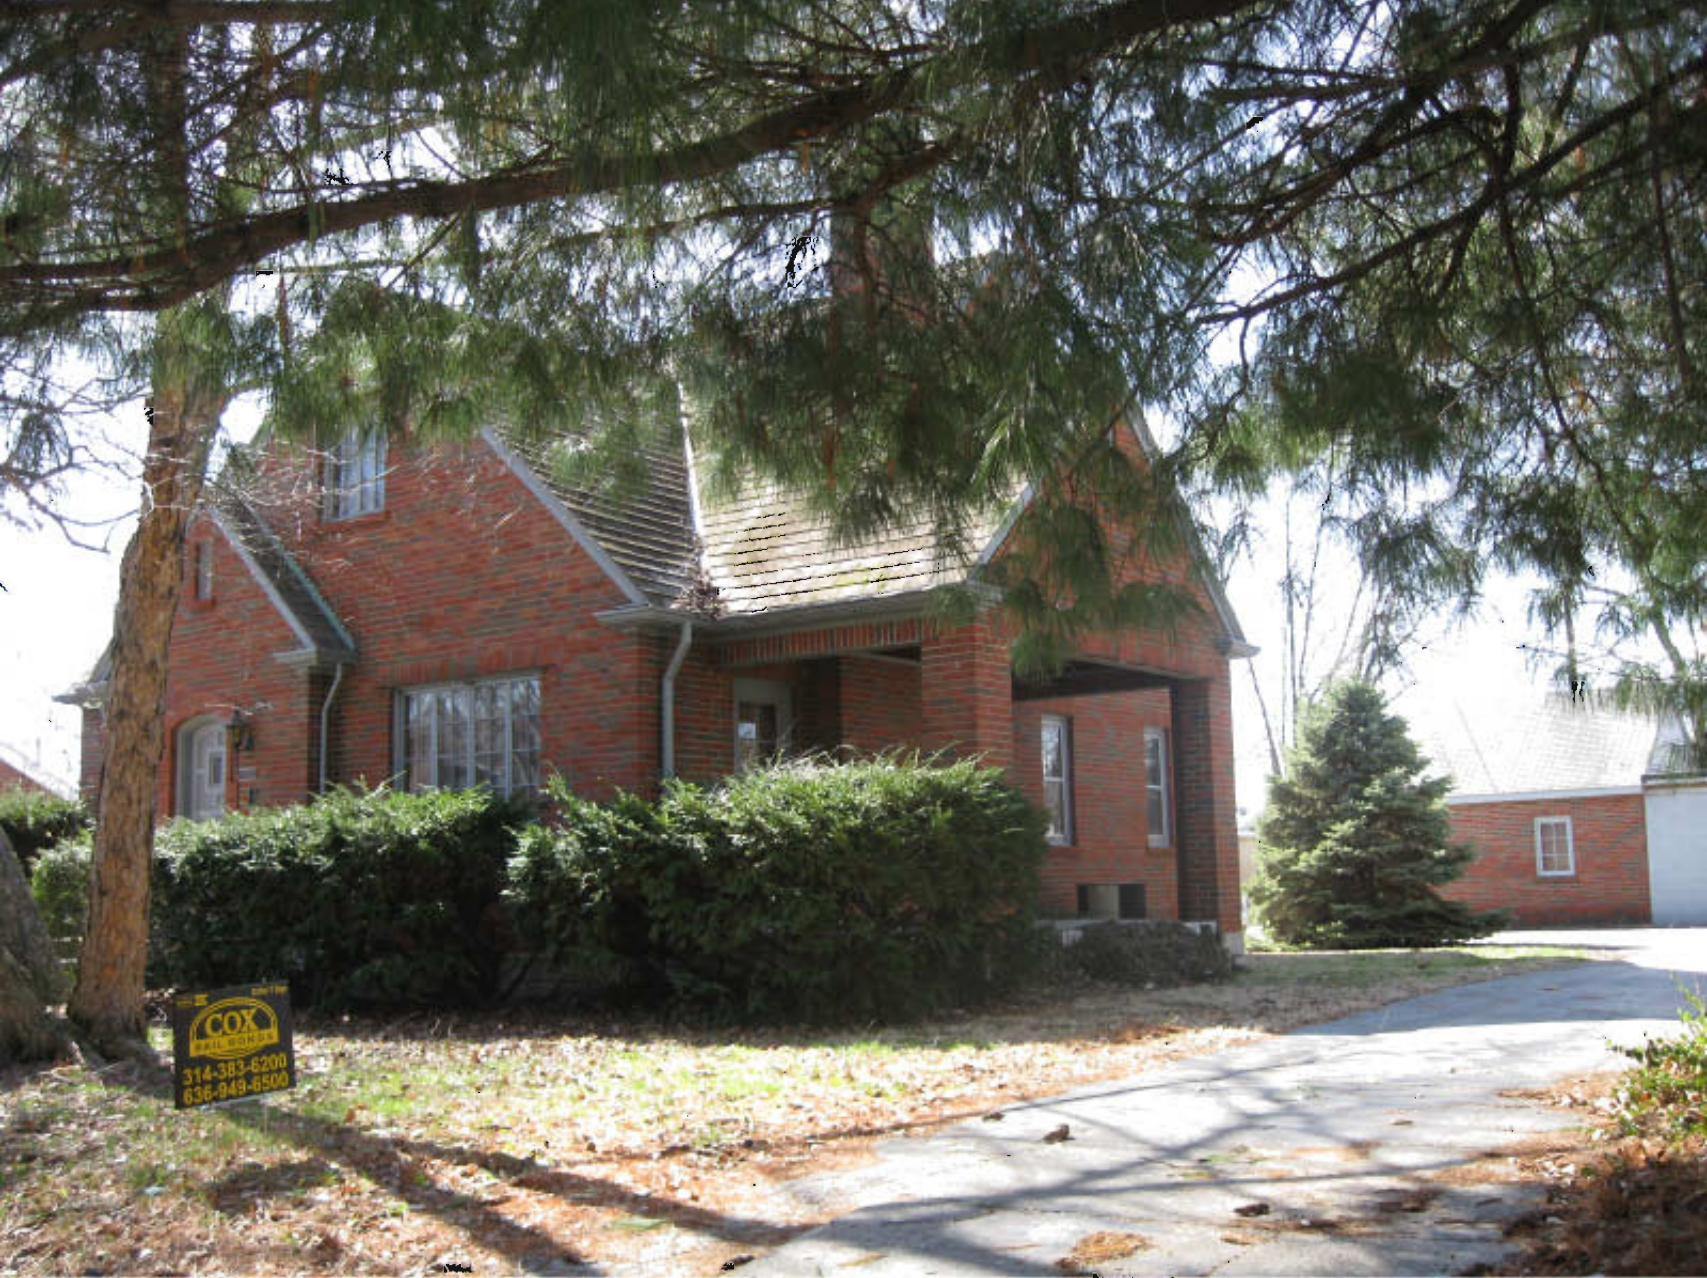
vestibule and side porch. Across the rear, there is a large shed roofed wall dormer, the sides of which have replacement siding. The sides and rear of the house have a variety of multi-paned casement windows or 4 over 4 wood sashed windows. The rear door is a half light, wood paneled door which opens onto a two-bay porch having a concrete slab porch floor and flat roof supported by simple square posts with small capitals. Opening onto the flat roof is a second floor door with three horizontal lights over three horizontal wood panels. Across the rear, the scored concrete foundation is visible. Some windows and the rear door have aluminum storms, but the side porch door has an old wooden storm door.
