ARCHITECTURAL/HISTORIC INVENTORY FORM

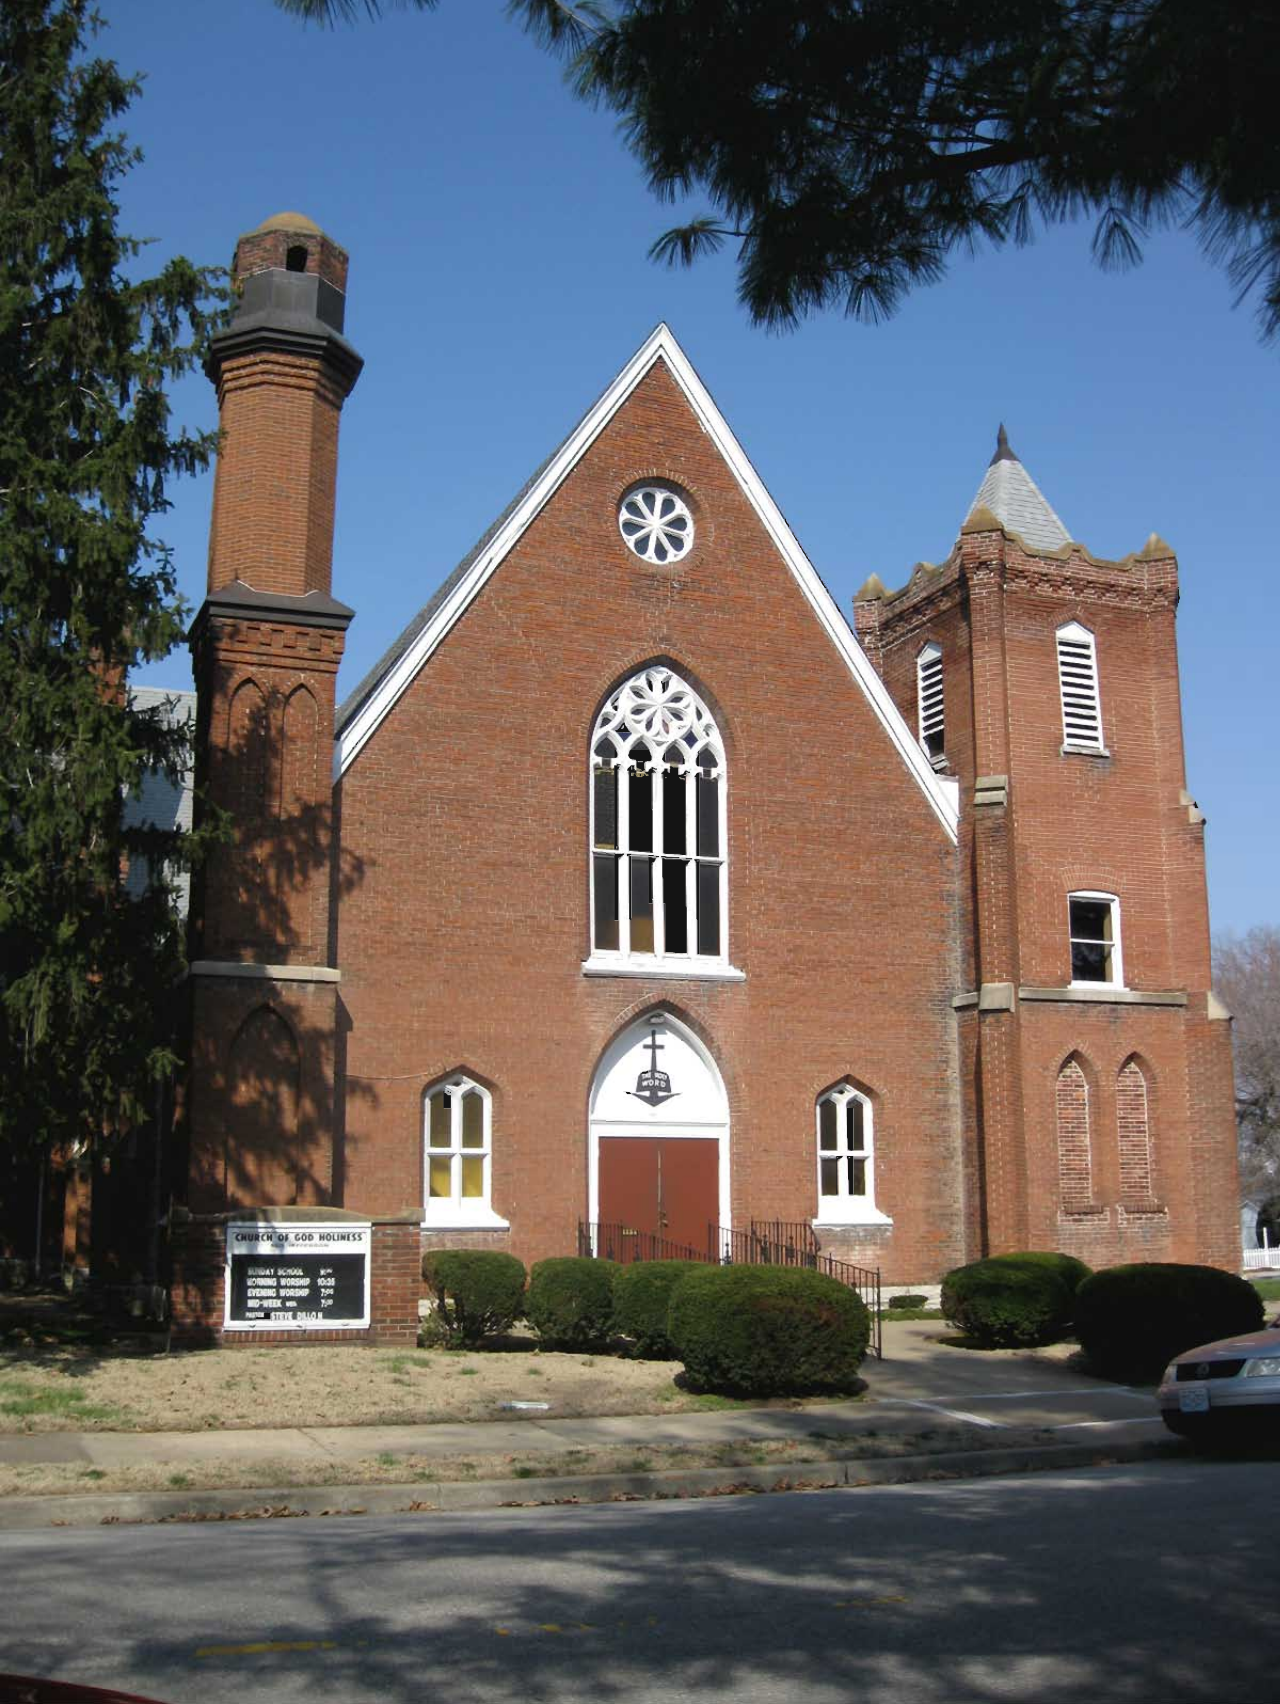
This red brick church has cross gables creating a T-shaped plan. The steeply pitched roof was noted in the 1886 Sanborn map as being a "very sharp roof." The main entry is located along Jefferson Street in a tall Gothic arch doorway with paired doors and an enclosed transom. To either side of the entry is an ogee arched window opening with paired, two-light windows deeply set in the tracery wood frames. Above the entry is a large, Gothic arched tracery window and there is a rosette window near the gable peak. The tower at the southeast corner of the facade is tiered into three sections, with corner buttresses and a continuous sloped lintel course for the second floor segmental arched, sashed window. On the first floor level there are two Gothic arched faux window openings. The third level has a wood louvered, ogee arched opening into the belfry. At the top of the tower, there is a crenellated brick parapet and a pyramidal roof set behind the castellated parapet. The east elevation of the square tower is similarly oriented but on the north side there are no windows, but there is a louvered opening into the belfry as there is in the upper level of the west side of the tower. The tower at the southwest corner (which probably was originally on top of the southeast tower) is also tiered into five sections. The base appears to be newer construction (probably built to as a base for the old tower top). The first tier has a single Gothic arch faux window with a sloped stone ledge to the next level, which has paired slender Goth arch faux windows. Above is a crenellated course with another sloped stone ledge to an octagonal level topped by another crenellated section and above that the top section has a domed top with Tudor arched openings on alternating facets of the octagonal section. The side elevations have five Gothic arched, tracery windows separated by brick buttresses. To the north of the windows on the east elevation, the cross gabled wing has another entry into the church from North Benton Street. In this gabled wing are windows and doors matching the Jefferson Street facade, except without a rosette window. The corners of this wing also have angled buttresses. On the rear, north elevation, there are five Gothic arched openings, but the windows have been modified; the east one is a faux window opening and the upper halves of the other windows have been covered with boards on top of the original wood frames of the tracery windows. There are also two windows near the corner of this wing on the west elevation and nestled on the interior corner of the cross gabled wings is a tall exterior brick chimney. The church has a rock-faced, coursed limestone foundation. The only other alterations visible are the replacement doors on both street elevations, the concrete ramp up to the front entry and the metal railings on this ramp and the stairs to the east entry.

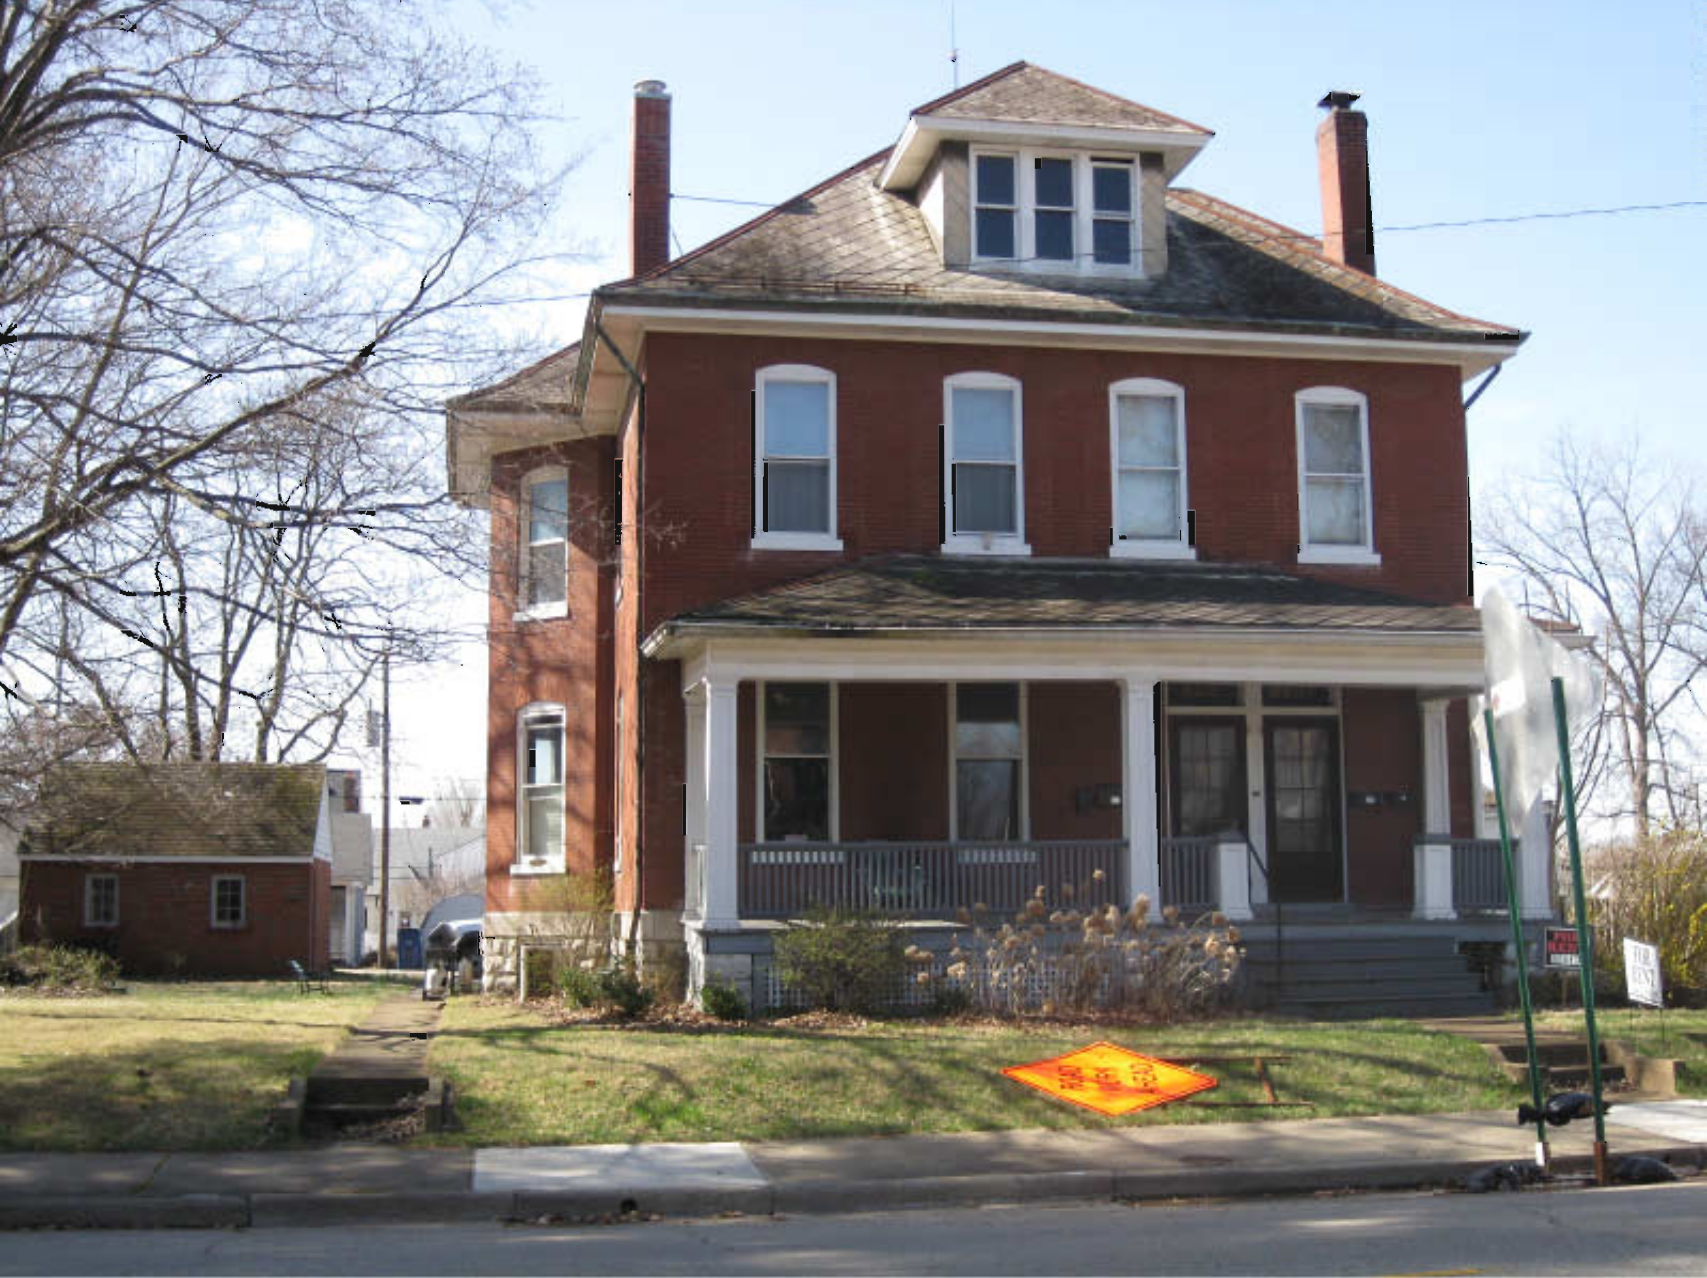
This 2.5 story, hipped roof, red brick, Colonial Revival house has wide enclosed eaves on the main roof and on the front hipped dormer, with its three narrow 1/1 wood sashed windows. The walls of the dormer are clad in the same asbestos cement, diamond pattern shingles as the roof, but this is probably a replacement material given the age of the house. There is a full width hipped roof porch with wide eaves that is supported by square, tapered, paneled wood columns (three across the face of the porch and two pilaster strips against the brick walls). While the columns retain their original capital treatment, the entablature under the eaves has been clad in vinyl siding. It retains its simple flat baluster railing with square wooden newel posts in the east porch bay to define the broad wooden steps leading to the entries. There are currently paired, 6-pane, half light doors with transoms still addressed as they were when it became apartments during World War II (553 and 553a). Over the doors are 8-light, one panel storm doors. The doors are separated in a single masonry opening with a small recessed panel mullion. In the west half of the facade on the first floor there are two windows and upstairs, there are four windows across the facade, all with segmental arched openings with 1/1 wood sashed windows and painted stone sills. The windows on the other elevations are similar to those on the facade. The porch retains its original limestone piers and has lattice work under the porch floor. On each side slope of the roof, in the front part of the house, is a tall, red brick interior chimney and there is another on the west side near the rear. On the east elevation, there is a hipped roof with wide eaves over a clipped corner, two story, brick bay window, which has windows on each face. The coursed, rusticated limestone foundation with a dressed limestone cap forms a high watertable around the house. On the rear, there is a shorter hipped roof wing, offset toward the west to provide room for the large, wraparound, L-shaped, two story porch with a shallow hipped roof. The porch retains its simple flat baluster railing, square porch posts, wood floors, and separate cornice detailing for each level. There is an internal staircase leading up to the second floor of the porch, and two sets of wooden steps provide access to the lower level of the porch, one facing east and one facing south. There are transomed doorways in the middle bay of the rear wing as well as nestled on the rear wall to the east of this wing. There is a hipped dormer with wide eaves and paired 1/1 sashed windows centered in the rear wing. Some of the windows have aluminum storm windows. The only other alteration may be the front doors and additional rear doors that were built during the period of significance (and as such have historic significance) to accommodate the conversion to apartments.

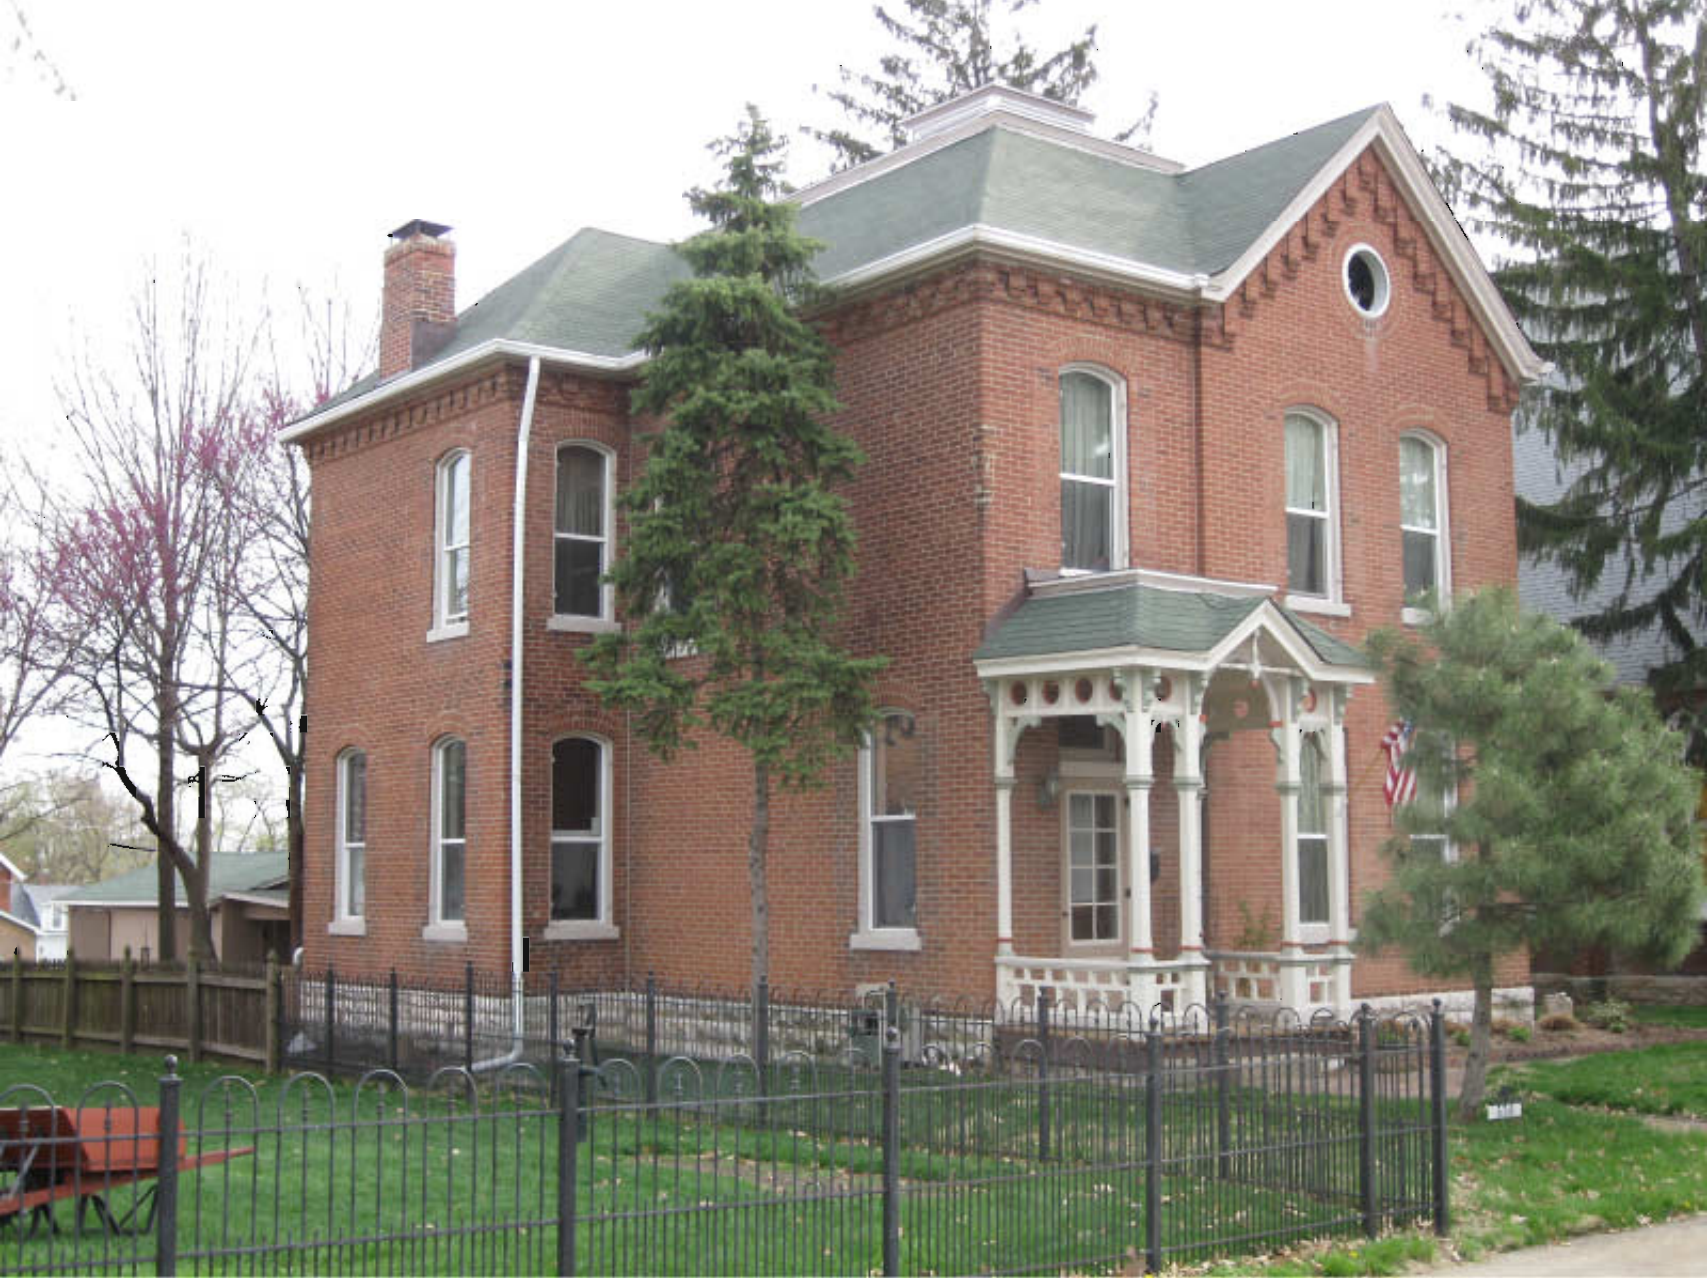
one window, instead of the two as the first floor has. There are chimneys piercing through the roofs of both bays. The rear has another two story hipped roof wing, with an end wall chimney. In the ell created on the west side of this wing, there is another rear doorway, with a hipped roof supported by brackets over what was probably a transomed doorway originally (although the transom has been boarded in and a storm door installed).

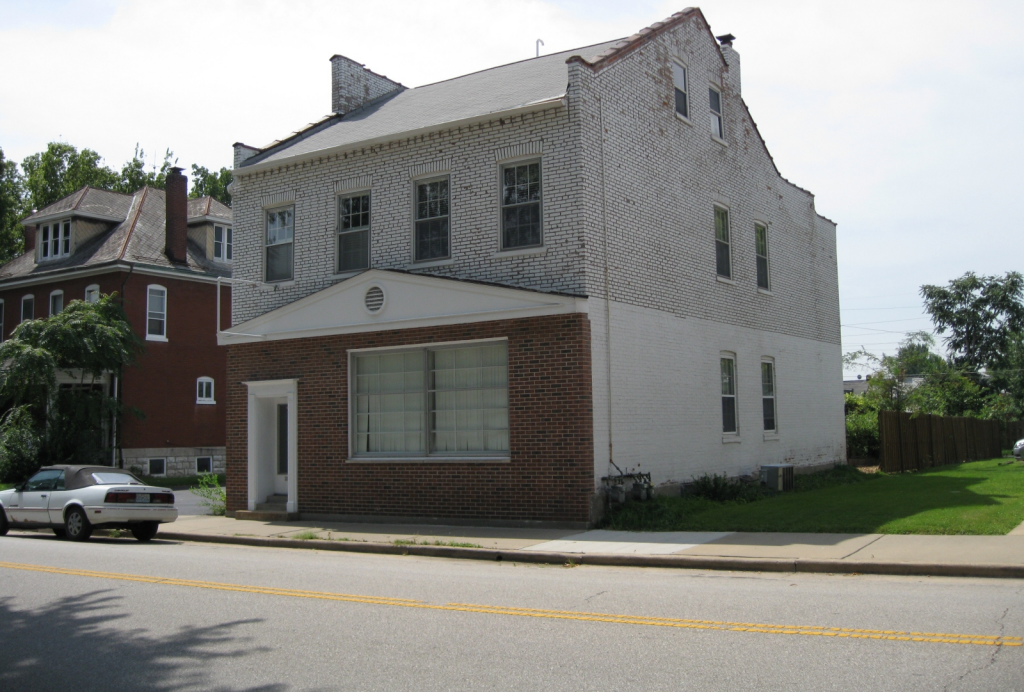
This mid-nineteenth century, 2.5 story, Adamesque house is a side gabled, painted brick building that originally had a symmetrical four bay facade, and still retains the four second floor windows on the facade. Like the other windows, these are flat-headed, 6/6 windows with soldier course brick lintels and painted stone sills. The building has a brick dentil course across the facade and parapets on the gable ends, the west side being a parapet that follows the gable shape, but the east parapet is a stepped parapet, emulating a broad end wall chimney. The building was originally L-shaped, still visible where the shaft of the L along the west elevation extends back into the flat roofed section across the rear (and that wall is still unpainted). Historically, there was an open, two story porch nestled into the interior corner of the L on the rear, but that was enclosed after 1947 and a two story addition positioned behind this enclosed porch (with a one car garage clad in vinyl siding and a second floor gabled roof, prefabricated metal framed sunroom on the second floor). These alterations alone would not make this a noncontributing building, but the first floor of the facade has been significantly altered, with a newer brick veneer capped with a broad wooden pediment, and besides the recessed doorway with entablature and pilasters, it also has a large multipaned picture window.

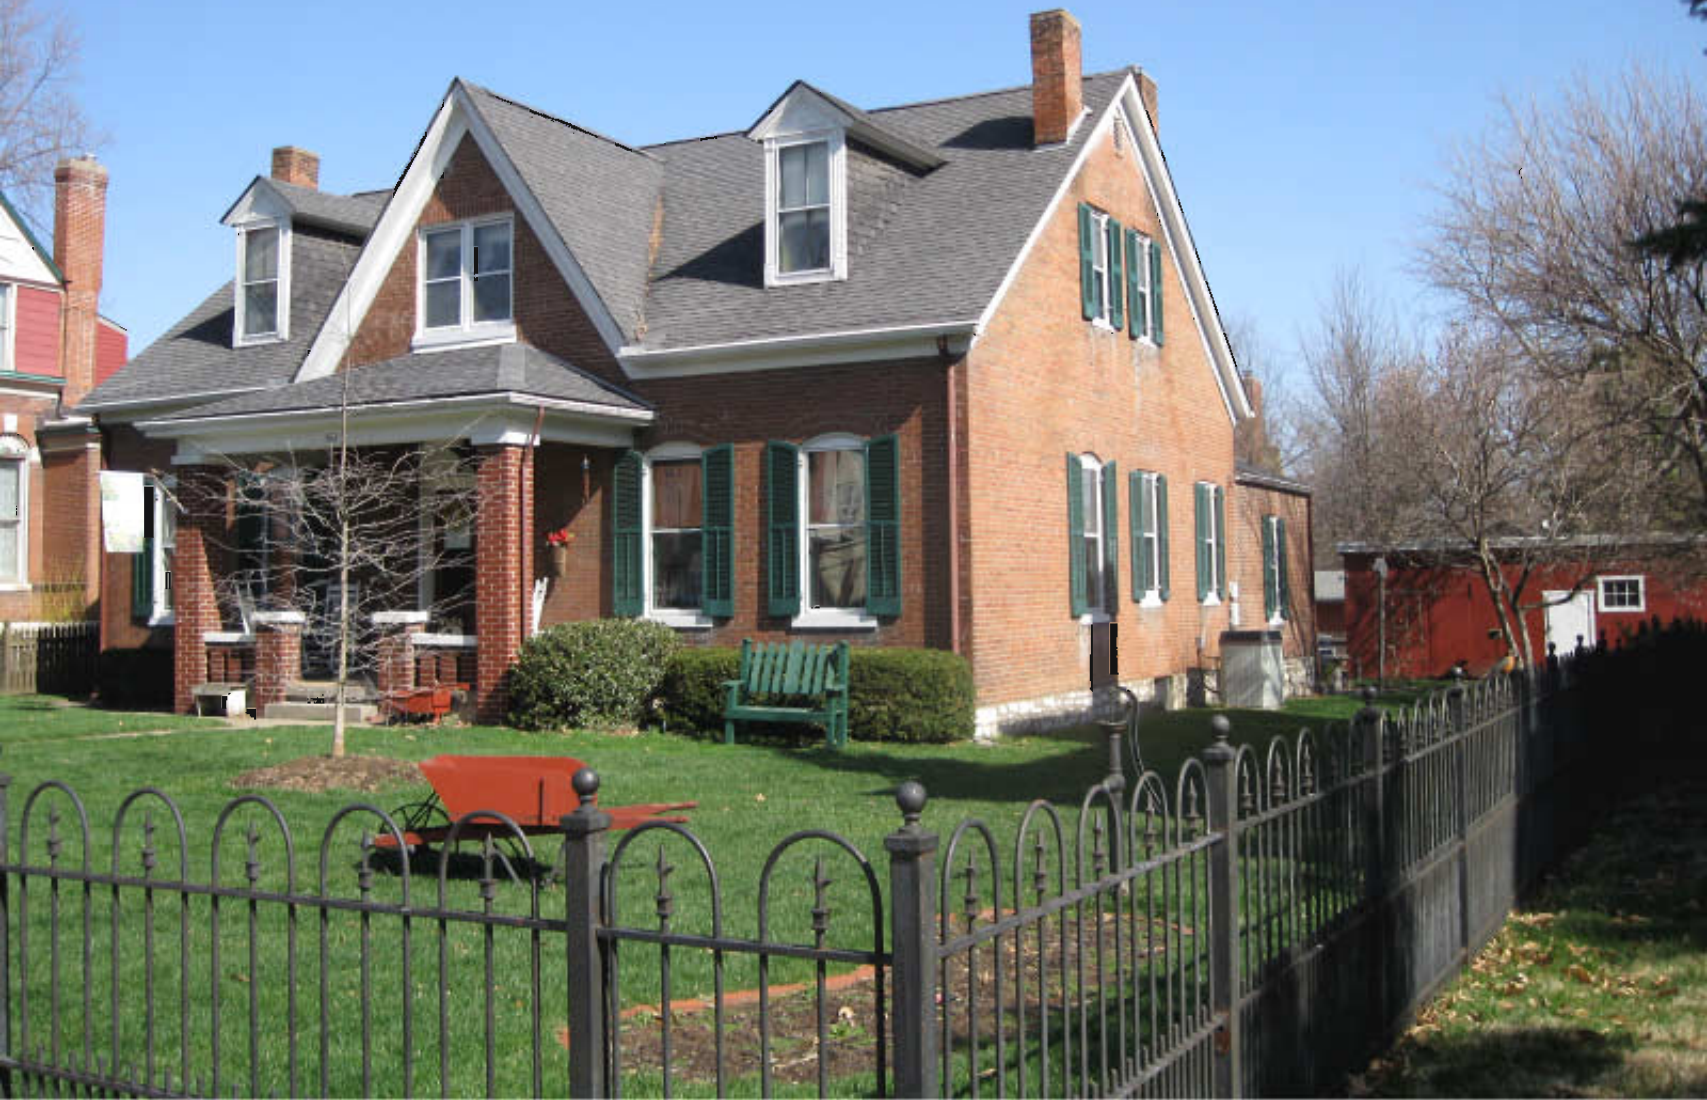
This 1.5 story, side gabled, red brick residence has a symmetrical facade with a broad cross gable that has paired 1/1 wood sashed windows with a soldier course brick lintel (this may represent a later alteration since they are the only ones with 1/1 sashes). Below this centered gable is a hipped roof porch that appears to have been added between 1900 and 1909 to replace a smaller porch. It has simple brick corner posts that extend to the ground and similar brick newel posts with a pierced brick railing and concrete porch floor, detailing more common to Craftsman designs, but an alteration added during the period of significance. The paired, wood panel with round arched light doors in a segmental arched opening with a two-light transom appears to date from the original construction of the house. In each outer bay there are two segmental arched, wood shuttered, 2/2 wood sashed windows with stone sills. Centered above each pair of windows is a gabled dormer with decorative pilaster strips and pediment and a 2/2 wood sashed window. On each side of the house, positioned on either side of the ridge, is an interior brick chimney, four in all. The windows on the side elevations are also segmental arched openings with wood shutters and 2/2 wood sashed windows. On the west end of the house, there is a rear, one story gabled wing with an interior chimney piercing the ridge of the rear wall. There is a window on the west side and a small window on the rear. This wing is shown on the earliest fire insurance maps. The house roof sheds down over an enclosed rear porch that spans from the remainder of the rear elevation (it appears that the portion next to the house was enclosed by 1909 from the Sanborn maps). The outer section of this porch now extends to the rear wall of the brick wing and is a 2004 addition that includes skylights and banks of wood clad 1/1 windows as well as a half-light, multipaned door. The enclosed walls of this rear porch are clad with fiber cement siding.

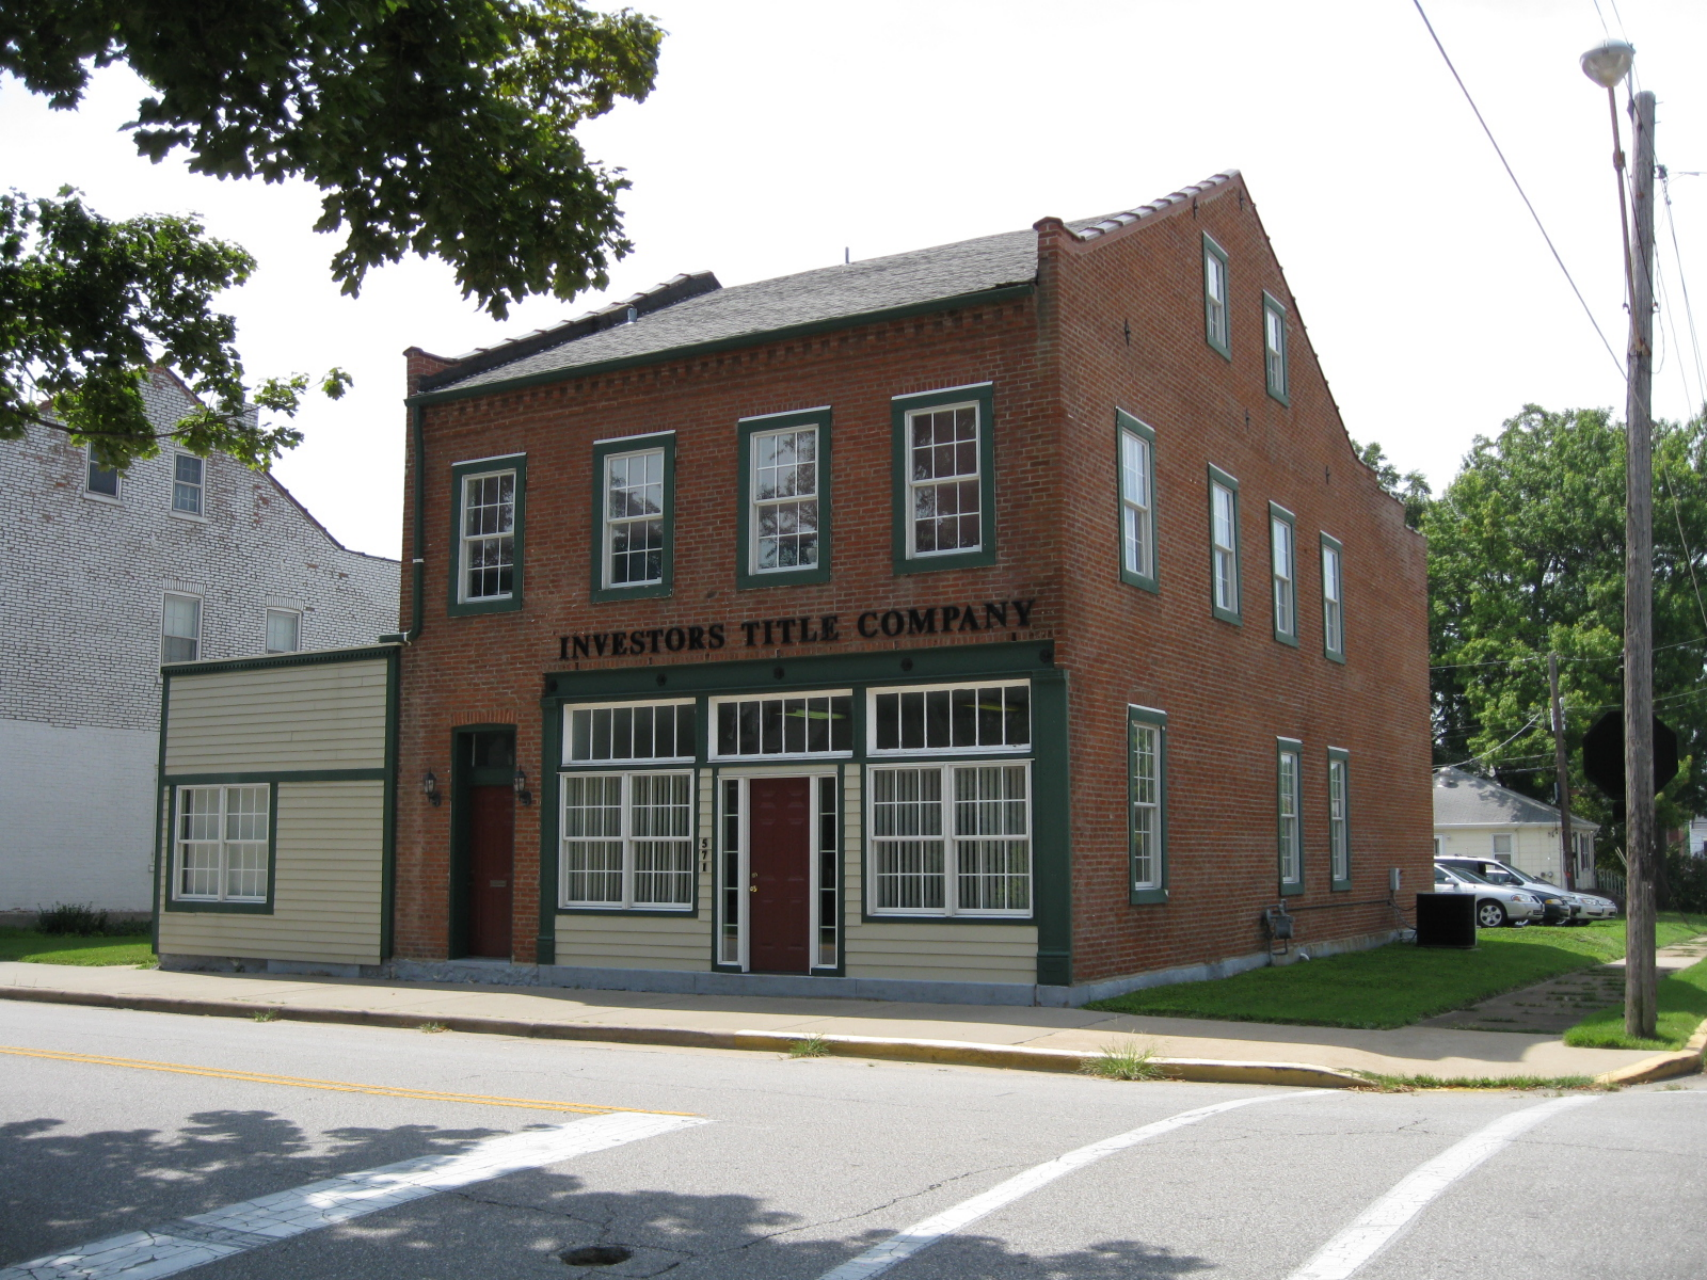
Along the east side, is a false front, wood framed, side shed roofed, one story storefront addition. The siding may be original, but it looks like it is a replacement siding, and the trim and paired 6/6 sashed windows on the facade most likely represent a recent reconfiguration of its facade. About half way down the east elevation of this addition are two simple door openings but there are no other openings into this addition. Sanborn maps date the front portion of this addition from 1886-1893 and the rear portion from 1900-1909. As an addition to the 2.5 story building, it is still contributing to the district, but the alterations, especially to the facade, have seriously affected its historic integrity.

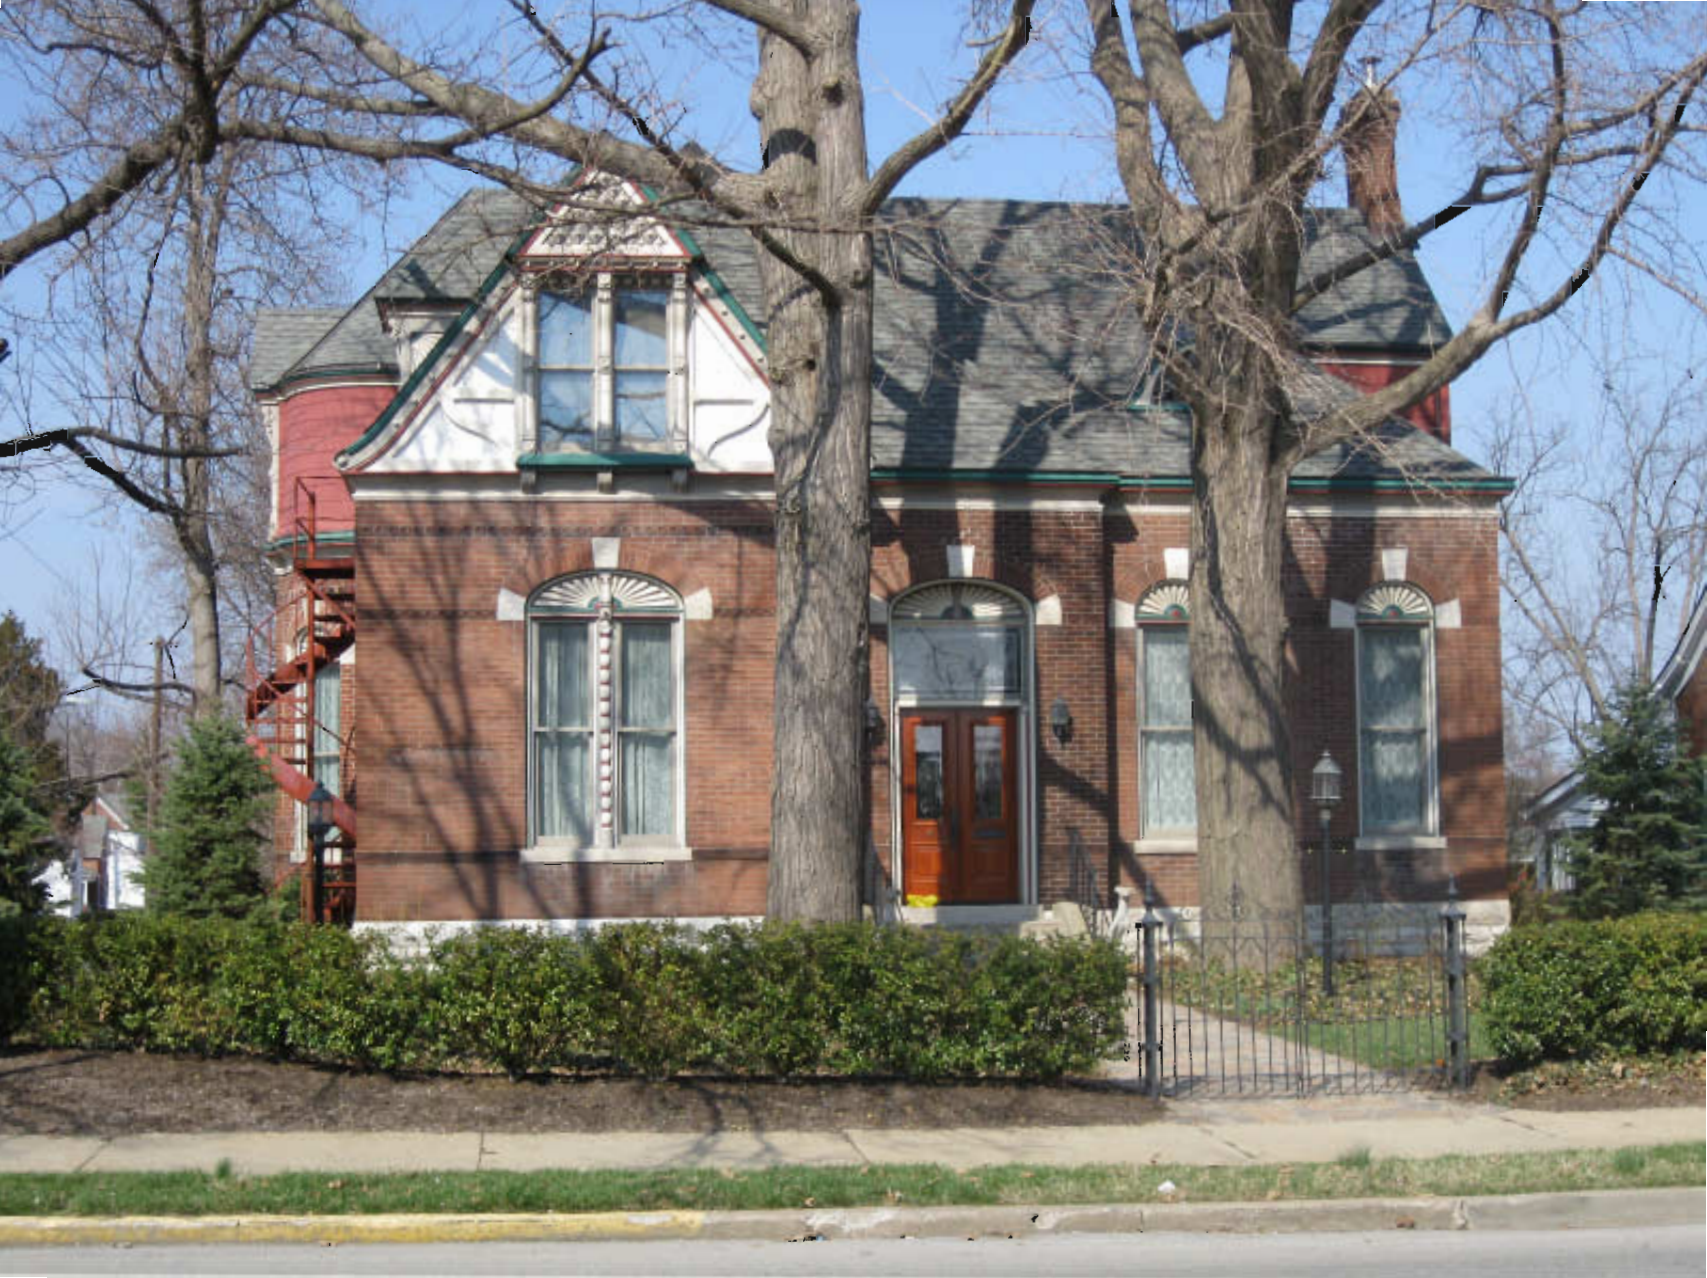
The only other visible alteration to the exterior is the metal spiral fire escape that extends from the west elevation's hipped dormer near the facade. It is likely that this is a remnant of the building's use as a public library, probably added when the second floor was converted to use for the public rather than simple storage in 1956, but that has not been confirmed.

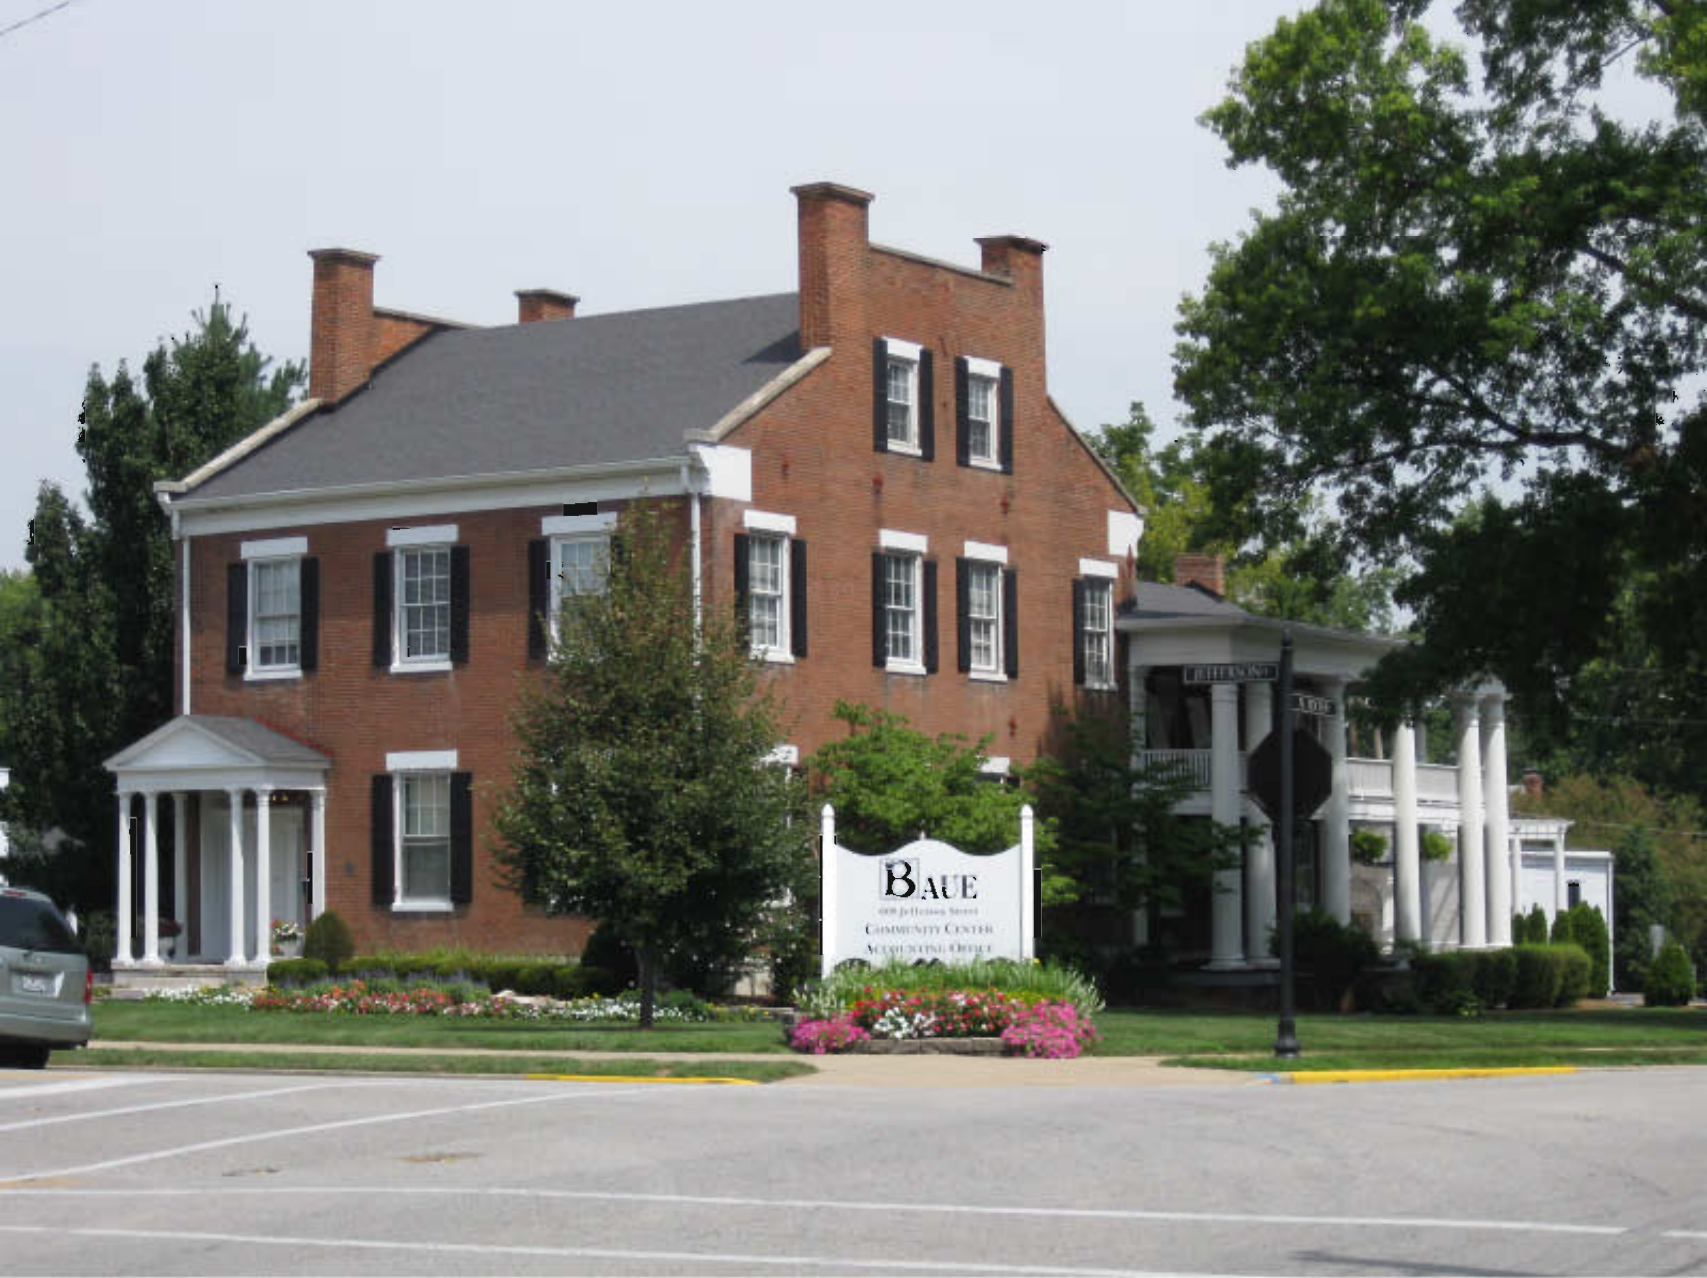
Many of the windows have combinations storm windows, the roof has replacement gutters, and at least one of the chimneys has a metal vent cap.

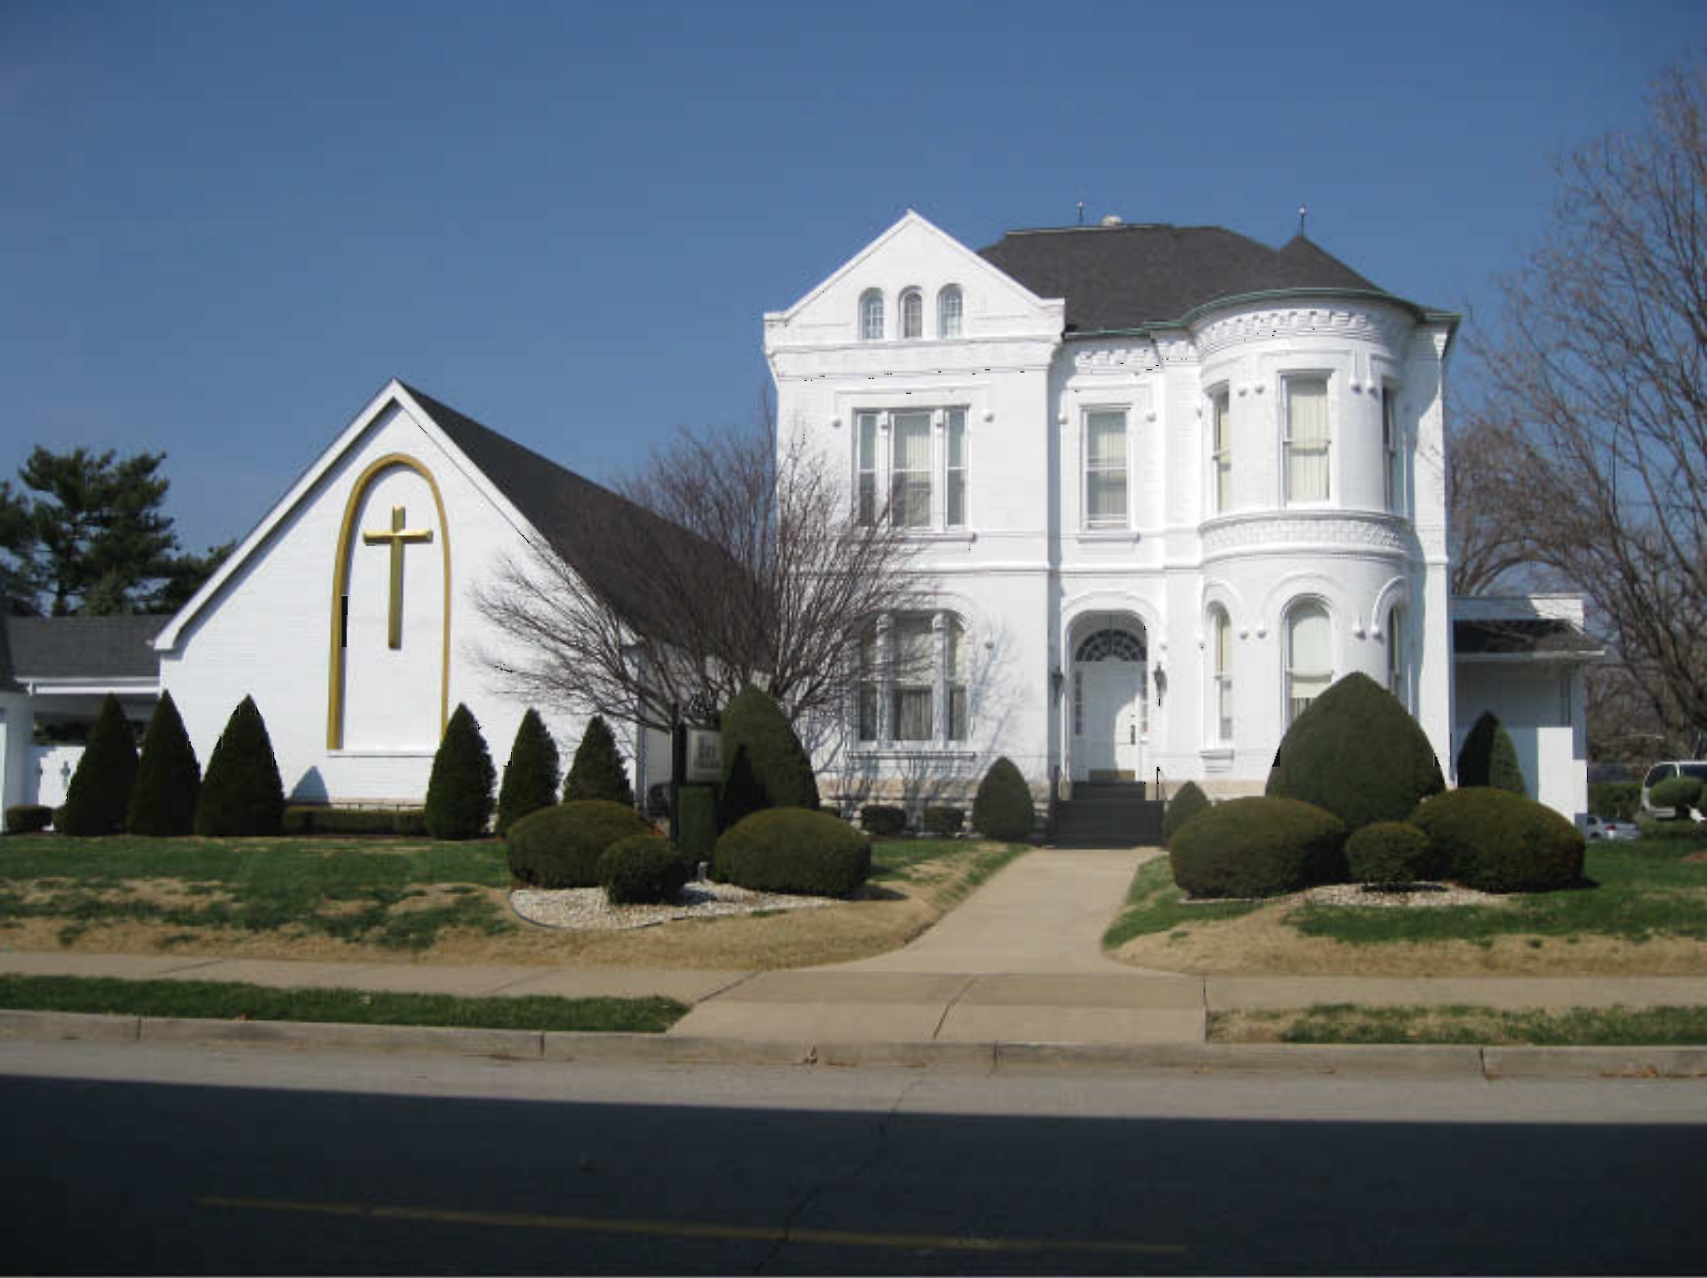
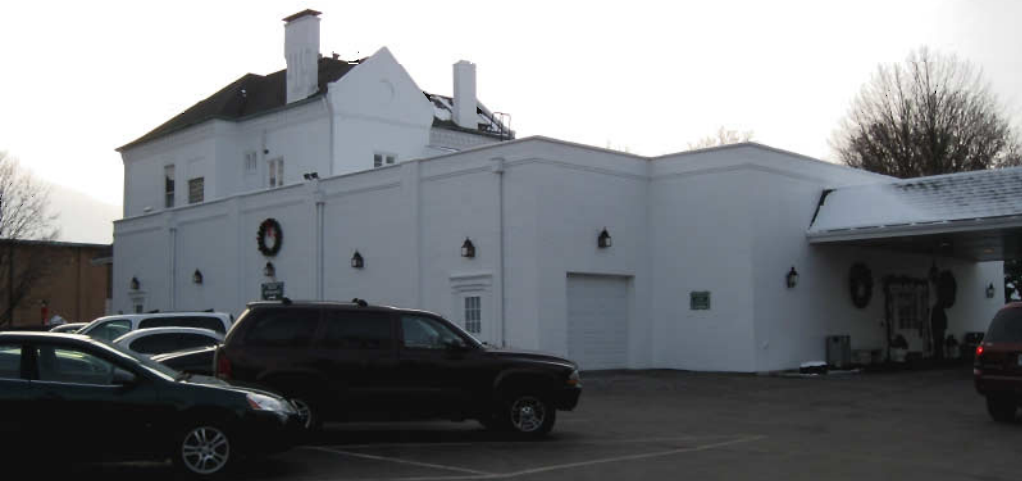
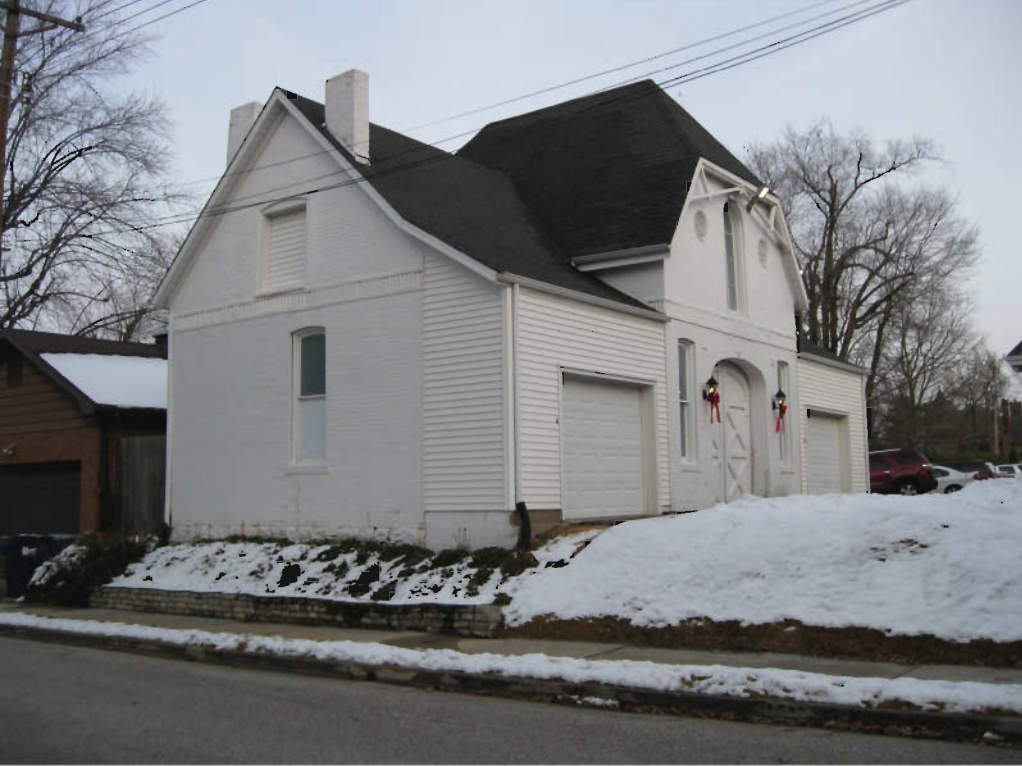
remainder of the rear wing was added in 1971. The rear wing is a large, brick, flat roofed, parapeted wing that extends out on the east side, connecting behind the side entry, and it wraps around the rear of the old house and west at the back of the original house. Aerial photos show that the addition incorporates the shed roofed second story sleeping porch. Along the west side of the house is an end gabled, 1-story, painted brick chapel with a large, round arched niche on its facade. This chapel appears to be minimally attached to the house near the back end of the west elevation. There is a hipped roof porte cochere connected by a side gabled roof over the walkway to the west side of the chapel.

The early additions and alterations, completed by 1960-61, are part of the historic development of the property and the rear addition, which is obscured by plantings and positioned behind the historic house and chapel, does not drastically impact the historic character of the street facade and it seems to still be a contributing building in the historic district, both because these additions/alterations were made within the period of significance of the district but also because of their historical importance in the commercial development of the neighborhood.
