ARCHITECTURAL/HISTORIC INVENTORY FORM

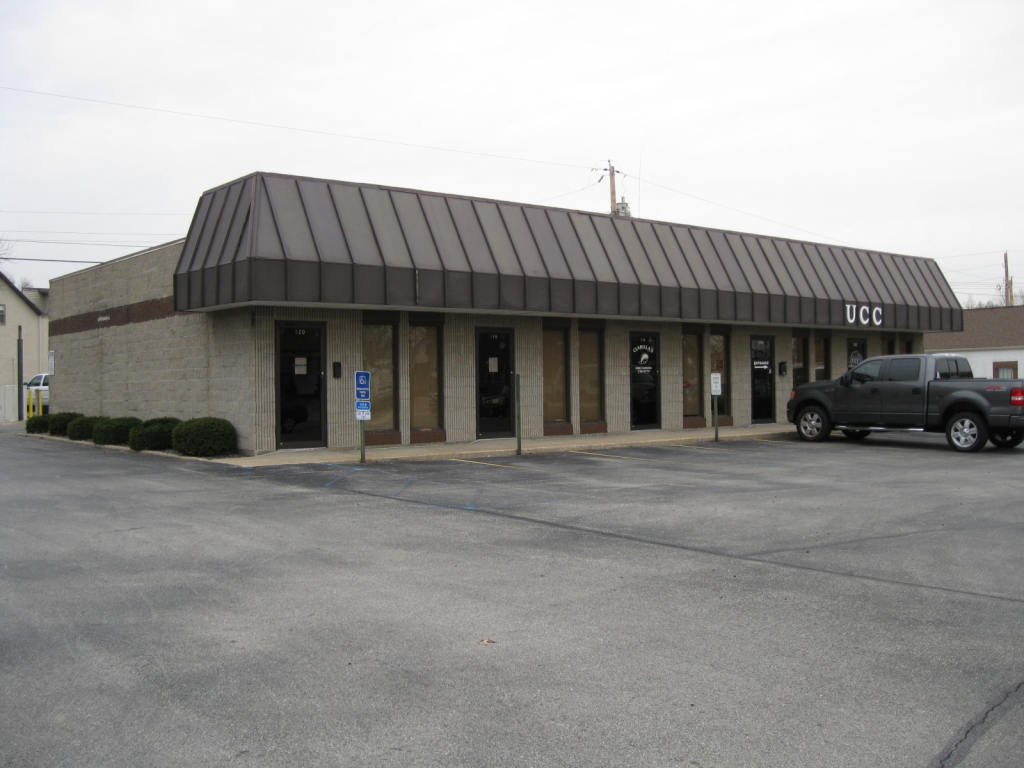
This flat roofed, one story, corrugated textured concrete block commercial building has a false, standing seam, mansard on the facade. The facade is divided into five commercial spaces, each with an aluminum framed glass door west of a pair of single light, full height wood framed windows.

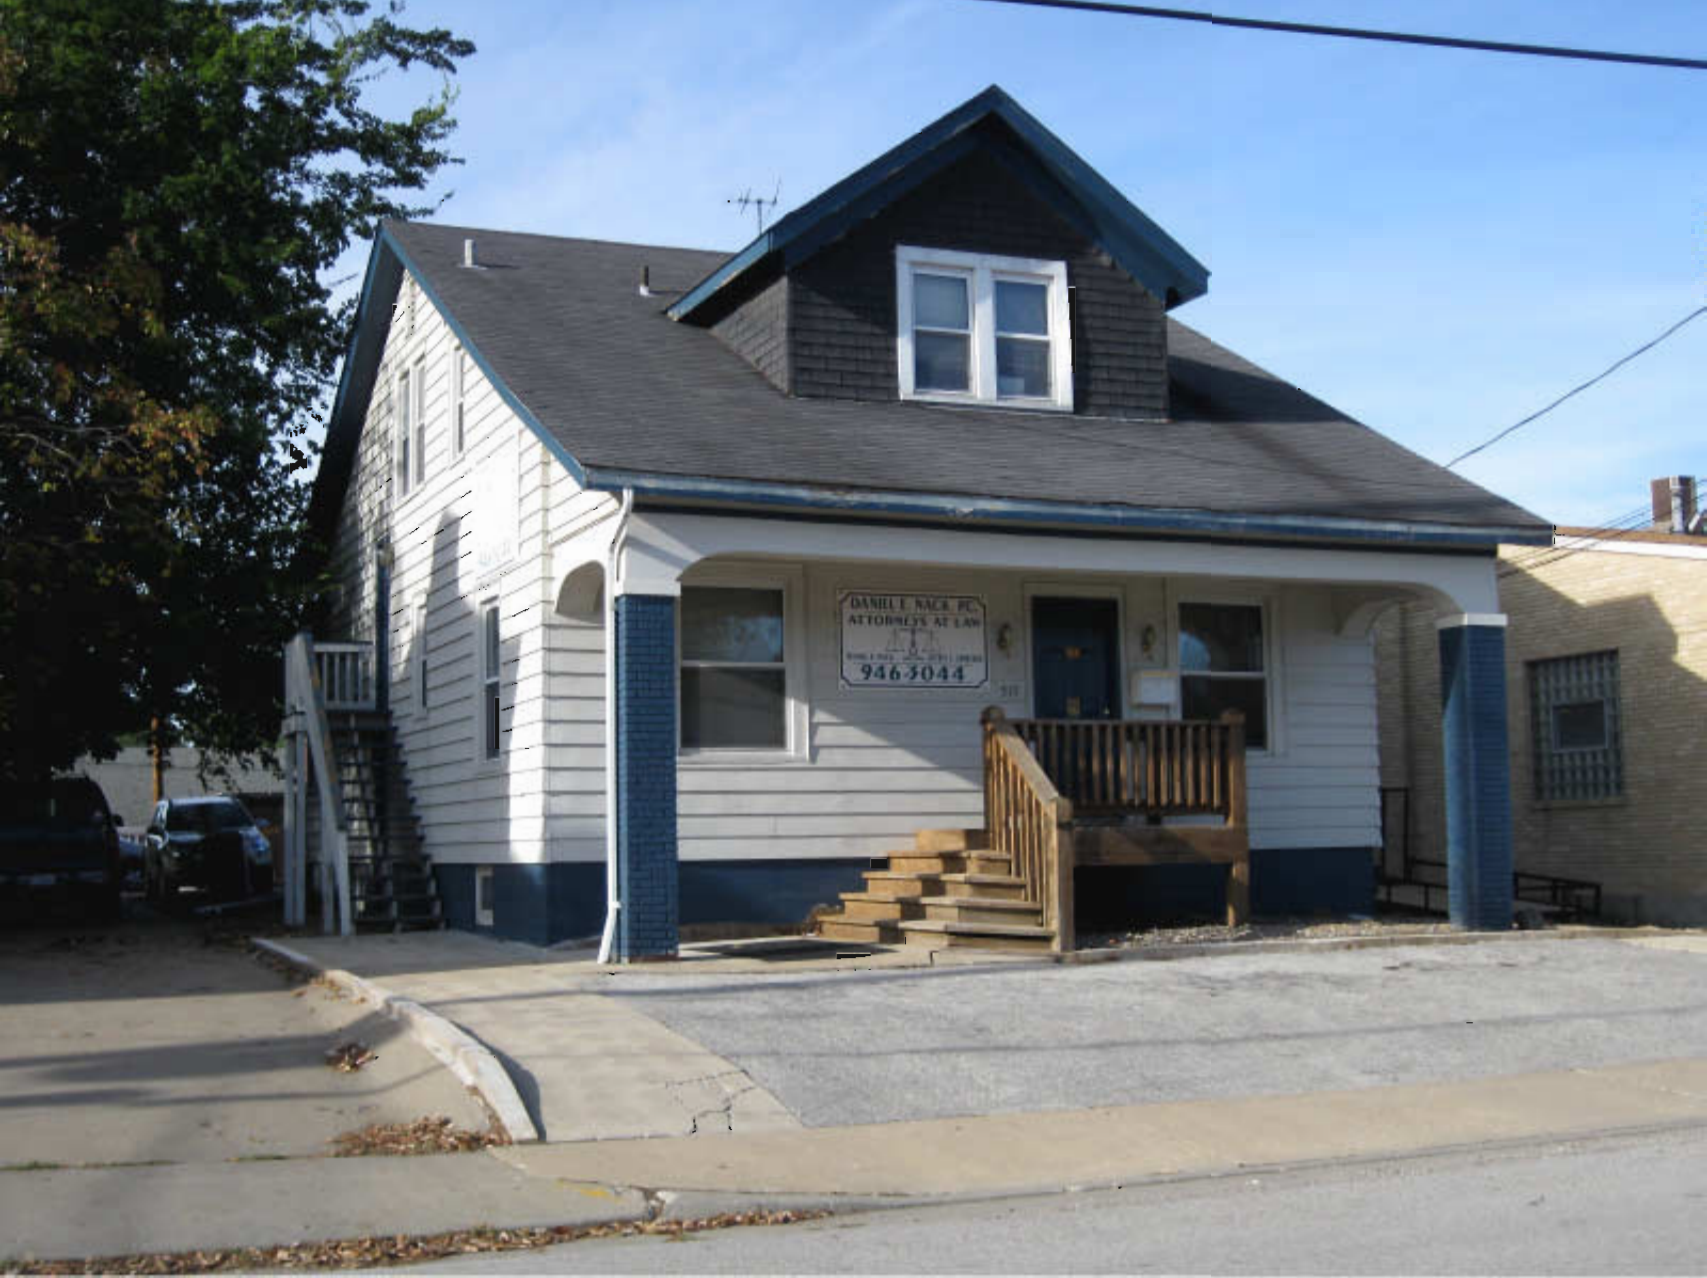
This 1.5 story, frame, side gabled Craftsman bungalow has wide eaves and a large, gabled dormer with paired 1/1 wood sashed windows on the facade and another on the rear elevation. The side gable extends to incorporate the full-width front porch which has basket-handle arched lintels that are supported by brick piers that extend to the ground. In the west half of the facade, the entry door is positioned next to a 1/1 wood sashed window and near the east end of the facade is another 1/1 wood sashed window. The front porch floor has been removed and a stained, wooden entry stoop has been positioned within the original porch to access the front door. On the east side, there is an exterior set of wooden stairs with a wooden balustrade to access the second floor apartment via a doorway where there was originally a window at the stair landing. The house retains its original scored concrete foundation and 2-light basement windows. The dormer is clad with wood shingles, which may be original. On the west side, there are two small stained glass windows. The other windows all appear to be original 1/1 wood sashed windows, but they are covered with combination storms. The front door and apartment door have both been replaced. The original siding has been covered with wide aluminum siding. If the siding were removed to reveal the original siding and a porch floor reintroduced, this might be a contributing building in the historic district, but as is, it is noncontributing.

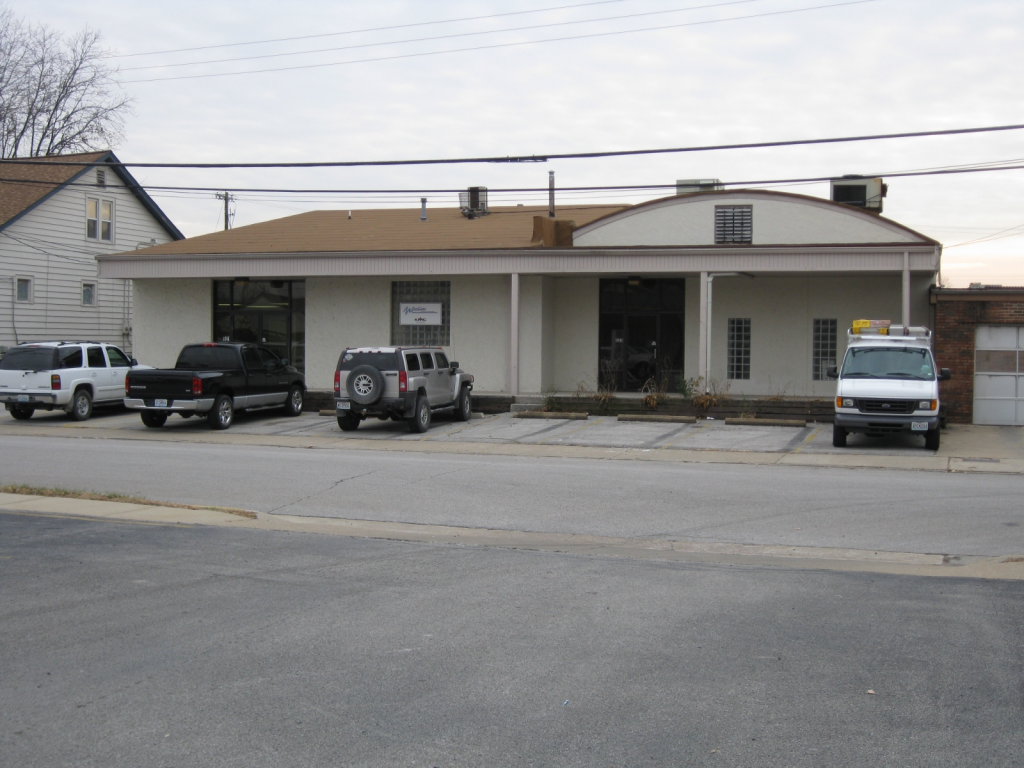
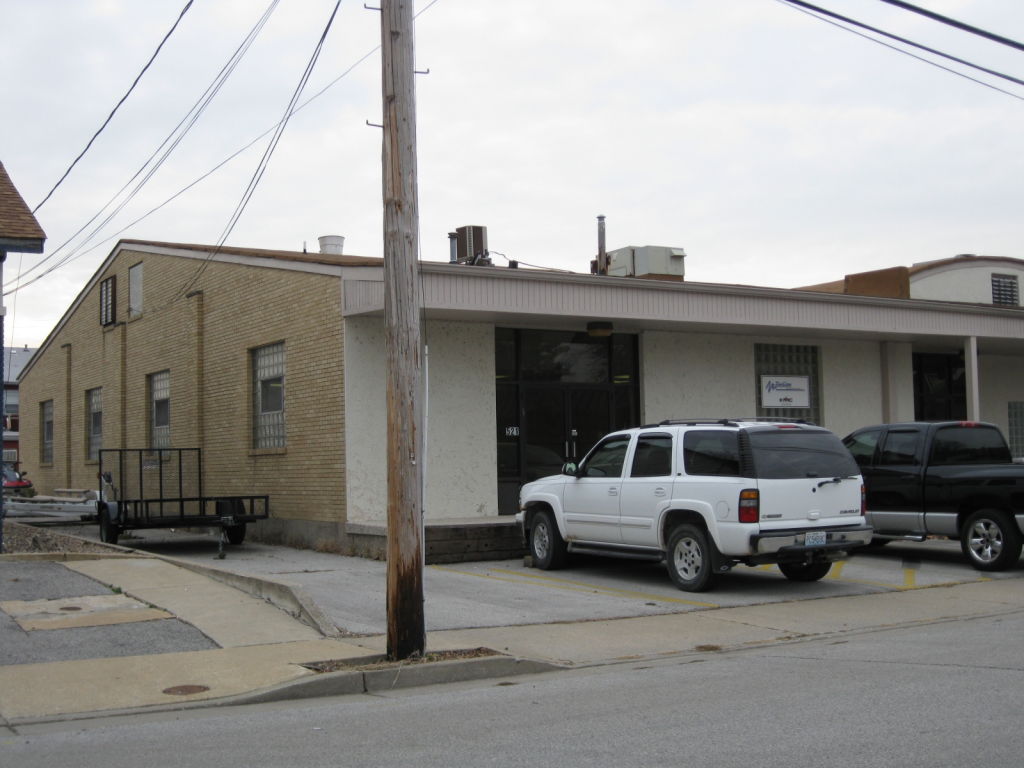
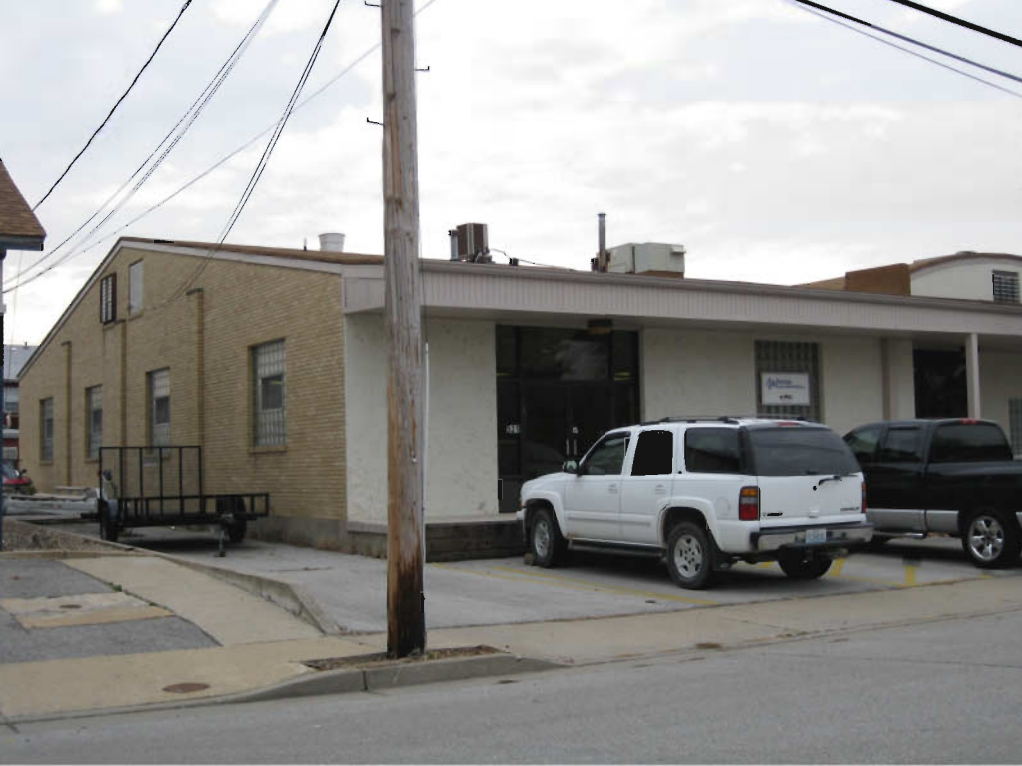
This one story warehouse building appears to have started with the west portion that has a barrel vault roof facing the street and later had a shallow, side gabled addition along the east side. It is likely that the glass block windows are historic given the 1945 construction date. It appears that the modified large openings were originally overhead doorways since this was a dairy warehouse; however, these have now been infilled with aluminum commercial storefront framed doorways and transoms, but the use of dark framing and dark glass help to maintain the sense of void from when the loading doors were open. There is a concrete loading dock across the middle and east section with a shed roof supported by simple square posts. While the front wall has been painted, the light tan brick walls on the east side are unpainted, with four window openings separated by brick piers (windows now vented glass block, which might be original in this wing). Without knowing when the addition on the east half was built (it had to be post 1959), it is not possible to determine whether this would be a contributing building in the historic district. As it stands now, the building has to be identified as noncontributing because this addition is not identified as historic.

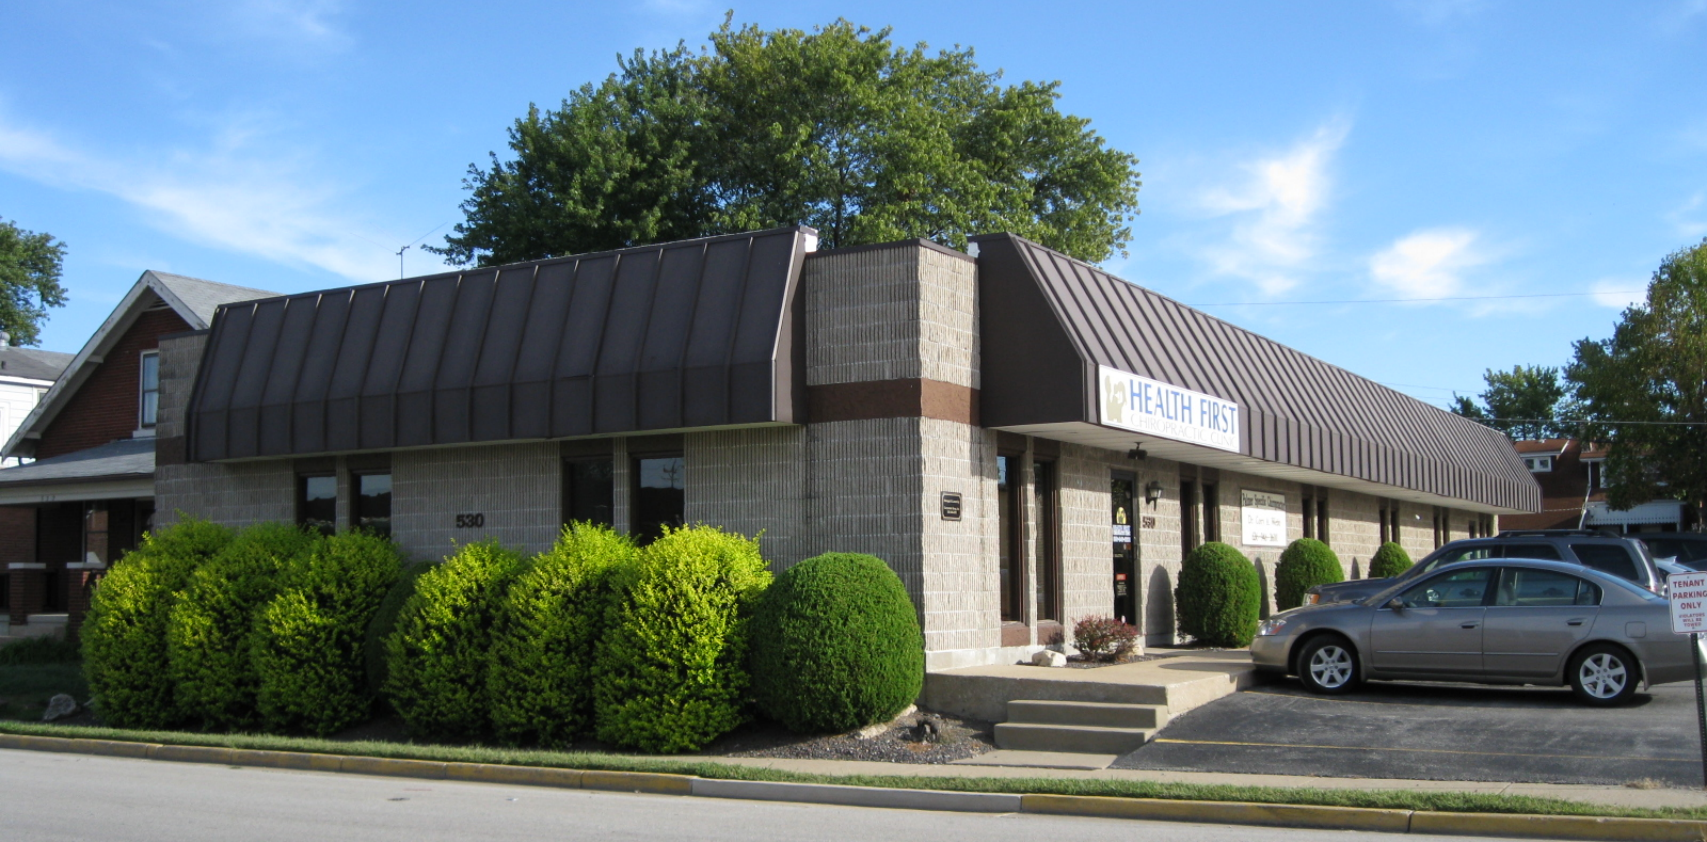
This flat roofed, one story, corrugated-texture concrete block commercial building faces east into the parking lot. Along the street elevation, there is a partial width, standing seam, false mansard roof and two pairs of single-light, full height windows. On the facade there is another nearly full width, false standing seam mansard roof. There are seven bays, with all but the doorway in the second bay having paired, single-light, full-height windows. The door is a full-light, aluminum framed door.

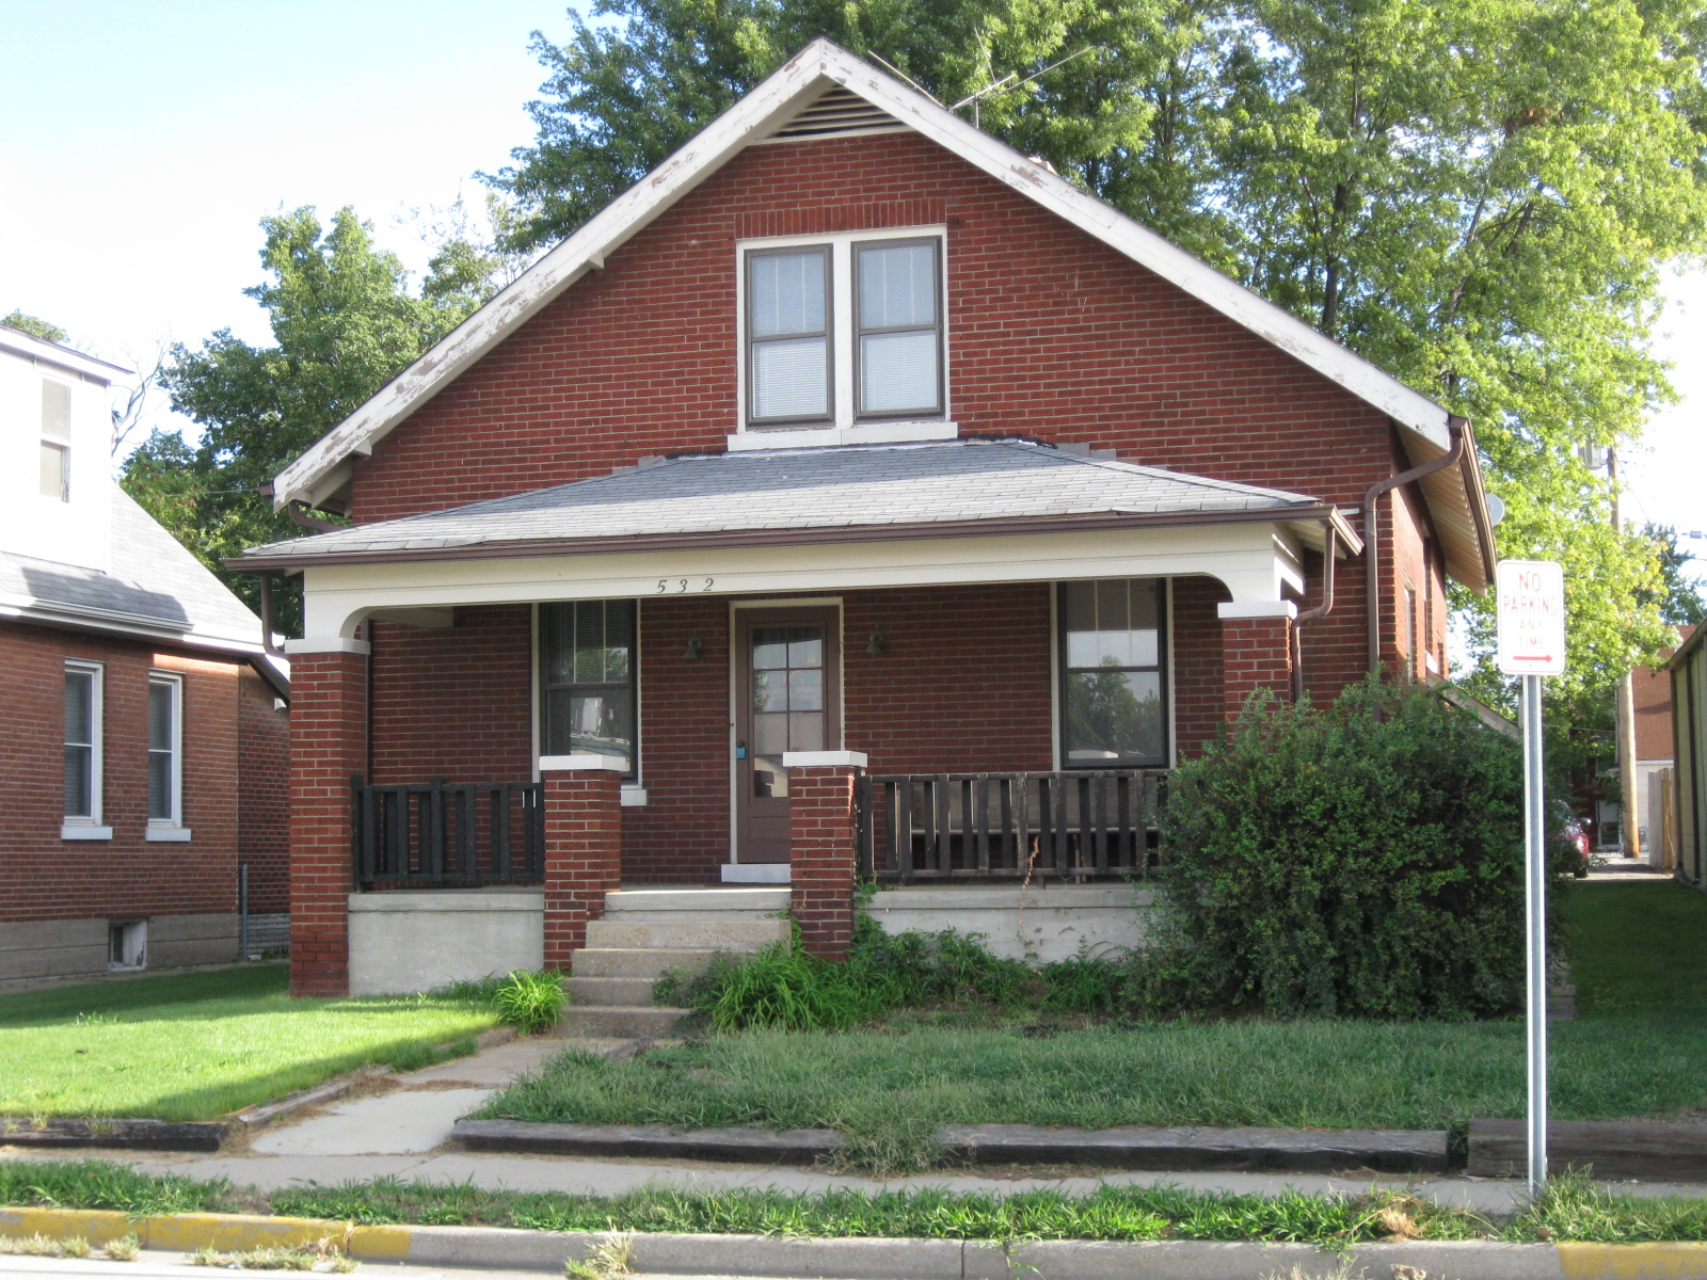
This 1.5 story, red brick, end gabled, Craftsman bungalow has a hipped roof, full width front porch. The raised concrete foundation forms an elevated watertable and has a series of 3-light basement windows on each side. There is a soldier course of brick above the concrete foundation and windows and doors have soldier course lintels. The roof has wide eaves with exposed rafters (obscured by the attached gutters) and a shed roofed dormer with wide eaves with exposed rafters (obscured by a nonhistoric fascia board) on the west side in front of an interior brick chimney flue (with its original concrete cap) that straddles the ridge in the center of the house. The dormer is clad with what appears to be wood shingles. The house retains its original 3/1 wood sashed windows that have concrete sills. There are paired windows in the gable ends above the front porch and on the rear. On the facade, there is a 3/1 wood sashed window on either side of the front entry door, although they are not symmetrically placed. The front entry door also has three lights at the top of the wood paneled door. It retains its old wooden, 8-light, wooden storm door. The front porch has a broad basket-handle arched beam that rests on tall square brick piers with concrete caps. Like the corner piers, the square brick newel posts on either side of the concrete steps extend to the ground, with the stucco foundation of the porch between these piers. The porch floor is concrete. The railings have been replaced. On the west elevation there are two small stained glass windows that help define the room inside as the living room. There are two other bays of windows. On the east elevation, there are paired sashed windows near the facade. Centered on this elevation is a side entry door with a shed roofed, knee braced doorway and paired sashed windows with a concrete sill directly above the shed roof. Behind the doorway is another pair of windows. On the rear, there is a window on the west side and a small 2/1 sashed window next to the rear half light door, which has an old wood framed, 8-light storm door. The porch has a shed roof and older, wooden side entry stairs, but the porch floor, railing, and corner posts are replacements, stained wood. The only other alteration is the aluminum storm windows.

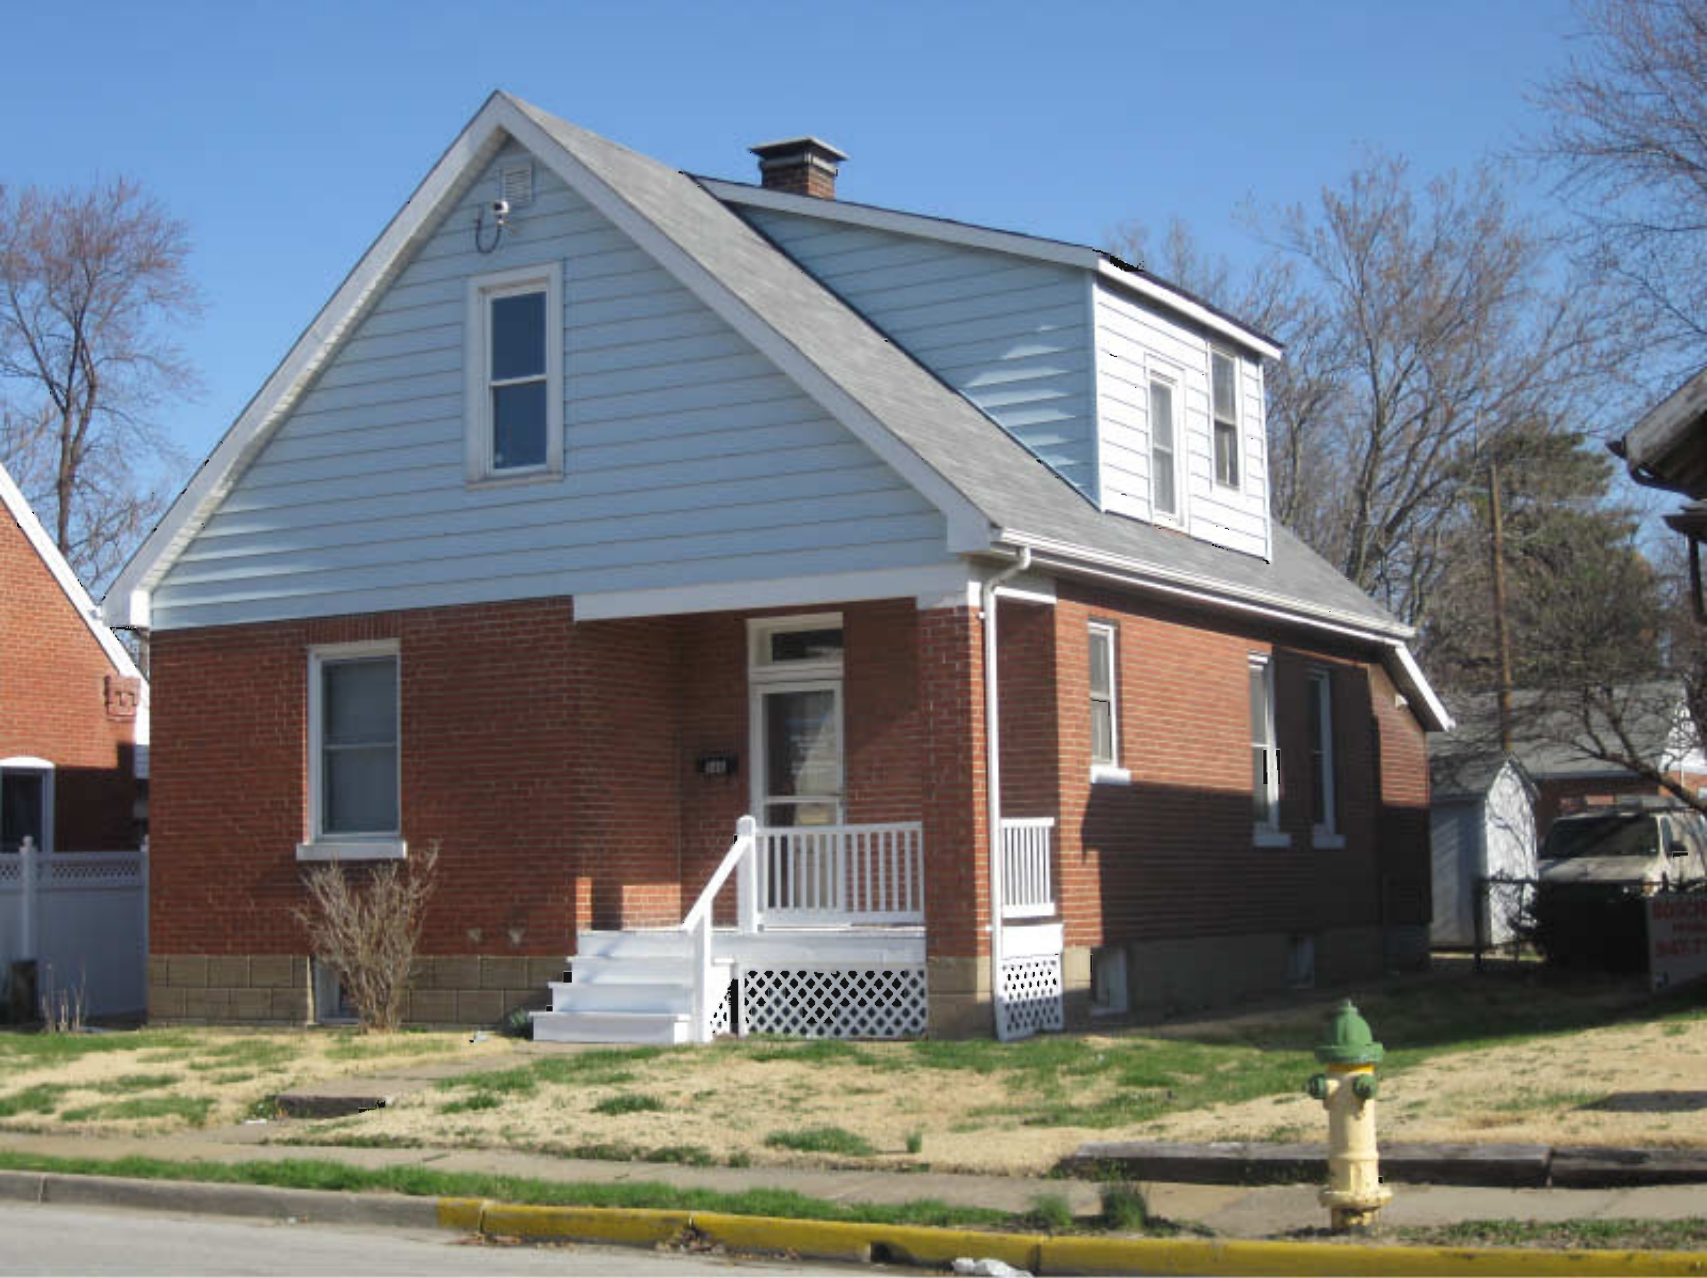
This 1.5 story, red brick, gable-front house has a frame second floor with broad shed-roofed dormers on either side, with a straddle ridge chimney positioned behind the dormers. The gable ends have slight returns on the fascia of the eave overhang. The gable end and dormers are noted on the 1947 Sanborn map as being frame construction, now clad in vinyl siding. The recessed corner front porch in the east bay of the facade has a square brick corner pier that rests on a pier of the same shaped concrete block used for the foundation. The porch retains its wood porch floor and steps as well as the simple square newel post and balustrade. The front entry door has a transomed, half light wood paneled door. There is one window in the west bay of the house. Windows on this house are replacement 1/1 sashed windows that retain the original dimensions and the original painted concrete sills. The basement windows punctuate the concrete block foundation and are the original 3-light awning windows. The windows in the east dormer are staggered, seeming to indicate that this is the location of the staircase. On the rear, there is a shed roofed, 1-story, brick porch extension, clearly built with a different brick, but also shown on both the 1929 and 1947 Sanborn maps. Both ends of this porch were clearly shown as enclosed rooms on the Sanborn maps, and the one on the west end has a door opening at grade that has been boarded in. The porch has pierced openings, now with storm window panels flanking the rear door, which has a half light (3 horizontal lights) paneled door. This porch wing was built on concrete block piers, not a full foundation even though it is built of brick. The roof has wide eaves. The rear steps have been replaced with pressure-treated, unpainted wood. Like the front, there is a single window in the gable end. Despite the loss of the original windows, the openings appear to retain their original dimensions and the upper windows still have the trim exposed (not covered with siding) and as such the house is still contributing to the historic district.

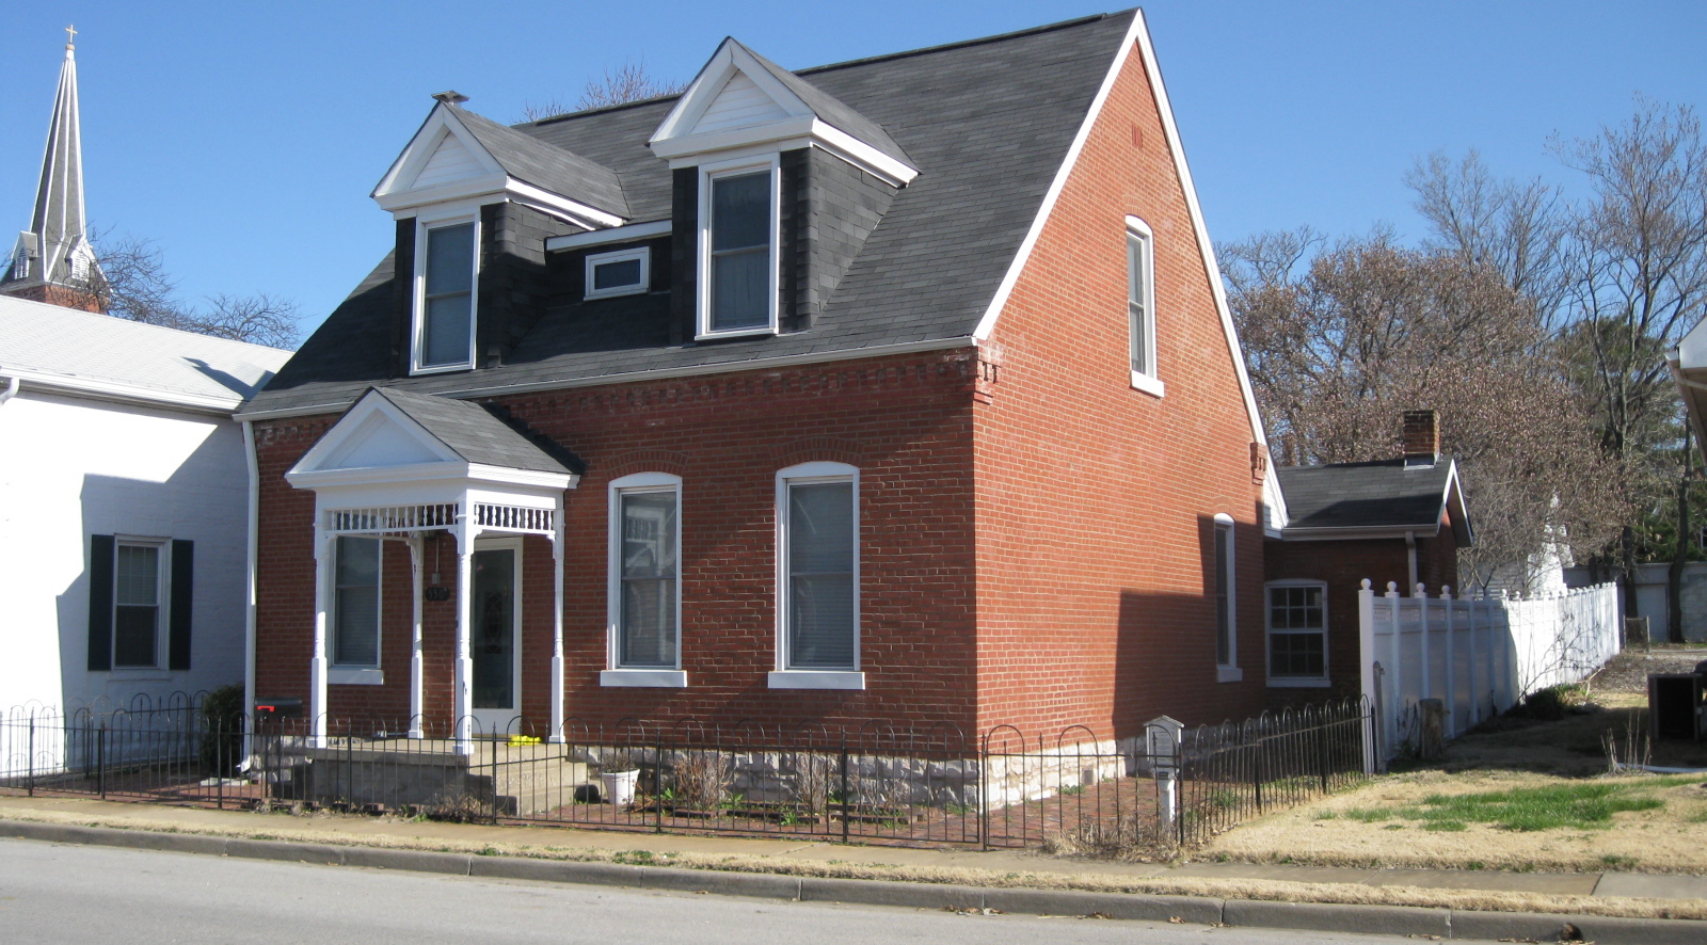
the street that retains its original wooden, 6/6 sashed window and there appears to be a matching window on the opposite elevation, facing north. There is an interior, straddle ridge chimney. The rear enclosed porch is clad in vinyl siding and has skylights. The window sills and brick mold have been wrapped with aluminum and the windows have been replaced.

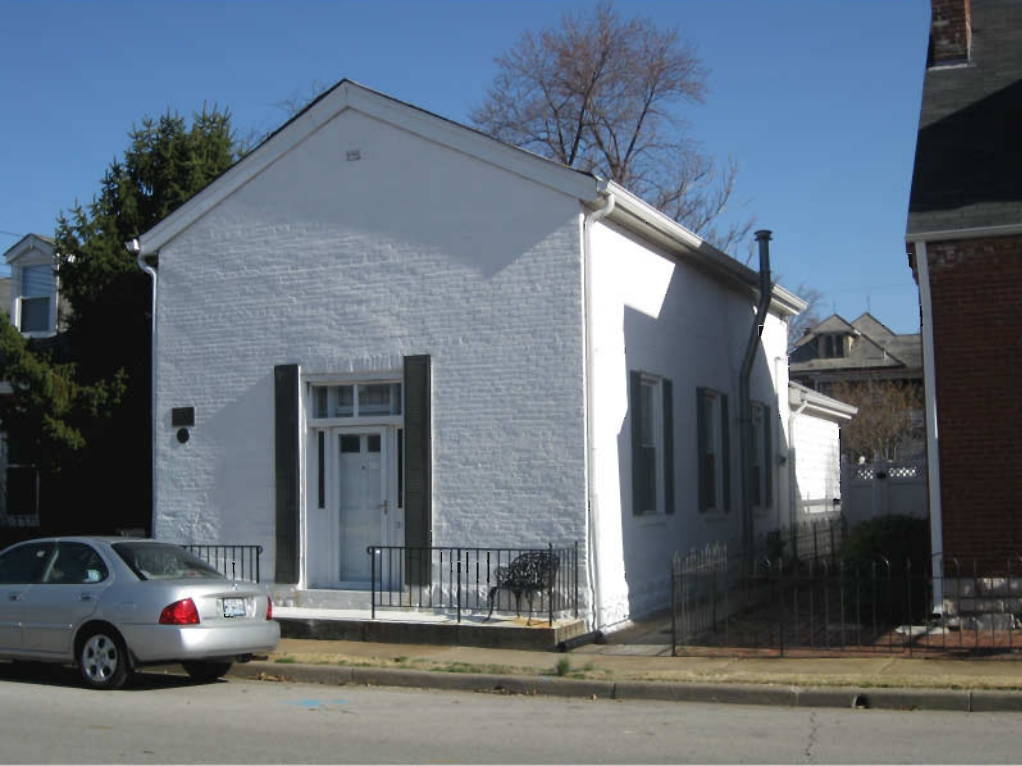
Since the building was listed in the National Register in 1980, it has had an at grade concrete pad with iron railings added across the façade, and there has been a one story, gabled addition added across the rear of the house. This replaces the rear shed roofed, enclosed rear porch wing that was added in 1947 when the church building was remodeled into a residence. An exterior metal flue has been attached on the east elevation wall between the second and third window bay. Except that it appears to be better maintained, it appears unaltered otherwise since 1980, although the current photos do not show the window fenestration pattern clearly (it was wooden 6/6 windows in 1980).

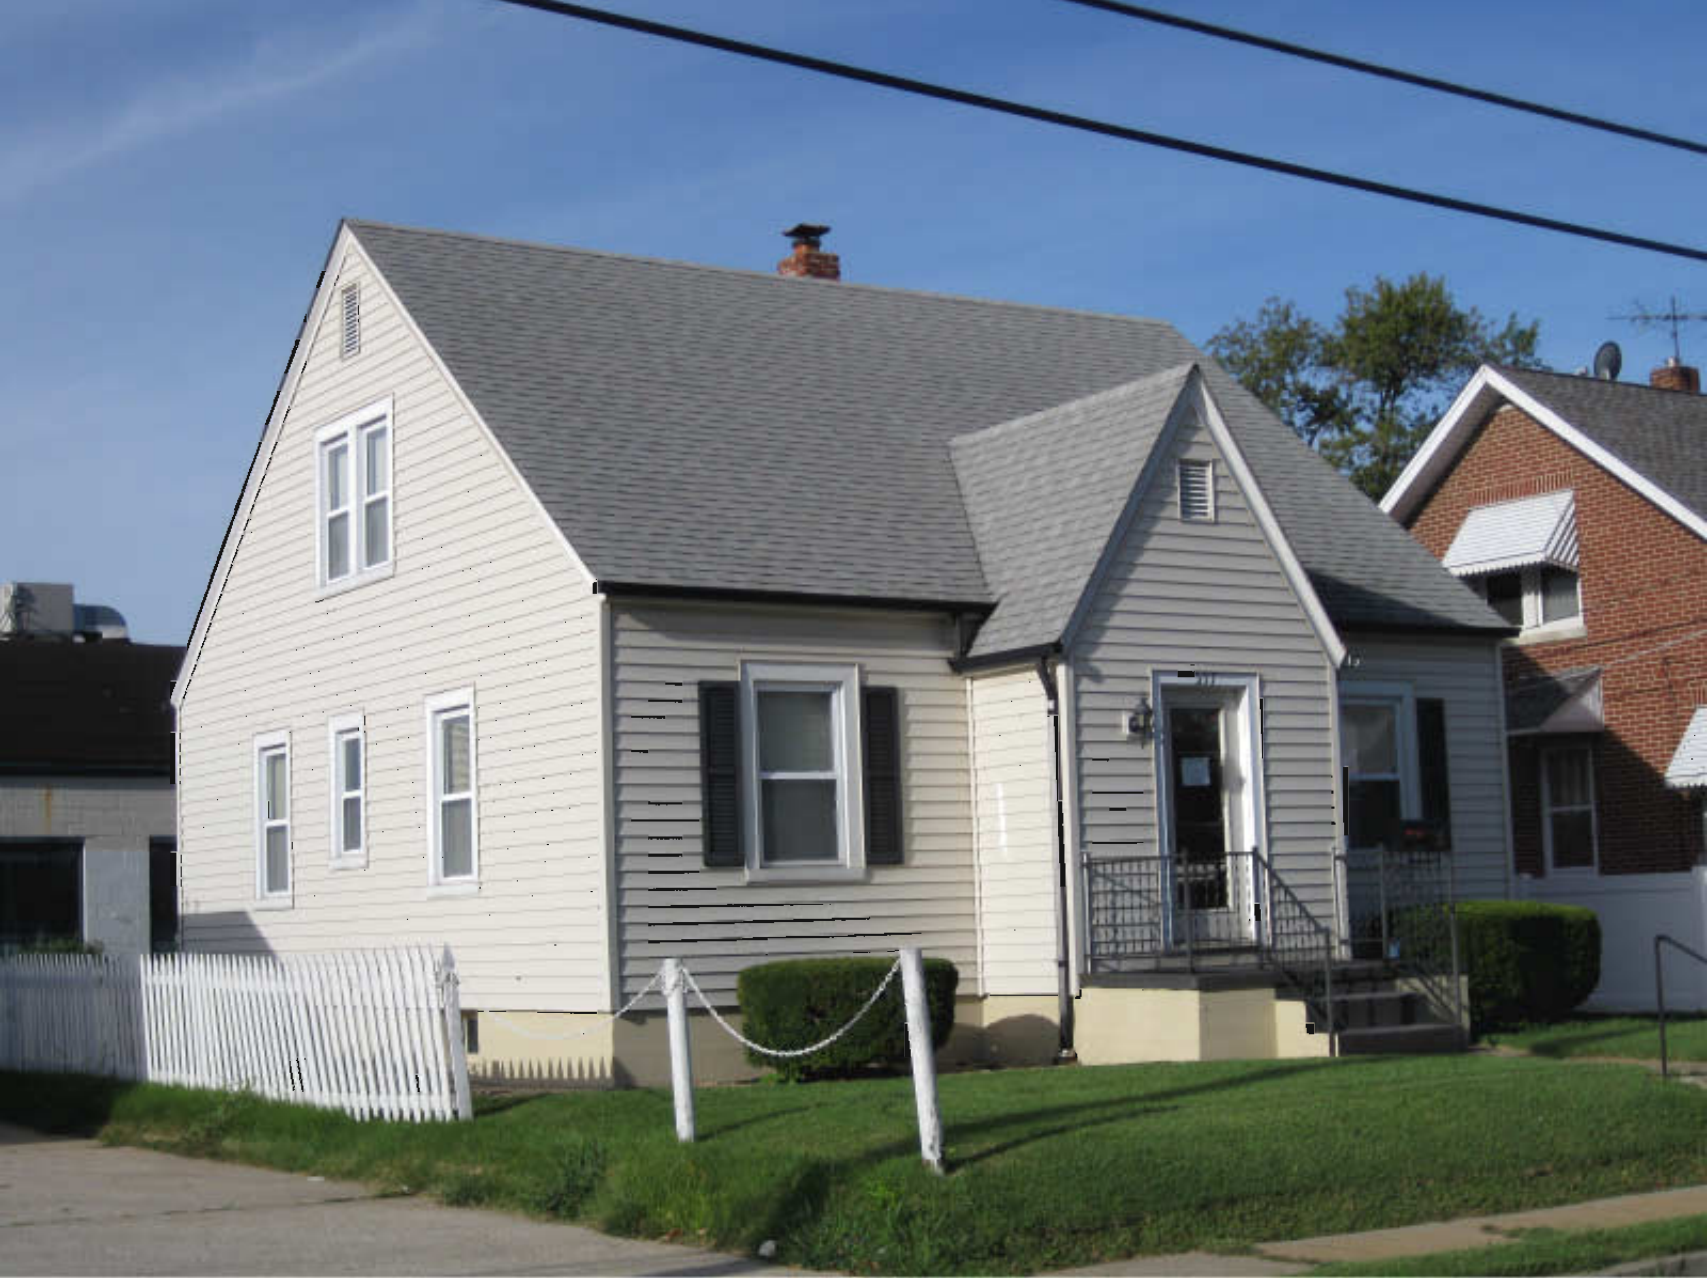
This frame, side gabled, 1.5 story, Cape Cod house has a symmetrical facade with a steeply pitched, one story, cross gabled vestibule centered on the facade. On either side of the vestibule is a sashed window. The house has replacement vinyl siding, the trim around the windows has been wrapped with aluminum and there are faux shutters on the facade. The windows are replacement 1/1 sashed windows and the front door is a full-light, metal framed door that opens onto the original concrete stoop that spans the width of the vestibule, but the wrought iron railings appear to be later replacements. There is a rear slope interior, brick chimney flue and a shed roofed dormer on the rear of the house. The house appears to retain the original 3-light basement windows. Without knowing what the original wall finish was, and because so many of the other details have been replaced, the house is noncontributing to the historic district.

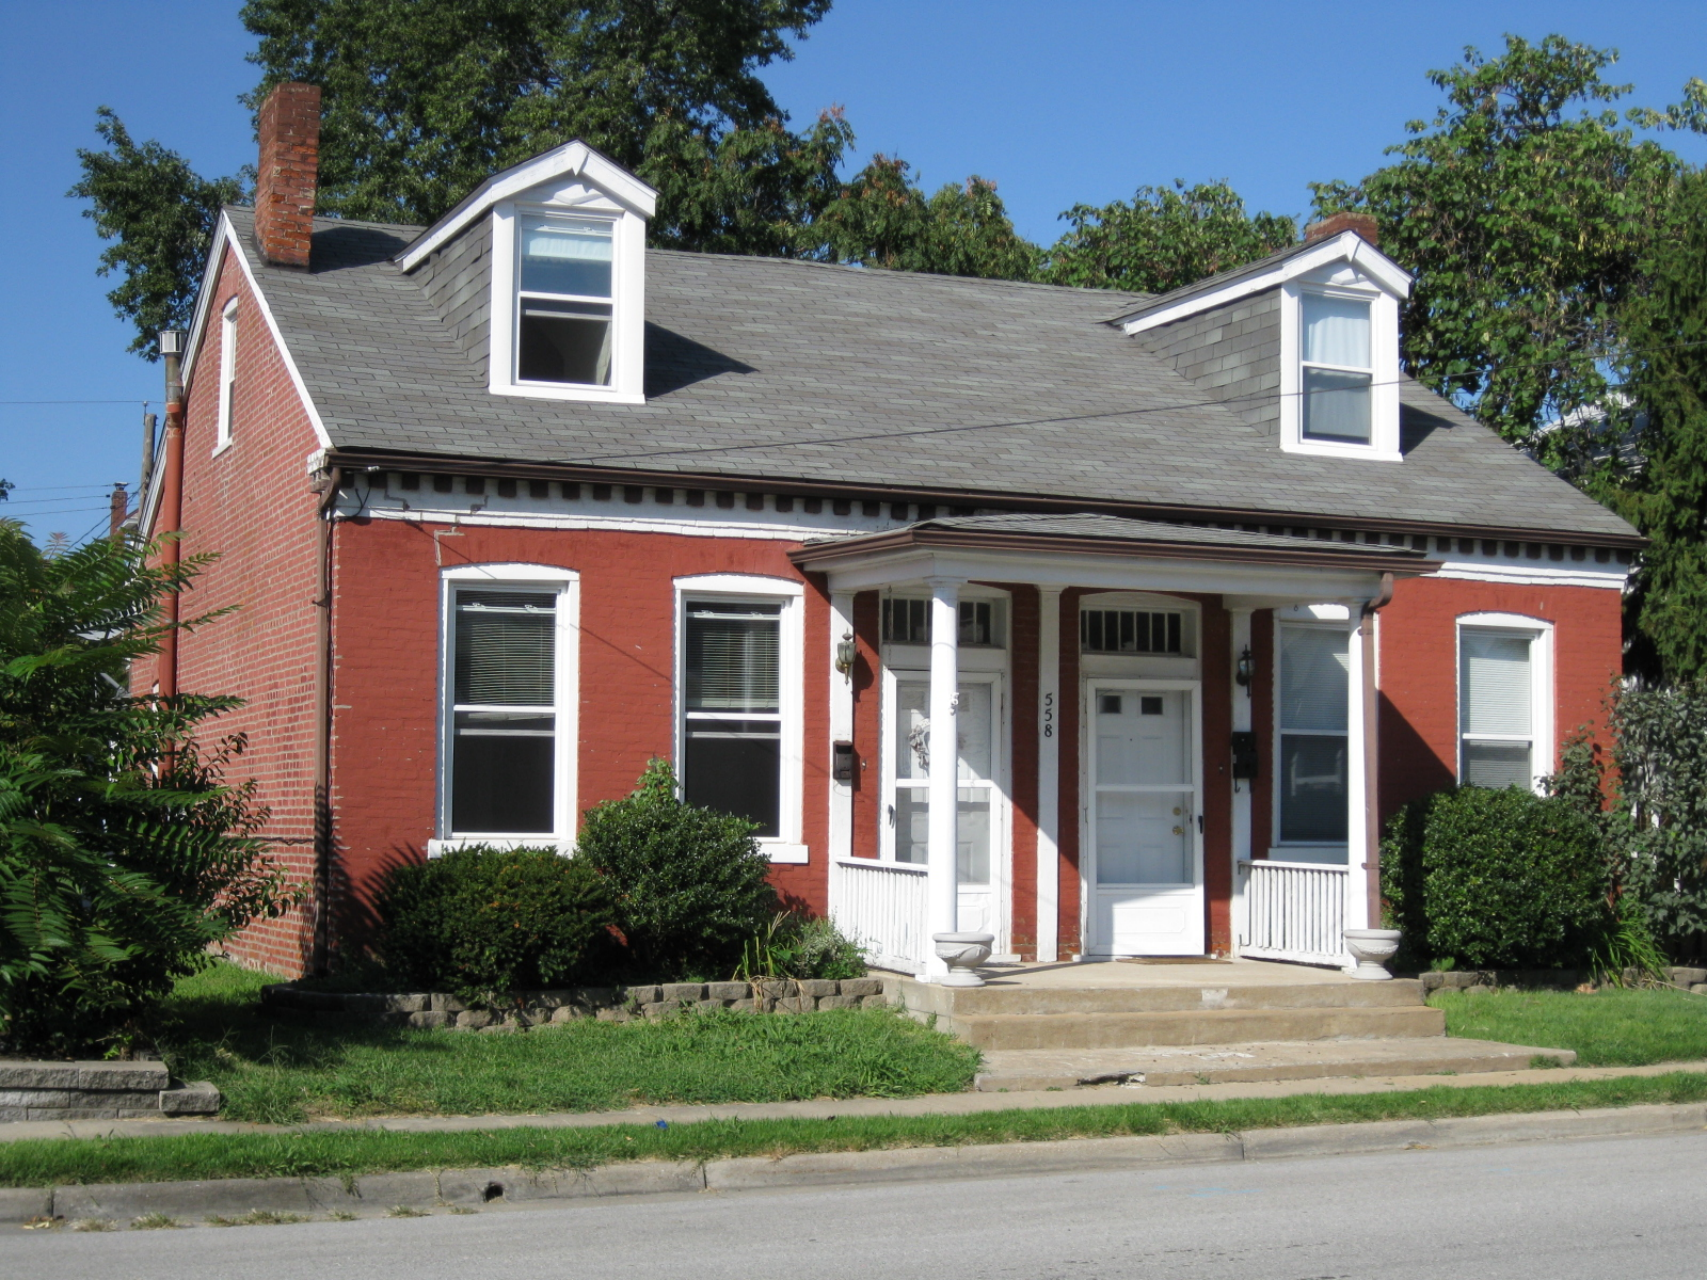
This side gabled, 1.5 story, brick duplex has two gabled dormers on both the front and rear elevations. The building is built with seven-course common bond red brick and has a brick cornice highlighted by brick dentils under the narrow eave of both the front and rear elevations, which form gable returns on both ends of the house. The facade is symmetrical with six bays of openings. The outer two openings on each side are segmental arched window openings with dressed stone or concrete (painted) sills. The center two openings are the entry doors, also segmental arched openings, with transoms divided into narrow vertical lights. The doors appear to be replacement paneled doors with storm doors. The shallow hipped roof porch (that was added between 1893 and 1900) is supported by simple square posts as well as both corner and center pilasters against the brick, all with simple capitals. On either side is the original simple balustrade railing, but the porch floor is concrete with broad concrete steps spanning the entire width of the porch, a recent replacement. On both side elevations there are only two windows, one near the rear on the first floor and one on the second floor centered under the gable ridge. There are two interior chimneys positioned in front of the gable ridge on each end of the building. The dormers have interesting diamond embellishments above the windows and a keystone-like feature in the gable fascia. The side walls of the dormers are clad in asphalt siding now. On the rear is a cross gabled, one story brick wing with the roof continuing to shed over the corner porches. The rear doors are positioned in this rear wing and there is an additional window facing north in the front portion of the house as well as one in the west unit on the north wall of the rear wing. The porches have concrete slab floors at grade and simple square posts. The siding on the sides of the porch roof has been changed, one has simple painted vertical boards while the east one has vertical slats tiered onto the side wall like shingles. Affixed on the rear of the east wing there is a short gabled roofed, prefabricated outbuilding resting on a concrete slab. There was a rear wing added between 1917 and 1929 that was in this same position and dimension, and it appears this outbuilding, which is sealed against the house is being utilized inside as additional living space, covering over the original window opening. All of the windows have been replaced with 1/1 windows. Although there are some alterations, the window sashes, the front doors, and the porch floors, the duplex retains its characteristic features in the fenestration pattern, the porch, the dormers and the historic brick detailing and as such is contributing to the historic district.
