ARCHITECTURAL/HISTORIC INVENTORY FORM

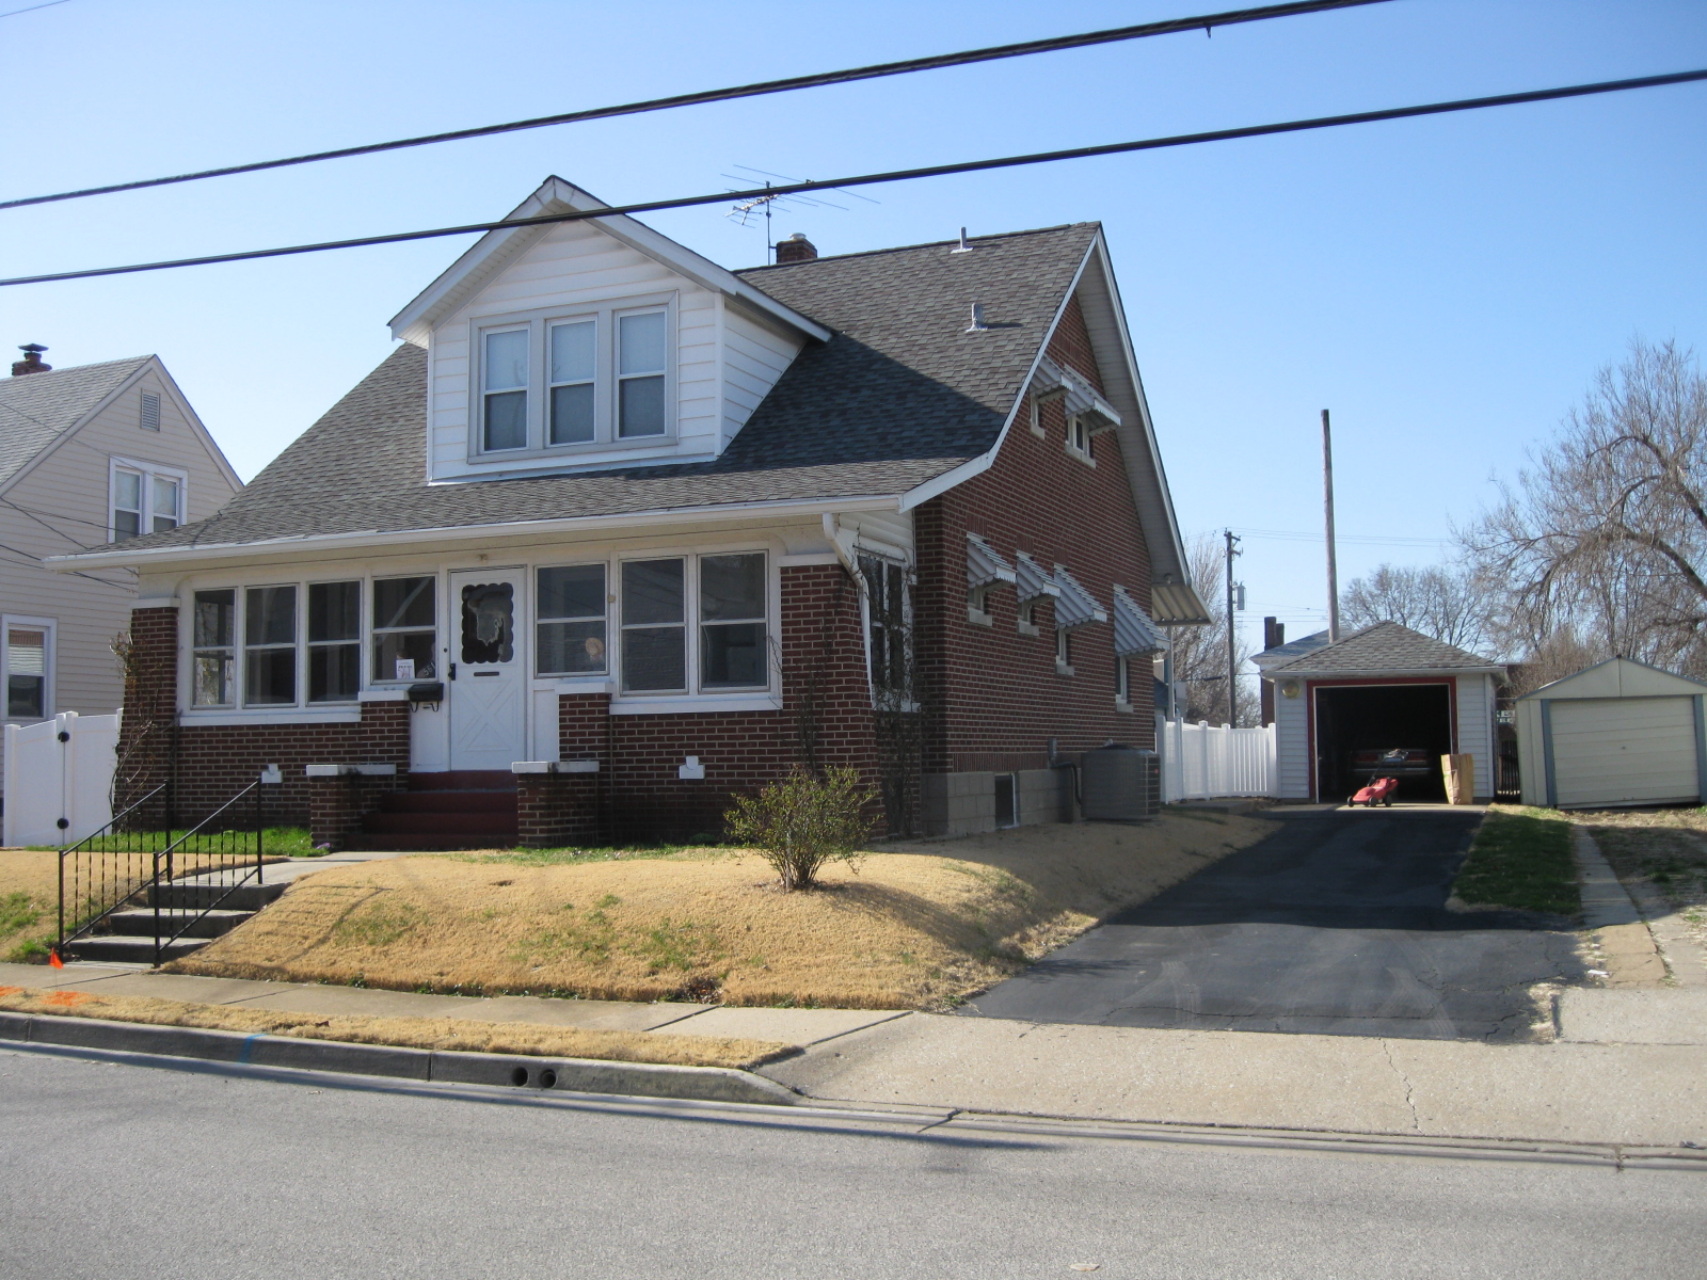
This 1.5 story, dark red brick Craftsman bungalow has a steeply pitched, side gabled roof with wide enclosed eaves that connects on the front to a shallower pitched shed roof porch that spans the width of facade. At each corner, the basket-handle arched lintels extend down to the tapered brick corner piers. There are large brick half piers and half walls on the concrete steps that are centered on the facade. Brick half wall railings with concrete caps span between the piers. The porch is enclosed with aluminum storm windows and a storm door, but the original paired sashed windows flanking the front door are visible inside the porch. Above the porch, centered on the facade is a broad, gabled dormer with wide eaves. It has replacement aluminum siding but retains its 3 original, 1/1 wood sashed windows. The scored concrete foundation is visible on the side elevations and the house retains its historic 1/1 wood sashed windows, although they are protected by aluminum storm windows and aluminum awnings. There are two square, stained glass small casement windows on the west side and on the east side there is a side entry door with a shed roof projecting over the side entry stoop. This entry retains its original half light, wood paneled door. On the rear, there is another central, gabled dormer and an enclosed shed roofed porch. A metal canopy has been added at the southwest corner of the house over a surface-level rear patio. Alterations are limited to the application of additional materials (dormer siding, storm windows, metal awnings) and are easily reversible without damaging the original historic fabric of the house. It is a contributing building in the historic district.

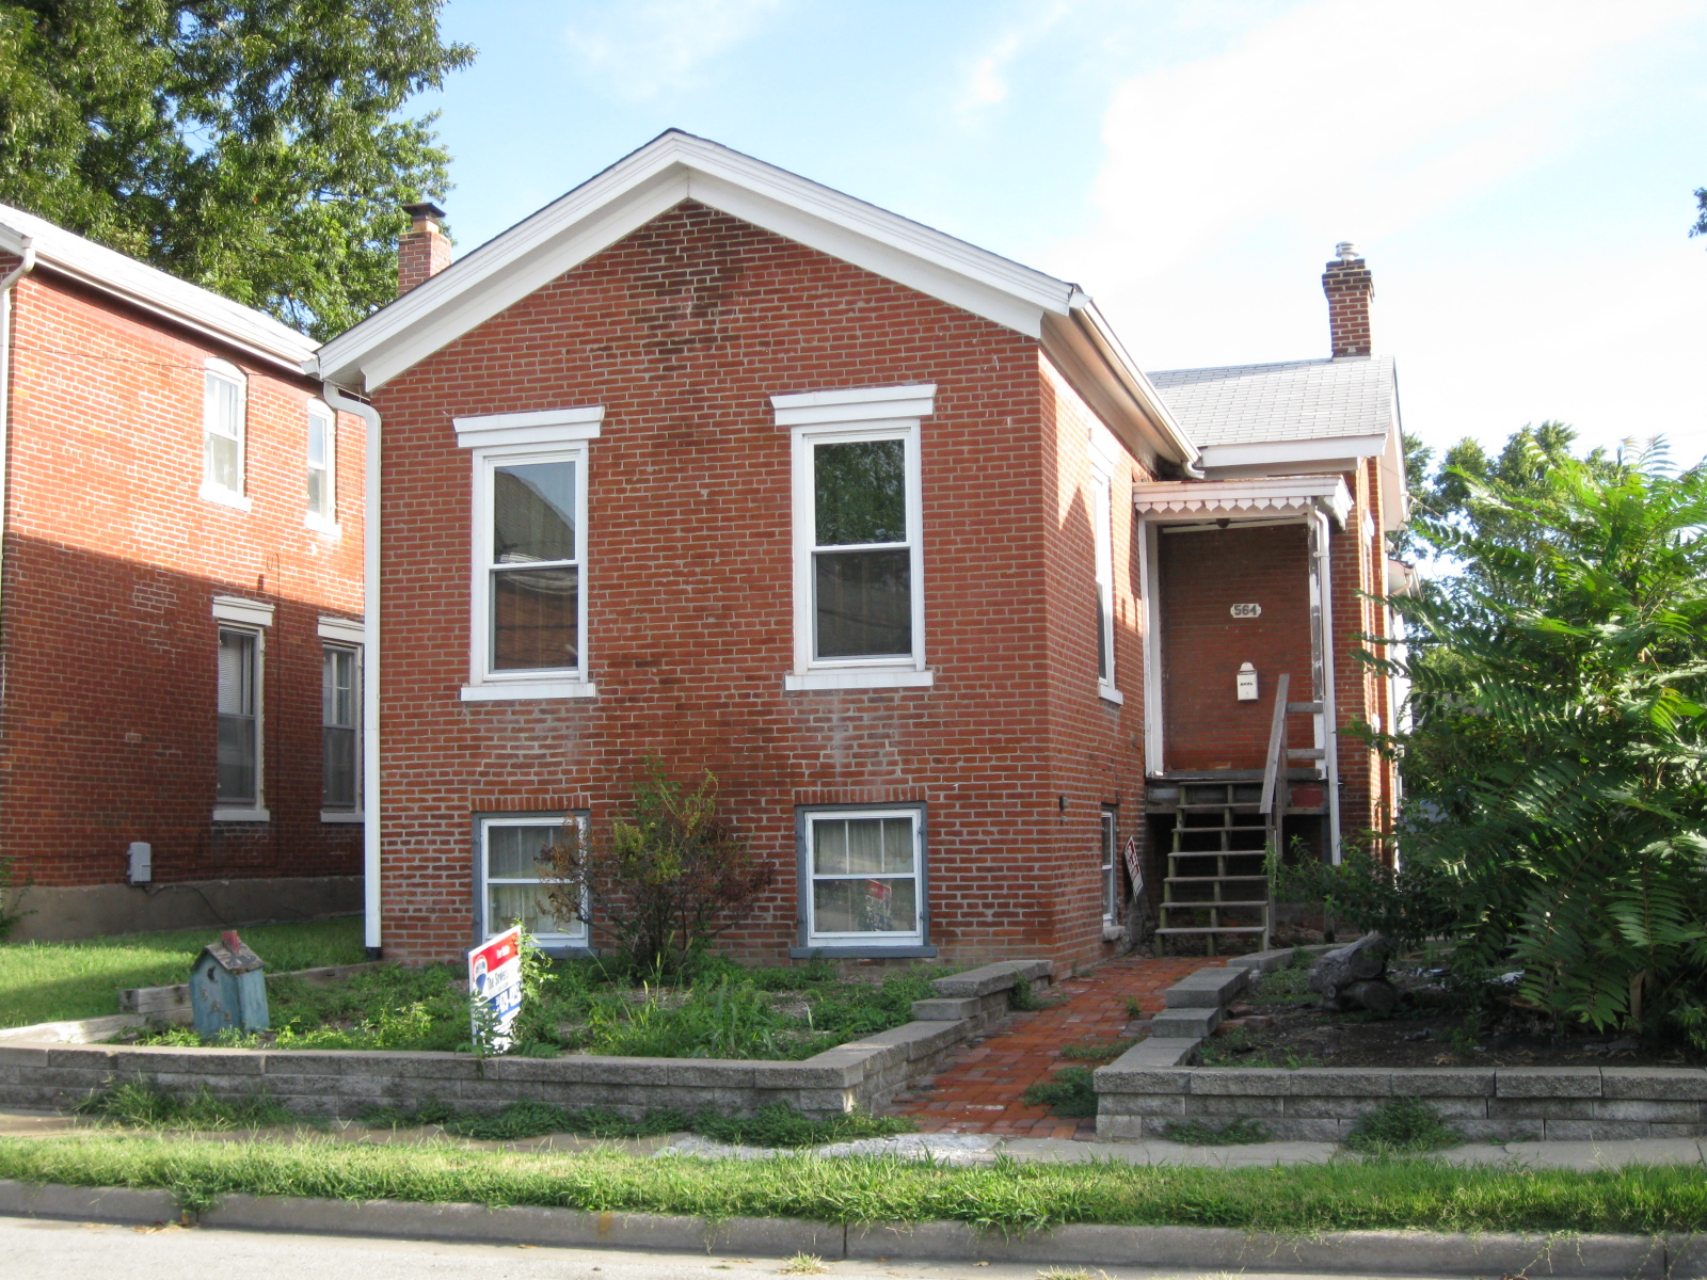
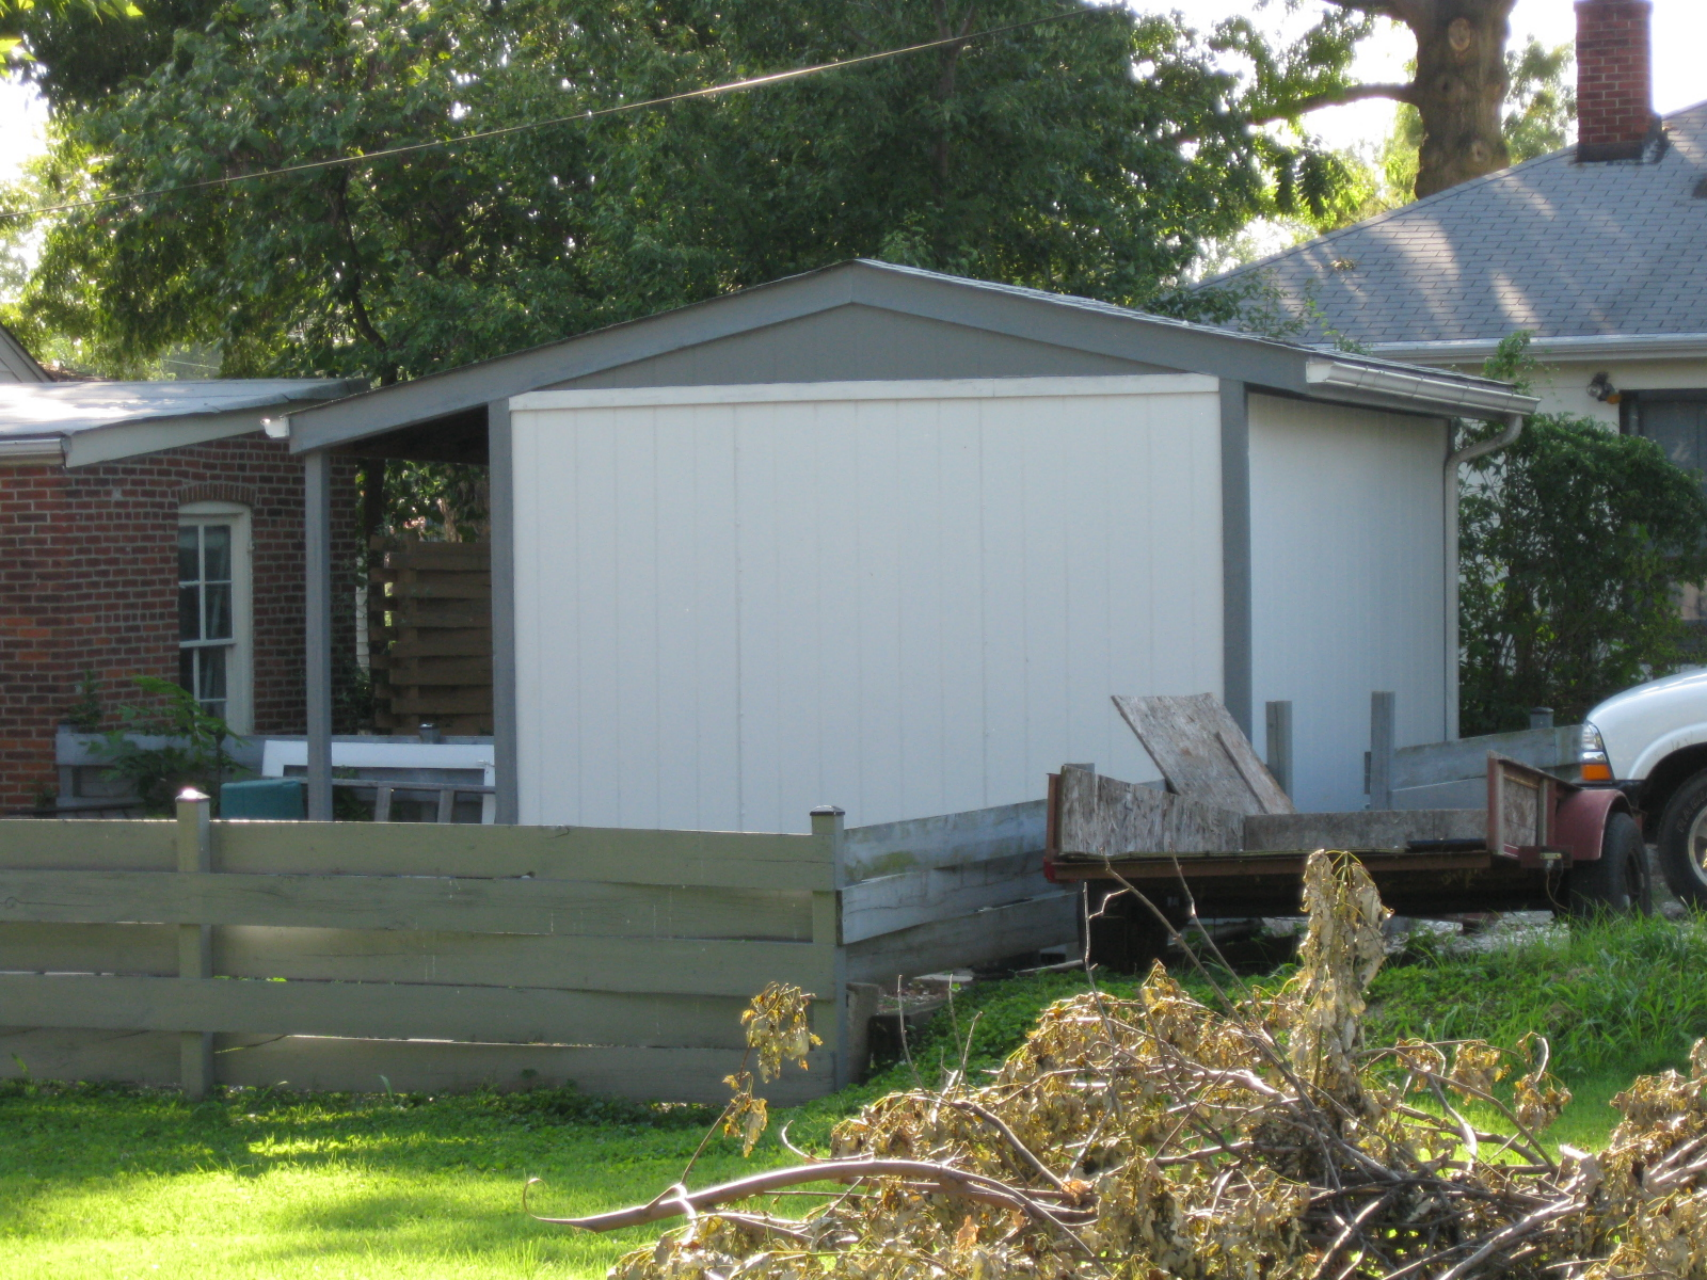
This one story, L-shaped brick house has a raised basement. Nestled on the interior corner of the L is a small porch with a very shallow hipped roof supported by simple square posts, but the fascia incorporates an interesting shaped shingle. The porch (added between 1900 and 1909) retains its original bead board ceiling and simple balustrade railing along the east side. It has a wood porch floor and wood steps that extend down the half-flight toward the front, but the railing on the stairs appears to be a replacement, unpainted and taller to meet code. The door is nestled at the corner facing east and has 4-light sidelights and a transom over the half light door. In the front gabled wing (shaft of the L), there is one bay of windows facing east in front of the porch and there are two bays of windows on the facade, all with first floor windows that are 1/1 replacement sashed windows that have tiered splayed lintels and simple sill that have been wrapped with metal. Below these windows in the basement level, there are header course brick lintels and simple sashed 3/3 wood sashed windows. On the wing facing east, there is a corbelled brick, end wall chimney straddling the ridge with a bay of windows in front of the chimney that match the details of the facade windows. On the rear, a gabled, frame wing was added between 1900 and 1909 that had a shed roofed porch facing east, but at some point after the 1947 Sanborn map was published, the porch was enclosed. There is an off-centered, round arched, 4-light window in a rectangular opening on the second floor of the gable end (which is now clad with wide board siding). On the first floor, there is one 2/2 wood sashed window. Within the enclosed porch section there is a non-historic, multipaned door with a sidelight that faces north and two newer 1/1 windows facing east (that wall is vertical board paneling but the rear wall appears to be stuccoed or simple vertical boards). Spanning this north elevation there is now a full-width shed roofed porch with simple square post supports and a wood porch floor, but this porch was also added after 1947. Despite these alterations on the rear, and the encasement of the window trim and replacement windows, this is one of the oldest buildings in the area and it still retains its historic front porch and a corbelled chimney, as well as the original fenestration pattern. As such, it is still contributing to the historic district.

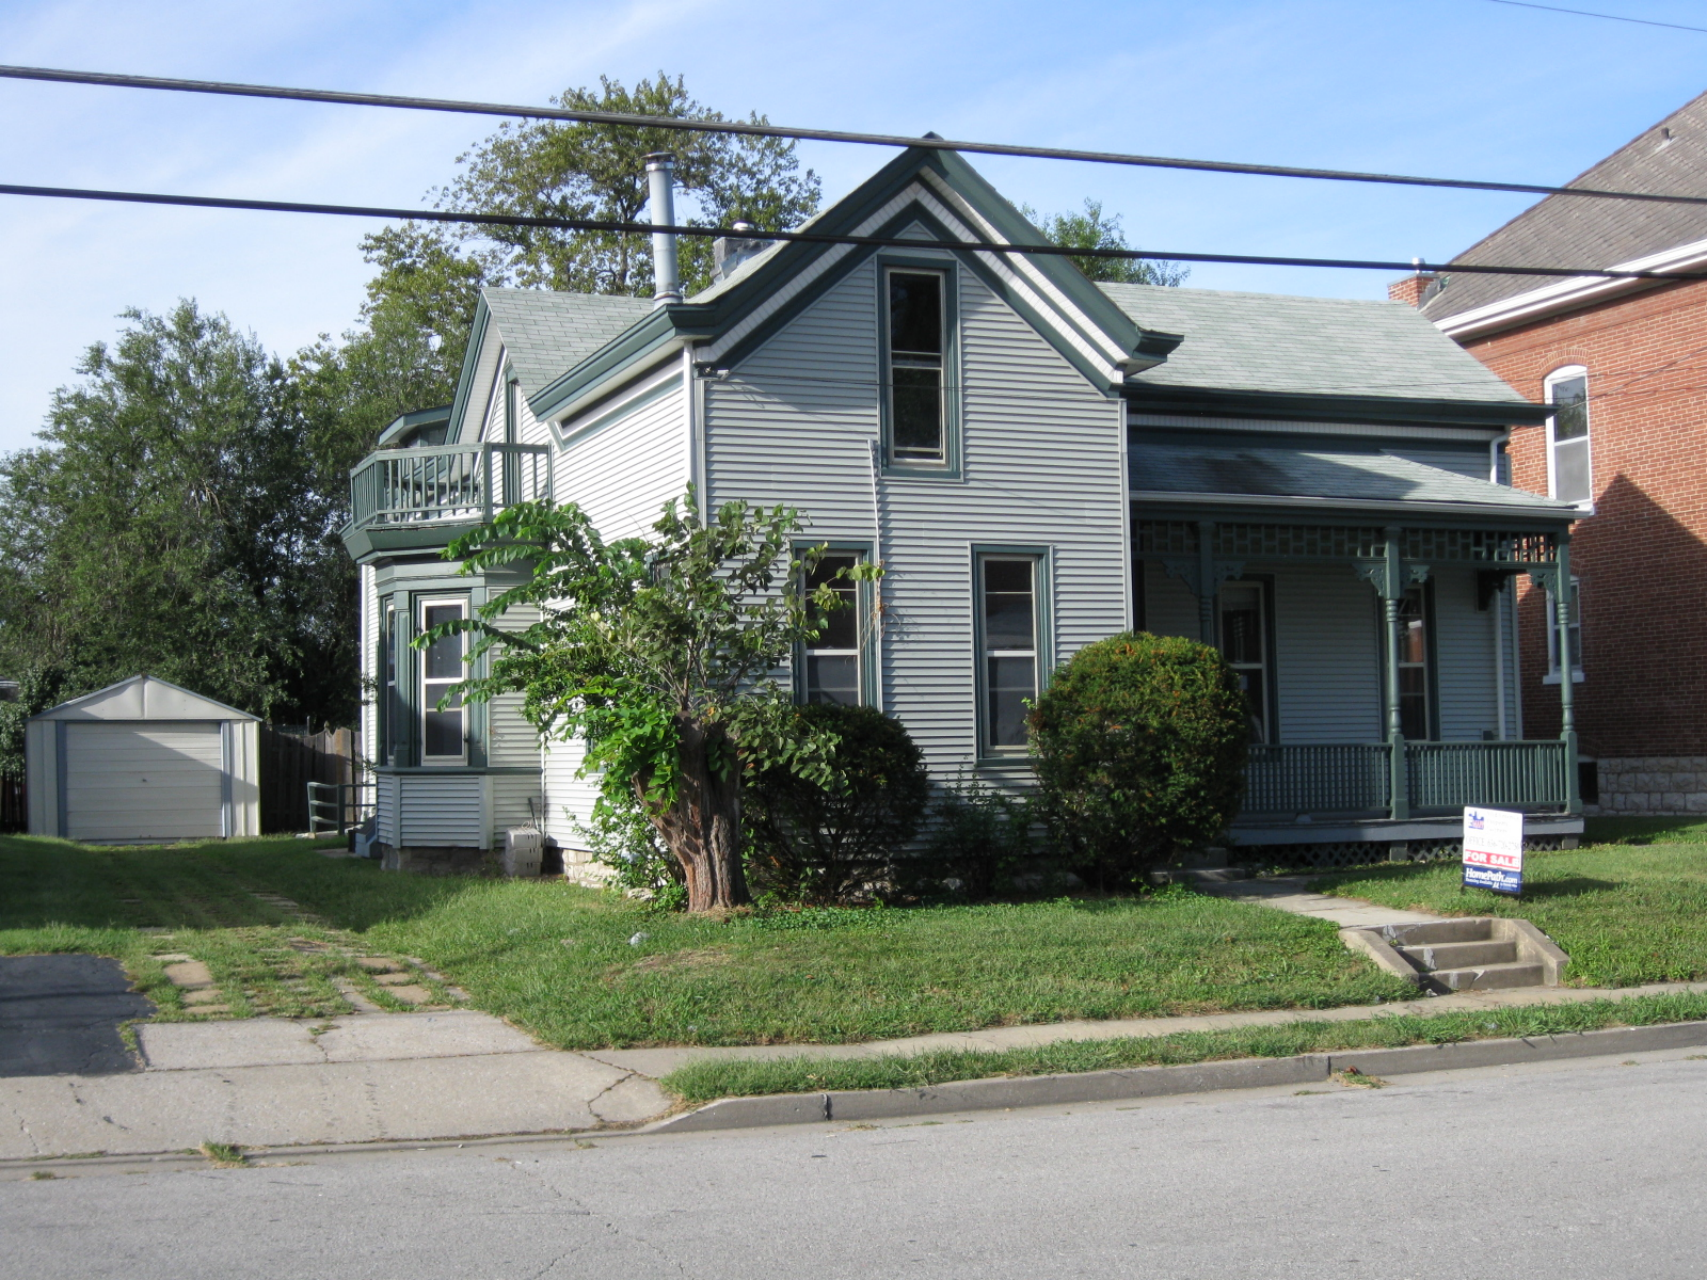
This Folk Victorian, 1.5 story, frame house has three gabled wings connecting to form an asymmetrical, T-shaped plan house with a rock-faced limestone foundation. The gable front wing forming the east bay of the facade has a central 1/1 wood sashed window on the second floor above the two first floor 1/1 wood sashed windows. The side gabled wing, recessed back on the west side of the facade has a hipped roof porch nestled into the interior corner. The porch retains its original geometric fretwork and scrollwork brackets on the turned porch posts and simple wood balustrade as well as the wood porch floor. There are two 1/1 wood sashed windows west of the transomed doorway, but the door has been replaced with a modern metal paneled door with a fanlight. Simple stone piers are visible under the low porch floor. On the west elevation of this gabled wing are 2 first floor and 1 second floor 1/1 wood sashed window. On the east elevation there is a canted bay window with a flat roof that has a replacement railing on the rooftop. Above the bay window is the gable end of the cross gable with a central window opening onto the rooftop of the canted bay. Behind the gabled wall dormer is a shed roofed dormer centered on the side gable of the cross gabled rear wing with four more 1/1 wood sashed windows on its east elevation. This rear wing has a porch along the west side which was partially enclosed at the end between 1917 and 1929. The house has replacement vinyl siding and aluminum storm windows which detract from the historic integrity of the house but the siding did not cover the window trim. Distinctive window trim and pilaster mullions are still exposed on the canted bay window as is the distinctive trim around the front door. The major historic feature, the spindlework front porch is still intact. Because it still retains its most distinctive elements, the house is minimally contributing to the historic district despite the replacement siding.

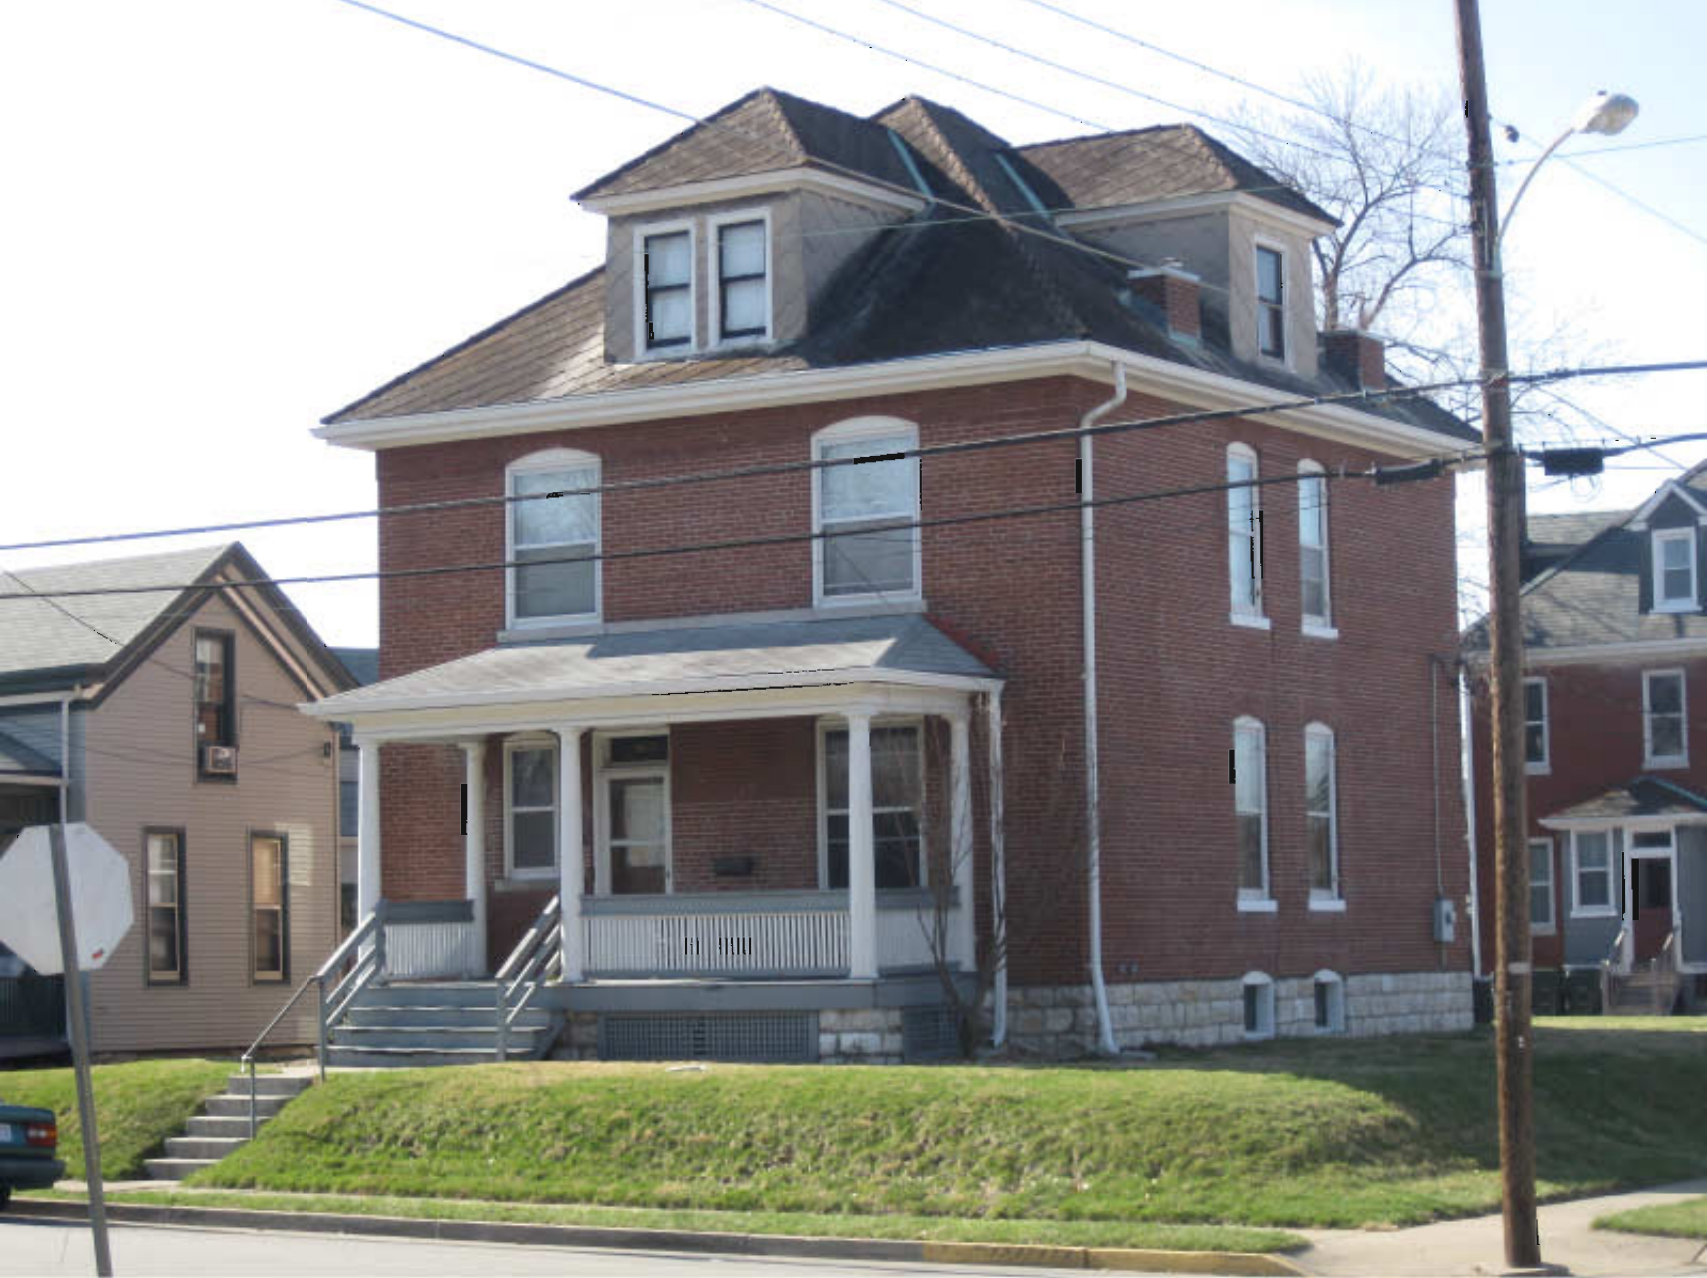
This red brick, 2.5 story, Four Square house has wide enclosed eaves on the hipped roof and hipped dormers on the facade (with paired 1/1 wood sashed windows), on the west elevation (with one 1/1 wood sashed window) and on the south, rear, elevation (with a single window that is boarded over). The roof and dormer walls are clad with diamond patterned asbestos cement shingles. On the west elevation, symmetrically positioned on either side of the dormer are two short red brick, interior wall chimneys. There is another chimney on the east side. The foundation is coursed, rock faced limestone. The windows have segmental arched openings with tall splayed brick lintels and dressed limestone sills. The windows are the original 1/1 wood sashed windows. Basement windows are also segmental arched openings, with the splayed brick lintels extending above the stone foundation. The windows are single light awning windows. Most of the facade is spanned by a hipped roof porch supported by Doric columns at the corners and off-centered by the broad wooden steps at the east end of the porch. The porch retains its original wood balustrade, but a secondary railing has been added across the top to raise the height to meet current code. There are rock-faced limestone piers under the wood porch floor and latticework between the piers. There is a large sashed window in the west bay of the first floor on the facade as well as in both openings on the second floor, but there is a small sashed window next to the transomed entry in the east bay. The entry door is the original, half light wood paneled door. On the west elevation there are two bays of narrow windows, positioned together near the center of the wall. Windows are similarly positioned on the east elevation but these windows are tiered, probably for a staircase inside. On the rear, there are four bays, all with windows on both levels, except for the second bay from the west where there are rear doors on both levels. There is a flat roofed, two story porch spanning all but the western bay. It has a concrete floor with a brick foundation under the middle two bays where the first floor of the porch is enclosed with lap siding. There are broad wooden stairs, a wood porch floor on the remainder of the first floor porch as well as a wooden porch on the second floor with both levels having a wood balustrade railing and simple square support posts. The windows and doors have been covered with aluminum storms. Otherwise the house appears unaltered.

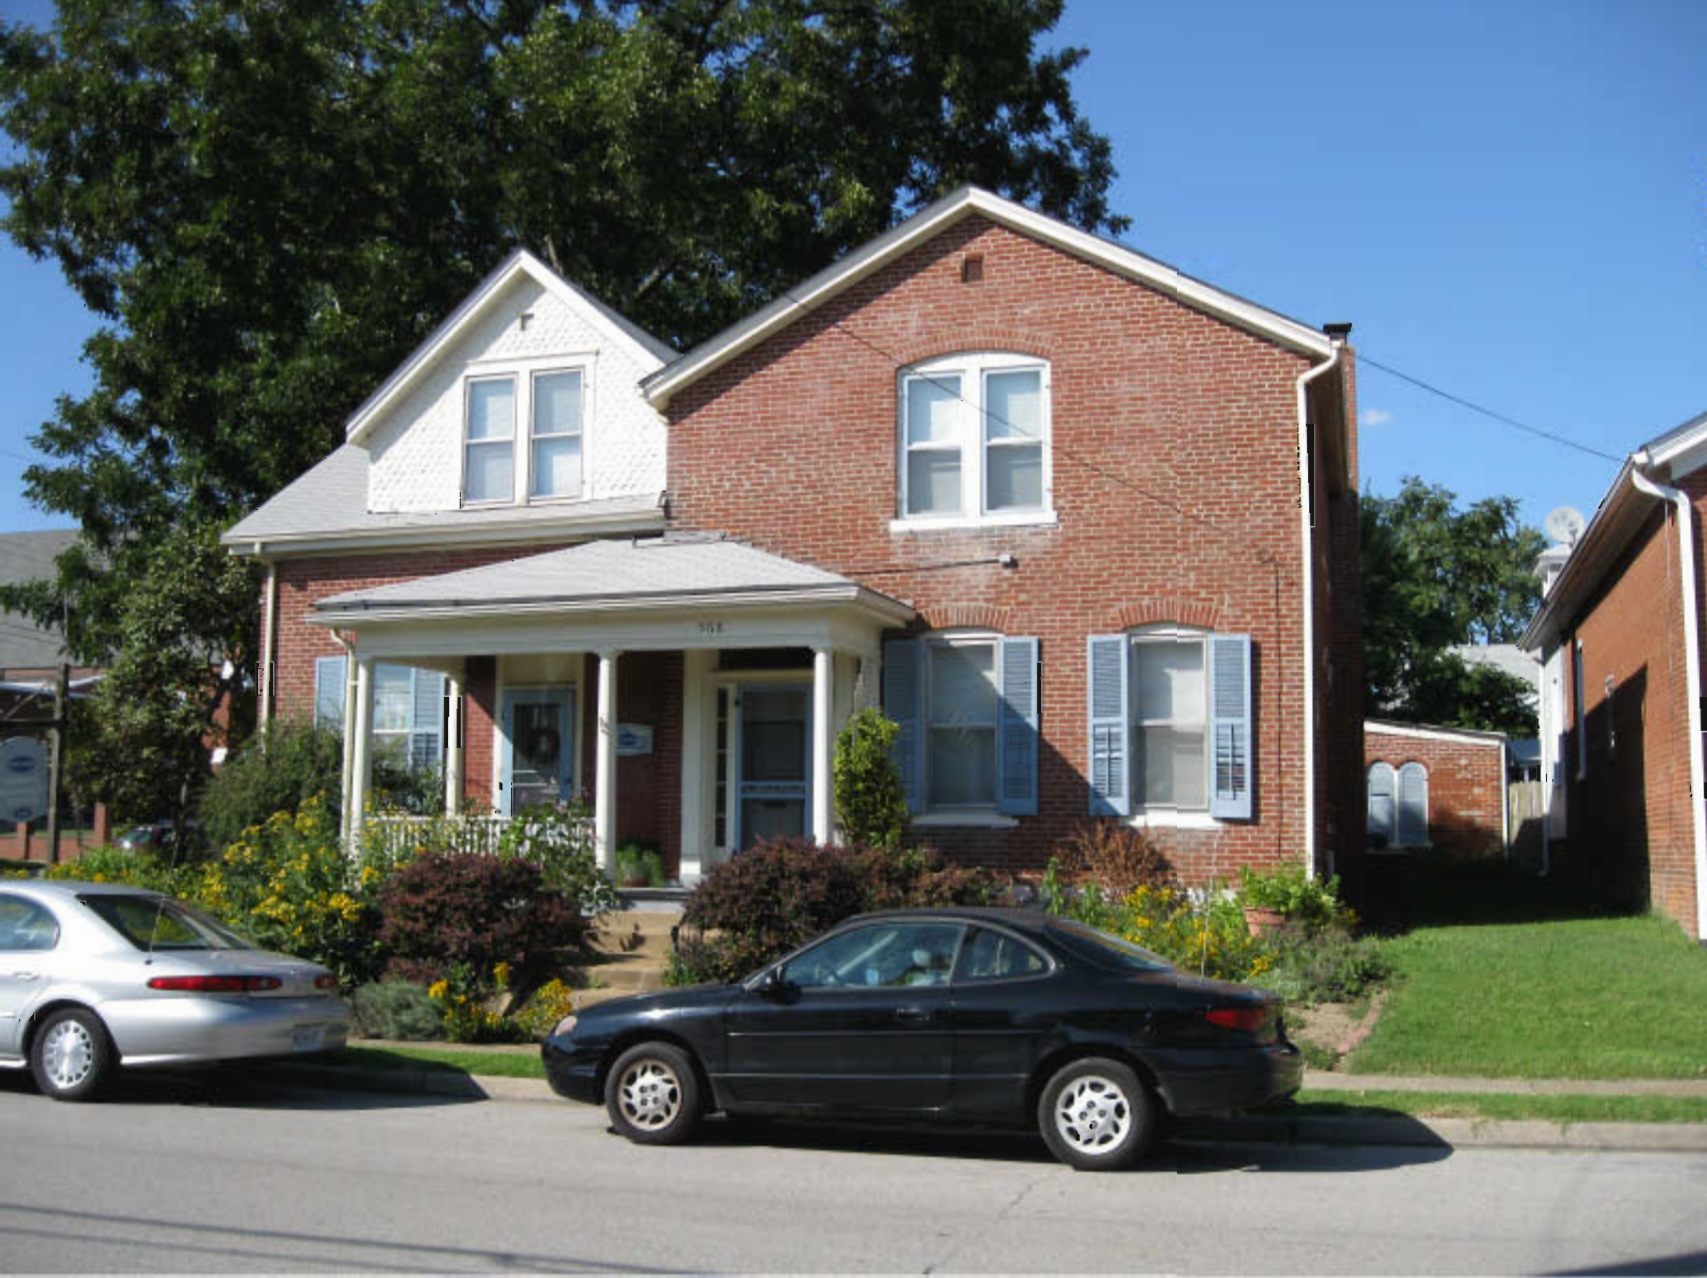
wall at this entry projects slightly, separating it from the wall on the other half of the facade. The west doorway is simpler, with a boarded-in transom over a half light door that has an old wooden screen door. On the west side, there are single 1/1 wood sashed windows on the first floor and paired 2/2 wood sashed windows with a pilaster mullion in the segmental arched opening on the second floor. On the east elevation there are windows on both levels as well as an end wall brick chimney. On the rear, the original rear, one-story, gabled roofed wing is brick but the rear wing added on the west side of the rear elevation between 1900 and 1909 is frame and has a shed roof (now sided with vinyl siding), but it has the 2/2 wood sashed window and peaked trim facing west. Straddled between these two rear wings is a shorter, shed roofed wing that has a series of 6 light casement windows, one facing west. It too is frame and has been resided with vinyl. The additions were all added during the period of significance and besides the replacement siding, the only obvious alteration is the addition of aluminum storm windows.

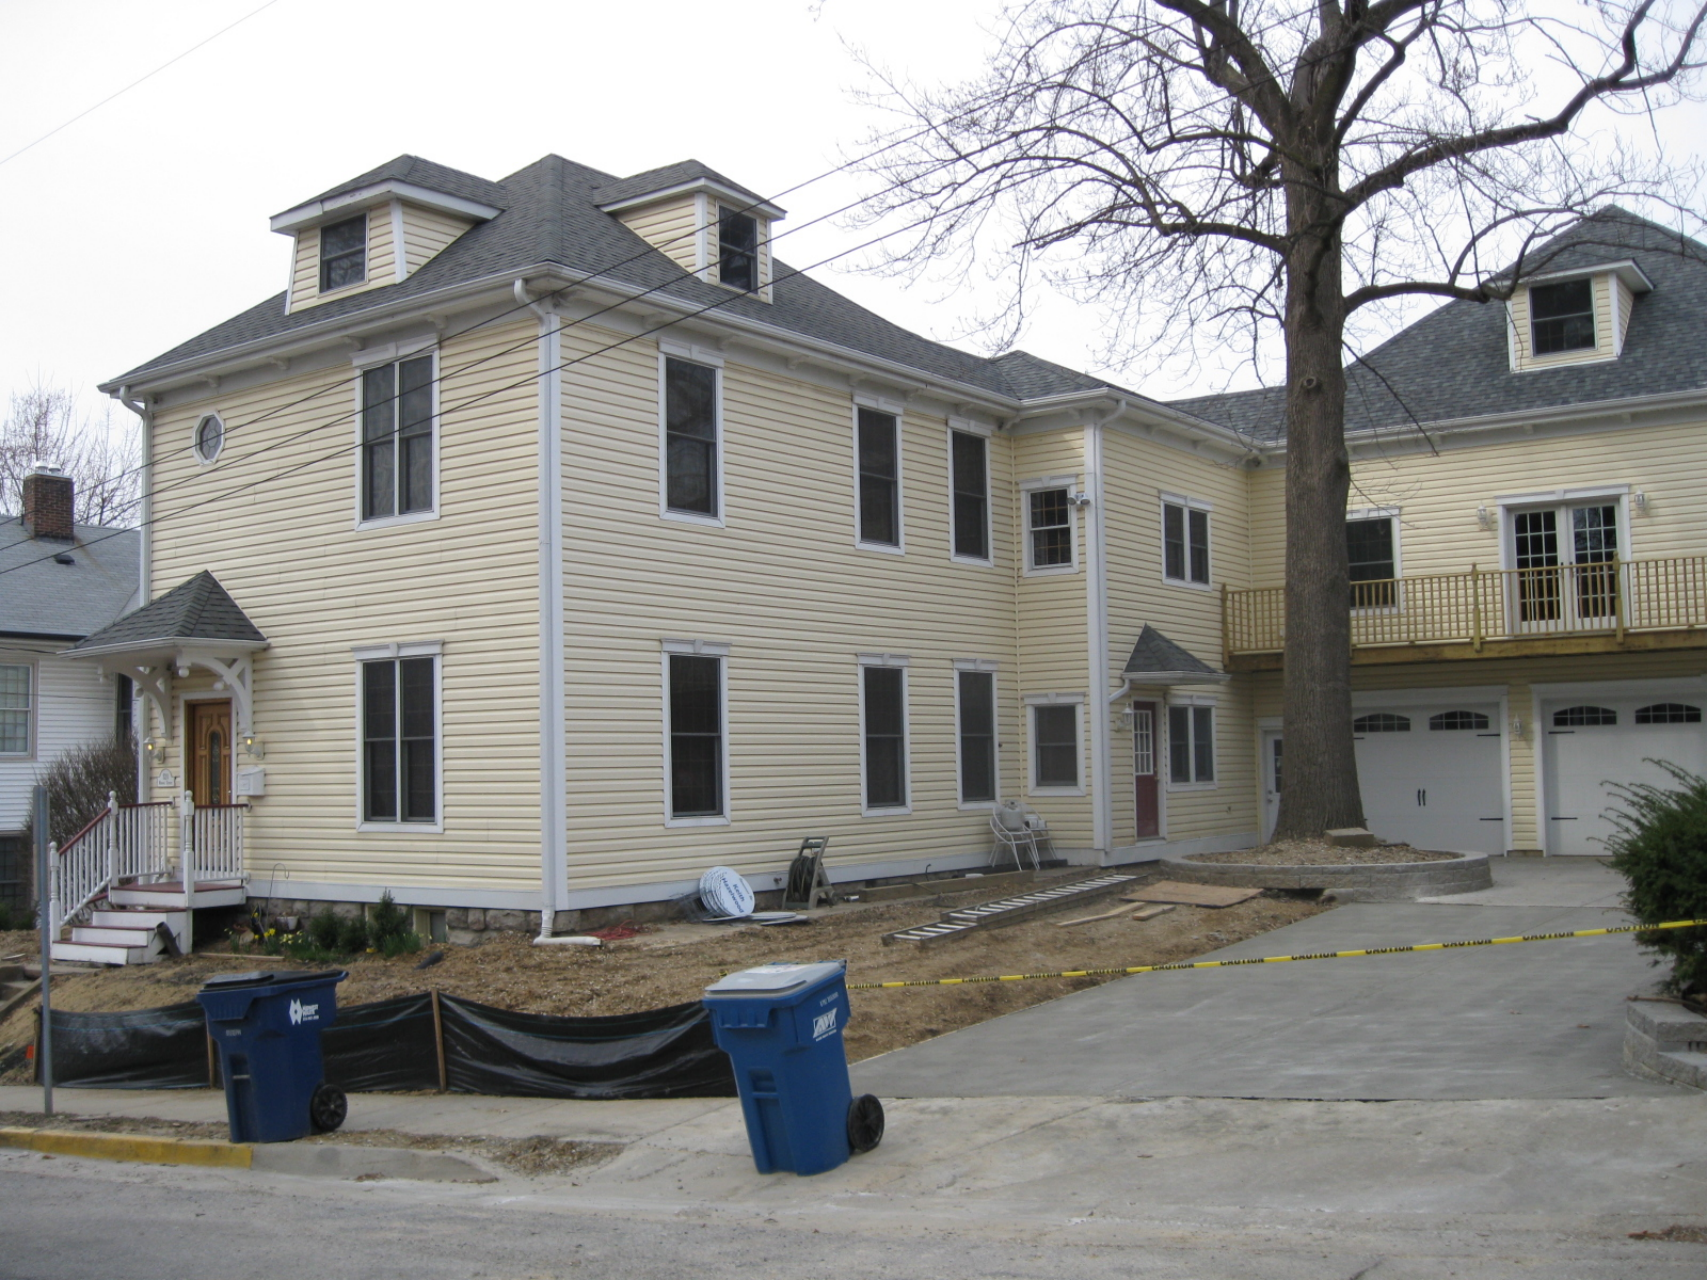
This two story, hipped roof, frame house originally had very narrow lap siding that has been replaced by vinyl siding. There are hipped dormers on the facade and both sides of the house. The façade has paired windows on both levels of the east end. Based upon a 1930 photo, the window on the west end of the second floor, above the entry, was a double-hung window but it is now a small octagonal window. The entry retains the hipped roof and oversized curved braces visible in this 1930 photo but the simple steps to the door have been replaced with a wooden stoop with turned baluster railings. The windows appear to have originally been 1/1 wood sashed windows but these have been replaced with 6/6 vinyl windows. The window pattern on the side elevations matches the historic photo, but the two-story wing on the rear, shown on the 1909-1947 fire insurance maps with a two-story open porch along the east side, was remodeled with the first floor of the porch enclosed in 1983-84 (according to the current owner) and then fully enclosed by an addition that projects slightly along the east side in 2002. In 2009-2010 the two-story, hipped roof, three-car garage wing was added at the northeast corner of the house, creating an L-shaped plan. There are paired French doors centered above the garage doors and a full width balcony spanning over the garage doors. There is a hipped dormer window centered on this wing. While the house is clearly identifiable when compared to the 1930 photo, the compilation of these alterations and additions compromises the historic integrity enough that the building is not contributing to the district.

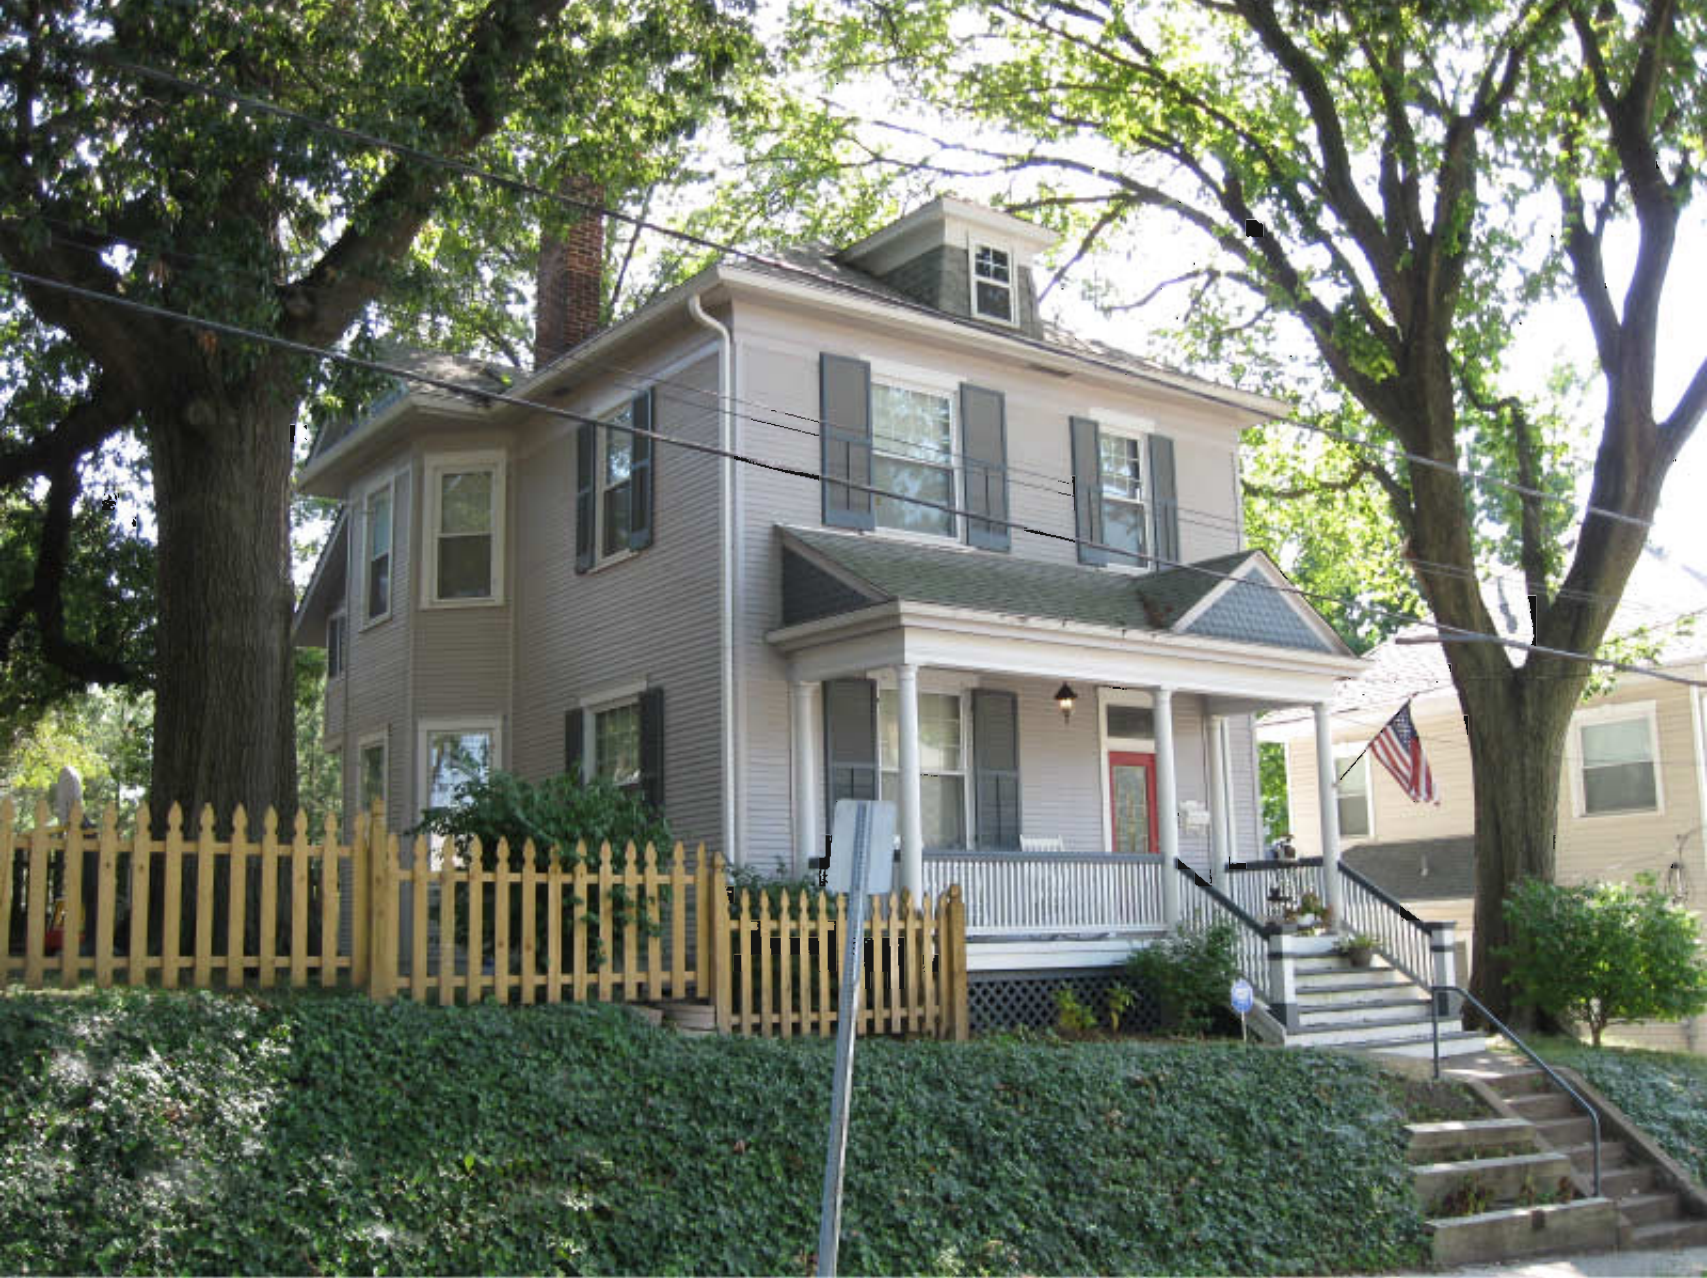
Built around 1904, this Four Square house still retains its original weatherboard siding. It has a shallow-pitched hipped roof with a hipped, battered wall dormer on the facade. The full width, shed roofed porch is supported by Doric columns, with one positioned slightly off-center to frame the broad entry stairs where there is a pediment on the porch roof which has wood fishscale shingle siding. There are also Doric pilasters against the house. There is latticework below the wood porch floor spanning between the brick piers. The balustrade appears original, but it is doubtful that the railing on the stairs is original, although it replicates the same details. The entry door is at the west end of the first floor and is a transomed, rectangular light door, but it appears to be a metal replacement. To the east of the entrance on both floors are wide sashed windows, and above the entrance is a slightly narrower window. The house has functional wooden shutters on most windows, even on the side elevations. On the east side, near the rear is a two story, canted bay with sashed windows on each facet and a hipped roof that connects to the main roof. There is a shed roofed, two story wing on the rear that was originally one story (half open as a porch at the east end) but became a two story porch by 1917 and was enclosed after 1947. The second floor of this rear wing appears to project beyond the first floor. There is a tall interior, brick chimney positioned in front of the bay window on the east side of the house. The windows have been replaced with windows that have multi-paned muntins in the upper sashes, but this gridwork is only on the interior of the glass, although the original windows were more likely 1/1 wood sashed windows. The house has a stone foundation.
