ARCHITECTURAL/HISTORIC INVENTORY FORM

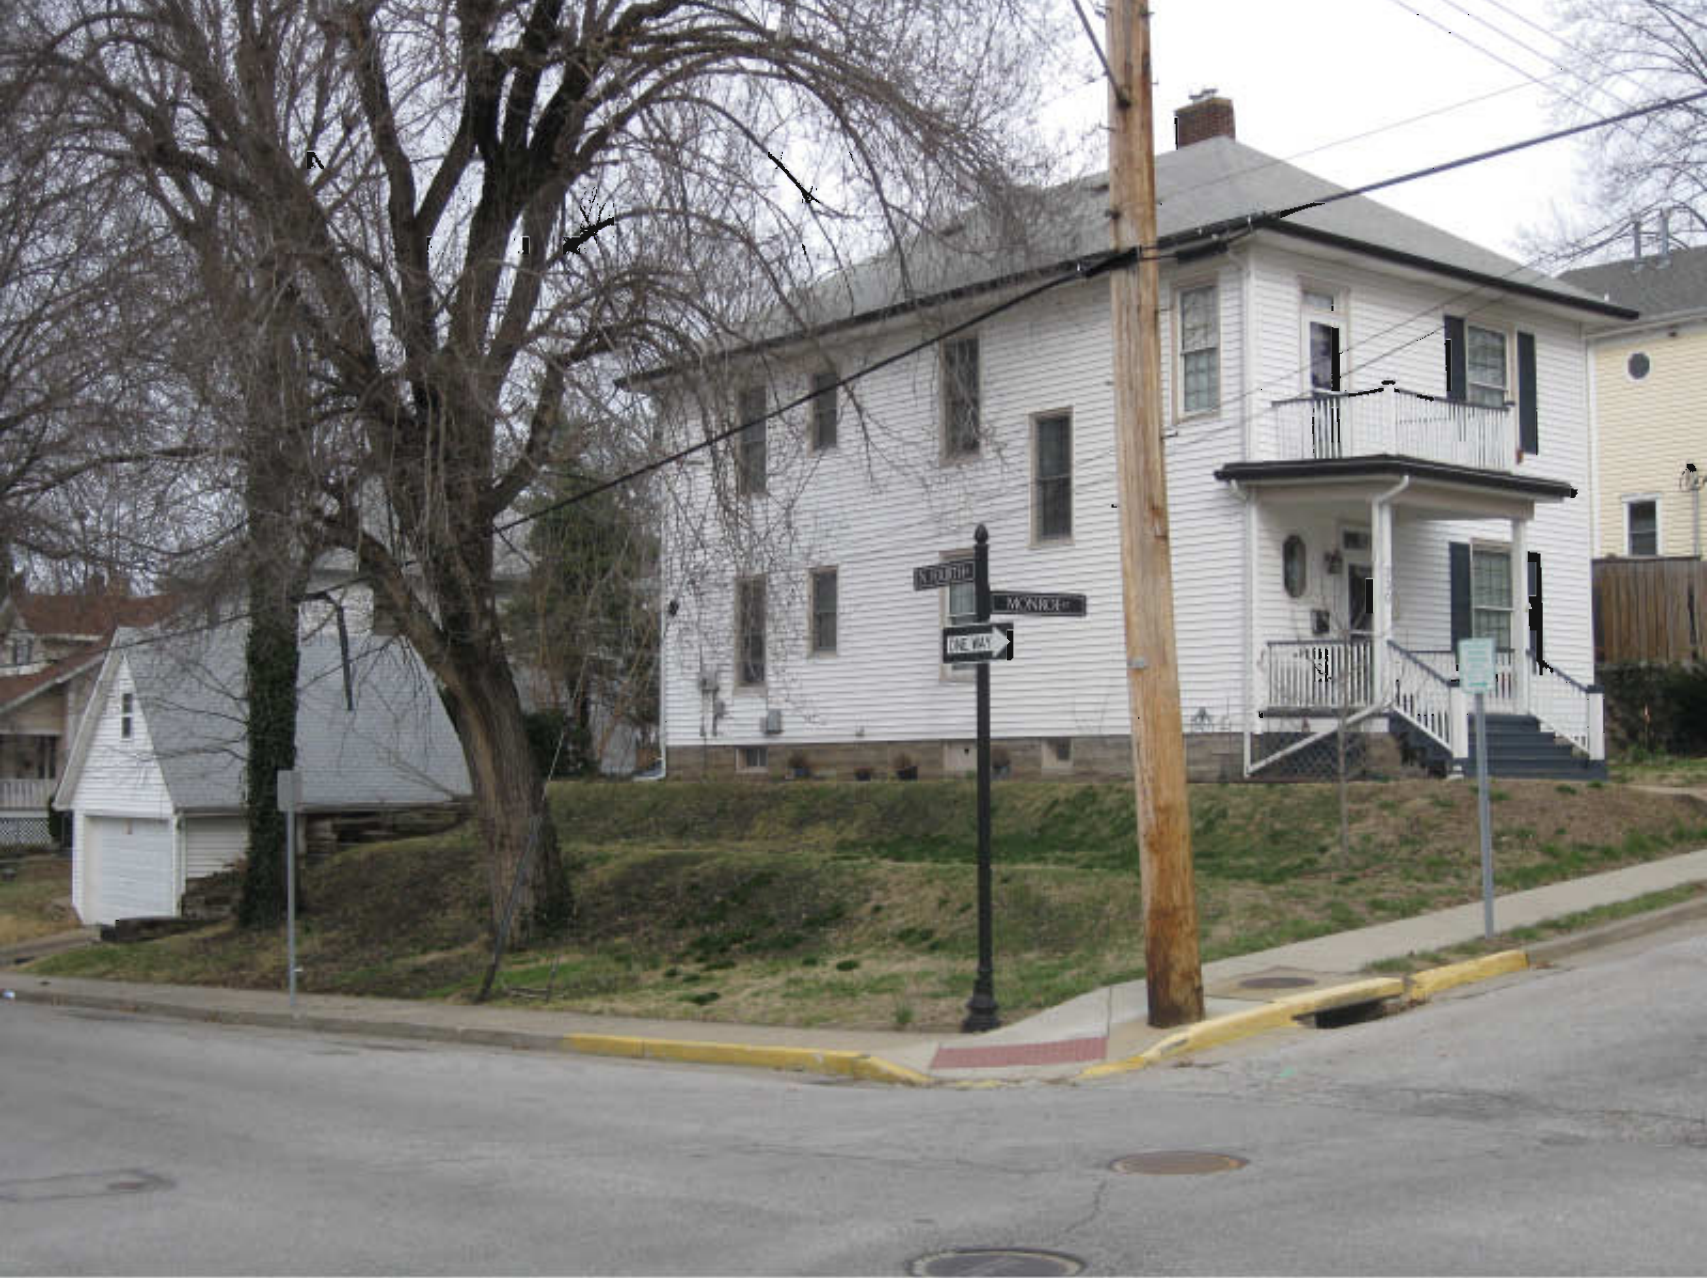
Built between 1910 and 1917, this two story, hipped roof house has a two bay facade with wide, sashed windows in the east bay and doors on both the first and second floor of the west bay since the porch roof is flat, forming a simple balustraded railing on the second floor. Although the 1917 fire insurance map shows a two story porch on the west half of the facade, the 1929 map and the 1947 update map show a full width porch. However, this appears to be a mistake on the later maps because the porch appears to be original, with the original wooden balustrade and simple square corner posts on both levels with a wood porch floor and steps. The first floor entry has a single light transom and wood door that is 2/3 glazed. To the west side of the door is an elongated octagonal art glass window. On the second floor the transomed door is centered on the porch and also appears to be a 2/3 glazed door. On the east side, the rear half projects slightly as a hipped wing, with a slender sashed window on each level facing the street and two additional sashed windows on each level facing east. In front of this shallow side wing there is a single bay with a sashed window on each level. The house has been sided in vinyl siding and has replacement multipaned windows, but the distinctive porch features remain along with the basic house form and as such it is a contributing building in the historic district. There is an interior brick chimney near the junction of the hipped roof from the east wing and main roof.

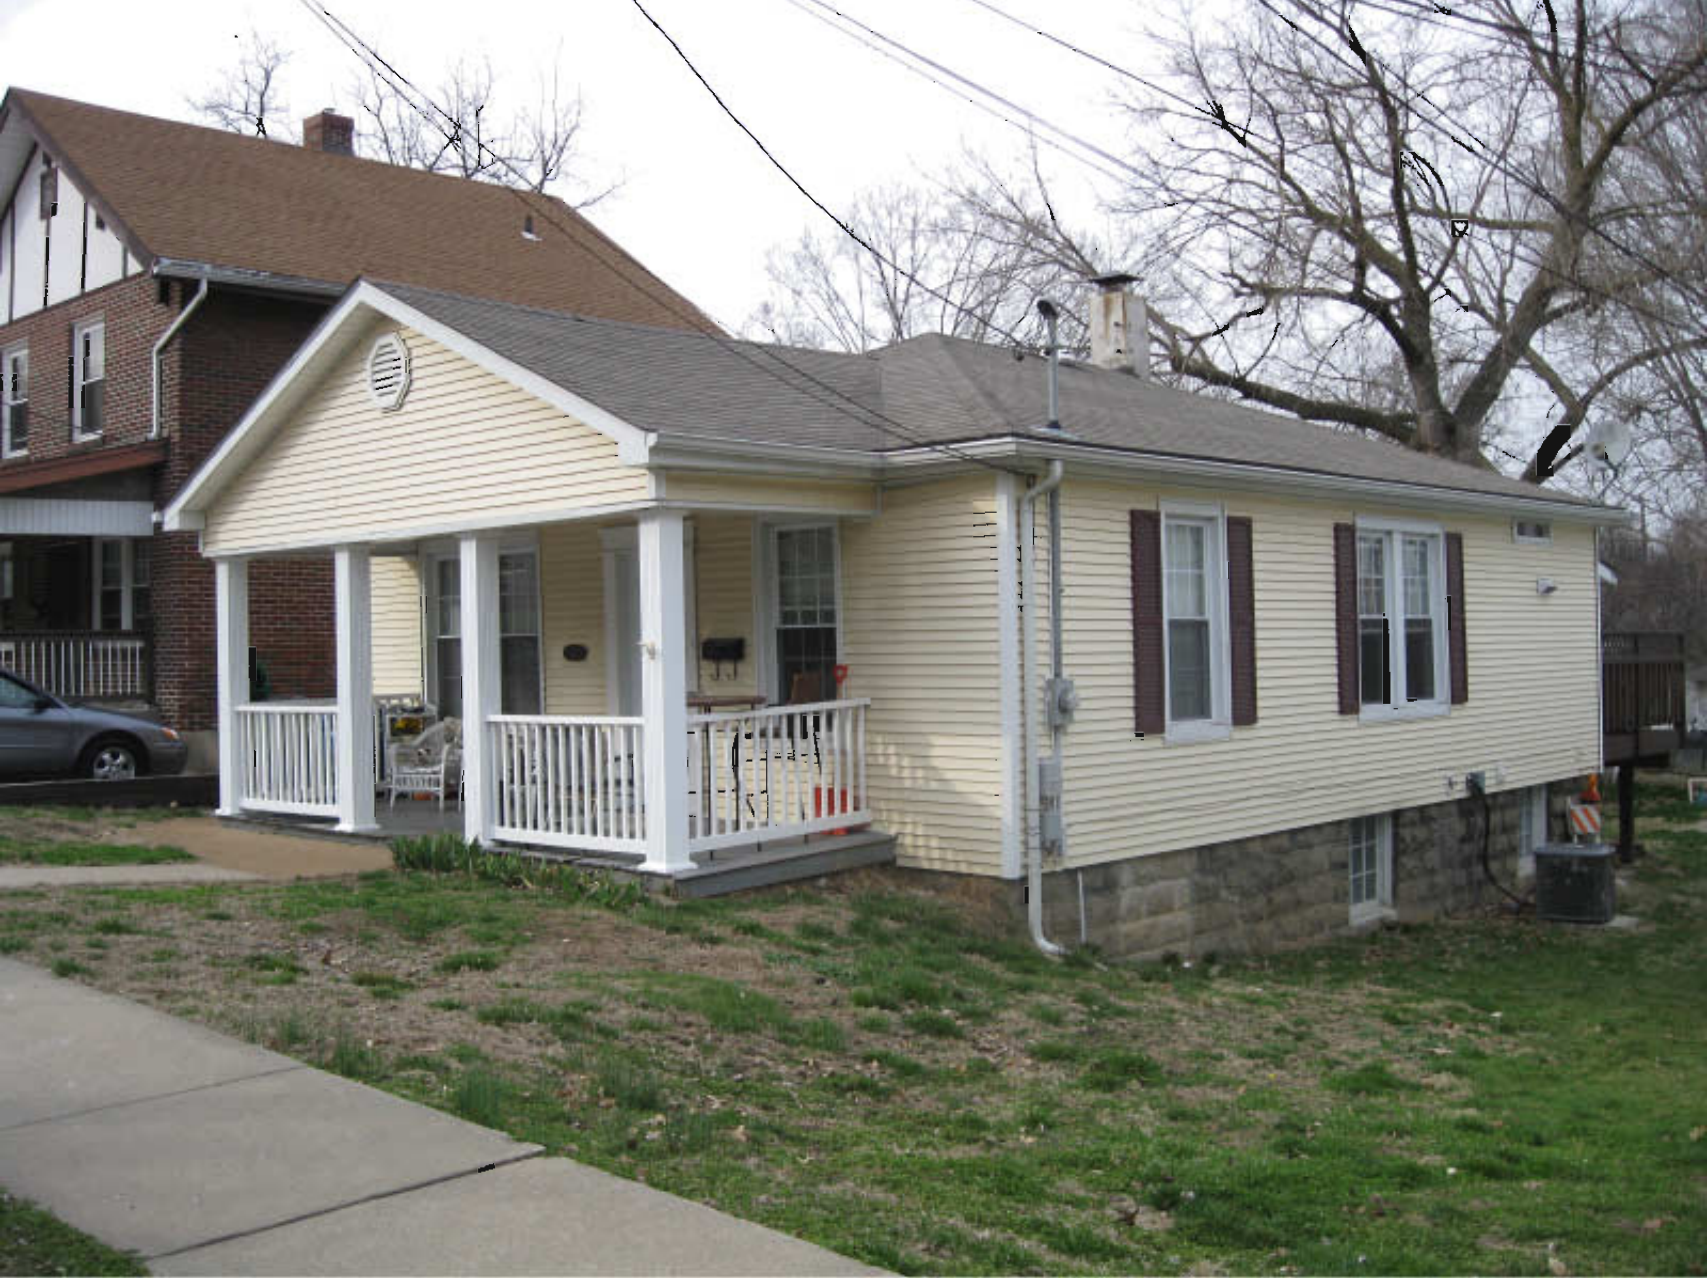
This one story, frame, hipped roof house has a full basement with a faux stone concrete block foundation that becomes progressively more visible on the side since the yard slopes drastically downhill toward the rear and east side of the lot. Across the facade is a nearly full width, gabled roof porch supported by four square columns. There are paired sashed windows to the west of the door and a single sashed window to the east, but like the other windows on this house, they are recent vinyl replacements with a 6/6 window pattern, probably not matching the original window pattern. The front door is a replacement with an oval light. The walls have been reclad with vinyl siding, probably closely matching the original wall finishes. The porch posts appear to be replacement fluted vinyl square posts and vinyl railings, although the porch floor is still wood, resting nearly at grade. The interior brick chimney has been stuccoed. Because of the alterations, the house is noncontributing to the historic character of the district.

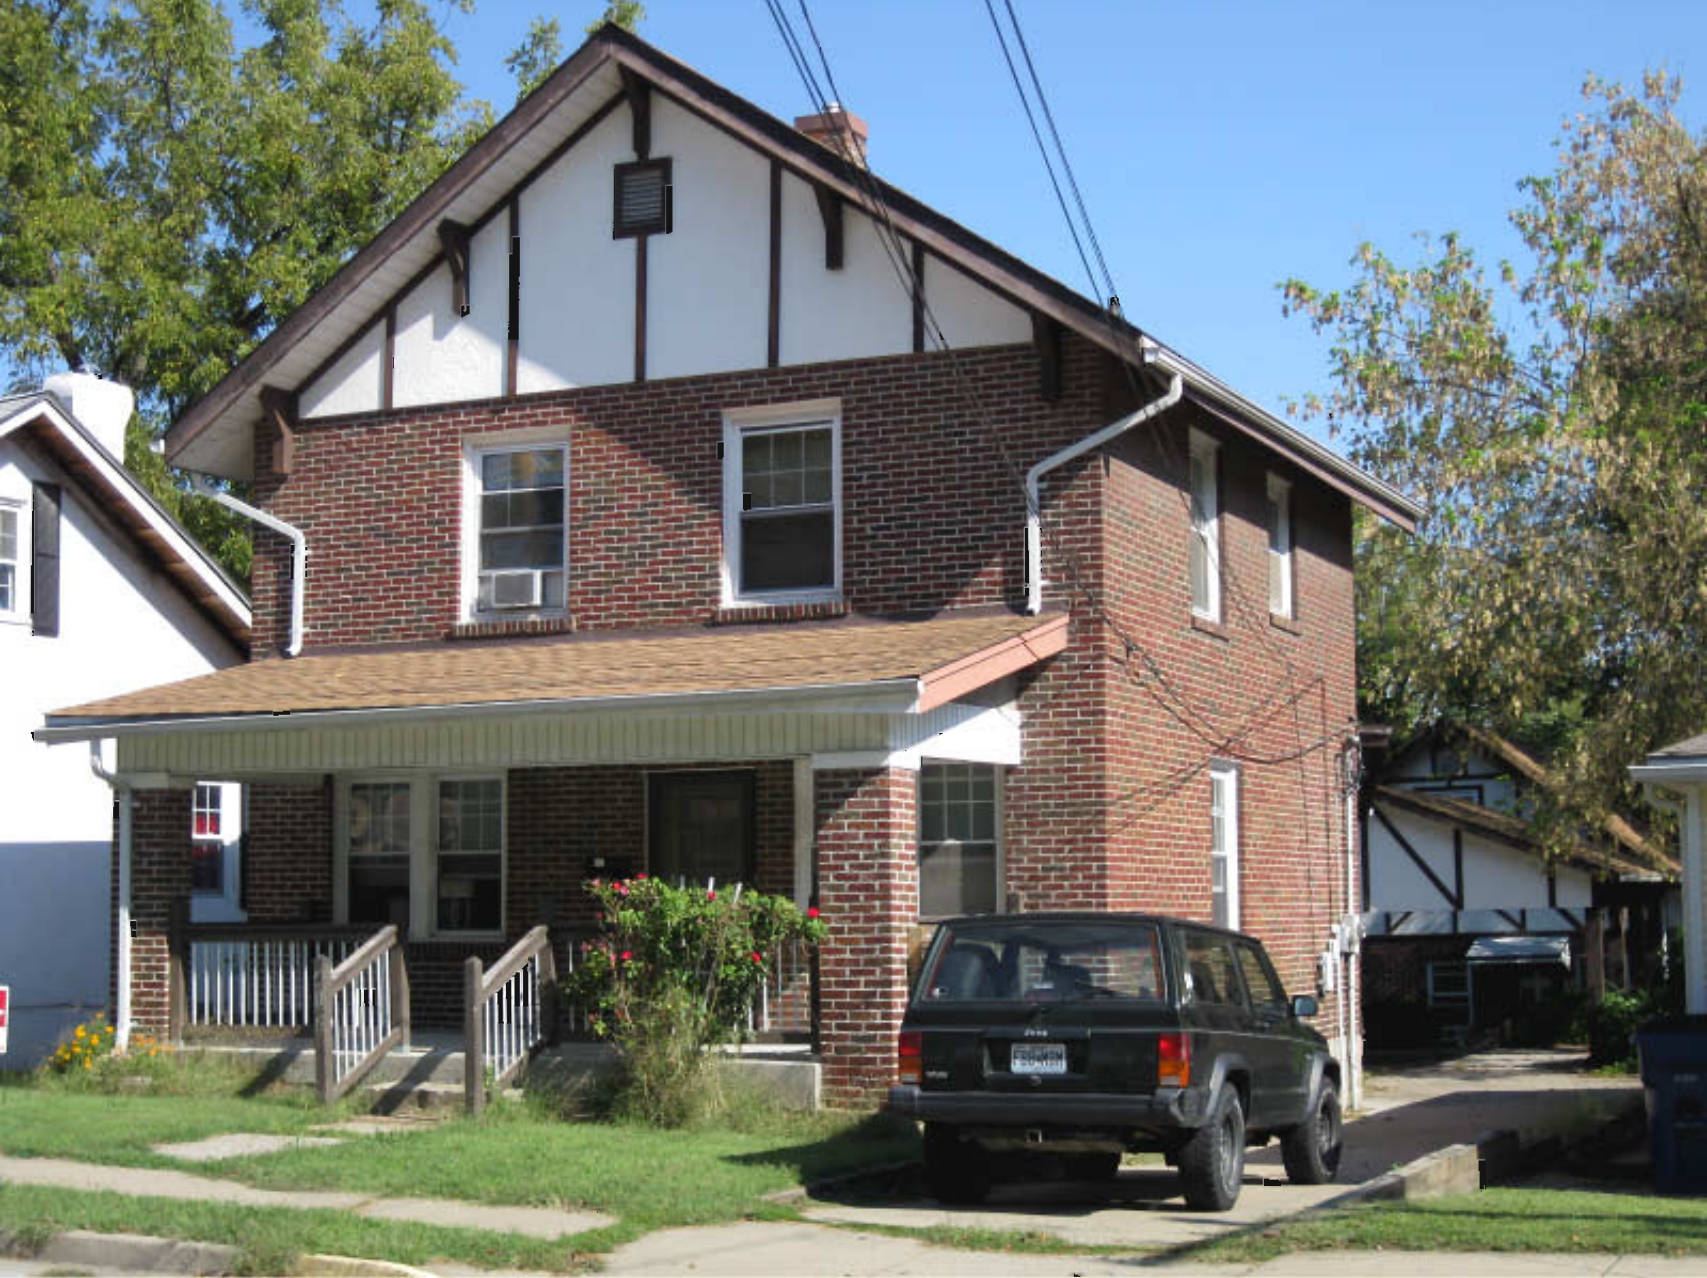
This two story, end gabled, multicolored brick house has a full-width, shed roofed porch with brick corner piers that extend to the concrete bases at the ground level. The porch floor is poured concrete and the porch appears to retain its original simple balustrade railings although it is likely that the railings down the steps are a recent alteration. The porch retains the original stucco in the sidewalls of the roof but the fascia above the brick piers has been clad with vertical replacement siding. The gable ends (front and rear) above the second floor windows are clad with false, half-timbered stucco and the wide eaves are supported by a series of small knee braces, but the underside of the eaves has been clad with aluminum or vinyl siding. The facade is symmetrical, with two sashed windows on the second floor and paired windows on the first floor flanking the central doorway. Like the other windows on the house, these are 6/1 replacement windows. The front door is a half-light (9 pane) door with a storm door. On the rear, the house retains the original full-width shed roof porch. There is a large, interior brick chimney near the rear on the ridgeline. Despite the alterations, the house still retains its distinctive Craftsman features (half-timbered stucco, knee braces, variegated brick, wide eaves) and as such is contributing to the historic district.

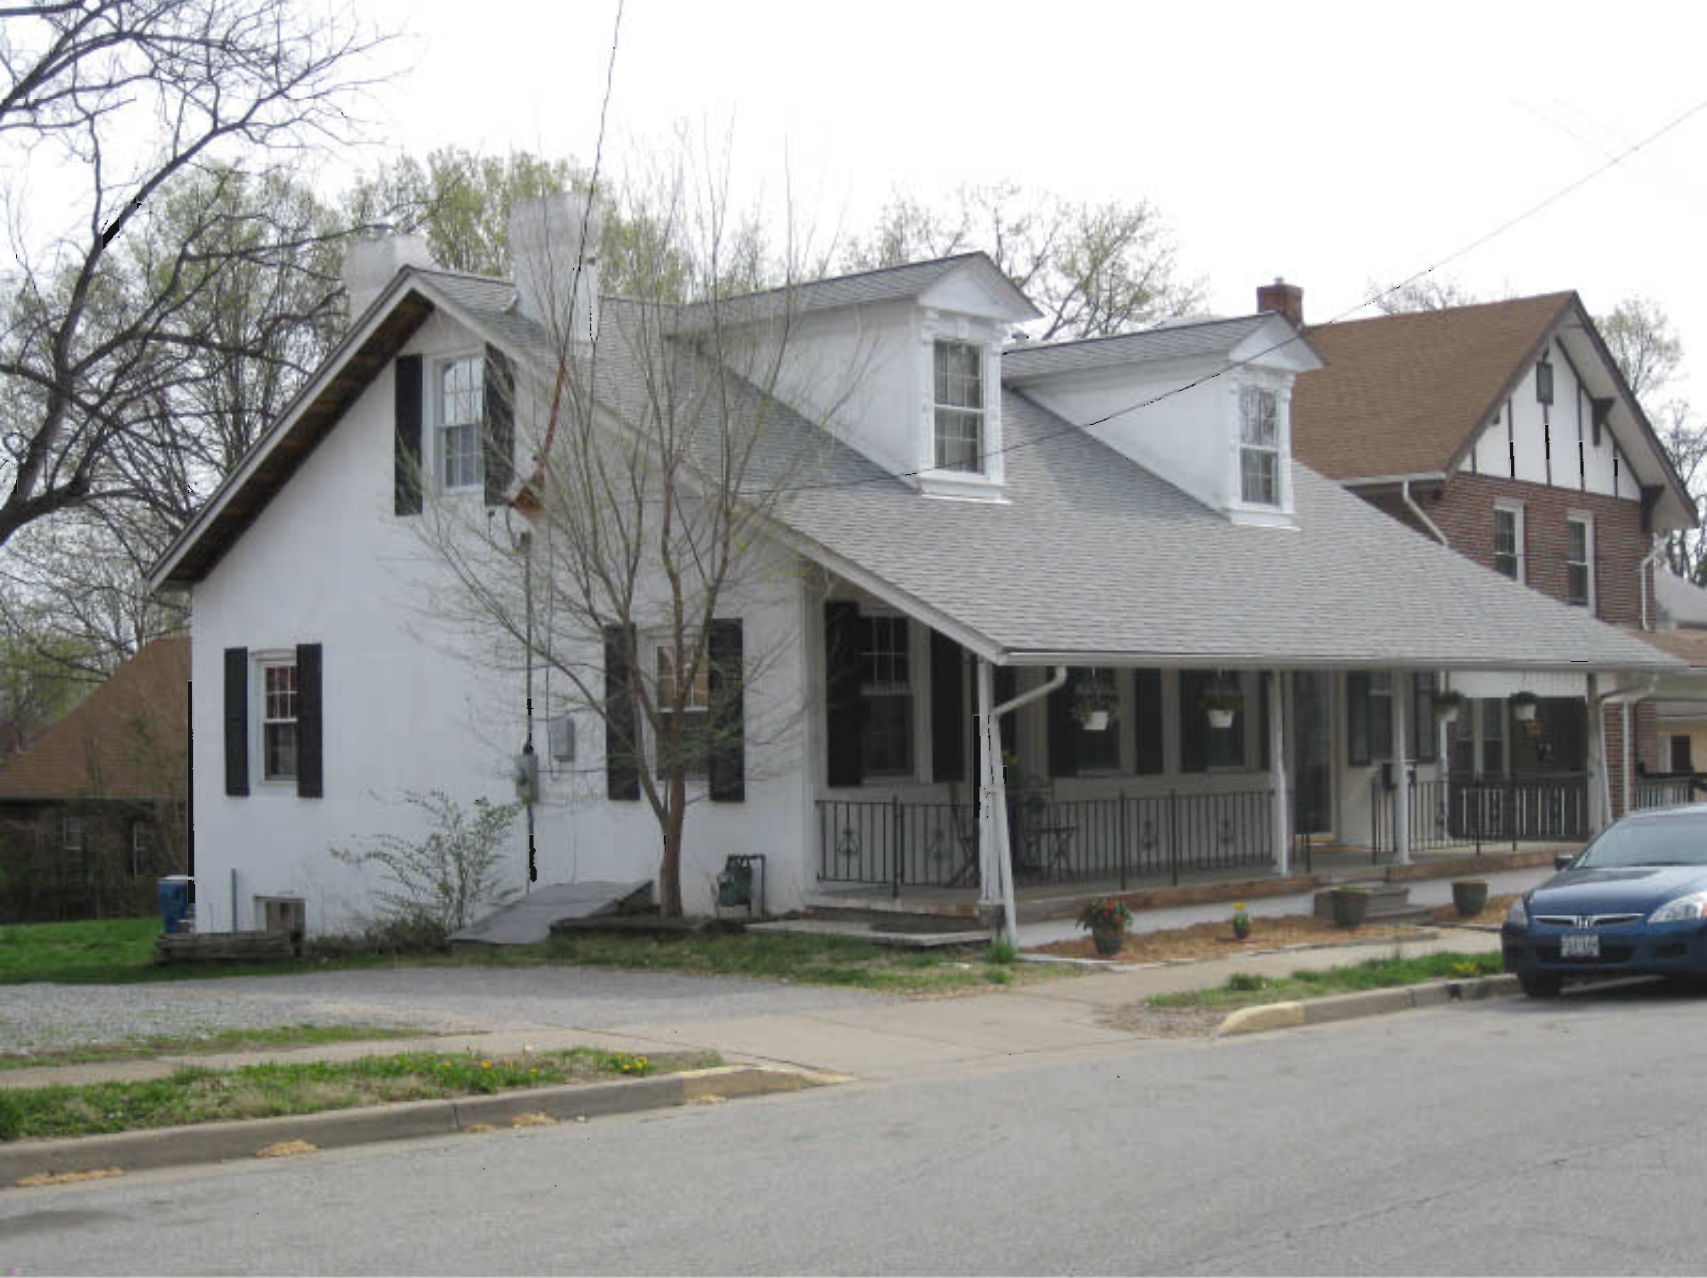
Built ca. 1890, the side gabled, 1.5 story, stucco house has wide eaves and a full width porch. The shed roof of the porch is a continuation of the main roof and there are two gabled dormers with incised lintels and elaborate pilaster strips and brackets flanking the wood sashed 6/6 windows. The first floor of the facade is divided into six bays, with 6/6 sashed replacement windows flanking each of the two 4-panel wood entry doors. The transoms over the doors have been boarded in. The porch posts appear to have been at least partially replaced since the lower half of the square posts are slightly larger than the upper portions. The metal railings are replacements as is the concrete porch floor. The windows on the side elevations in the gable ends are wooden, 6/6 sashed windows but the windows on the first floor are replacement 6/6 windows and the shutters appear to be recent additions and not necessarily replacements of historic shutters. There are four chimneys, paired on either side of the ridge on both ends of the house. On each side of the house is a sloped trap door to access the basement and 3-light basement windows. Despite the alterations to the porch supports, the house retains enough of its historic features to be a contributing building in the historic district.

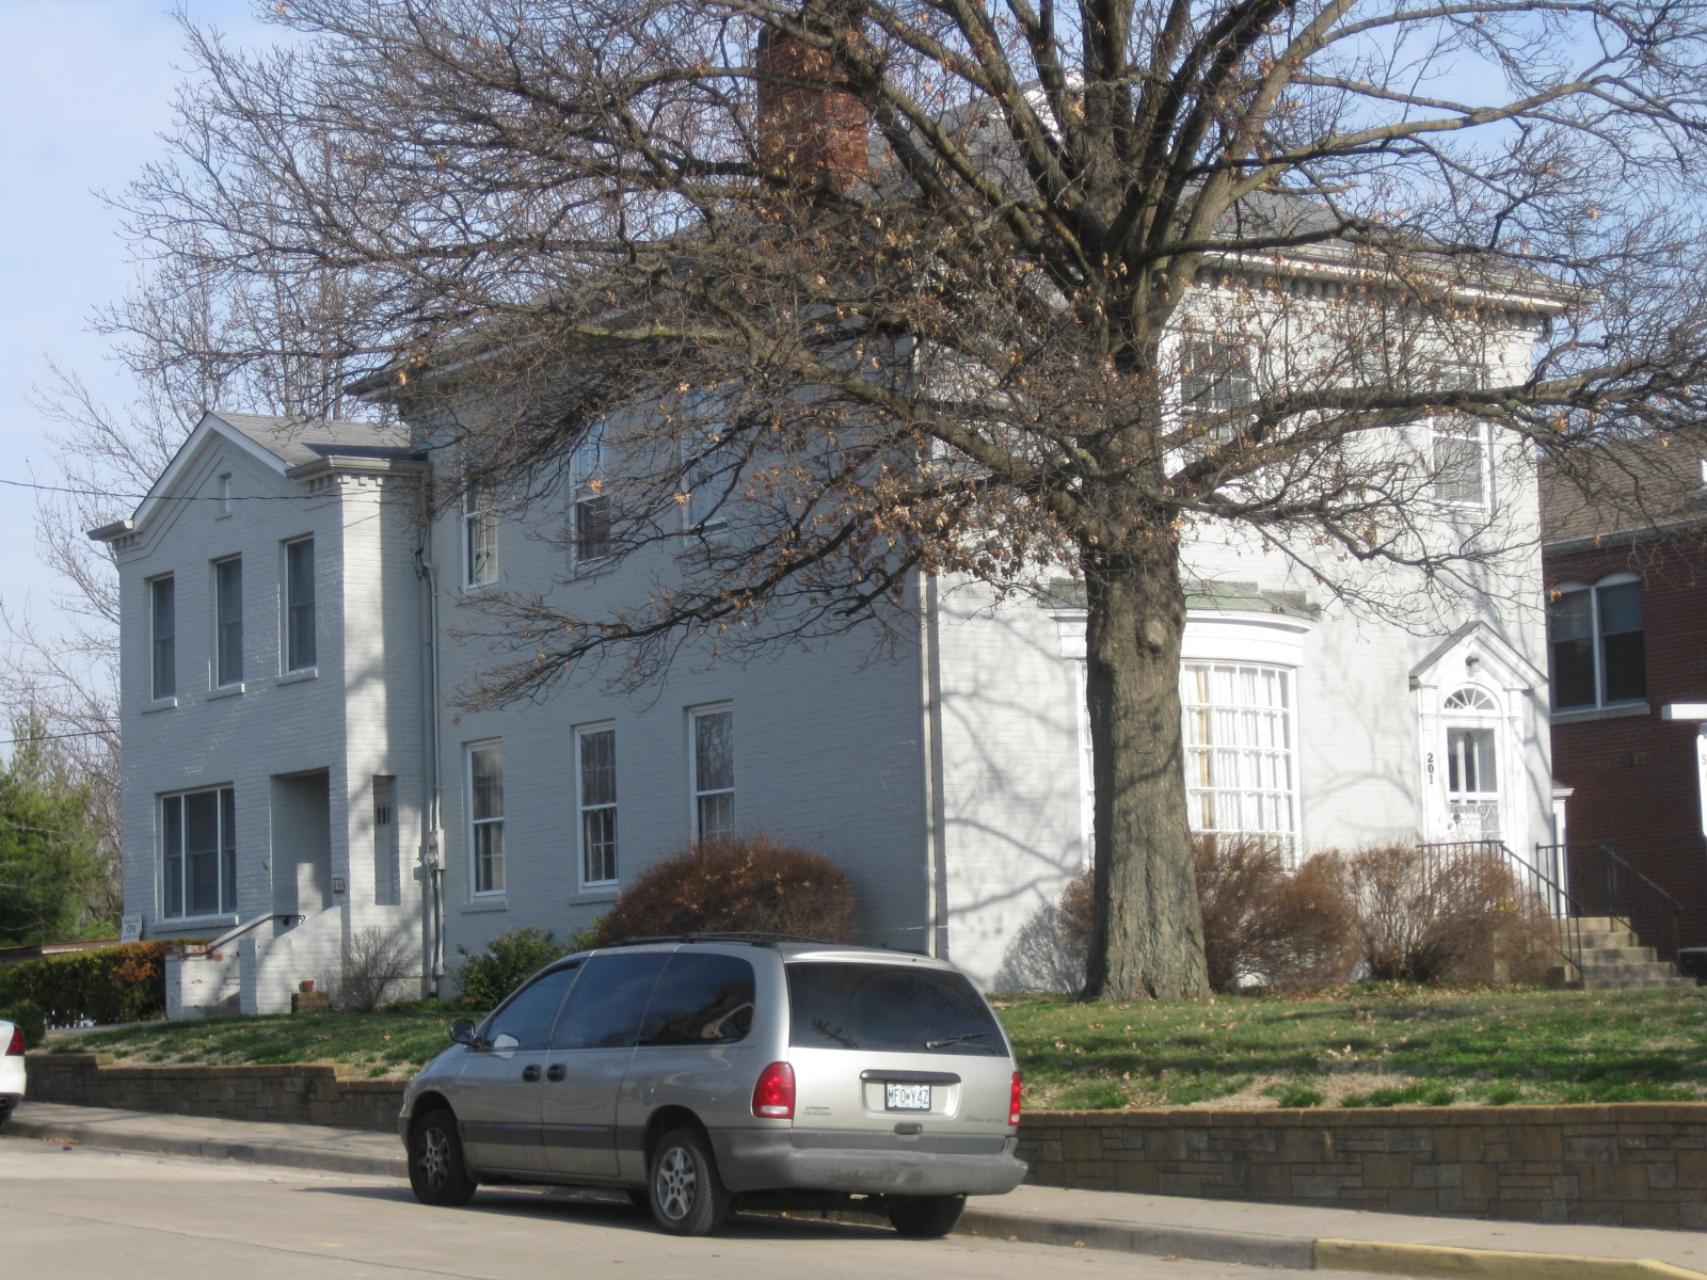
Despite the addition to the house that faces south with a secondary entry, the main facade of the house and its street elevation still retain the appearance of the house from its 1917-1929 era and as such it is contributing to the historic district.

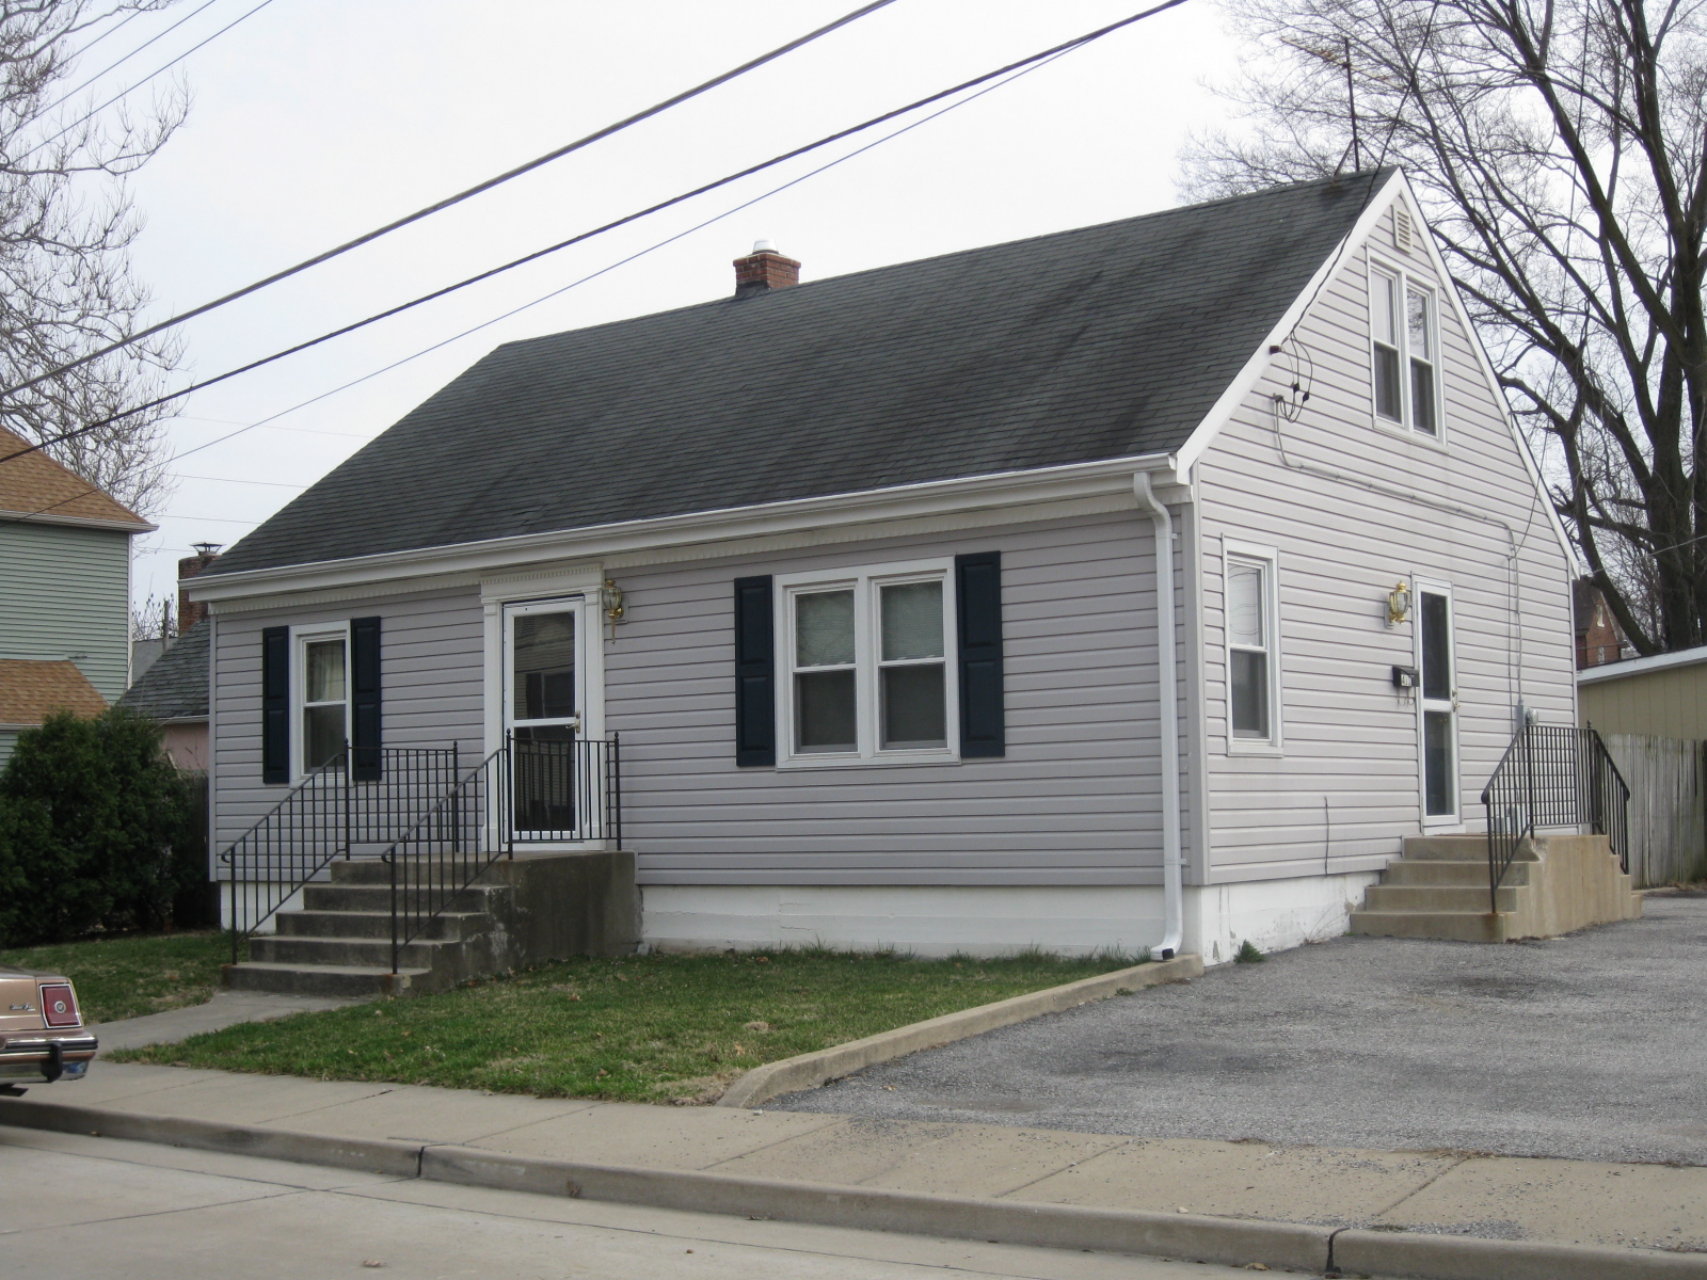
This simple, 1.5 story, side gabled, frame, Cape Cod house has simple pilasters supporting the entablature surrounding the front entry door which is located just east of center on the facade. The door is obscured from view by the storm door. To the west of the door are paired, sashed 1/1 windows and to the east is a single, 1/1 sashed window. Both windows have faux shutters, which may be original to the design, but the vinyl siding is a replacement material. On the west side elevation there are paired 1/1 sashed windows in the gable end. On the first floor of that elevation there is a single, 1/1 sashed window near the facade and to the south there is a side entry door. Like the entry on the facade there is a concrete stoop with metal railings, both of which appear to be original to the construction of the house although the railings may be replacements. There is a brick, interior chimney off-center behind the ridge. The east elevation has paired windows in the gable end and two sashed windows on the first floor. The house has a concrete foundation. The windows appear to be replacements. Since the house has been clad in vinyl siding and the windows replaced, it is counted as noncontributing.

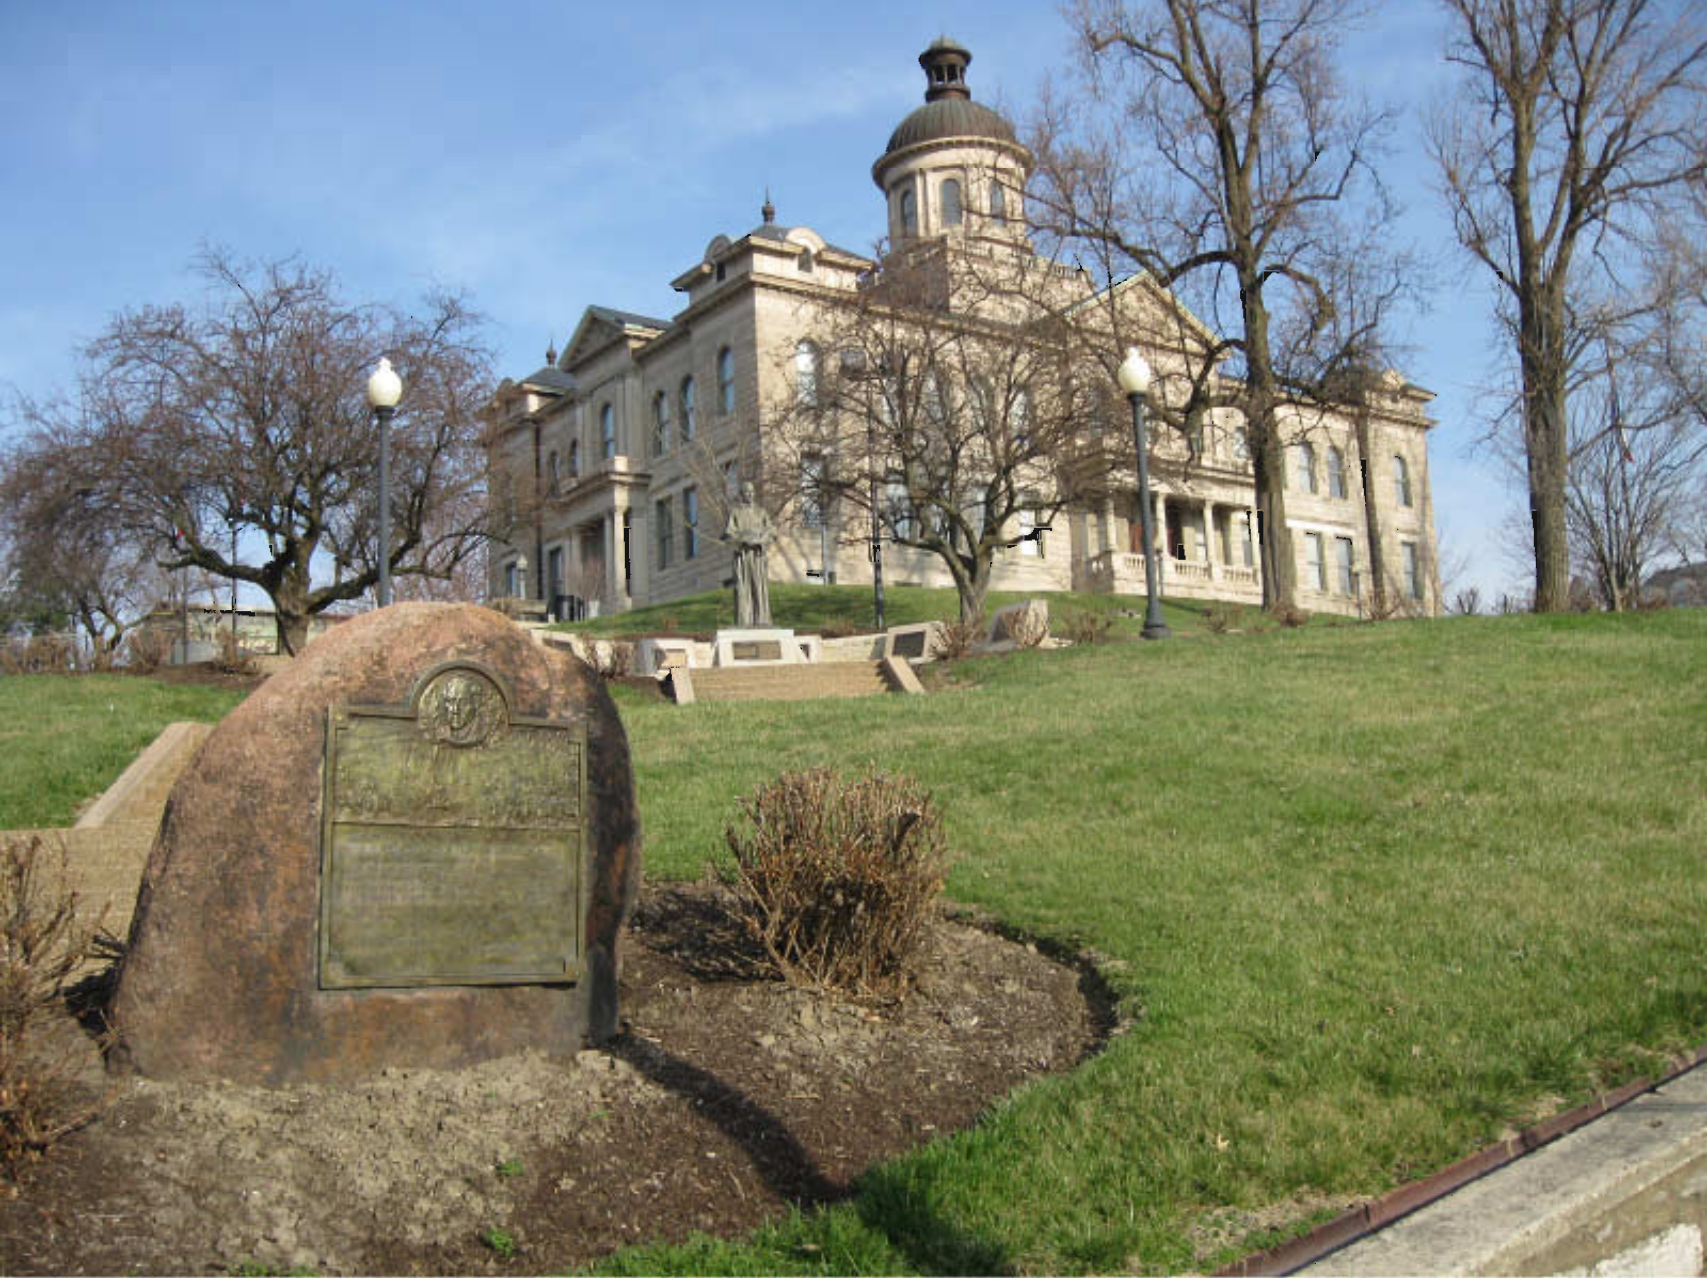
The 1909 Sanborn shows the boiler in the basement, the dome as 80 feet tall, and notes that the building had steam heat, electric and gas lights and was a fireproof construction except for the 2nd floor ceiling and roof. It also identifies the east portico as being 40 feet high. Between 1917 and 1929, the Sanborn shows that the lights had not been converted all to electricity and made additional structural notations: concrete floors, steel beams in the basement, first and second floors with a wood truss roof.

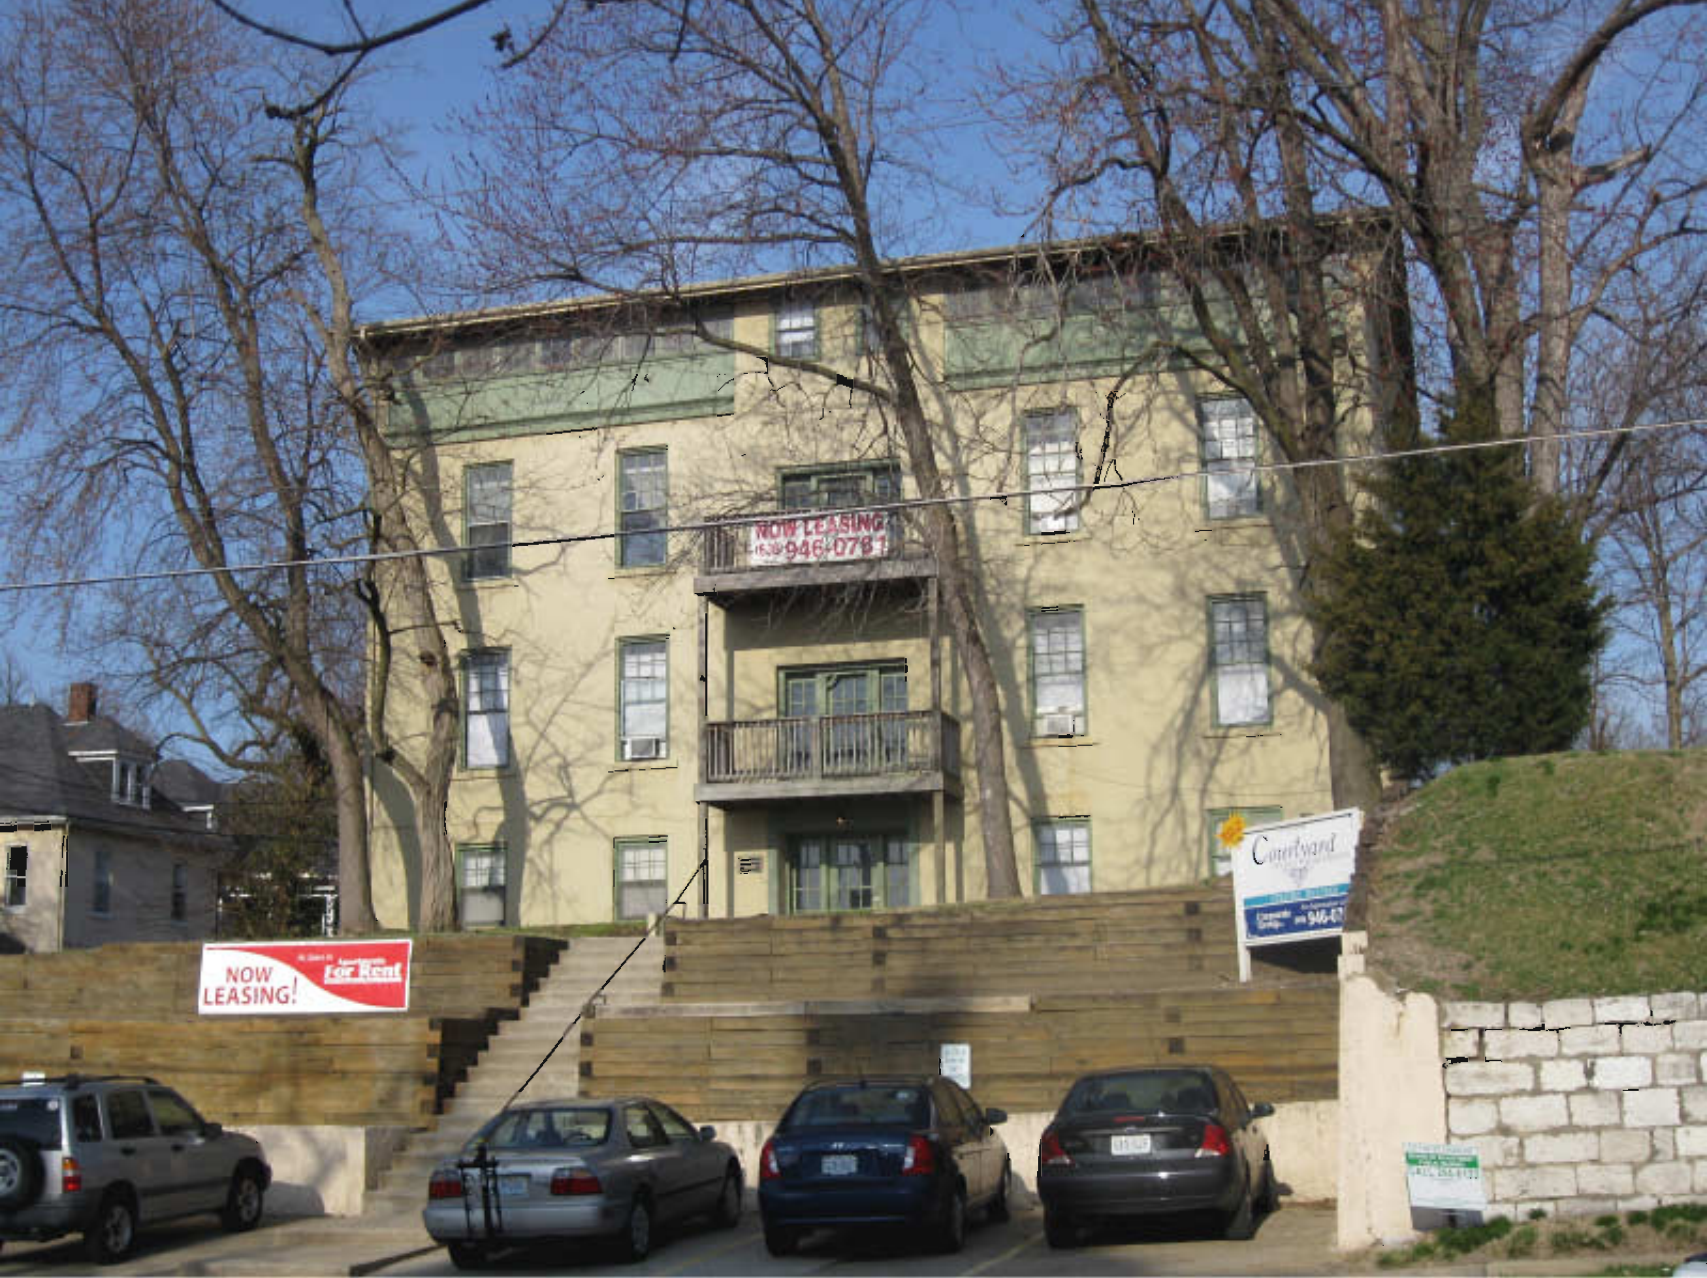
The original building was a 3.5 story college building, converted in 1891 to residential use, and by 1906 it was used as a private residence, apparently with renovations completed to the interior only at that time. Between 1917 and 1929, most likely around 1921, renovations to the exterior to convert the building into apartments included creating wider eaves which reduced the roof pitch although the ridge remained the same, creating the recessed fourth floor porches on all four corners. Those renovations probably added the stucco to the walls (although it could have been added later), but the facade today is mostly just painted brick, and the other elevations only have remnants of the stucco, except for the stone foundation which is stucco. The fire insurance maps identify the front porch on the 1929 map, after the renovations, but show it as a one-story porch, apparently either an error or the second and third floor doors were added at a later date and the porch extended to three stories tall.

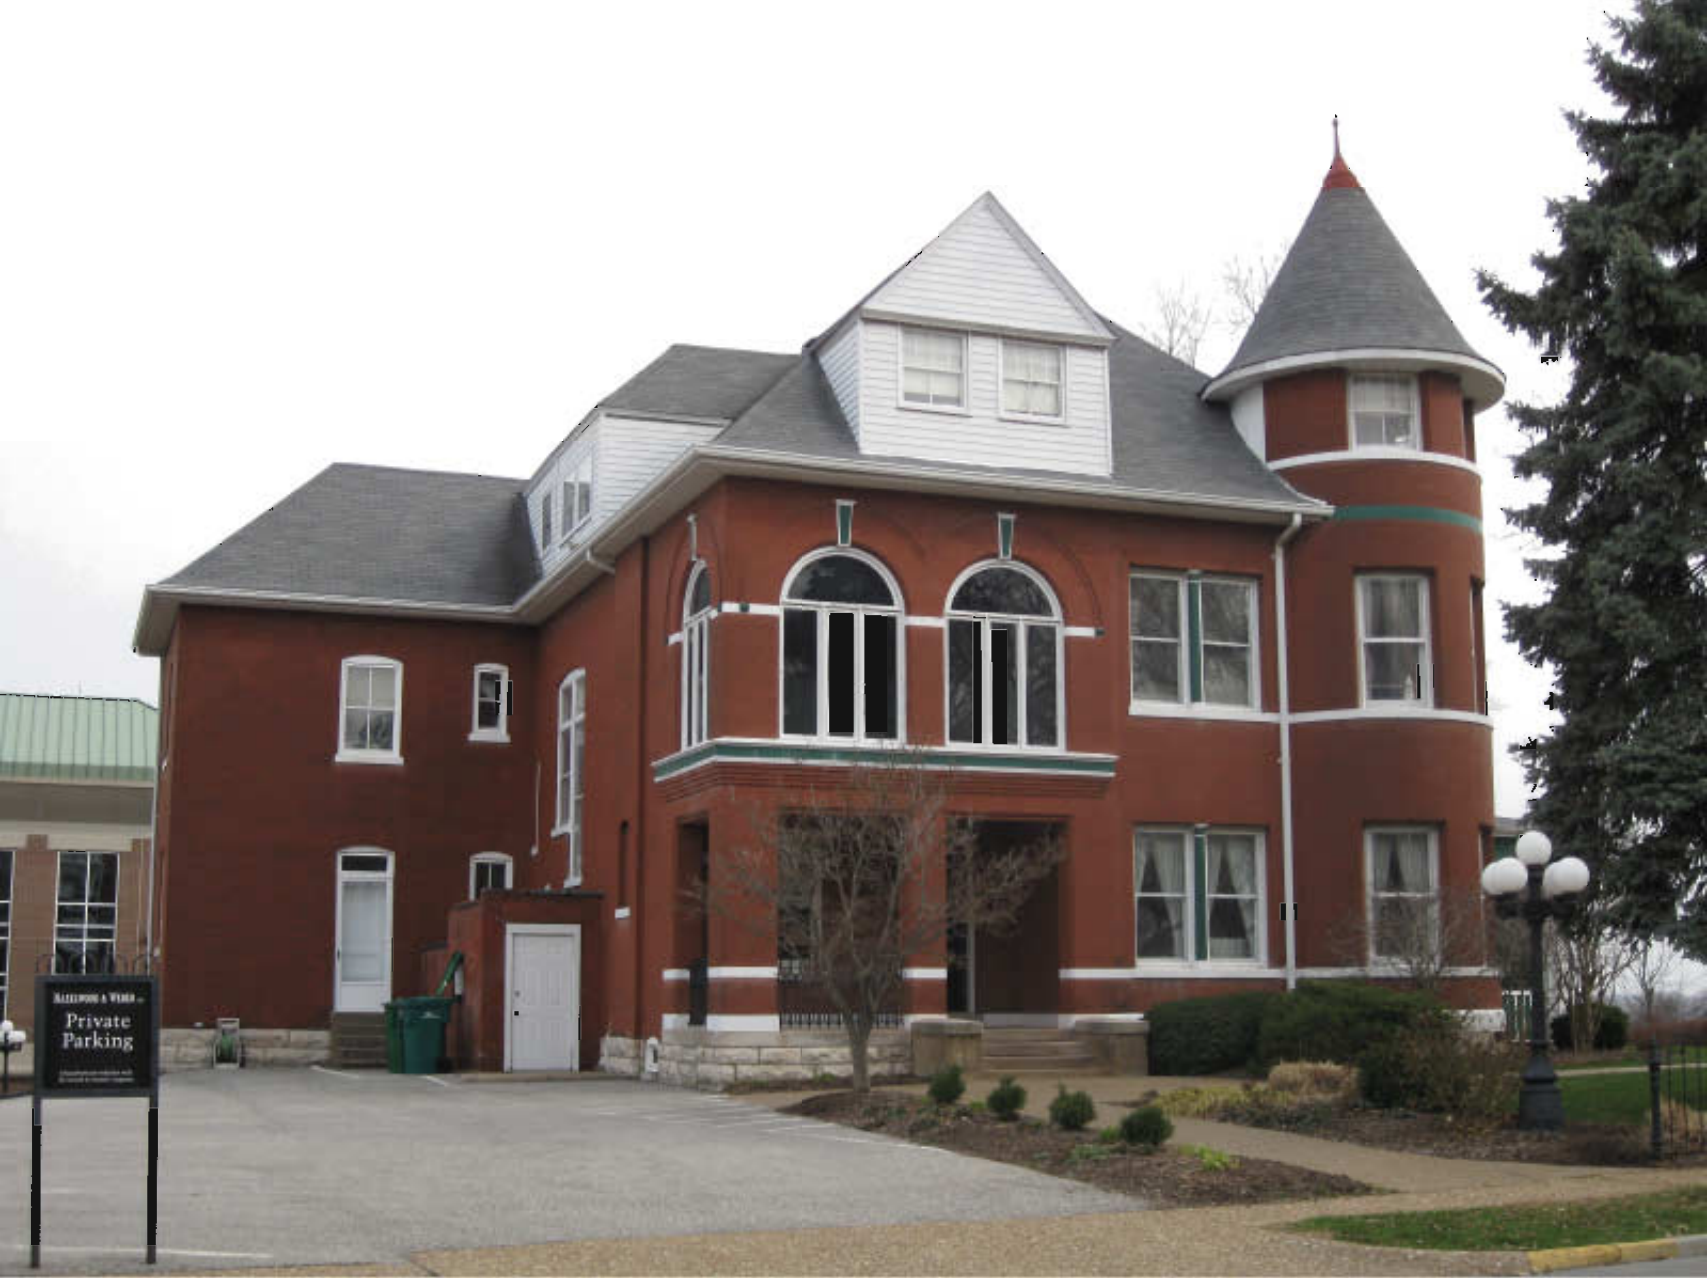
The door on the facade of the north wing may be a later conversion of what was a window opening, probably done when the house was converted to the American Legion Hall in the 1940s. The small, one story, tiered parapet roofed, brick wing inset into the corner between the north wing and the main house also appears to be a later addition to access the basement since it has a wood door on the facade. Although the second floor facade porch arched windows have been enclosed with 3-light wood casement windows with a half round transom. The one story east and south elevation porches have been enclosed as well. In fact, these alterations may all date from the historic use of the building by the American Legion. It is difficult to date the iron porch railing in the north bay and in the north side of the front porch.
