ARCHITECTURAL/HISTORIC INVENTORY FORM

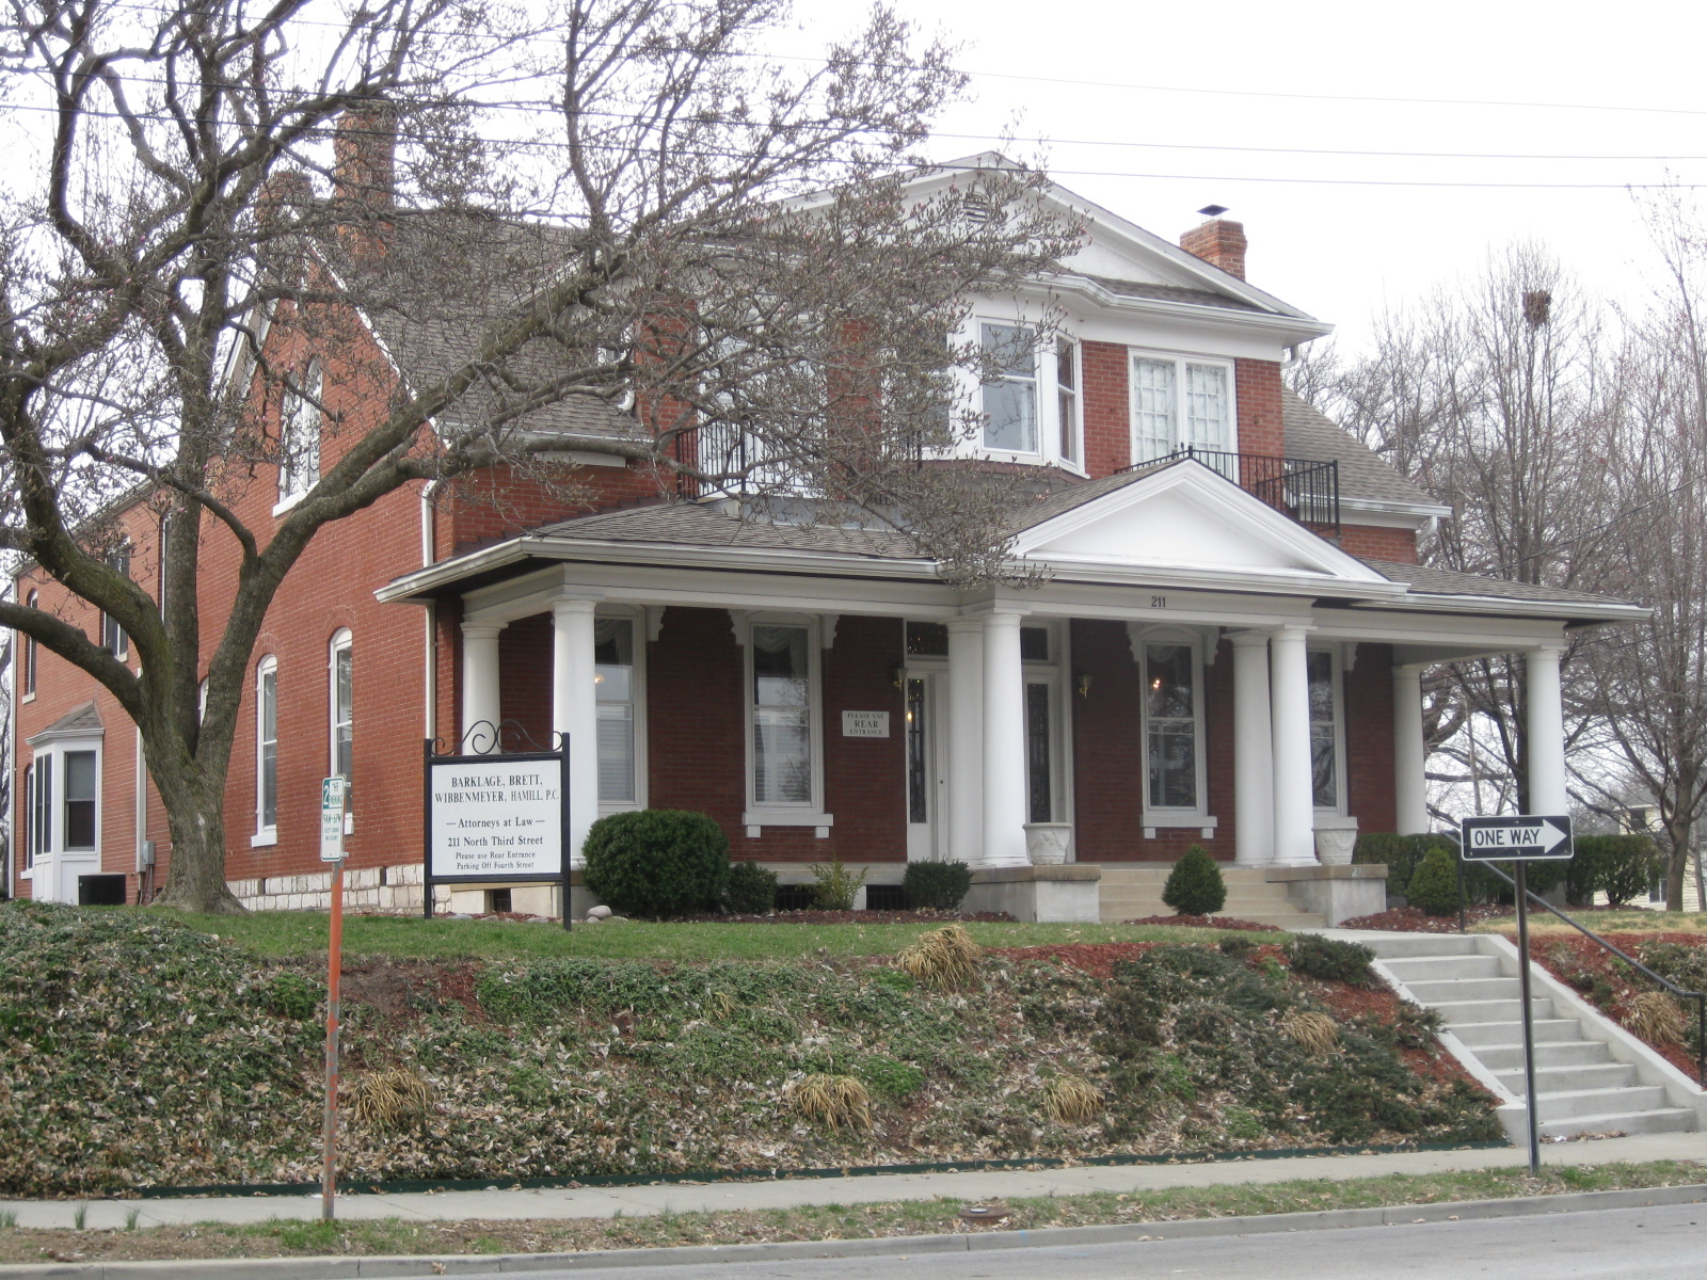
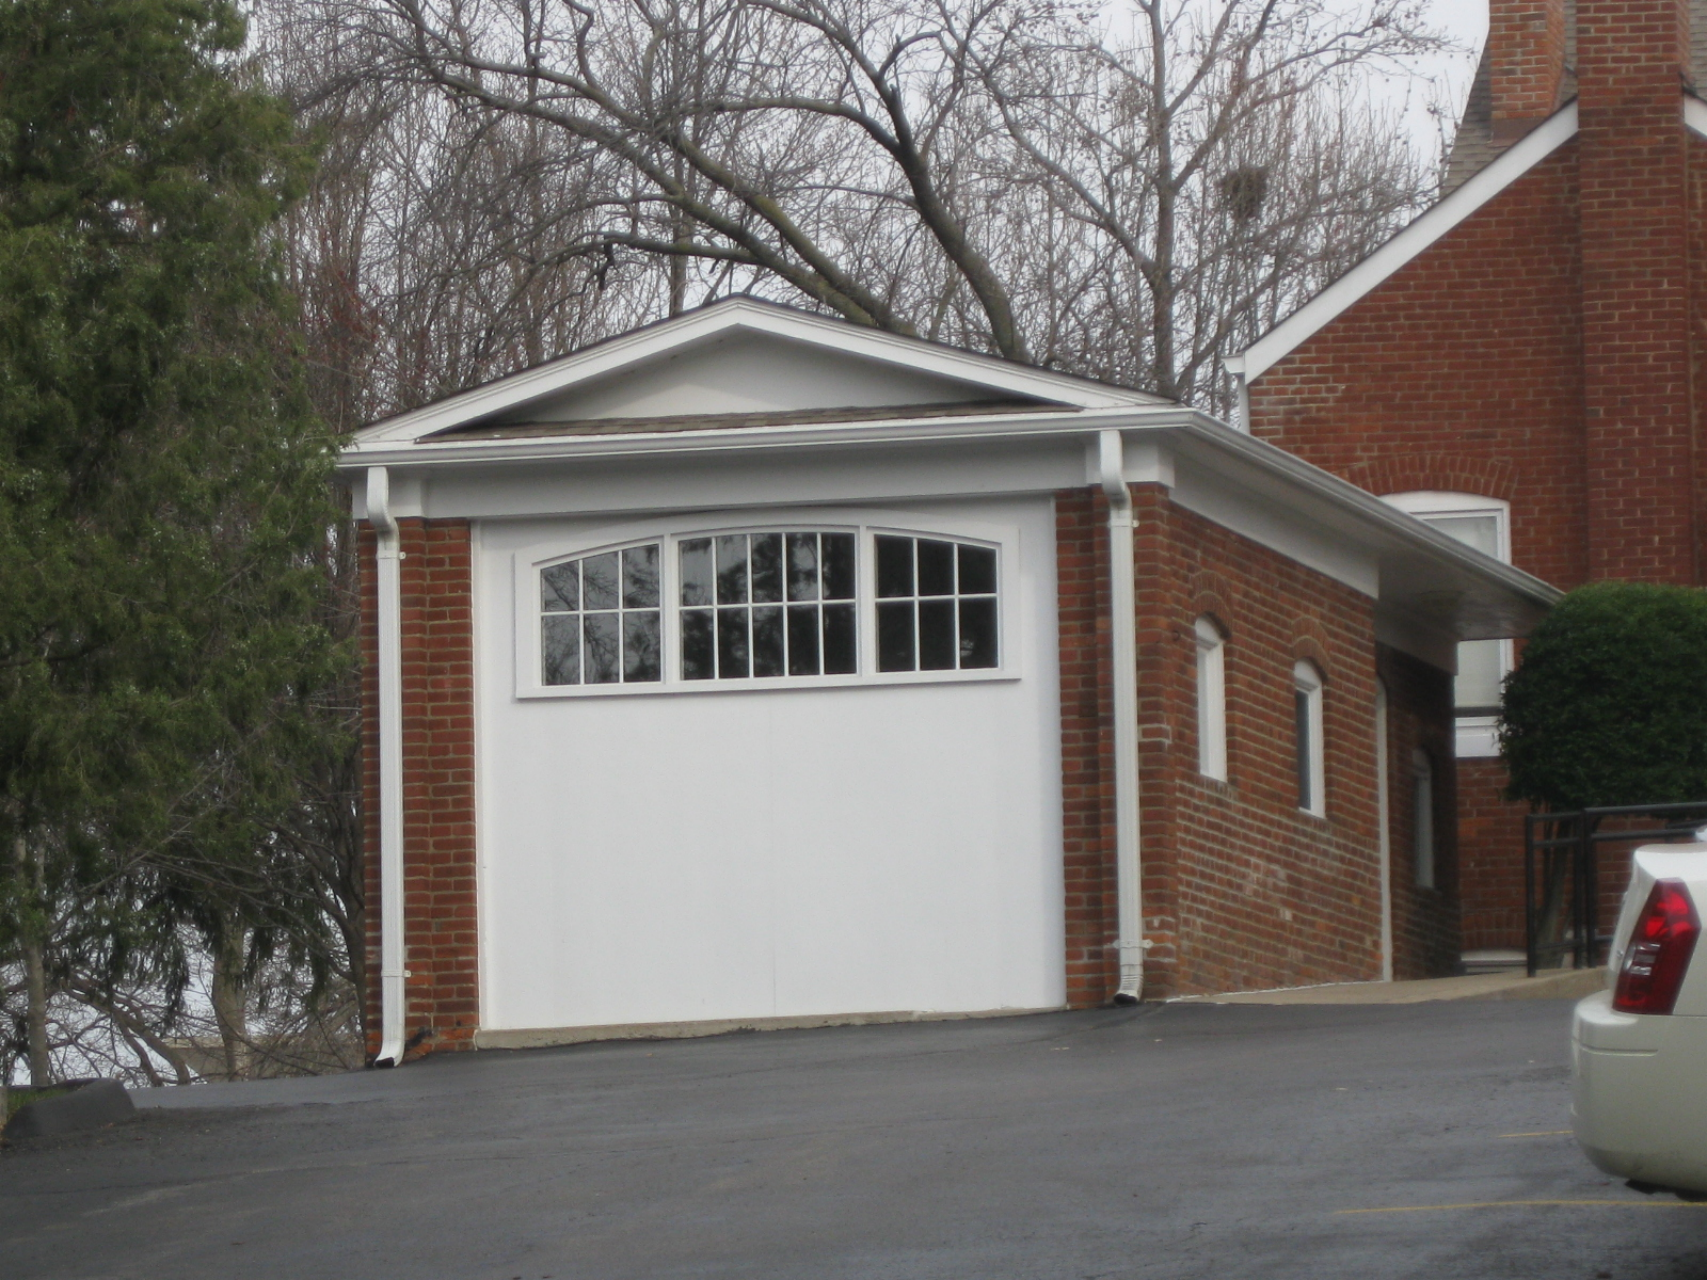
On the north end of the rear (west) elevation is a gabled, one story, ell wing with an end wall brick chimney. This ell dates at least to the 1900 fire insurance map. On the south half of the rear is a newer, intersecting gabled roof addition, completed after 1947. The souther ell is two stories and brick, with segmental arched window openings facing south and a first floor canted bay window. Other than storm windows and metal chimney flues, the exterior appears not to have had any other alterations.

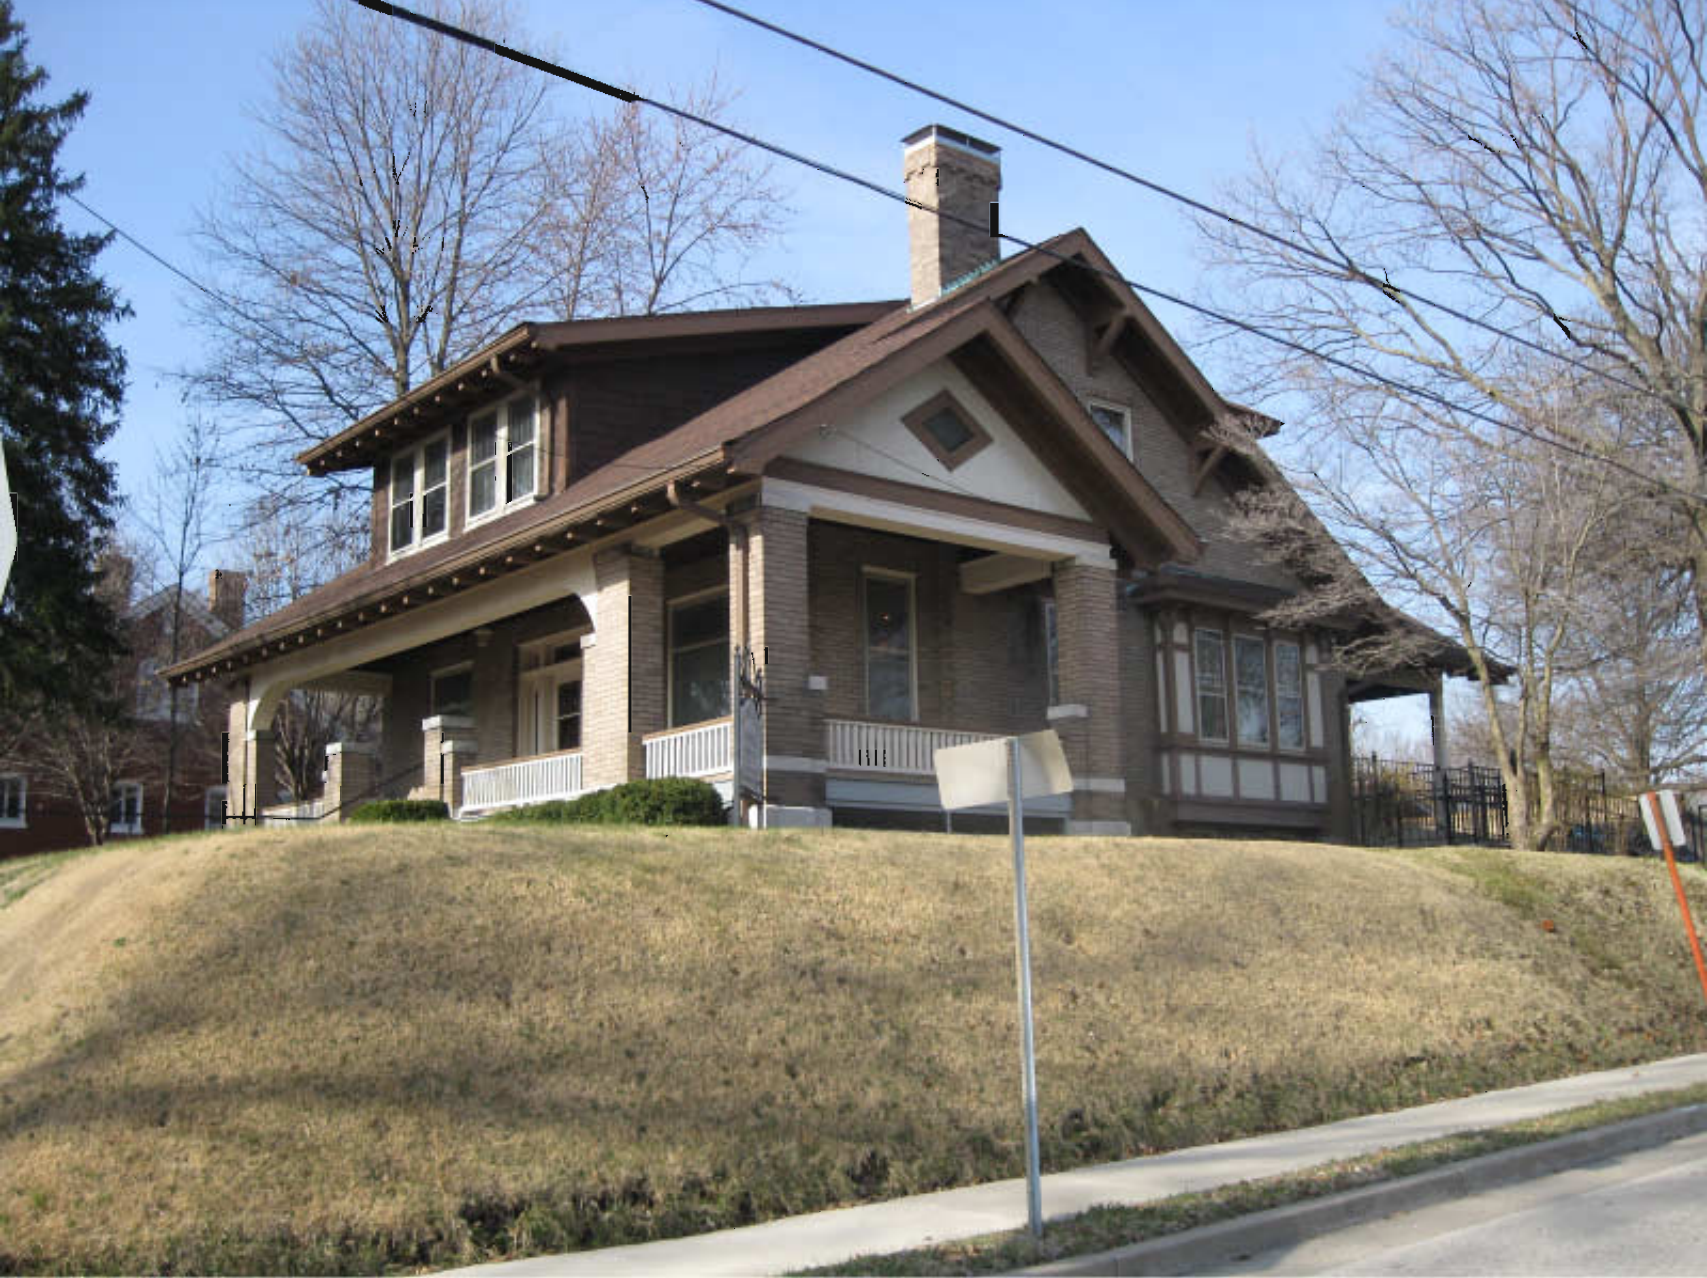
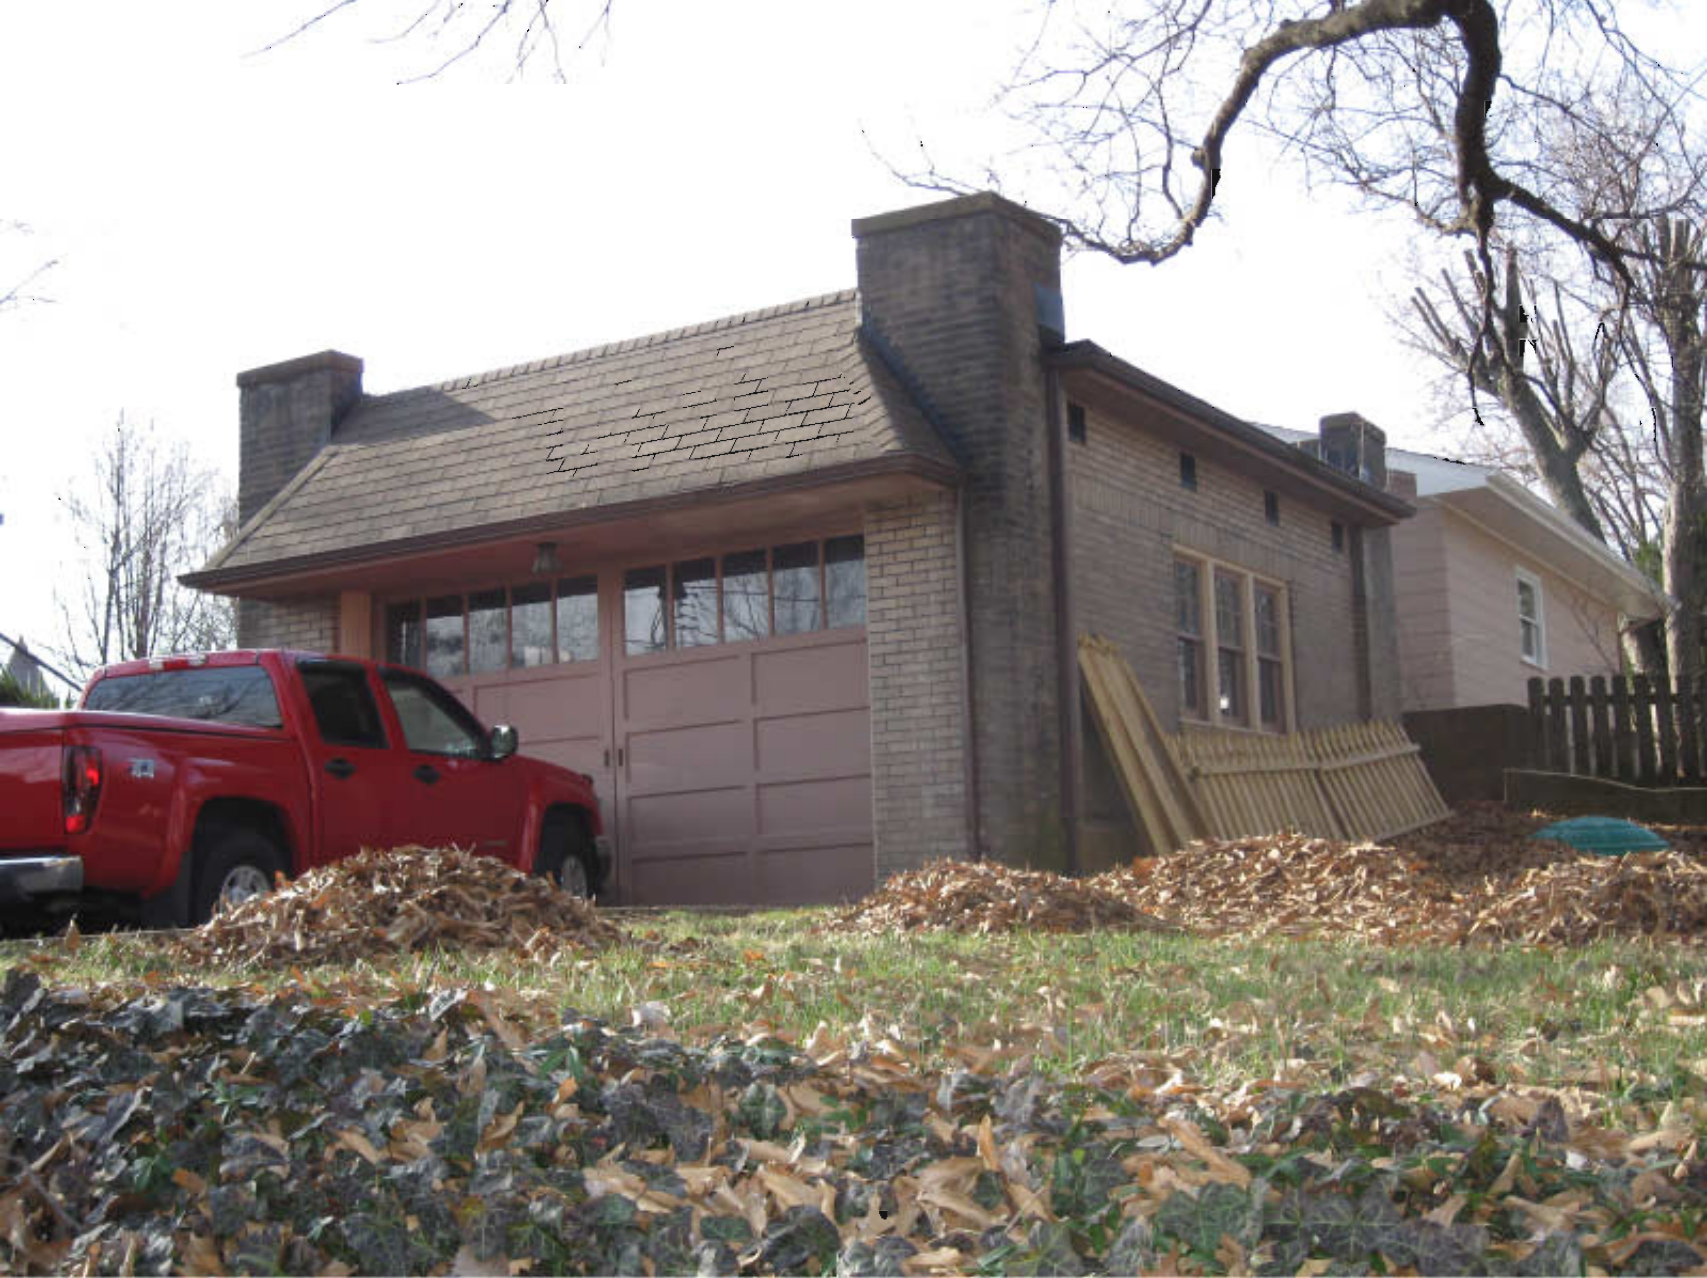
The 1.5 story, three-bay facade of this side gabled Craftsman bungalow has wide eaves with exposed rafters and knee braces in the gable ends. It has a full width front porch that is incorporated into the main roof of the house. It extends to the north beyond the facade as a one-story, side gabled porch open on all four sides. The house is clad with running bond, blond brick which is also used for the large brick piers at each end of the three-bay facade as well as on both corners of the one story gabled porch at the north corner that creates a wraparound porch. The three-bay section has a slightly arched wood beam that extends between the piers that rest on secondary brick piers that rise two-thirds the height of the porch opening. Shorter brick piers with attached smaller piers frame the central opening to the porch, which has a wood porch floor and retains its original, low-height wood railings with square balusters. The concrete steps have short concrete wing walls. The brick piers extend to the ground with banding in line with the porch floor and the footings of the piers. The central entry has a full light, leaded glass door with leaded glass transom and sidelights. Flanking the entry are large single light windows with leaded glass transoms and cast stone sills. The north gable end of the one story front porch extension has a diamond fixed light attic vent/window. On the back half of the north elevation is a hipped roof, flattened bay with half timbered walls and art glass upper sashed windows (this was apparently added between 1917 and 1929 based upon the fire insurance maps). Centered on the facade is a large, shed roofed dormer with wide eaves and exposed rafters. The walls of the dormer are currently clad with asphalt shingles (an alteration) but retain the two pairs of 1/1 windows with leaded glass upper sashes. The sashed windows on the other elevations are 6/1 windows with the upper sash lights arranged to form small squares across the top and rectangular panes below. There are hipped dormers on the rear slope of the main roof and shed dormers on each slope of the rear gable around the rear, gabled porch. The chimneys at the ridge of the north and south elevations appear to be built of different brick, possibly indicating a later alteration or a rebuild. Storm windows have been added. Basement windows have 3-light windows.

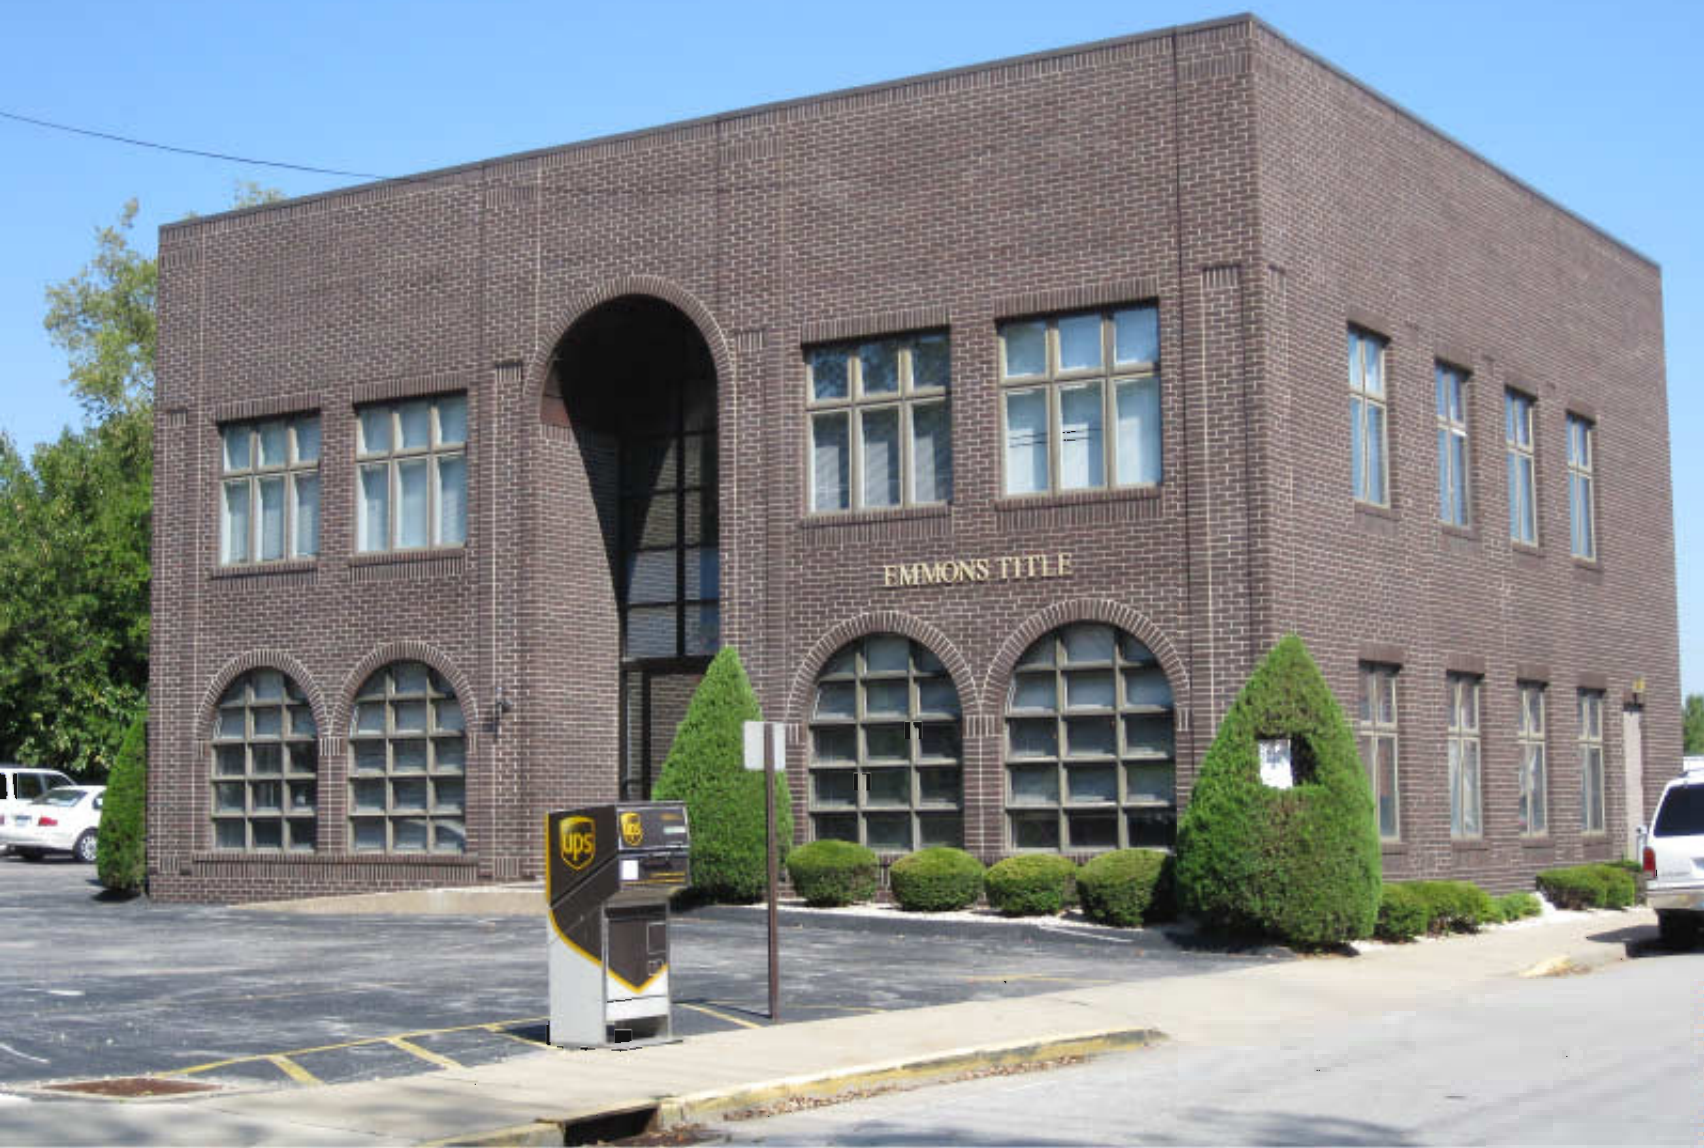
This flat roofed, brown brick building has concrete parapet caps on all but the north elevation, which is also devoid of windows. The street (east) elevation is not the facade; it has five bays with paired transomed, fixed light or single light casement windows in all bays on both levels, except the north bay, which has a steel security door that opens at grade. The facade faces south, into the parking lot and is divided into five bays with a tall, two-story high, round arched recessed entry filled with a 10-light window above the aluminum framed door and sidelight. On either side of the recessed entry are two round arched 15-light window openings on the first floor and two triple unit, transom with fixed light or single light casement windows on the second floor. Flanking the entry bay and at the corners are flattened brick pilasters with recessed brick panels that terminate at the second floor lintel level. Matching pilasters are located on the adjacent side elevations at these corners. The west elevation has five bays of windows on each level, the same paired, transomed, fixed light or single light casement windows.

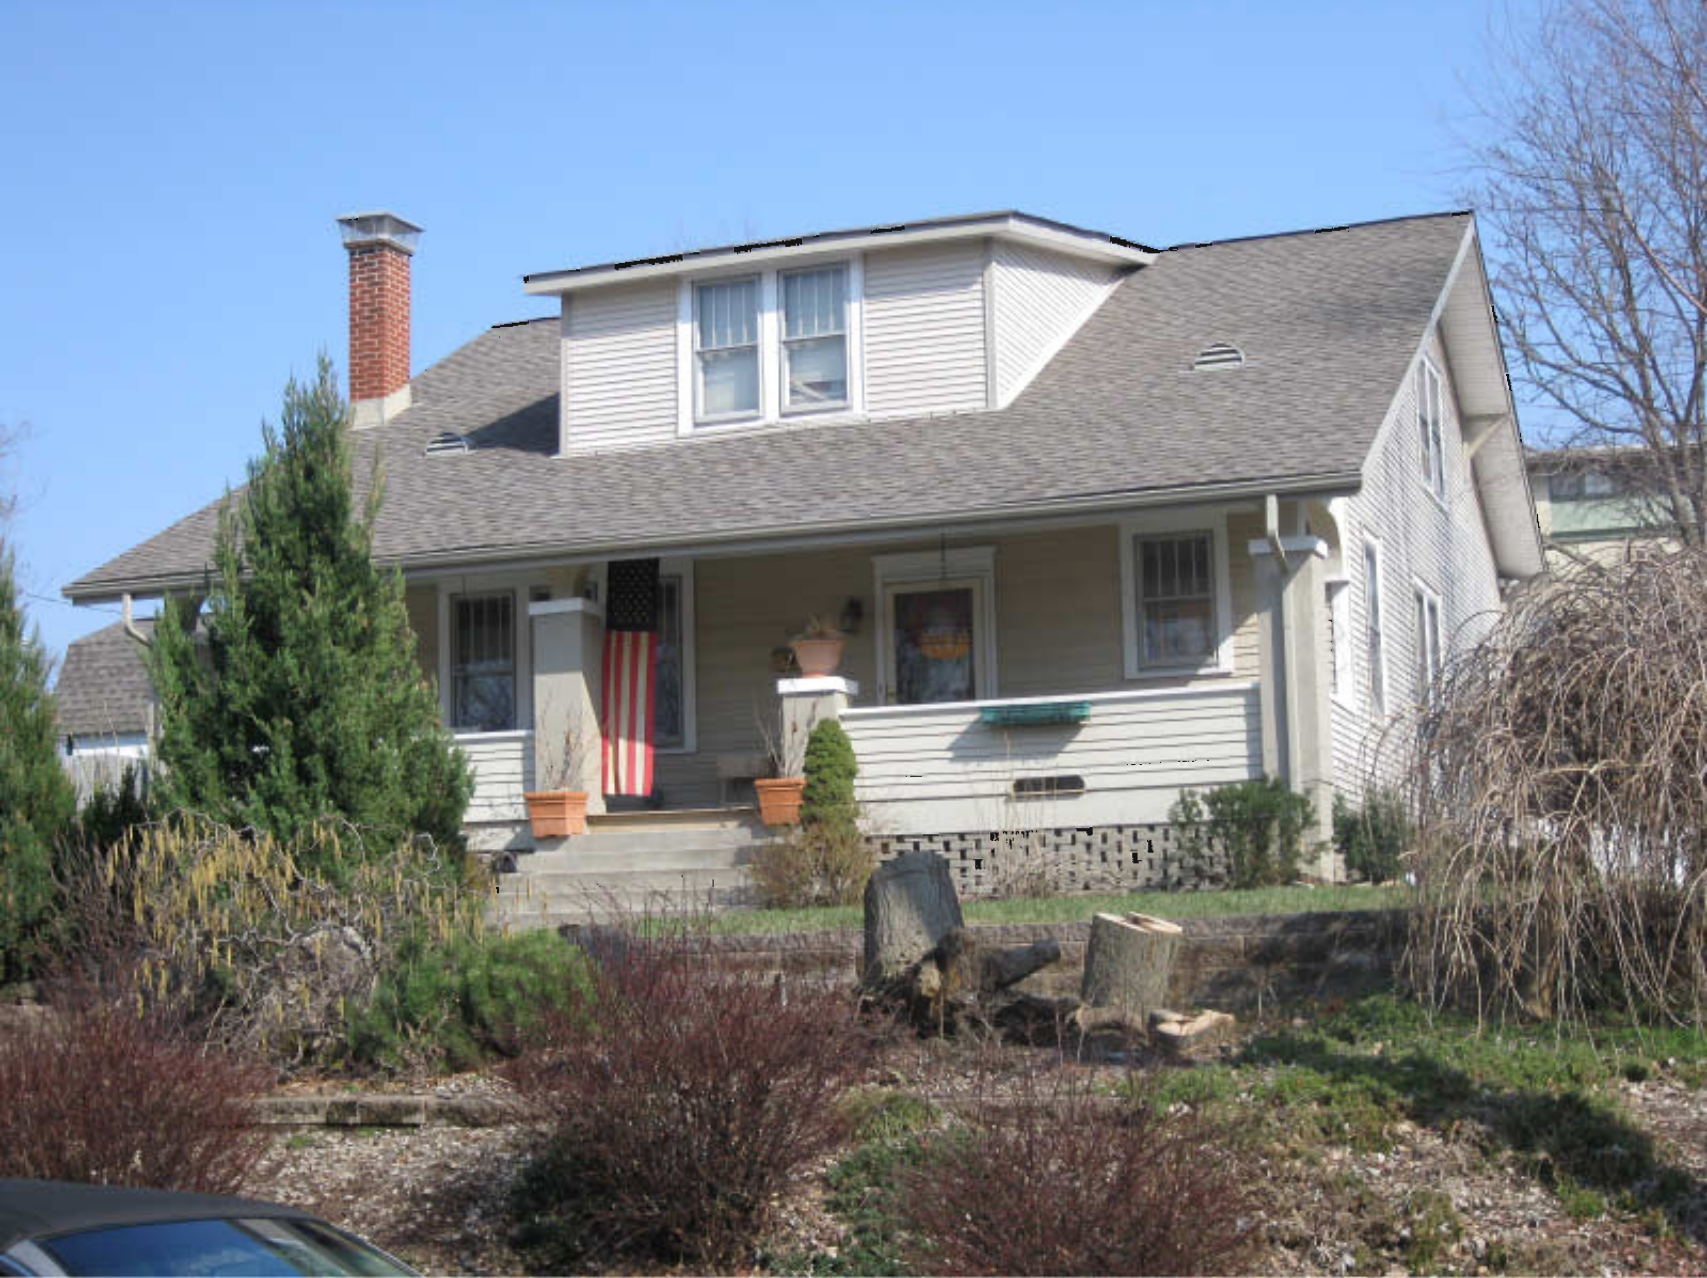
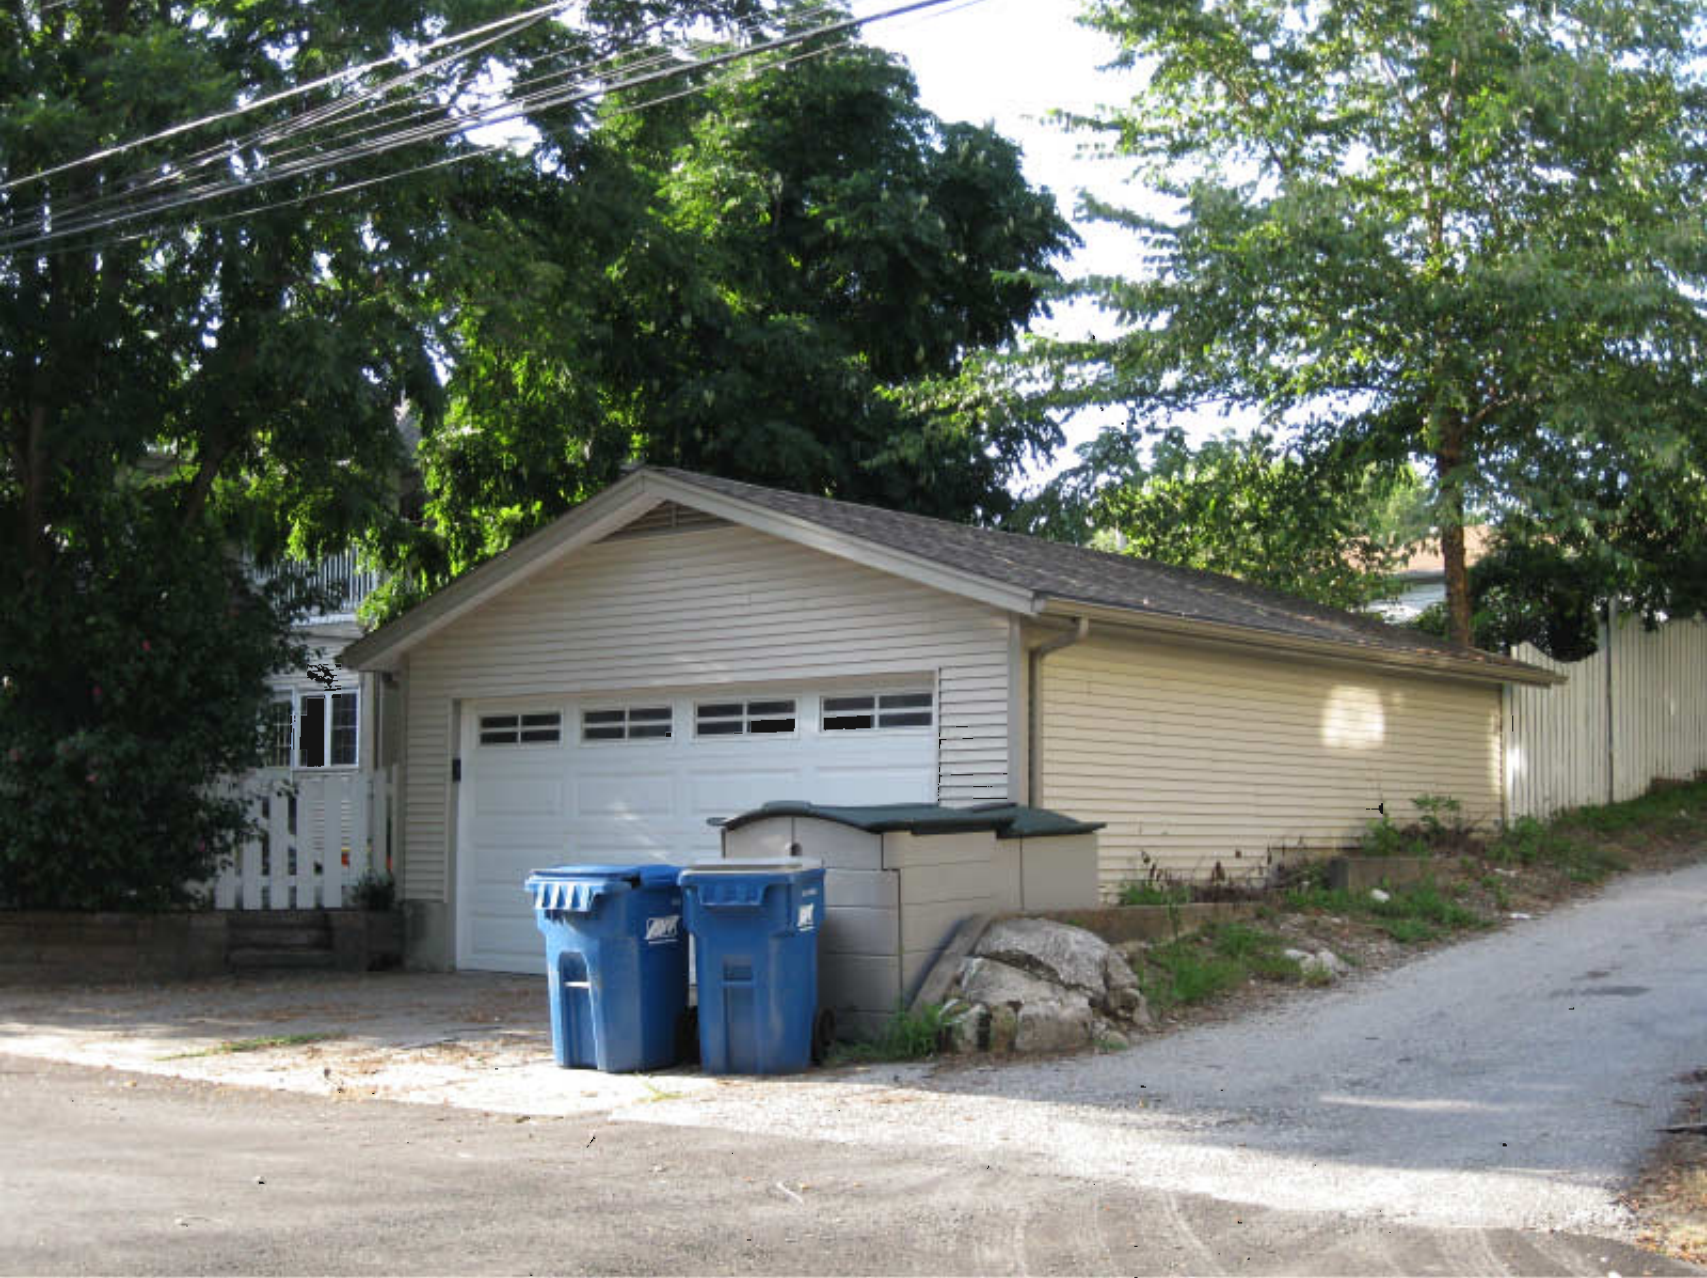
This 1.5 story, side gabled, frame, Craftsman bungalow has a central shed dormer that has paired 4/1 wood sashed windows. The first floor facade is divided asymmetrically into three bays, with the oval glass entry door slightly off-center (and covered by a storm door). The house originally had weatherboard siding (still retained on the facade) and still retains the wide eaves with the alternating wide and narrow boards in the soffits as well as the knee braces in the gable ends. Since the front facade of the house as well as the porch railing retain the alternating rows of wide and narrow weatherboards, the facade also retains the original crown capped trim on the windows and doors (a feature now obscured on the secondary elevations where the vinyl siding wraps on top of the outer edge of the wood trim). To the south of the entry, there is a single 4/1 wood sashed window and to the north of the entry is a triple window unit of 4/1 wood sashed windows. The full width porch has a shed roof that is an extension of the main side gable roof, which is supported at the outer corner and at the north side of the concrete entry steps by a stucco pier that extends nearly to the roof with a flat concrete cap where there is an arched beam that curves to form a post within the cap of the stucco pier. This same kind of arched beam caps the opening on each side of the porch, forming a bracket against the facade wall. To the south of the porch steps, there is a shorter stucco pier with a concrete cap that serves as a newel post for the weatherboard railing. The porch floor is wood and the corner piers extend to the ground with the porch foundation being parged brick. The front dormer as well as the sides and rear elevations have been reclad with vinyl siding and after 1947 there was a two-story addition with a hipped roof added to the northeast corner of the house, but it is not a prominent feature on the facade.

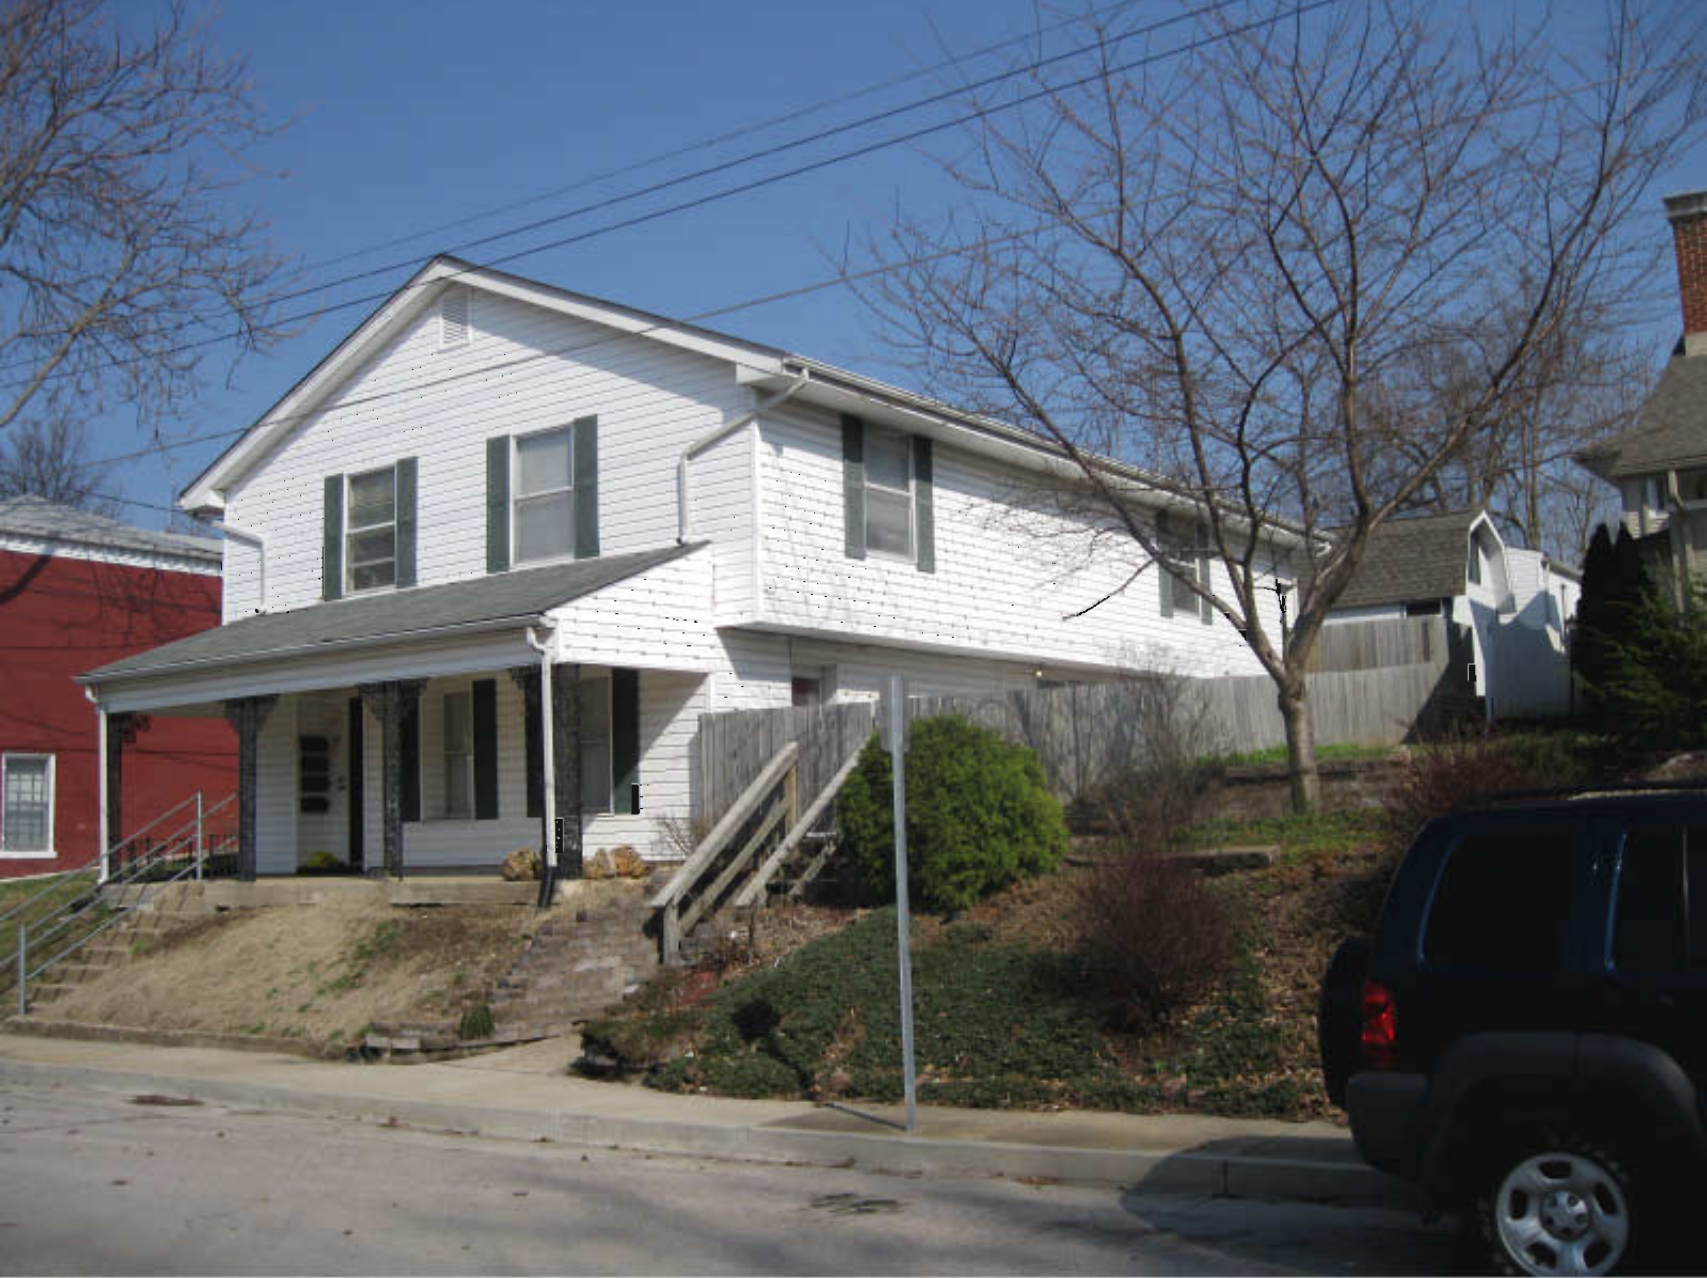
This 2-story, end gabled house has vinyl siding and the second floor overhangs the first floor walls on each side, possibly an indication that the second floor was added to a pre-1891 brick house (also the thickness of the window openings on the first floor seems to indicate this as well). The first floor is divided into three bays, with an enclosed, projecting entry at the north end and 1/1 sashed windows in the other two bays as well as in the two sashed windows on the second floor facade. There is a full width, shed roofed porch with a concrete porch floor supported by wrought iron columns. The building has been altered substantially, making it difficult to determine its historic appearance or verifying whether this is a modified pre-1893 house.

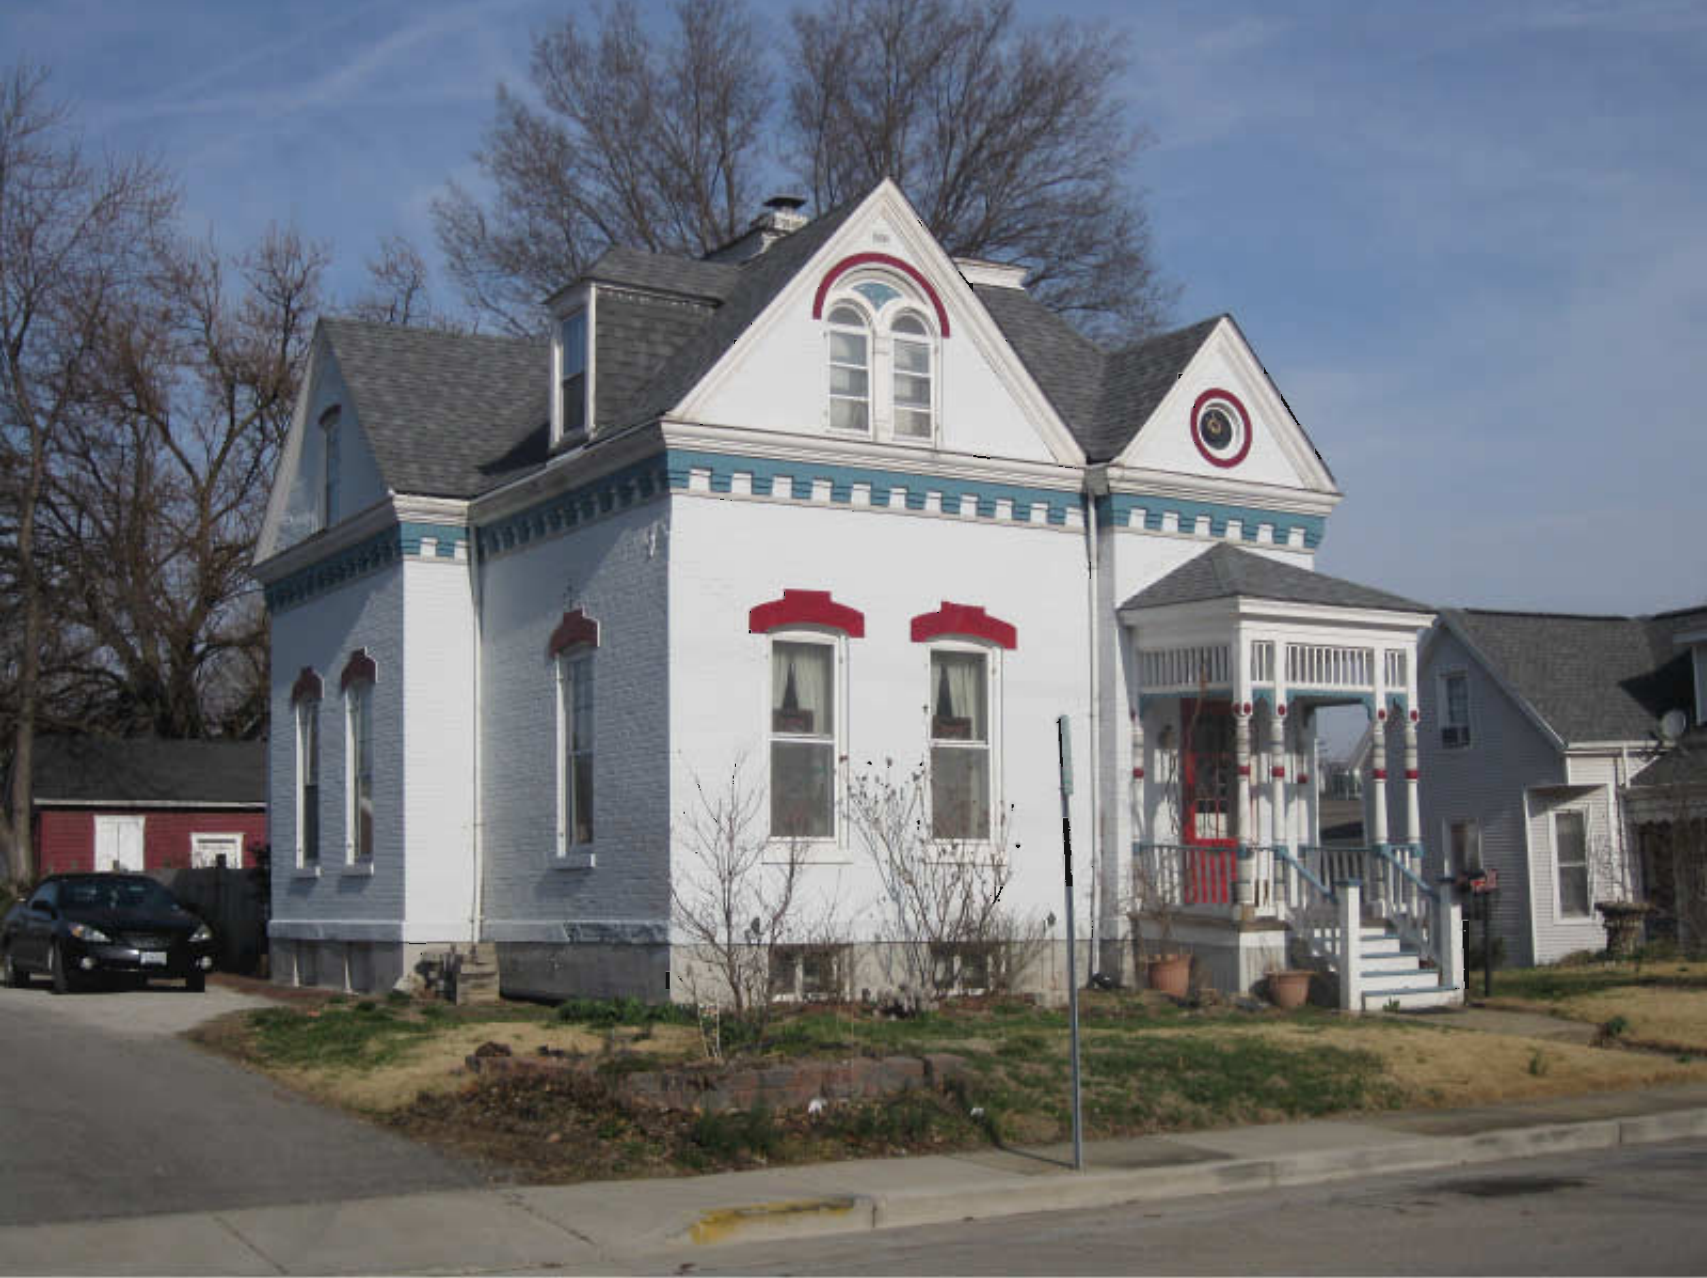
This 1.5 story, three-bay wide, painted brick house has a truncated hipped roof with a central brick chimney. The paint scheme highlights the brick arched with brick keystone lintels and the crenellated cornice that surrounds the house. The windows have simple stone sills. Most windows are 1/1 wood sashed windows, but some of the windows toward the rear are 2/2. Separating what was a dressed stone foundation is a projecting band of brick creating a watertable line, both of which have been stuccoed. Flanking each side are intersecting gabled roof 1.5 story wings that project slightly (the one to the north has a window on the east facade) and each has two windows on the side elevations. On the south side, near the front is a hipped roof dormer, and two similar dormers are found on the rear elevation, all having 8-light casement windows. On the facade, there are two cross gables, the one to the south being taller and having paired windows with separate half round transoms that are connected under a single round arched lintel with a small infill transom. The smaller cross gable has a round window. There are two windows on the facade in the south bay and a small hipped roof, spindlework projecting porch. The main entrance is a two-panel door with a half light framed by a colored glass border, and above the door is a two light transom. Although the 1893 map shows no front porch, it is shown on the 1900, 1909 and 1917 maps and is again omitted from the 1927 and 1947 maps, so it is not clear whether the current porch is a recreation or the historic porch which was accidentally omitted from several fire insurance maps. There is a rear, one-story, gabled roof L-shaped wing has a side porch on the south side that was (poorly) enclosed after 1947 utilizing plywood sheets with a stucco finish. This rear ell has an interior end chimney. The enclosed porch has vinyl windows and the historic wood windows have had storm windows added. Basement windows are 2-light windows, both on the facade and in the gabled side wings.
