ARCHITECTURAL/HISTORIC INVENTORY FORM

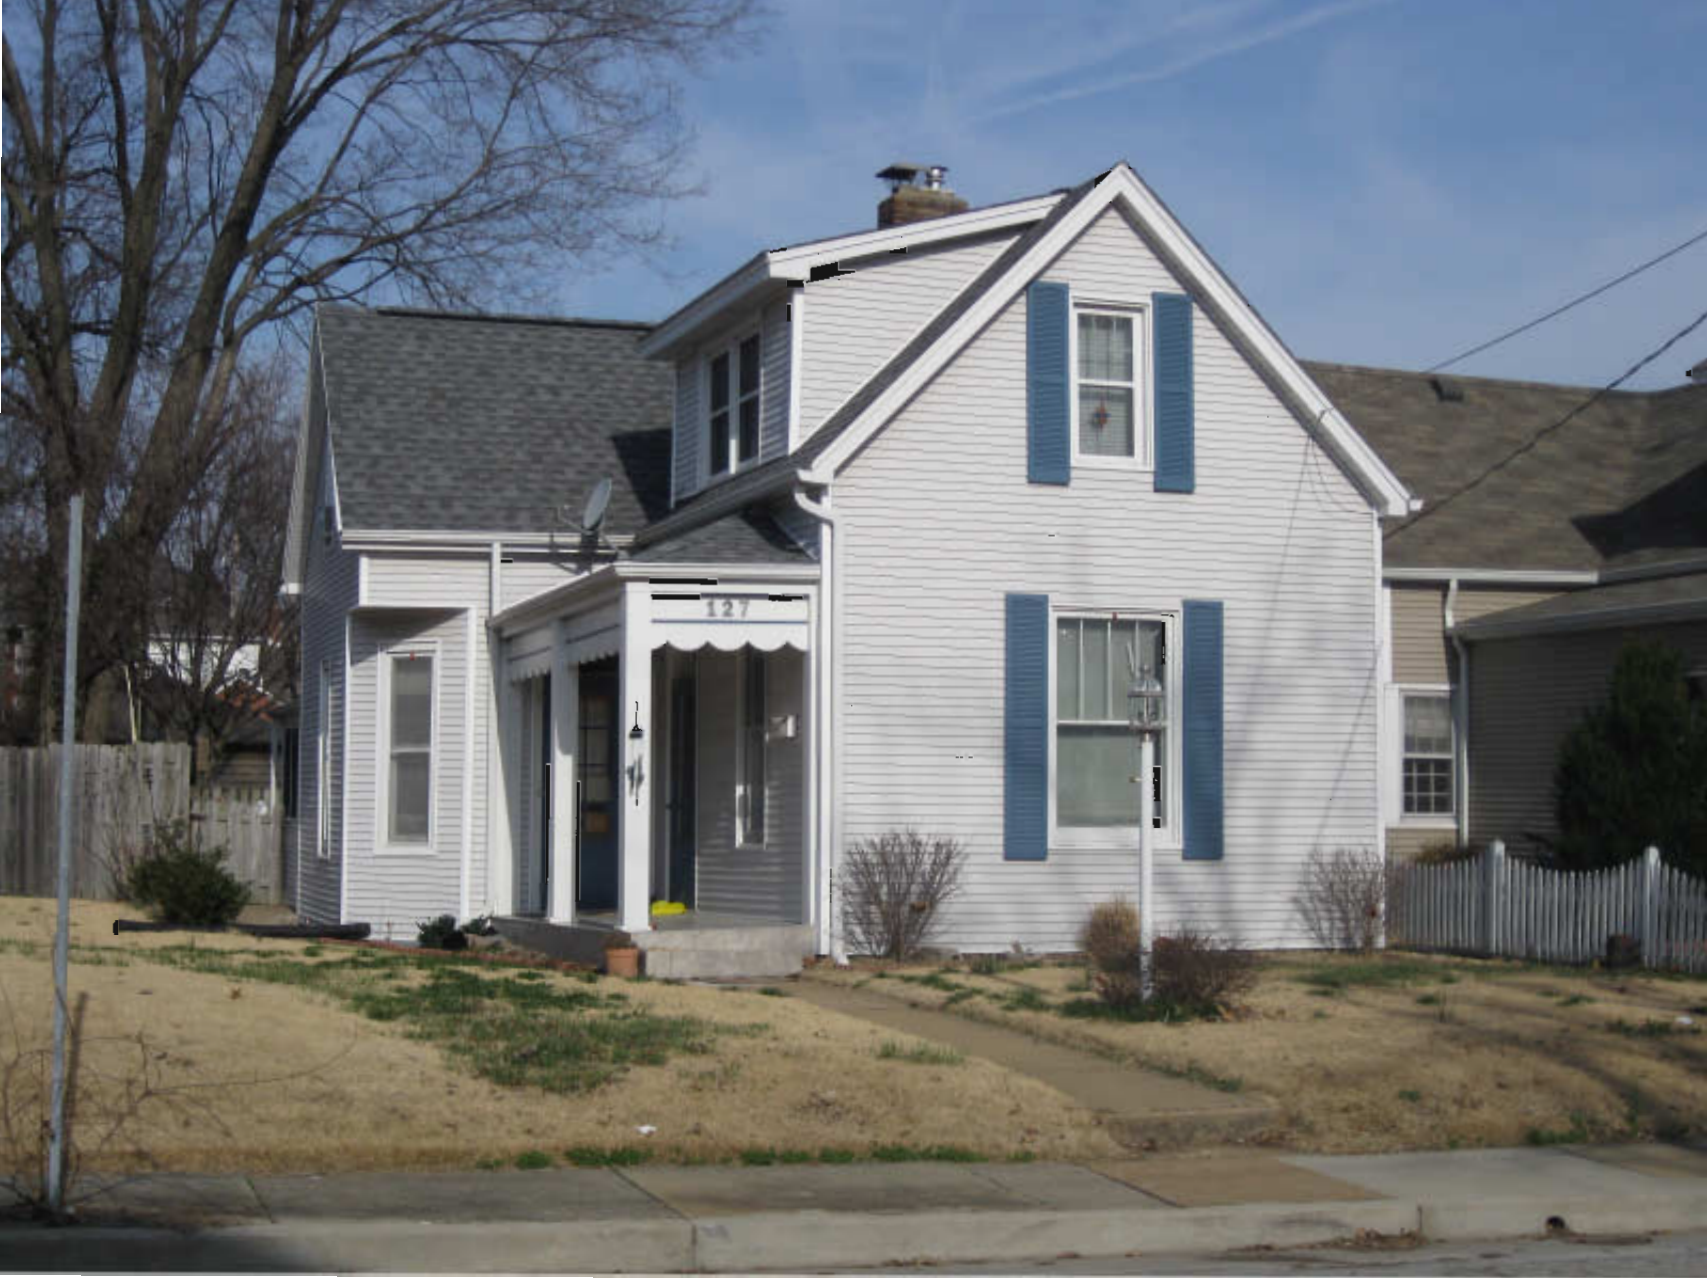
This 1.5 story, frame, end gabled house has an intersecting gable that creates side gabled wings across what was originally the rear of the house, although a one story gabled wing was added across the north half of the rear between 1900 and 1909 and that addition was extended across the south half of the rear elevation between 1917 and 1929. There is a wood sashed window on the facade of the gabled 1.5 story wing on the north side and a clipped corner window on the south side of the 1.5 story gabled wing. Adjacent to this canted window is one of the two doors, the other being adjacent on the south side of the front section of the house. Both doors are half light wood doors with single light transoms and both have wood storm doors with six lights. These doors open into the narrow porch that extends along the south side of the front wing. This porch was apparently added between 1909 and 1917 when it first appeared on the fire insurance maps. It has simple square posts supporting its hipped roof with scalloped trim under the eaves, although that trim and the porch posts appear to be a recent modification, as does the concrete (tiled) porch floor. The large window on the facade is a 4/1 wood sashed window, but the second floor facade, gable end window is a 6/1 vinyl replacement window. There is a shed roofed dormer facing south which has paired vinyl replacement windows. The house has been sided recently with vinyl siding and has had nonhistoric vinyl shutters added. Despite these alterations, the house retains its basic form and the historic porch configuration, and as such is contributing to the historic district.

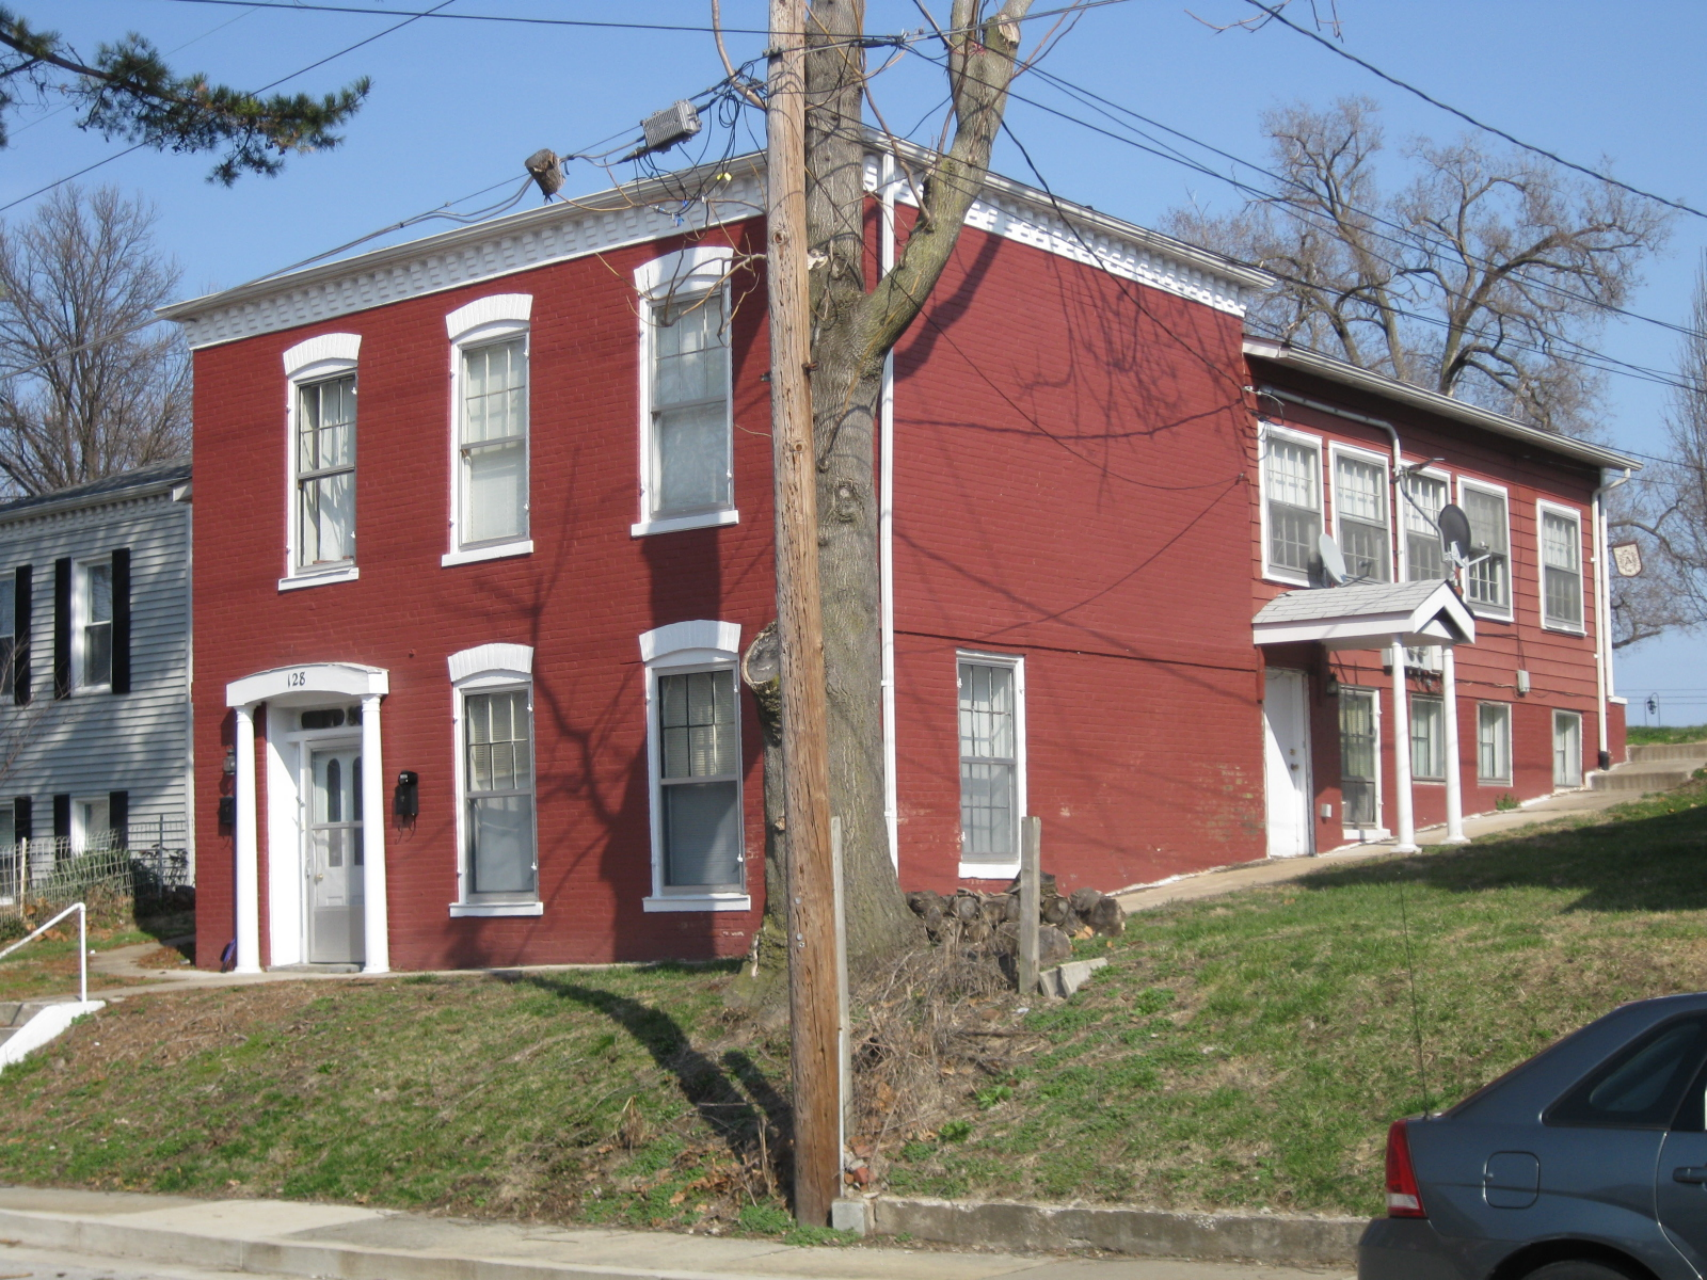
This simple, 5-course common bond brick, two story house has a low-pitched hipped roof and a crenellated brick cornice. The facade is divided visually into three bays, with segmental arched window openings in each bay except for the first floor north bay which serves as the entry. It too has a segmental arched opening, accentuated by a slightly projecting, arched hood supported by slender Doric columns that flank the Italianate door which has two half-round arched lights over two vertical panels. The door is flanked by narrow 5-light sidelights with diamond patterned yellow glass and topped by a 2-light transom that has rounded ends at the center. It appears the front section was built in 1837 as a single story building and it remained that way for many years since it is shown as a small one story house in the 1867 Bird's Eye View. On the earliest fire insurance maps (1893) this was identified as a one story house with a basement, rather than as a two story house, but this appears to be just a notation differentiation since the ground level rises sharply on the sides, so that the lower floor is no longer above grade. On that map it also shows the rear wing and the building itself shows a visual change in the brick coursing between the first and second floor levels in the front bay. The windows on the facade are 6/1 wood sashed windows with stone sills, but the side elevation windows are 6/6 and it is possible that the front windows were also originally 6/6 sashes (more commonly associated with nineteenth designs). A similar window is located on the first floor of the south elevation near the facade and all of these windows have shutter hinges still intact. On the rear, there is a one story wing that was added either when the second floor was added to the front or at some other point prior to 1893 when it first appears on the fire insurance map (and probably prior to 1891 given the two separate residences in the building that were listed in the 1891-1892 directory). It is two stories in height if you count the partial height first floor above grade and positioned toward the north side, with an open porch along its south side, but at some point after 1947 this was enclosed as a two story vinyl sided addition. Since it too has the 6/6 windows (four bays of windows), it is verification that this represents an early addition. A gabled roof supported by simple corner posts covers the entry slab for the side entry slab door in the west bay of the south side of this enclosed porch. There was a small one story addition added behind the northeast corner of the rear wing between 1917 and 1929. Storm windows and storm doors have been added.

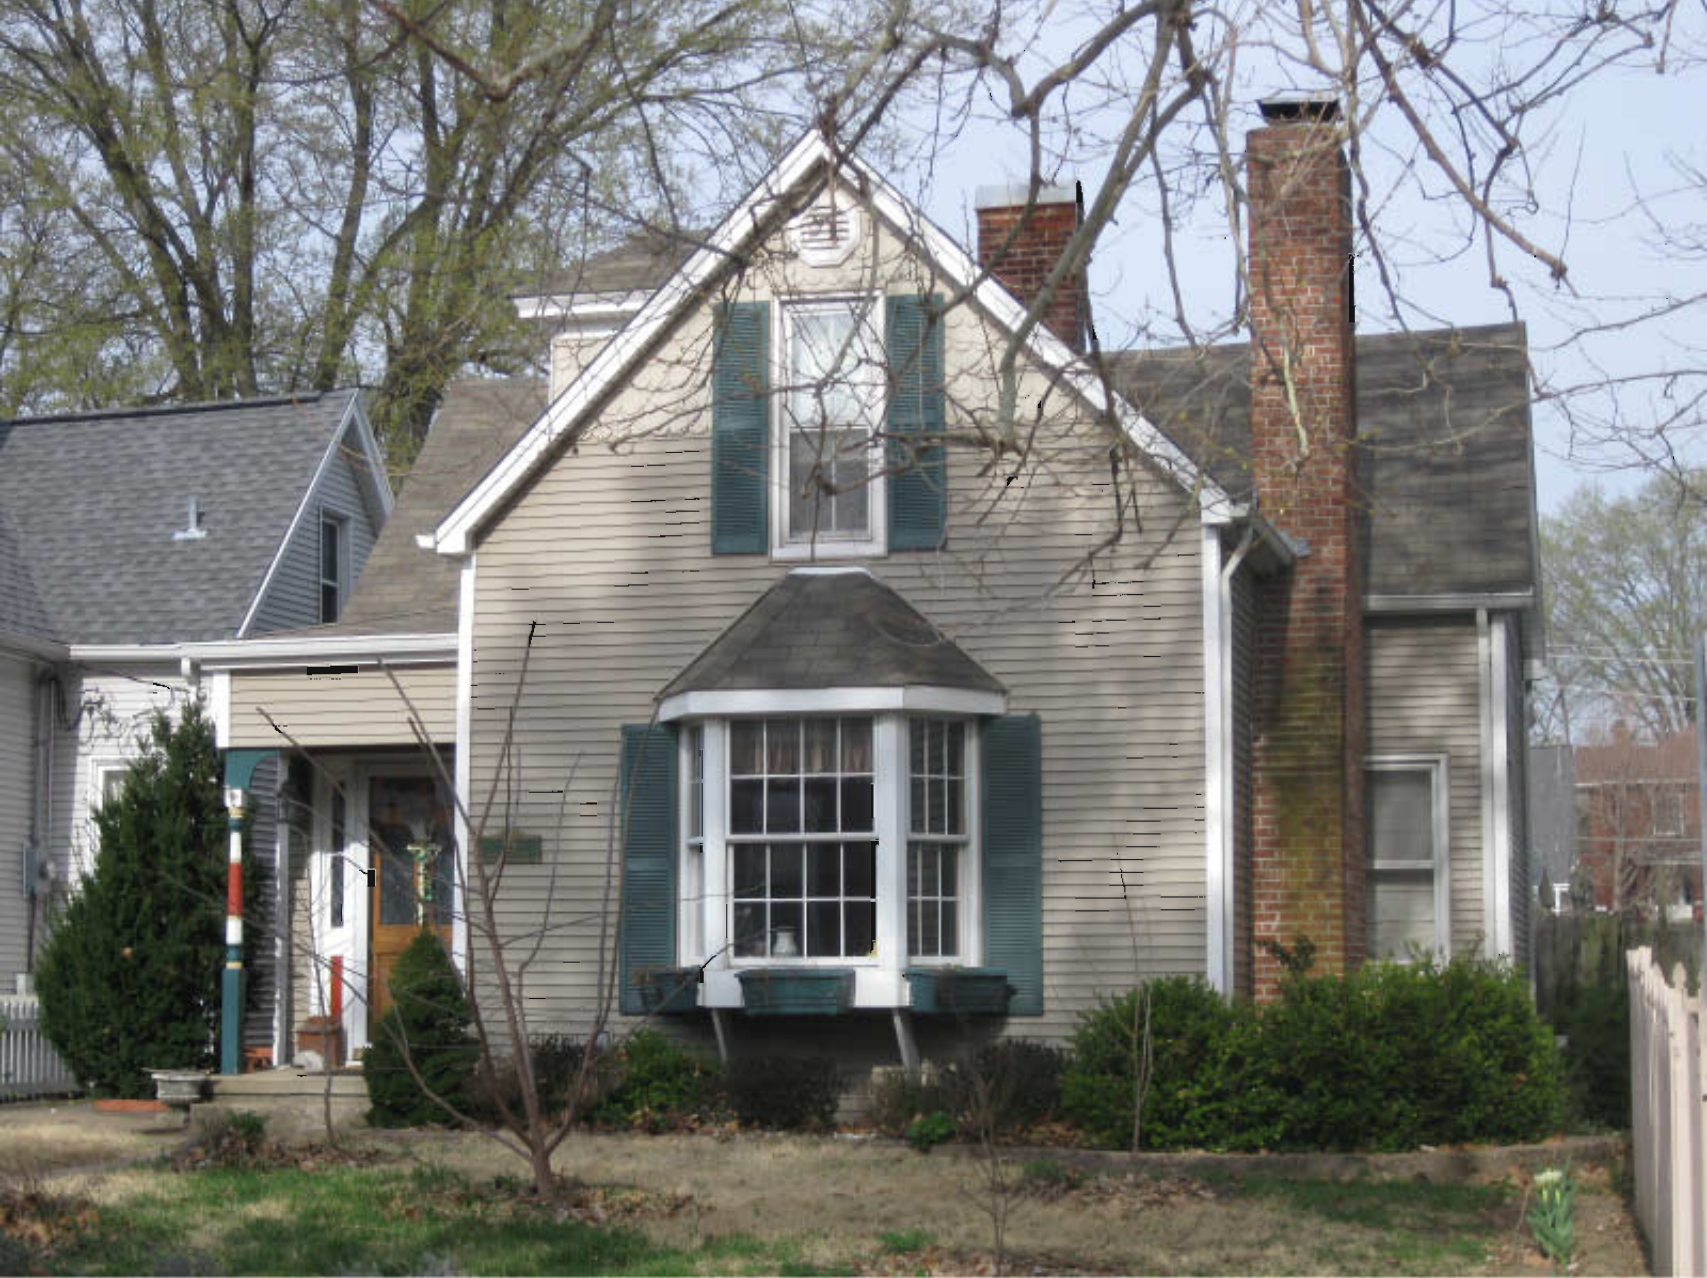
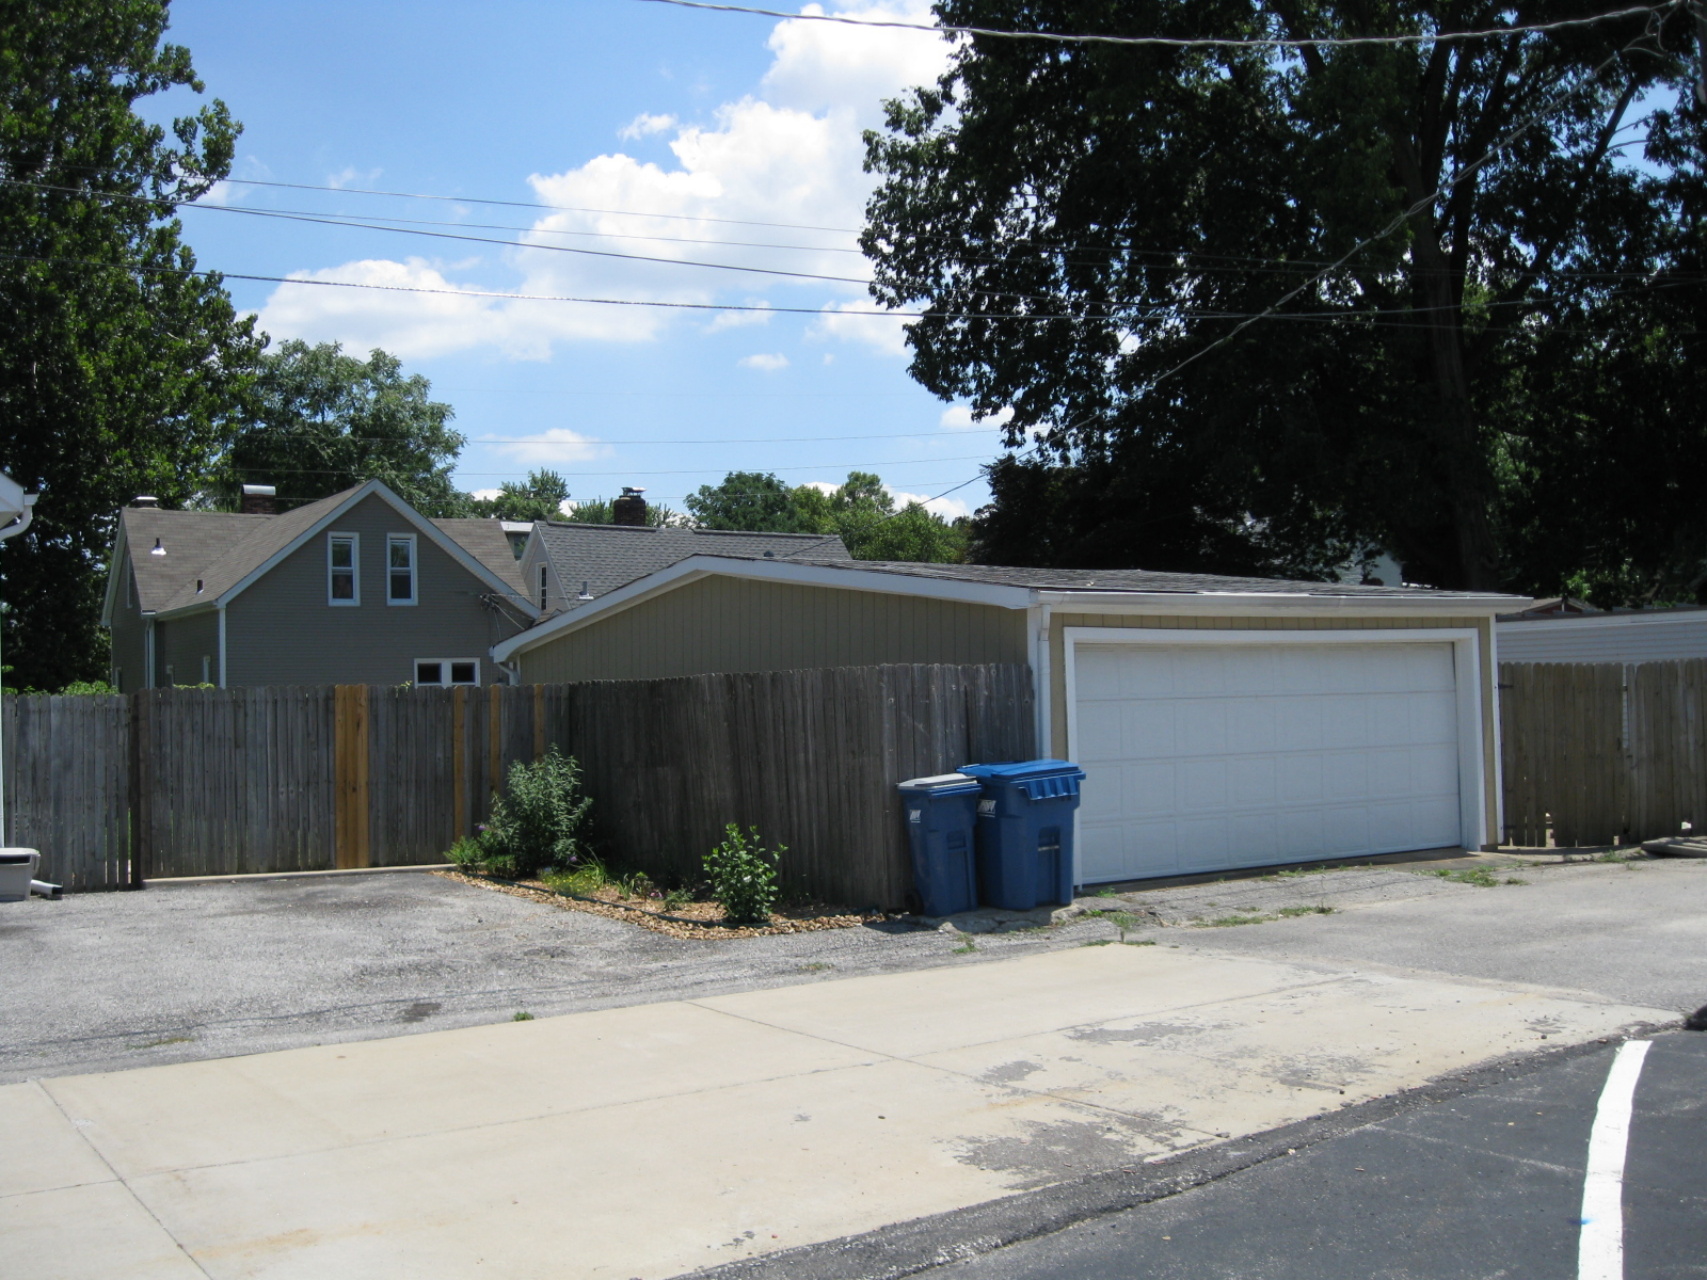
This 1.5 story, frame, Folk Victorian cottage has a steeply pitched, side gabled roof with a large crossed gabled wing centered on the facade. To the south side of this wing is the shed roofed extension of the main roof over the front entry corner porch which is nestled into the interior corner between the cross gables. This porch has a concrete floor and step, with a spindlework post at the outer corner. The outer corner of the house at the back of this porch has a clipped corner which serves as a two leaded glass lights over half panel side light for the adjacent front entry door on the east elevation of the house. The door appears to be a modern replacement with 4 leaded glass lights in the upper half over 2 vertical panels. On the facade of the central front wing there is a canted bay window (with 3 multipaned sashed windows) and on the second floor above is a 2/2 wood sashed window. In the bay north of this wing, there is a 1/1 window nestled on the east wall behind the exterior brick chimney attached to the north wall of the central front wing. To the south of this central front wing, there is a hipped dormer. There is also another brick interior chimney near the center of the house. The house has been reclad with vinyl siding, shutters, and soffits. Some of the windows have been replaced, especially those in the bay window, but it does retain the 2/2 historic window on the second floor facade. It has fishscale shingles in the gable end of the central front wing, but these may be vinyl replacements, although they maintain the Folk Victorian appearance of the house, along with the turned porch column and the original building form with its complex roofline and its irregular cross plan configuration that is distinctive to Folk Victorian houses.

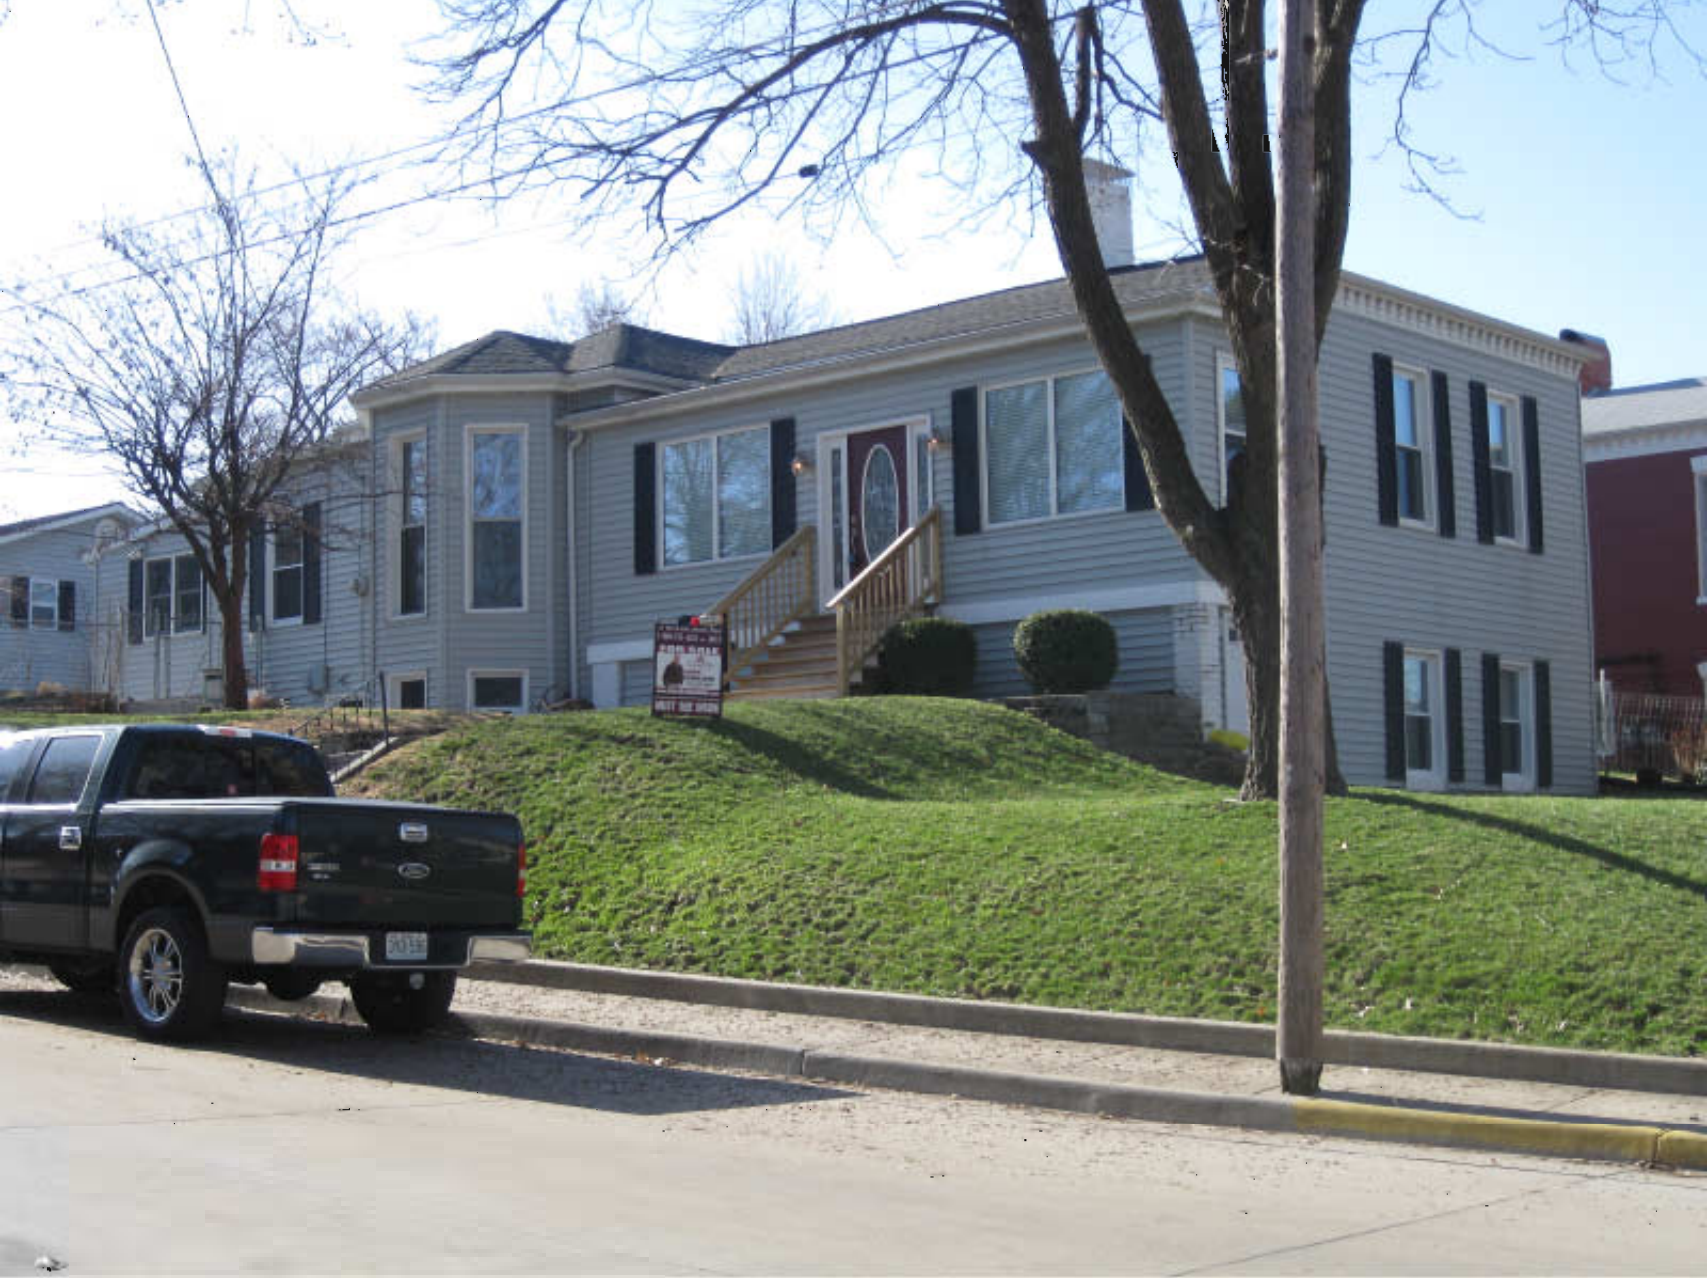
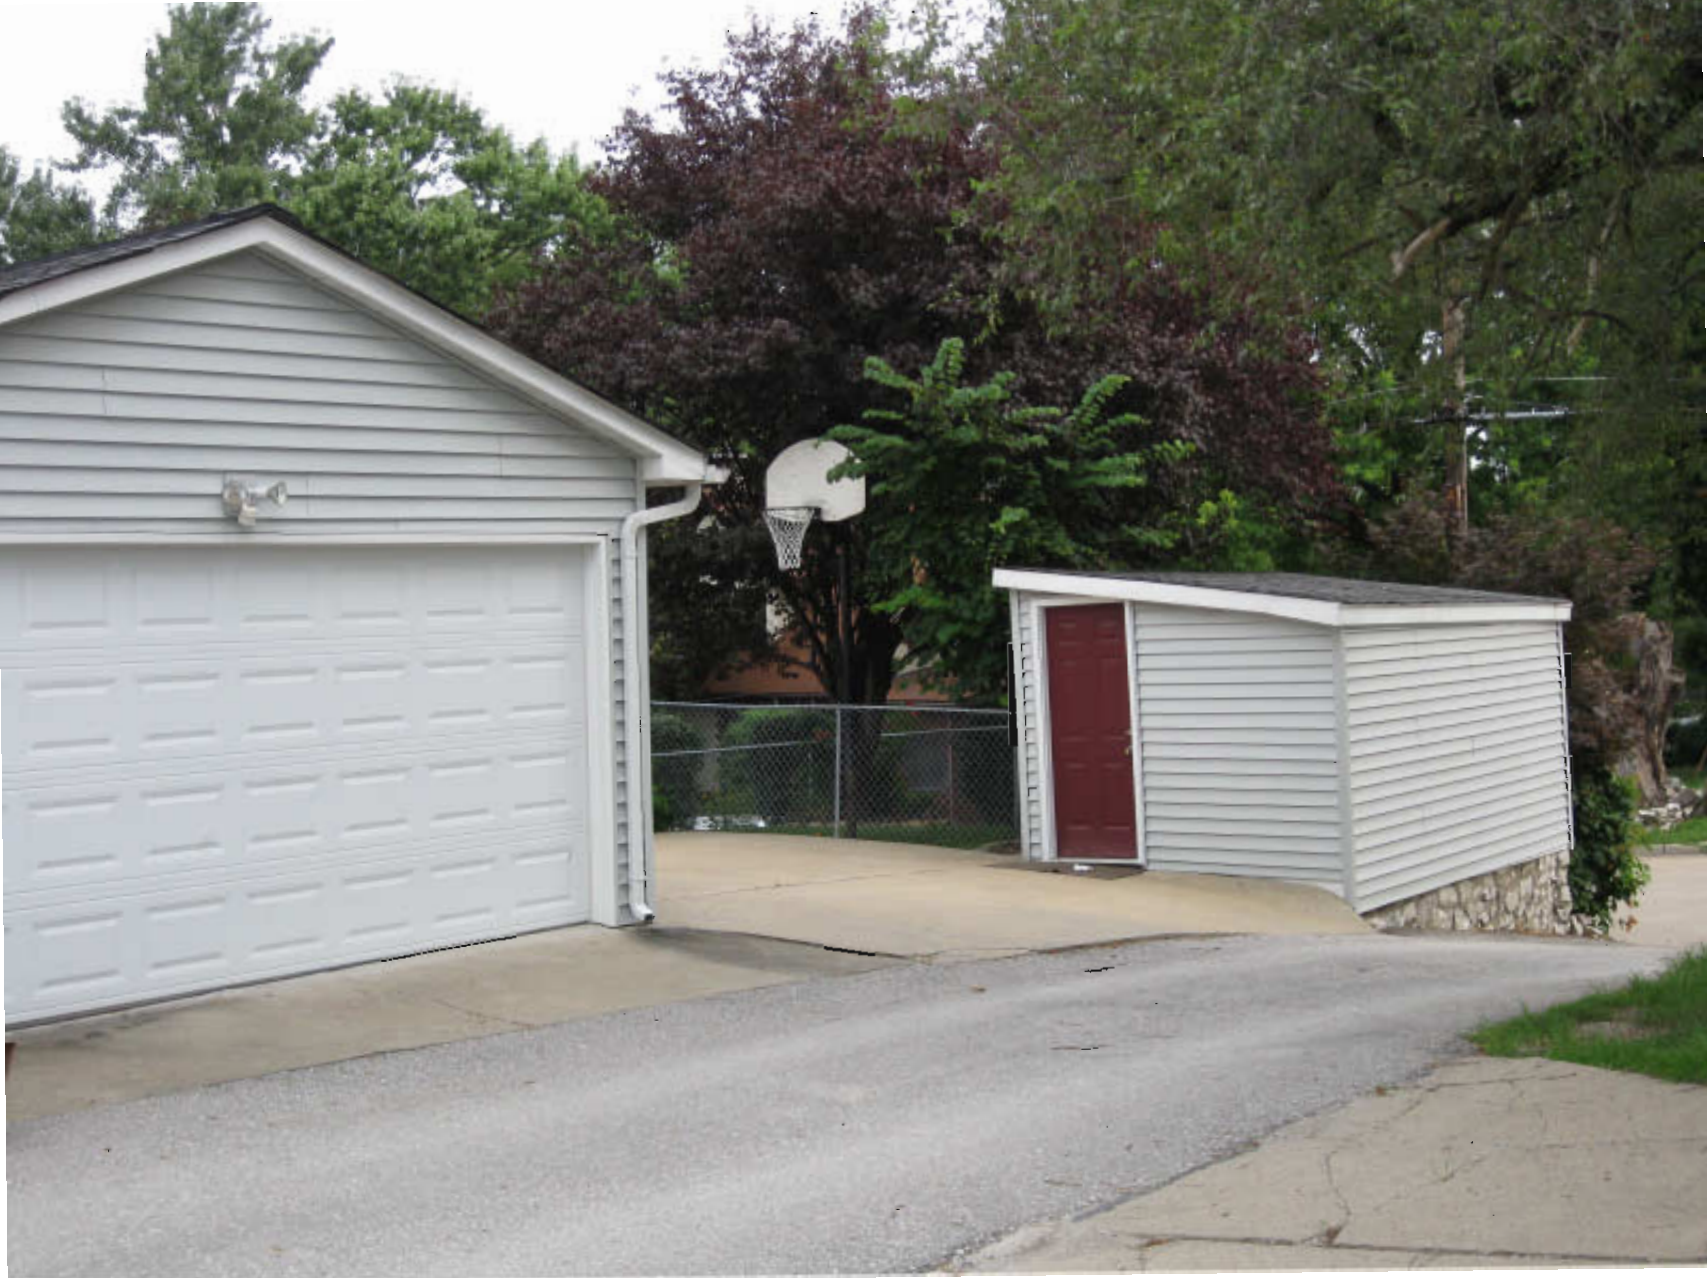
This one story, brick Folk Victorian residence retains the brick dentil molding on the north and west elevations just below the shallow hipped roofline, but the entire house has been clad in vinyl siding, obscuring the masonry walls. It still retains enough of its original plan to identify it as a Folk Victorian design originally, including the original canted bay window on the facade that projects from an intersecting cross gable, which originally represented the eastern end of what was a T-shaped floorplan. Between 1900 and 1909, the house was enlarged, adding the section immediately to the east of this bay window. Then between 1910 and 1917, the hipped roof porch was added, spanning from the bay window to the west corner of the facade. In recent years, a shed roofed addition was added to the east end of the house and the former front porch was enclosed, with large slider windows on either side of the sidelighted door. Its former use as a porch is still evident with the brick corner piers connected by a flat fascia board. The house has been resided in vinyl siding and fake shutters added to what is now a six bay facade and to the pair of windows on both the first floor and exposed basement level on the west side. The windows have been replaced with vinyl 1/1 windows. The extensive alterations obscure much of the architectural character that identified this building historically.

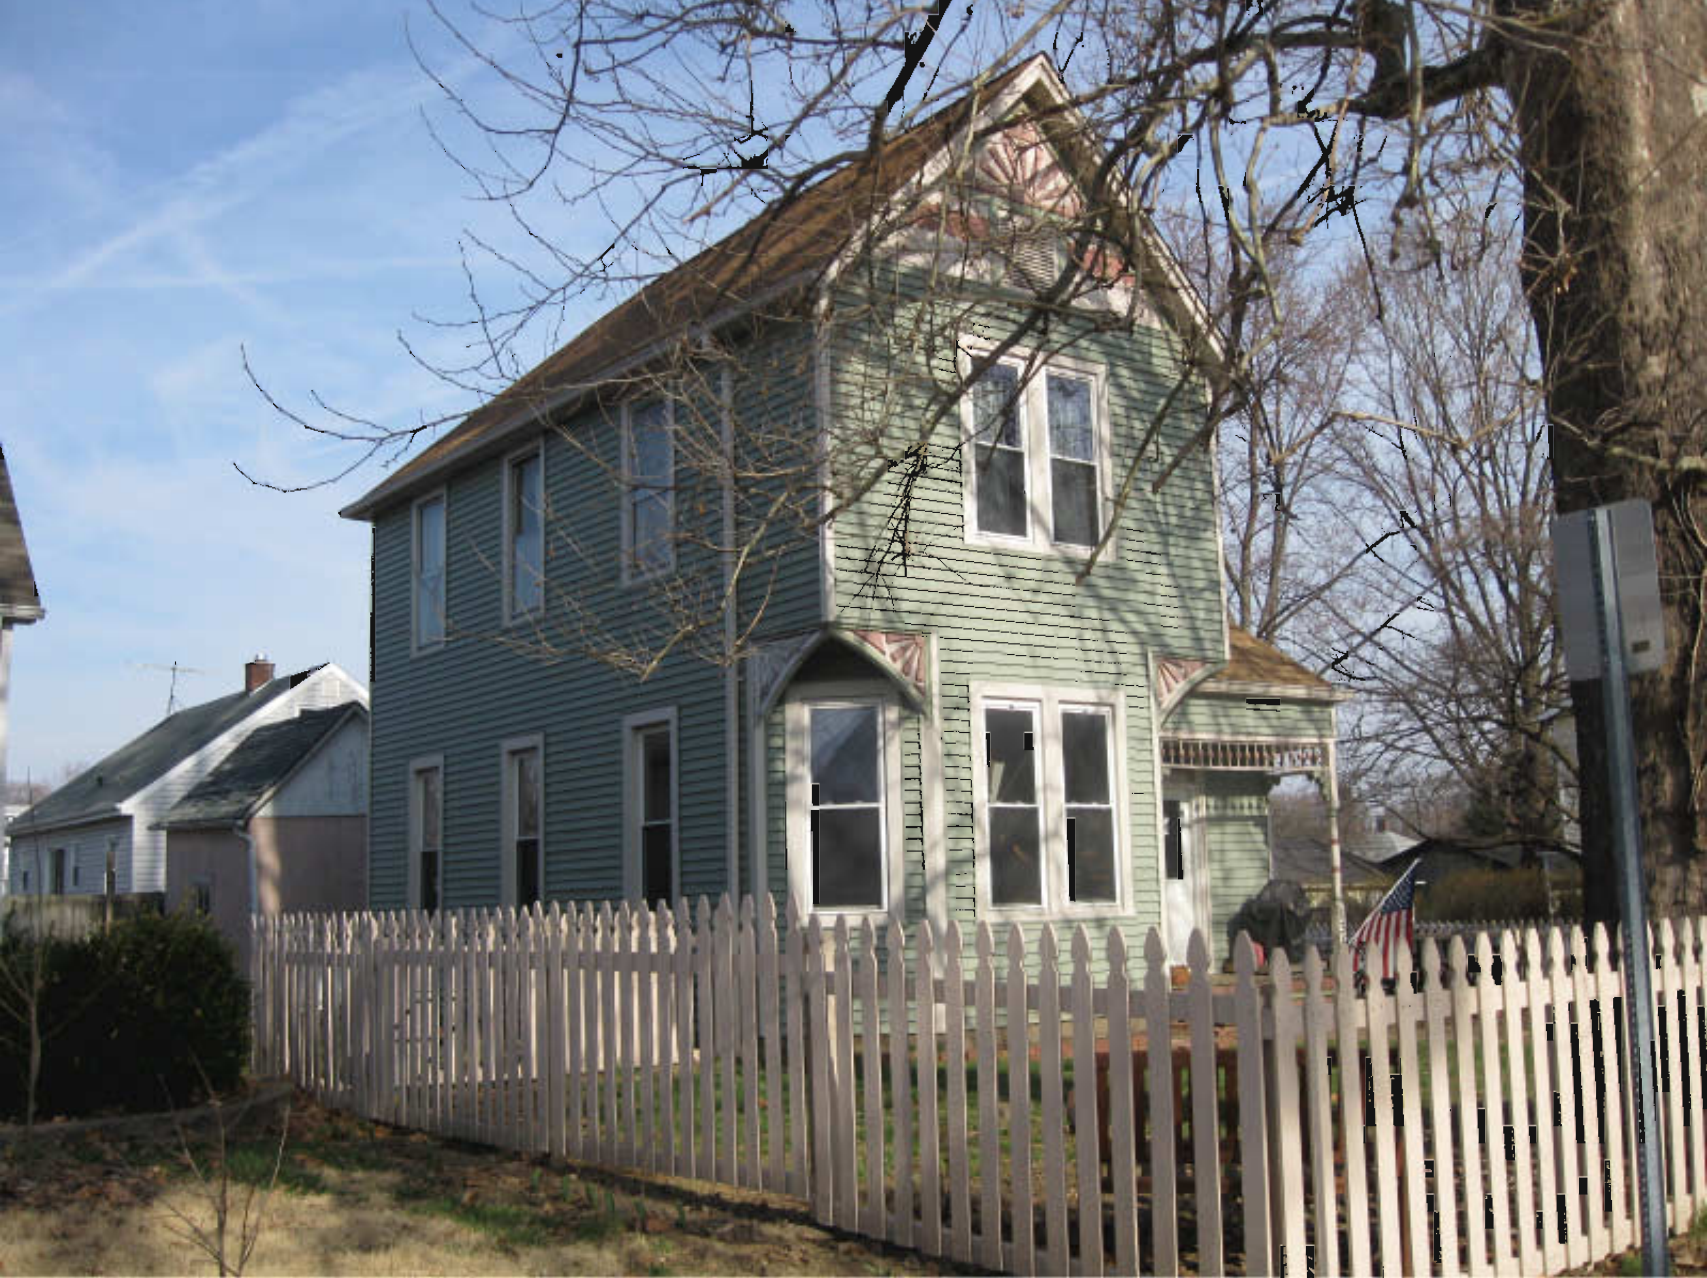
This Folk Victorian residence is a two story, frame, L-shaped house with a gabled roof. Although the 1917 and 1929 fire insurance maps show a different footprint, it is apparently just a change in how the small eyebrow dormer enclosure over the front corner porch is drawn, not indicating an addition because aerial photographs show that the roofline still forms an L-shaped building with this corner porch nestled on the interior corner. Set on the interior corner is a steeply pitched hipped roof that has eyebrow dormers on both sides to provide detailing to the large expanse of roofing (a feature often found on Shingle style residences where the walls and roof were all clad in shingles, merging into each other visually, but there is no indication this house was originally clad with shingles). The porch has a spindlework spandrel and a turned corner porch post with decorative brackets supporting the spandrel. The front gable end has imbricated shingles and a sunburst ornamentation in the gable end as well as sunbursts suspended over the cutaway corners on the first floor of this wing. These elements are all wood, carefully preserved, even though vinyl siding now clads the house. On each level of the front gable end wing there are paired sashed 1/1 windows that appear to be replacements although it is likely they were also originally 1/1 windows. On the south side, the three bay depth of the building is clearly visible, with vertically aligned windows in each bay. There are additional 1/1 windows in the cutaway corners of the front wing and there is a slender 1/1 sashed window above the front porch, facing east. The front door is not visible behind the storm door and the foundation has been coated in concrete stucco.

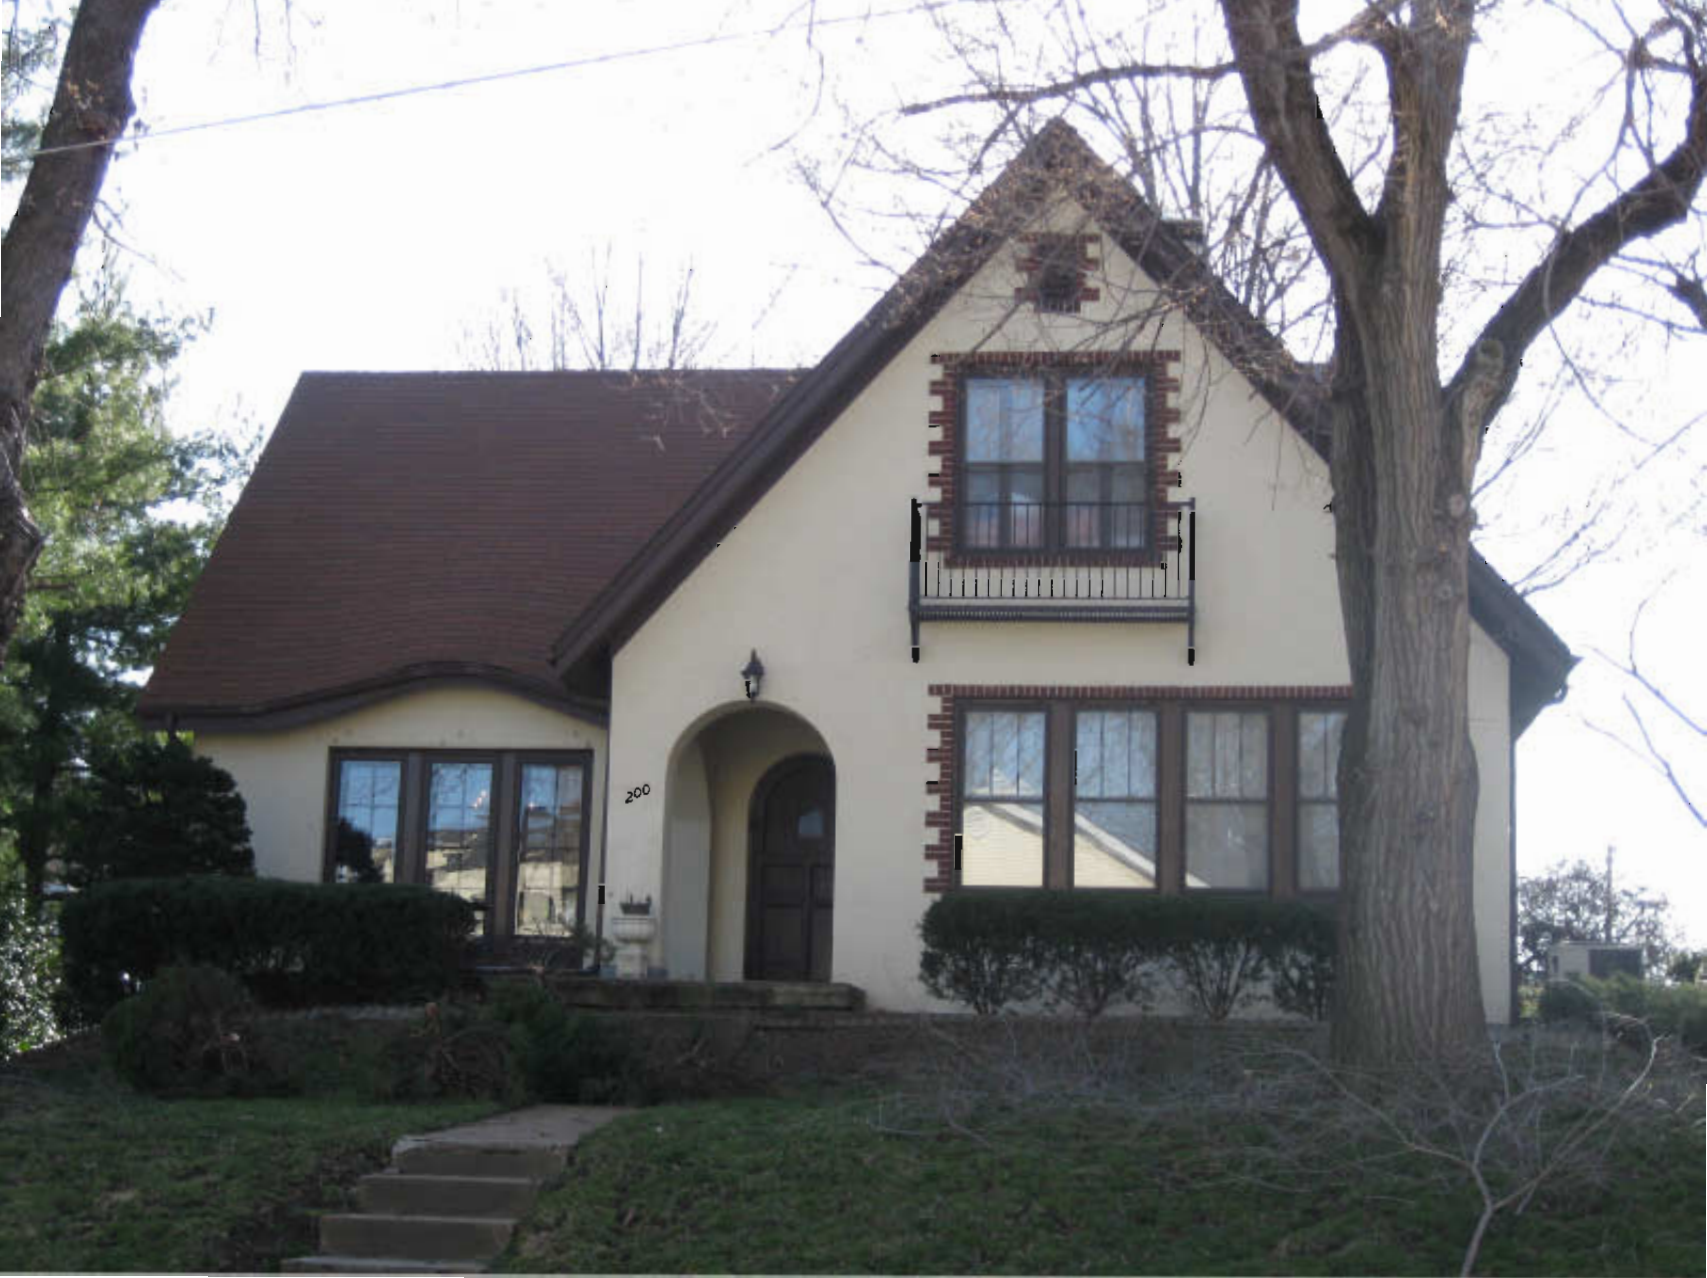
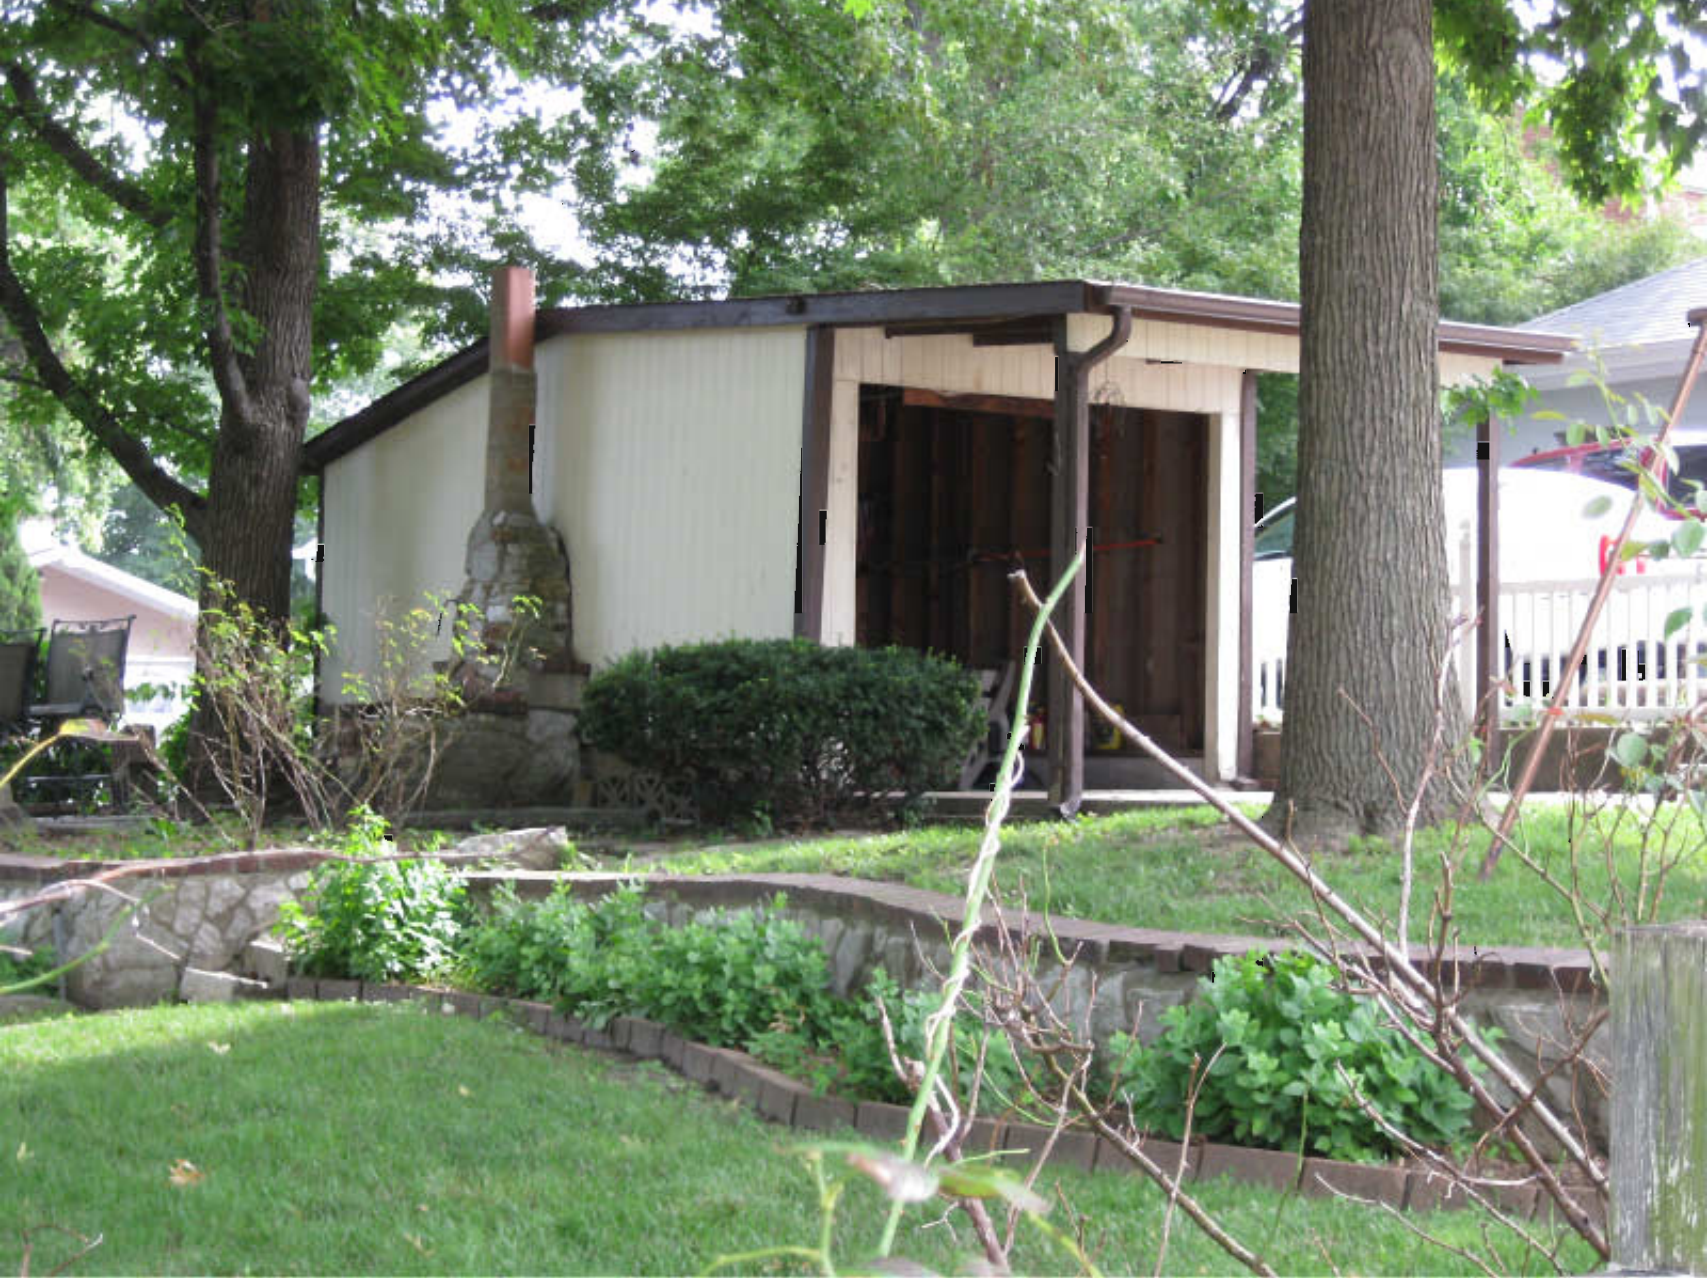
This 1.5 story, stucco, Tudor Revival residence has a steeply pitched gabled roof with a broad intersecting crossed gabled wing, projecting toward the street to create an L-shaped floorplan. The roof, fascia and eaves on the facade north of this cross gable has been bowed to evoke the thatched roofs found on English rural cottages. Below, there are three 8-light French doors clustered together. In the northwest corner of the gabled wing is a recessed corner porch, with round arched openings facing south toward the street as well as on the north side. This arch form is mirrored in the round arched, wood plank door that has strap hinges with a small rectangular light. There is a wood screen door that is arched as well. Over the entry arch is what appears to be the original wrought iron lantern porch light. The stone porch floor extends outside the facade wall of the entry arch and extends across in front of the cluster of French doors. To the south of the entry porch are four 3/1 (vertically lighted) wood sashed windows clustered together and framed by brick quoins, lintel and sill. Above, this same brick treatment frames two pairs of casement windows with a simple iron balcony positioned below this window opening. There is also a small attic vent accented and framed by this same brick quoin treatment in the attic of this gable end. The chimney is also stucco, positioned on the right slope, in the center of the roof. Basement windows are single light. On the rear is a two-story wing with stucco on the first floor and a frame second floor, but this is shown on the 1929 map, indicating it was original to the construction of the house. The screened in porch at the southeast corner of the house was added after 1947 but does not affect the streetscape view of the property. The only other visible alteration are the storm windows and a 1/1 window in the south gable end.
