ARCHITECTURAL/HISTORIC INVENTORY FORM

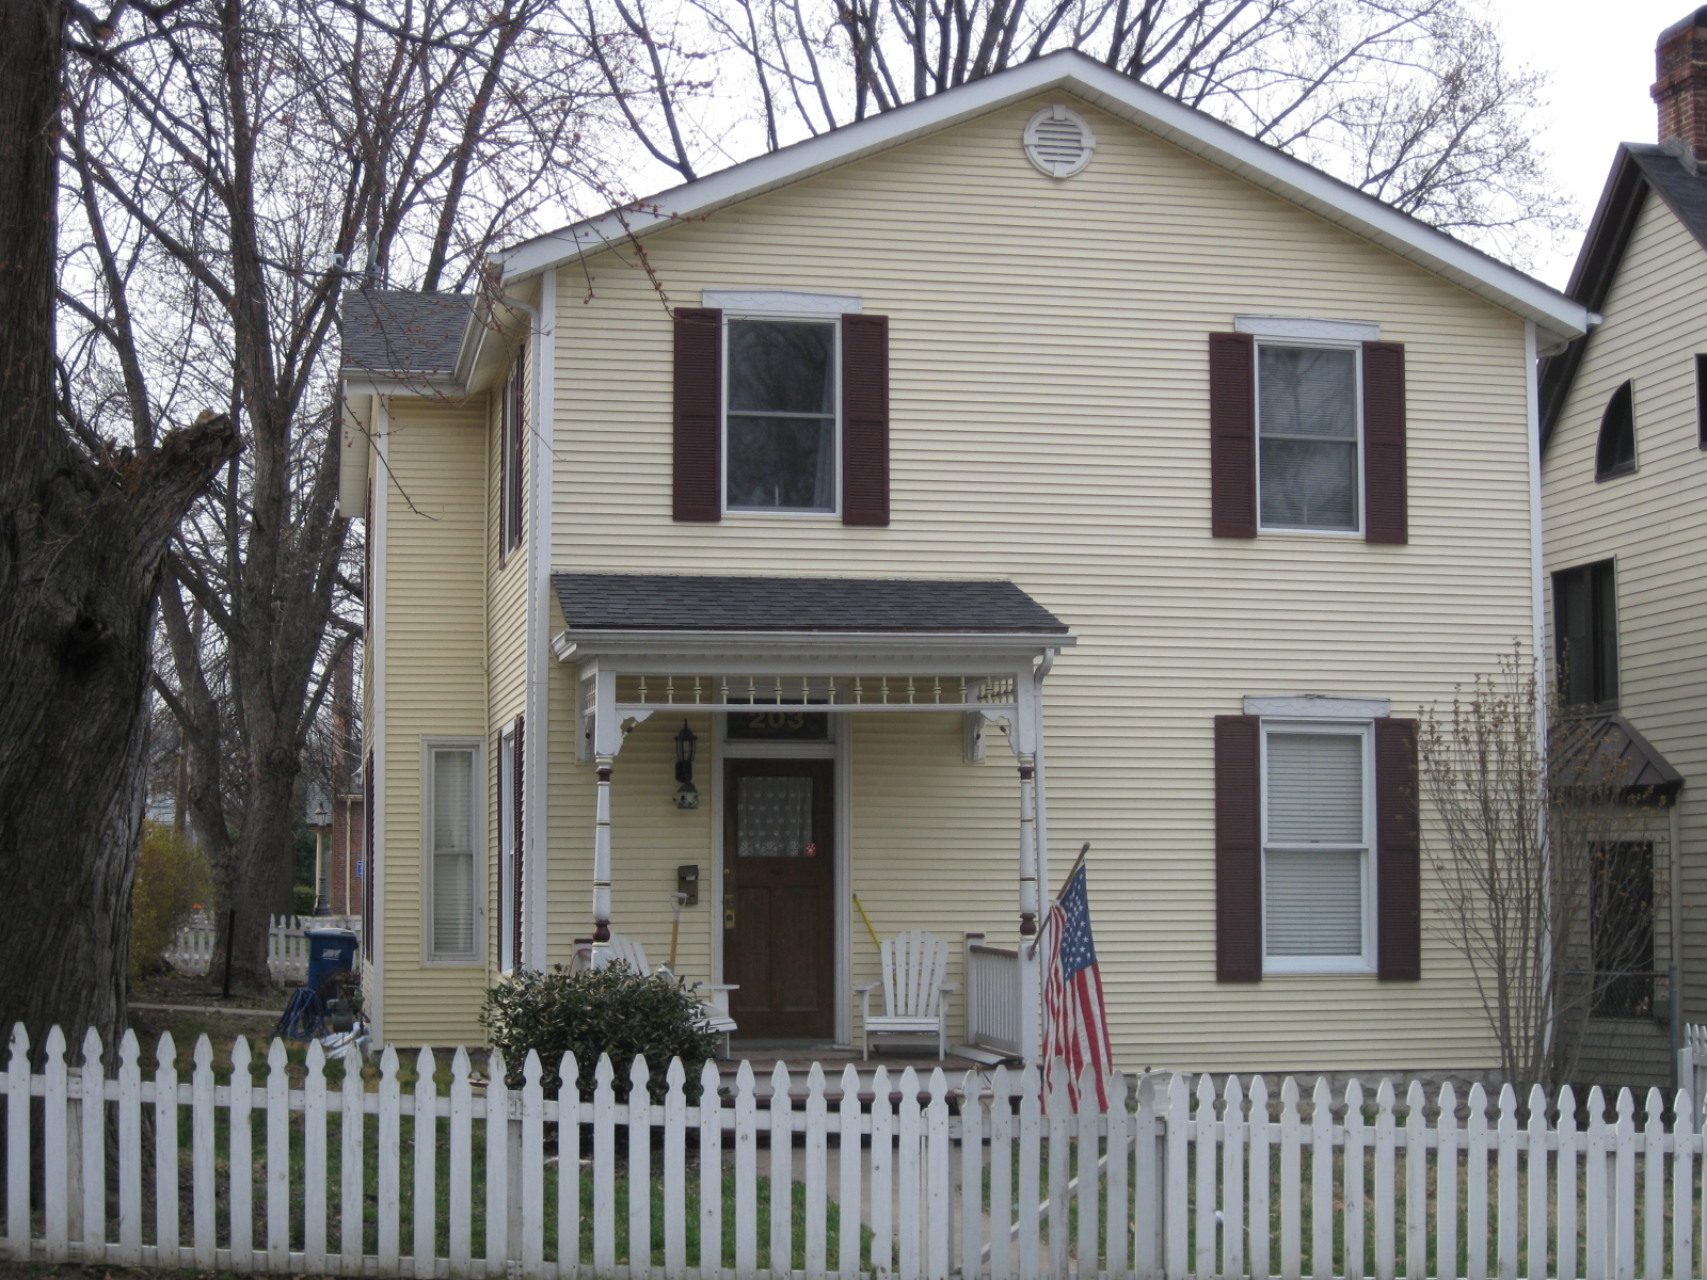
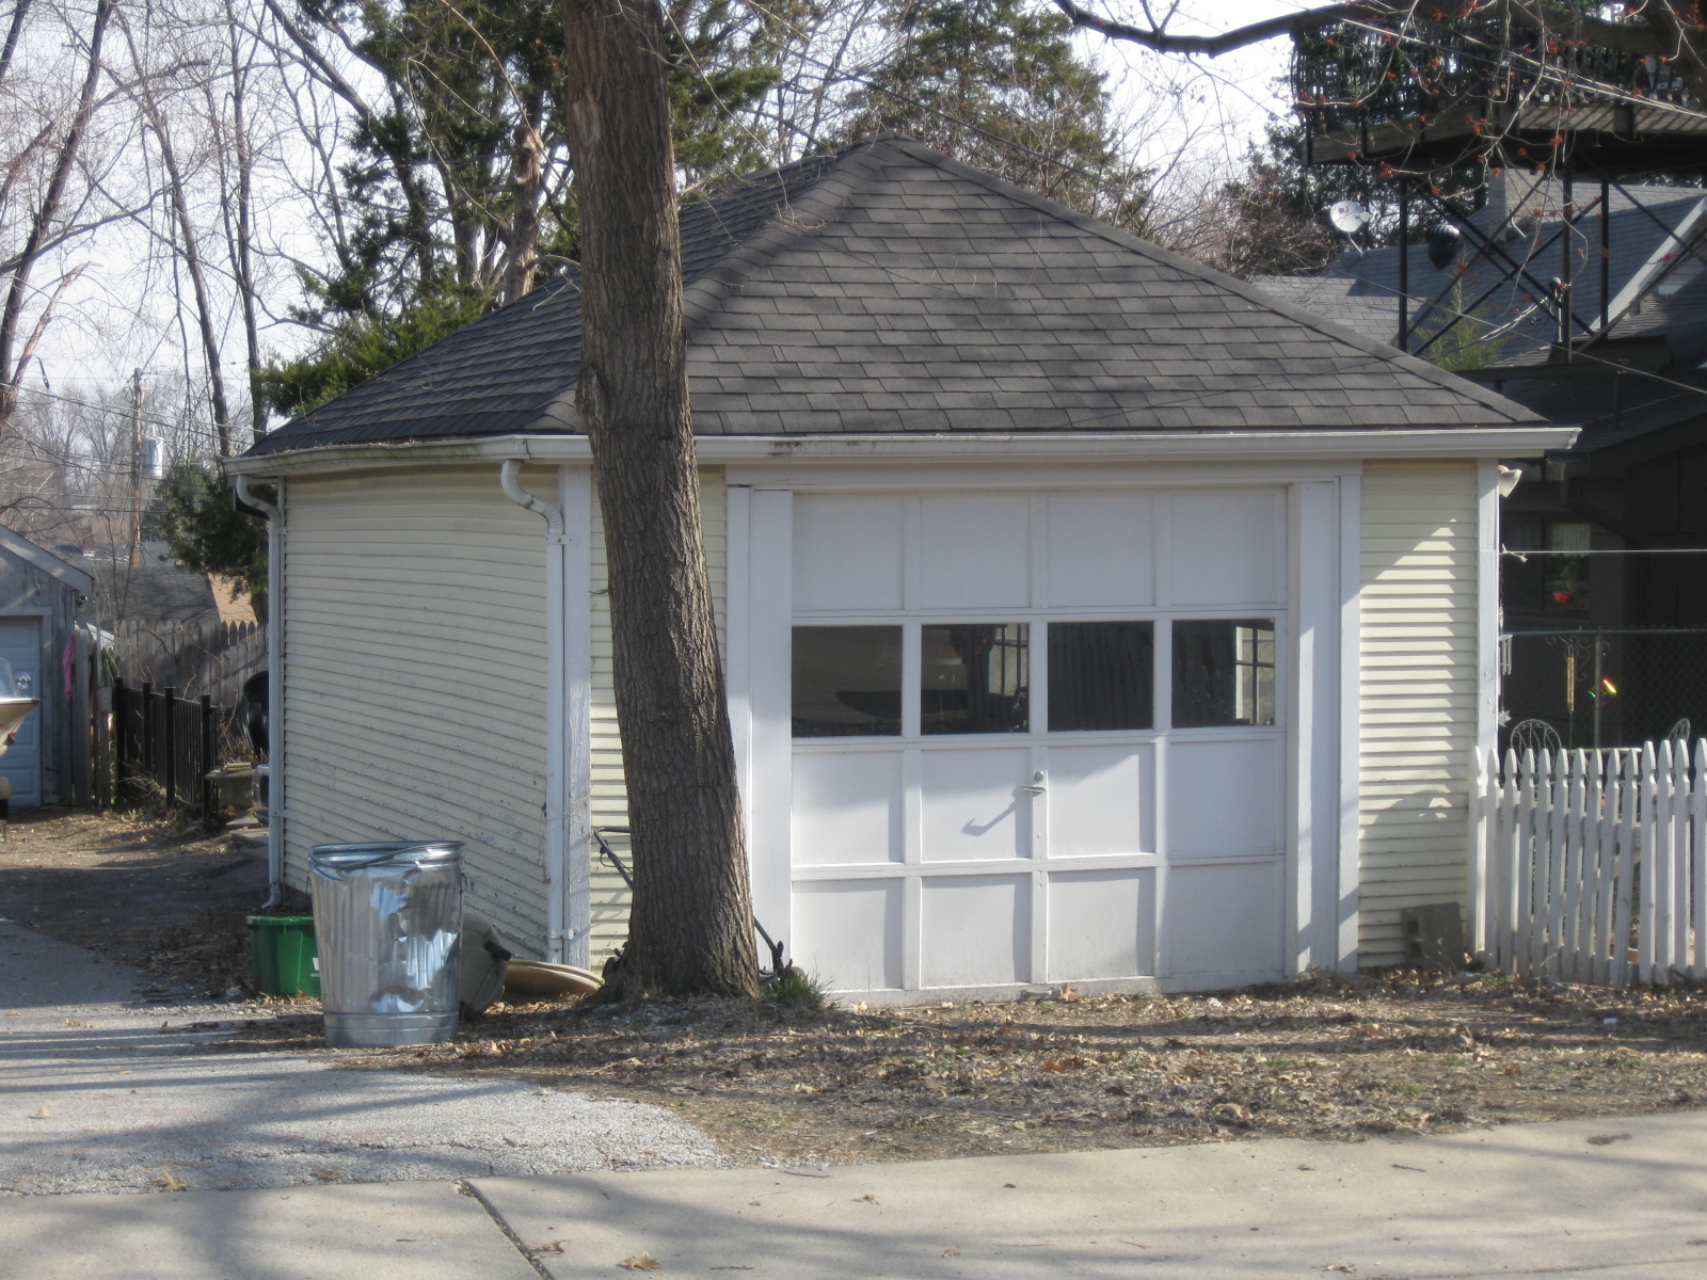
This two story frame house was historically a 1.5 story, front gabled house with imbricated shingles in the front gable; however, the roof height was increased and the pitch decreased at some point after 1988, but the original shed roofed, one-bay front porch was retained. The façade is divided into two vertical bays. There is a 1/1 wood sashed window on the first floor and newer 1/1 windows upstairs. The porch retains the bracketed apandrel and turned corner posts reesting on the low wood porch floor, all characteristic of the Late Victorian design. The door, with its two tall vertical panels and square light, may be the historic door. The house has vinyl siding and incised lintels (which do not appear original).

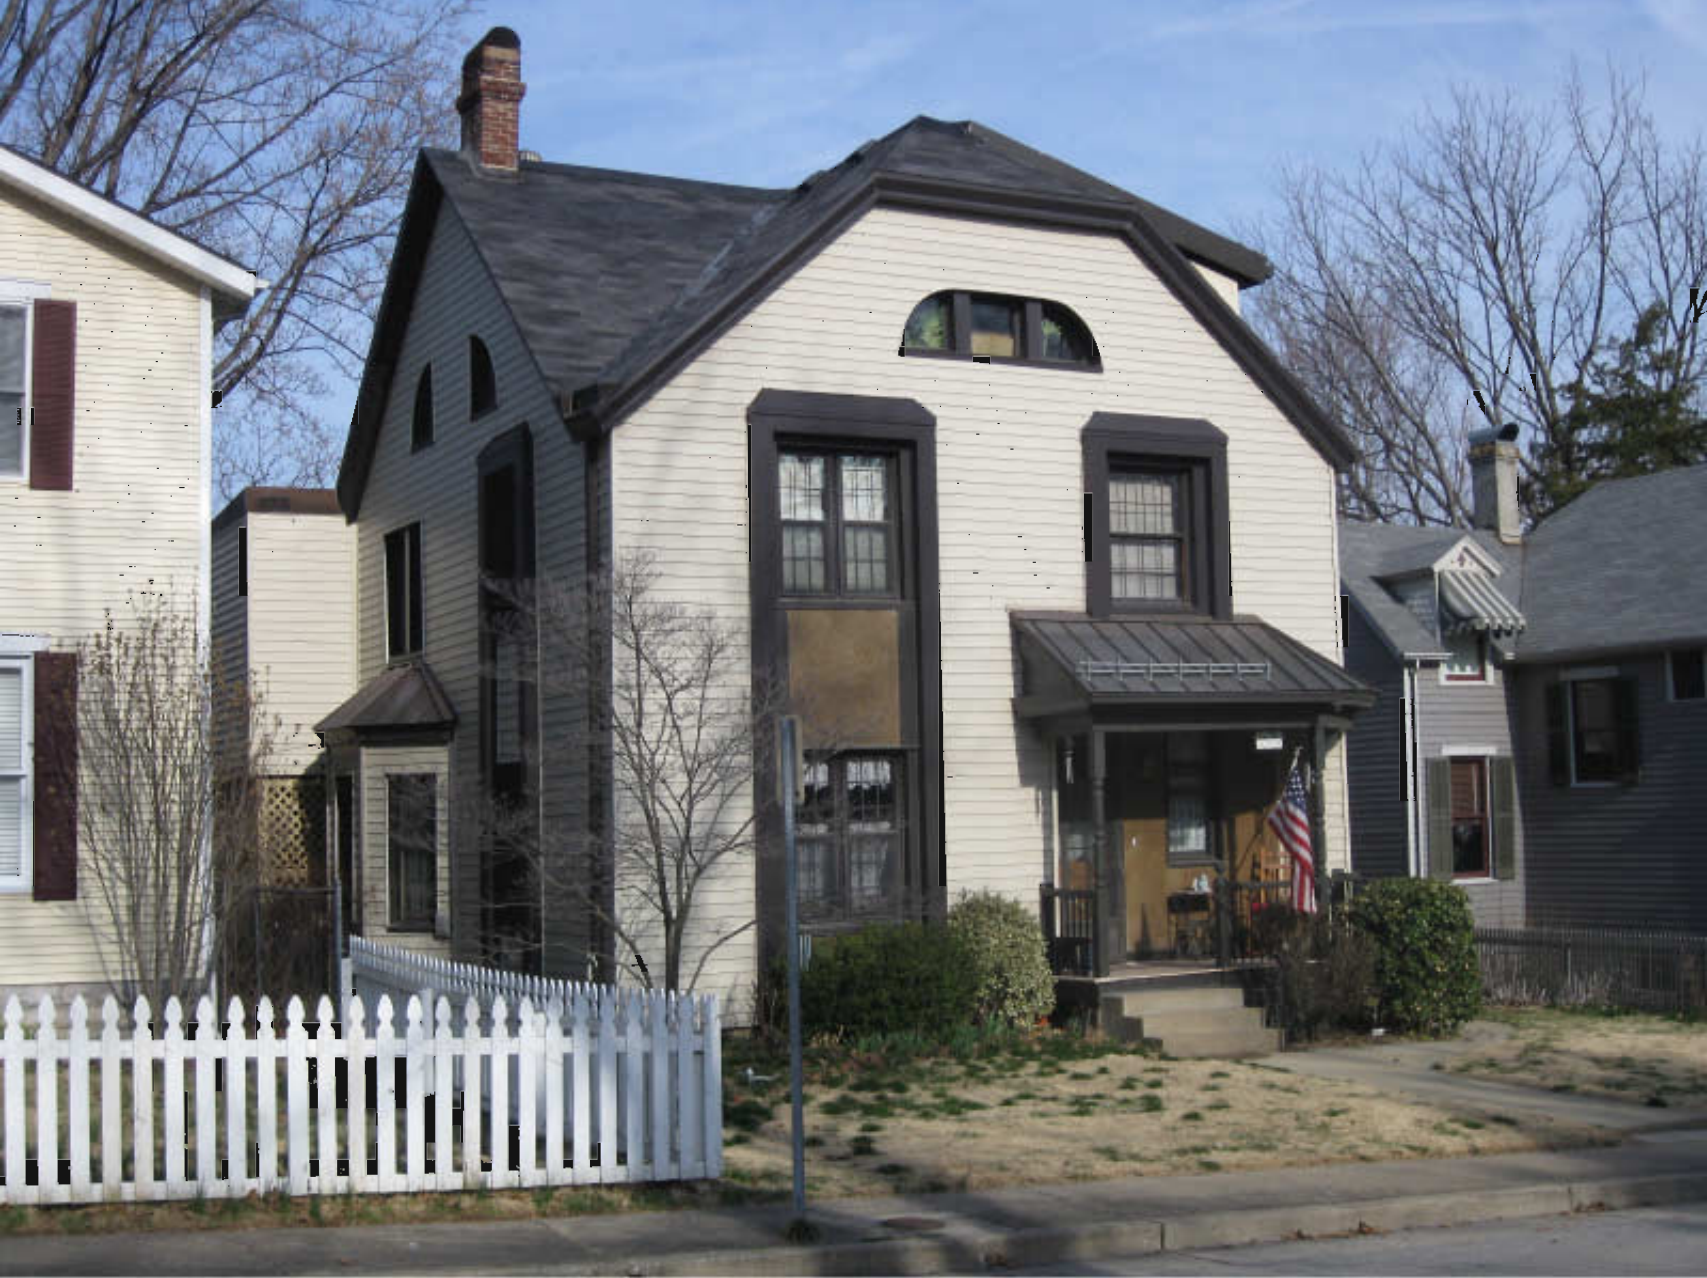
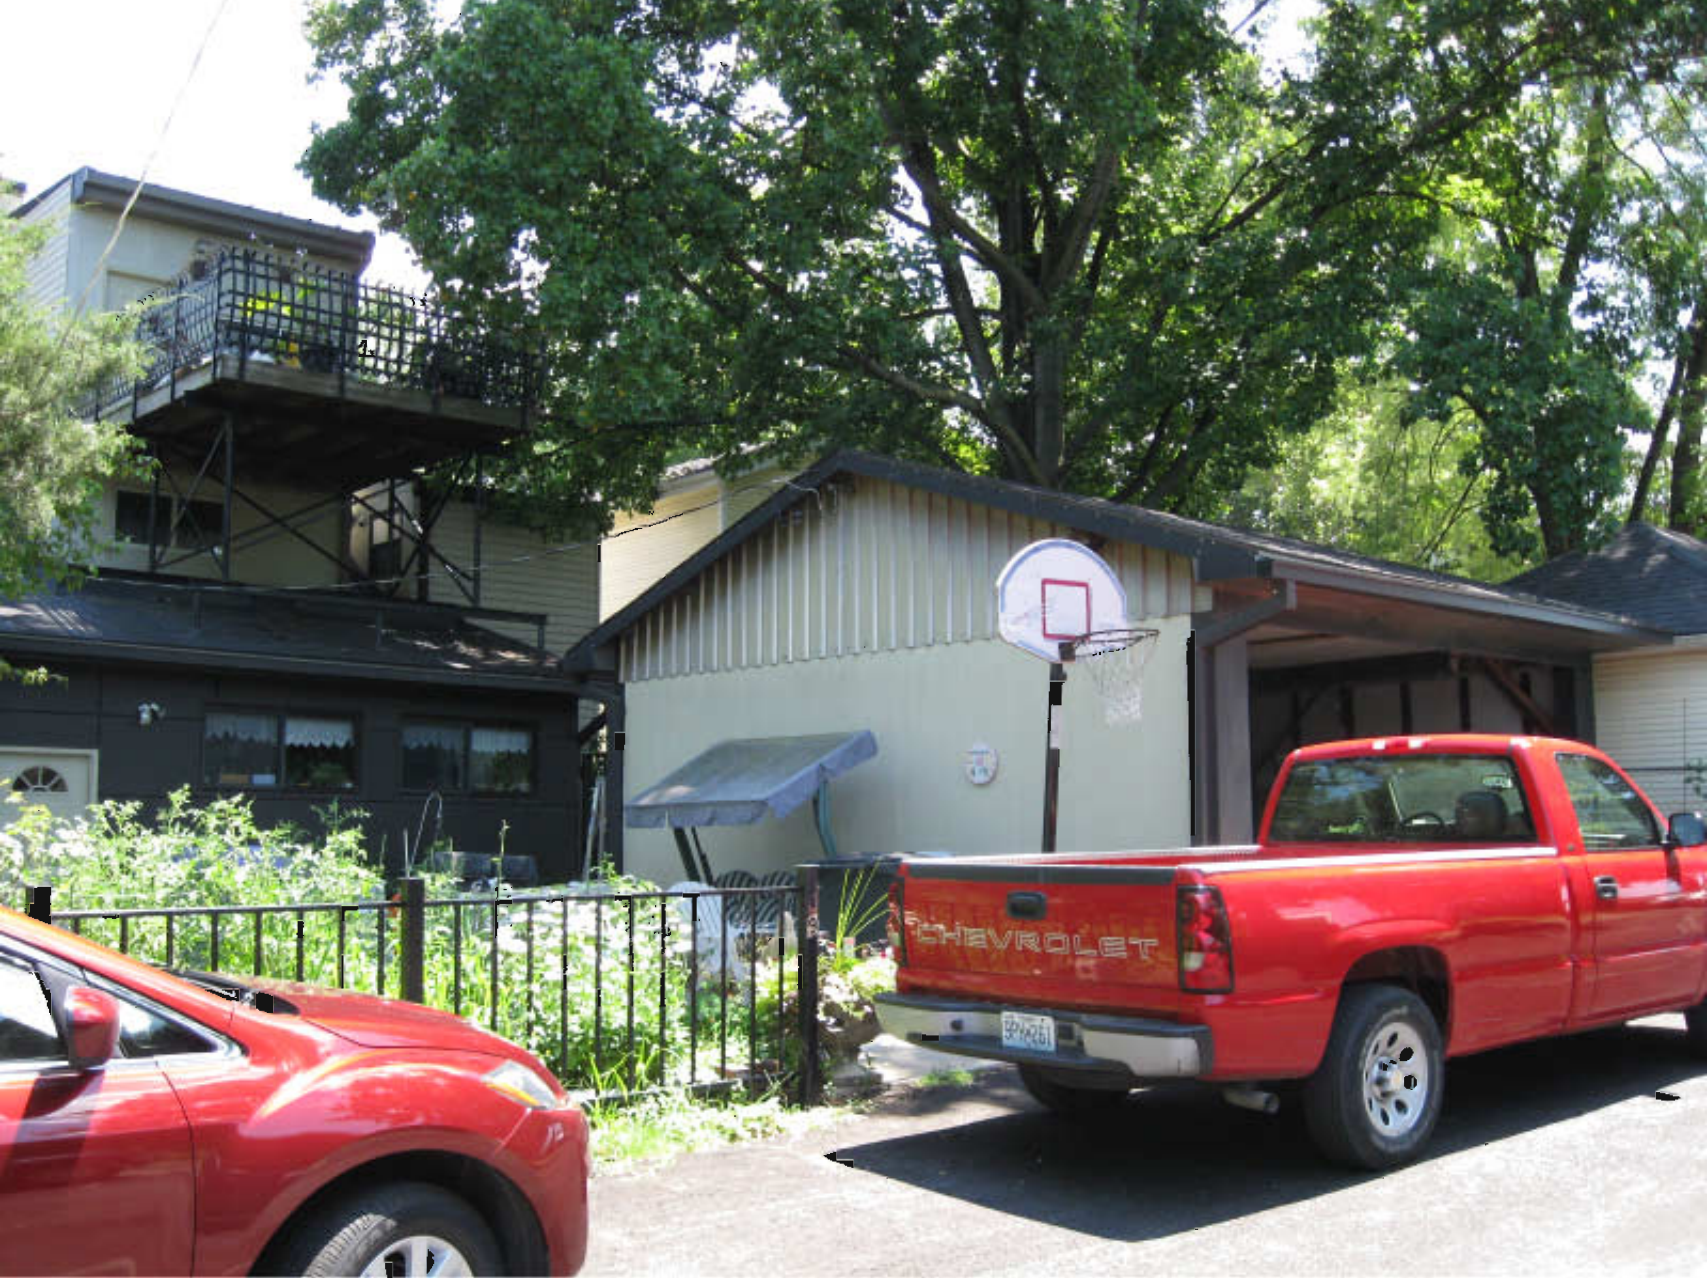
This 2.5 story house appears to have had numerous alterations, disguising or removing the original Late Victorian stylistic features, although the basic house plan, including the small front porch in the north bay of the two bay facade, and the canted bay window on the south side, conform to the shape identified on the fire insurance maps. The house was originally a T-shaped plan with a cross gable forming the front wing, but it now has a shed roofed dormer (added in 1988) on the north side and a shallow mansard roof on the two story addition across the rear of the building. The front porch has a nonhistoric standing seam metal roof, but retains the dentil molding on the fascia, the curved shape on the north end and the turned corner posts may be historic as well, but the railings are newer. The half-light, horizontal paneled door and 1/1 window under the porch roof are set into a stucco wall panel that spans the area under the porch. The window above the porch and the bay of windows on the south end of the facade, as well as in the front bay of the south elevation are framed by heavy framework connected between the floor levels by stucco panels and have replacement multipaned windows. The remaining walls have replacement vinyl siding. There are pairs of quarter-round windows on the south side as well as the facade (on the facade they flank a small square window), all of which appear to be remnants of historic features. In 1917-1929 the rear one story wing was enlarged and at some point after 1947 it was extended even further south and became a full two story wing spanning the rear of the house.

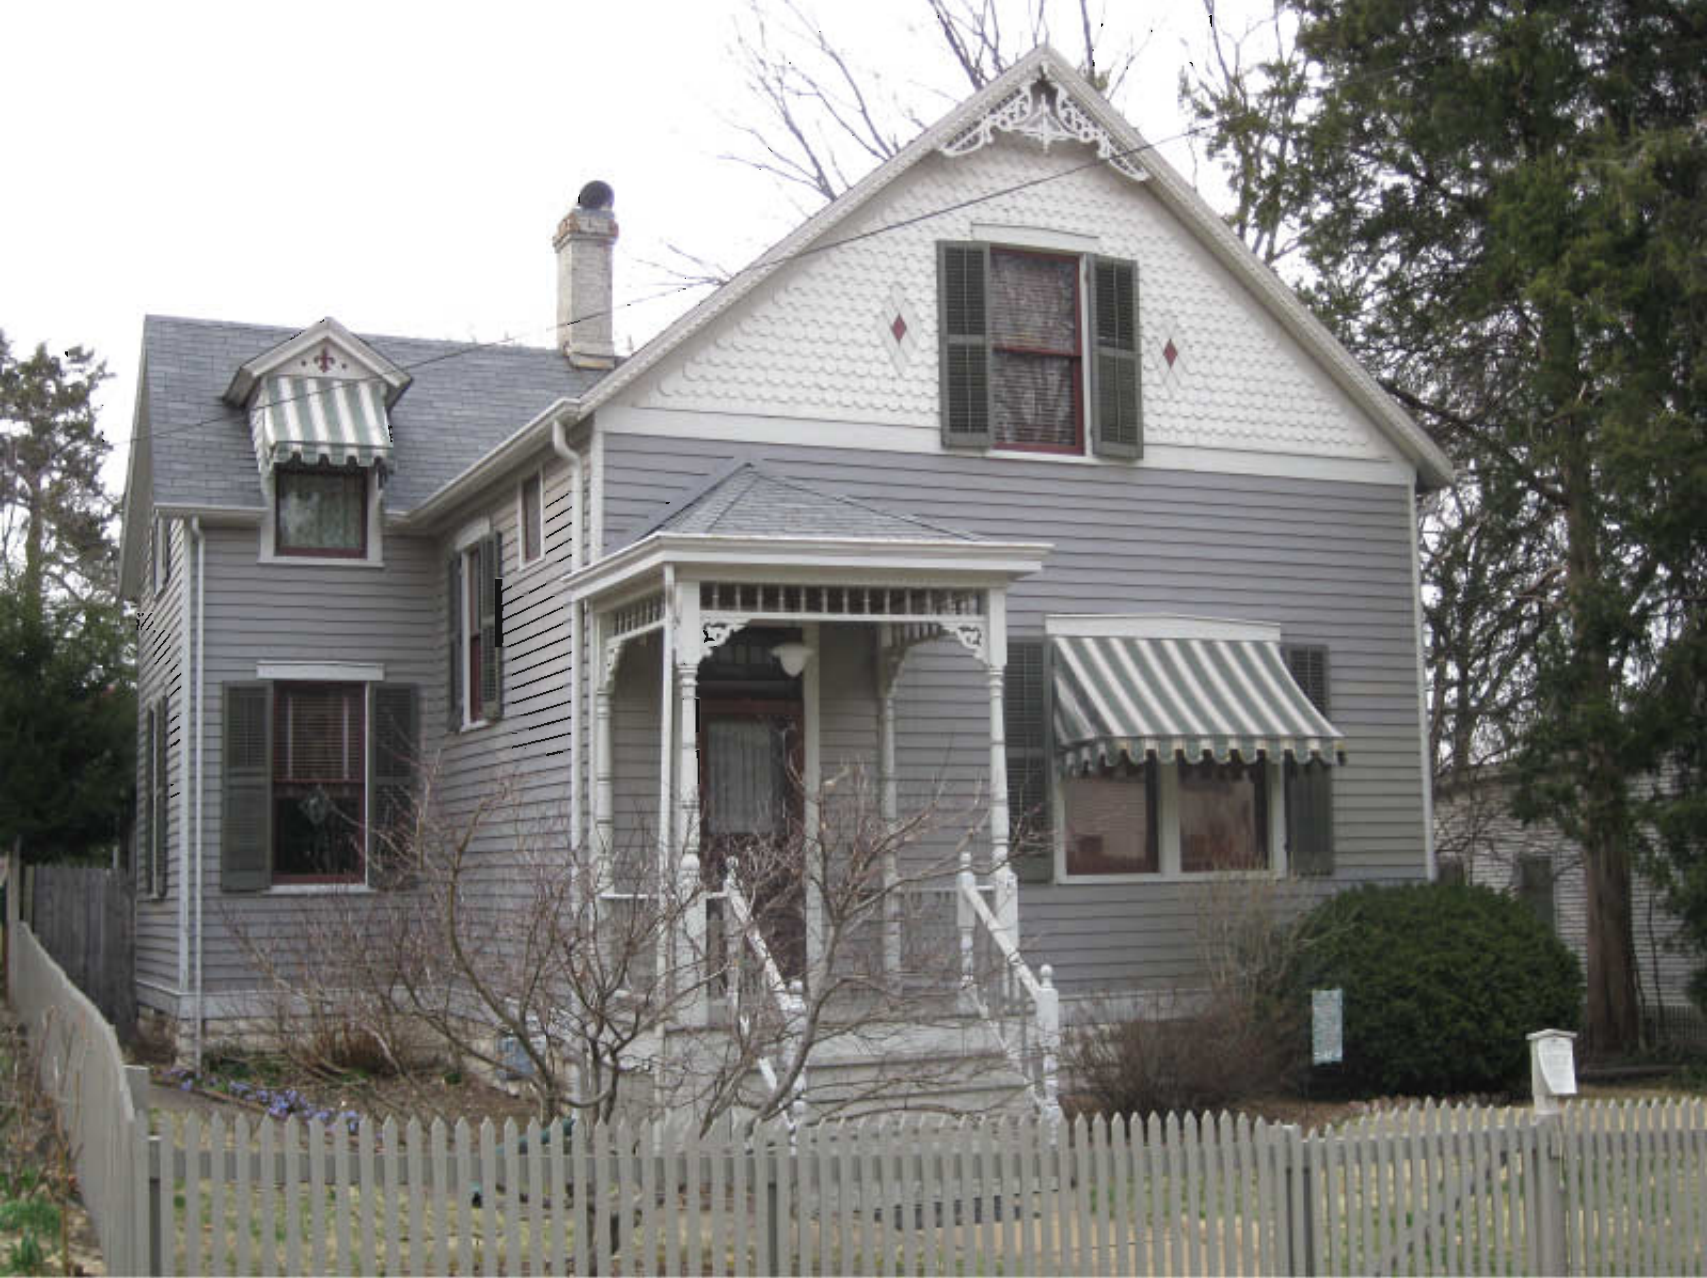
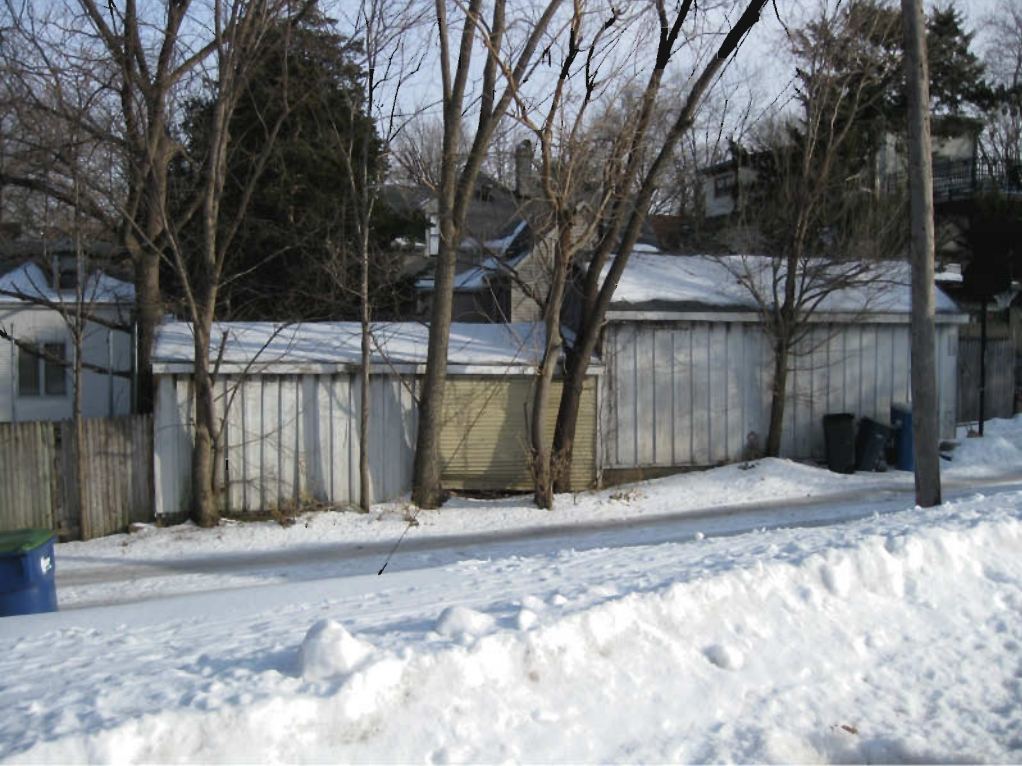
This 1.5 story, frame, Folk Victorian residence has a side gabled roof with a broad, cross gable wing on the front. The entry porch is located on the south bay of this cross gabled wing. It has a hipped roof, spindlework spandrels and scrollwork brackets on the turned corner porch posts on top of the wood porch floor and wooden steps. The railings are an Eastlake design and now extend down both sides of the stairs, but the railings on the stairs may be a later alteration, done in keeping with the historic details of the house. The transomed door is a half-light wood paneled door with three small square panels over two horizontal panels and it has a wooden storm door. The gable end of the cross gable is clad with a variety of shaped shingles while the other walls are clapboard. The narrow bargeboard of the front gable is scalloped and there is a scrollwork and spindlework bracket in the gable end. Facade and front cross gable windows are 1/1 wood sashed windows with decorative, incised, peaked lintels and wood louvered shutters. The front cross gabled wing has paired windows in the north bay and a single window above. In the south side gabled bay is a similar window with a gabled wall dormer with a fleur-de-lis in the gable end. There is a brick chimney which retains its corbelled cap at the ridge of the side gabled roof. The rear and side windows are 2/2 windows. Except for what may be some restoration work, the canvas awnings on some windows, and the railings on the stairs, the only possible alteration may be the facade windows which seemed to have tinted glass.

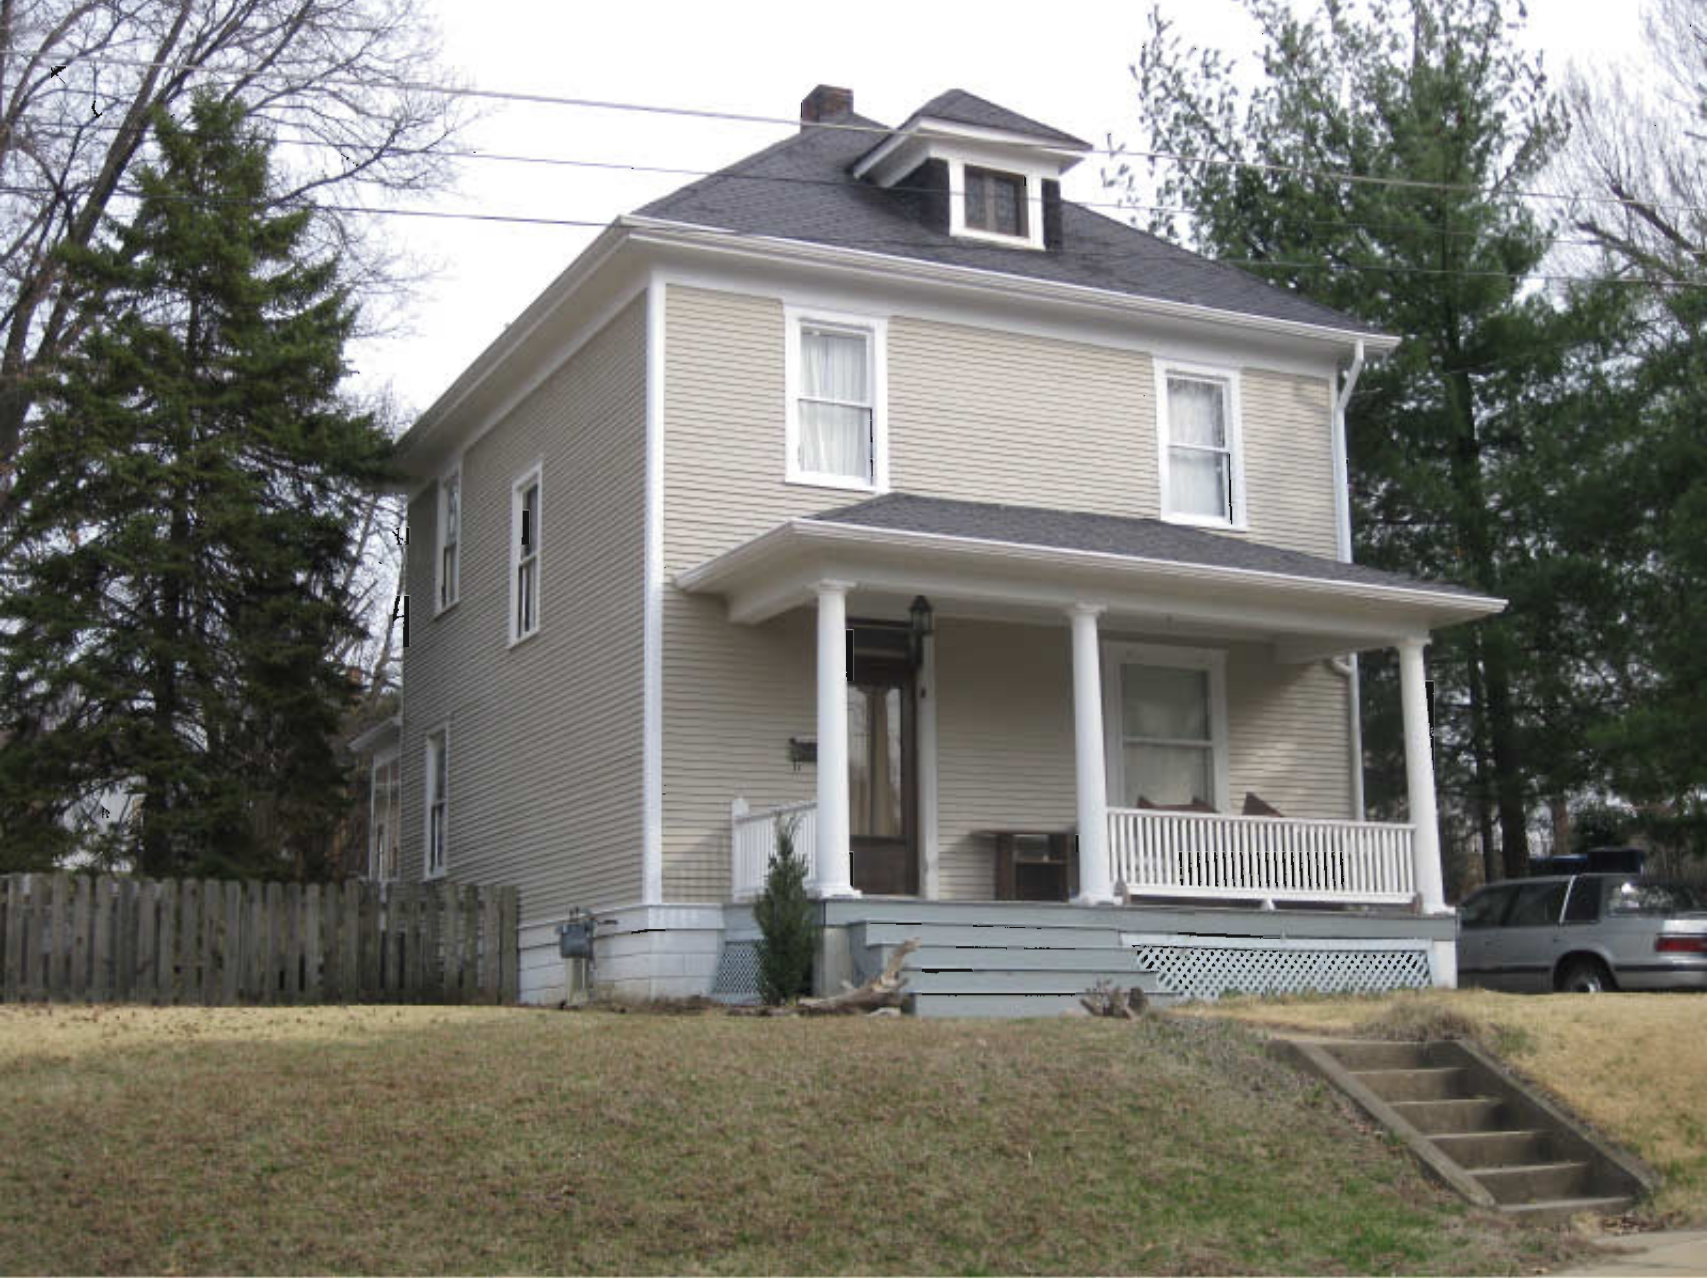
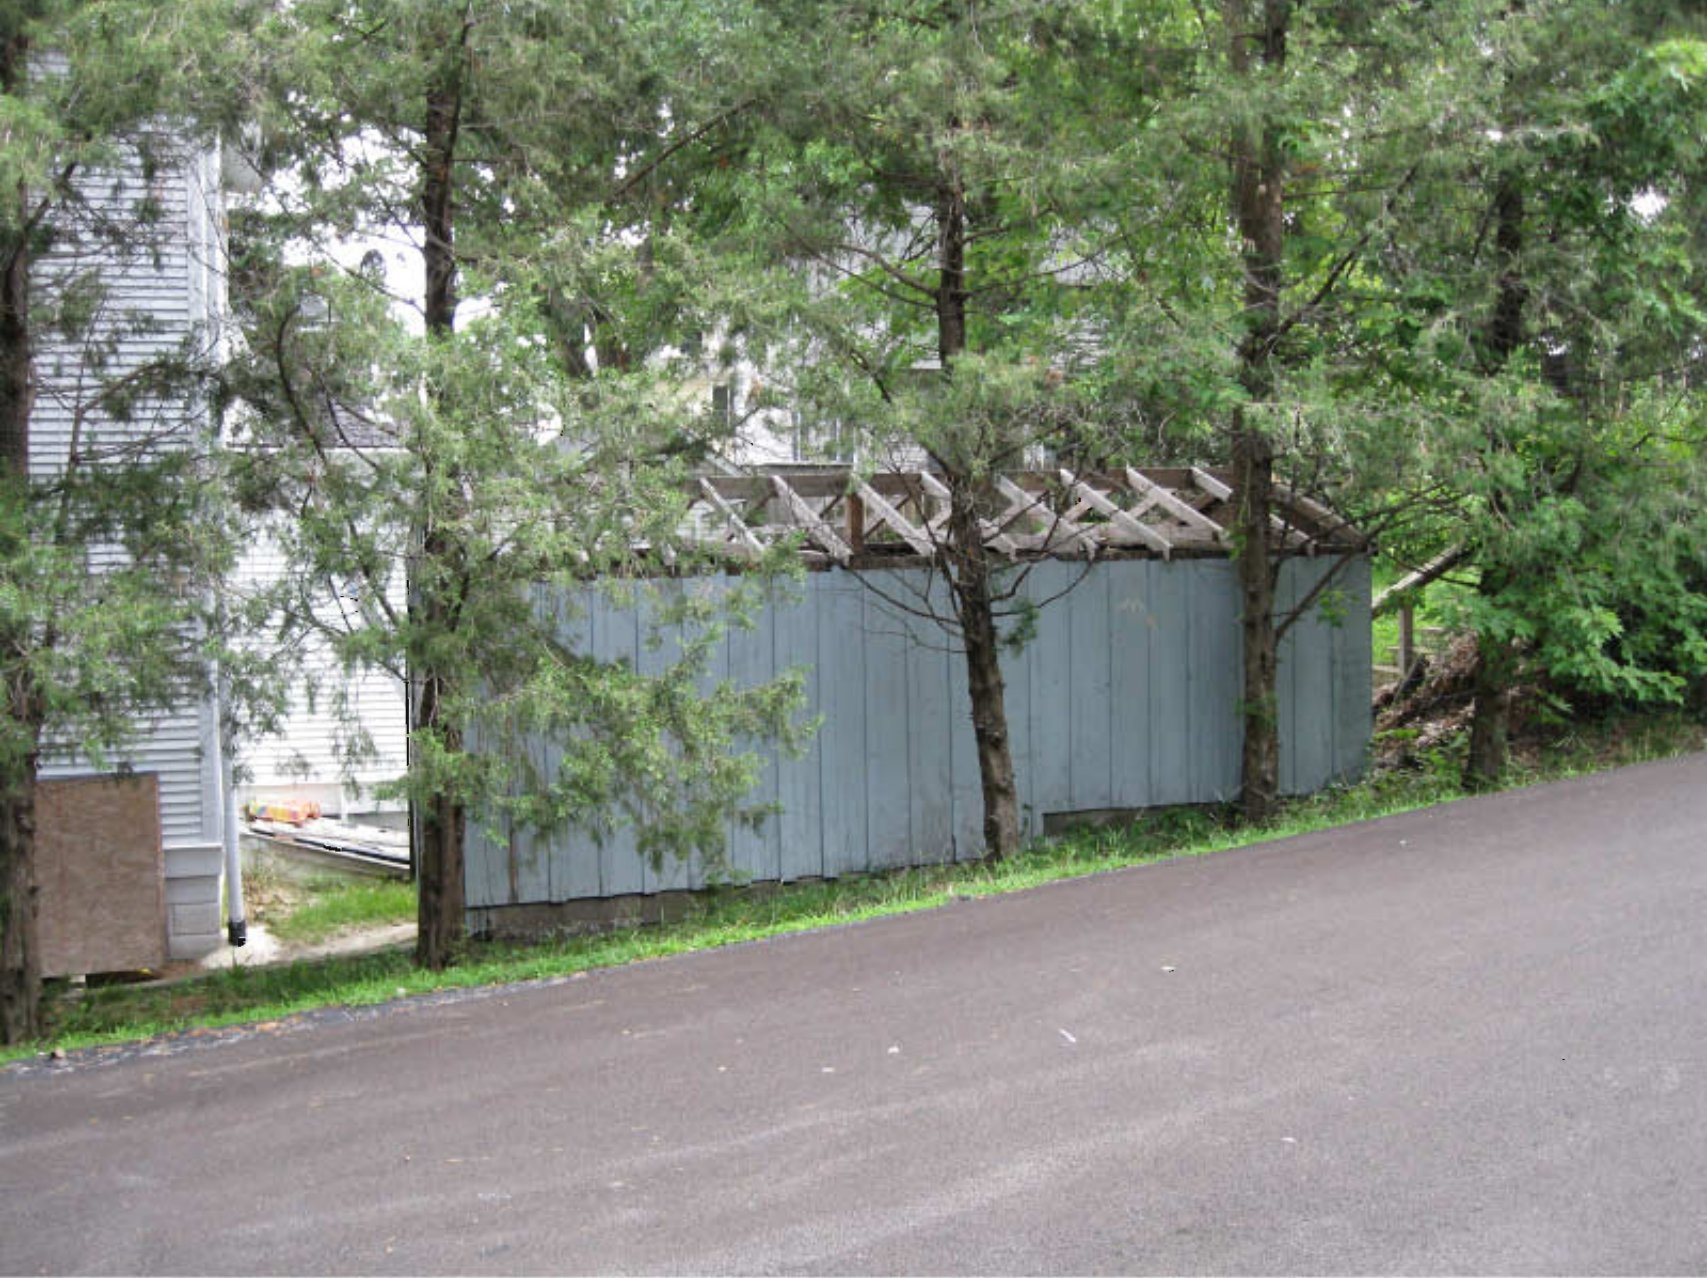
This Four Square, frame house has a hipped roof with a hipped dormer and enclosed eaves. The walls are clapboard with cornerboards and there is a scored concrete foundation. The brick chimney is centered at the ridge. The full width porch also has a hipped roof, supported at the corners by Doric columns with an additional column slightly off-center in the north bay to frame the broad, wooden porch steps leading up to the wooden porch floor. Between the columns are the original simple baluster railings. The window in the south bay, first floor is a large 1/1 wood sashed window. The two upper level windows are also 1/1 wood sashed windows, as are those on the other elevations. The dormer has a pair of casement windows. There is a hipped roof porch on the rear that has turned posts, with the south half enclosed (prior to 1929). The basement windows are 2-light windows. Like the neighboring house, the full width front porch is shown on the 1917 fire insurance map but it is mistakenly omitted from the 1929 and 1947 maps.

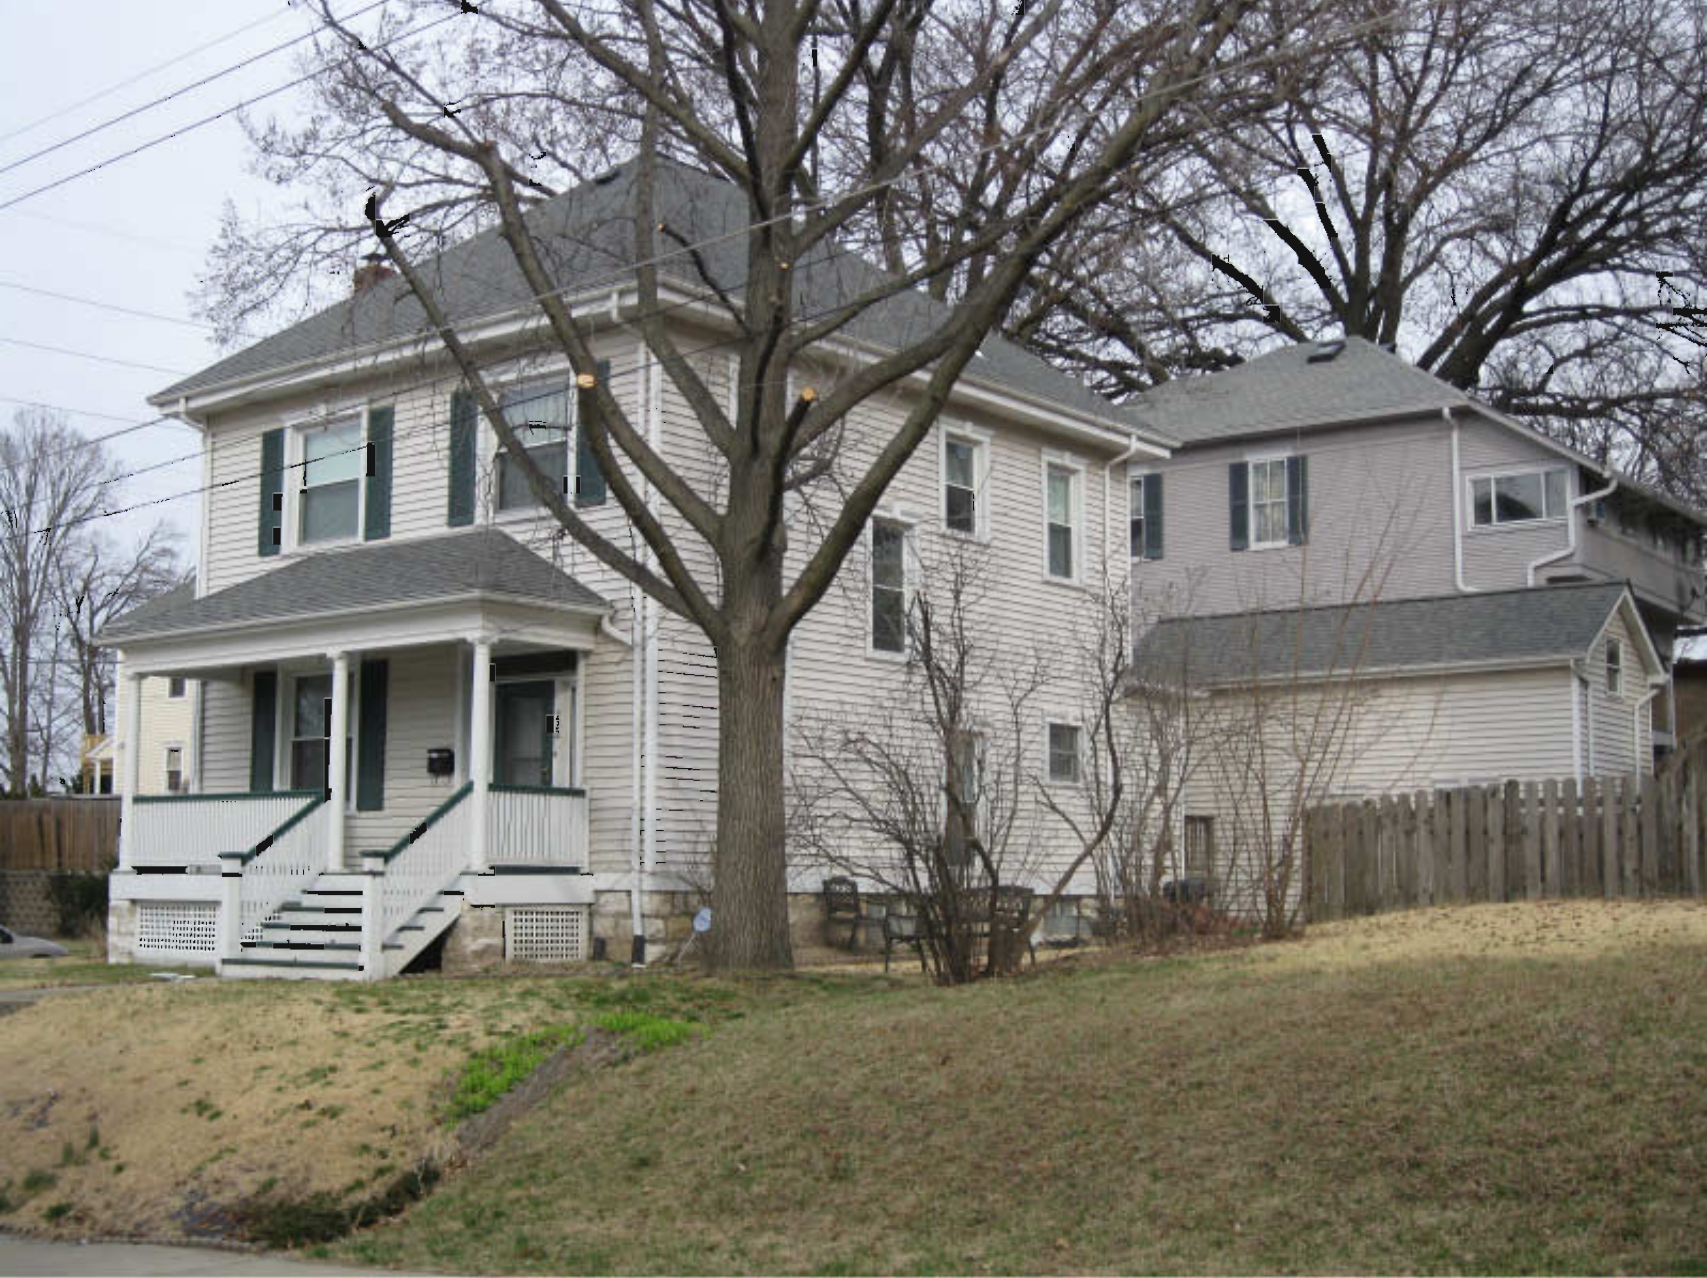
This Four Square, Colonial Revival house is two stories, with a hipped roof with wider eaves. The house has been sided with vinyl siding, but this probably closely approximates the original siding. It has a rock faced, coursed limestone foundation. The full width porch has a hipped roof with slender Doric columns at each corner and slightly off-center to frame the wide wooden steps. The simple balustrade railing that extends between the columns may be the original, but it is likely that the matching rails and square newel posts flanking the stairs are recent additions. Below the porch is what appears to be the original pierced panels between the rock faced stone piers. The two bay facade has the sidelighted, and transomed doorway positioned in the south bay. The windows have flat, crowned lintels with keystones, and these are metal and were added when the vinyl siding was installed. While the 1/1 windows are vinyl replacements, they too probably match the original window pattern. The shutters are vinyl. The screen door obscures the view of the front door, but it appears to be a replacement door. The hipped roof, one story porch on the rear appears to have always been mostly enclosed based upon the fire insurance maps, but the south end was probably originally a small open porch, enclosed between 1917 and 1929. Basement windows are 2 light windows. Because the replacement siding so closely mirrors the historic pattern, including the wider corner boards and the skirting board, with the window trim projecting out, and because it retains its original porch, the building still retains its historic appearance and is minimally contributing to the historic district.
