ARCHITECTURAL/HISTORIC INVENTORY FORM

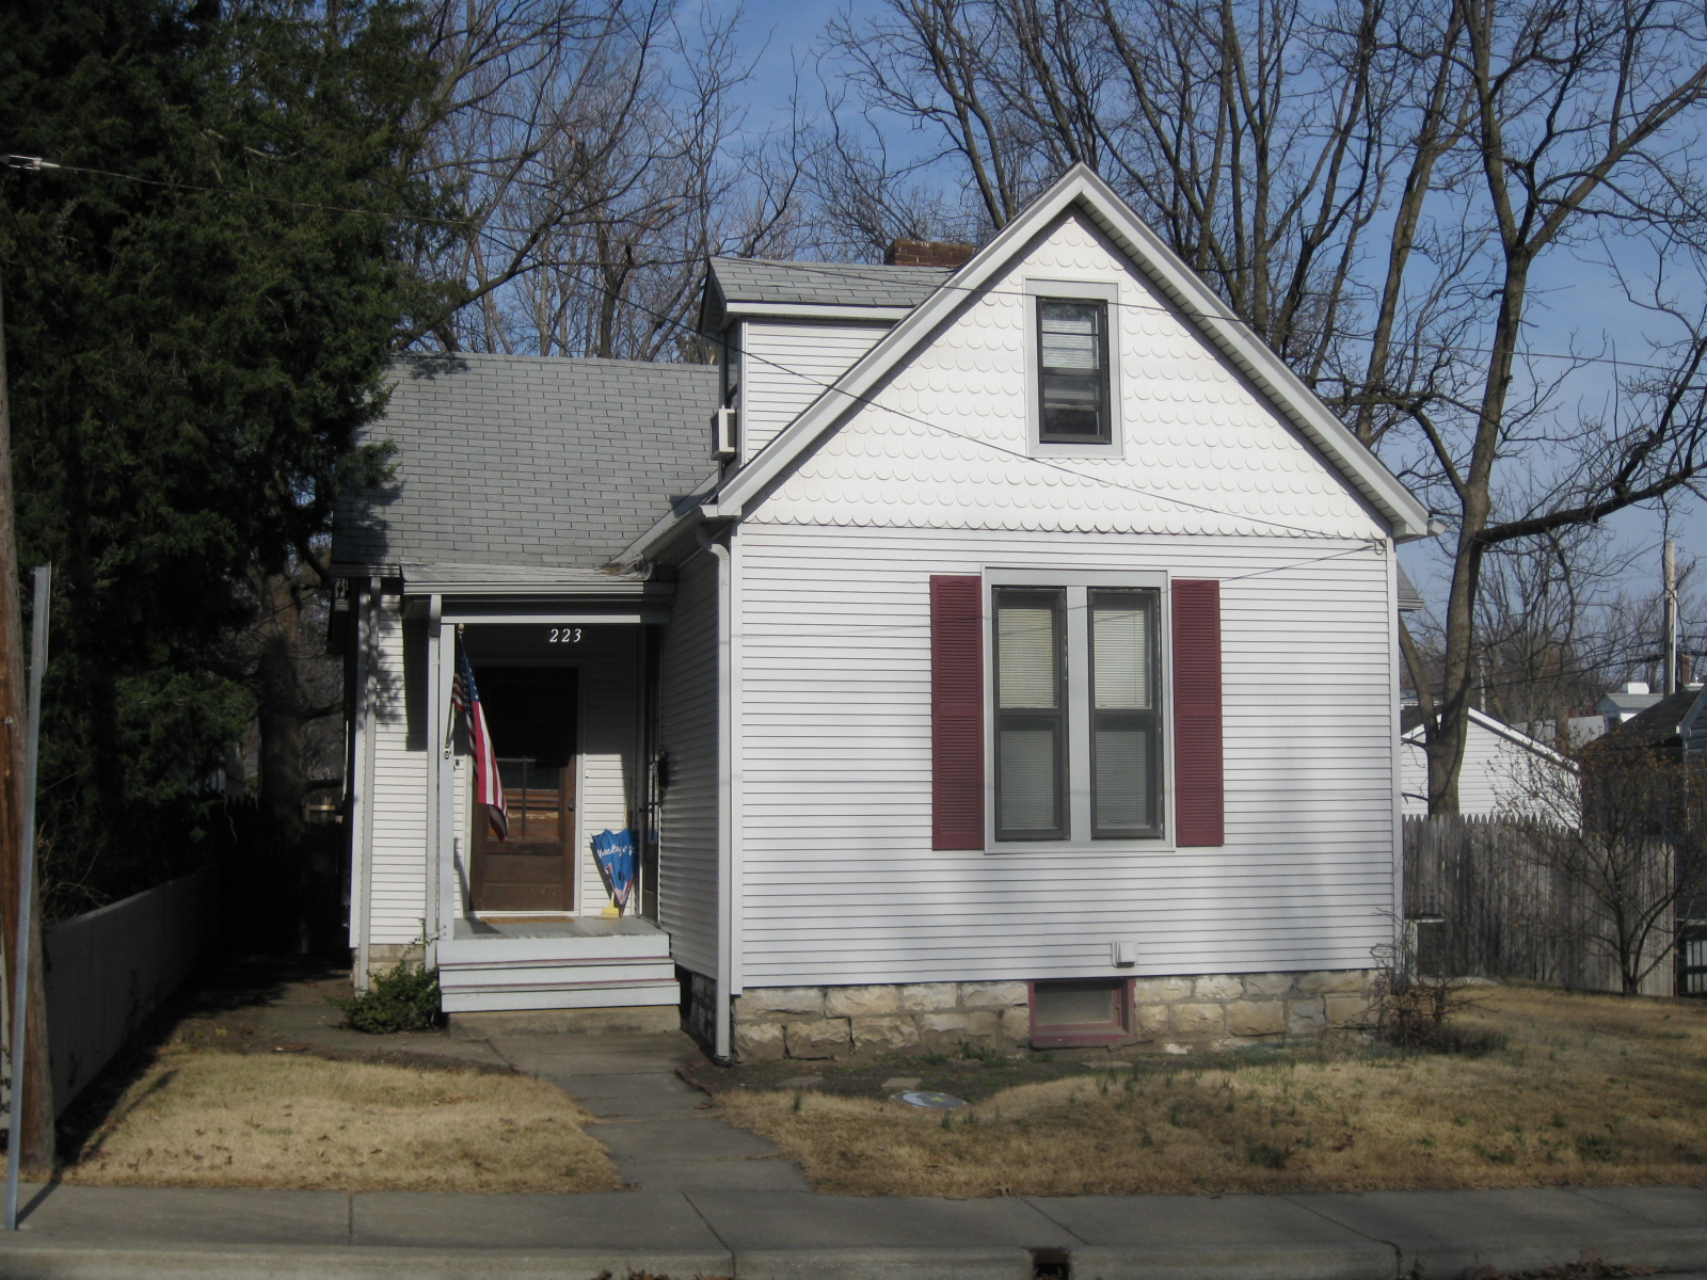
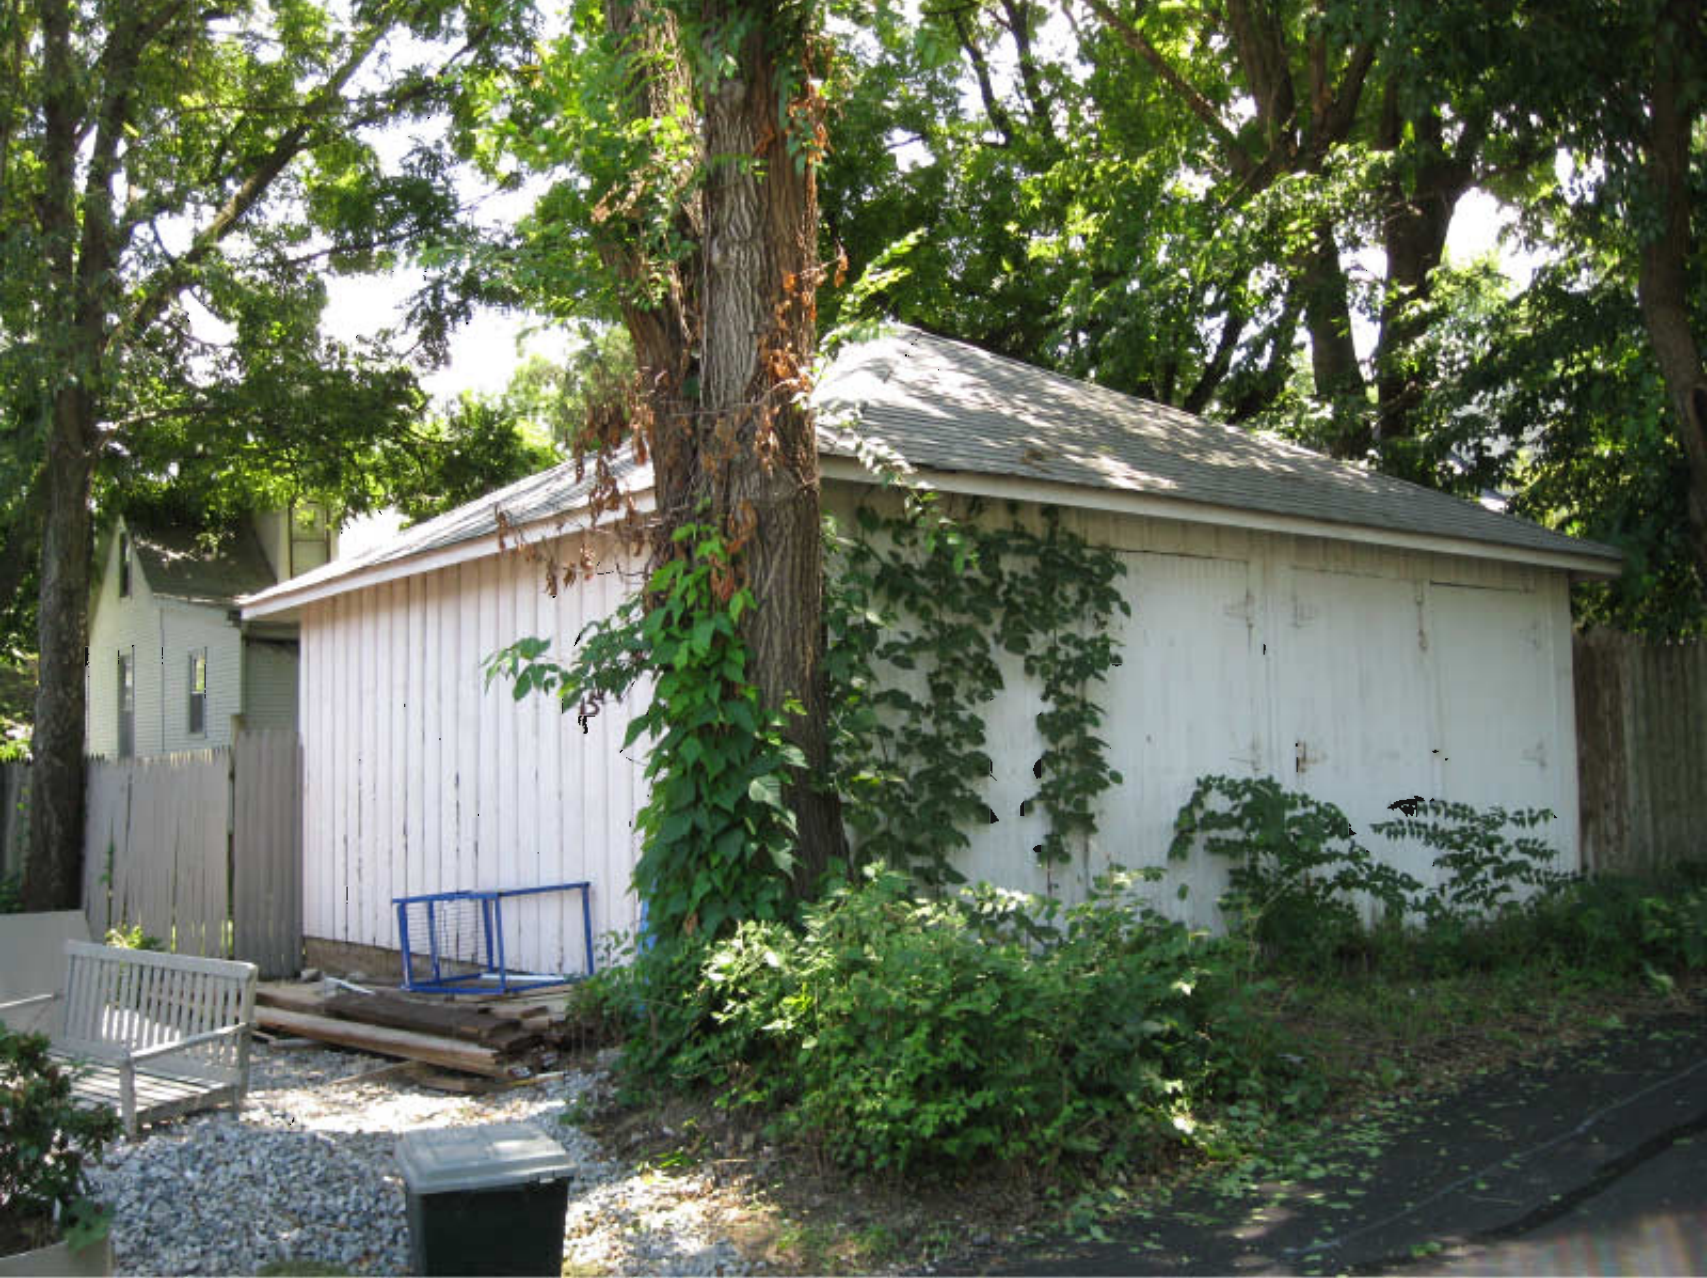
This 1.5 story, frame Folk Victorian house was originally a T-shaped plan with the front gabled wing with a full-width rear porch but between 1900 and 1909 the north half of the rear porch was transformed into a shed roofed, one story rear wing. In 1979, a hipped roof addition with a dormer was added to the south side of the rear addition. Recessed into the south bay, next to the front gabled wing is a small, shed roofed porch with two shallow steps and a simple square corner post. There are two entry doors, one facing south and the other facing east off of this porch. Both doors have half lights. The east facade door has a six light/one panel wood storm door and the other one has a wood screen door. There are paired narrow 1/1 wood sashed windows on the facade of the front gabled wing with a single 1/1 wood sashed window on the second floor. There is a gabled dormer on the south side of this gabled wing and a brick chimney at the ridge behind the dormer. The foundation is coursed, rock faced limestone with beaded mortar. The walls have been reclad with vinyl siding, with vinyl fishscale shingles on the second floor of the front gabled wing, but these most likely approximate the original siding. The shutters are nonhistoric.

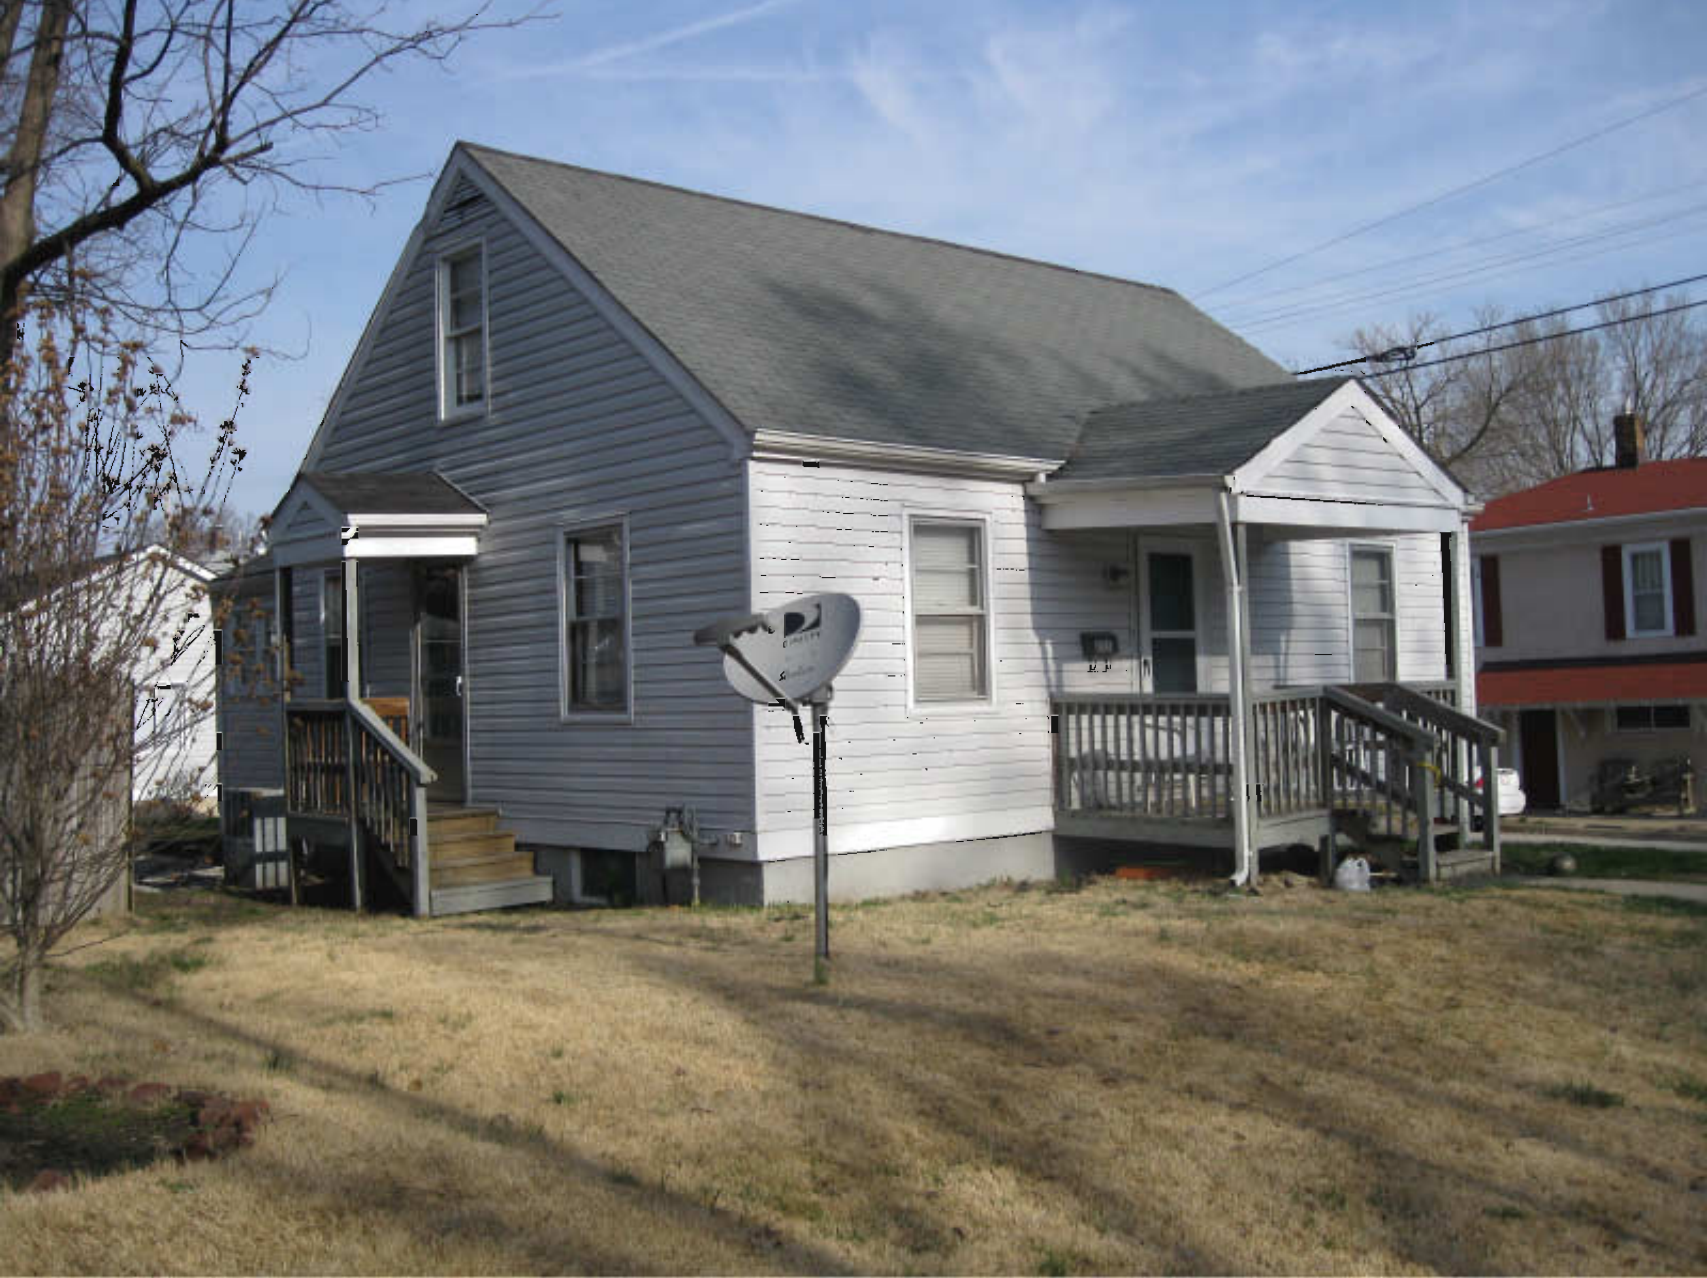
The 1.5 story, side gabled, simple, Cape Cod house has a gabled roof over the central porch, which is supported by simple square corner posts. The facade is divided into three bays, with 2/2 (horizontal light) windows on either side of the front porch. The horizontal paneled door has two horizontal lights in the upper half. The porch railings and steps have been replaced with railings that are modern, constructed like a deck. On the south side is a small, gabled roofed side entry porch flanked by sashed windows and with another window on the second floor above the porch. The house may date from the 1940s, like the county tax records indicate, but it has only been on this property for about 10 years. The house is now clad in vinyl siding and it has storm windows.

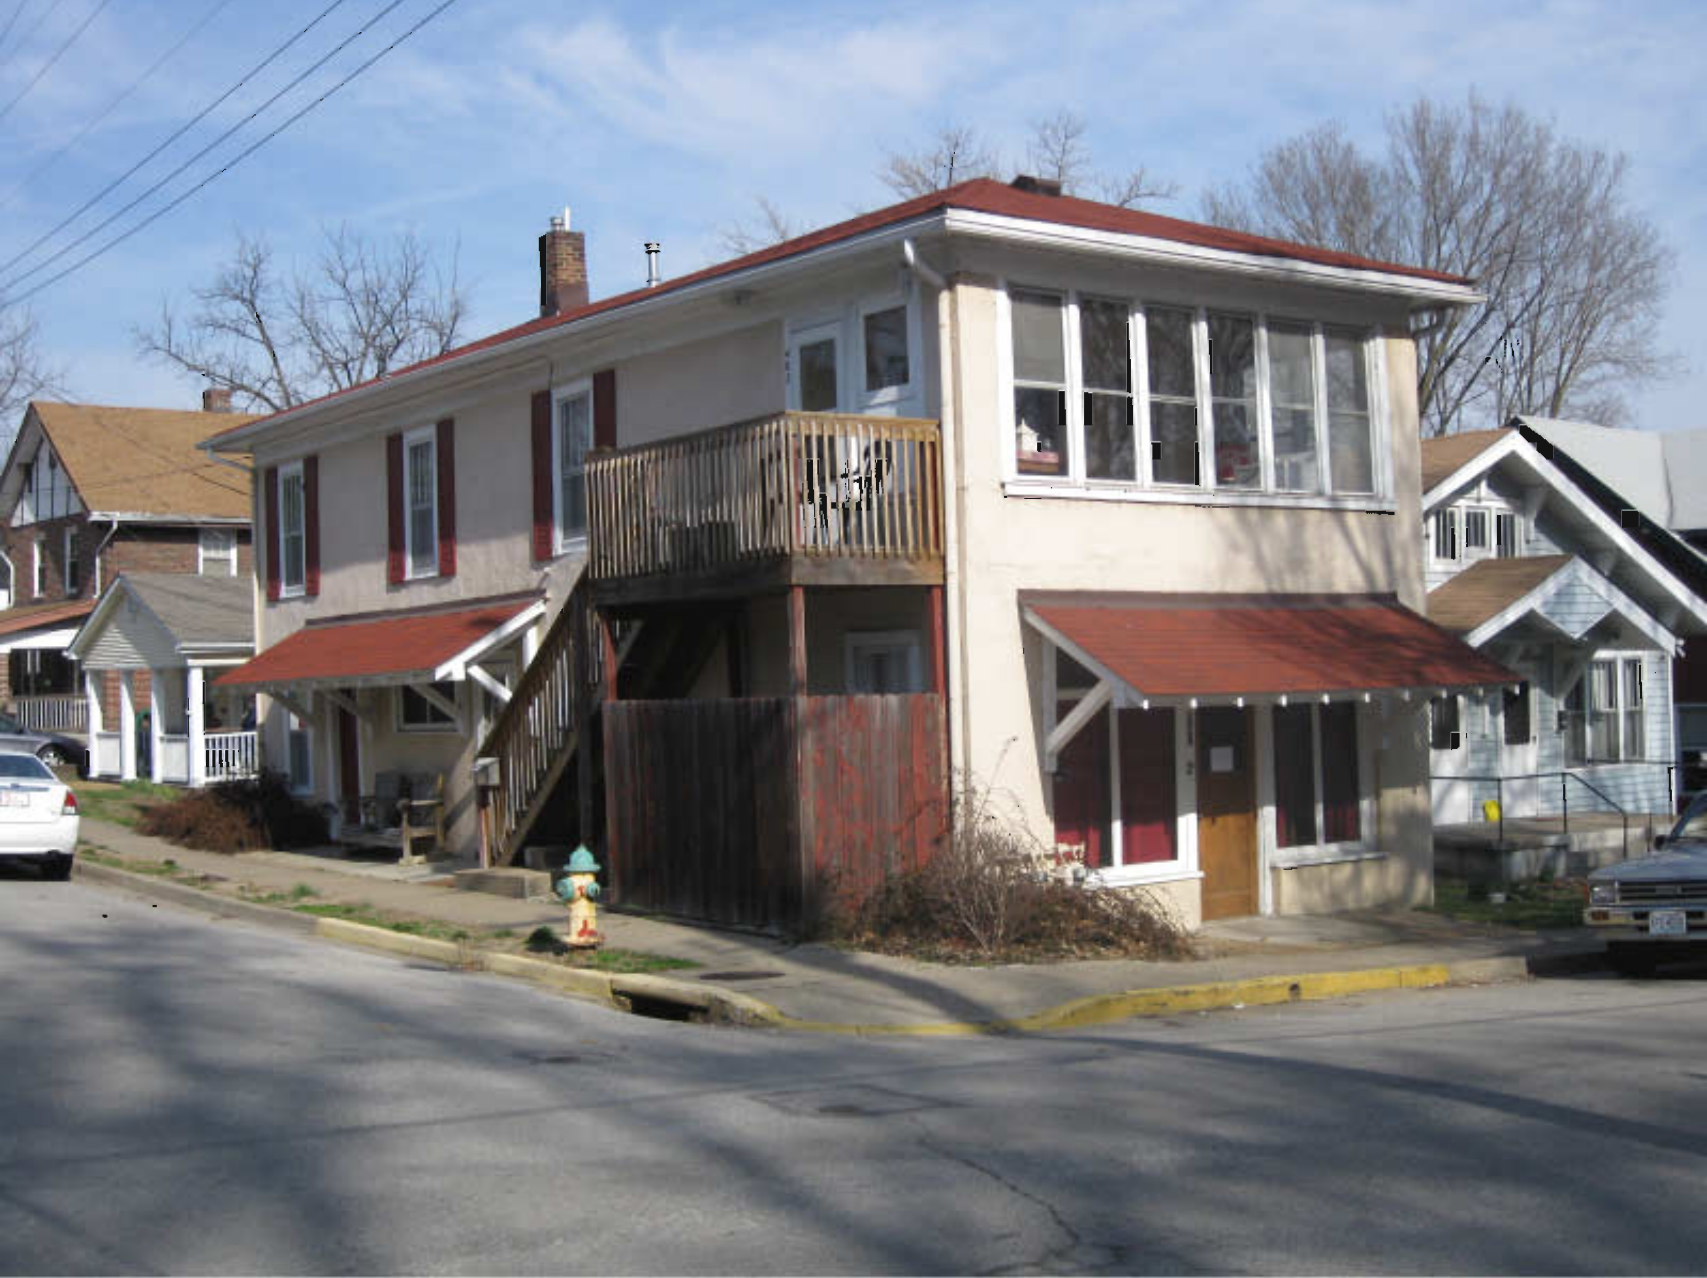
This two story, stucco, hipped roof with wide enclosed eaves, corner building has a commercial storefront facing North Fourth Street and another entry facing Monroe, mostly likely the entrance to the apartment upstairs. Over both entries are shed roofed, knee braced awnings with exposed rafters, a distinctive Craftsman feature. The storefront appears to be the original wood framed display windows with five light transom over the paired display windows on either side of the entry door. The door is a simple wood door with a square light near the top. Below the display windows, the stucco walls are continuous. Above the storefront there is a broad opening that is an enclosed sleeping porch, with six 1/1 sashed windows enclosing the porch, but the 4/1 (vertical light) windows at the back of the sleeping porch are clearly visible. On the south street elevation, the awning covers two entry doors separated by a high 2-light hopper window. The door to the west has four small square lights across the top while the other door appears to have multiple lights, but is covered by a storm door obscuring its visibility. At each end of the first floor there are sashed windows (the one on the east end is behind the non-historic wood fence below the stairs. Although the wooden staircase leading to the second floor entry at the east end of this elevation is not historic, it replaced the historic stairs which were in this same location/configuration (and shown in a 1976 ca. photo at the historical society). On the second floor, there are three 4/1 (vertical light) wood sashed windows with fake shutters and the doorway with a sidelight with a high square light over a wood panel, both with storms. The second floor apartment is addressed as 402 Monroe Street. There is a brick, straddle ridge chimney near the rear of the building. There are also 4/1 windows on the second floor of the north elevation and 3-light basement windows. Besides the stairs, the only other visible alterations are the aluminum storm windows. Although the fire insurance maps note the building has a brick first floor, there is no indication that the stucco is a later alteration.

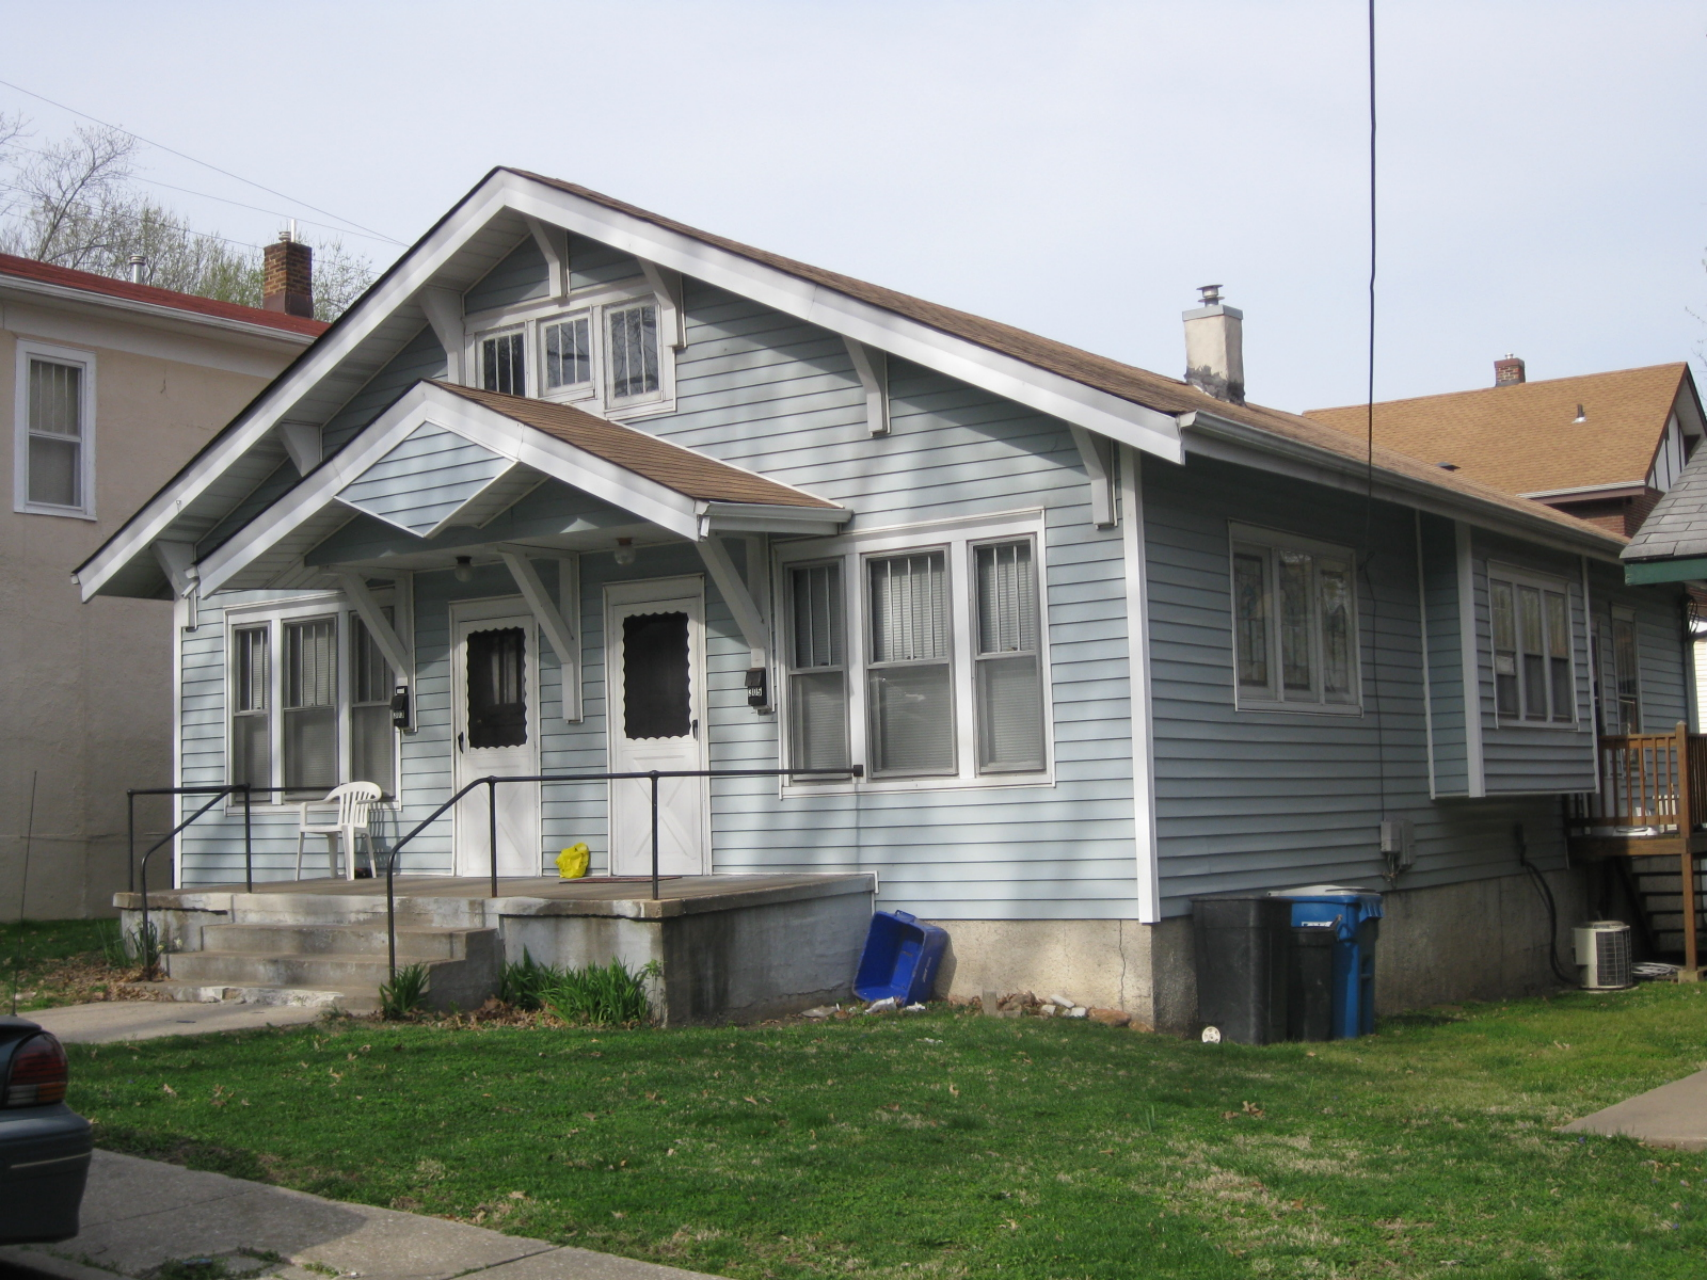
This one story, end gabled, frame duplex has wide eaves supported by a series of small knee braces. The facade is divided symmetrically with a central attic window consisting of tripartite window of 3-vertical light windows. The facade is divided into four bays with tripartite window units on either side of the entry porch. These window units have 3/1 windows flanking a 4/1 window, all vertical light, wood sashed windows. The simple concrete stoop with pipe railings and broad concrete steps accesses the two entry doors with three vertical lights in the upper portion of the doors (covered by storm doors now). Over the doorways and porch stoop is a gabled roof supported by knee braces, but it is unclear whether the diamond shaped panel in the gable end is historic or an embellishment added with the vinyl siding. Both the north and south elevations are similar, with tripartite art glass windows forming a high horizontal band near the east end and a boxed bay window with three vertical light sashed windows near the rear. The rear door and a simple series of steps is positioned near the back, but at least the north side has replacement wood steps. There are also two stuccoed chimney flues on either side of the ridge near the rear of the building. The vinyl siding probably replaces a similar profile clapboard, but vinyl also encases the eaves (which may have originally had open rafters) and the small knee braces under the eaves. Since the distinctive vertical light and art glass windows as well as the porch roof with its large knee braces are still intact and characteristic features of Craftsman designs, the building is still contributing to the district despite the other alterations.

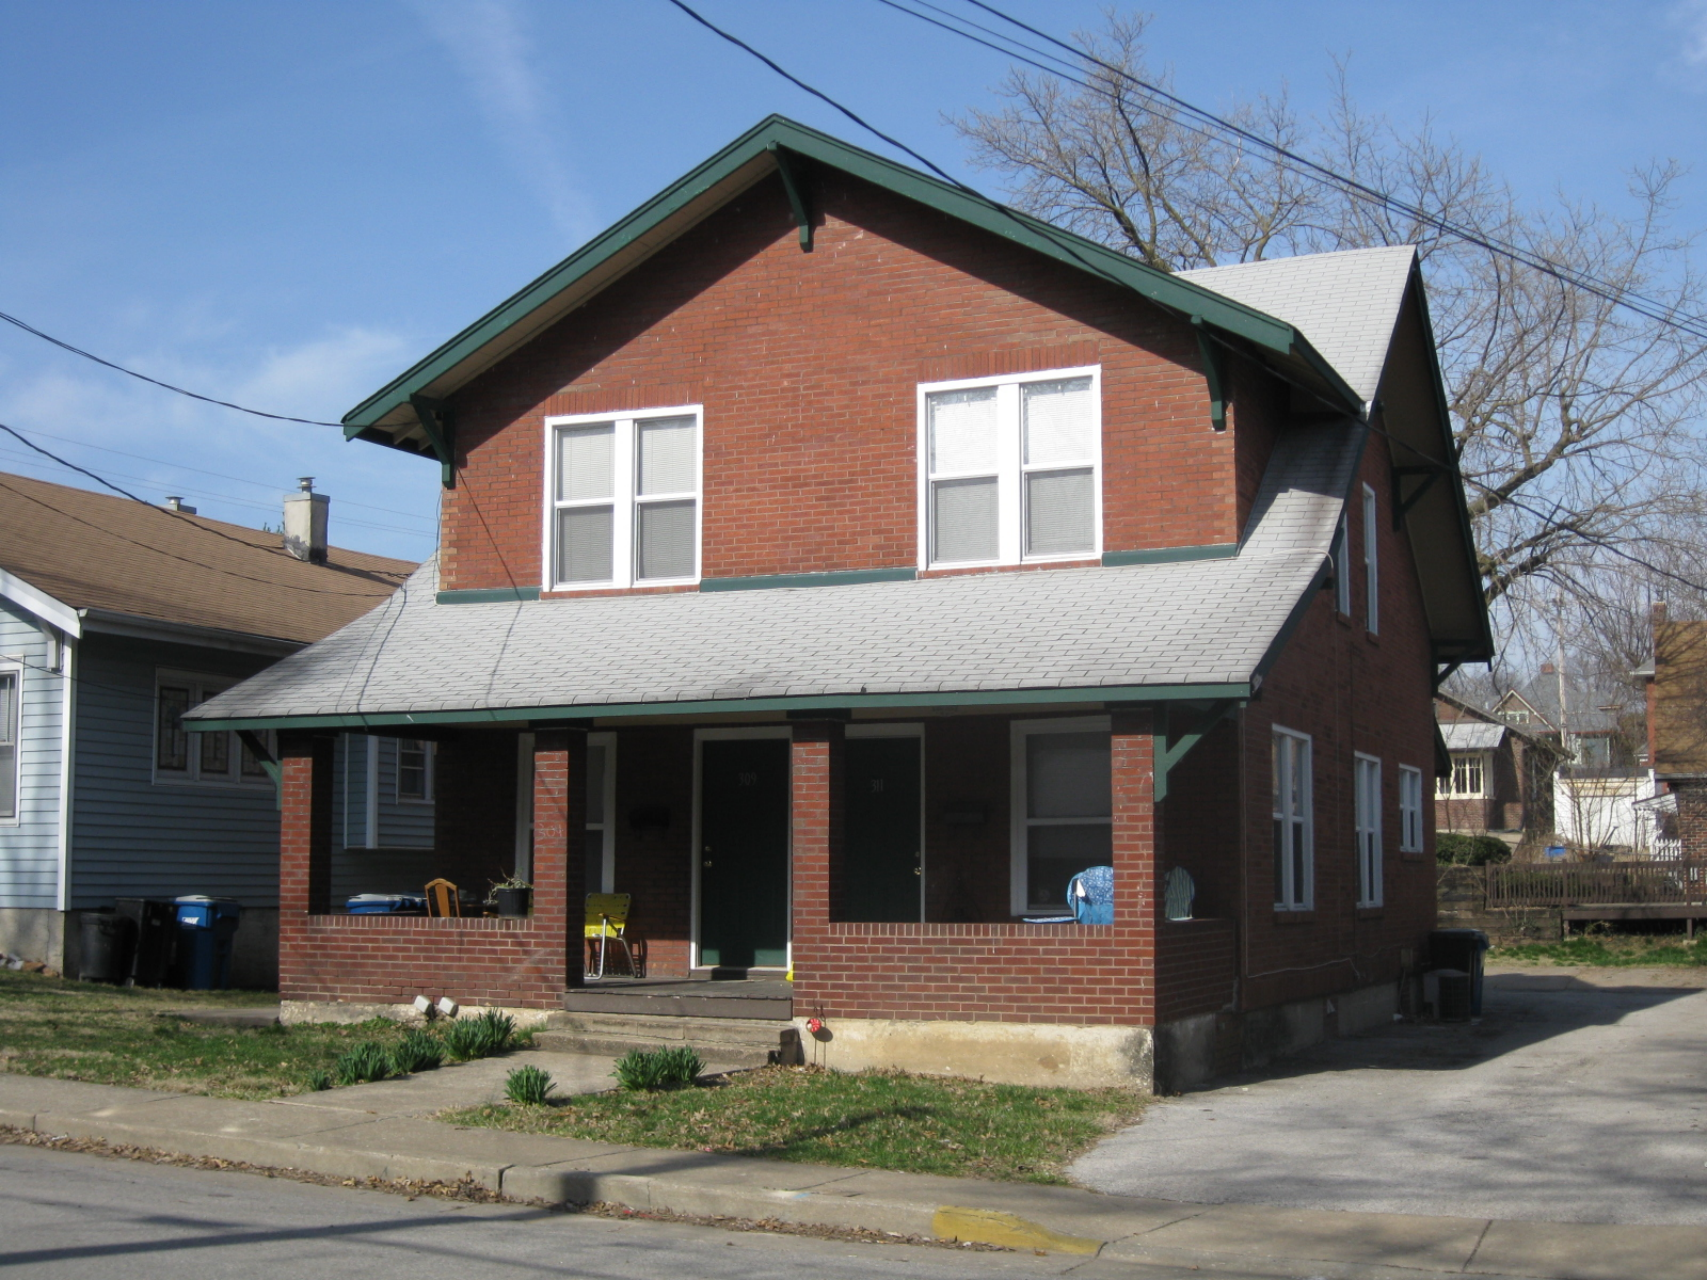
This 1.5 story side gabled house has a broad cross gabled dormer than spans the facade with the shed roof of the full width porch extending from the main roof. The house is red brick with wide eaves supported by knee braces. The facade is divided symmetrically with paired sashed windows on the second floor and four brick piers on top of the brick half-wall railings supporting the porch roof with concrete stairs in the center bay. Three are two entry doors in the center bay with a sashed window in each outer bay. The concrete foundation is punctuated by what appear to be bricked in basement windows on each side. On the first floor of the side elevations are three paired sashed windows, with the rear pair being shorter. There are two sashed windows on the second floor. All of the windows have brick soldier course lintels and brick sills. There is a soldier course of brick at the foundation on each side. On the back, there was originally a shed roofed, one story porch, which still retains its wide eave overhang, but was enclosed as some point after 1947. The front doors appear to be later replacements and the windows have been replaced with vinyl 1/1 windows.

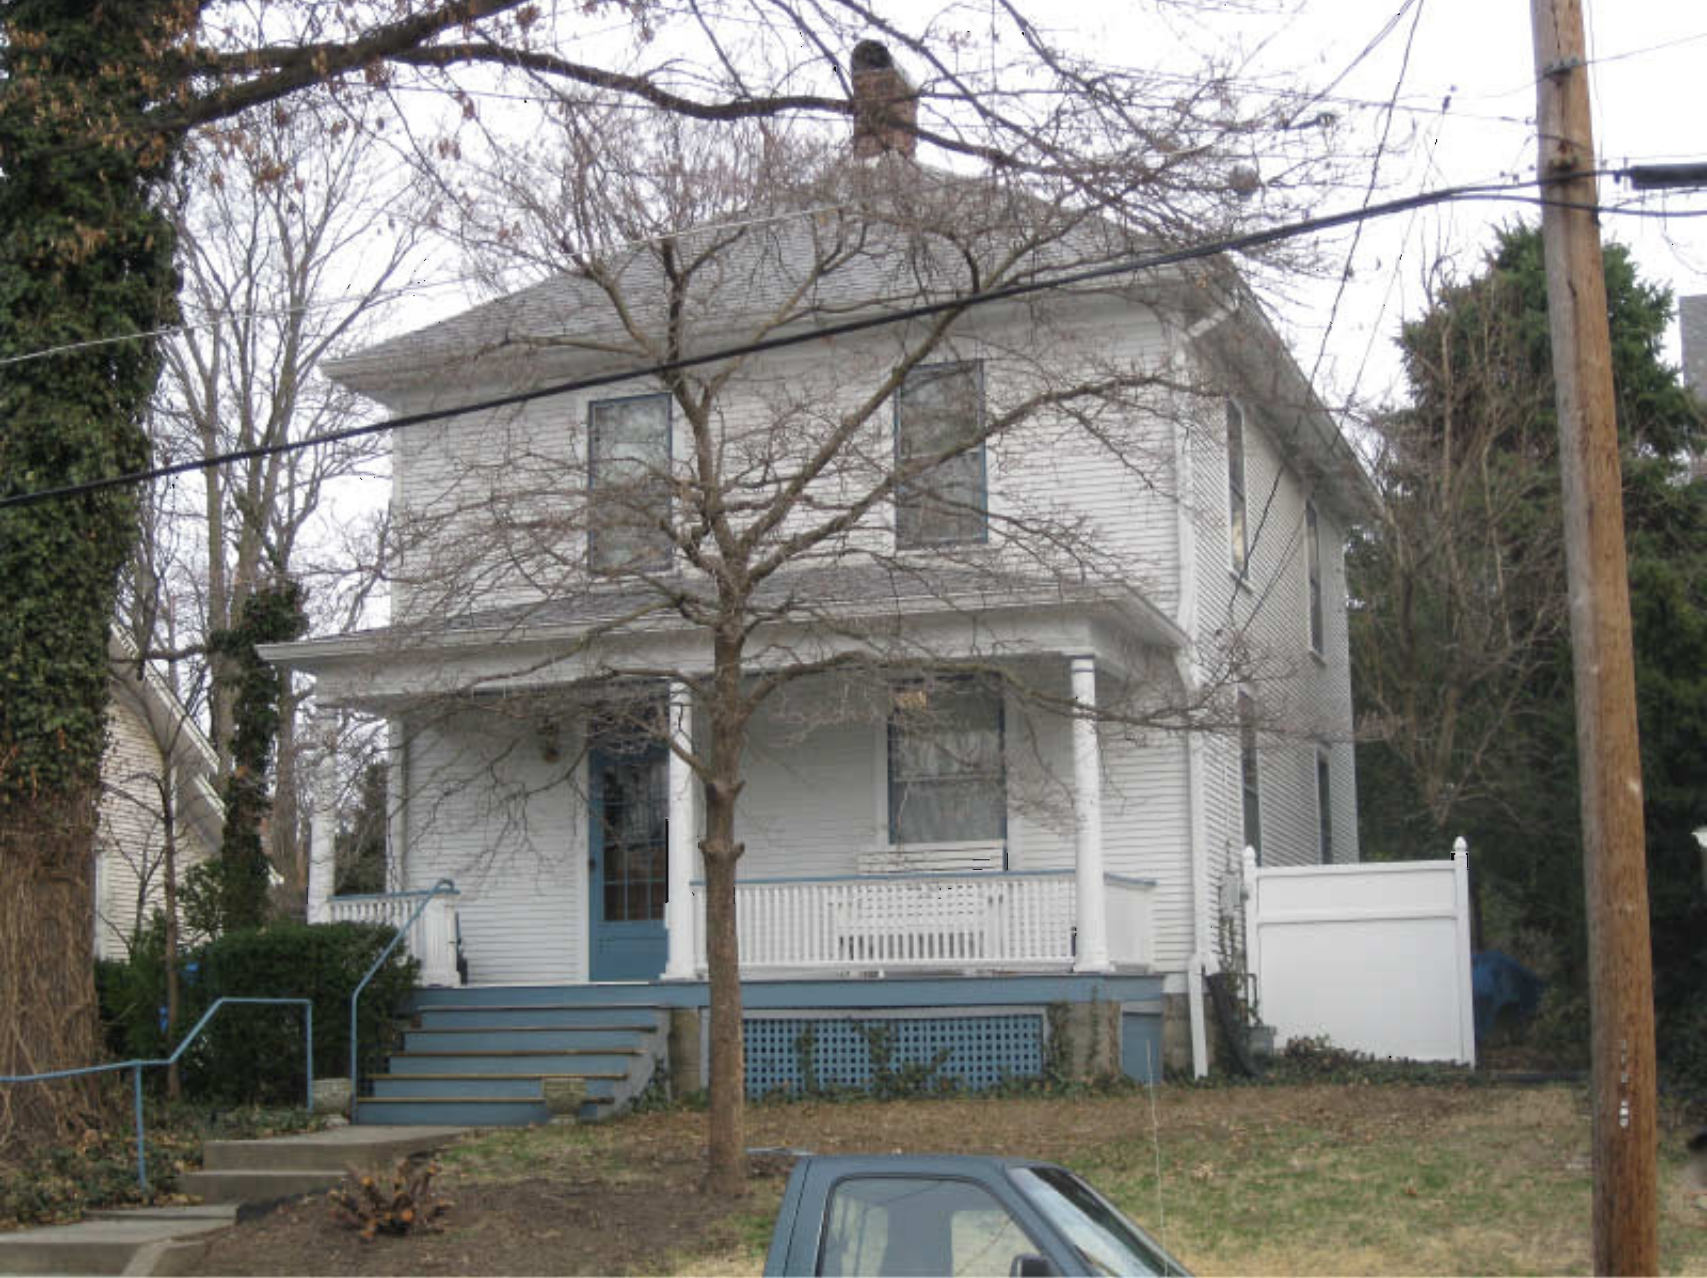
This two story, hipped roof with wider, enclosed eave house is divided into two bay on the facade. It has clapboard siding with cornerboards and a rock faced, coursed limestone with beaded mortar foundation. This Four Square house has Colonial Revival detailing, primarily the three Doric columns that support the entablature of the full width, hipped roof porch. The porch retains its original flat baluster railing, wood porch floor, and pierced wood panels between the limestone piers, and wide wood stairs. The center column is positioned on the north side of the stairs but on the east side the railing terminates in a paneled square newel post. The entry is in the north bay and the door is a half light over three panels (top one horizontal, bottom two vertical). There is a single light transom above the door and a 12-light wooden storm door. The porch retains its bead board ceiling. The other openings on the first and second floors of the facade are filled with 1/1 windows (which appear to be the original wood windows with storms) similar to the four windows symmetrically aligned on the south elevation. The sashed windows on the north elevation are positioned with a single sashed window near the facade and a paired window unit near the rear on the first floor while the two sashed windows upstairs are staggered, apparently in line with the staircase inside. On the rear, the 1917 map showed an open, one story porch on the north two-thirds of the rear wall, but by 1929 the center section was shown as enclosed and by 1947 there was another section added to extend the enclosed porch to the south end of the rear elevation. This is a hipped roof porch supported by simple posts. There is a tall brick chimney on the north slope.

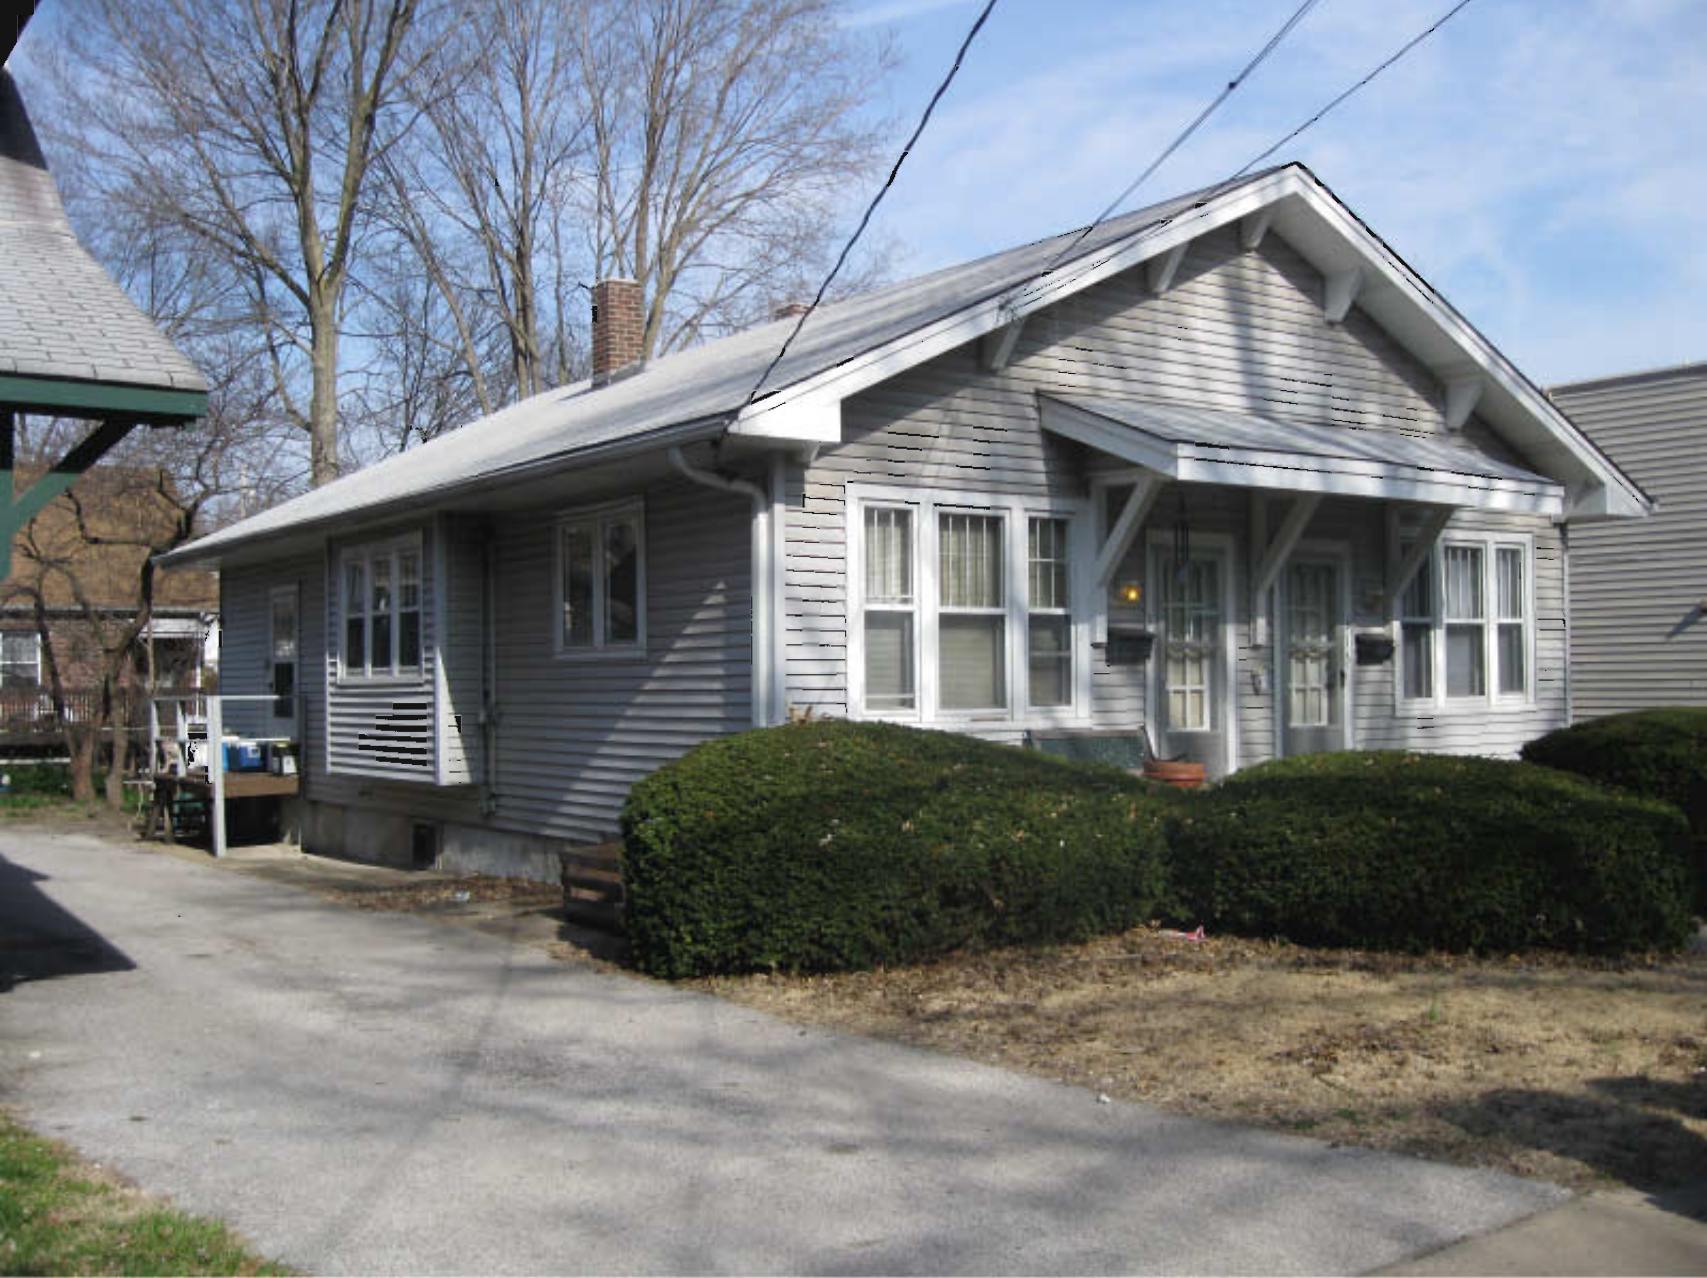
This one story, end gabled, Craftsman duplex is a frame building with a symmetrical facade. It has wide eaves supported in the gable end by a series of knee braces. The facade is divided into four bays, with a shed roof supported by three large knee braces spanning the two entry doors in the center two bays. The doors are the original 12-light French doors. The front entry stoop is barely visible but appears to be a concrete stoop, probably the original given the period of construction. On either side of the entry bays there are triple window units, consisting of 4/1 wood sashed windows flanked by 3/1 sashed windows. On each side elevation are paired, single light casement windows near the front. Midway on each side is a shallow, rectangular oriel window with a triple window unit with vertically lighted upper sashes. Behind the oriel window there is a side porch and doorway. The south side porch appears to be the original wood porch with the steps facing the rear yard, but the 2x4 railing appears to be a replacement. The porch on the north side is similar but its porch floor appears to have replacement decking. There are simple brick chimneys offset on either side near the rear of the house. The duplex has been sided recently with vinyl siding, encapsulating the eaves of the house, which probably had exposed rafters originally, and covering the knee braces in the main roof. However, the siding probably closely mirrors the original wall finish and is placed around the window and door trim, minimizing its impact on the architectural integrity. In addition, the original shed roof and knee braces, which are prominent features, were not altered with this renovation.

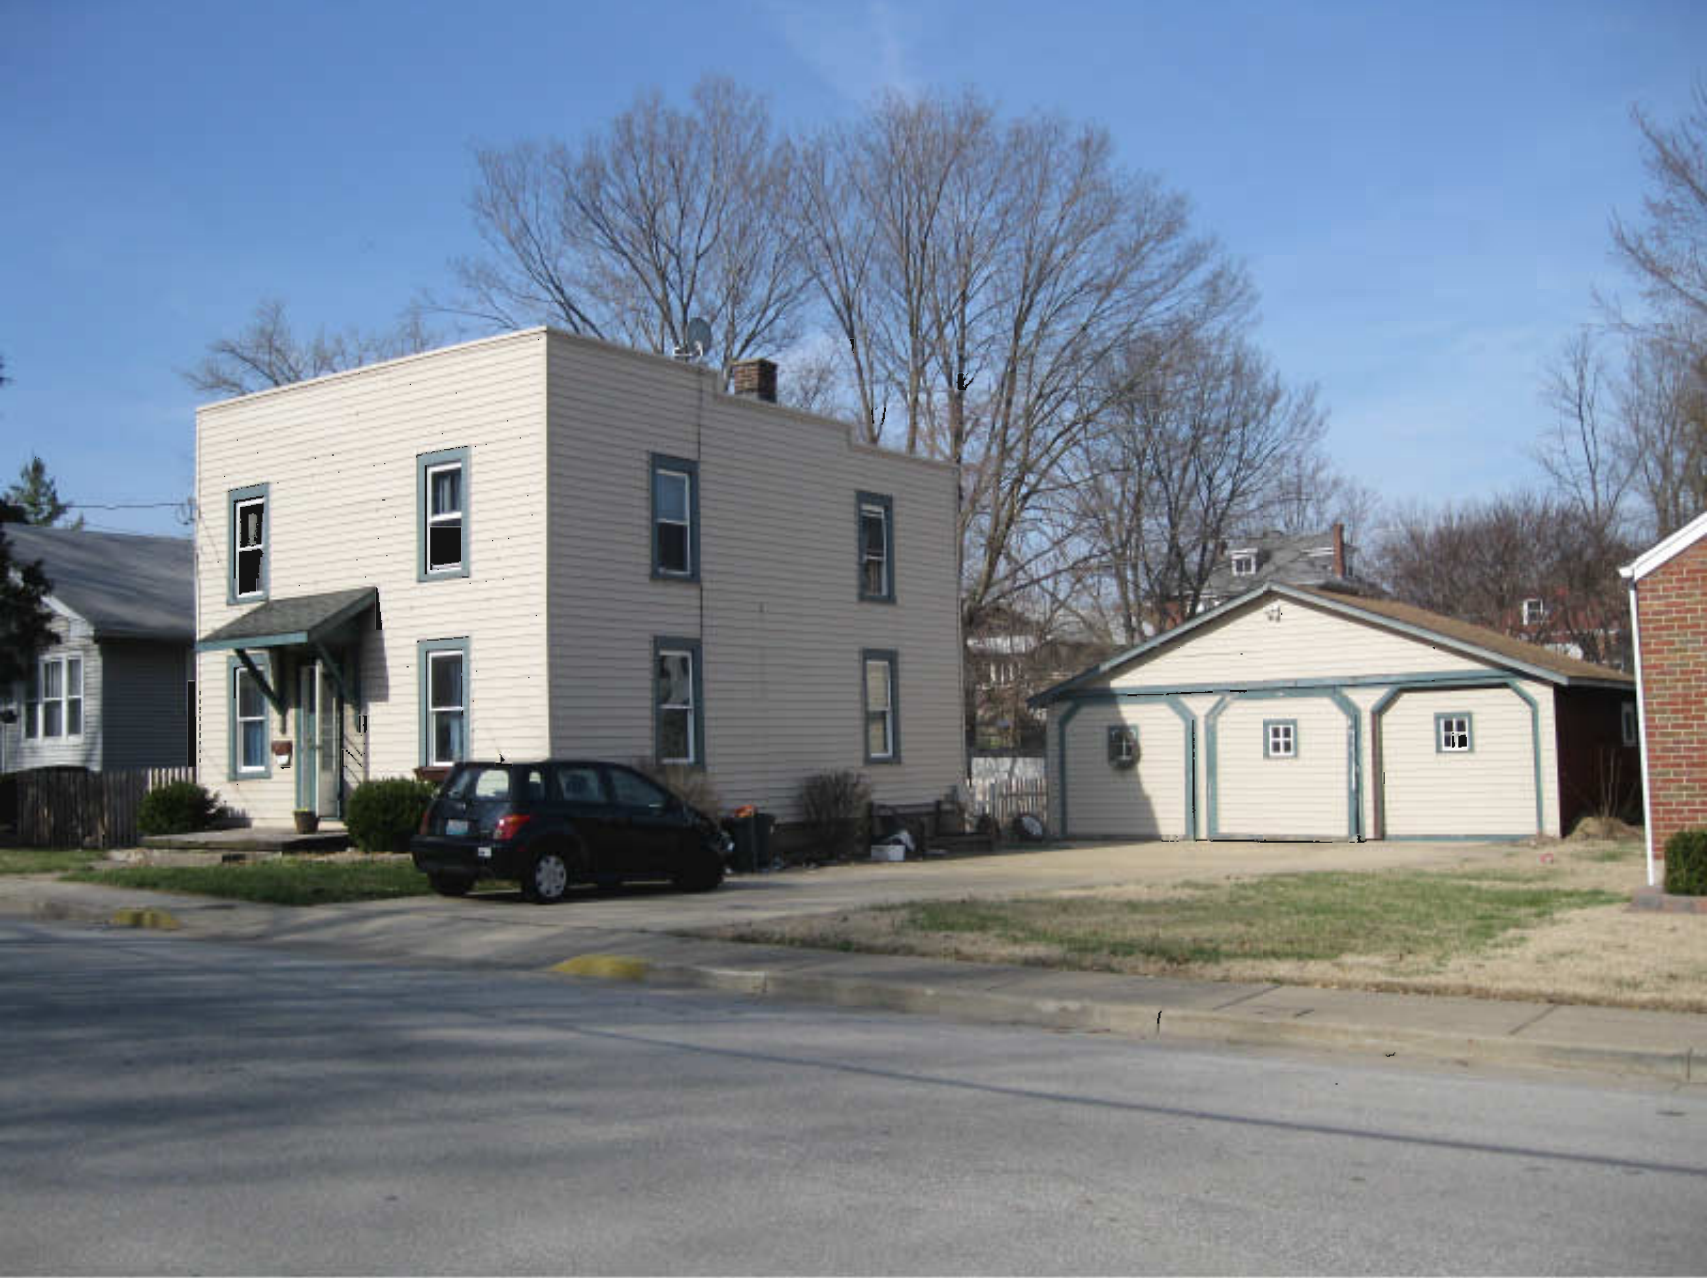
Built between 1910-1916 to replace a smaller paint shop located closer to the street, this two story building has a flat roof with stepped parapets on each side elevation, which seems to indicate that it is a brick building that has been covered with vinyl siding. The three-bay facade is divided symmetrically with 1/1 sashed windows on each level of the outer two bays. The wooden, 15-light entry door opens onto a very low concrete stoop and is covered by a shed roof supported by large knee braces, a Craftsman feature probably added when the building became a private residence in the mid-1920s. On the side elevations there are additional sashed windows and a small interior brick chimney. The windows appear to be replacement vinyl windows. The building was always utilitarian in design, but the new siding appears to change the historic appearance and it is noncontributing to the historic district. If the siding were removed to reveal the original wall cladding, the building would probably be contributing in the historic district.
