ARCHITECTURAL/HISTORIC INVENTORY FORM

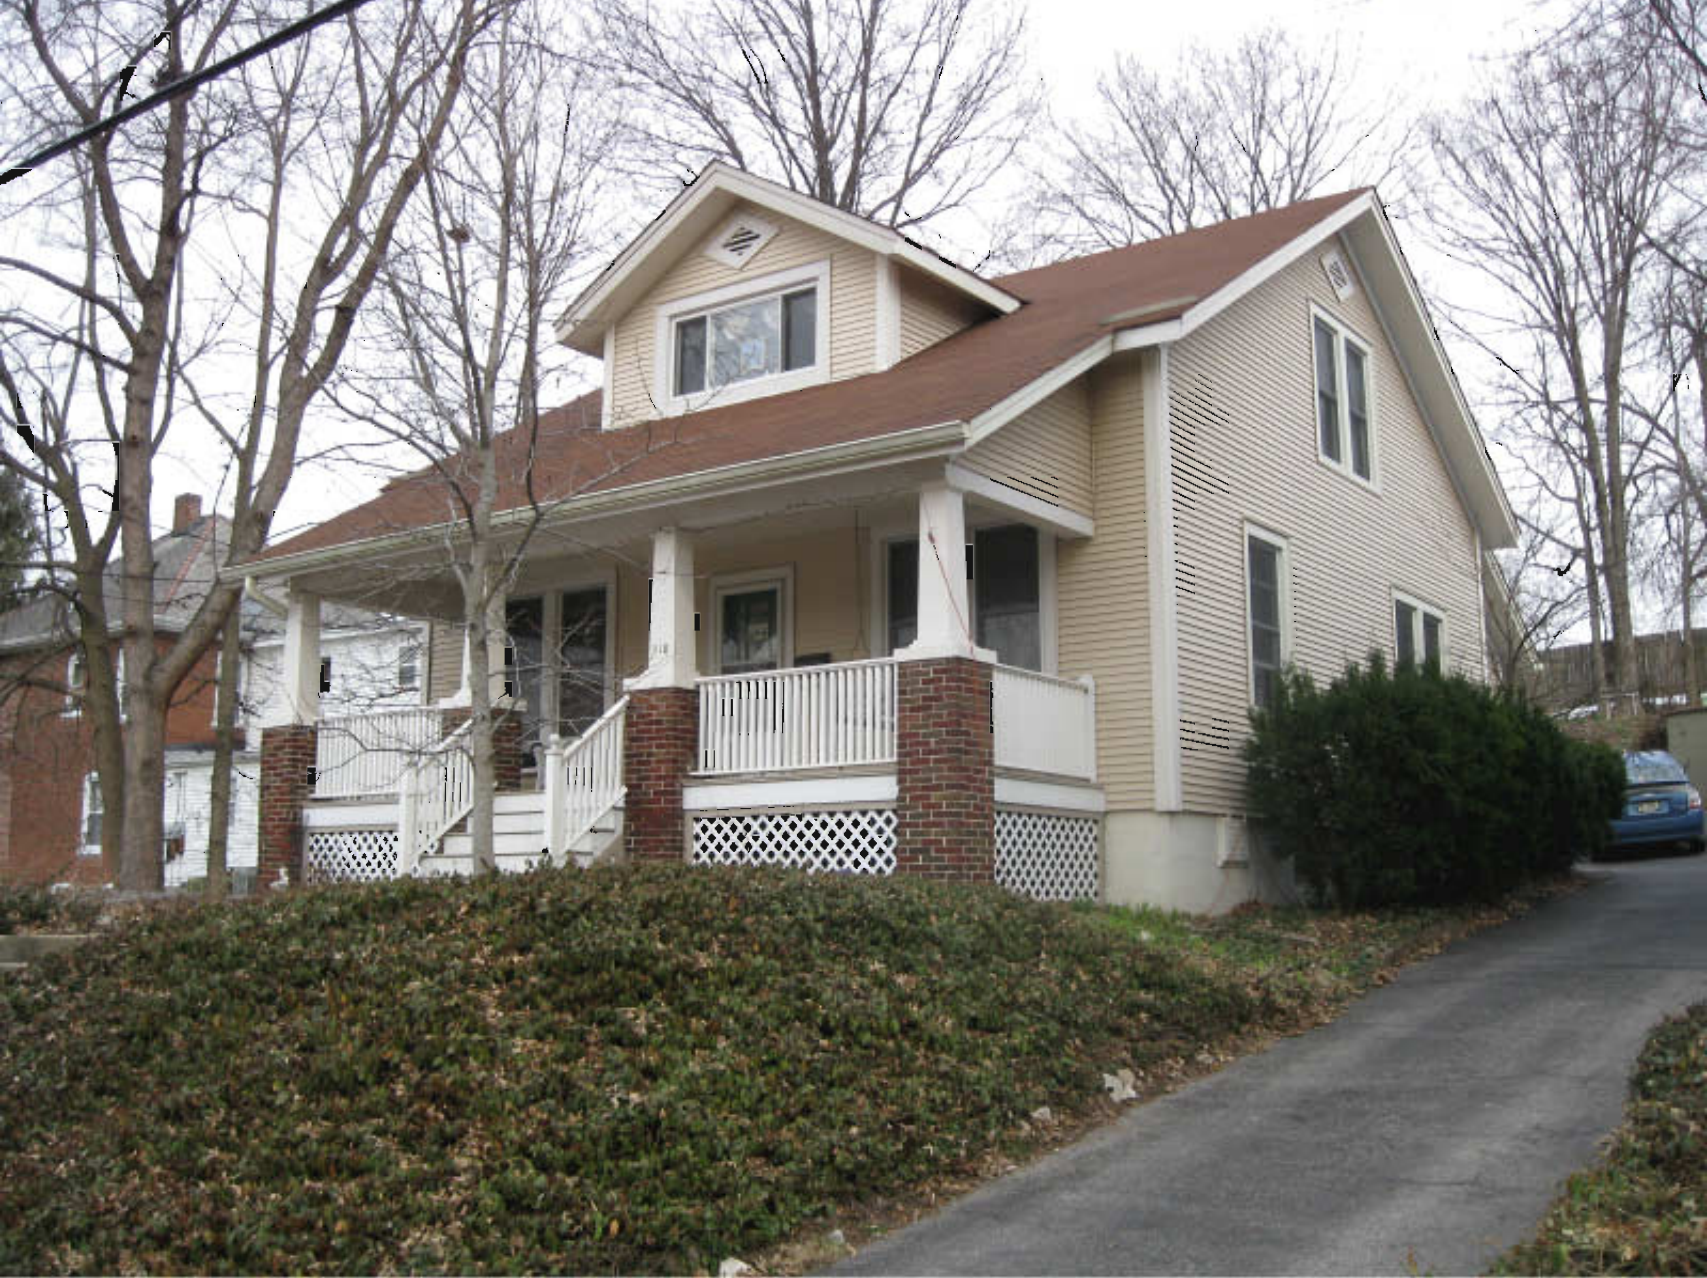
This 1.5 story, side gabled, frame house has a full width porch with a shed roof that continues the main house roof, but is slightly narrower. The porch roof is supported by battered boxed half-columns that rest on brick pedestals that extend to the ground. The porch has a wood porch floor and steps with latticework between the brick piers and it retains its original, simple wood balustrade. On either side of the entry door are paired, sashed windows. The door is a full light, Craftsman style wood door (with the muntins positioned to frame a large center panel of glass). Centered over the porch is a gabled dormer with a wide horizontal window that appears to have recently replaced a three-part window that is shown in a 1940-era photo, but the diamond shaped attic louver above the window (a detail also found on the side elevations) appears original to the design. The house has been carefully resided with vinyl siding, retaining wider cornerboards and window trim, but the eaves have been clad in vinyl and may have originally been exposed rafters. The house appear to be the original wood 1/1 windows with storm screens, but they may be replacement windows. It has a storm door. Despite the alterations, the house still retains enough of its original design features, especially the original porch features, front door, and diamond motif, as well as its original house form and roofline to be easily identified as a bungalow.

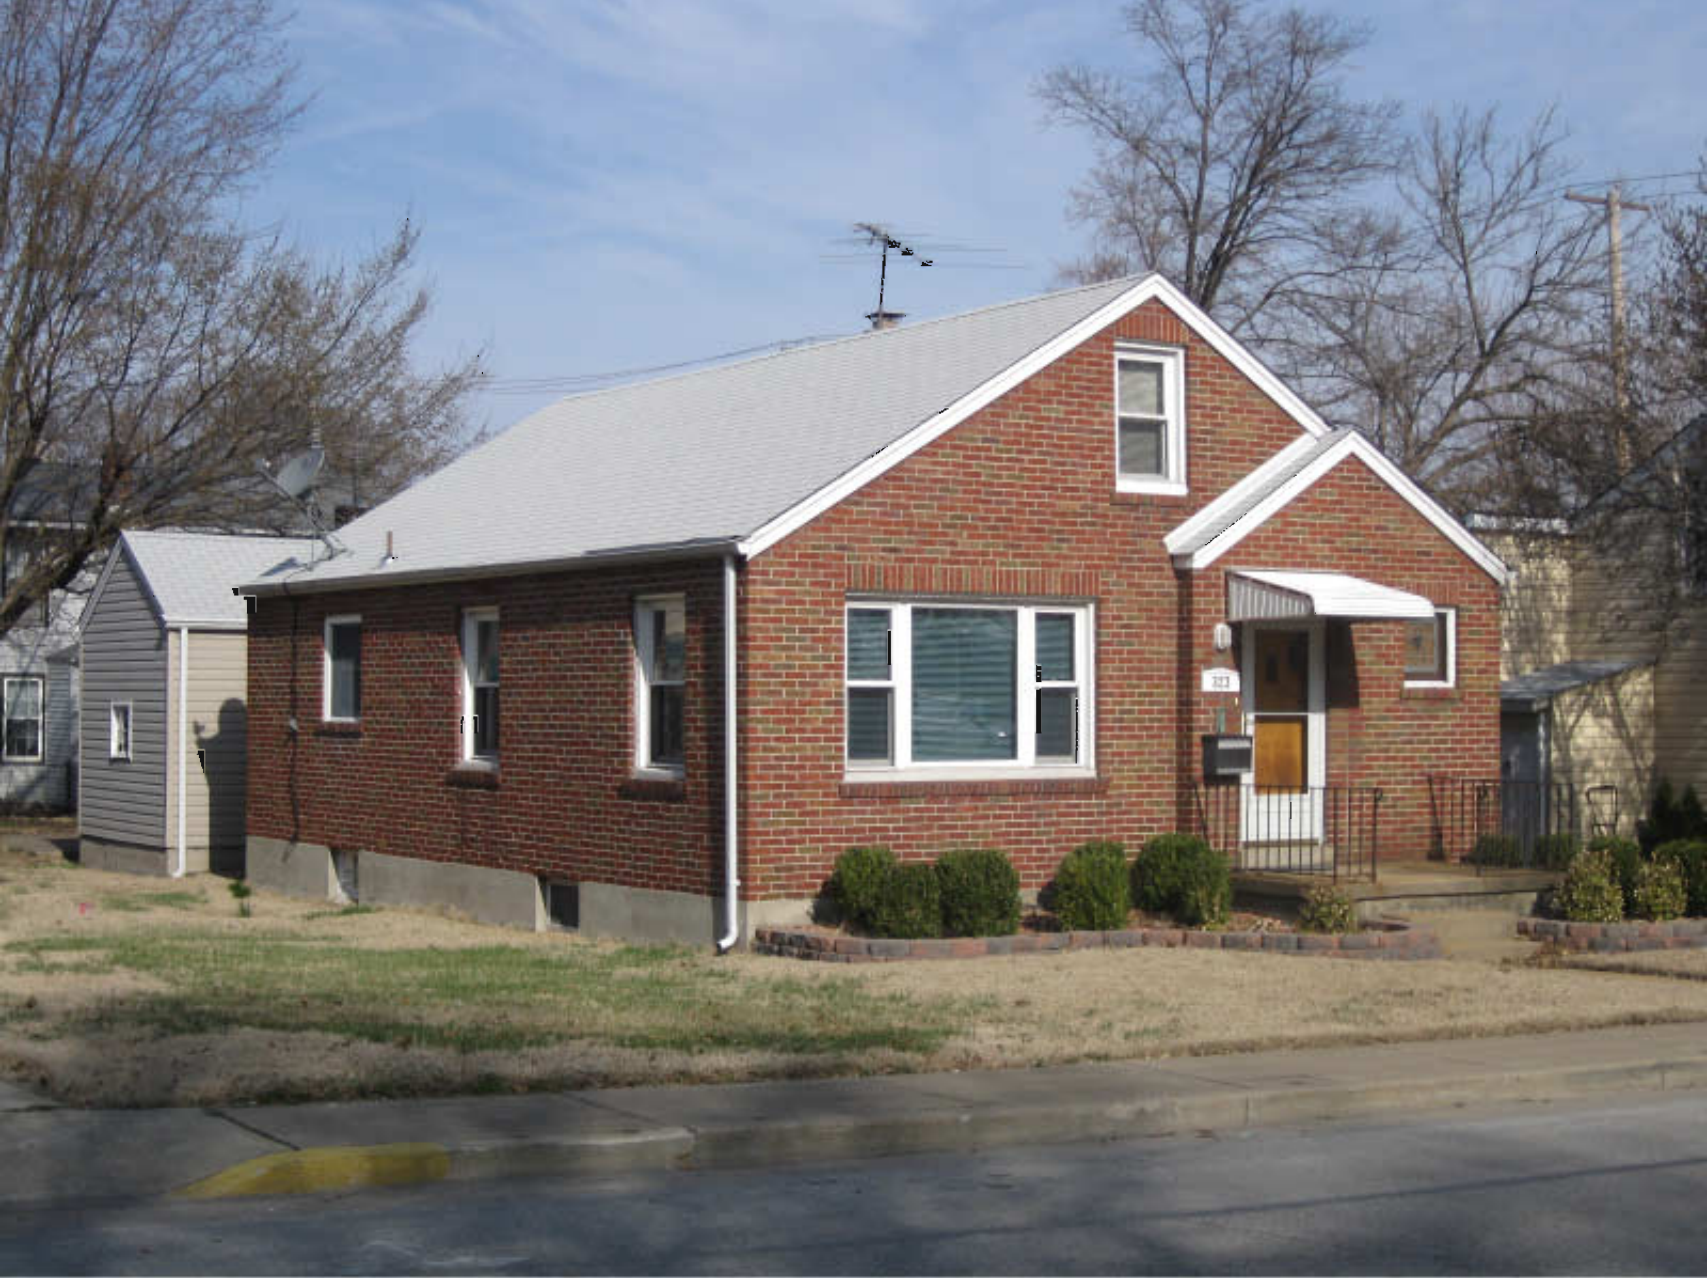
This simple, 1.5 story, red brick, end gabled house has a facade that is divided into two bays on the facade. The north bay has a slightly projecting, one story gabled roofed entry vestibule with a square, art glass sidelight to the north side of the simple entry door. The door has three stepped lights near the top of the unpaneled door, a door that is common to 1950s house designs. Spanning this bay is a simple, low entry stoop with wrought iron railings. To the south is a feature common to many Minimal Traditional designs, a three part window that consists of a plate glass window flanked by narrow sashed windows. Centered on the second floor is a 1/1 sashed window. The only embellishments to the facade are the soldier course lintels and brick sills (side windows do not have these brick lintels). On the side elevations, the poured concrete foundation with the small wood framed basement windows creates a high watertable and there are three bays of sashed windows. On the back of the house is a small enclosed breezeway with a stone foundation (indicating it may have originally been an open porch that was later enclosed). It has a wooden six-panel door flanked by 1/1 sashed windows. The breezeway connects to the end gabled, one car frame garage. The garage and breezeway have been sided in vinyl siding and may be slightly later additions since they are not brick, but they are characteristic of designs of the 1950s. The garage door with its square paneled design is also characteristic of 1950s garages. Since the garage is connected to the house by an enclosed breezeway it is not counted as a separate building.

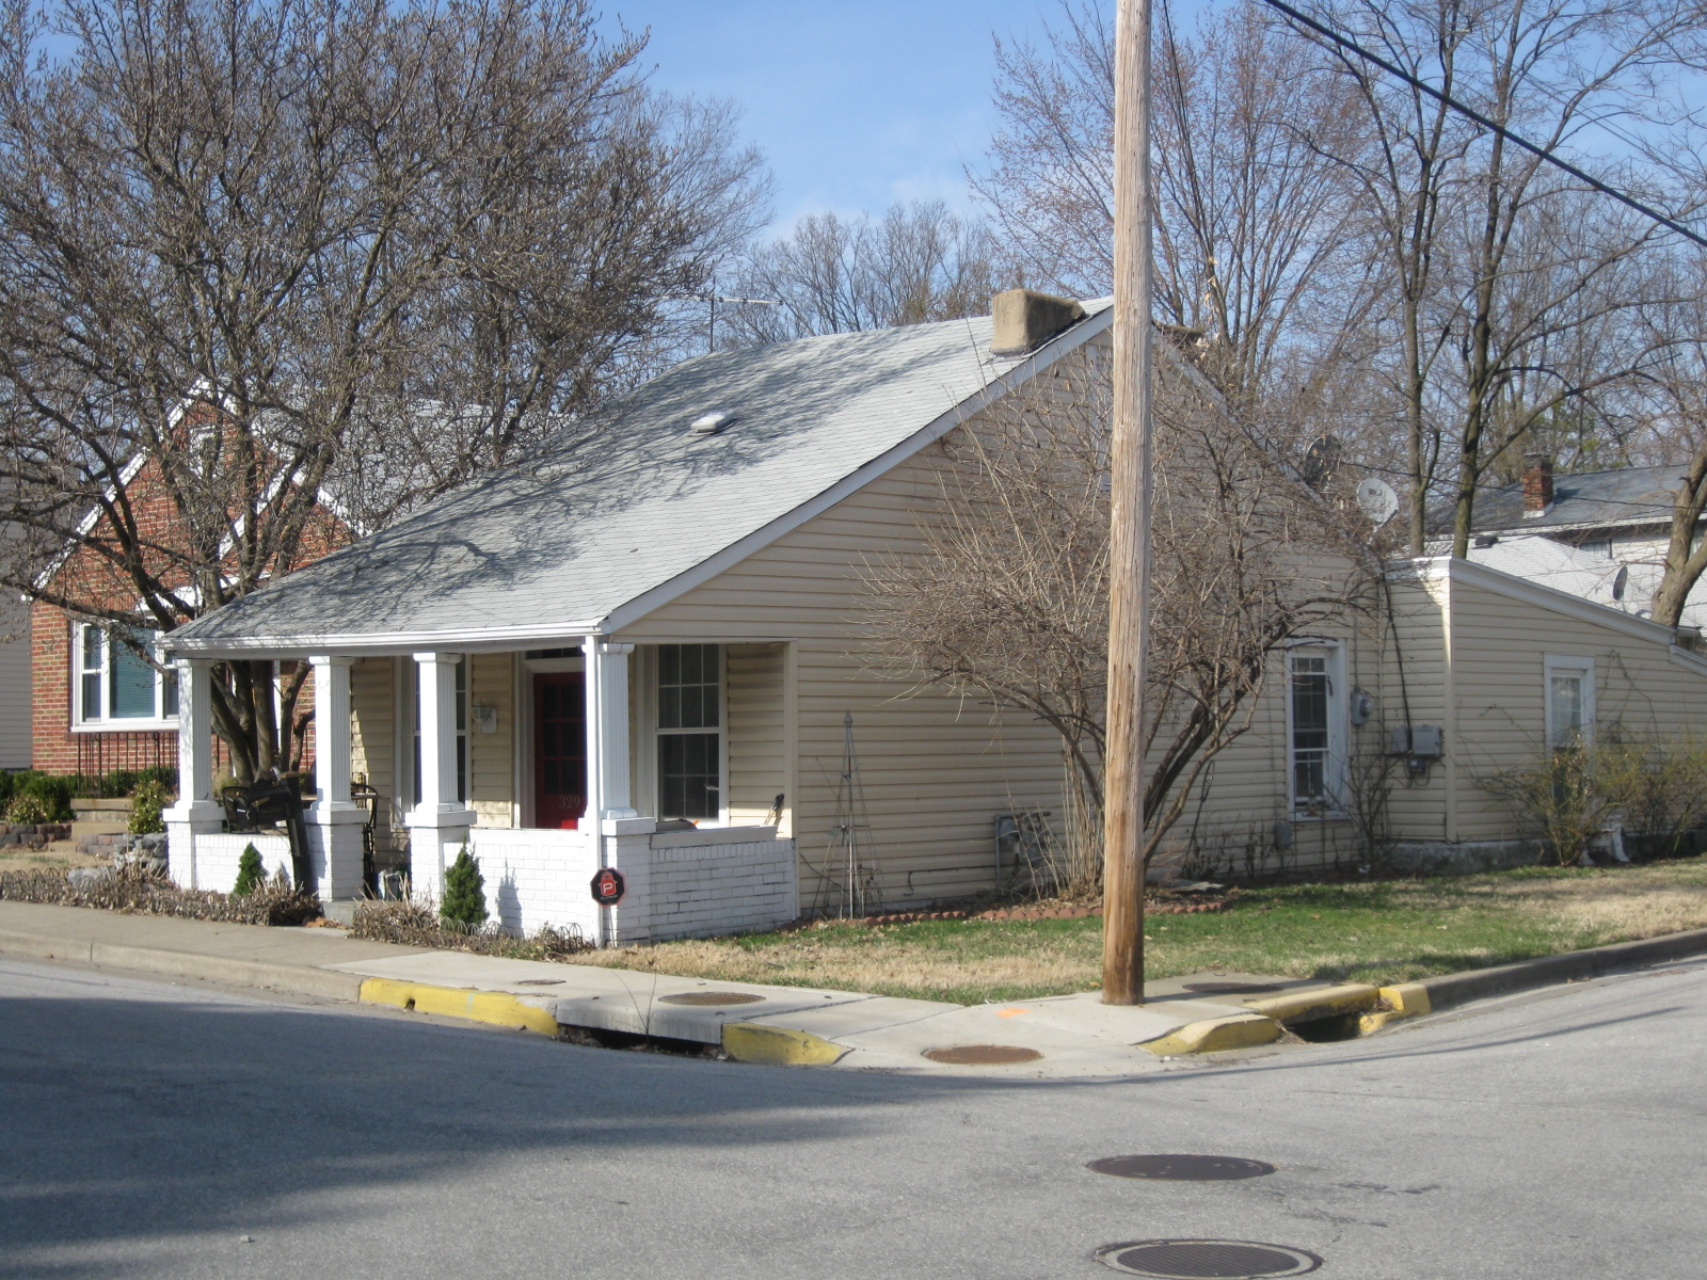
This 1.5 story, side gabled house has a full width porch, with its shed roof being an extension of the main roof. It is supported by square half columns (currently clad with vinyl) resting on brick piers that extend to the ground. Between the piers are brick half-wall railings. The door is centered on the facade and has a nine light wood door with a narrow transom (the door does not appear original). To either side of the door are sashed windows, now with replacement 6/6 vinyl windows. On the north side, facing Adams, there is a second floor sashed window and a window near the rear of the front section on the first floor but it seems that there would have been other first floor windows which are now covered with the vinyl siding on the house. The fire insurance map seems to indicate that this was originally a brick wall, now clad in vinyl. Behind this front section of the house is a one story, shed roofed wing that was added between 1900 and 1909. It is slightly wider than the front section, extending out on both sides. Spanning across the rear is a small shed roofed addition which was added between 1917 and 1929 (with a slightly shorter roof than the 1900-1909 shed roofed addition); the south two-thirds of that addition was historically an open porch, but it has since been enclosed (after 1947), now with five 6/6 windows. The chimneys flanking the ridge of the front gable on the north end have been stuccoed and shortened. A circa 1975 photo shows 3/1 sashed windows on the front, a 6/1 window on the south side, and the porch with battered box half columns on the brick piers.

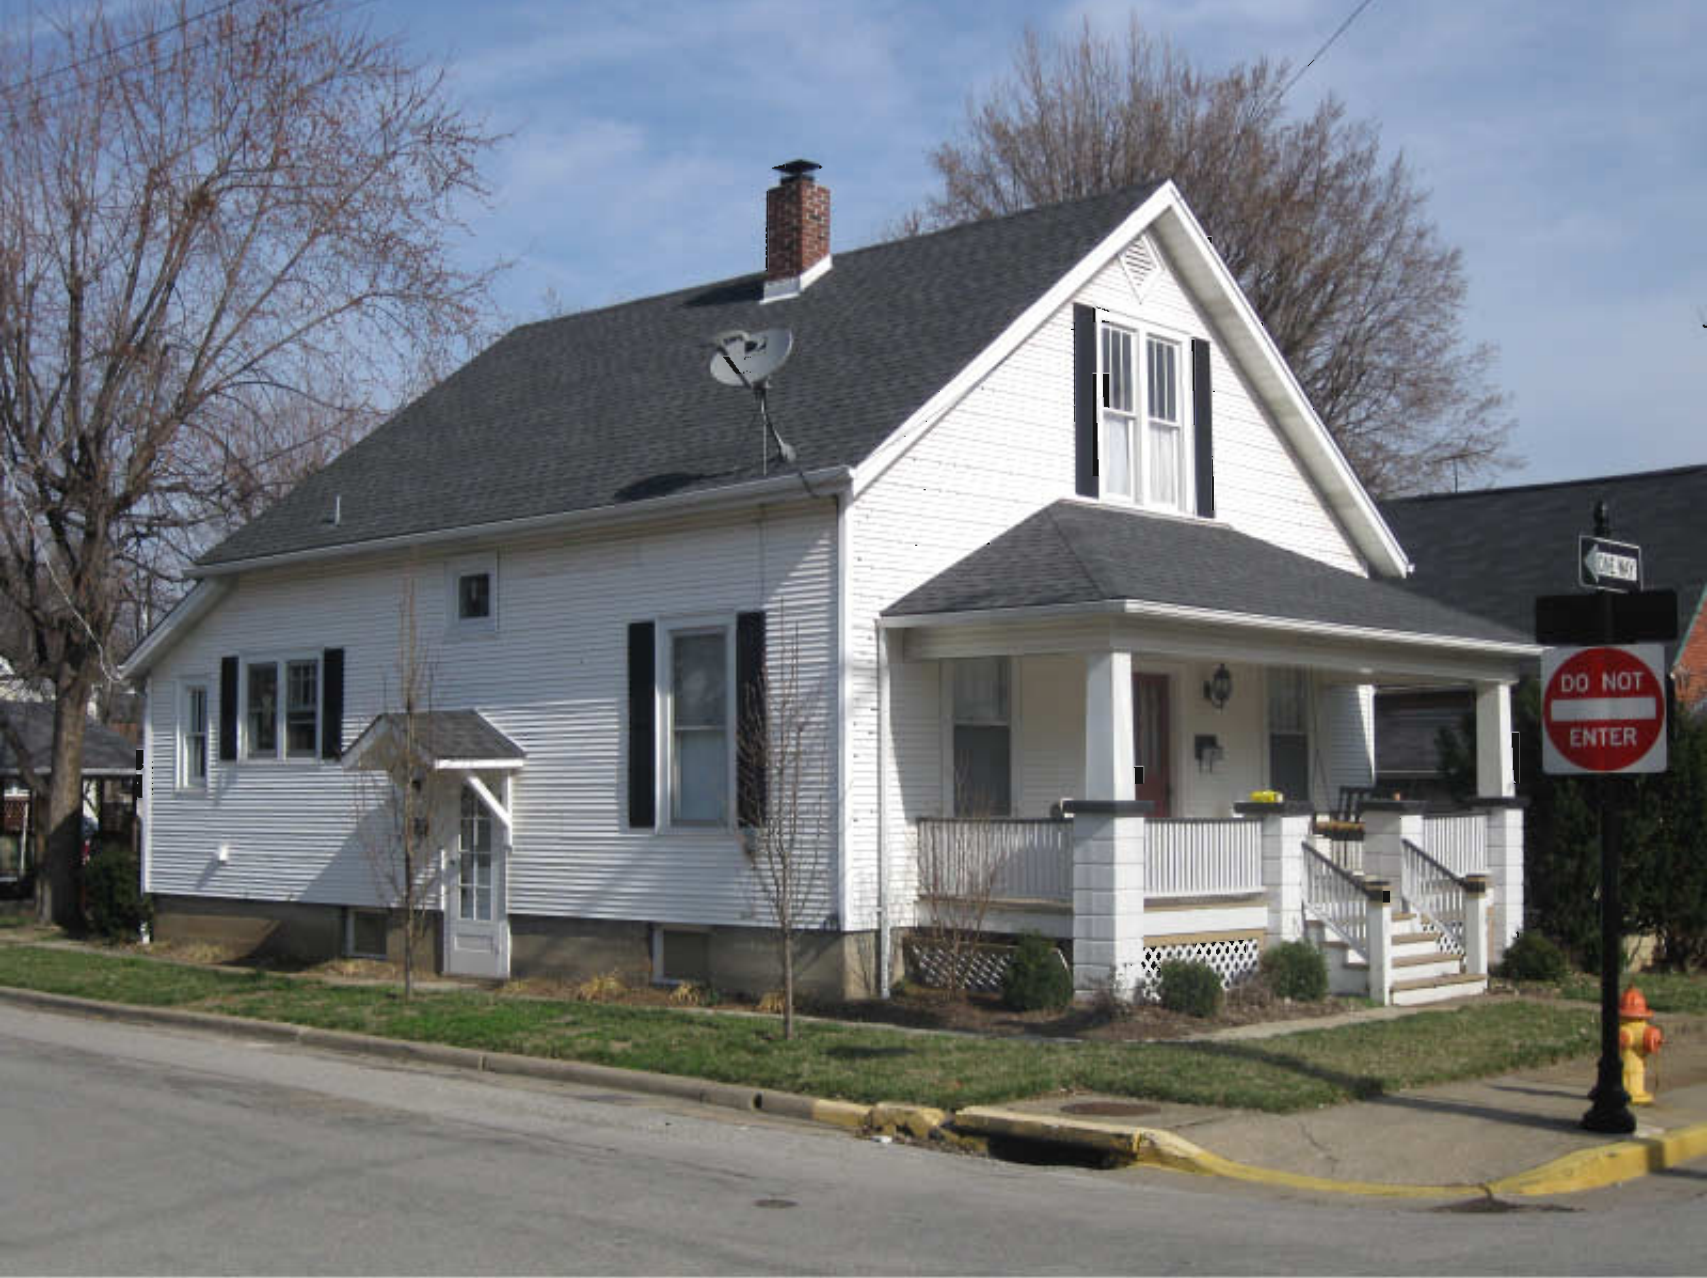
This 1.5 story, frame Craftsman bungalow has an end gabled roof with a hipped roofed, full width porch supported by battered half columns resting on scored concrete piers. The porch retains its wood porch floor and its simple wood balustrades. Between the concrete piers, under the porch, is framed lattice. The wood steps have matching railings, with square newel posts, which may be a later alteration since most porches did not have railings on stairs historically. The front door is wood with 3 vertical lights over 3 vertical panels. On either side of the door are 4/1 (vertical light) wood sashed windows and the paired second floor windows are 3/1 vertical light wood sashes. Other windows are either 1/1 or 3/1 sashed windows. There is an art glass window nestled near the eaves above the south (Adams Street) side entrance. This entrance has a small gable roof supported by knee braces over the ground level doorway (a wood paneled door with an 8-light, 1-horizontal panel wood storm door). Near the peak is a simple brick chimney flue. At the rear of the house is a one story shed roofed extension that was apparently part of the original design, although the open rear porch that spanned the north half of the rear facade has been removed (at some point after 1947) and a gabled roof, one story addition added to the house. The house has been reclad with vinyl siding and the shutters on the second floor window and the large side window are probably not original to the design, but the design retains enough of its Craftsman detailing (porch details and vertical light windows and door), that it is still a contributing building in the historic district.

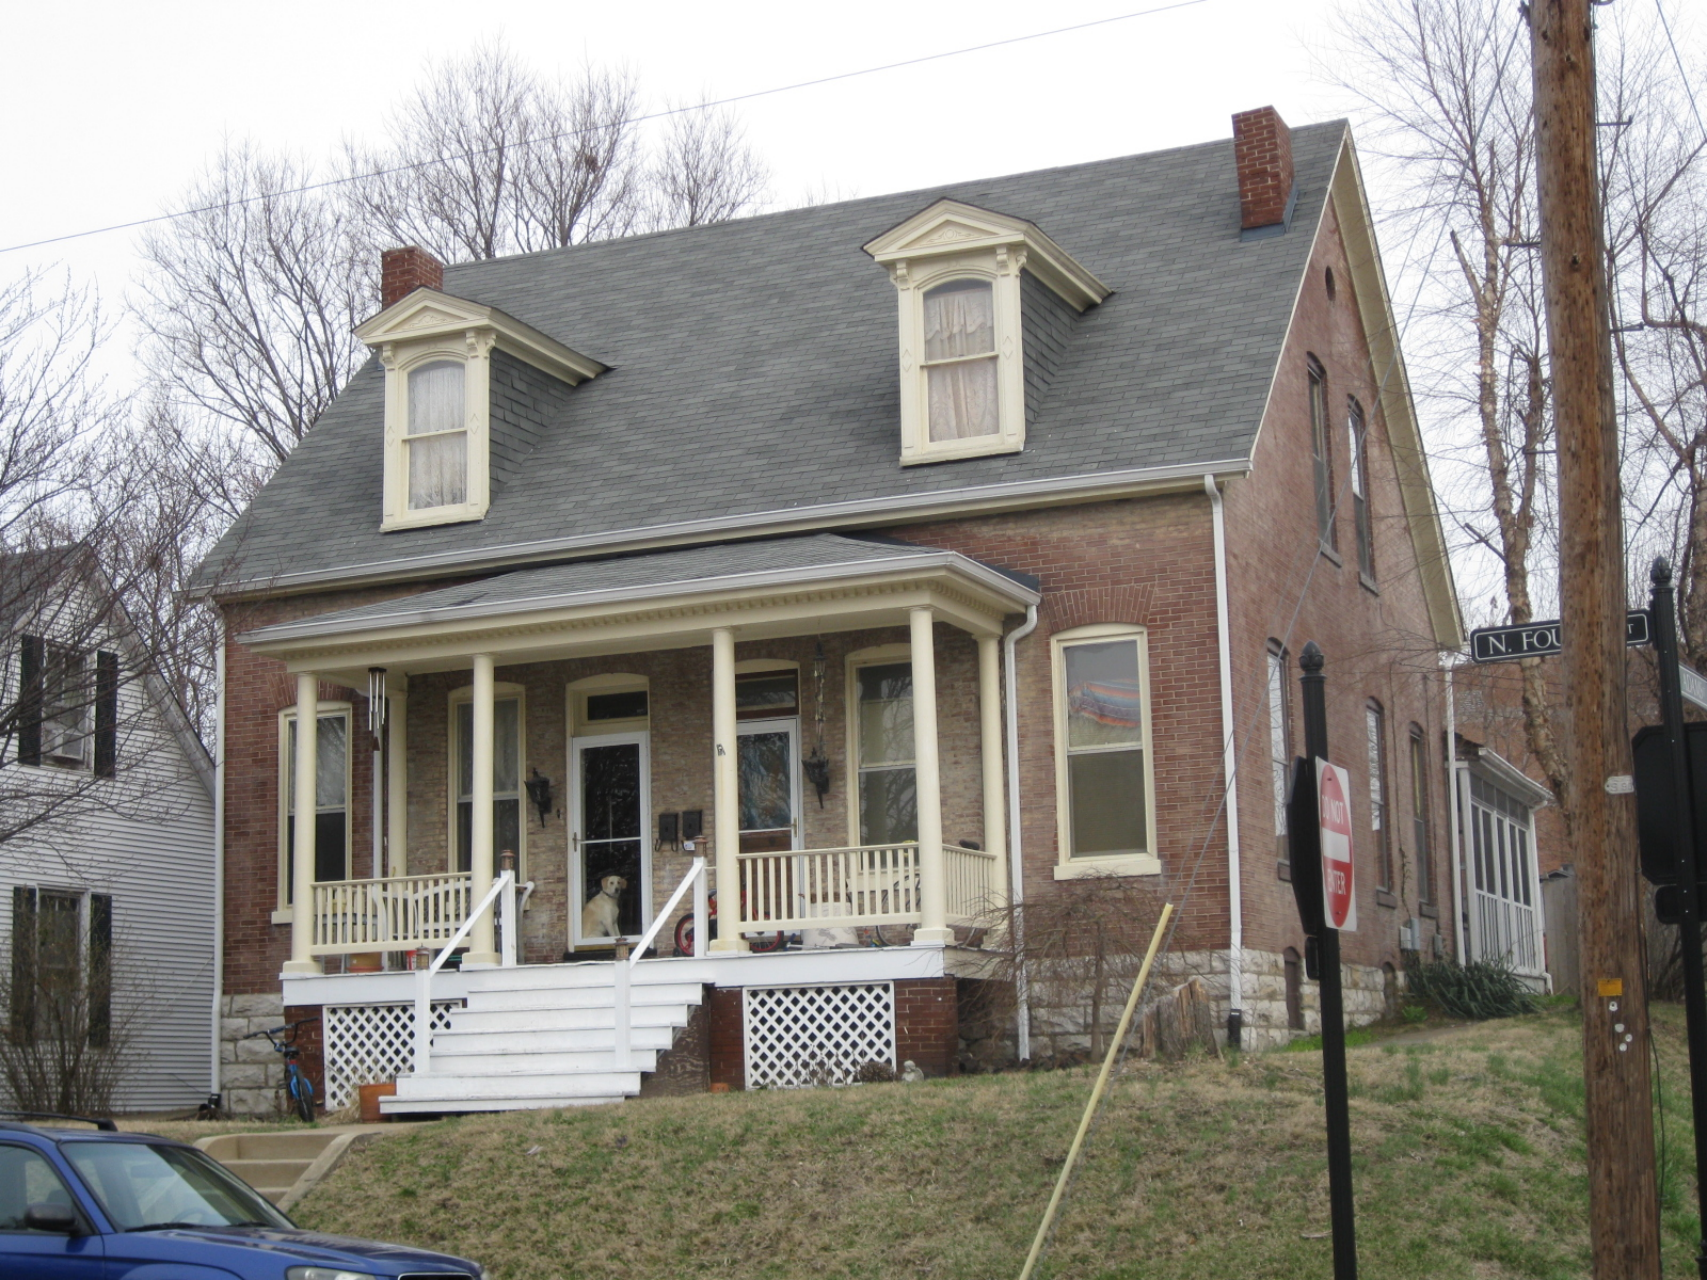
This 1.5 story, side gabled, brick house has a steeply pitched roof with two tall, gabled dormers on the facade and rear elevations. The front dormers each have a pedimented gable end with scrollwork detailing in the gable end and decorative brackets and millwork on the segmental topped 1/1 window. At either end on the front and back side of the ridge are brick end wall, interior chimneys, four in all. The first floor facade is divided into six bays with segmental arched 1/1 wood sashed windows in each bay except for the two center bays which have segmental arched, transomed doorways. The doors are half light, 3 panel doors and the transoms are single light. The front porch spans four bays and has a hipped roof supported by four slender Doric columns (with matching pilasters at the brick wall). The porch has brick piers spanned by lattice and a wood porch floor and steps. The roofline of the porch is embellished with dentil molding and it has a simple balustrade. The foundation is coursed, rock faced limestone, visible on the facade since the land slopes downhill toward the street. On the rear is an intersecting 1.5 story gabled wing which is shorter in height than the front wing. This wing is original to the design and also has segmental arched 1/1 windows. There is a corbelled brick chimney in the ridge of this rear wing. On each side there was originally a shallow open porch incorporated under the same roof, which extends down to the one story height on each side. The south side porch has been screened in but the one on the north side has been enclosed. The basement windows have been boarded and the windows and doors have had storms added.

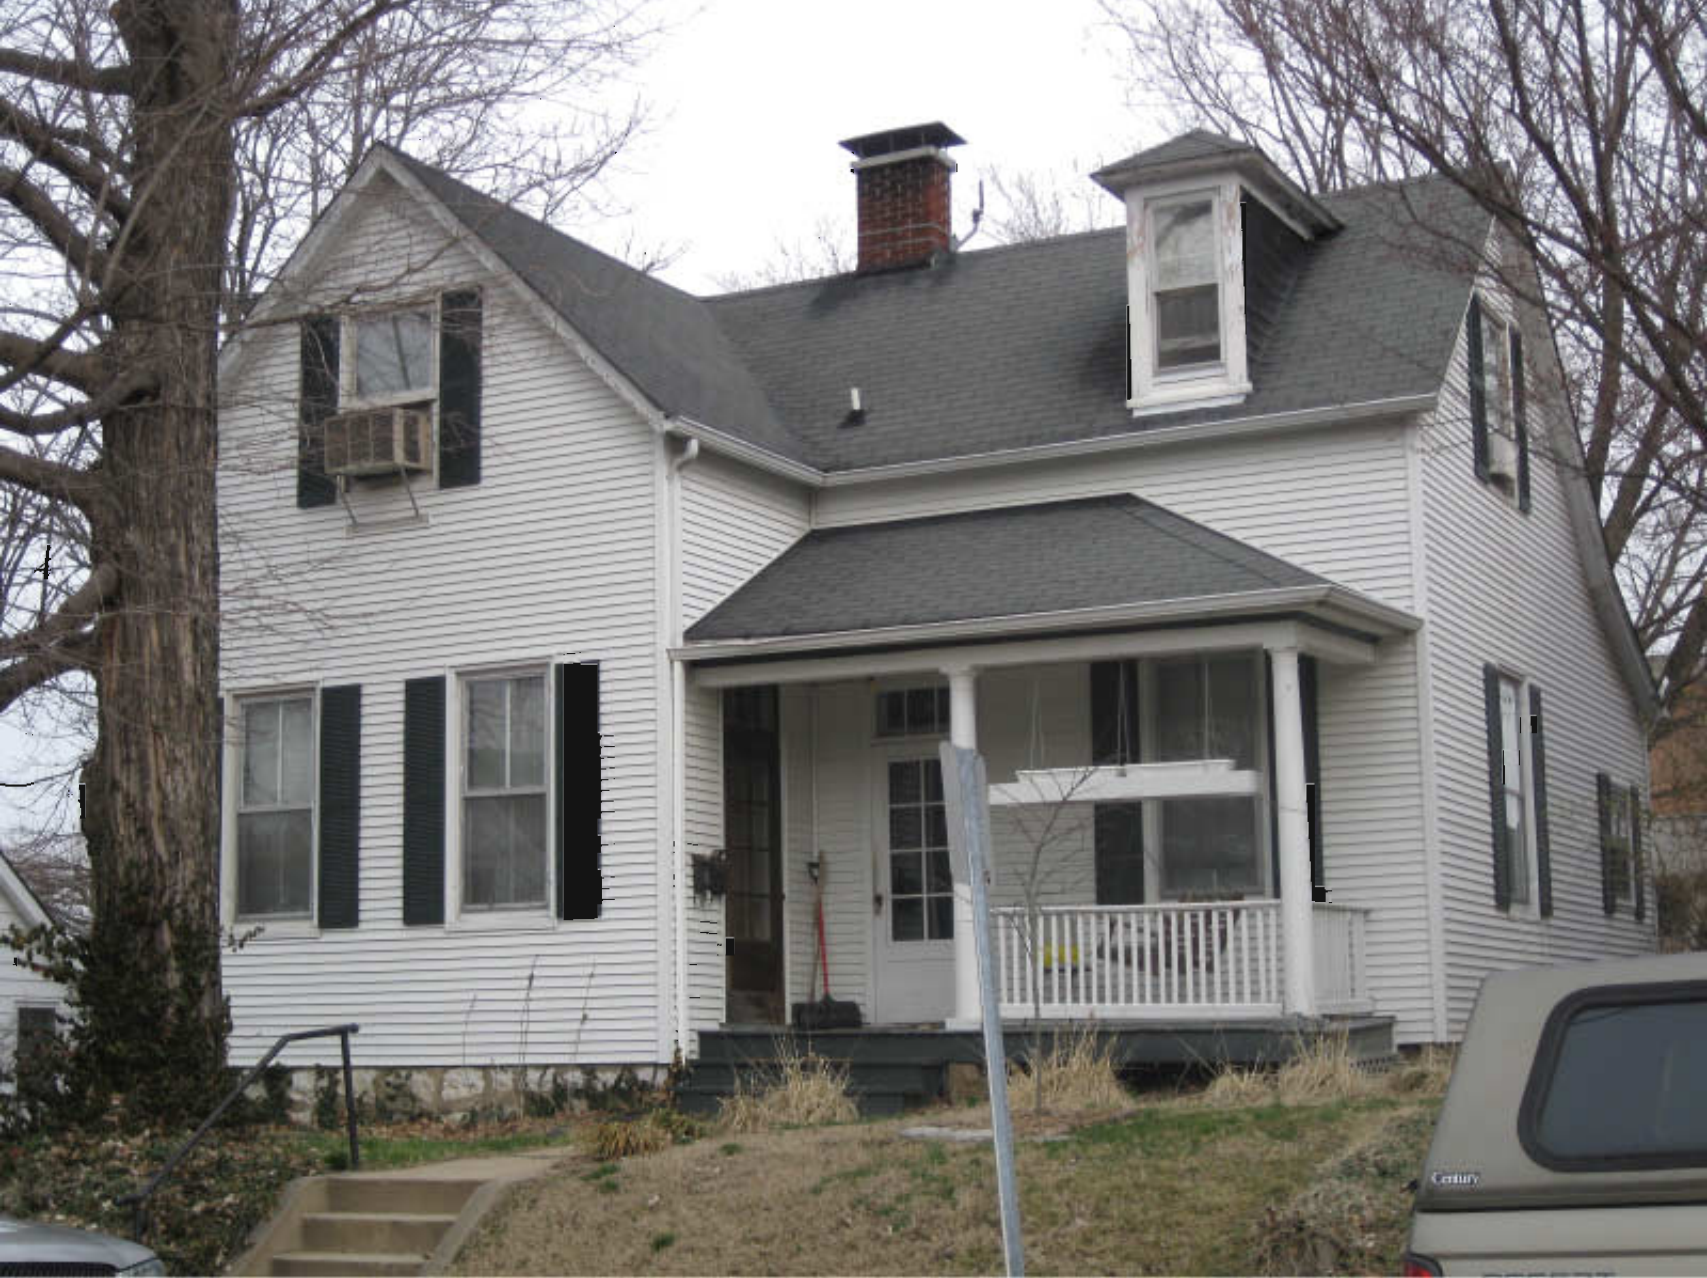
This 1.5 story, gabled roof, frame house was originally a T-shaped house creating a large gable end, projecting wing on the north end of the facade. The hipped roof porch was apparently added between 1900 and 1909, replacing a small enclosure nestled in the interior corner of the facade. This porch has a hipped roof with slender Doric columns and simple wood balustrades resting on the wood porch floor. There are two transomed doors opening onto the front porch, one in each wing and they both have 8-light wood storm doors that obscure the main doors, but the single light transoms are protected by 3-light wood storms. At the south end of the facade on the first floor, under the porch roof is a broad 2/2 wood sashed window. In the front gabled wing there are two 2/2 sashed windows with one 2/2 window in the gable end. Over the porch, there is a hipped roof dormer with a 1/1 wood sashed window. There is a large brick chimney with a modern metal chimney cap centered in the ridge. The foundation is rock faced limestone. On the back of the house, there was a shed roof addition that may actually be an enclosure of the original rear porch. This alteration occurred between 1917 and 1929. The house has been sided with vinyl siding, apparently covering at least some portion of the window trim, and shutters have been added. While this changes the proportions of the window openings slightly, the house retains enough other detailing, with its complex roofline, dormer, and porch details, to be contributing to the historic district.

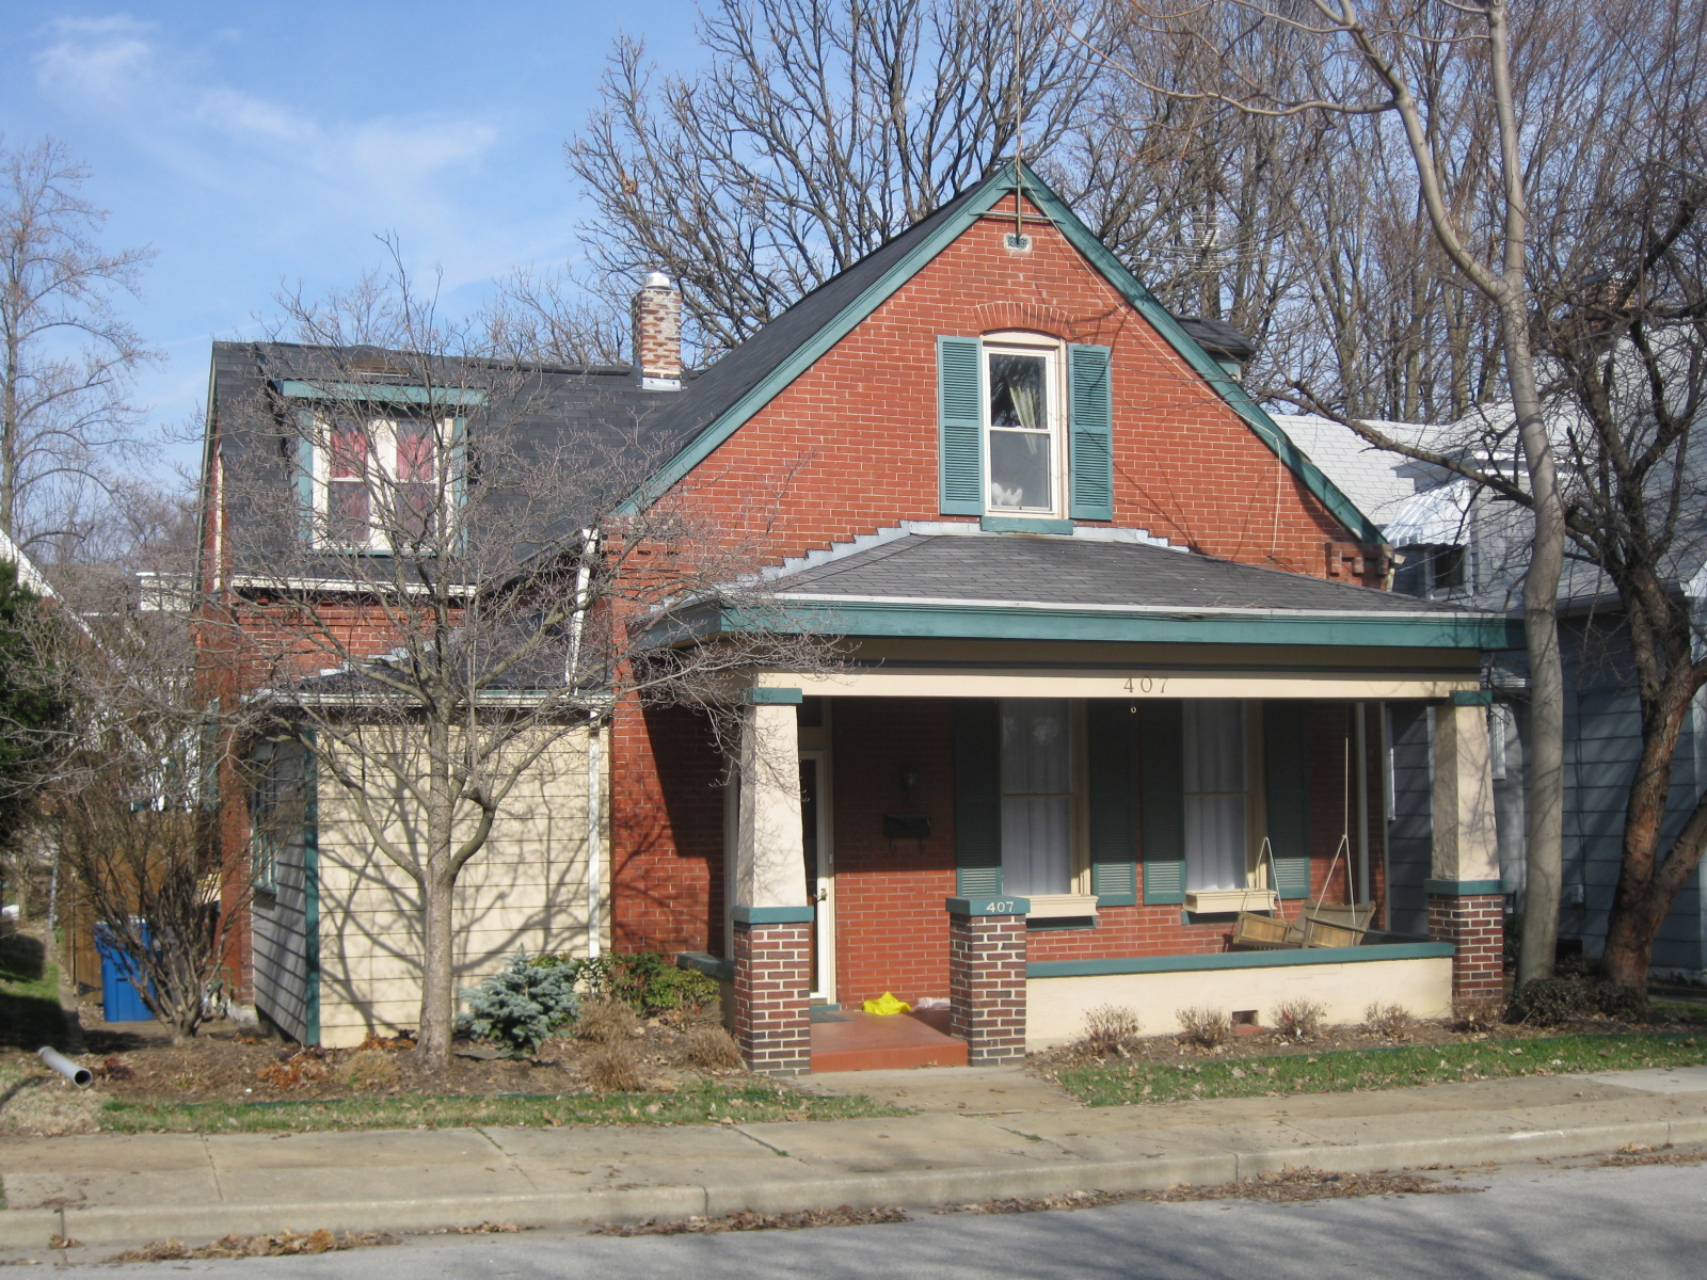
This 1.5 story house was originally an L-shaped house shown on the 1900 fire insurance map. The gable end of the front wing spans nearly two-thirds of the width of the facade with the deeply recessed south side gabled wing having a shed roofed dormer with paired 1/1 windows. Originally, there was a small one-bay porch at the south end of the main gable end front wing, but between 1917 and 1929 the gable end wing was spanned by a full width, hipped roof porch with its battered half columns on top of brick piers. The half wall railings are now stucco (possibly originally brick) and the porch floor is concrete. There are two 1/1 sashed windows next to the oval light door. There are wooden shutters on the facade windows, including the window above the porch. When the porch was added, a small, one story, hipped roof, framed room was added to the interior corner of the L, south of this gabled wing (it is currently covered with vinyl siding but it may have originally been an enclosed sun porch). There is a denticulated brick frieze in the eaves and incomplete cornice returns on the front gable. On the north side, in front of the cross gable, there is a gabled dormer. The main facade walls are running bond but the north elevation is one-course common bond. The openings on the main facade are segmental arched, with the area above the windows and door having incised panels. On the north side, also added in 1917-1929, is a box bay window. The addition on the rear was enlarged by 1917 and again between 1917 and 1929 with a porch wrapping around the south and west walls of the addition. Other than the vinyl siding and storm door, the house appears to have changed little since 1929 from the street.

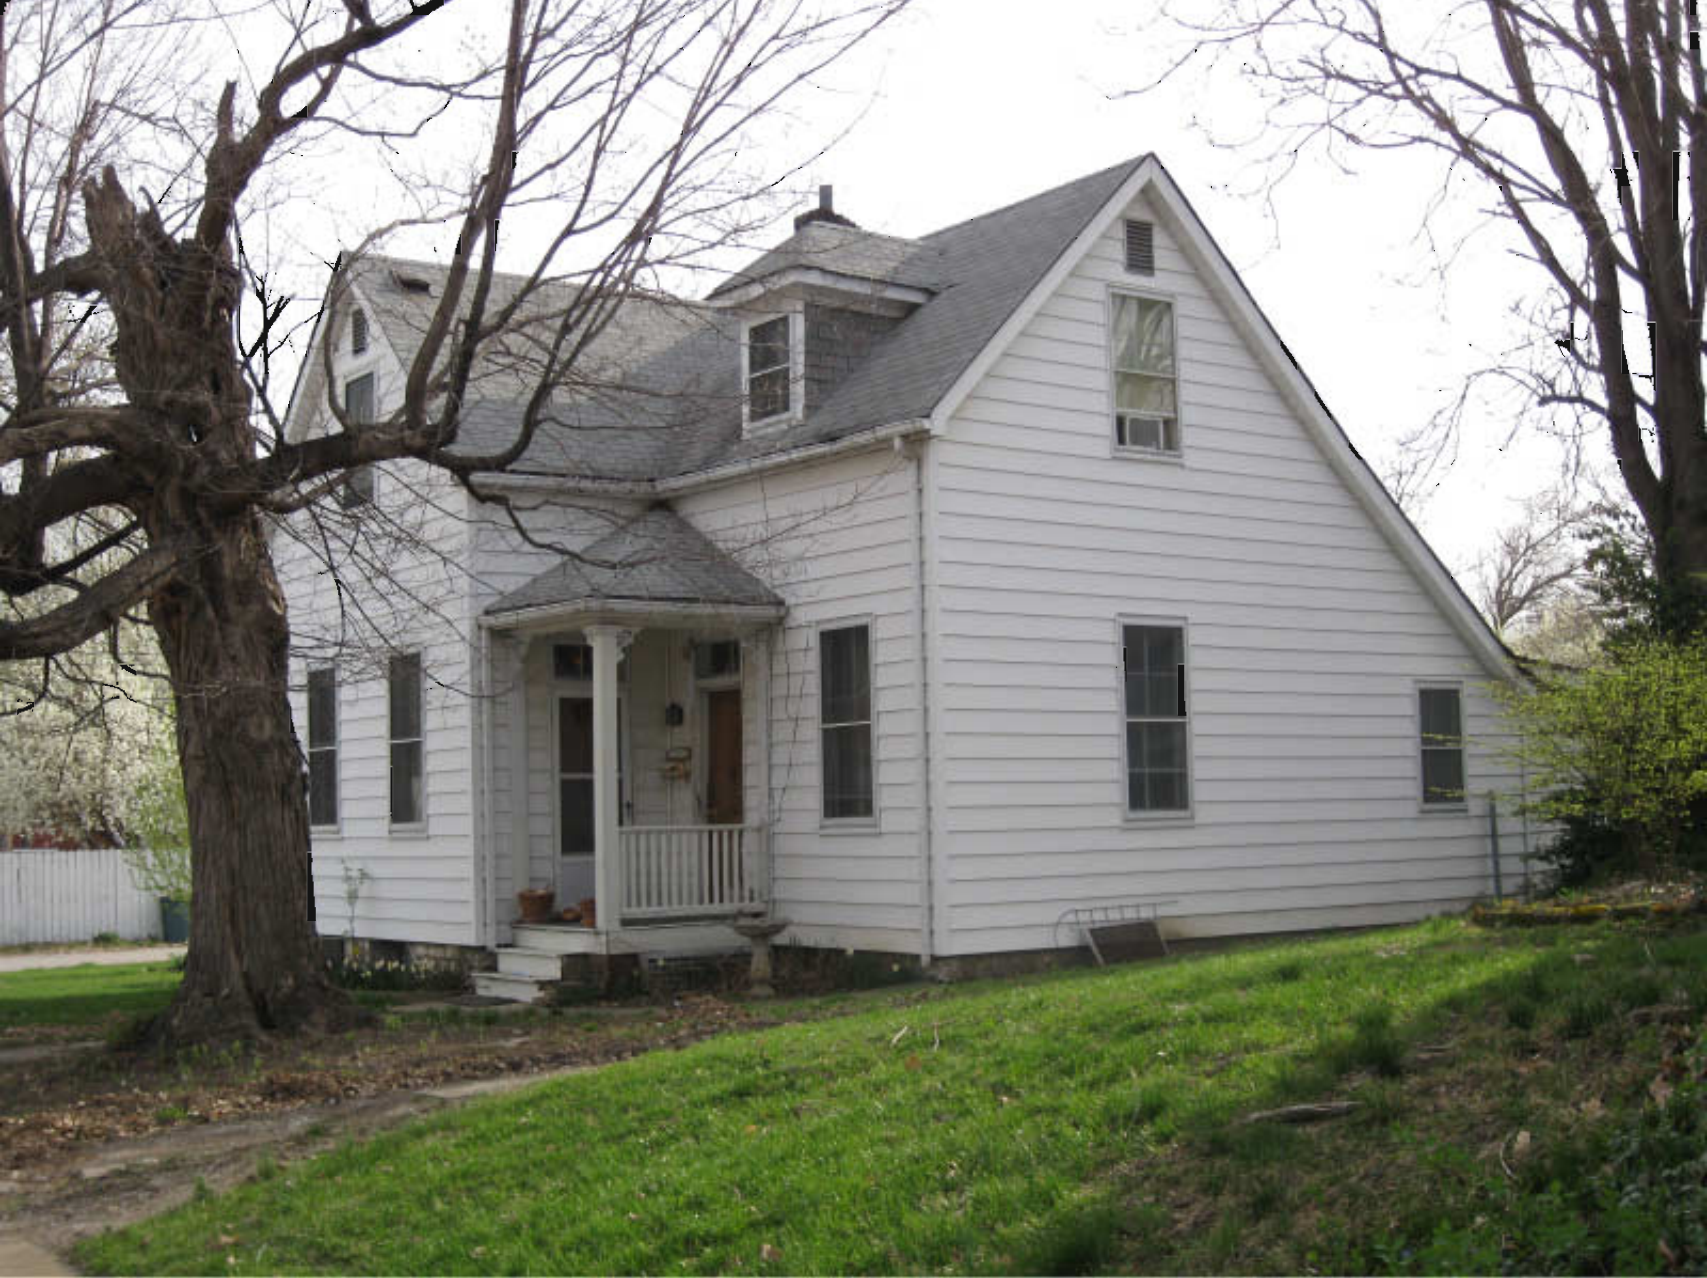
This 1.5 story, frame house originally had a T-shaped plan with a small front porch nestled in the interior corner and a full-width rear porch. The north bay of the facade is the end gabled, projecting wing with the side gabled intersecting wing extending to the south. By 1909, the front porch had been lengthened to the full width of the south wing. Then between 1917 and 1929, the front porch is shown again with a single bay front porch and the rear porch had been enclosed, making the house L-shaped. There are hipped dormers over the south wing facing the street, and two over the north wing facing north. The hipped roof porch is one bay wide, nestled in the interior corner of these two wings. The porch has a simple square corner post and pilasters with a wood porch floor/steps and simple wood balustrade. There are two doors opening into the porch with four panel doors and two-light transoms. On the rear, where there was a full-width rear porch, this was enclosed as a shed-roofed extension of the main roof of the south gabled wing, and in 1982 a small, one story, shallow shed roofed addition was added to the east end of the north gabled wing. Around 1995, the shed roofed deck was added to the north side of the house. The wide vinyl siding and vinyl soffits obscure the historic wall finishes and cover the window trim, although the windows are the original 2/2 wood sashed windows and the front porch treatment may date from the 1917-1929 alterations given the simplicity of its design and the historic balustrade.
