ARCHITECTURAL/HISTORIC INVENTORY FORM

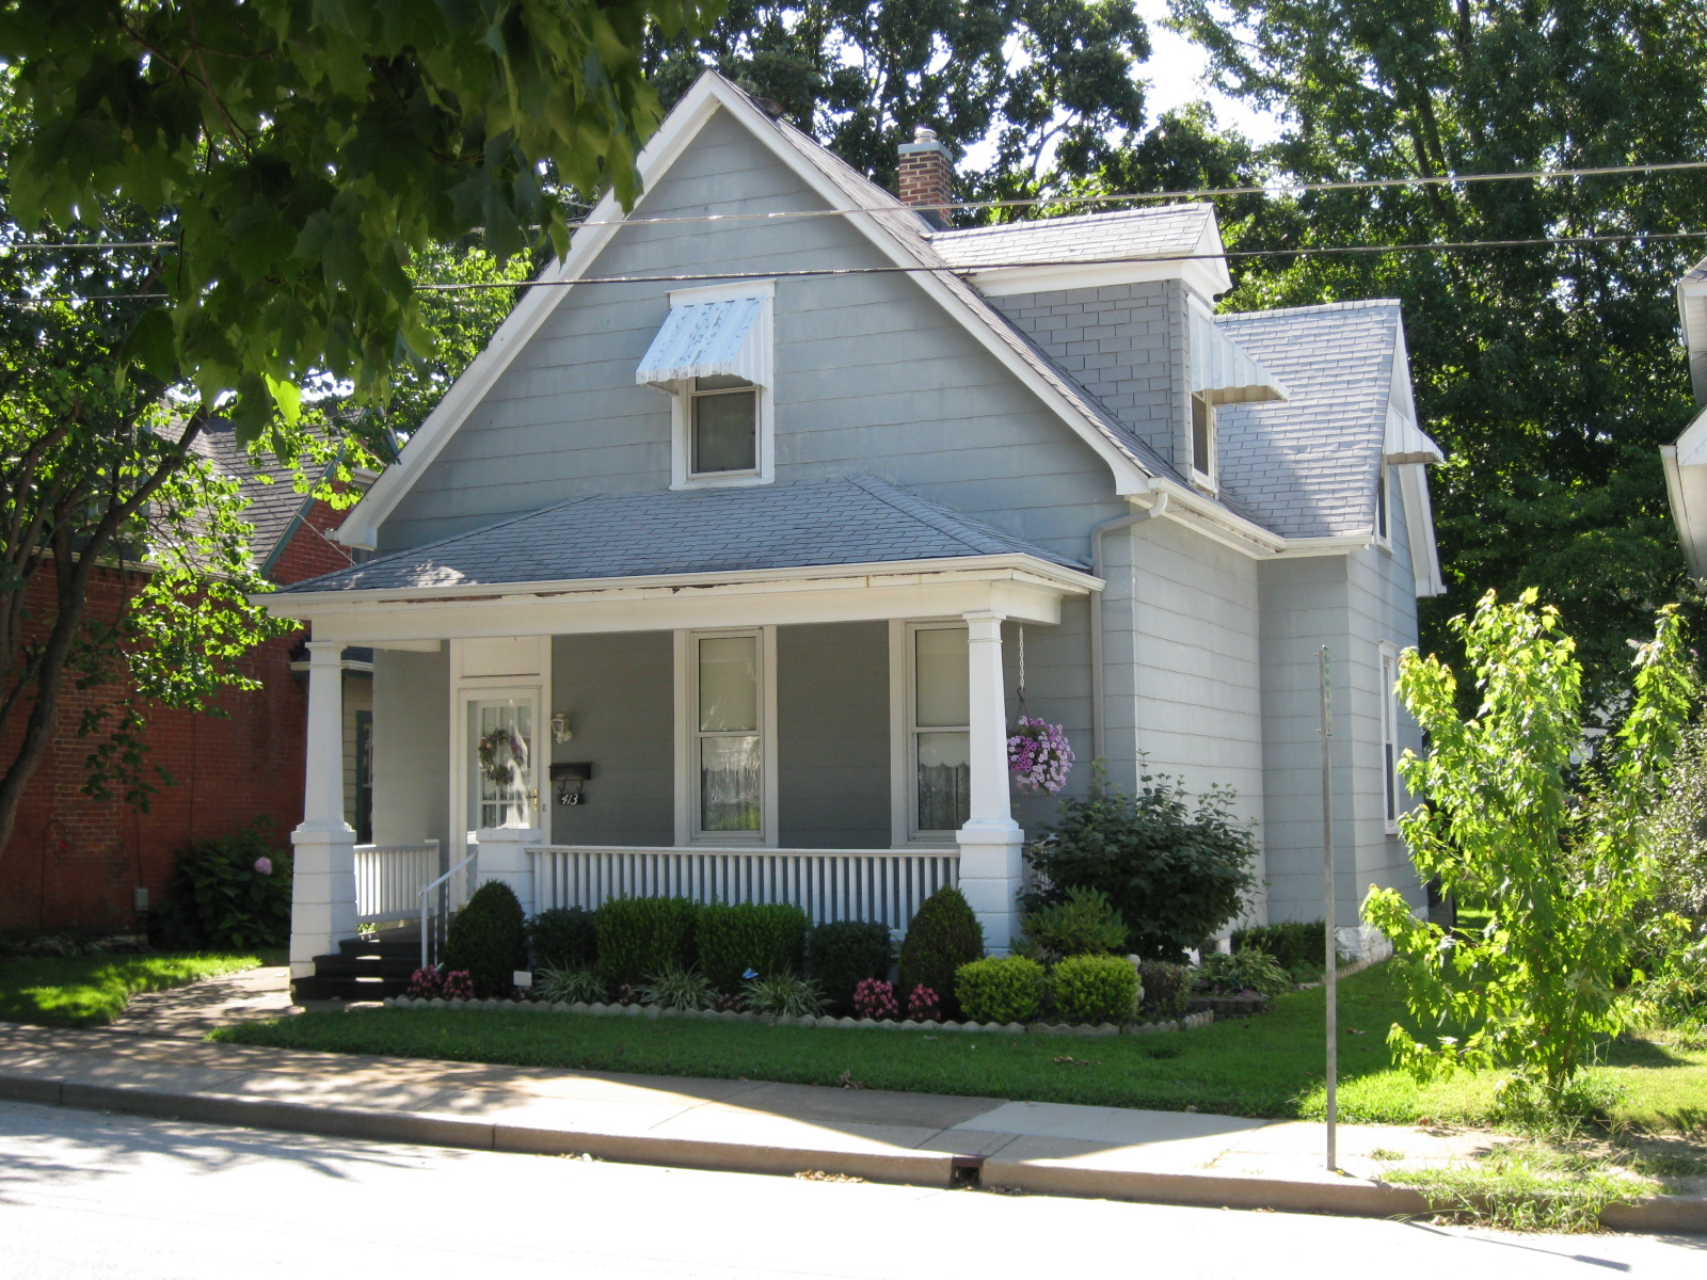
This 1.5 story, cross gabled house has an irregular plan shape, but was originally a cross gabled plan, still the prominent feature of the house. The broad end gable faces the street with a single window on the second floor above the porch. While it originally had a small porch just at the front entry, between 1917 and 1929 the full-width front porch was added with its Craftsman inspired battered half columns resting on scored concrete piers. The porch has its original wood porch floor and steps as well as the historic simple balustrade. There are two 1/1 wood sashed windows north of the 15-light front door. Its transom has been boarded in. On the south side of this gabled facade wing is a small, one story, hipped roof wing that was added between 1917 and 1929 (based upon the fire insurance maps). On the east elevation of this wing is a small art glass window. On the south side of the front-gabled facade wing is a hipped roof dormer and on the north side is a pedimented dormer. On either side, the cross gabled wings project slightly with 1/1 sashed windows on both levels. Probably by the early 1950s, asbestos shingle siding was added to the house and since then aluminum awnings have been added to the second floor windows. The only other alteration is the use of aluminum storm windows that protect the historic 1/1 wood sashed windows. Despite these alterations, the house retains most of its historic design details and the asbestos siding actually represents a change during the period of significance of the historic district.

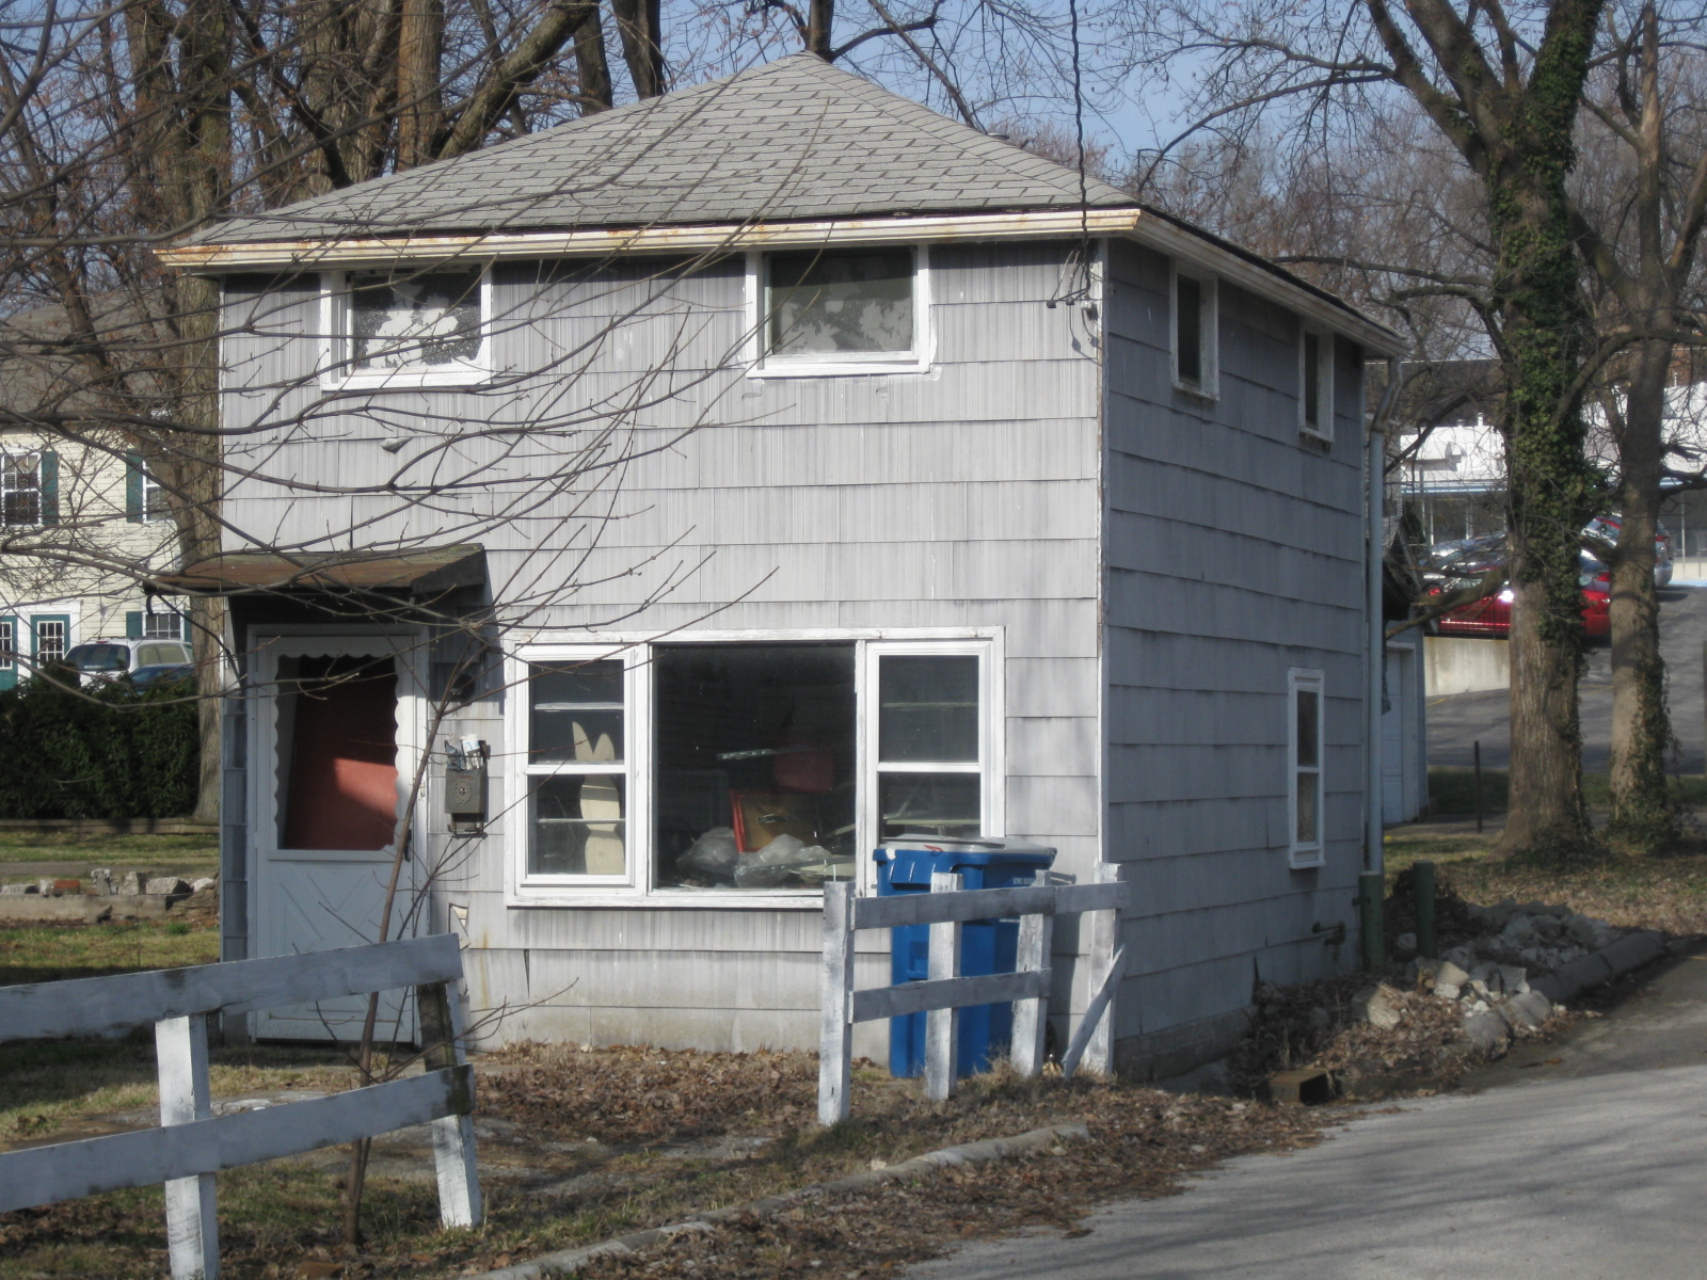
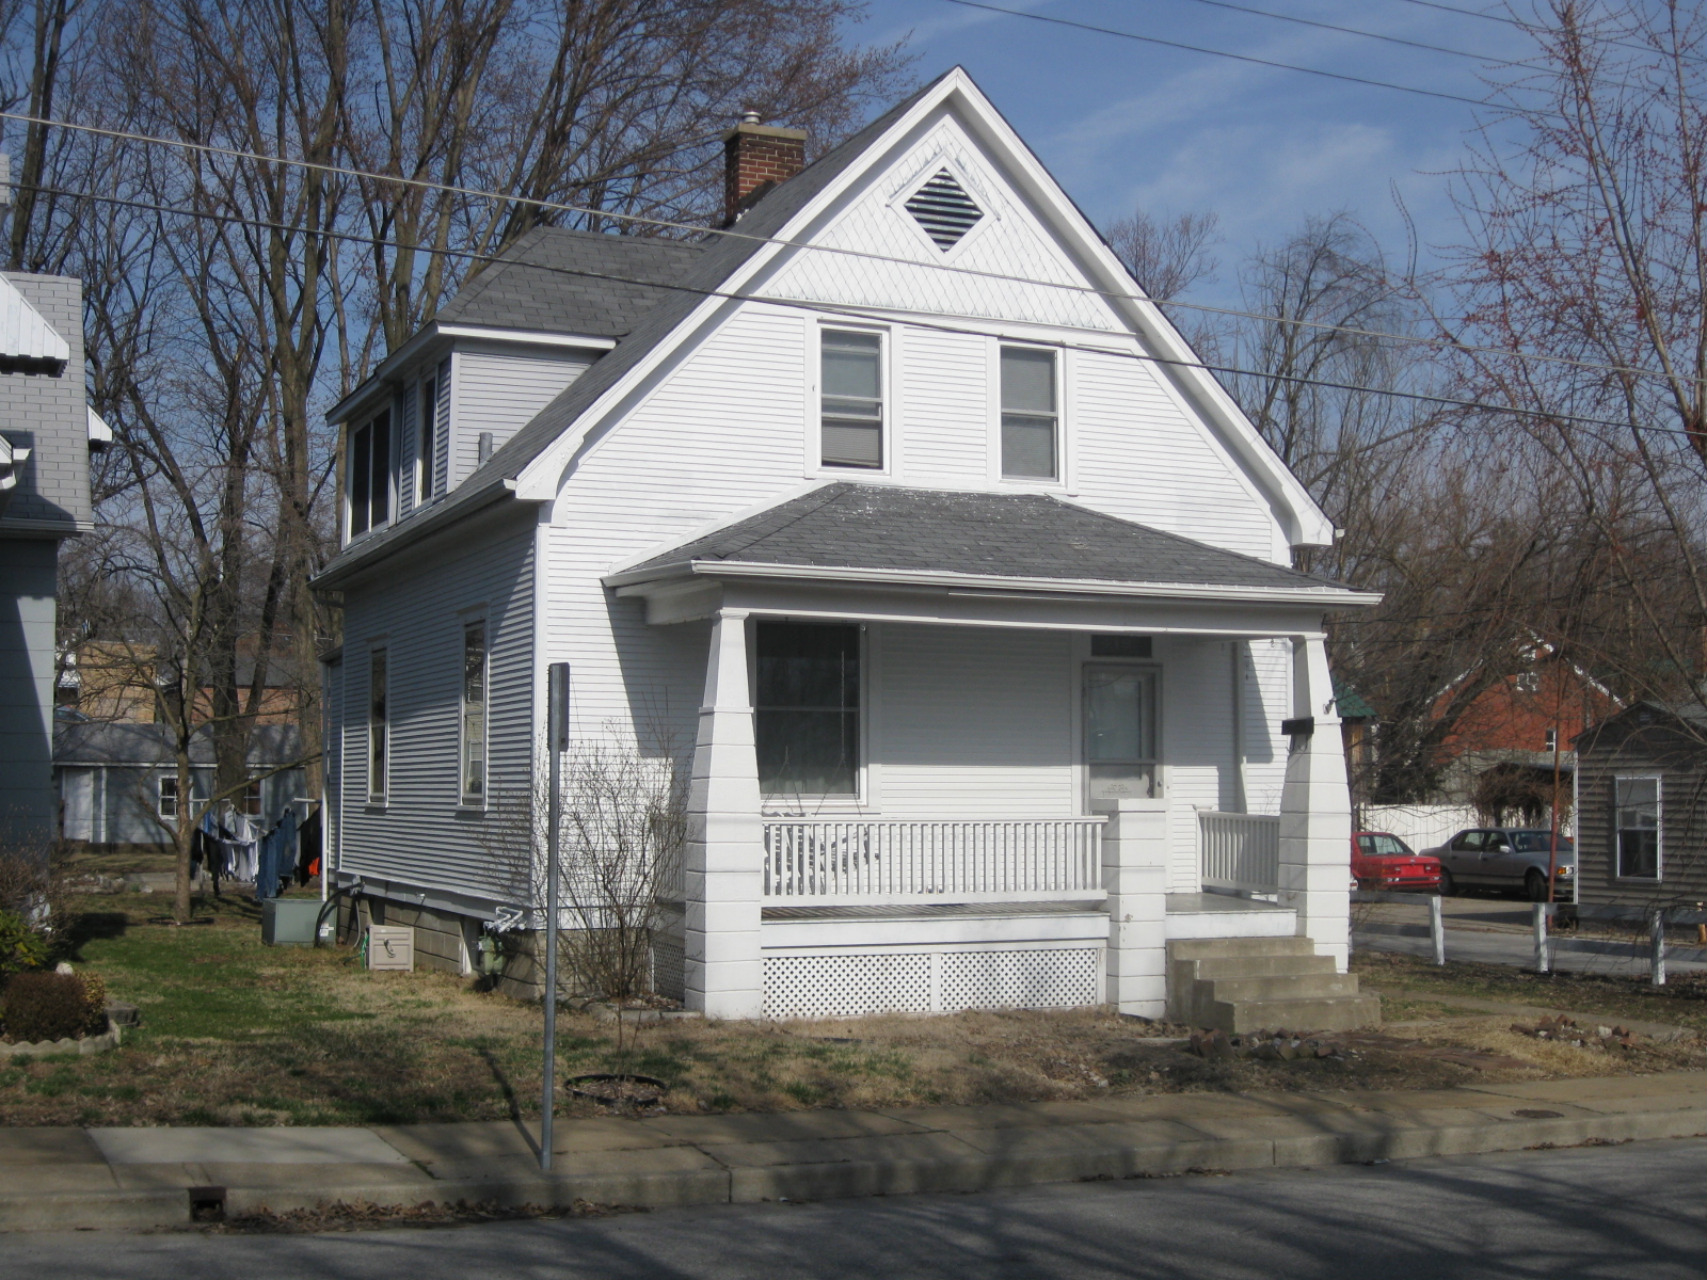
This 1.5 story end gabled, clapboard house has a full width, hipped roof porch supported by battered box columns. Both the porch and main roof have boxed soffits. The porch has a bead board ceiling, a wood porch floor and what are probably replacement concrete steps. The battered columns extend to the ground with latticework below the porch floor and simple wood balustrades. There is a large 1/1 wood sashed window on the first floor to the south of the transomed, half light, multipaneled door. On either side, there are large hipped dormers, the one on the north has paired 1/1 sashed windows while the one on the south has a single 1/1 sashed window, but directly to the west of this dormer is a shed roofed dormer that was added at some point that has paired 1/1 windows. The gable end above the two second floor 1/1 wood sashed windows is clad in diamond pattern wood shingles with a diamond-shaped ventilator. This second floor treatment is mirrored on the rear elevation where there is a shed roofed, one story room that is original to the design, although the south half was originally an open porch that has since been enclosed. There is a shed roofed dormer on the south side of the rear gable. Like the battered piers, the foundation is scored concrete. The windows are all 1/1 wood sashed windows, except for the north elevation where they are 2/2. The enclosed rear porch appears to have been extended slightly to the west since it has a concrete block foundation. The chimney at the ridge is a simple brick chimney. Basement windows are wood, single light awning windows. Some windows and the front door have had storms added. The dormers and their soffits have been clad in vinyl.

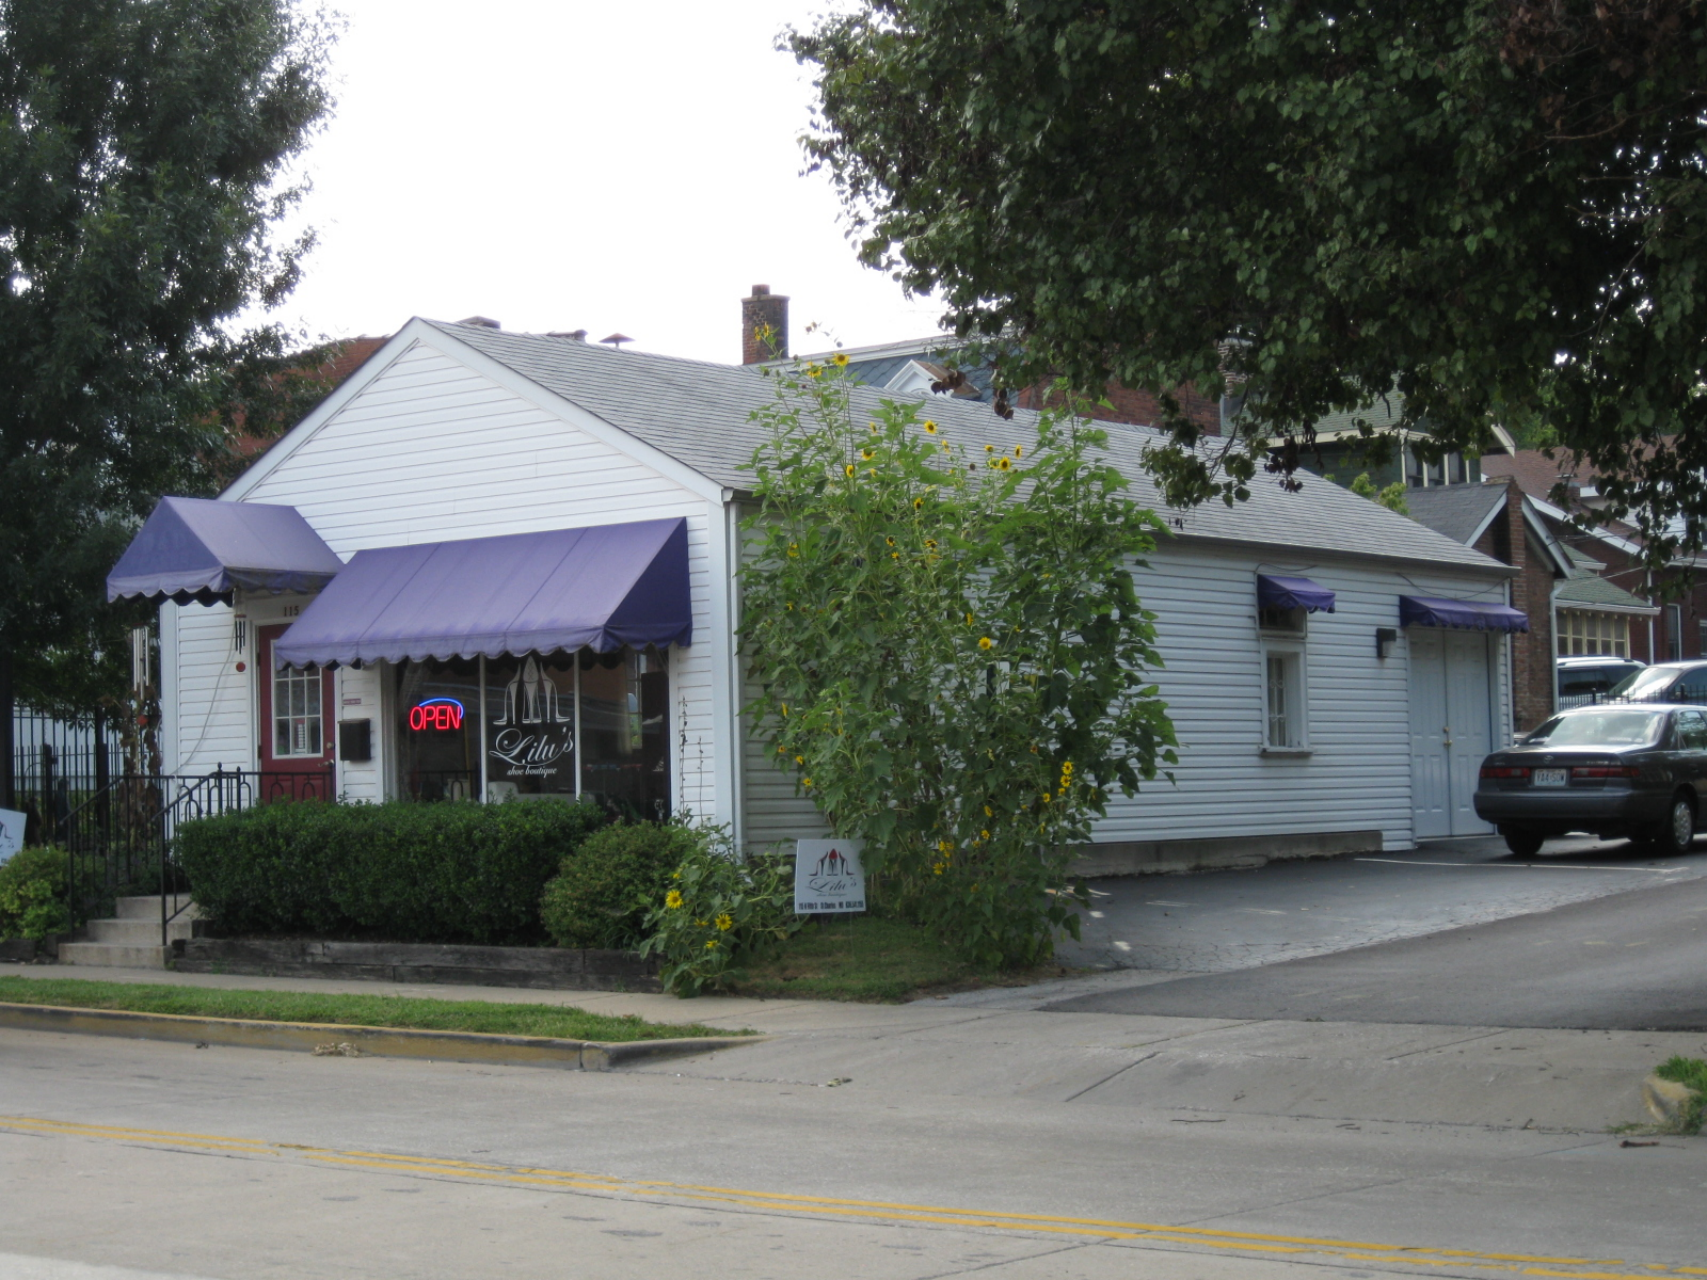
This one story, end gabled, frame building has a large display window which appears to be the original aluminum framed window. At the south end of the facade is a half-light, paneled door that is accessed by a concrete stoop with metal railings. There is a freight doorway, with paired paneled doors at the west end of the north elevation, with windows scattered on both the north and south side elevations. The building has been reclad with vinyl siding and has awnings over all openings. The front door, with its multipaned grid in the half light also appears to be a replacement door. Because of the replacement siding and door this building is identified as noncontributing to the district, but if historic photos show the appearance has not changed substantially with the new siding, it probably would be contributing to the district.

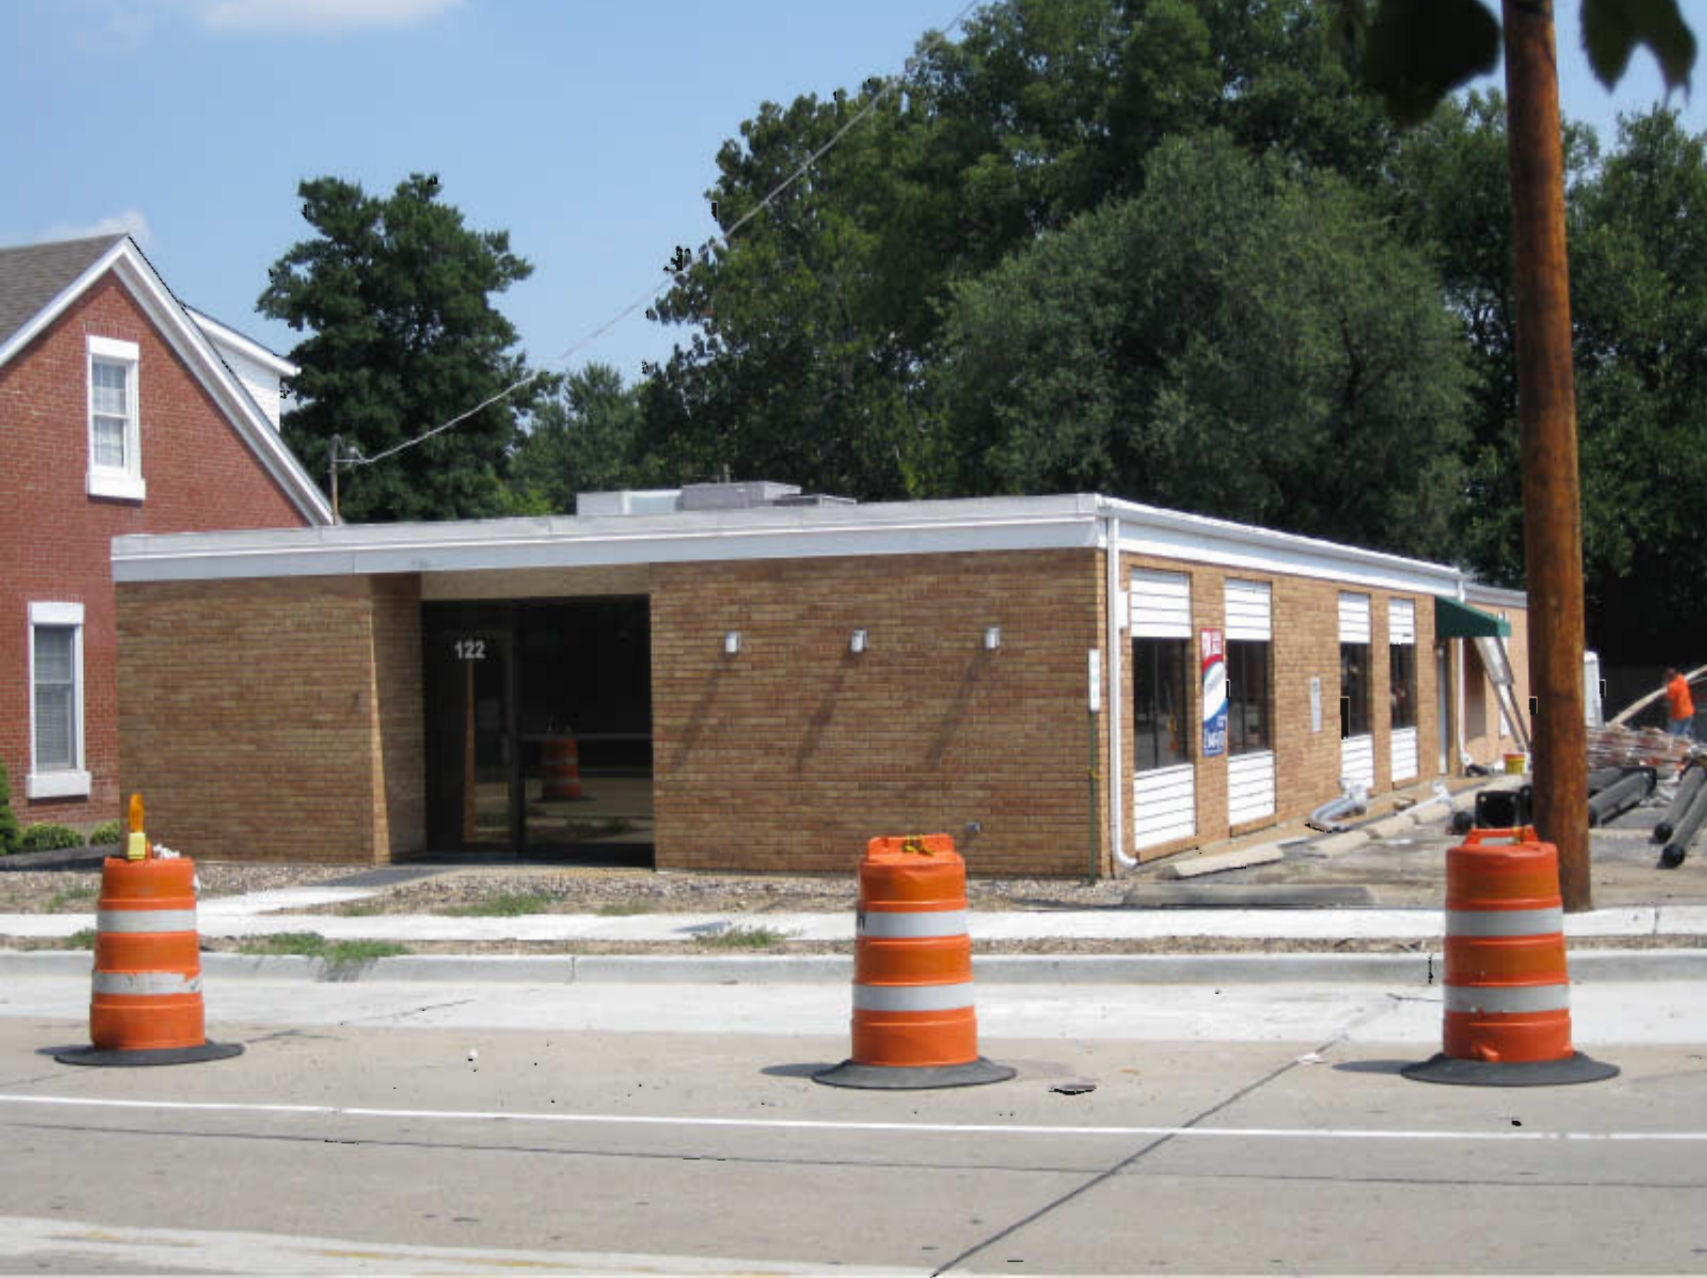
This flat roofed, one story brick office building has a simple facade with an off-centered, recessed entry with anodized aluminum commercial storefront framing and doors in the recess. Along the south side, there are four bays with smoked glass windows that appear to be later replacements since there is siding infilling above and below each window. The back bay on this side is a secondary entry with an awning. Behind the original building is a 1997 flat roofed brick addition. Since this was built after the period of significance for the historic district, this building is noncontributing to the district.

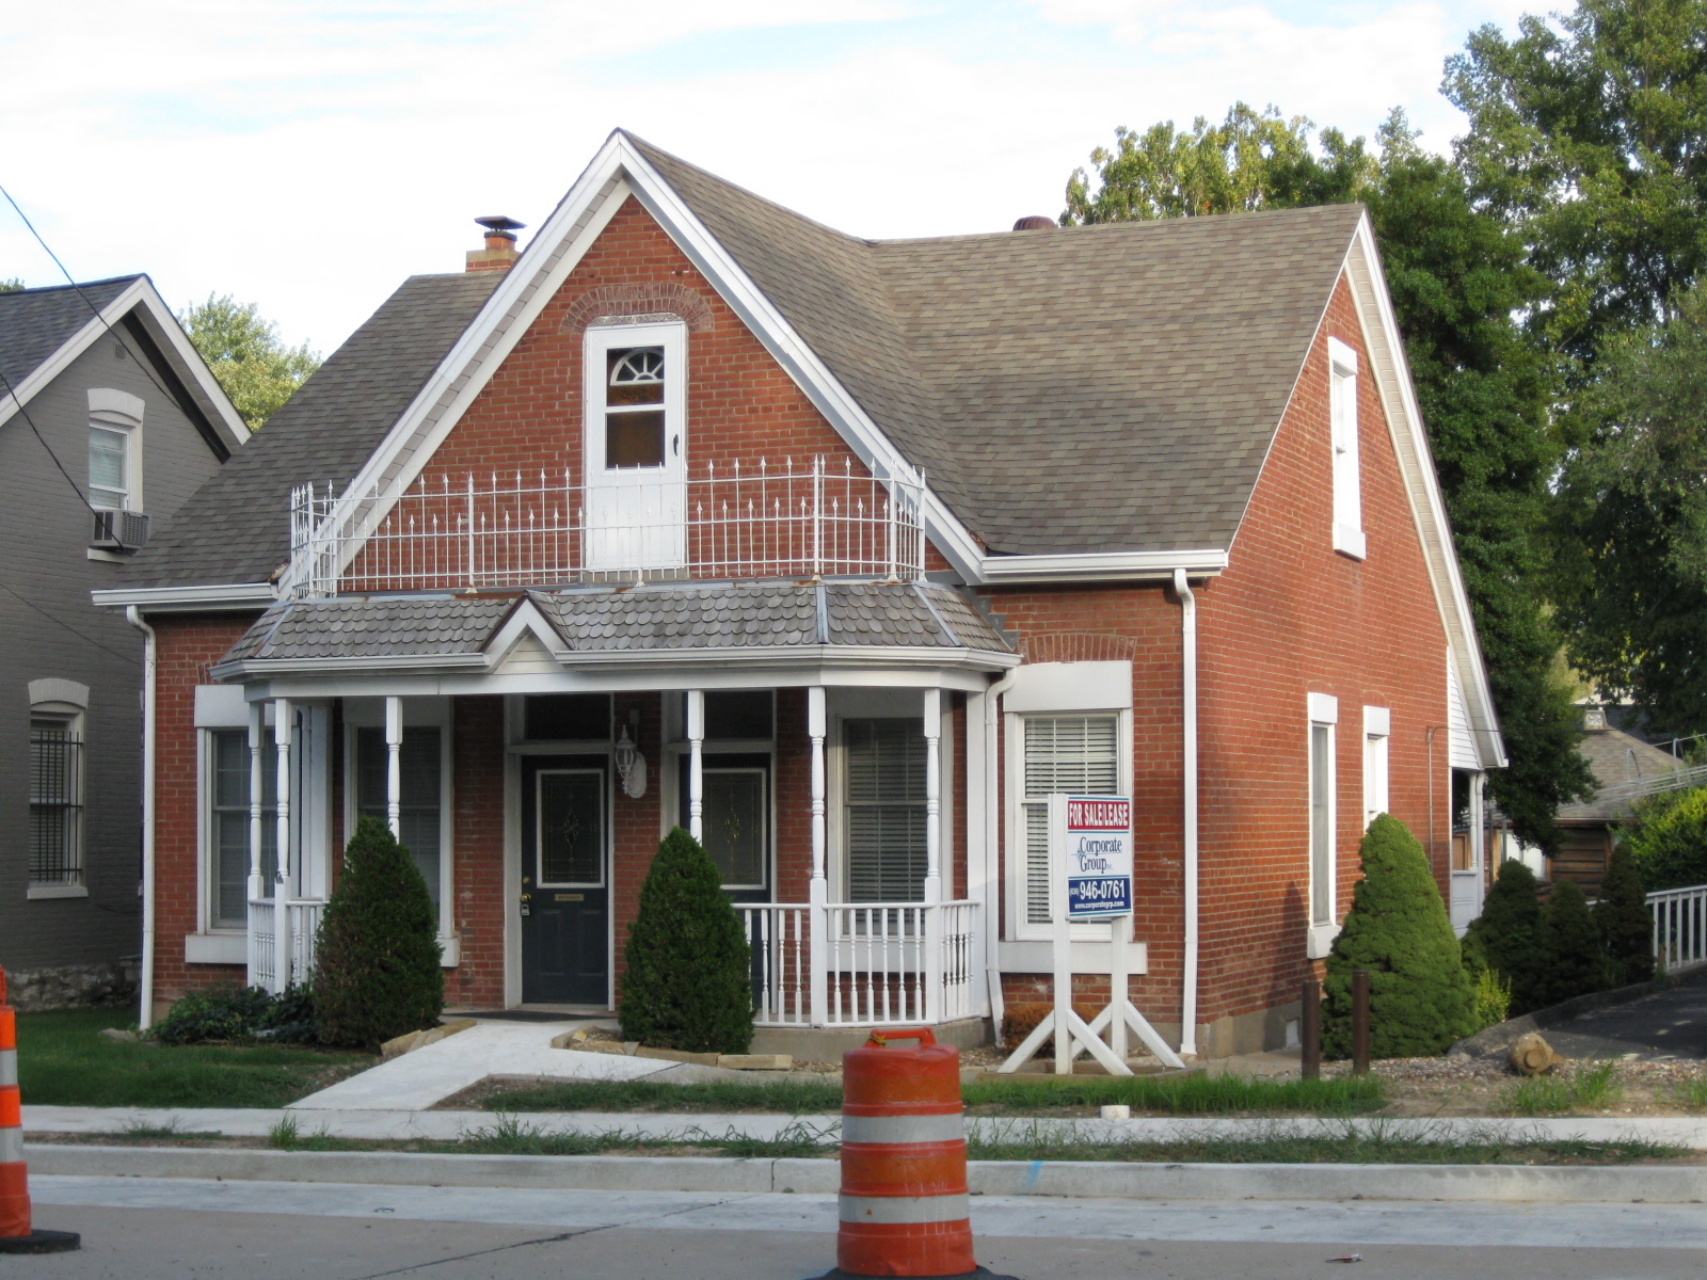
This 1.5 story, red brick, side gabled house has a large cross gable centered on the facade which incorporates a doorway that accesses the rooftop of the front porch. The porch spans four of the six bays on the facade and has a wood shingled mansard roof with a small cross gable over the central stairs. A 1970 photo in the St. Charles County Historical Society show that this porch had turned posts, spindlework spandrels (which are now missing), and a turned balustrade railing. The railing and porch floor have been replaced when the porch was reworked in 1996 and the railing height is too tall and the porch floor is now concrete. The center two bays are transomed doorways, but the doors are modern half-glazed doors with metal comes. The door on the second floor of the facade is also a replacement with a fanlight in the upper part of the door but it is obscured by the aluminum storm door. The windows on the first floor and in the gable ends on each side elevation are replacement 6/9 sashes with the upper portion of the window opening infilled to accommodate the shorter windows. Between 1917 and 1929, the one story rear addition had been completed (south portion as a framed shed roof room) although the north portion with its brick walls and gabled roof date from 1983-1900. The brick walls are a five-course common bond and the foundation is scored stucco. The soffits are clad in vinyl. The rear shed roofed dormer was added prior to 1996 and does not appear to be historic. The metal railing on the porch roof is not original and it is not known whether it replaced a similar feature or not since the 1970 photo does not cover this portion of the porch. Despite the alterations to the porch and windows, the house maintains its basic Folk Victorian details and as such is still contributing to the historic district.

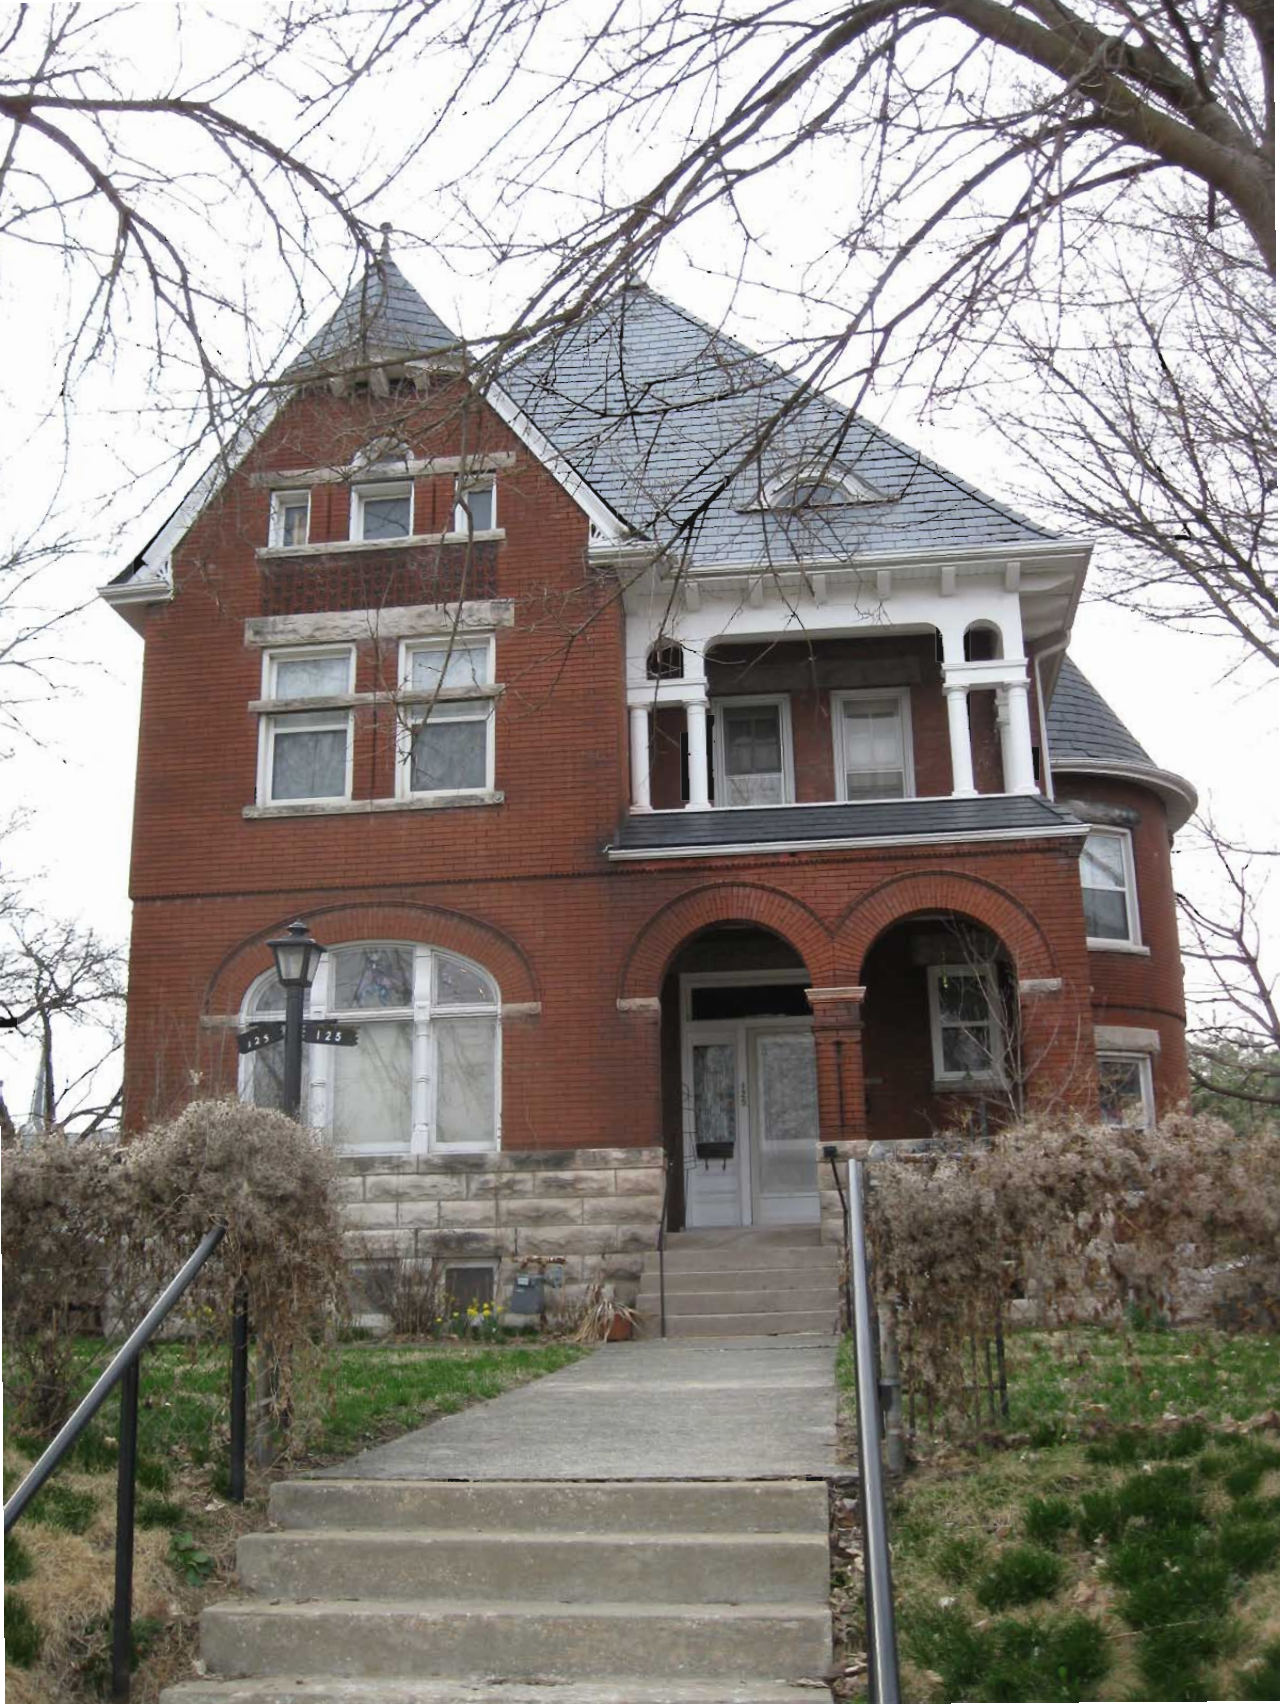
Between the first and second floor, there is a sawtooth terra cotta course that links the two bays across the facade. On the first floor of the south cross gabled bay is a baskethandle arched window (with similar detailing as the porch arched lintels) that contains a tripartite casement window with tripartite stained glass transom. There are turned mullions between the casements. On the second floor there are paired 1/1 sashed windows that not only have a stone sill and lintel but also a stone band that spans across the upper sash (in front of the actual window). Above the paired windows is a frieze of ornamental red terra cotta tiles laid in a checkerboard pattern. This extends to the stone sill of the attic level openings—three deeply recessed single light casement windows that are also connected by a massive stone lintel with a round arched transom with a brick lintel detail above the stone of the center window, which creates a stylized Palladian window. At the base of the gable end returns there is a small quarter sunburst pattern. There is a small roof overhang with modillions at the peak of this gable end with a finial above.

On the north side, behind the porch there are three round arched windows apparently leading up the stairwell inside with a round two story bay with a conical roof behind it. There is a hipped dormer facing north. On the south side of the house is a two story, canted bay with a cross gabled roof that has half timbered stucco in the gable end along with two 1/1 sashed windows. On the back of the house is a brick two story, hipped roof wing with three segmental arched 1/1 sashed windows on the first floor and two on the second floor, as well as a gabled roof enclosed entry that enters the basement level of this wing. A side porch on the south side has been enclosed (originally a 1 story open porch, but two stories by 1900 and enclosed between 1917 and 1929). After 1947, the first floor of the enclosed porch appears to have been extended slightly to the south to enlarge the room inside. The enclosed porch now has a shed roofed entry facing west. The brick is laid in a running bond pattern on the facade and 5-course common bond on the rear with the mortar tinted red. Except for the side porch, the house appears to have had few alterations and retains a high degree of integrity.

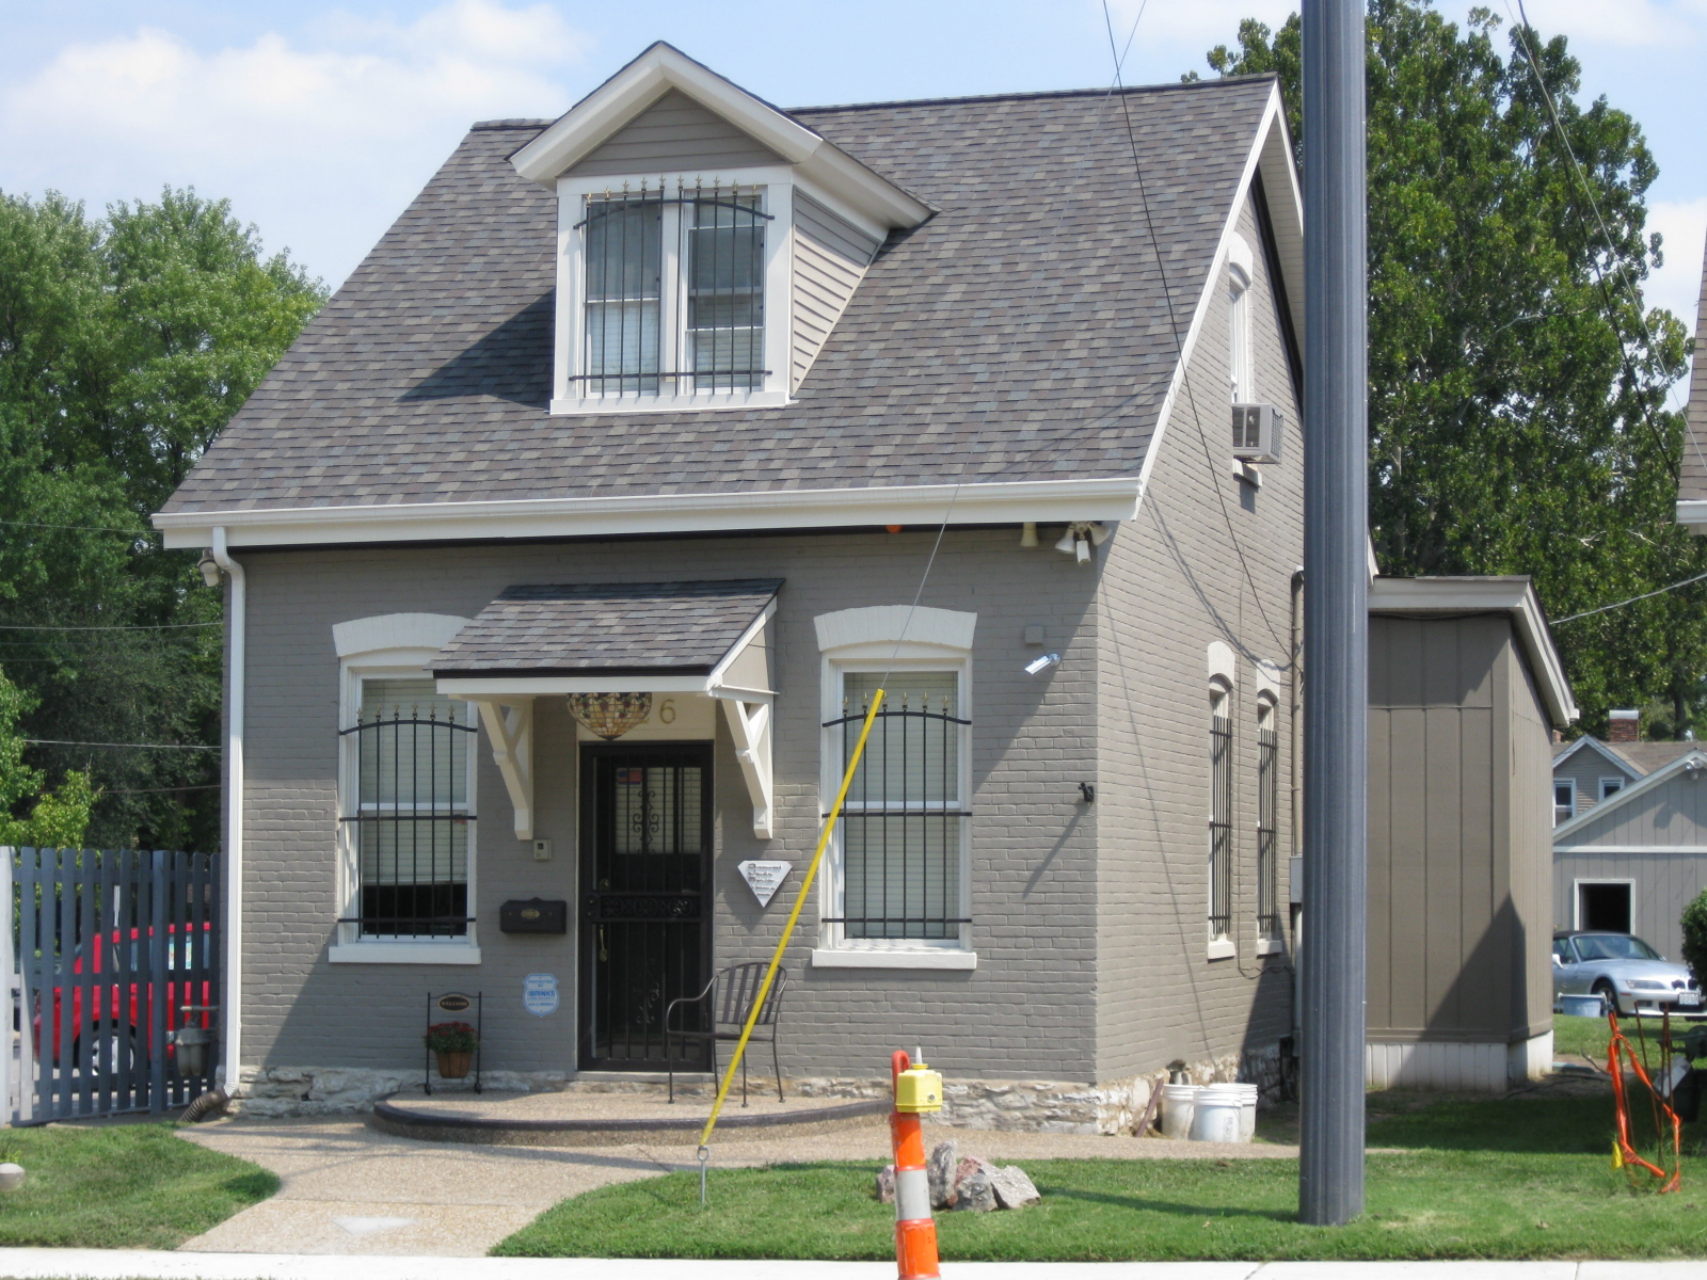
This 1.5 story, painted brick, side gabled house has a gabled dormer centered on the facade with two 1/1 wood sashed windows. The dormer is clad in lap siding. Centered on the three bay facade is a shed roof supported by large knee braces, a feature that was probably added between 1900 and 1909 when a small one bay porch is first shown on the fire insurance map. Below is a low half-round concrete stoop. The front door was probably added with the porch roof since both are Craftsman features, common to that era; the door has two tall vertical panels under a square light divided into three panes of glass. On either side of the entry bay there are segmental arched openings with 1/1 rectangular wood sashed windows. On the sides there are additional 1/1 wood sashed windows in segmental arched openings. On the rear there is another gabled dormer, but this one has only one 1/1 wood sashed window. In the back, the one story shed roofed addition on the south side was added between 1900 and 1909 and it is clad with vertical board siding, matching the garage. The shed roofed porch on the north portion of the rear elevation was enclosed after 1947 but appears to date back to at least 1893. The brick is laid in a 5-course common bond pattern. It appears that the house was "modernized" between 1900 and 1909, adding the rear addition and the Craftsman porch and front door. There are storm windows and storm doors that have been added. Bars have been added to most windows.
