ARCHITECTURAL/HISTORIC INVENTORY FORM

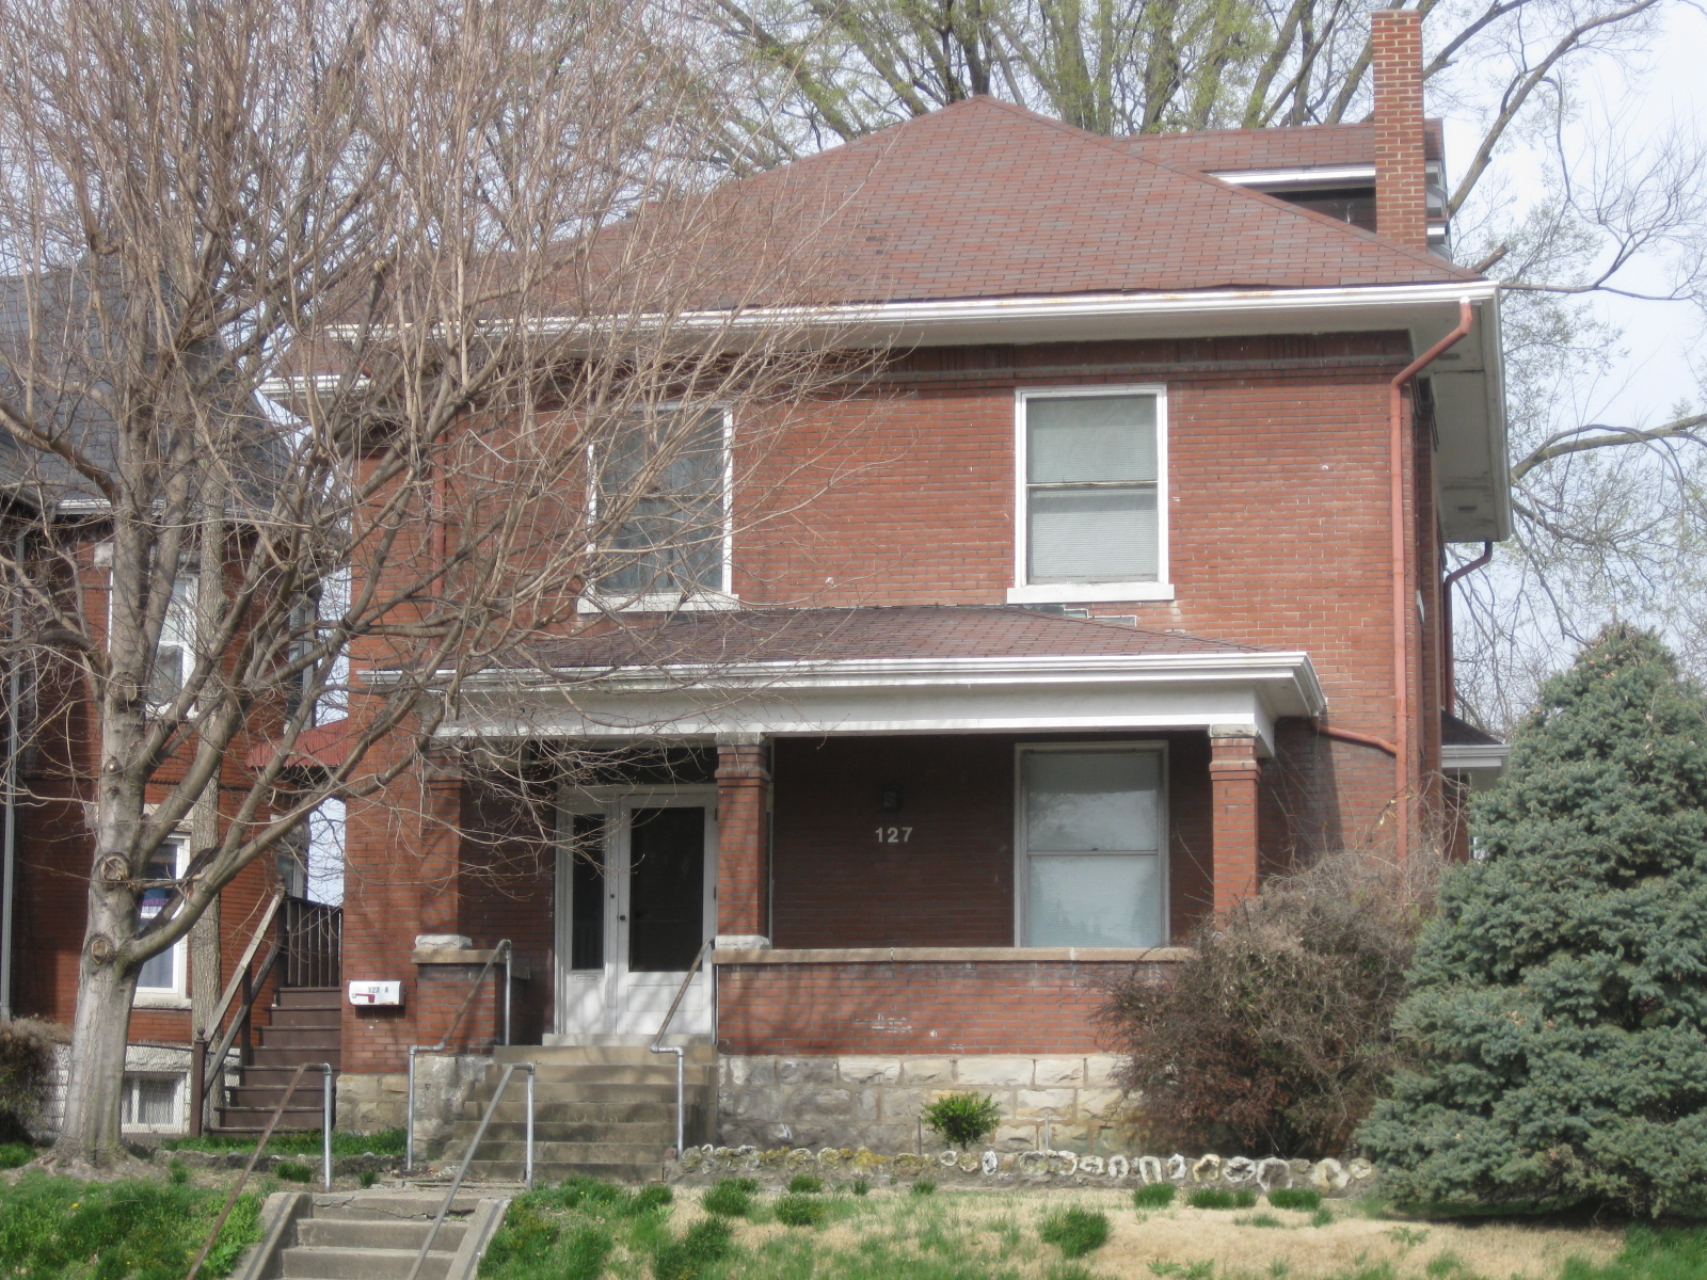
This 2.5 story brick house has a hipped roof with very broad eaves clad in wood. The house design looks like a Four Square from the street, but is a much deeper house. The horizontal detailing, is influenced by the Prairie School popular during the early twentieth century, especially the clean lines, wide eave overhangs of both the main roof and the full width hipped roof porch, and the additional horizontal lines created by the half-wall brick railing and its concrete cap. The porch has brick half columns with simple brick and stone caps; they are positioned at the corners of the porch and a third one frames the opening at the broad entry steps. The facade is divided into two bays with wide 1/1 wood sashed windows on the second floor as well as one on the first floor. These all have concrete sills. The glazed entry door is located in the south bay with single light sidelights and transom. On the north side, there are 1/1 wood sashed windows in paired dormers that create another horizontal line on the facade. In front of these dormers is an exterior wall, broad and flat brick chimney. The north side is divided into four bays with 1/1 sashes in each bay on both levels, except on the first floor the back two bays are spanned by a flattened, one story, brick, hipped roof, oriel window that has a triple 1/1 window unit. On the south side of the house, there is a two story gabled bay in the center two bays that has a round arched attic window deeply set in the pedimented gable end. There are windows in each bay on this facade, except that the bay has a side door and smaller window on the first floor. The aluminum awning over this door/window and the side stoop may be later alterations. The foundation forms a high watertable line of ashlar patterned limestone with beaded joints. The basement windows are 2-light windows. The two story rear porch was enclosed between 1917 and 1929, with lap siding walls on the first floor and banks of multipaned sashed windows on the second floor. The brick piers on this porch have been spanned with a poured concrete foundation. There is a basement level trap door on the rear of this porch. Storm windows and storm doors have been added but little else seems to have been altered.

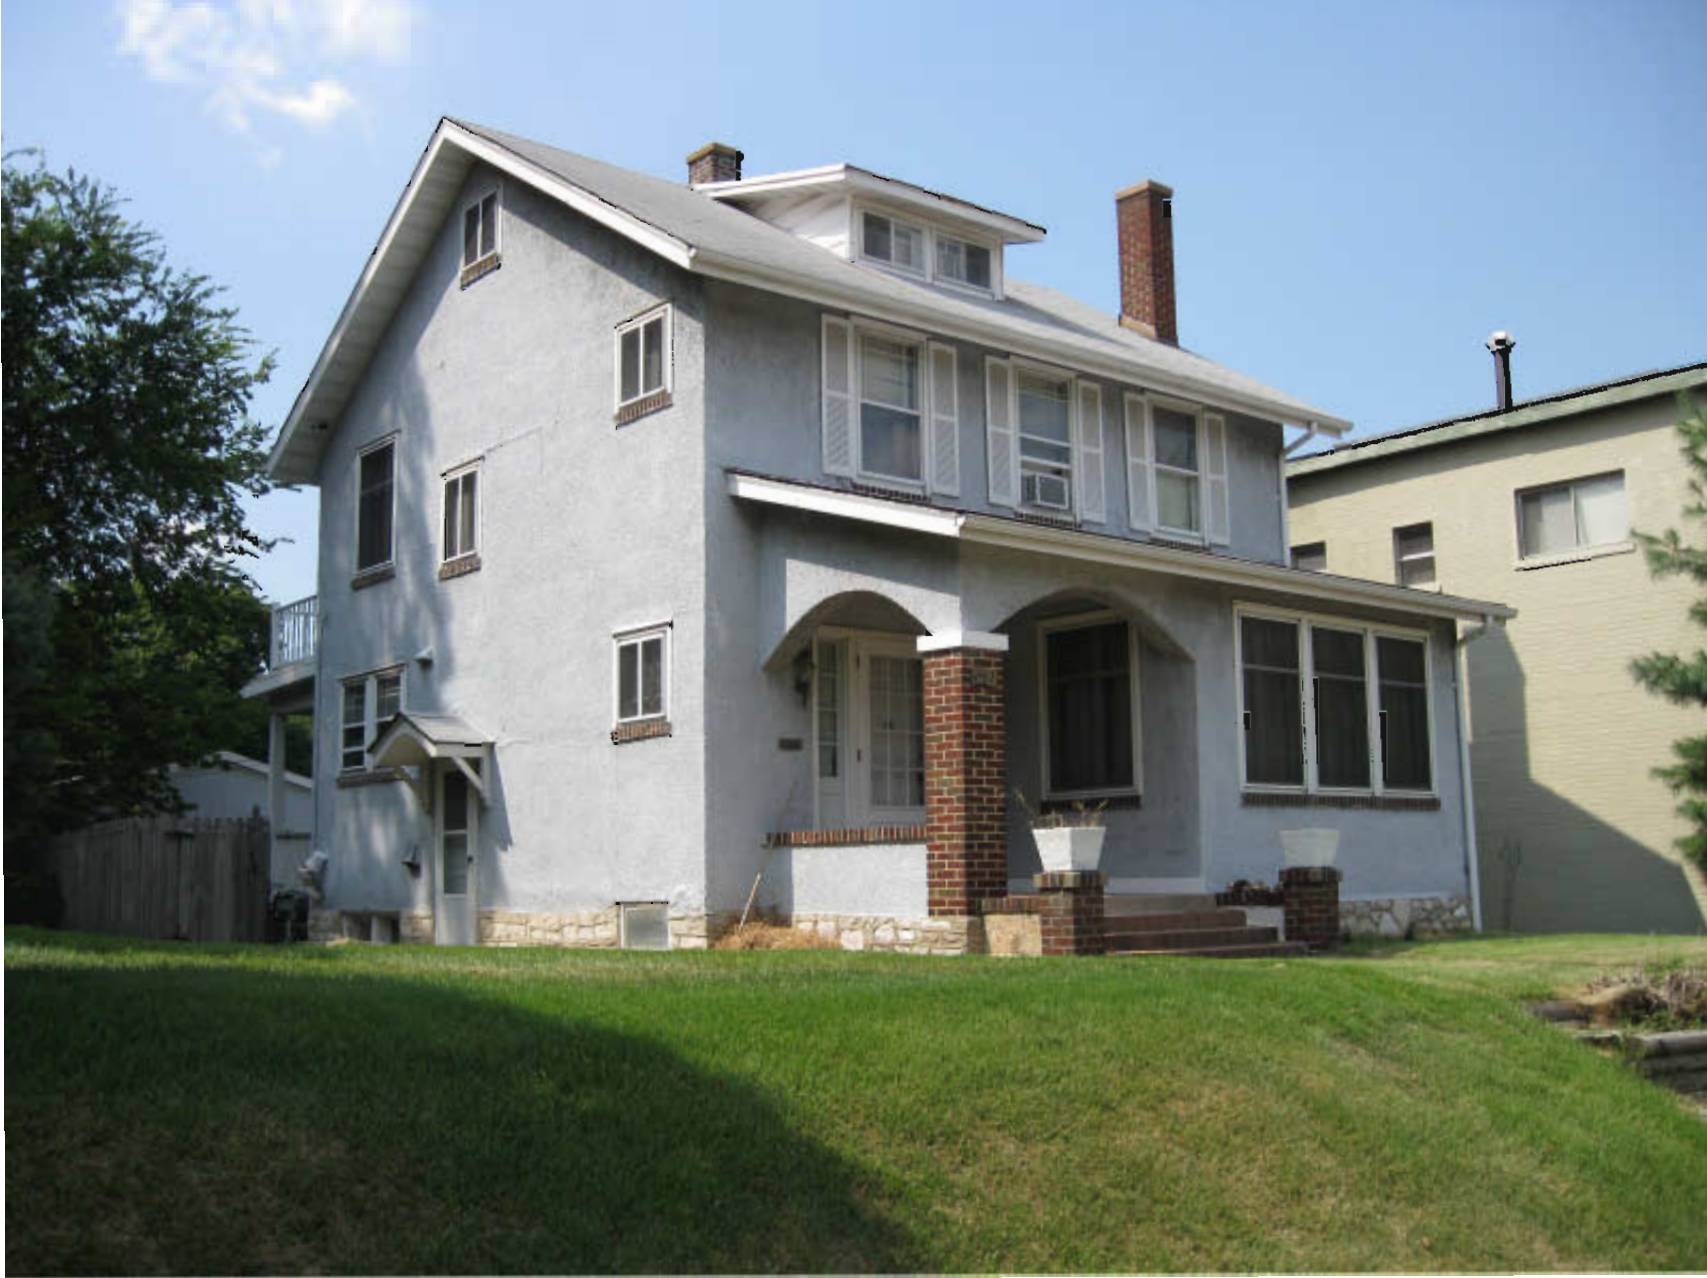
This 2.5 story, side gabled, stucco, Craftsman house has wide eaves (that probably had exposed rafters originally) both on the main roof and on the shed roofed porch and the broad, shed dormer centered on the facade. The paired dormer windows each have an awning window with a 3/1 muntin pattern (covered by paired sliding storms). The second floor of the facade has three windows, with muntins near each side and top of the upper sashes, a distinctly Craftsman window style. The full width, shed roofed porch is partially enclosed (originally) as a sunroom, with one window on each side and 3 windows spanning the facade of the sunroom, each having paired casements with three vertical lights across the top of two tall vertical lights. The south third of the porch is a corner porch with arched openings (one on each elevation) supported at the outer corner by a brick pier. There is a stucco half wall railing along the south side and the facade is spanned by concrete steps framed by stucco knee walls with brick piers. Brick forms the cap on the knee walls and half wall railing, as well as the window sills. The front door has a twelve light wooden storm door and four light sidelights, but the actual door seems to be a replacement 6-panel door and it is likely the original door was also similar to the storm door. There are windows scattered on each side elevation, often casement windows, a gabled roof supported by knee braces over the south side entry and a flattened bay with a shed roof on the north side. There is also a brick, end wall chimney on the north side. On the rear, there is a small one-story wing with a porch on the south side, both of which appear to be original to the building since they are shown on fire insurance maps. The soffits have been clad with vinyl and windows are covered with aluminum storms that do not match the muntin lines of the windows. The stucco is noted on the fire insurance maps, and appears to be original to the design. The shutters do not appear to be original and they detract from the Craftsman design.

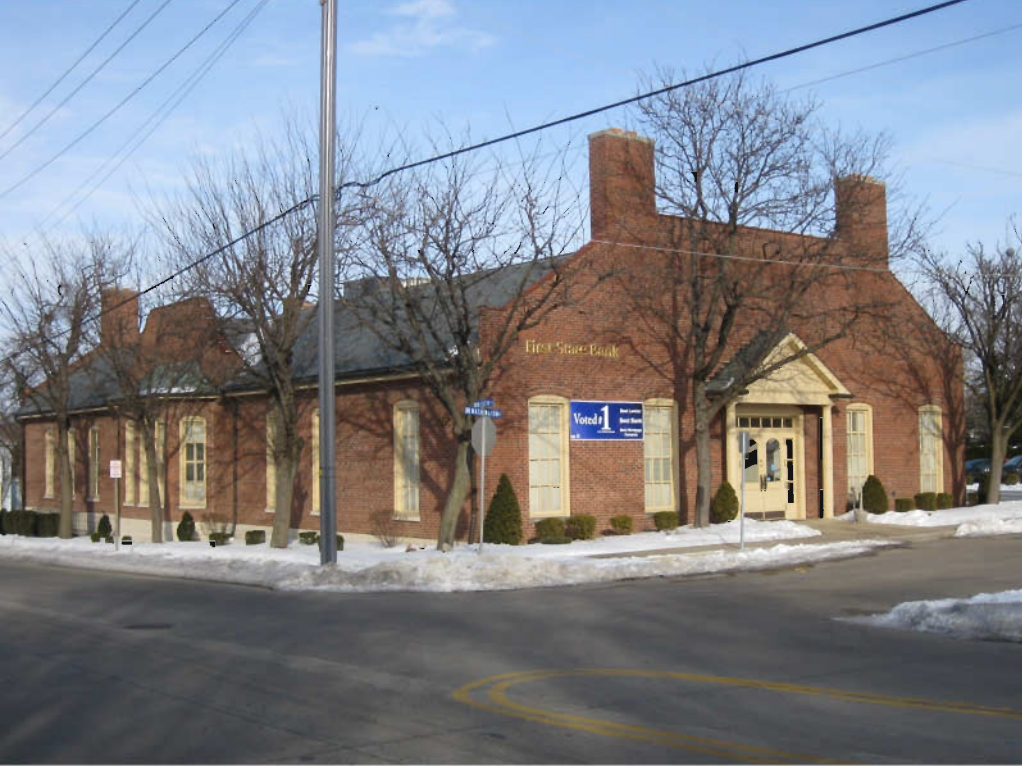
Built around 1965, this red brick commercial building has a gabled roof with gabled end parapets with dual chimneys on each end, one facing Washington and one facing north toward the parking lot. The windows are fixed, 12-light windows in segmental arched openings. The foundation is rock-faced ashlar limestone. There are three bays of windows on each side of the flattened three window bay that faces Fifth Street. Although the building is addressed on Fifth, the entrances face Washington on the south and the parking lot on the north side, and there is a drive-thru banking facility under a flat roofed canopy on the east side. The entry facing Washington has paired, half-round light wood doors with sidelights and a multipaned transom under a gabled roofed portico supported by Doric columns on each corner. This entry is centered with two bays of windows on either side. The elevation and entry facing the parking lot on the north side matches the Washington elevation, but due to elevation changes there is a waterfall staircase.

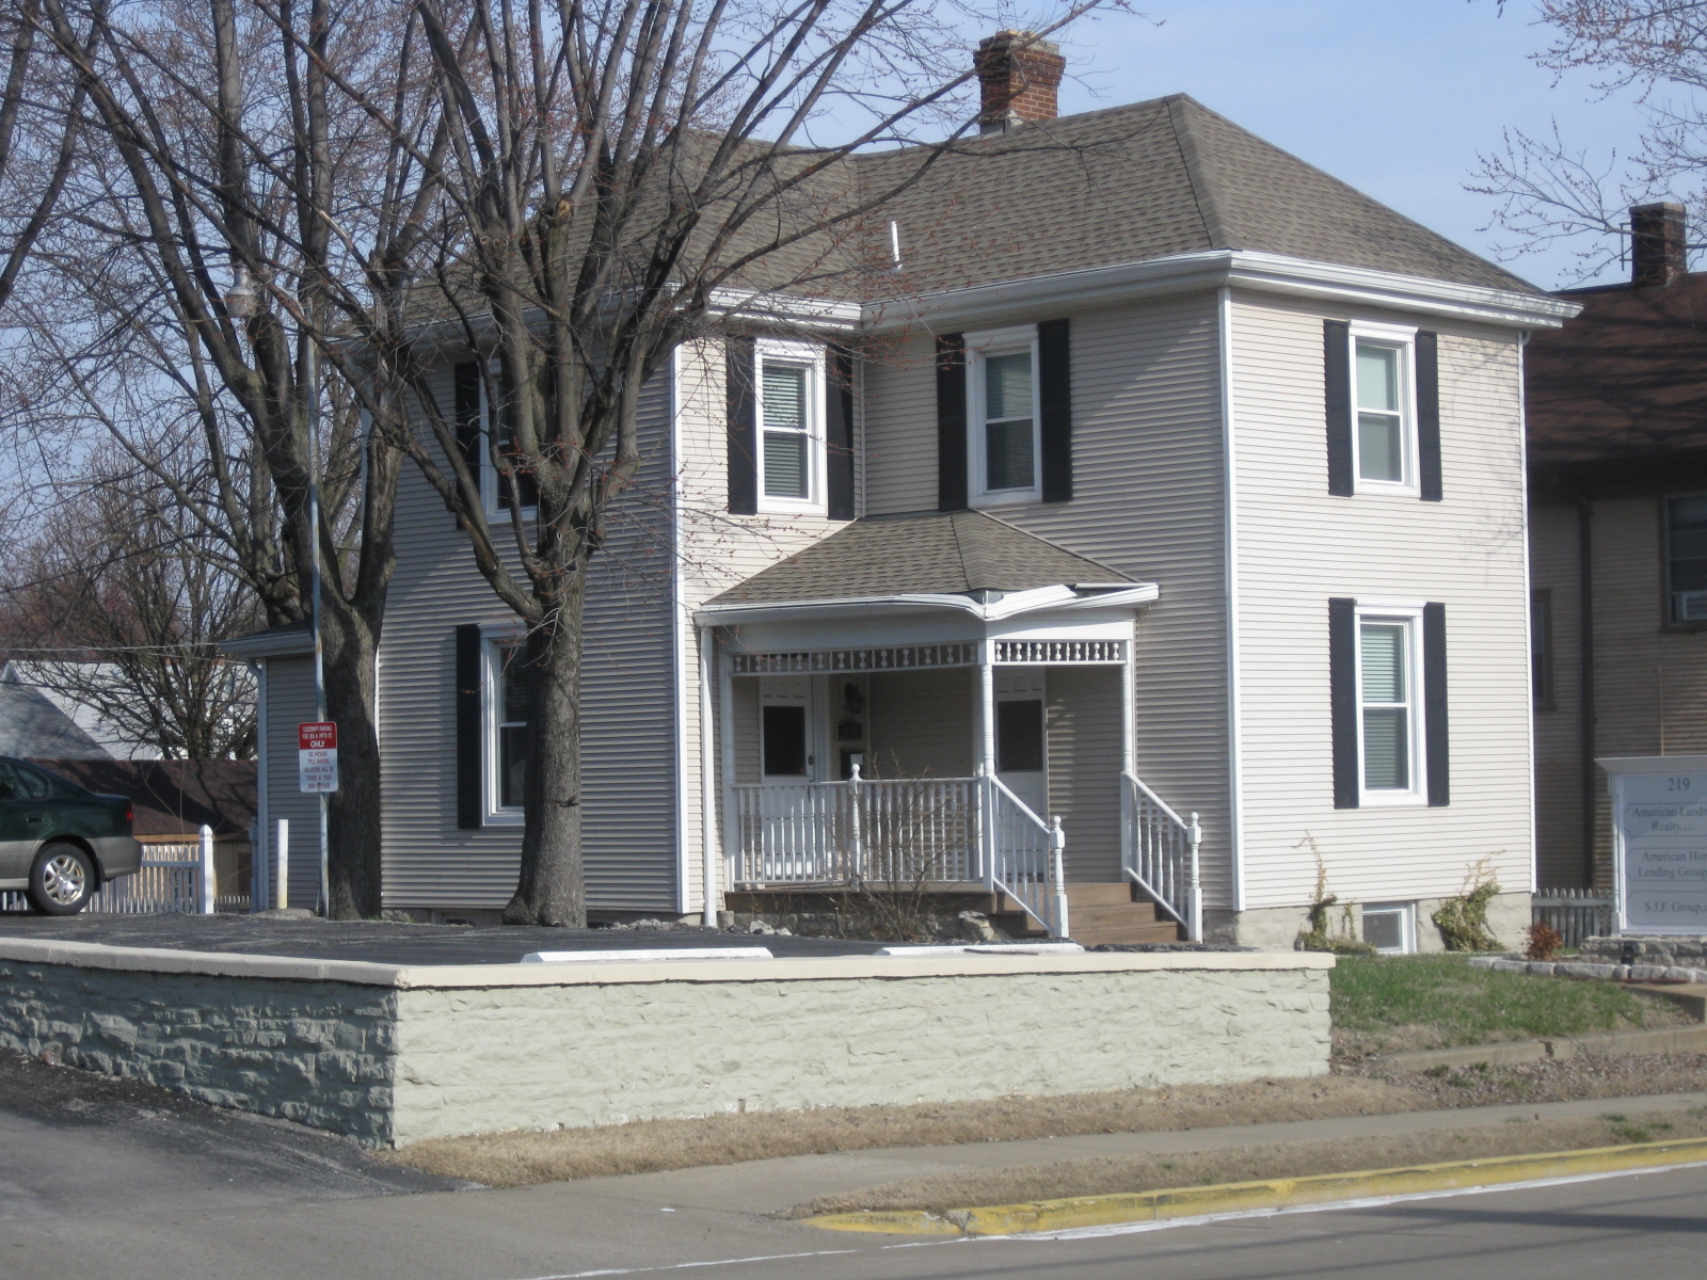
This T-shaped, two-story, hipped roof, Folk Victorian house has a small, one-story, hipped roof porch nestled into the interior corner on the southwest side of the shaft of the T. The end of the shaft faces the street and has one bay of windows and there are windows positioned above the porch on each elevation. In the porch there are two doors, one on each elevation. The doors are transomed with the original Victorian, half light, paneled wood door (3 small square panels above and below the light with a horizontal panel at the base of the door). The porch roof has spooled spandrels spanning between the turned porch posts at the corner and walls, which appear to be the original porch details, but the turned wood balustrade was replaced in 2006, replacing a nonhistoric wrought iron railing. On the back of the building there is an enclosed one story hipped roof wing that was originally an open porch, but between 1909 and 1917, the north half had been enclosed and the south half was enclosed at some point after 1947. The house retains its interior brick chimney with its corbelled cap and the limestone foundation with its beaded joints. Windows are the original 1/1 wood sashed windows. It also retains the original wood, two-light basement windows. The house has been resided in vinyl siding and has nonhistoric shutters, but it appears that the house still retains its historic appearance.

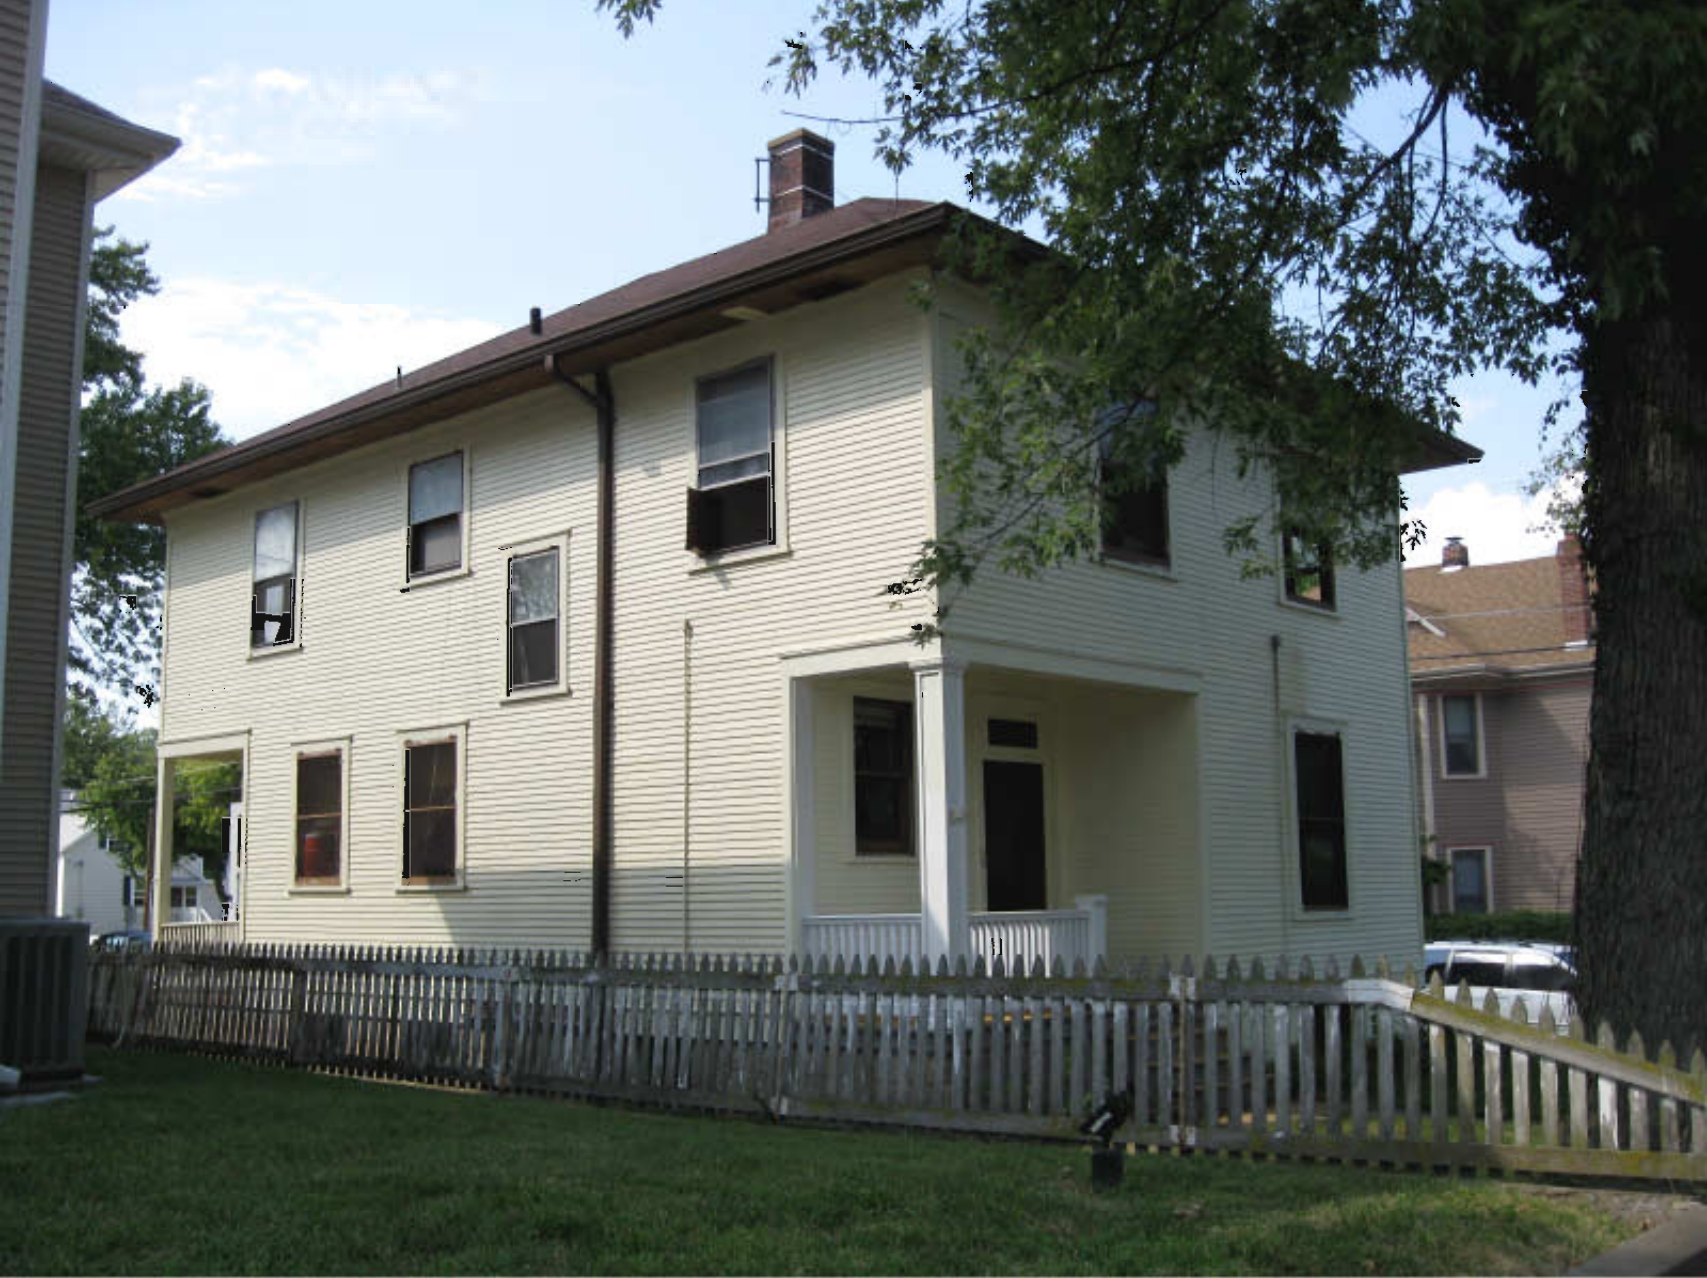
This two story, hipped roof, frame house has wide, enclosed eaves. The house retains its original clapboard siding and crowned trim around the 1/1 wood sashed windows. The facade is divided into two bays with 1/1 windows on both levels of the north bay and one on the second floor of the south bay above the recessed corner porch. The porch features a square, paneled, corner column and the original simple wood balustrade railing that extends from the corner along the south side of the porch opening and across the facade to a square, capped newel post. There is a 1/1 sashed window to the south side of a transomed, half light, two horizontal panel wood entry door. The wood porch floor has a concrete block foundation and wood porch steps. The north street elevation is divided into three bays with windows on each level of the front two bays and a canted, hipped roof bay window in the west bay that has a sashed window on each of the three sides of the bay. On the rear of the house there is a shed roof supported by curved braces over the back door and at the southwest corner of the house is another recessed first floor porch, but this one has a simple square post at the corner and railing along the south side with a second rear entry door. There is a brick interior chimney. Basement windows are 2-light awning windows. The house has wooden storm windows and interchangeable screens. The house appears to have no alterations.

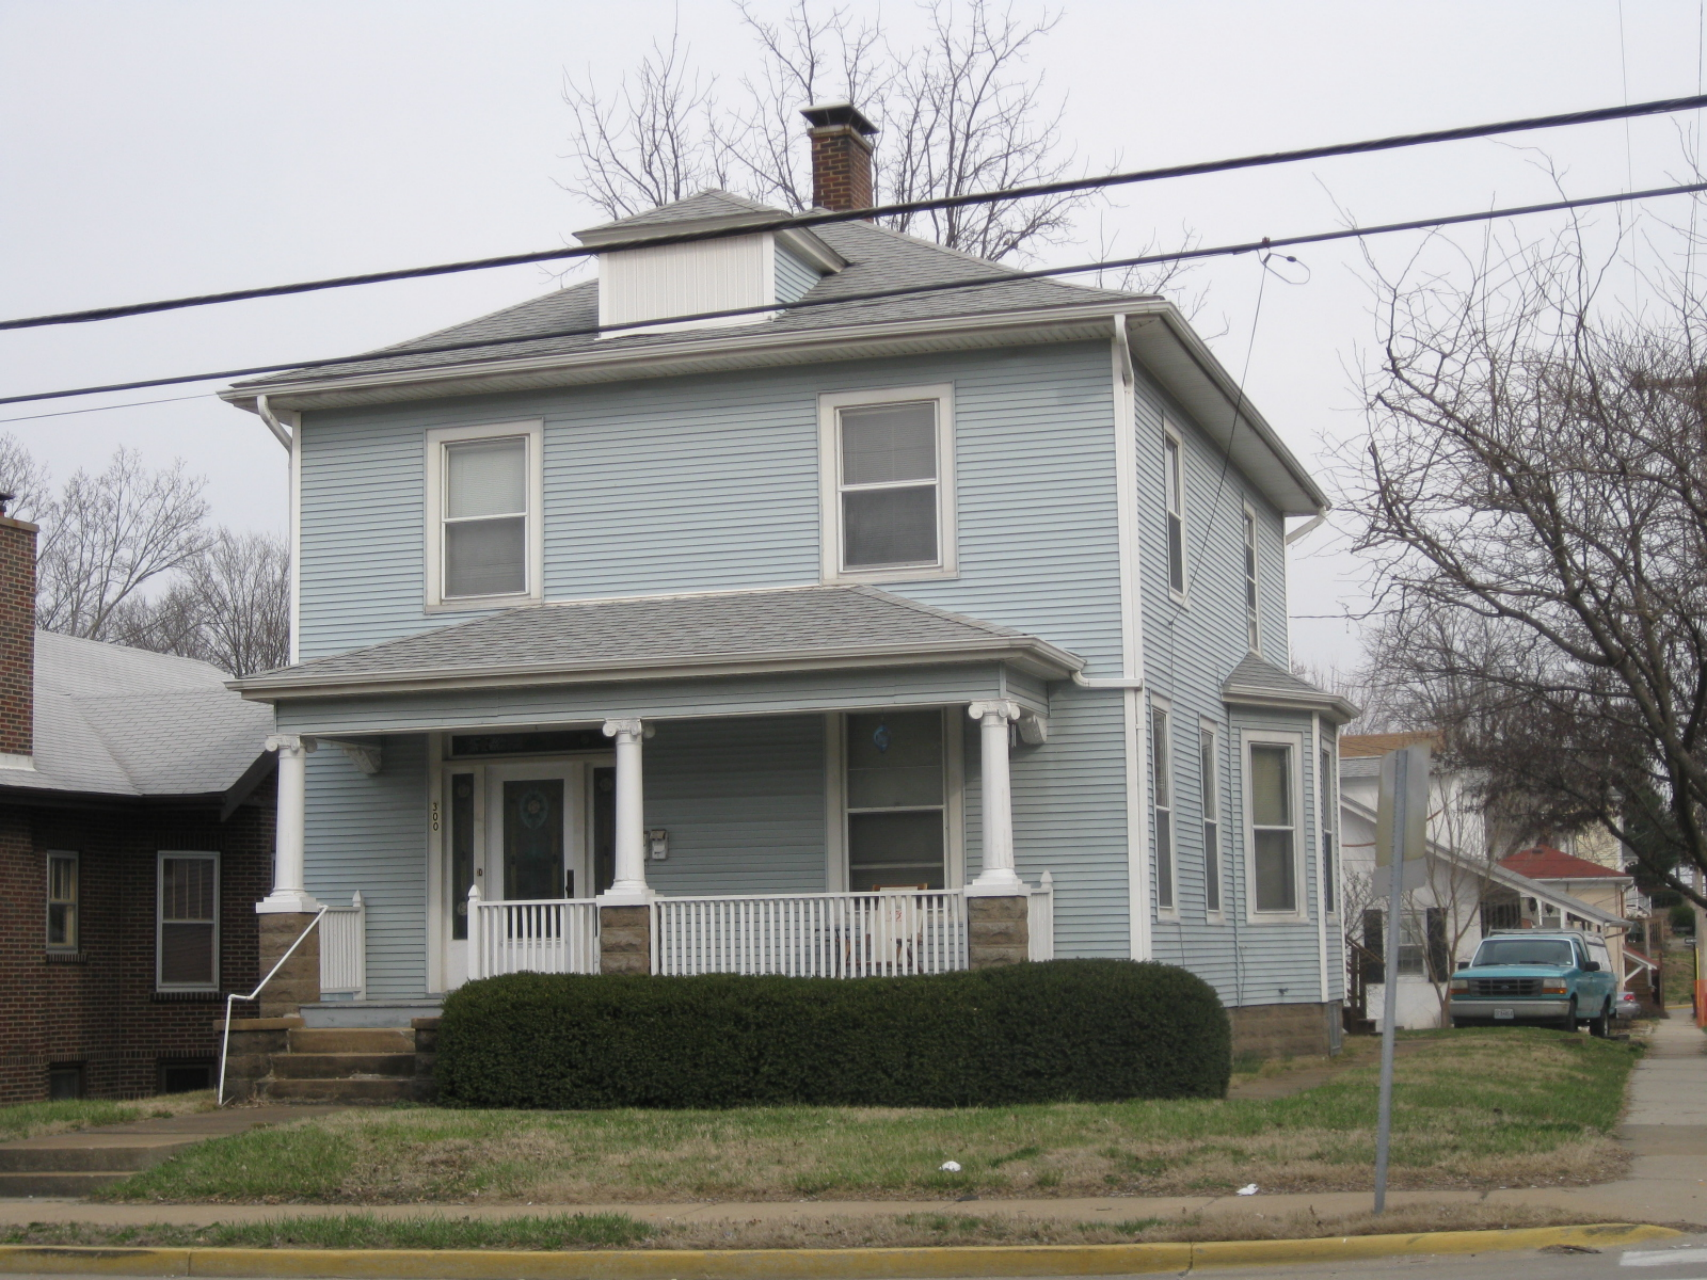
This two-story, hipped roof, frame house has a bellcast hipped dormer on the facade and a full width hipped roof porch supported by Ionic style, half-columns resting on faux stone plinths that extend to the ground. The foundation of the porch and the knee walls on either side of the concrete steps entering the north bay of the porch are also this same faux stone, which matches the foundation blocks. The porch floor is wood and it has simple flat baluster railings between the plinth blocks. The facade is divided into two bays with 1/1 wood sashed windows in each bay except for the north entry bay which has a sidelighted and transomed, 3/4 light entry door, all with decorative stained glass. Although the front of the house appears to be Four Square design, the side elevations clearly indicate that the house is not laid out like Four Square houses, since the sides are deeper than the facade and windows are not symmetrically positioned. There is a one story, hipped roof, canted bay on the south side elevation and on the rear is a hipped roof, full width porch that has been enclosed, portions of it enclosed between 1917-1929 and the other half enclosed by 1947. The house is now covered with vinyl replacement siding, and metal storm windows have been added to some windows as well, but the basic appearance of the house is not seriously altered since the siding was positioned around the window trim. The facade of the dormer has been boarded over. On the rear, there is a large structure incorporating steps over the rear, enclosed porch that creates a second floor deck but it is not clear when this was added since it was not documented in the Community Development files, although it appears to date from c. 1995. Despite these alterations, the house is still a contributing building in the historic district, in part because the prominent stylistic features, the porch columns and railings, as well as the stained glass entry and basic building elements are still in place.

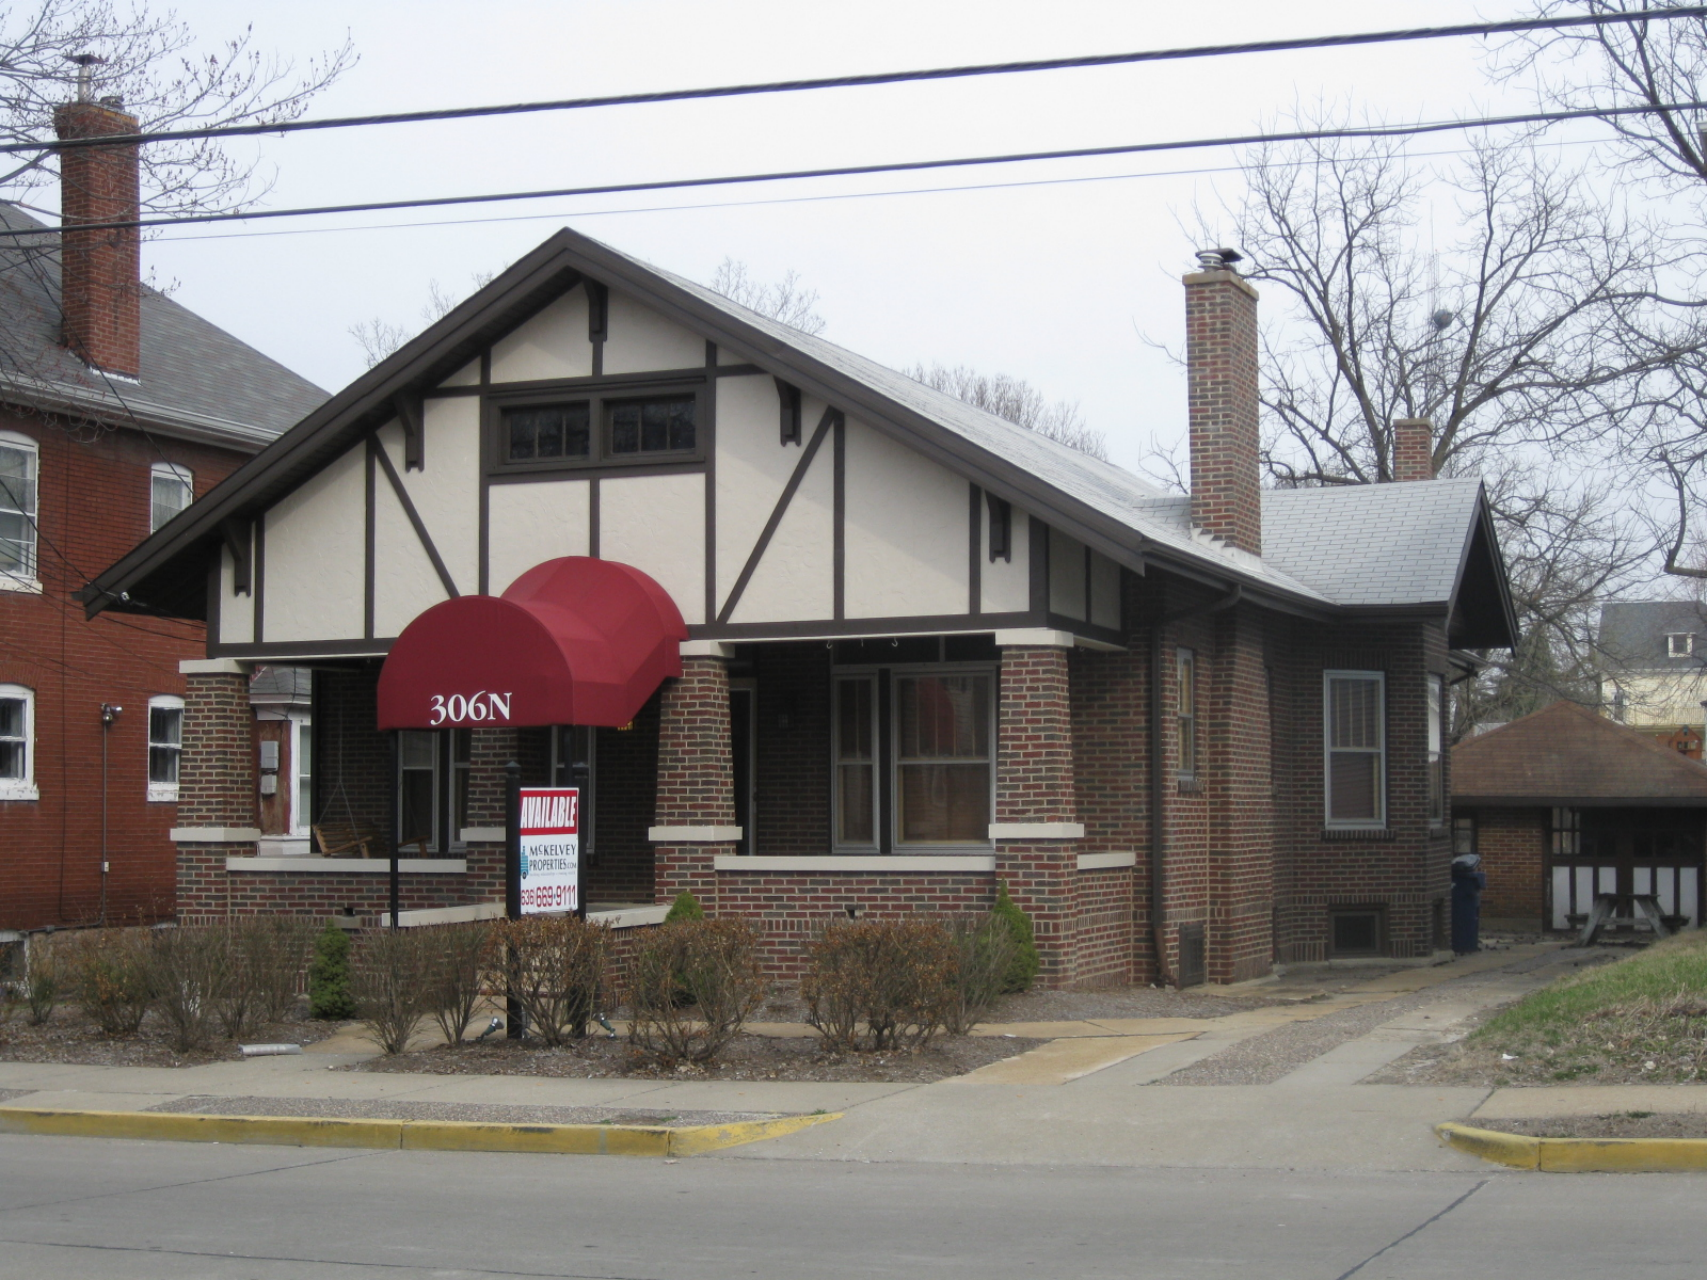
This one story, brown brick, end gabled Craftsman bungalow has a porch that is incorporated under the main eaves of the house, spanning the entire facade. It is supported by battered brick half columns that rest on brick plinths that extend to the ground with brick half wall railings between the four columns. The plinths, railings, and columns are all capped by simple poured concrete caps. There are brick knee walls on either side of the concrete steps leading into the porch and the two interior columns are positioned closer together flanking the central stairs and doorway. The stairs are protected by an arched canvas awning supported by metal posts, and the street address, "306N," is applied to the front of the awning. The gable end above features a series of knee braces supporting the wide eaves and the walls are clad with false half timber stucco. Centered in the gable end are two attic windows, each with three vertical lights. The front door is centered on the three bay facade and it is a leaded glass, wood door with a leaded glass transom. To each side there is a tripartite window consisting of a 5/1 wood sashed window flanked by narrow 2/1 wood sashed windows, all spanned by a leaded glass transom with an interesting geometric pattern. On the south elevation, there are short 3/1 sashed windows flanking the battered exterior wall brick chimney that pierces through the wide eaves with exposed rafters. Behind is a gabled roof, canted bay with 4/1 wood sashed windows. On the rear, is a shed roofed sunroom which spans most of that elevation. Above are two 3-light attic windows and there are knee braces supporting the gable end. Above the brick half wall railing and continuous concrete sill cap are a series of slender, 3/2 casement windows. On the south side of the porch is a Craftsman style door with 6 lights over two tall vertical panels. Other than the use of aluminum storm windows, the house appears to have no alterations, except for the addition of a rounded canvas awning that extends over the sidewalk.

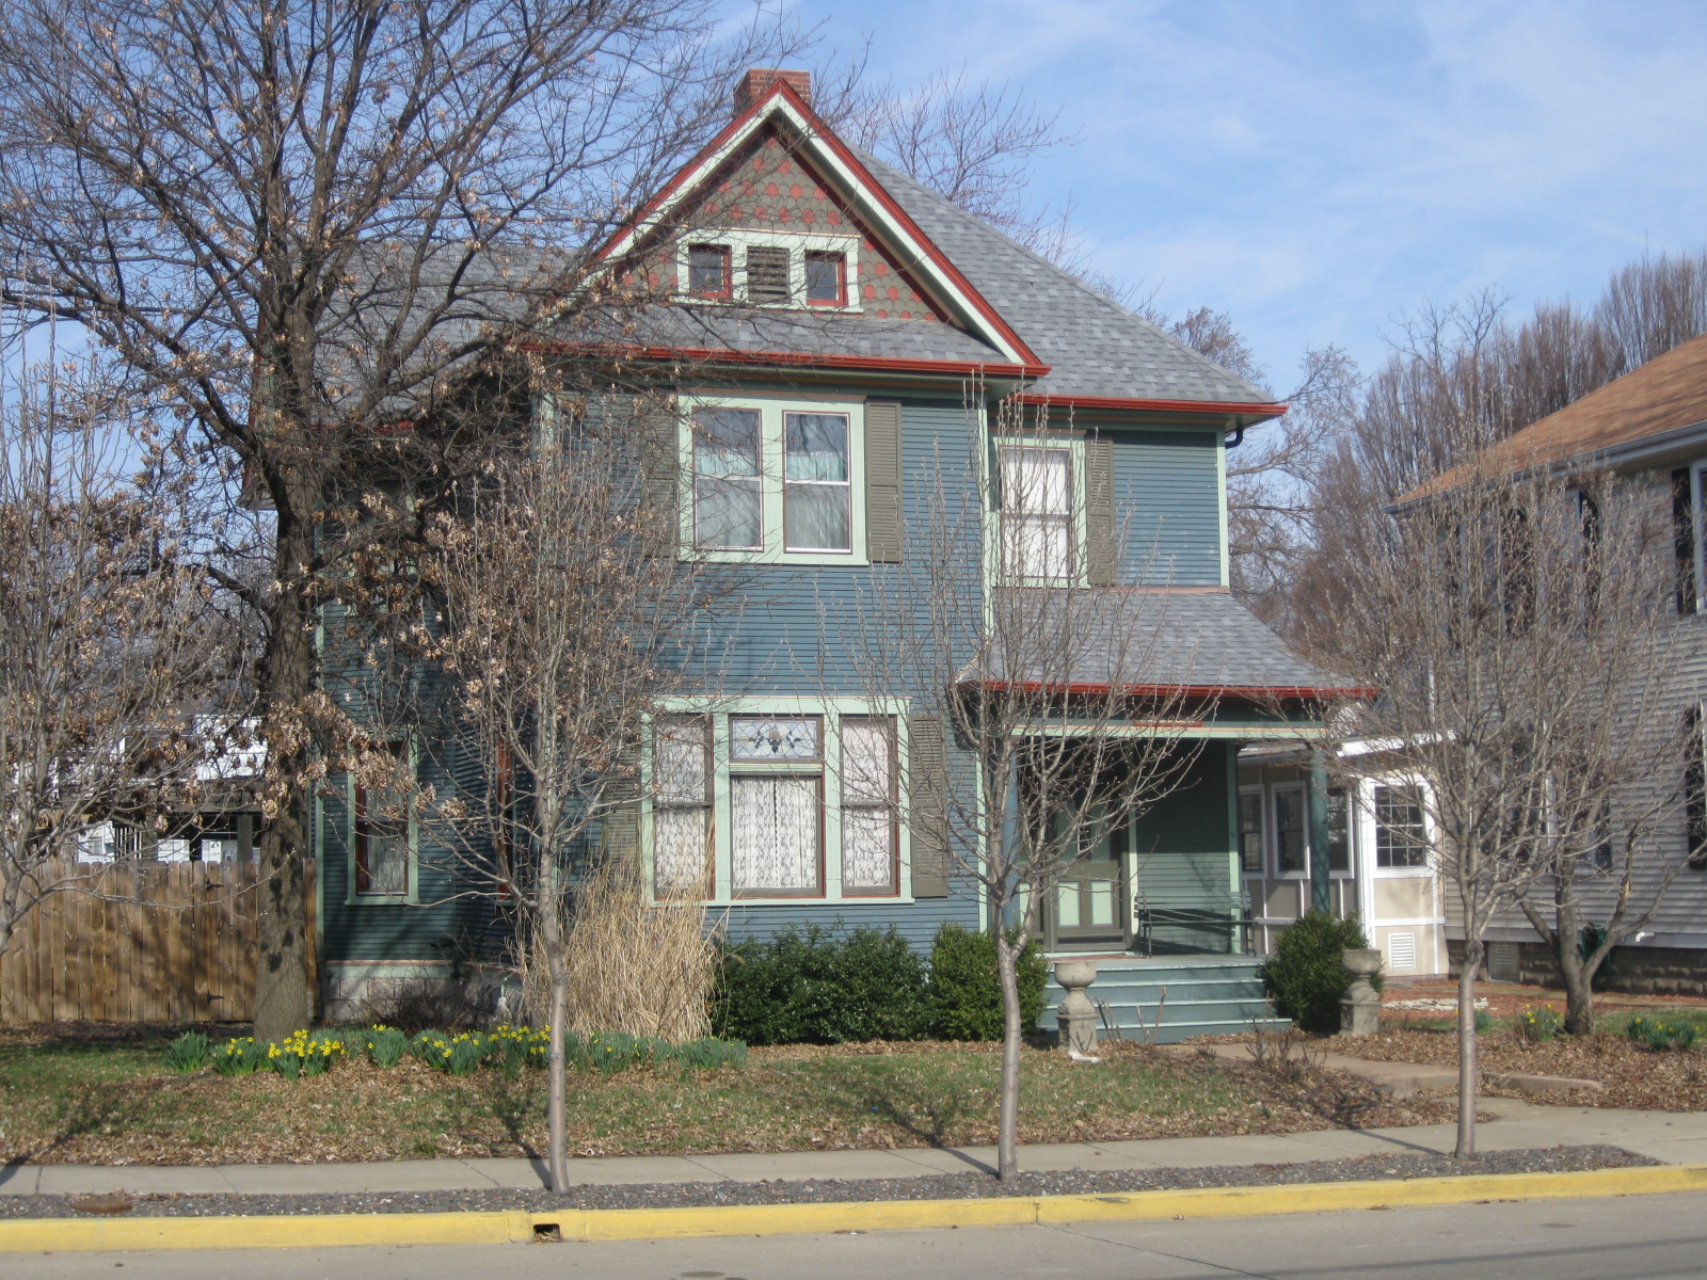
This Queen Anne house has the characteristic hipped roof with cross gables with a brick interior chimney at the peak of the hip. The eaves retain the original bead board and the walls are weatherboard siding with cornerboards. The front gabled wing spans the south half of the facade and the gable end is clad in shaped shingles with single light tripartite window in the gable end. Below are paired, 1/1 wood sashed windows. On the first floor there is a tripartite window with narrow, 1/1 wood sashed windows flanking a large single light window with a stained glass transom. In the north bay, there is a single 1/1 sashed window on the upper level above the shed-on-hipped roof porch that spans the north bay, which is recessed so that the porch facade is nearly flush with the south gabled wing. The porch foundation piers are limestone, matching the house foundation. There are Doric columns at each front corner of the porch resting on the wood porch floor, with broad wood steps leading up to the paired entry doors. There is latticework between the stone piers. The paired doors are six panel style doors, but the two small panels at the top are glass. Above the paired doors is a leaded glass transom with colored glass squares. On the south elevation is a cross gabled, canted bay two story wing. There is a hipped roof dormer above a slight wall projection that spans the two center bays of the north elevation. Originally the first floor of the area behind the canted bay was an open porch but between 1917 and 1929 this was enclosed and a gabled roof wing was added across the rear. The second floor has a series of replacement single light windows in what was probably originally an enclosed sleeping porch and above, in the gable end is a broad, triangular window, a modern alteration. The second floor overhangs slightly and at some point after 1947 a one story porch was added to the south and west of the rear elevation. The second floor deck on the rear appears to be a later addition. The front porch is probably missing an original railing and most windows have storm windows added, but otherwise the facade appears to have few alterations.

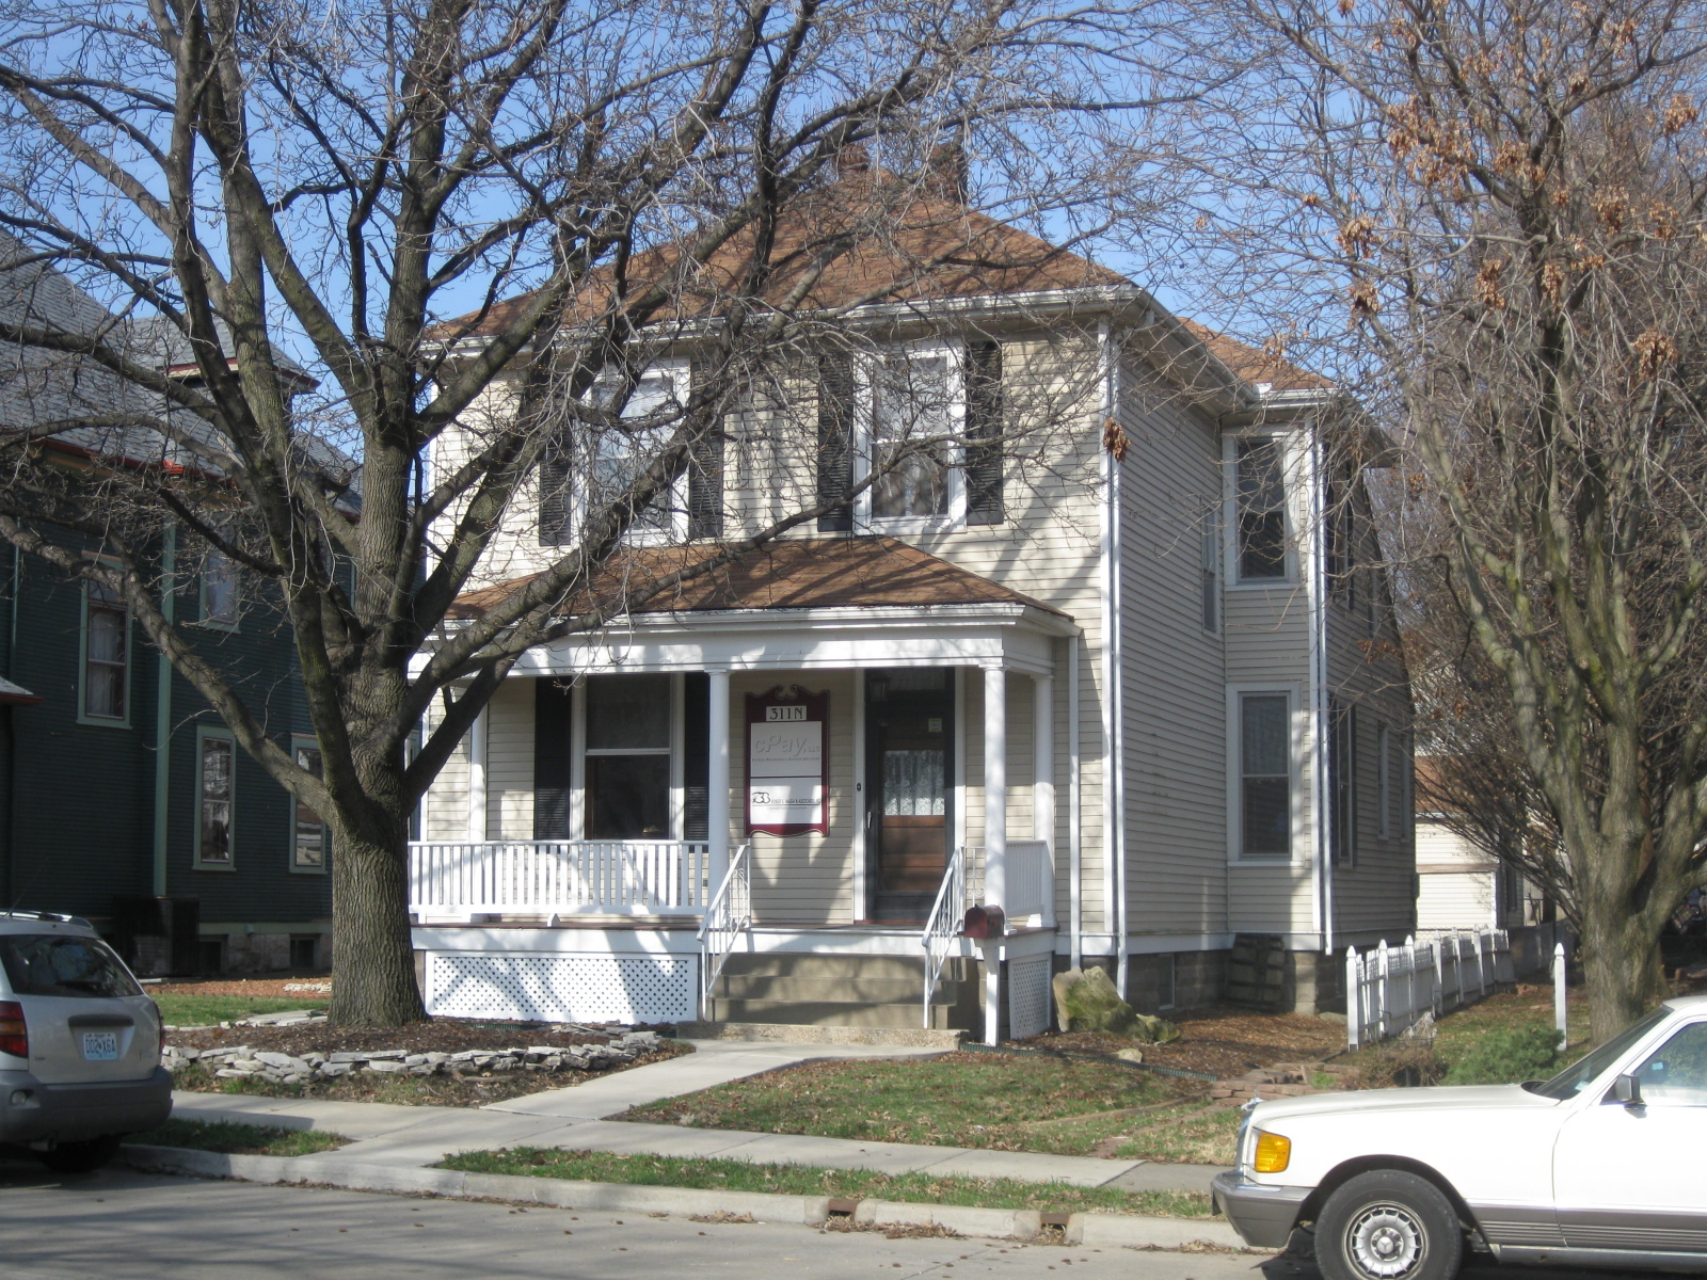
This simple Colonial Revival design is a two-story, frame, hipped roof with boxed soffits house that is slightly L-shaped because the back wing is off-set toward the north. The house has a full width, hipped roof porch supported by Doric columns positioned to mirror the two bay facade design. The windows appear to be the historic 1/1 wood sashed windows, but the shutters and vinyl siding are recent replacements. The foundation is a faux stone concrete block and the basement windows are 2-light awning windows. The Colonial Revival detailing is limited to the Doric columns and simple entablature on the porch. The wood floor of the front porch rests on faux stone piers and there are broad steps spanning the north bay in line with the entry door which is a wood paneled, half light door with a single light transom. Between the piers is latticework. The porch railing appears to be a replacement with wider slat balusters and the metal railings on the steps are recent additions. There is a one-story wing that spans the rear elevation and it was sometimes identified as a 1.5 story wing on the fire insurance maps since the roof sheds down from the main hip roof. The porch on the southwest rear corner was apparently built between 1917 and 1929, based upon the fire insurance maps, but in recent years, it has been extended slightly toward the south side and enclosed with vinyl 6/6 windows and wood panels with overlaid strips in a grid pattern. The soffits have been covered with vinyl as well and storm windows have been added. Despite the alterations, the house retains its principal historic features, the Colonial Revival porch and the basic house plan and as such is still contributing to the historic district. Despite the fact that the 1929 and 1947 fire insurance maps do not show a front porch, this is probably an error since the porch is clearly shown on earlier maps and appears to be historic in design and materials.
